Manhattan Beach Dune Restoration Project

Restoration and Monitoring Plan

July 2021

Karina Johnston, Chris Enyart, Maggie Jenkins, Sara Cuadra, and Dane Lazarus
The Bay Foundation

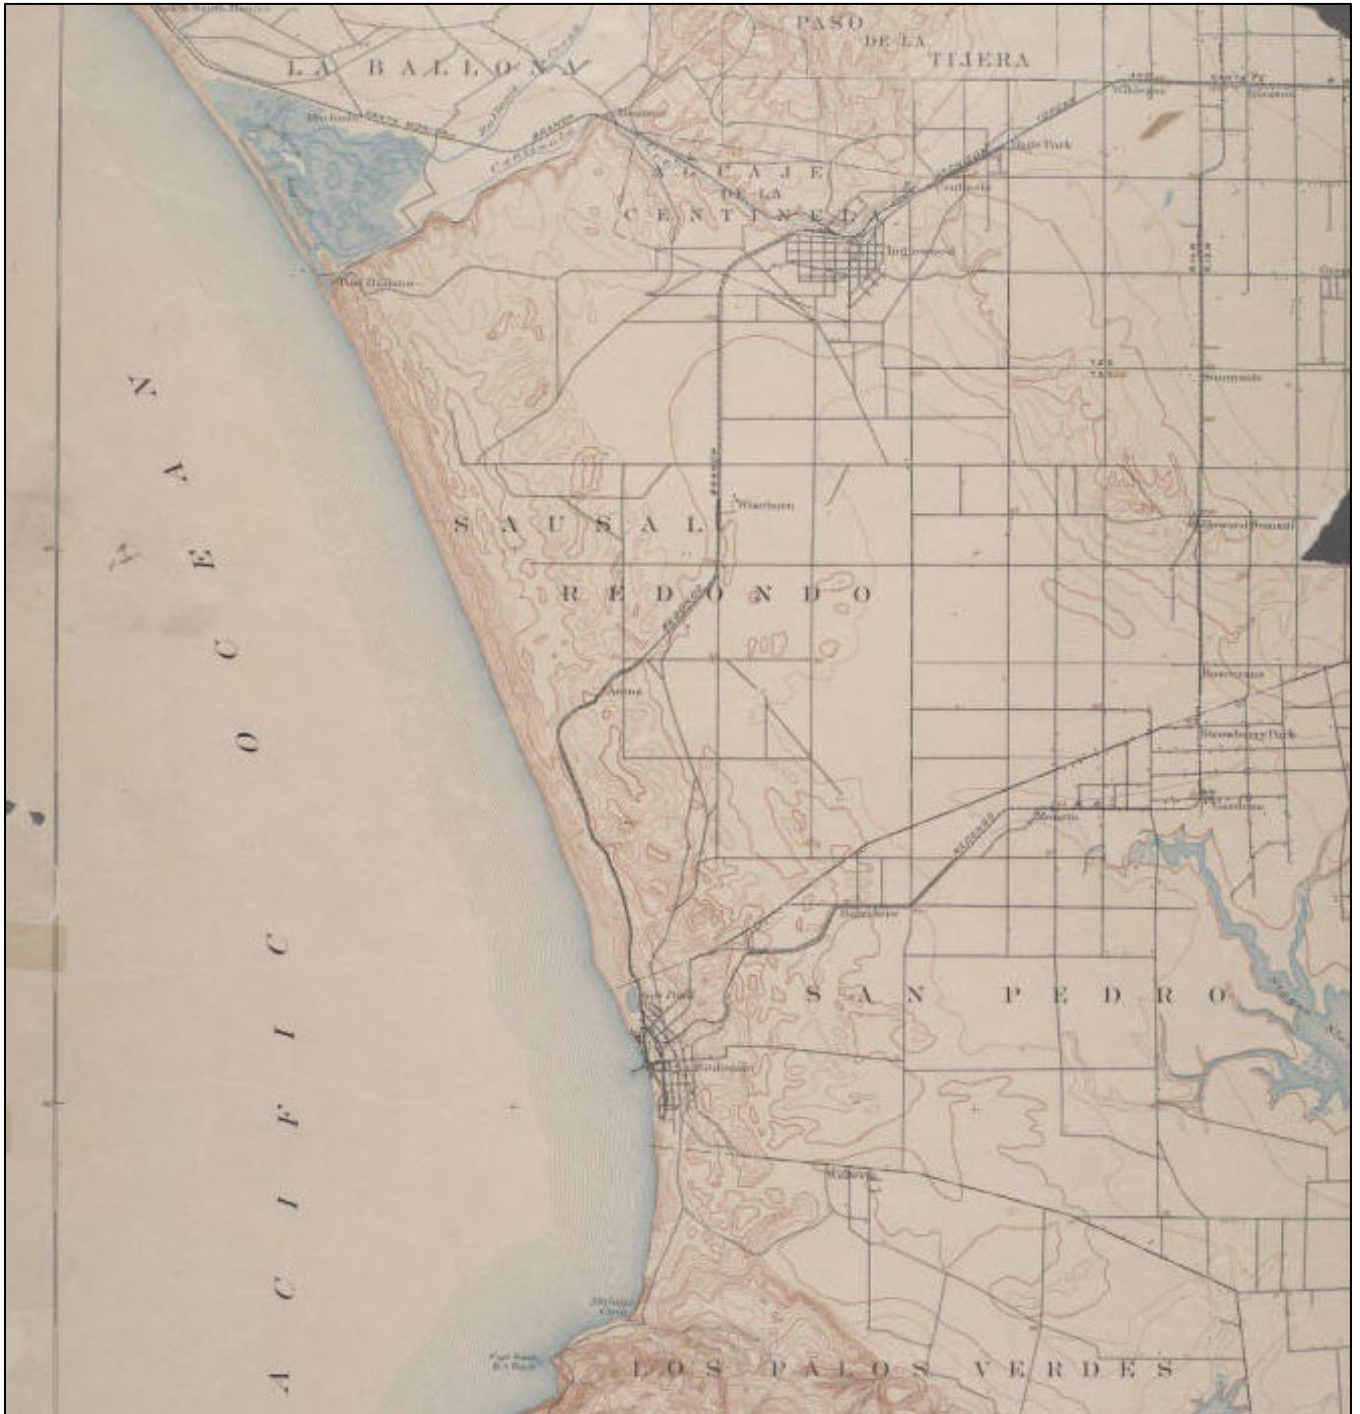
Figure 2. USGS (United States Geological Survey) Topographical map from 1896 for the Redondo quadrangle (courtesy: USC Digital Library, downloaded March 2021, cropped).

Prior to development in the late 1890s, Manhattan Beach was comprised of a narrow sandy beach backed by expansive coastal dunes, standing as high as 60 feet (Figures 1 and 2). From 1888 forward, developers began to build atop these natural dunes, first creating a seaside resort. It later grew into the City of Manhattan Beach after year-round residents arrived to support the newly constructed Standard Oil refinery built atop the dunes just north of Manhattan Beach in 1911. Despite development,

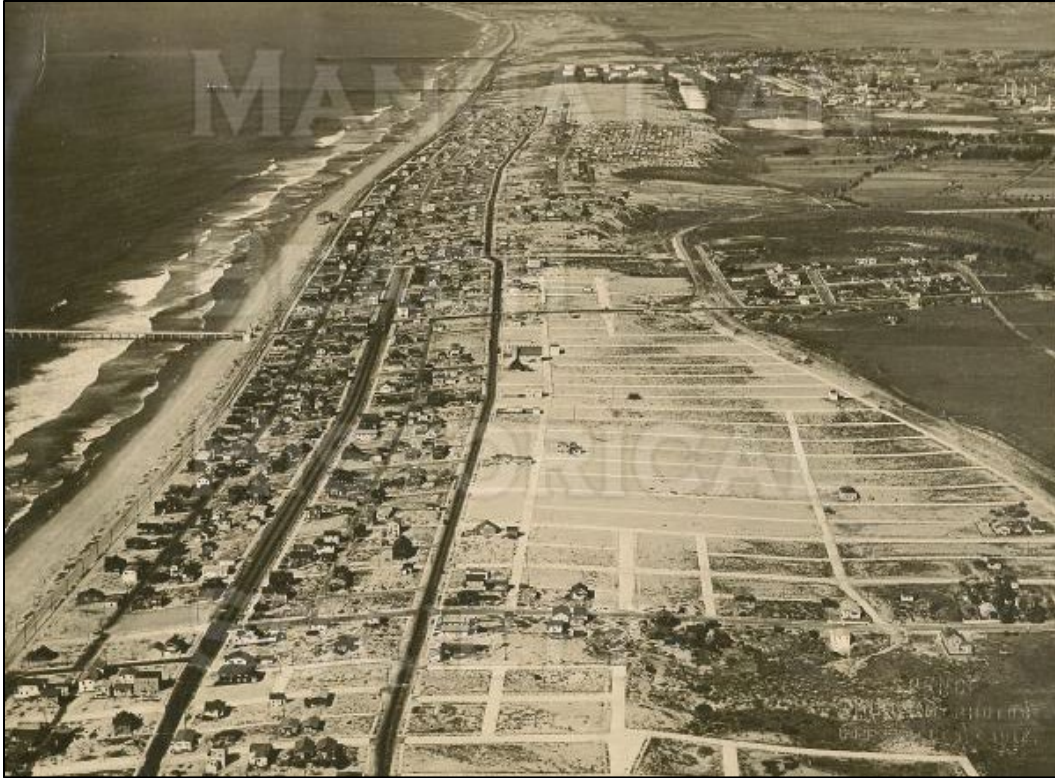
Figure 3. Aerial photo of Manhattan Beach looking north, showing development on natural coastal dunes, circa 1927. Photo courtesy of the Manhattan Beach Historical Society.

prevailing winds continued to move sand across streets, railroads, and boardwalks (Figure 3). Manhattan Beach residents planted *Carpobrotus edulis* (iceplant) to control the drifting sand (Figure 4). Some remnant sand dunes exist at Sand Dune Park at the northern end of Manhattan Beach, but the historical dunes have been largely urbanized and developed by residential and commercial properties (ESA 2021).

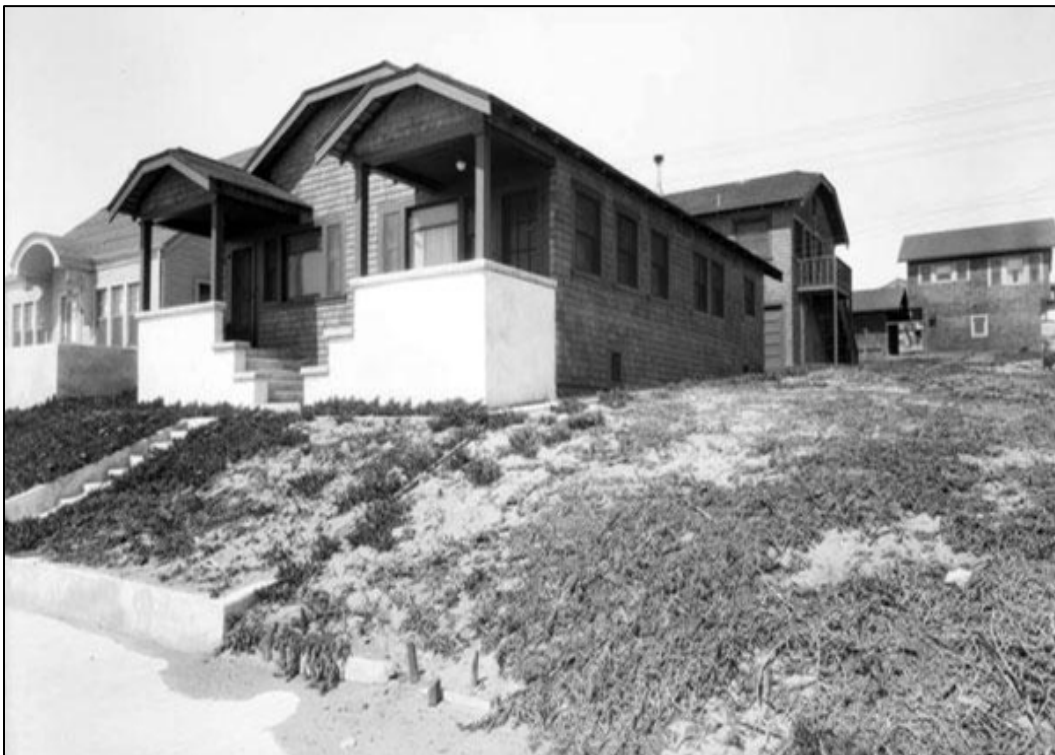
Figure 4. Iceplant visible on original coastal dunes where homes were being developed in Manhattan Beach, 1925. Courtesy of the Dick Whittington Photography Collection, USC Libraries.

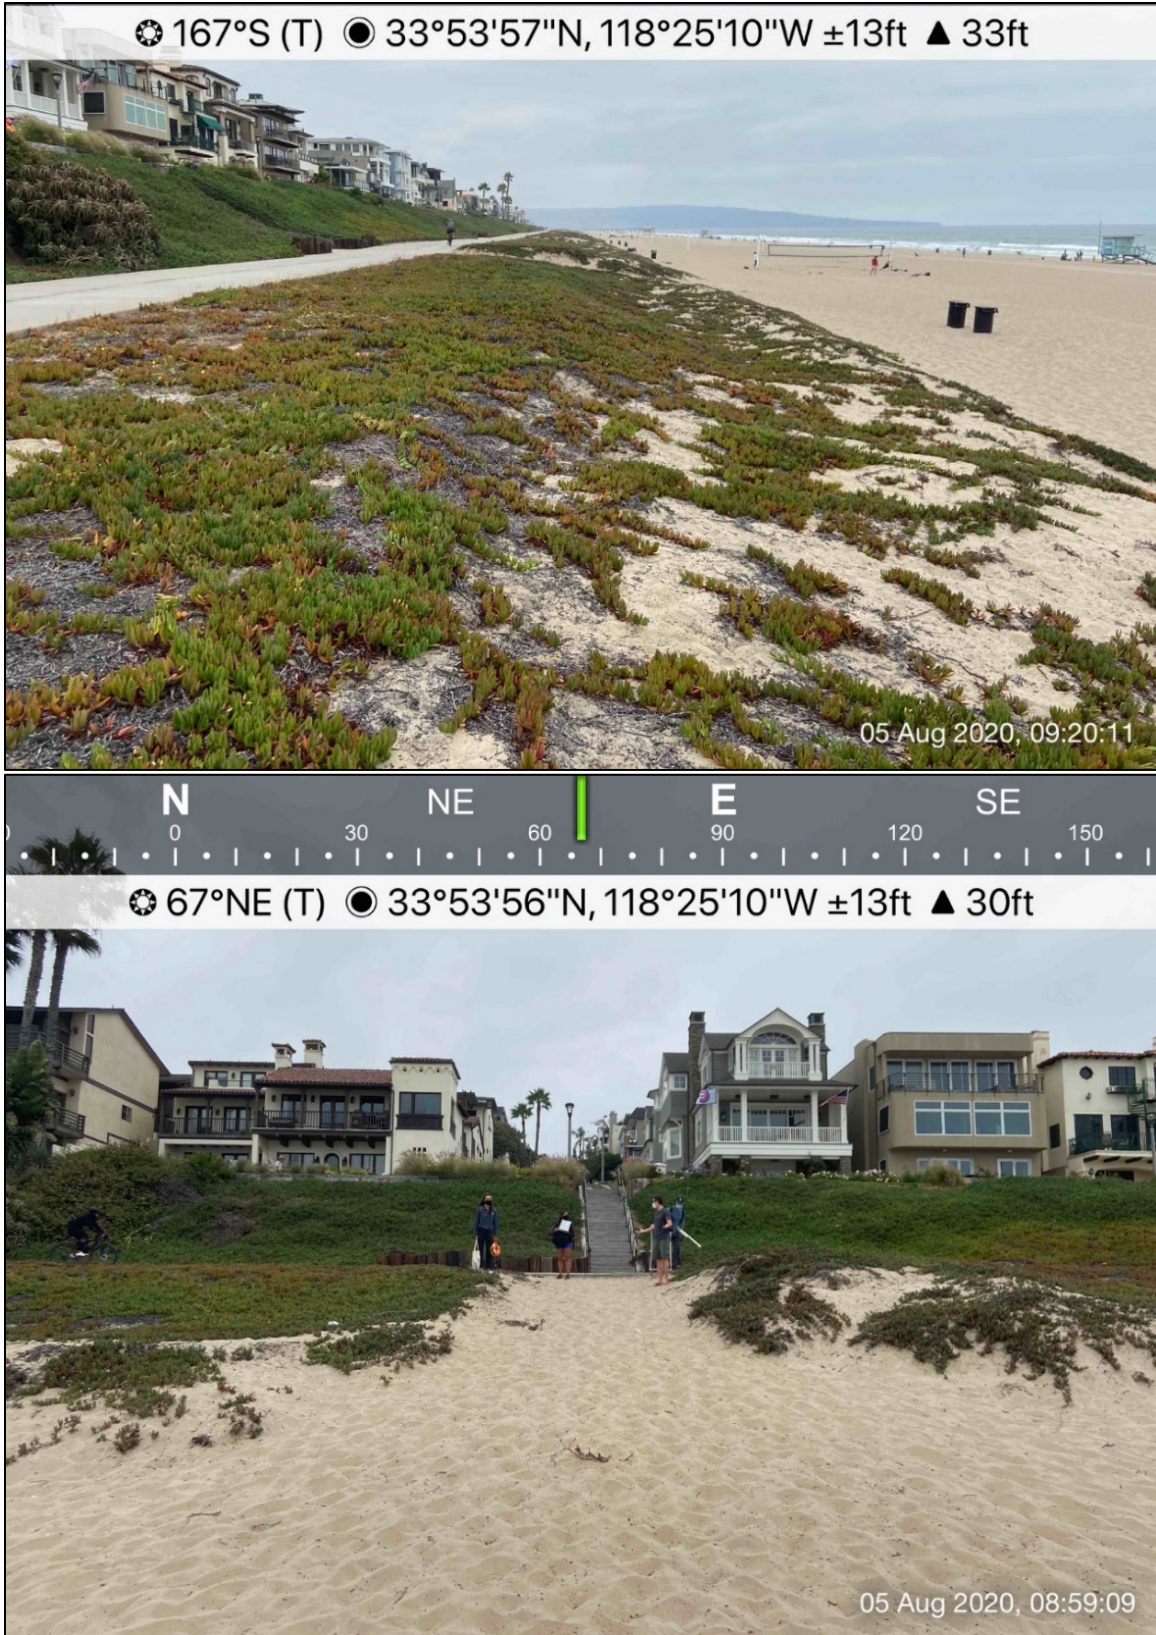
Figure 9. Representative photographs from project area showing iceplant dominated dunes (top) and beach access pathways (bottom).

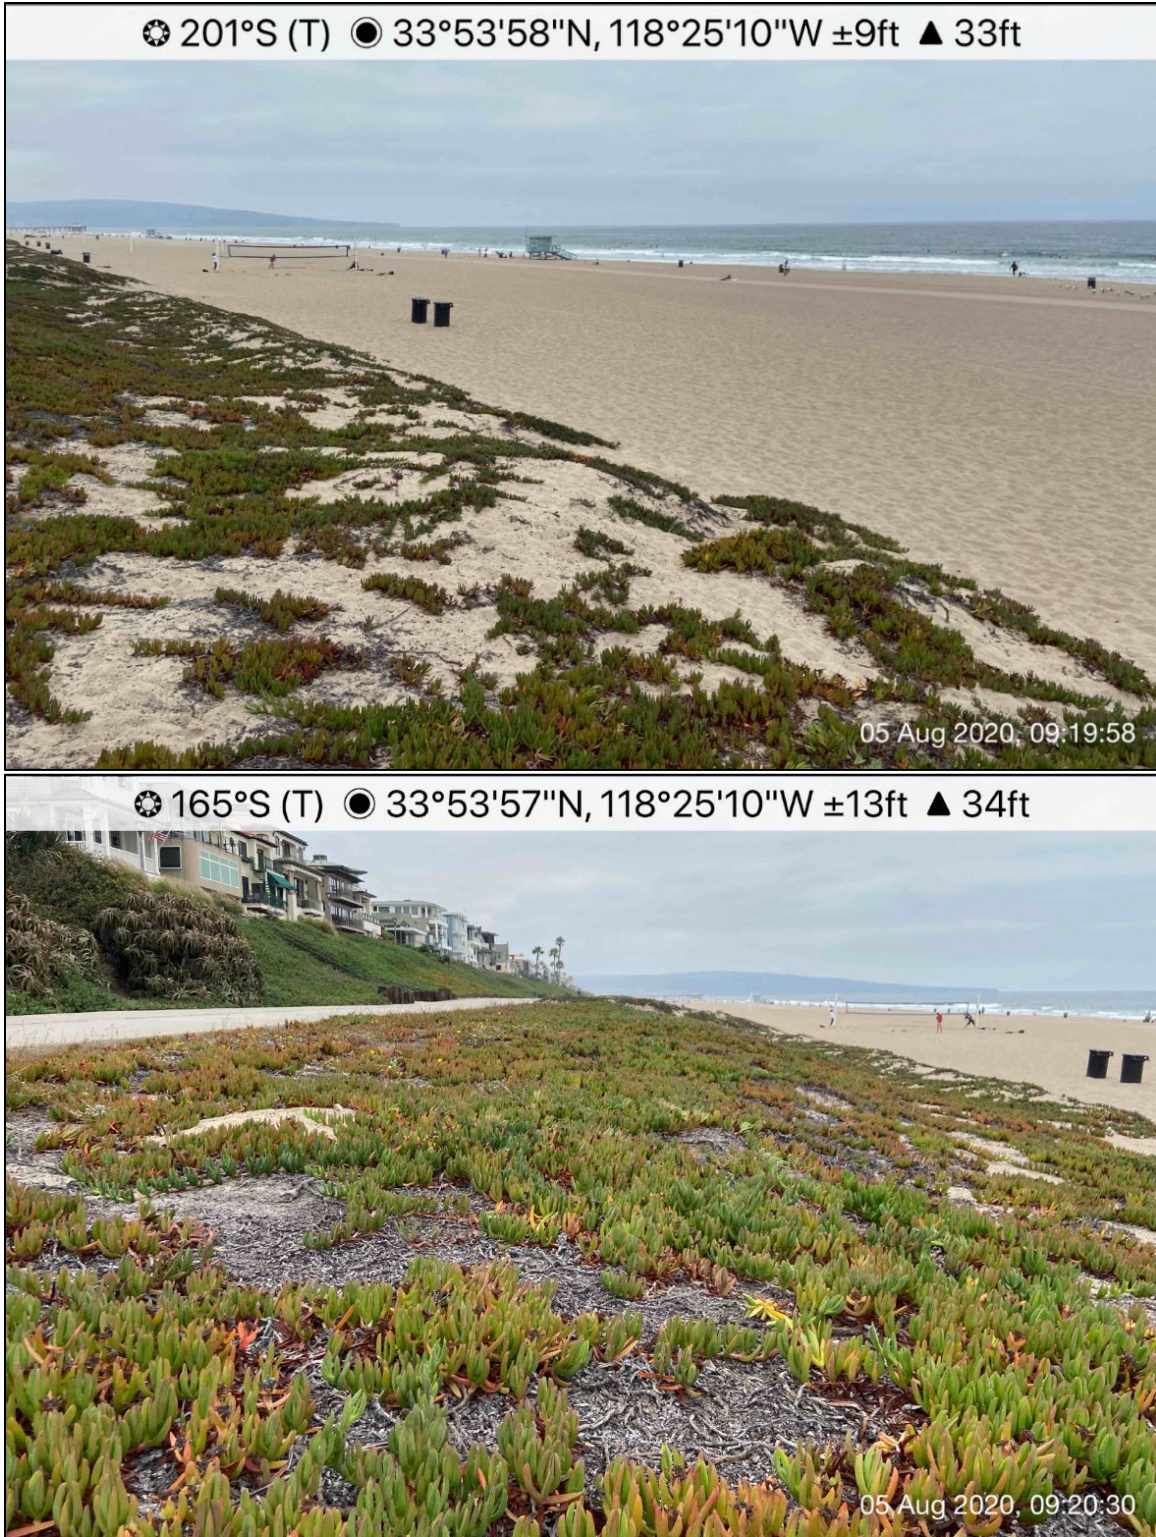
Figure 10. Representative photographs from project area showing sparser iceplant cover in the foredune area (top) and denser cover in the backdune area (bottom).

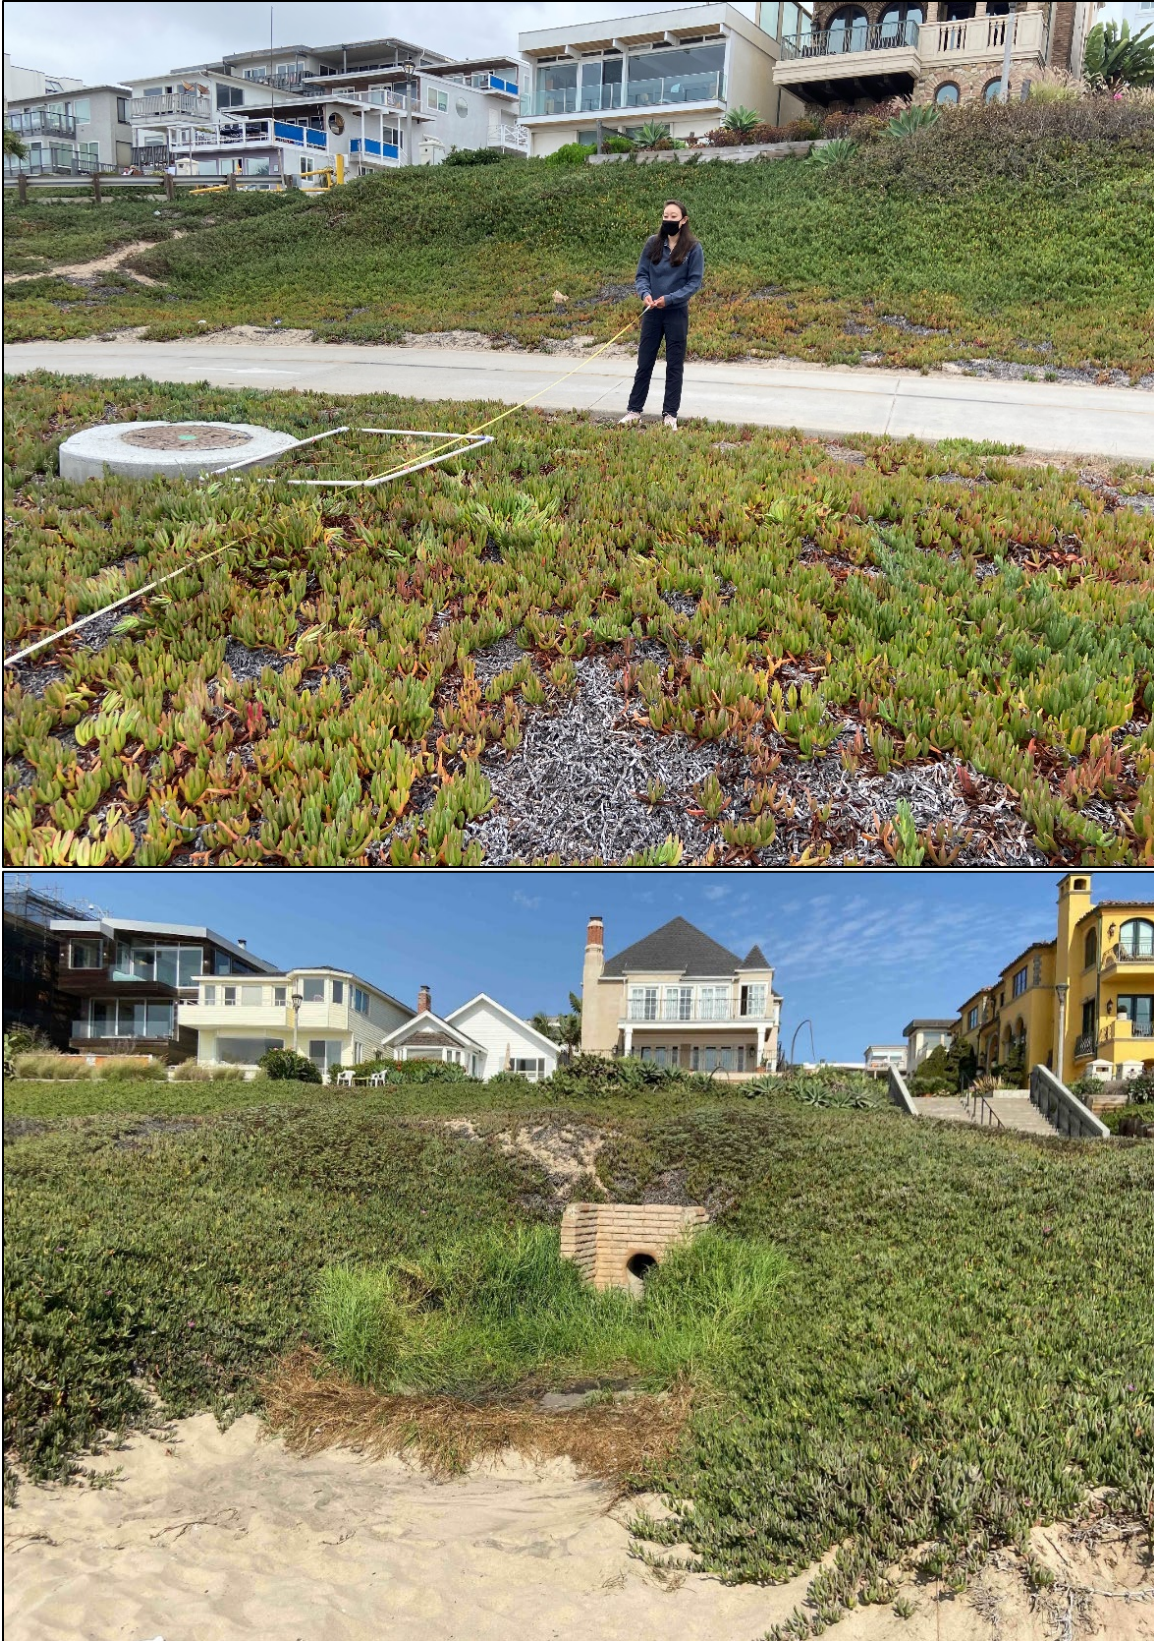
Figure 11. Photos showing one of the seven maintenance holes within the project area (top) and one of the two outfalls adjacent to the area (bottom).

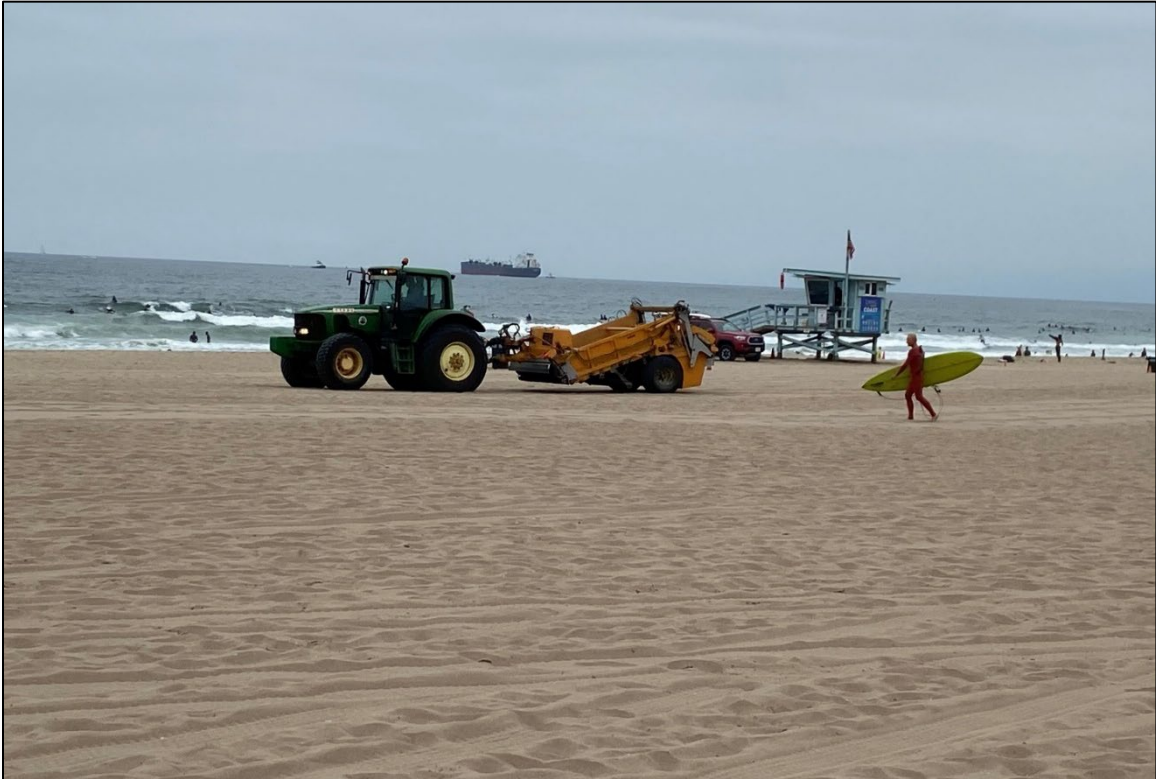
Figure 12. Photo of beach grooming activities oceanward of the project area.

The beach seaward of the project area is managed by grooming activities conducted by LACDBH (Figures 12 and 13). This area includes volleyball courts, approximately 30 feet from the project footprint, and lifeguard towers. The area also supports other types of beach recreation further seaward (e.g., Figure 14 and Figure 15). Directly landward of the proposed project area is a heavily used bike path, the Marvin Braude Bike Trail (Figure 16). Further inland, densely developed residential lots, commercial areas, and infrastructure are present, as well as a paved walking "Strand" (Figure 17). The restoration area extends from 23rd Street, to the south, to 36th Street to the north. The portion of the beach between 26th Street and 28th Street, seaward of the County Lifeguard Training Center, is not included in the scope of this project (Figure 8). This area is referred to as the 26-28 block throughout the document. This 26-28 block is comprised of some existing dunes and hummocks with patchy iceplant and native beach bur (*Ambrosia chamissonis*) and larger unvegetated expanses (Figure 18, Figure 19). This area is also used for vehicle access by the LA County lifeguards and LACDBH. The 26-28 block was not included within the restoration area due to planning by the City for a potential stormwater infiltration project in that location at some point in the future.

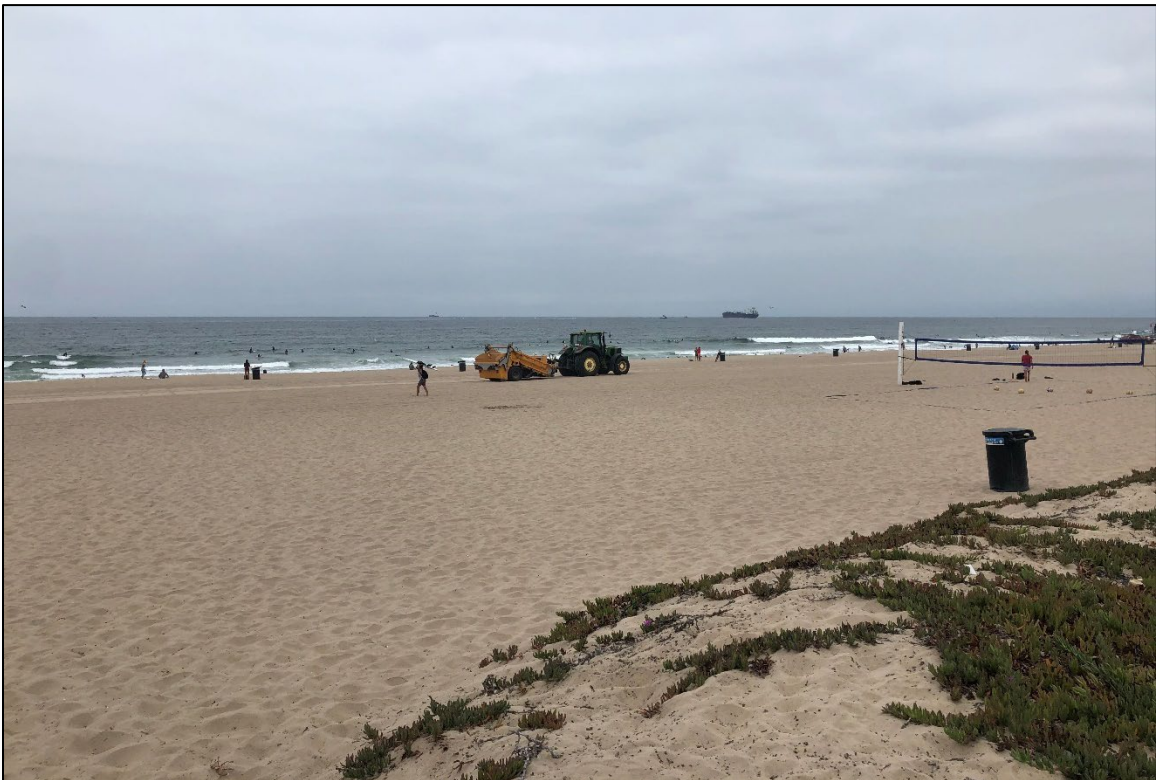
Figure 13. Photo of beach grooming activities oceanward of the project area.

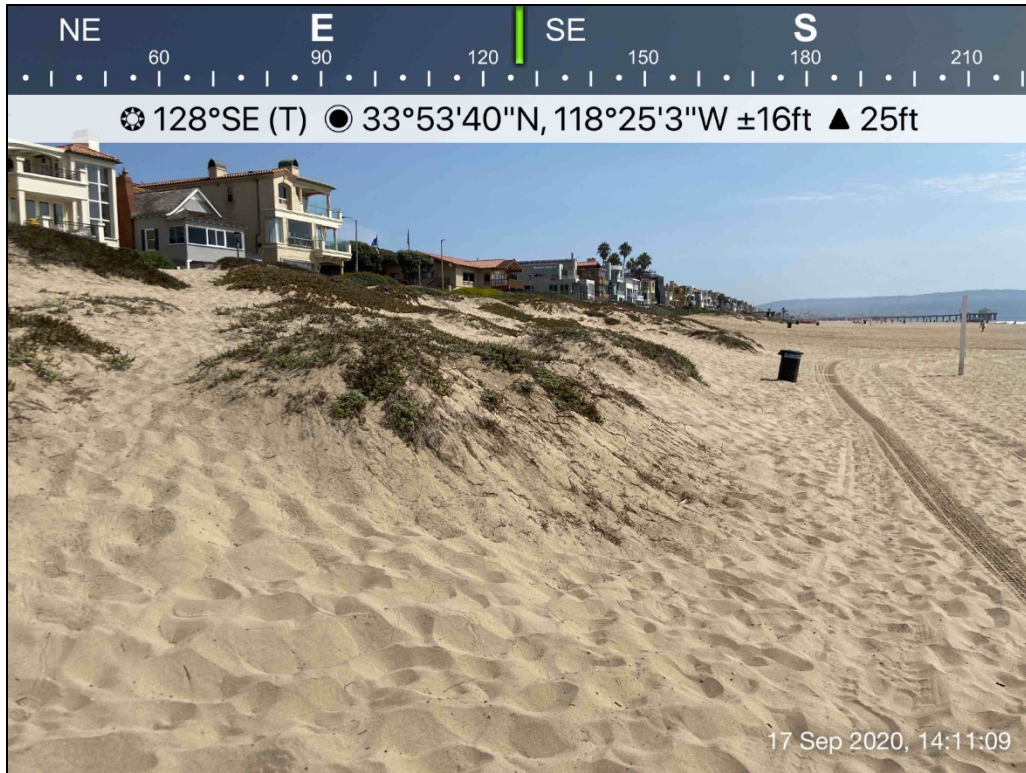
Figure 18. Photo of dune hummocks with patchy iceplant and some native beach bur in 26-28 block area outside of the project footprint (between 26th Street and 28th Street).

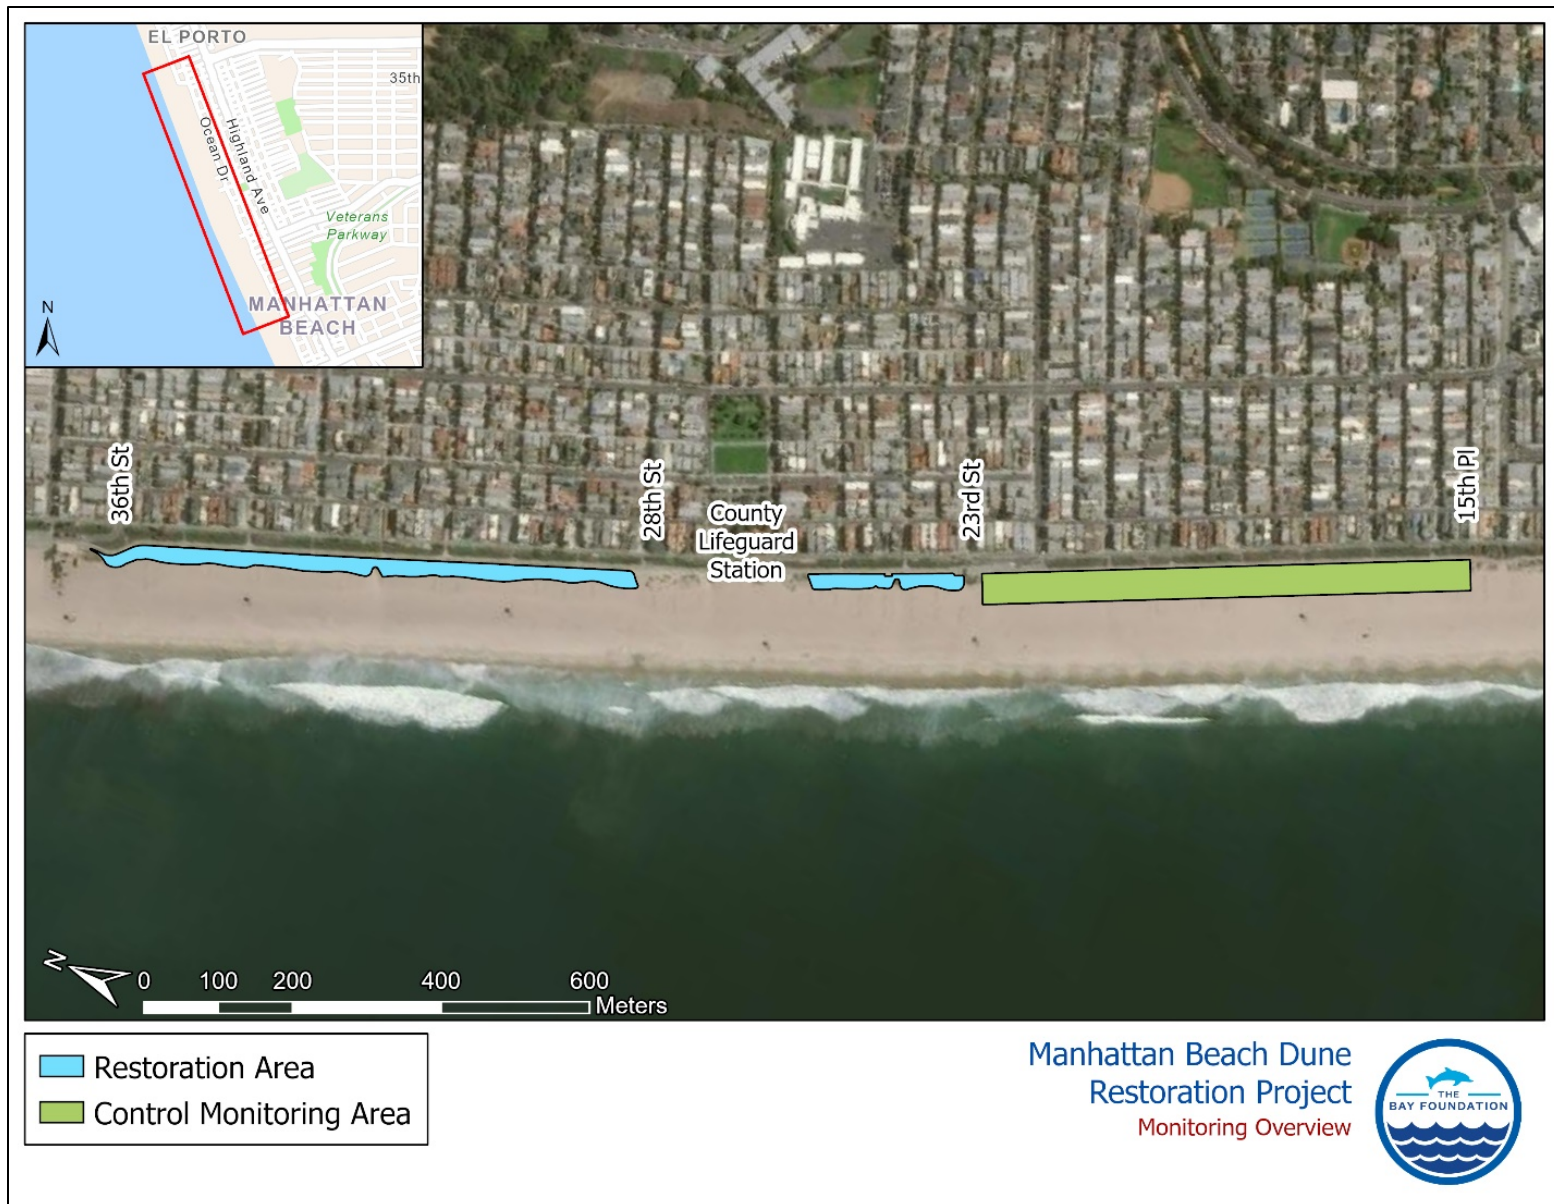
Figure 21. Overview of restoration and control monitoring areas.

Vegetation cover and elevation were measured along ten transects: four 30-meter transects (T1, T5, T6, T7), and two 100-meter transects (T4 and T10) running approximately east to west, two 50-meter transects running approximately north to south (T2 and T9), and two 12-meter transects (T3 and T9) also running east to west targeted down access pathways. Transects were established in targeted areas to best capture ambient on-site conditions. T7 is located outside of the project footprint in the 26-28 block area between the northern and southern portions of the project area (Figure 22). At the time of baseline data collection, this area was tentatively planned to be included in a future restoration phase. While this area is no longer part of the scope of this project, data were included in the analyses to best characterize the contiguous dune system. Eight control transects were also established in the area to the south of the project footprint. Control transects include two 30-meter transects (C1 and C3) and two 100-meter transects (C2 and C6) running east to west, two 50-meter transects running north to south (C4 and C7), and two 12-meter transects (C5 and C8) running east to west along the access pathways. Figure 21 displays the restoration and control monitoring areas and Figures 22 and 23 display maps of the final restoration and control monitoring transects, respectively.

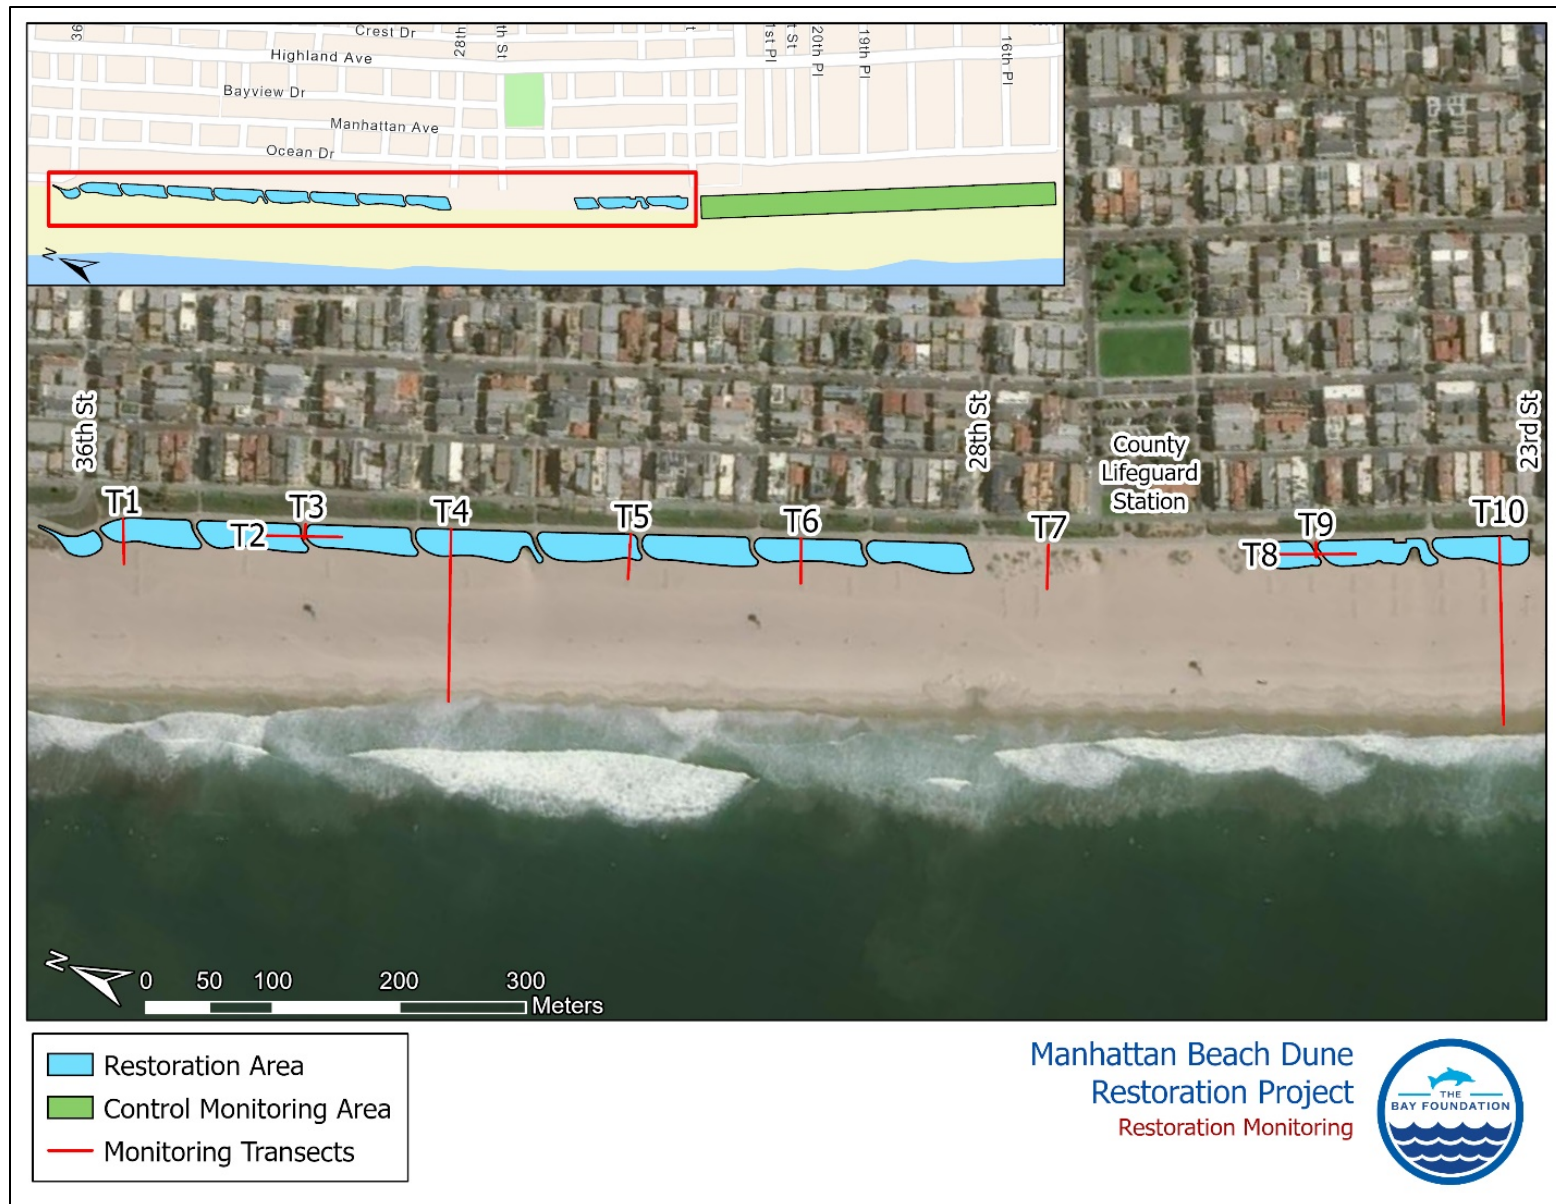
Figure 22. Map of restoration monitoring transects.

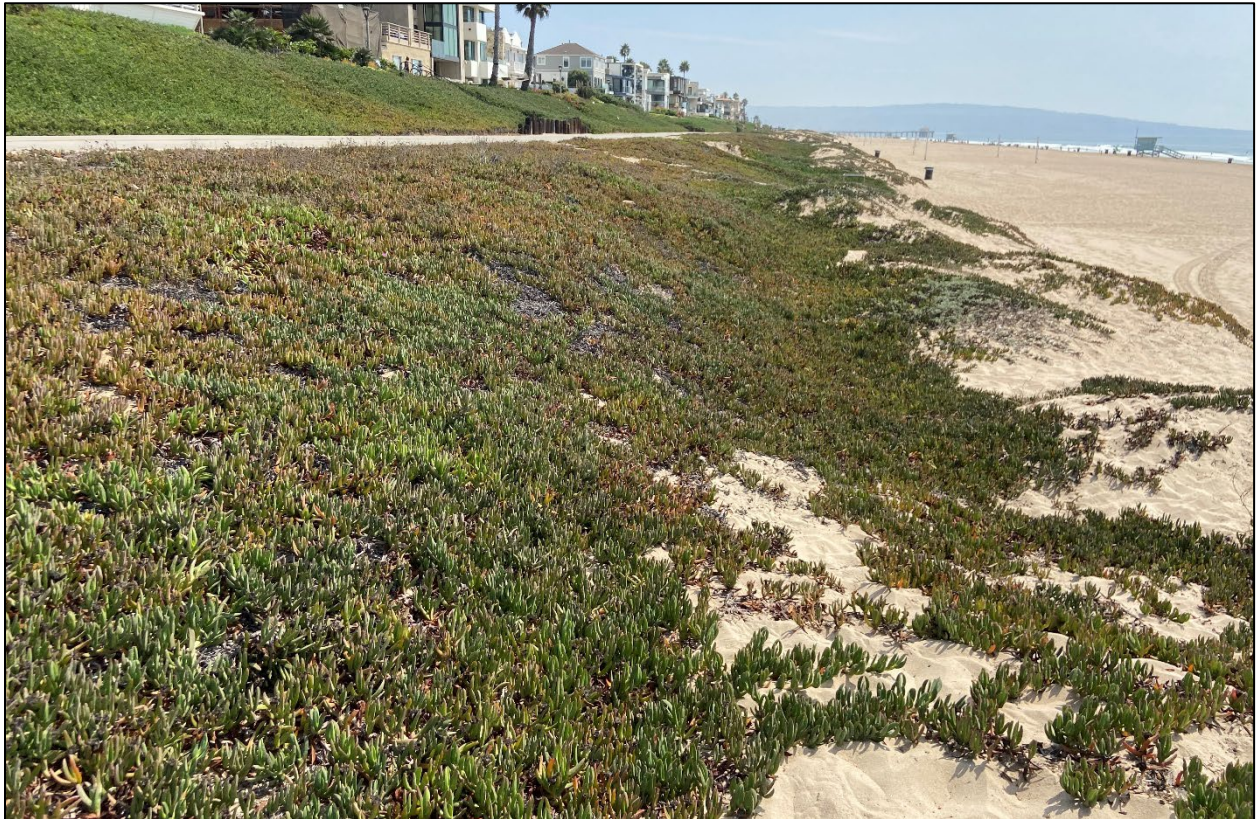
Figure 24. Representative photograph of the project site along the bike path showing existing dunes dominated by non-native iceplant, with low density presence of native beach evening primrose (bottom).

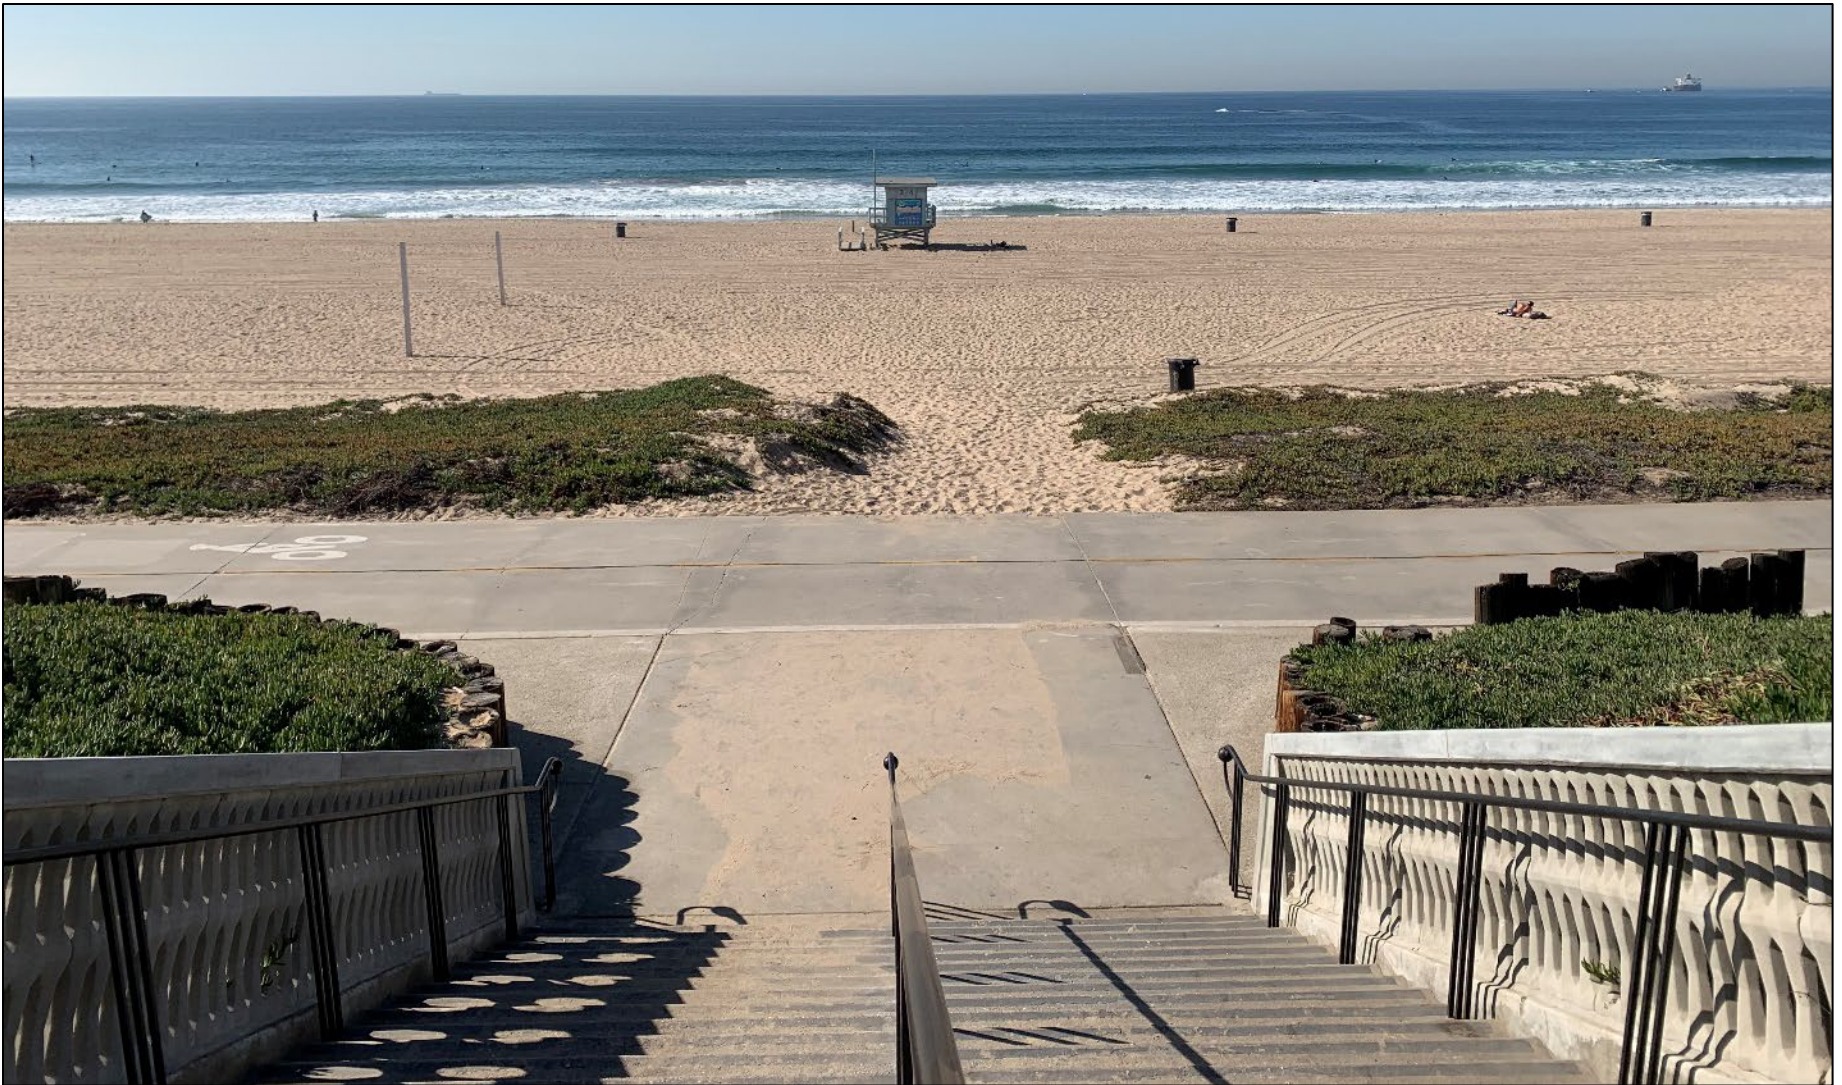
Figure 25. Representative photo of the project site showing an unvegetated beach access pathway and existing dunes. The project site has a wide, groomed beach and a narrow strip of dunes with iceplant and scattered other non-native and native plants.

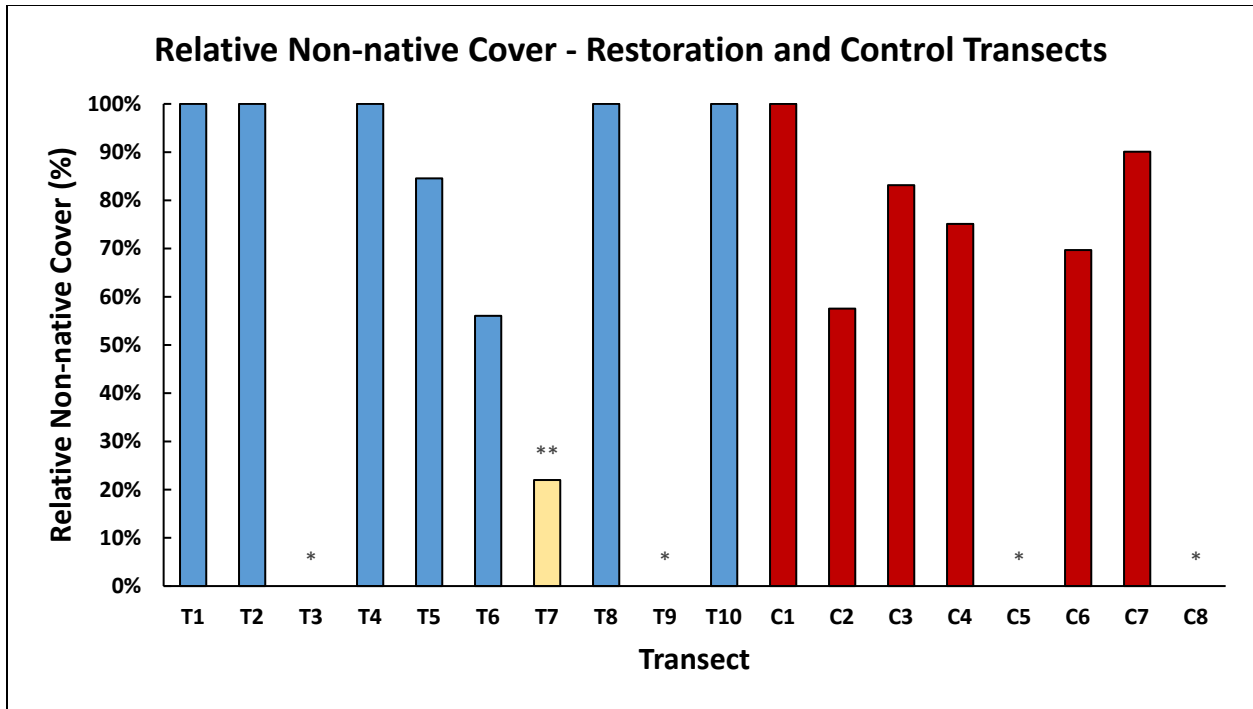
Figure 26. Relative non-native cover for all restoration (blue) and control transects (red) using the line-intercept method. A single asterisk (*) indicates an unvegetated beach access path. A double asterisk (**) indicates a transect with predominately native vegetation in the 26-28 block dune area outside of project footprint (yellow bar).

Table 1 displays monitoring protocols conducted for the baseline assessment. Line-intercept transect and cover class quadrat survey methods were used to assess vegetation cover. Line-intercept transects document every species observed directly below the transect tape where the vegetation crosses a minimum of 0.01 m (or 1 cm) and are useful for characterizing patchy habitats with substantial bare ground. Data were evaluated as percent cover by species. The estimated relative percent cover was calculated using the line-intercept transect data. To determine relative percent cover of all species present within each transect, line-intercept data were summed by species and divided by the total length of the transect occupied by vegetation. Species were characterized as native and non-native and the relative non-native percent cover within each transect was calculated by summing the length occupied by non-native species and dividing by the total length of the transect occupied by vegetation.

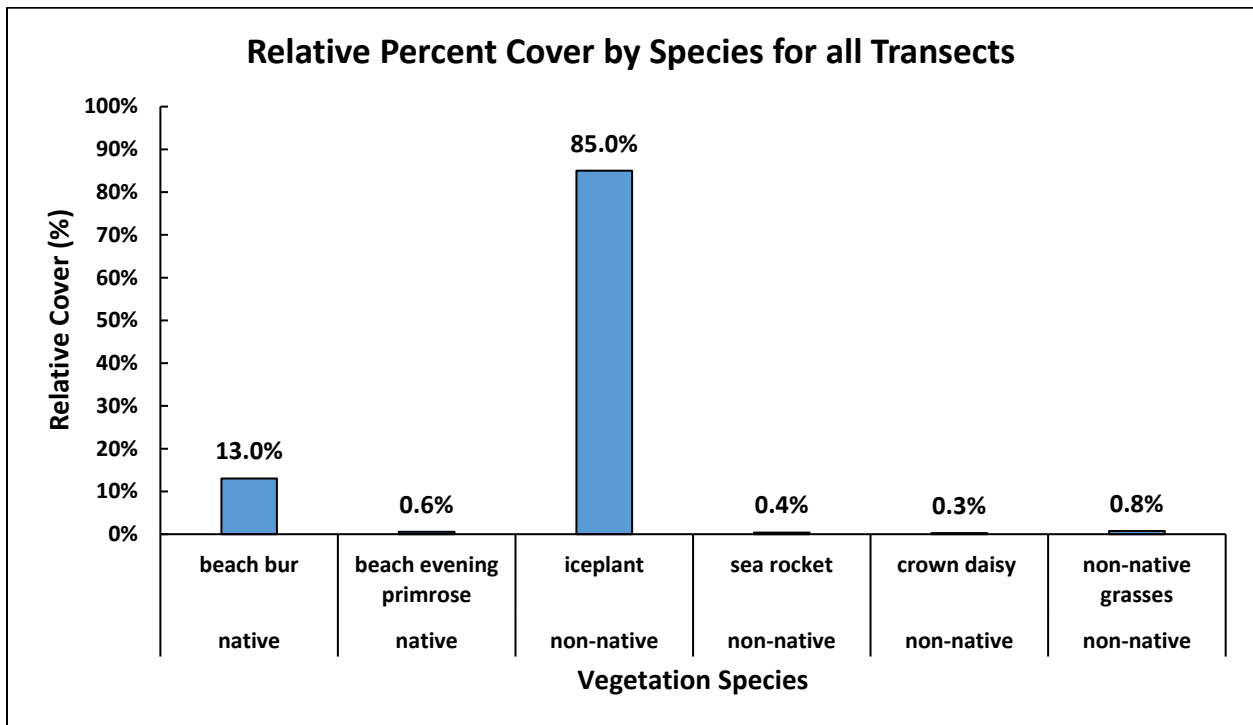
Figure 27. Relative percent cover by species for all transects using the line-intercept method.
