Manhattan Beach Dune Restoration Project

Restoration and Monitoring Plan

July 2021

Karina Johnston, Chris Enyart, Maggie Jenkins, Sara Cuadra, and Dane Lazarus
The Bay Foundation

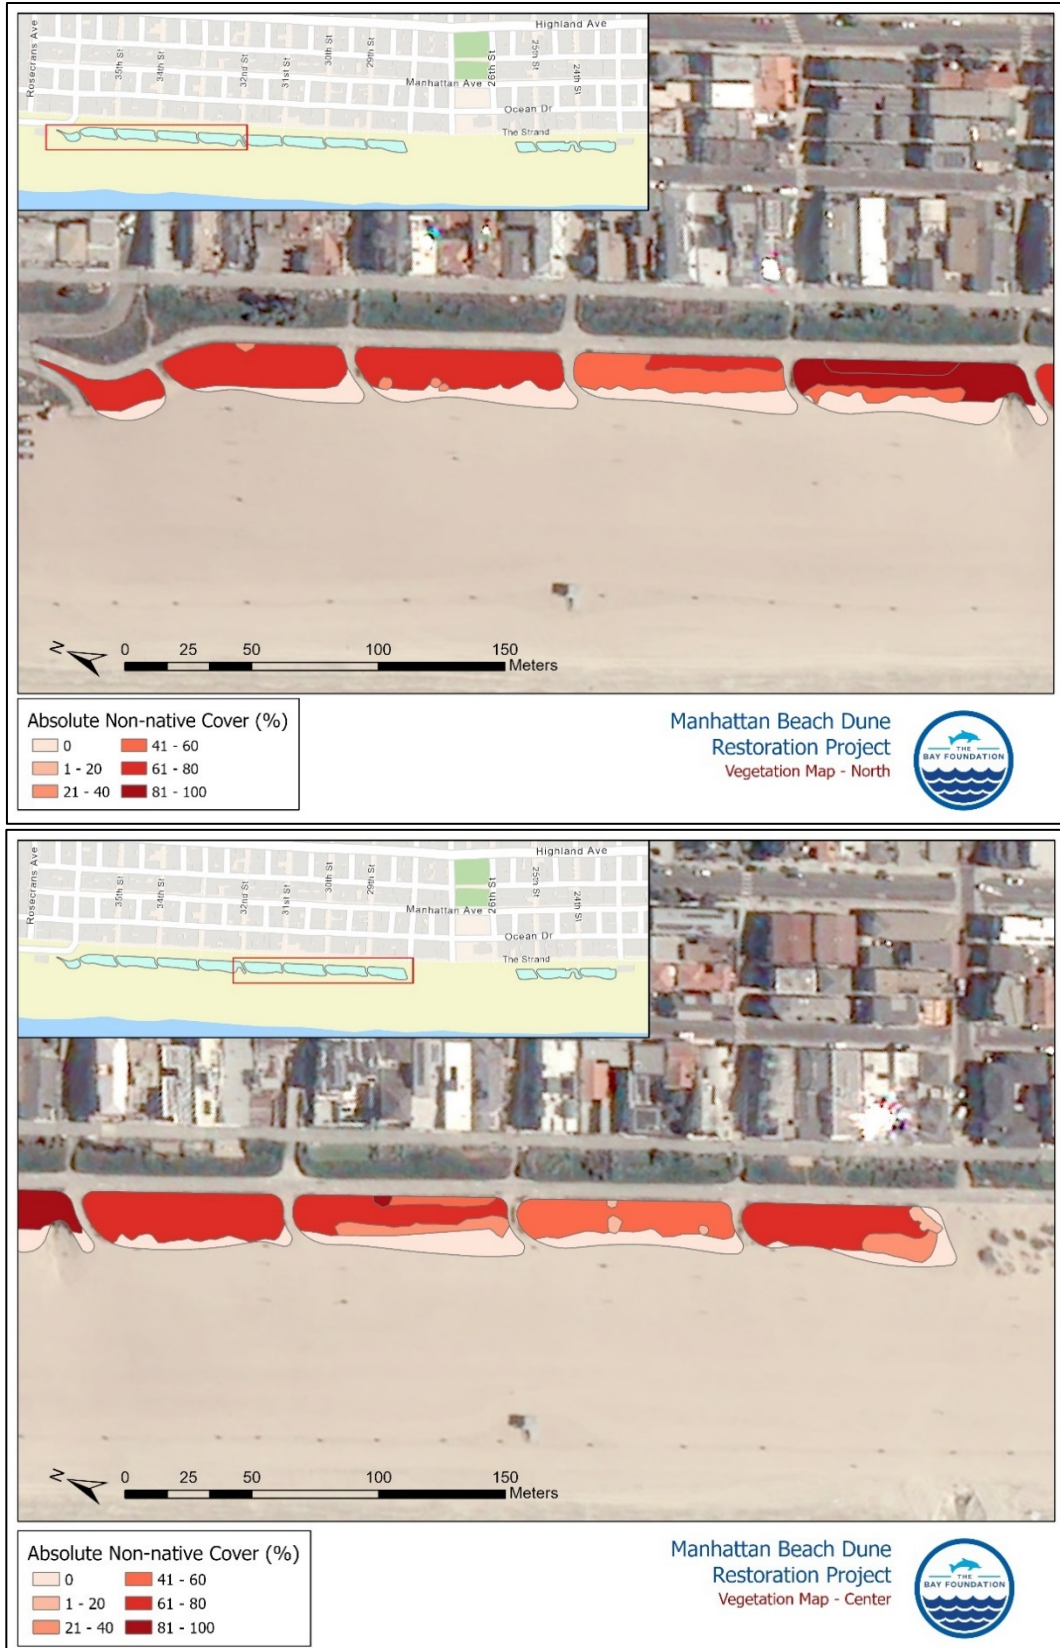
Figure 28. Vegetation mapping results showing absolute percent non-native cover between 36th and 32nd Street (top) and between 32nd and 28th Street (bottom).

The vegetation mapping results identified a similar pattern as the transect surveys, with large areas of high absolute non-native cover dominated by iceplant and small scattered patches of native cover. (Figures 28 and 29). Most areas with zero non-native cover on the seaward edge of the project footprint are on groomed beach outside of the current dune footprint (Figures 28 and 29). The 26-28 block outside of the project footprint was omitted from the vegetation mapping figure; however, field observations, aerial imagery, and cover surveys showed less iceplant and higher native cover, primarily consisting of beach bur. Part of this area is unvegetated from the bike path down to the beach and is used for vehicular access for LA County Lifeguards and other beach management operations. Additional species recorded in vegetation mapping included native annual Canadian horseweed (*Erigeron canadensis*) and non-native sow thistle (*Sonchus oleraceus*). Appendix 1 includes a full list of plant species encountered during field work.

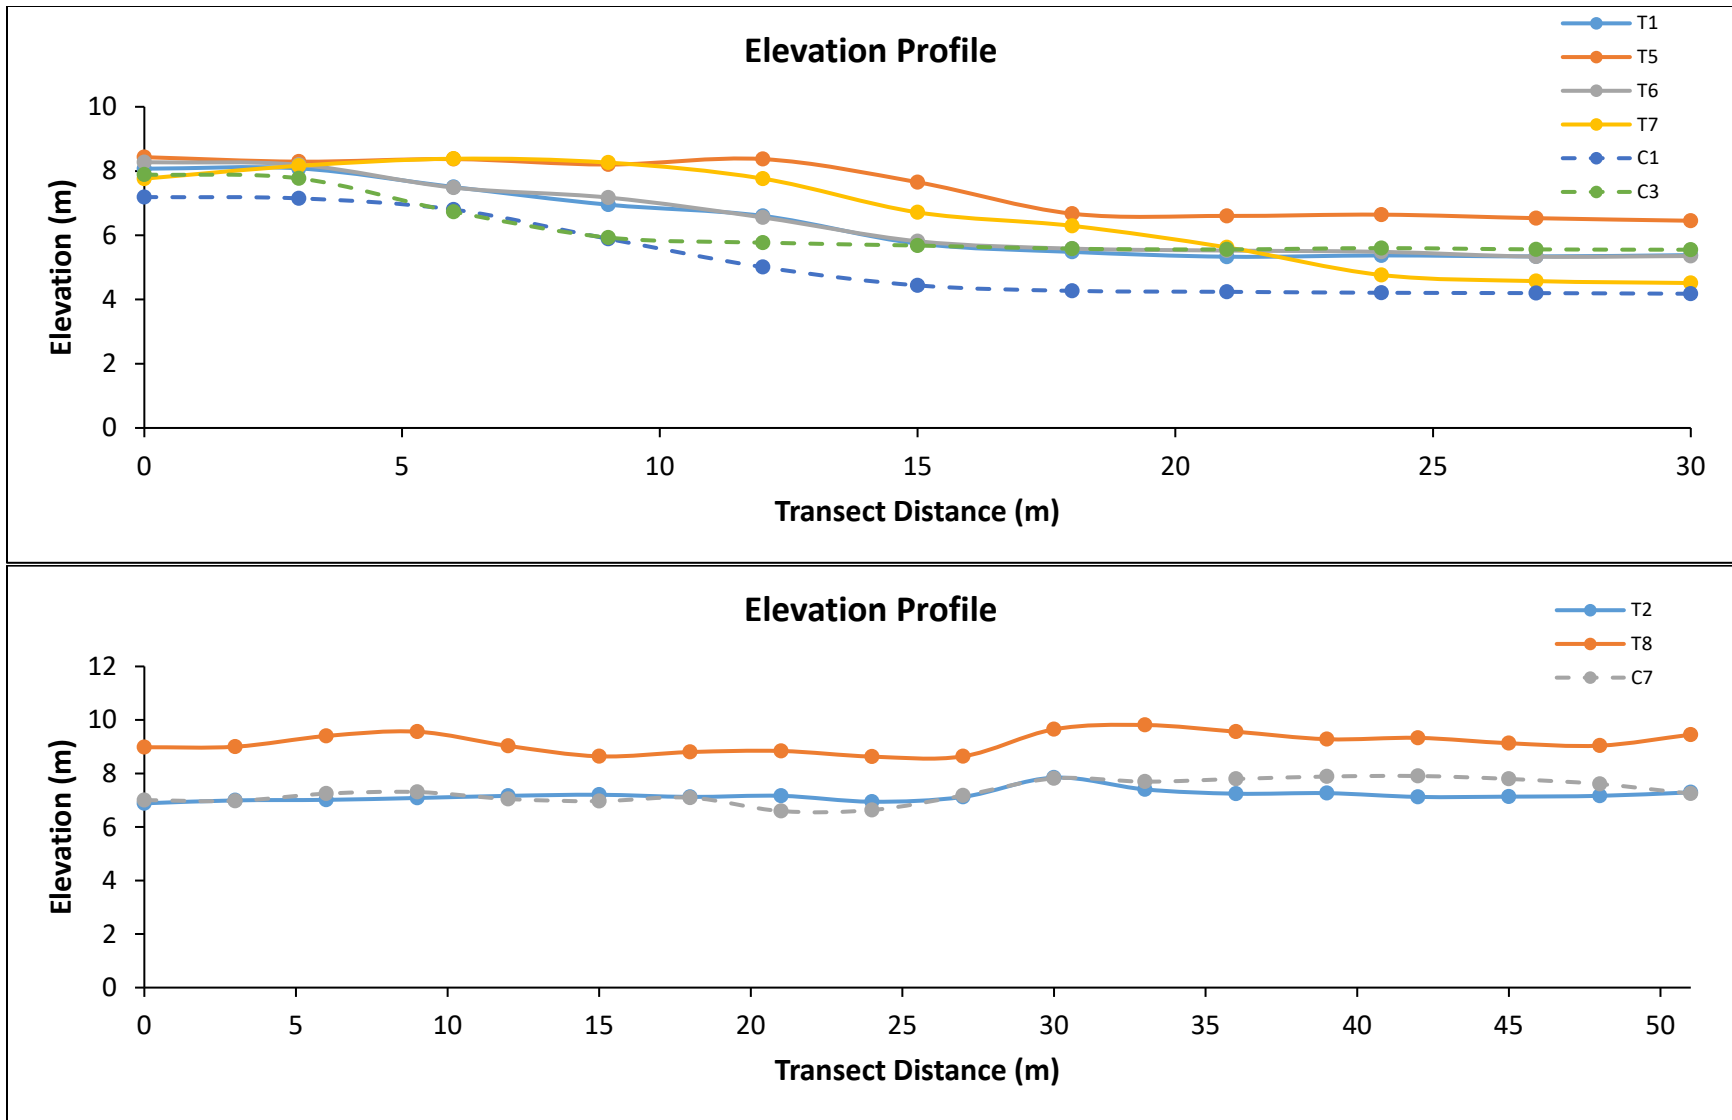
Figure 30. Elevation profiles for 30-meter transects running perpendicular to the shoreline, east to west (top) and 50-meter transects running parallel to the shoreline, north to south (bottom). The solid line indicates restoration transect and dotted line indicates a control transect (Elevation in NAVD88). Note variable x- and y-axis ranges.

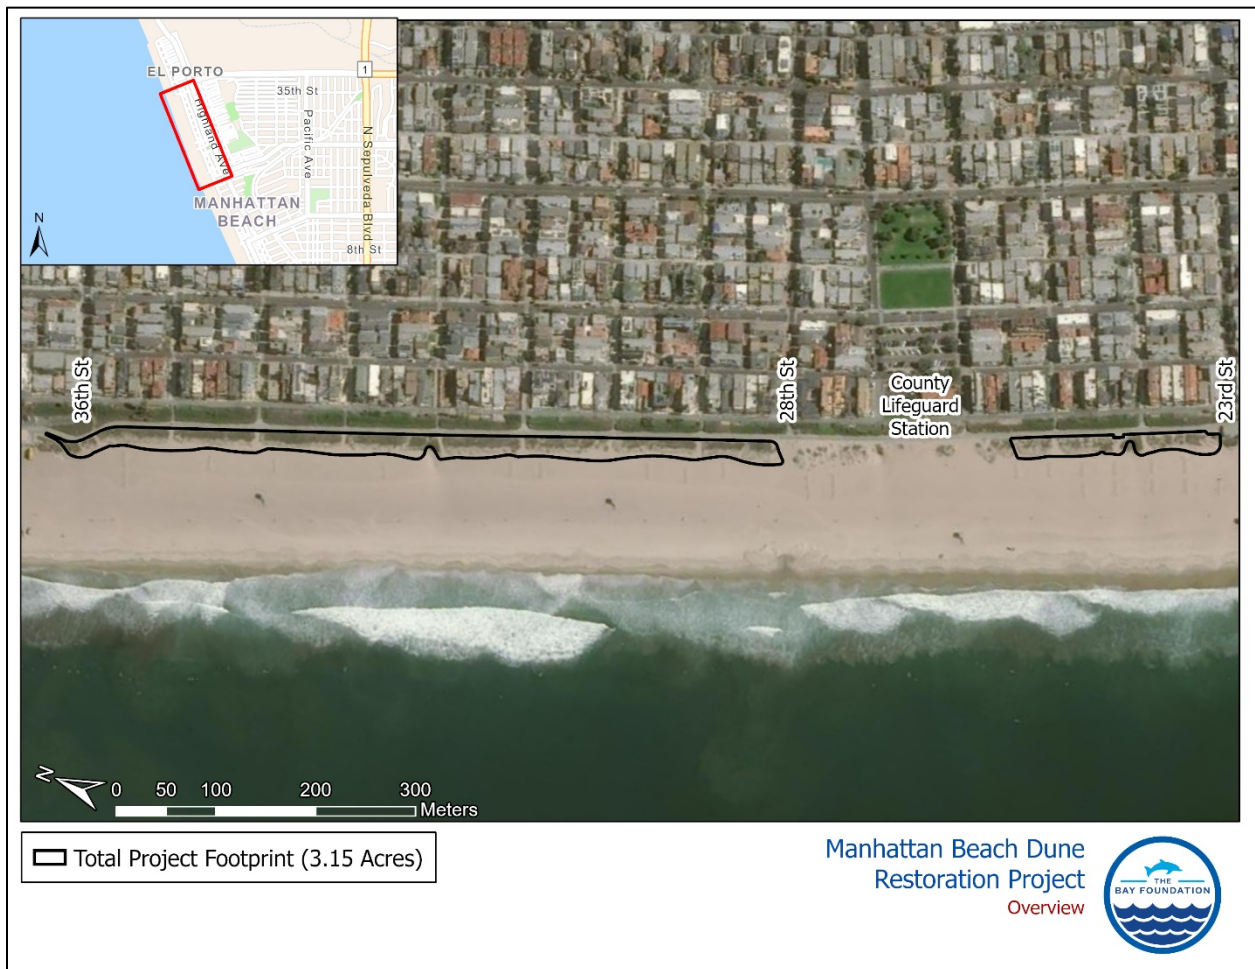
Figure 32. Overview of project area from 36th Street (north) to 23rd Street (south).

The project aims to restore 3.15 acres of impacted beach and dune habitat into a healthy living shoreline that will provide rare coastal habitat, ecosystem services, and adaptation measures for coastal storms and SLR (Figure 32). This pilot project will use a combination of native plants and seeds and strategically placed fencing, wooden slats, symbolic pathways, and signage as part of the implementation plan. Encouraging accretion of sand through native vegetation, sand fences, and wooden slats will build topography and increase elevation across the upper shore to store sand. This will help alleviate the effects of large winter storms and in the long-term, SLR. Intact and native dune systems are more resilient to disturbance than degraded systems.

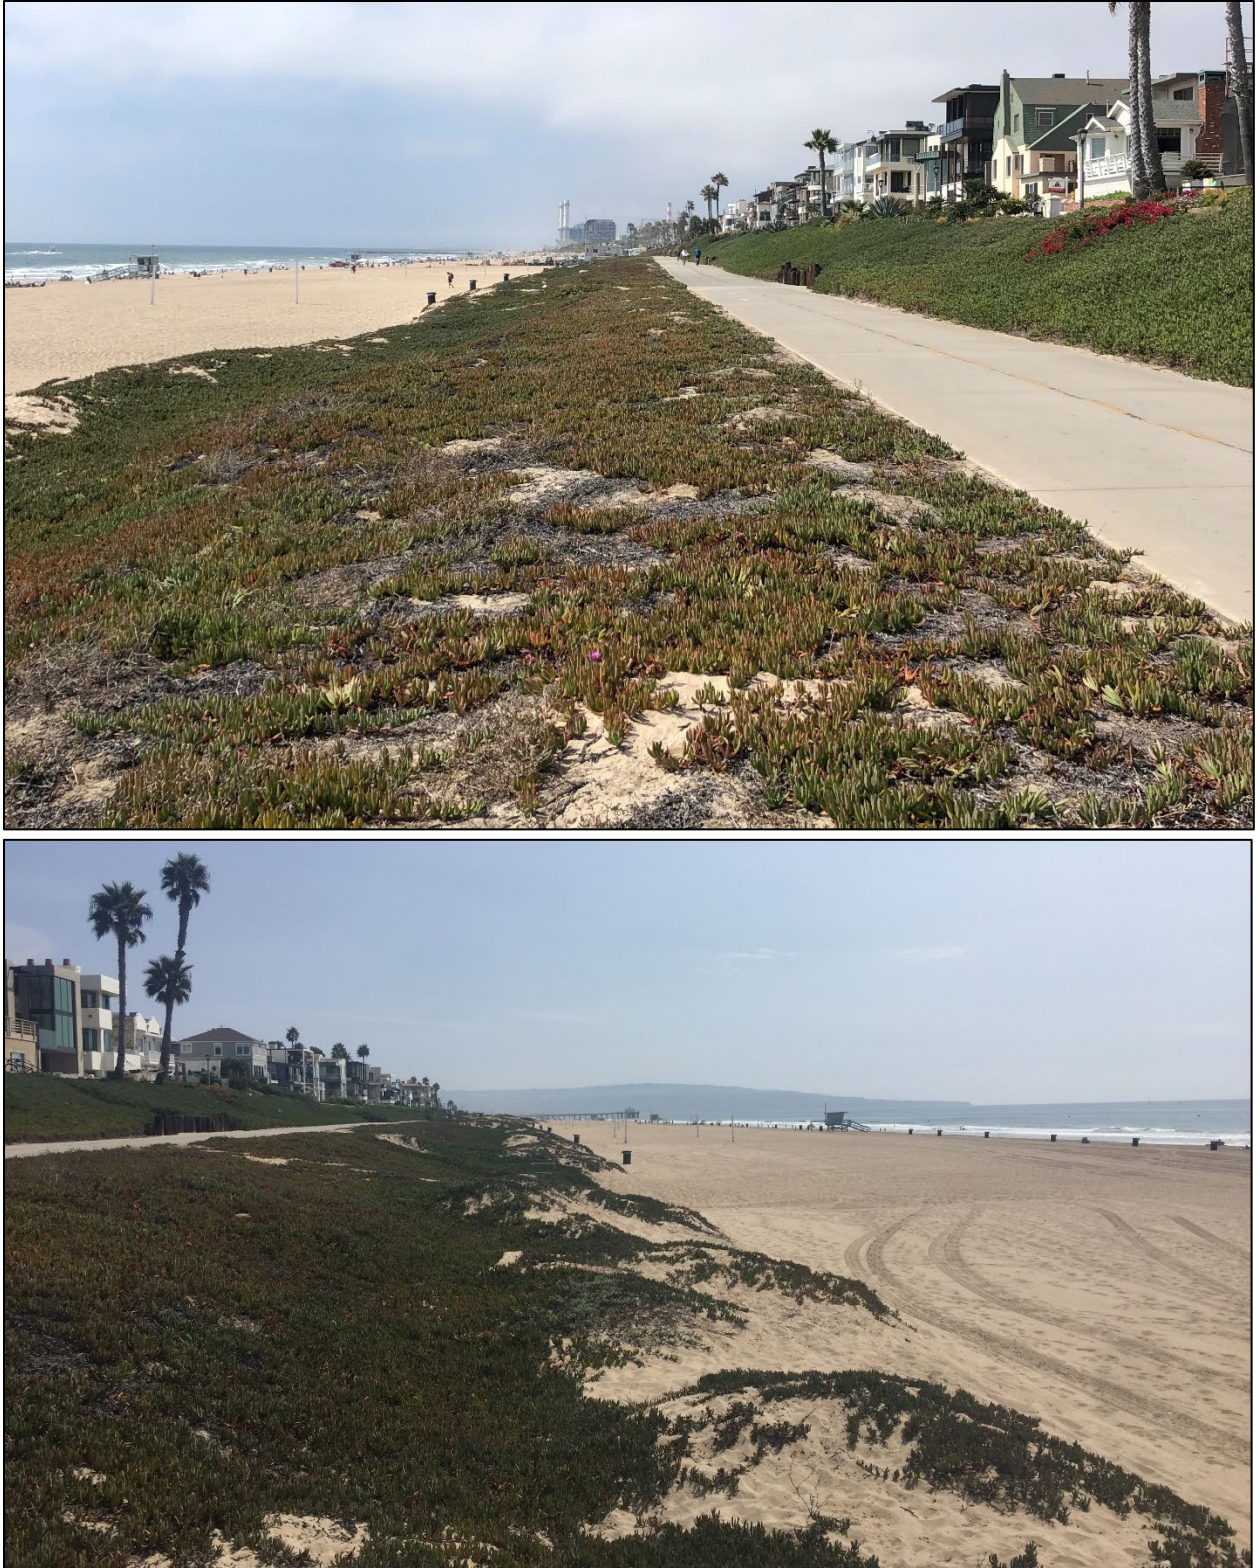
Figure 33. Representative photos of the existing dunes on site.

The existing dunes are currently predominantly covered in a monoculture of non-native iceplant, which is relatively sparser in the foredune area and grows denser toward mid-dune and back dune areas (Figure 33). Native species and other non-natives are also sparsely scattered throughout the site. The proposed project footprint includes an expanse seaward past the existing dune toe and vegetation line in a portion of the beach that is currently groomed (Figure 33). Furthermore, the site includes beach access pathways that perpendicularly cut through the site, which will be maintained for beach access. Restoration actions will include removal of iceplant and other non-natives, maintaining any existing native cover, planting and seeding of native foredune and back dune species, installation of sand fencing and biomimicry stakes (wooden slats) to promote dune growth in targeted areas, preserving all existing beach access pathways, and delineating pathways and dune restoration perimeters with symbolic post and rope fencing. A 5-ft grooming buffer and minimum 25-ft clearance for grooming equipment (30 feet total) will be left between the seaward post and rope edge and the volleyball courts. Additionally, access to maintenance holes will be maintained through accessible portions of post and rope fencing and unvegetated pathways (8-ft wide). Post and rope fencing will also wrap up and around, as to not include or restrict access to the two stormwater outfalls. A minimum width of 25 feet will be left between the north and south post and rope borders to allow access for equipment necessary for outfall maintenance needs.

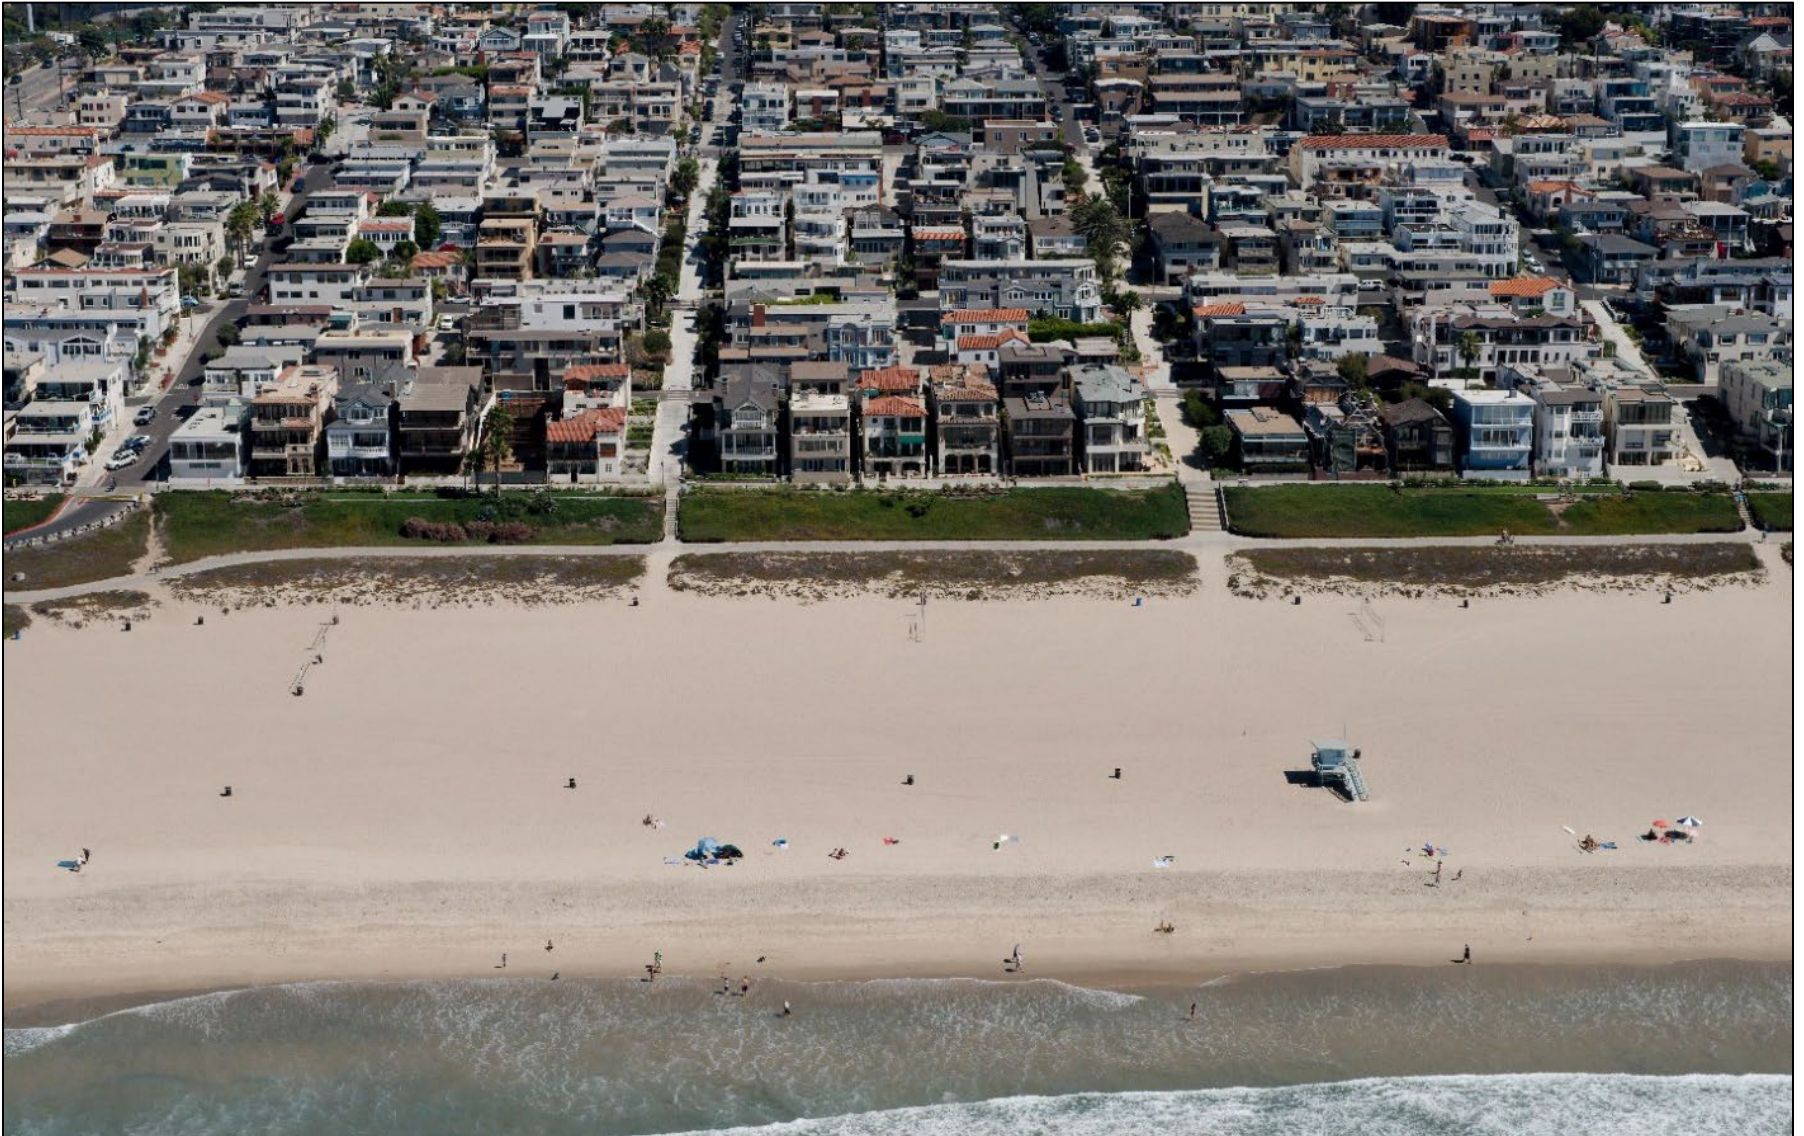
Figure 34. Aerial photograph of northern portion of the MBDR project area showing current conditions (courtesy CA Coastal Records Project).

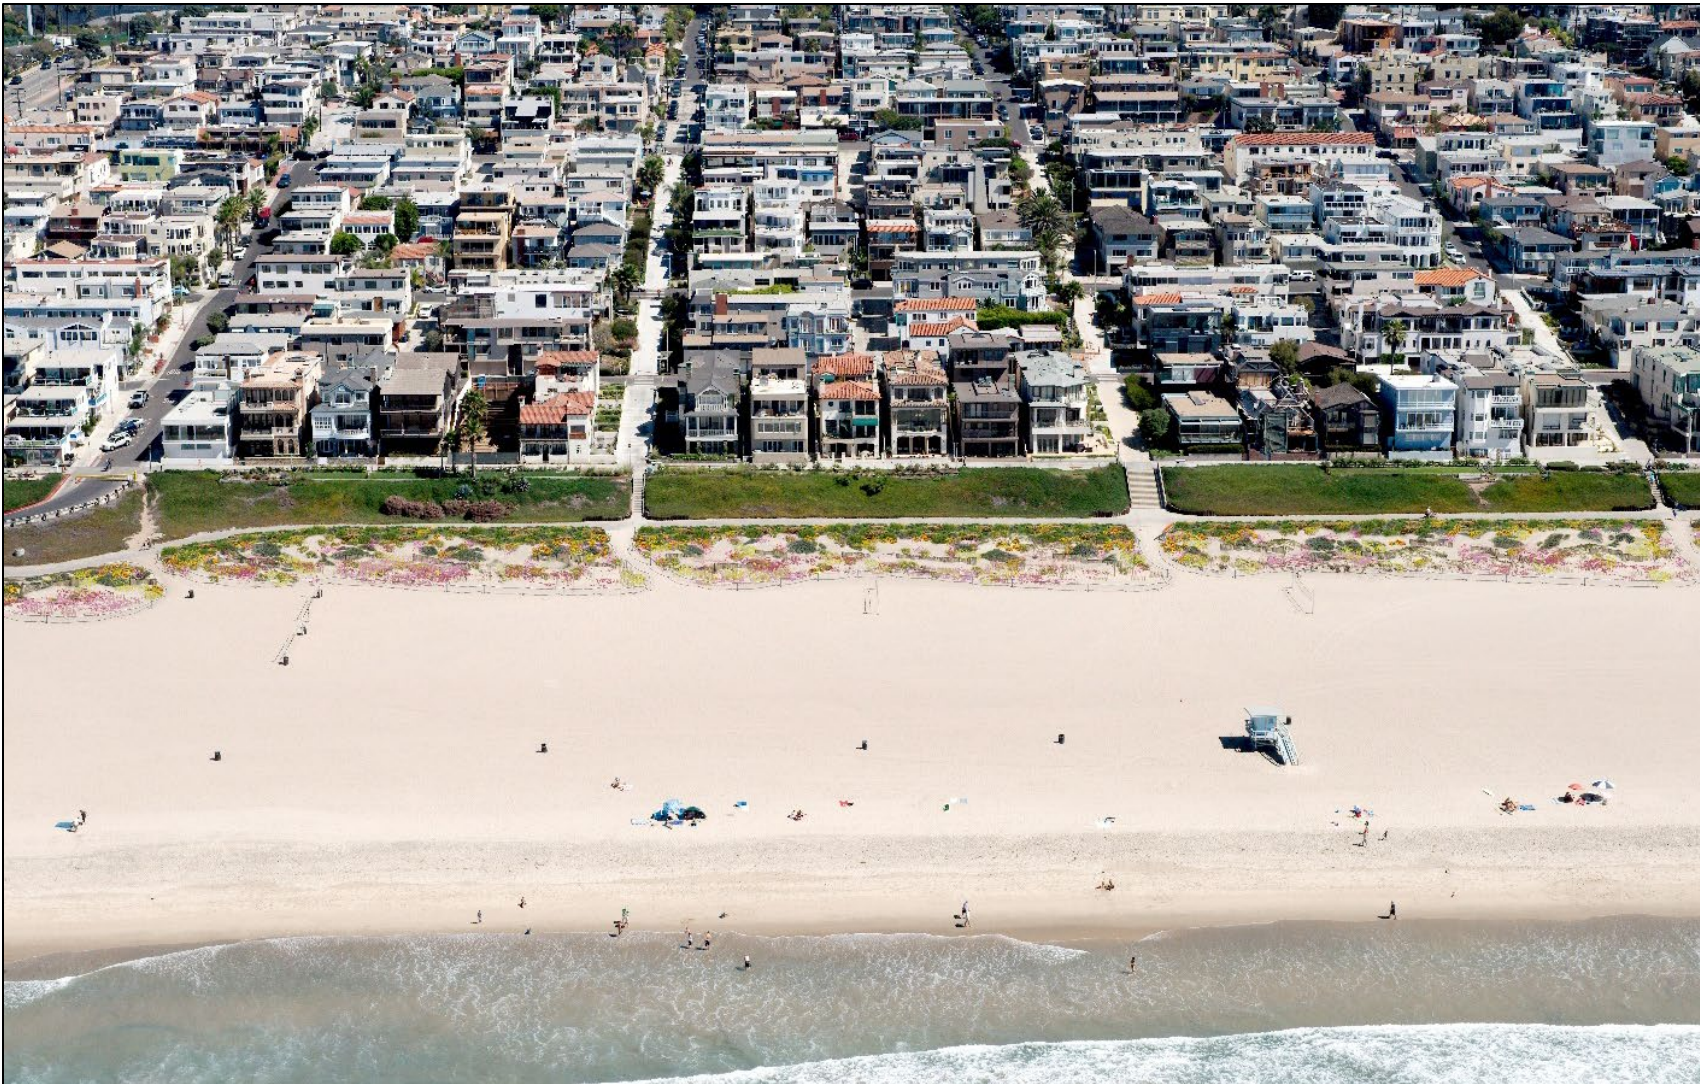
Figure 35. Artistic rendering of northern portion of the MBDR project area five years post-restoration (credit: RIOS).

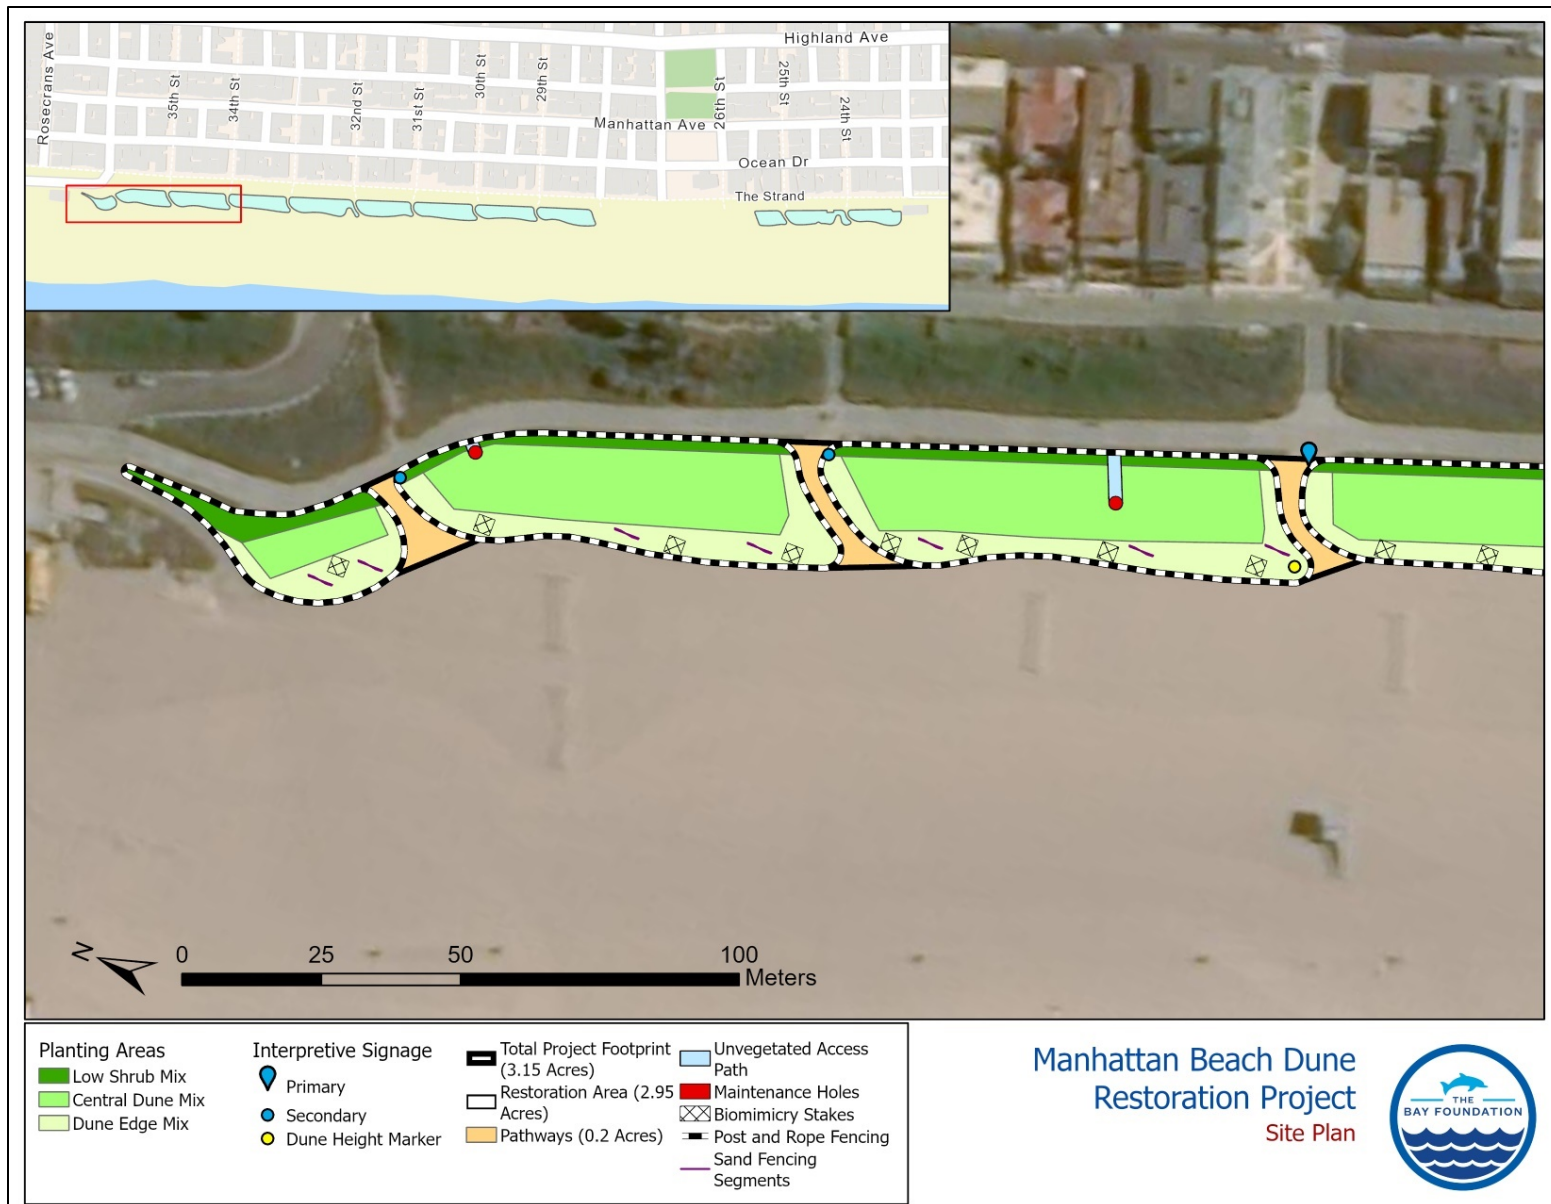
Figure 43. Project site plan (block 1 of 4) from 34th to 36th Street.

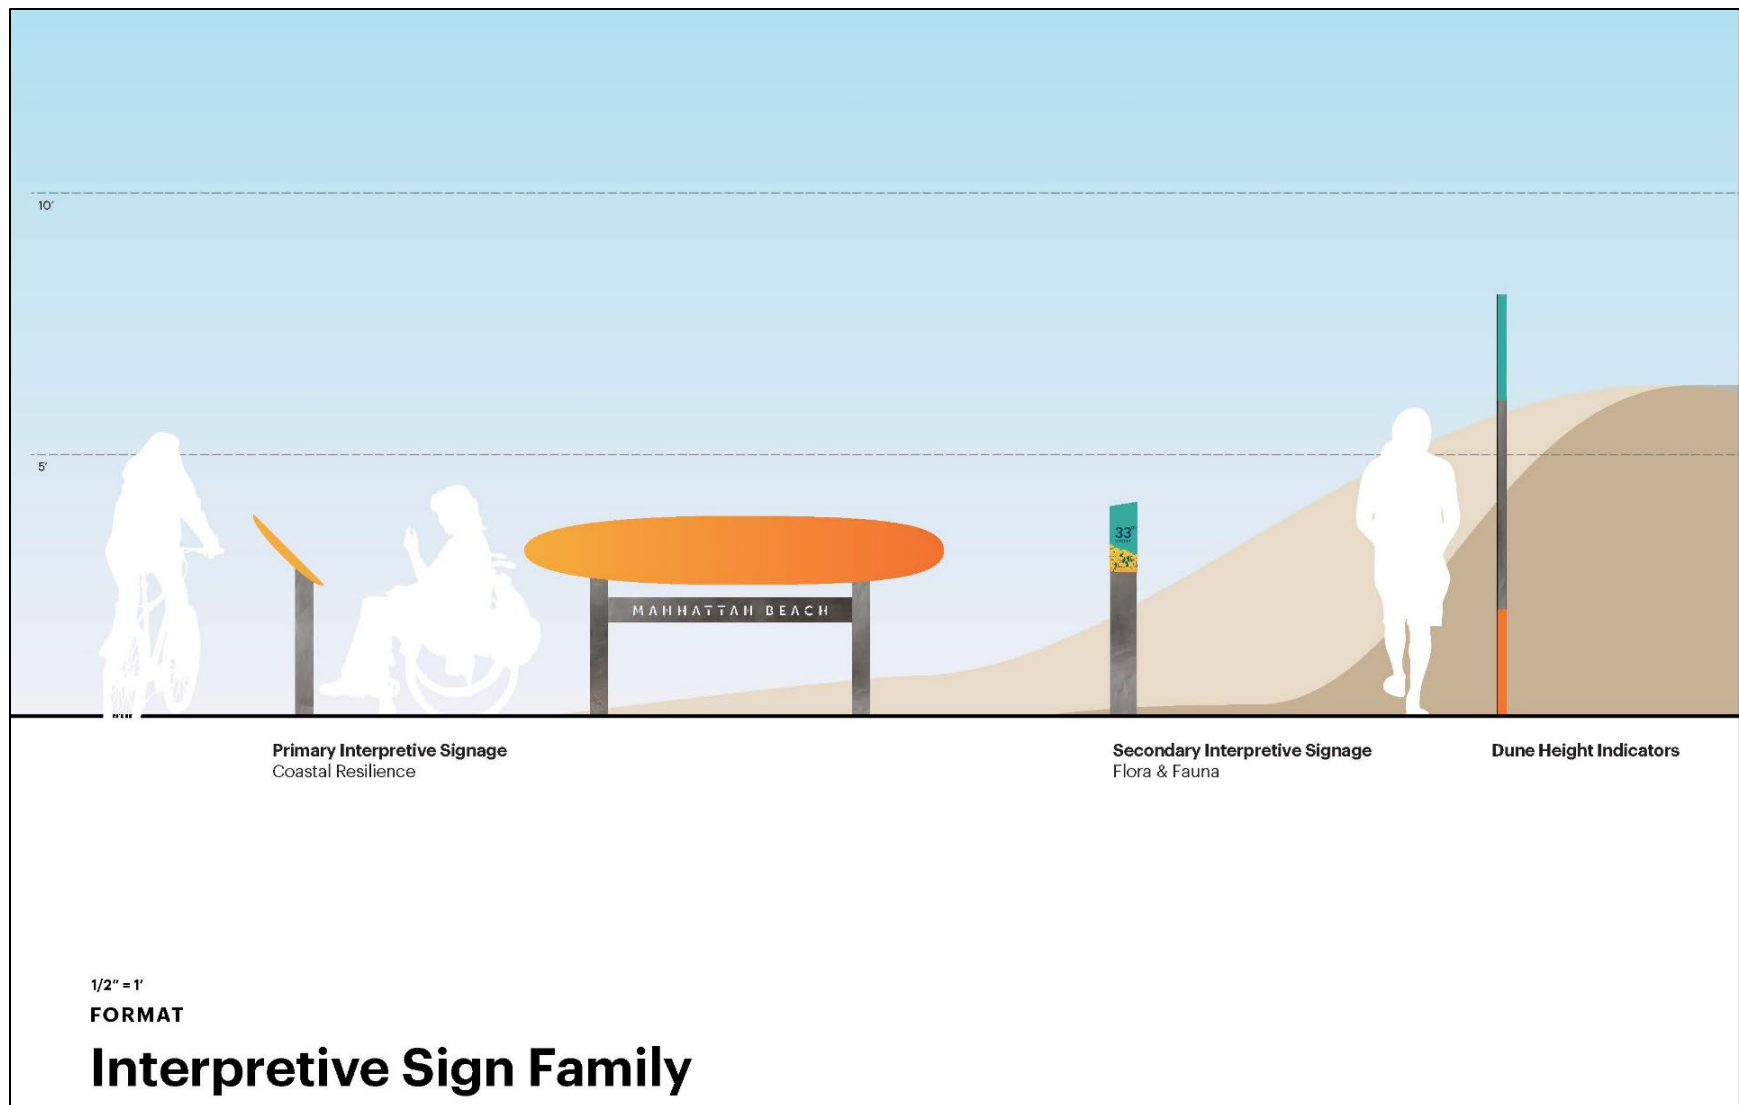
Figure 47. Interpretive signage overview. See Appendix 4 for full signage package.

Interpretive signs or exhibits offer stories that are designed to stimulate visitors' interest while challenging their imaginations, and present new perspectives on familiar topics. Interpretive signage will be installed at the project site and have been designed by the project design consultant team, comprised of RIOS and Coastal Restoration Consultants (e.g., Figure 47). Interpretive signage has been designed with guidance from the City of Manhattan Beach's style guide. Signage includes: one primary sign with a general overview of the project and dune ecology (content for the primary sign also includes a Spanish translation); small secondary signs to be situated adjacent in the site to major perpendicular streets with a description of various native flora relevant to the project and street numbers to be used as a navigational aid; and dune height indicators designed as an interactive element to allow beach visitors to track dune height over time. A minimum of one primary sign and four secondary signs will be installed, and others will be included pending funding availability. Signs were developed specifically for use in the MBDR restoration area to help engage the public with the site and to facilitate a unique opportunity for education and recreation on their way to and from the beach. Interpretive signs went through external public review including during workshops and by project partner teams. The full interpretive signage package can be found in Appendix 4.

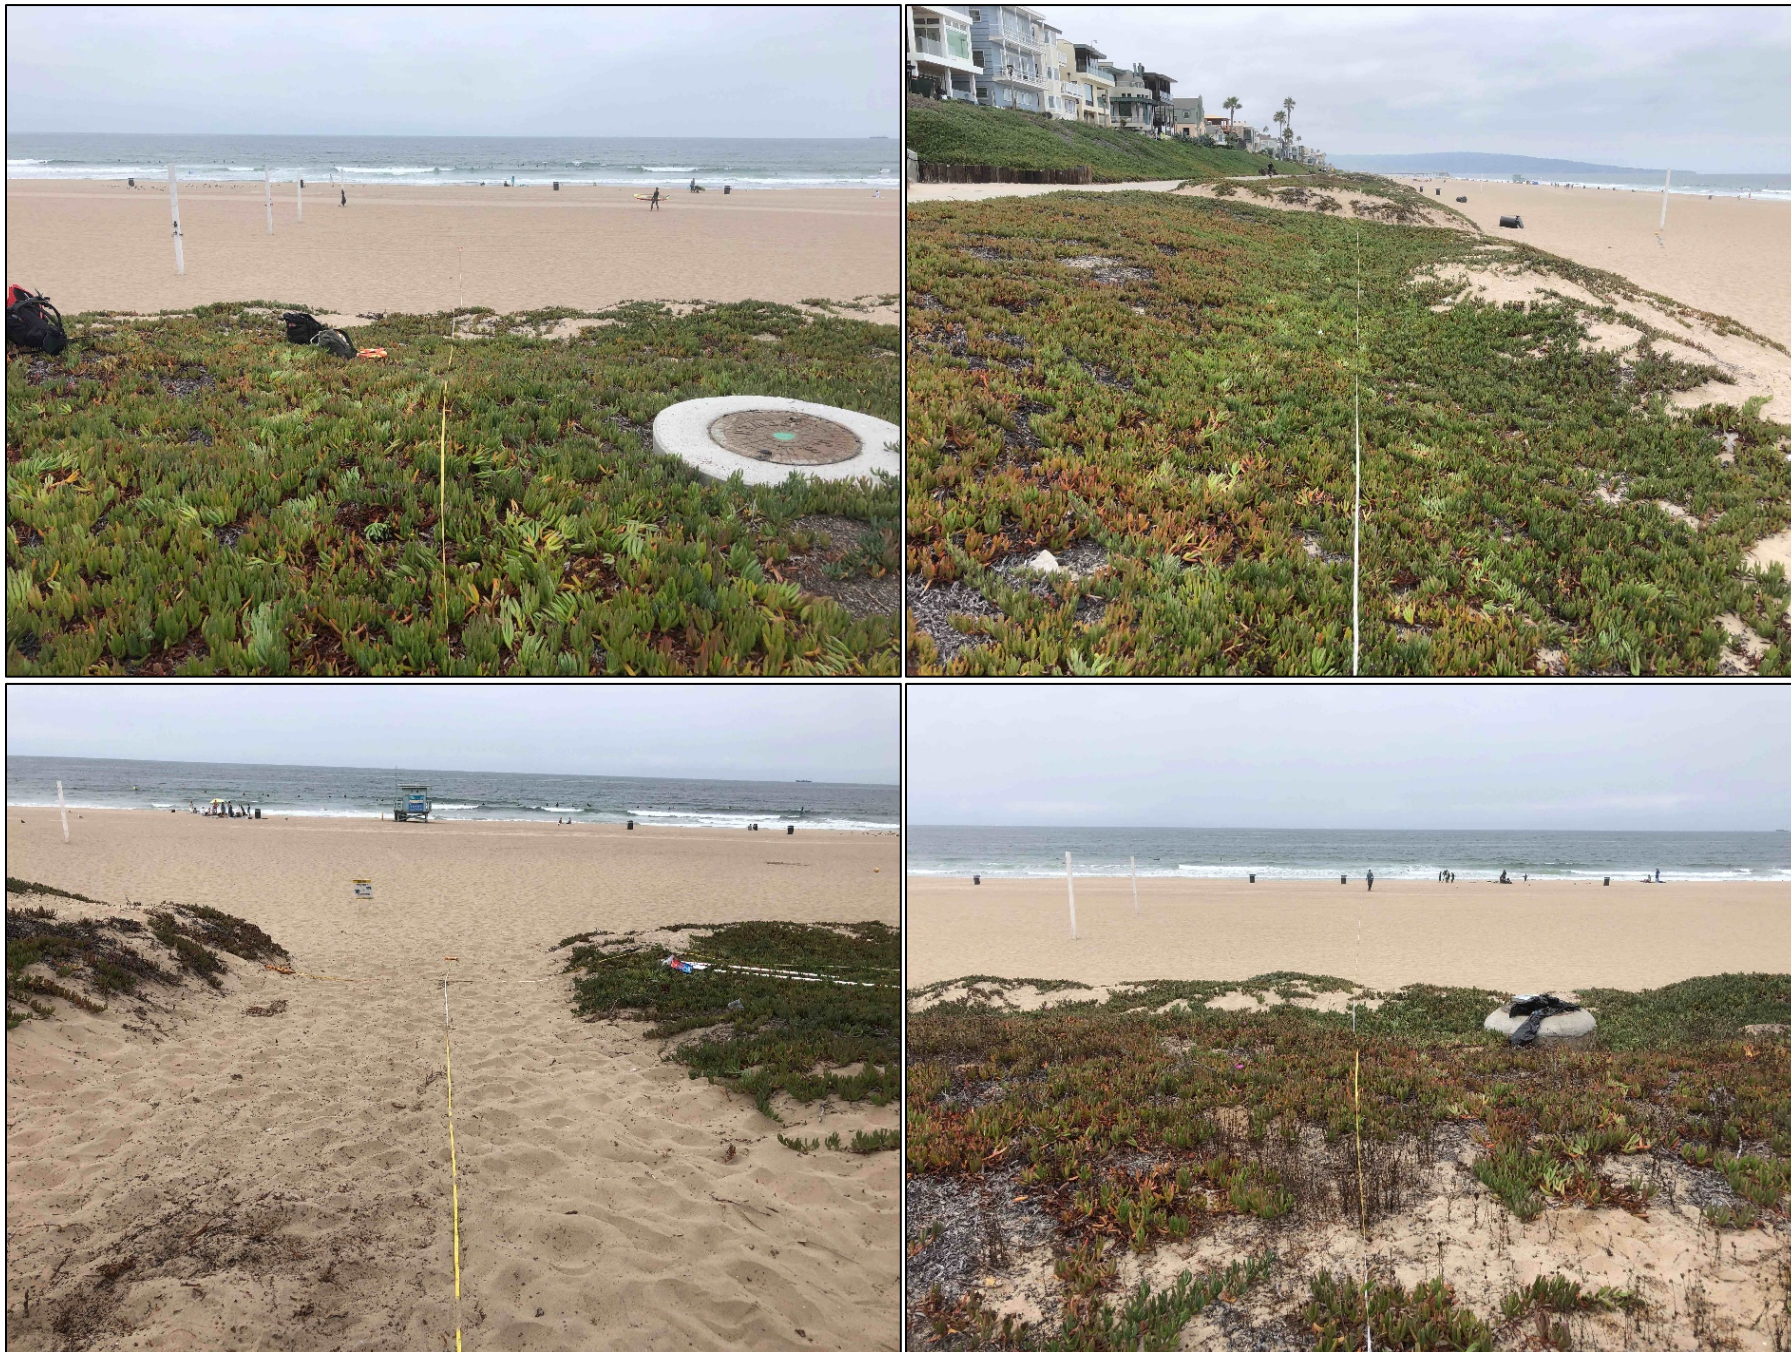
Photo Points T1 (top, left), T2 (top, right), T3 (bottom, left), and T4 (bottom, right) taken on 5 August 2020.

Additional georeferenced photo point pictures of the project area can be found in Appendix 2. Photos support results of the vegetation cover and elevation surveys, depicting existing degraded dunes dominated by invasive iceplant with some intermittent patches of native cover.

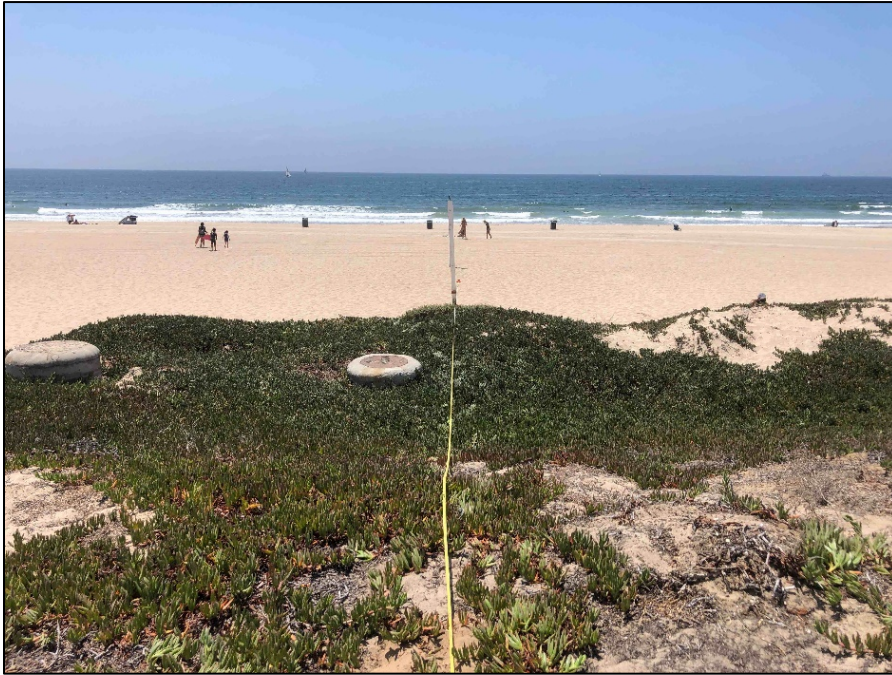
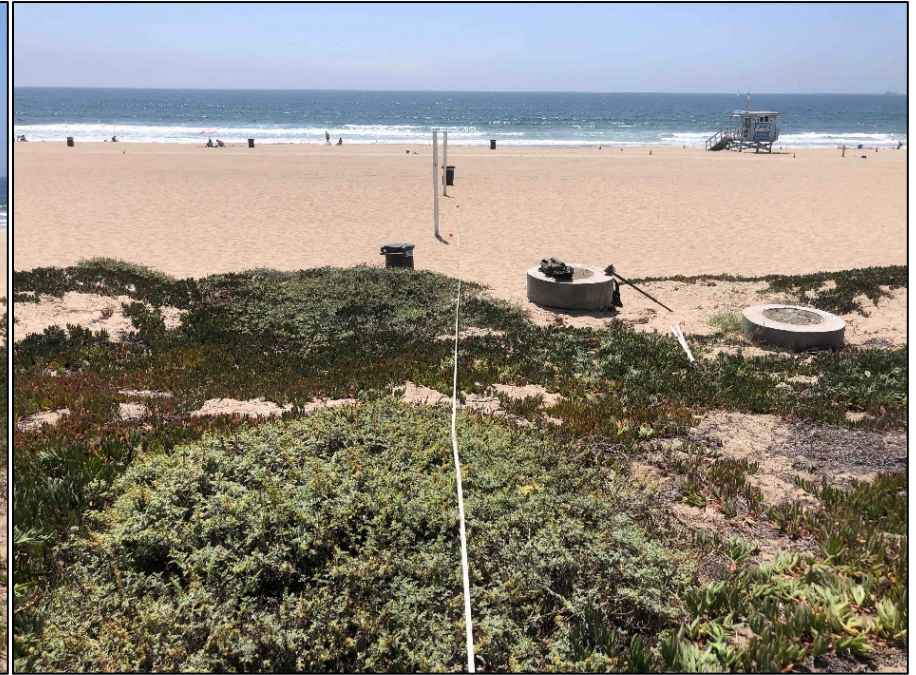
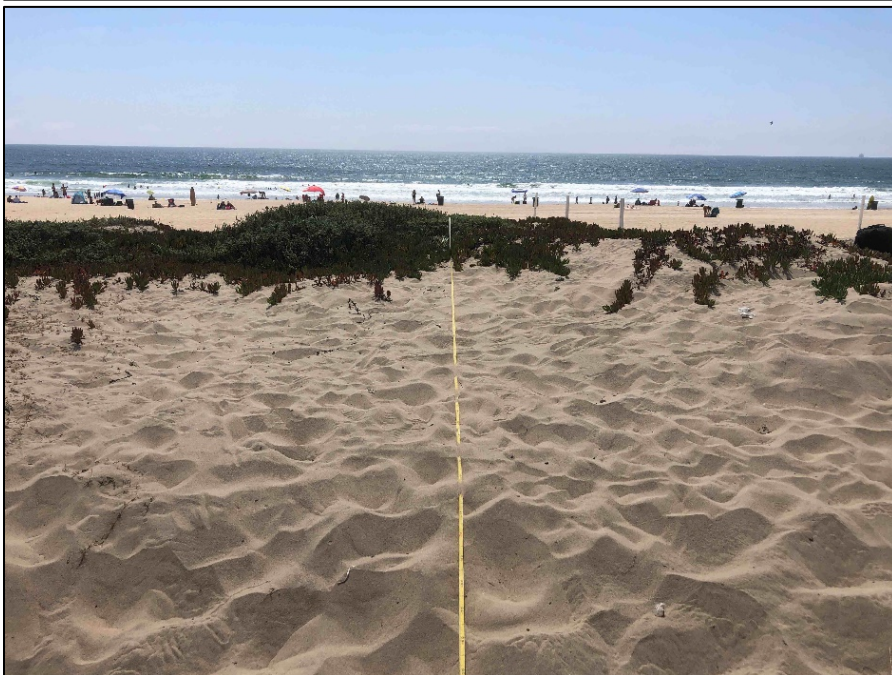
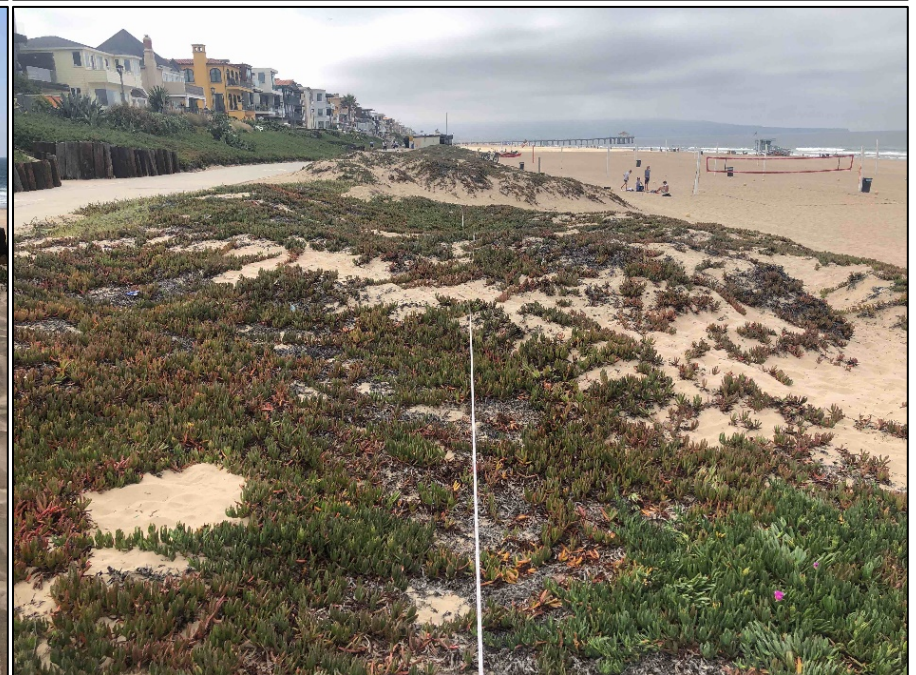
Photo Points T5 (top, left), T6 (top, right), T7 (bottom, left), and T8 (bottom, right) taken on 5 and 11 August 2020.

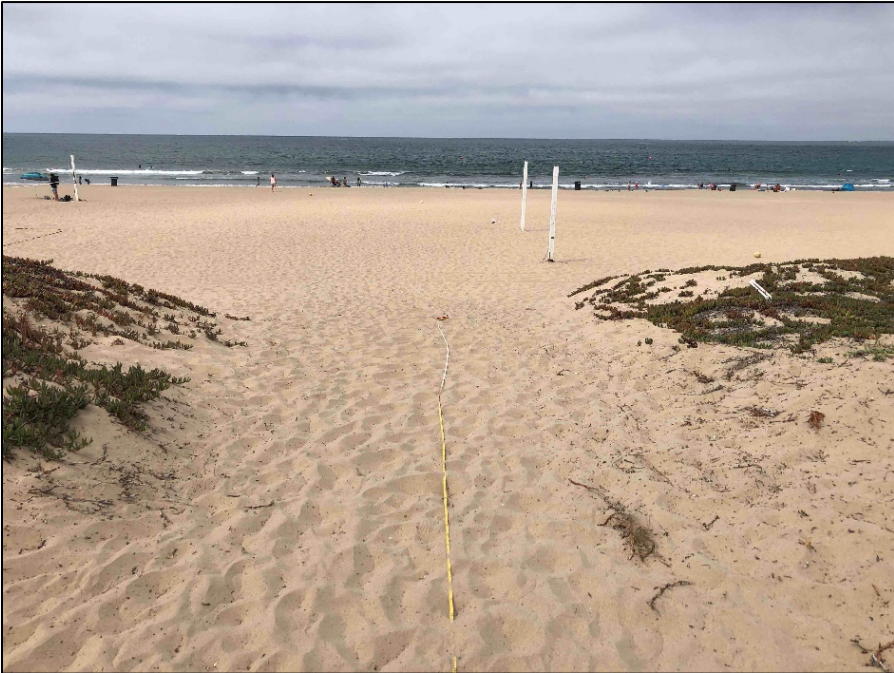
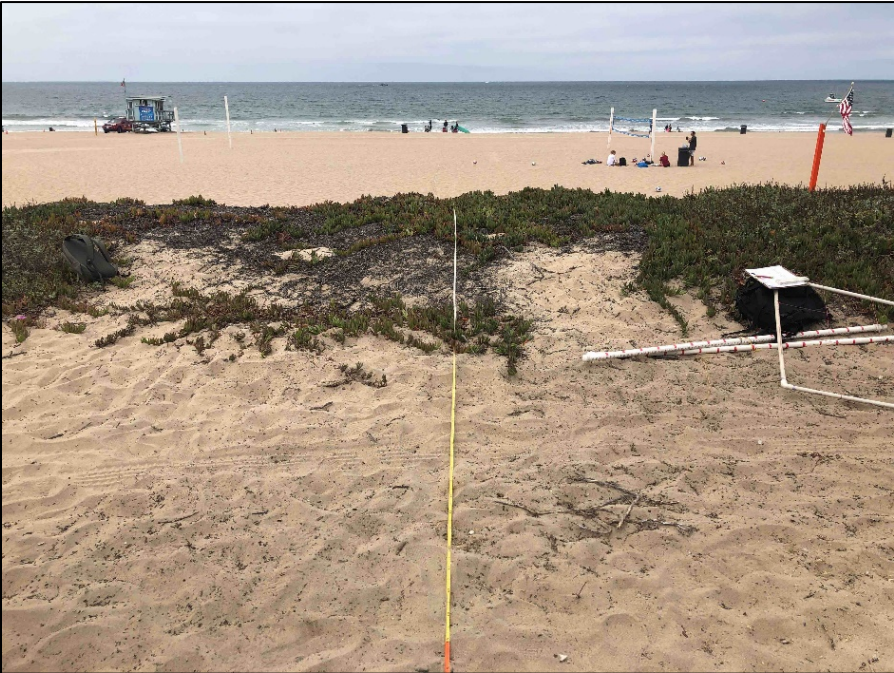
Photo Point T9 (left) and T10 (right) taken on 11 August 2020.
