Manhattan Beach Dune Restoration Project

Restoration and Monitoring Plan

July 2021

Karina Johnston, Chris Enyart, Maggie Jenkins, Sara Cuadra, and Dane Lazarus
The Bay Foundation

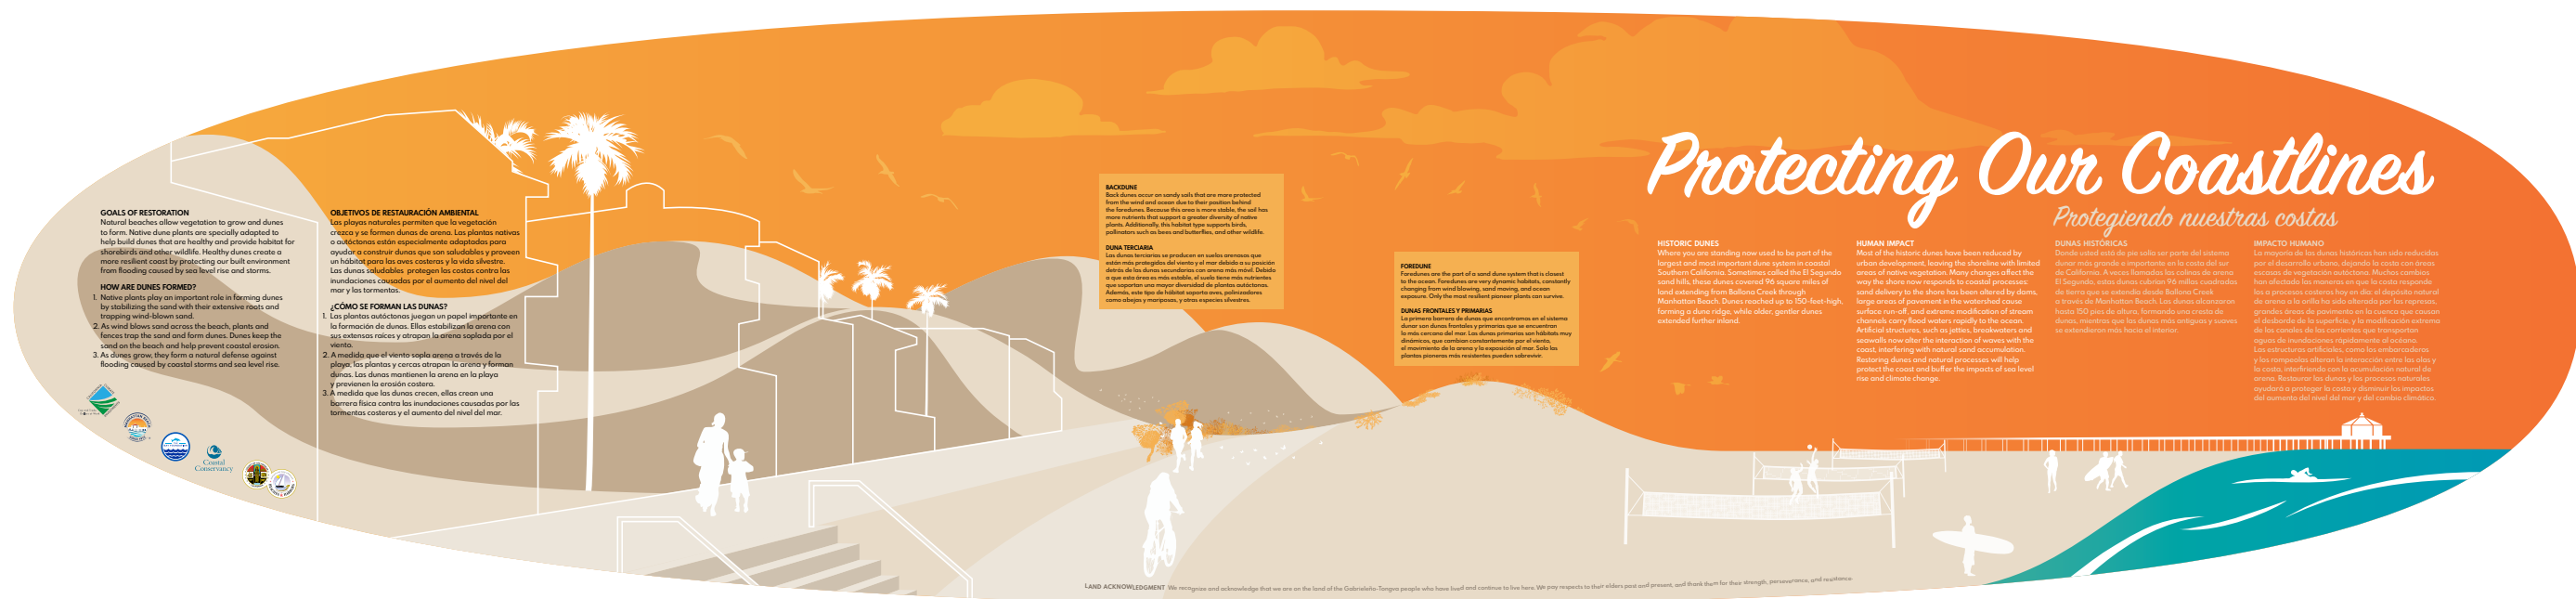
Interpretive Signage: Long Board

GOALS OF RESTORATION
 Natural beaches allow vegetation to grow and dunes to form. Native dune plants are specially adapted to help build dunes that are healthy and provide habitat for shorebirds and other wildlife. Healthy dunes create a more resilient coast by protecting our built environment from flooding caused by sea level rise and storms.

HOW ARE DUNES FORMED?
 1. Native plants play an important role in forming dunes by stabilizing the sand with their extensive roots and trapping wind-blown sand.
 2. As wind blows sand across the beach, plants and fences trap the sand and form dunes. Dunes keep the sand on the beach and help prevent coastal erosion.
 3. As dunes grow, they form a natural defense against flooding caused by coastal storms and sea level rise.
