Class II, Type 11 Site Plan

1.6 Project Description: The Florida Highway Patrol Test Track Facility is a new construction project in Gadsden County. The purpose of the survey is to provide existing site conditions for design of new test track facility. The site is a 180 +/- acres of recently cleared planted pines.

Florida Highway Patrol Test Track Facility located
at the Pat Thomas Law Enforcement Academy

FPID: 439931-32-01
Section No.: 50000000

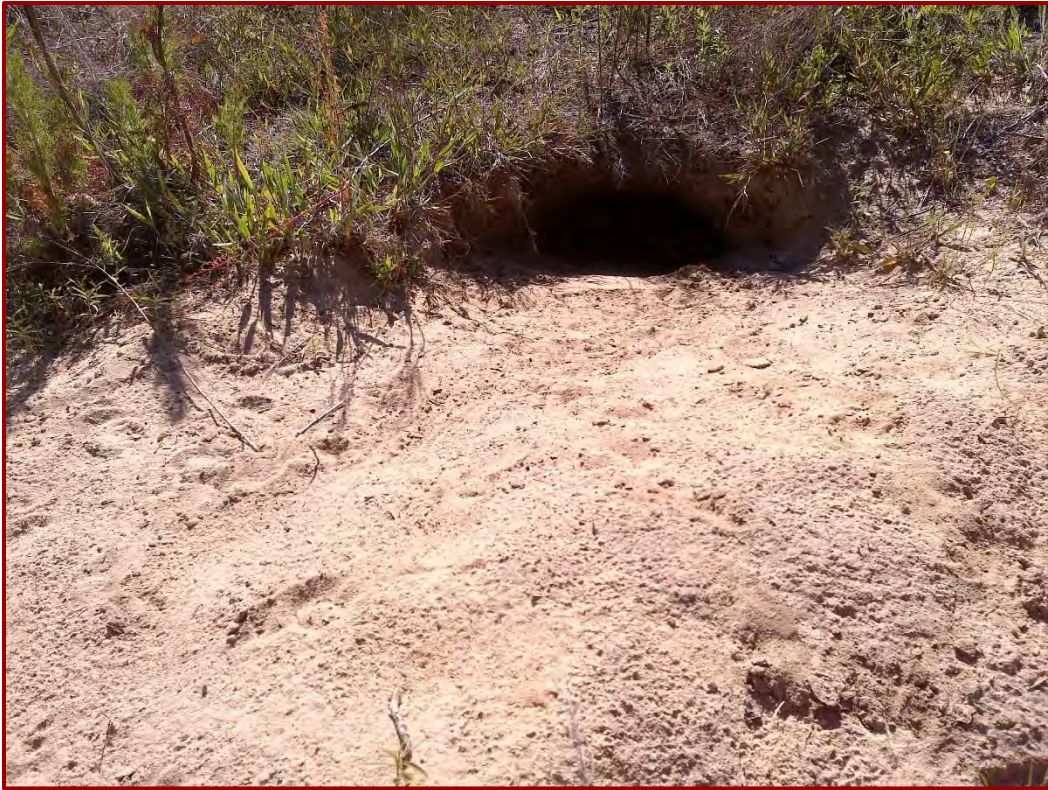
TYPICAL PHOTO OF GOPHER TORTOISE BURROW

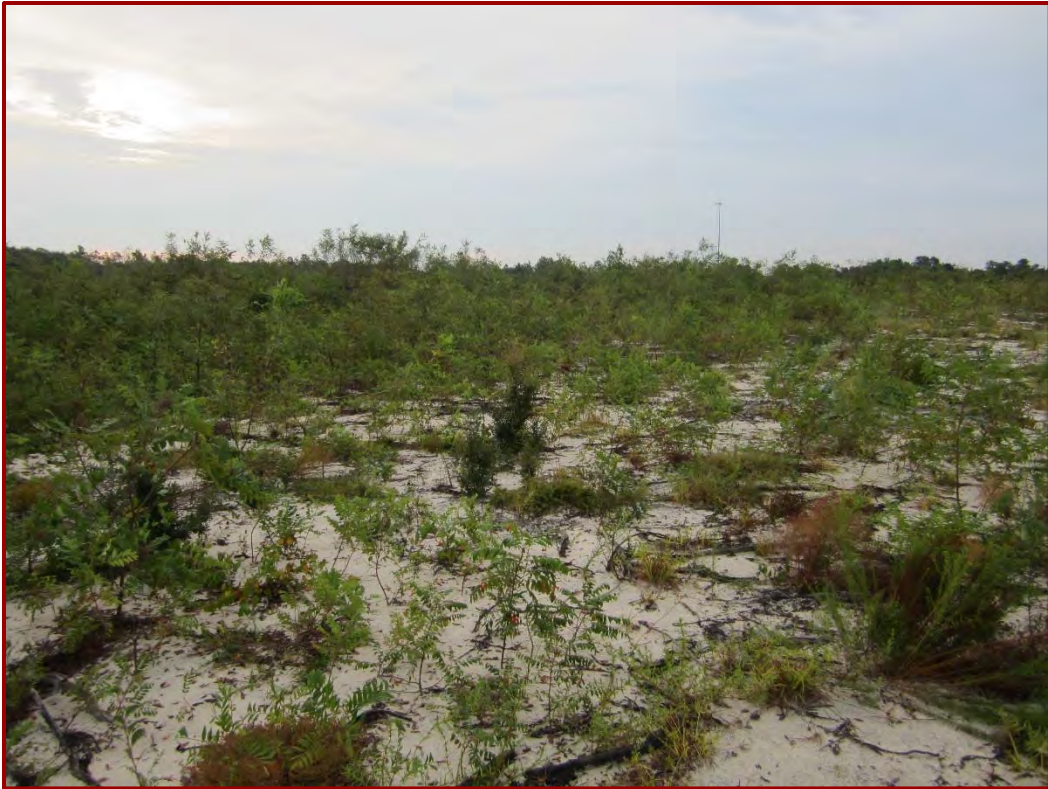
PHOTOGRAPH OF TYPICAL GOPHER TORTOISE HABITAT TAKEN AT LOCATION OF ONE BURROW.

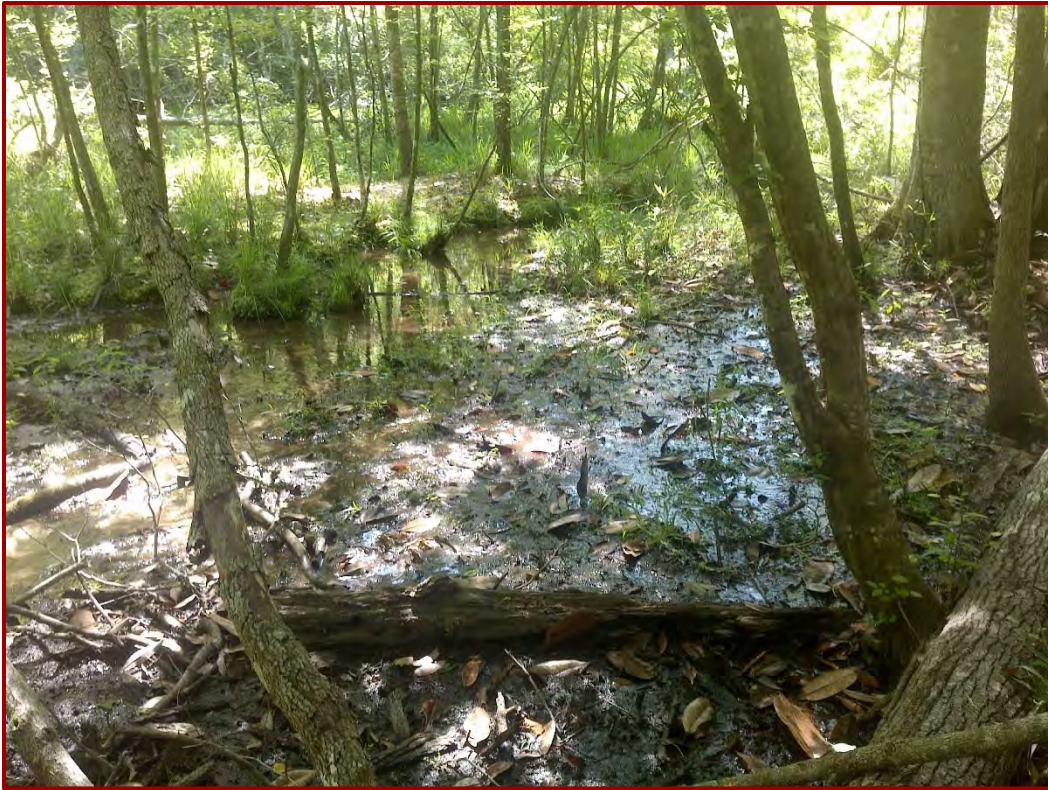
PHOTOGRAPH OF WETLAND LOCATION AT NORTH EAST CORNER OF PARCEL.

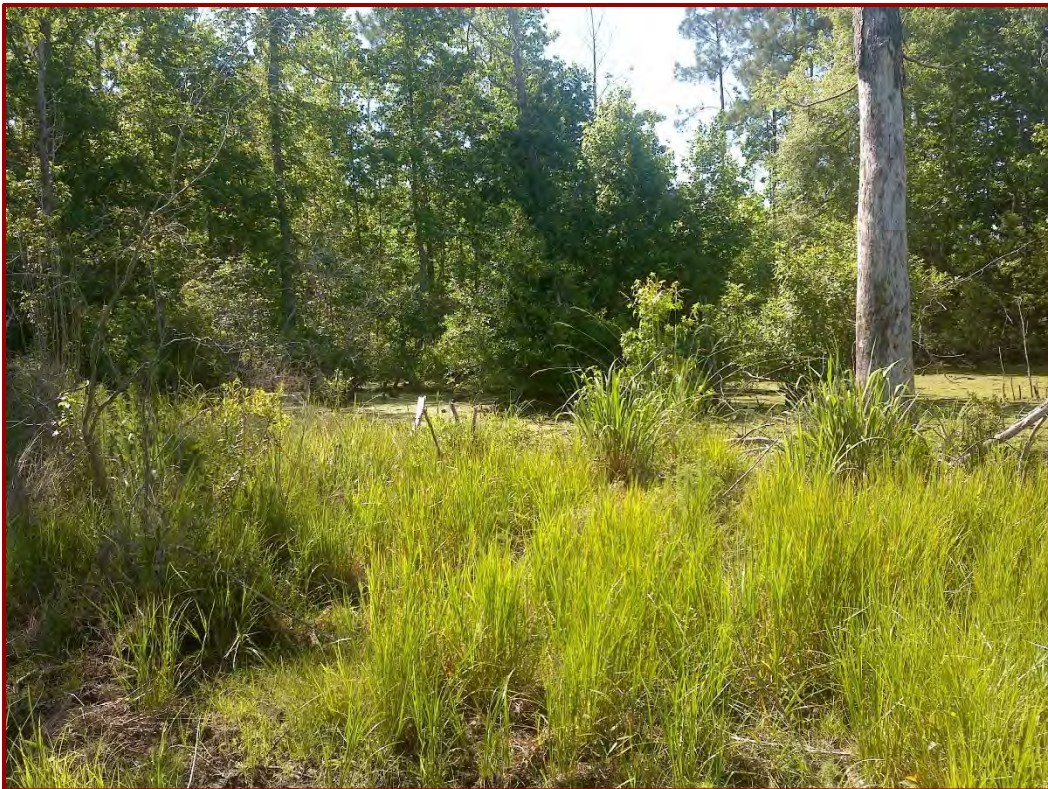
PHOTOGRAPH OF CRESCENT SHAPPED WETLAND LOCATED AT CENTER OF PROPERTY.

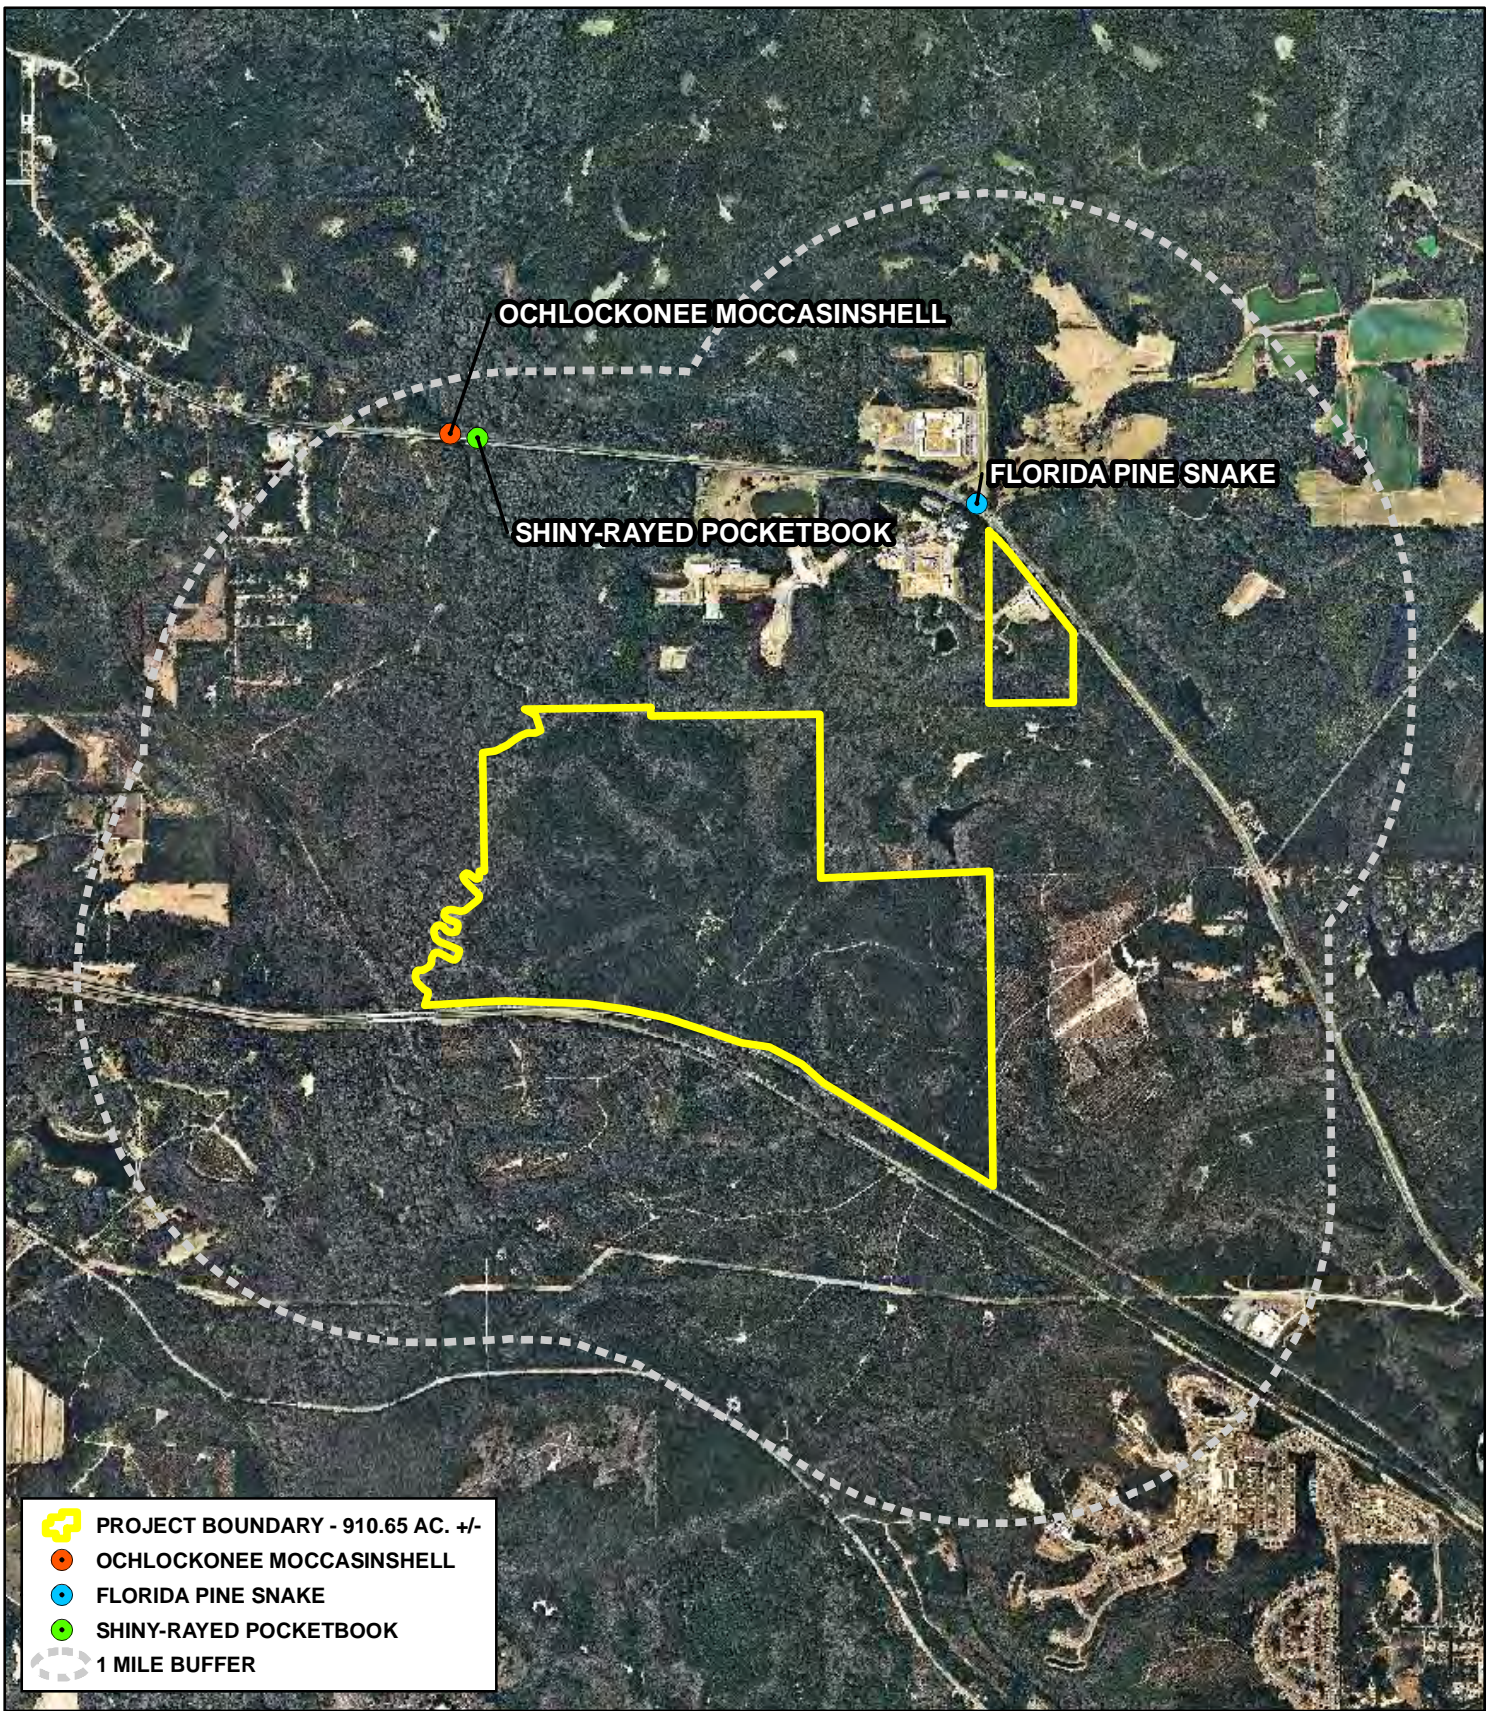
Figure 6 - FNAI Map
Florida Public Safety Institute
Gadsden County, Florida

The results of the FNAI database search identified three listed species occurrences previously observed within a one-mile radius of the project site (**Figure 6**). These species included the FNAI-listed Florida pine snake (*Pituophis melanoleucus mugitus*), Ochlockonee Moccasinshell (*Medionidus simpsonianus*), and the Shinyrayed Pocketbook (*Lampsilis subangulata*). These species were not observed during our site assessment.
