Cefn Cynfal, Llanddewi Ystradenni Powys Historic Environment Appraisal

Report by: Trysor

For: Seren Energy

April 2014

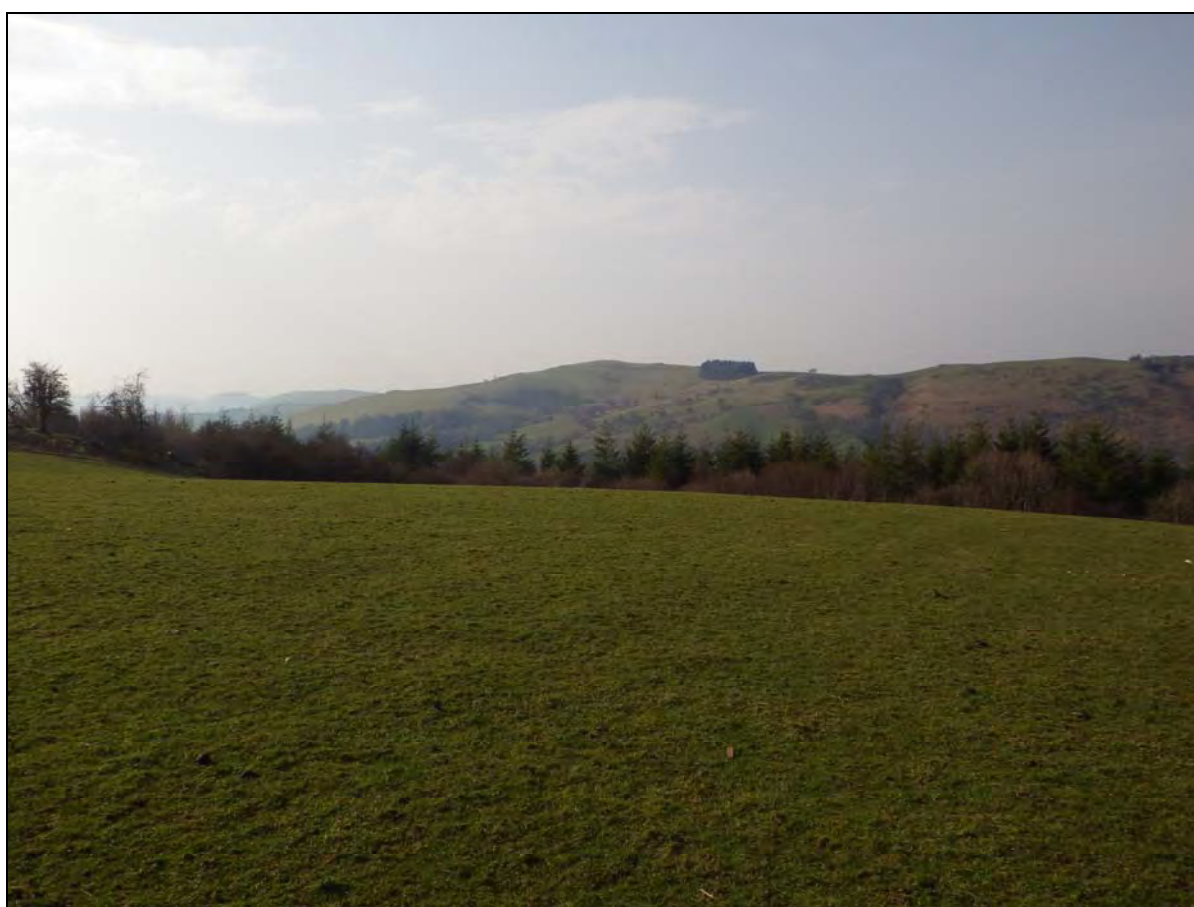
Cover photograph: From the approximate location of the proposed turbine, looking northwest towards the hillforts of Gaer and Cwm Cefn y Gaer.

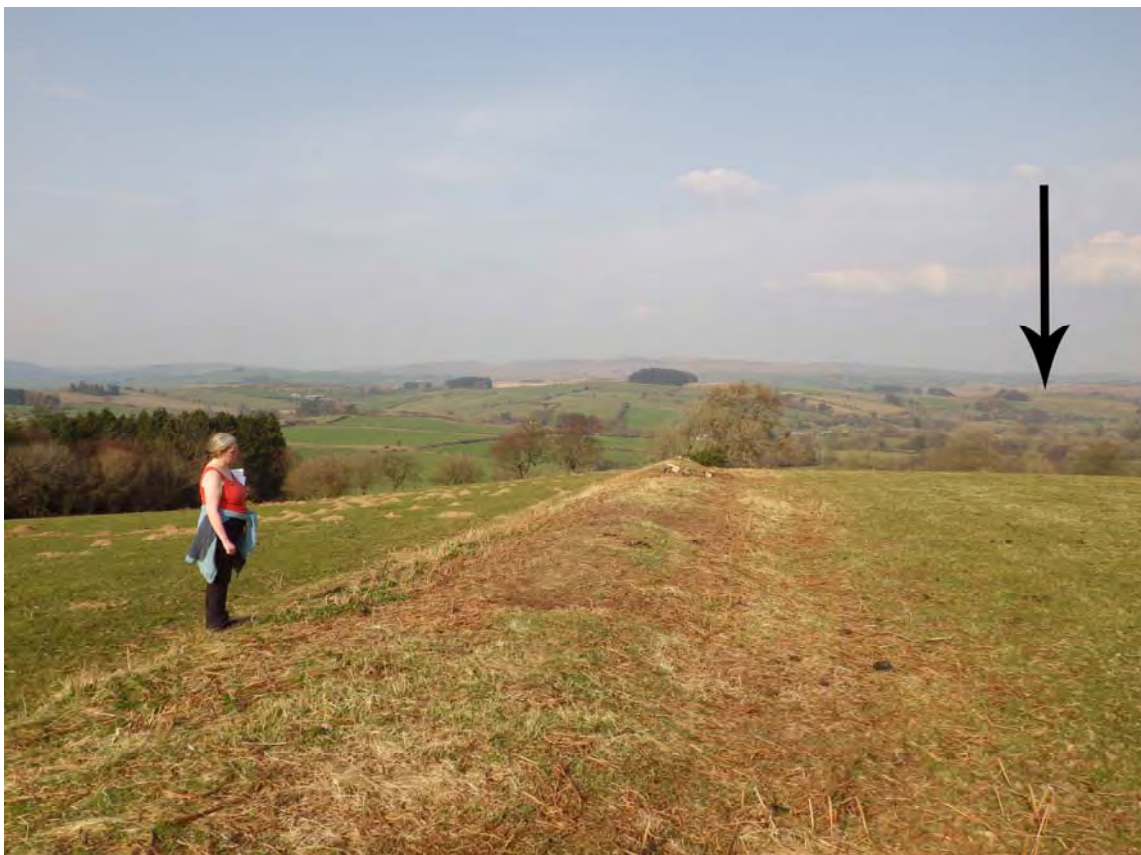
Plate 1: The arrow marks the location of the Cwmharan hillfort, looking east-northeastwards from boundary bank ID number 13 at the proposed turbine site.

10.2.3 The development would only cause a Low, indirect, visual impact for this hillfort as the two locations are over 2km apart.

10.2.4 The turbine would not affect local views of the hillfort and would not affect its essential setting.

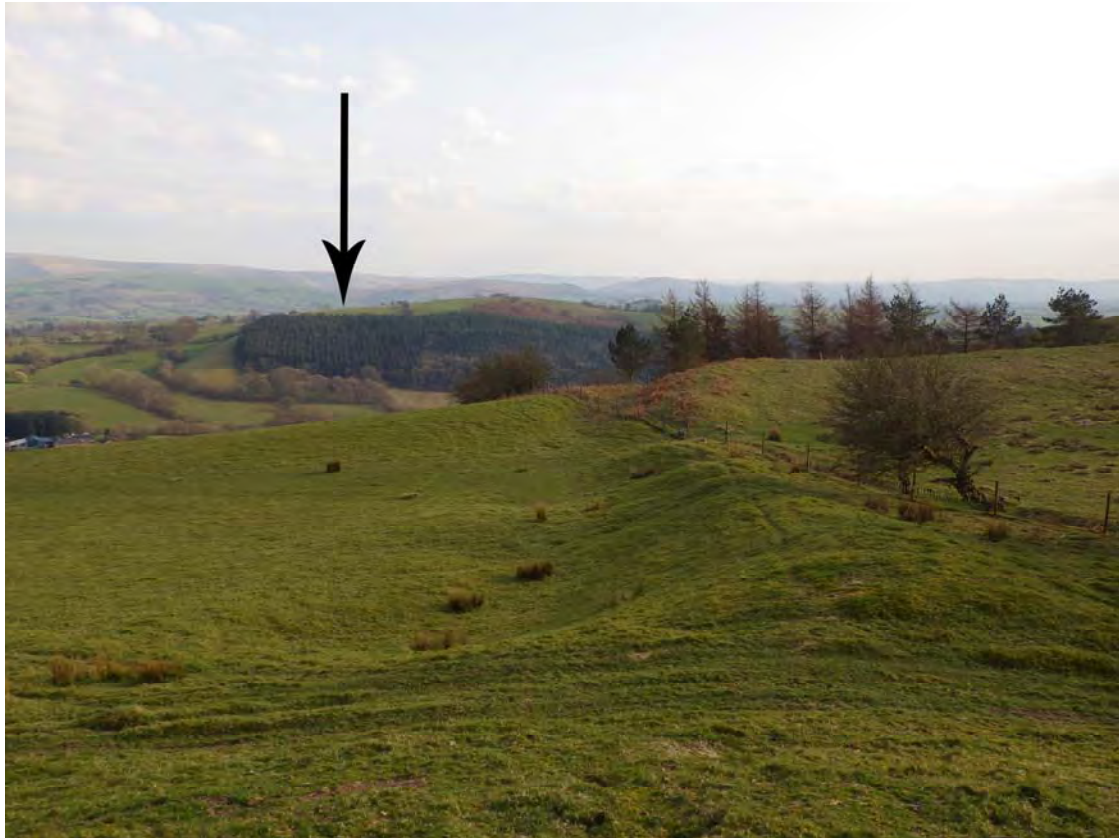
Plate 2: The view south from the eastern entrance into Cwm Cefn y Gaer hillfort. The arrow marks the proposed turbine site.

10.3.4 Overall, the development would have a Moderate impact on this hillfort. This is largely due to the indirect, visual impact caused by the relatively close proximity of the turbine, at just over 1km. The turbine would be clearly visible from within the south half of the hillfort enclosure.

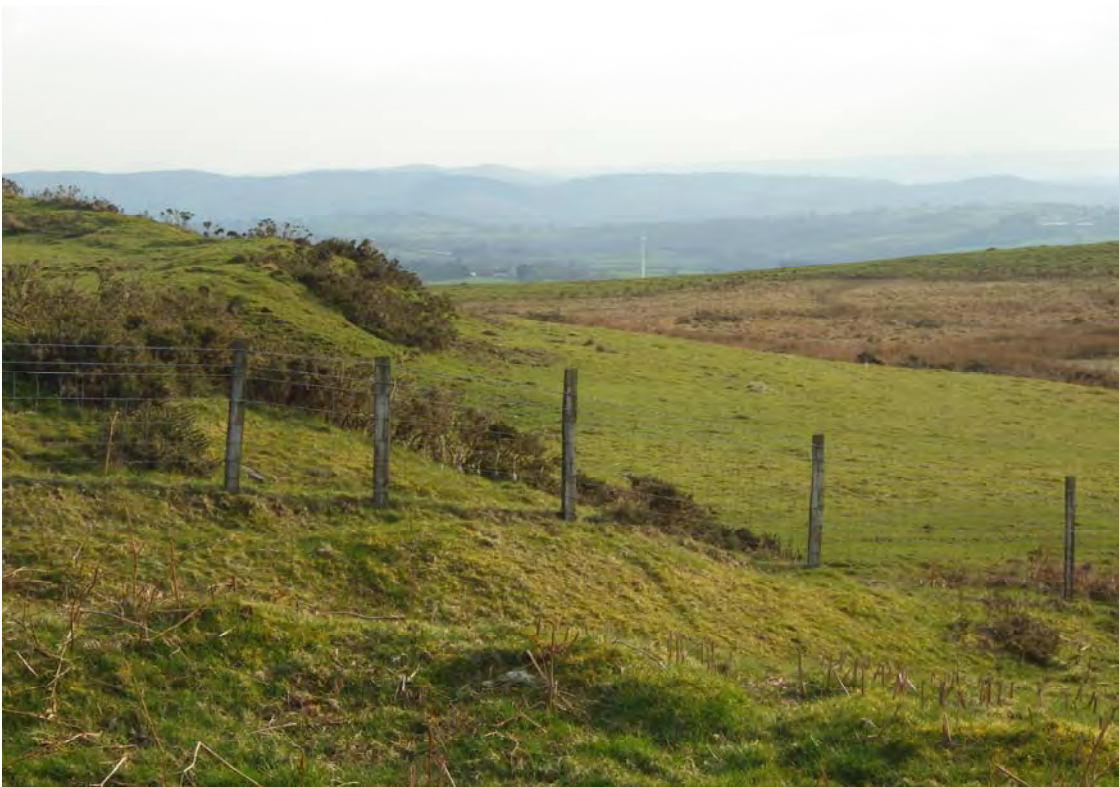
Plate 3: The view south from the western entrance into the Cwm Cefn y Gaer hillfort. The Cefn Cynfal site would not be visible from here, but the existing Dolidre turbine can be seen below.

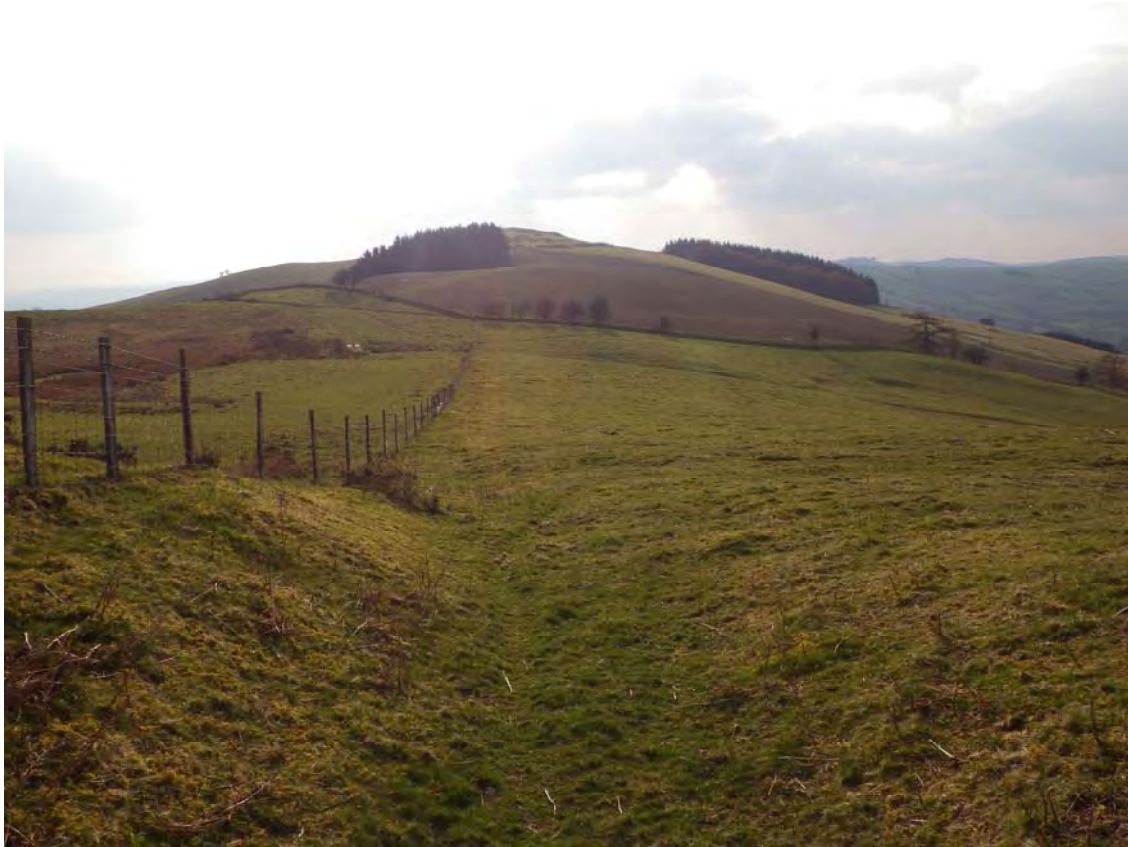
Plate 4: The view westwards from the western entrance of Cwm Cefn y Gaer hillfort, looking towards Gaer. The stronger defences on the northern side of the Gaer hillfort can be seen.

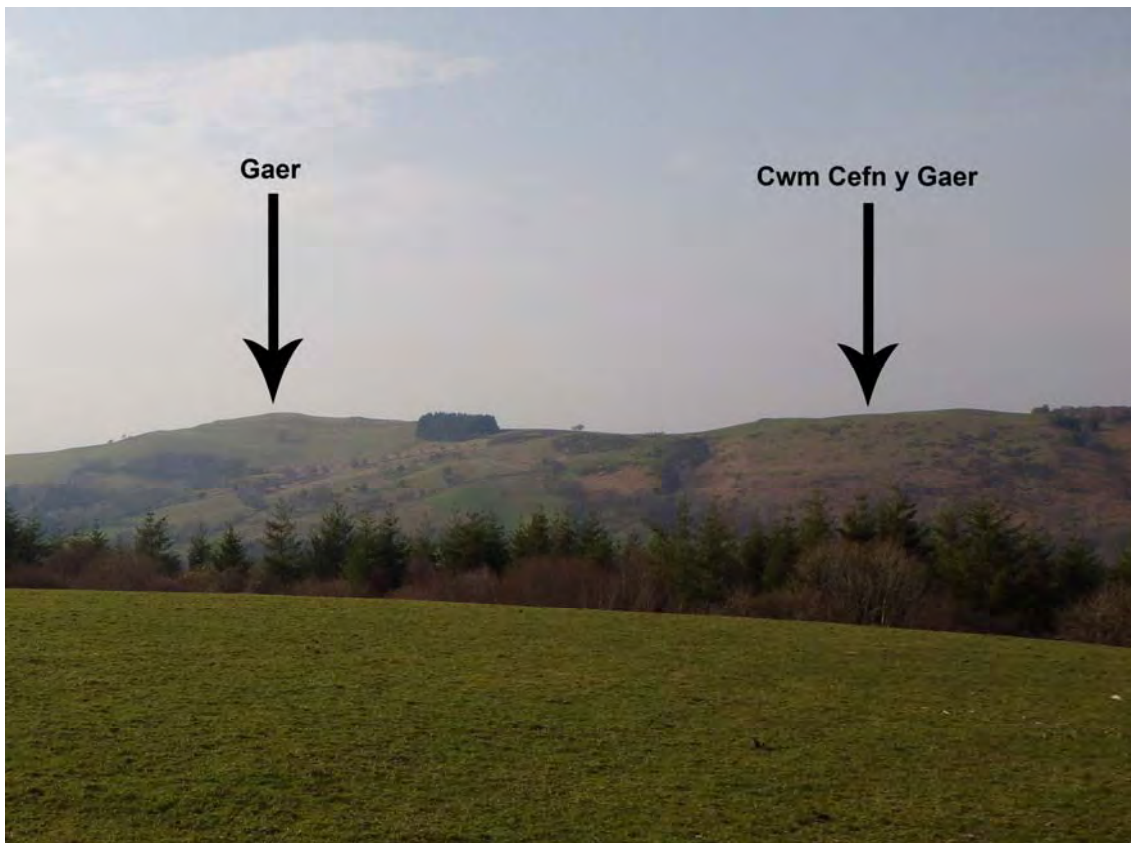
Plate 5: The arrow marks the location of the Gaer and Cwm Cefn y Gaer hillforts, looking north-northwest from the proposed turbine site.

10.4.4 Overall, the development would have a Moderate impact on this hillfort. This is largely due to the indirect, visual impact caused by the relatively close proximity of the turbine. The turbine would be visible from within the southern and eastern sides of the hillfort enclosure.

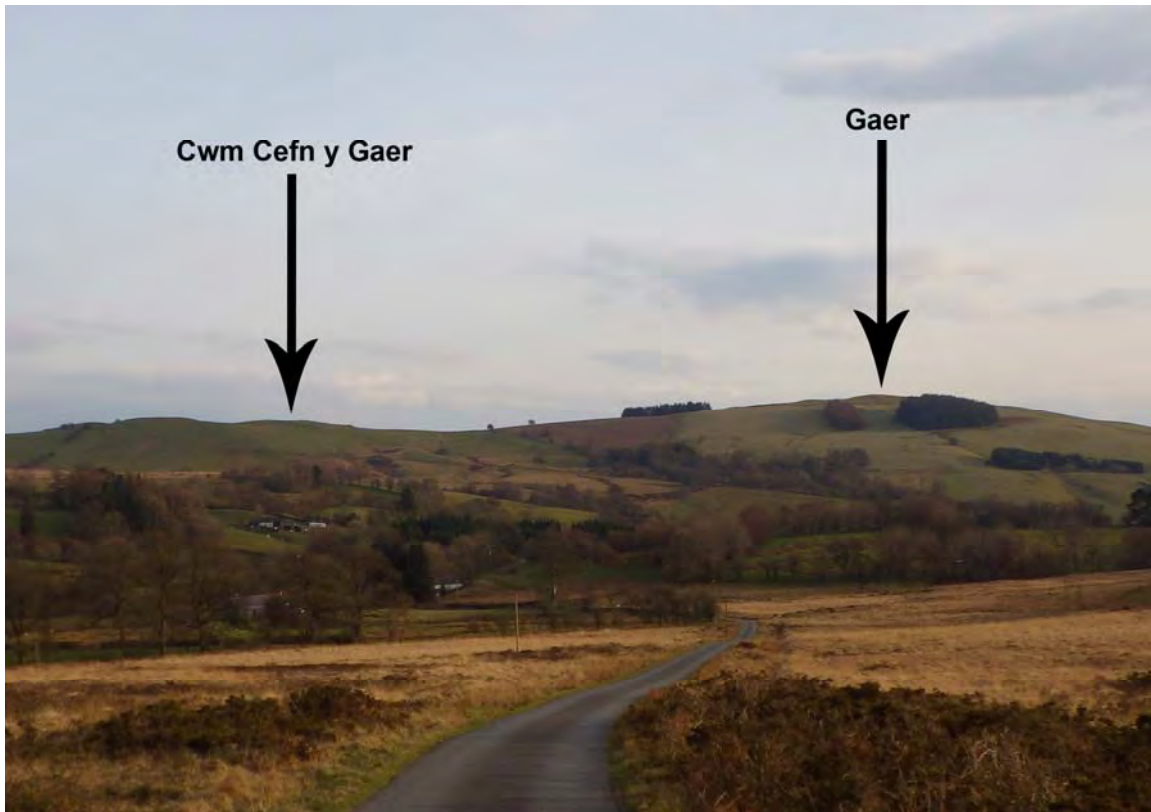
Plate 6: The arrows mark the location of the Gaer and Cwm Cefn y Gaer hillforts, viewed from the north.
