Stream Corridor Riparian Area Restoration

Oklahoma Conservation Commission

**EPA FY 2003 104(b)(3) Wetlands
CD976400-01-0, Project 2**

**September 2008
Draft Final Report**

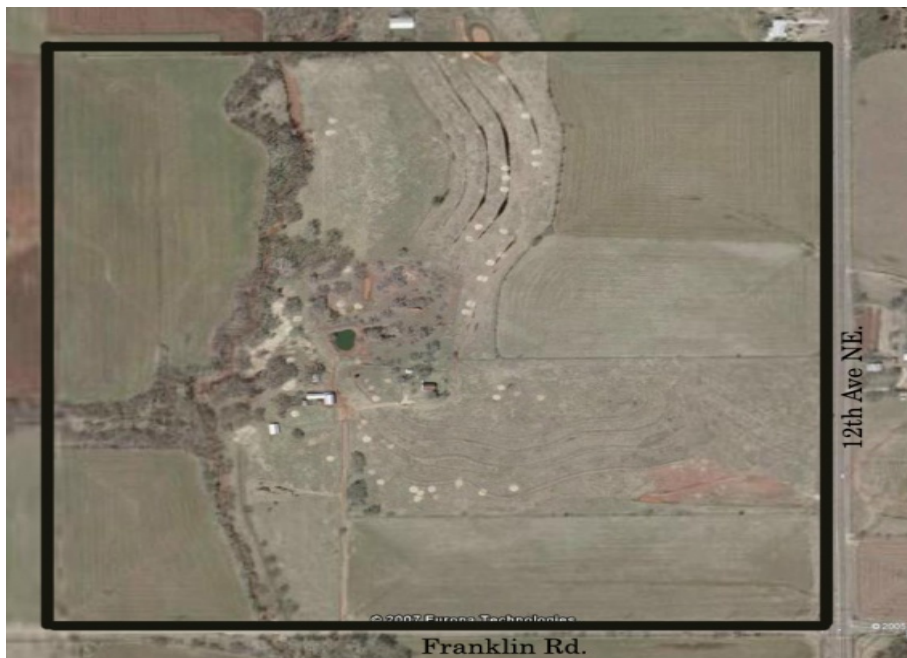
This property was originally purchased by the City in 2003 for a new 2.5- 4.5 MGD Wastewater Treatment Plan (WWTP). Those plans have since been shelved. The project site is situated northwest of the intersection of 12th Ave. NE and Franklin Road. Total site area is approximately 160 acres. The site is bordered by Franklin Road on the south, 12th Ave NE. on the east and agricultural farm lands on the west and north. The property can be described as the Southeast Quarter of Section 5, Township 9N, Range 2W of the Indian Meridian, Cleveland County, Oklahoma.

Approximately one half of the site is located within the 100-year floodplain. These areas compose approximately 80 acres located in the southern one third and western one third of the property. The floodplain designation is zone A or areas of flooding during the 100-year event with an undetermined flood hazard factor.

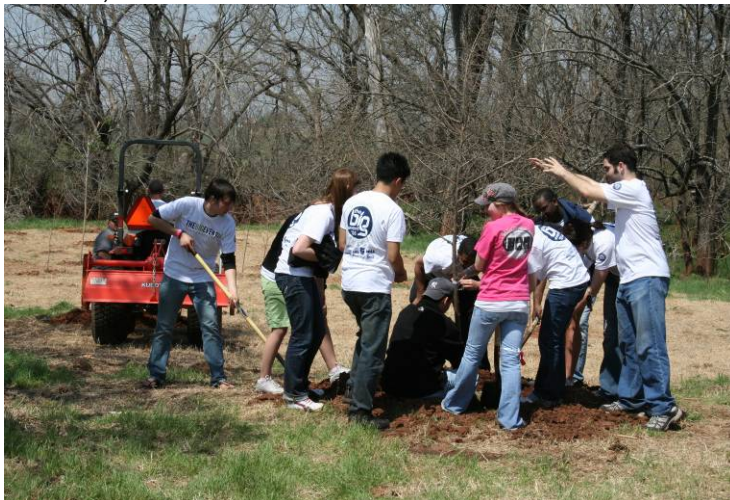
After removing the cattle and initial site clean-up, a restoration plan was developed for the stream corridor riparian area. The plan (Appendix B) calls for the development of a riparian area consisting of three zones projecting out from the stream to a distance of approximately 100 feet. Zone 1 (~5 acres) consists of the first 15-30 feet closest to the stream and is comprised of native riparian tree species to central Oklahoma. This zone is the most important for stabilizing the streambank and riparian area. Zone 2 (~18 acres) is an intermediate zone consisting of a mixture of native trees and shrubs

ranging from 60-110 feet wide where active management may take place. Its purpose is to provide the necessary contact time and carbon energy resource for buffering to occur, as well as long term storage of nutrients in the forested areas. Zone 3 (~60 acres) consists of native grass species and is designed for runoff control and provides sediment filtering, nutrient uptake, and the space necessary to convert concentrated flow to uniform, shallow sheet flow.

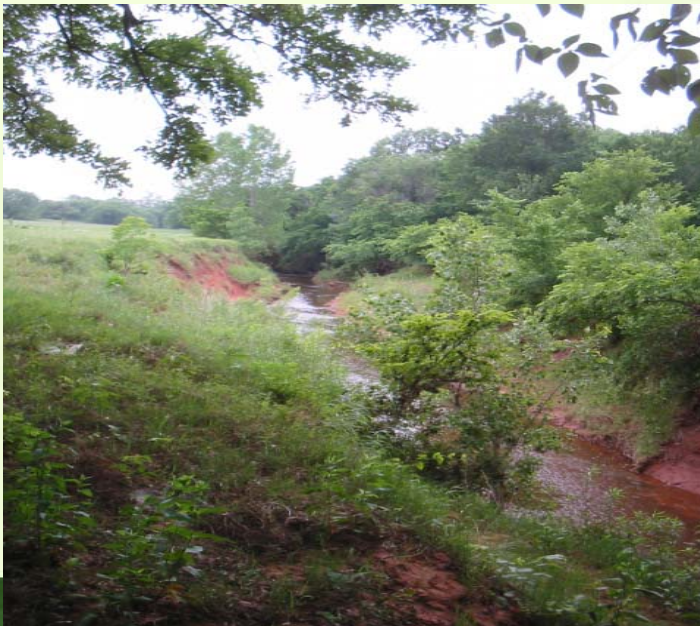
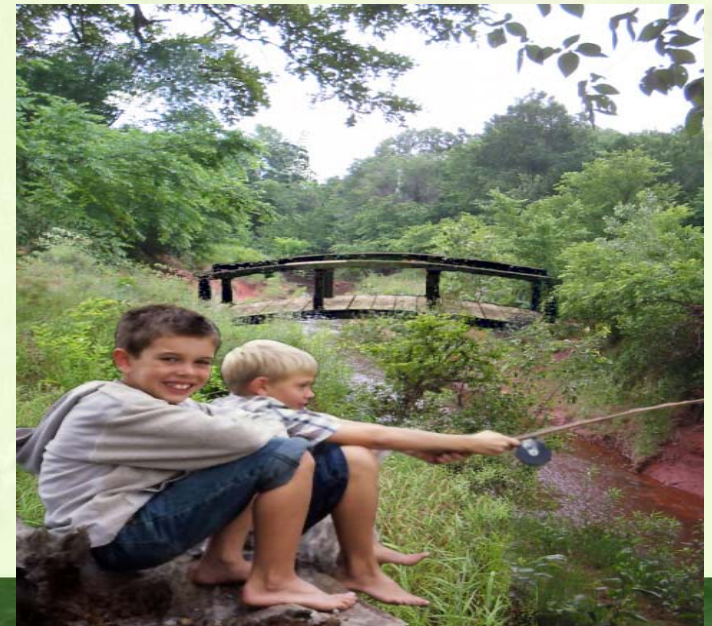
The layout to the right demonstrates what is planned to be in place by the end of the grant period for this project. Below are a "before" and a desired photo-shopped "after" picture of one aspect for this phase of the project.

1. Planting along the channelized portion of the river on the north side of the property. Plants will mainly include native hardwood species and grasses.
2. Construction of walking trails as a loop from the barn to northern boundary of the property and back to the barn.
3. Planting of native grass species on both sides of the confluence.

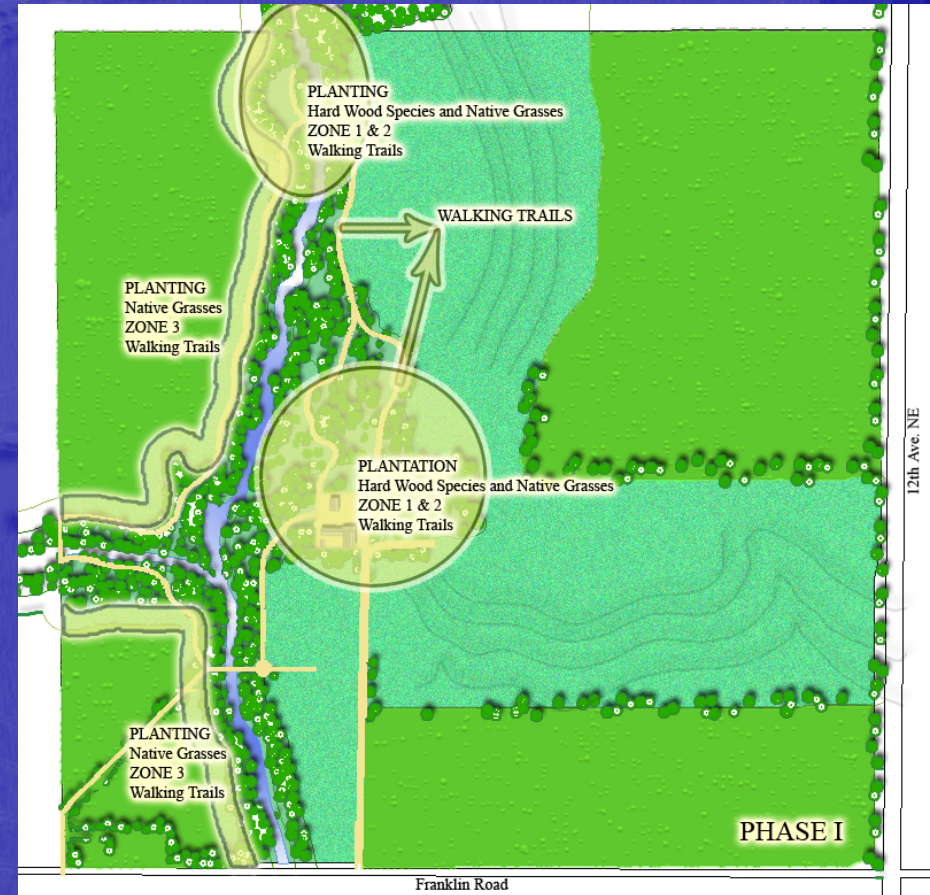
Work description

- Plantation along the channelized portion of the river on the north side of the property. Plants will mainly include native hard wood species and grasses.
- Construction of approximately 2.5 miles of walking trails
- Plantation of native grass species on north –east side of the confluence, and west of the barn to mitigate scour.
- Planting native grass in the riparian zone 3 on the west side of the river

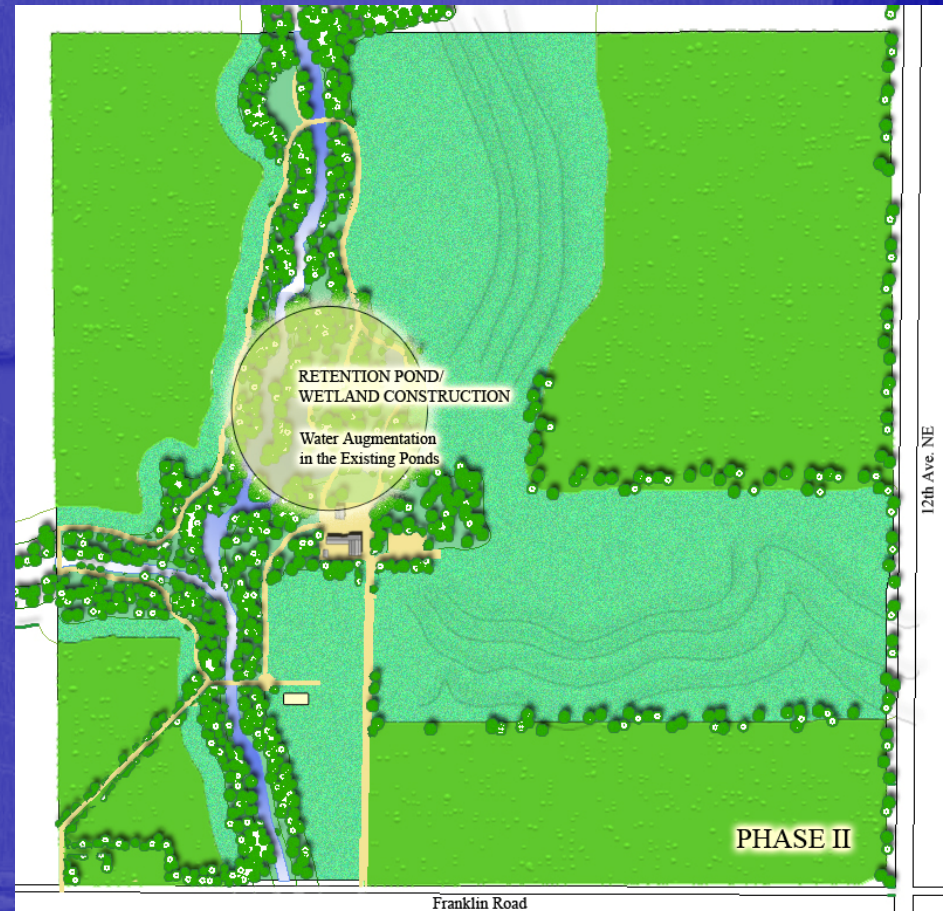
PHASE II

Work description

- Wetland Construction:
Construction of a retention pond on north-east side of confluence and south side of the barn.
- Approximate area: 1.96 acres
- Water Augmentation in the existing pond on north-east of the barn.

The City plans to construct a wetland/retention pond on the northeast side of confluence and south side of the barn. Its approximate size would be 1.96 acres.

Additionally, an augmentation to the existing pond on the northeast side of the barn is planned.

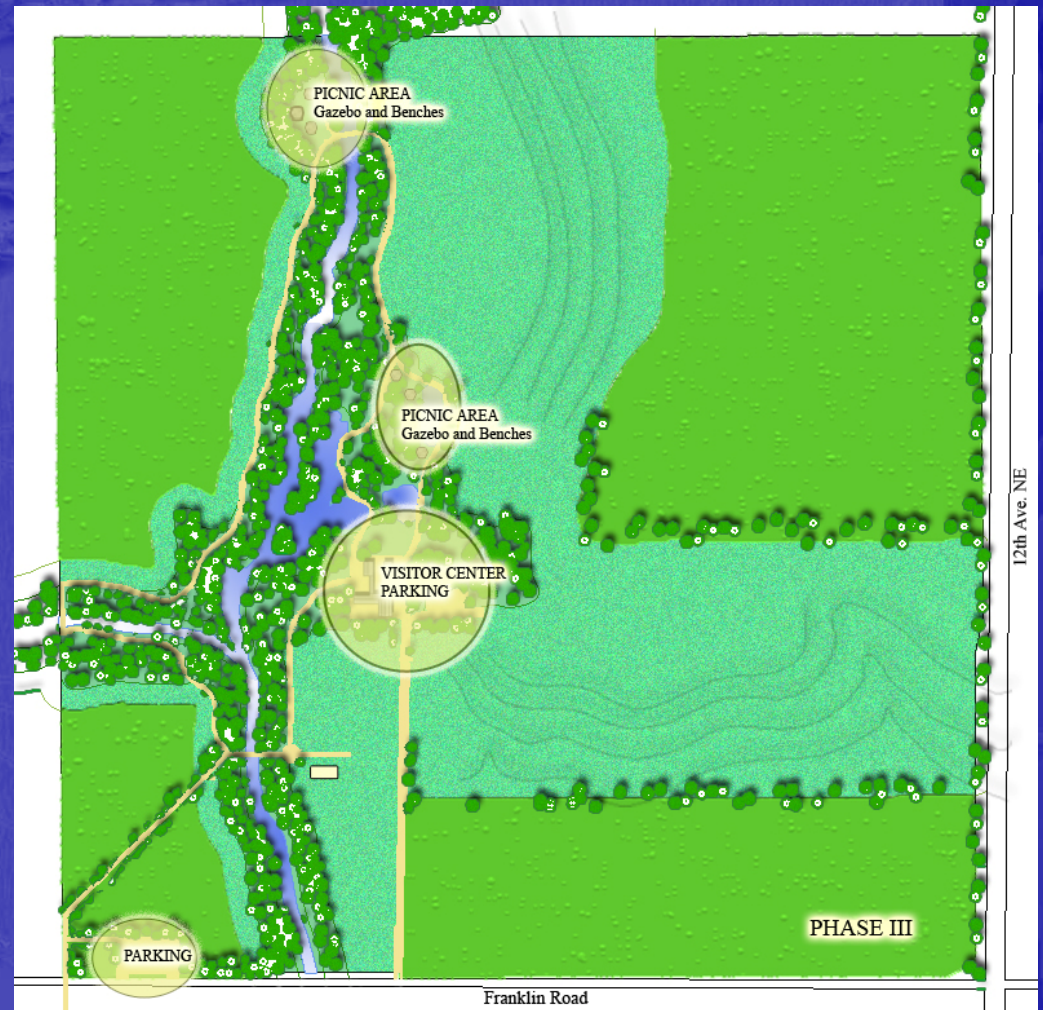
PHASE III

Work description:

- Renovation and adaptation of existing barn as visitor's center
- Construction of Gazebo in picnic areas.

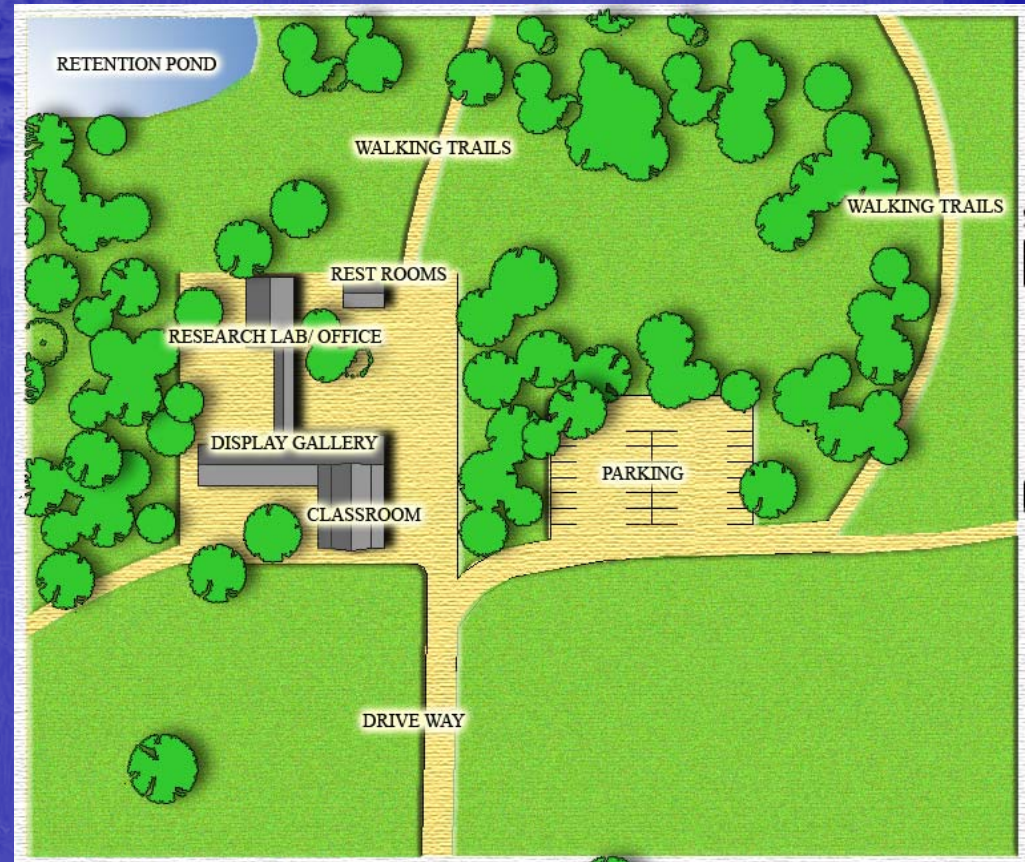
Visitor's Center Detail

An additional structure separate from the two barns is constructed for the restrooms. Parking is provided for visitors on the east side of the barn.

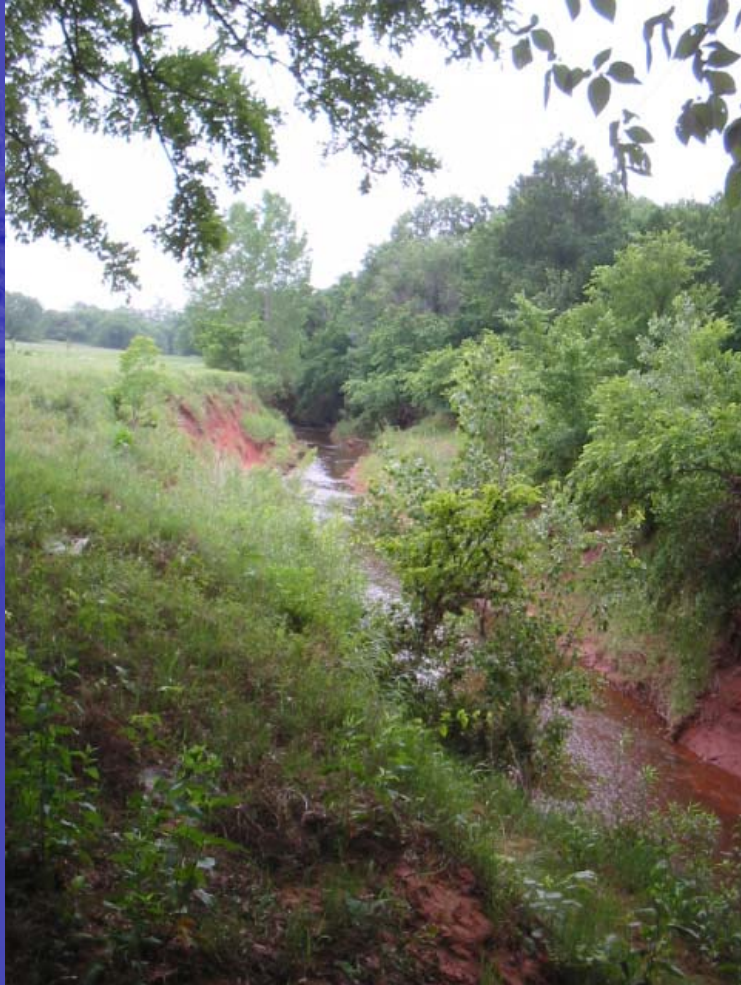
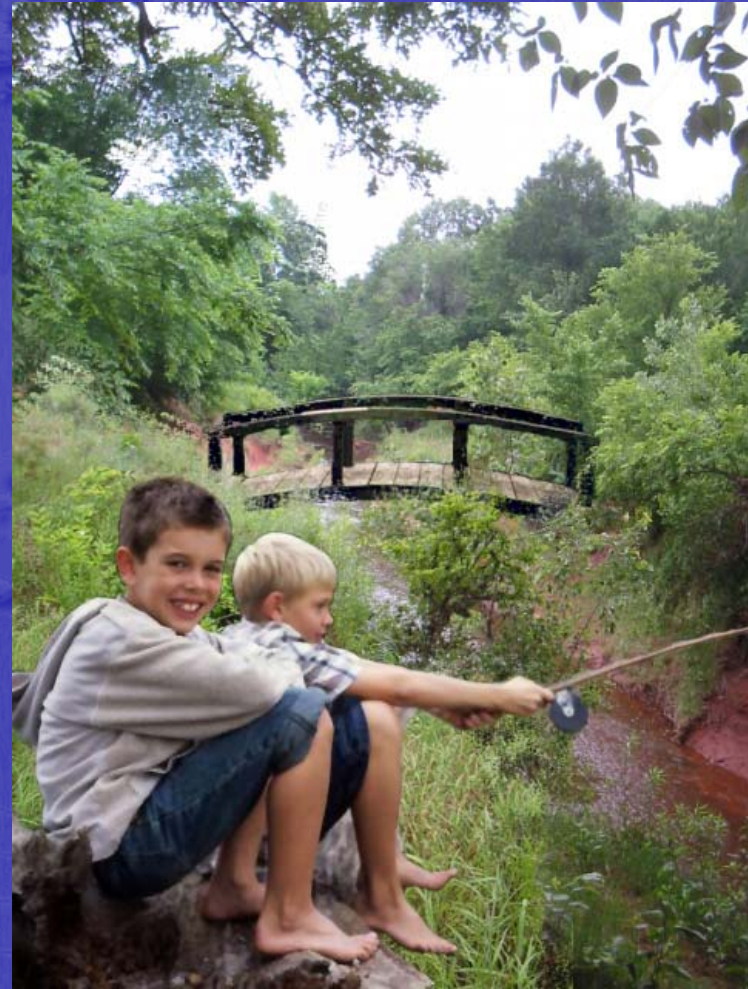
“Before” and “After” Picture of the creek from north looking south at the channelized area

Left hand side picture shows the existing condition and right hand picture show condition after plantation and installation of bridge.

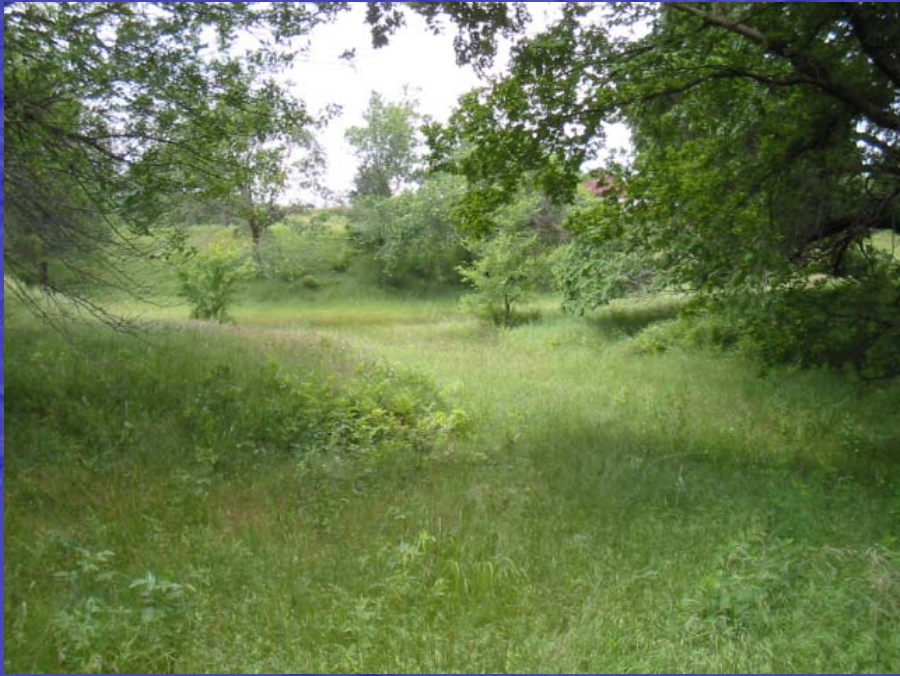
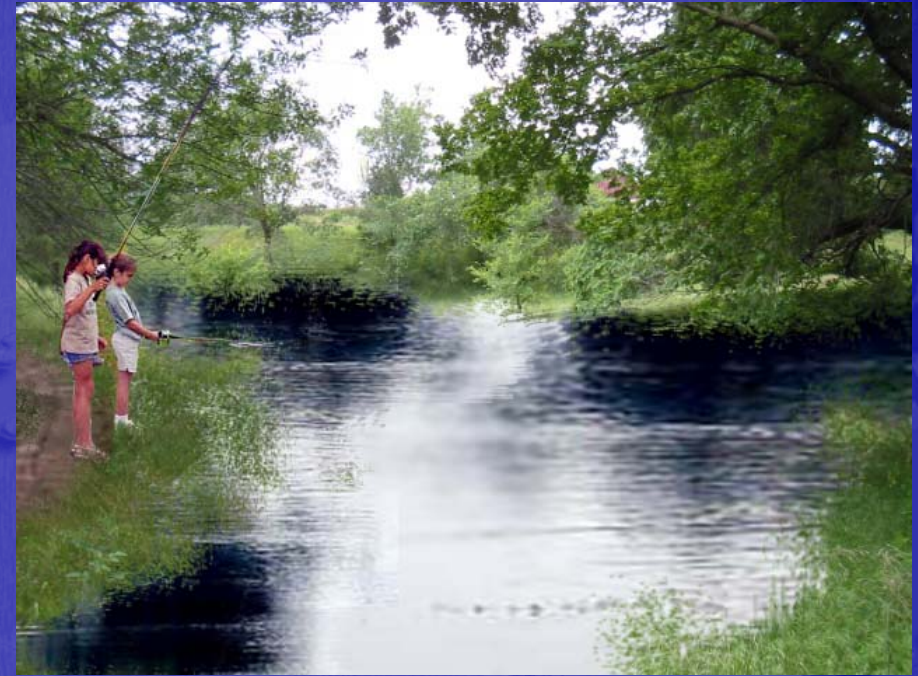
“Before” and “After” Picture of the low laying area north east of the barn.

Left hand side picture shows the existing condition and right hand picture show condition after construction of retention pond .

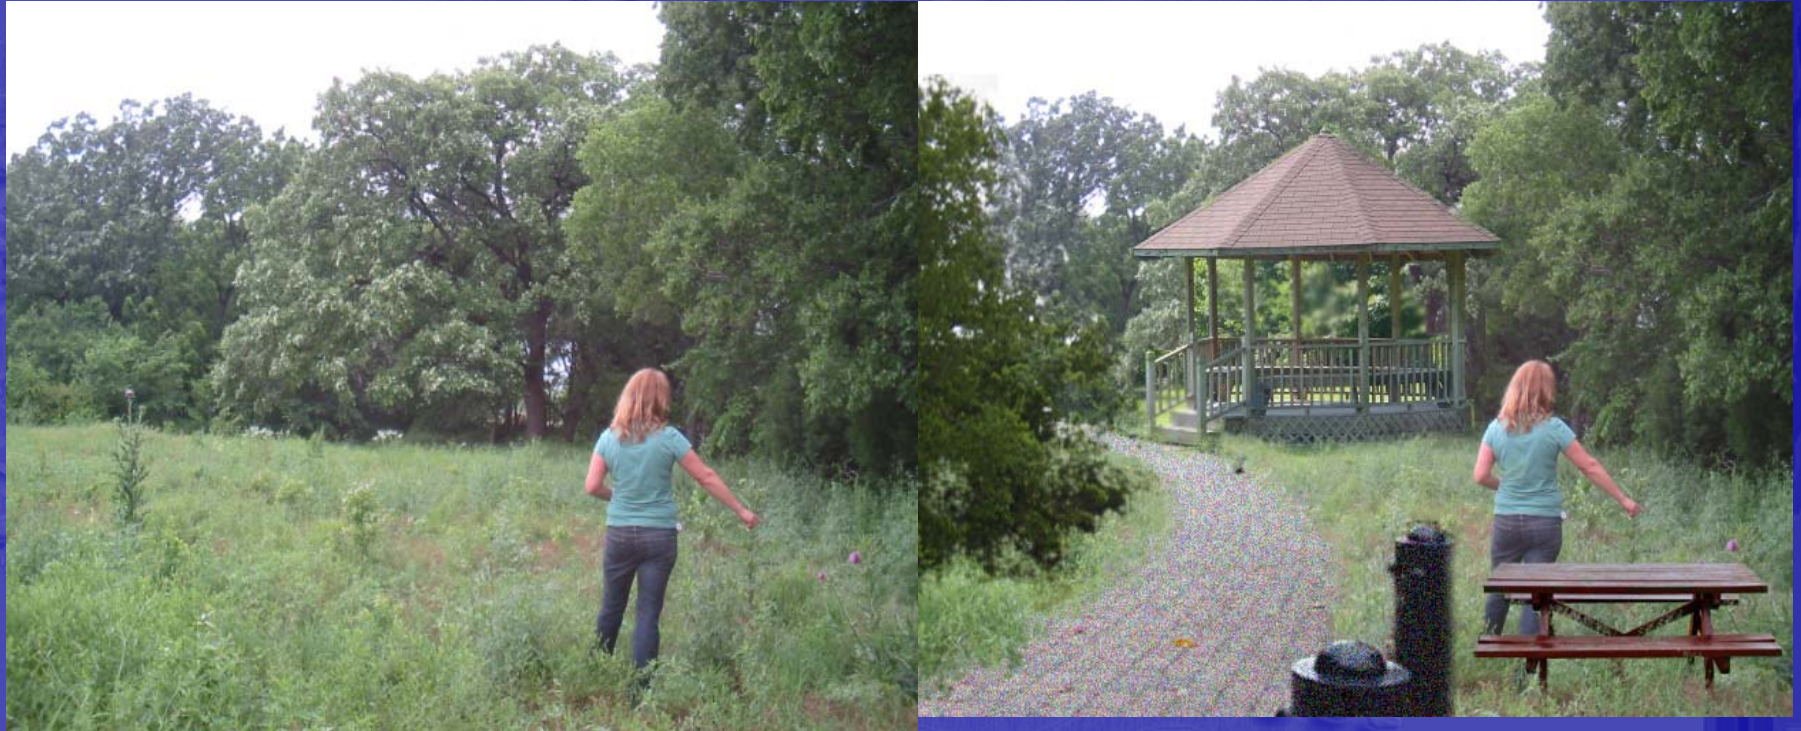
“Before” and “After” Picture of the area near the channelized portion of the creek.

Left hand side picture shows the existing condition and right hand picture show condition after additional planting, construction of picnic area and gazebo.

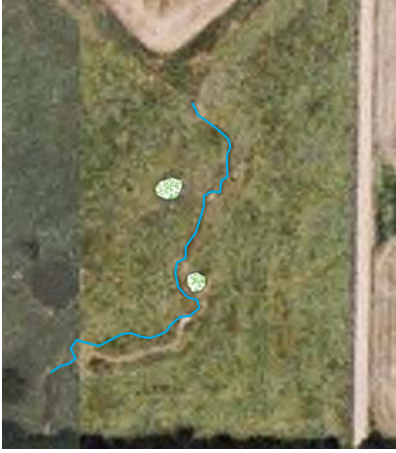
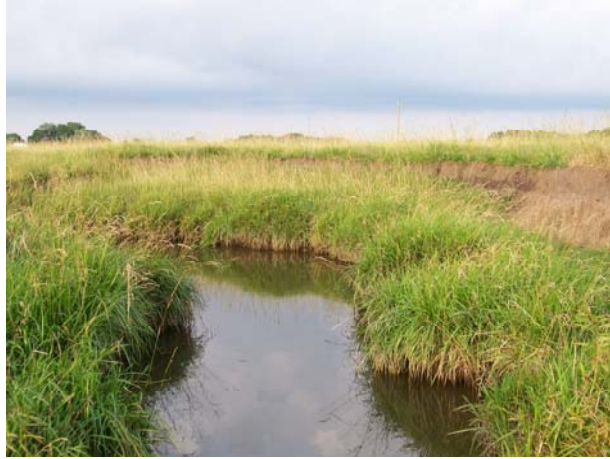
Above: Little Elm Creek reach. Left: The reach studied (blue) begins near a drainage stream from the field above, and passes through a pasture. Right: View of the stream and pasture.

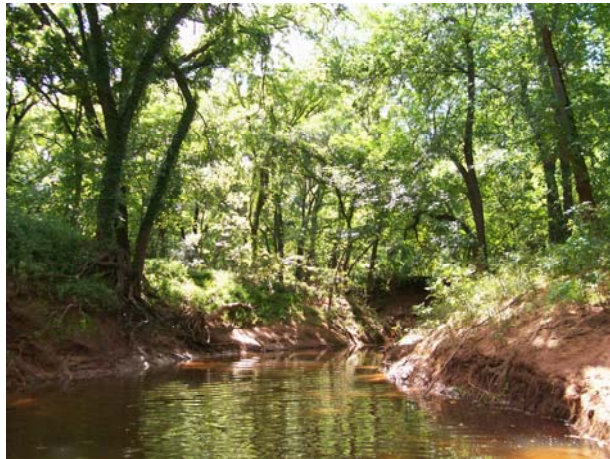
Above: North Fork Creek reach studied. Left; The reach (blue) and riparian area (green) is downstream of a road and surrounded by fields. Right: Dense riparian vegetation characterizes the reach. Also note that North Fork is much wider than Little Elm.

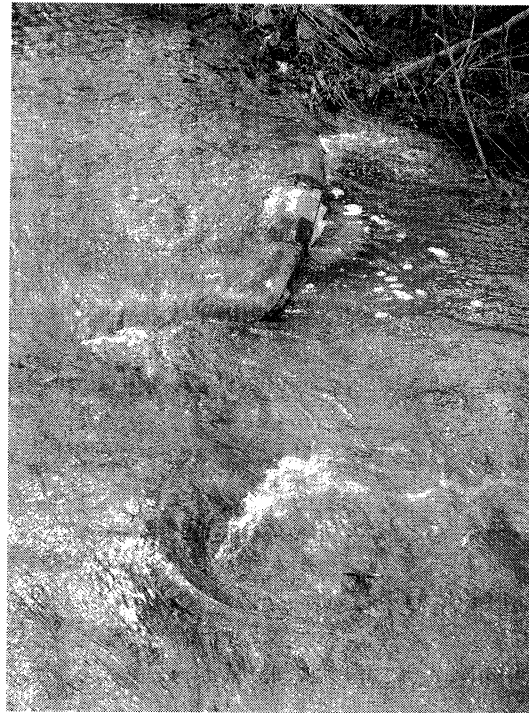
Picture 5 (L): Picture of Right Bank (XS6) of Little Elm Creek showing the damage done by cattle trampling and Picture 6 (R): Picture of the detritus present in the stream banks and bed in North Fork Creek

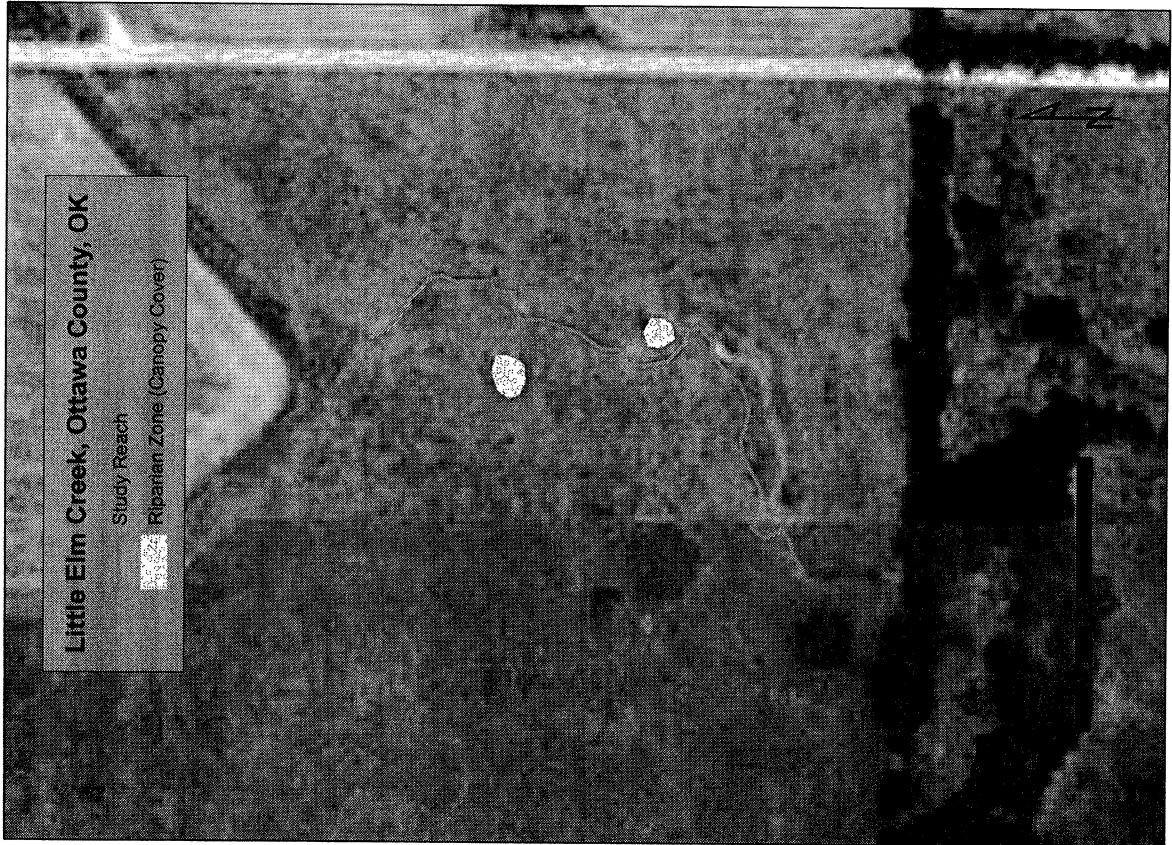
Figure 4: Little Elm Creek Reach (L) and North Fork Reach (R) showing the manner in which riparian area was calculated, and the riparian corridor width

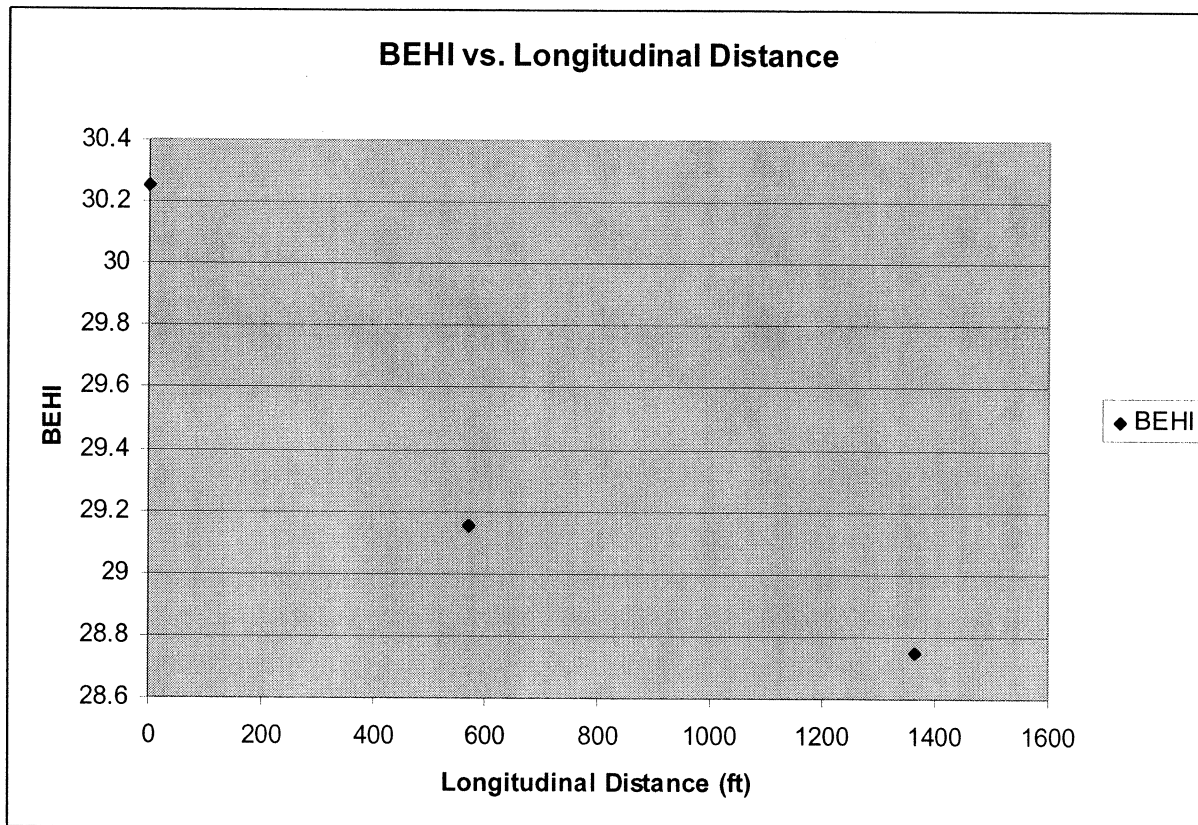
Figure 1: Plot of BEHI vs. Longitudinal Distance along Little Elm Creek (top) and North Fork Creek (bottom)
