MATRIX	Service Bulletin Foot Plate Design Change		
Effective Date: April 7, 2017	Models Affected:	Bulletin Num.	
Prepared by: Eric Chen	S5X-01 (CS08), S5X (CS11), S3x-01(CS15)

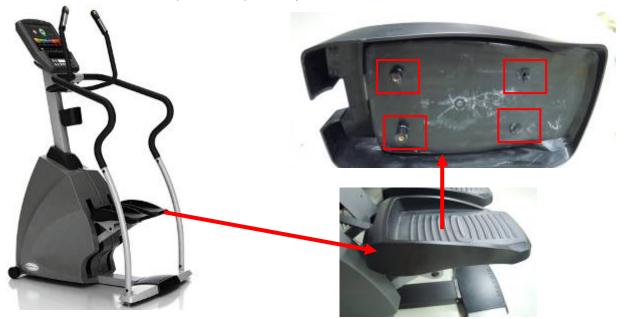
The plastic boss at the bottom of the plastic foot plate may break.

The plastic boss of foot plate is not strong.

- 1. JHT has designed a new foot plate and pedal set to avoid possible breakage (used in production April 2017). See Table 1 & 2.
- 2. In the field, if an old foot plate on a unit produced before April 2017 must be replaced, please order the new service kit (SAP #1000408091; includes both left and right foot plate sets). See Table 1 & 3.
- 3. The new application is available starting April 7, 2017.

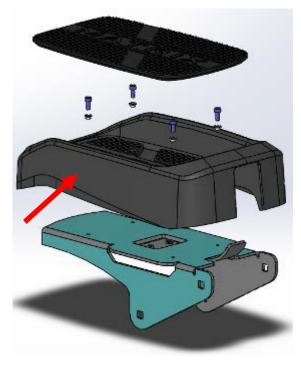
New design for production line and field (for units produced **on or after** April 7, 2017)

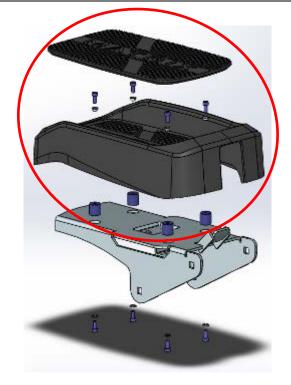
New design for field only- service kit #1000408091 (for units produced **before** April 7, 2017)

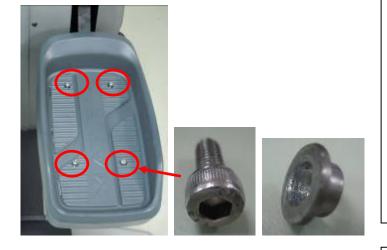
Installing the new foot plate (For units produced **before** April 2017)

1. Put 4 new spacers on the old pedal set.

2. Attach the spacers to the pedal set using 4 screws and 4 washers (use the original screws and washers which were removed from the unit).

3. Use 4 new screws and 4 new spacer rings to attach the new foot plate to the old pedal set.

4. Put the new cushion on the new foot plate.
