## Impact of the *Ada Tepe* mine on the ecological status of Krumovitsa river

November, 2020

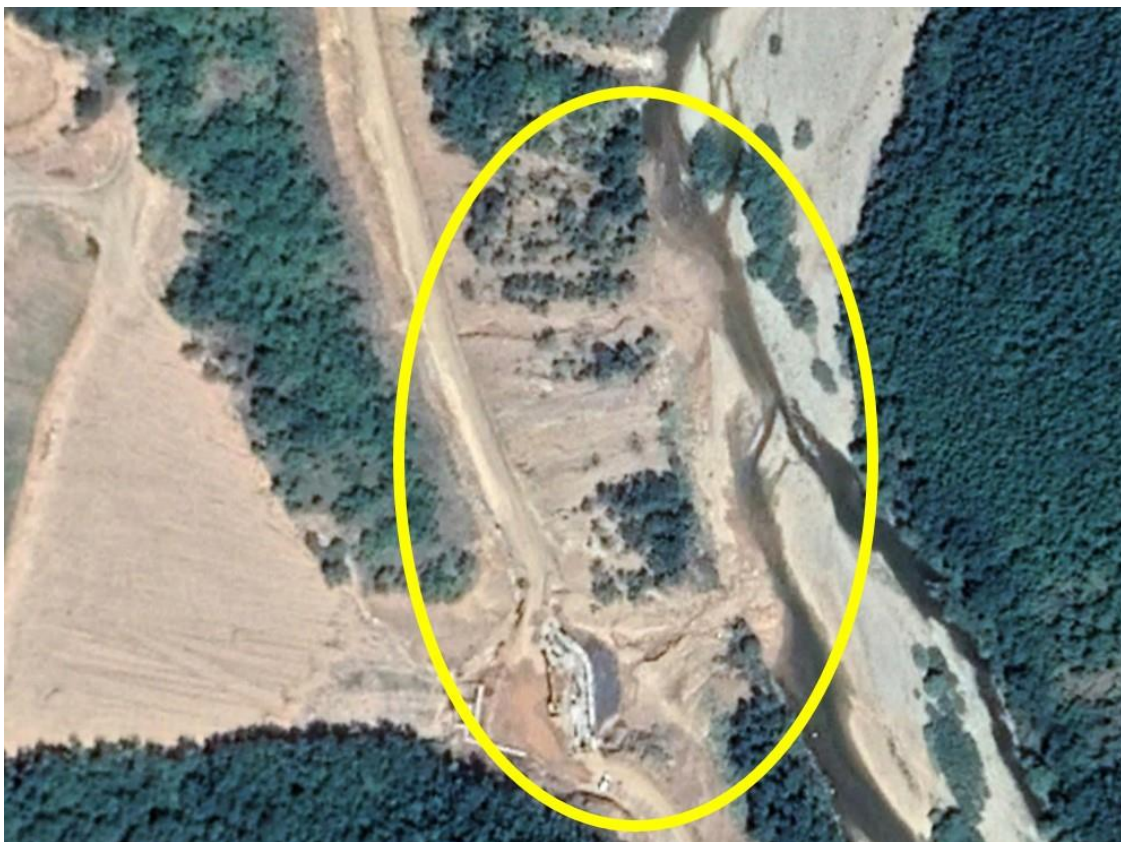
**Figure 2.** Google Earth Satellite picture of Krumovitsa river and erosional flows coming from the mine area. Date of the picture: 22.07.2018 (during the construction period of the mine).

The Figure 2 shows the erosional flows during the construction stage and brought us to the conclusion that these measures were either not taken, or were insufficient, or they did not work during the construction phase.

1. Waste water management and monitoring needs to be improved by considering biological elements and introducing more monitoring localities.
2. Measures to prevent further discharge of erosional waters coming from the mining area and flowing into the Krumovitsa river right below the mine should be undertaken in due course.
3. The accumulated bottom sludge should be sampled and analysed for pollutants. Depending on the results, appropriate measures should be undertaken.
4. Similar independent study as this one should be conducted in the late spring or summer of the next year during more favourable water flow conditions. That would allow collecting of enough MZB samples for assessment of the impact of the mine on the ecological status of Krumovitsa river.

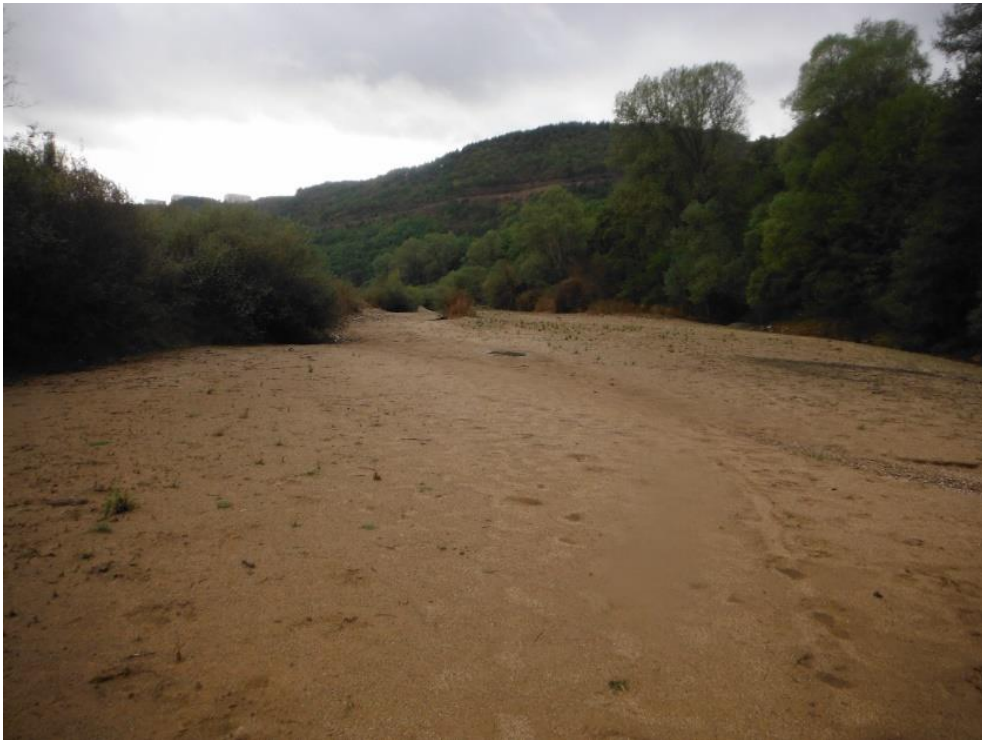
A registered impact caused by mining activities, was so-called blanketing of the river bed accompanied by river bed clogging (colmatation). The field trip coincided in time with a moderate rainfall and turbid erosional water flows coming from the mining area and mouching the Krumovitsa river bed were observed and documented (Pictures 4 and 5). The affected section of the river was approximately 2 km long. The impact was especially acute next to the mine and decreased with distance from the mining area. The observed riverbed clogging led us to the assumption that the erosional flows from the mine have not appeared recently, but their occurrence has started at least some years ago (the river bed clogging is time dependent process). These flows are even more visible on Google Earth satellite pictures from 2018 (Figure 2) taken during the construction phase of the mining project. Clogging is especially emphasized during low and extremely low water discharge conditions in the river bed due to almost 100% sedimentation of the erosional water flows coming from the mining area. The described negative impacts are visible on the pictures in Appendix 3.

*Picture 1: Dry river bed of Krumovitsa river downstream the mine, blanketed by sludge and mud*

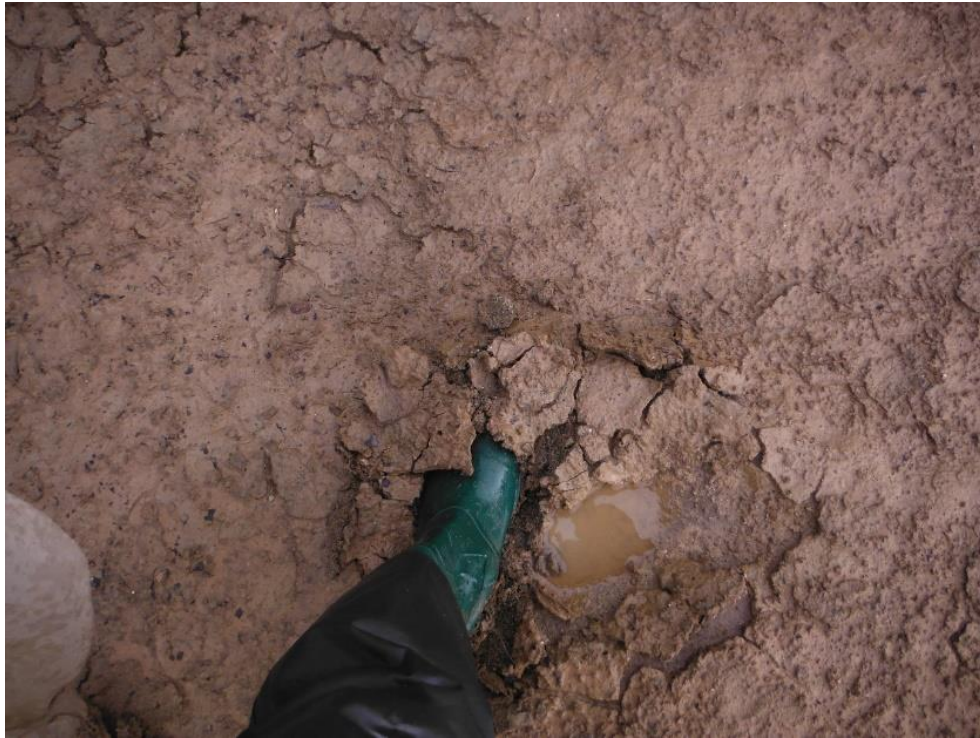
*Picture 2: Deep layer of fine muddy sediments in the river bed caused by erosional flows coming from the mining area*

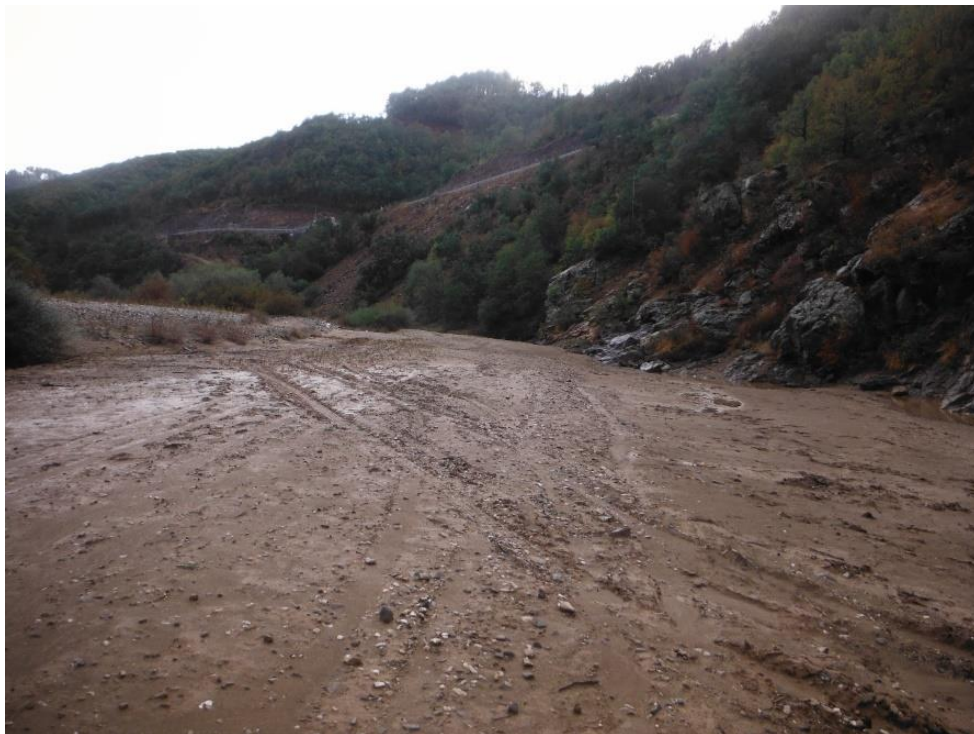
*Picture 3: The blanketing is especially acute close to the mine*

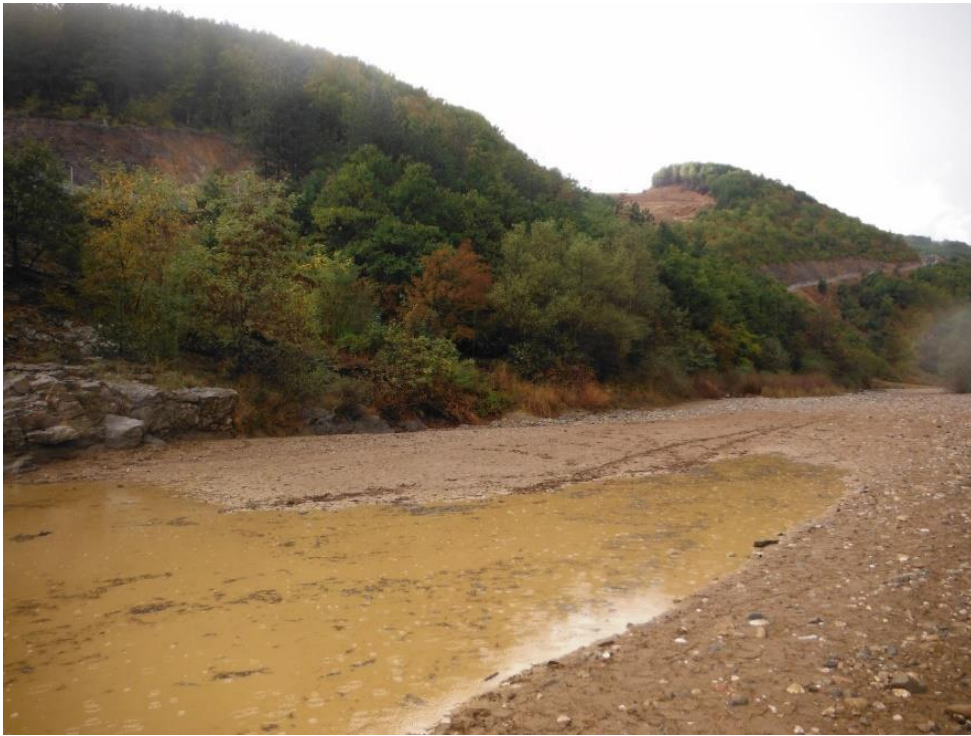
*Picture 4: Formation of turbid water pools (from erosion flows) after rain*

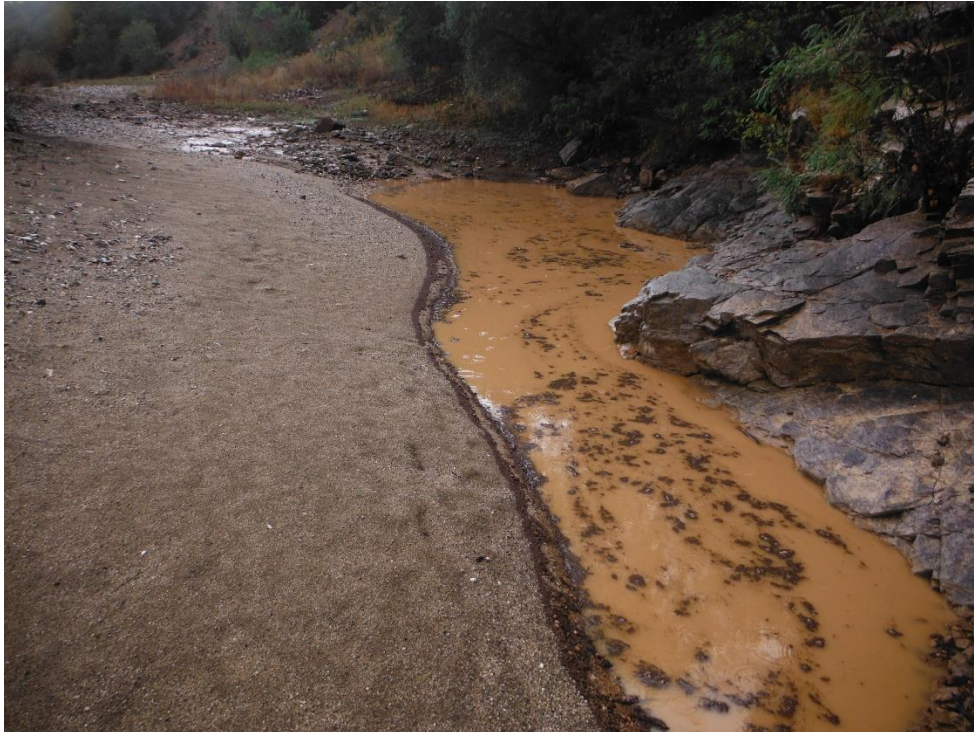
*Picture 5: Upstream of this pool the river is not affected by the erosional flows coming from the mining area*

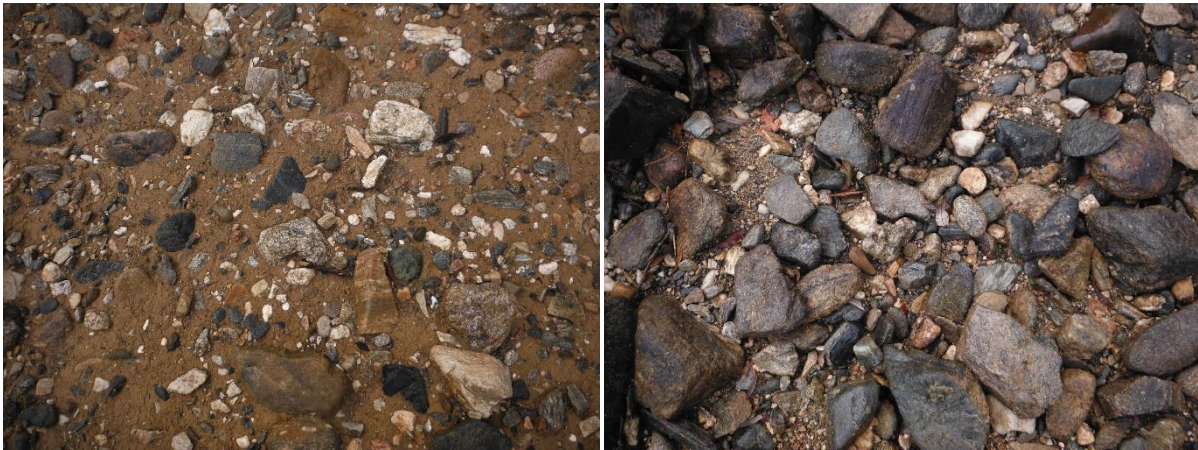
Turbid waters naturally flow through the Krumovitsa river bed during high discharge condition and do not cause blanketing as well as do not result in colmatation. River bed clogging/colmatation disconnects surface water from hyporheic water by inhibiting exchange processes and reduces the recharge processes between surface- and ground waters (Brunke 1999). In some cases, MZB use interstitial as a refugium in order to protect themselves from risks that are threatening them at the substrate surface, such as floods, predators or droughts

Picture 6: Filled up interstitial spaces downstream the mine (left) and natural substrate upstream the mine (right)

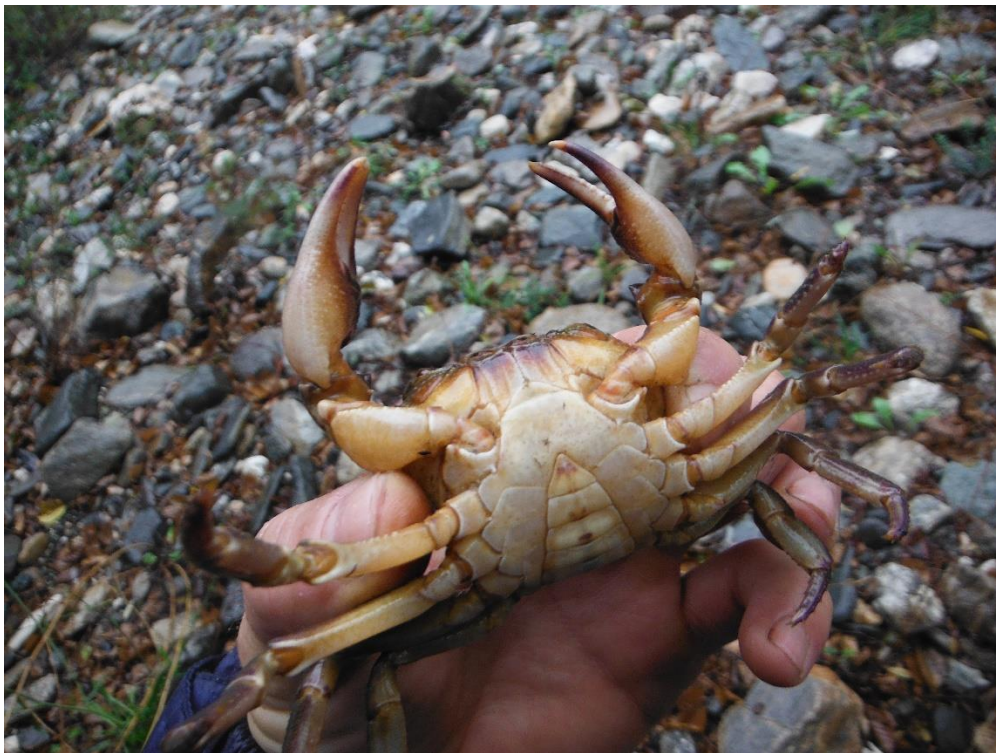
Picture 7: The freshwater crab (*Potamon ibericum*) is typical for sub-mediterranean rivers and it is widespread along Krumovitsa river.

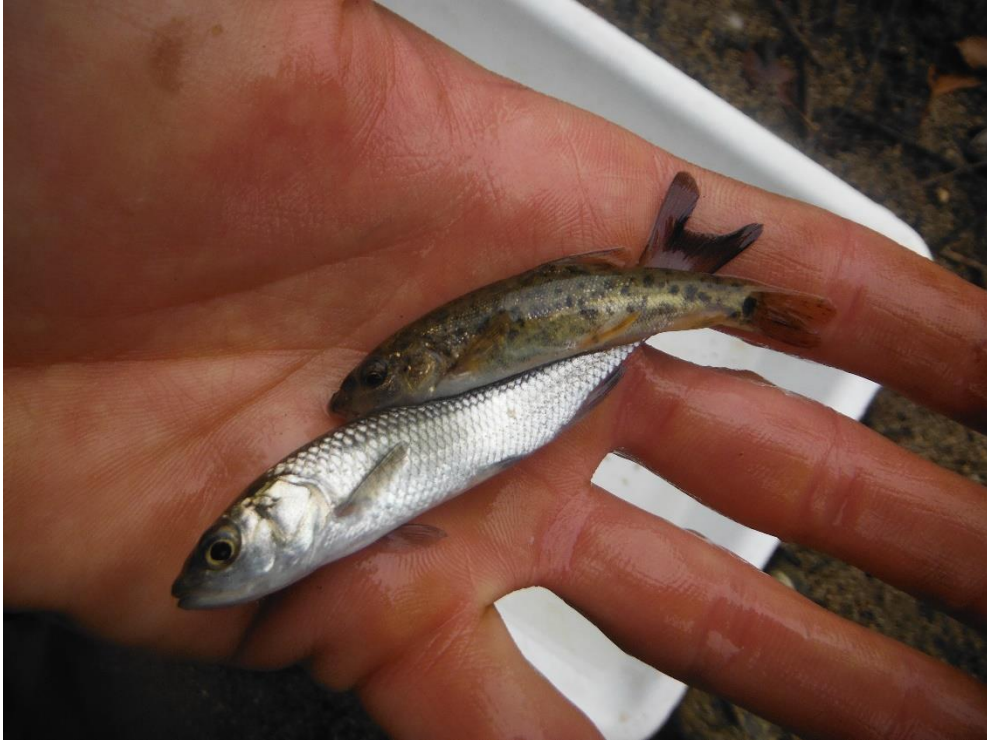
Picture 8: The orpheus dace (*Squalius orpheus*) and the round-scaled barbel (*Barbus cyclolepis*) are dominant fish species in Krumovitsa river

Regarding the ichthyofauna, the existence of fish was visually observed along the whole studied section of the Krumovitsa river in most of the pools left in the dry river bed. 6 species from the river section upstream the mine were registered. The pools downstream the mine were too turbid and only 3 species were recognised there. This does not prove that other species are absent, because the method used is selective and largely dependent on water transparency. In Appendix 2 the species registered for the aim of this study are listed and compared to those, caught during the AA study in 2010. Two species that are listed in Appendix 2 of the Habitats Directive were found – the round-scaled barbel (*Barbus cyclolepis*) and the balkan spined loach (*Sabanejewia balkanica*). The Balkan spined loach has not been registered in the Krumovitsa river upstream of Dolna Kula village (downstream of Krumovgrad) during the AA study and our observation indicates greater present importance of Krumovitsa river for the population of this rare species in that Rodopi - Iztochni Habitats Directive site. A positive observation was that otter excrement were registered several times along the entire studied river section, that assume existence of feeding recourses for this predator (Picture 16).

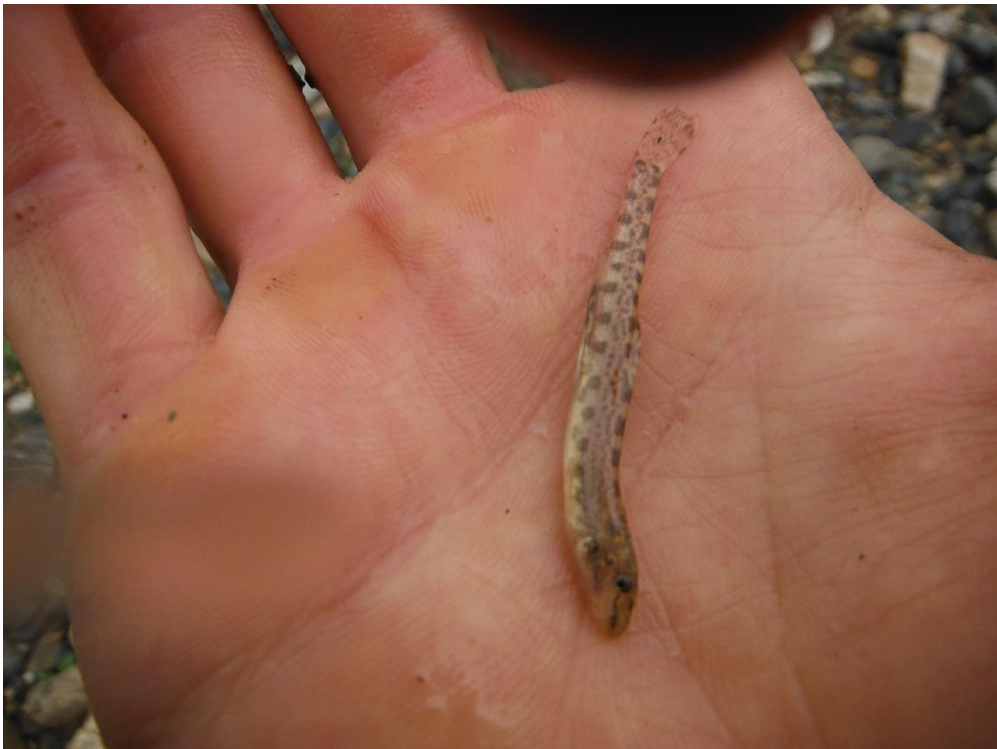
Picture 9: The balkan spined loach (*Sabanejewia balkanica*) together with the round-scaled barbel are included in Appendix 2 of the Habitats Directive

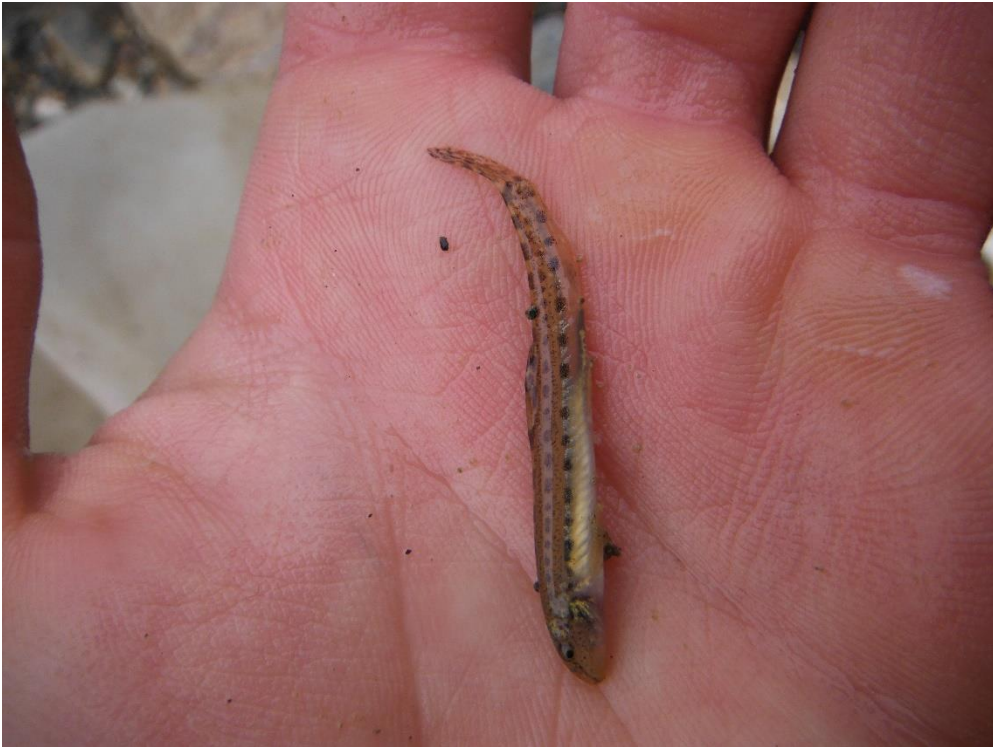
*Picture 10: The bulgarian spined loach (Cobitis strumicae) is another endemic species (for the South-east Balkans) that inhabits the Krumovitsa river*

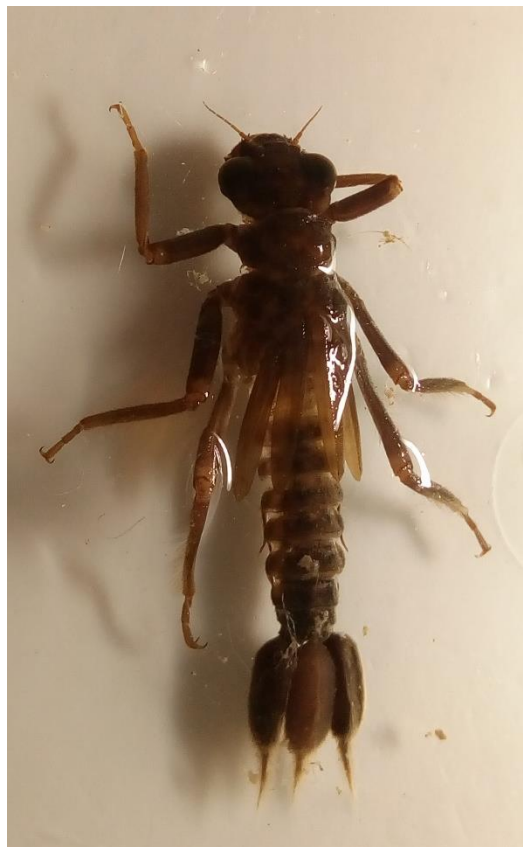
*Picture 13: The white-legged damselfly larva (Platycnemis pennipes) is a relatively large predator that inhabits the river bottom*

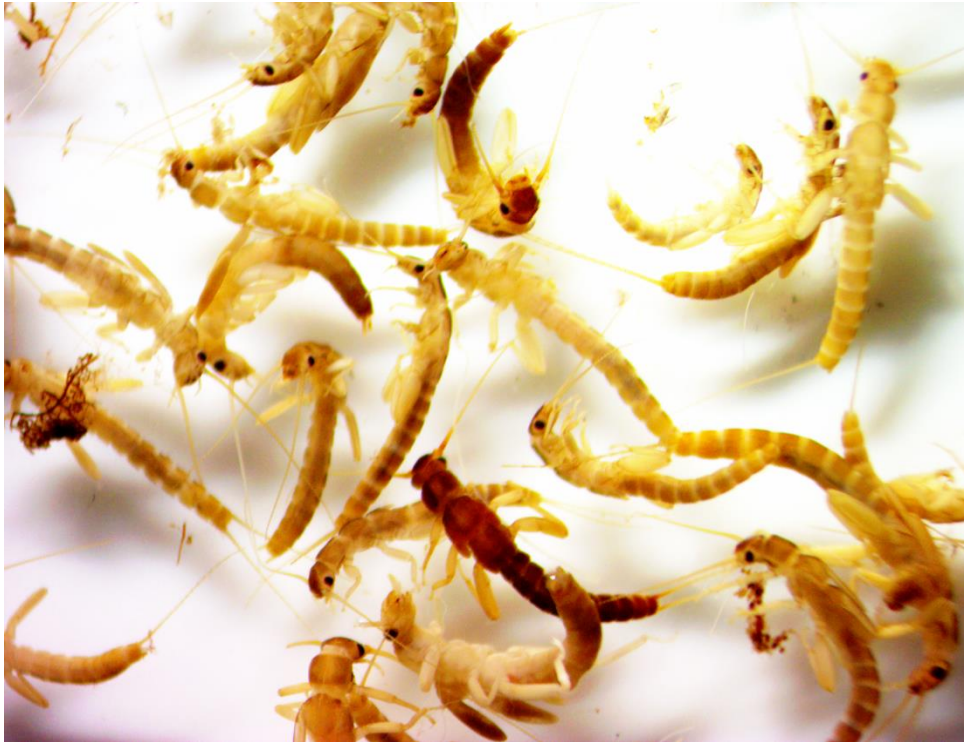
*Picture 14: Stonefly larvae of family Leuctridae are the most numerous taxa in the samples and are among the animals which enter the interstitial during unfavourable conditions*

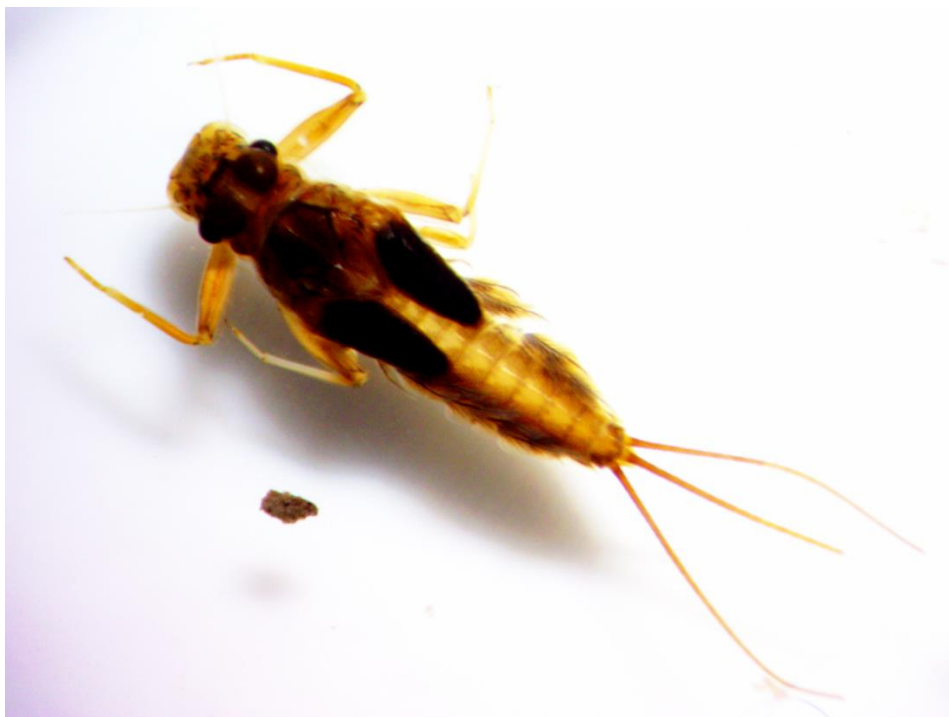
*Picture 15: The mayfly larvae *Habrophlebia cf. marginata* is also entering the interstitial but can spend the draughts in the stagnate pools as well*

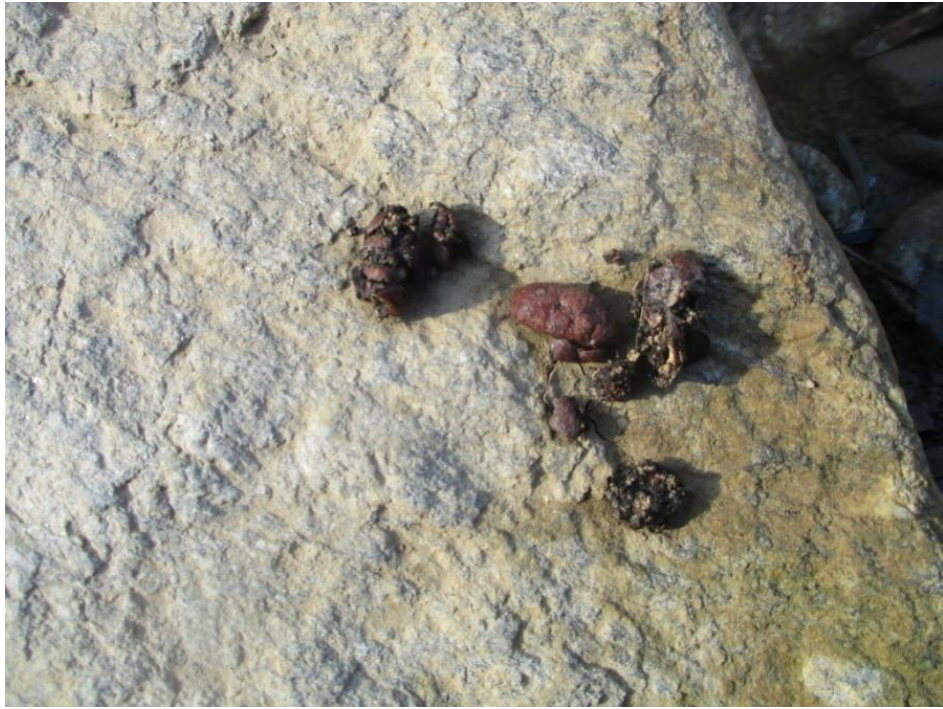
*Picture 16: Otter (Lutra lutra) excrements were registered along the studied section of Krumovitsa river*
