2011 Site Investigation Report

Eklutna Army Sites

Formerly Used Defense Site (FUDS) F10AK0097

Eklutna, Alaska

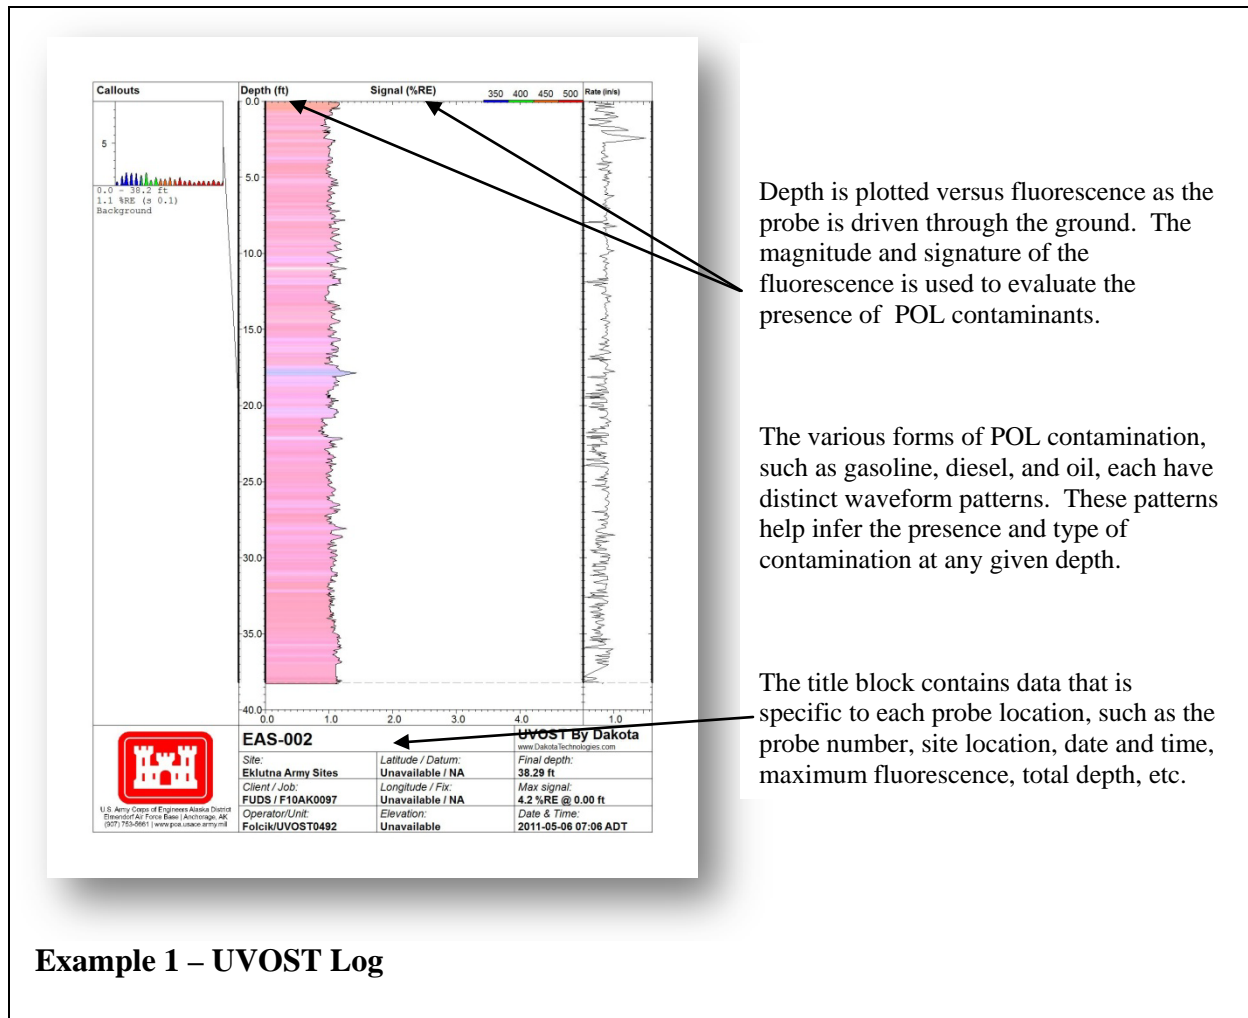
The UVOST software package allows for analysis of the amount of fluorescence at each of the four different response wavelengths that make up the LIF reading. The amount of fluorescence at each of the four wavelengths is called the LIF signature. LIF data is displayed graphically as fluorescence versus depth in real time as the field team operates the UVOST equipment and collects LIF readings. UVOST logs display the data and are created after completing the investigation at a given probe location. Example 1 illustrates a typical UVOST log:

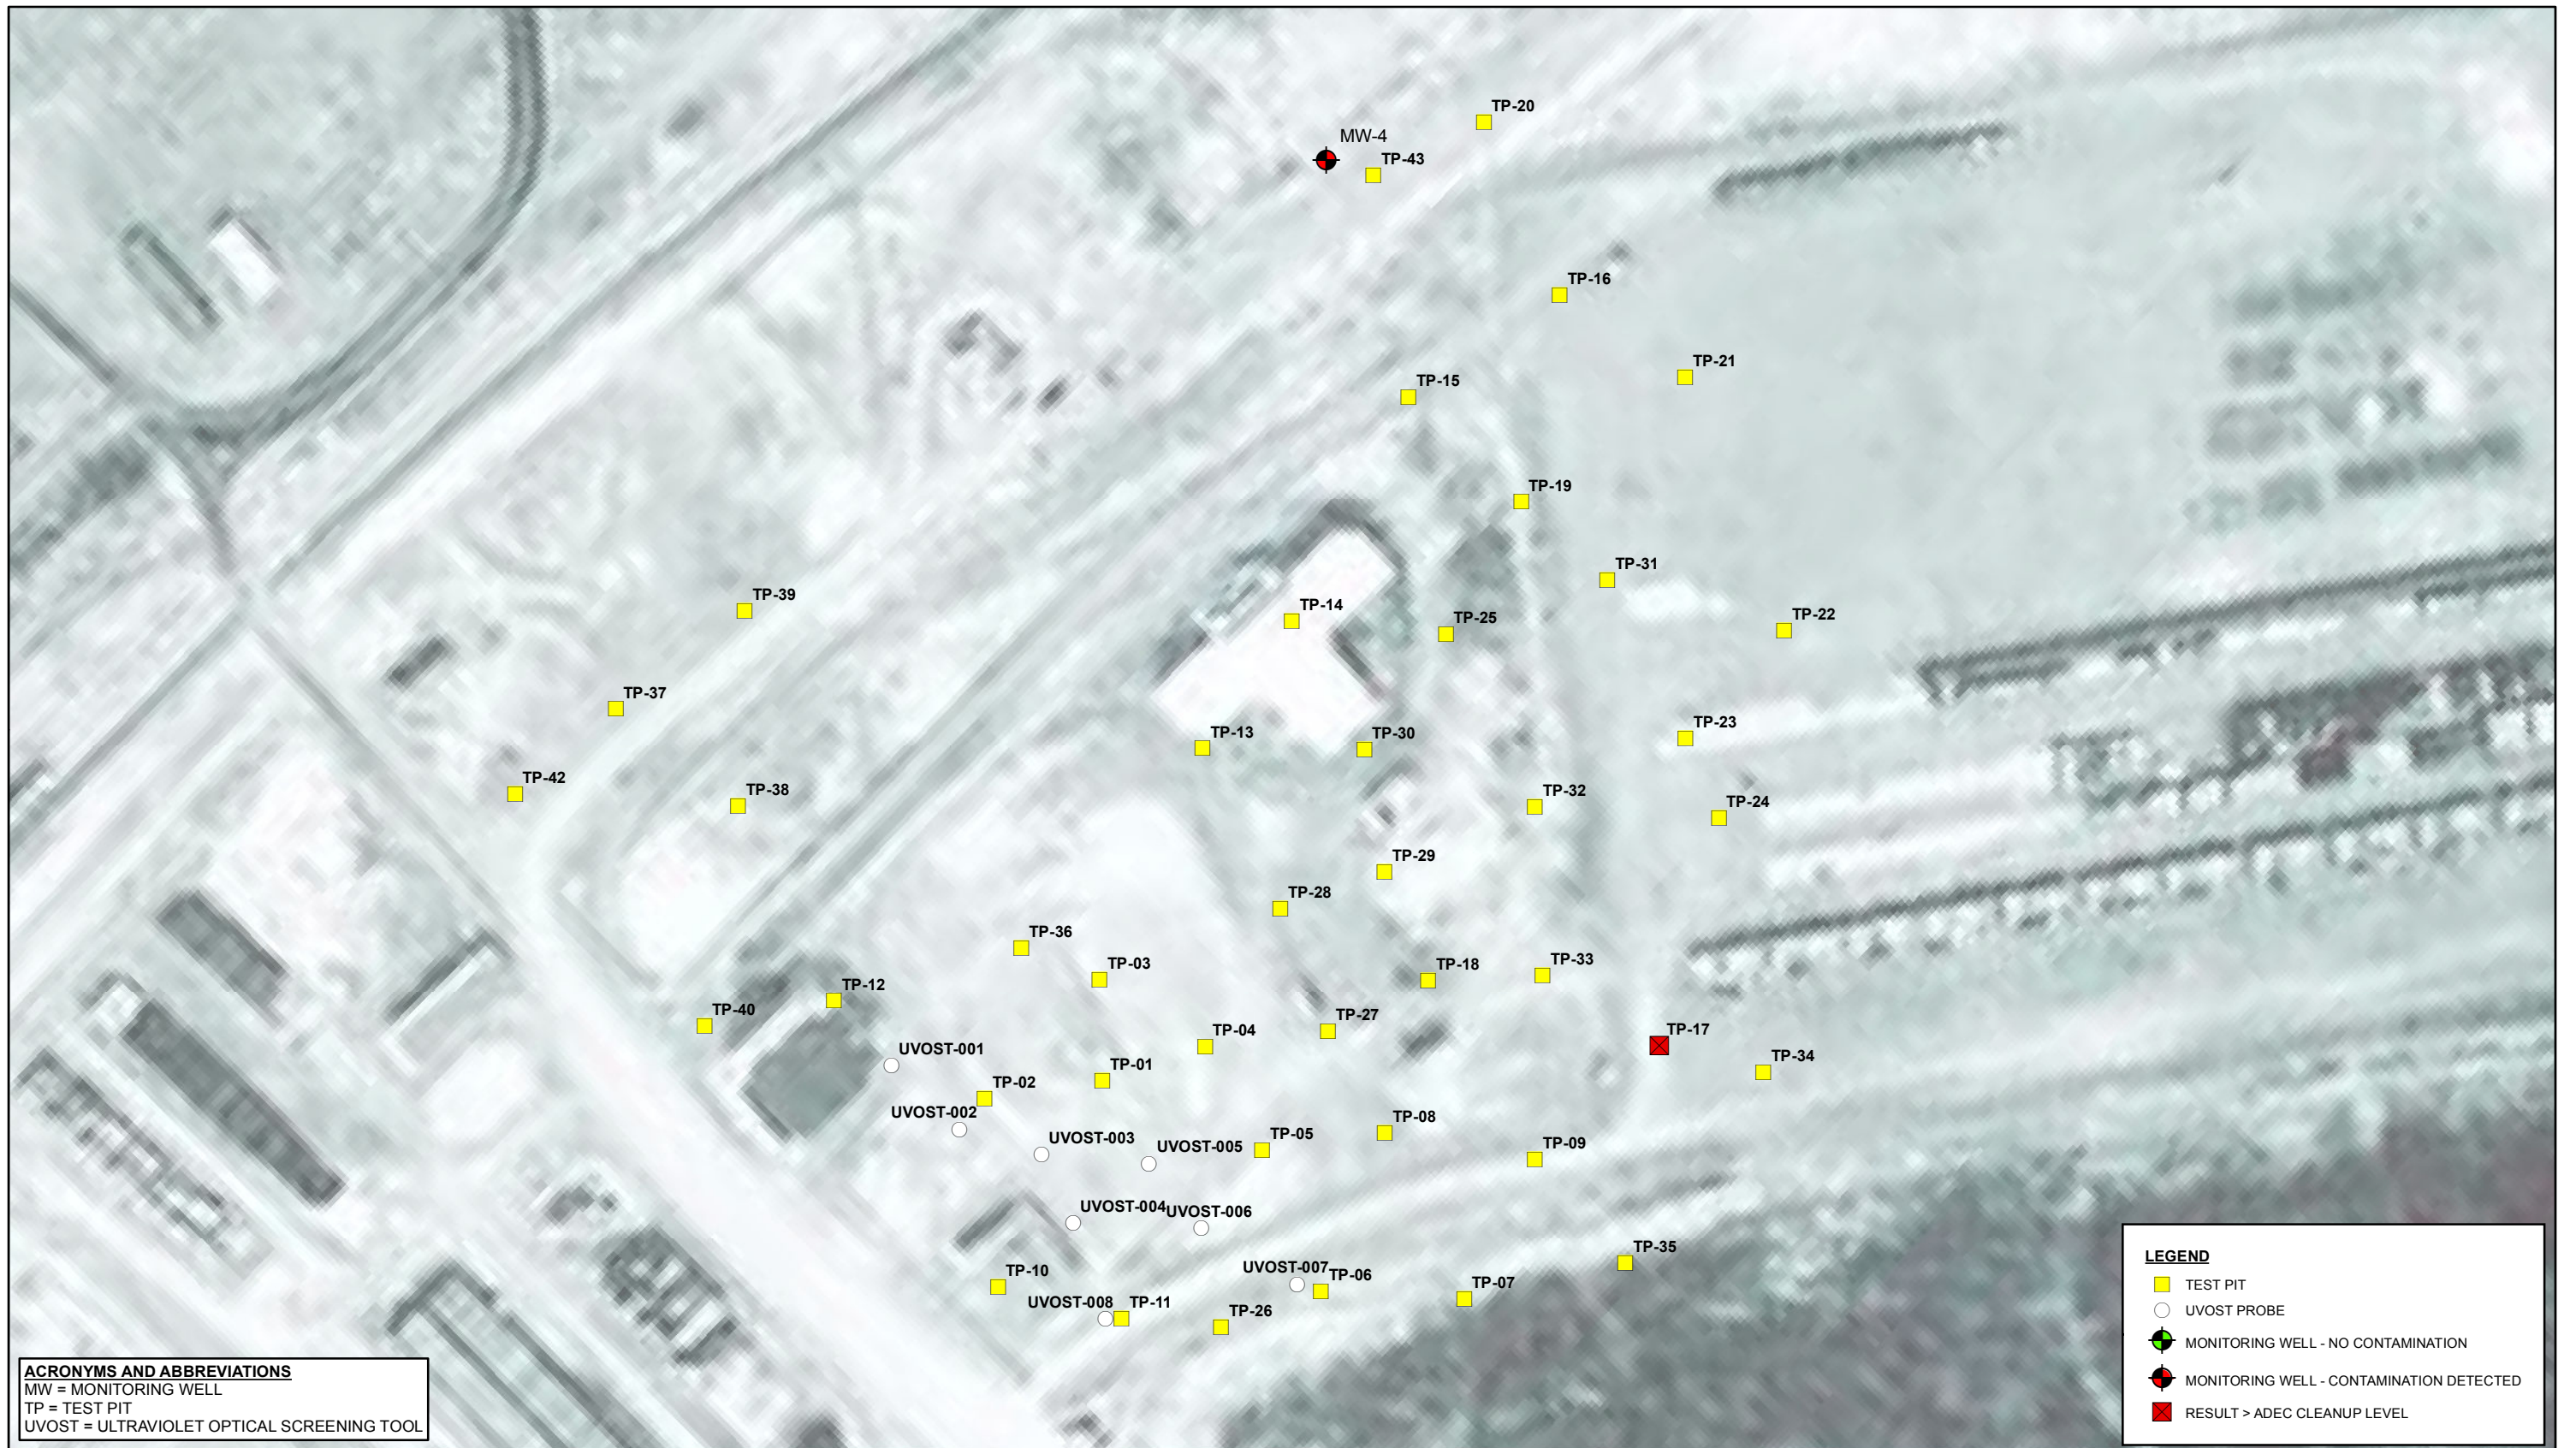
UVOST PROBE AND TEST PIT LOCATIONS EKLUTNA ARMY SITES FUDS 2011 INVESTIGATION	
EKLUTNA ARMY SITES - F10AK0097	FIGURE 3
EKLUTNA, ALASKA

NOTES
 1. BACKGROUND IMAGERY IS DATED 19 MAY 1964.
 2. IMAGERY IS ROUGHLY GEOREFERENCED TO GOOGLE EARTH IMAGERY DATED 14 APRIL 2011 THAT WAS GEOREFERENCED USING 2011 GPS SURVEY INFORMATION.
 3. MONITORING WELLS WERE INSTALLED BY DENALI DRILLING FOR ALASKA AGGREGATE PRODUCTS.

Four of the forty-two test pits excavated were not sampled. While excavating test pit 14 a concrete slab was encountered at 2 feet bgs. Figure 3 indicates that the encountered slab is the foundation for the former Bureau of Indian Affairs building. Test pits 7, 19, and 35 contained only fill material. The investigation area is being used by the gravel pit operator for overburden storage. It was assumed that the fill encountered at these test pit locations was not present during the Department of the Army's use of the site and therefore was not sampled.

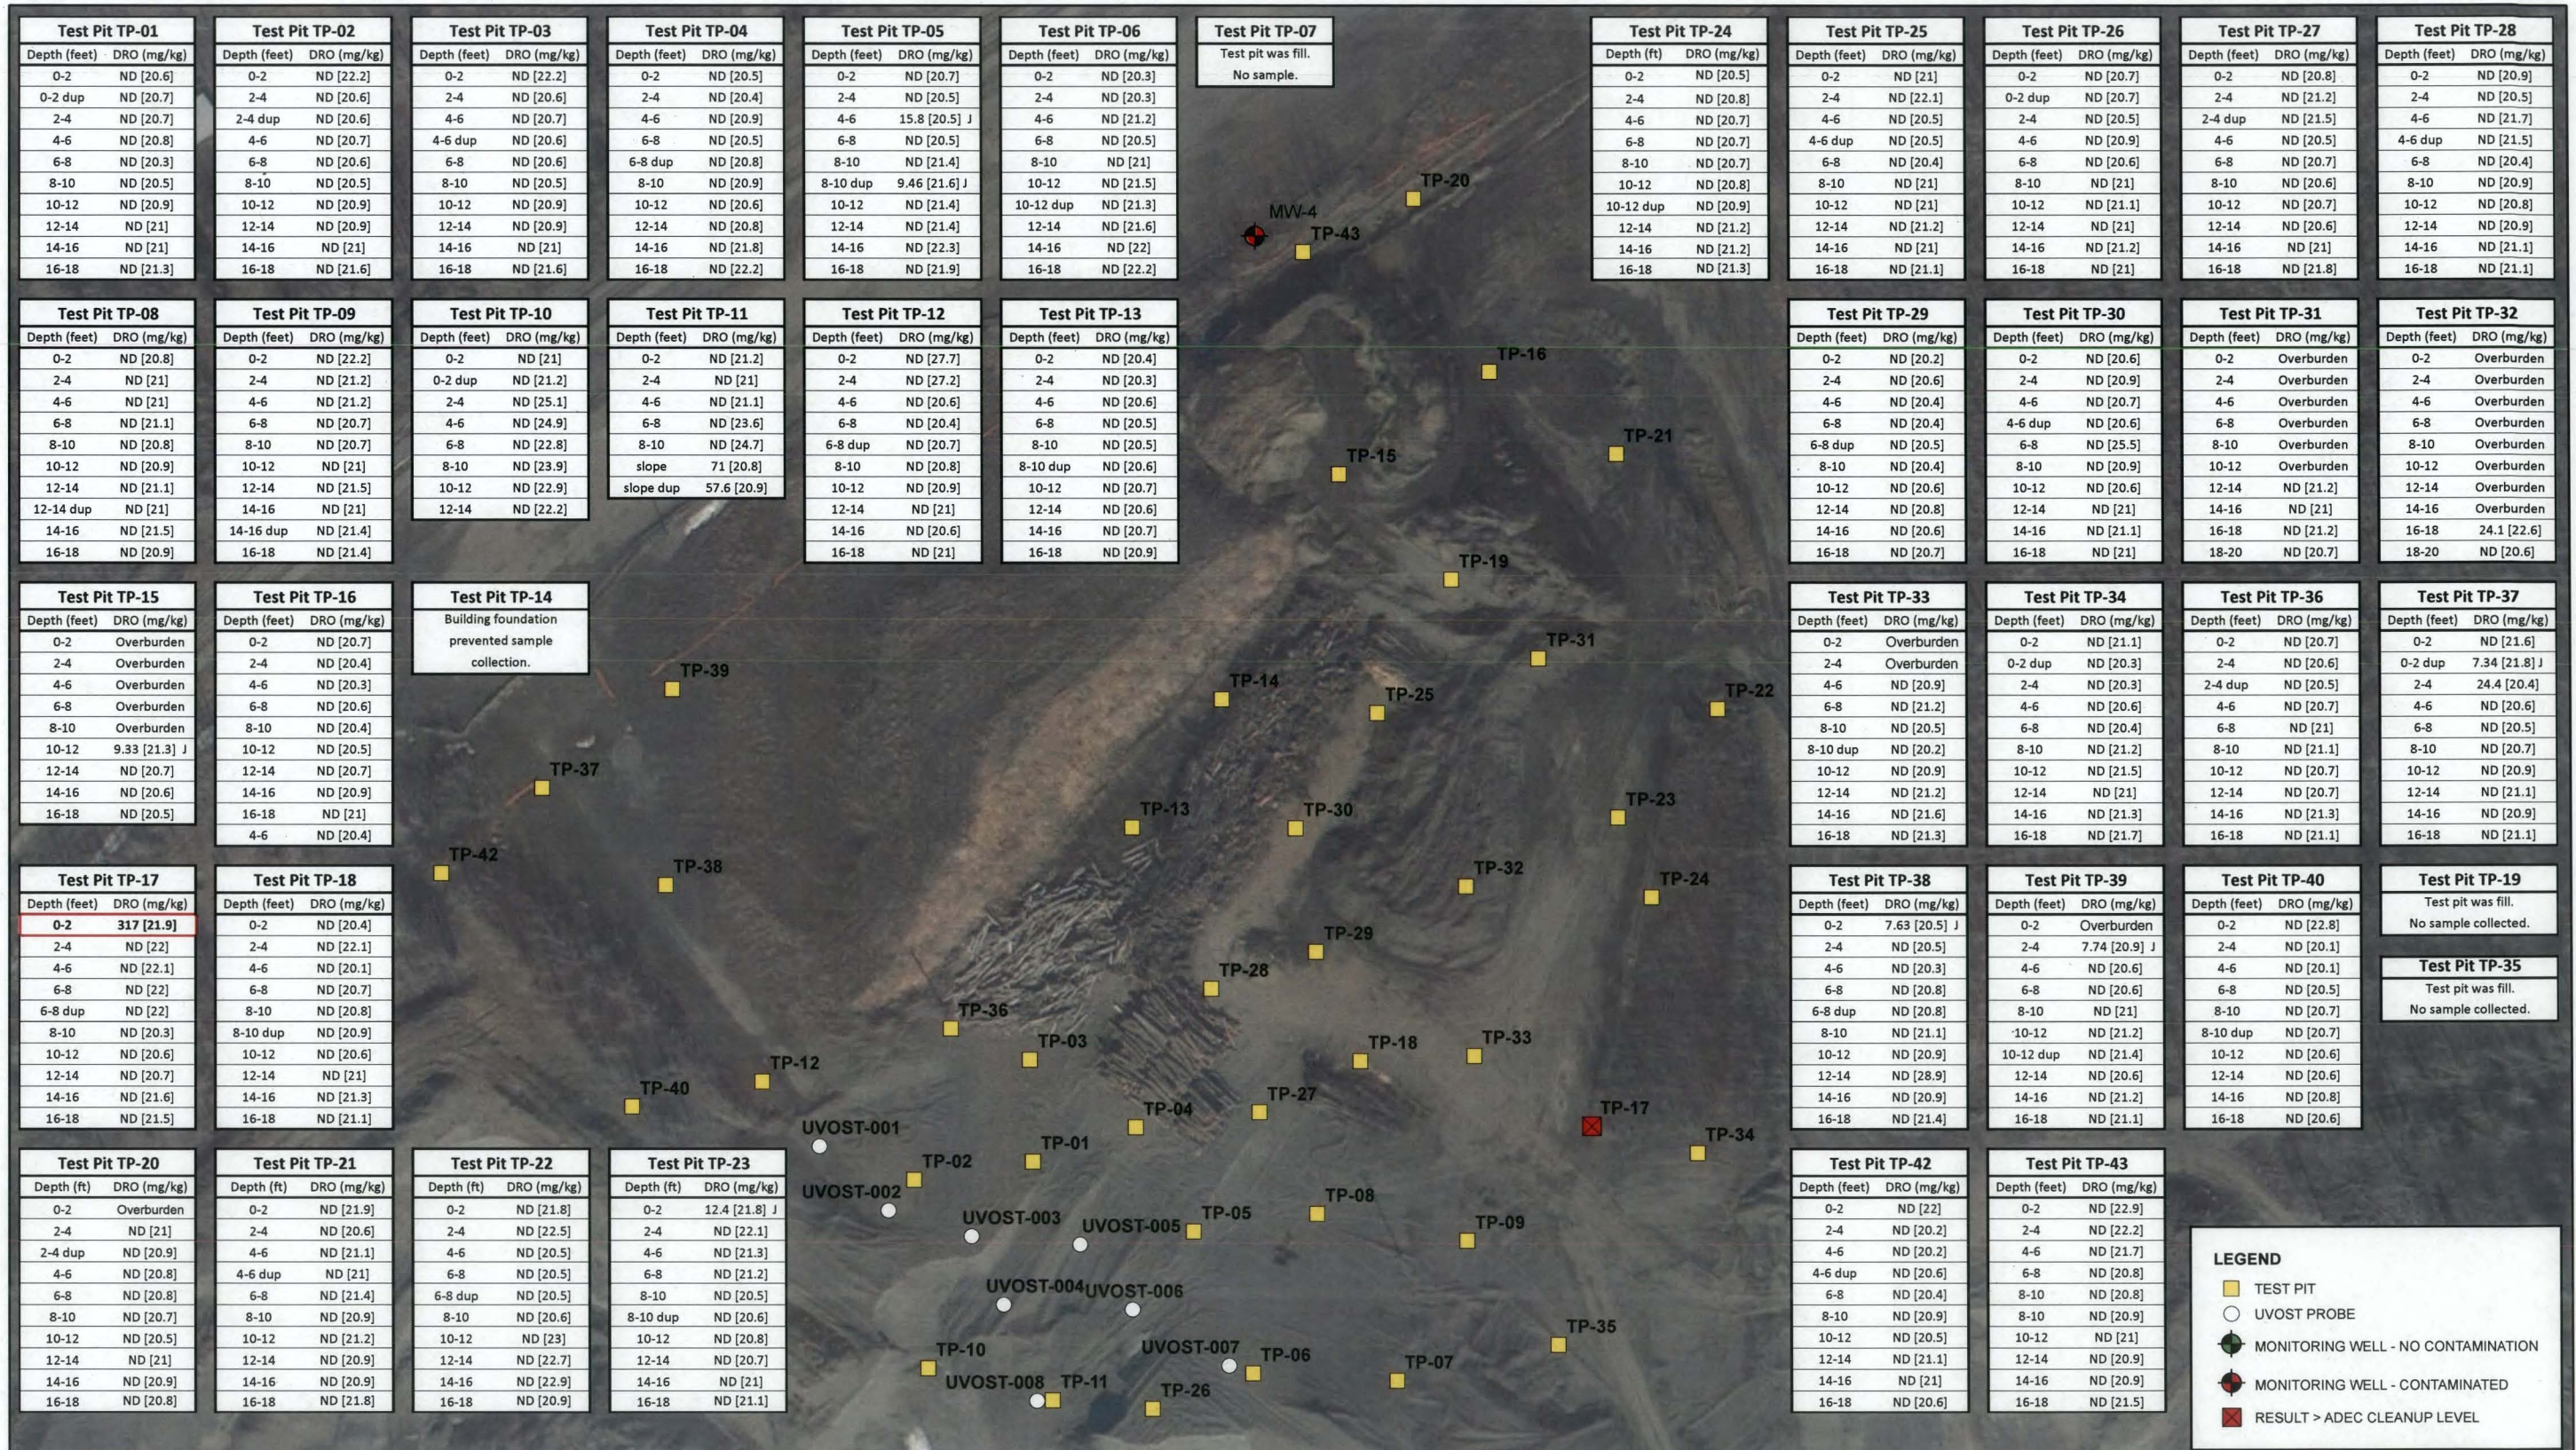
FIGURE 4

- BACKGROUND IMAGERY IS DATED 14 APRIL 2011 FROM GOOGLE EARTH PRO UNDER THE USACE ENTERPRISE LICENSE AGREEMENT, 2009.
- DEPTHS ARE FEET BELOW GROUND SURFACE AT THE TIME OF EXCAVATION. GROUND SURFACE ELEVATIONS HAVE CHANGED SINCE THE SAMPLING WAS CONDUCTED.
- BOLD RESULTS IN RED BOX EXCEED THE ADEC METHOD 2 SOIL CLEANUP LEVEL.
- TEST PIT TP-41 WAS SKIPPED IN THE TEST PIT SEQUENCE.
- UVOST-008 WAS LOCATED AT TP-11, HOWEVER IT IS SHOWN IMMEDIATELY ADJACENT IN THIS FIGURE.
- OVERBURDEN - THE INVESTIGATION AREA IS BEING USED FOR OVERBURDEN STORAGE. IT WAS ASSUMED THAT THE FILL ENCOUNTERED AT THESE TEST PIT LOCATIONS IS NOT RELATED TO DOD'S USE OF THE SITE AND THEREFORE WAS NOT SAMPLED.

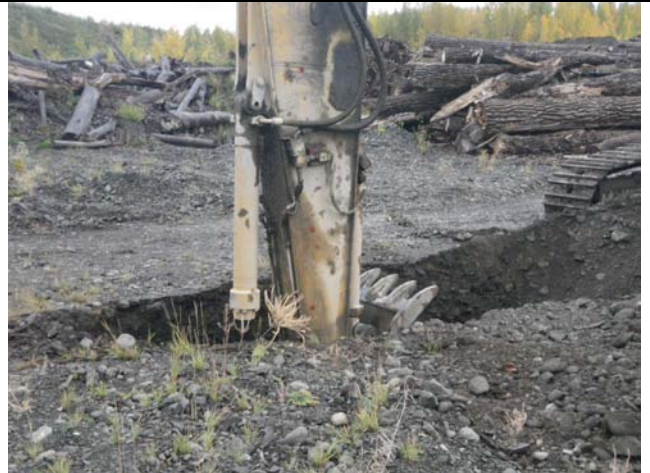
Photo 2. Test pit depth estimated based on scale on excavator arm (red dots)

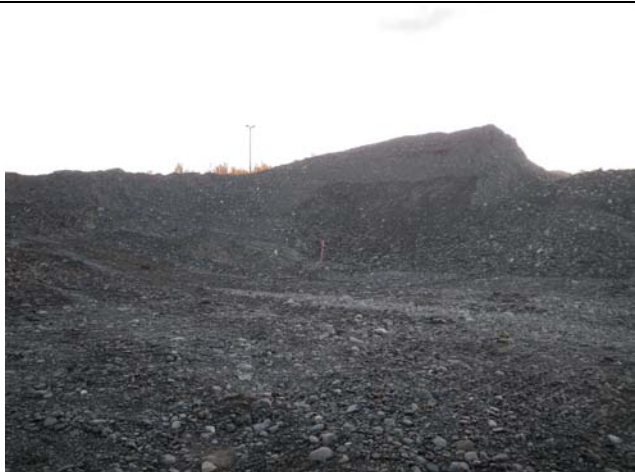
Photo 18. Backfilled test pit 11 (looking southeast)

Headspace field screening was performed in conjunction with the analytical soil sampling. With exception to test pits 11, 38, and 39 all field screening head space samples registered 0 with the PID. Test pits 38 and 39 PID readings ranged from 0 to 40. Test pits 38 and 39 contained moist sand instead of gravel. The field chemist did not observe any fuel odors in either test pit. The elevated PID readings are likely the result of the different soil type and elevated moisture content. The field screening sample collected from the slope of test pit 11 did have a noticeable fuel odor and generated a PID reading of 11.

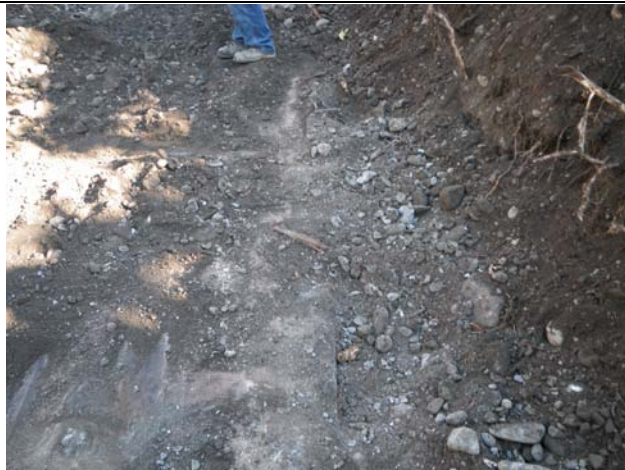
Photo 19. Concrete foundation encountered at test pit 14

- hit what looks to be a foundation
- excavated 2' depth, 15' wide, and ~ 60' length
- another small test pit ~ 20' to the East and the foundation was still there
- moving to TP-15
