RE: Wrangell Monofill Project – CSP2 Report

SAMPLING AND ANALYSIS REPORT
TREATED STOCKPILE AND MONOFILL SITES
WRANGELL, ALASKA
ADEC File # 1529.38.006
APRIL 11, 2018

2018 Treated Stockpile Sampling Diagram
 Construction of Solid Waste Monofill for Lead Contaminated Soil
 ADEC AR Term Contract 18-70020-01
 Byford Junkyard Site, Zimovia Hwy, Wrangell, Alaska

2018 Monofill Site and Vicinity Sampling Diagram
 Construction of Solid Waste Monofill for Lead Contaminated Soil
 ADEC AR Term Contract 18-70020-01
 Pat's Creek Rd, DNR Rock Pit #2 Wrangell, Alaska 99929

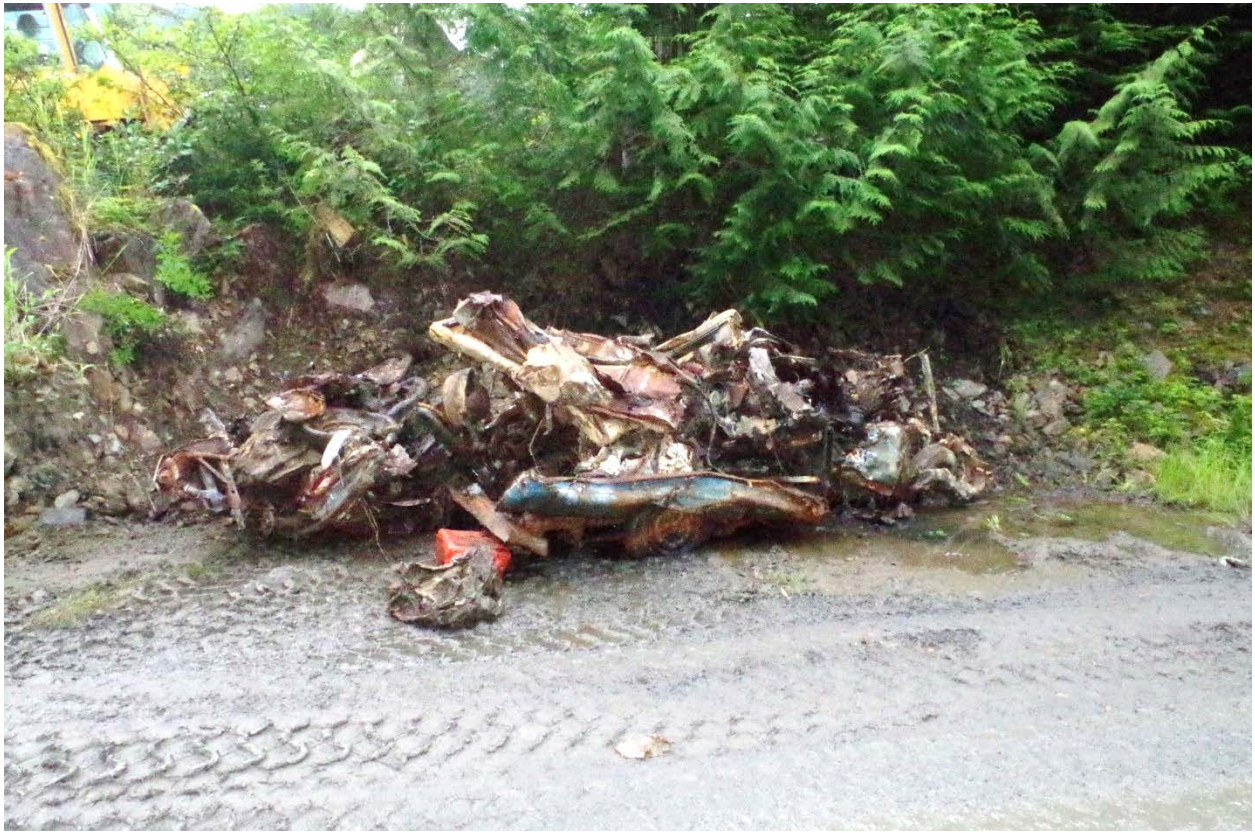
Photo 1: Image of crushed vehicles removed from the pit in August 2017.

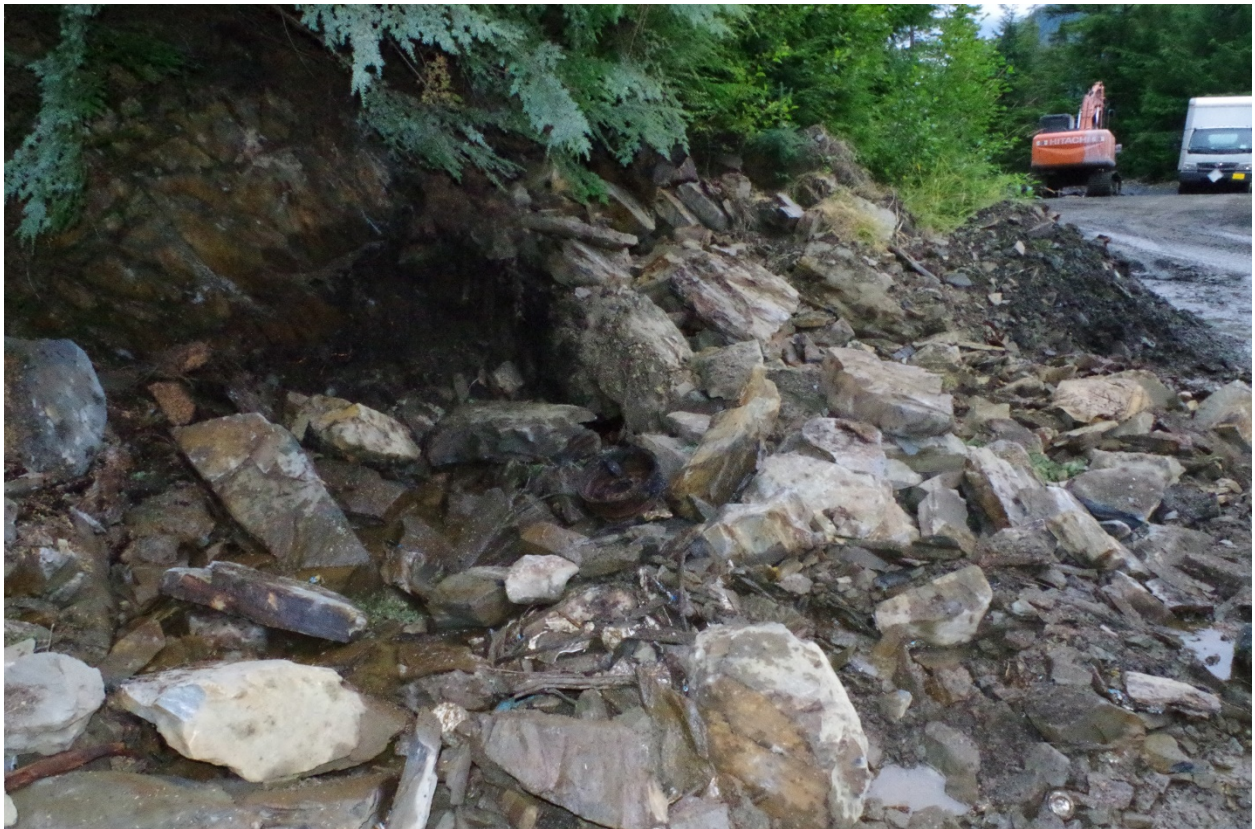
Photo 2: Location inside the pit entrance where the vehicles were encountered.

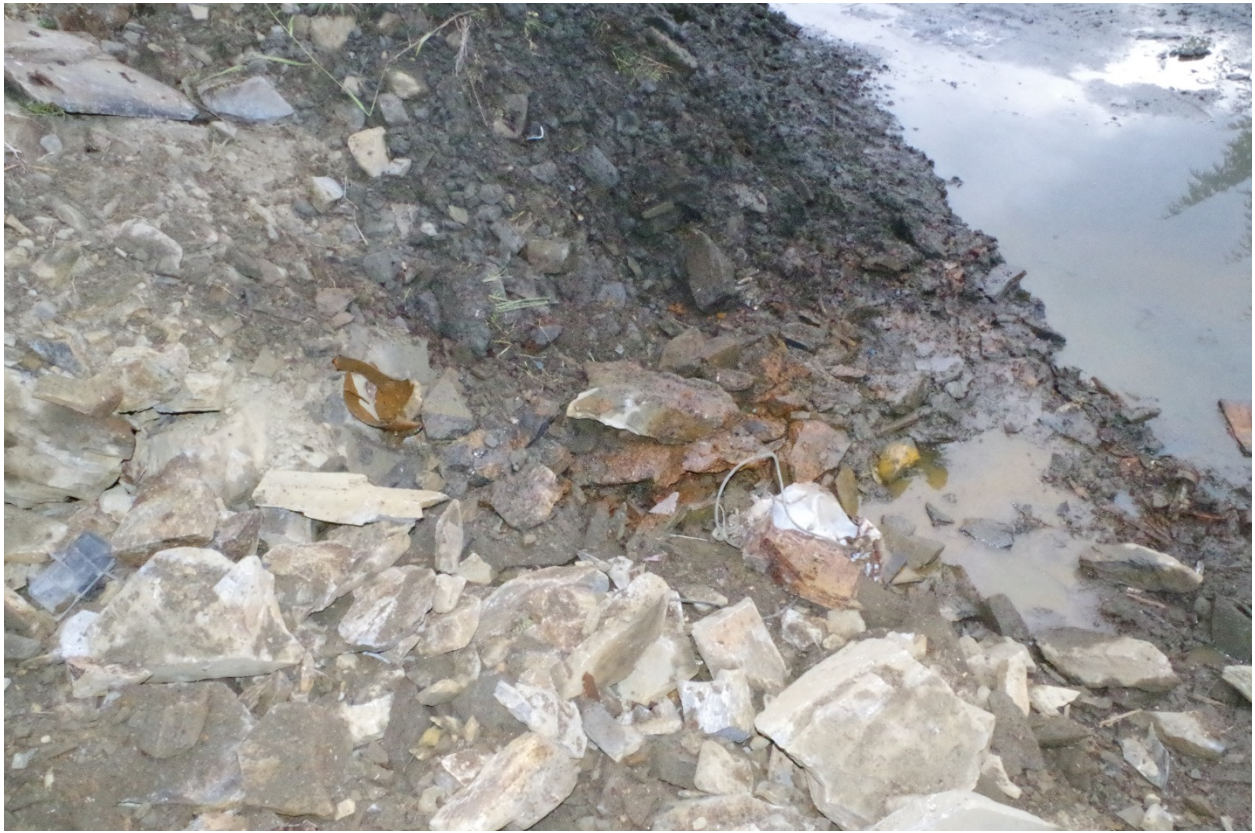
Photo 3: Close-in view of where the crushed vehicles were found.

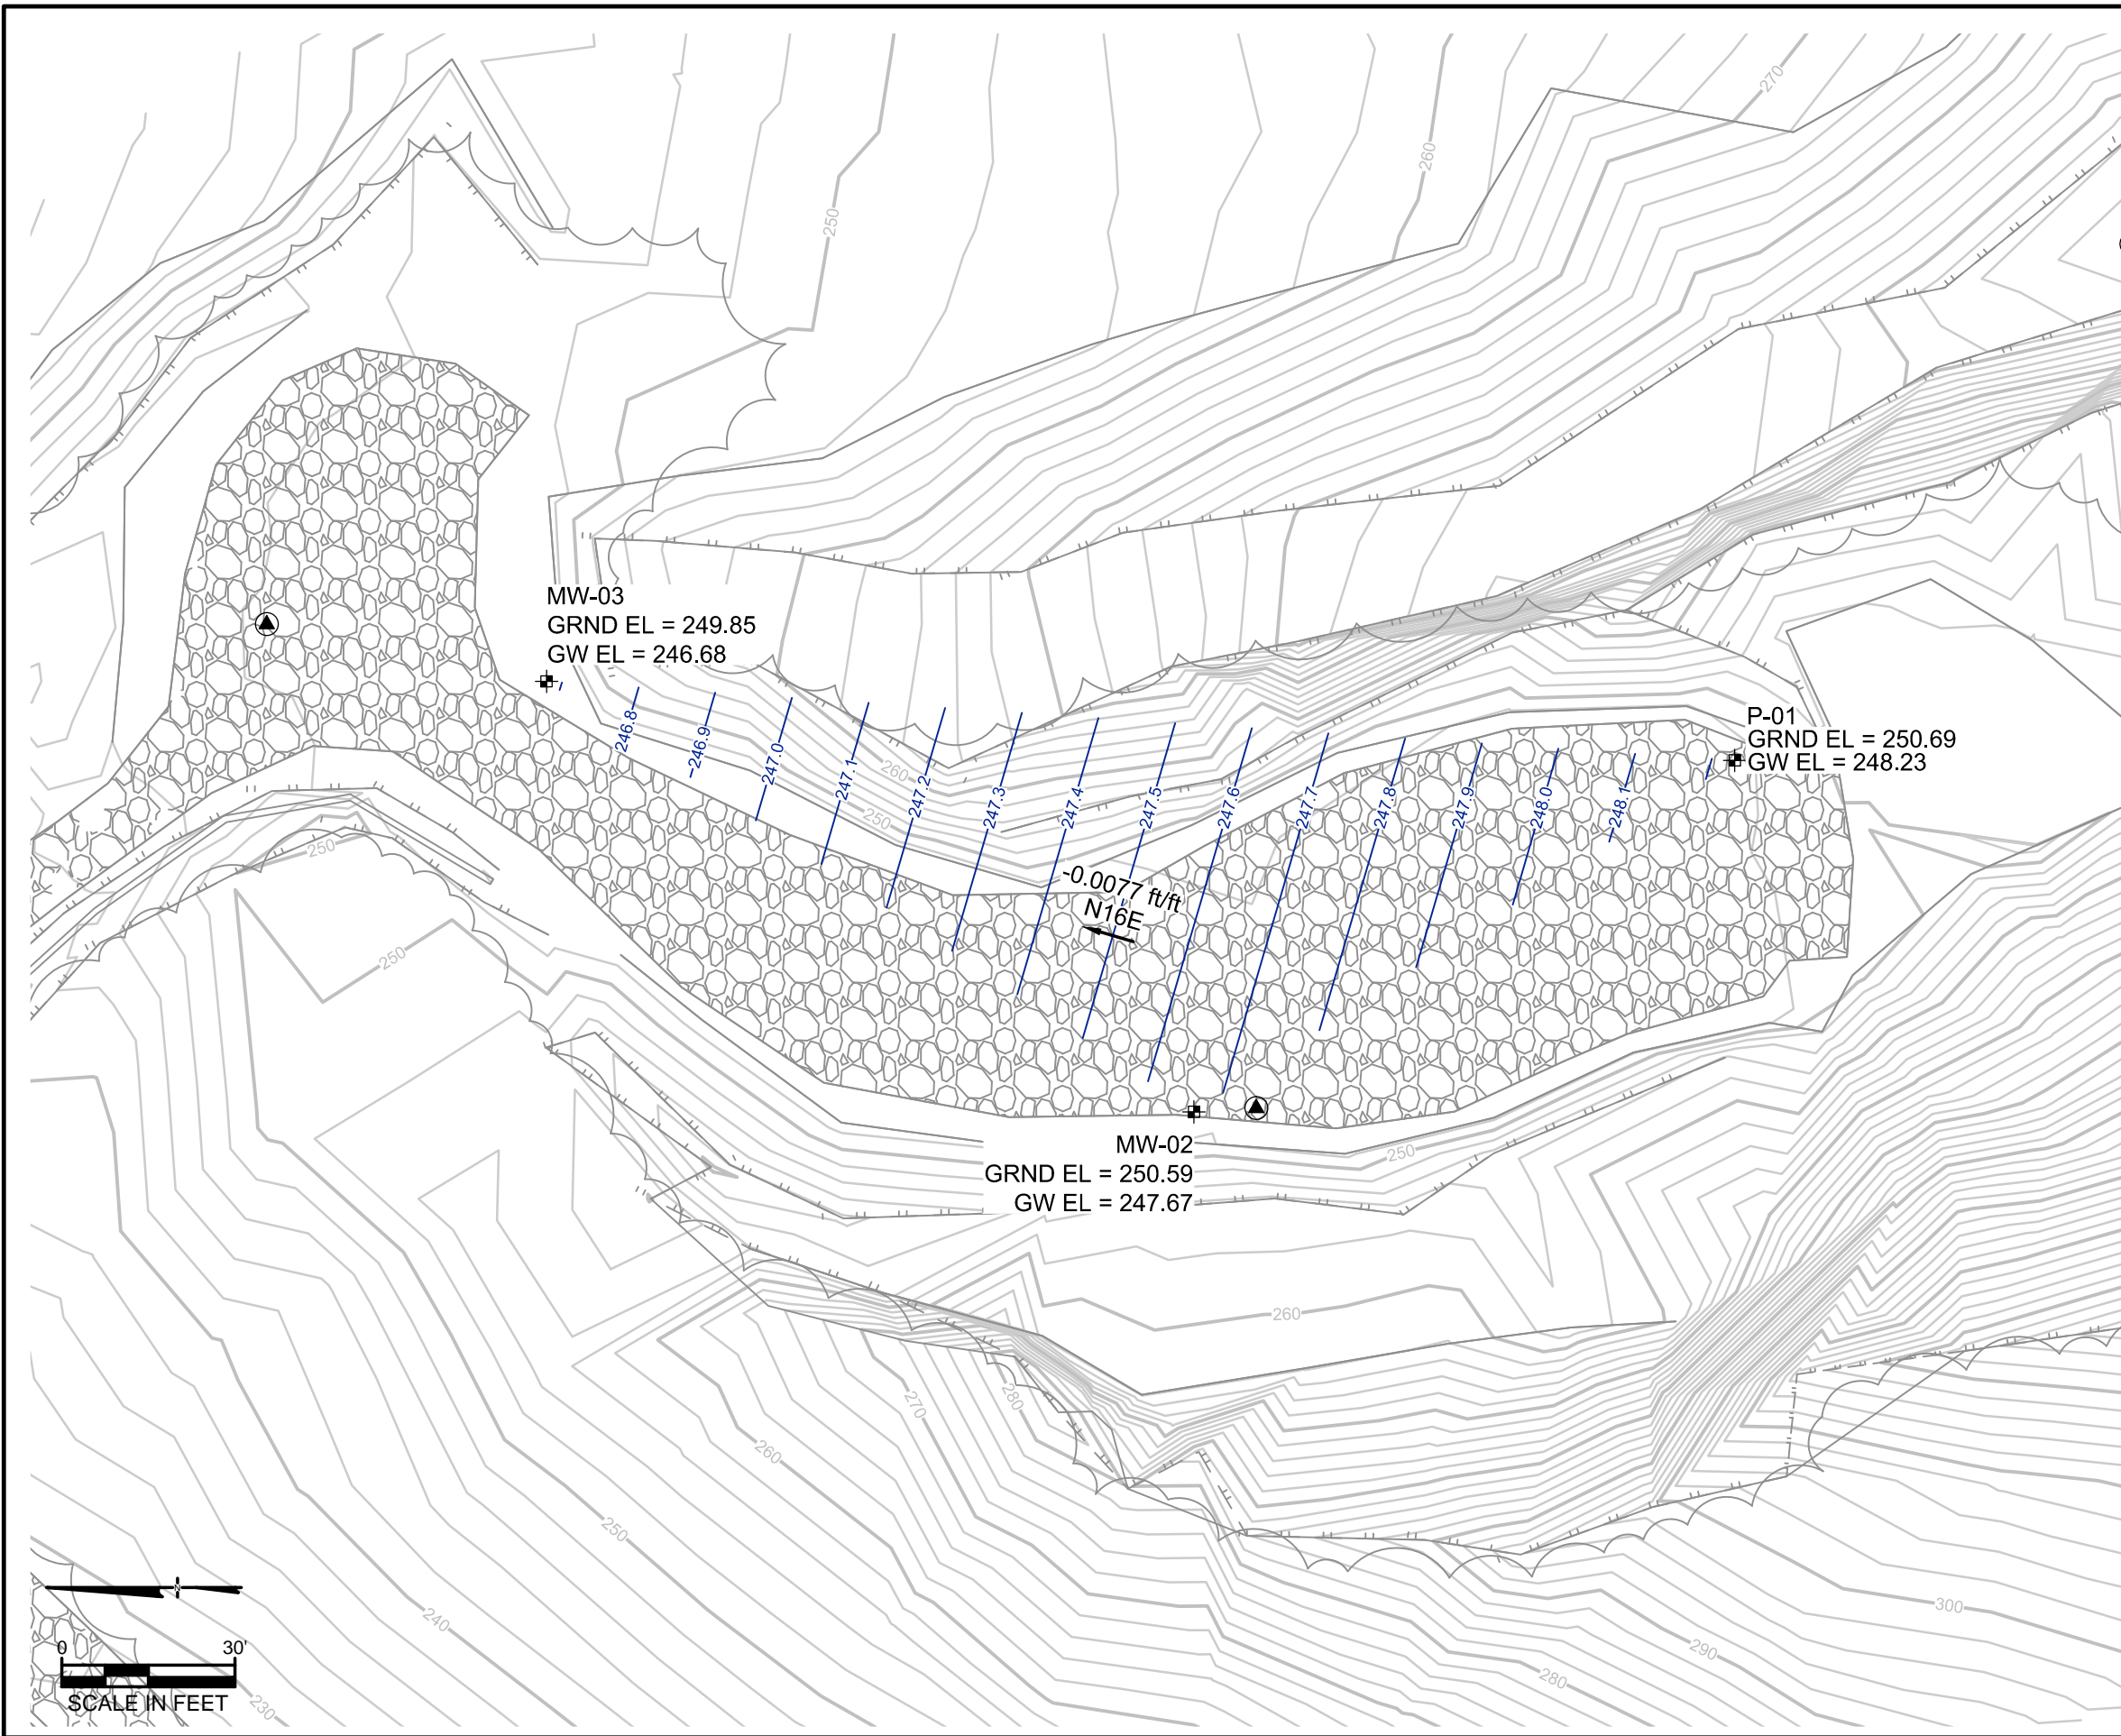
P:\PRJ\SDCADD\CADD\PNG0736 WRANGELL\C3D\WORKING SURFACES\GROUNDWATER

- 300 — EXISTING GROUND MAJOR CONTOURS (5)
- — EXISTING GROUND MINOR CONTOURS (1)
- 248.0 — GROUNDWATER CONTOURS (0.1')
- ⊕ GROUNDWATER WELL
- ⊙ SURVEY CONTROL MONUMENT

- Geosyntec/Ahtna- groundwater contour map for the rock pit
- Figure 1 Monofill Site with rock pit survey showing base layer drainage, French drain system, and proposed catch basin
- Figure 2 Monofill Site detail view of French drain, catch basin
- Figure 3 Monofill Site vicinity surface water flow diagram
- Images of crushed and buried vehicles encountered in the pit
- Nortech Sampling and Analysis Report – Treated Stockpile and Monofill Sites, April 11, 2018

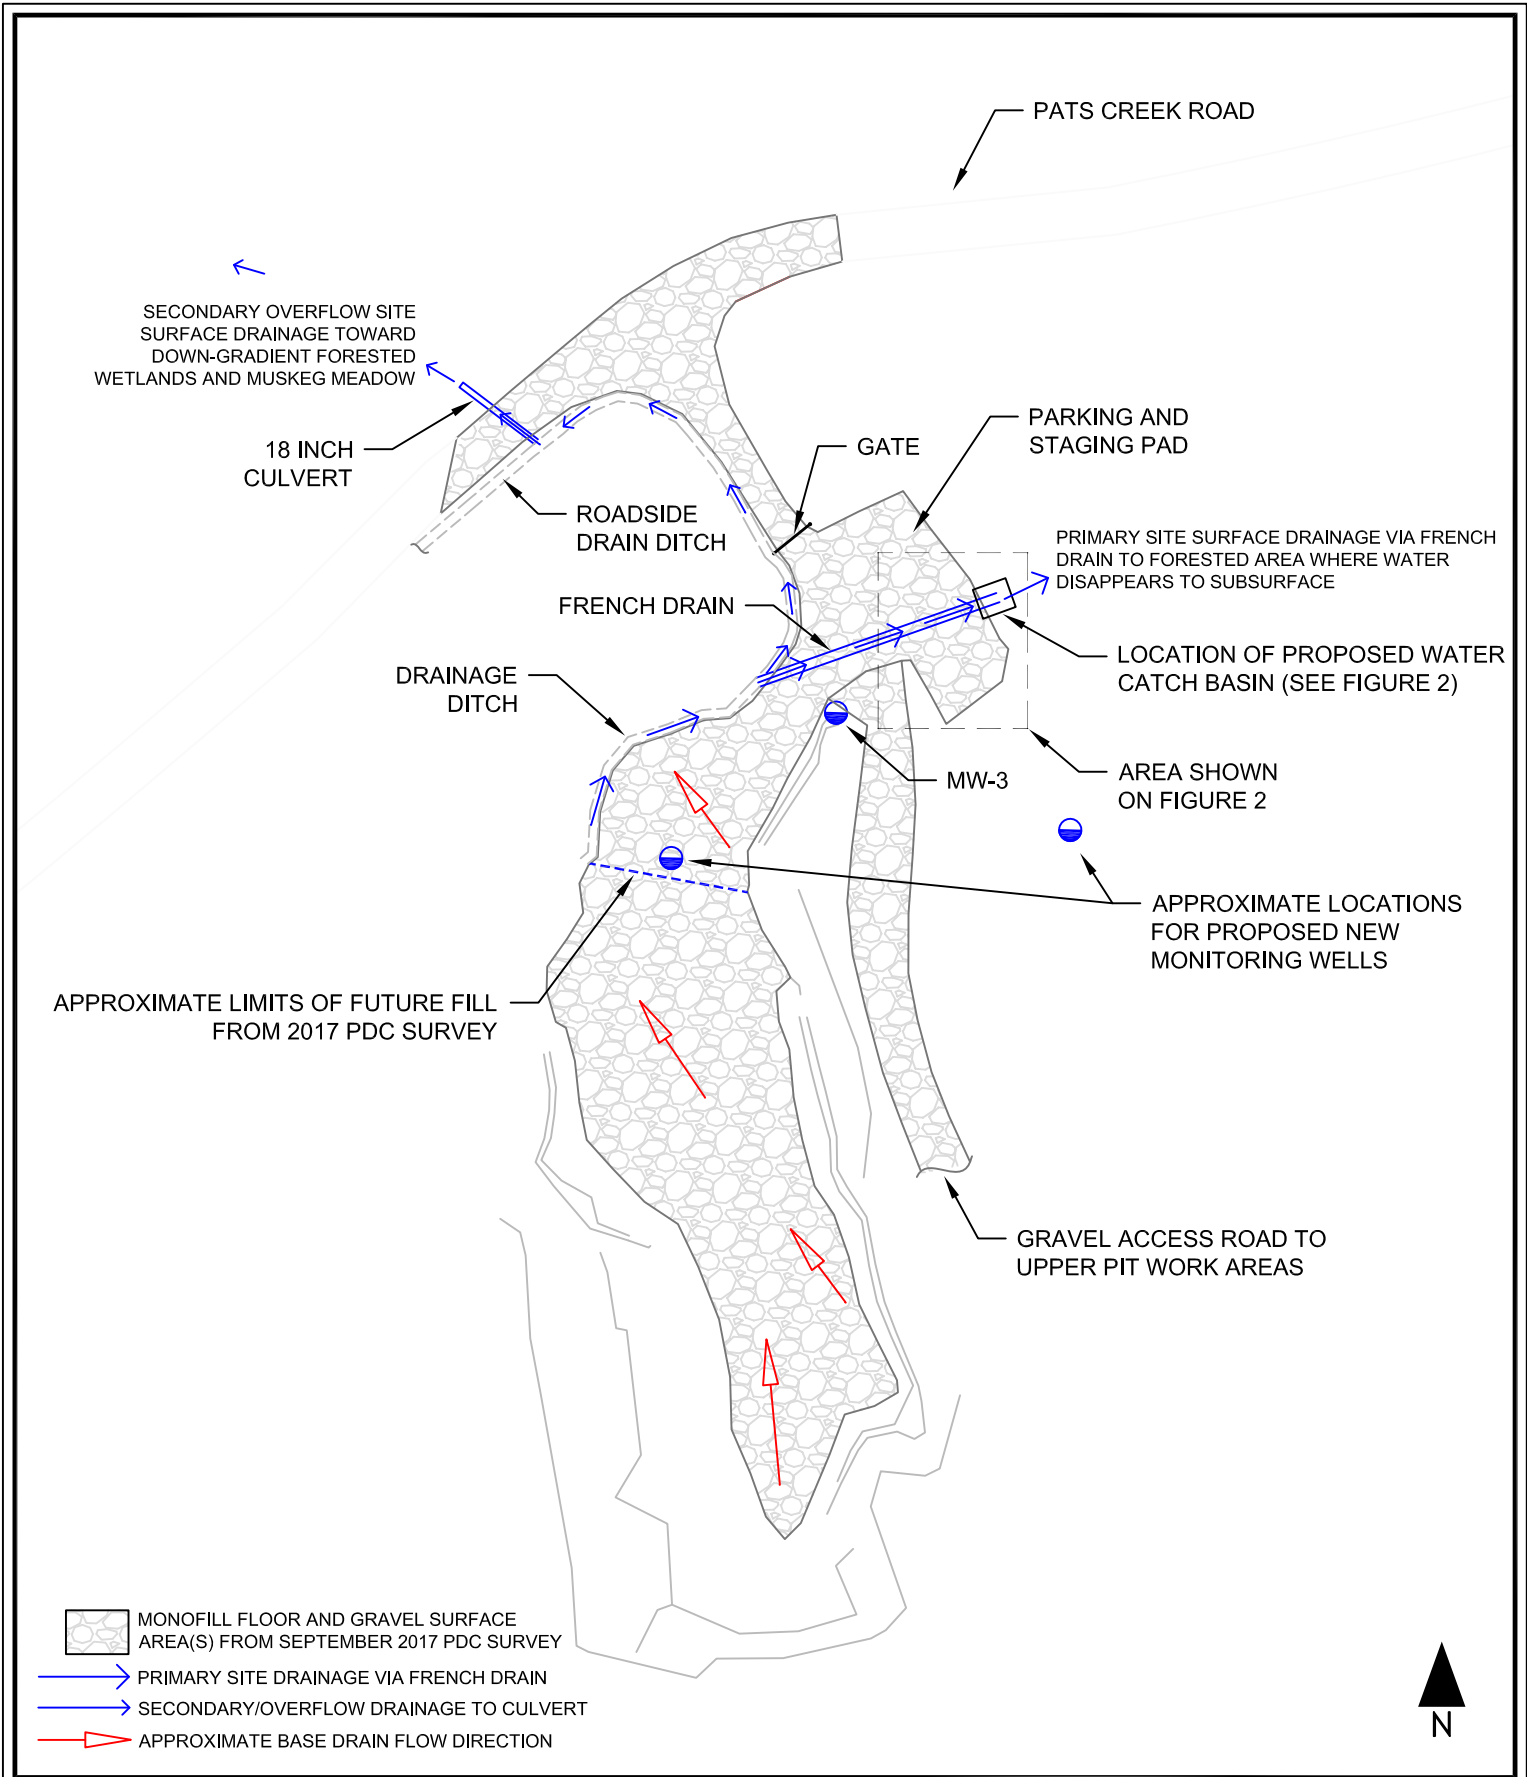
Figures 1 and 3 show surface drainage flows inside the pit and area hydrologic flows. Note that groundwater flow direction (see groundwater contour map) is different from the base layer flow direction. DEC is currently conducting fate and transport modeling in conjunction with the re-evaluation of the HELP Model calculations, based on the concentrations of contaminants detected in the pore water of the stockpile. The DEC will use these concentrations coupled with the annual infiltration rate through the monofill cover design to model the contaminant concentration that may exit the monofill through the drainage base layer and its relationship to regulatory criteria for groundwater and surface water aquatic life.

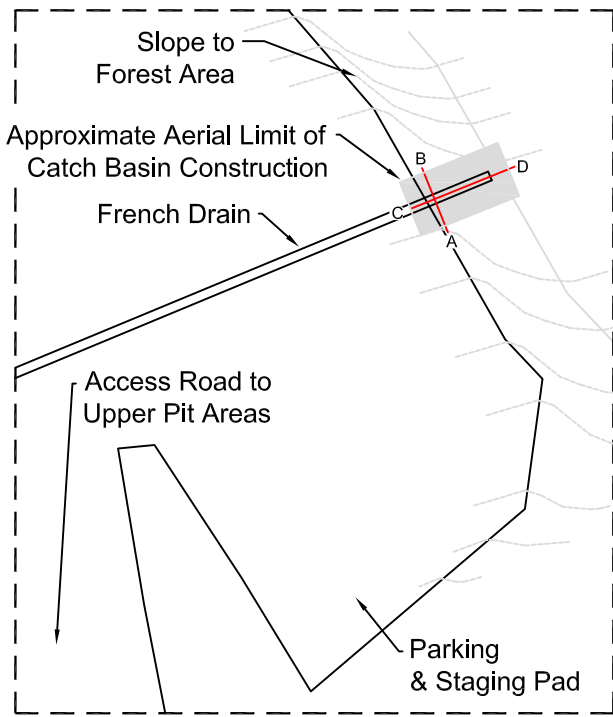
Profile View of French Drain and Catchment Basin Along Section Line C to D

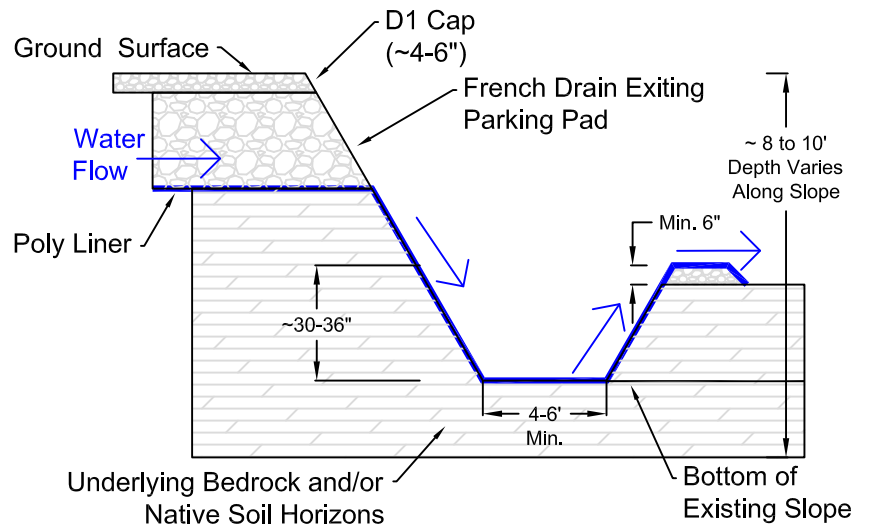
Profile View of French Drain Exiting the Parking Pad Along Section Line A to B

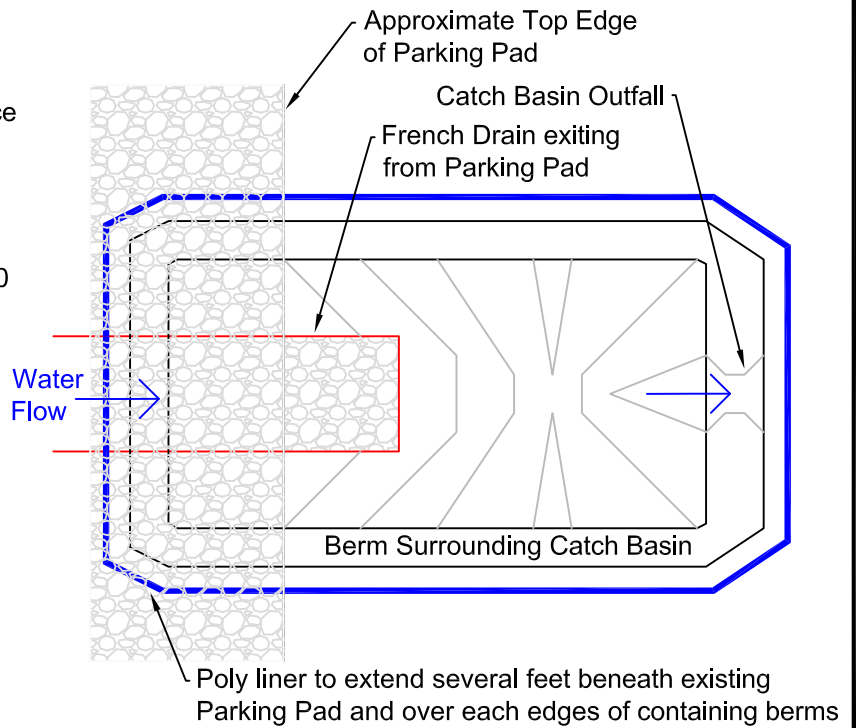
Aerial View of French Drain and Catch Basin

NOTE: All depths and dimensions are approximate. Schematic drawings are not to scale (vertical or horizontal) and are intended to show generalized details for the conceptual construction design of the catch basin. Dimensions may vary based on site conditions during construction. Catch Basin to be constructed to store minimum volume of 300 gallons of water. As Built drawings will be made subsequent to final construction.

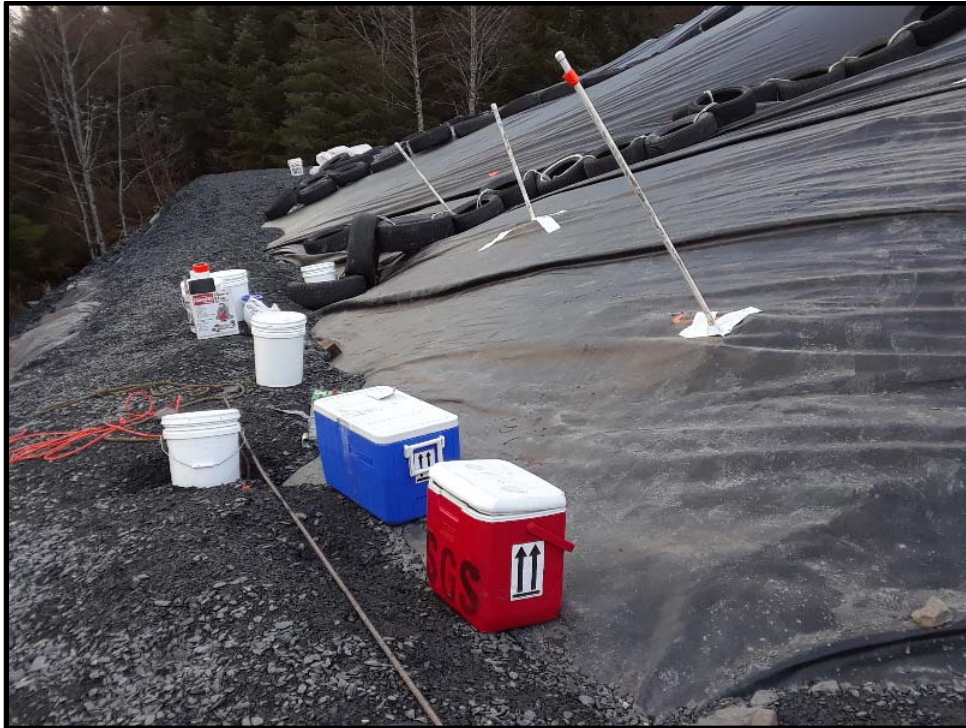
Photo 1: Looking northwest at the pore water sampling points installed in the southwestern corner of the treated stockpile at the former Byford Junkyard Site.

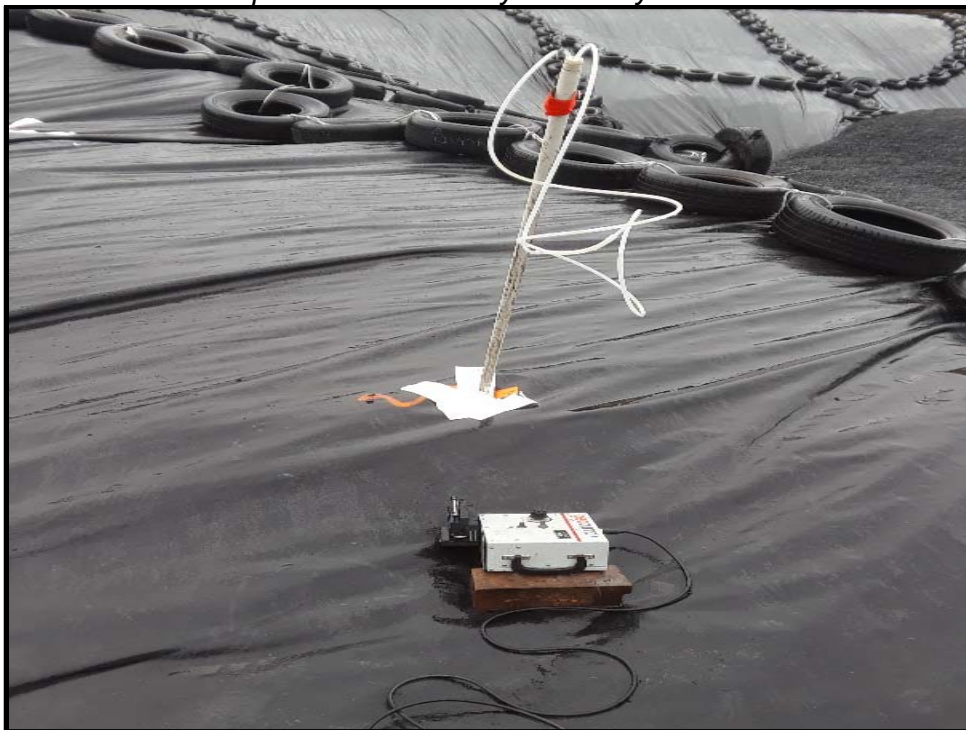
Photo 2: Looking east at sampling point W3 at the Byford Junkyard Site being prepared for pore water purging and sample collection.

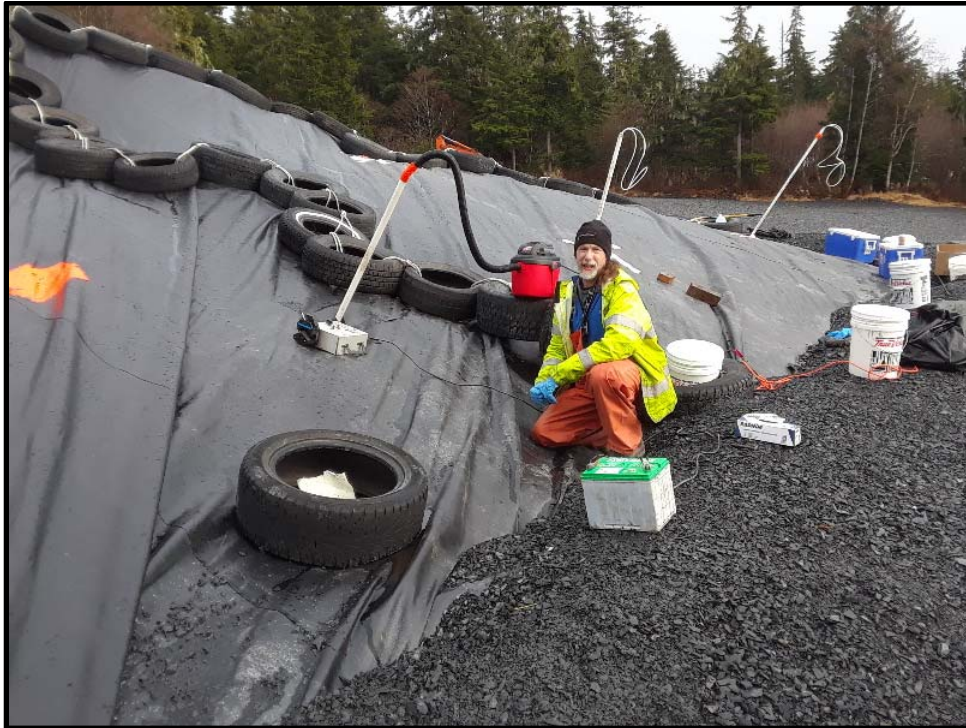
Photo 3: Looking east at sampling point W3 at the Byford Junkyard Site. Note vacuum suction being applied to sample point in attempt to draw additional pore water for sample collection.

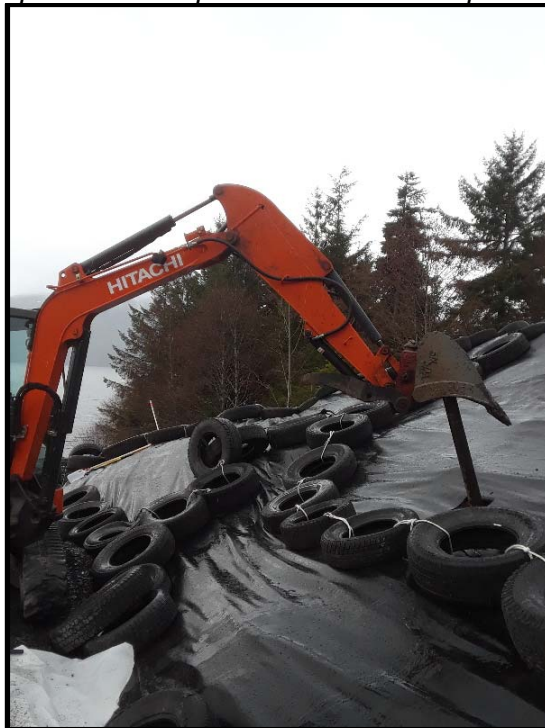
Photo 4: Looking southwest during the soil sampling of TSP-10. Note mini excavator used to advance steel pipe into the stockpile to desired depth. Pipe was then removed and a hand auger was used for collection of soil for analysis at desired depth interval(s).

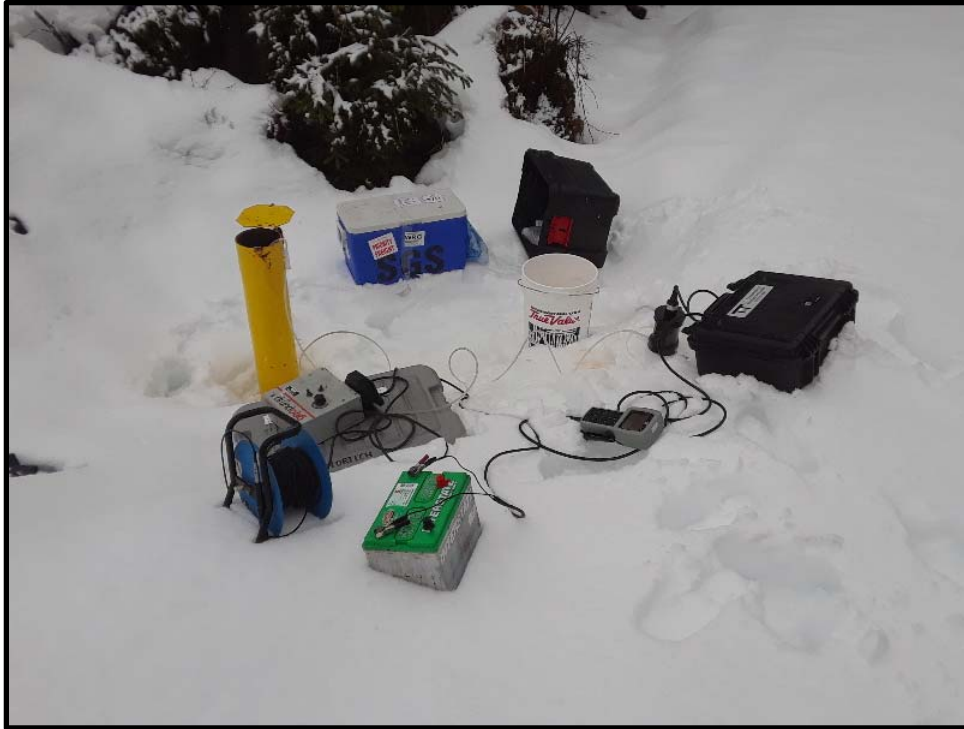
Photo 5: Looking south at MW-3 in DNR Pit #2 (Monofill Site) during well purging and water quality monitoring.

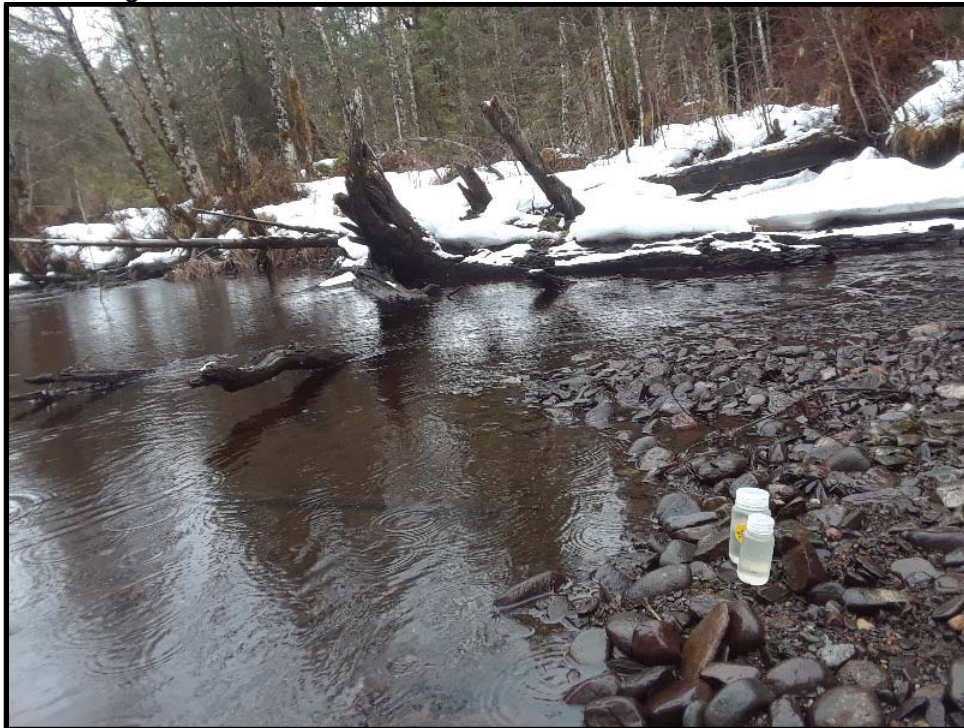
Photo 6: Looking southeast at surface water sample collection location (PT-001) in the principal tributary located down-gradient of the Monofill Site. Note the low volume of water in the stream at time of sampling.

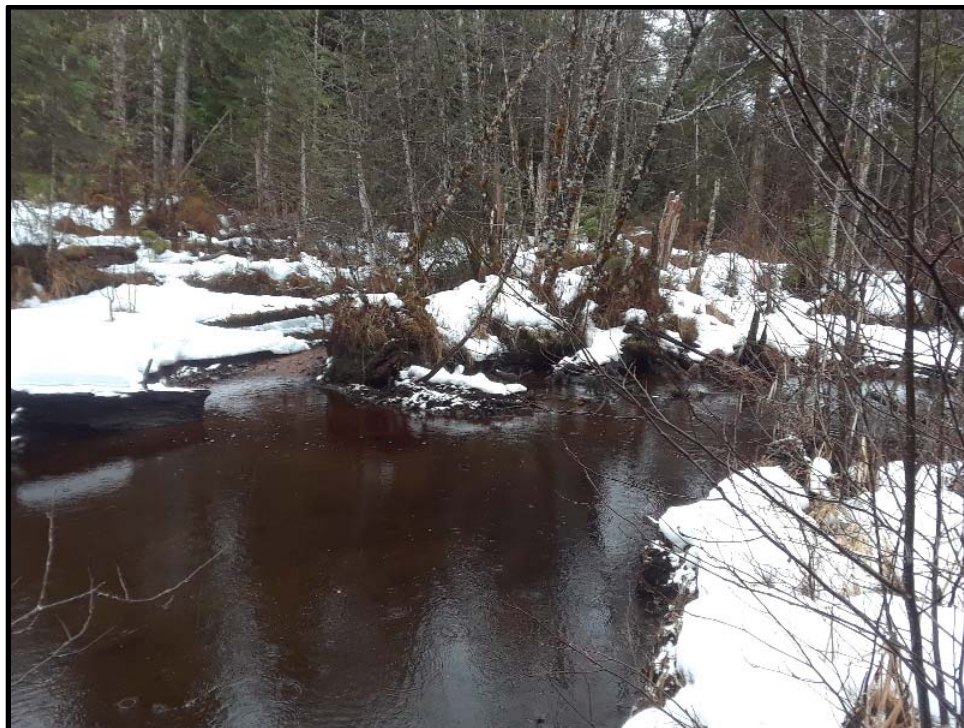
Photo 7: Looking south at location where water from the forested wetland and muskeg meadow(s) confluences the principal tributary down-gradient from the Monofill Site. Surface water samples PT-001 and PT-100 (duplicate) were collected at far right of image.

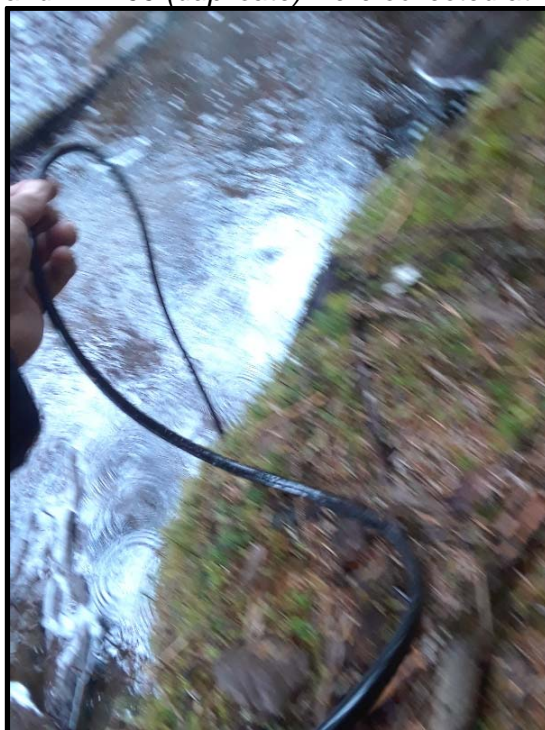
Photo 8: Looking south during water quality monitoring of the principal tributary down-gradient from the Monofill Site. Note this location is approximately 50 feet downstream from sampling location PT-001 at the nearest location deep enough to submerge the instrument probe.

Water quality parameters measured in the surface water stream were taken subsequent to sample collection, not prior to sampling as described in the approved SAP. Furthermore, the water quality parameters were collected at a location approximately 50 feet down-stream from the sampling location at the nearest accessible location deep enough to fully submerge the instrument probe. This was due to low-flow winter stream conditions.

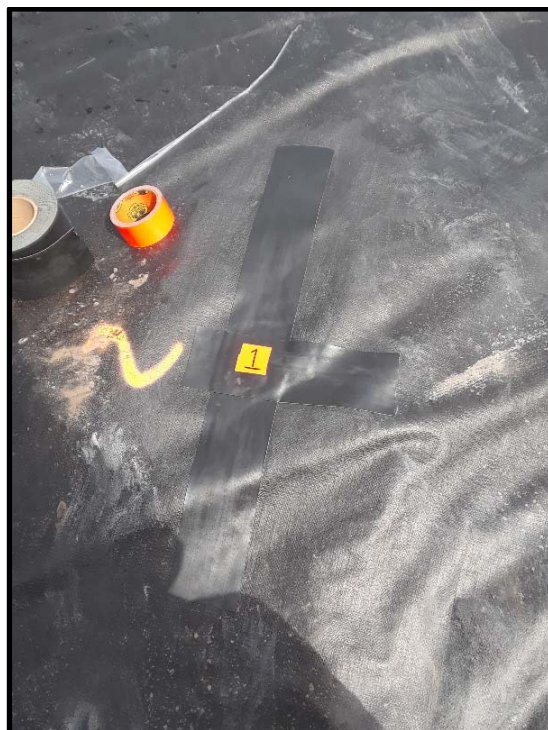
Photo 9: Looking down at pore water sampling point W1 after cutting and capping the PVC casing and tape repairs to the stockpile covering.

At the request of ADEC, the three pore water sample points were not removed from the treated stockpile. Each sampling point was cut below the surrounding soil stockpile elevation, capped and covered with a piece of flat plywood to protect the stockpile cover from being damaged by the sampling points prior to securing and taping the stockpile cover.

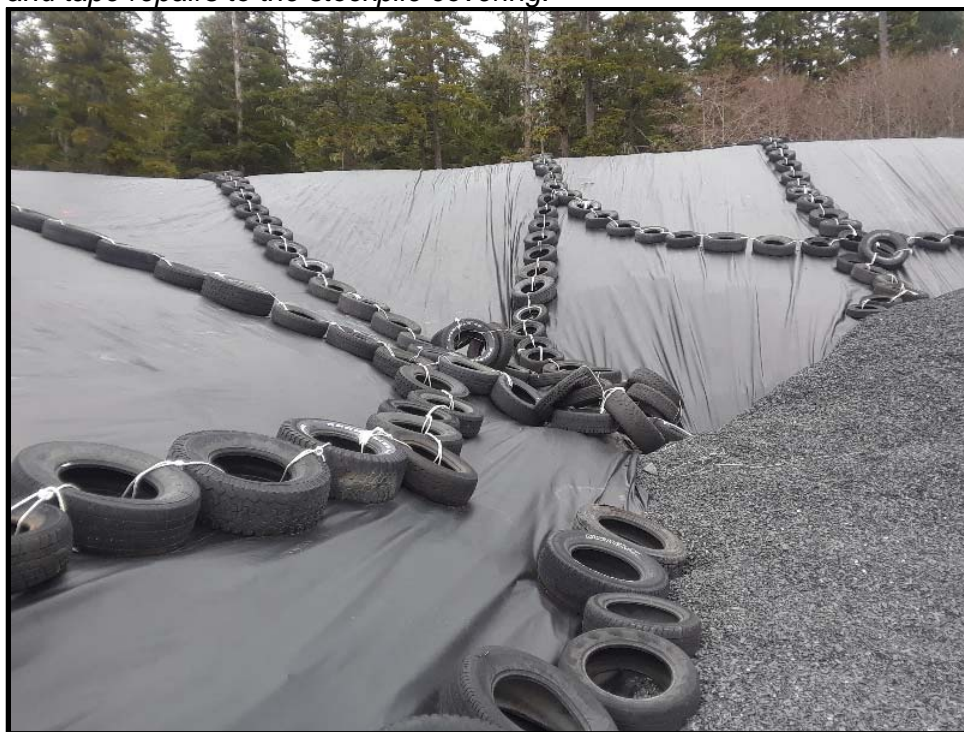
During the inspection, Mr. Pratt confirmed that the tires securing the cover have shifted over the winter and that the stockpile cover has also shifted. In several areas it was observed that the cover has been stretched and pulled taut. In other areas, the cover was wrinkled and/or folded over upon itself. It was also observed that a taped seam between two layers of covering was stressed and beginning to pull apart on the northwestern portion of the stockpile. This is likely the result of the shifting of the cover that has occurred in the past six months.

Photo 10: Looking north at the treated stockpile prior to investigation. Note the tires piled up near the toe of the stockpile slope which resulted when snow load on the stockpile shifted the securing "tire chains" during the winter/spring of 2018.

On March 22, Ron Pratt conducted an inspection of the treated stockpile. The primary purpose of this inspection was to assess the integrity of the stockpile cover, to identify any holes or penetrations of the cover and to repair any observed damage to the cover. A total of 11 small penetrations were observed in the cover during this inspection and were repaired with six inch wide rubberized repair tape.

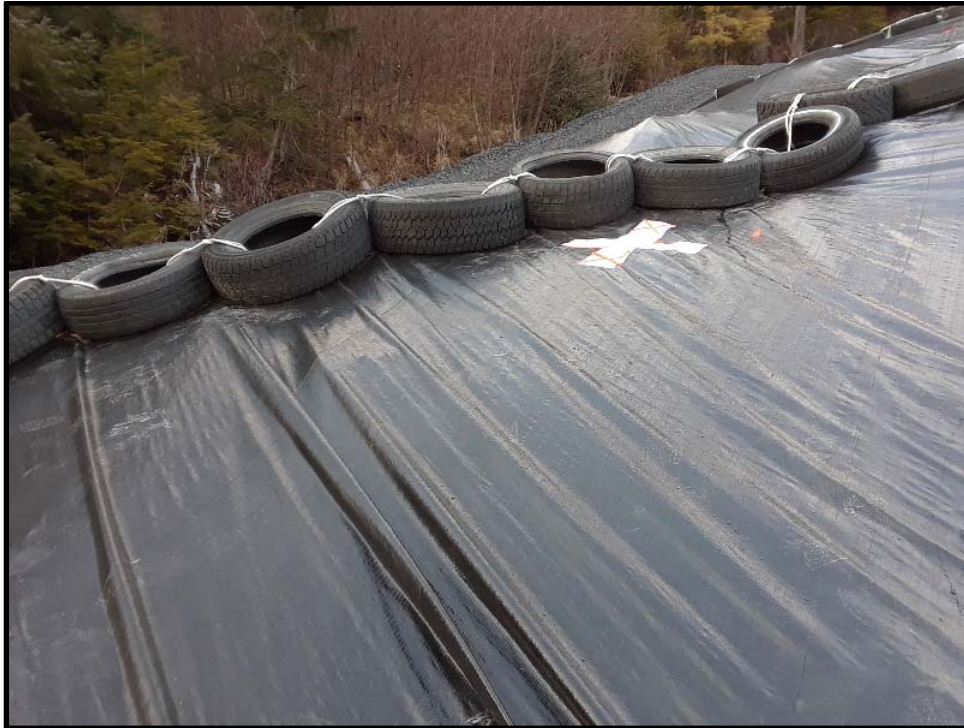
Photo 11: Looking northwest at the treated stockpile and location of TSP-2 after tape repairs to the stockpile cover. Note wrinkles in the cover resulting from tire shifting that occurred during the winter/spring of 2018.

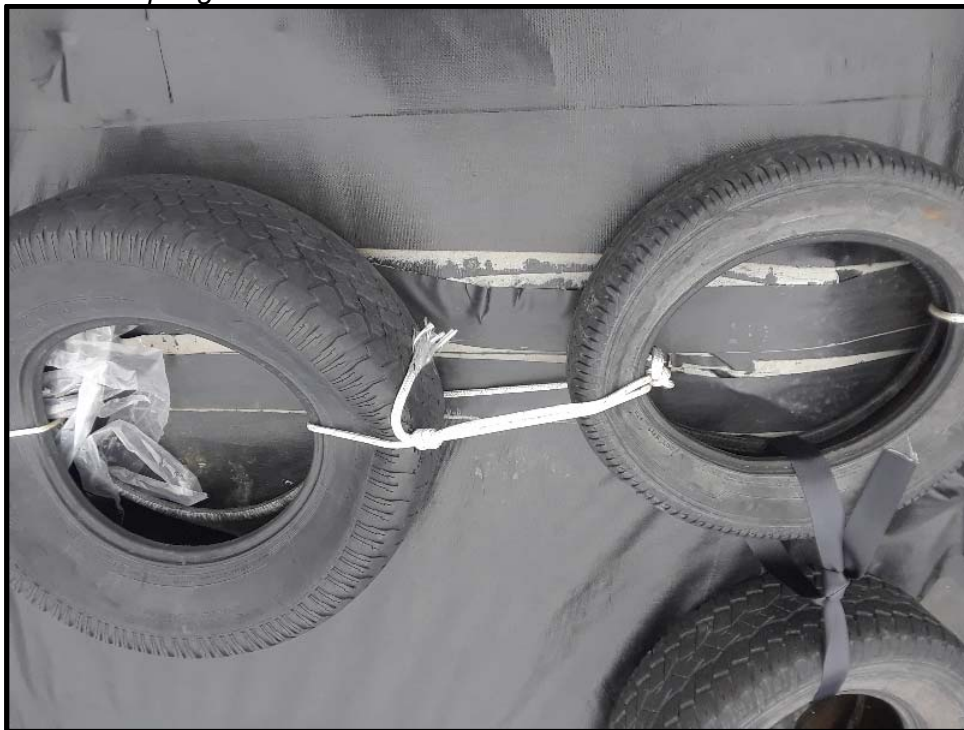
Photo 12: Looking down at one of the taped seams on the stockpile covering. Note the apparent stress on the taped seam resulting from the shifting of the tires and stockpile cover which occurred during the winter/spring of 2018.
