US Route 202 (Concord Pike)
Rocky Run Parkway to Whitby Drive
Pedestrian Access Route Assessment

FINAL REPORT

JUNE 2018

CONTRACT NO. T201801101, AGREEMENT 1793 – TASK 3
NEW CASTLE COUNTY, DELAWARE

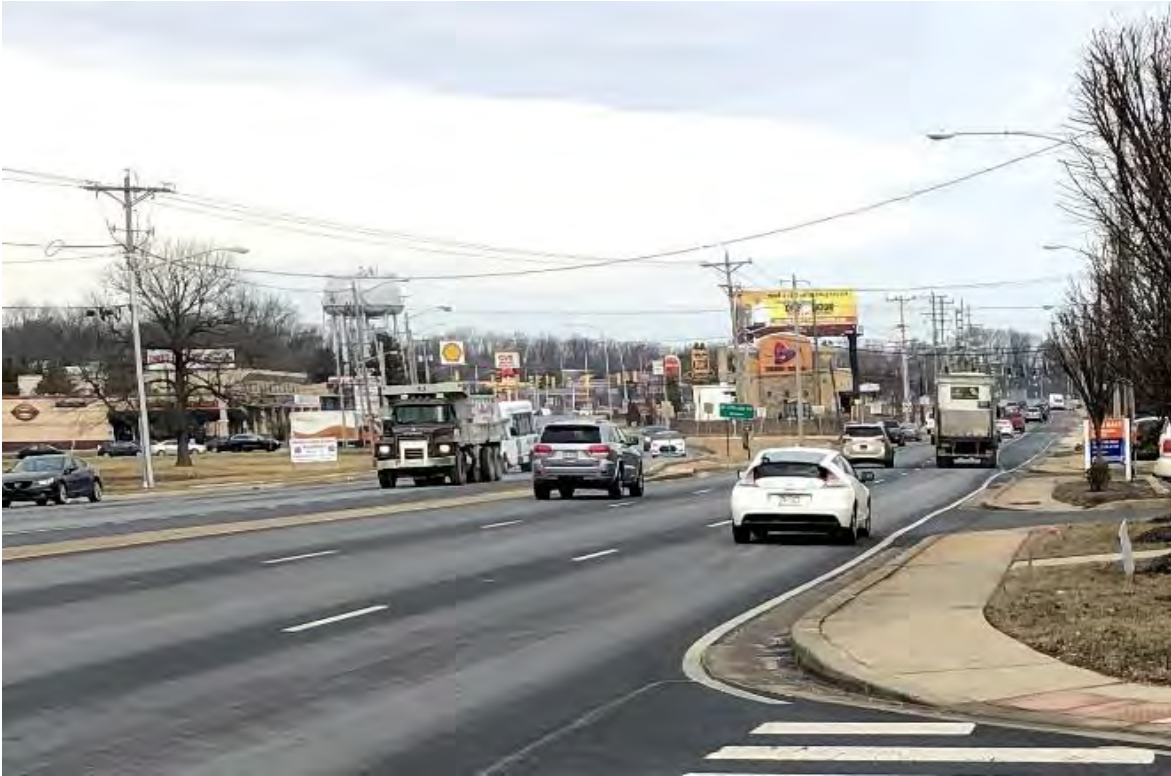
Figure 1 – Study Area Map

Figure 1 shows the study area location, which is located along US 202 to the north of the City of Wilmington in Talleyville. The project limits include both directions of US 202 between the southern intersection of Rocky Run Parkway and Whitby Drive, Silverside Road from US 202 to Brookfield Lane, Mt. Lebanon Road from US 202 to the westernmost entrance to Woodley Park, and Garden of Eden Road from US 202 to the trailhead at Brandywine Park. This section of US 202 is 1.07 miles in length.

US 202 looking north from Prospect Ave

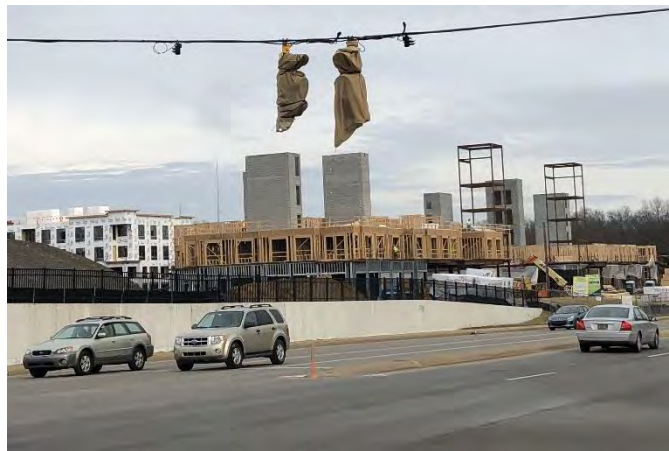
- [Concord Plaza – Silverside Road](#)
This mixed-use redevelopment project will be located on three adjacent parcels on the north side of Silverside Road to the east of the Talleyville Shopping Center. The project will contain approximately 6,200 total square feet in four 5-story buildings and two 4-story buildings, with 341 apartments, office space, retail space, and other amenities including a fitness center, lounge, technology center, private meeting rooms, and swimming pool. The approved construction plans show a 5-foot wide sidewalk across the entire property frontage, new accessible curb ramps and high-visibility crosswalks across both of the site driveways, and a reconstructed curb ramp on the east side of the shopping center driveway. The plans show new lighting poles along the southern side of the internal parking lot, but do not provide any roadway lighting directly adjacent to Silverside Road. This project was under construction at the time of this study.

Concord Plaza under construction

In conjunction with the Concord Plaza development, the intersections along Silverside Road adjacent to the project at Rose Avenue and Brookfield Lane will be upgraded. Proposed signal plans were obtained from DeIDOT Development Coordination and are included in **Appendix B**. At both intersections, the plans call for reconstructing the curb ramps at each of the corners. These intersections were under construction at the time of this study.

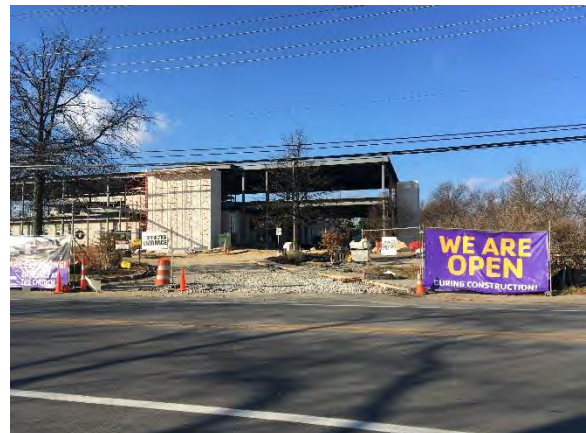
Construction for a building expansion of the YMCA on the north side of Mount Lebanon Road began in the spring of 2017. The 16,000 square foot 2nd floor addition will house a youth wellness center, new and renovated classrooms for preschool, community education rooms, a larger fitness center, and a second fitness studio. The project will include new accessible curb ramps and crosswalks across both driveways, but will not reconstruct the existing sidewalk along the north side of Mount Lebanon Road. The project will also add an accessible curb ramp on the south side of the road to accommodate a new marked crosswalk across Mount Lebanon Road at the western, exit-only entrance. This project was under construction at the time of this study.

YMCA under construction

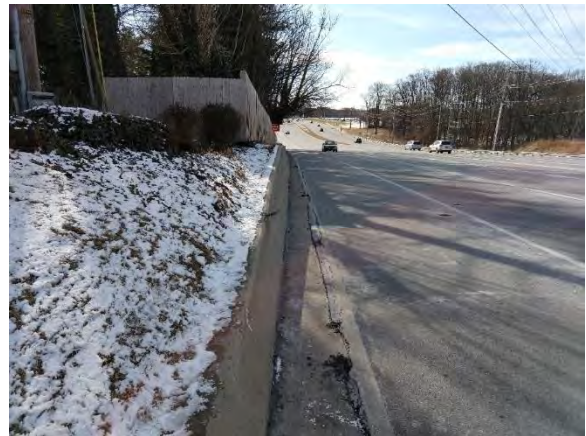
At the north end of the study area, there is approximately 600 feet of missing sidewalk along northbound US 202 between Rocky Run Parkway and the Rocky Run Creek. This stretch is located on property owned by the Widener University Law School and passes in front of their southernmost entrance, which has a curbed median with no curb ramps. The adjacent property is higher than the roadway grade in this area and is retained by a 4.5 foot high barrier that slopes back to roadway grade in both directions.

Missing sidewalk along NB US 202

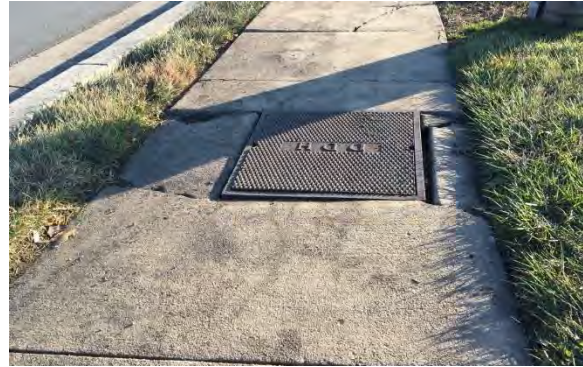
varies with several segments exceeding a 3% cross slope, and the curb ramps at the northern driveway to the office complex are non-compliant. Utility covers located within the PAR have created non-compliant horizontal gaps at four locations along this stretch, and there are vertical elevation differences at three additional locations south of Righter Parkway. Between Passmore Road and Garden of Eden Road, the sidewalks are 60" or wider and in good condition.

Horizontal gap at utility cover

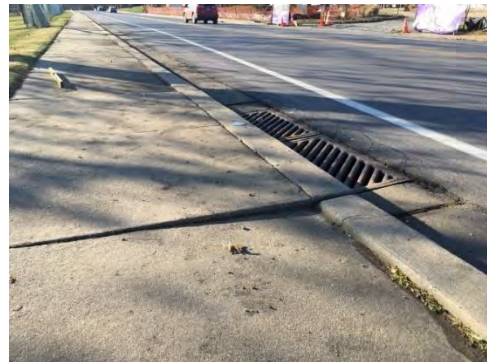
On the north side of Silverside Road, the 280 foot-long stretch of sidewalk between US 202 and Rose Avenue is in poor condition with a width less than 48" and a cross slope exceeding 3%. The sidewalk and curb ramps east of Rose Avenue were not inventoried as they will be reconstructed as part of the Concord Plaza redevelopment.

Elevation difference near inlet

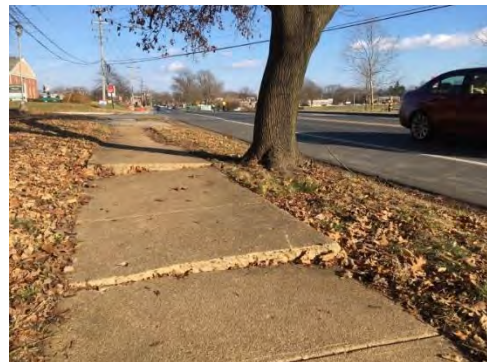
Sidewalk along the south side of Mount Lebanon Road is also 60" wide and in good condition; however, there are three locations where the vertical elevation difference exceeds 1" due to the sidewalk settling adjacent to drainage inlet boxes. One curb ramp at the school district driveway was found to be non-compliant.

Elevation difference due to tree roots

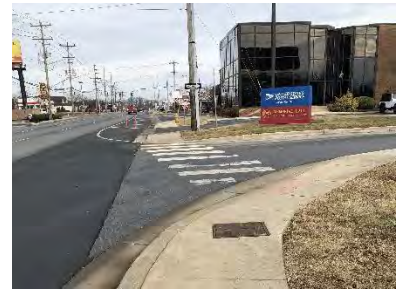
Missing signal heads at Mt. Lebanon intersection

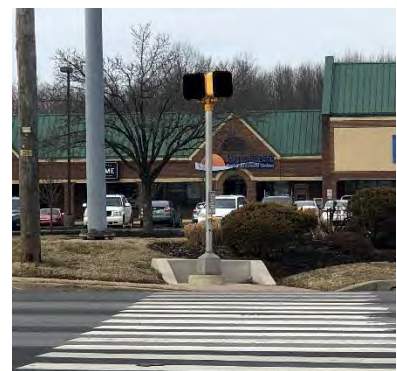
- No pedestrian crossing is provided across the north leg of the intersection
- Two pedestrian pushbuttons are located on a single pole on the SE and SW corners. The reach dimension for push buttons on the SE corner exceeds 10”.
- Pedestrian clearance times for crossing US 202 and the shopping center driveway should be re-evaluated
- Pedestrian signal heads on the SW corner are misaligned (twisted) and not visible from the corresponding crosswalks
- There are potential tripping hazards on the NW and SW corners (5” & 7” foundation exposure)

Misaligned pedestrian signal heads at Prospect Ave

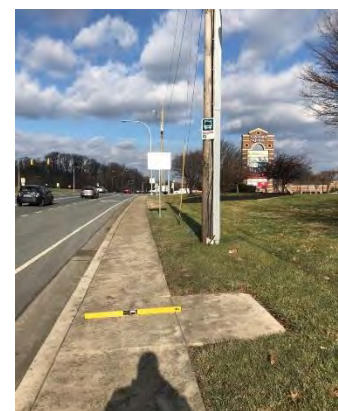
Figure 8 – Transit Facilities and Ridership

Figure 8 shows location, ridership, and compliancy for the eighteen bus stops present within the study area, while **Table 2** summarizes facilities and ridership at each stop. Bus stops with the highest ridership are located at the north end of the corridor at Rocky Run Blvd and in the central bifurcated portion of US 202 between Silverside Road and Mt. Lebanon Road. DTC provided data on ridership patterns within the study area, including ridership load profiles from December 2016. In the AM period, trip activity is primarily generated by riders boarding in Wilmington accessing retail jobs within the corridor, while in the PM period, trips are primarily generated by retail workers heading back into Wilmington, both in the late afternoon and early evening. This activity is supplemented by shoppers who have flexibility to access corridor businesses later in the AM period and return during the late lunch or early afternoon periods.

Bus stop with waiting pad At Concord Square

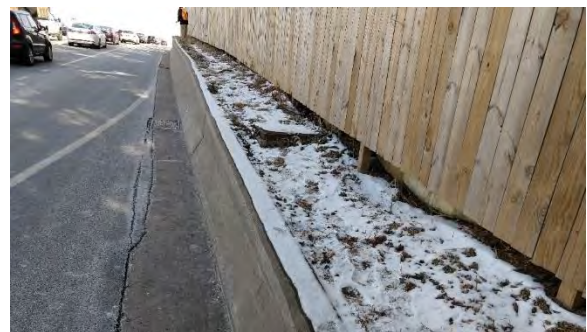
Missing sidewalk at Widener University

The land adjacent to the proposed sidewalk is higher than the roadway grade and retained by a 4.5 foot high barrier. **Figure 13** shows potential options to address the grade difference that were evaluated during this study. These include: (1) constructing new sidewalk adjacent to the existing barrier and adding a railing; (2) constructing new sidewalk at roadway grade by removing the barrier and re-grading the slope; and (3) constructing new sidewalk at roadway grade by replacing the barrier with a new retaining wall. For each of these options, the recommended section includes a buffer area between the adjacent right turn lane and sidewalk. While detailed right-of-way information was not available for this study, measurements scaled from a historical land development plan for parcel 0602900009 (included in **Appendix B**) show that up to 30 feet of right-of-way may be available adjacent to the parcels owned by Widener University. These options should be evaluated further during engineering design based on updated right-of-way and topographic survey information.

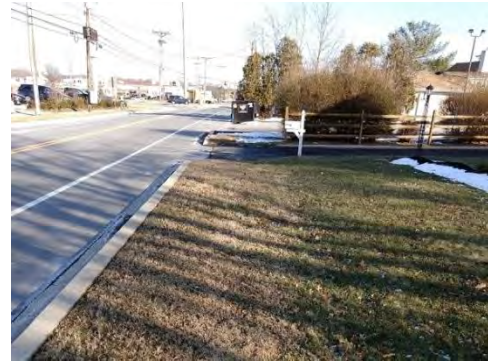
Missing sidewalk on Garden of Eden Rd

Figure 14 shows a concept plan for the proposed sidewalk segment, which crosses four private properties. Two of these properties contain residential uses with lawn frontages, while the other two are commercial uses with paved parking lots extending to the curblines. A defined pedestrian space should be provided across each of the properties, which may require driveway modifications on the commercial properties as shown in the concept plan. Grading and drainage layouts will determine whether curb ramps are needed at each of the driveway crossings.

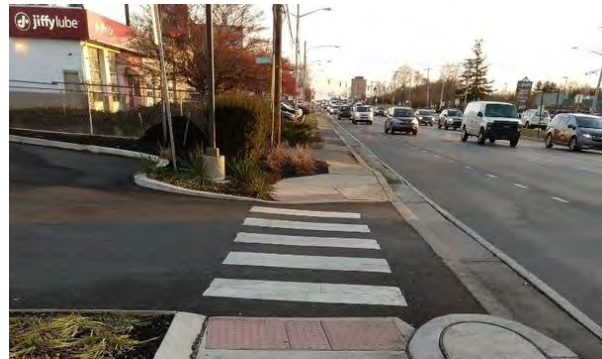
Marked crosswalks are an important feature in defining the pedestrian access route and increasing the visibility of pedestrians to motorists turning in and out of businesses. New sidewalks, curb ramps, and crosswalks that were added with the recent Taco Bell and Seasons Pizza developments provide a model for pedestrian design in this corridor.

New crosswalk installation at Seasons Pizza

At commercial driveways where curb ramps are being added or reconstructed, the use of high-visibility crosswalks should be considered based on criteria established by DeIDOT’s Traffic Section.

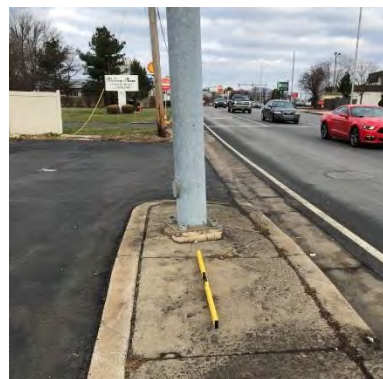
PAR obstruction along southbound US 202

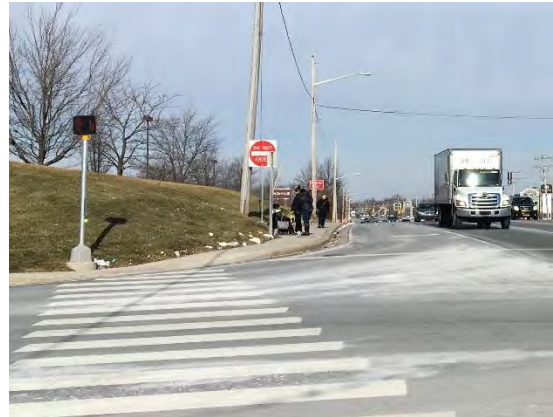
Riders waiting for bus at US 202 / SB Rocky Run Parkway stop

Transit recommendations include reconstructing non-compliant sidewalk in front of three bus stops and adding compliant pads at five locations where none exist today. In addition, DTC’s draft *Bus Stop Facilities Matrix* (included in **Appendix G**) was used to evaluate the need for amenities such as benches or shelters at existing stops. Proposed bus stop improvements are listed in **Table 6** and shown on **Figure 11**. Coordination with DTC will be necessary early in the design phase to confirm the exact location and extent of these improvements.

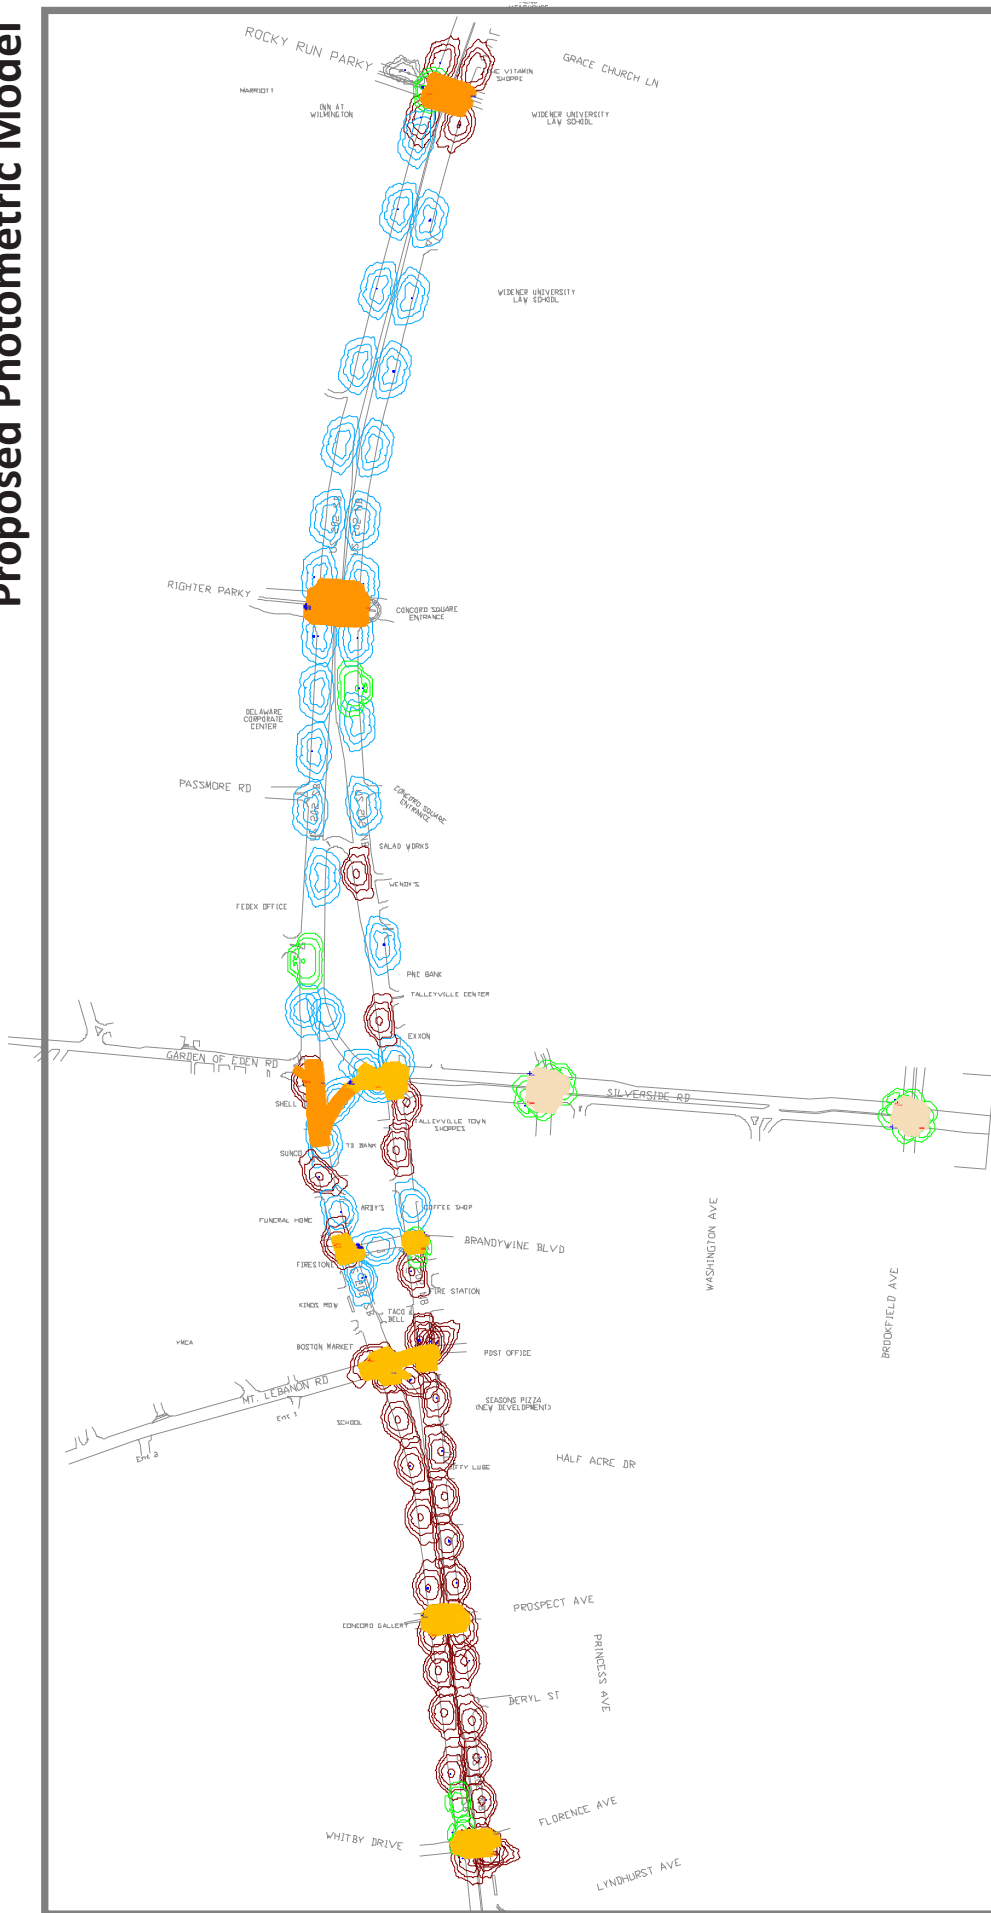
US 202 Safety Audit Existing Roadway Lighting with Proposed Recommendations

- *Average maintained illuminance of 1.0 foot-candles or greater*
- *Average-to-Minimum illuminance uniformity ratio of 4:1 or less*

Proposed Photometric Model
