Kuhio Beach Improvements Summary of Beach History and Engineering Design

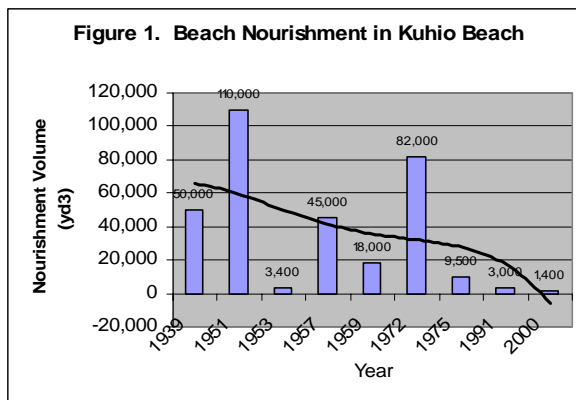
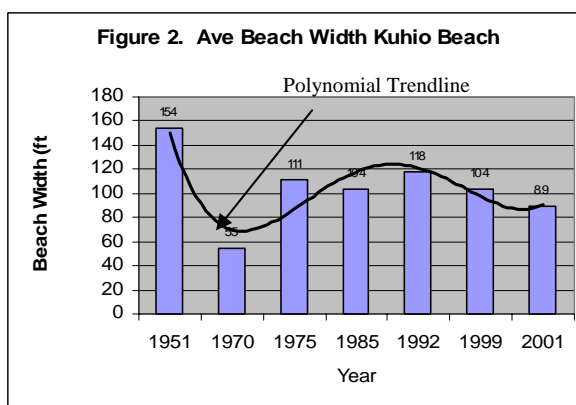
Despite these efforts, today major segments of the beach have little to no sand at high tide and few will disagree that overall, the beach here is in a degraded state. Beach loss in Kuhio Beach is characterized by a 65 foot decrease in the average beach width from 1951 to 2001 with the widest beaches in 1951 and the narrowest in 1970 (Figure 2). A recent

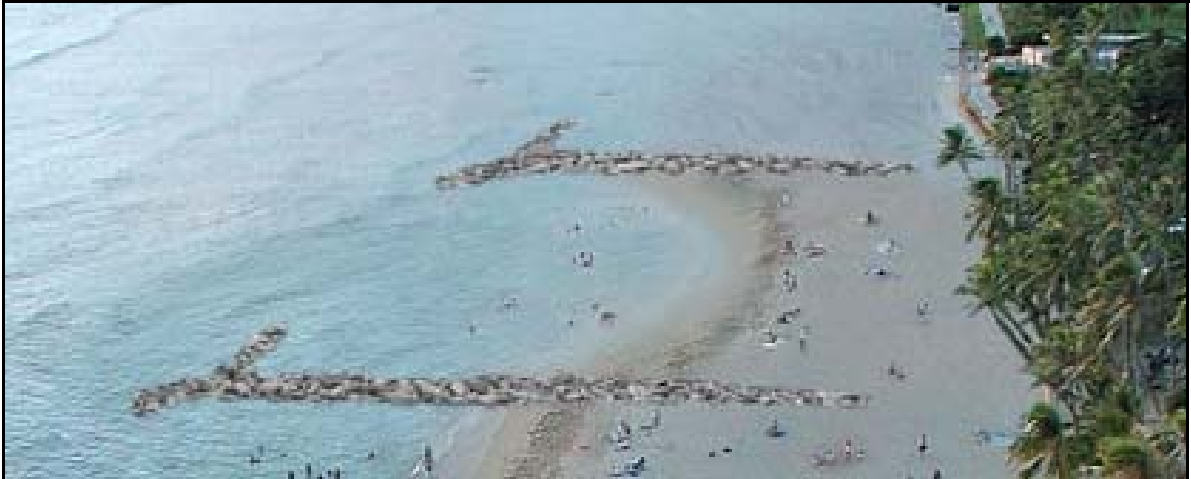
Figure 4. Rendition of T-Head Conceptual Design .

These “T-head” groins would improve the existing conditions in several ways: improve water quality by increasing circulation; stabilize the beach face utilizing the predominant wave energy to push sand into the beach; improve access to the swimming and surfing sites; improve public safety by removing the hazardous breakwater offshore; and improve the general aesthetics of the area by reducing the amount of hard structures (Figure 4).

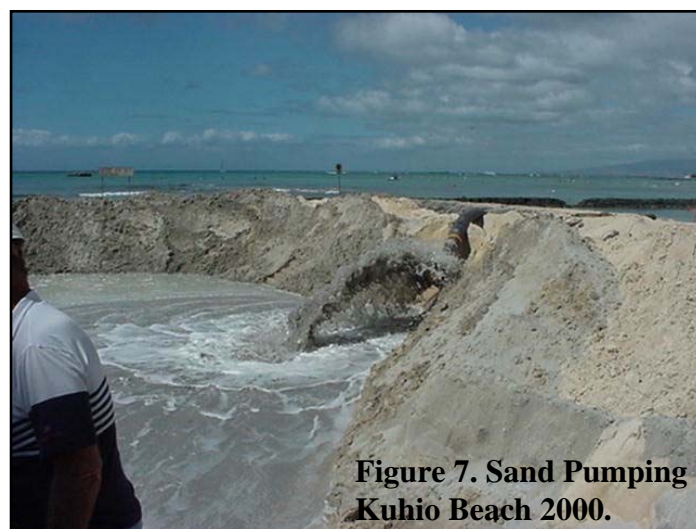
**Figure 7. Sand Pumping
Kuhio Beach 2000.**

- 1991** Kuhio Beach 3000 cubic yards of sand added.
- 2000** Kuhio Beach. Pilot offshore sand pumping project 1,400 cubic yards delivered from offshore Queens (Figure 7).
