## **Appendix G Hydrological Assessment**

For the hydrological assessment of the Nadarivatu Scheme, data provided by the design engineers for the Qaliwana and Nukunuku catchments was used to describe the existing flow regime in the Sigatoka and Ba Rivers and to predict the potential downstream impacts from hydropower generation.

**ARCHAEOLOGICAL IMPACT ASSESSMENT REPORT FOR  
BA/SIGATOKA HYDRO-ELECTRIFICATION PROJECT**

**Baseline Water Quality and Biological Survey of the Proposed New  
Hydroelectricity Generating Facility Sites at the Headwaters of the Ba  
and Sigatoka Rivers.**

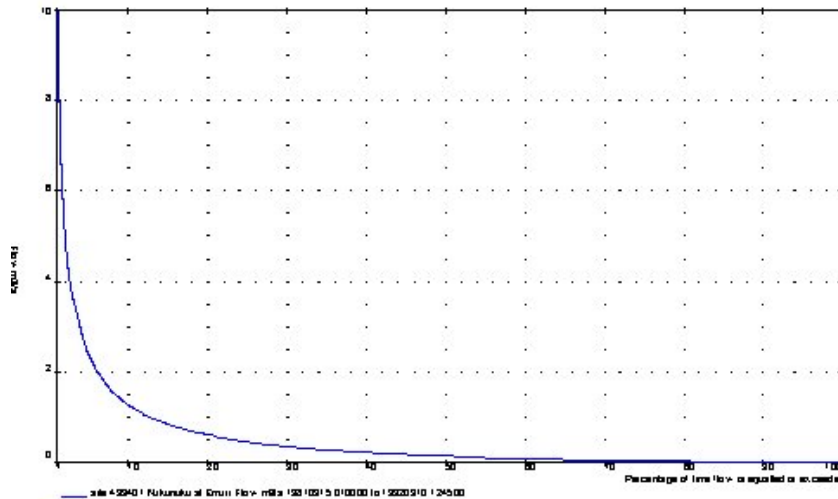
■ **Figure 2 Flow distribution for the Nukunuku catchment at Lewa (1981 – 1992)**

Low flow analysis of the data indicates that both catchments have little base-flow storage capacity. This is probably due to the underlying strata being fractured basalt that drains rapidly. The soils are clay formed by tropical weathering. This limits infiltration and so there is a quick runoff response with little base-flow component. This is shown clearly in the flow distribution curves for the Qaliwana and Nukunuku in Figure 1 and Figure 2 respectively. The overall shape of the flow duration curve means there is a large duration of low flows in the catchment. Higher flows occur for a limited amount of time.

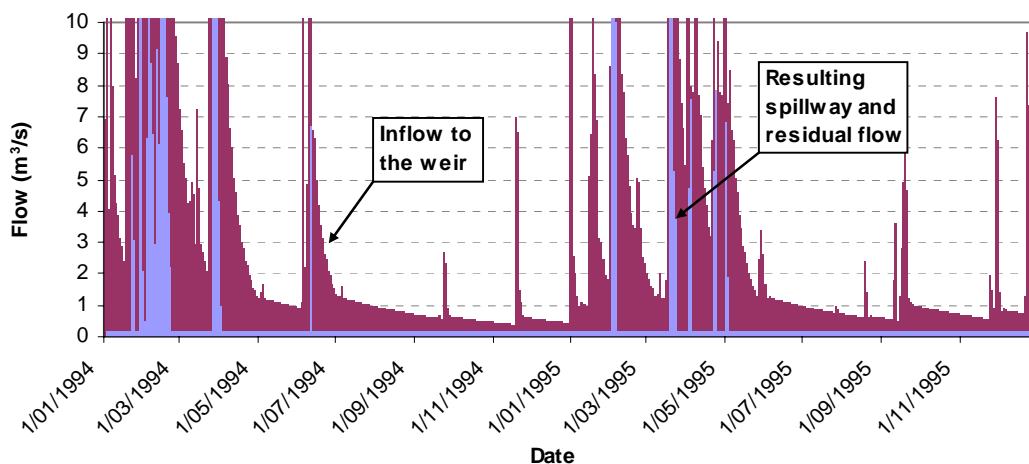
- **Figure 3 Mean daily Qaliwana and Nukunuku Creek inflows to the weir/lake and resulting spillway and residual flow to the Sigatoka River for the period 1 January 1994 to 31 December 1995.**

Figure 3 illustrates the impact of the proposed scheme on the Sigatoka River downstream of the proposed weir utilising data from 1994 to 1995. The dark hydrograph shows the natural river flow without the weir, and the light hydrograph the flow with the weir in place and the water diverted to the power scheme.

Figure 3 shows that flows downstream of the diversion weir will be significantly reduced with the minimum flow of  $0.2\text{m}^3/\text{s}$  only exceeded approximately 8% of the time as shown in Figure 4. Large floods will be reduced slightly but the more frequent floods will be significantly reduced.

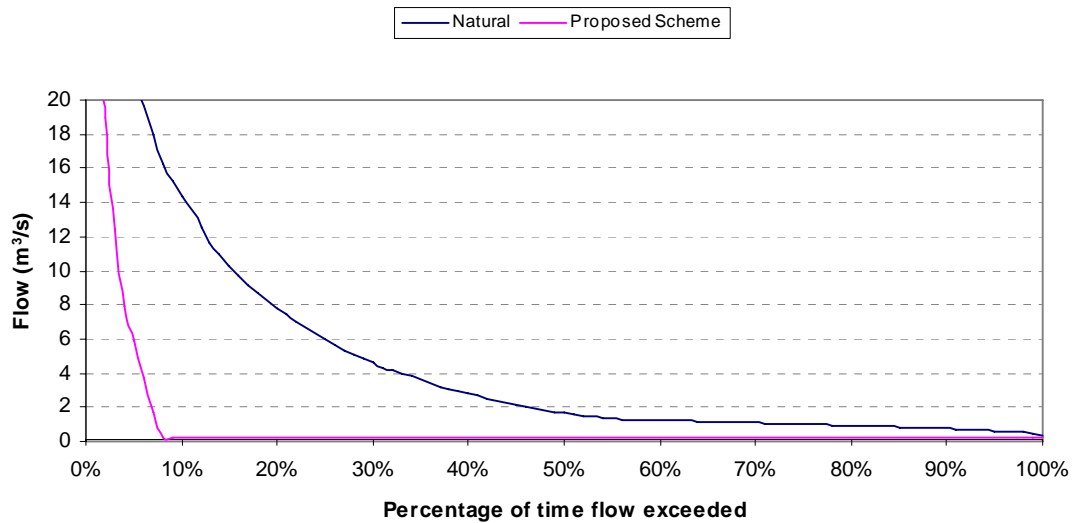
■ **Figure 4 Flow Duration Curve for Qaliwana and Nukunuku Creek combined flow at the confluence.**

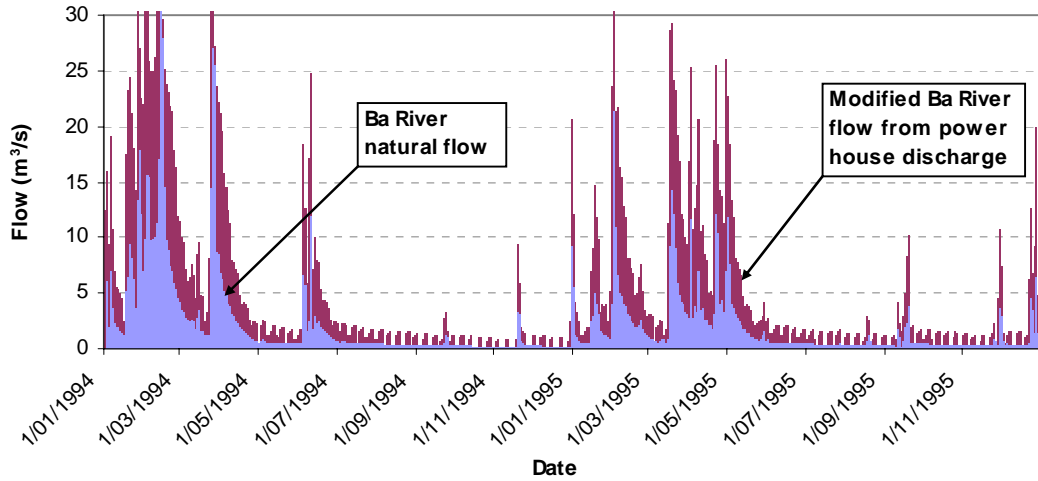
■ **Figure 5 Mean daily Ba River flow and modified flow as a result of the proposed Nadarivatu Scheme discharge for the period 1 January 1994 to 31 December 1995.**

six out of every seven days because it is not planned to generate every day. Furthermore, generation generally will only be part of the day so the actual increase in flow due to generation will be higher than the average for the day (maximum 15 m<sup>3</sup>/s).

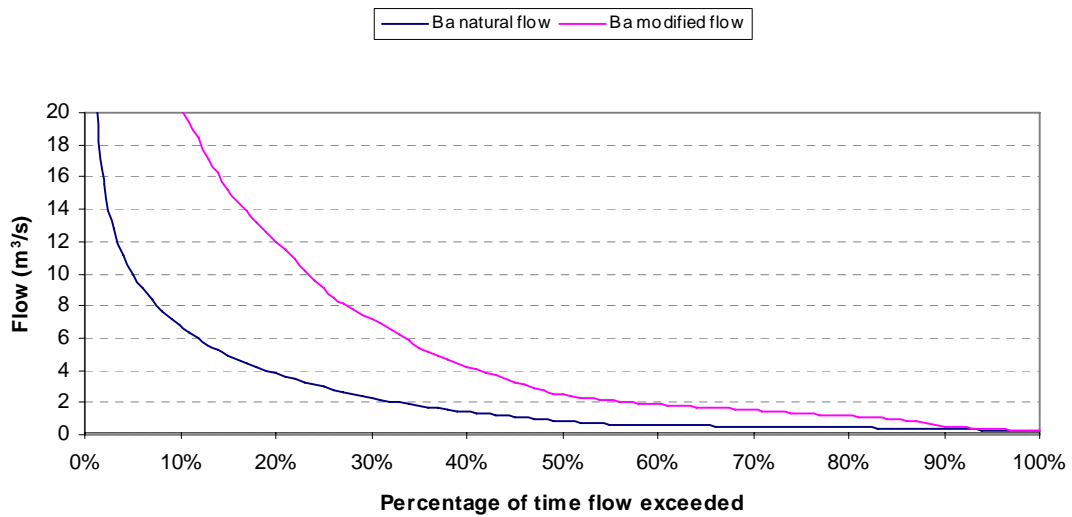
■ **Figure 6 Flow Duration Curve for Ba River downstream of powerhouse**

The duration of increased flows in the Ba River relative to the natural flows immediately downstream of the powerhouse is shown clearly in Figure 6.
