Brake Health Effectiveness (BHE) Test Waiver Development Summary

BNSF Railway

TUESDAY, MAY 29, 2018

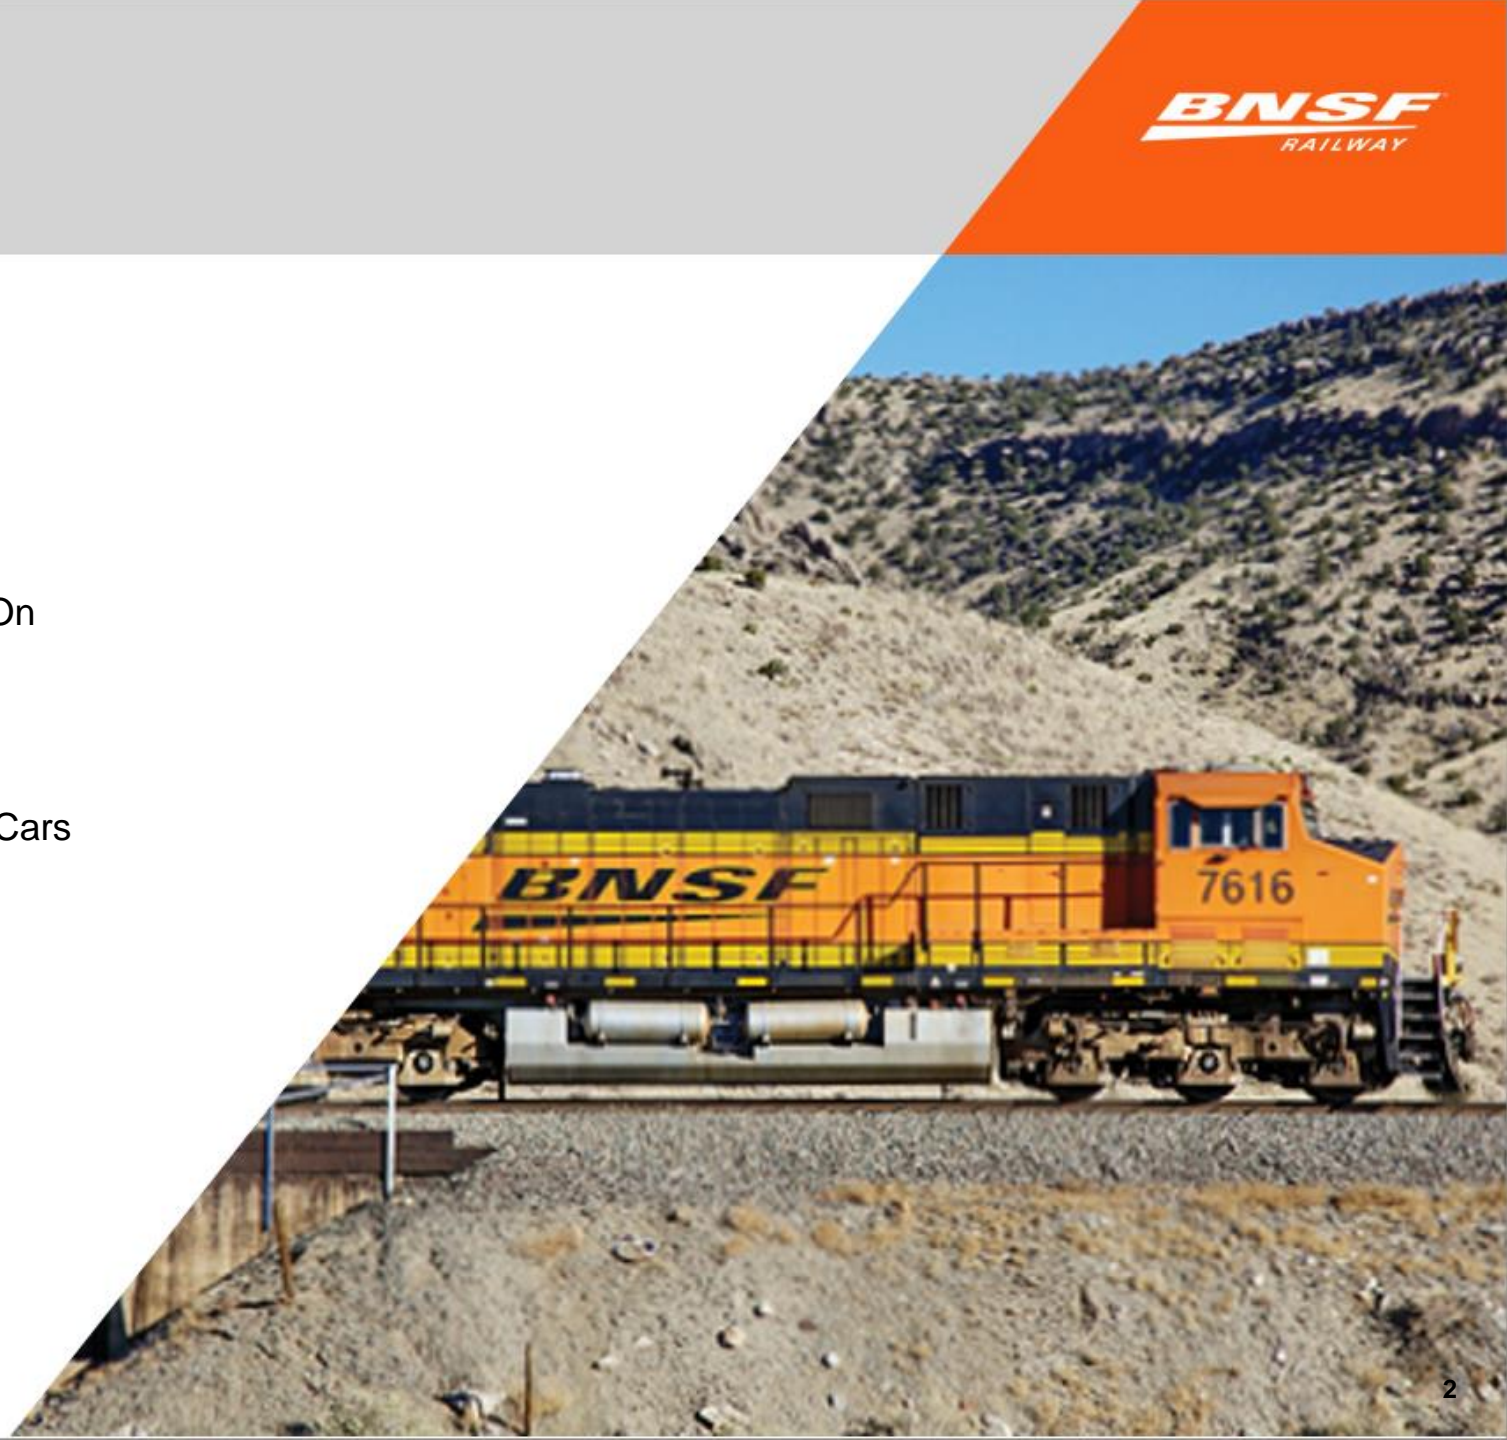
Objective:

- Use detector technology to support California to Chicago intermodal trains
- Trans-con intermodal
- Improve network velocity
- Improve brake effectiveness
- Employee risk reduction

Method:

- Utilize Wheel Temperature Detectors (WTDs) to identify ineffective car brakes & improve overall safety
- Identify outlying wheel temperatures before and after downhill braking events with differential temperature algorithms
- Intermodal trains from the intermodal facilities in California to Chicago
- Apply existing WTD technology with “BNSF” differential temperature algorithms tailored to lesser gradients

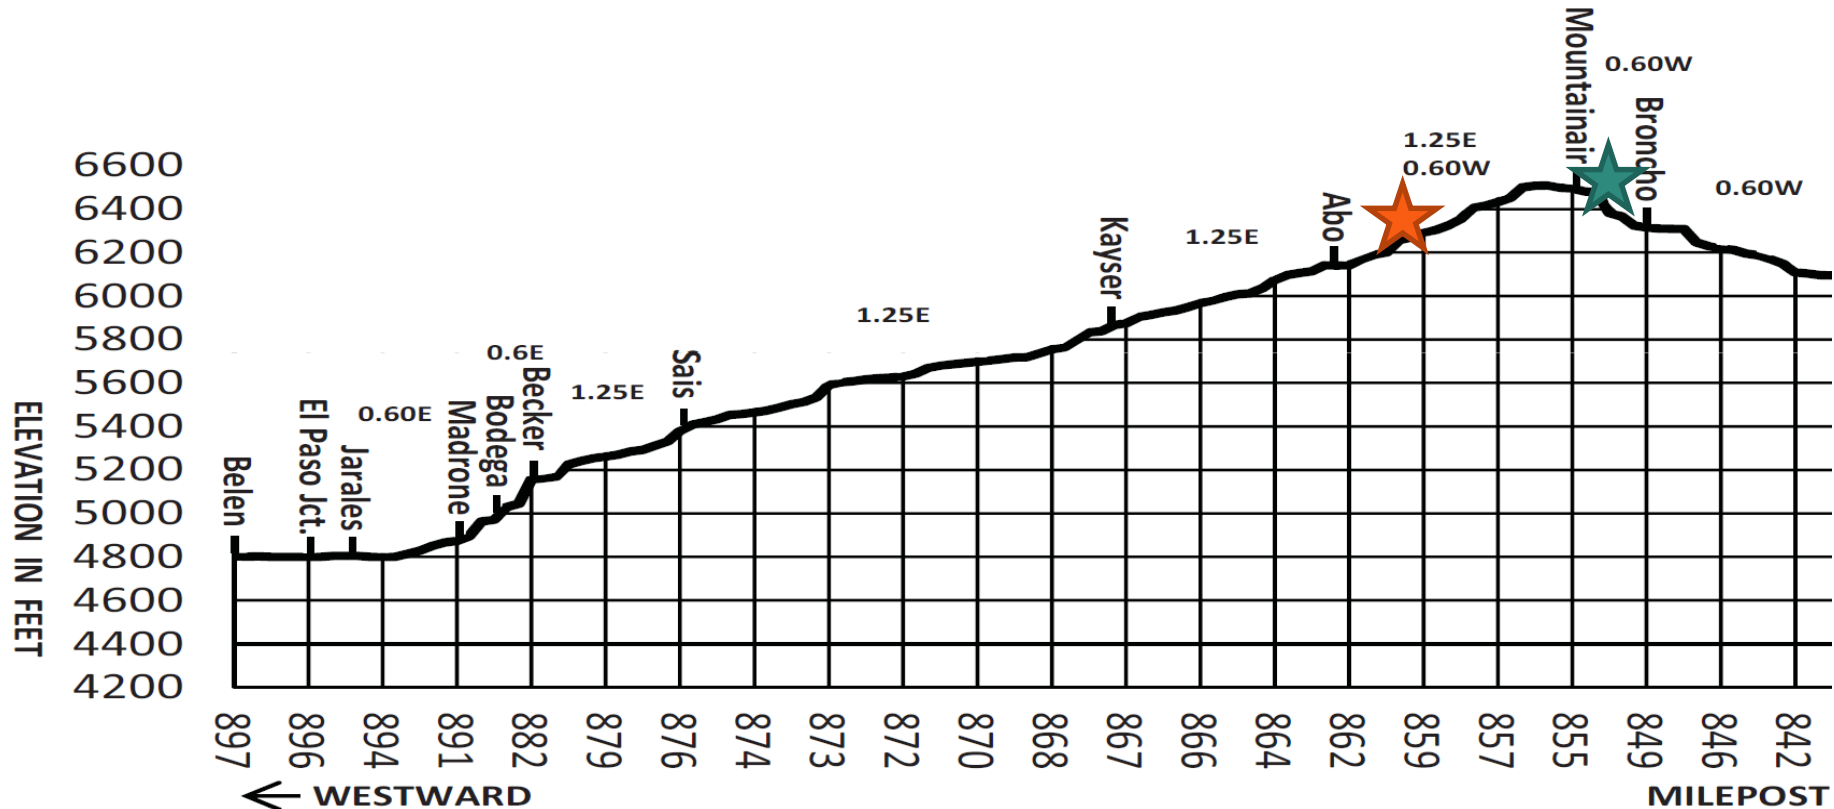
Cold Wheel Detection (CWD) Systems

- Westbound brake health effectiveness test
 - Clovis Subdivision test for westbound traffic
 - MP 851.8 (Mountainair) – Baseline measurement using CWD to ensure brakes are NOT applied.
 - MP 860 (Abo) – Brake effectiveness test using CWD to identify inoperative brakes.

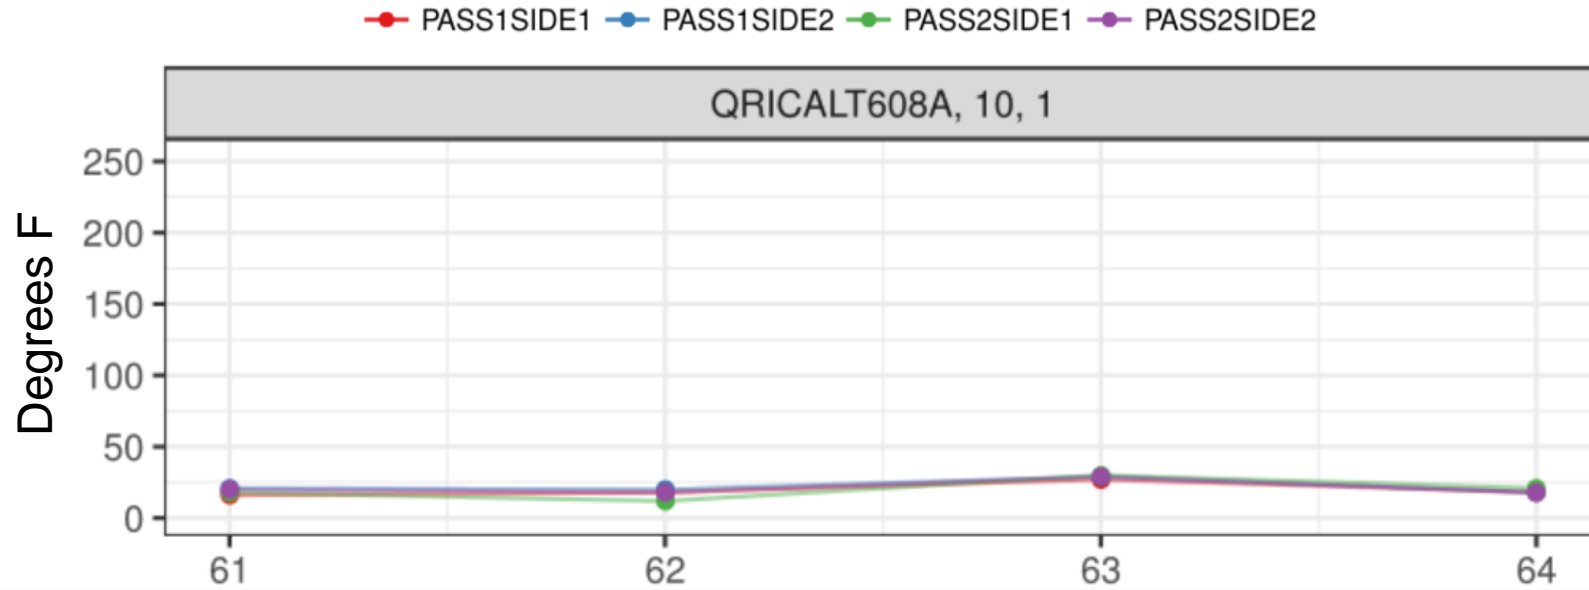
Valve 1

Examples of Failed Valves and Corresponding Wheels

No difference between braking & non-braking sites

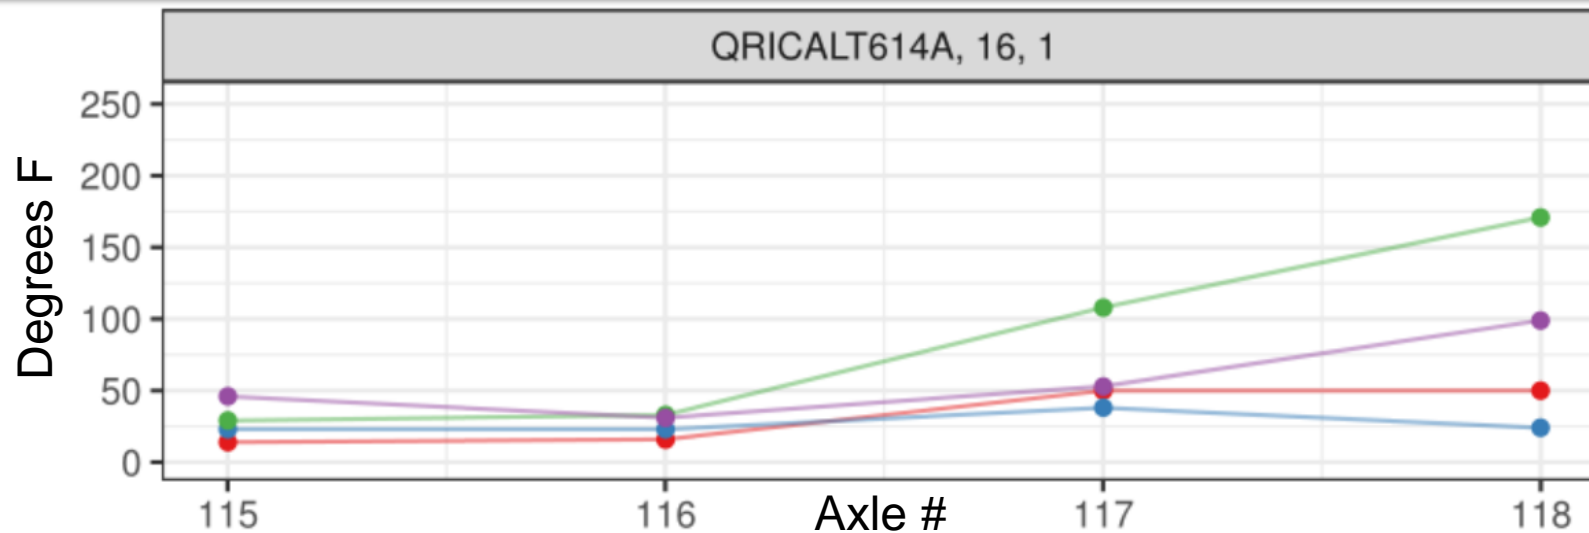
Valve 2

Unable to differentiate sites (below threshold)

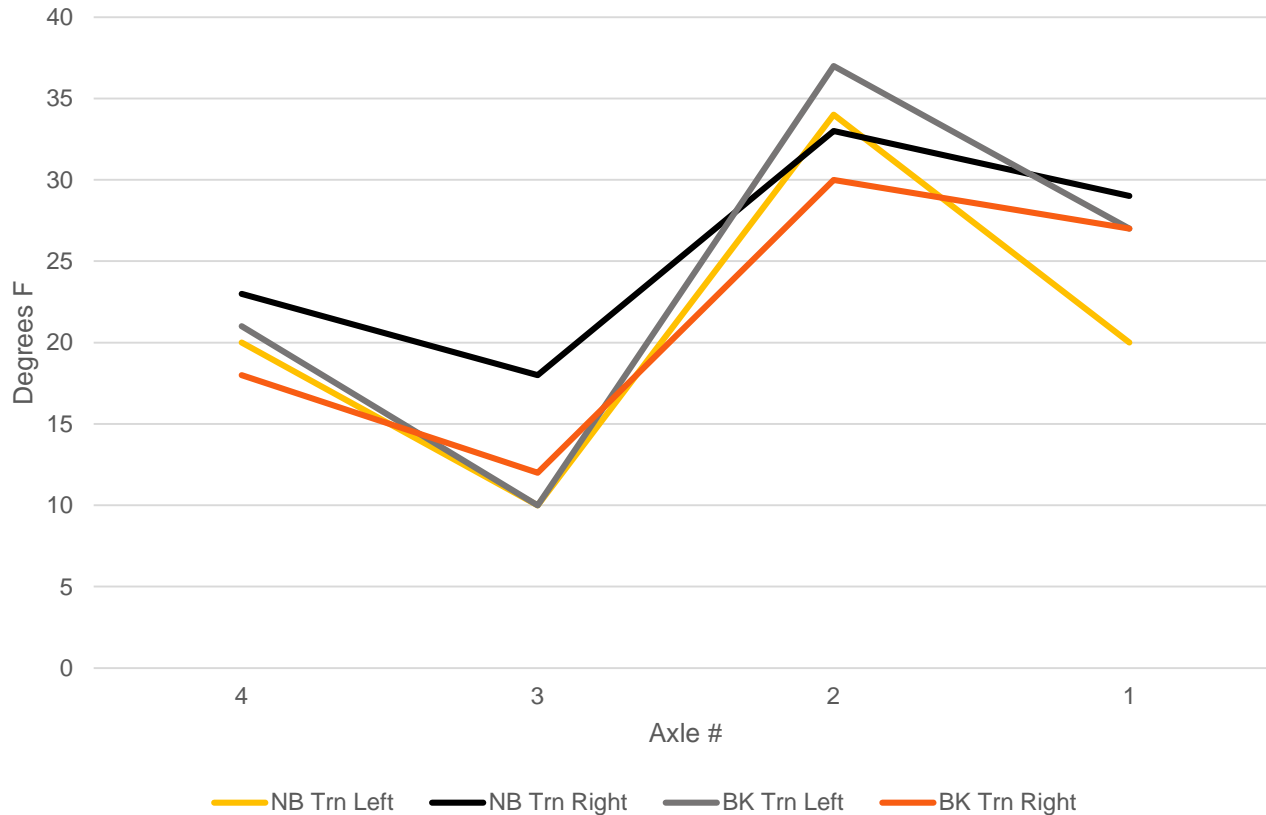
Example of Brake Lever Defect – DTTX 469316

1 valve: 2 wheels cold, 2 wheels hot
Indicates brake lever issue – inspection supports finding

Component (examples)	Findings/Repaired Component(s)	Component Location
1) Brake Lever (angularity, oblong pin holes)	<u>off due to clevis</u>	<u>A-Location</u>
2) Brake Rods - Top and Bottom (signs of wear or binding)	<u>Good</u>	<u>None</u>
3) Brake Clevis (check for good condition)	<u>Short and Long Clevis in wrong location</u>	<u>Removed and switched over</u>
4) Brake Beams (broken/cracked/damaged brake heads)	<u>Good</u>	<u>None</u>
5) Brake Shoes (eg. missing or thin)	<u>Good</u>	<u>None</u>

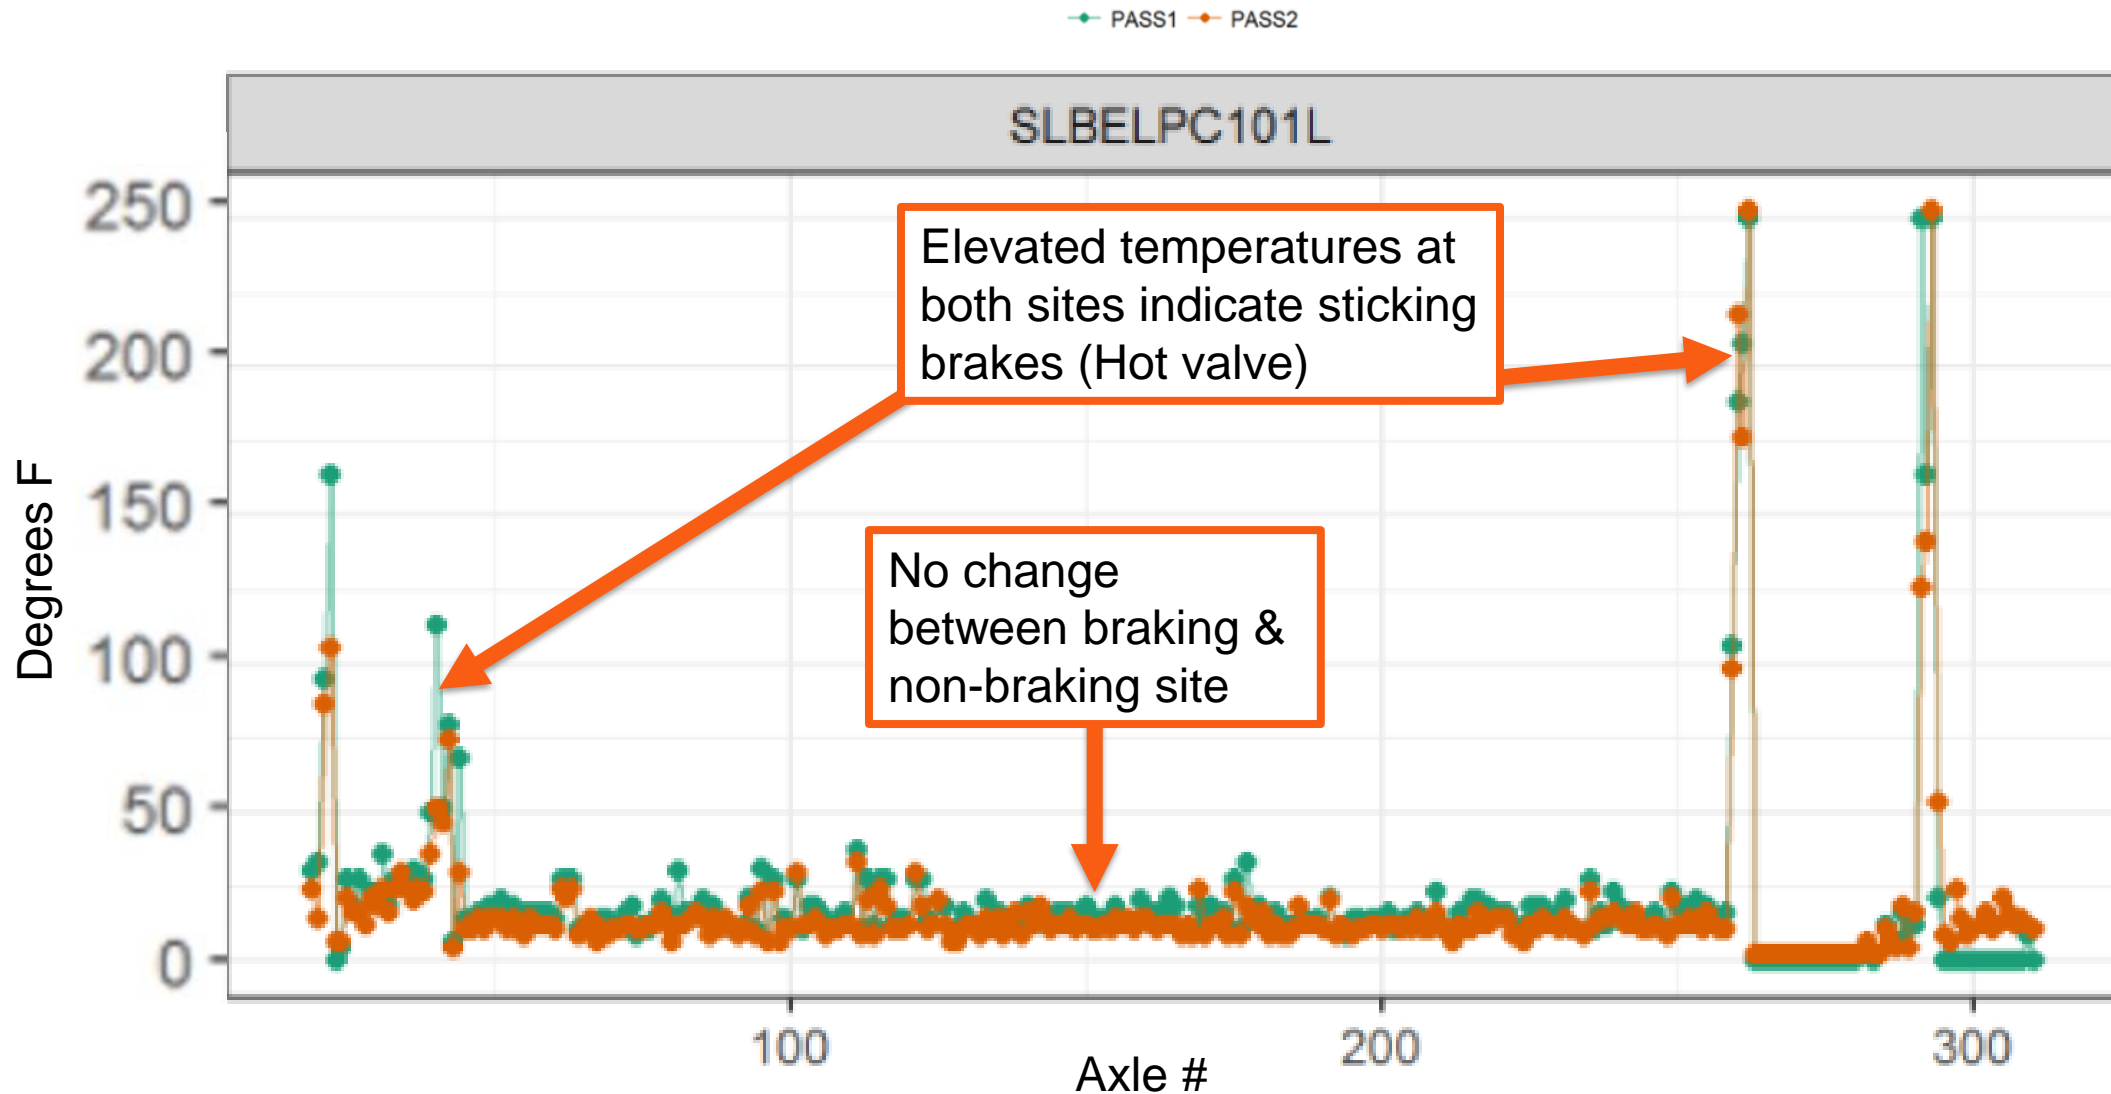
Examples Non-Braking Train with Sticking Brakes

- In cases where a car had a valve with the brakes applied at both the baseline & braking sites, a different alert is applied
 - The algorithm can not correctly interpret the performance of the brakes
 - The measurements may be similar or different at each site on a car with sticking brakes
 - If the average temperature of the wheels is greater than 50°F at the baseline site, the valve is identified as a “Hot valve”
 - Hot valves will be considered ineffective in the percentage of good valves
 - Hot valves will be inspected for sticking brakes or applied hand brakes

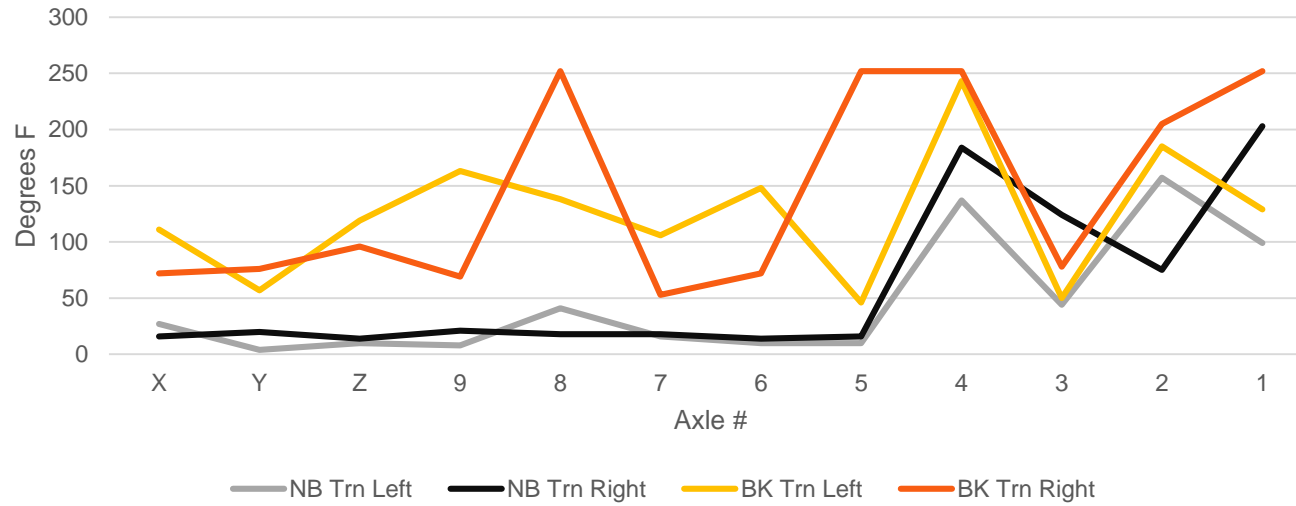
Hand Brake Applied

Example of Hand Brake Left On

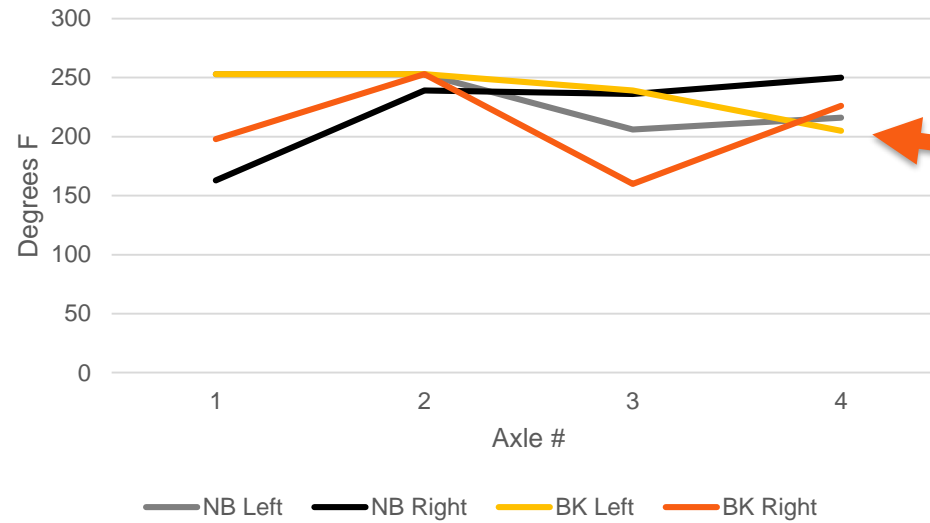
Example of a Sticking Brake Valve

Elevated temperatures at both sites indicates sticking brakes (Hot valve alarm)

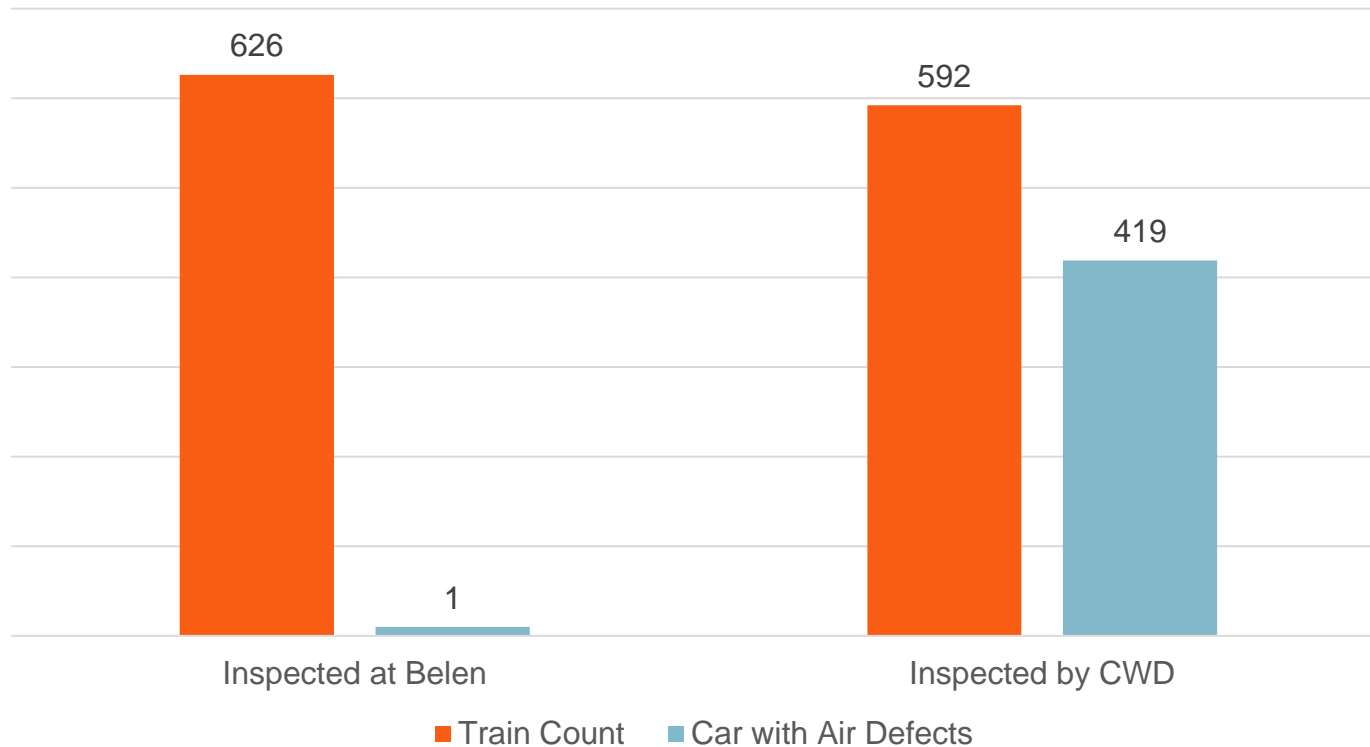
Preliminary BHE Defect Identification Rates

Extended Haul Intermodal Trains
April 2018

- Current visual inspection not a strong indicator of brake effectiveness
- Wheel temperature based inspections identify more brake system issues
- Fleet statistics show cars in service with ineffective brakes that have not measurably impacted safety
- High confidence that bypassing intermediate inspections with CWD process and repairing cars at destination will not be detrimental to air brake health
- Identifying and repairing cars with ineffective brakes at destination will increase the overall health of the fleet

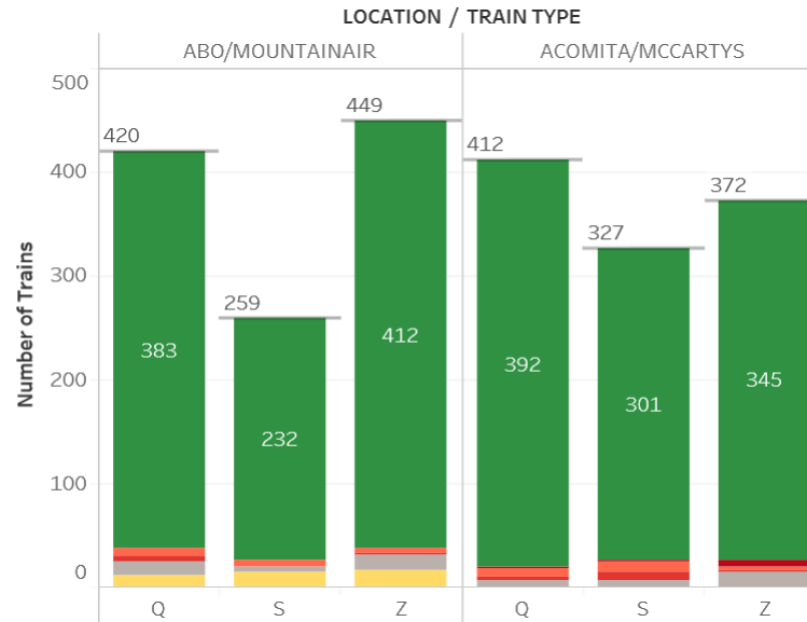
CWD Message Analysis

- Shows the performance of detector reporting
- Ability to understand why messages were not received
 - Passed on opposite main
 - Switched mains between sites
 - One or both sites did not report, or error occurred with message processing

LOCATION	TRAINS	SUMMARY	Percentage
ABO/MOUNTAINAIR	Q, S, Z	BOTH_MATCH	91.05%
		BRK_MISSING	1.68%
		NBRK_MISSING	0.53%
		NO_CWD	3.01%
		SWITCH	3.72%
		BOTH_MISSING	0.00%
ACOMITA/MCCARTYS	Q, S, Z	BOTH_MATCH	93.43%
		BOTH_MISSING	1.08%
		BRK_MISSING	1.80%
		NBRK_MISSING	1.08%
		NO_CWD	2.61%
		BOTH_MISSING	0.00%

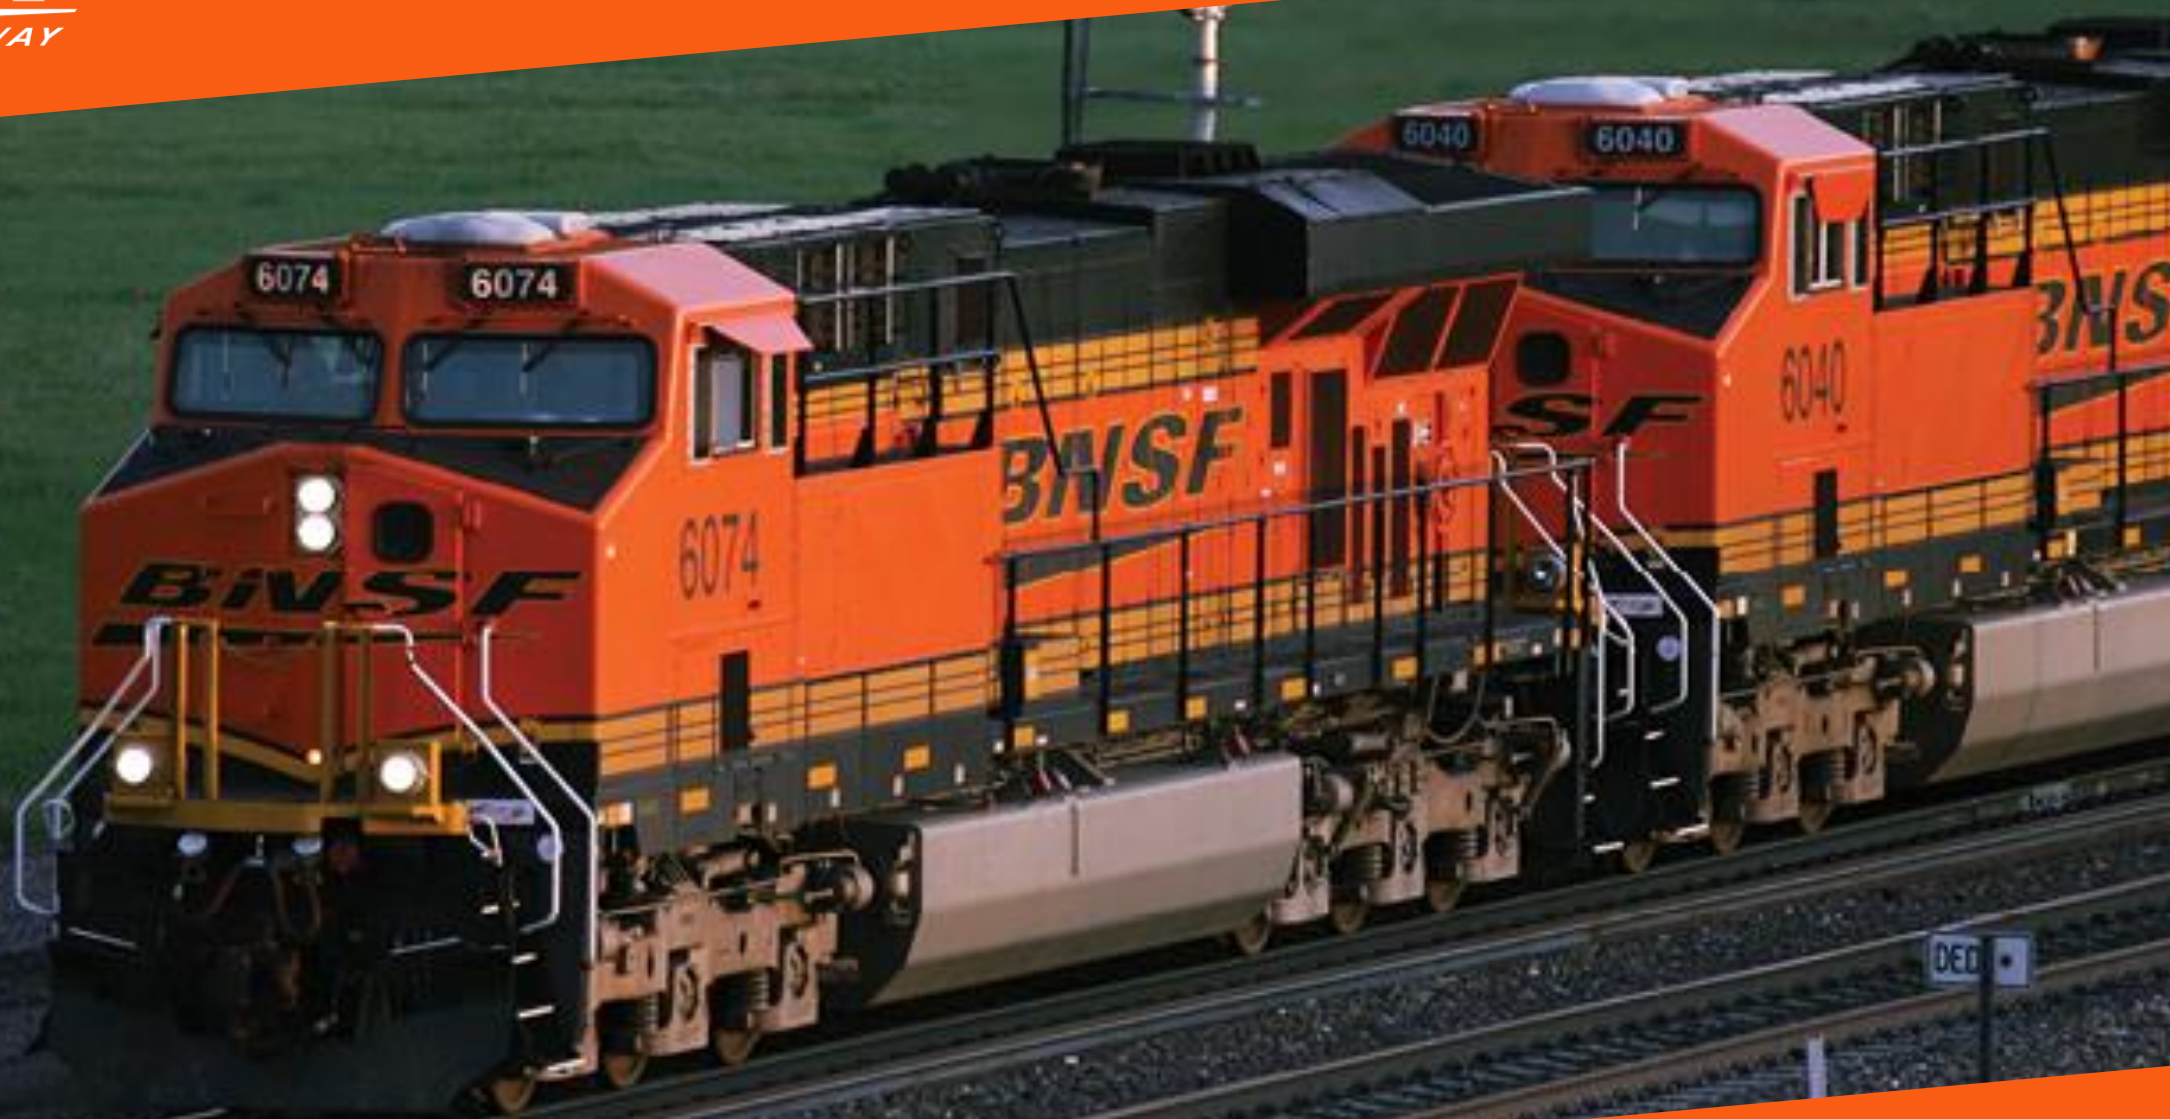
Released October 2017:

“FOR THE PURPOSES OF TESTING BRAKE HEALTH EFFECTIVENESS, ALL LOADED INTERMODAL TRAINS (EXCLUDING “V” SYMBOLS) OPERATING WESTBOUND ON MAIN TRACK TWO ARE REQUIRED TO MAKE AT LEAST A 10 LB. RUNNING AIR BRAKE SET AT MP 859 AND MUST HOLD SET UNTIL REAR OF TRAIN HAS CLEARED TRACK-SIDE WARNING DETECTOR AT MP 860. STRETCH BRAKING, IF REQUIRED, IS PERMITTED WHILE PERFORMING THIS RUNNING AIR BRAKE SET. PLEASE ADDRESS ANY QUESTIONS YOU MAY HAVE TO YOUR ROAD FOREMAN OF ENGINES.”

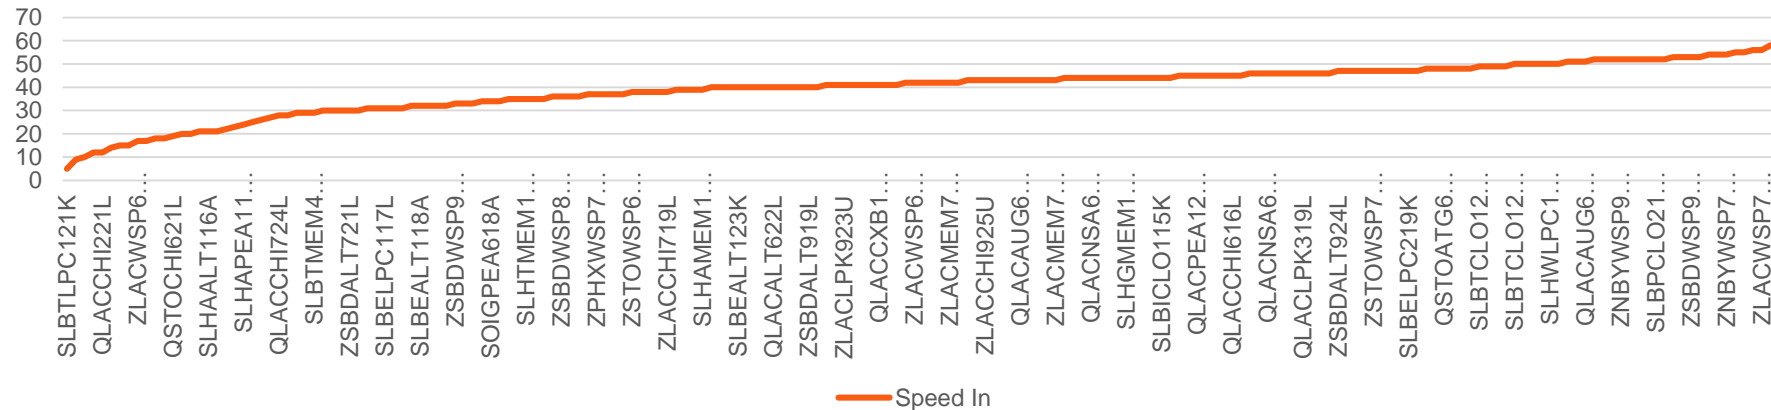
Speed In Braking Trains - Avg 40 MPH
