**2020 ANNUAL REPORT FOR THE
BIG TUJUNGA WASH MITIGATION AREA
LOS ANGELES COUNTY, CALIFORNIA**

**LOS ANGELES COUNTY
PUBLIC WORKS**
900 South Fremont Avenue
Alhambra, California 91803-1331

CHAMBERS GROUP, INC.
5 Hutton Centre Drive, Suite 750
Santa Ana, California 92707
(949) 261-5414

July 2021

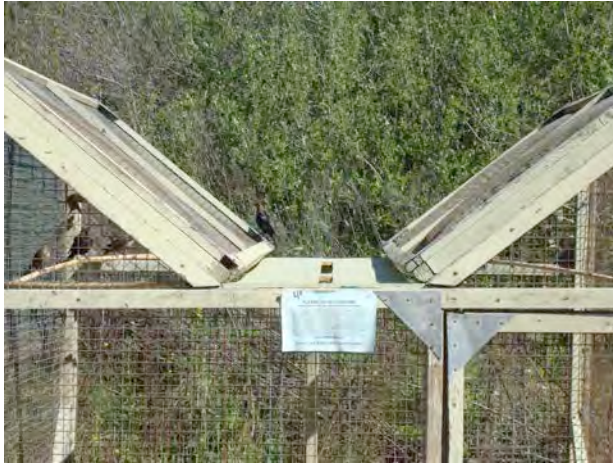
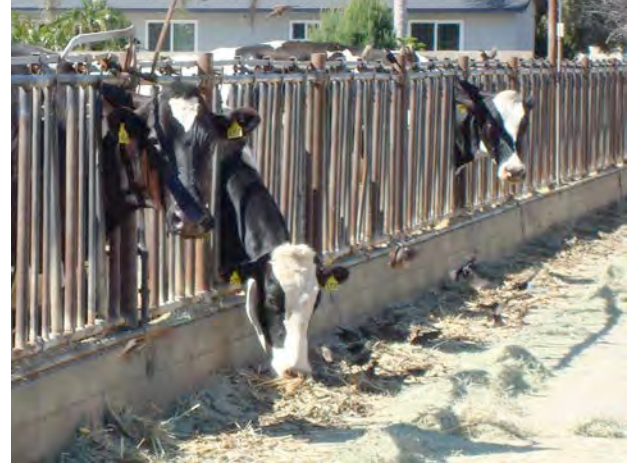
Male cowbird interacts with decoys before entering trap. Cowbirds foraging for seed and insects at a dairy.

The traps are baited with live decoy cowbirds, abundant bait seed and clean water, shade, and perches to attract cowbirds whether they are seeking food, water, shelter, companionship, and/or sex. Since female cowbirds lay the eggs, they are the primary targets of trapping programs. Males are also important as they may participate in egg removal and host nest destruction activities, and are required to fertilize each egg before it is laid. The sex ratio of the at-large cowbird population is assumed to be 1:1. The goal of trapping programs is to capture as many females as possible and achieve a capture sex ratio at or below 1:1.

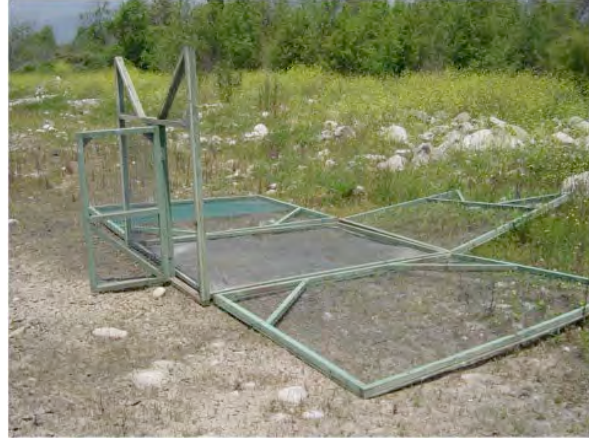
Cowbird trap placed and "flowered" for easy assembly.

Each trap is 6 feet wide, 8 feet long, and 6 feet tall, with a 1 3/8-inch-wide capture slot on top through which cowbirds can drop down and in but cannot fly up and out. The traps include: 1 floor, 2 side, 2 end (door and back), and 2 top panels, and a plywood slot board.

Each trap was aligned in the field on a north-south axis. A foraging tray was placed on the front portion of the floor panel centered under the capture slot. Four perches made of dead giant reed or ½ inch diameter dowel were installed in each trap: one in each trap corner at chest height (except above the door) and one in a rear corner at knee height (for subordinate birds). A warning/ informational sign was stapled to the front of each trap (Appendix 1). Shade cloth was applied to the west-facing side panel. Finally, a one-gallon water guzzler, approximately 1 pound of sunflower-free wild birdseed (on the foraging tray), and live decoy cowbirds were added to each trap, as available, and the trap was locked (in 2020, Covid-19 precluded the capture of live decoys at some of GWB's historic off site locations, so not all traps contained the live decoys on April 1).

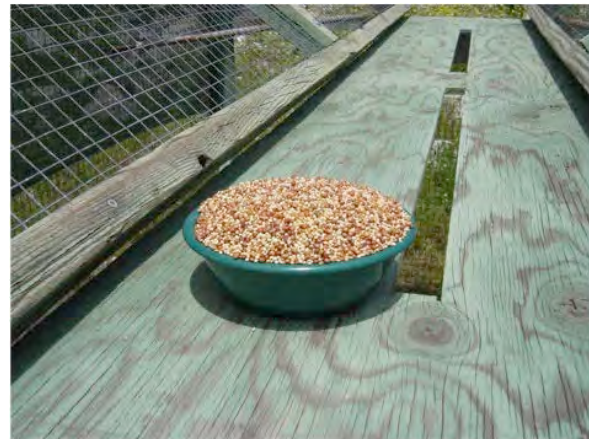
Bait seed ready to be added through the capture slot.

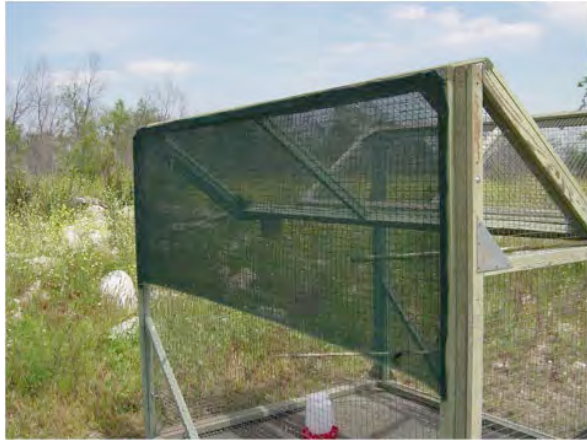
Shade cloth on the west-facing panel.

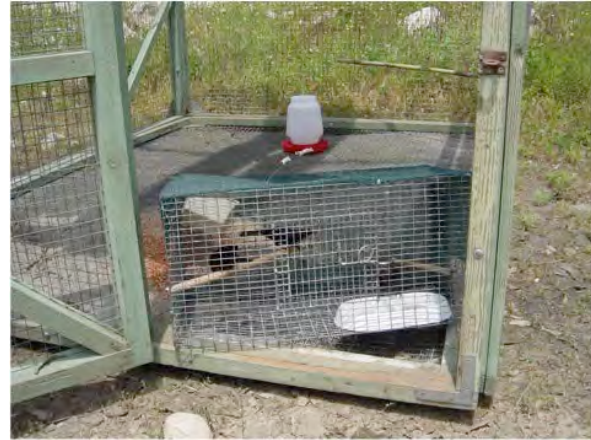
Adding live decoy cowbirds to trap from transport cage.

Each trap contained live decoy cowbirds by 7 April, and 2-3 males and 5-6 female decoys as of 15 April and subsequently. The right primary wing feathers of each female decoy were kept clipped to ensure their demise upon accidental release or escape. Most of the live decoys used to stock the traps in the early season were captured on site or off site at other programs nearby.

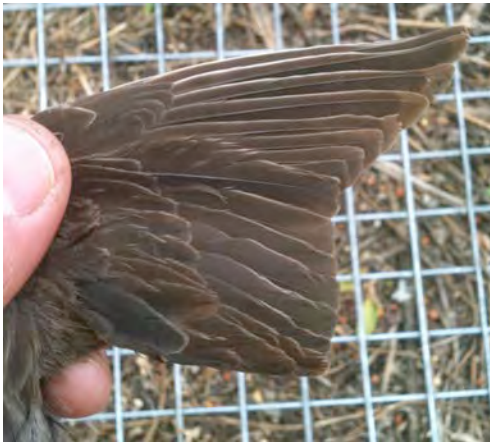
Unclipped wing.

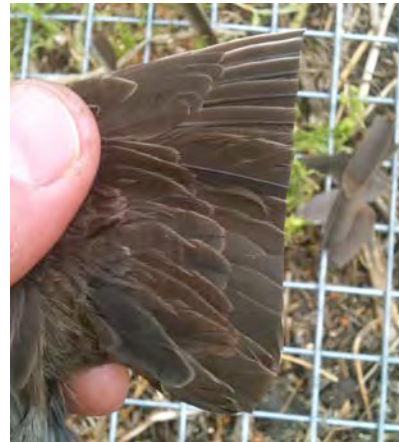
Clipped wing.

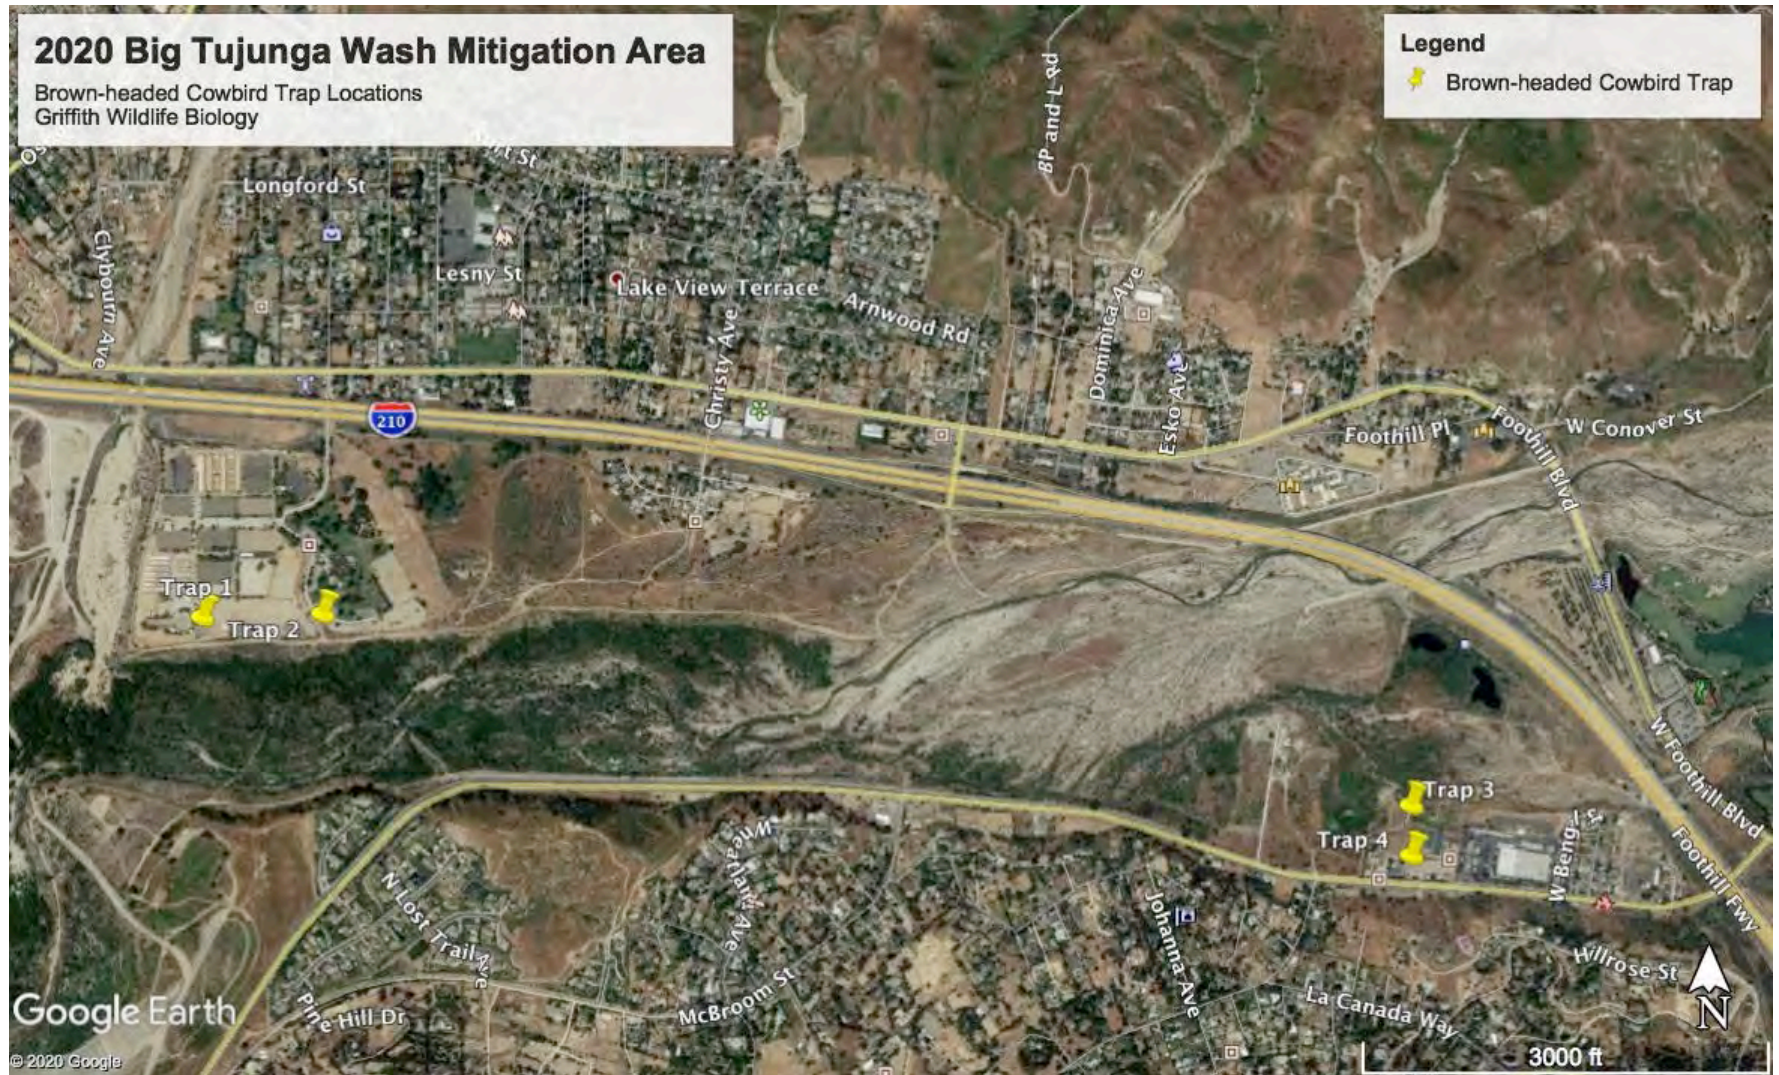
Figure 3. 2020 Big Tujunga Wash Mitigation Area brown-headed cowbird Traps 1 and 2 photos.

Four cowbird traps were placed, activated, operated, serviced, disassembled, and stored per the *Brown-headed Cowbird Trapping Protocol* (GWB 1992, updates) and state and federal permit requirements (Figure 2-4). Trap 1 (Hansen Dam Stables), Trap 2 (upstream of Hansen Dam Stables), Trap 3 (just outside Gibson Ranch), and Trap 4 (Gibson Ranch) were in foraging areas adjacent to riparian habitat. The traps were placed, assembled, and activated on April 2, then operated until June 30 (90 days, 13 weeks).

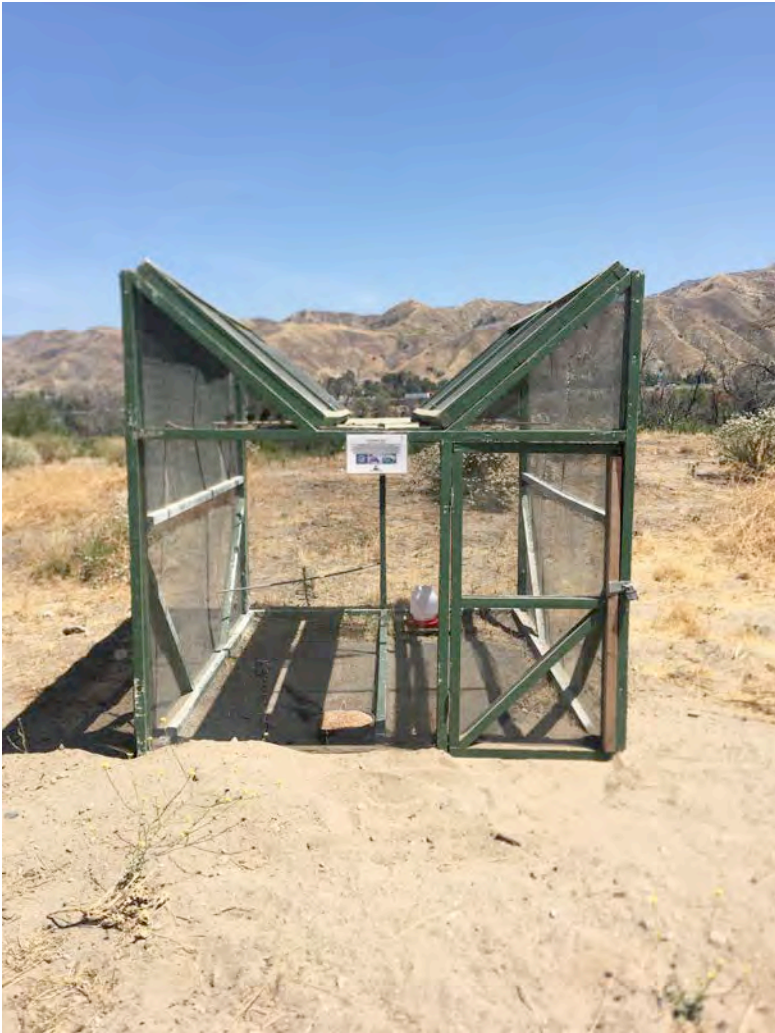
Trap 3

Figure 4. 2020 Big Tujunga Wash Mitigation Area brown-headed cowbird Traps 3 and 4 photos.

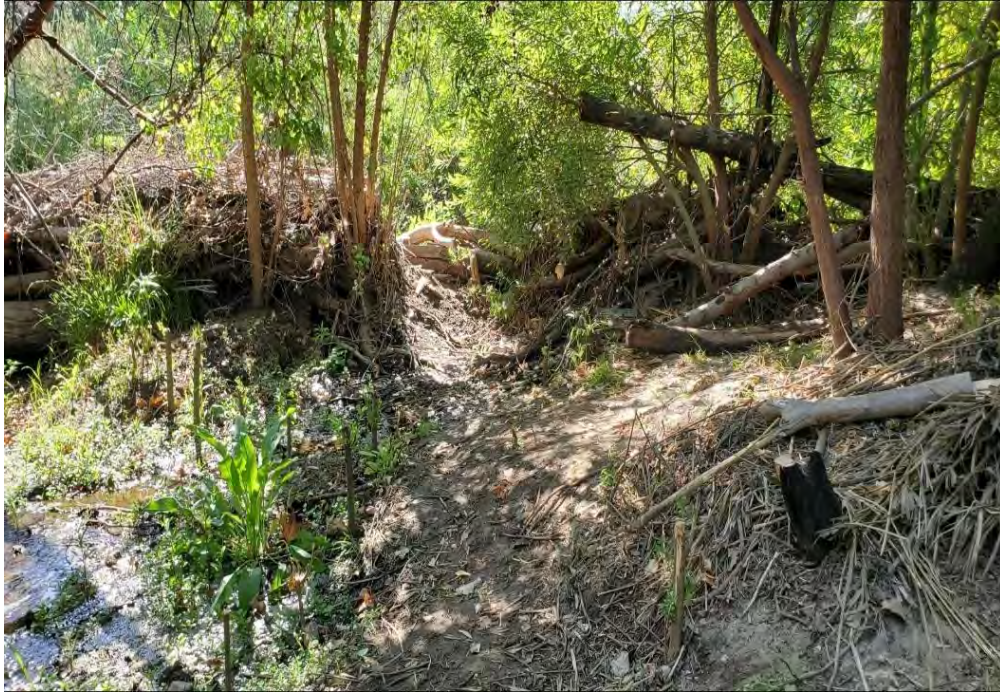
Photo 3: Example of the new day-use area encountered approximately 600 feet downstream from the south Wheatland Avenue entrance, on July 9, 2020.

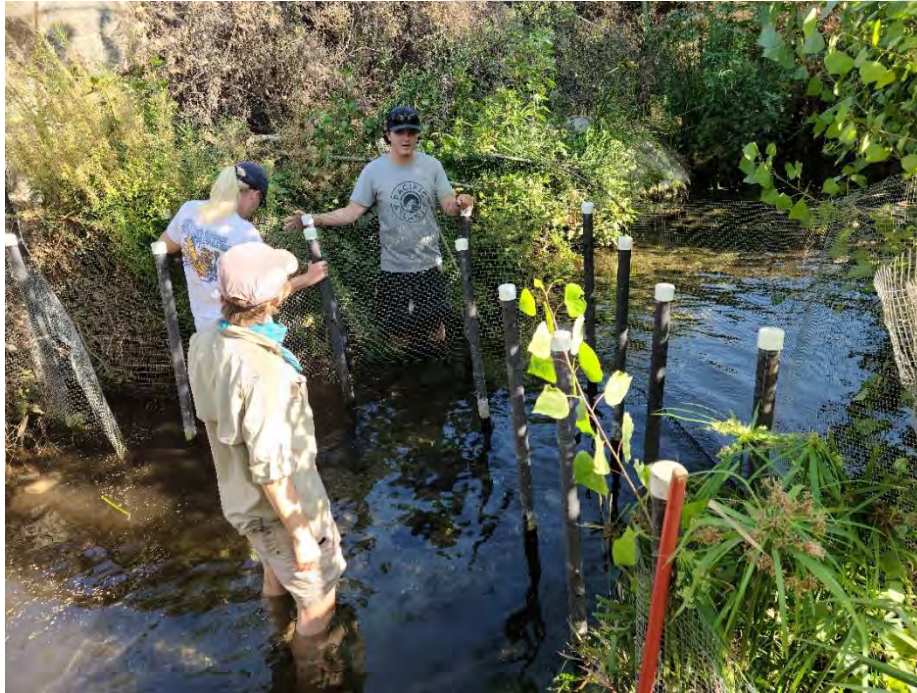
Photo 1: Example of biologists installing a new exclusionary net on September 4, 2020.

Most of the fish captured with the seine were young. A large number of exotic largemouth bass are being observed and caught downstream of the ponds. This is due to the damaged exclusionary fence that needs repairs to prevent further migration of exotic fish downstream. A total of three illegal dams were also encountered in the Creek during the removal efforts and were deconstructed by the biologists. It appeared that a new day-use area was being built approximately 600 feet downstream (west) of the south Wheatland Avenue entrance. Sand has been brought in to the area and vegetation has been removed. No individuals associated with the construction of this area were present at the time of the effort. Another new day-use area was also observed approximately 75 feet to the east of the south Wheatland Avenue entrance near the trail. Both of these areas have been reported to the County to help secure resources for their removal.

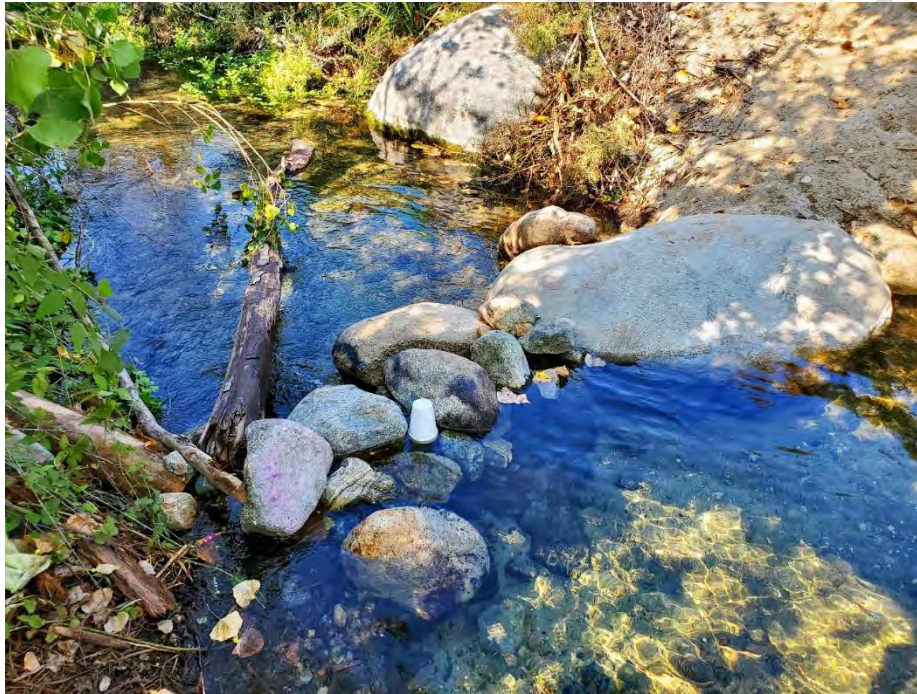
Photo 3: A rock dam was encountered in the Creek approximately 10 feet downstream of the exclusionary net. The biologists removed the dam on October 7, 2020.

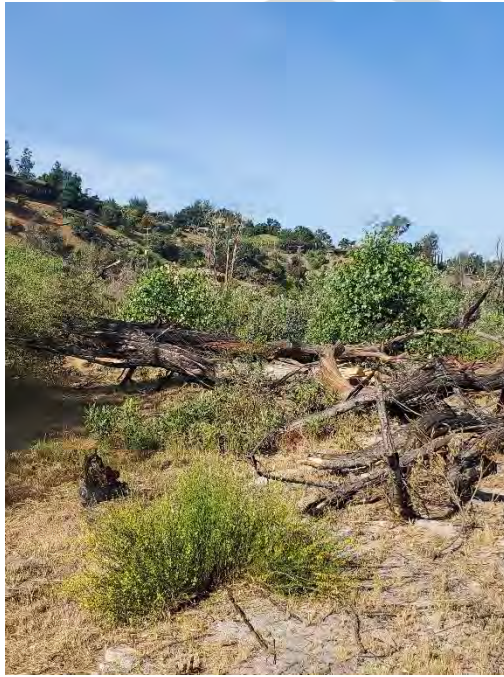
Photo 1: The eastern trail realignment section where the large willow snag was discovered obstructing the trail **before** trail maintenance efforts, on May 7.

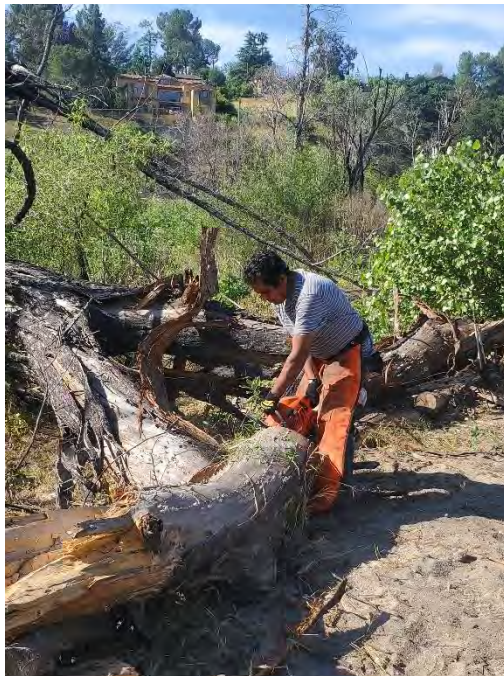
Photo 2: Crew member reducing the willow snag on the eastern trail realignment section, on May 7.

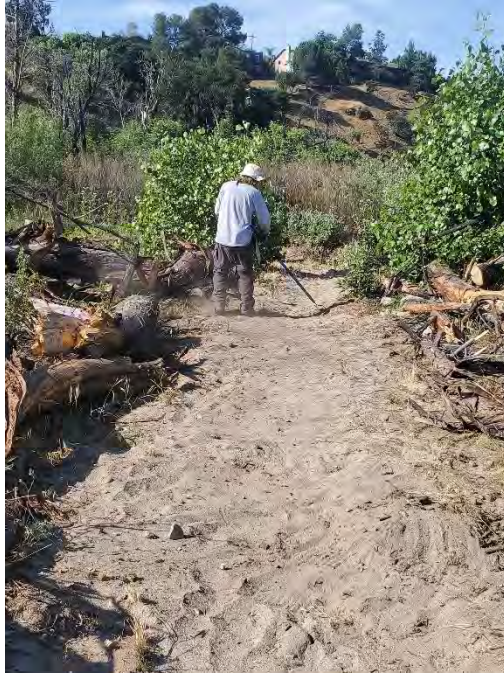
Photo 3: The trail cleared of the large willow snag in the eastern trail realignment section **after** trail maintenance efforts, on May 7.

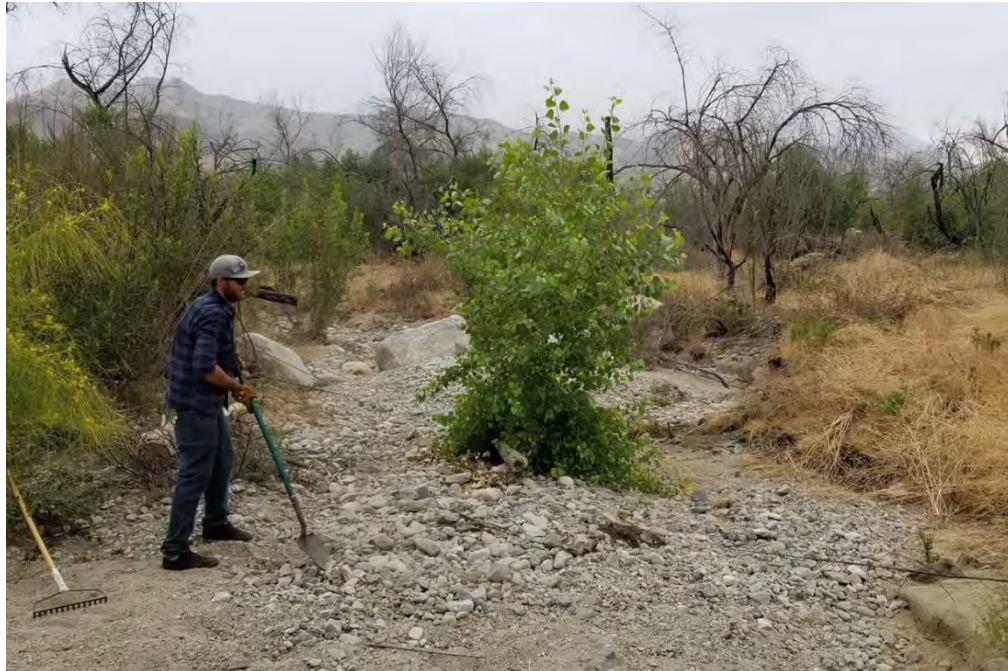
Photo 4: Gravel and stones cover the trail before crew efforts, on June 19.

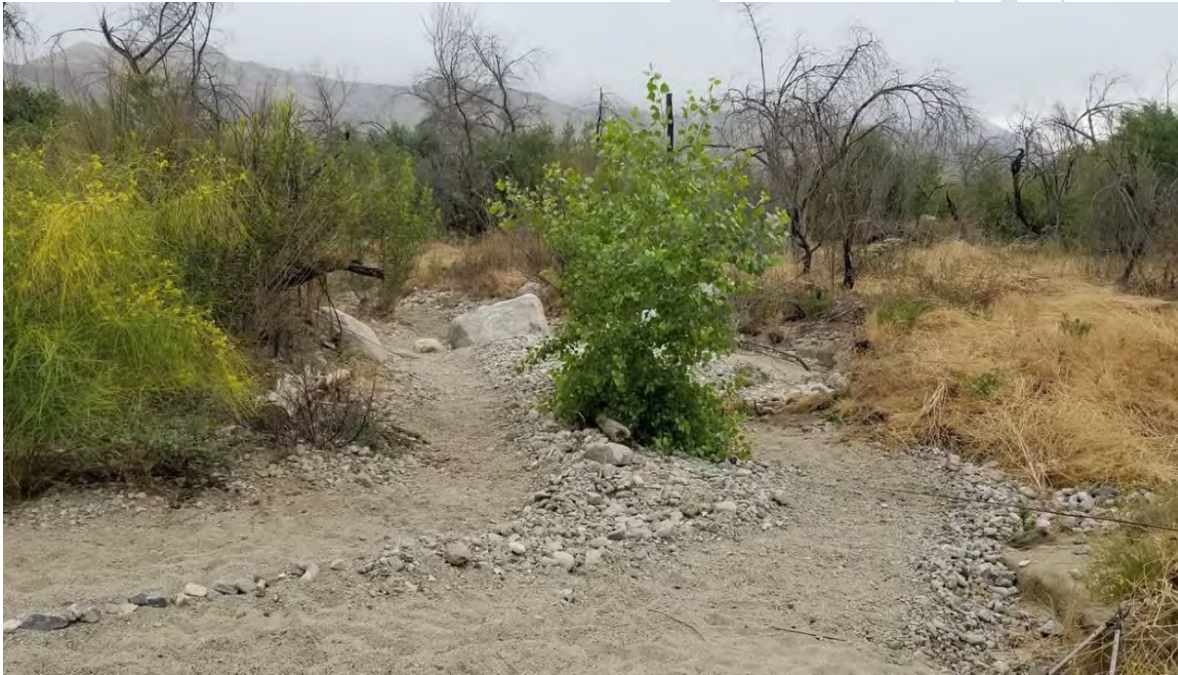
Photo 5: Gravel and stones removed from trail to promote safe passage and delineate the trail boundaries after crew efforts, on June 19.

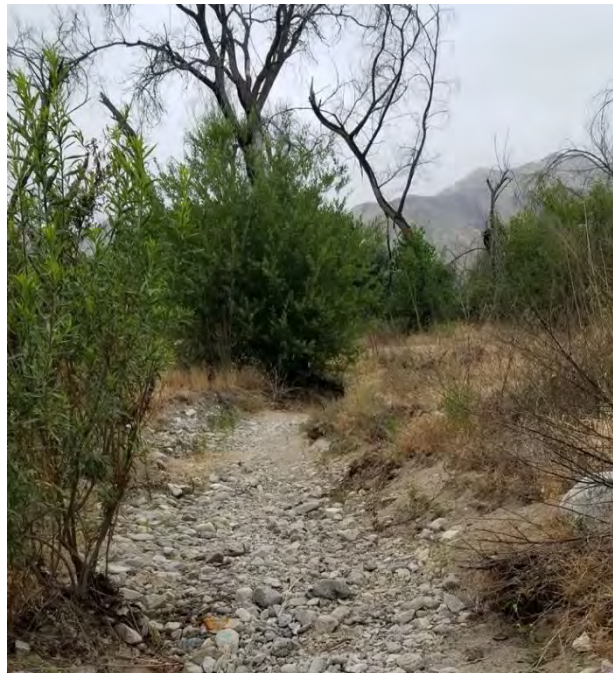
Photo 6. Rocks and debris covering the trail creating a hazardous route for visitor traffic before trail maintenance was performed, on June 19.

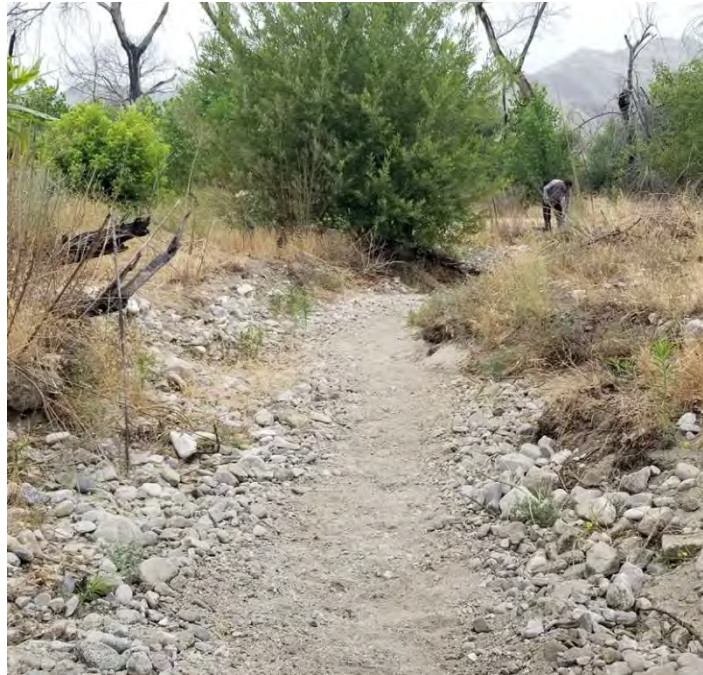
Photo 7. Rocks and debris removed from the trail creating a safe route for visitor traffic after trail maintenance was performed, on June 19.

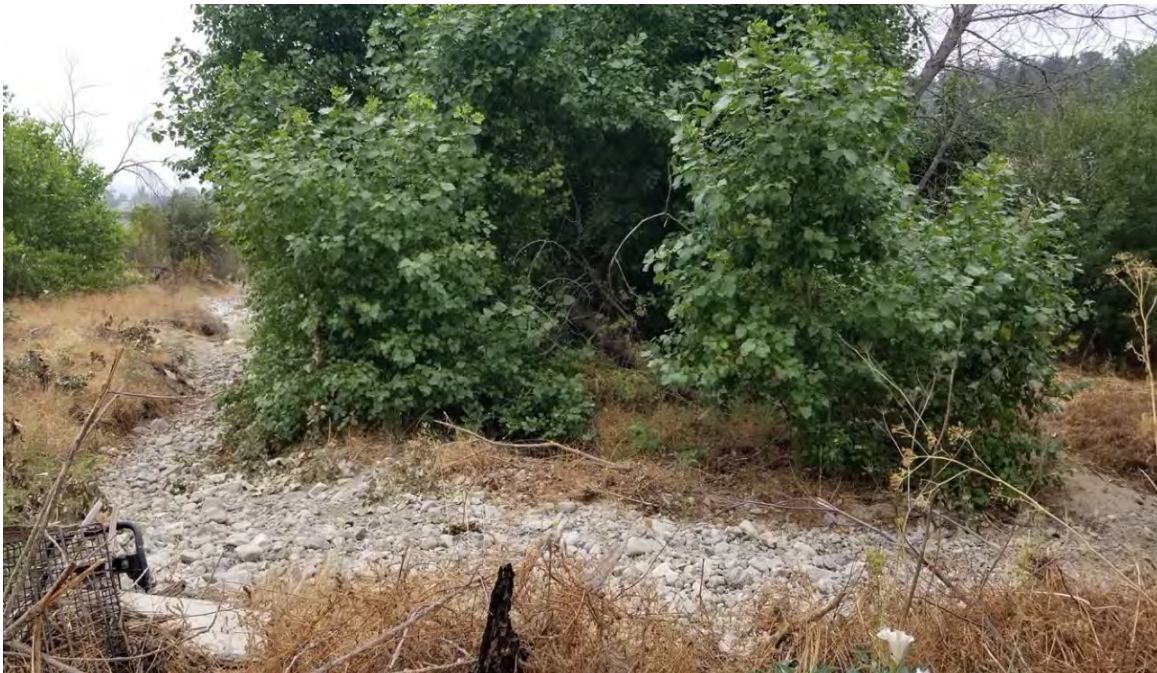
Photo 8. Seasonal flooding causes stones to surface making navigation along the trails difficult before maintenance was performed, on June 19.

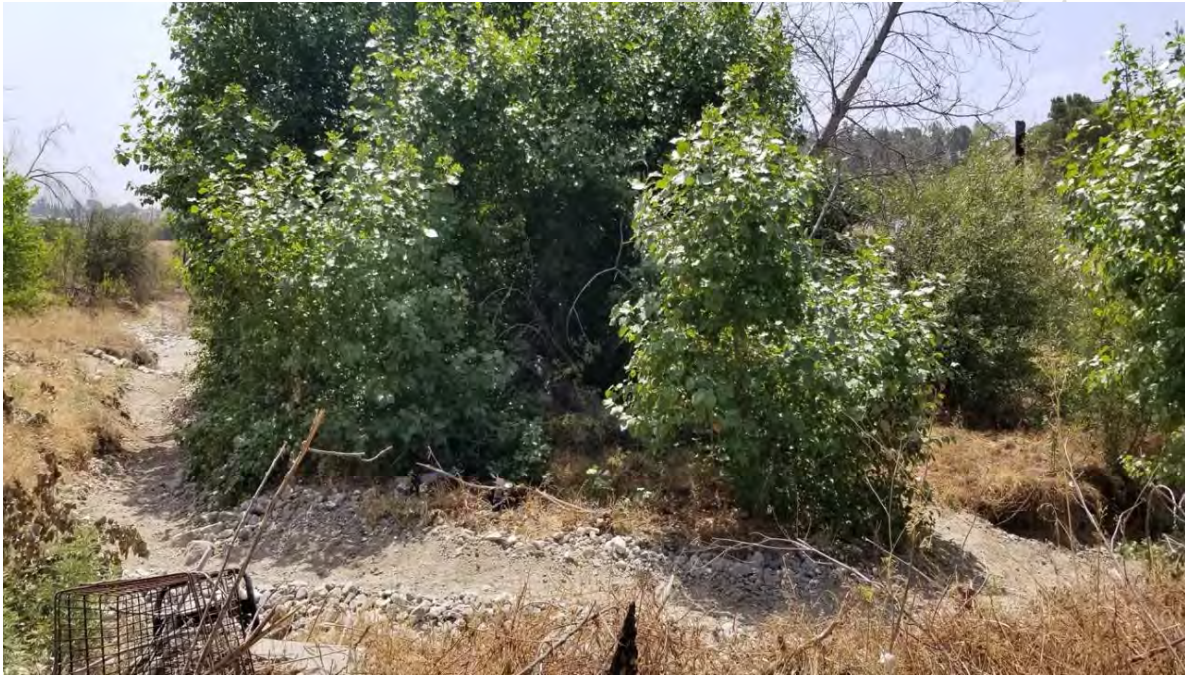
Photo 9. Rocks were removed and used to clearly delineate authorized trails, to minimize off-trail riding, and provide for safe navigation for the public, on June 19.

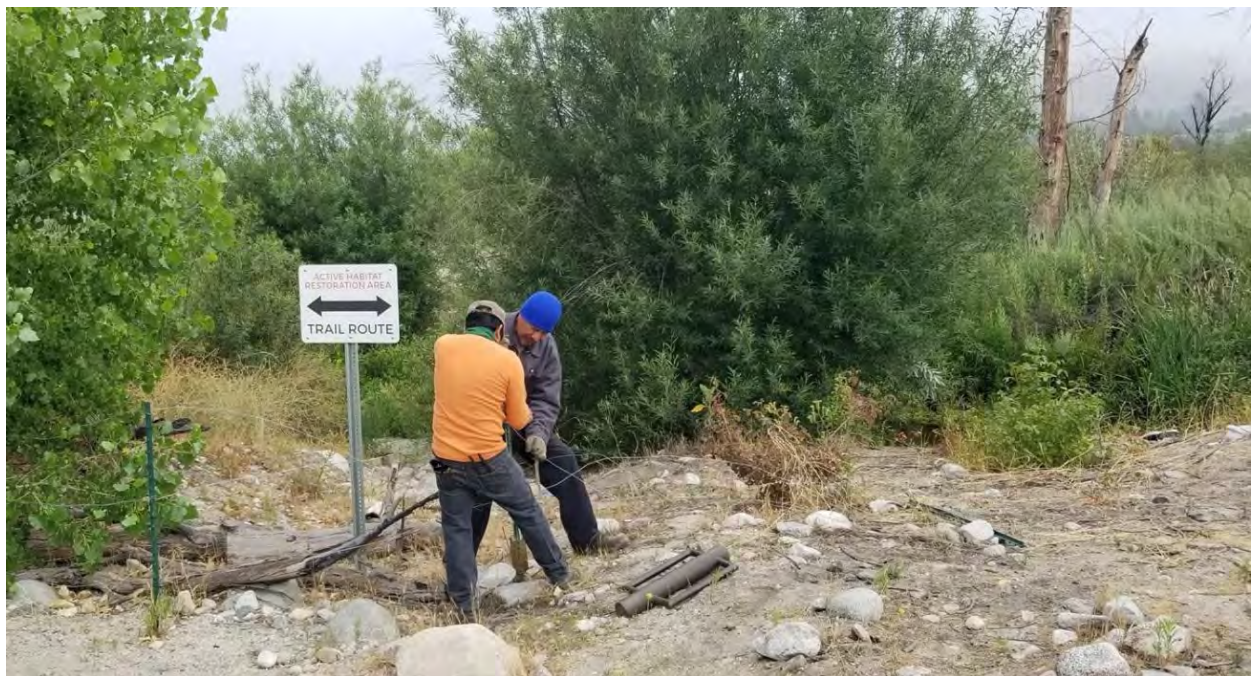
Photo 10. Crew members repairing the vandalized creek crossing closure, resetting T-posts, and replacing the wire fencing, on June 26.

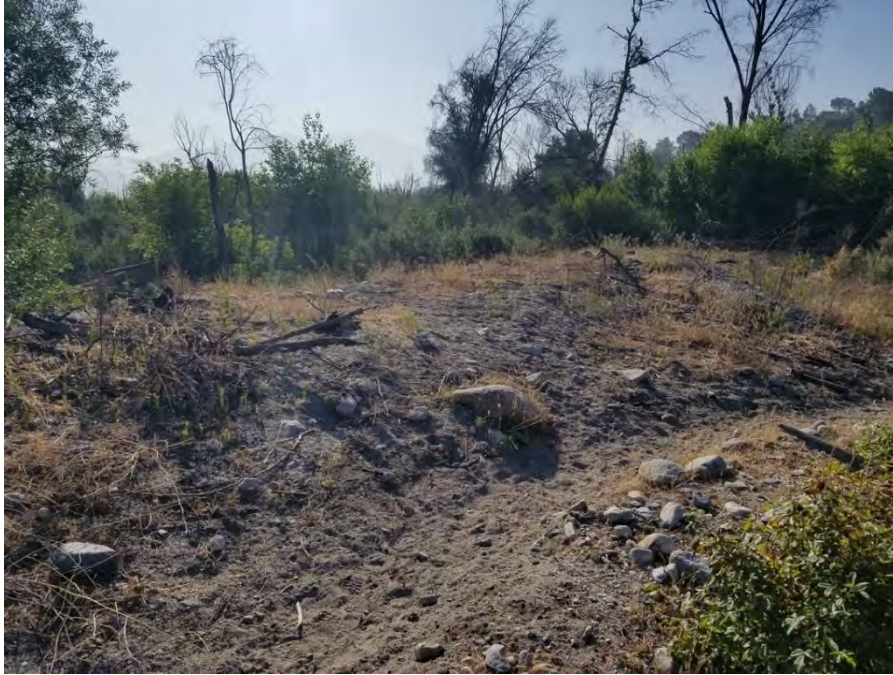
Photo 11. Example of an emerging unauthorized trail before trail maintenance was performed, on June 26.

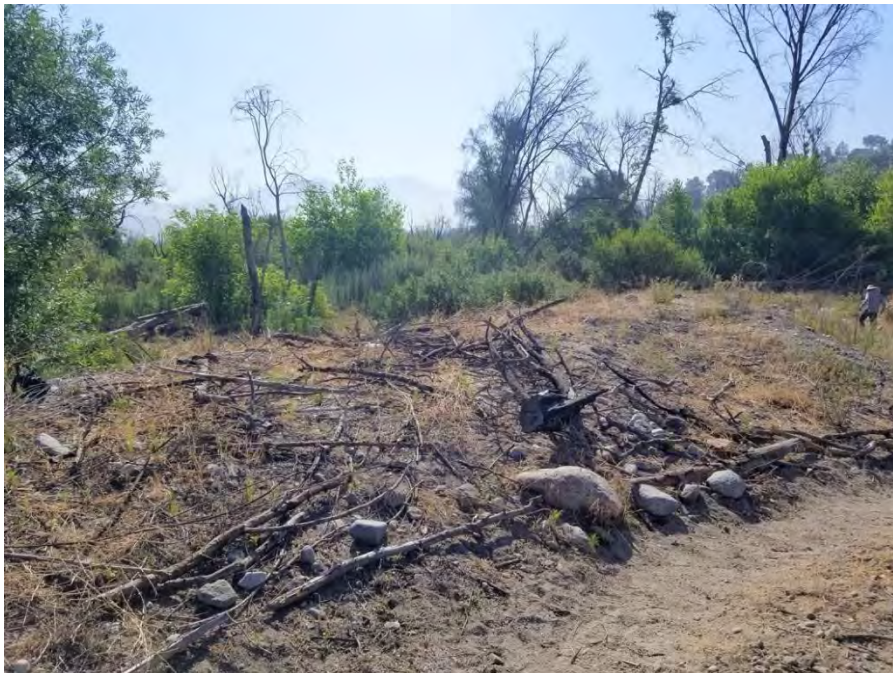
Photo 12. Example of rocks and snag debris used to discourage unauthorized trail established after trail maintenance was performed, on June 26.

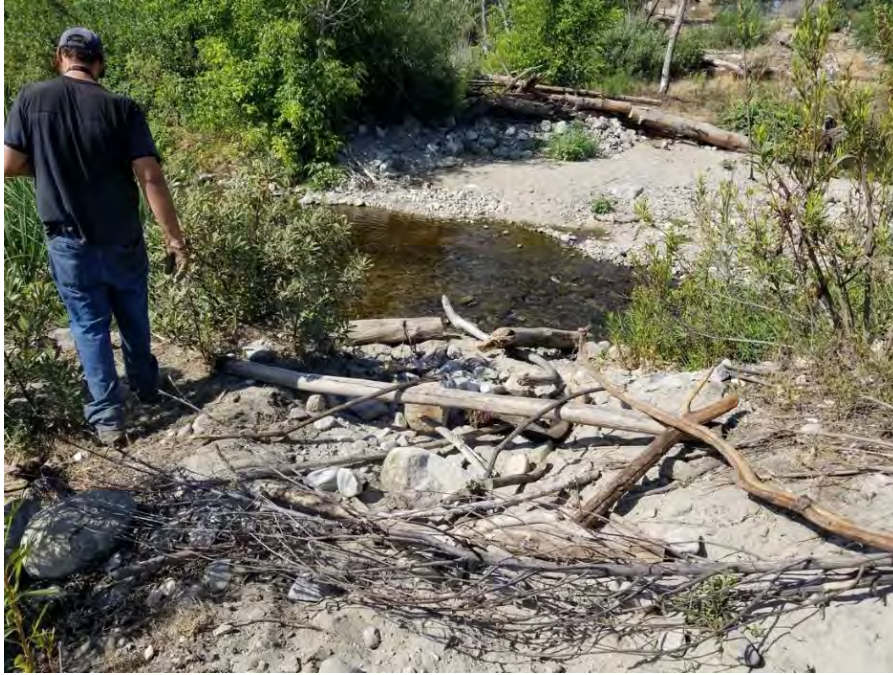
Photo 13. Crew members used rocks and snag debris to discourage unauthorized creek crossings, on June 26.

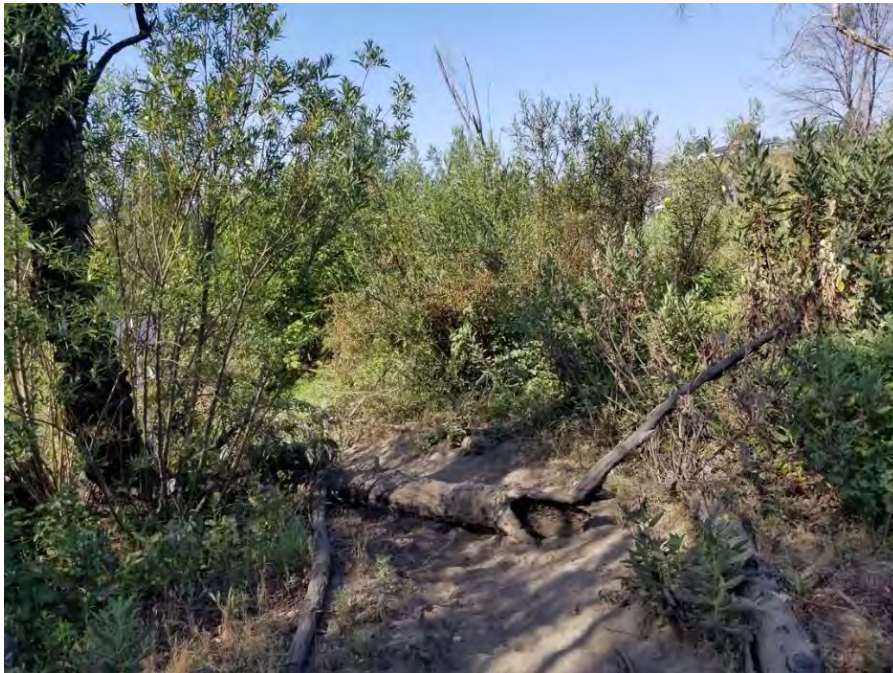
Photo 14. Example of snag debris obstructing the trail and potentially causing visitors to deviate from the authorized trail, on June 26.

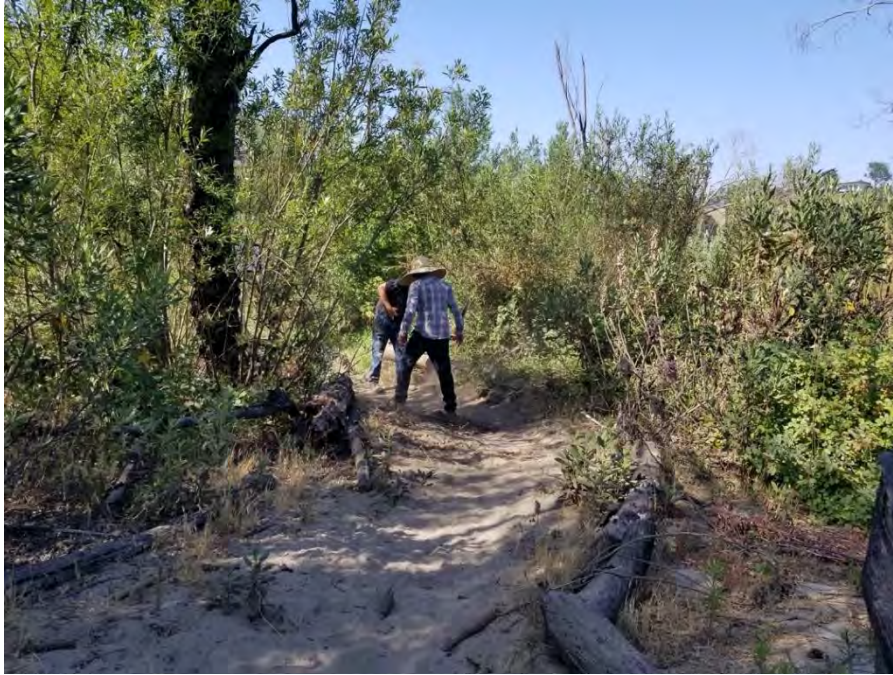
Photo 15. Crew members removing the obstruction to promote public safety and minimize the potential for negative impacts on the surrounding habitat, on June 26.

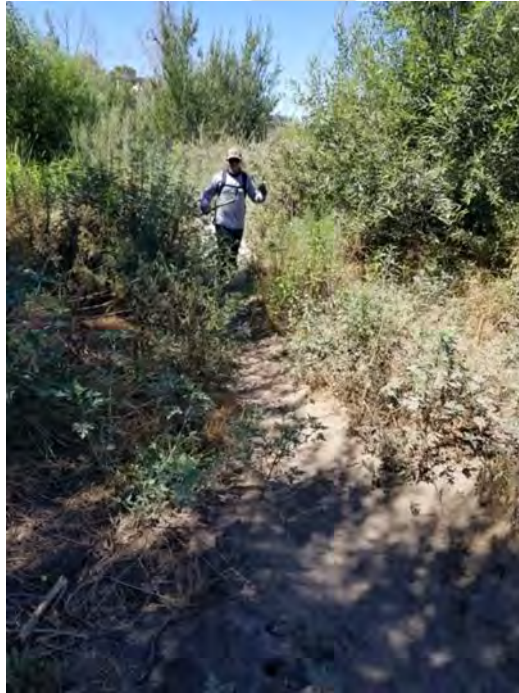
Photo 1: Biologist pulling vegetation that was narrowing an authorized trail, on July 20.

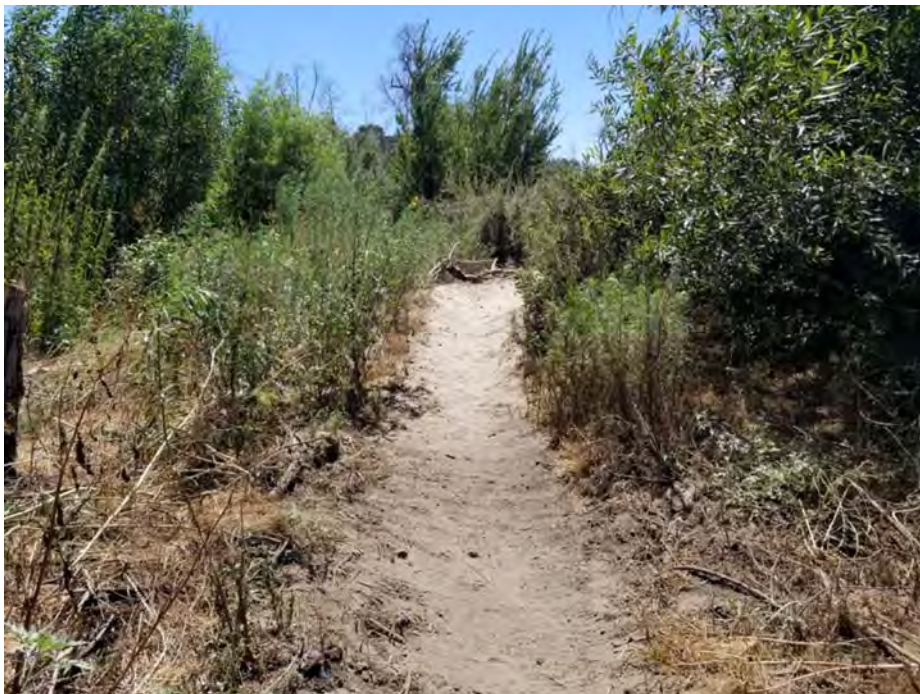
Photo 2: After clearing impeding vegetation, on July 20.

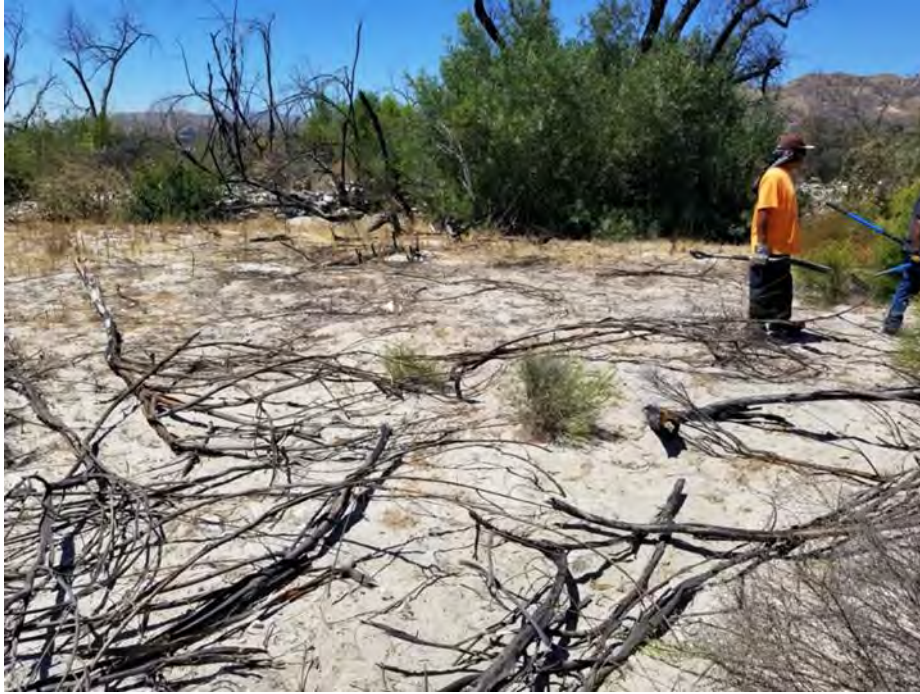
Photo 3: Crew blocking unauthorized trails using snags and other natural debris, on July 31.

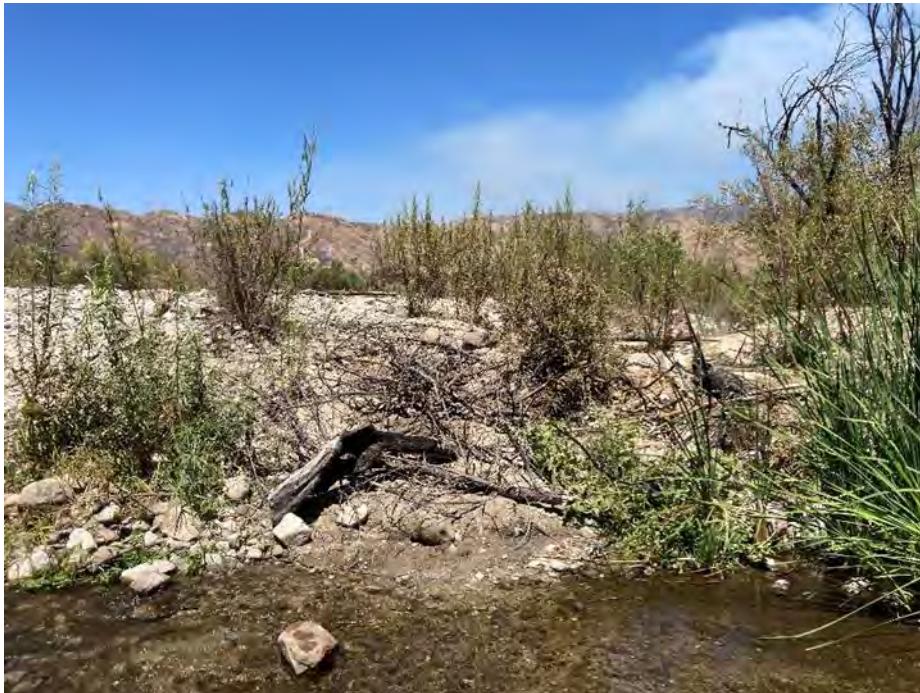
Photo 4: Unauthorized trail that had formed crossing Haines Canyon Creek to access the trails in the Big Tujunga Wash. Snags and other natural debris were used to block the area and discourage continued use, on July 31.

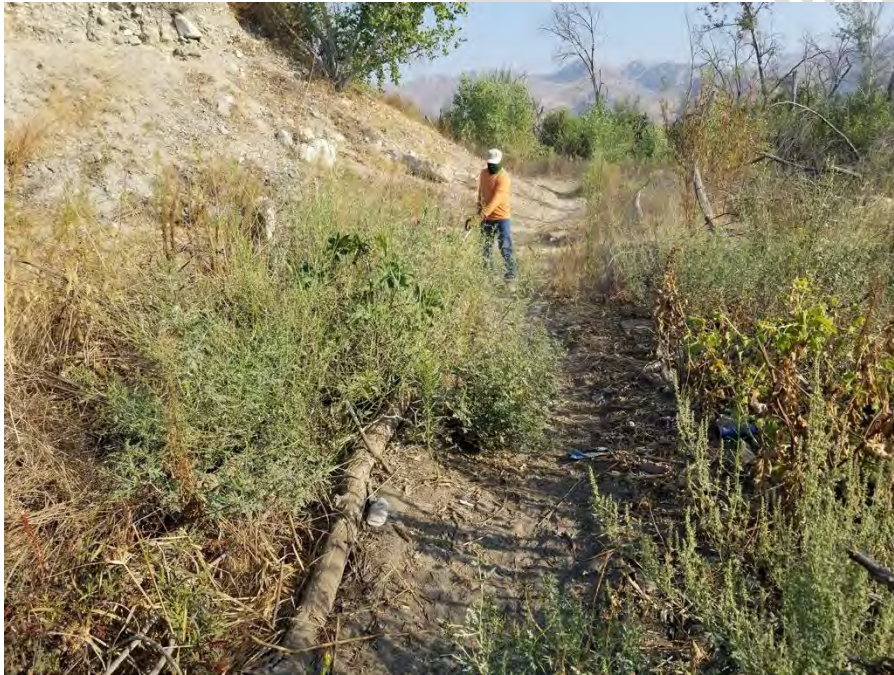
Photo 1. The overgrowth of natives and non-natives were blocking and narrowing the trail below Cottonwood Avenue bluff, on September 28.

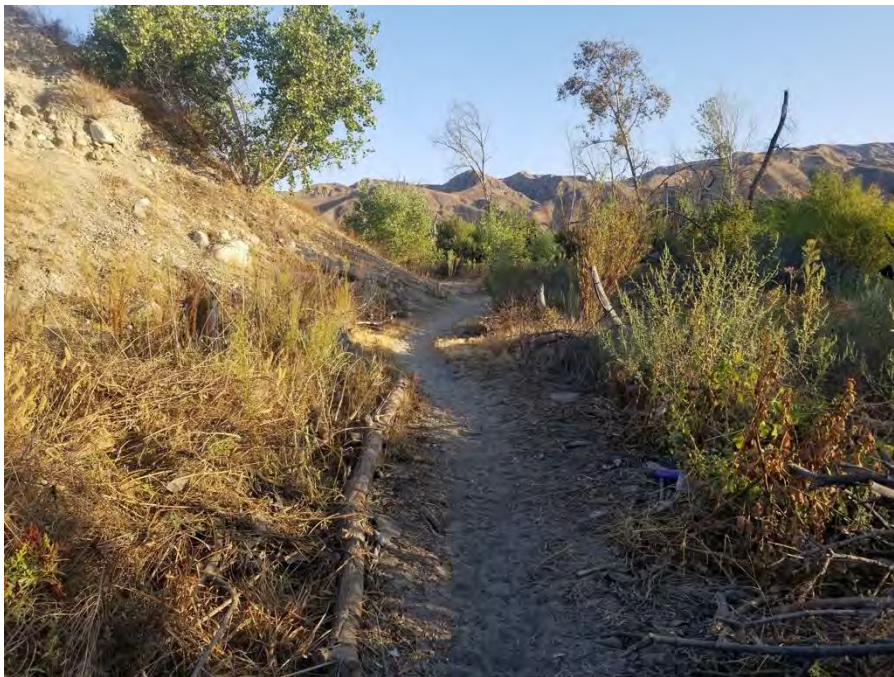
Photo 2. The crew used weed-whippers to clear the trail and trim back vegetation at a margin of 4 feet, on September 28.

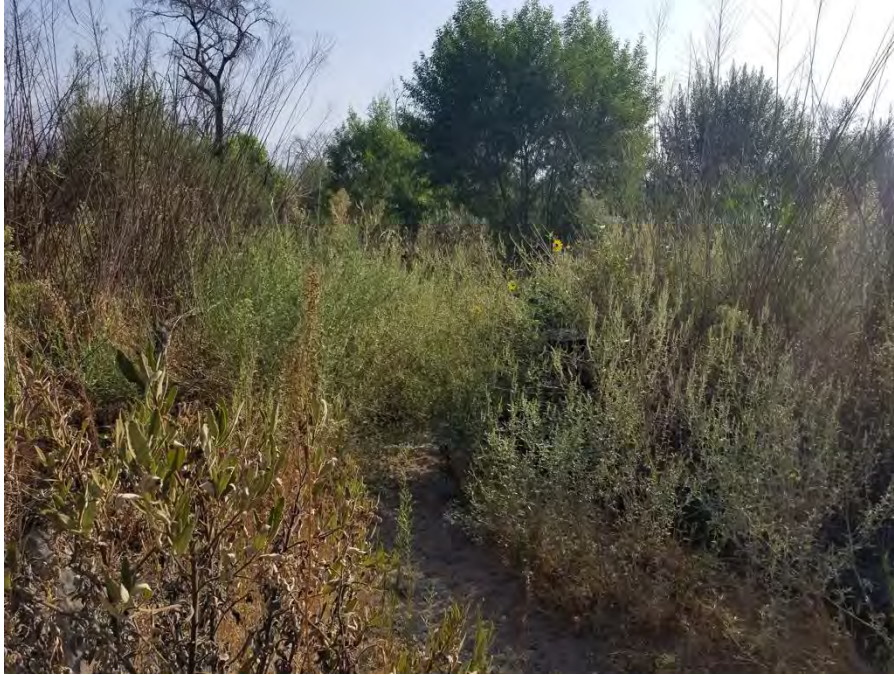
Photo 3. Working towards the equestrian center, natives and non-natives were obstructing and narrowing the trail, on September 28.

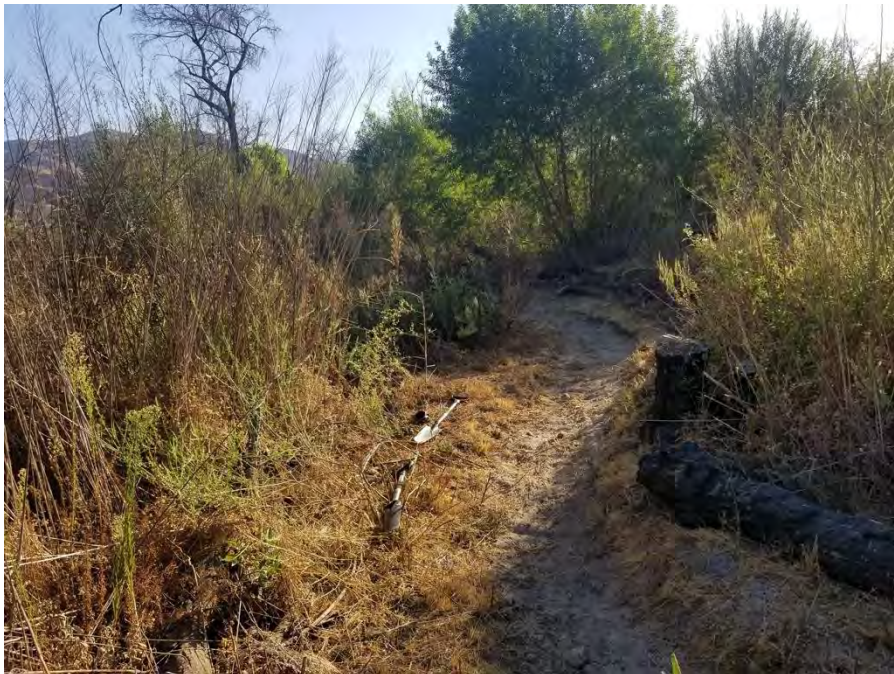
Photo 4. The crew used weed-whippers to clear the trail and trim back vegetation at a margin of 4 feet, on September 28.

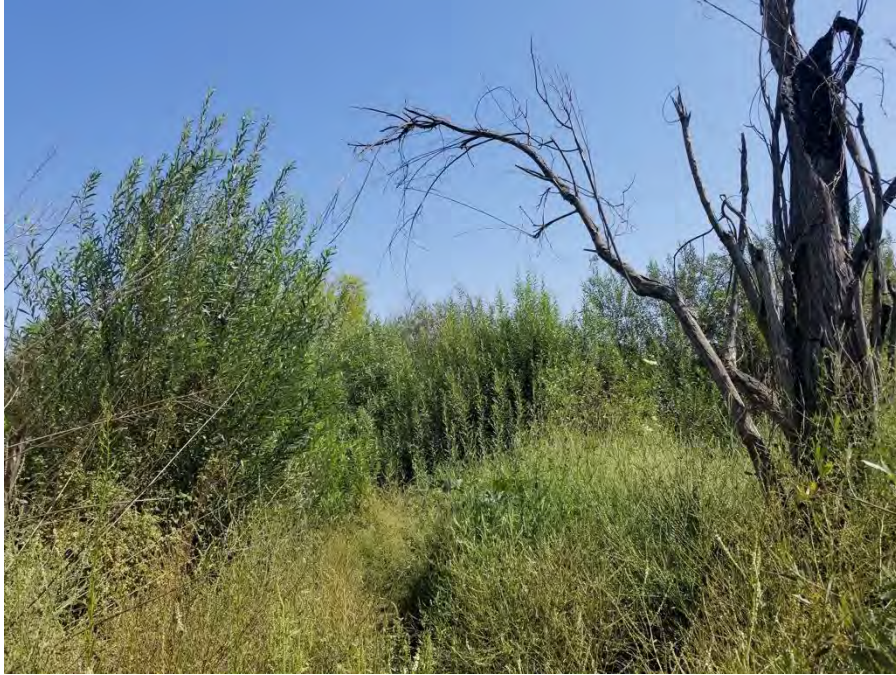
Photo 5. Working towards the equestrian center, natives and non-natives were obstructing and narrowing the trail, on September 28.
