**2020 ANNUAL REPORT FOR THE
BIG TUJUNGA WASH MITIGATION AREA
LOS ANGELES COUNTY, CALIFORNIA**

**LOS ANGELES COUNTY
PUBLIC WORKS**
900 South Fremont Avenue
Alhambra, California 91803-1331

CHAMBERS GROUP, INC.
5 Hutton Centre Drive, Suite 750
Santa Ana, California 92707
(949) 261-5414

July 2021

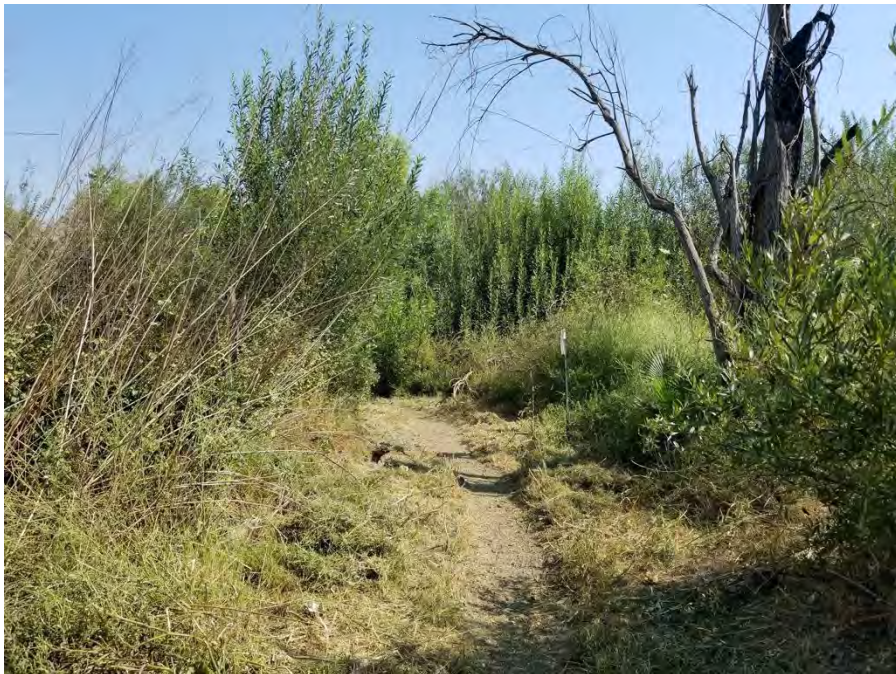
Photo 6. The crew used weed-whippers to clear the trail and trim back vegetation in order to help prevent deviations from the authorized trail, on September 28.

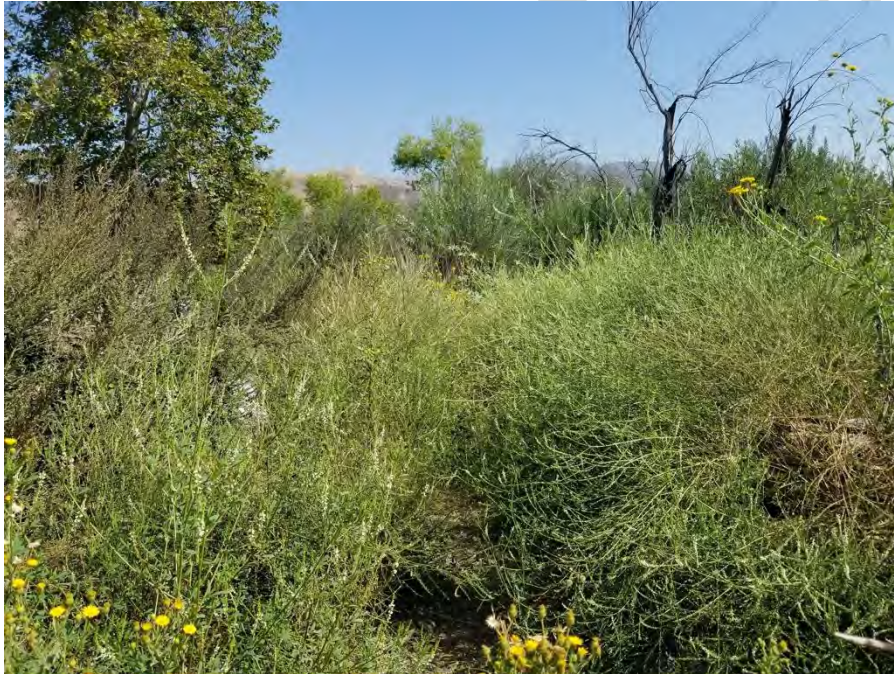
Photo 7. Working towards the equestrian center, natives and non-natives were obstructing and narrowing the trail, on September 28.

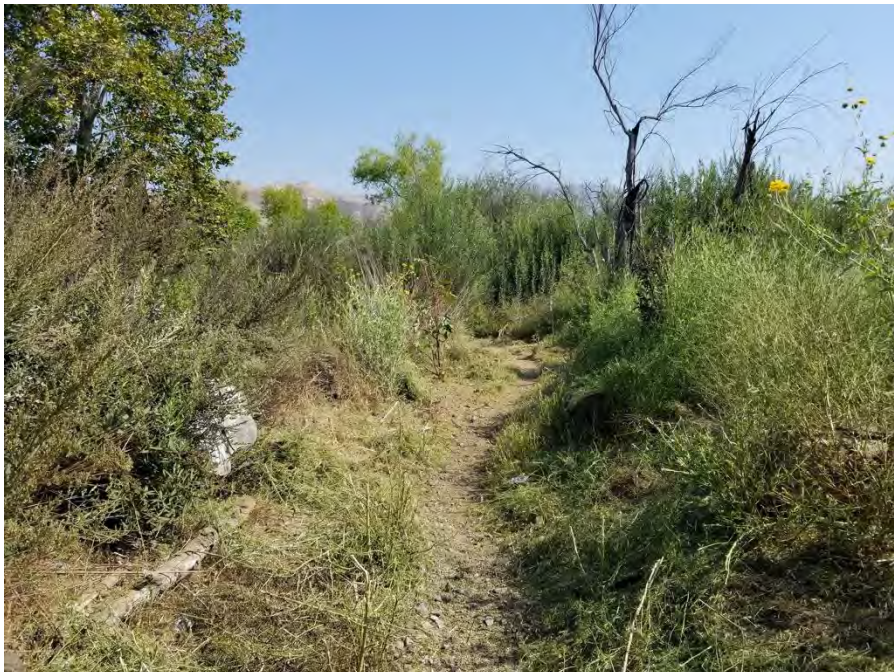
Photo 8. The crew used weed-whippers to clear the trail and trim back vegetation in order to help prevent deviations from the authorized trail, on September 28.

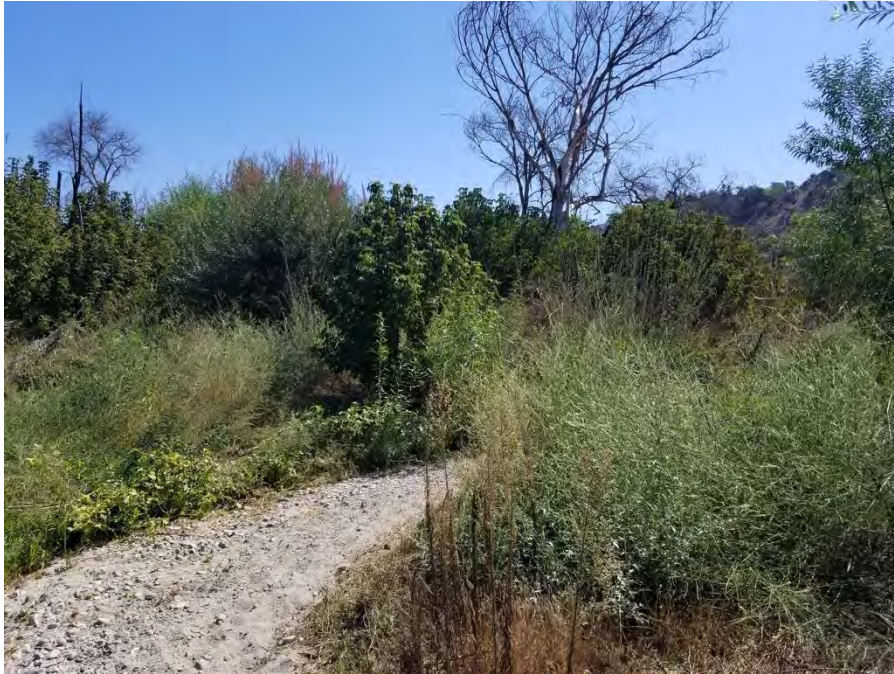
Photo 9. Example of several areas along the trail that were covered in patches of flowering white sweetclover, on September 29.

On September 29, trail maintenance resumed below the equestrian center and continued northwest towards the Tujunga Ponds. The crew focused on pruning overhanging Fremont cottonwood (*Populus fremontii*) for a more navigable route and hand-pulling minor patches of flowering shortpod mustard that lined the trail. The crew observed a patch of 11 young Cootamundra wattle plants (*Acacia baileyana*) within 15 feet of the trail and removed them to prevent their dispersal and colonization elsewhere along the trail. Cootamundra wattle is a fast-growing tree/shrub species native to Australia that produces mass amounts of seed pods that have a high rate of germination. Upon forming dense stands, they shade out native plants and their nitrogen-fixing capabilities create soil unfit for native plant germination. Removal of this species required the use of shovels and machetes to completely uproot the plants. Many portions along the trail were covered in patches of flowering white sweetclover (*Melilotus albus*) that grew nearly 20 feet outward, away from the trail. To prevent further maturation and successive growth, the crew used weed-whippers to trim the large patches down to the base. Targeting white sweetclover along the trail is essential to minimize its dispersal and dominance in the eastern riparian areas (Photos 9 and 10).

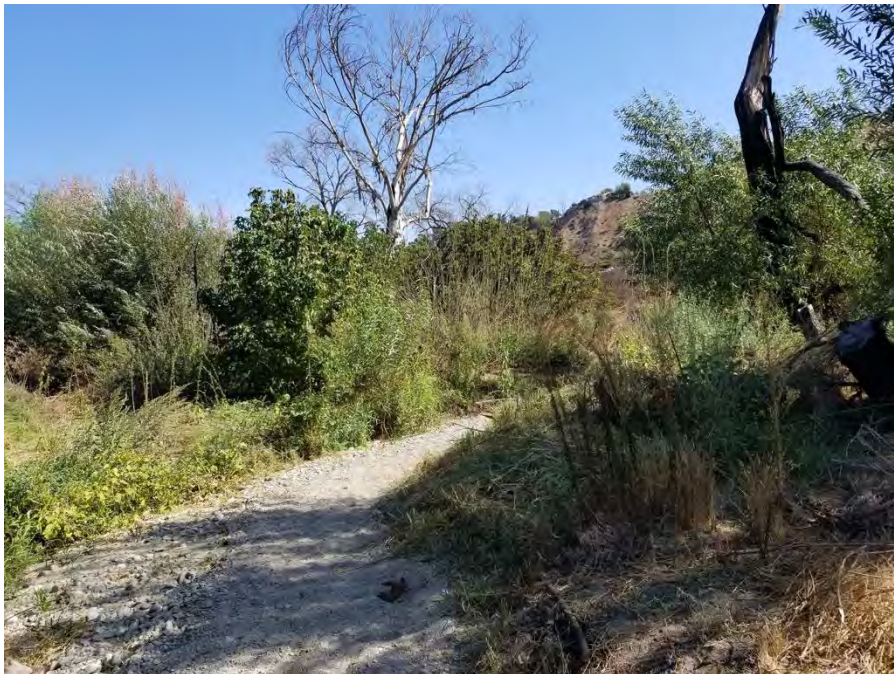
Photo 10. After the removal of white sweetclover using weed-whippers to efficiently prevent further maturation and successive growth, on September 29.

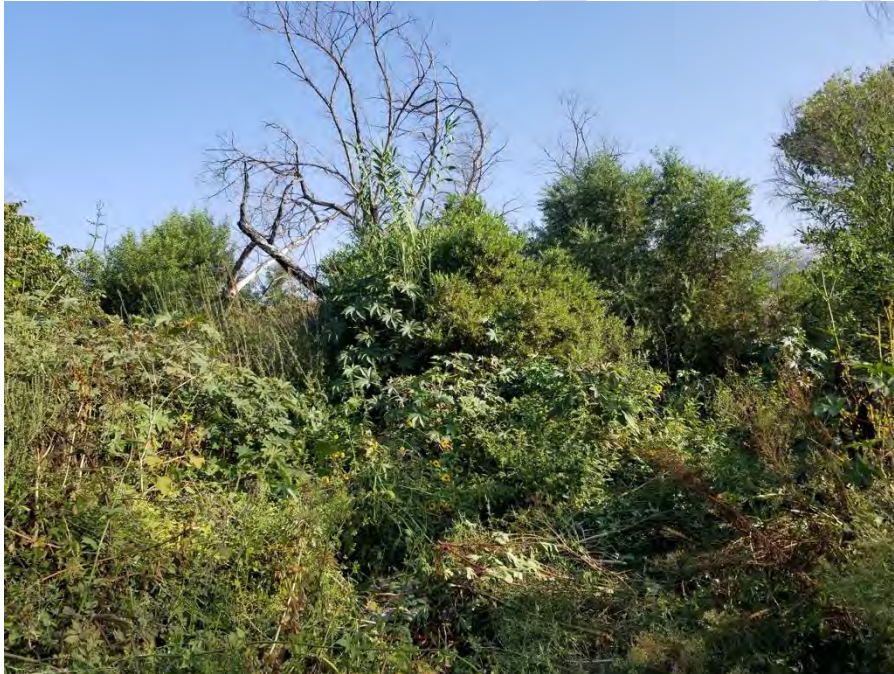
Photo 11. Heading south along the trail that follows the western edge of eastern riparian area, large patches of castor bean adjacent to the trail, were blocking the trail, on September 30.

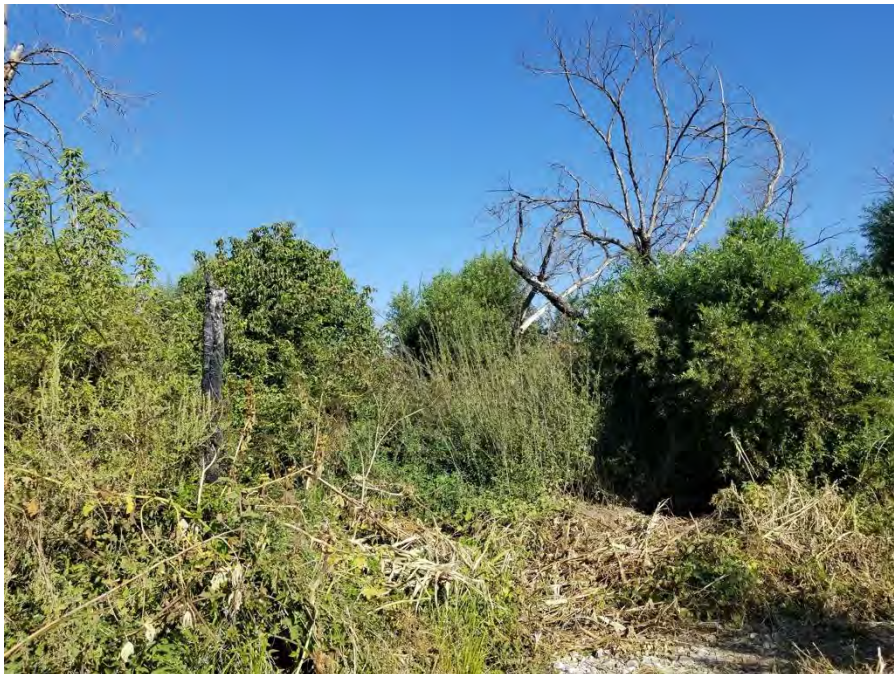
Photo 12. After the removal of castor bean using machetes and shovels to remove root structures to reduce the potential for regrowth, on September 30.

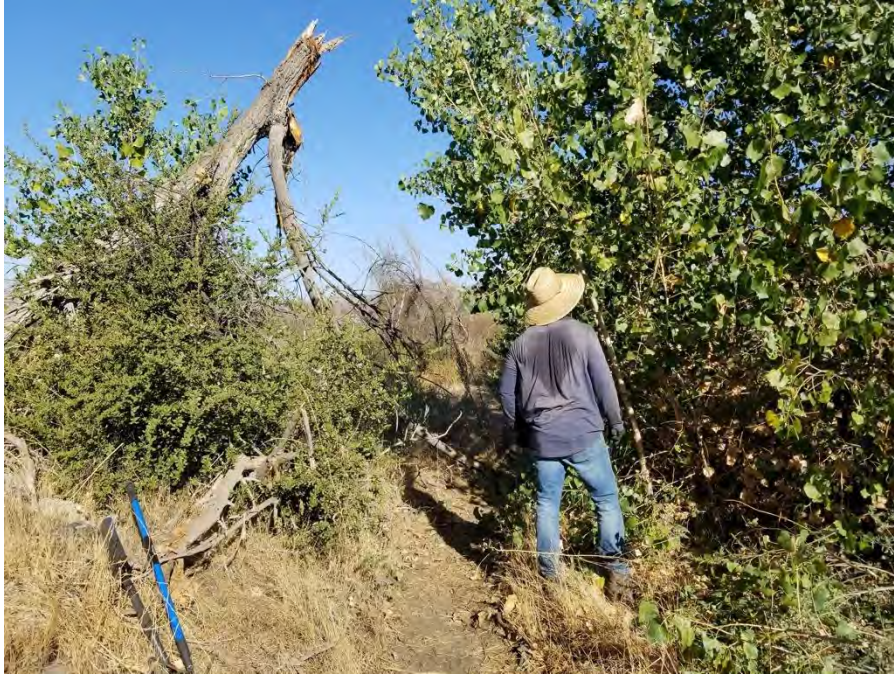
Photo 13. The crew sawed large tree limbs from a fallen tree that was obstructing the trail, on September 30.

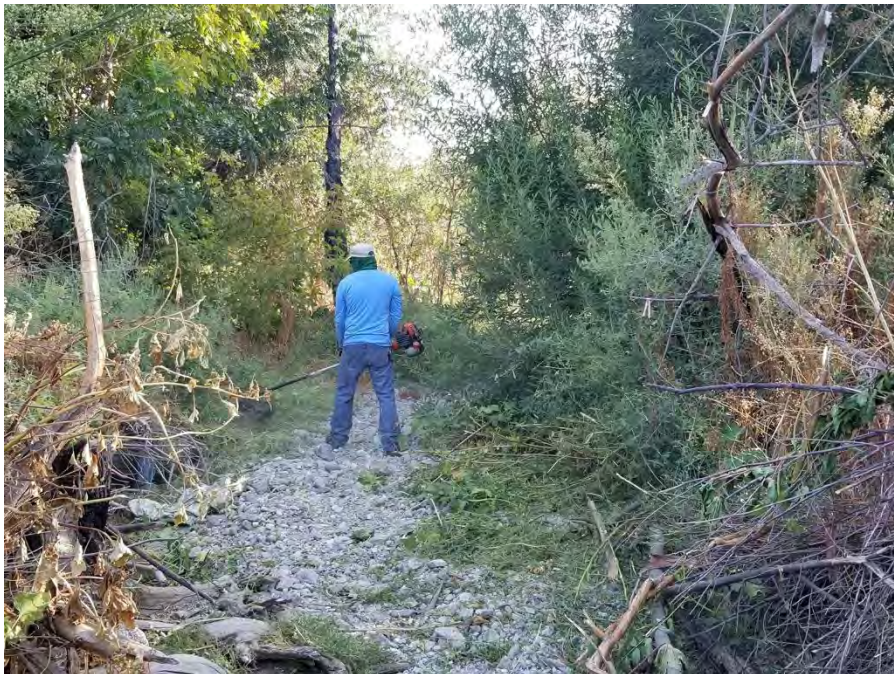
Photo 14. The crew used weed-whippers to create a more navigable route where the trail was indistinguishable due to overgrowth of vegetation, on September 30.

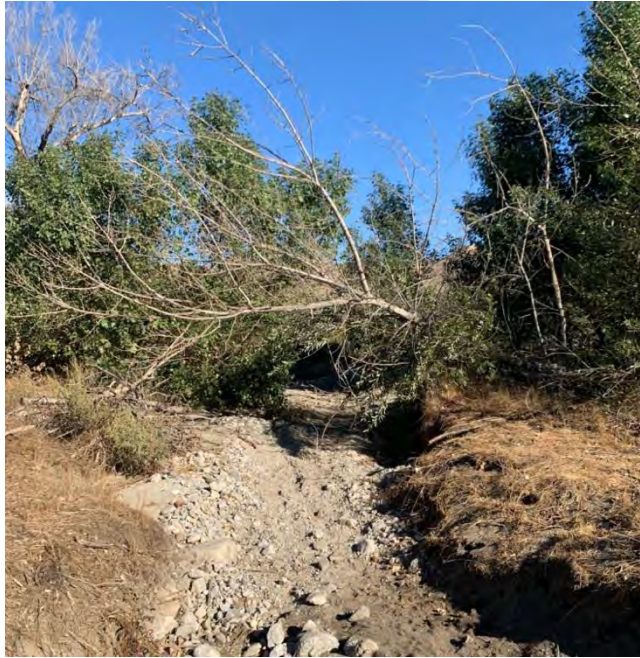
Photo 1. The crew encountered a fallen tree below the equestrian center in the eastern riparian area, on October 1.

occurred during the high wind events in prior weeks. As the crew approached the area below the equestrian center, they observed a tree that had fallen and obstructed the trail. The crew used a chainsaw to cut the tree into smaller segments and successfully pulled the crown of the tree off to the side of the trail (Photos 1 and 2). The crew also focused on removing hazardous rocks and debris that had turned up and accumulated on the trail due to heavy equestrian traffic that over time, changes the trail composition under foot. In efforts to conserve native plants and wildlife and to avert unauthorized trail bypasses, the crew raked the larger stones to the sides of the trail and used the smaller rocks to delineate the authorized trail (Photos 3 and 4).

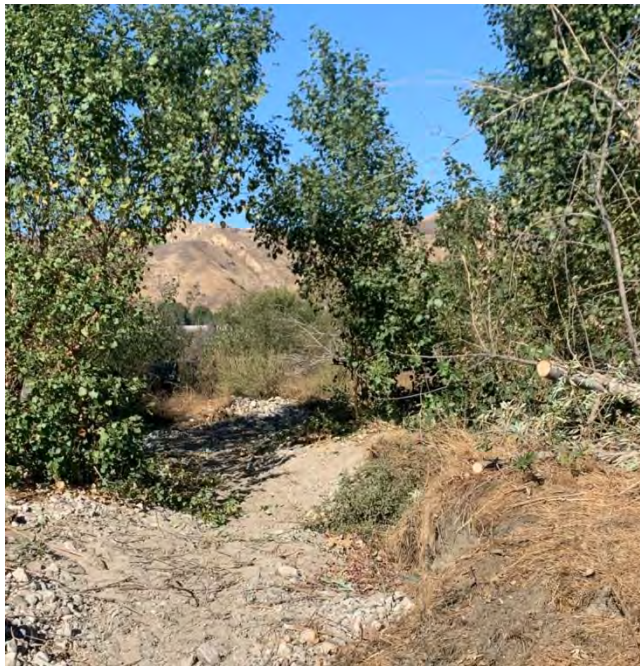
Photo 2. The crew used a chainsaw to cut the tree into smaller segments and successfully pulled the crown of the tree off to the side of the trail, on October 1.

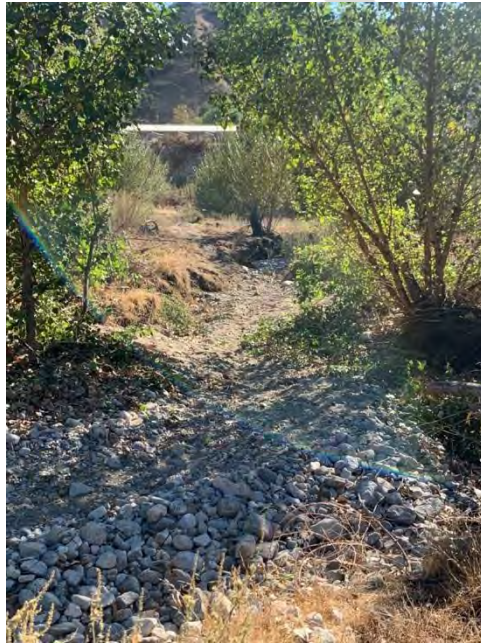
Photo 3. Below the equestrian center, rocks and debris had turned up and accumulated on the trail due to heavy equestrian traffic, on October 2.

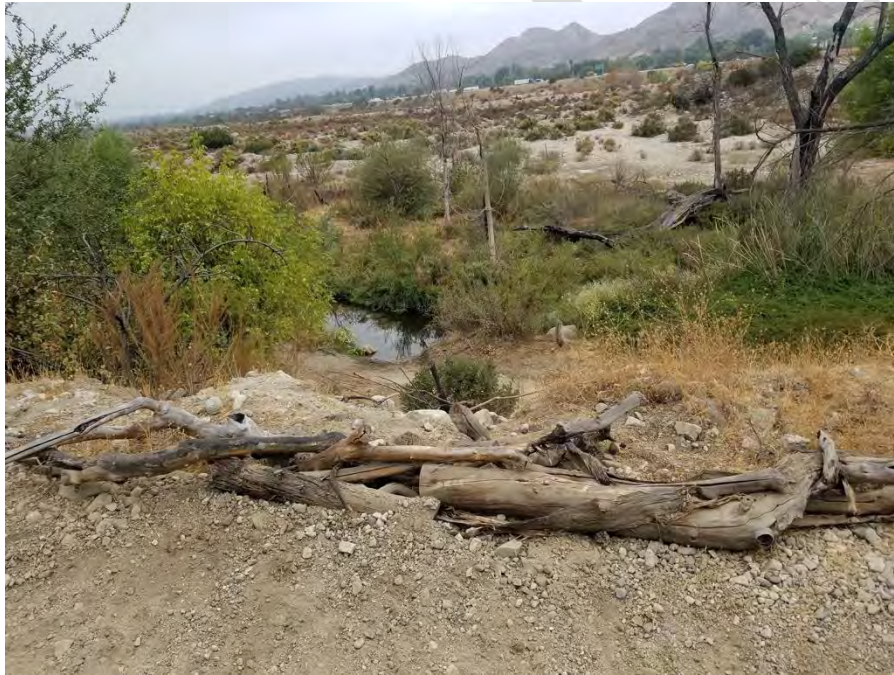
Photo 5. Logs and branches were utilized to delineate the authorized trail after an unauthorized trail that was a shortcut from the top of Cottonwood Avenue bluff down to the trail below was identified and blocked off, on October 28.

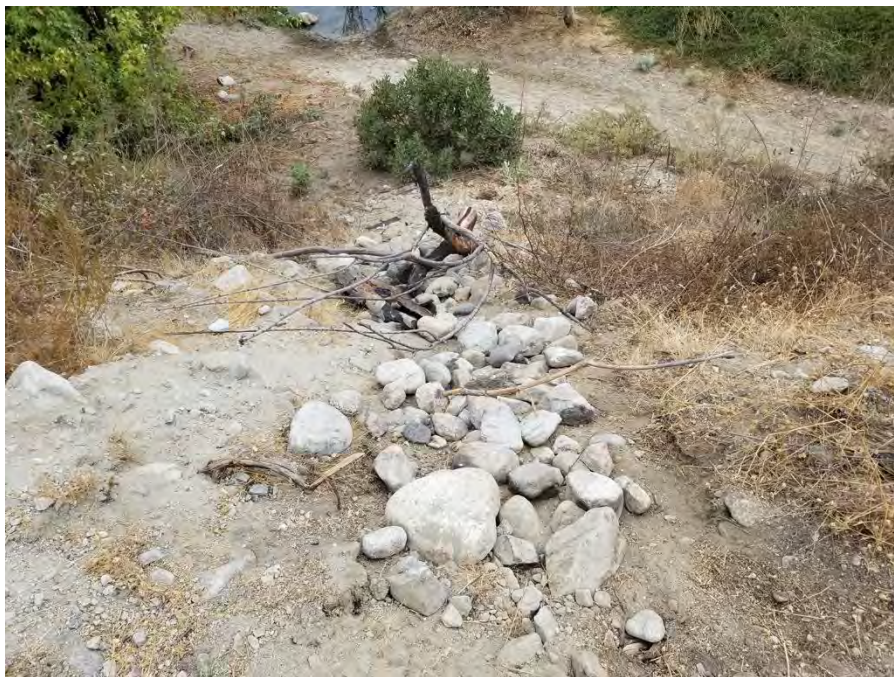
Photo 6. Large rocks that had rolled down into the trail due to hiker usage were used to cover and block the unauthorized shortcut, on October 28.

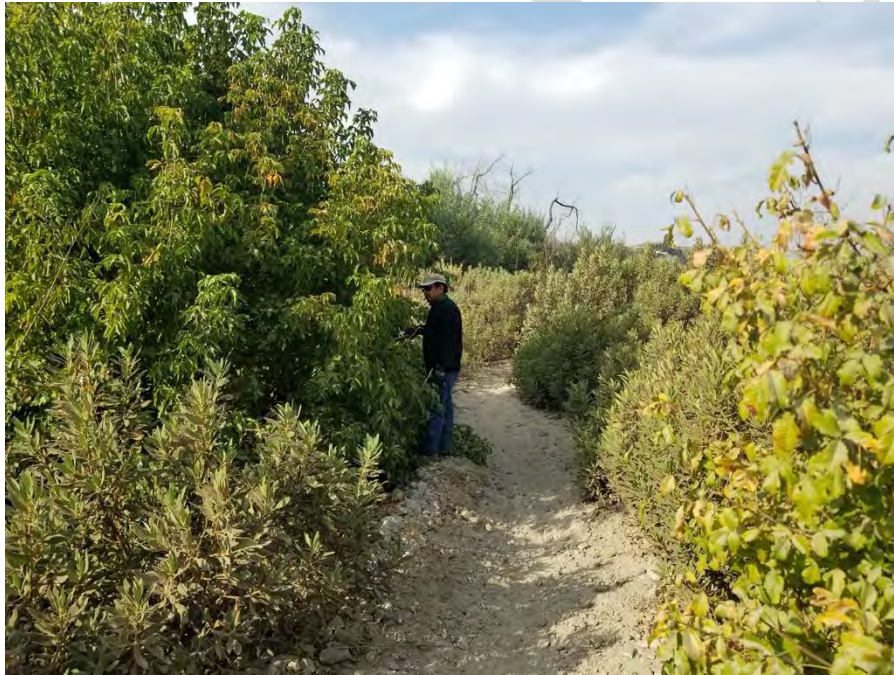
Photo 7. Heading toward the eastern alignment, the crew focused on pruning overgrown thick-leaved yerba santa, bur-sage, and horseweed providing a more navigable route, on October 29.

On October 28 through 30, the crew started trail maintenance on the western portion of the Mitigation Area below Cottonwood Avenue bluff and worked towards the eastern portion of the alignment in the western riparian area. The crew observed an unauthorized trail that was a shortcut from the top of Cottonwood Avenue bluff down to the trail below. This caused hillside erosion debris to roll down onto the authorized trail creating an unsuitable and hazardous path for horses. Logs and branches were utilized to delineate the authorized trail and the large rocks that had rolled down due to hiker usage were used to cover and block the unauthorized shortcut (Photos 5 and 6). Heading toward the eastern alignment, the crew focused on pruning overgrown thick-leaved yerba santa (*Eriodictyon crassifolium*), bur-sage (*Ambrosia acanthicarpa*), and horseweed (*Erigeron canadensis*) for a more navigable route, and on hand-pulling minor patches of flowering shortpod mustard (*Hirschfeldia incana*) and sweet alyssum (*Lobularia maritima*) that lined the trail. Sweet alyssum is an ornamental groundcover that grows in sandy, loamy, and heavy soil. This annual/perennial has slowly become more prominent in the western riparian area, and thus, was targeted for removal by hand-pulling. Patches of flowering white sweetclover (*Melilotus albus*) grew along several portions of the trail and were uprooted and removed using shovels. Targeting white sweetclover along the trail is essential to minimize its dispersal and dominance in both the western and eastern riparian area. As the crew approached the western portion of the alignment, they trimmed overhanging arroyo willow (*Salix lasiolepis*) that impeded the trail making a less navigable route for equestrians. The crew then walked the remainder of the trail to ensure a maintained and safe path for all users (Photos 7 and 8).

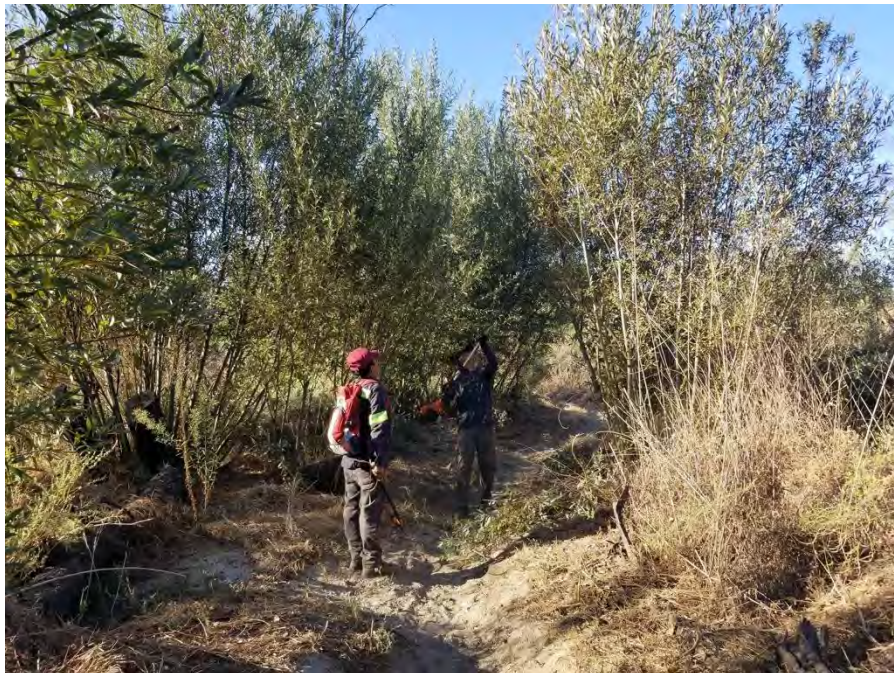
Photo 8. As the crew approached the western trail alignment, they trimmed overhanging willows that impeded the trail making a less navigable route for equestrians, on October 30.

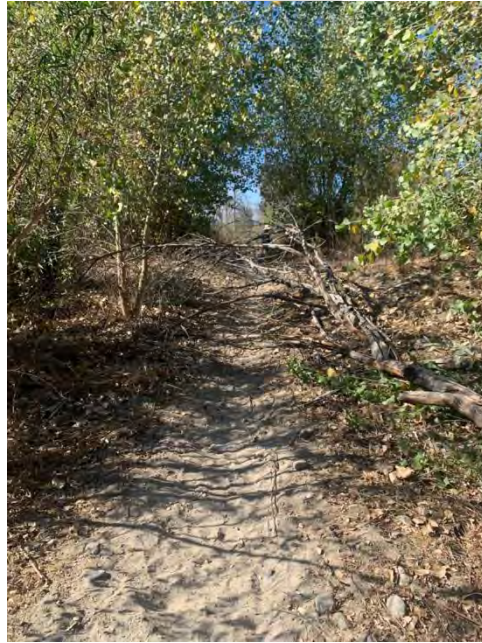
Photo 1. The crew encountered a snag that had fallen onto the trail that follows the western edge of the eastern riparian area, on December 11.

the trail (Photos 1 and 2). Patches of vegetation found overgrowing the trail were trimmed back including native horseweed (*Erigeron canadensis*) and common sunflower (*Helianthus annuus*) that drooped over into the trail, and non-native shortpod mustard (*Hirschfeldia incana*) and white sweetclover (*Melilotus albus*). These patches of overgrowth were trimmed back or pulled, at a margin of 4 feet, to prevent further constriction and narrowing of the trail. The crew also focused on removing hazardous rocks and debris that had turned up and accumulated on the trail. Heavy equestrian traffic turns up gravel and cobble, and over time, changes the trail composition under foot. Crew members raked the rock and debris creating a distinguishable and suitable path for both equestrians and hikers.

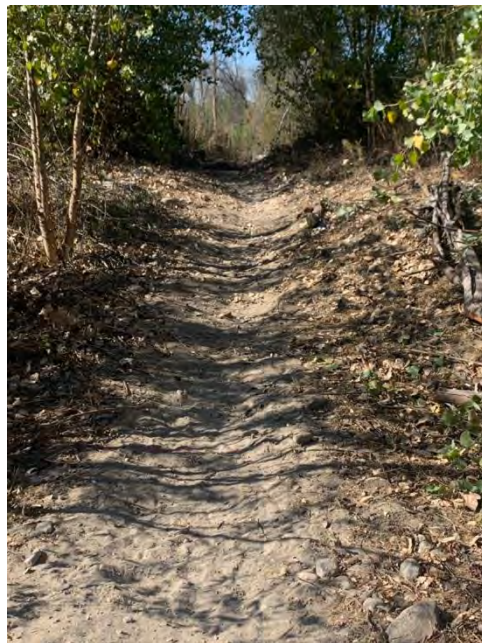
Photo 2. After the crew safely lifted and dragged the snag over to the side and sawed-off any remaining branches that were impeding the trail, on December 11.

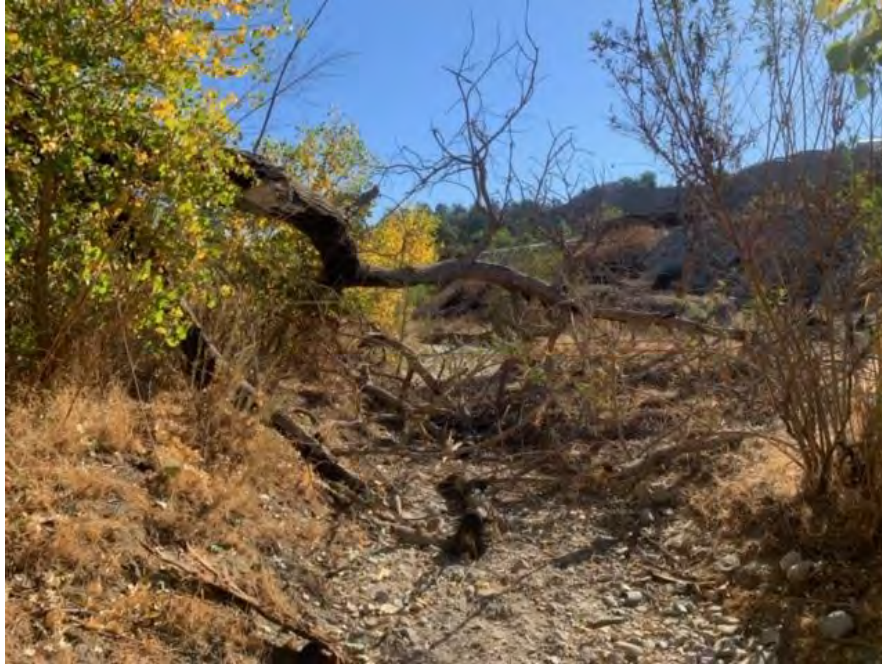
Photo 3. The crew encountered a fallen snag below the equestrian center in the eastern riparian area, on December 14.

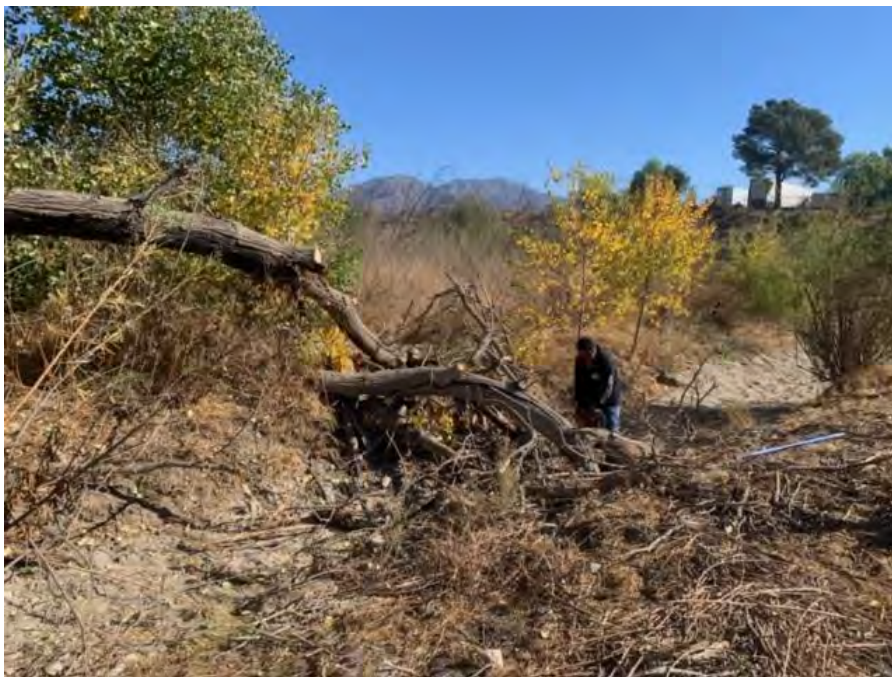
Photo 4. The crew used a chainsaw to cut the tree snag into smaller segments, on December 14.

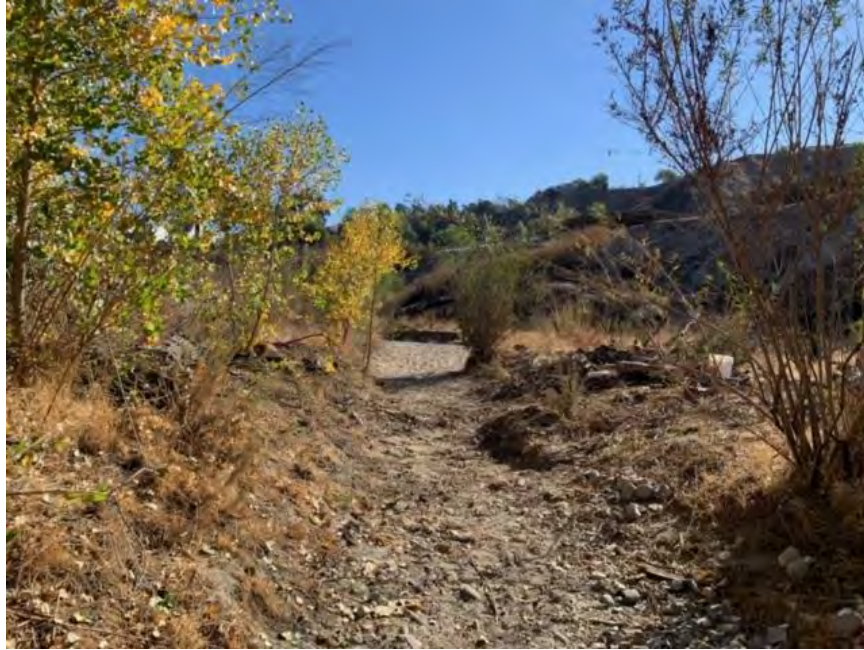
Photo 5. The crew then moved the cut segments off to the sides of the trail, clearing the obstruction and creating a safe path for equestrians and hikers, on December 14.

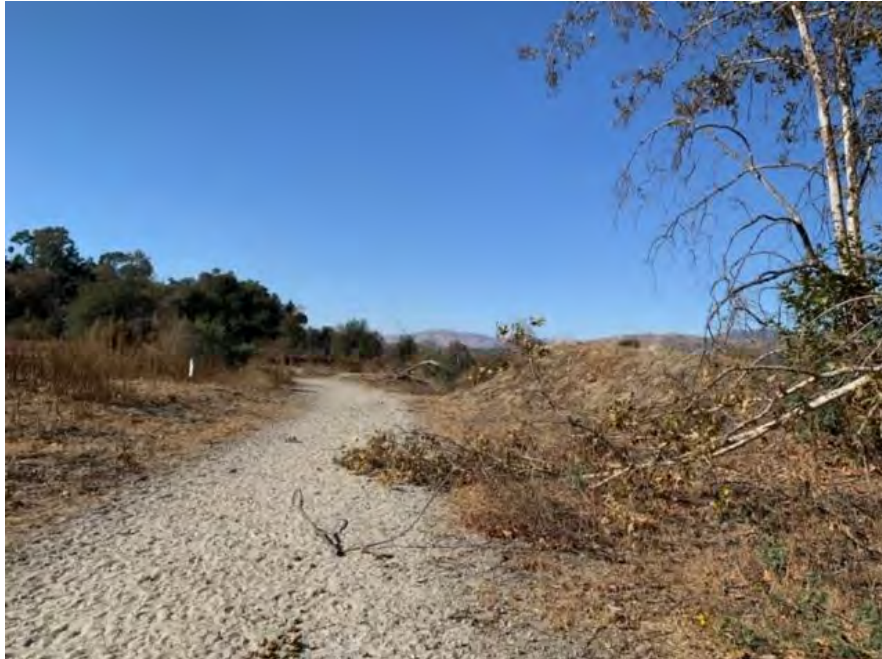
Photo 6. The crew encountered a fallen sweet gum tree that landed with the crown protruding into the trail, on December 15.

On December 15, the crew worked on the trails in the western riparian area, starting where work ended the previous day and working east until reaching the western portion of the alignment near the south Wheatland Avenue entrance. Patches of vegetation found overgrowing the trail were trimmed back including native thick leaved yerba santa (*Eriodictyon crassifolium*), horseweed, and annual bur-sage (*Ambrosia acanthacarpa*) that impeded the trail, and non-native shortpod mustard, white sweetclover, and sweet-alyssum (*Lobularia maritima*). These patches of overgrowth were trimmed back or pulled out by the root to prevent further constriction and narrowing of the trail and to minimize the dispersal and spread of non-native species along these high traffic areas. The crew continued to rake aside hazardous rocks and debris that had turned up and accumulated on the trail to create a safe and suitable path. The crew also cleared a fallen sweet gum tree (*Liquidambar styraciflua*) that had landed with its crown protruding into the trail. The fallen tree was pulled to the side where it would not cause a hazard to equestrian users or hikers (Photos 6 through 8).

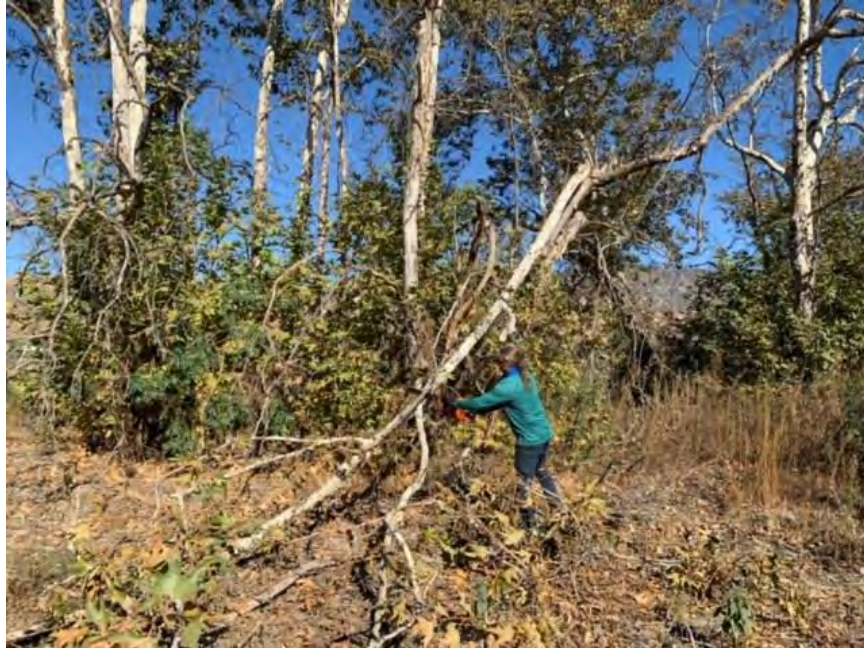
Photo 7. The crew members pulled the fallen tree to the side where it would not cause any risk to equestrian users or hikers, on December 15.

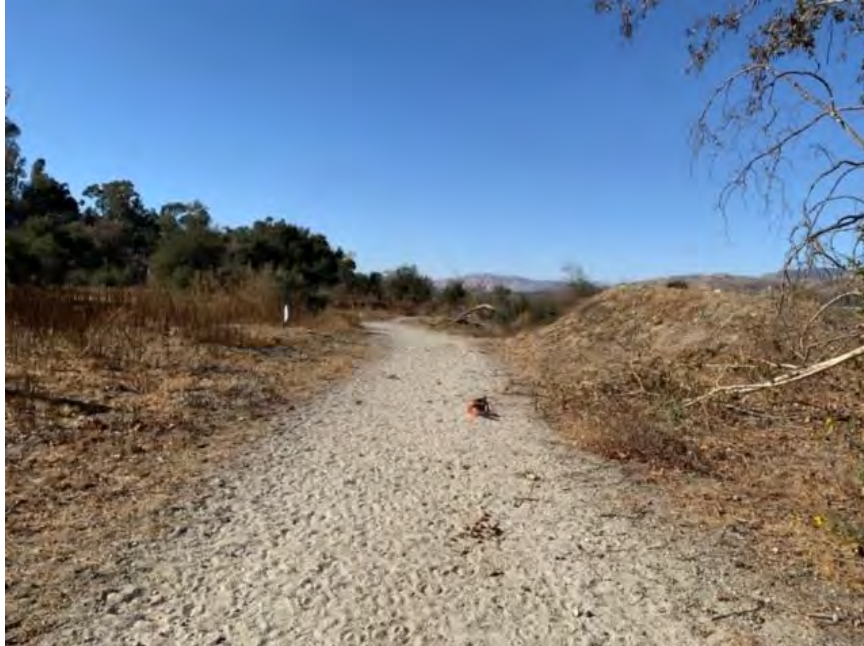
Photo 8. After the sweet gum tree had been fully removed from the trail to create a safe and suitable path, on December 15.

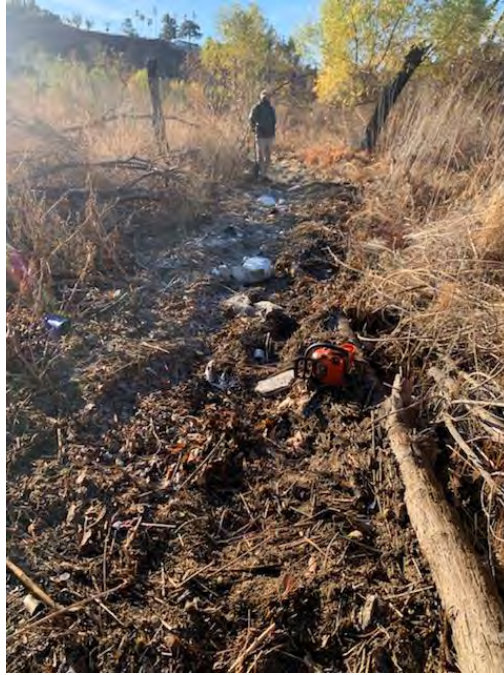
Photo 9. Below the equestrian center, branches and debris as well as upturned rocks had accumulated on the trail making the trail boundaries less distinguishable, on December 30.

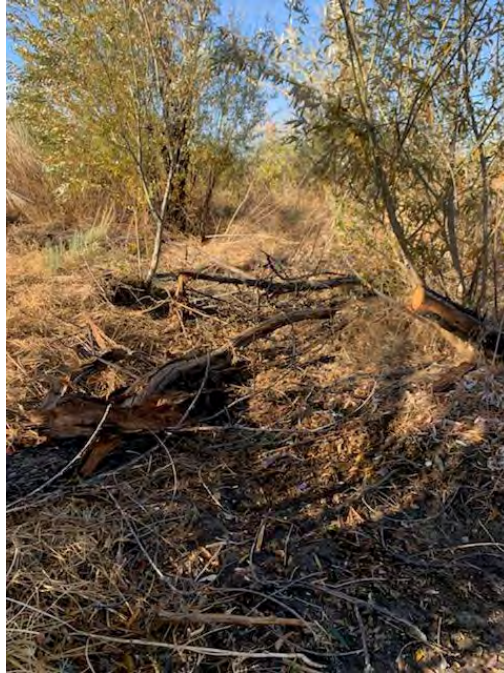
Photo 11. North of the equestrian center, a tree along the trail had snapped and fallen obstructing the trail, on December 30.

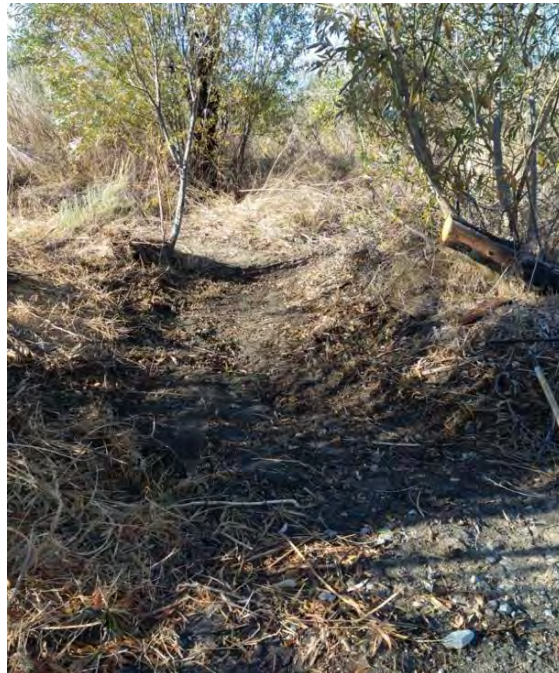
Photo 12. After the crew safely used a chainsaw to cut the fallen tree debris into segments and clear it from the trail, on December 30.

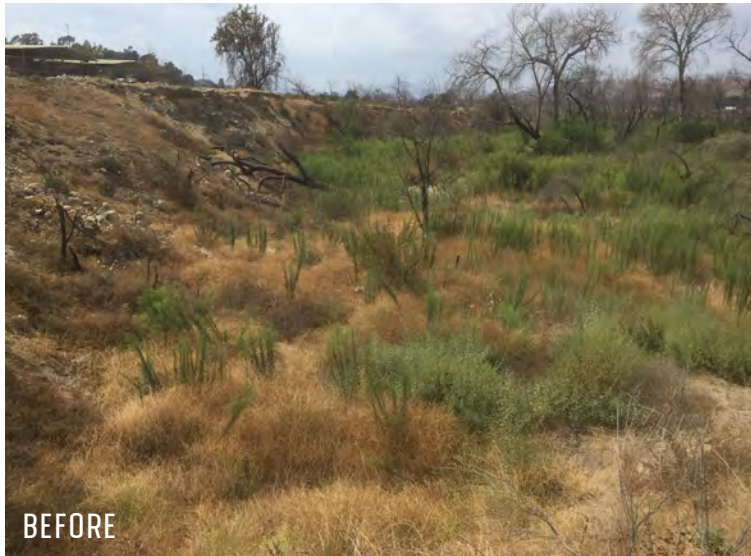
BEFORE

The area beneath the Equestrian Center at Big T is an example of how mustard forms fields of dry vegetation that connect living vegetation. Fire can easily spread between shrubs and trees.

Another goal during mustard removal it to reduce the amount of potential fire fuel on the property. After mustard matures, the plants dry out leaving behind a thicket of dry twigs. These dry mustard plants form fields that connect shrubs and trees that would otherwise not likely be exposed to low-burning flames (left photos). The dry twigs act as tinder which allows fires to start and spread quickly and stoke flames that would not normally burn hot enough to set fire to living shrubs and trees.

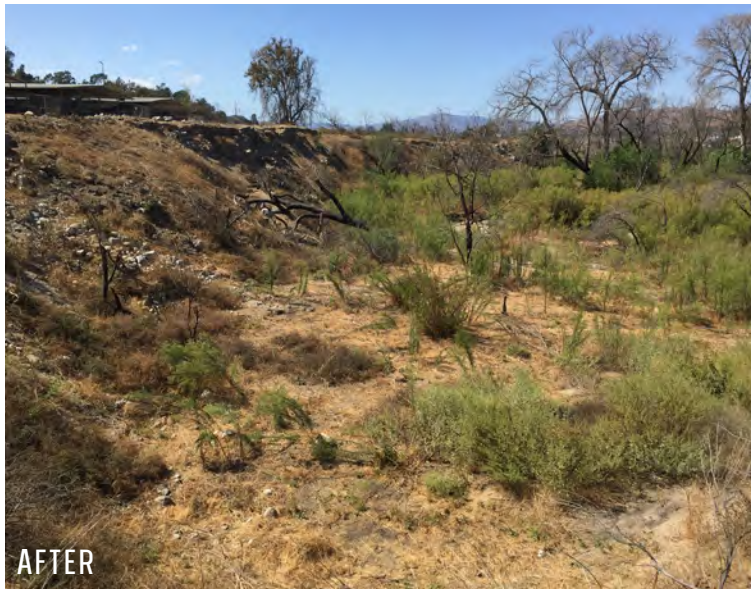
AFTER

After mustard is removed, there is no longer a bridge between living shrubs and trees.

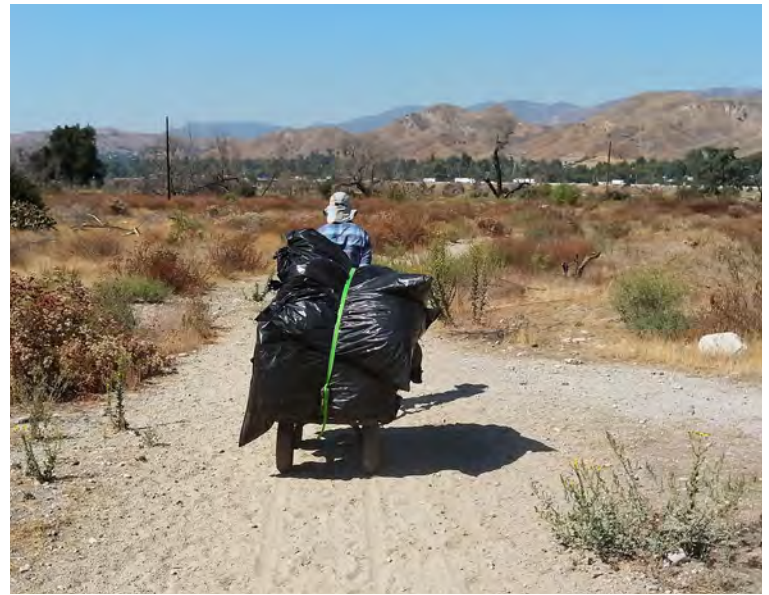
Mustard plants were hauled off-site after removal.

The restoration crew cut down and collected as much of the dead vegetation and mature seeds as possible (top right photo). The vegetation and seeds were collected in garbage bags and removed from the property. Community members who noticed the large pile of garbage bags along Cottonwood Avenue last year will have an idea of how much dry fuel was collected!

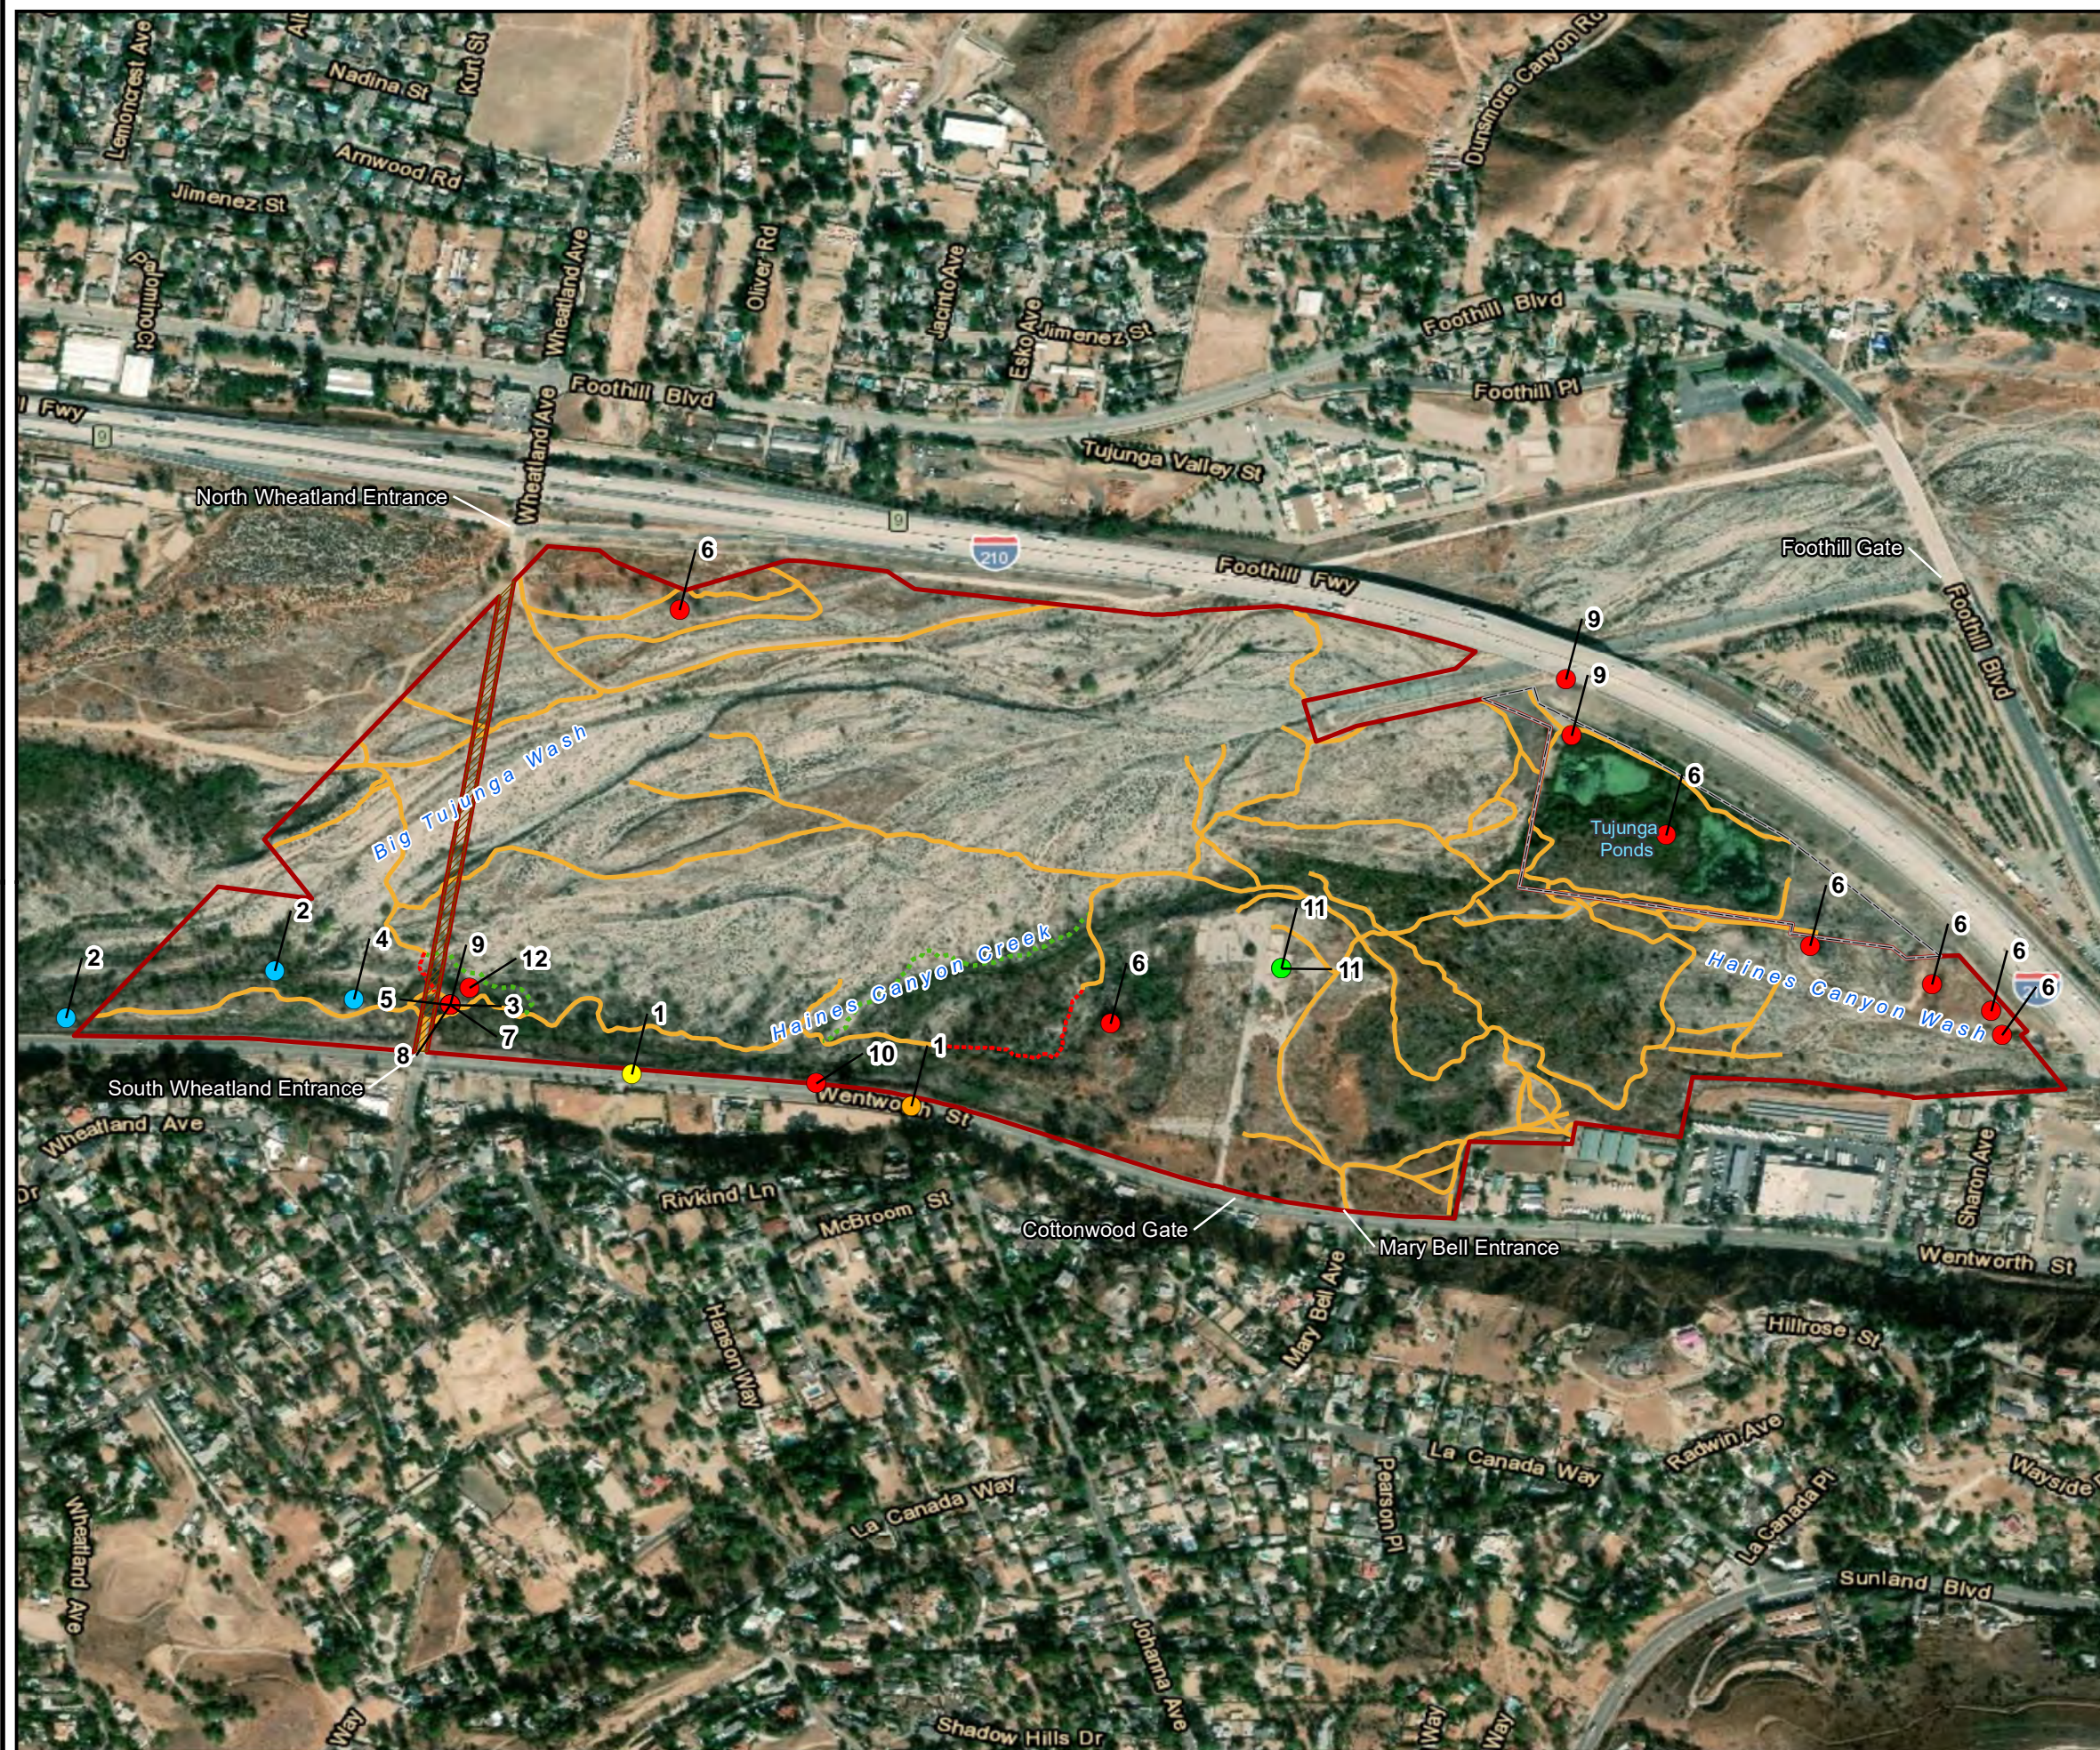
Mitigation Area Incident Map

January 2019 to December 2019

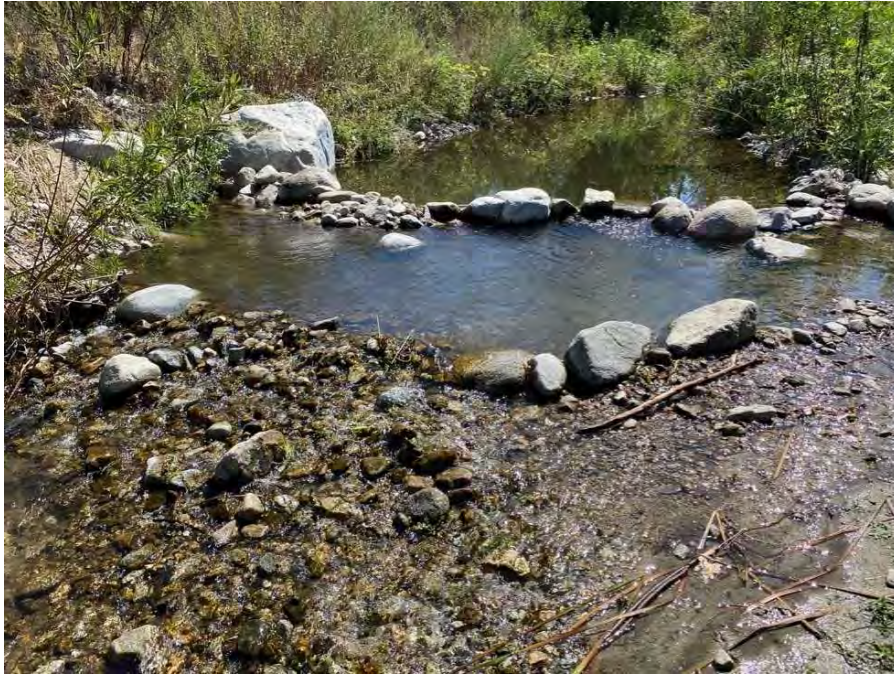
Photo 1: Illegal dam composed of large rocks and boulders observed on August 30, 2020, during a public outreach effort. The dam was located along Haines Canyon Creek northwest of the south Wheatland Avenue entrance.
