**2020 ANNUAL REPORT FOR THE
BIG TUJUNGA WASH MITIGATION AREA
LOS ANGELES COUNTY, CALIFORNIA**

**LOS ANGELES COUNTY
PUBLIC WORKS**
900 South Fremont Avenue
Alhambra, California 91803-1331

CHAMBERS GROUP, INC.
5 Hutton Centre Drive, Suite 750
Santa Ana, California 92707
(949) 261-5414

July 2021

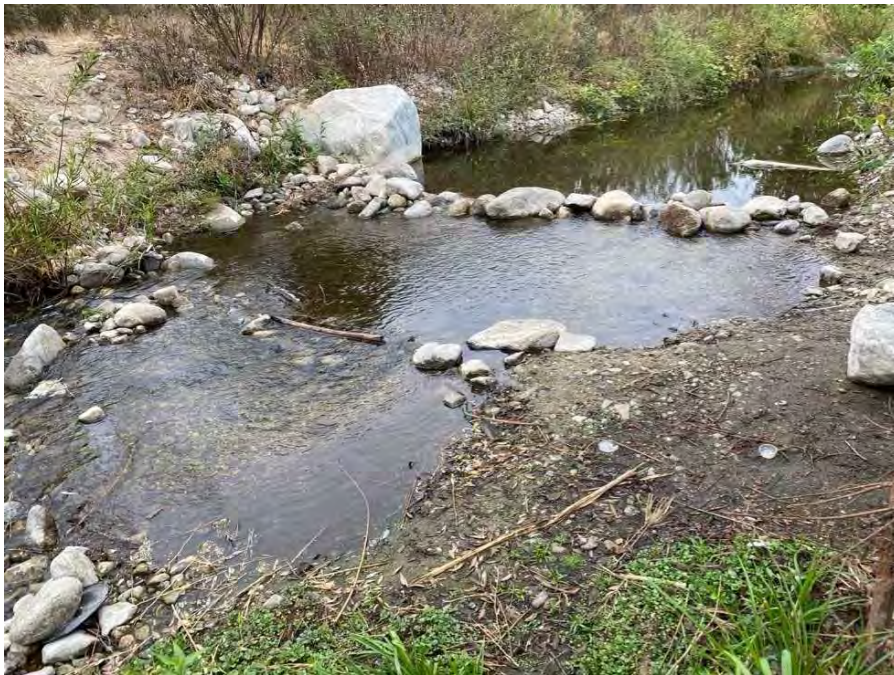
Photo 2: Illegal dam composed of large rocks and boulders observed at the same location as Photo 1 during the October 10, 2020 public outreach effort. The dam was located along Haines Canyon Creek northwest of the south Wheatland Avenue entrance.

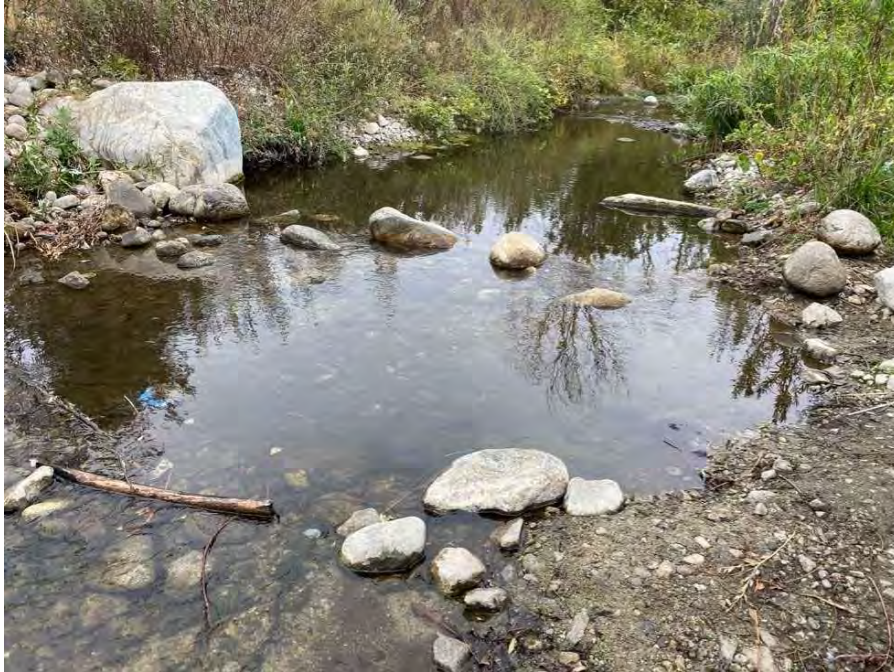
Photo 3: Post-removal of dam during the October 10, 2020 public outreach effort. The dam was located along Haines Canyon Creek northwest of the south Wheatland Avenue entrance.
