**Botanical Assessment
for the proposed Houdenbek Dams
near Op-die-Berg, Witzenberg Municipality
Western Cape Province**

Prepared for EnviroAfrica

March 2019

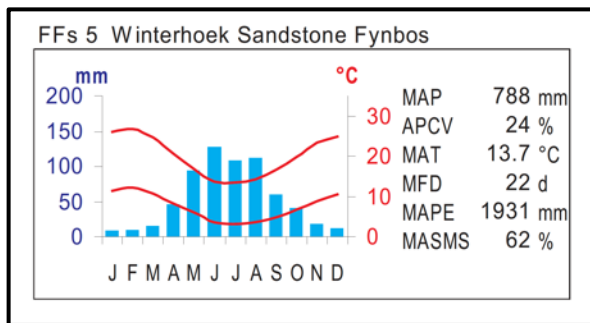
Figure 6. Climate diagram for Winterhoek Sandstone Fynbos, the principal vegetation type in the study area (Rebello *et al.* in Mucina & Rutherford, 2006) showing MAP – Mean Annual Precipitation; APCV = Annual Precipitation Coefficient of Variance; MAT = Mean Annual Temperature; MFD = Mean Frost Days; MAPE = Mean Annual Potential Evaporation; MASMA = Mean Annual Soil Moisture Stress.

The study area falls within the Winter Rainfall Region of the Western Cape Province. It experiences a Mediterranean-type climate with cool to cold, wet winters and hot, dry summers. The climate diagram for Winterhoek Sandstone Fynbos (Figure 6) most closely approximates the climate of the Houdenberg study area.

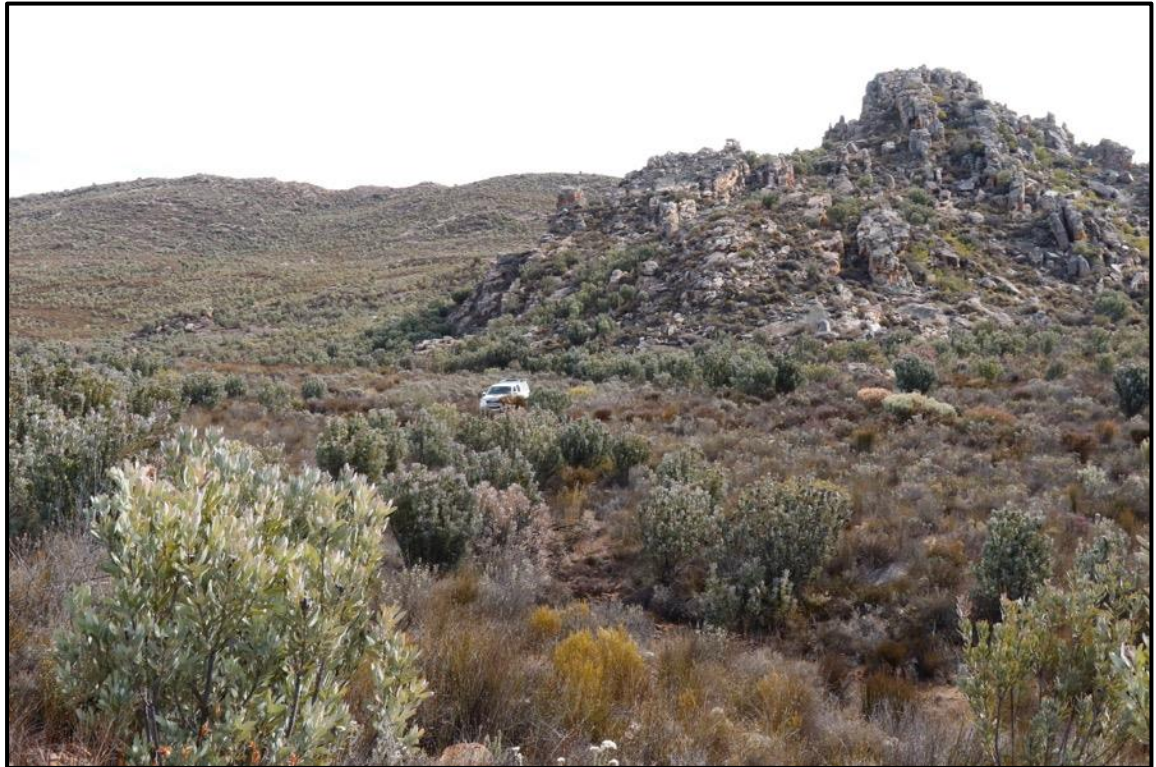
Figure 8. A view of the typical proteoid-restioid shrubland on sandstone substrate in the valley where the proposed Harmony Dam would be constructed.

The preferred site (Option 1) for the Harmony Dam is disturbed very little. The only disturbance is a two-spoor farm track. Selection of this option would result in flooding of pristine fynbos in the dam inundation area (Figure 8).

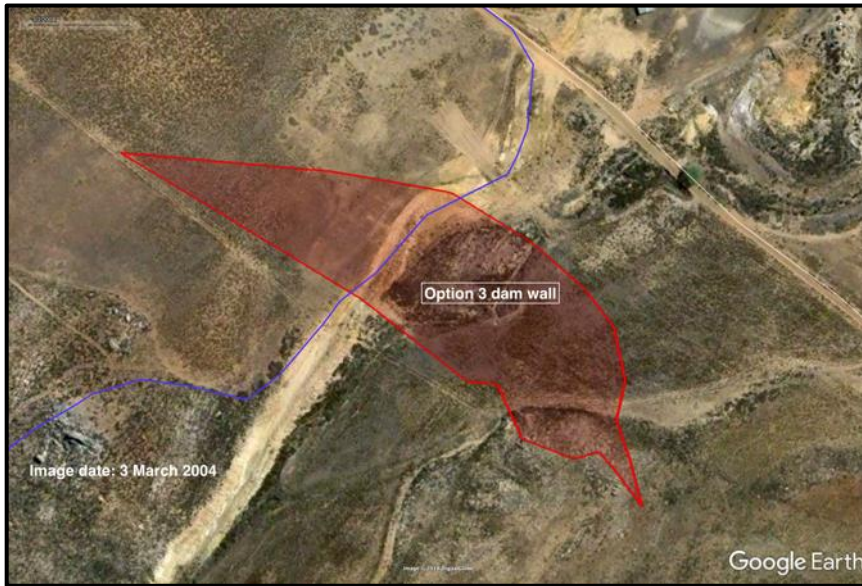
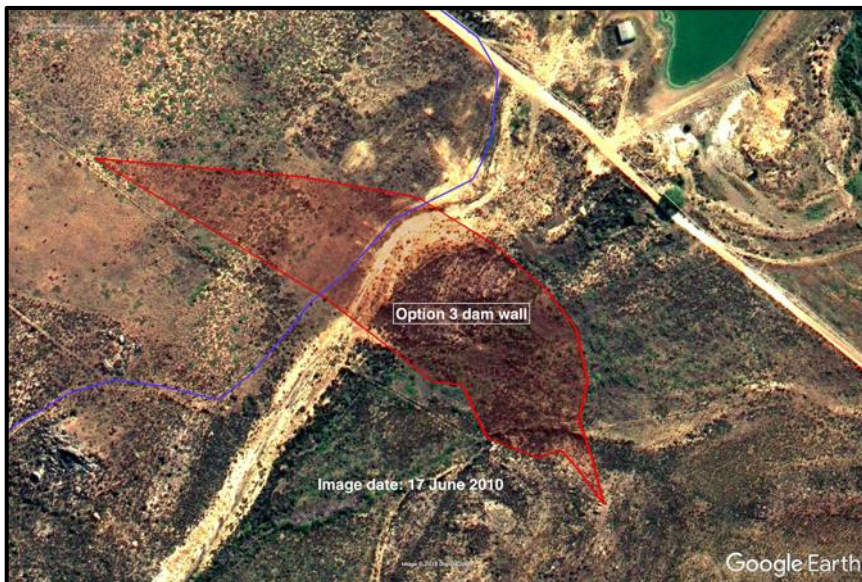
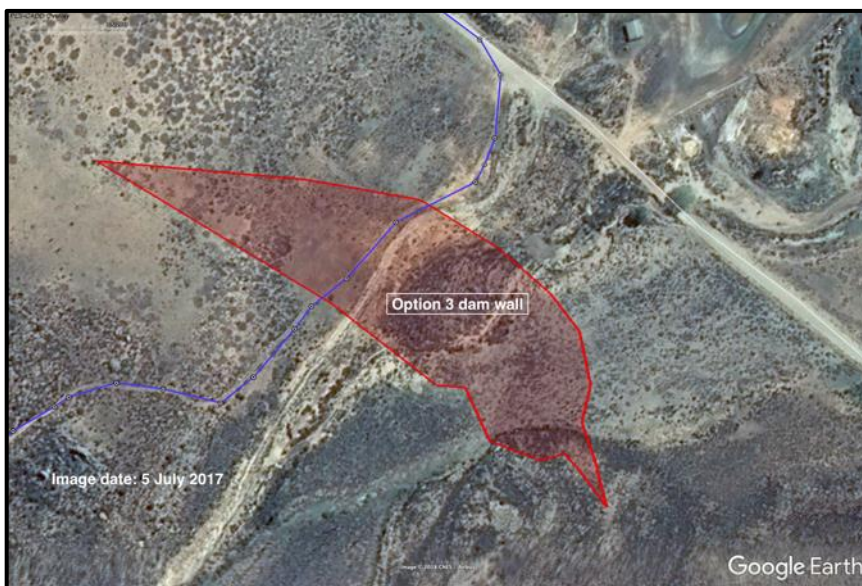
Figure 9. Aerial image (Google Earth™) of 3 March 2004 with the Option 3 dam wall superimposed.

Figure 10. Aerial image (Google Earth™) of 17 June 2010 with the Option 3 dam wall superimposed.

Figure 11. Aerial image (Google Earth™) of 5 July 2017 with the Option 3 dam wall superimposed.

The Option 3 site, however, is much more disturbed. No photographs are available but it is clear from historical images obtained from Google Earth Pro TM that there has been some agricultural activity in the area where the dam wall would be constructed. Assuming that Option 3 may be pursued, the dam water would flood an area that has partly been disturbed and is partly undisturbed fynbos (Figures 9—11).

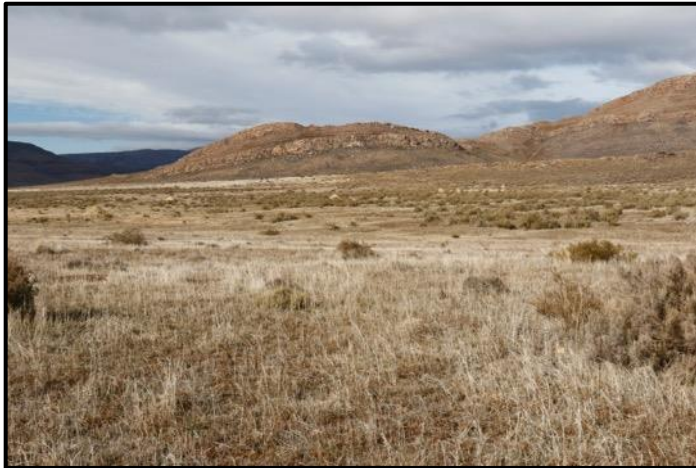
Figure 12. The site of the proposed Toeka Dam in an area completely transformed by agriculture.

The site selected for the Toeka Dam is entirely disturbed by agriculture. Only secondary vegetation is present, it having colonized the fallow lands (Figure 12).

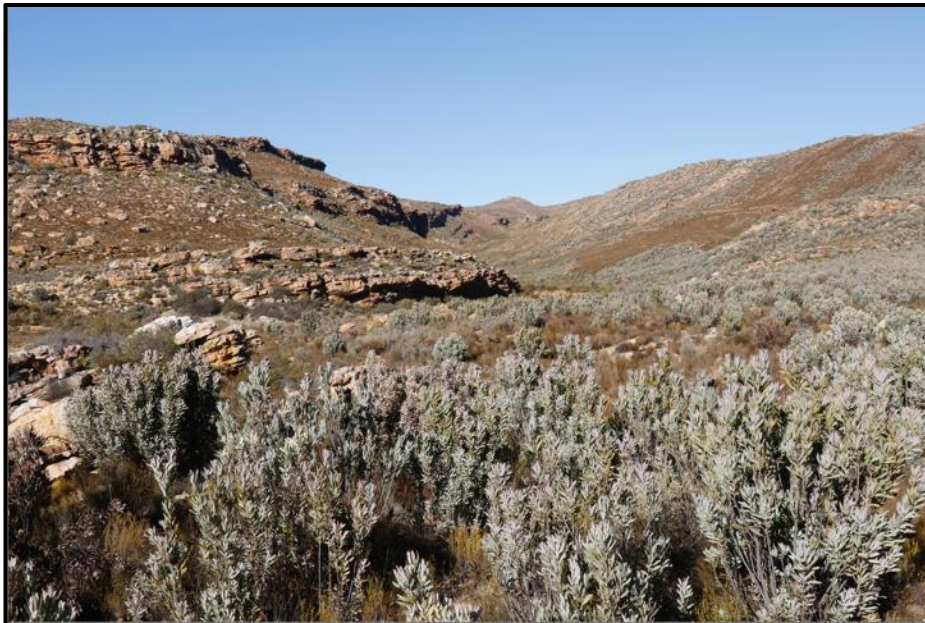
Figure 13. View up the valley where the proposed Harmony Dam would be located in Winterhoek Sandstone Fynbos.

At the two-spoor track on the west side of the valley. The vegetation is uniform in the area of the dam footprint (Figure 13). It consists of an open to mid-dense, tall proteoid stratum, dominated by *Protea laurifolia*, with a low closed (dense) restioland understorey. Species recorded include: *Centella* sp., *Cymbopogon marginatus*, *Ehrharta ramosa*, *Elytropappus gnaphaloides*, *Hypodiscus argenteus*, *Ischyrolepis* sp., *Leucadendron* sp., *Leucospermum calligerum*, *Metalasia densa*, *Muraltia spinosa*, *Passerina obtusifolia*, *Phyllica* sp., *Protea* sp., *Restio* sp., *Stoebe capitata*, *Tetraria capillacea*, *Thamnochortus* sp.

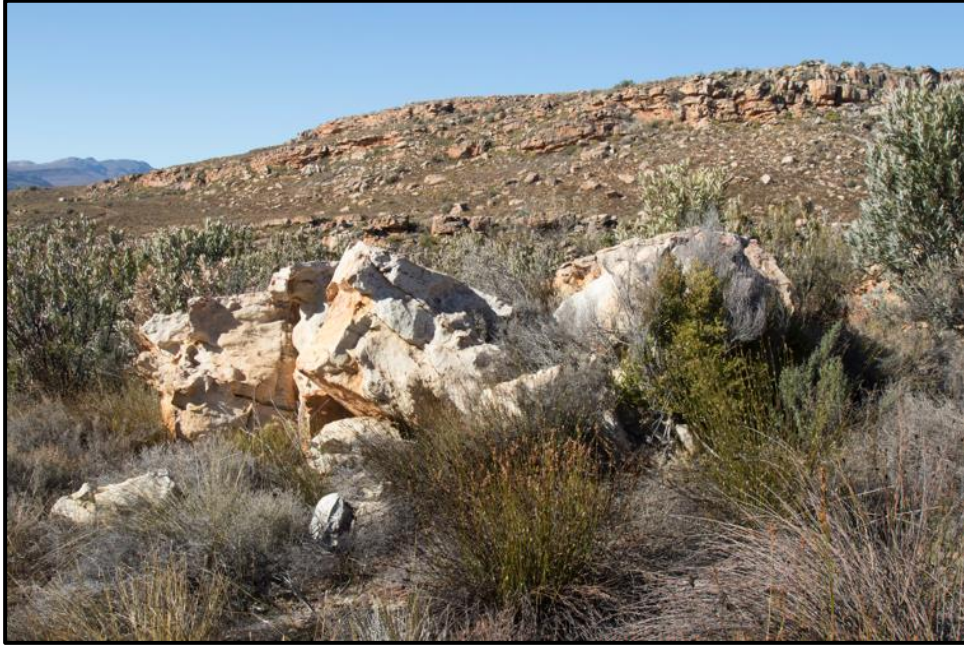
Figure 14. Large sandstone boulders are found in part of the study area.

Area with localized large sandstone boulders (Figure 14). The same vegetation community is found as at waypoint HD1 but with some additional species namely, *Anaxeton* sp.,

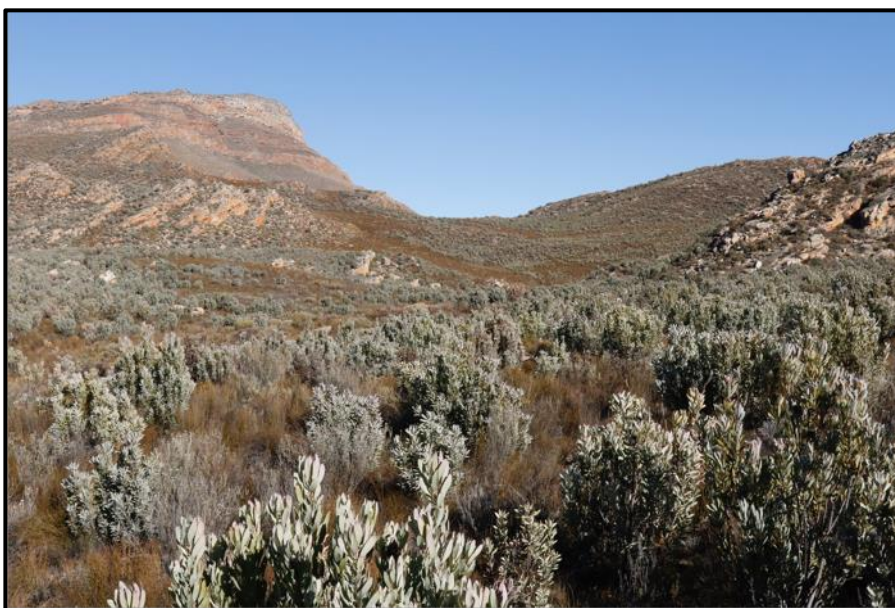
Figure 15. The area around waypoint HD3.

This area has a mid-dense stand of *Protea laurifolia* in the upper stratum, 1—2.5 m tall. The lower stratum is strongly restioid and the plant community is the same as at waypoint HD1 and HD2 but with the additional presence of *Phyllica* sp. and *Protea laevis* (Figure 15).

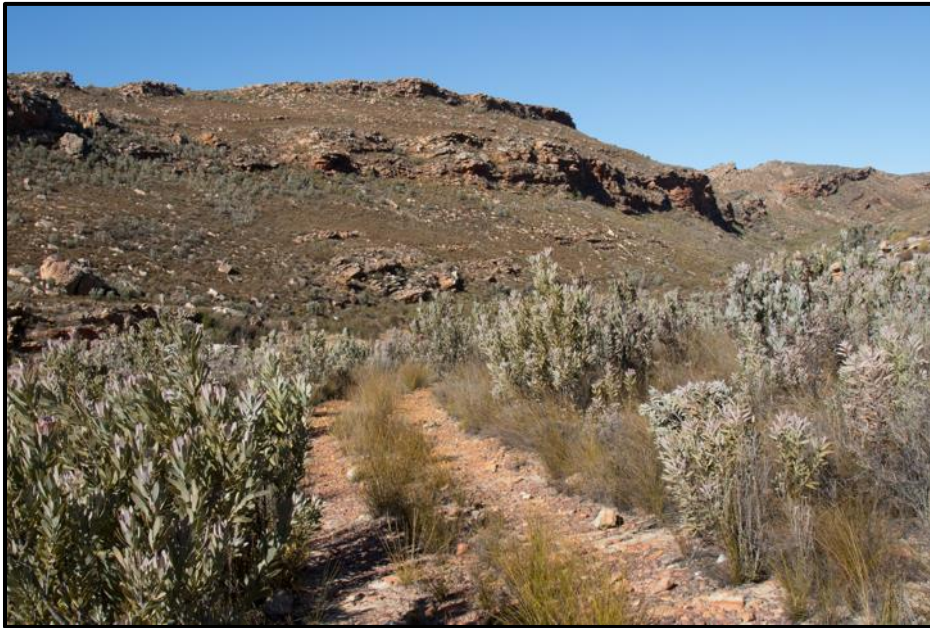
Figure 16. A two-spoor track leads up the valley through the site proposed for the Harmony Dam.

This waypoint is located on a two-spoor track at the upper end of the Option 1 and Option 2 dam footprint (inundation area). The vegetation is the same proteoid fynbos as found at waypoints HD1—HD3. In addition, *Leucadendron salignum* and the ground protea *Protea laevis* (Figure 17) were found here.

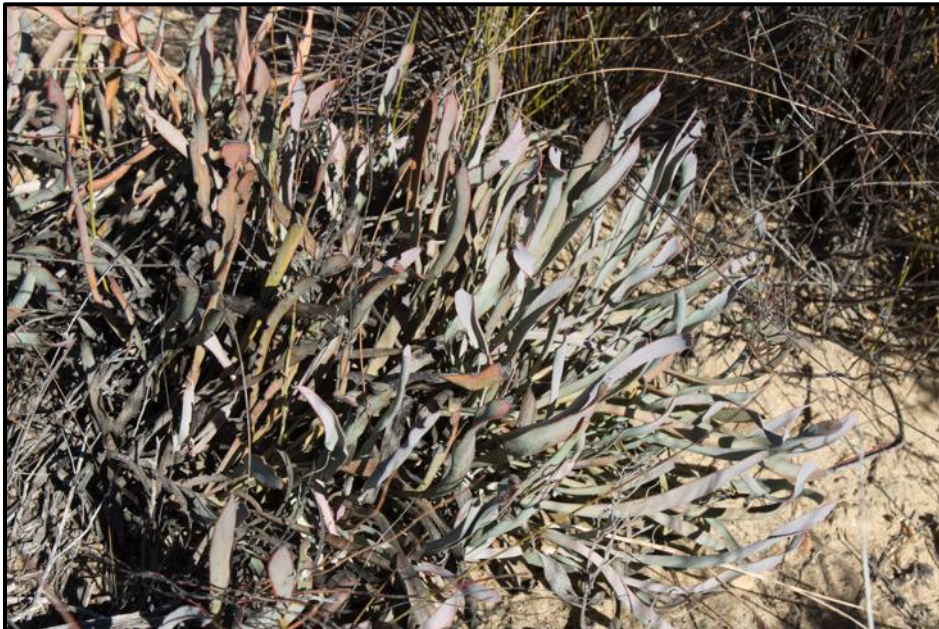
Figure 17. *Protea laevis*.

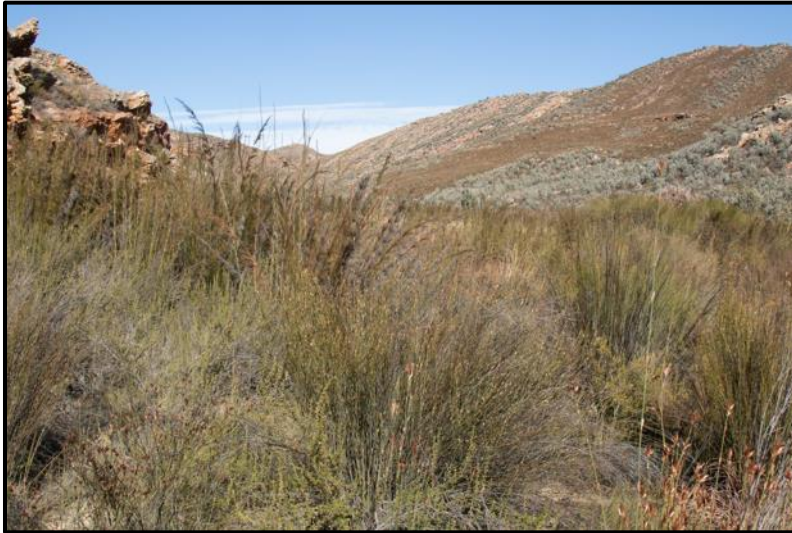
Figure 18. The seasonal stream channel with dominant Restionaceae

This waypoint was recorded at the dry stream channel (Figure 18). Species include *Asparagus aethiopicus*, *Cannomois* sp. – dominant, *Cliffortia juniperifolia*, *Cliffortia strobilifera*, *Cymbopogon marginatus*, *Elytropappus gnaphaloides*, *Elytropappus rhinocerotis*, *Eragrostis curvula*, *Erica* sp. – very small flowers, *Imperata cylindrica*, *Muraltia spinosa*, *Rhodocoma gigantean*, *Searsia undulata* and *Willdenowia* cf. *incurvata*

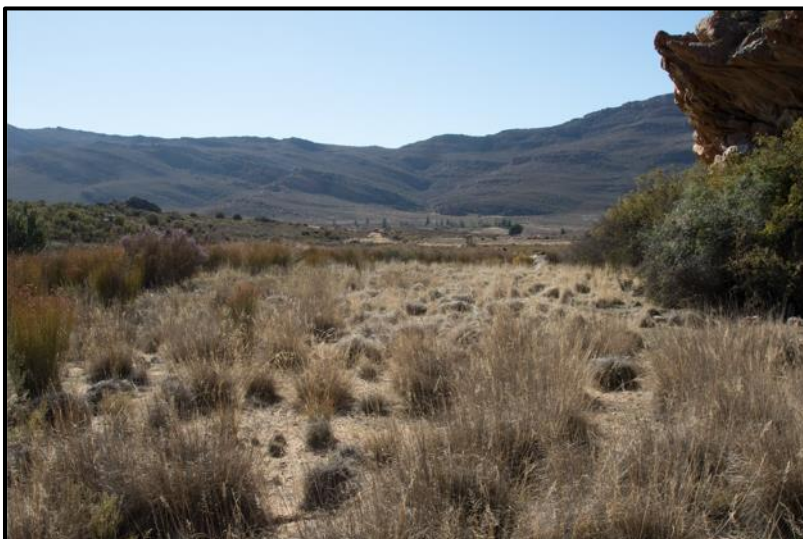
Figure 19. Open grassy area on alluvium with a shrubby thicket community next to the sandstone cliffs.

Open grassy area on alluvium. Vegetation is almost exclusively *Eragrostis curvula* (Figure 19). Near the sandstone cliffs is a third community dominated by *Searsia undulata* with *Asparagus lignosus* (entwined in the shrubs).

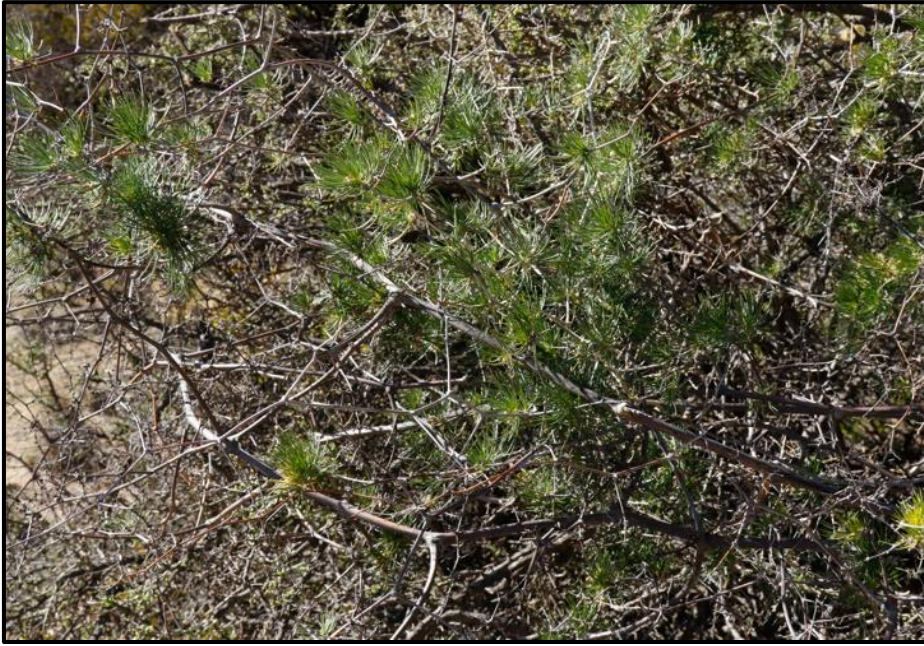
Figure 20. *Asparagus lignosus*

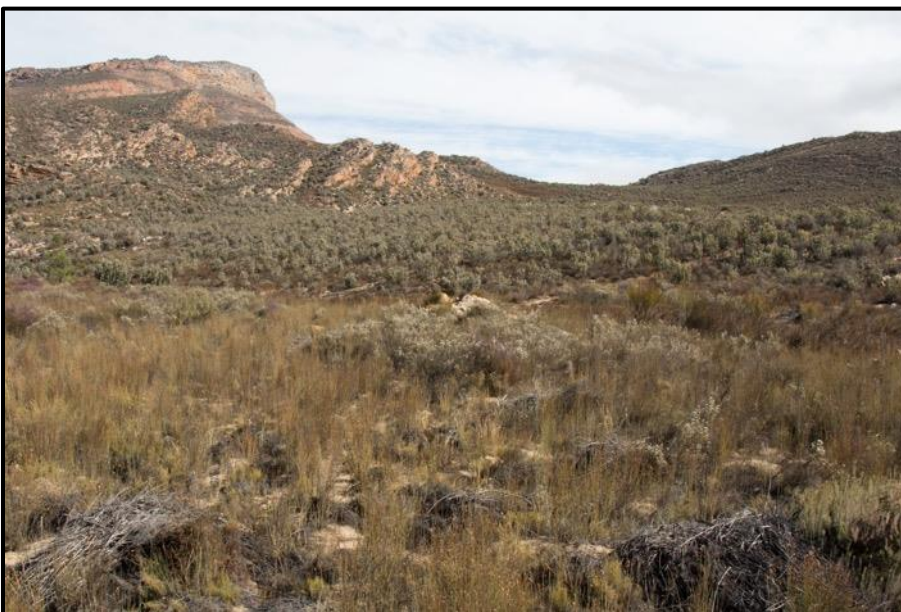
Figure 21. Area of the proposed Harmony Dam Option 1 site

This waypoint was recorded at a soil pit more or less where the Option 1 dam wall would be. The vegetation on the sandy alluvium is dominated by restios, mainly *Willdenowia incurvata*. No *Protea laurifolia* occurs at this location. *Leucadendron brunioides* var. *brunioides* was recorded here (Figure 21).

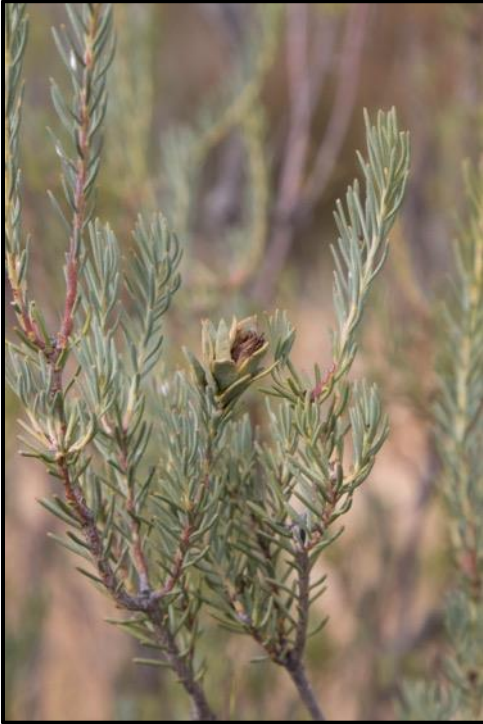
Figure 21. *Leucadendron brunioides* var. *brunioides*

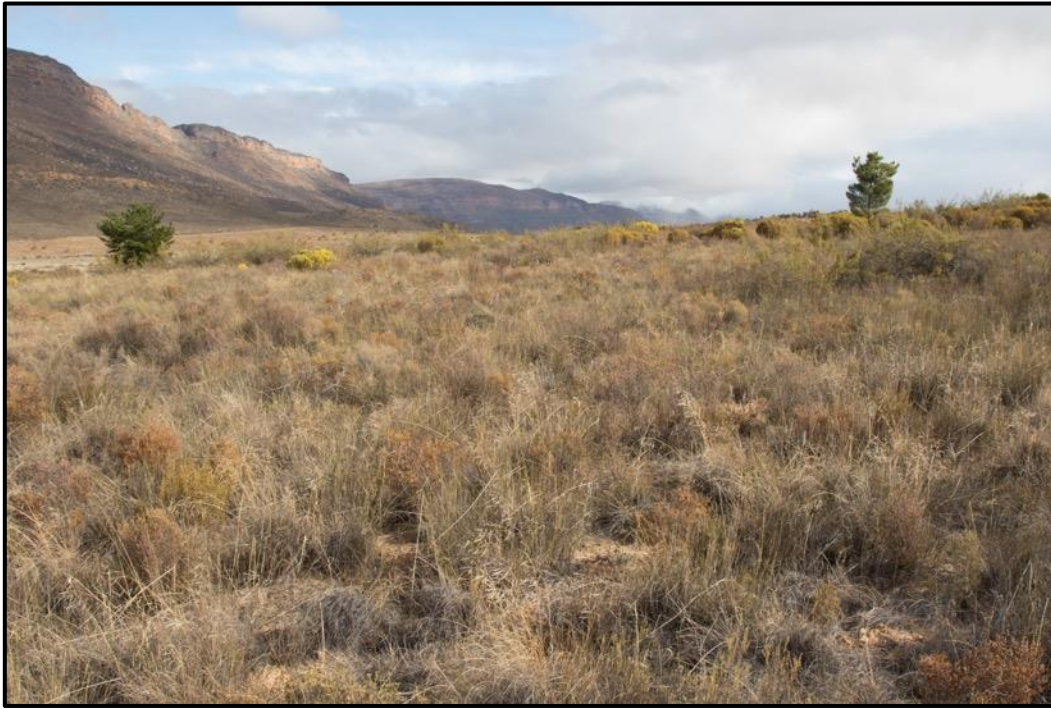
Figure 22. Uncultivated area around waypoint TD1 near the proposed position of the Toeka Dam wall.

At TD1 the vegetation is a low, mid-dense graminoid shrubland with occasional emergent proteoids (*Leucadendron salignum*) (Figure 22). Species record include, *Askidiosperma* sp., *Cliffortia ruscifolia*, *Ehrharta ramosa*, *Elytropappus gnaphaloides*, *Eriocephalus africanus*, *Hypodiscus argenteus*, *Metalasia densa*, *Muraltia spinosa*, *Passerina obtusifolia*, *Pentameris macrocalycina*, *Pentaschistis* sp., *Phylica* sp. (2), *Phylica* sp. (3), *Tenaxia stricta*, *Tetraria crassa* and *Tetraria ustulata*.

This area appears to have not been previously cultivated. A contour ridge runs NE—SW and beyond the ridge to the east, the area has been previously cultivated. A few invasive pine trees (*Pinus radiata*) occur here.

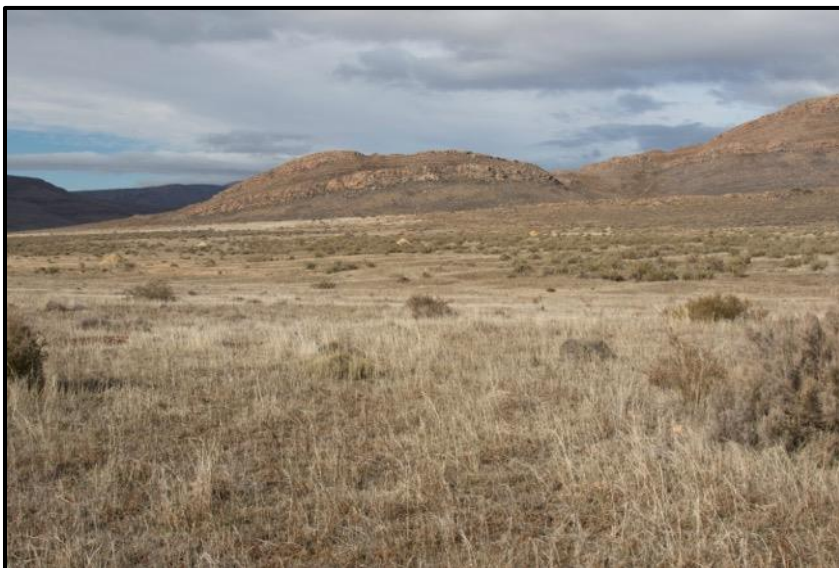
Figure 22. Cultivated area that was originally Kouebokkeveld Shale Fynbos, now transformed but with secondary vegetation present.

The area proposed for the Toeka Dam is open, shallowly undulating and has been previously ploughed. Now it has stands of opportunistic shrubs that have recolonized, together with abundant grasses (Figure 22). *Elytropappus rhinocerotis* is co-dominant with *Muraltia spinosa* and *Passerina obtusifolia*. The only other notable species is *Carpobrotus edulis*.

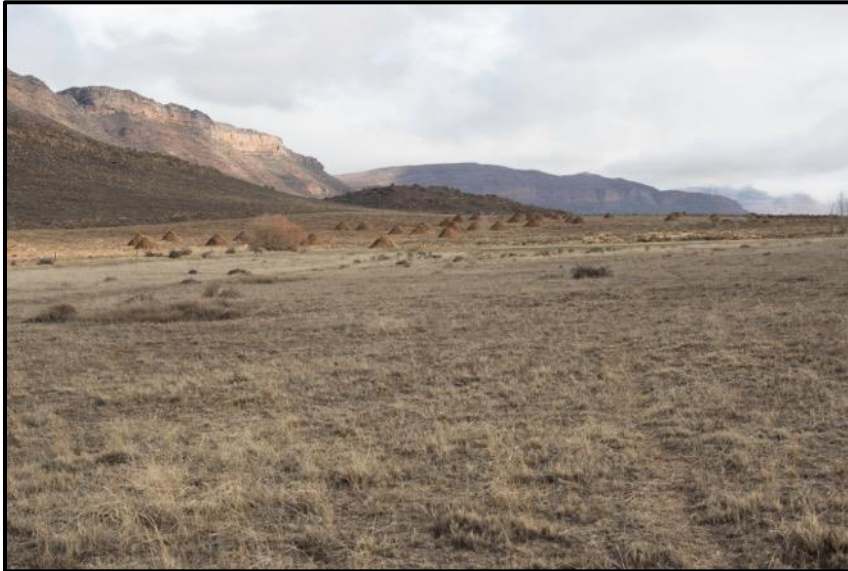
Figure 23. *Cynodon dactylon* (kweekgras) is the dominant grass at waypoint TD3.

At this waypoint the cover is mainly the grass *Cynodon dactylon* (kweekgras) with a few scattered shrubs of *Muraltia spinosa*.

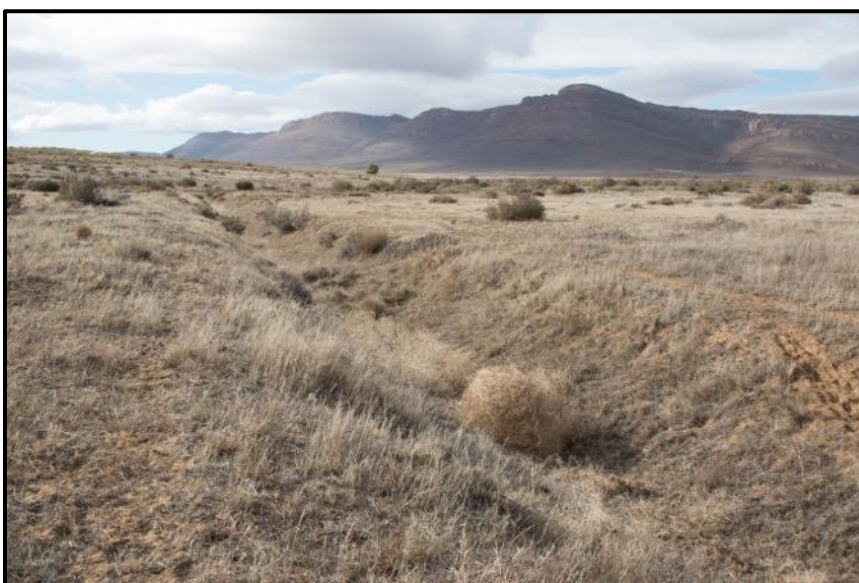
Figure 24. A drainage ditch runs through the proposed Toeka Dam site.

This waypoint is at a deep drainage ditch (dry at the time of sampling) that crosses the Toeka Dam site. Large mats of *Carpobrotus edulis* are found in places but no vegetation of any importance was noted.

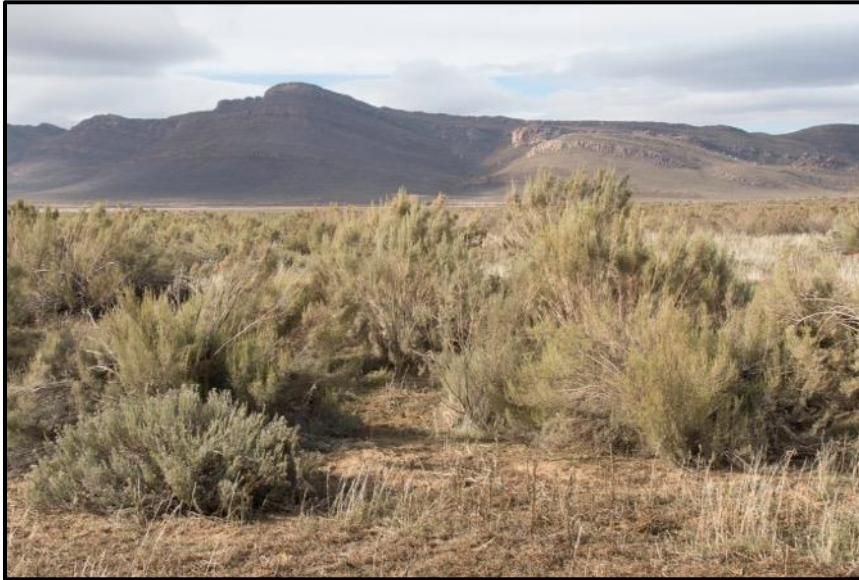
Figure 25. Mid-high renosterbos shrubs dominate the upper stratum with a graminoid field stratum.

This waypoint was recorded towards the east-northeast end of the Toeka Dam site close to where the wall would be situated. The area is completely dominated by *Elytropappus rhinocerotis* shrubs, 1-1.5 m tall with open to mid-dense cover (Figure 25).

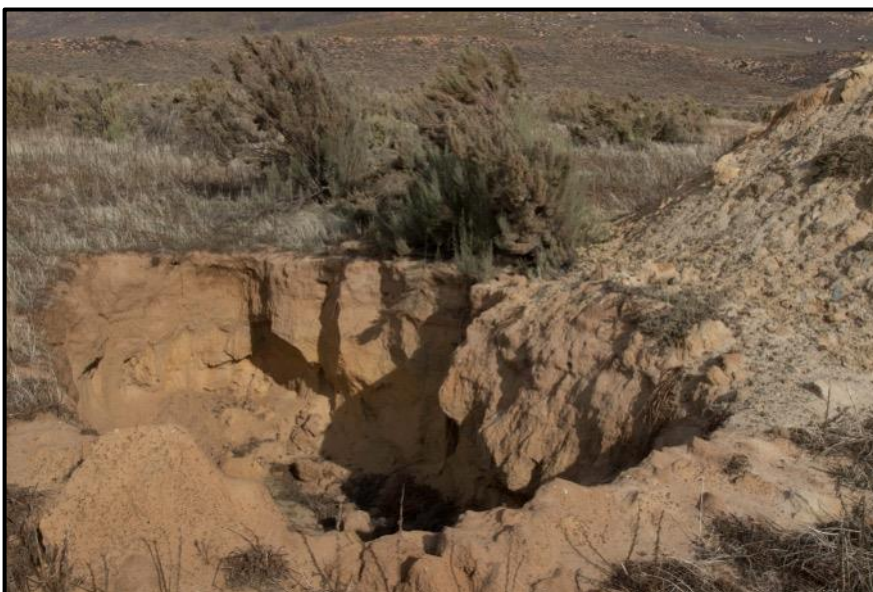
Figure 26. A soil pit in the alluvial sandy soil of the proposed Toeka Dam site.

Soil pits have been excavated at the Toeka Dam site and this waypoint was at one of the pits in the area of the proposed dam wall. The vegetation is all secondary colonization of previously ploughed land. *Elytropappus rhinocerotis* is dominant. The soil is deep yellow-brown alluvial sand.
