**WATER USE LICENSE APPLICATION  
FRESH WATER REPORT  
PROPOSED DEVELOPMENT OF ERF 4440  
KURUMAN**

A requirement in terms of Section 21 (c) and (i) of the  
National Water Act (36 of 1998)  
June 2020

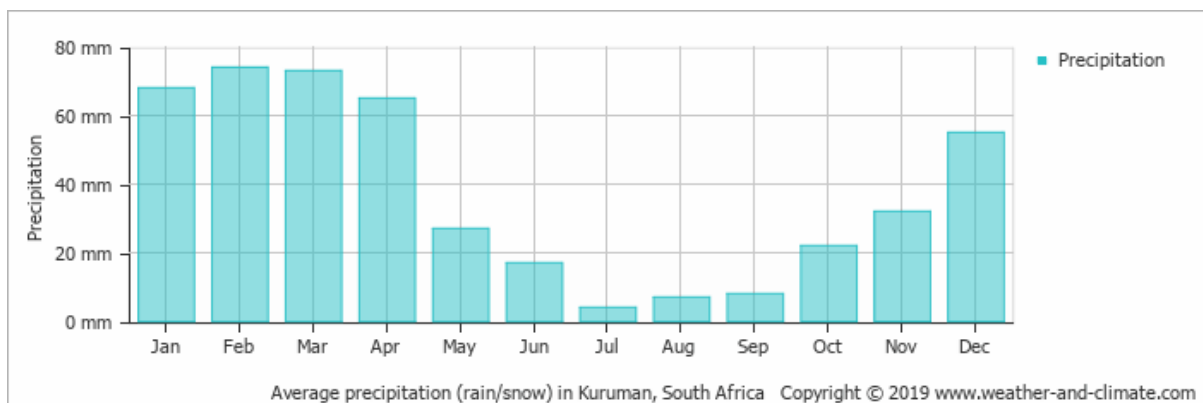
**Figure 2** Kuruman average rainfall

Kuruman is in the summer rainfall area (Figure 2), with an average annual rainfall of 472mm. Rainfall is variable, with long period of drought. Rain often comes with violent electric afternoon thunderstorms.

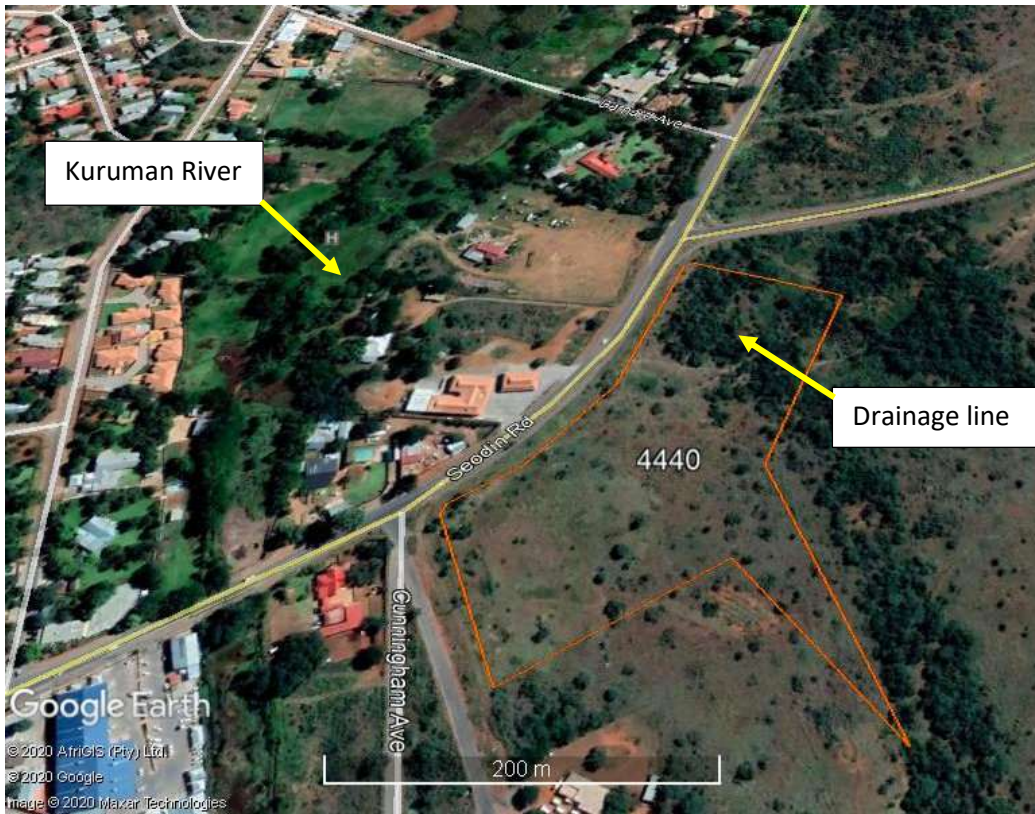
**Figure 4 Erf 4440**

Erf 4440 is depicted in Figure 4. It is located in the sub-catchment shown in Figure 5.

The corner of Erf 4440 (Figure 4) on Seodin Road and Cunningham Avenue is 70m away from the Kuruman River. This is within the 100m buffer zone, which “triggers” the need for a WULA. If this corner of Erf 4440 is above the 1:100 year-flood line, to override the 100m buffer requirement, there is a drainage line in the northern corner of Erf 4440, which is regarded as a legitimate water resource and for which a WULA is required.

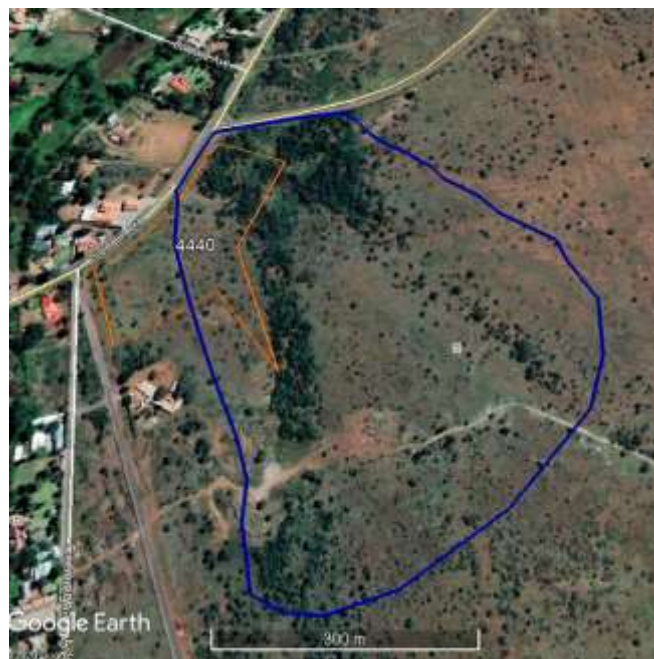
**Figure 5 Sub-catchment**

The sub-catchment of the drainage line is very small at only 27 hectares. This was established by using the elevations on Google Earth as well as the polygon function. The sub-catchment is only 723m long. This was measured from the culvert in the north west corner of the sub-catchment to the south east boundary.

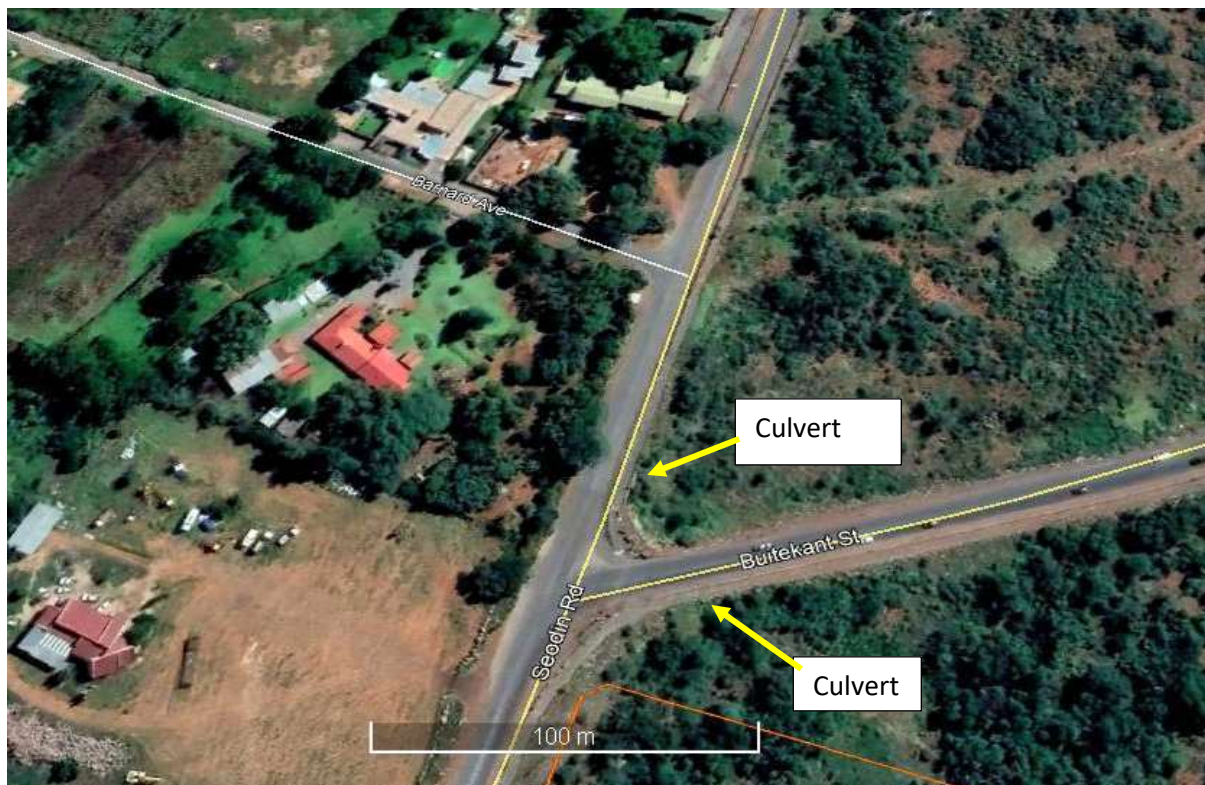
**Figure 6** Position of culverts

This drainage line is marked by a culvert on the corner of Buitekant Street and Seodin Road (Figure 6 and 7). There is another culvert underneath Seodin Road, through which this drainage line passes on its way to the Kuruman River.

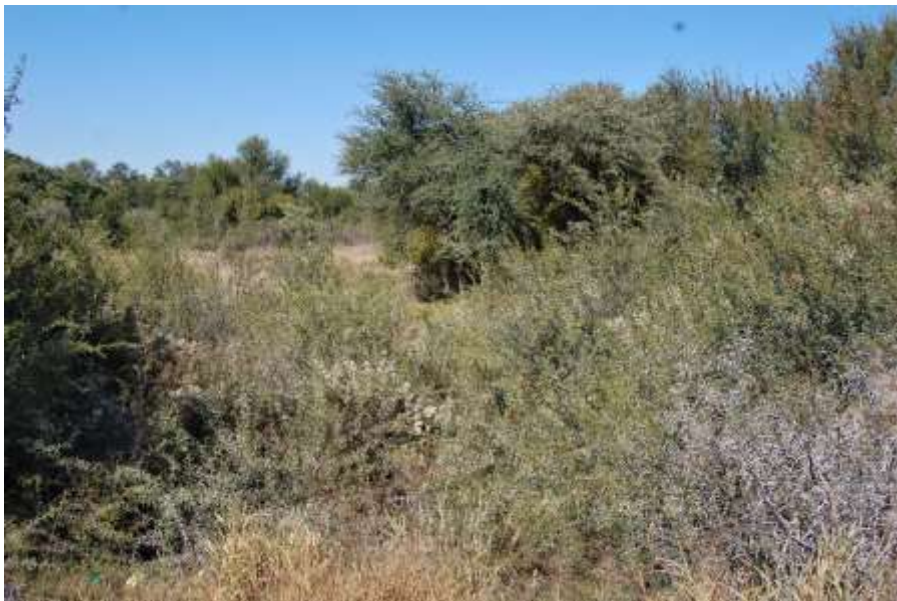
**Figure 8** Overgrown drainage line

The drainage line is densely overgrown with mainly sweet thorn trees (*Vachellia karoo*, Figure 8). There was a camel thorn tree (*Vachellia erioloba*) as well.

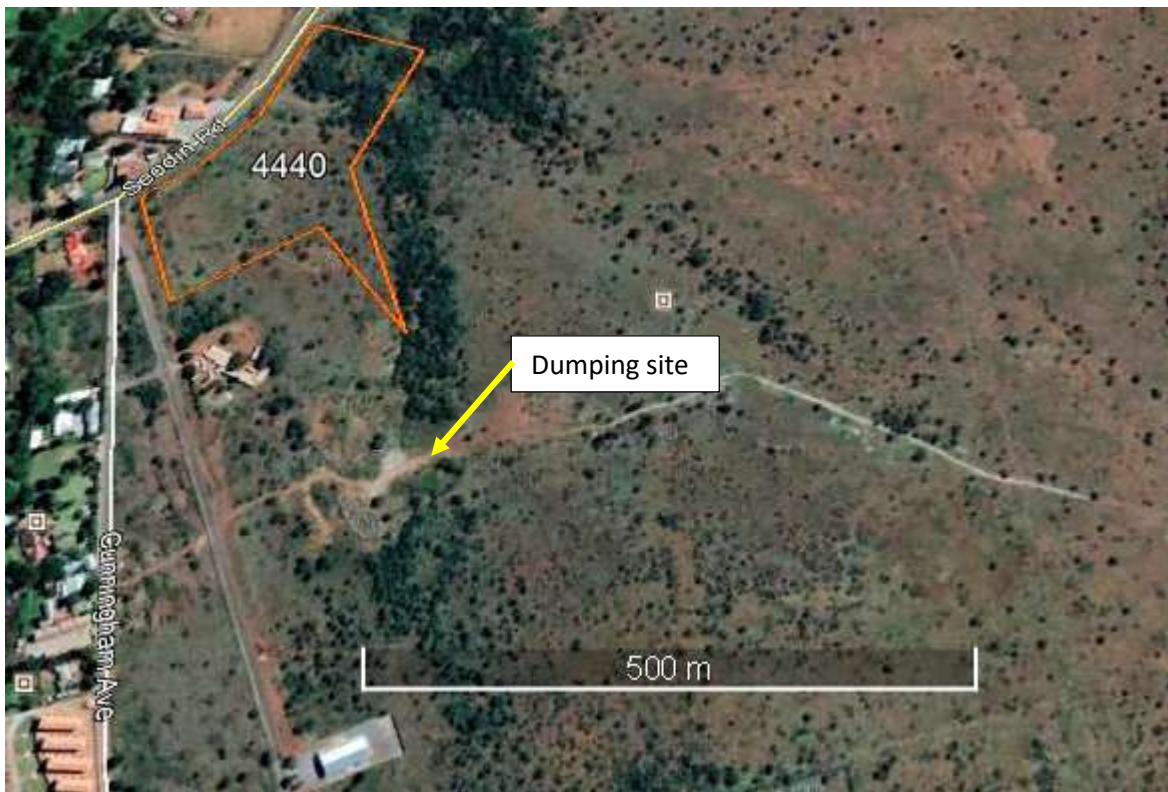
**Figure 9** Drainage line

The drainage line has two legs towards the south and south east, where it frizzles out, probably because the shallow groundwater is too little to support a stand of trees (Figure 9).

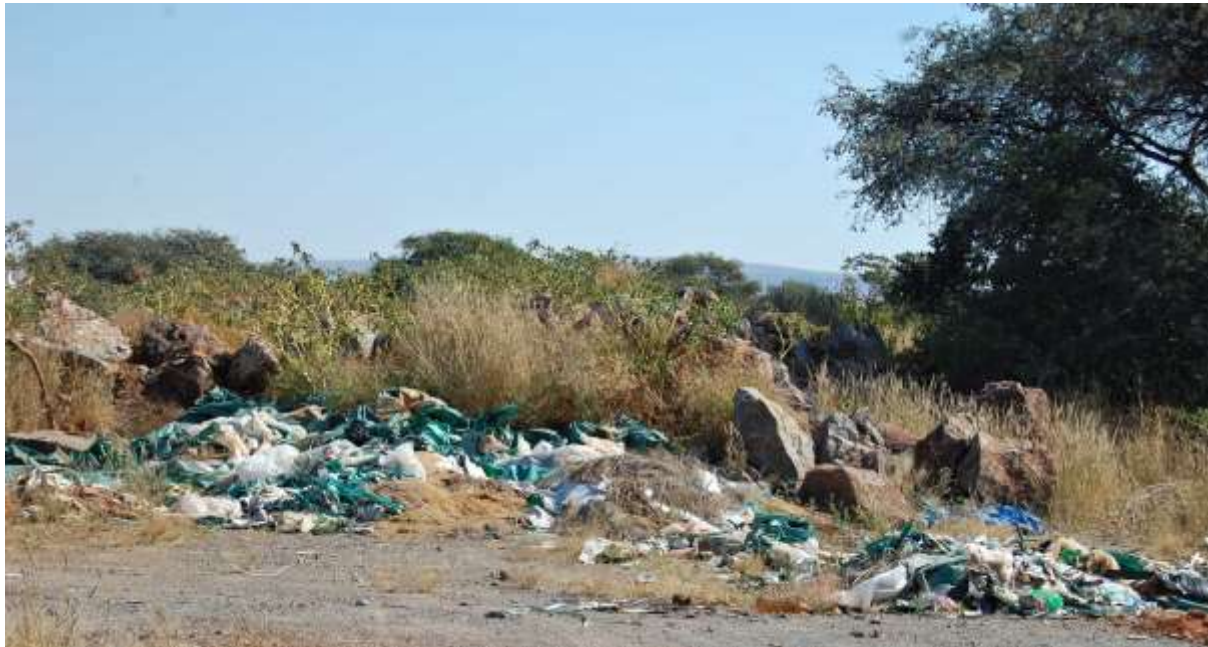
**Figure 10** Dumping site

There is a dumping site in the drainage line, with building rubble and domestic waste (Figure 10).

it is unlikely that sediments and building rubble will wash down the drainage line. The two downstream culverts would help to prevent downstream contamination. Due vigilance is required, should the worst loom, and measures should be taken to contain any contaminated runoff from reaching the river.

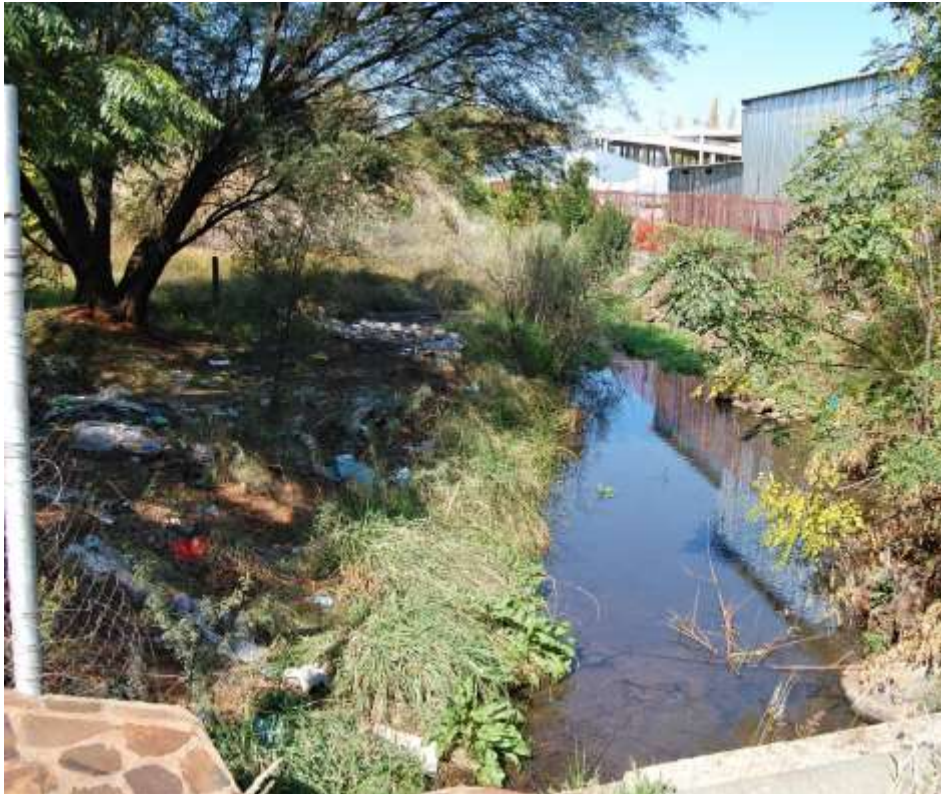
**Figure 11** Kuruman River in Barnard Street

The closest point of the Kuruman River to Erf 4440 is at the bridge in Barnard Street. The river here has been transformed into a narrow and straightened canal. The one bank is right up the back of a commercial building (Figure 11).

The water here was fast flowing, at an estimated rate of  $100\text{ls}^{-1}$ , the water was clear but really smelly. It was decided not to attempt biomonitoring, because of the possible health risk.

The other bank was strewn with litter and domestic waste.

It seemed as if the riparian zone of the river on the left bank (looking upstream, is rather wide, perhaps 20m, but entirely transformed, away from a natural condition.

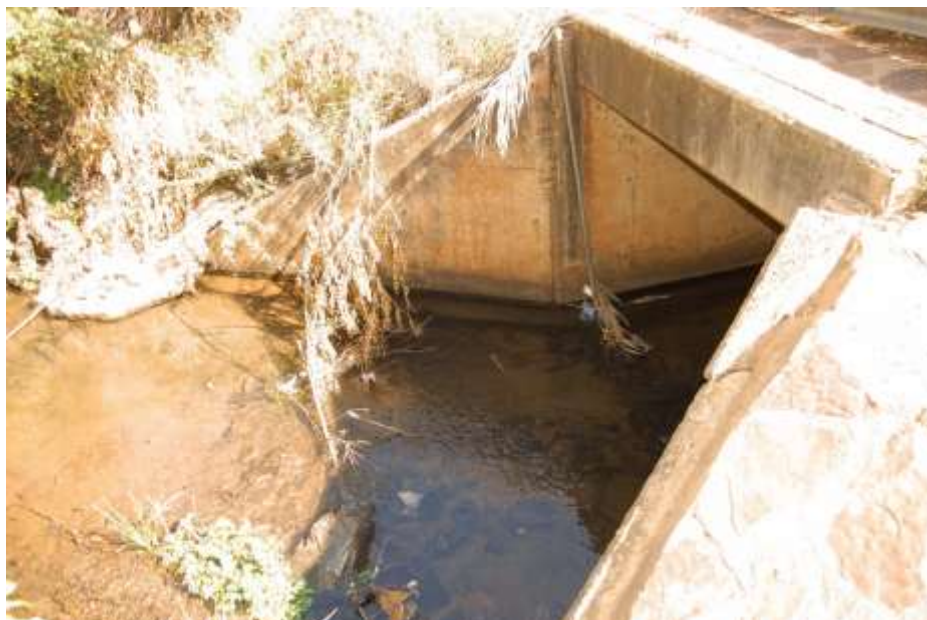
**Figure 12** Culvert in Barnard Street

The culvert serves as an indication for the size of a flood that the city planning has allowed for (Figure 12).

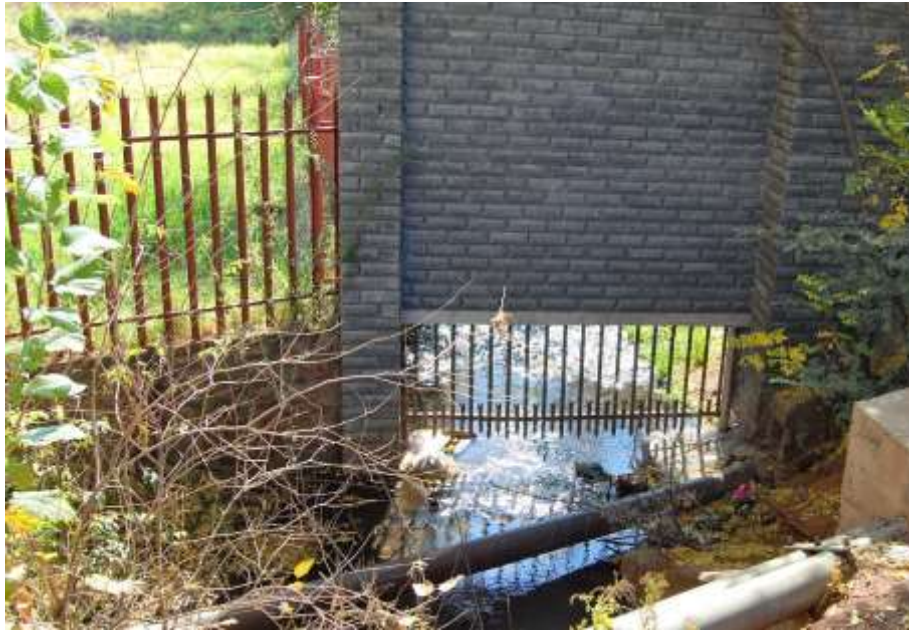
**Figure 13** Kuruman River downstream from Barnard Street Culvert

Looking downstream, the river has been limited to a narrow canal, suited to urban drainage, but not for allowing ecological functioning (Figure 13).

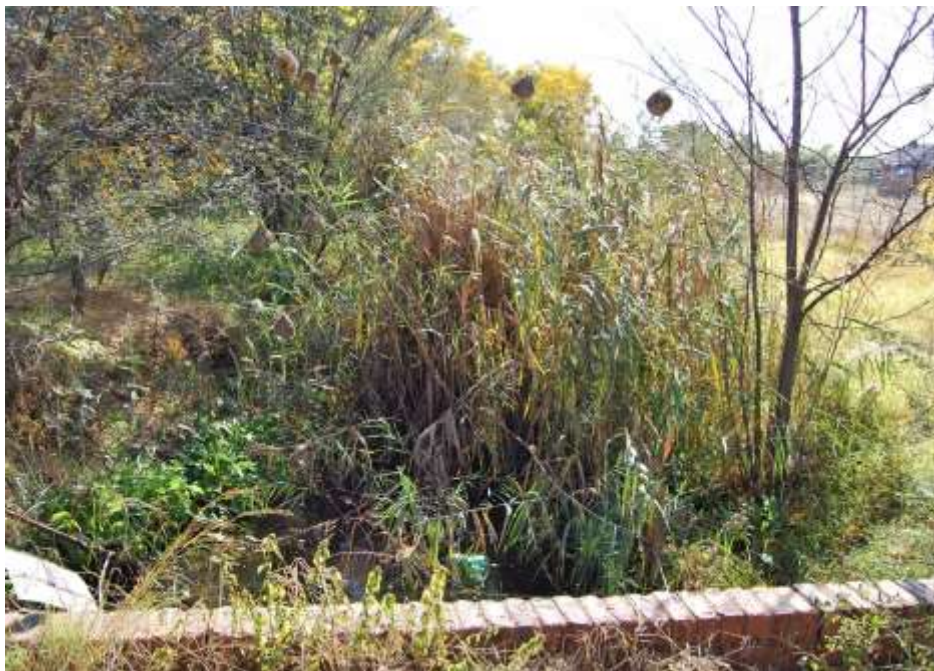
**Figure 14** Kuruman River Poolman Street

Further downstream, the river still has been shaped into a narrow channel, overgrown with reeds and with little open water (Figure 14). The riparian zones has been transformed into pastures and residential plots (Figure 15).

The narrow and straightened Kuruman River is overgrown with *Phragmites* reeds, while the original natural condition would have been a dense cover of bushveld trees, with only reeds where the canopy was open. These reeds are not exotic, as in Table 3, but do not belong there, so they were regarded as exotic for the purpose of this evaluation.

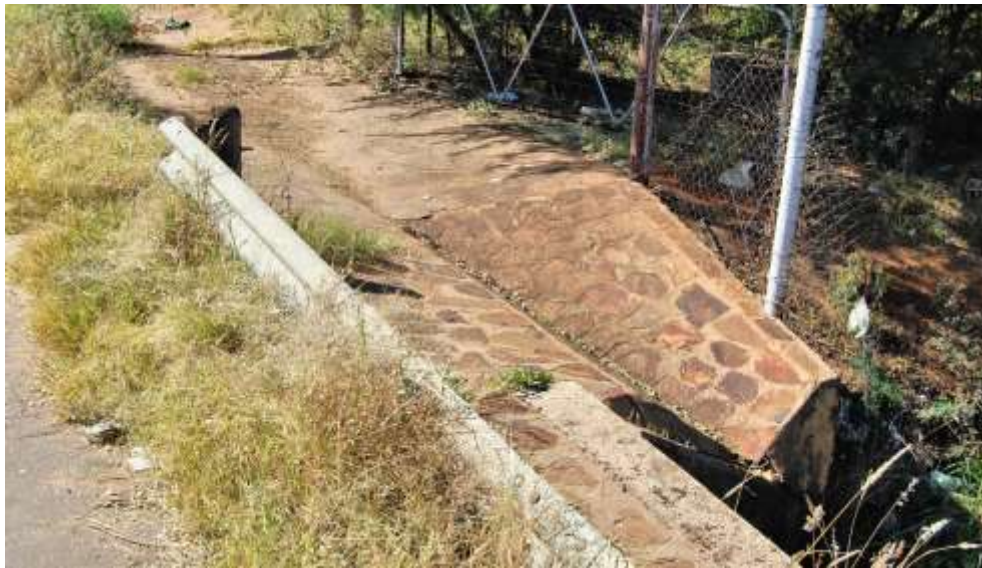
The new development on Erf 4440, the resulting increased urban runoff into the upper Kuruman River does not bode well for this important aquatic habitat. Runoff is channelled straight into the river (Figure 17). Further deterioration can be limited if a River Maintenance Plan is to be compiled, preferably by qualified and experienced specialists in this area of expertise, which includes a habitat restoration program.

**Figure 17** Stormwater infrastructure in Barnard Street
