Fresh Water Report

**For the licensing of a proposed new bridge, new road sections and replanting
of orchards on**

Farm Visgat 207, Ceres RD

November 2021

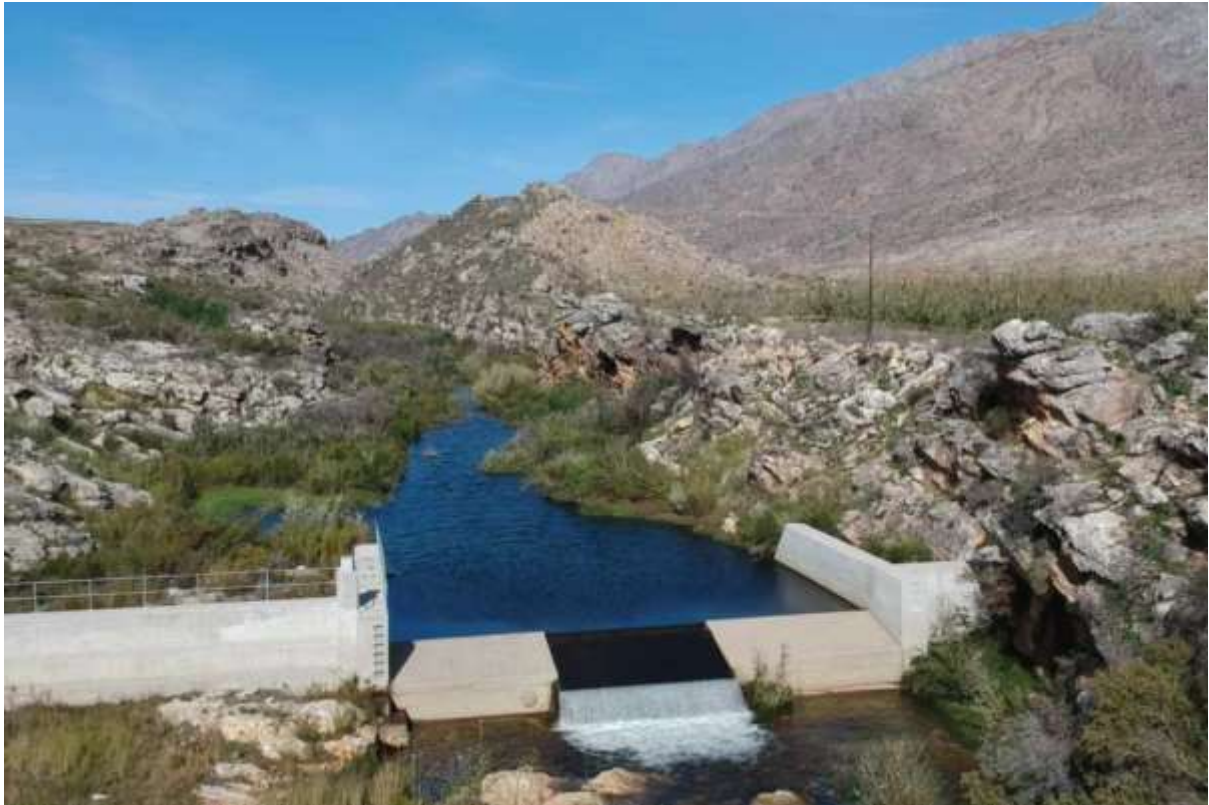
Figure 5 Weir (Doornkraal Agri webpage)

river at a weir near the southern farm boundary (Figure 5) into a holding dam up the slope, from where the entire farm is irrigated (Figure 6).

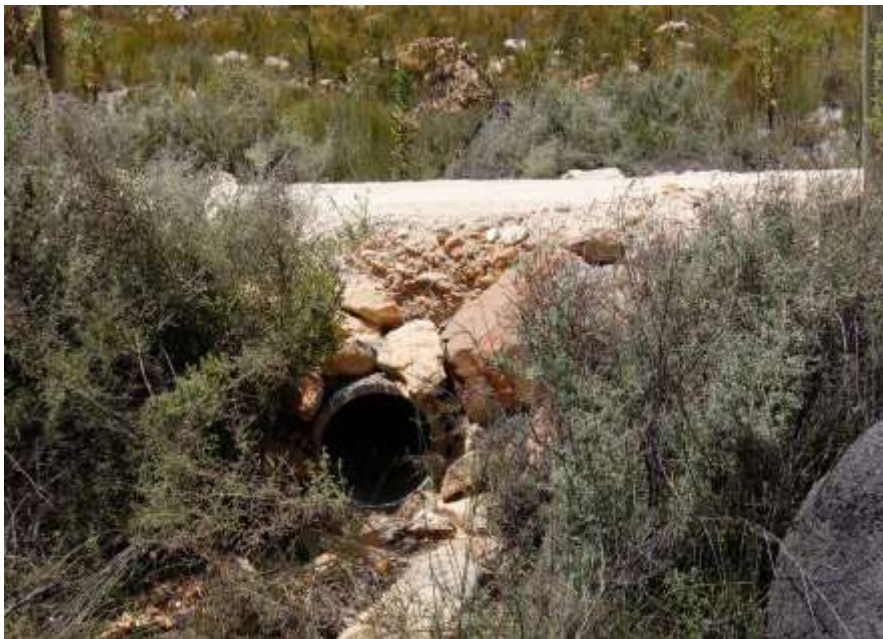
Figure 10 Pipe culvert

The streams underneath the road through pipe culverts (Figure 10).

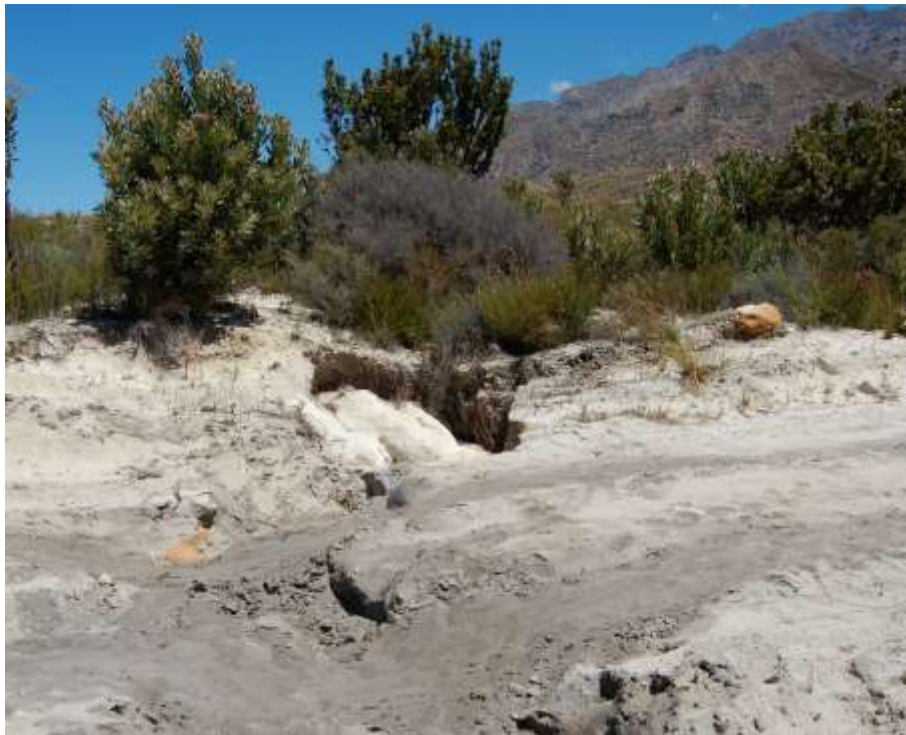
Figure 12 Erosion

The farm road along this stream, leading to the southerly new block of orchard, was heavily eroded (Figure 12).

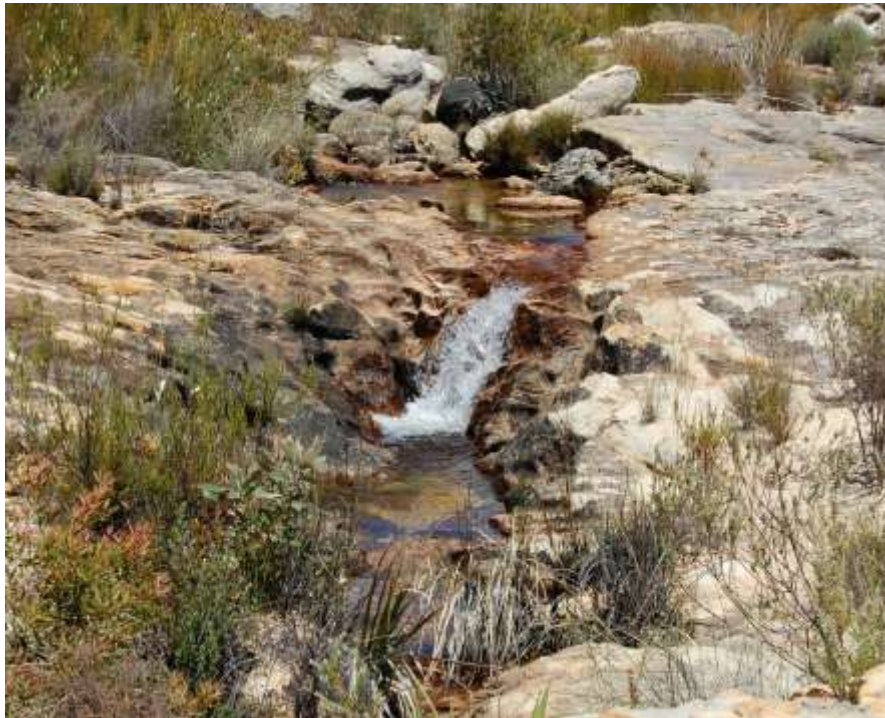
Figure 13 Run

Further up the road to the south, at the southmost new road section, the stream was much stronger (Point No.2 on Figure 1), over small waterfalls (Figure 13) at a flow rate of approximately 5 liters per second.

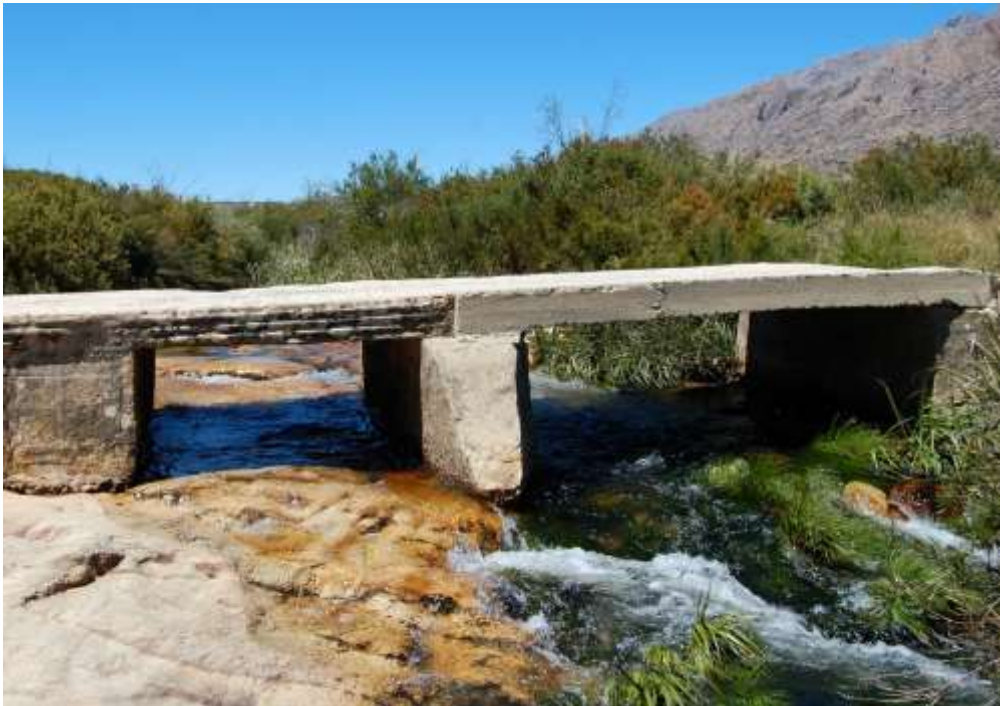
Figure 14 Bridge

The sample was taken on both sides of the bridge (Figure 14), upstream and downstream on 11 November 2021. The coordinates of the sampling point were as follows:

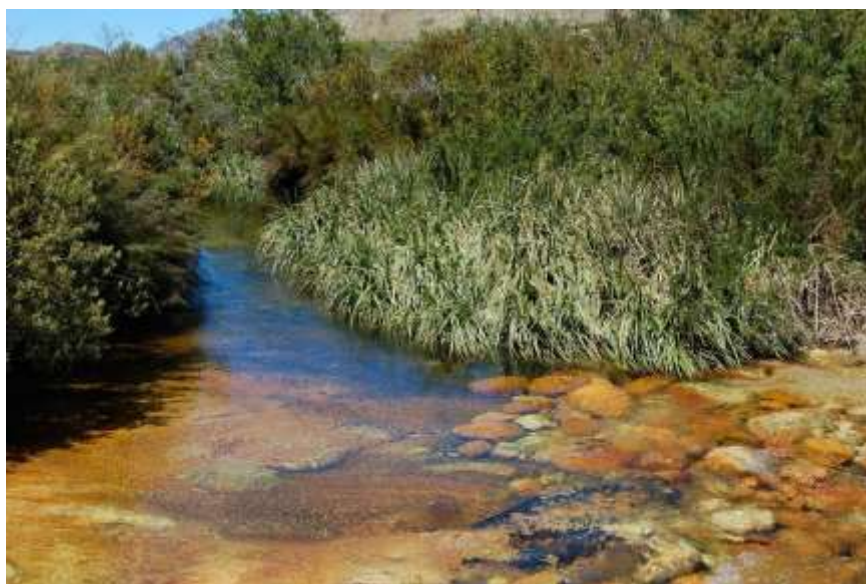
Figure 15 Palmiet

Mush of the stream was lined with a healthy stand of palmiet *Prionium serrata* (Figure 15). This formed most of the emerging vegetation habitat, along with a variety of riparian shrub. Submerged vegetation was present in the form of drowned grasses and sedges.

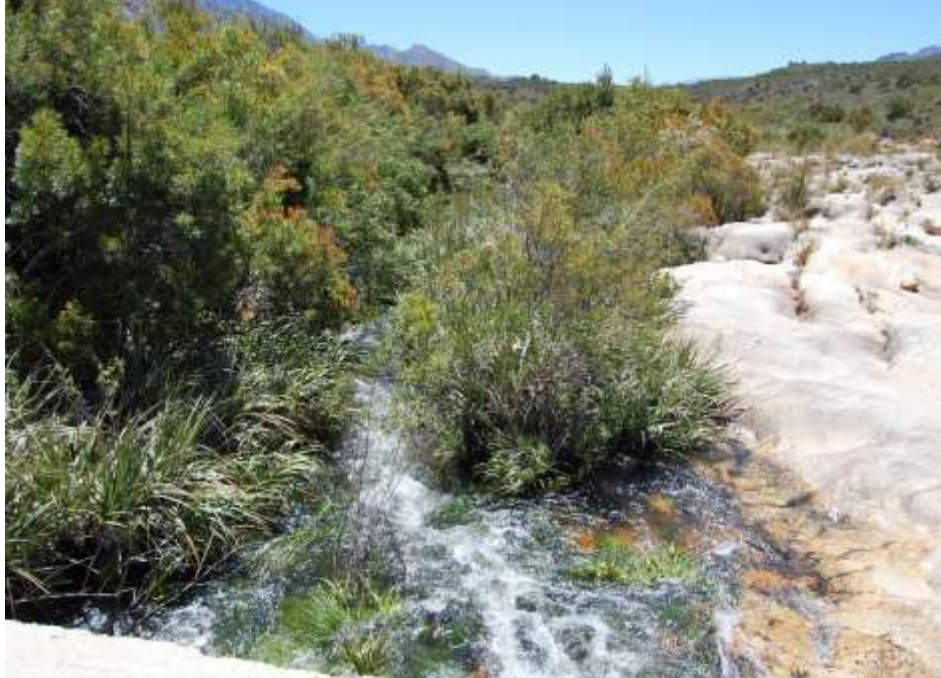
Figure 16 Stream downstream of the bridge

The river downstream of the bridge is channelled into a narrow gorge (Figure 16). The river here was a white-water rapid at the time of the site visit.

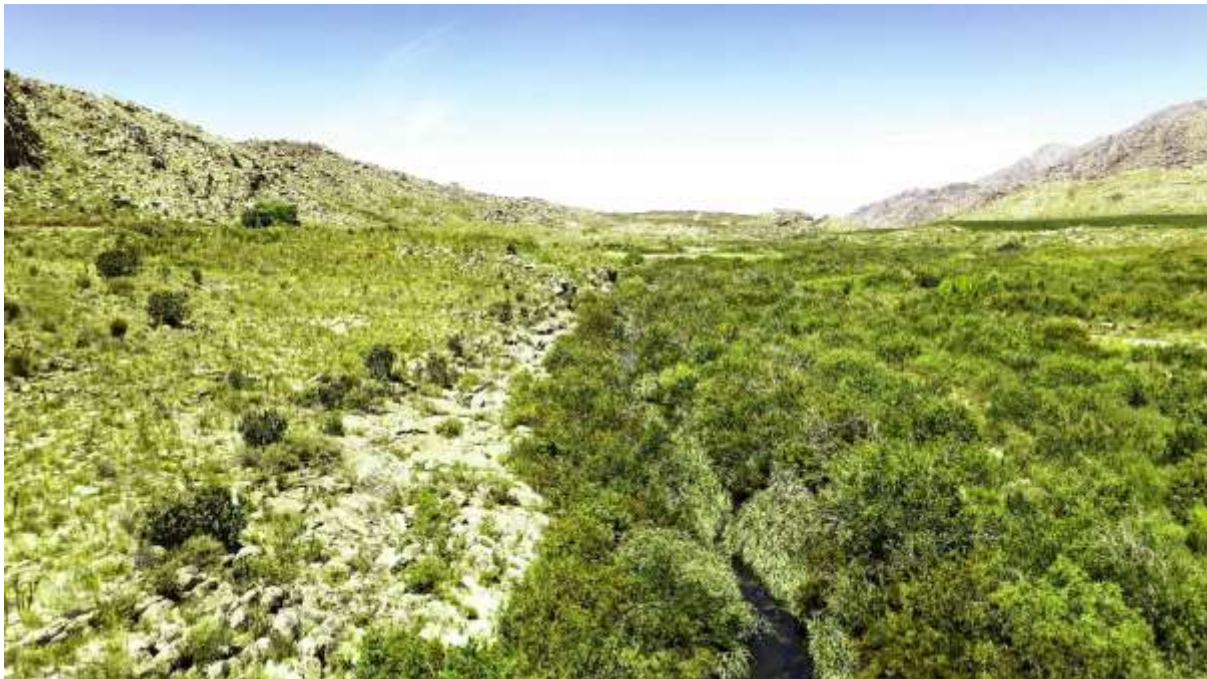
Figure 17 Riparian zone

A drone image (Figure 17) shows a wide and well-developed riparian zone. The river at the sampling point upstream of the bridge is lined with a bank of barren sandstone towards the east. The opposite bank has a much wider riparian zone.

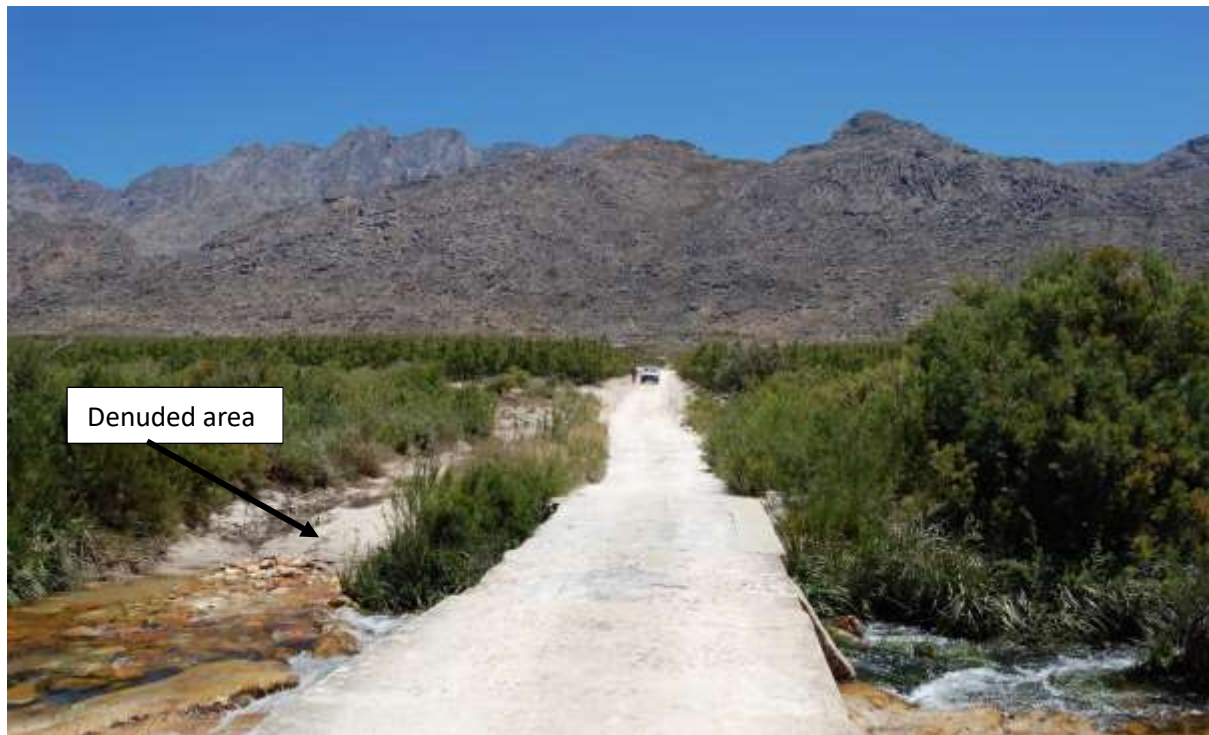
Figure 18 East bank across the bridge

The riparian zone on the east is marked with large-scale pear orchards (Figure 18).

Note that the area adjacent and upstream of the bridge was denuded of vegetation when heavy earth-moving machinery passed through the river, as the bridge would not carry the weight. This is the area where the new bridge will be located.

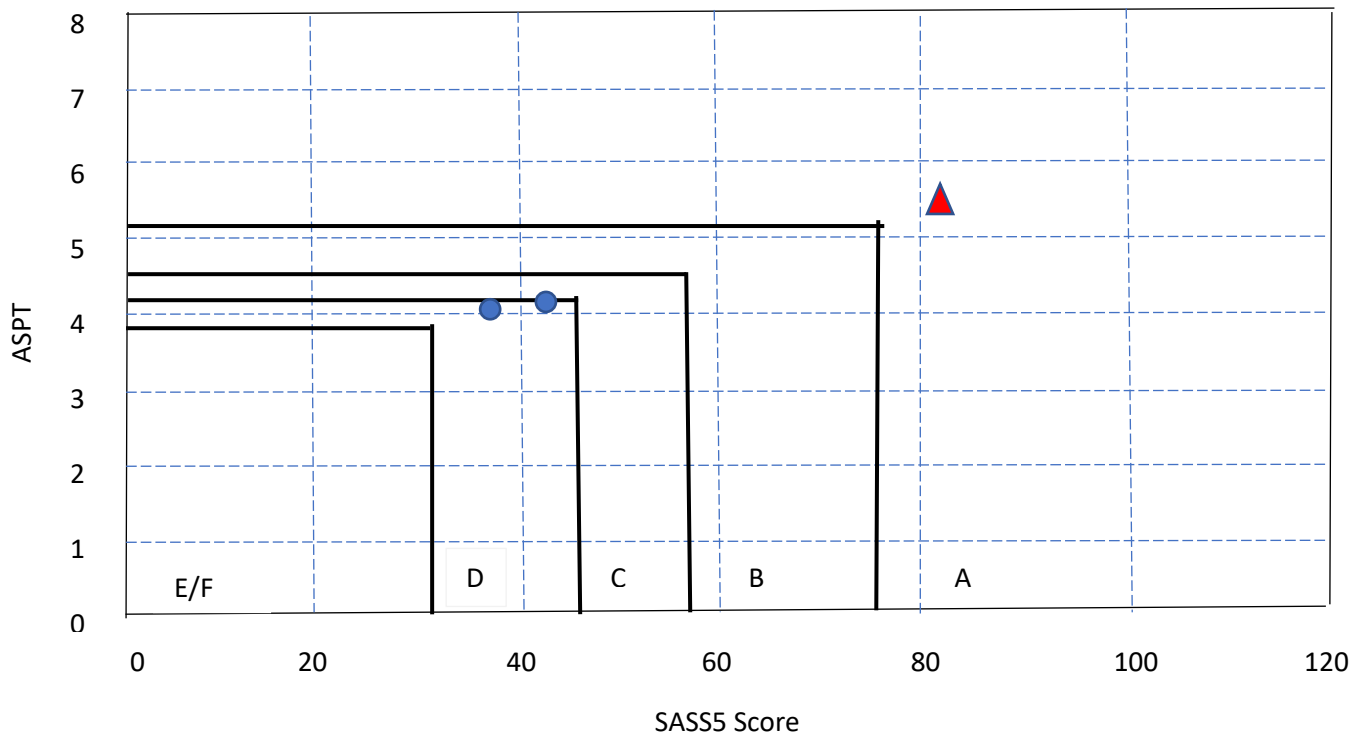
Figure 19 Visgat Biomonitoring Results

The score was much higher than that of samples taken at previous occasions for similar projects lower down the Olifants River close to the town of Klawer and close to the confluence of the Doring and the Olifants River. These samples indicated a “D” classification, with a marked impact from agriculture (Figure 19).

Integrity Class	Description
A	Pristine; not impacted
B	Very Good; slightly impacted
C	Good; measurably impacted with most ecological functioning intact
D	Fair; impacted with some loss of ecological functioning
E	Poor; loss of most ecological function
F	Very Poor; loss of all ecological function
