**BOTANICAL ASSESSMENT FOR THE PROPOSED
UPGRADE OF THE ACCESS ROAD AND BRIDGE OVER
THE OLIFANTS RIVER ON THE FARM VISGAT 207, AND
DEVELOPMENT OF THREE AGRICULTURAL AREAS,
CERES, WITZENBERG MUNICIPALITY,
WESTERN CAPE PROVINCE**

Report prepared for EnviroAfrica: Client Doornkraal Agri

1. Introduction

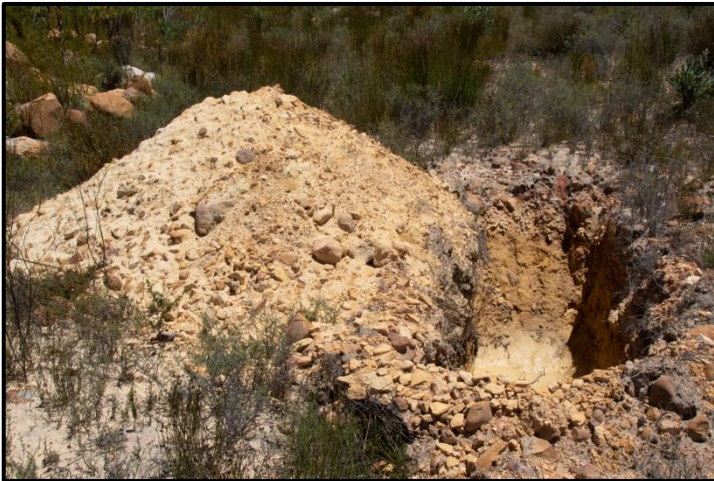
Figure 3. The yellow, rocky soil on the slopes where the road upgrade and agricultural expansion will take place is derived from the Skurweberg Formation sandstone.

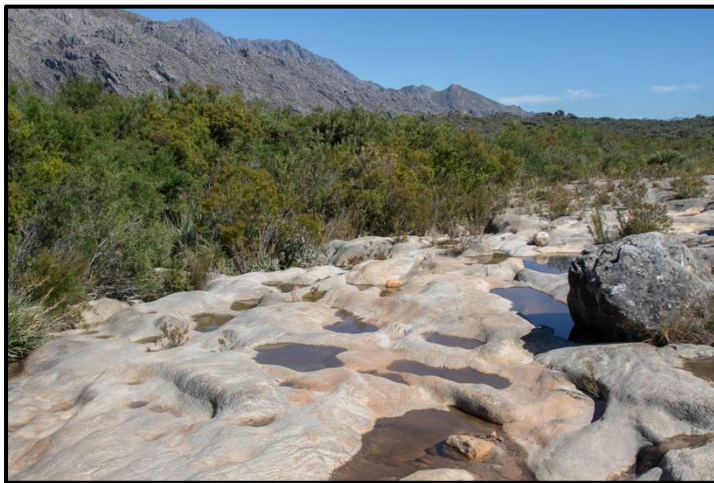
Figure 4. The sandstone bedrock polished by water and sand action over a very long time. This location is just below the existing bridge.

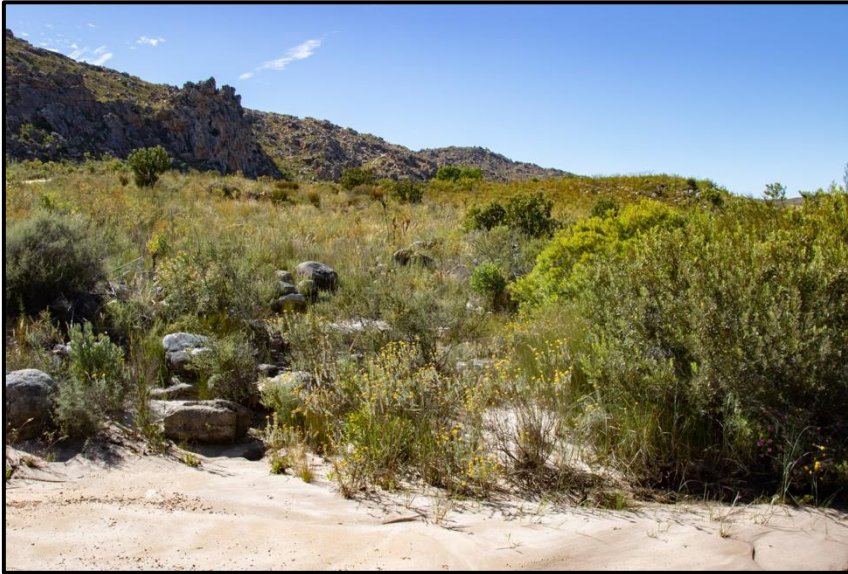
Figure 5. Alluvial sand on the bank of the Olifants River at the point where the new bridge would cross the river.

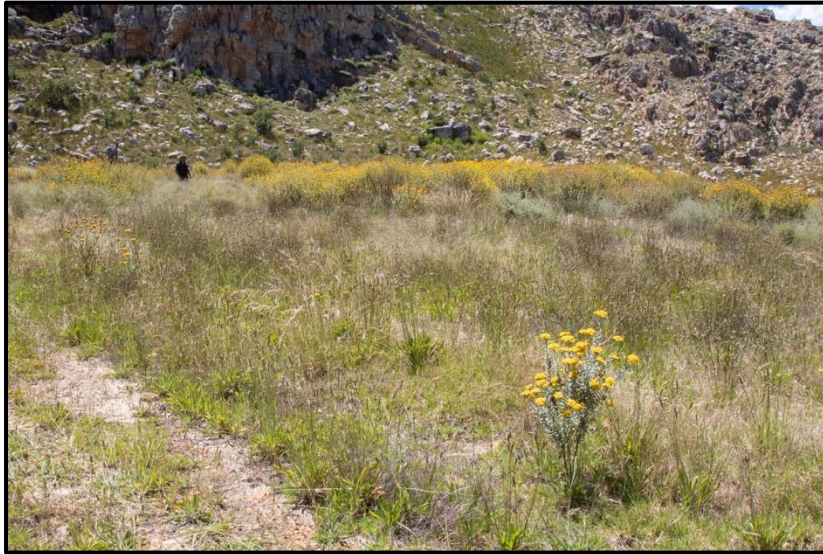
Area 1 has been disturbed in the past by what appears to have been agricultural activities. It was burnt in the most recent fire and is now fallow (Figure 9). Further details are given below.

Figure 9. Agricultural Area 1 that was previously disturbed and is not colonized by ruderal species, many of which are exotic, weedy plant species.

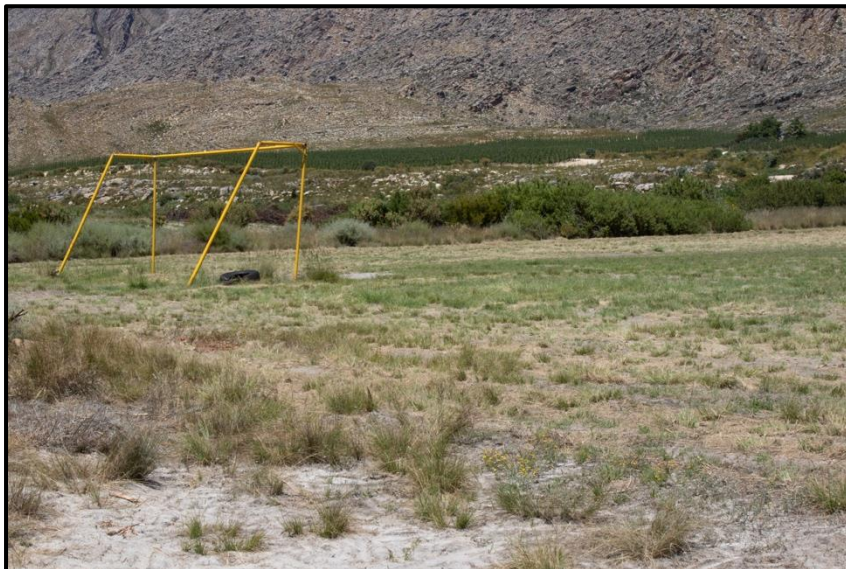
Area 2 is presently a soccer pitch for the farm labourers. The natural vegetation (fynbos) has been replaced by grass that is regularly mown (Figure 10). One part of the area is also disturbed by being transformed to grassveld (fallow) with heaps of cleared vegetation on the north side (Figure 11).

Figure 10. The soccer pitch with no natural fynbos vegetation.

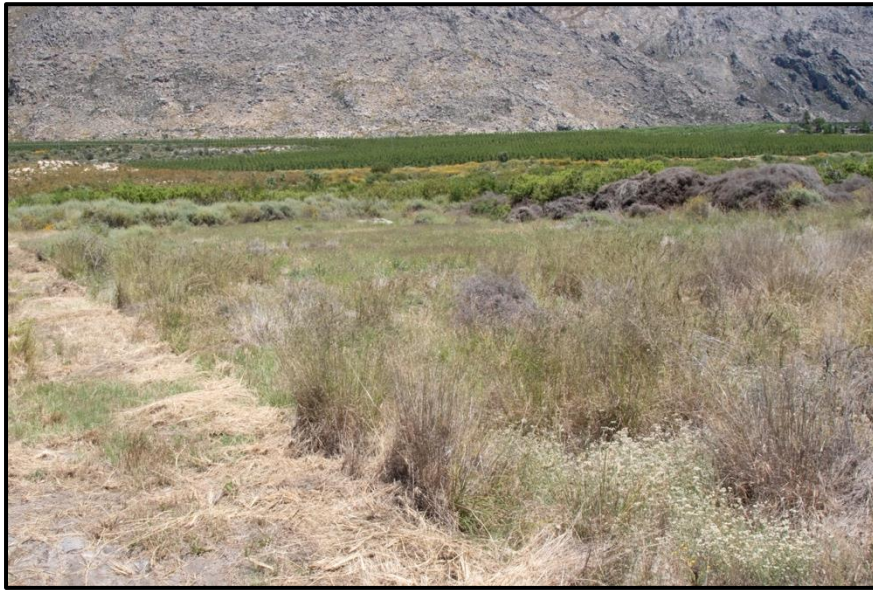
Figure 11. The northern part of agricultural Area2 that has been transformed and is now grassveld, with heaps of cleared vegetation at the northern edge.

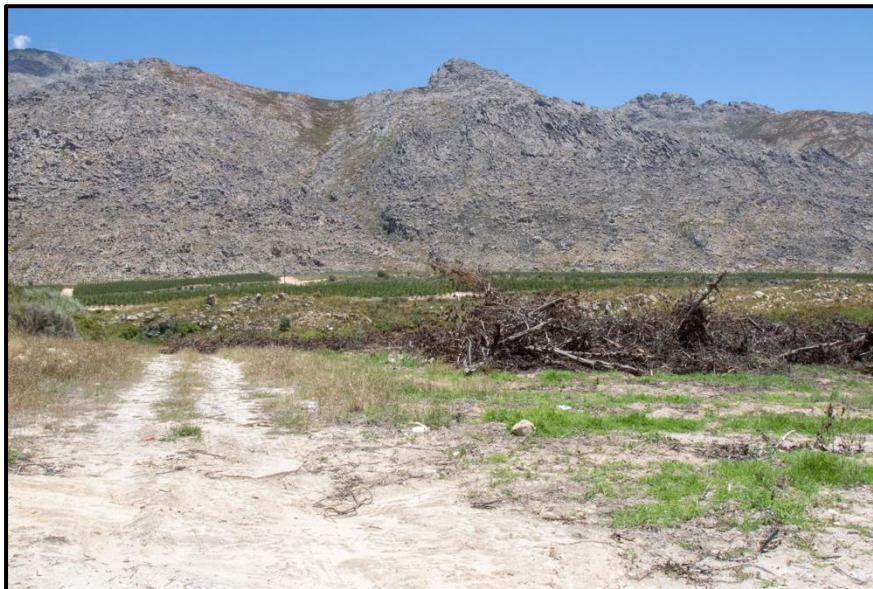
Parts of Area 3 are relatively undisturbed, but parts have been disturbed by the existing road that traverses the site and an area that has been used to dump agricultural waste (Figure 12). In addition, large sandstone boulders that were removed from cultivation area have been dumped in Area 3 as well (Figure 13). With the advent of the upgraded road, the section of the existing road that traverses Area 3 would be incorporated into the agricultural development of Area 3. The new section of road would run alongside the new orchard block.

Figure 12. Agricultural waste dumped in Area 3.

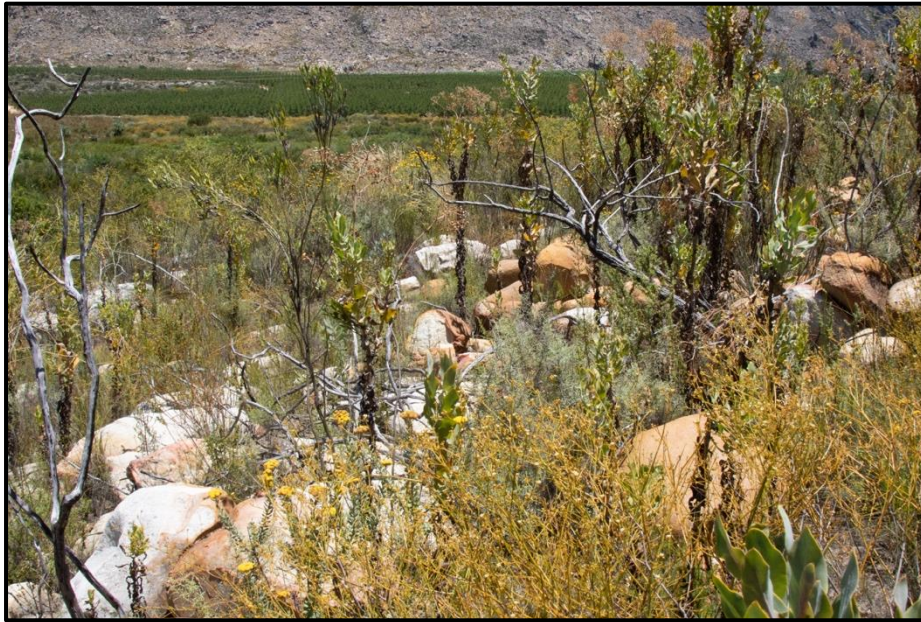
Figure 13. Boulders that have been removed from cultivated area have been dumped at this location in Area 3.

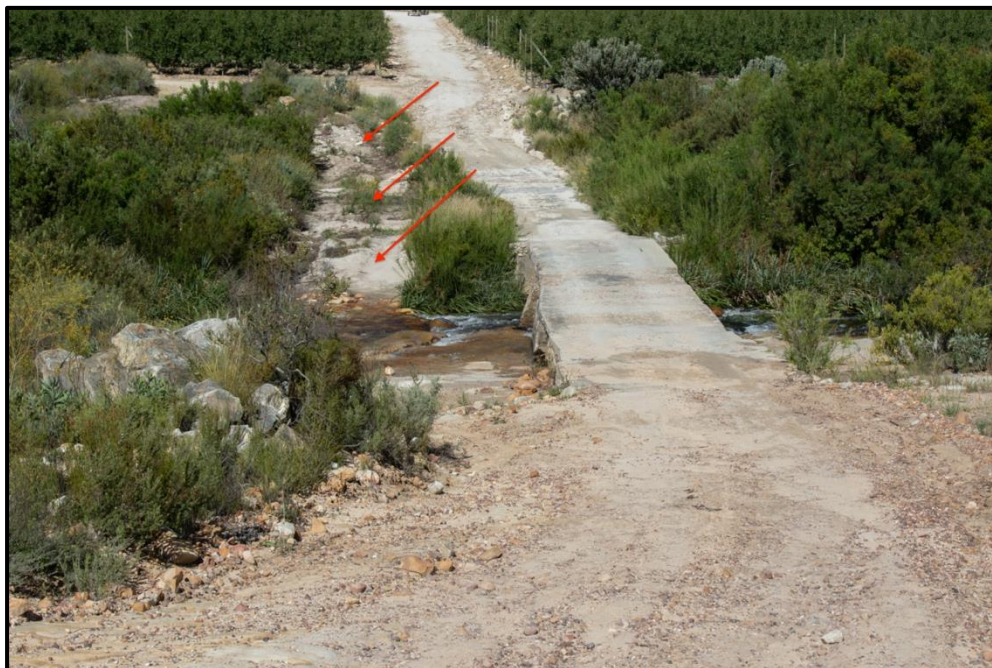
Figure 16. The existing bridge over the Olifants River with disturbance of the riparian zone shown by the red arrows.

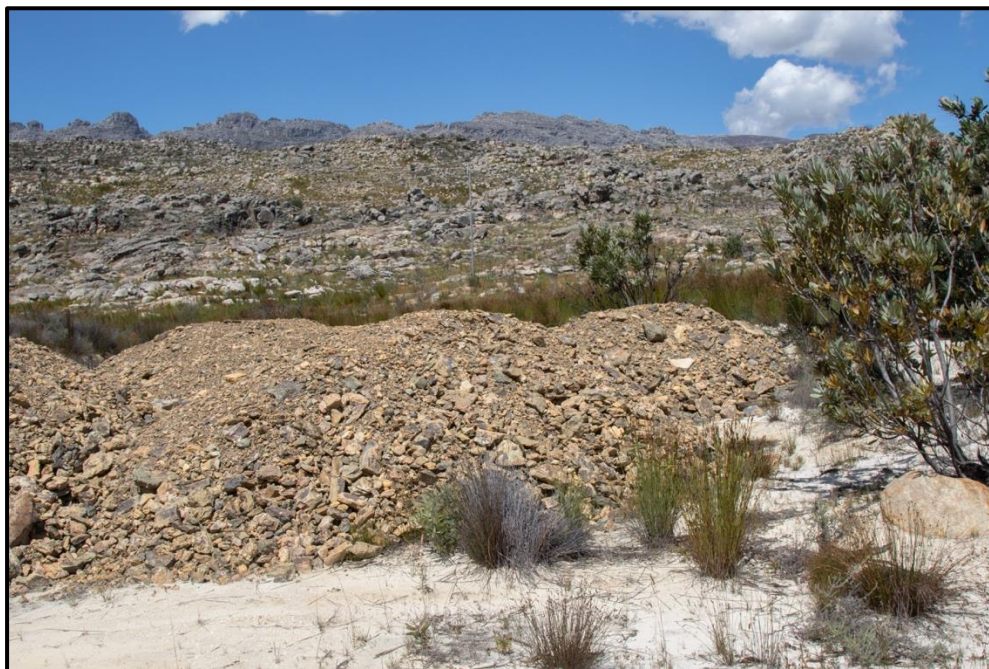
Figure 23. Heaps of soil dumped just north of the northern extremity of Site 3.

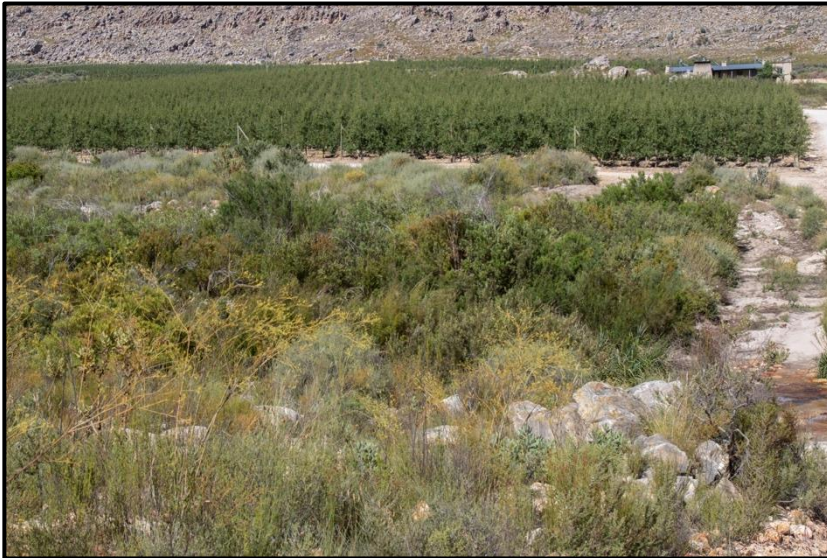
Figure 28. The route of the realigned road and bridge will result in removal of the fynbos vegetation in the foreground and west of the river as well as the riparian vegetation seen here. Part of the fruit orchard on the west side may also be lost.

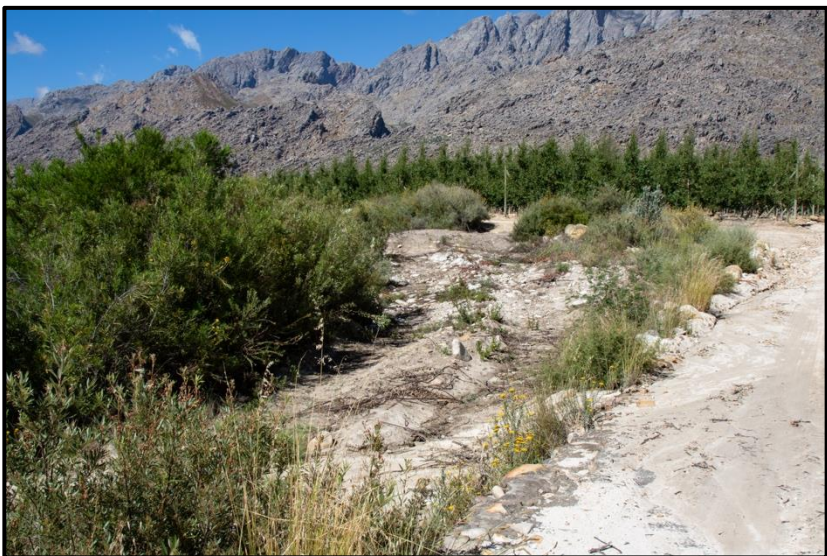
Figure 30. The existing bridge on the right side of the photo with disturbed riparian zone immediately south of the bridge (left side).

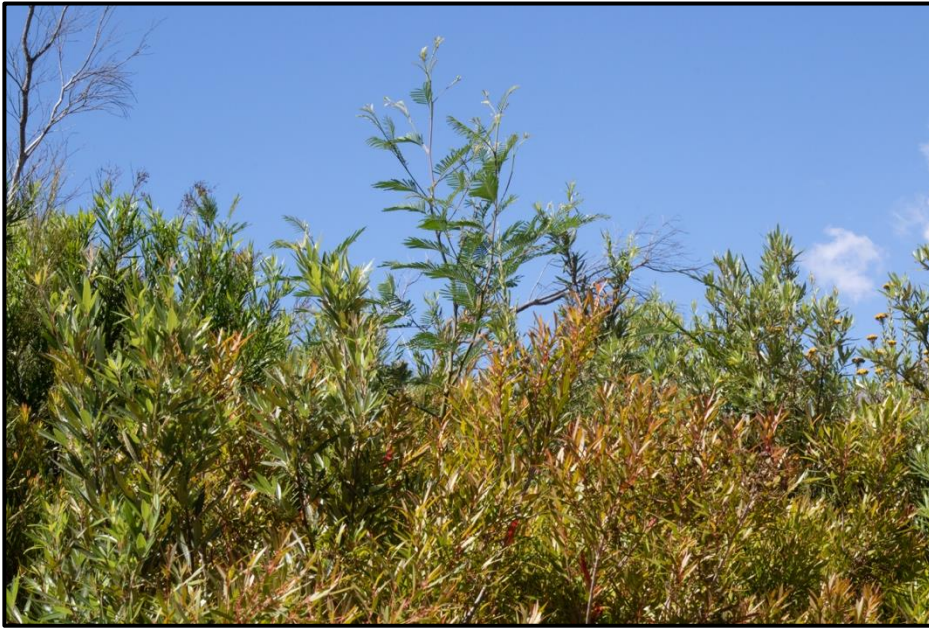
Figure 35. Invasive exotic *Acacia mearnsii* (black wattle) [tall shrub in centre] must be eradicated.

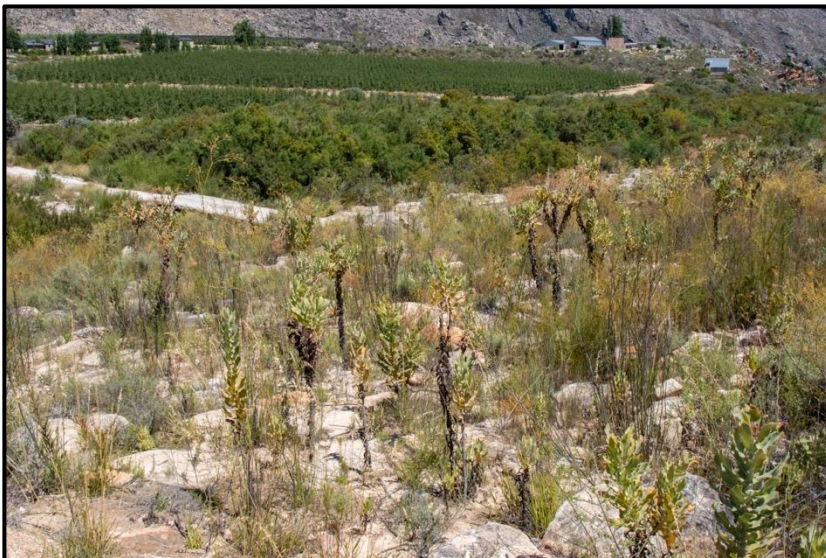
Figure 35. The re-alignment of the access road near the bridge would result in loss of some of the fynbos on the boulder slope seen here.

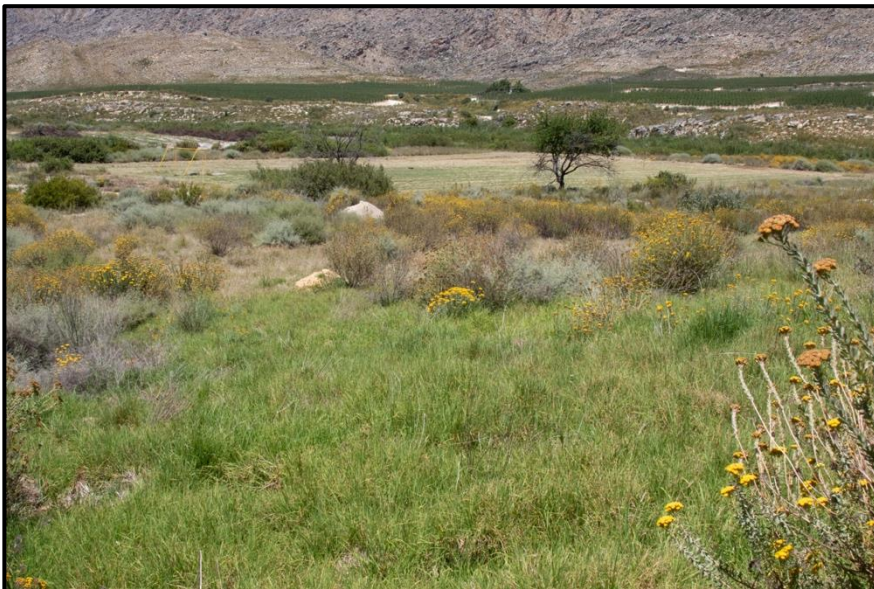
Bromus diandrus, *Ehrharta villosa*, *Eragrostis curvula*, *Helichrysum* sp., *Pennisetum clandestinum* (exotic Kikuyu grass) [Figure 39], *Plantago lanceolata* and *Senecio* sp.

Figure 39. A significant part of the agricultural Area 1 is invaded by exotic Kikuyu grass (*Pennisetum clandestinum*).

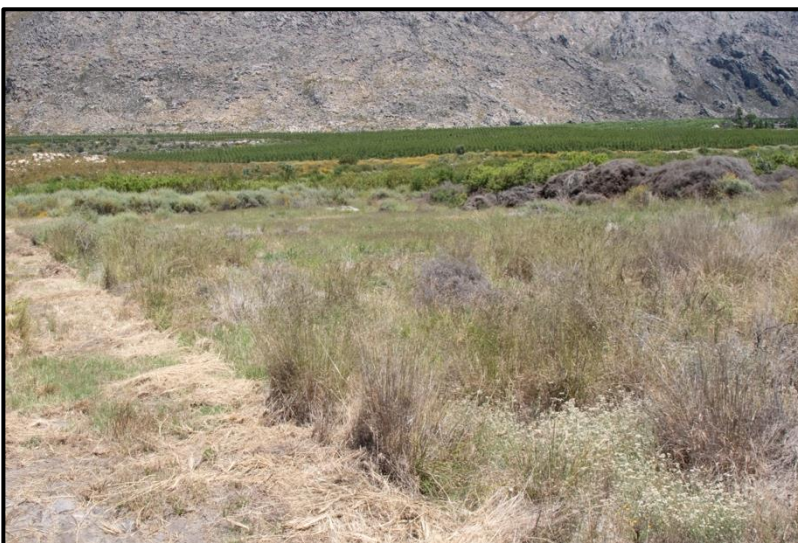
Figure 42. The area to the north of the soccer pitch is completely transformed from fynbos vegetation. Heaps of mown vegetation are at the northern extreme of the area proposed as the Area 2 agricultural area.

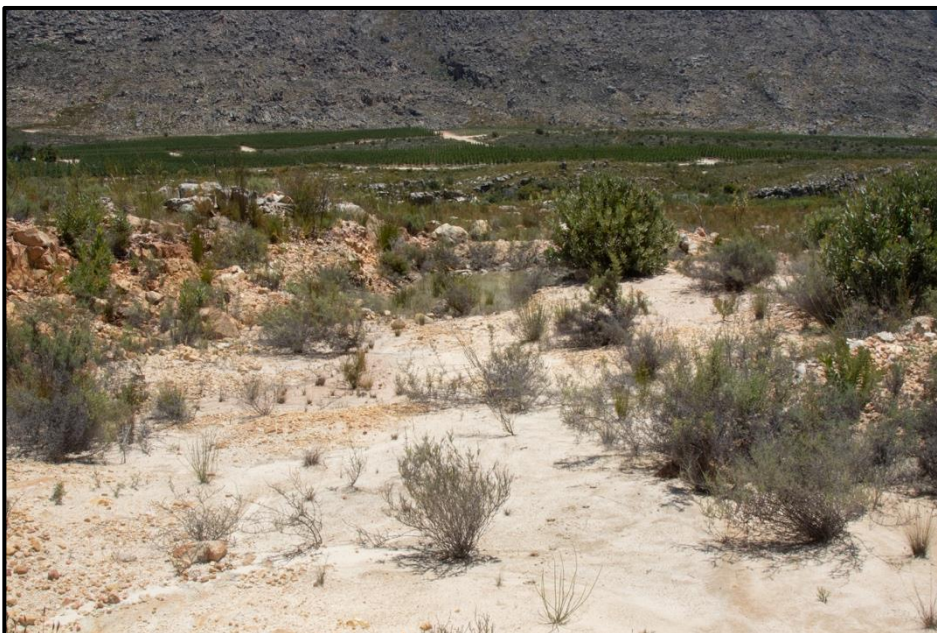
There is some historical disturbance (see Figure 50) along the Site 2 upgrade route (Figure 19) The young fynbos is recovering since the last fire (Figure 20).

Figure 50. Disturbed area apparently scraped for road building material.

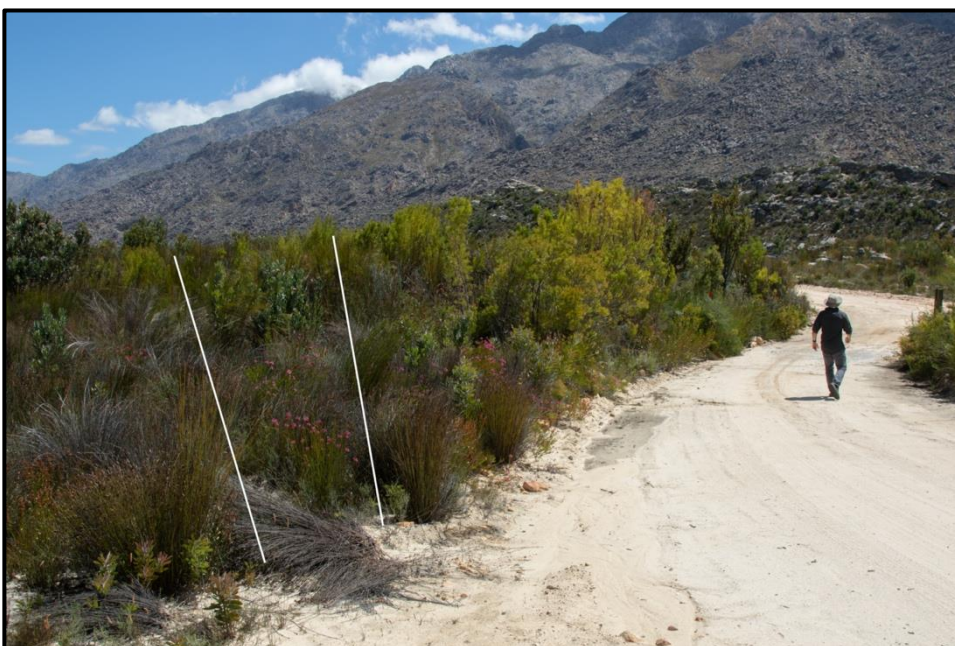
Figure 54. The northern intersection points between the existing road and the upgraded, re-aligned section of Site 3. The white lines indicate the approximate alignment of the new road section through mature fynbos vegetation.

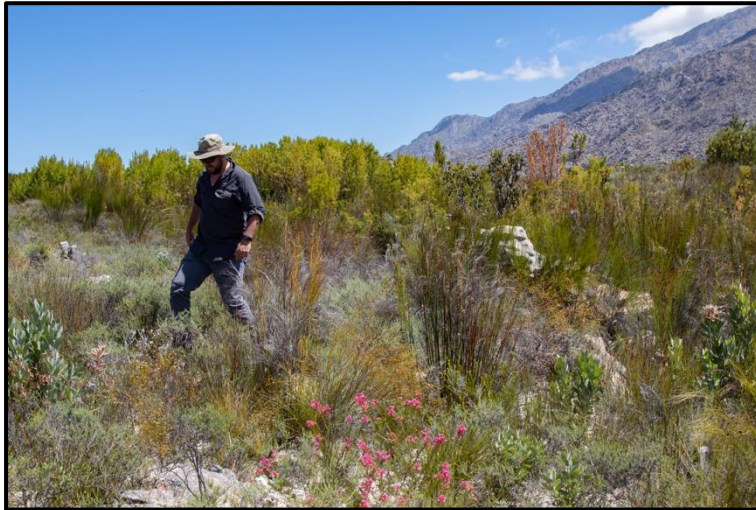
Figure 55. The Site 3 upgrade route would traverse unburnt vegetation in good condition and then a perennial stream.
