Aquatic Ecology Assessment

Caval Ridge Mine

Horse Pit Extension Project Aquatic Ecology Assessment

August 2021

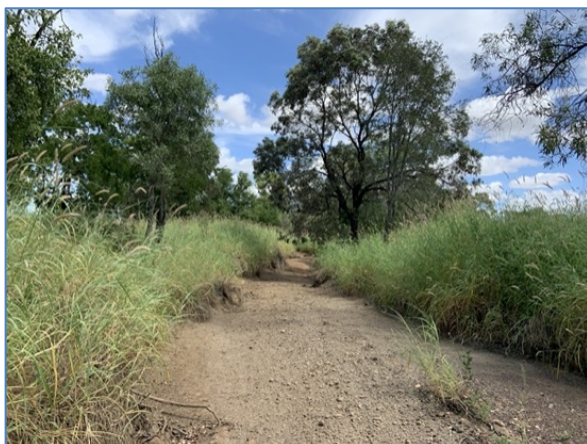
Figure 4.2 Dry channel at site H1 (unnamed tributary of Horse Creek downstream of the Project footprint) in April 2020

In minor waterways and drainage channels, which were typically dry during all three surveys, aquatic habitat features were limited (**Figure 4.2**). Potential aquatic habitat in the dry

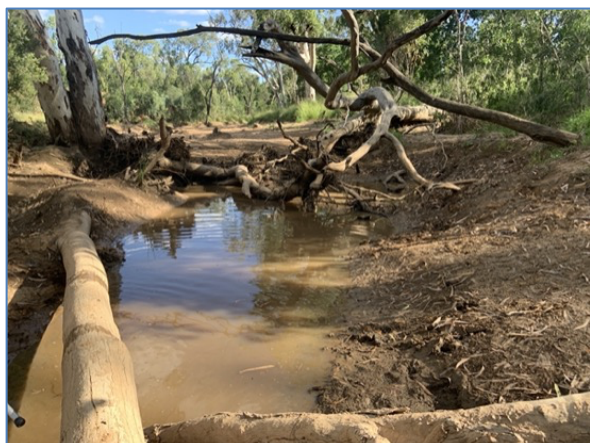
Figure 4.3 Pool habitat at site Ch2 (Cherwell Creek downstream of CVM and upstream of the Project footprint) in April 2020

In major waterways, in-stream features were more abundant with shallow and deep pools, variable substrate (dominated by sand but with larger substrate types present in low abundance), in-stream woody debris and moderate to high coverage of trailing and overhanging bankside vegetation (**Figure 4.3**). Bed and bank stability were low to moderately disturbed from cattle access, terrestrial weeds and feral animals. Although riparian vegetation was reduced as a result of land clearing associated with the adjacent land uses, the banks remained moderately vegetated by predominantly mature native trees (namely *Eucalyptus*, *Casuarina* and *Acacia*) with a sparse to moderate groundcover of grasses.

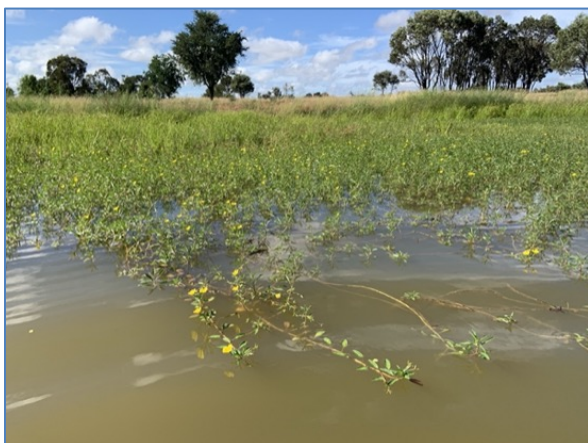
Figure 4.4 Aquatic plant communities at site HT1D in April 2020

Although connectivity to downstream habitats was typically limited due to the construction of dam walls, these sites contained water during the December 2019 (LW1, HT1D and U1D) or November 2020 (LW2) surveys, and would therefore provide dry season refuges for aquatic flora and fauna.

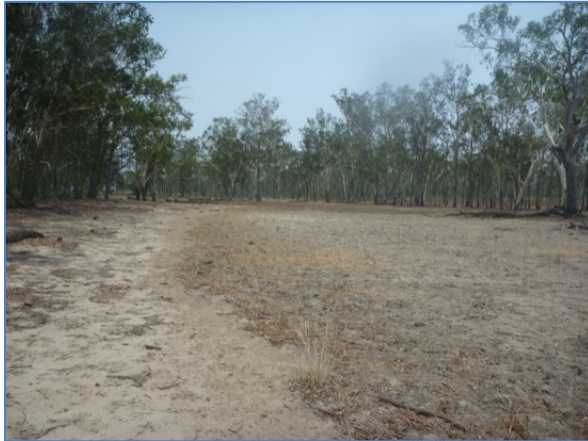
Figure 4.5 Site PW1 (HES wetland and WPA) in December 2019

During the field survey in December 2019, the wetland was dry (**Figure 4.5**). The dry bed contained some potential habitat features, including emergent aquatic plants, some overhanging and trailing vegetation, terrestrial detritus and woody debris. Canopy cover and shading was limited throughout the site. The riparian zone was reduced due to vegetation clearing, but a continuous band of trees and grasses with some shrubs bordered the wetland. There were some terrestrial weeds growing in the dry bed, but otherwise disturbance was relatively low.

Based on the December 2019 survey, the wetland did not provide substantial aquatic habitat. This site was unable to be surveyed in April 2020 due to property access issues. However, it is possible that this wetland provides habitat for aquatic fauna during and after high rainfall / flow events.

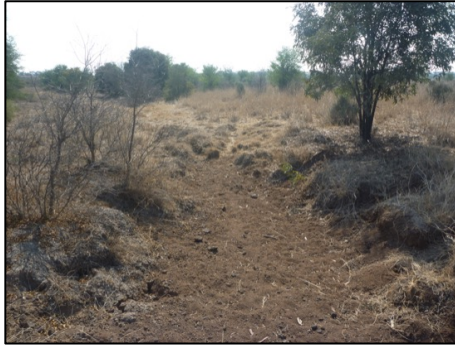
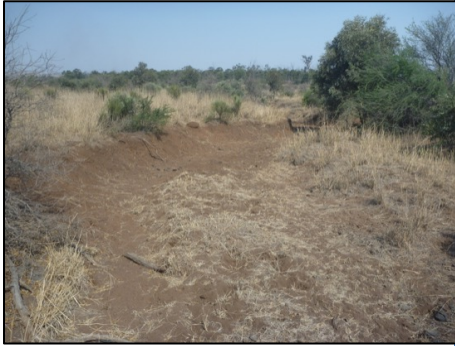
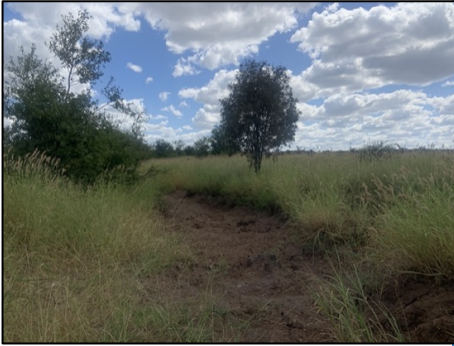
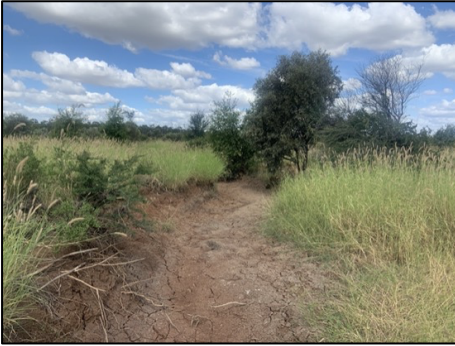
| | | | | | | | | | | | | | | | | | | | | | |
| Aquatic Ecosystem Value: Low | | MNES/MSES: None present or likely to occur | | Dry season refuge: No | | Connectivity: Limited due to location in catchment and presence of CVM downstream | | | | | | | | | | | | | | | | | | | | | | |
| <p>In-stream condition: Fair</p> <p>Key potential habitat features included:</p> <ul style="list-style-type: none"> • small amounts of small and large woody debris and detritus • a limited range of sediment grain sizes (predominately silt/clay with some sand), and • little trailing and overhanging bank vegetation. <p>The site was dry during both the December and April surveys.</p> | | <p>Riparian condition: Poor</p> <p>The riparian zone was semi-continuous around the perimeter of the waterway, although the extent of the vegetation had been reduced due to historic clearing. Vegetation consisted of grass, shrubs and some trees (predominantly eucalyptus and casuarina). Banks were low (1 m – 1.5 m high) and gently sloping with minimal erosion. There were some exotic terrestrial riparian species at the site.</p> | | <p>External Impacts: High</p> <p>External impacts at the site were mostly associated with the surrounding land-use and included:</p> <ul style="list-style-type: none"> • reduced riparian vegetation as a result of land clearing. | | <p>Water Quality: N/A</p>

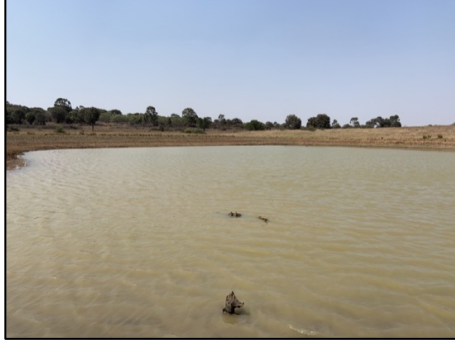
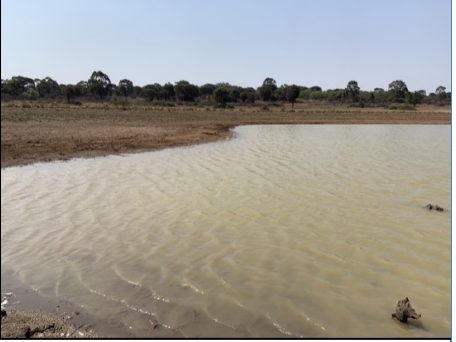
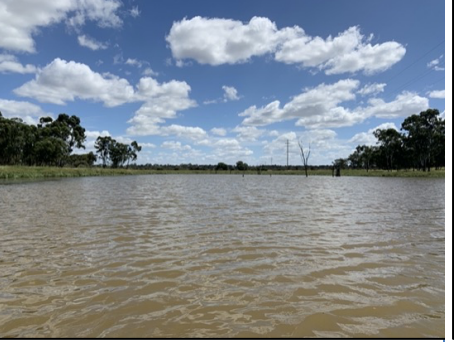
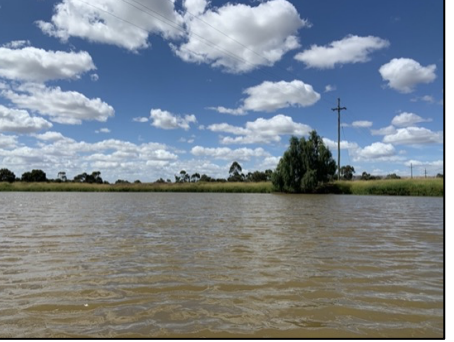
| | | | | | | | | | | | | | | | | | | | | | |
| Aquatic Ecosystem Value: Moderate | | MNES/MSES: None present or likely to occur | | Dry season refuge: Yes | | Connectivity: Poor due to high dam walls, location in catchment and presence of CVM downstream | | | | | | | | | | | | | | | | | | | | | | |
| In-stream condition: Fair Key habitat features included: <ul style="list-style-type: none"> • diverse and abundant aquatic plants • a variety of woody debris • periphyton • sediment grain sizes predominately silt/clay, and sandy gravel • shallow & deep pools, and • trailing and overhanging bank vegetation. | | Riparian condition: Poor The riparian zone was continuous around the perimeter of the waterway, although the extent of the vegetation had been reduced. Vegetation consisted of grass, ferns and weeds. Banks were low (1.5 m – 2 m high) and gently sloping with some erosion. There were some exotic terrestrial riparian species at the site. | | External Impacts: High External impacts at the site were mostly associated with the surrounding land-use and included: <ul style="list-style-type: none"> • reduced riparian vegetation as a result of land clearing • grazing by livestock • feral animals, and • the presence of an artificial dam. | | Water Quality: Poor

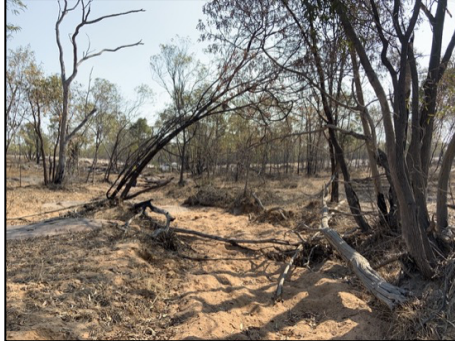
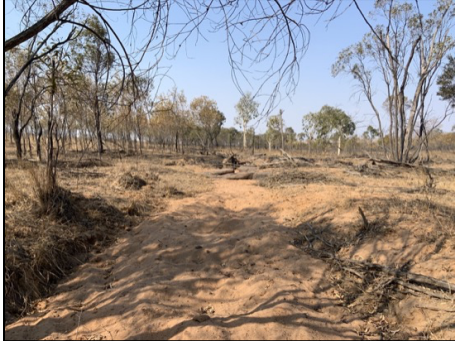
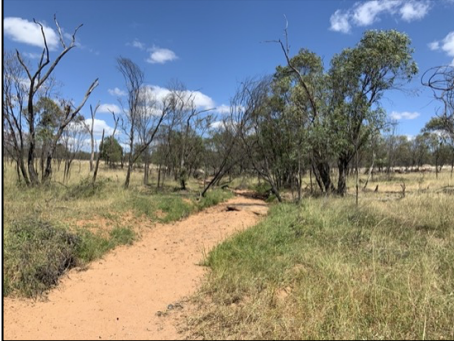
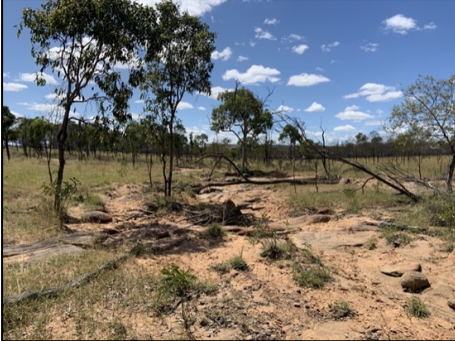
| | | | | | | | | | | | | | | | | | | | | | |
| Aquatic Ecosystem Value: Low | | MNES/MSES: None present or likely to occur | | Dry season refuge: No | | Connectivity: Limited due to location in catchment and presence of CVM downstream | | | | | | | | | | | | | | | | | | | | | | |
| <p>In-stream condition: Fair</p> <p>Key potential habitat features included:</p> <ul style="list-style-type: none"> • ephemeral channel • some woody debris • predominately sandy sediments with some cobbles and boulders, and • little trailing and overhanging bank vegetation. <p>The site was dry during both the December and April surveys.</p> | | <p>Riparian condition: Poor</p> <p>The riparian zone was semi-continuous around the perimeter of the waterway, although the extent of the vegetation had been reduced due to historic clearing. Vegetation consisted of trees, grasses and weeds. Banks were low (approximately 1 m high) and gently sloping with some erosion. There were some exotic terrestrial riparian species at the site.</p> | | <p>External Impacts: High</p> <p>External impacts at the site were mostly associated with the surrounding land-use and included:</p> <ul style="list-style-type: none"> • reduced riparian vegetation as a result of land clearing • grazing by livestock, and • feral animals. | | <p>Water Quality: N/A</p>

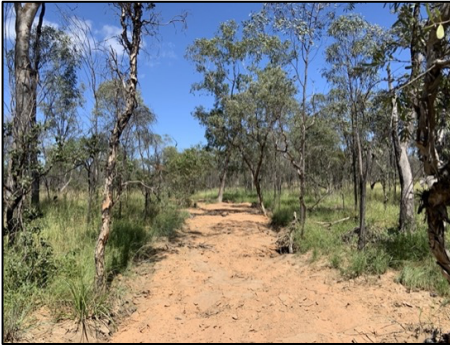
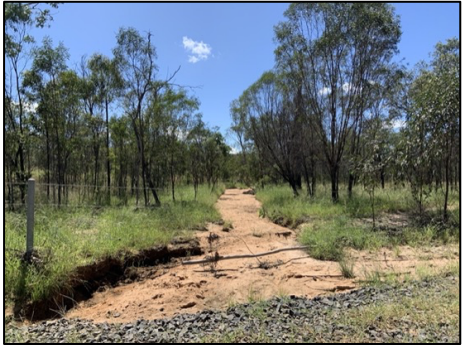
| | | | | | | | | | | | | | | | | | | | | | |
| Aquatic Ecosystem Value: Low | | MNES/MSES: None present or likely to occur | | Dry season refuge: No | | Connectivity: Limited due to location in catchment and presence of CVM downstream | | | | | | | | | | | | | | | | | | | | | | |
| In-stream condition: Fair Key potential habitat features in April included: <ul style="list-style-type: none"> • well defined ephemeral channel • some woody debris • predominately sandy sediments with some cobbles and boulders, and • little trailing and overhanging bank vegetation. The site was not sampled during the December survey and was dry during the April survey. | | Riparian condition: Fair The riparian zone was continuous around the perimeter of the waterway, although the extent of the vegetation in the broader region had been reduced due to historic clearing. Vegetation consisted of trees, grasses and weeds. Banks were low (approximately 0.5 m high) and gently sloping with some erosion. There were some exotic terrestrial riparian species at the site. | | External Impacts: High External impacts at the site were mostly associated with the surrounding land-use and included: <ul style="list-style-type: none"> • grazing by livestock • feral animals, and • vehicle track crossing. | | Water Quality: N/A

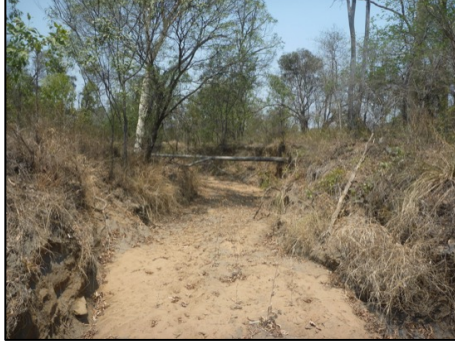
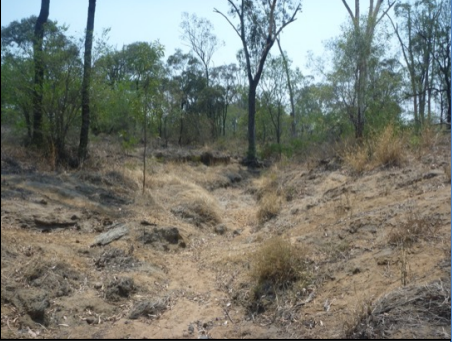
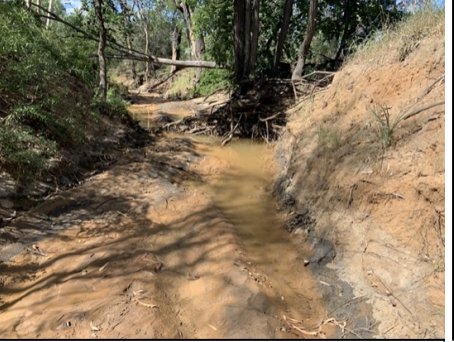
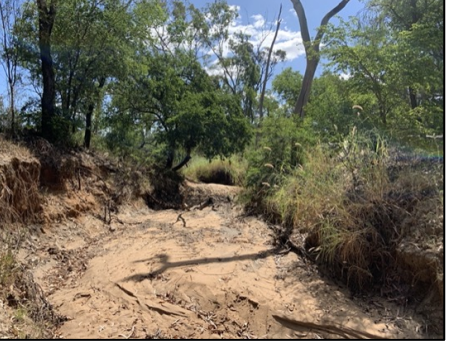
| | | | | | | | | | | | | | | | | | | | | | |
| Aquatic Ecosystem Value: Low | | MNES/MSES: None present or likely to occur | | Dry season refuge: No | | Connectivity: Moderate, during periods of flow | | | | | | | | | | | | | | | | | | | | | | |
| In-stream condition: Fair Key habitat features in April included: <ul style="list-style-type: none"> • sandy ephemeral channel • shallow pools • some woody debris & detritus • predominately sand and silt/clay sediments with some pebbles & gravel, and • some trailing and overhanging bank vegetation. The site was dry during the December survey. | | Riparian condition: Fair The riparian zone was semi-continuous around the perimeter of the waterway, although the extent of the vegetation had been reduced due to historic clearing. Vegetation consisted of trees, grasses, shrubs, ferns/sedges and weeds. Banks were low (1.8 m – 2 m high) and gently sloping with moderate levels erosion. There were some exotic terrestrial riparian species at the site. | | External Impacts: High External impacts at the site were mostly associated with the surrounding land-use and included: <ul style="list-style-type: none"> • reduced riparian vegetation as a result of land clearing • grazing by livestock, and • feral animals. | | Water Quality: Fair

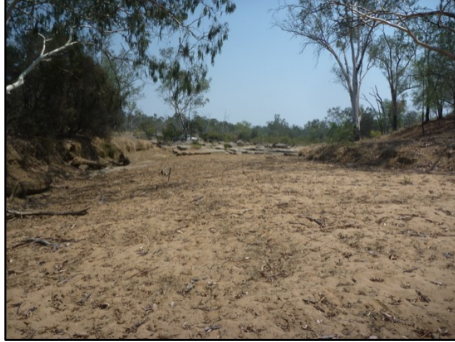
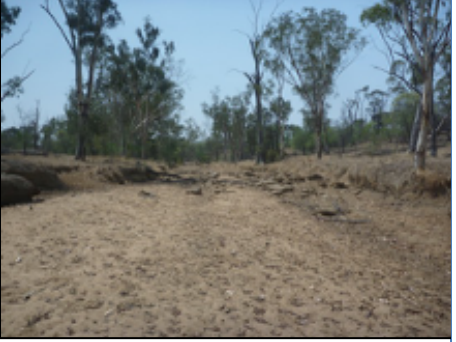
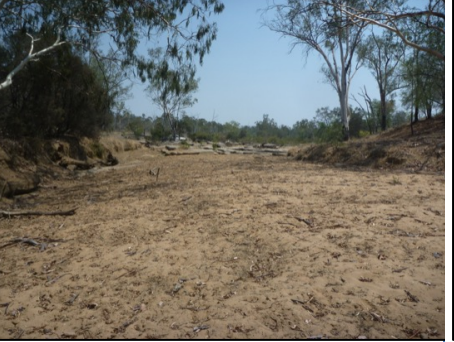
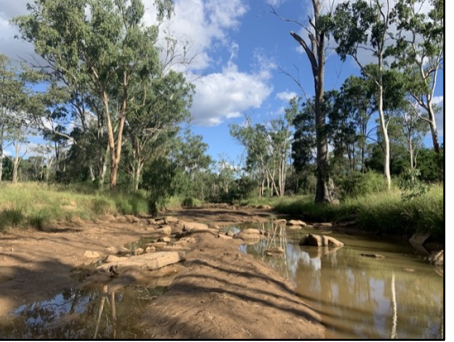
| | | | | | | | | | | | | | | | | | | | | | |
| Aquatic Ecosystem Value: Moderate | | MNES/MSES: None present or likely to occur | | Dry season refuge: No | | Connectivity: Good, during periods of flow | | | | | | | | | | | | | | | | | | | | | | |
| In-stream condition: Fair Key habitat features in April included: <ul style="list-style-type: none"> • some woody debris • shallow pools • predominately sand and silt/clay sediments with some boulders, and • some trailing and overhanging bank vegetation. The site was dry during the December survey. | | Riparian condition: Good The riparian zone was semi-continuous around the perimeter of the waterway, although the extent of the vegetation had been reduced due to historic clearing. Vegetation consisted of trees, grasses, shrubs, ferns and weeds. Banks were low (3.5 m – 2 m high) and gently sloping with some erosion. There were some exotic terrestrial riparian species at the site. | | External Impacts: Moderate External impacts at the site were mostly associated with the surrounding land-use and included: <ul style="list-style-type: none"> • reduced riparian vegetation as a result of land clearing • grazing by livestock • feral animals, and • vehicle track crossing. | | Water Quality: Good

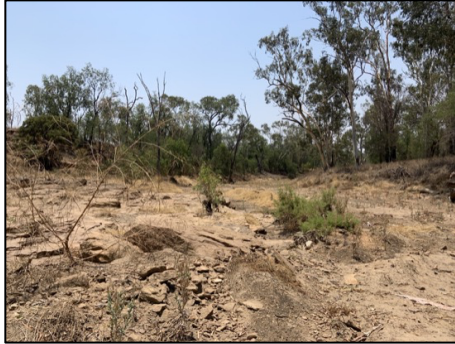
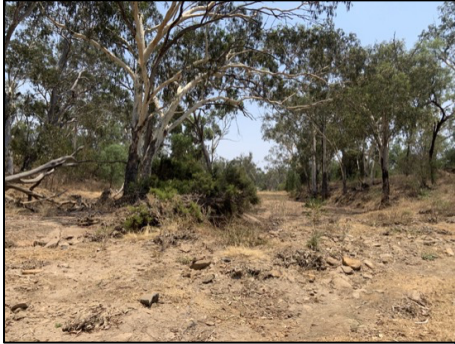
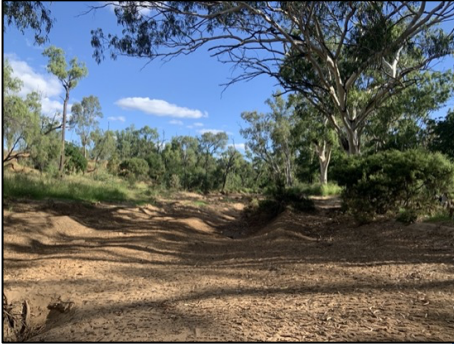
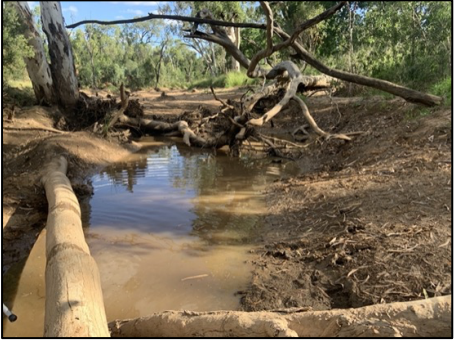
| | | | | | | | | | | | | | | | | | | | | | |
| Aquatic Ecosystem Value: Moderate | | MNES/MSES: None present or likely to occur | | Dry season refuge: No | | Connectivity: Good, during periods of flow. | | | | | | | | | | | | | | | | | | | | | | |
| In-stream condition: Fair Key habitat features in April included: <ul style="list-style-type: none"> • wide sandy ephemeral channel • some woody debris & detritus • predominately sandy sediments with some silt/clay, and • some overhanging and trailing bank vegetation. The site was dry during the December survey. | | Riparian condition: Fair The riparian zone was semi-continuous around the perimeter of the waterway, although the extent of the vegetation had been reduced due to historic clearing. Vegetation consisted of trees, grasses and weeds. Banks were intermediate (3 m – 4 m high) and gently sloping with moderate erosion. There were some exotic terrestrial riparian species at the site. | | External Impacts: High External impacts at the site were mostly associated with the surrounding land-use and included: <ul style="list-style-type: none"> • reduced riparian vegetation as a result of land clearing • grazing by livestock, and • feral animals. | | Water Quality: Fair

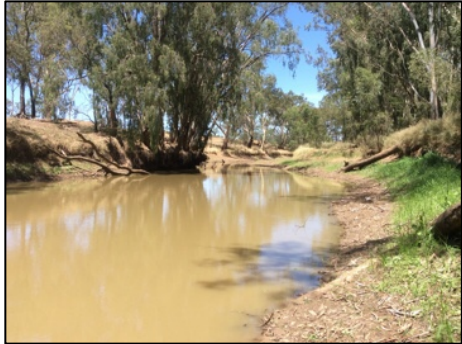
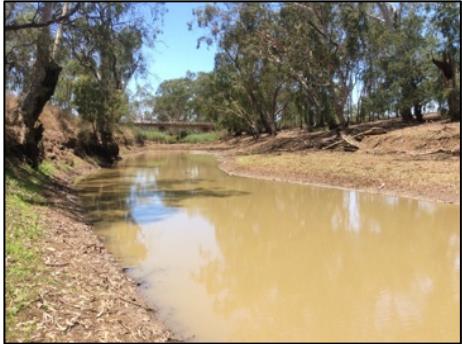
| | | | | | | | | | | | | | | | | | | |
| Aquatic Ecosystem Value: Moderate | | MNES/MSES: None present or likely to occur | | Dry season refuge: Potential | | Connectivity: N/A | | | | | | | | | | | | | | | |
| <p>In-stream condition: Poor</p> <p>Key habitat features in November 2020 included:</p> <ul style="list-style-type: none"> • wetted channel • silty/clay/muddy sediments • some shading of reach • some snags, woody debris & branches, and • little detritus in stream. <p>The site was wet during the November 2020 survey.</p> | | <p>Riparian condition: Good</p> <p>The riparian zone was narrow with surrounding agricultural land upstream. Some sedges were around the perimeter of the waterway. Evidence of deer, pig and horse disturbance was present in the surrounding riparian zone. Left and right bank height was low (approximately 2 m high) and steeply sloping on the left and gently sloping on some areas on the right near the bridge. Site was approximately 10 m wide. The wetted area was a still pool not connected downstream. The water appeared to be receding in subsequent survey days. It was unclear where water was fed from (e.g. upstream farm dam releases, groundwater etc.) and it was also unclear whether downstream earthworks were influencing water levels (e.g. damming water or restricting flow). While the waterway was a dry season refuge during the survey, it was unclear if water consistently endured the entire dry season or whether it was influenced by current land use and earthworks that occurred during the surveys.</p> | | <p>External Impacts: Moderate</p> <p>External impacts at the site were mostly associated with the surrounding land-use and included:</p> <ul style="list-style-type: none"> • reduced terrestrial vegetation as a result of land clearing • grazing by livestock, and • feral animals. | | <p>Water Quality: N/A</p>

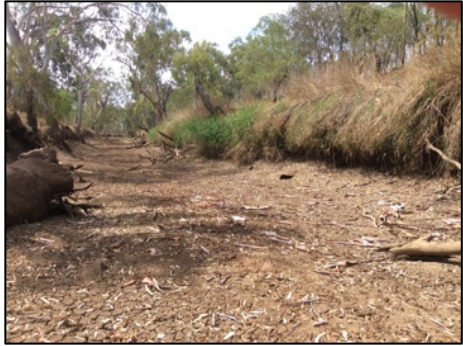
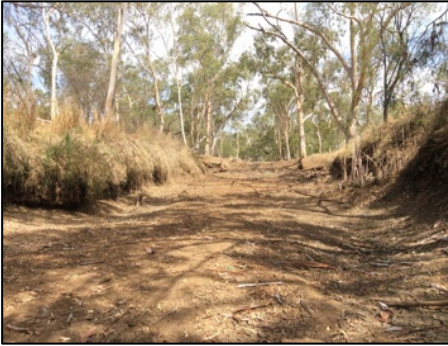
| Site: GCO2 | | Location: Upstream | Stream Order: 5 | Waterway: Grosvenor Creek | |

| Site: GCO2 | | Location: Upstream | Stream Order: 5 | Waterway: Grosvenor Creek | |
|---|--|--|---|---|---|
| Aquatic Ecosystem Value: Poor | | MNES/MSES: None present or likely to occur | | Dry season refuge: N/A | |
| In-stream condition: Poor Key habitat features in November 2020 included: <ul style="list-style-type: none"> • ephemeral channel • consolidated dry sediments • some shading of reach • some snags, woody debris & branches, and • little detritus. • eroded bank The site was dry during the November 2020 survey. | | Riparian condition: Good The riparian zone was a scattered semi-continuous/continuous mix of grasses, trees, and weeds. A dead eel was in the vicinity of the site. There was a road crossing downstream of the site, and there was water present approximately 200 m downstream of the site. Left and right banks were approximately 4 m high and steep. Channel was approximately 10 m wide. | | External Impacts: Moderate External impacts at the site were mostly associated with the surrounding land-use and included: <ul style="list-style-type: none"> • reduced terrestrial vegetation as a result of land clearing • grazing by livestock, and • feral animals. | |

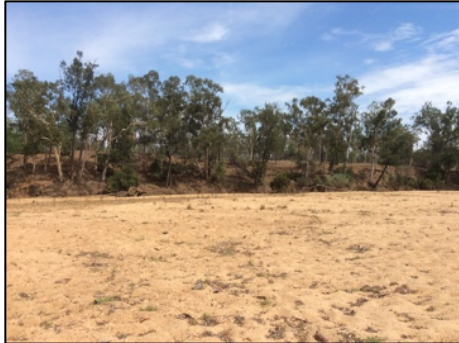
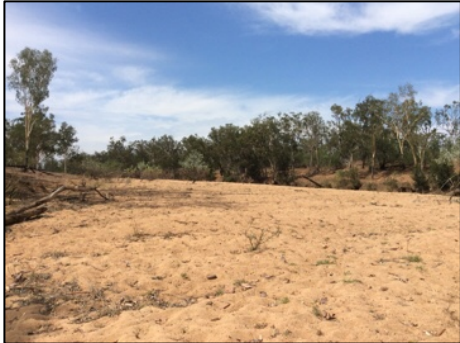
| | | | | | | | | | | | | | | | | | | | | | | | | | |
| Aquatic Ecosystem Value: Moderate | | MNES/MSES: None present or likely to occur | | Dry season refuge: N/A | | Connectivity: N/A | | | | | | | | | | | | | | | | | | | | | | |
| <p>In-stream condition: Poor</p> <p>Key habitat features in November 2020 included:</p> <ul style="list-style-type: none"> • ephemeral channel • predominately sandy sediments with some pebbles, gavel and clay/silt • little shading of reach • no trailing vegetation, and • some large snags, woody debris & branches. <p>The site was dry during the November survey.</p> | | <p>Riparian condition: Good</p> <p>The riparian zone was a scattered semi-continuous/continuous mix around the perimeter of the waterway, and the extent of the vegetation had been reduced. Vegetation consisted grasses, trees, and weeds. Left bank height was low (approximately 0.5 m high) and gently sloping; the right bank was higher (approximately 15 m high), steep banks with moderate erosion. There were some exotic terrestrial riparian species at the site. Site was wide (approximately 60 m wide).</p> | | <p>External Impacts: Moderate</p> <p>External impacts at the site were mostly associated with the surrounding land-use and included:</p> <ul style="list-style-type: none"> • reduced terrestrial vegetation as a result of land clearing • grazing by livestock, and • feral animals. | | <p>Water Quality: N/A</p>

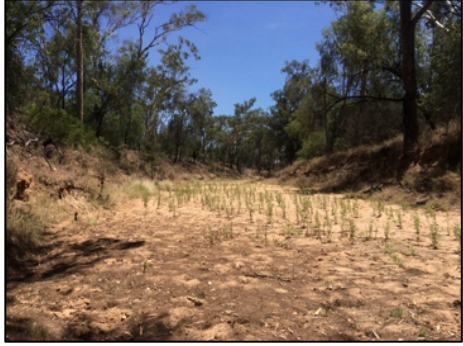
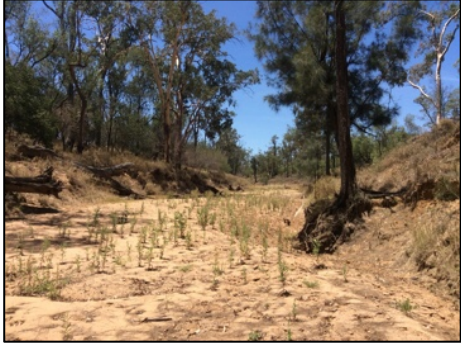
| | | | | | | | | | | | | | | | | | | |
| Aquatic Ecosystem Value: Moderate | | MNES/MSES: None present or likely to occur | | Dry season refuge: N/A | | Connectivity: N/A | | | | | | | | | | | | | | | |
| In-stream condition: Moderate Key habitat features in November 2020 included: <ul style="list-style-type: none"> • ephemeral channel • unconsolidated sand sediments • established terrestrial weeds in the channel • some shading of reach • little snags, woody debris & branches, and • little detritus. The site was dry during the November 2020 survey. | | Riparian condition: Fair The riparian zone was a scattered semi-continuous/continuous mix of grasses, trees, and weeds. Left and right bank height was approximately 5 m high, with moderate sloping on the left bank, and steep slopes on the right. Channel was approximately 20 m wide. | | External Impacts: Moderate External impacts at the site were mostly associated with the surrounding land-use and included: <ul style="list-style-type: none"> • reduced terrestrial vegetation as a result of land clearing • grazing by livestock, and feral animals. | | Water Quality: N/A

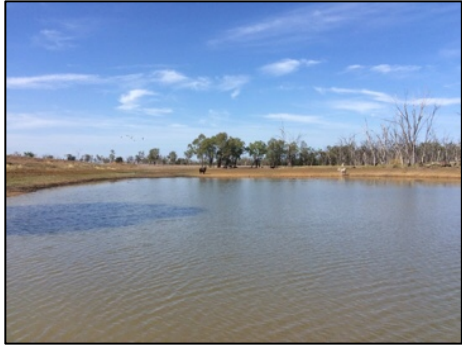
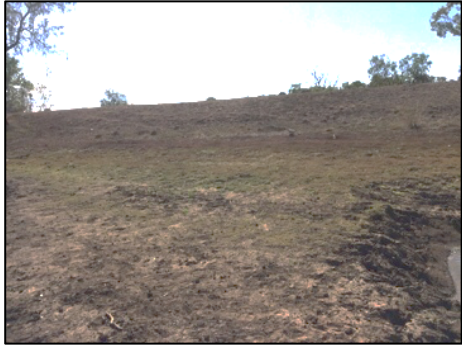
| Site: LW2 | | Location: Upstream | Stream Order: 2 | Waterway: Wetland | | | | | | | | | | | |
|--|---|--|---|---|---|---|---|---|---|---|---|---|---|---|---|
| Upstream: November 2020

| | | | | | | | | | | | | | |
| Aquatic Ecosystem Value: Poor | MNES/MSES: None present or likely to occur | Dry season refuge: Yes | Connectivity: Not connected | | | | | | | | | | | | |
| In-stream condition: Fair Key habitat features in November 2020 included: <ul style="list-style-type: none"> • shallow & deep pools • aquatic plants • predominately fine sediments (sand & silt/clay) • little trailing & overhanging vegetation, and • some snags, woody debris & detritus. The site was wet during the November 2020 survey. | Riparian condition: Good The riparian zone was a scattered continuous mix with isolated trees around the perimeter of the waterway, and the extent of the vegetation had been reduced. Vegetation consisted of grasses, shrubs, trees and weeds. Banks were generally low (approximately 1 m high) and gently sloping with moderate erosion. Damming side of the waterway had a more steeply sloping bank, approximately 5 m high. There were some exotic terrestrial riparian species at the site. | External Impacts: Moderate External impacts at the site were mostly associated with the surrounding land-use and included: <ul style="list-style-type: none"> • reduced terrestrial vegetation as a result of land clearing • grazing by livestock, and feral animals. | Water Quality: | | | | | | | | | | | | |
| | | |

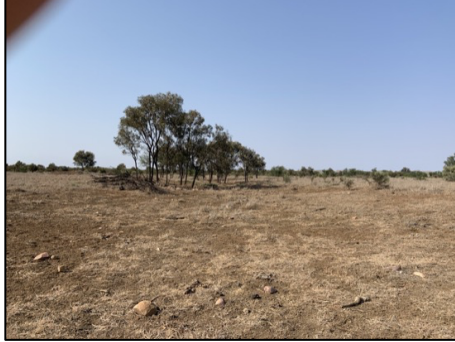
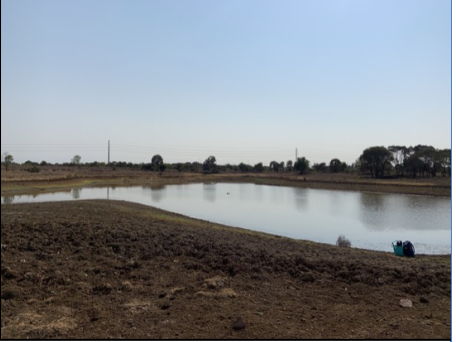
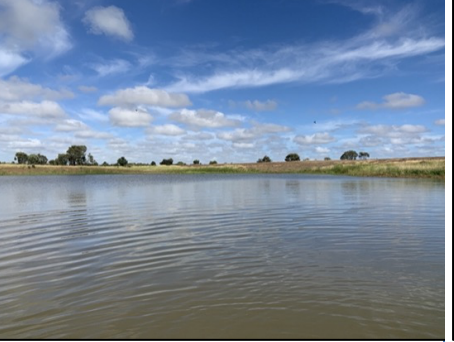
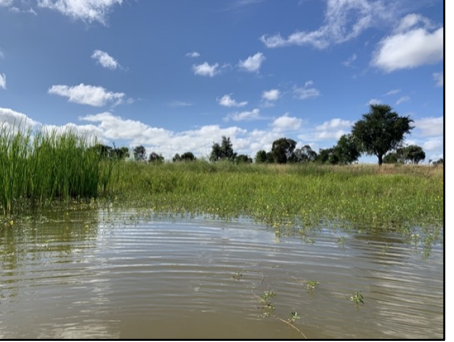
| | | | | | | | | | | | | | | | | | | | | | |
| Aquatic Ecosystem Value: Moderate | | MNES/MSES: None present or likely to occur | | Dry season refuge: Yes | | Connectivity: Poor, isolated from main watercourse by dam | | | | | | | | | | | | | | | | | | | | | | |
| In-stream condition: Fair Key habitat features included: <ul style="list-style-type: none"> • farm dam on ephemeral channel • aquatic plants lining channel • shallow & deep pools • predominately silt/clay sediments • little trailing bank vegetation and woody debris, and • some detritus. | | Riparian condition: Poor The riparian zone was isolated around the perimeter of the waterway, and the extent of the vegetation had been reduced due to historical clearing for agriculture. Vegetation consisted grasses, ferns and weeds. Banks were low (approximately 2.5 m high) and gently sloping with moderate erosion. There were some exotic terrestrial riparian species at the site. | | External Impacts: Extreme External impacts at the site were mostly associated with the surrounding land-use and included: <ul style="list-style-type: none"> • reduced riparian vegetation as a result of land clearing • grazing by livestock • feral animals, and • the presence of an artificial dam. | | Water Quality: Poor

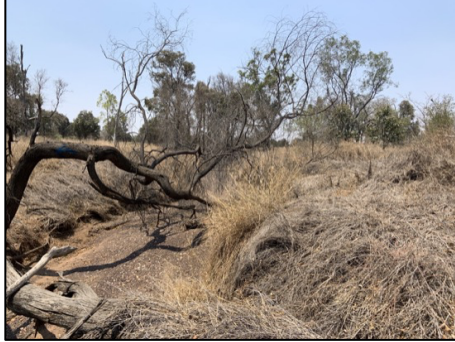
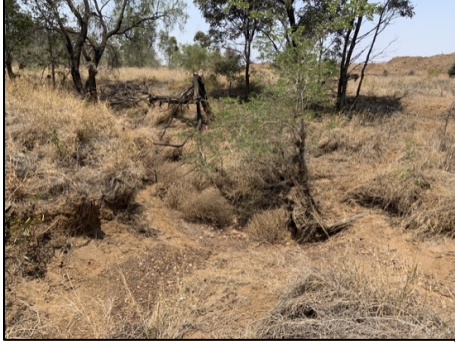
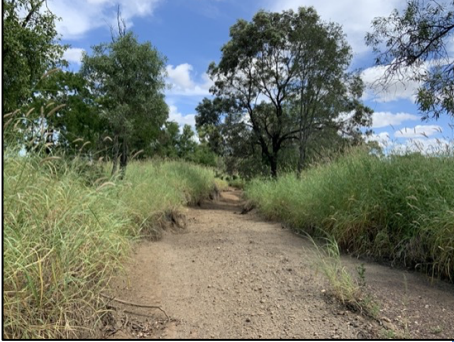
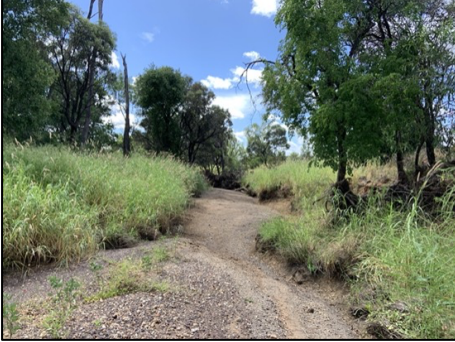
| | | | | | | | | | | | | | | | | | | | | | |
| Aquatic Ecosystem Value: Low | | MNES/MSES: None present or likely to occur | | Dry season refuge: No | | Connectivity: Limited, during periods of flow | | | | | | | | | | | | | | | | | | | | | | |
| In-stream condition: Fair Key potential habitat features included: <ul style="list-style-type: none"> • ephemeral waterway • predominately sandy sediments with some gravel and pebbles, and • moderate snags and woody debris. The site was dry during both the December and April surveys. | | Riparian condition: Fair The riparian zone was semi-continuous around the perimeter of the waterway, and the extent of the vegetation had been reduced. Vegetation consisted grasses, trees and weeds. Banks were low (approximately 1.8 m high) and gently sloping with moderate bank and extensive bed erosion. There were some exotic terrestrial riparian species at the site. | | External Impacts: High External impacts at the site were mostly associated with the surrounding land-use and included: <ul style="list-style-type: none"> • reduced riparian vegetation as a result of land clearing • grazing by livestock, and • feral animals. | | Water Quality: N/A

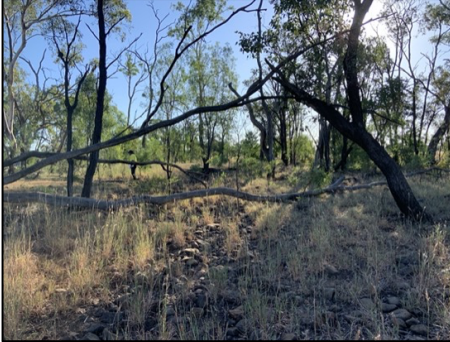
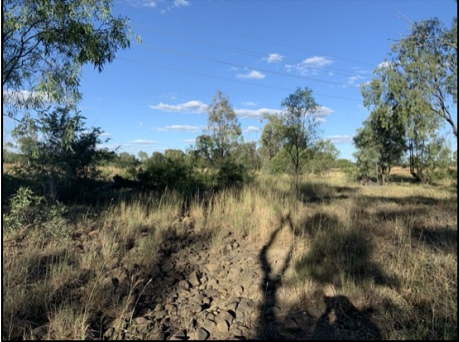
| | | | | | | | | | | | | | | | | | | | | | |
| Aquatic Ecosystem Value: Low | | MNES/MSES: None present or likely to occur | | Dry season refuge: No | | Connectivity: Limited, during periods of flow | | | | | | | | | | | | | | | | | | | | | | |
| <p>In-stream condition: Poor</p> <p>Key potential habitat features in April included:</p> <ul style="list-style-type: none"> • ephemeral waterway • rocky narrow channel • predominately cobbled sediments with some sand • little snags and woody debris, and • little trailing & overhanging vegetation. <p>The site was not sampled during the December survey and was dry during the April survey.</p> | | <p>Riparian condition: Fair</p> <p>The riparian zone was semi-continuous around the perimeter of the waterway, and the extent of the vegetation had been reduced. Vegetation consisted grasses, trees and weeds. Banks were low (approximately 1 m high) and gently sloping with moderate erosion. There were some exotic terrestrial riparian species at the site.</p> | | <p>External Impacts: High</p> <p>External impacts at the site were mostly associated with the surrounding land-use and included:</p> <ul style="list-style-type: none"> • reduced riparian vegetation as a result of land clearing • grazing by livestock, and • feral animals. | | <p>Water Quality: N/A</p>

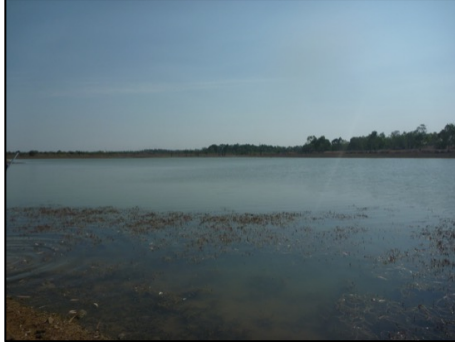
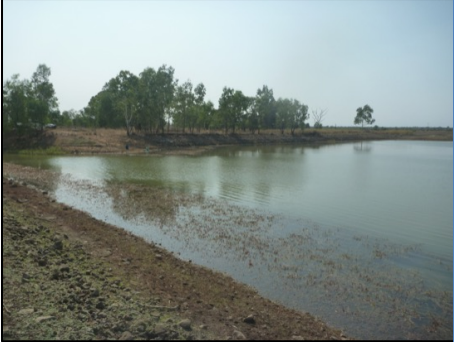
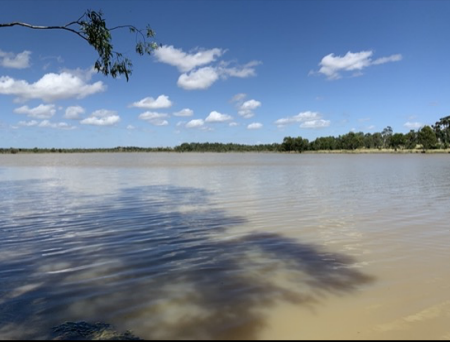
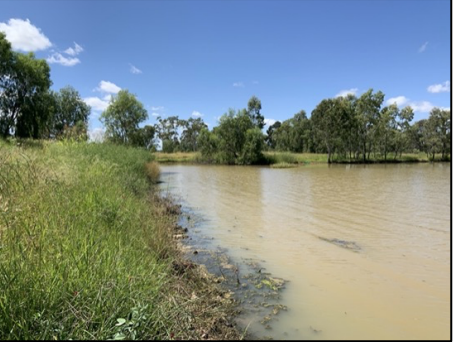
| | | | | | | | | | | | | | | | | | | | | | |
| Aquatic Ecosystem Value: Moderate | | MNES/MSES: None present or likely to occur | | Dry season refuge: Yes | | Connectivity: Limited due to high dam walls | | | | | | | | | | | | | | | | | | | | | | |
| In-stream condition: Fair Key habitat features included: <ul style="list-style-type: none"> • shallow & deep pools • aquatic plants • predominately fine sediments (sand & silt/clay) • little trailing & overhanging vegetation, and • some snags, woody debris & detritus. | | Riparian condition: Fair The riparian zone was a scattered continuous mix with isolated trees around the perimeter of the waterway, and the extent of the vegetation had been reduced. Vegetation consisted grasses, shrubs, trees and weeds. Banks were low (approximately 3 m high) and gently sloping with moderate erosion. There were some exotic terrestrial riparian species at the site. | | External Impacts: High External impacts at the site were mostly associated with the surrounding land-use and included: <ul style="list-style-type: none"> • reduced riparian vegetation as a result of land clearing • grazing by livestock • feral animals, and • presence of an artificial dam. | | Water Quality: Poor

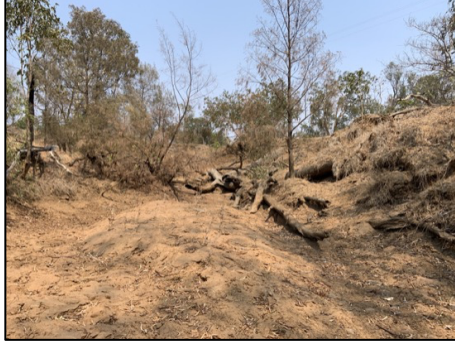
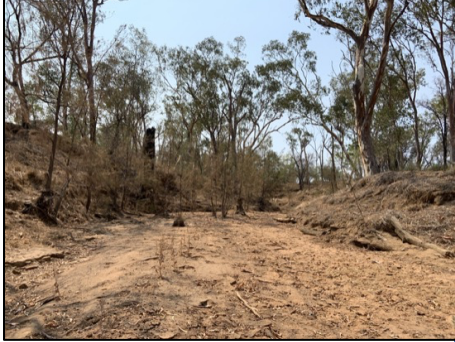
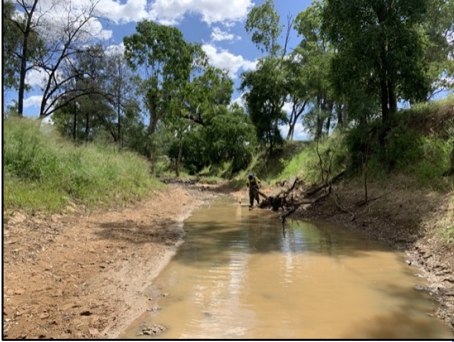
| | | | | | | | | | | | | | | | | | | | | | | | |
| Aquatic Ecosystem Value: Moderate | | MNES/MSES: None present or likely to occur | | Dry season refuge: No | | Connectivity: Good, during periods of flow | | | | | | | | | | | | | | | | | | | | | | |
| In-stream condition: Good Key habitat features in April included: <ul style="list-style-type: none"> • ephemeral channel • predominately sandy sediments with some pebbles, gavel and clay/silt • moderate overhanging vegetation • some shallow pools, and • some snags, woody debris & branches. The site was dry during the December survey. | | Riparian condition: Good The riparian zone was a scattered semi-continuous/continuous mix around the perimeter of the waterway, and the extent of the vegetation had been reduced. Vegetation consisted grasses, shrubs, trees, ferns and weeds. Banks were low (approximately 4 m high) and gently sloping with moderate erosion. There were some exotic terrestrial riparian species at the site. | | External Impacts: High External impacts at the site were mostly associated with the surrounding land-use and included: <ul style="list-style-type: none"> • reduced riparian vegetation as a result of land clearing • grazing by livestock, and • feral animals. | | Water Quality: Fair

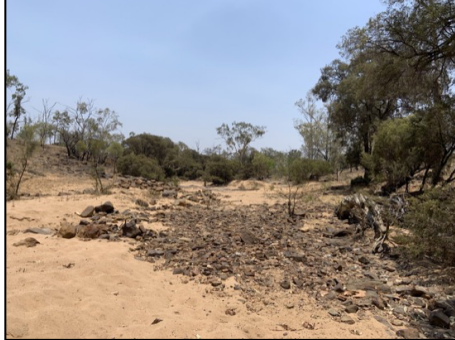
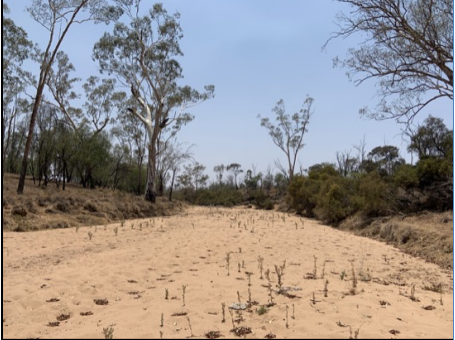
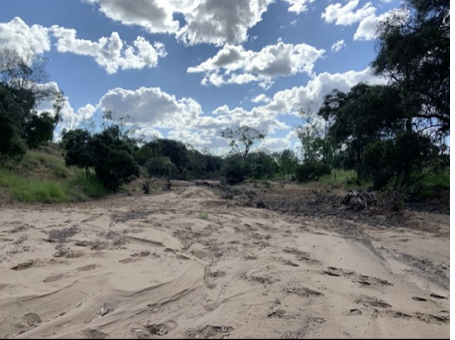
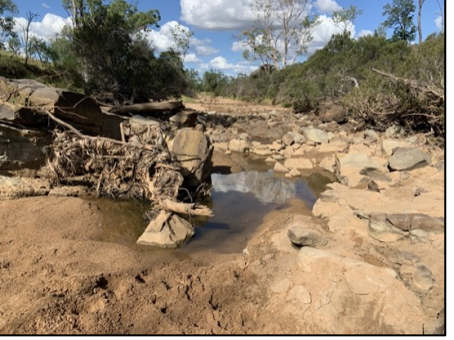
| | | | | | | | | | | | | | | | | | | | | | |
| Aquatic Ecosystem Value: Moderate | | MNES/MSES: None present or likely to occur | | Dry season refuge: No | | Connectivity: Good, during periods of flow | | | | | | | | | | | | | | | | | | | | | | |
| In-stream condition: Good Key habitat features in April included: <ul style="list-style-type: none"> • ephemeral channel • shallow pools • predominately sandy sediments with some pebbles, gavel and clay/silt • little overhanging & trailing vegetation, and • little snags, woody debris & branches. The site was dry during the December survey. | | Riparian condition: Good The riparian zone was a continuous width around the perimeter of the waterway, and the extent of the vegetation had been reduced. Vegetation consisted grasses, shrubs, trees, ferns and weeds. Banks were low (approximately 4 m high) and gently sloping with moderate erosion. There were some exotic terrestrial riparian species at the site. | | External Impacts: Moderate External impacts at the site were mostly associated with the surrounding land-use and included: <ul style="list-style-type: none"> • reduced riparian vegetation as a result of land clearing • grazing by livestock, and • feral animals. | | Water Quality: Good

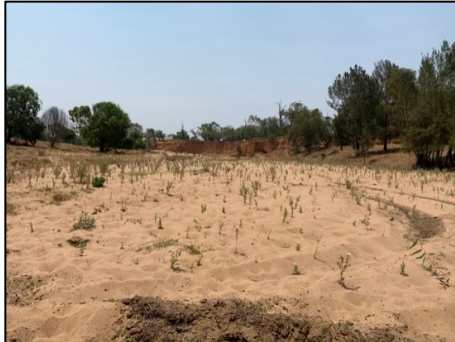
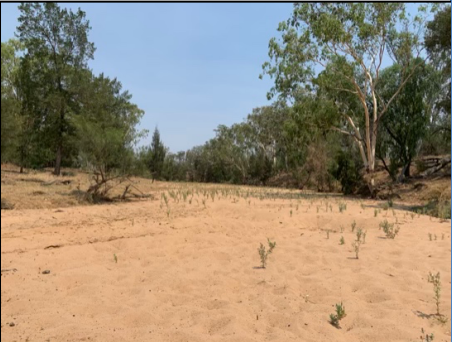
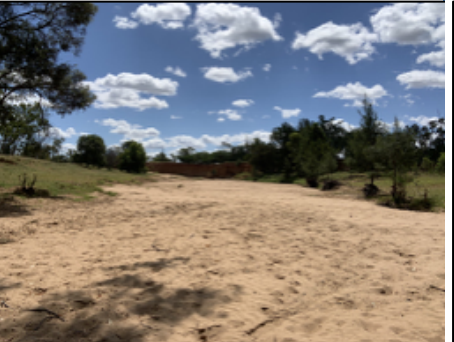
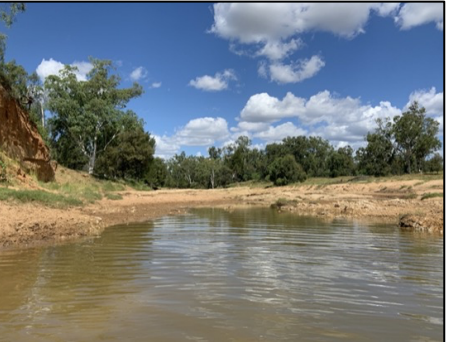
| | | | | | | | | | | | | | | | | | | | | | |
| Aquatic Ecosystem Value: Moderate | | MNES/MSES: None present or likely to occur | | Dry season refuge: No | | Connectivity: Good, during periods of flow | | | | | | | | | | | | | | | | | | | | | | |
| In-stream condition: Good Key habitat features in April included: <ul style="list-style-type: none"> • ephemeral channel • predominately sandy sediments with some clay/silt • some overhanging vegetation • little snags, woody debris & branches • shallow pool at eroded bend. The site was dry during the December survey. | | Riparian condition: Fair The riparian zone was a semi-continuous/ continuous mix around the perimeter of the waterway, and the extent of the vegetation had been reduced. Vegetation consisted grasses, shrubs, trees, ferns and weeds. Banks were low (2.5 m – 3.5 m high) and gently sloping with extensive erosion. There were some exotic terrestrial riparian species at the site. | | External Impacts: Moderate External impacts at the site were mostly associated with the surrounding land-use and included: <ul style="list-style-type: none"> • reduced riparian vegetation as a result of land clearing • grazing by livestock, and • feral animals. | | Water Quality: Fair

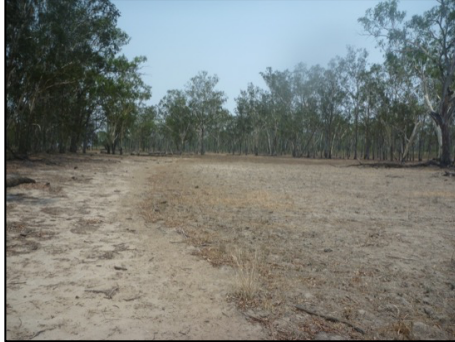
| | | | | | | | | | | | | | | | | | | | | | | | | | |
| Aquatic Ecosystem Value: Low | | MNES/MSES: None present or likely to occur | | Dry season refuge: No | | Connectivity: Limited, would only hold water during periods of high flow | | | | | | | | | | | | | | | | | | | | | | |
| <p>In-stream condition: Poor</p> <p>Key potential habitat features in December included:</p> <ul style="list-style-type: none"> • predominately clay/silt sediments • little overhanging & trailing vegetation • emergent aquatic plants, and • little snags, woody debris & branches. <p>The site was dry during the December survey and was not sampled during the April survey due to property access issues.</p> | | <p>Riparian condition: Fair</p> <p>The riparian zone was reduced but continuous around the perimeter of the wetland, and the extent of the vegetation had been reduced. Vegetation consisted trees predominantly eucalyptus, grasses and shrubs. There was some erosion in the dry bed. There were some exotic terrestrial riparian species at the site.</p> | | <p>External Impacts: Moderate</p> <p>External impacts at the site were mostly associated with the surrounding land-use and included:</p> <ul style="list-style-type: none"> • reduced riparian vegetation as a result of land clearing • grazing by livestock, and • feral animals. | | <p>Water Quality: N/A</p>

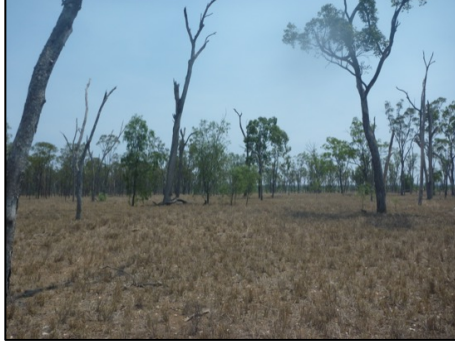
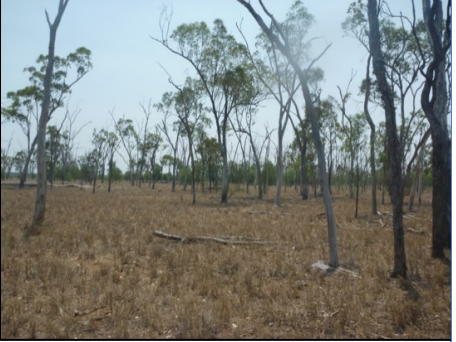
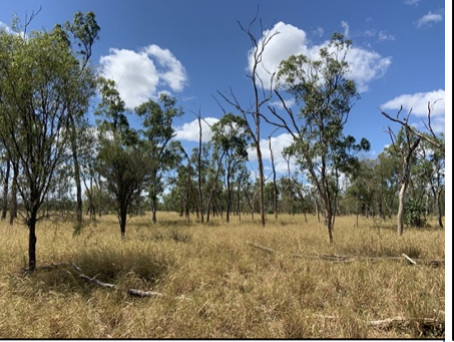
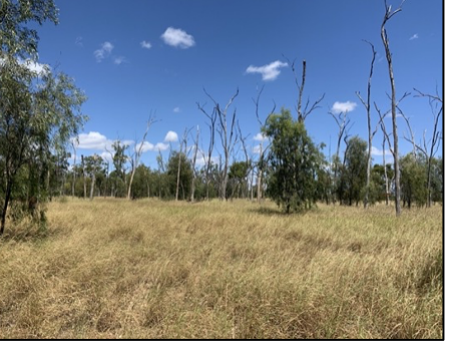
| | | | | | | | | | | | | | | | | | | | | | |
| Aquatic Ecosystem Value: N/A | | MNES/MSES: N/A | | Dry season refuge: N/A | | Connectivity: N/A | | | | | | | | | | | | | | | | | | | | | | |
| <p>In-stream condition: N/A</p> <p>No aquatic habitat features recorded at this site. Site is likely incorrectly mapped as a palustrine wetland, with terrestrial ecological values only.</p> | | <p>Riparian condition: Fair</p> <p>This site did not feature a riparian zone as no aquatic ecological features were evident, however, terrestrial vegetation in the broader region consisted grasses, shrubs, trees, and weeds. There some exotic terrestrial species at the site.</p> | | <p>External Impacts: Moderate</p> <p>External impacts at the site were mostly associated with the surrounding land-use and included:</p> <ul style="list-style-type: none"> • reduced terrestrial vegetation as a result of land clearing • grazing by livestock, and • feral animals. | | <p>Water Quality: N/A</p>

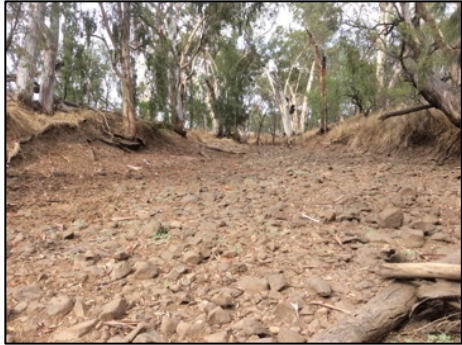
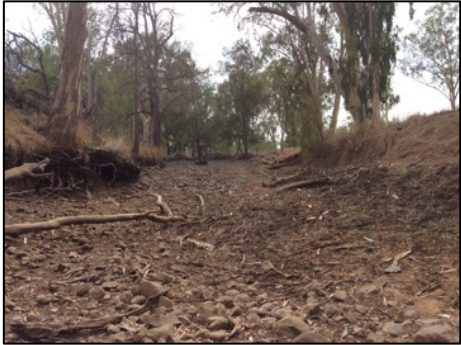
| | | | | | | | | | | | | | | | | | | |
| Aquatic Ecosystem Value: Moderate | | MNES/MSES: None present or likely to occur | | Dry season refuge: N/A | | Connectivity: N/A | | | | | | | | | | | | | | | |
| In-stream condition: Fair Key habitat features in November 2020 included: <ul style="list-style-type: none"> • substrate predominately sand, rocks and pebbles • moderate shading of reach • extensive snags, woody debris & branches, and • some terrestrial detritus. The site was dry during the November 2020 survey. | | Riparian condition: Good The riparian zone was a scattered semi-continuous/continuous mix of grasses, large trees, and weeds. Both banks were approximately 4 m high, with some eroded bank areas around tree roots, providing good habitat for fish and macroinvertebrates. Channel was approximately 10 m wide. Large trees in the riparian zone provided moderate-extensive shading throughout the reach. | | External Impacts: Moderate External impacts at the site were mostly associated with the surrounding land-use and included: <ul style="list-style-type: none"> • reduced terrestrial vegetation as a result of land clearing • grazing by livestock, and feral animals. | | Water Quality: N/A

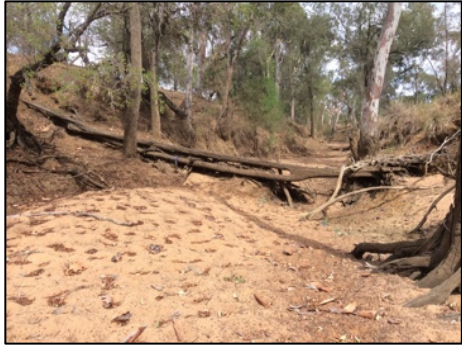
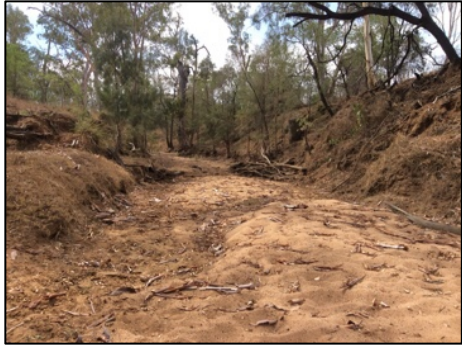
| | | | | | | | | | | | | | | | | | | |
| Aquatic Ecosystem Value: Moderate | | MNES/MSES: None present or likely to occur | | Dry season refuge: N/A | | Connectivity: N/A | | | | | | | | | | | | | | | |
| <p>In-stream condition: Fair</p> <p>Key habitat features in November 2020 included:</p> <ul style="list-style-type: none"> • substrate predominately unconsolidated sand • moderate-extensive shading of reach • extensive snags, woody debris & branches • some large snags, and • extensive terrestrial detritus. <p>The site was dry during the November 2020 survey.</p> | | <p>Riparian condition: Good</p> <p>The riparian zone was a scattered continuous mix of grasses, large trees, and weeds. Both banks were approximately 3 m high, with some eroded bank areas around tree roots, providing good habitat for fish and macroinvertebrates. Channel was approximately 10 m wide. Large trees in the riparian zone provided moderate-extensive shading throughout the reach.</p> | | <p>External Impacts: Moderate</p> <p>External impacts at the site were mostly associated with the surrounding land-use and included:</p> <ul style="list-style-type: none"> • reduced terrestrial vegetation as a result of land clearing • grazing by livestock, and feral animals. | | <p>Water Quality: N/A</p>

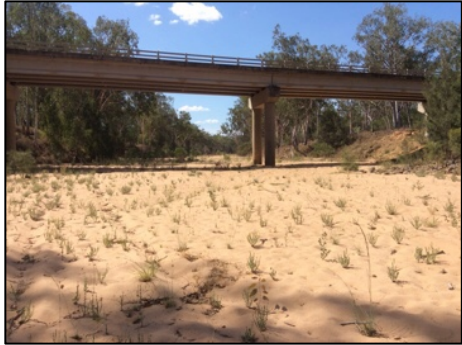
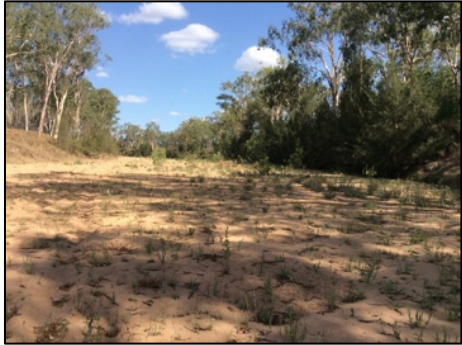
| | | | | | | | | | | | | | | | | | | |
| Aquatic Ecosystem Value: Moderate | | MNES/MSES: None present or likely to occur | | Dry season refuge: N/A | | Connectivity: N/A | | | | | | | | | | | | | | | |
| In-stream condition: Poor Key habitat features in November 2020 included: <ul style="list-style-type: none"> • ephemeral channel • unconsolidated sand sediments • established terrestrial weeds in the channel • moderate shading of reach • some snags, woody debris & branches, and • little detritus. The site was dry during the November 2020 survey. | | Riparian condition: Good The riparian zone was a scattered semi-continuous/continuous mix of grasses, large trees, and weeds. Left bank downstream was gently sloping while right bank was a higher reaching steep bank. The confluence of Grosvenor Creek and Isaac River was approximately 100 m upstream of the bridge. Channel was approximately 40 m wide. | | External Impacts: Moderate External impacts at the site were mostly associated with the surrounding land-use and included: <ul style="list-style-type: none"> • reduced terrestrial vegetation as a result of land clearing • grazing by livestock, and • feral animals. | | Water Quality: N/A
