Appendix D1: Services Investigation and Stormwater Management Report

HAYTERDALE AFRICAMPS

ROADS AND WET SERVICES REPORT: PROPOSED PERMANENT TENTED CAMP: FARM 406 HAYTERDALE, ZUURBERG ROAD, SUNDAYS RIVER VALLEY MUNICIPALITY NEAR ADDO IN THE, EASTERN CAPE

DATE : 23 March 2020

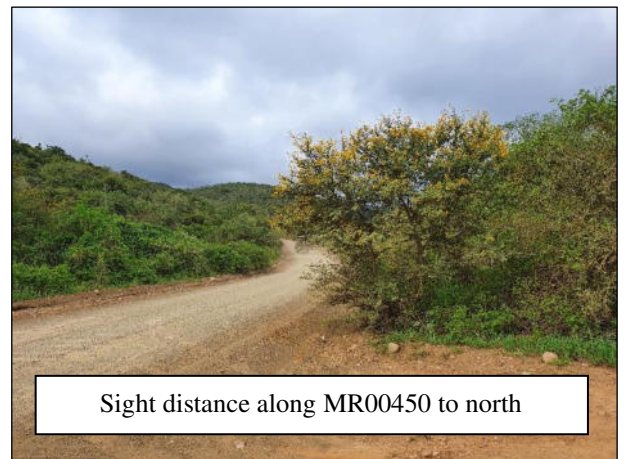
As such, it is proposed to create a new access to the tented camp approximately 300m south of the existing access point. Sight distances from this access point both to the north and the south meet the necessary requirements as specified in terms of **TRH 17: Geometric Design of Rural Roads** ⁽²⁾. TRH17 recommends that a single unit and trailer vehicle entering a road with a design speed of 60kph turning left or right requires shoulder sight distance of 250m. The requirement for a passenger car is 145m.

The proposed access location is indicated on **Figure 3** overleaf.

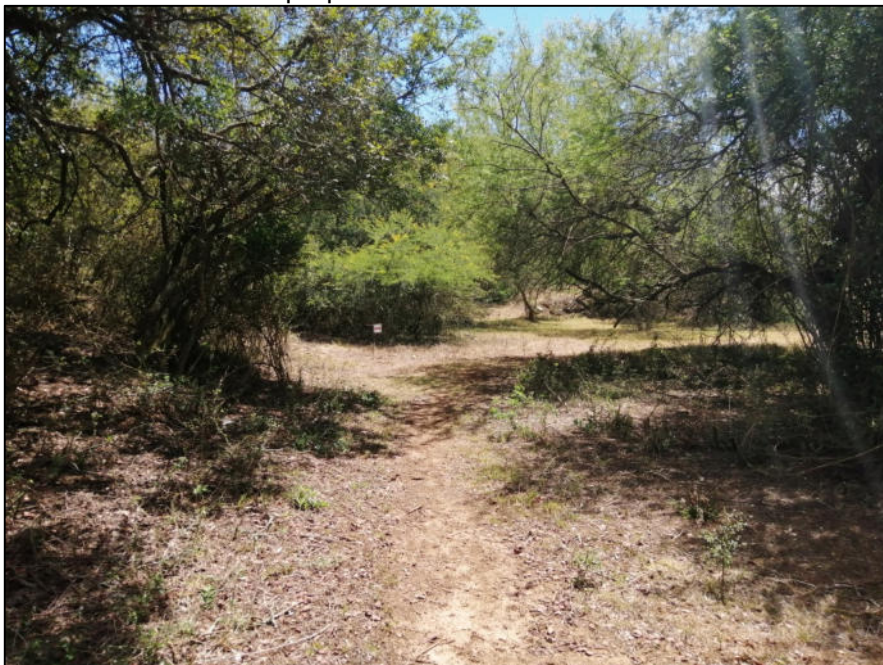
Figure 10. Existing gravel road / single-track path in the northern portion of the proposed access road, surrounded by sparse shrubs and grasses and mature Sweet Thorn trees.

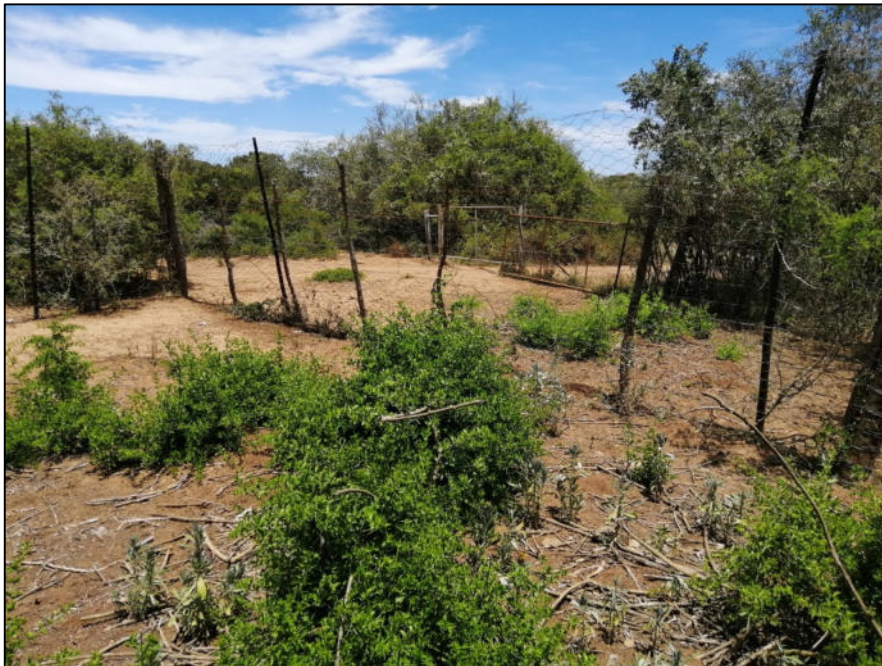
Figure 12. Proposed new entrance area at an existing fenced and gated gravel access road to the R335, in a cleared / maintained area at the southern end of the single-track path.

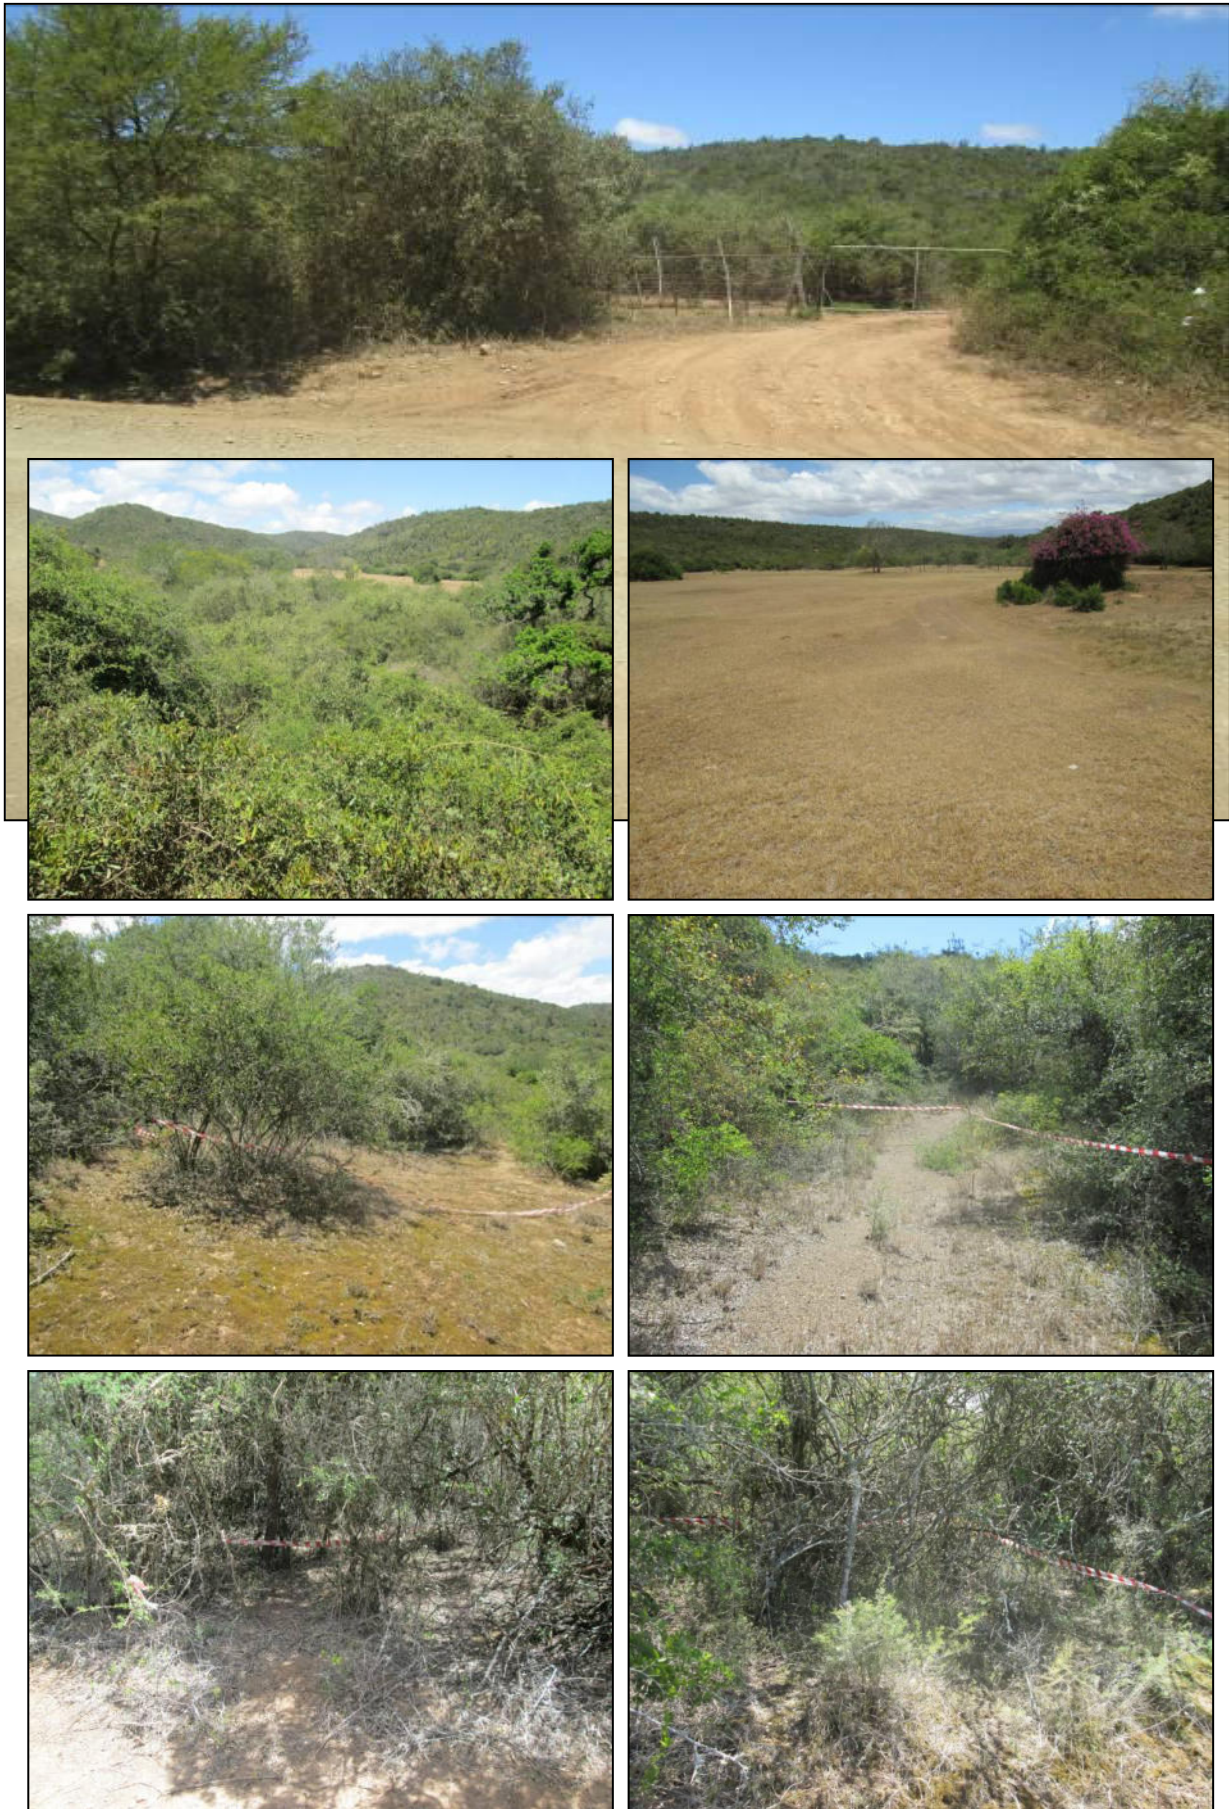
Figure 1. General views of the proposed site for development. The new entrance to the development is illustrated in the main image and top row of inserts. The bottom two rows are examples of the terrain where tented sites will be constructed.

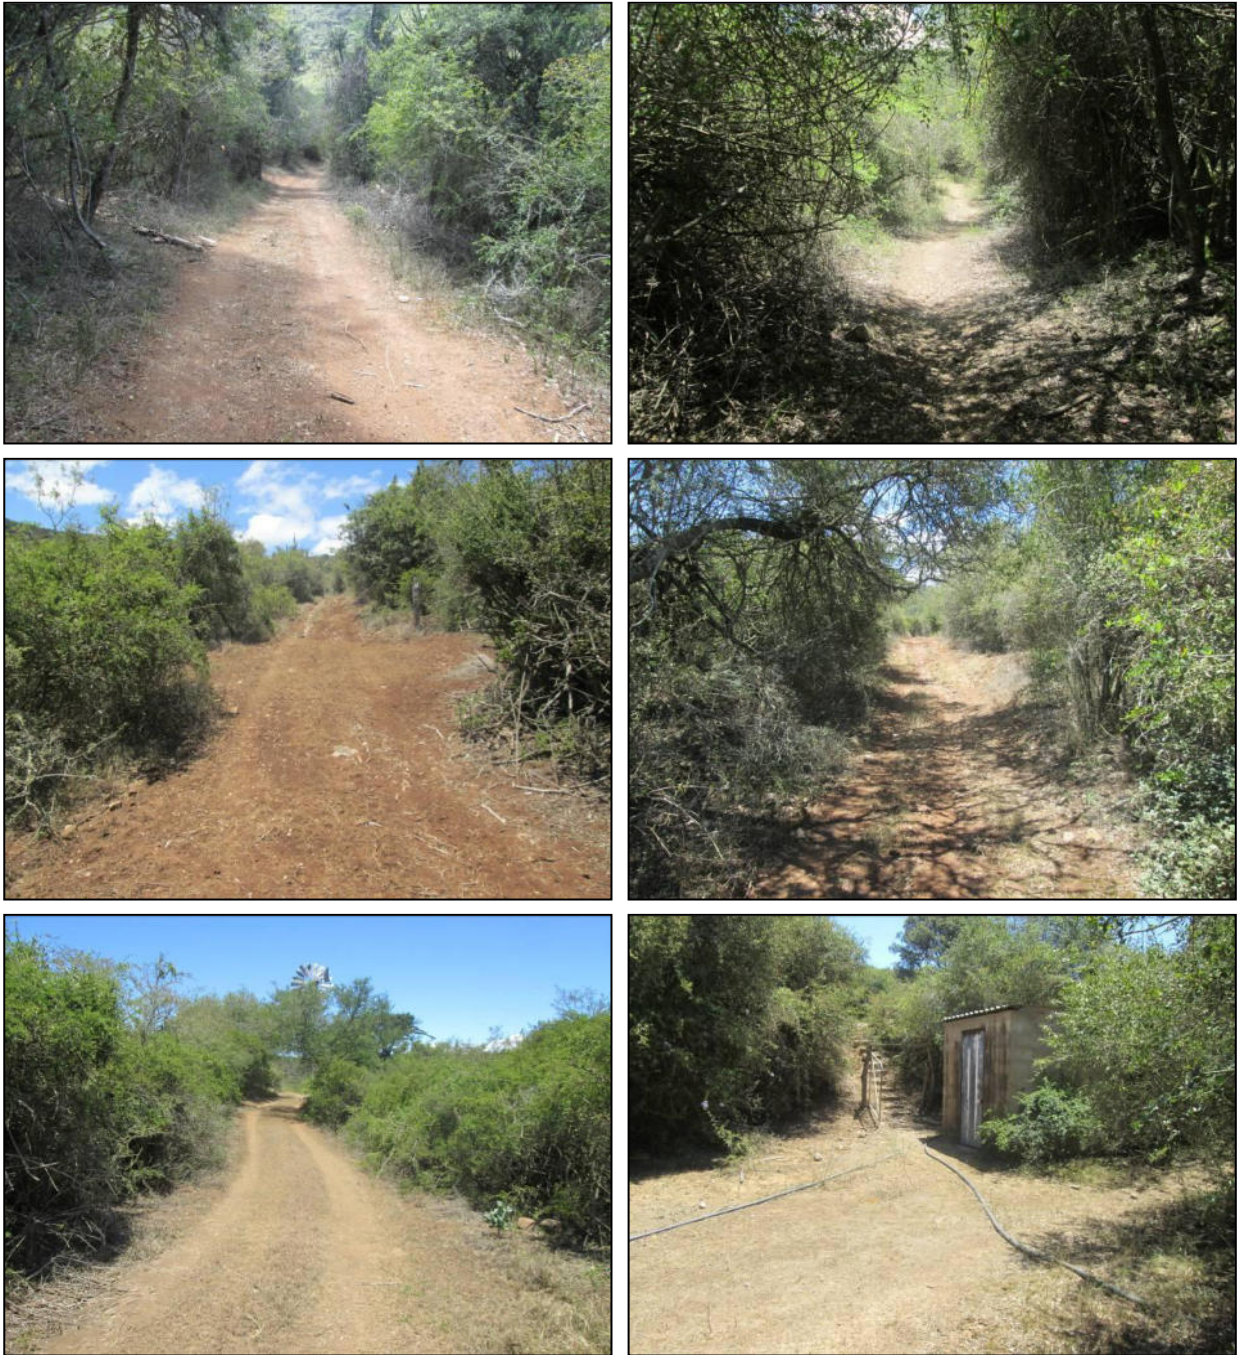
Figure 2. General views of the pipeline route east (top row inserts), west (middle row inserts) and the area for the placement of water tanks and other infrastructure (bottom row of inserts)

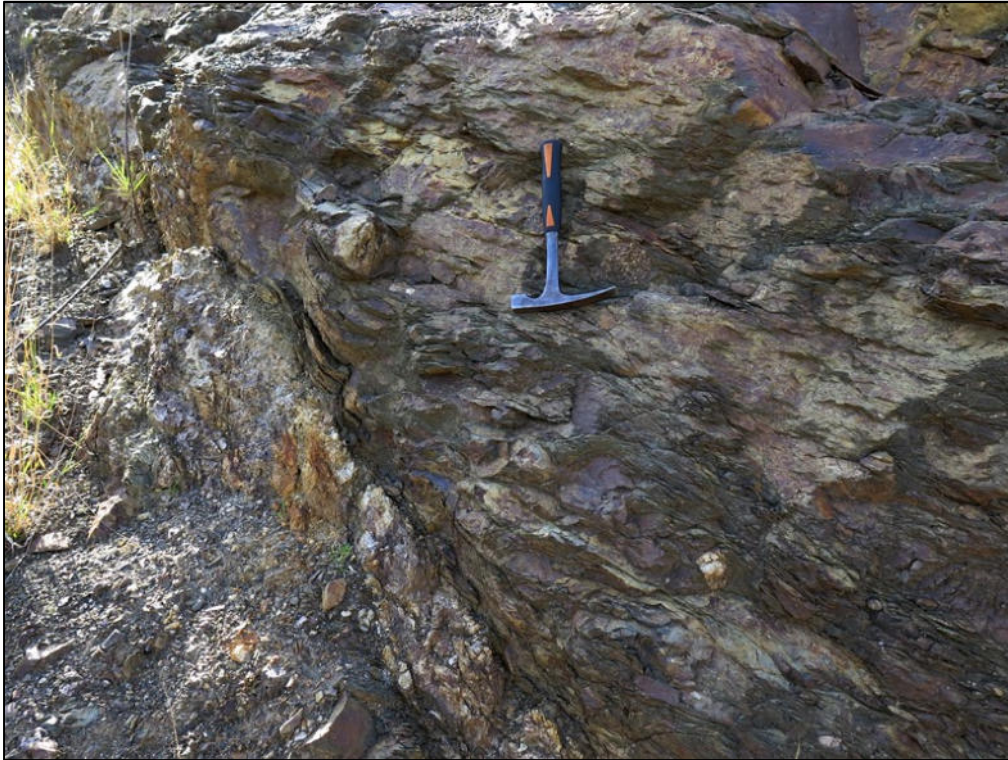
Figure 3: Deformed and faulted clast-poor Dwyka Group diamictite exposed in the roadside quarry along the R335, c. 1.4 km WNW of the project area (Pa in Fig. 14) (Hammer = 30 cm).

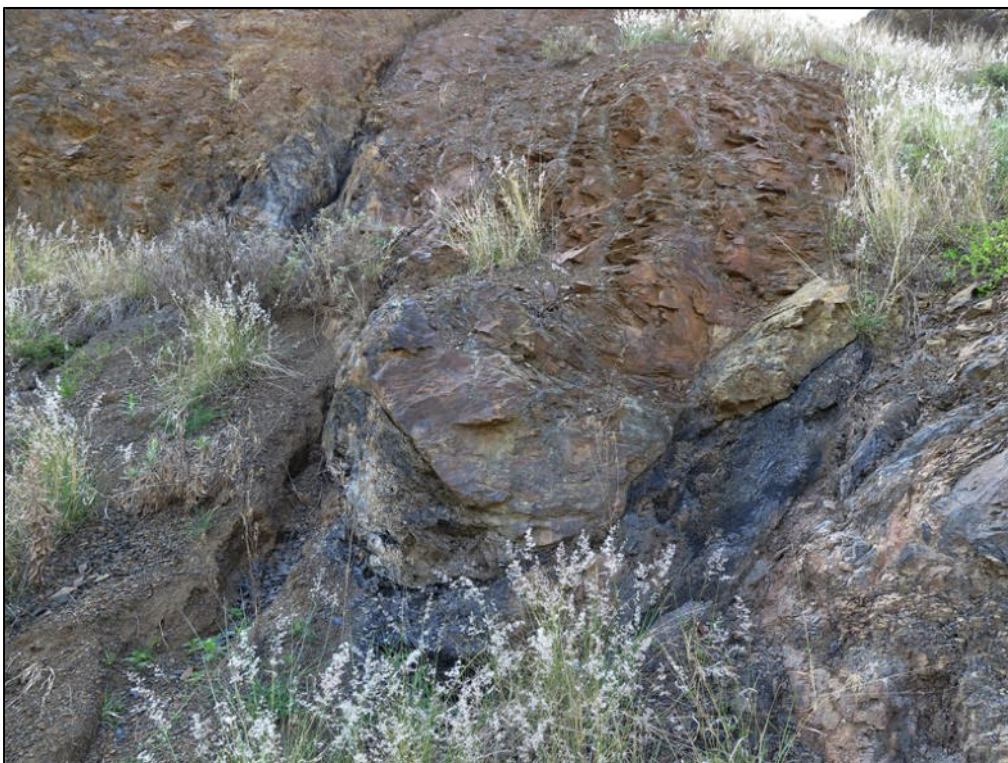
Figure 4: Highly-deformed contact between Dwyka diamictite / wacke with blackish mudrocks of the Prince Albert Formation, quarry c. 1.4 km WNW of the project area (Pa in Fig. 14).

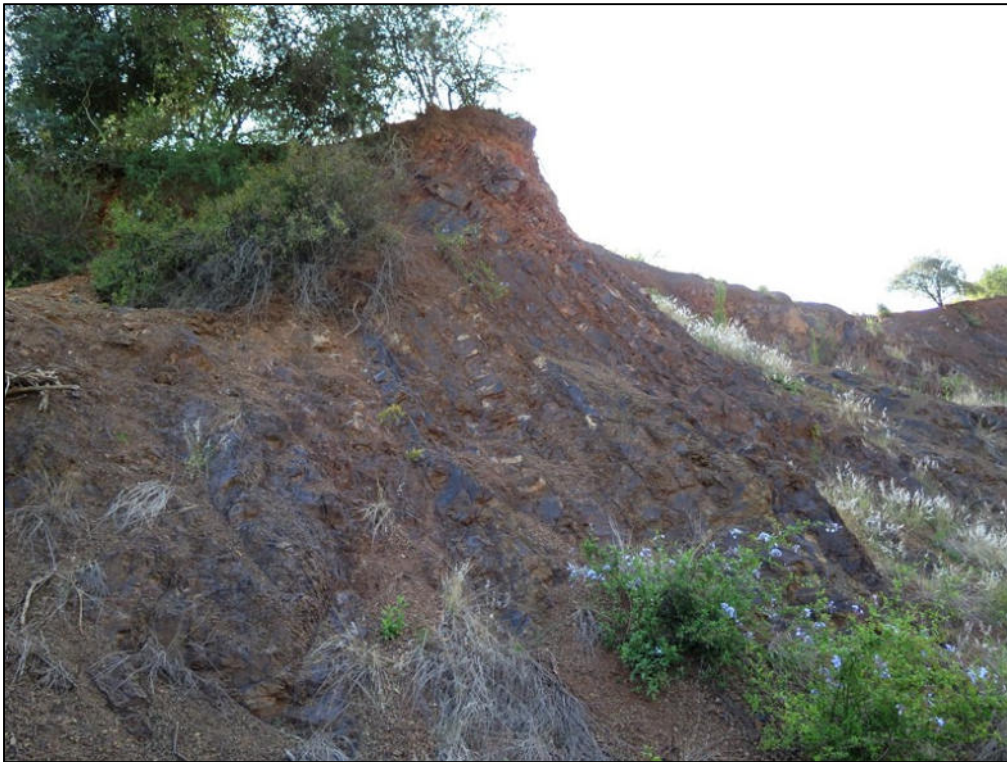
Figure 5: Steeply-dipping, highly fractured beds of Prince Albert Formation mudrocks, quarry c. 1.4 km WNW of the project area (Pa in Fig. 14).

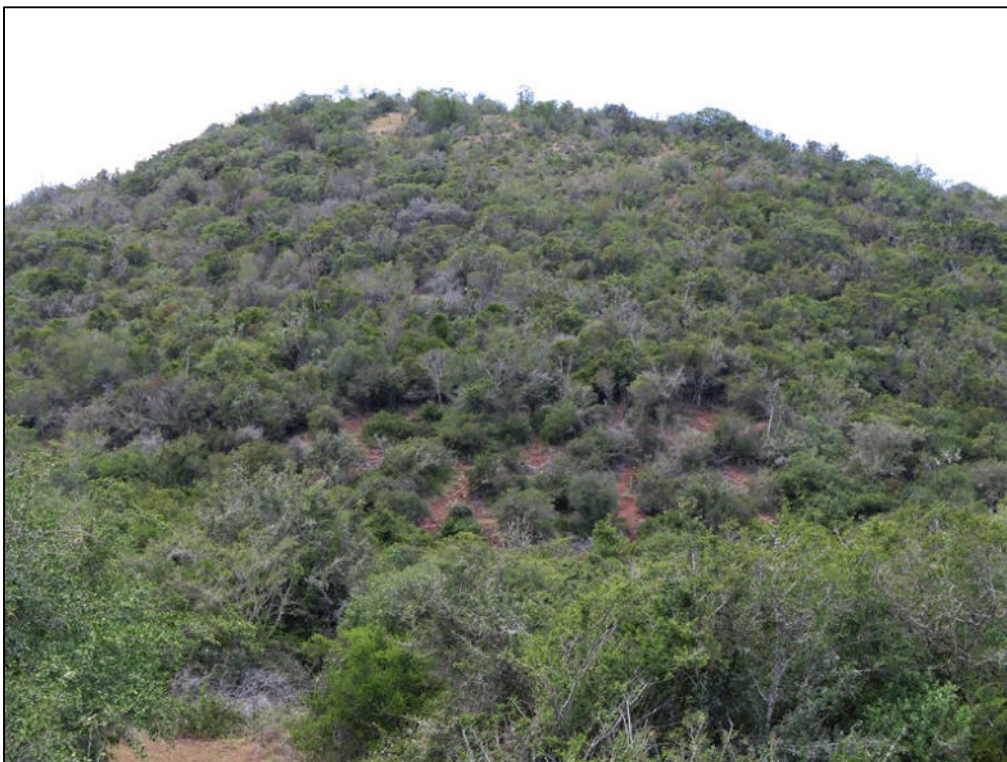
Figure 6: Typical steep, densely-vegetated hilly terrain within the project area on the northern flank of the Suurberg Range with hillslopes pervasively mantled by orange-hued, loose quartzitic colluvial gravels and gravelly soils.

Moderate to steep hillslopes within the area are almost entirely mantled with loose cobbly to bouldery colluvial gravels of angular to well-rounded, pale grey quartzite clasts that may be derived from the underlying Enon Formation bedrocks (Some of the clasts are anthropogenically flaked) (Figs. 6 & 7). Consolidated Enon bedrocks were not seen *in situ*, however. The colluvial gravels themselves are probably of Neogene to Holocene age. Given the presence of planed-off pediment surfaces at higher elevations within the Suurberg Range to the north, it is possible that some of these gravels are reworked from High Level terrace gravels of "Tertiary" age and not directly from Enon bedrocks.

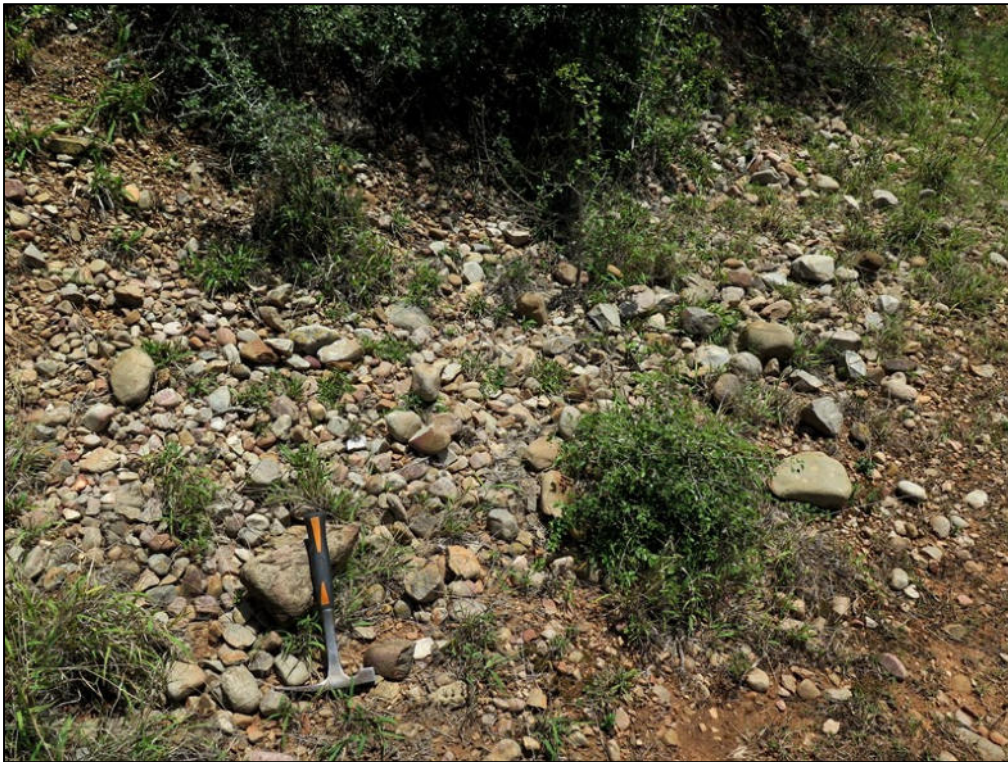
Figure 7: Unconsolidated, poorly-sorted, angular to well-rounded quartzitic gravels exposed along pathways in the project area (Hammer = 30 cm). Consolidated Enon Formation conglomerates were not observed *in situ*. The gravels are probably Late Caenozoic in age and may in part be reworked from High Level terrace gravels.

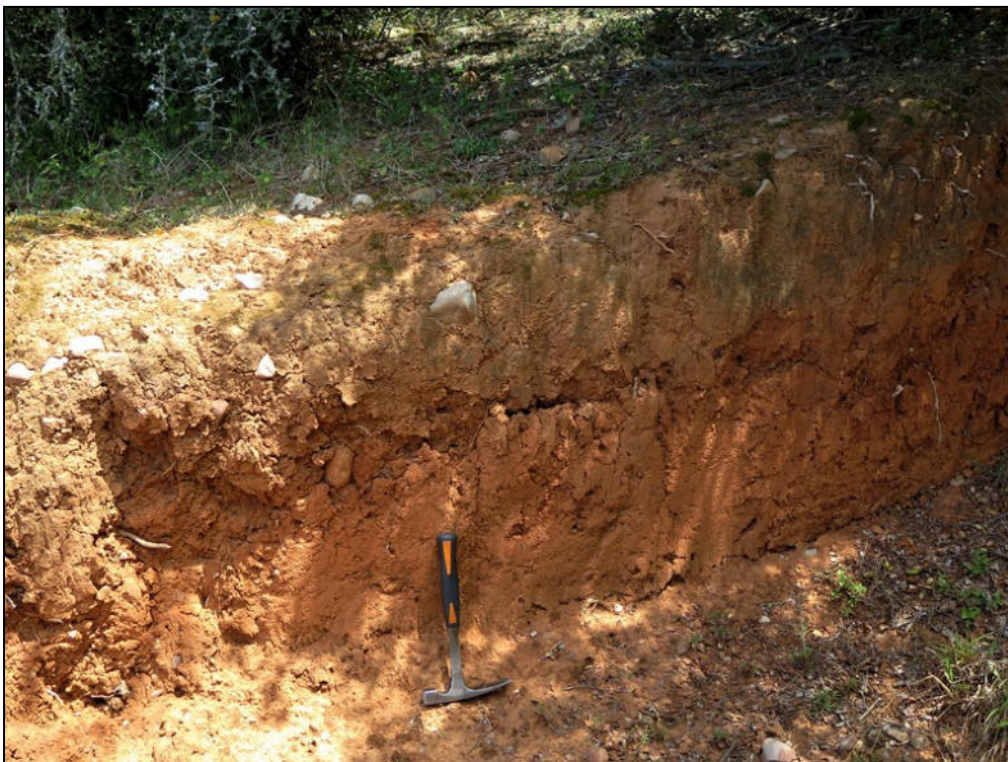
Figure 8: Thick, orange-brown sandy soils with dispersed quartzitic gravels exposed in an excavation on the lower hillslopes in the southern sector of the project area (Hammer = 30 cm).

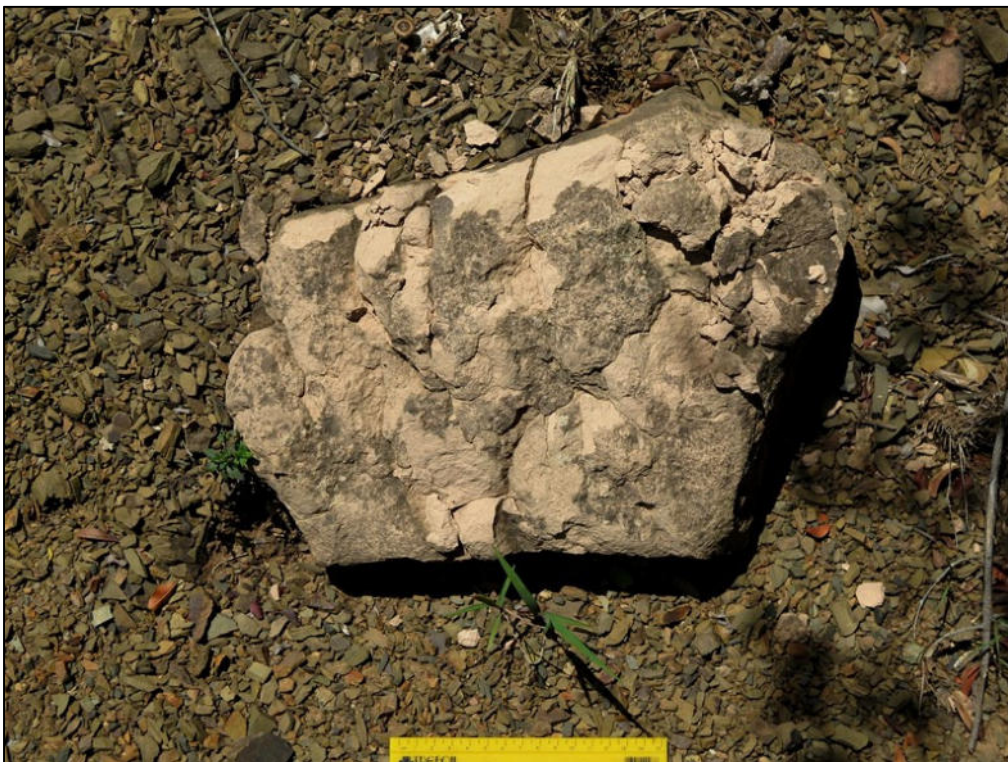
Figure 10: Float block of pinkish fine-grained sandstone of probable Suurberg Group provenance (Scale c. 15 cm long).

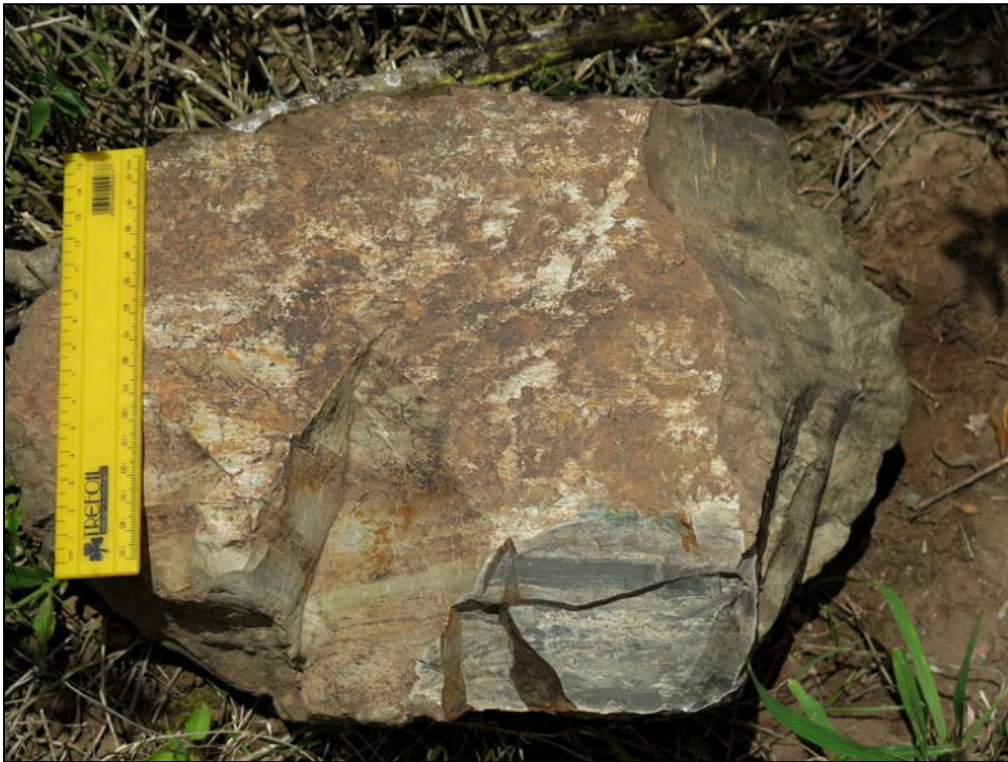
Figure 11: Float block of well-indurated, streaky greenish-grey tuff or tuffite from the Suurberg Group (Scale in cm and mm).

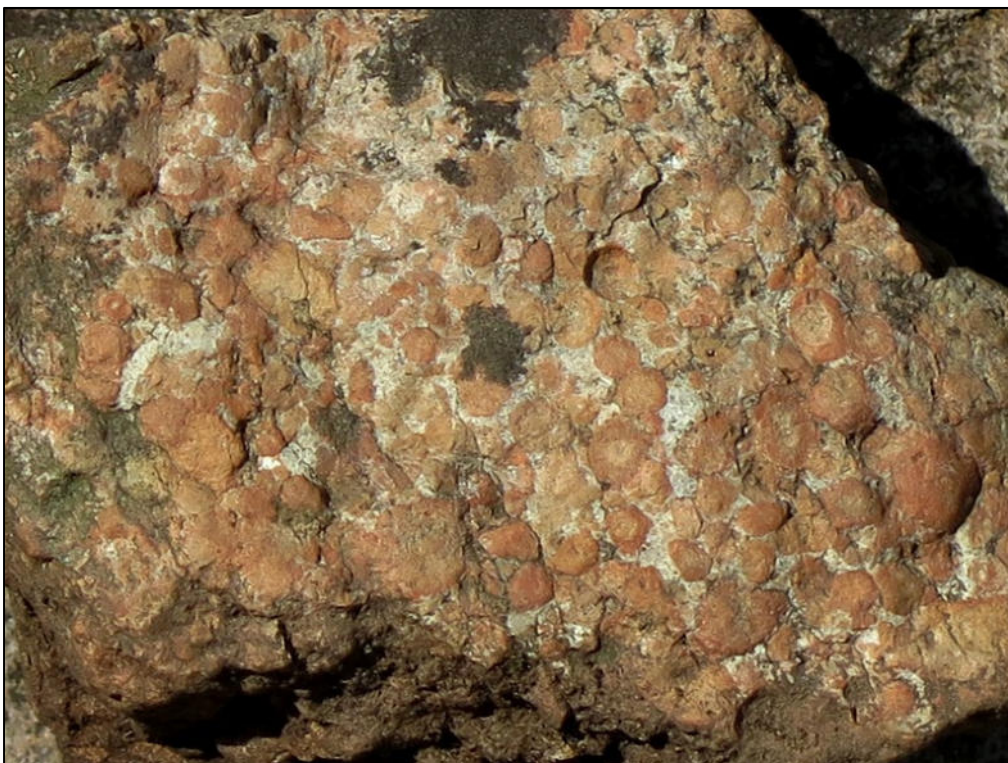
Figure 12: Detail of float block of pale spherulitic devitrified tuff, possibly from the Coerney Formation (Largest spherule c. 1 cm across).

On lower hillslopes and valley floors the gravels are covered by reddish-brown, gravel-rich sandy soils up to several meters thick, with darker loamy soils and calcrete nodules developed in some areas (Fig. 8). Surface gravels contain occasional blocks of spherulitic devitrified tuff, dense, pale grey-green streaky to laminated, crystal-rich tuff or tuffite, pinkish or orange-brown sandstone and grey-green to brown-weathering amygdaloidal basalt, all reworked from the Suurberg Group (*N.B.* At least some of the basalt blocks have been brought in by hand) (Figs. 10 to 13). Occasional scrapings into massive, pale brown to grey-green, blocky-weathering silty mudrock encountered along tracks towards the northern edge of the project area *might* represent sedimentary intercalations within the Suurberg Group (*cf* volcanogenic mudflow / lahar deposits) (Fig. 9).

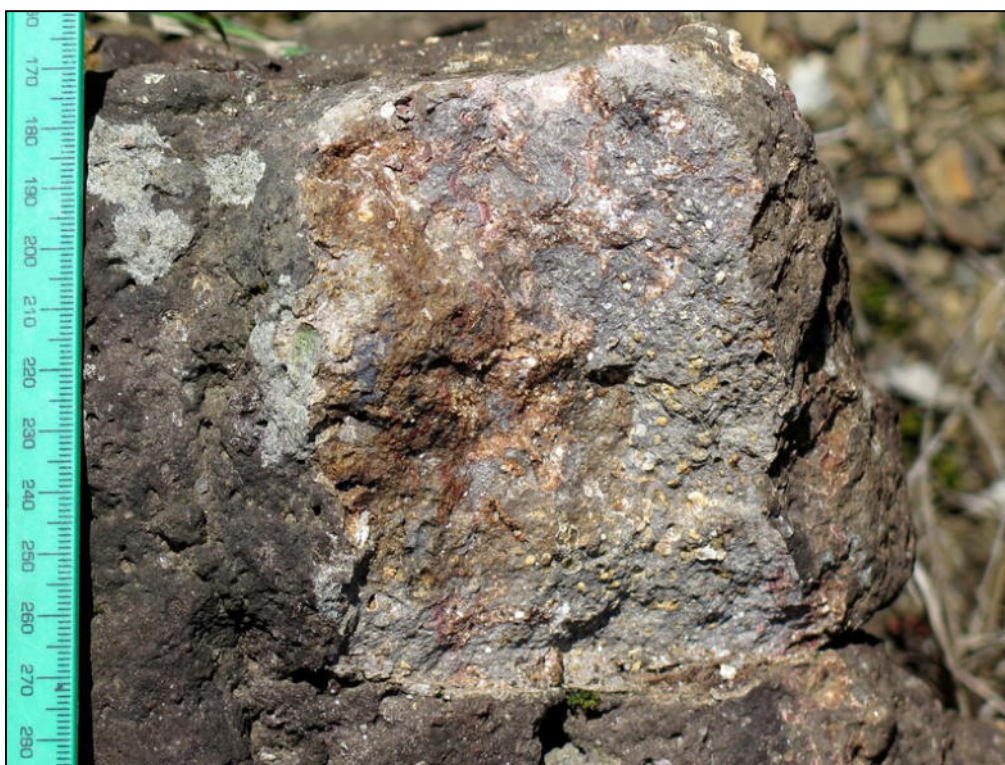
Figure 13: Close-up of fractured float block of Mimosa Formation basalt showing typical amygdaloidal texture with mineral-infilled gas bubbles (Scale in cm and mm).
