CEN INTEGRATED ENVIRONMENTAL MANAGEMENT UNIT
Environmental and Rural Development Specialist

Dale Stock – 24G application for clearing of vegetation, activities in the regulated area of a watercourse, abstraction of surface and groundwater, composting, and irrigation of pivots on a grass farm ‘Grass Galore’ in Theesecombe

- **Public Participation Report –**

12 July 2021

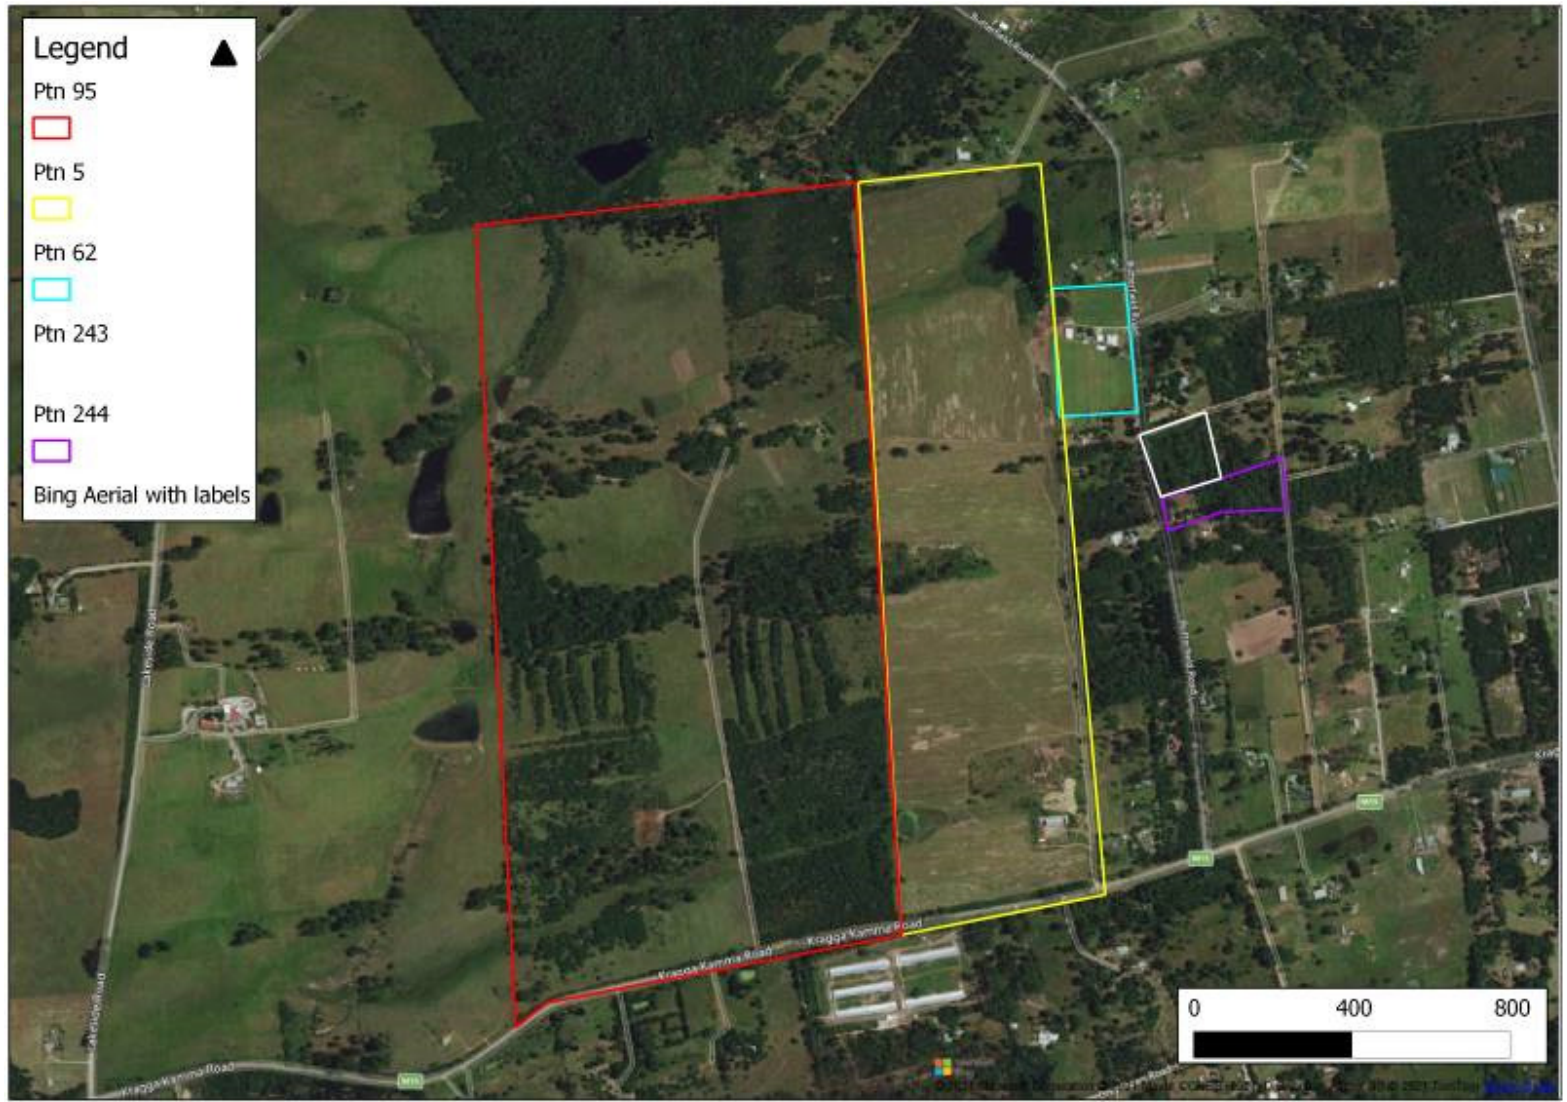
FIGURE 1: AERIAL IMAGE SHOWING THE PROPERTIES INCLUDED IN THIS APPLICATION.

Refer to Figure 1 and Figure 2, which are aerial images showing the location of the properties and activities included in the application.

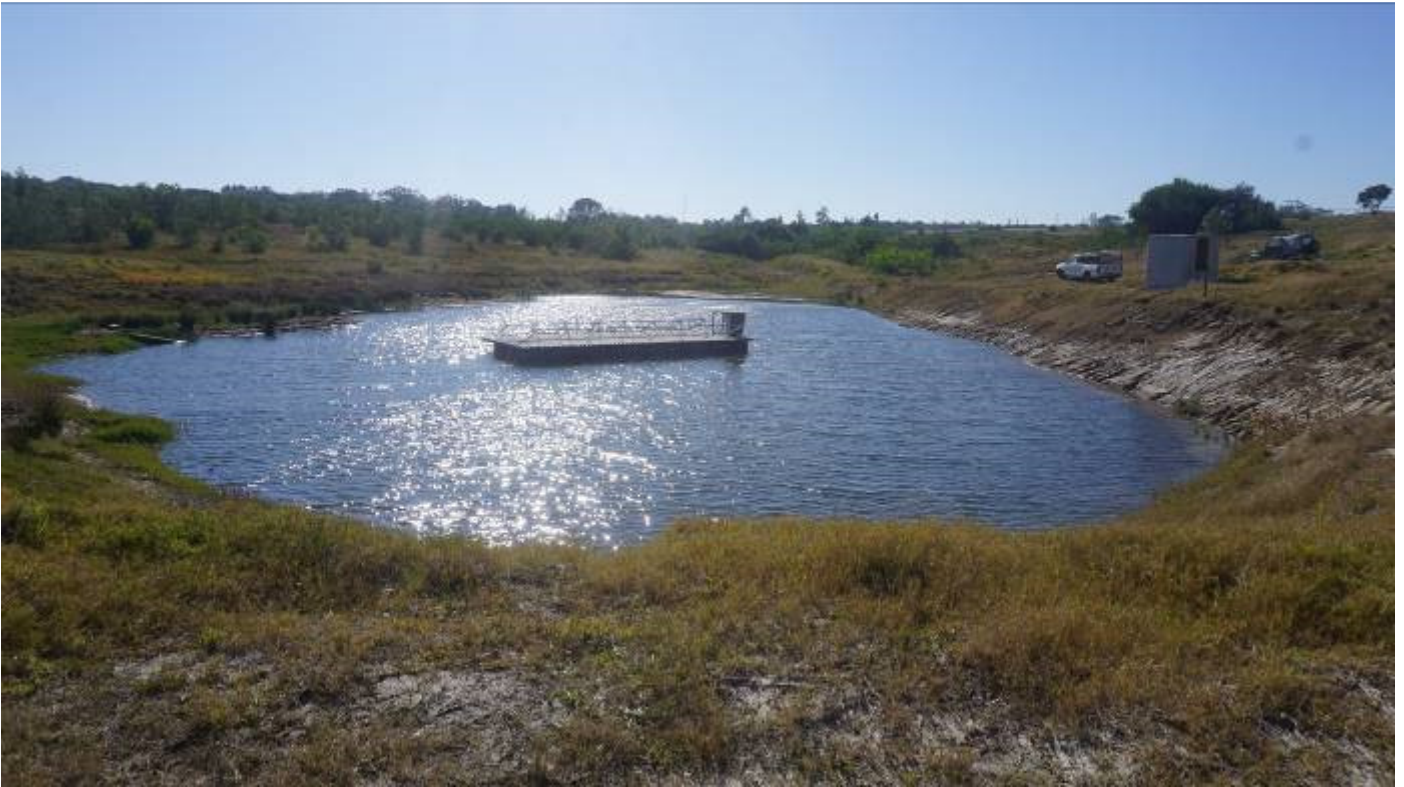
PLATE 5: A VIEW OF THE PIVOT DAM / DAM 3 ON PTN 95, WITH A FLOATING RAFT AND PUMPHOUSE.

- Water is abstracted from an in-stream dam (part of the Seaview Stream) on Ptn 95 (referred to as the Pivot Dam / Dam 3), and is pumped to a storage dam on Ptn 62 (Dam 1). Dam 1 is a storage dam, and is filled with water from Dam 3, borehole water, and rainwater harvesting. The Pivot dam was established many years ago by the landowner (Gwen Hornigold). The dam broke in 2011, and was rebuilt in 2012. Mr Stock upgraded the dam in 2017 by strengthening the wall, clearing out silt, and removing alien vegetation at the edges of the inlet to prevent damage. Rock and soil material was placed in the drainage area downstream of the dam, to change the flow path around the dam wall to alleviate erosion during high flow conditions. Water is pumped from this dam for the Hornigold's use, as well as for irrigation purposes by Mr Stock (from 2017).

- A raft and solar energy, pipes, and a pump house were installed to transfer water to the farm dam on Ptn 62
- Rainfall is the primary source of irrigation for the grass lawns, and the decision on when and how much to irrigate using water from the dam is implemented based on rainfall periods and volume. Irrigation using dam water is only done in the middle of a dry period. Soil moisture retention is optimised by composting, to reduce irrigation demand. When grass is harvested, a water tanker is used to irrigate small areas as it is not economically viable to use the Pivot irrigation on small areas/sections only. Over-irrigating at the grass farm is not a desirable option for Mr Stock, as it is economically inefficient (i.e. irrigating costs money, and with increased irrigation more mowing will be needed which also carries a cost), and causes waterlogged conditions which are not conducive to truck movement.

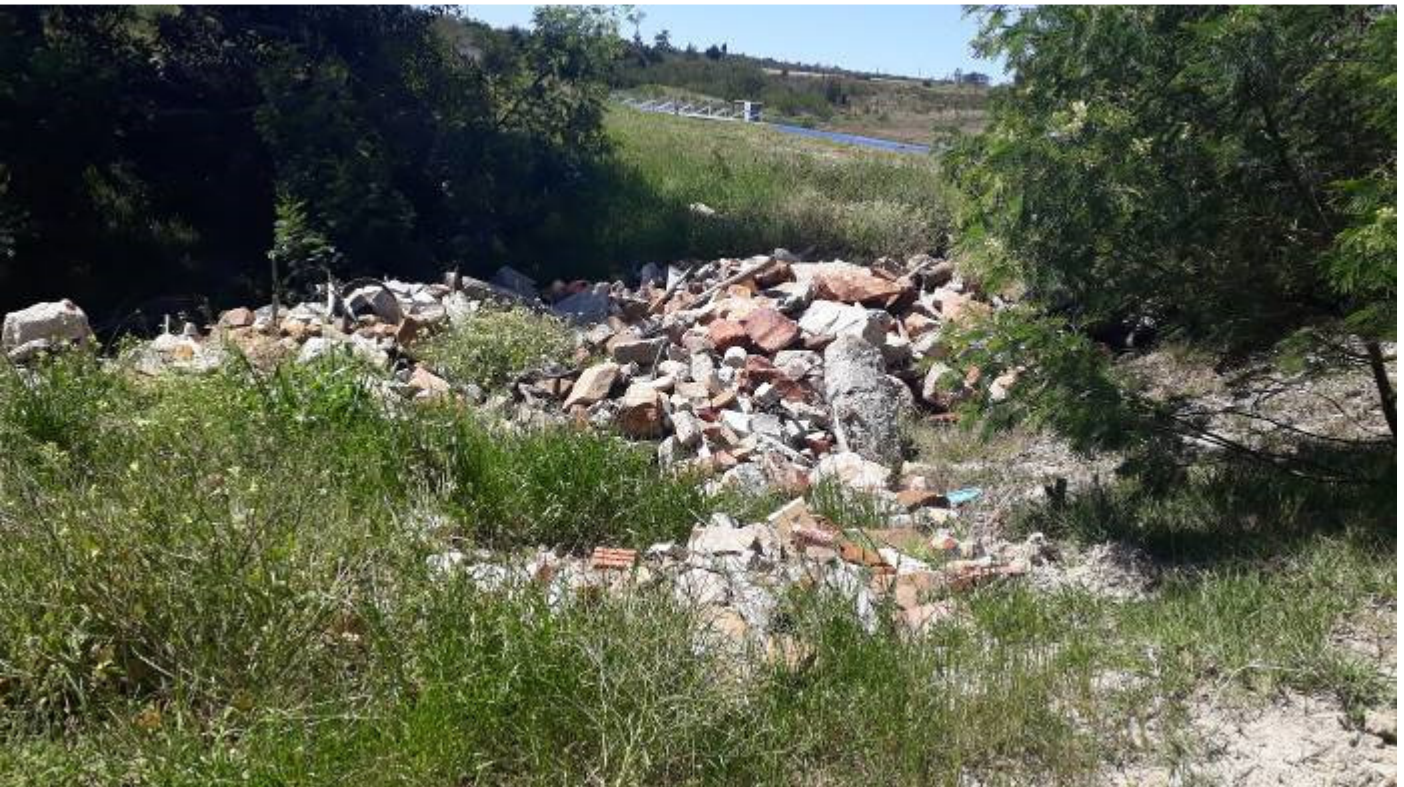
PLATE 6: PHOTO SHOWING MATERIAL THAT WAS PLACED DOWNSTREAM OF THE DAM WALL.

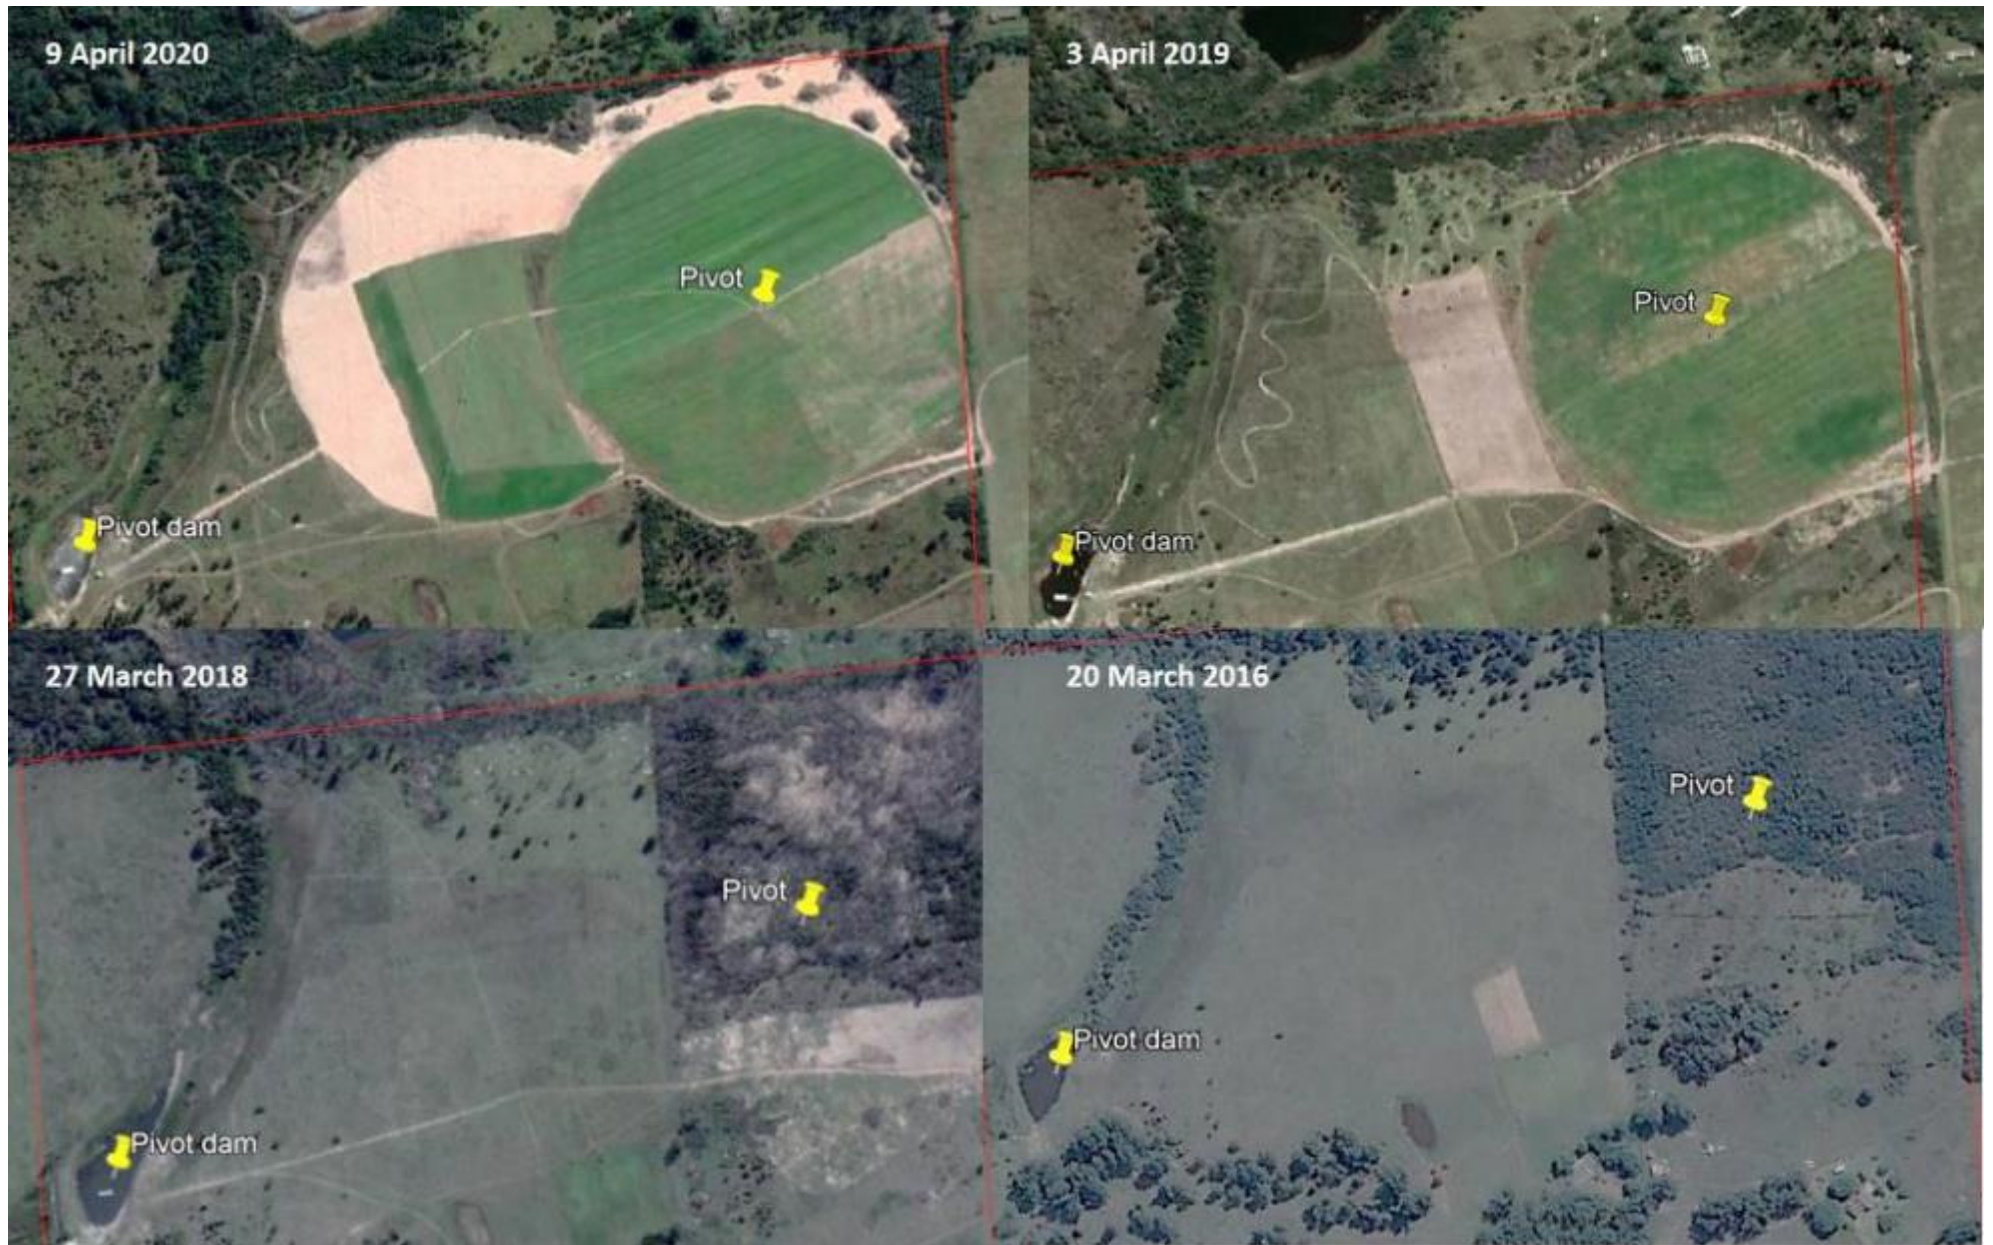
FIGURE 3: VEGETATION CLEARING TO ESTABLISH PIVOTS ON PTN 95 OF KRAGGA KAMMA 23, USING GOOGLE EARTH IMAGES.

- In the period between 2017 and 2018, vegetation was cleared to establish 2 pivots for lawns. The pivot sizes are 8.5 and 6.5 ha each.
- A history of Google Earth images were checked, and it appears that vegetation cover in the disturbed area was a combination of alien trees and low-growing vegetation. During the vegetation survey in October 2020, undisturbed areas surrounding the pivots were inspected to determine the likely vegetation type and composition of the area that was cleared. It is likely that vegetation cleared for the eastern Pivot was predominantly alien vegetation, while that of the western Pivot was mostly indigenous grassy fynbos. A remnant band of indigenous grassy fynbos runs in a N-S direction between the 2 pivots, and includes a mix of indigenous grasses, restios, sedges, and low shrubs.

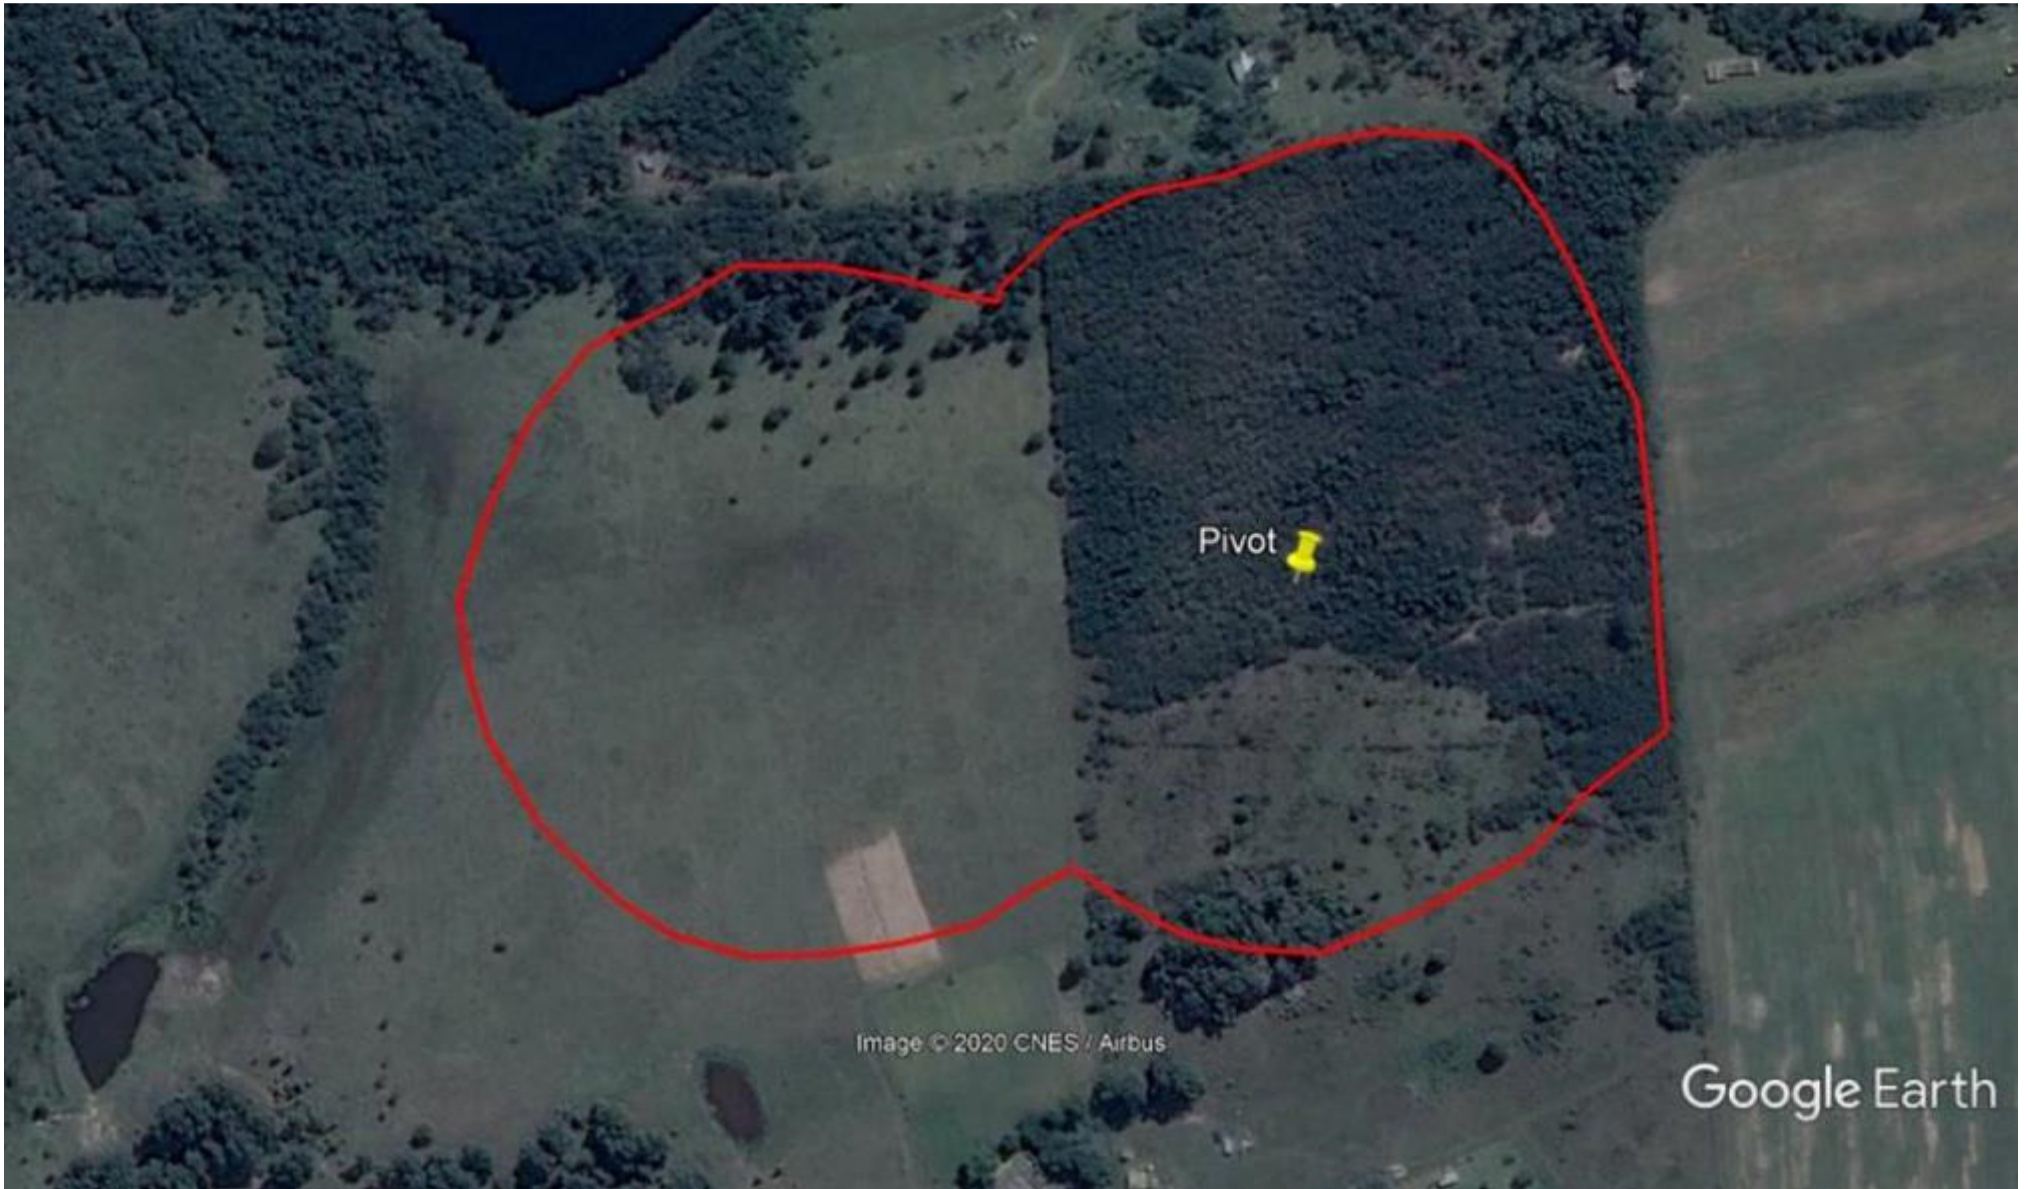
FIGURE 4: AREA DISTURBED TO ESTABLISH PIVOTS (RED OUTLINE, USING OCTOBER 2020 AERIAL IMAGE), OVERLAIN ON A MARCH 2016 (PRE-DISTURBANCE) GOOGLE EARTH IMAGE.

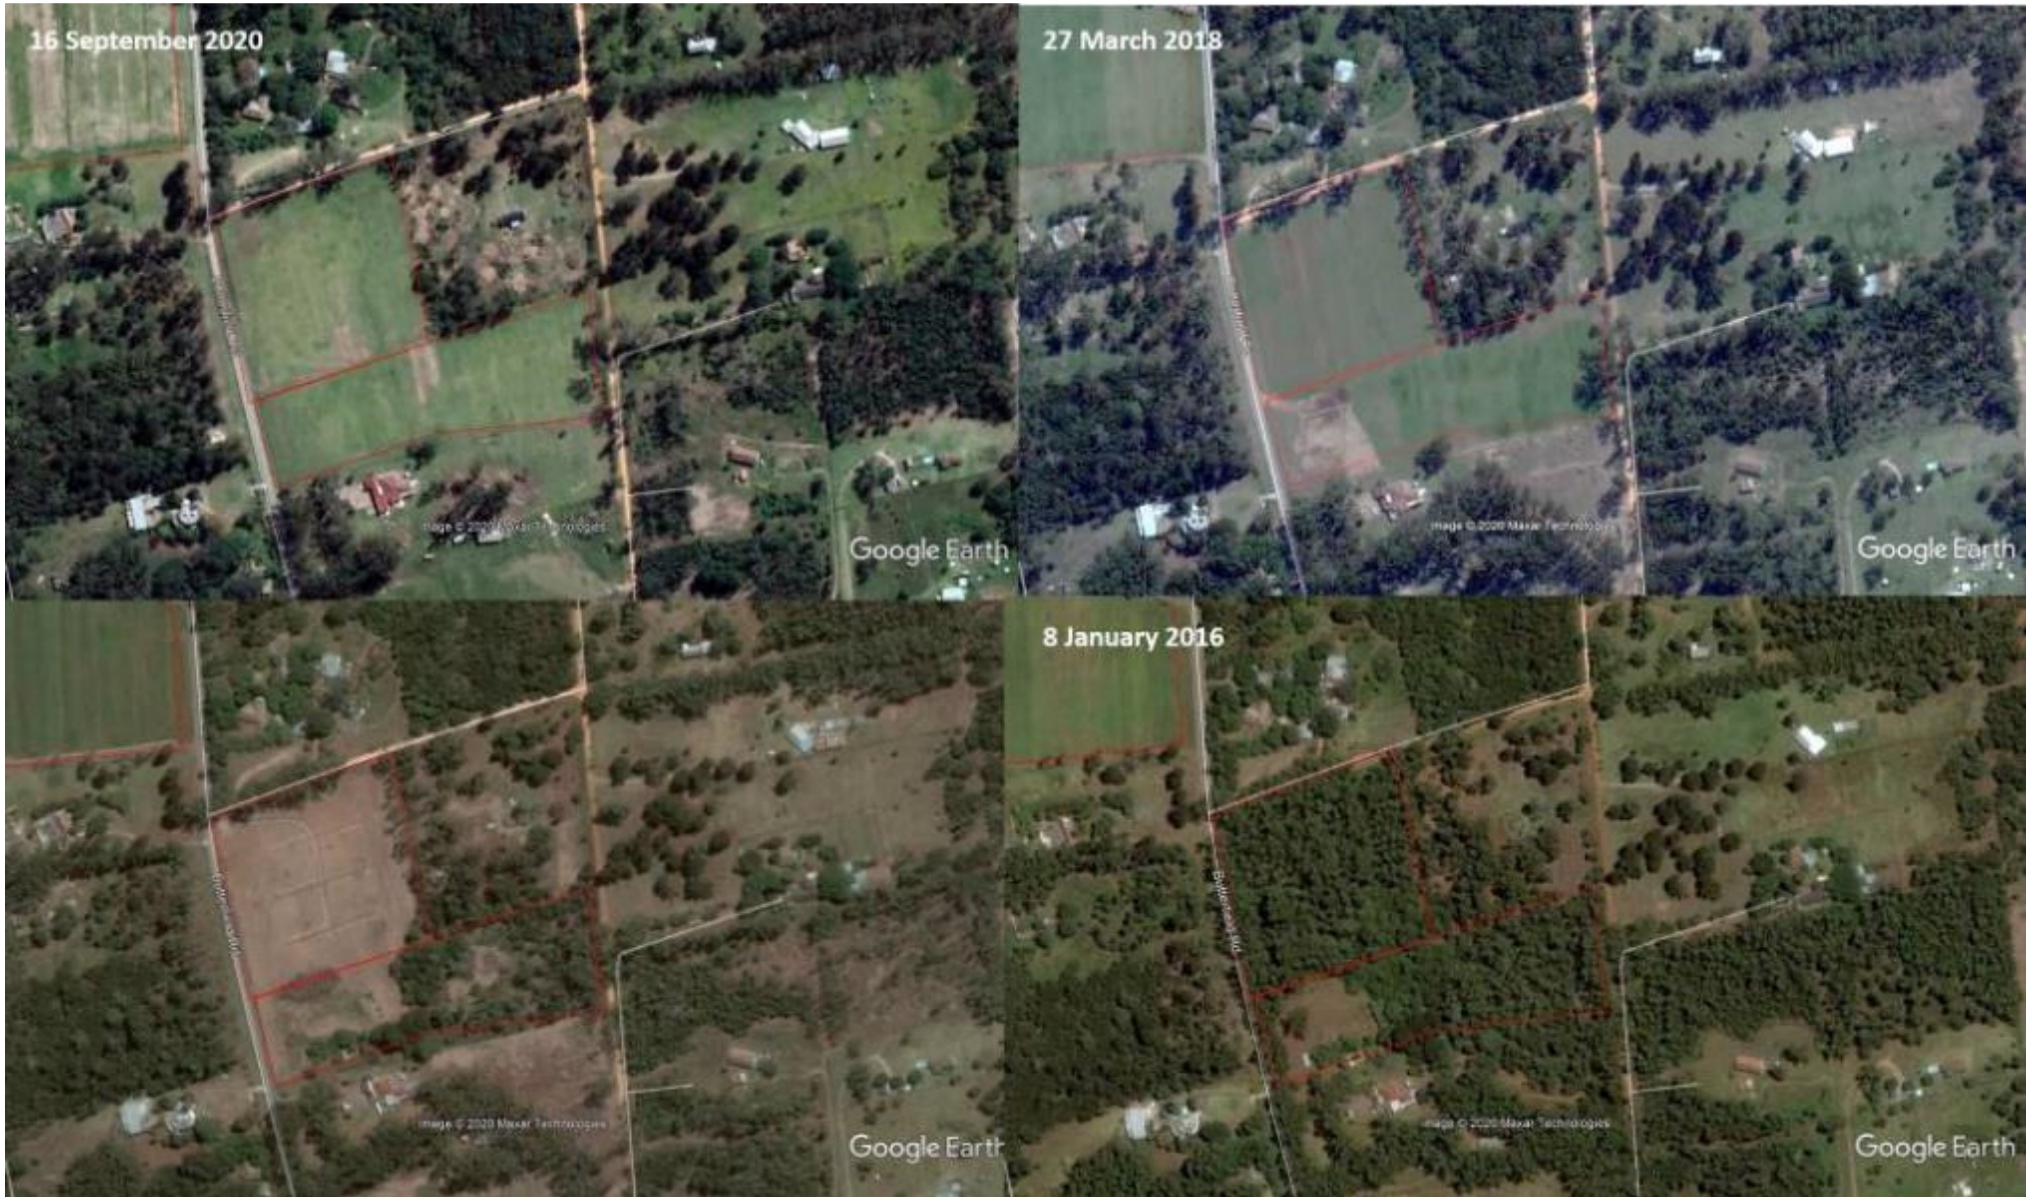
FIGURE 7: VEGETATION CLEARING TO ESTABLISH GRASS LAWNS (NOW USED FOR GRAZING ANIMALS) ON PTN 243 AND 244 OF KRAGGA KAMMA 23, USING GOOGLE EARTH IMAGES.

- In 2016, ~3.3 ha of vegetation was cleared to establish grass lawns for Grass Galore. Irrigation lines were laid, but subsequently Mr Stock determined the area unfeasible for this use. Irrigation stopped in 2017, and the area was subsequently used for grazing of domestic animals.
- From an inspection of a chronology of Google Earth aerial images, it appears as if vegetation cover prior to clearing was predominantly alien trees. During the vegetation survey in October 2020, the surrounding area was inspected, and it is confirmed that there would have been little indigenous vegetation, and mostly tall alien trees on the farms.

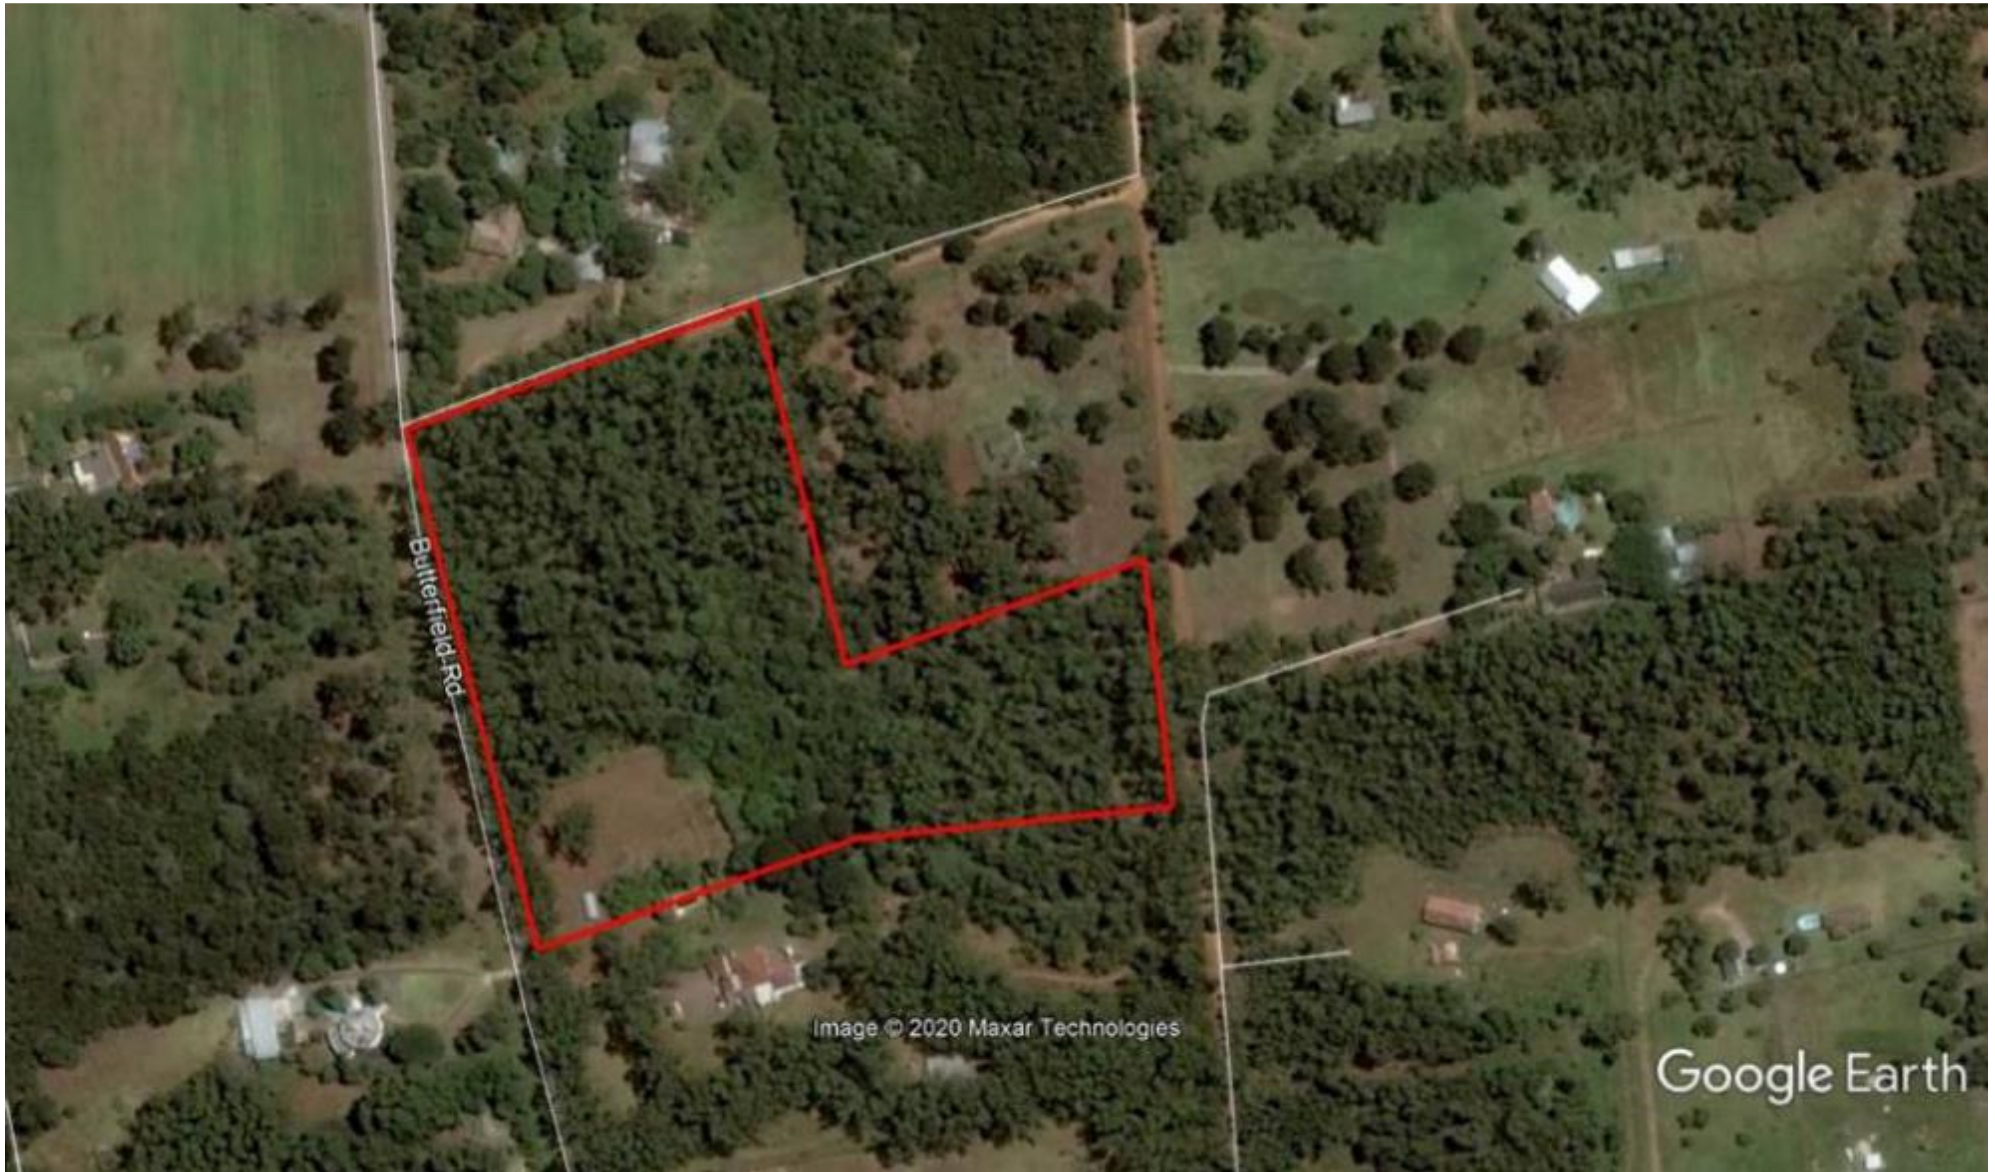
FIGURE 8: AREA DISTURBED TO ESTABLISH GRASS LAWNS (RED OUTLINE, USING OCTOBER 2020 AERIAL IMAGE), OVERLAIN ON A JANUARY 2016 (PRE-DISTURBANCE) GOOGLE EARTH IMAGE

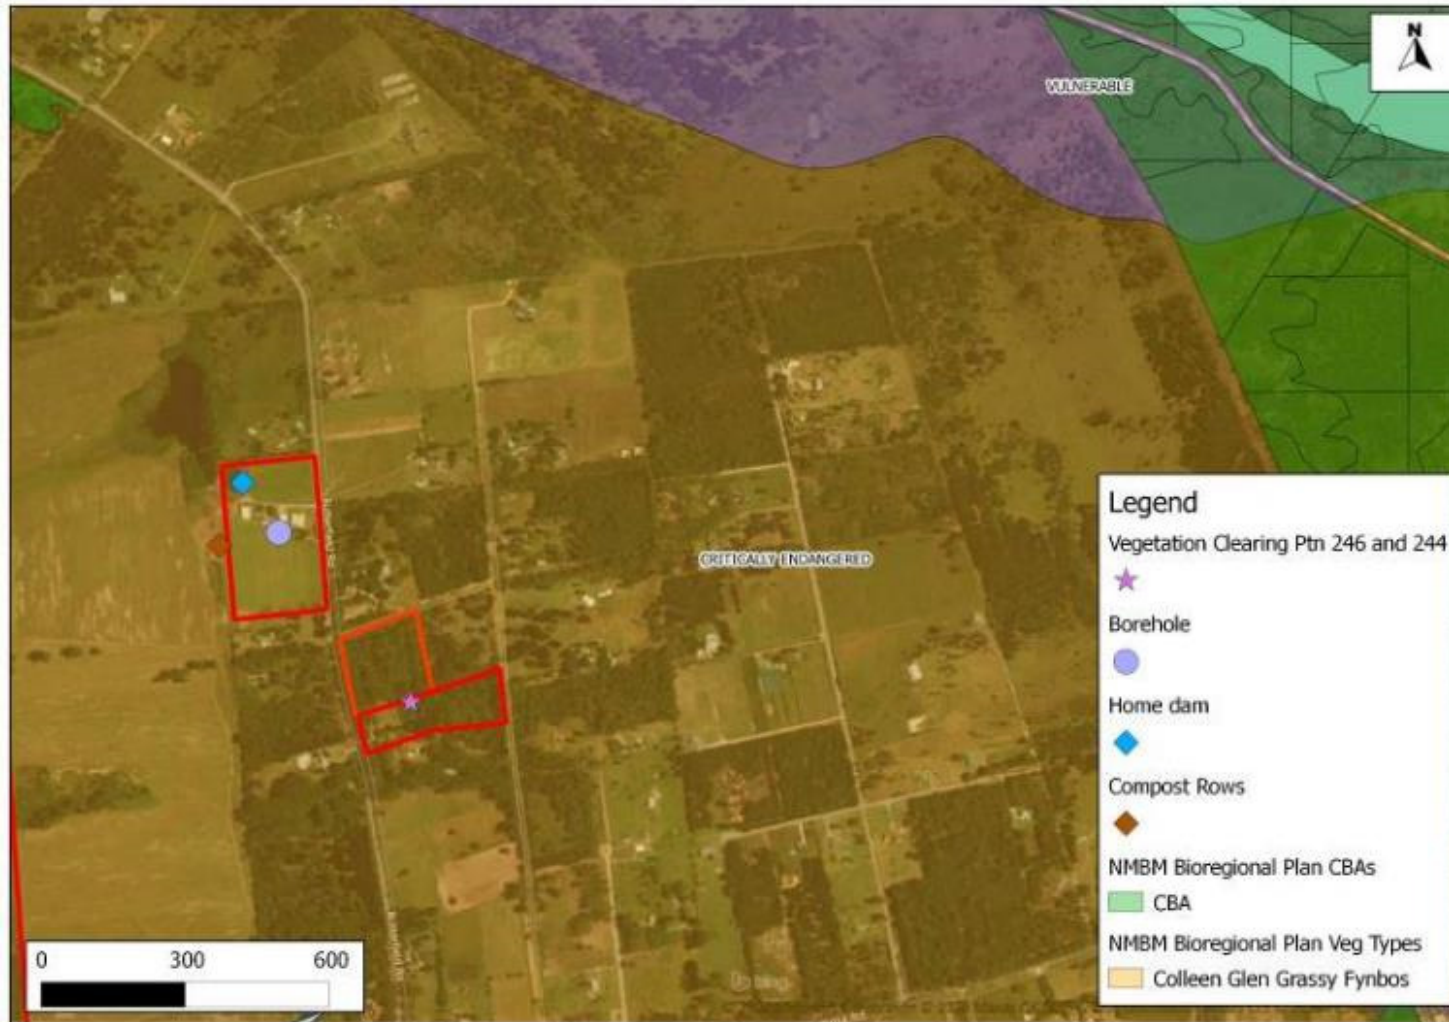
FIGURE 9: VEGETATION CLEARING ON PTN 243 AND 244 DID NOT TAKE PLACE WITHIN IS WITHIN A CRITICAL BIODIVERSITY AREA OR ECOLOGICAL PROCESS AREA. THE PRE-TRANSFORMATION VEGETATION TYPE IS DESCRIBED COLLEEN GLEN GRASSY FYNBOS (CRITICALLY ENDANGERED), BUT THIS WAS MODIFIED AS EARLY AS 2004 (NMBM BIOREGIONAL PLAN, 2015).

- Desktop information for the area established as grass lawns (and subsequently grazing area) shows that:
 - The area is not part of a Critical Biodiversity Area network or ecological support area in the NMBM's Bioregional Plan (2015). Pre-transformation vegetation type would have been Colleen Glen Grassy Fynbos (critically endangered) but disturbance and modification to the Farms occurred as early as 2004).
 - The northern tip of Ptn 243 is part of a Freshwater Ecological Support Area' in the East Cape Biodiversity Conservation Plan (2019). There are no watercourses or wetlands mapped on the Farms; however a natural wetland is mapped within 500 m of the site, to the south.

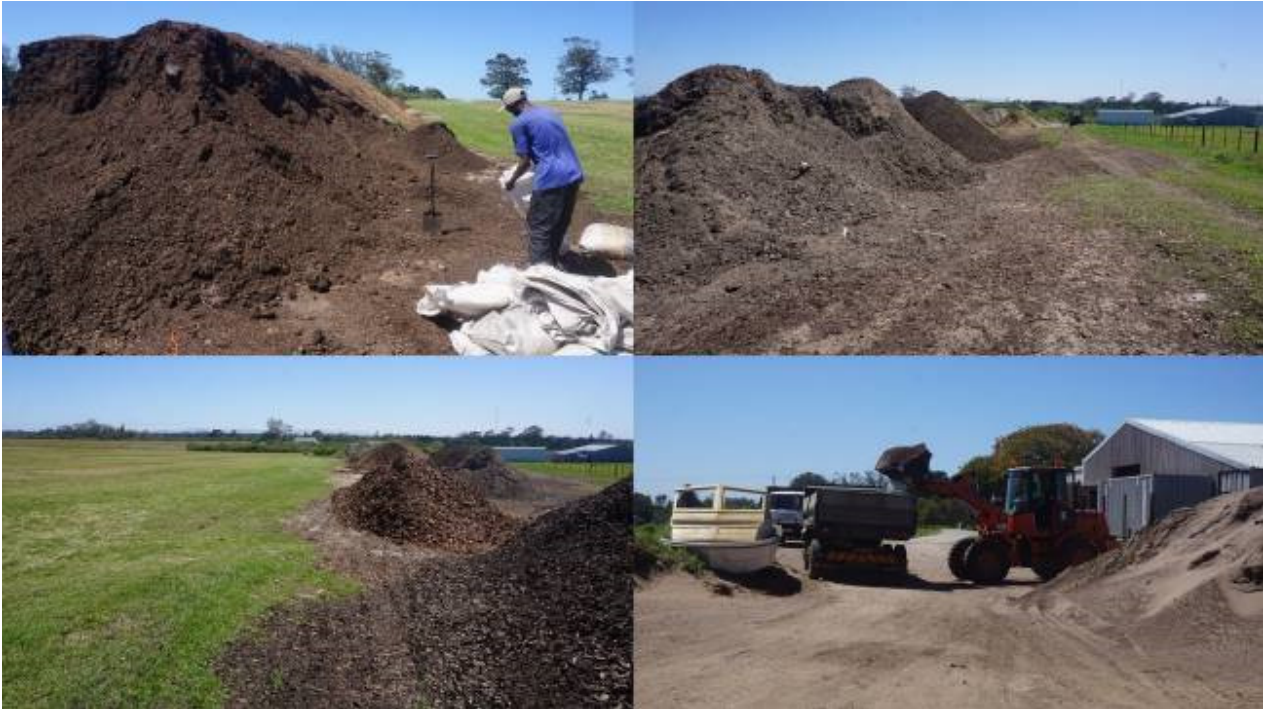
PLATE 8: PHOTOGRAPHS OF THE COMPOST PILES AND PROCESSING AREA ON PTN 5 AND PTN 62.

- Bedding litter from horse stables; tree bark and kraal manure are used to make compost. Material is stockpiled in a row on Ptn 5 of Farm Kragga Kamma 23. Piles are made using a front-end loader, and are manually turned for aeration. Approximately 150 m³ of compost is made per month in the process. A machine is used at the warehouses on Ptn 62 to chip bark and separate out finer materials to optimise the composting process. When ready, compost is applied on grass lawn areas on Ptn 243 and 244, and on Ptn 95.

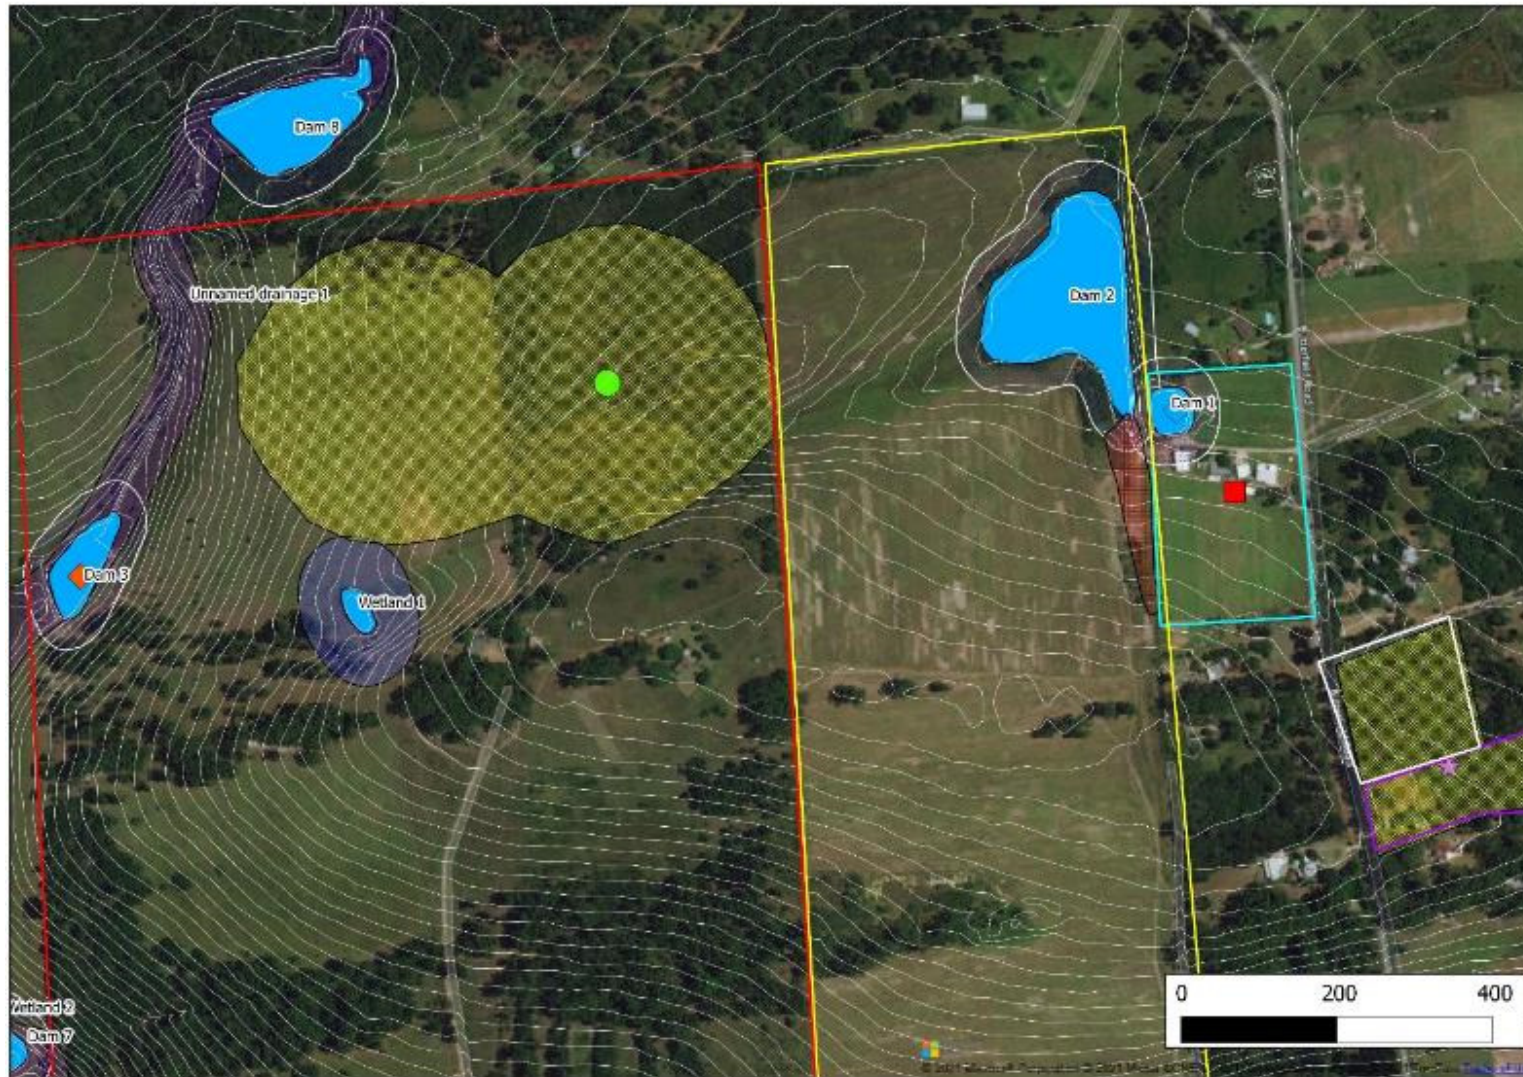
FIGURE 11: ACTIVITIES IN RELATION TO AQUATIC ENVIRONMENTS AND THEIR SUGGESTED BUFFER AREAS. ONLY THE COMPOST WINDROW (BROWN SHADING NEAR DAM 1 AND 2) FALLS WITHIN THE BUFFER AREA OF THE FARM DAMS, AND WILL BE SHIFTED TO AVOID THESE AREAS.

An aquatic specialist study was done by Karissa Nel. The specialist mapped aquatic environments in the surrounding area, and recommended buffer areas in which no activities must take place (other than abstraction for obvious reasons) (see Figure 11). The compost windrows are the only activity that are within the recommended buffer area of a farm dam, and will be shifted to avoid this area. Only one natural wetland within 500 m of the activities was identified. The catchment of the wetland is small, and runoff from the Pivot and irrigated areas does not flow into this wetland. The remainder are dams / artificial wetlands. The drainages are non-perennial/seasonal systems, with flowing water for a period after rainfall.

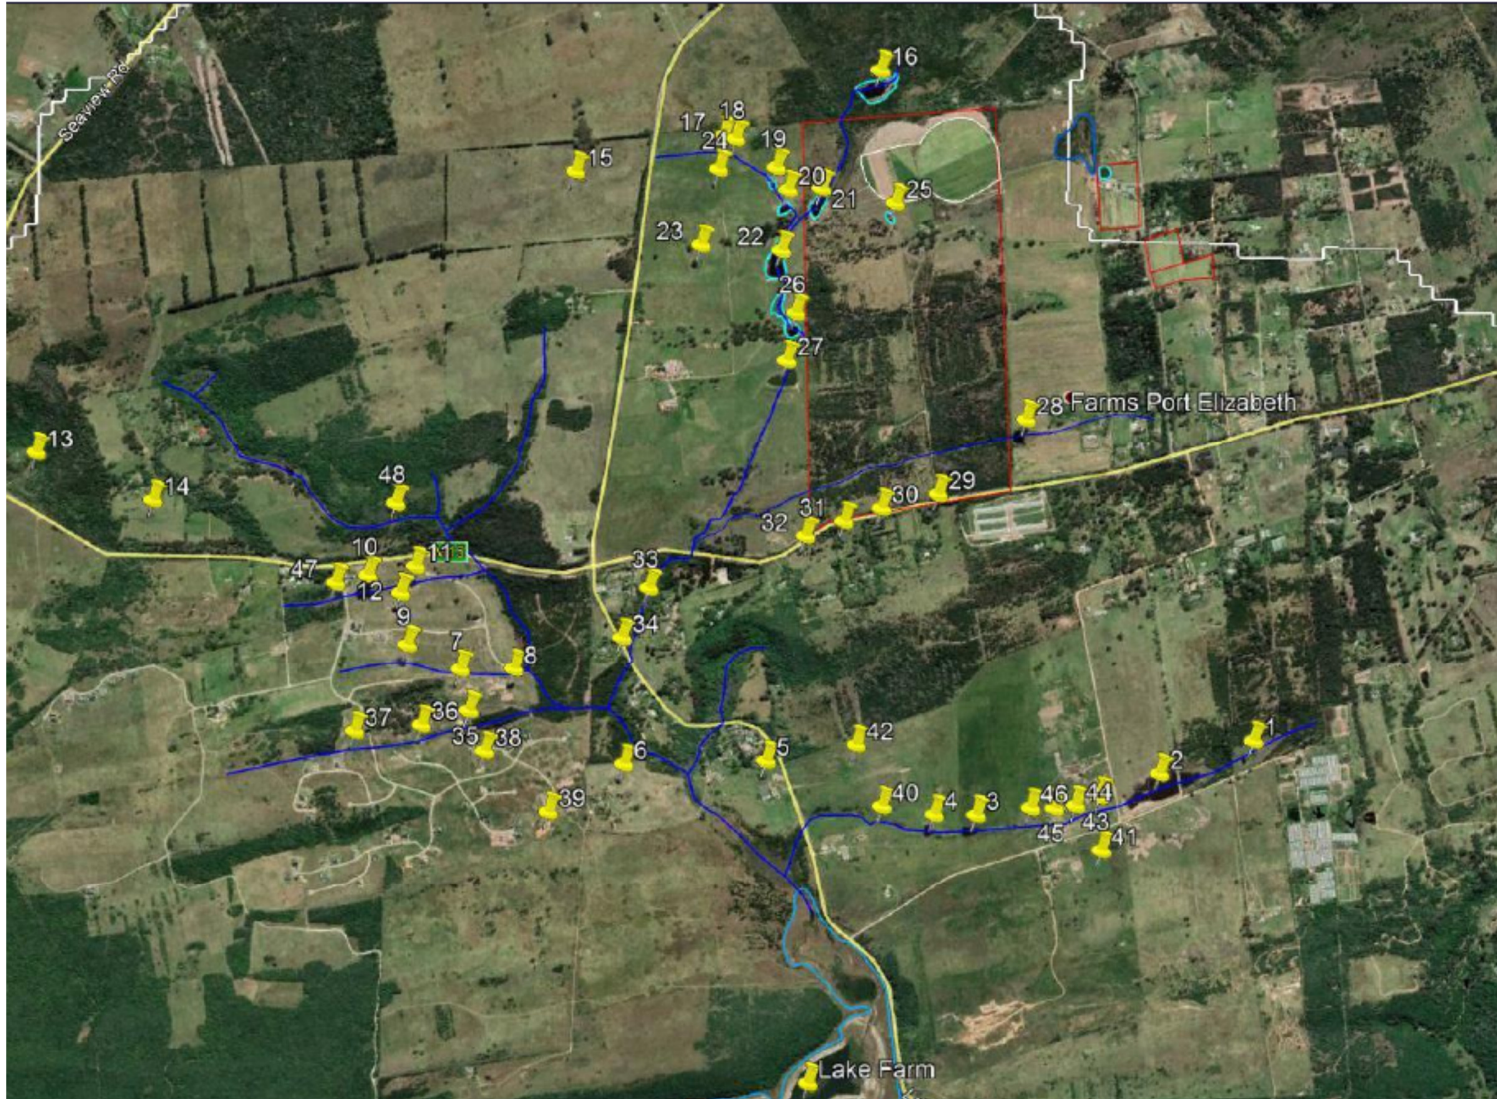
FIGURE 12: AN OVERVIEW OF DAMS, WETLANDS AND DRAINAGES IN THE LAKESIDE LAKE CATCHMENT (USING GOOGLE EARTHY 2020 IMAGERY).
