CEN INTEGRATED ENVIRONMENTAL MANAGEMENT UNIT
Environmental and Rural Development Specialist

Dale Stock – 24G application for clearing of vegetation, activities in the regulated area of a watercourse, abstraction of surface and groundwater, composting, and irrigation of pivots on a grass farm ‘Grass Galore’ in Theesecombe

- **Public Participation Report –**

12 July 2021

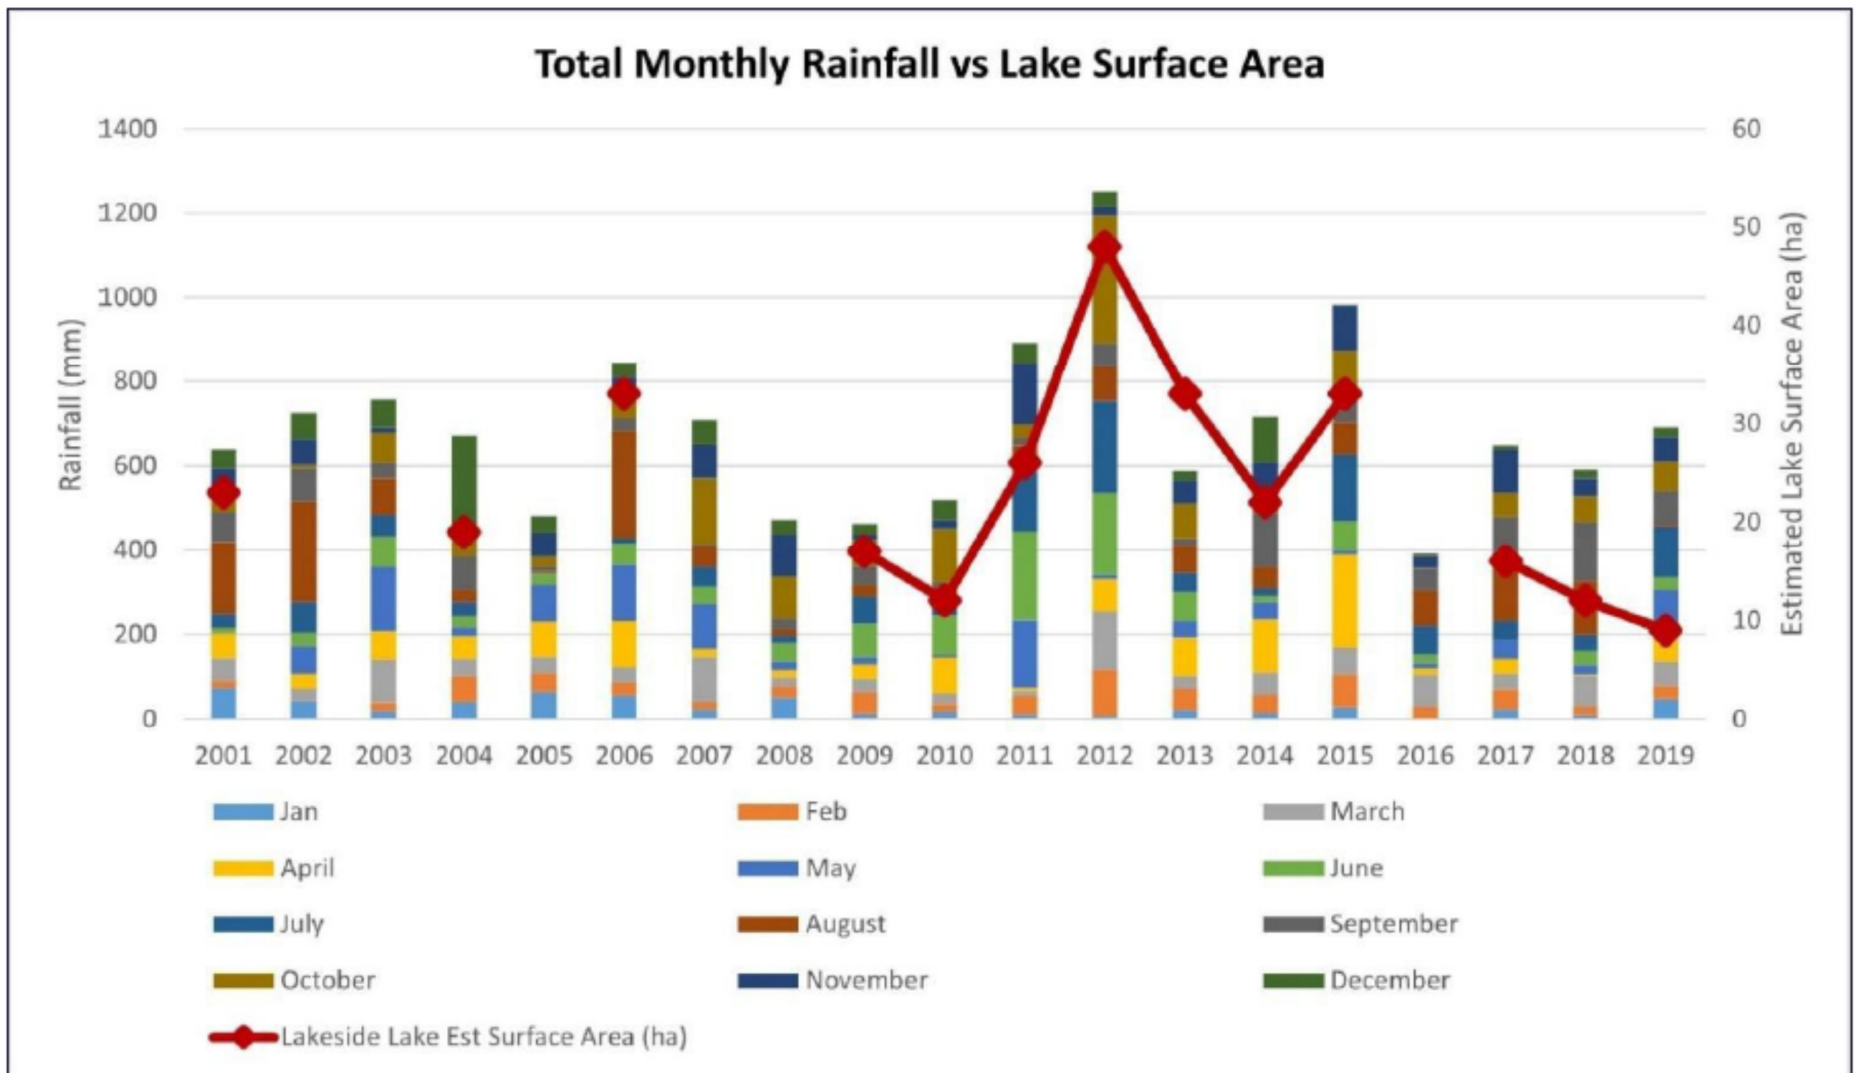
FIGURE 14: RAINFALL (2001 TO 2019) IN RELATION TO THE LAKE FARM LEVEL (ESTIMATED OFF AERIAL IMAGES).
