HORSE PIT EXTENSION EPBC ACT REFERRAL

Horse Pit Extension Project Aquatic Ecology Assessment

Prepared by Ecological Service Professionals Pty Ltd

August 2021

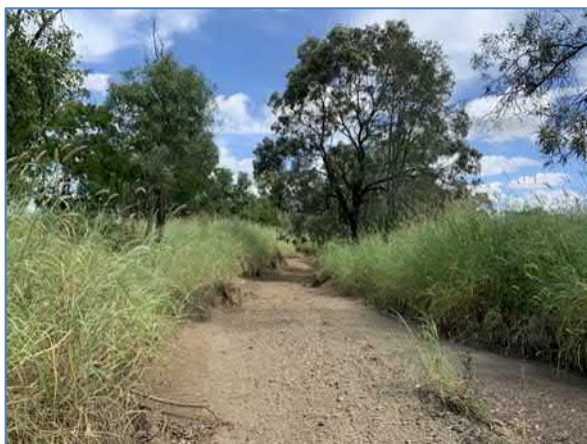
Figure 4.2 Dry channel at site H1 (unnamed tributary of Horse Creek downstream of the Project footprint) in April 2020

In minor waterways and drainage channels, which were typically dry during all three surveys, aquatic habitat features were limited (**Figure 4.2**). Potential aquatic habitat in the dry

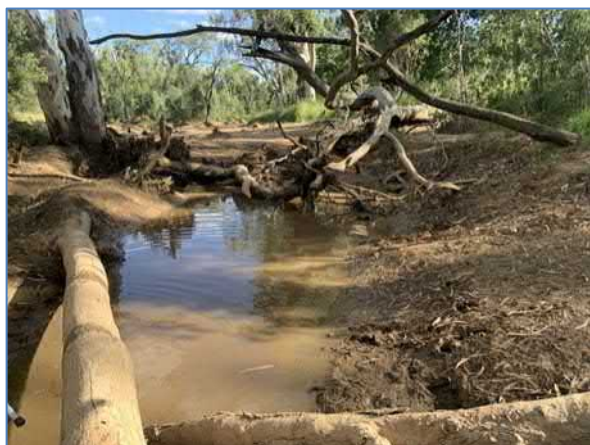
Figure 4.3 Pool habitat at site Ch2 (Cherwell Creek downstream of CVM and upstream of the Project footprint) in April 2020

In major waterways, in-stream features were more abundant with shallow and deep pools, variable substrate (dominated by sand but with larger substrate types present in low abundance), in-stream woody debris and moderate to high coverage of trailing and overhanging bankside vegetation (**Figure 4.3**). Bed and bank stability were low to moderately disturbed from cattle access, terrestrial weeds and feral animals. Although riparian vegetation was reduced as a result of land clearing associated with the adjacent land uses, the banks remained moderately vegetated by predominantly mature native trees (namely *Eucalyptus*, *Casuarina* and *Acacia*) with a sparse to moderate groundcover of grasses.

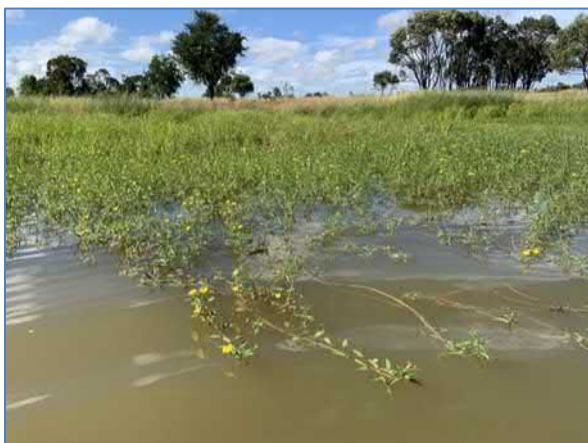
Figure 4.4 Aquatic plant communities at site HT1D in April 2020

Although connectivity to downstream habitats was typically limited due to the construction of dam walls, these sites contained water during the December 2019 (LW1, HT1D and U1D) or November 2020 (LW2) surveys, and would therefore provide dry season refuges for aquatic flora and fauna.

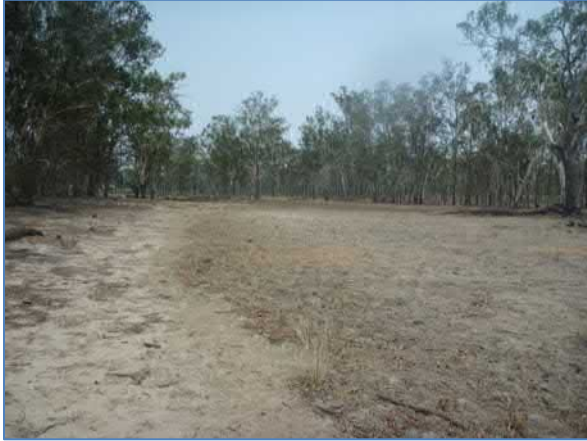
Figure 4.5 Site PW1 (HES wetland and WPA) in December 2019

During the field survey in December 2019, the wetland was dry (**Figure 4.5**). The dry bed contained some potential habitat features, including emergent aquatic plants, some overhanging and trailing vegetation, terrestrial detritus and woody debris. Canopy cover and shading was limited throughout the site. The riparian zone was reduced due to vegetation clearing, but a continuous band of trees and grasses with some shrubs bordered the wetland. There were some terrestrial weeds growing in the dry bed, but otherwise disturbance was relatively low.

Based on the December 2019 survey, the wetland did not provide substantial aquatic habitat. This site was unable to be surveyed in April 2020 due to property access issues. However, it is possible that this wetland provides habitat for aquatic fauna during and after high rainfall / flow events.

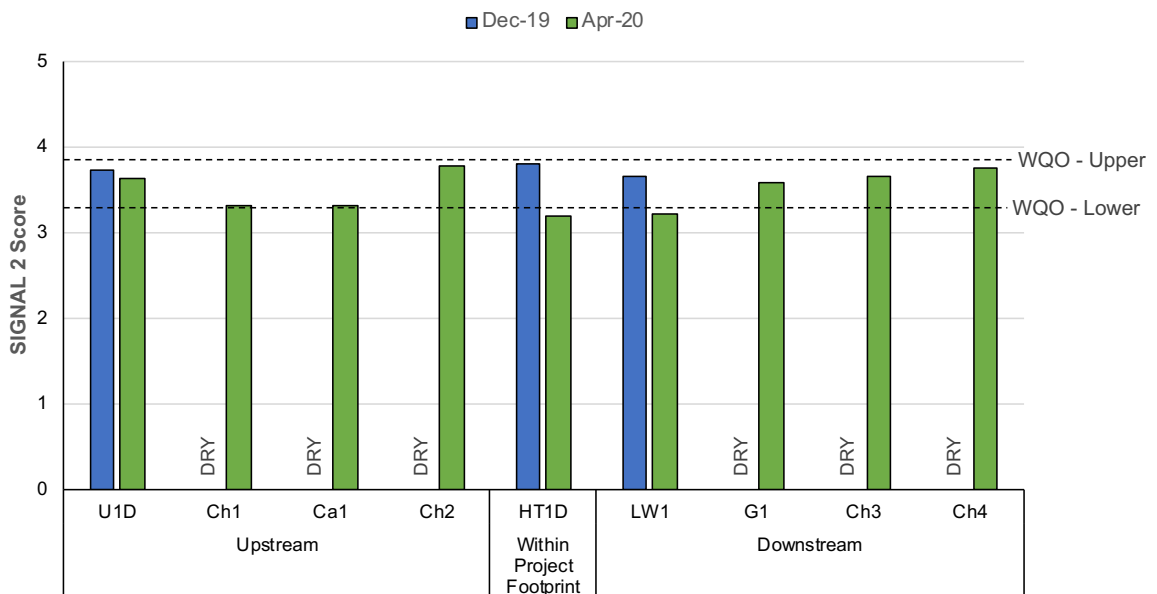
Figure 4.10 Total SIGNAL 2 scores of macroinvertebrates in bed habitat at each site; DRY indicates the site was dry and could not be surveyed

Overall, total SIGNAL 2 scores of macroinvertebrate communities in bed habitat were moderate to good, and did not vary substantially between surveys (**Figure 4.10**). Total SIGNAL 2 scores were within or slightly below the WQO range at all sites during the December 2019 and April 2020 surveys, indicating that a range of sensitive taxa were present in bed habitat at each site, and that communities were in similar condition to that expected from the broader region.

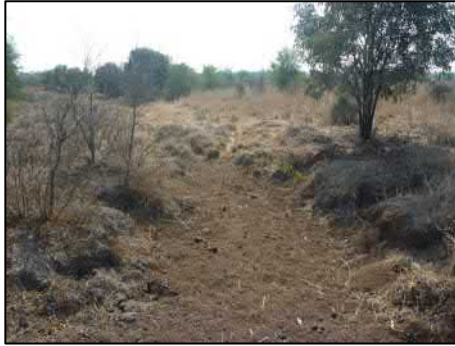
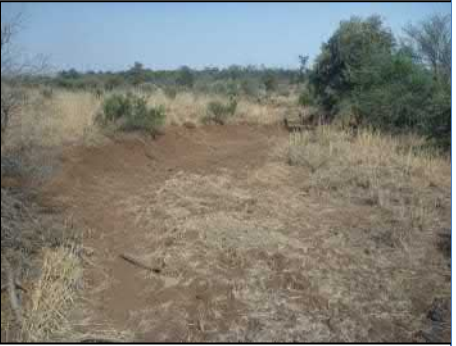
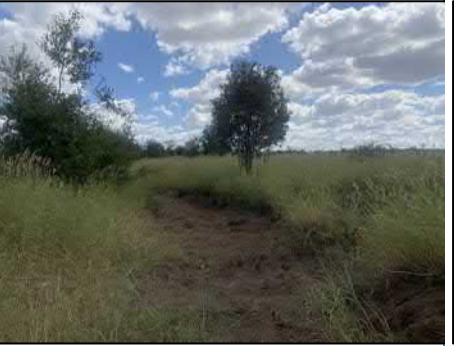
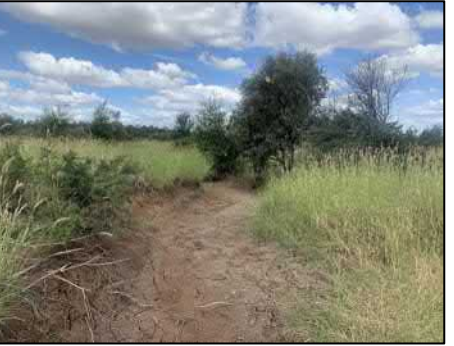
Site: U1		Location: Upstream		Stream Order: 1		Waterway: Unnamed tributary of Horse Creek																						
Upstream: December 2019		Downstream: December 2019		Upstream: April 2020		Downstream: April 2020

Aquatic Ecosystem Value: Low		MNES/MSES: None present or likely to occur		Dry season refuge: No		Connectivity: Limited due to location in catchment and presence of CVM downstream																						
<p>In-stream condition: Fair</p> <p>Key potential habitat features included:</p> <ul style="list-style-type: none"> • small amounts of small and large woody debris and detritus • a limited range of sediment grain sizes (predominately silt/clay with some sand), and • little trailing and overhanging bank vegetation. <p>The site was dry during both the December and April surveys.</p>		<p>Riparian condition: Poor</p> <p>The riparian zone was semi-continuous around the perimeter of the waterway, although the extent of the vegetation had been reduced due to historic clearing. Vegetation consisted of grass, shrubs and some trees (predominantly eucalyptus and casuarina). Banks were low (1 m – 1.5 m high) and gently sloping with minimal erosion. There were some exotic terrestrial riparian species at the site.</p>		<p>External Impacts: High</p> <p>External impacts at the site were mostly associated with the surrounding land-use and included:</p> <ul style="list-style-type: none"> • reduced riparian vegetation as a result of land clearing. 		<p>Water Quality: N/A</p>

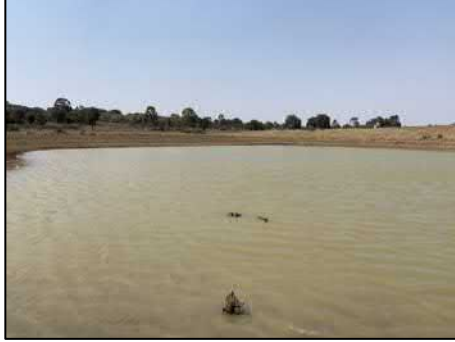
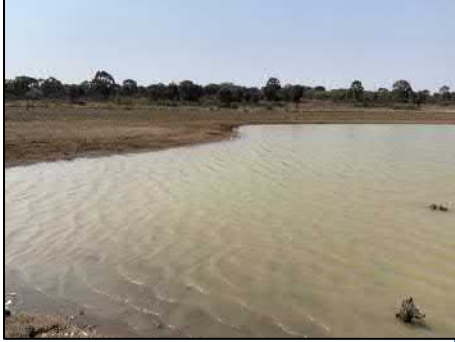
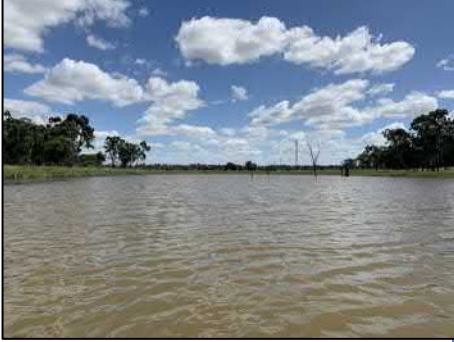
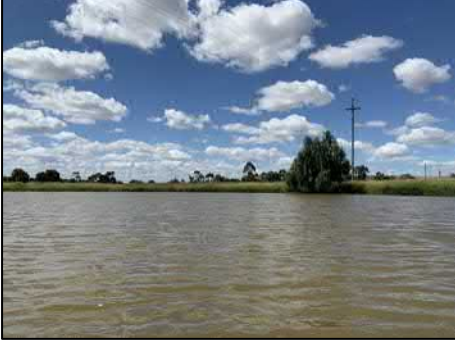
Site: U1D		Location: Upstream		Stream Order: 1		Waterway: Unmapped farm dam																						
Upstream: December 2019		Downstream: December 2019		Upstream: April 2020		Downstream: April 2020

Aquatic Ecosystem Value: Moderate		MNES/MSES: None present or likely to occur		Dry season refuge: Yes		Connectivity: Poor due to high dam walls, location in catchment and presence of CVM downstream																						
In-stream condition: Fair Key habitat features included: <ul style="list-style-type: none"> • diverse and abundant aquatic plants • a variety of woody debris • periphyton • sediment grain sizes predominately silt/clay, and sandy gravel • shallow & deep pools, and • trailing and overhanging bank vegetation. 		Riparian condition: Poor The riparian zone was continuous around the perimeter of the waterway, although the extent of the vegetation had been reduced. Vegetation consisted of grass, ferns and weeds. Banks were low (1.5 m – 2 m high) and gently sloping with some erosion. There were some exotic terrestrial riparian species at the site.		External Impacts: High External impacts at the site were mostly associated with the surrounding land-use and included: <ul style="list-style-type: none"> • reduced riparian vegetation as a result of land clearing • grazing by livestock • feral animals, and • the presence of an artificial dam. 		Water Quality: Poor

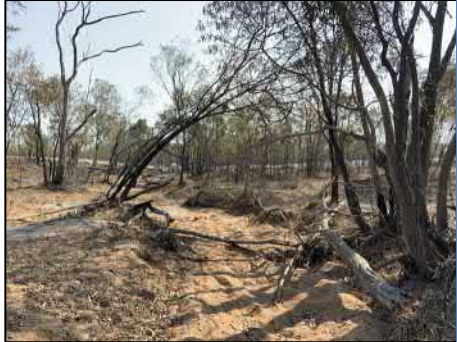
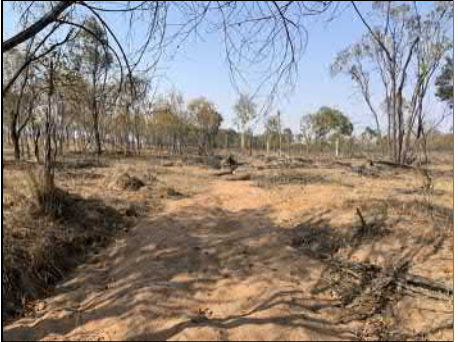
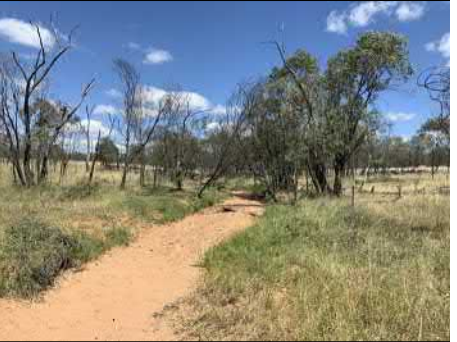
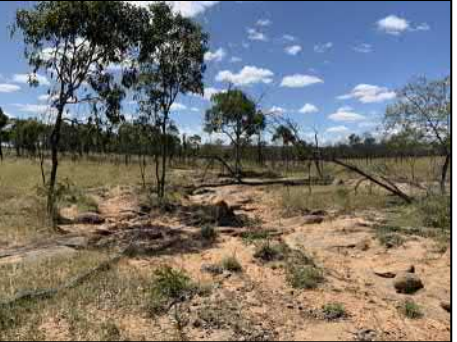
Site: U2		Location: Upstream		Stream Order: 1		Waterway: Unnamed tributary of Caval Creek																						
Upstream: December 2019		Downstream: December 2019		Upstream: April 2020		Downstream: April 2020

Aquatic Ecosystem Value: Low		MNES/MSES: None present or likely to occur		Dry season refuge: No		Connectivity: Limited due to location in catchment and presence of CVM downstream																						
<p>In-stream condition: Fair</p> <p>Key potential habitat features included:</p> <ul style="list-style-type: none"> • ephemeral channel • some woody debris • predominately sandy sediments with some cobbles and boulders, and • little trailing and overhanging bank vegetation. <p>The site was dry during both the December and April surveys.</p>		<p>Riparian condition: Poor</p> <p>The riparian zone was semi-continuous around the perimeter of the waterway, although the extent of the vegetation had been reduced due to historic clearing. Vegetation consisted of trees, grasses and weeds. Banks were low (approximately 1 m high) and gently sloping with some erosion. There were some exotic terrestrial riparian species at the site.</p>		<p>External Impacts: High</p> <p>External impacts at the site were mostly associated with the surrounding land-use and included:</p> <ul style="list-style-type: none"> • reduced riparian vegetation as a result of land clearing • grazing by livestock, and • feral animals. 		<p>Water Quality: N/A</p>

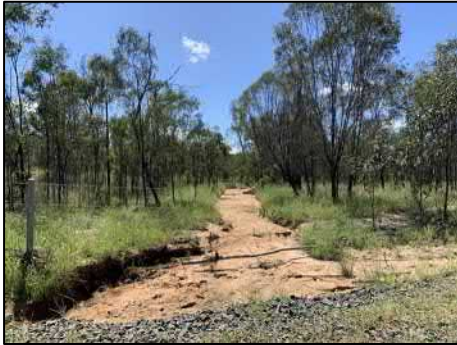
Aquatic Ecosystem Value: Low		MNES/MSES: None present or likely to occur		Dry season refuge: No		Connectivity: Limited due to location in catchment and presence of CVM downstream																						
<p>In-stream condition: Fair</p> <p>Key potential habitat features in April included:</p> <ul style="list-style-type: none"> • well defined ephemeral channel • some woody debris • predominately sandy sediments with some cobbles and boulders, and • little trailing and overhanging bank vegetation. <p>The site was not sampled during the December survey and was dry during the April survey.</p>		<p>Riparian condition: Fair</p> <p>The riparian zone was continuous around the perimeter of the waterway, although the extent of the vegetation in the broader region had been reduced due to historic clearing. Vegetation consisted of trees, grasses and weeds. Banks were low (approximately 0.5 m high) and gently sloping with some erosion. There were some exotic terrestrial riparian species at the site.</p>		<p>External Impacts: High</p> <p>External impacts at the site were mostly associated with the surrounding land-use and included:</p> <ul style="list-style-type: none"> • grazing by livestock • feral animals, and • vehicle track crossing. 		<p>Water Quality: N/A</p>

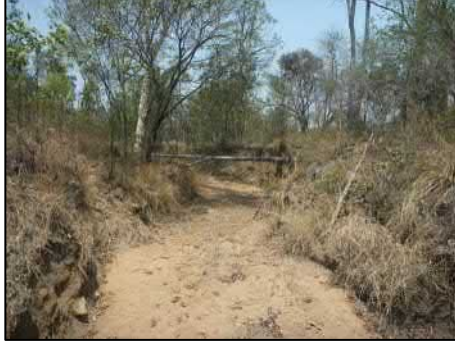
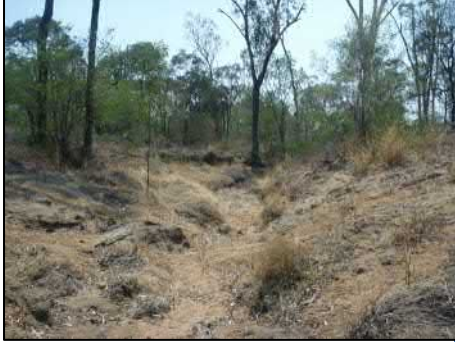
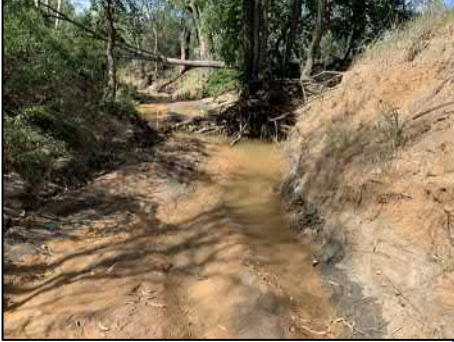
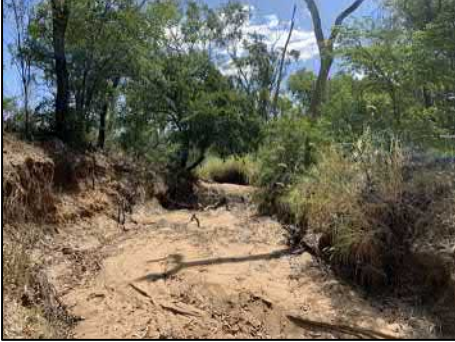
Site: Ca1		Location: Upstream		Stream Order: 2		Waterway: Caval Creek																						
Upstream: December 2019		Downstream: December 2019		Upstream: April 2020		Downstream: April 2020

Aquatic Ecosystem Value: Low		MNES/MSES: None present or likely to occur		Dry season refuge: No		Connectivity: Moderate, during periods of flow																						
In-stream condition: Fair Key habitat features in April included: <ul style="list-style-type: none"> • sandy ephemeral channel • shallow pools • some woody debris & detritus • predominately sand and silt/clay sediments with some pebbles & gravel, and • some trailing and overhanging bank vegetation. The site was dry during the December survey.		Riparian condition: Fair The riparian zone was semi-continuous around the perimeter of the waterway, although the extent of the vegetation had been reduced due to historic clearing. Vegetation consisted of trees, grasses, shrubs, ferns/sedges and weeds. Banks were low (1.8 m – 2 m high) and gently sloping with moderate levels erosion. There were some exotic terrestrial riparian species at the site.		External Impacts: High External impacts at the site were mostly associated with the surrounding land-use and included: <ul style="list-style-type: none"> • reduced riparian vegetation as a result of land clearing • grazing by livestock, and • feral animals. 		Water Quality: Fair

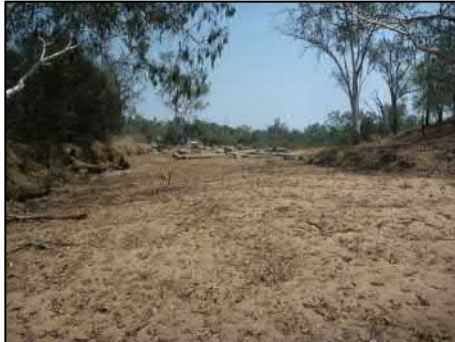
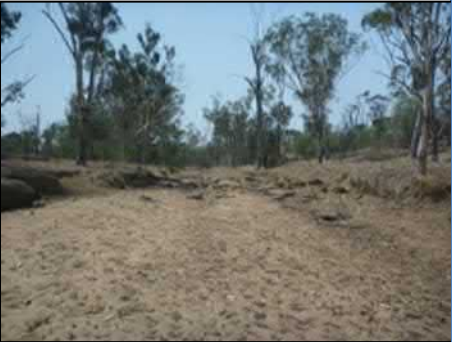
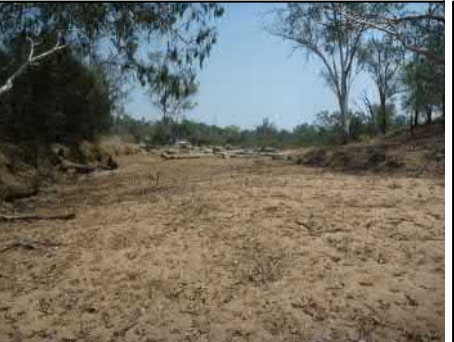
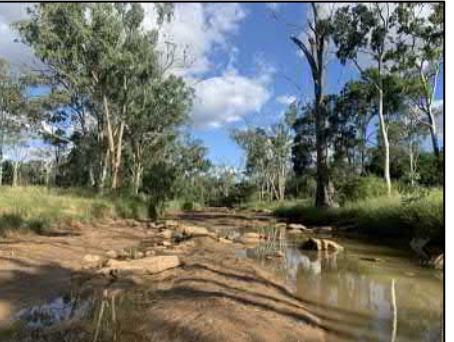
Site: Ch1		Location: Upstream		Stream Order: 4		Waterway: Cherwell Creek																						
Upstream: December 2019		Downstream: December 2019		Upstream: April 2020		Downstream: April 2020

Aquatic Ecosystem Value: Moderate		MNES/MSES: None present or likely to occur		Dry season refuge: No		Connectivity: Good, during periods of flow																						
In-stream condition: Fair Key habitat features in April included: <ul style="list-style-type: none"> • some woody debris • shallow pools • predominately sand and silt/clay sediments with some boulders, and • some trailing and overhanging bank vegetation. The site was dry during the December survey.		Riparian condition: Good The riparian zone was semi-continuous around the perimeter of the waterway, although the extent of the vegetation had been reduced due to historic clearing. Vegetation consisted of trees, grasses, shrubs, ferns and weeds. Banks were low (3.5 m – 2 m high) and gently sloping with some erosion. There were some exotic terrestrial riparian species at the site.		External Impacts: Moderate External impacts at the site were mostly associated with the surrounding land-use and included: <ul style="list-style-type: none"> • reduced riparian vegetation as a result of land clearing • grazing by livestock • feral animals, and • vehicle track crossing. 		Water Quality: Good

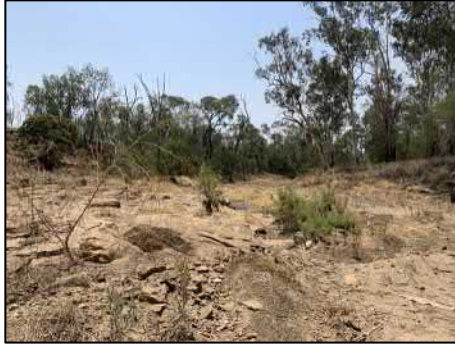
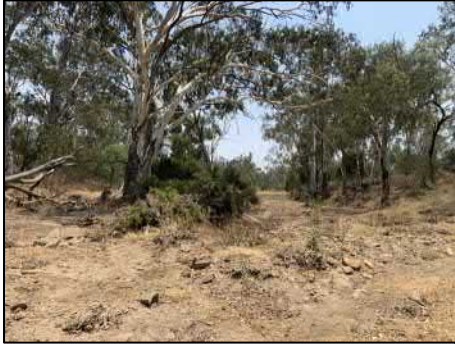
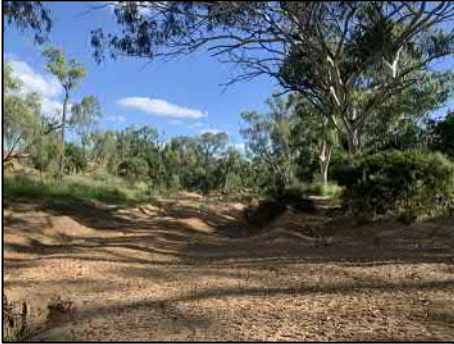
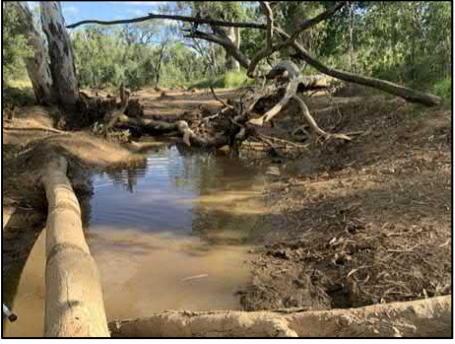
Site: Ch2		Location: Upstream		Stream Order: 5		Waterway: Cherwell Creek																						
Upstream: December 2019		Downstream: December 2019		Upstream: April 2020		Downstream: April 2020

Aquatic Ecosystem Value: Moderate		MNES/MSES: None present or likely to occur		Dry season refuge: No		Connectivity: Good, during periods of flow.																						
In-stream condition: Fair Key habitat features in April included: <ul style="list-style-type: none"> • wide sandy ephemeral channel • some woody debris & detritus • predominately sandy sediments with some silt/clay, and • some overhanging and trailing bank vegetation. The site was dry during the December survey.		Riparian condition: Fair The riparian zone was semi-continuous around the perimeter of the waterway, although the extent of the vegetation had been reduced due to historic clearing. Vegetation consisted of trees, grasses and weeds. Banks were intermediate (3 m – 4 m high) and gently sloping with moderate erosion. There were some exotic terrestrial riparian species at the site.		External Impacts: High External impacts at the site were mostly associated with the surrounding land-use and included: <ul style="list-style-type: none"> • reduced riparian vegetation as a result of land clearing • grazing by livestock, and • feral animals. 		Water Quality: Fair

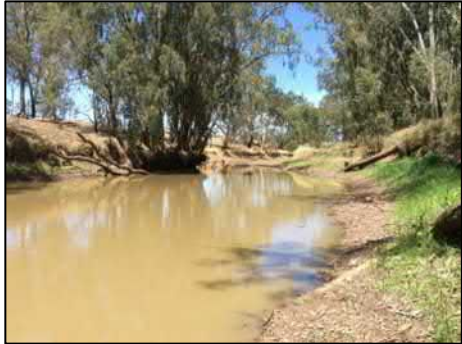
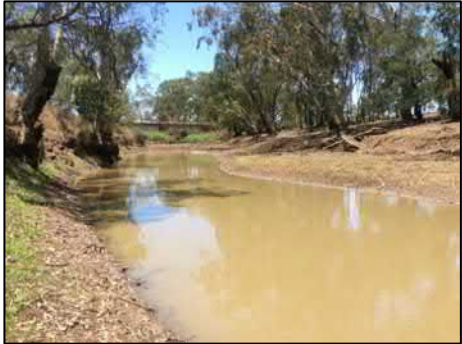
Site: GCO1		Location: Upstream		Stream Order: 5		Waterway: Grosvenor Creek															
Upstream: November 2020

Aquatic Ecosystem Value: Moderate		MNES/MSES: None present or likely to occur		Dry season refuge: Potential		Connectivity: N/A															
In-stream condition: Poor Key habitat features in November 2020 included: <ul style="list-style-type: none"> • wetted channel • silty/clay/muddy sediments • some shading of reach • some snags, woody debris & branches, and • little detritus in stream. The site was wet during the November 2020 survey.		Riparian condition: Good The riparian zone was narrow with surrounding agricultural land upstream. Some sedges were around the perimeter of the waterway. Evidence of deer, pig and horse disturbance was present in the surrounding riparian zone. Left and right bank height was low (approximately 2 m high) and steeply sloping on the left and gently sloping on some areas on the right near the bridge. Site was approximately 10 m wide. The wetted area was a still pool not connected downstream. The water appeared to be receding in subsequent survey days. It was unclear where water was fed from (e.g. upstream farm dam releases, groundwater etc.) and it was also unclear whether downstream earthworks were influencing water levels (e.g. damming water or restricting flow). While the waterway was a dry season refuge during the survey, it was unclear if water consistently endured the entire dry season or whether it was influenced by current land use and earthworks that occurred during the surveys.		External Impacts: Moderate External impacts at the site were mostly associated with the surrounding land-use and included: <ul style="list-style-type: none"> • reduced terrestrial vegetation as a result of land clearing • grazing by livestock, and • feral animals. 		Water Quality: N/A

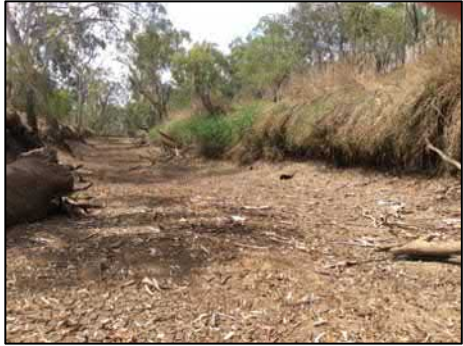
Site: GCO2		Location: Upstream	Stream Order: 5	Waterway: Grosvenor Creek	
Upstream: November 2020		Downstream: November 2020

Aquatic Ecosystem Value: Poor		MNES/MSES: None present or likely to occur		Dry season refuge: N/A	
In-stream condition: Poor Key habitat features in November 2020 included: <ul style="list-style-type: none"> • ephemeral channel • consolidated dry sediments • some shading of reach • some snags, woody debris & branches, and • little detritus. • eroded bank The site was dry during the November 2020 survey.		Riparian condition: Good The riparian zone was a scattered semi-continuous/continuous mix of grasses, trees, and weeds. A dead eel was in the vicinity of the site. There was a road crossing downstream of the site, and there was water present approximately 200 m downstream of the site. Left and right banks were approximately 4 m high and steep. Channel was approximately 10 m wide.		External Impacts: Moderate External impacts at the site were mostly associated with the surrounding land-use and included: <ul style="list-style-type: none"> • reduced terrestrial vegetation as a result of land clearing • grazing by livestock, and • feral animals.

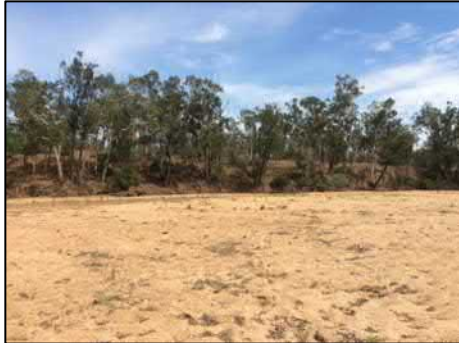
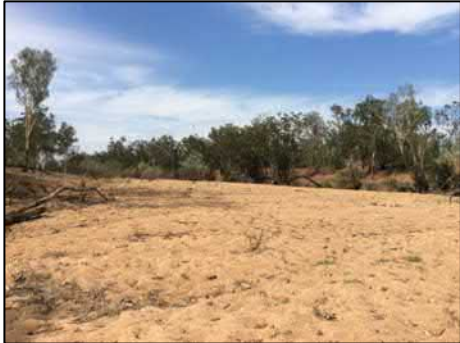
Site: IR01		Location: Upstream		Stream Order: 5		Waterway: Isaac River	
Upstream: November 2020		Downstream: November 2020

Aquatic Ecosystem Value: Moderate		MNES/MSES: None present or likely to occur		Dry season refuge: N/A		Connectivity: N/A	
In-stream condition: Poor Key habitat features in November 2020 included: <ul style="list-style-type: none"> • ephemeral channel • predominately sandy sediments with some pebbles, gavel and clay/silt • little shading of reach • no trailing vegetation, and • some large snags, woody debris & branches. The site was dry during the November survey.		Riparian condition: Good The riparian zone was a scattered semi-continuous/continuous mix around the perimeter of the waterway, and the extent of the vegetation had been reduced. Vegetation consisted grasses, trees, and weeds. Left bank height was low (approximately 0.5 m high) and gently sloping; the right bank was higher (approximately 15 m high), steep banks with moderate erosion. There were some exotic terrestrial riparian species at the site. Site was wide (approximately 60 m wide).		External Impacts: Moderate External impacts at the site were mostly associated with the surrounding land-use and included: <ul style="list-style-type: none"> • reduced terrestrial vegetation as a result of land clearing • grazing by livestock, and • feral animals. 		Water Quality: N/A Survey: Nov-20

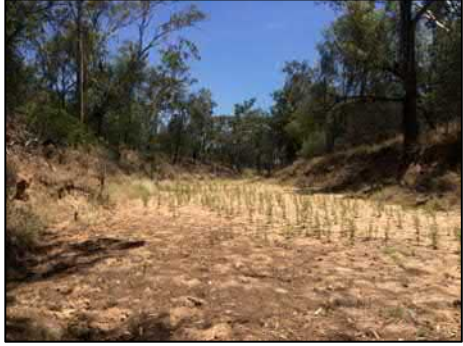
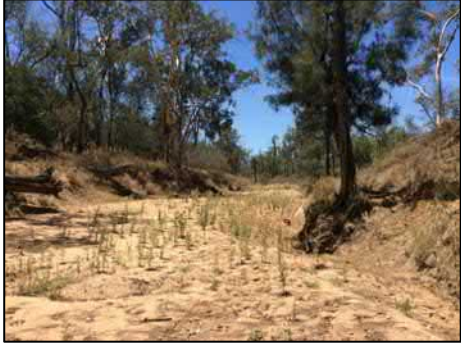
Site: HC01		Location: Downstream		Stream Order: 4		Waterway: Harrow Creek															
Upstream: November 2020

Aquatic Ecosystem Value: Moderate		MNES/MSES: None present or likely to occur		Dry season refuge: N/A		Connectivity: N/A															
In-stream condition: Moderate Key habitat features in November 2020 included: <ul style="list-style-type: none"> • ephemeral channel • unconsolidated sand sediments • established terrestrial weeds in the channel • some shading of reach • little snags, woody debris & branches, and • little detritus. The site was dry during the November 2020 survey.		Riparian condition: Fair The riparian zone was a scattered semi-continuous/continuous mix of grasses, trees, and weeds. Left and right bank height was approximately 5 m high, with moderate sloping on the left bank, and steep slopes on the right. Channel was approximately 20 m wide.		External Impacts: Moderate External impacts at the site were mostly associated with the surrounding land-use and included: <ul style="list-style-type: none"> • reduced terrestrial vegetation as a result of land clearing • grazing by livestock, and feral animals. 		Water Quality: N/A

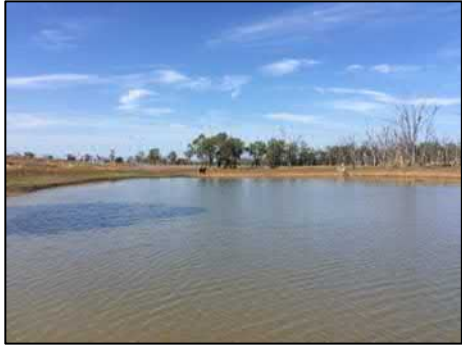
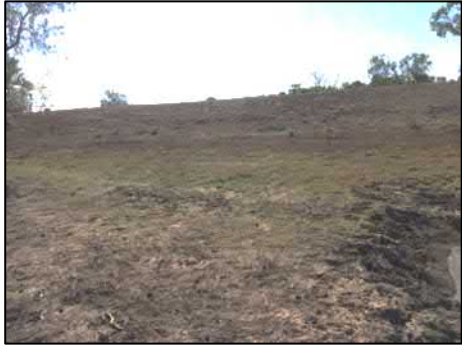
Site: LW2		Location: Upstream	Stream Order: 2	Waterway: Wetland														
Upstream: November 2020		Downstream: November 2020

Aquatic Ecosystem Value: Poor		MNES/MSES: None present or likely to occur		Dry season refuge: Yes														
Connectivity: Not connected																		
In-stream condition: Fair Key habitat features in November 2020 included: <ul style="list-style-type: none"> • shallow & deep pools • aquatic plants • predominately fine sediments (sand & silt/clay) • little trailing & overhanging vegetation, and • some snags, woody debris & detritus. The site was wet during the November 2020 survey.		Riparian condition: Good The riparian zone was a scattered continuous mix with isolated trees around the perimeter of the waterway, and the extent of the vegetation had been reduced. Vegetation consisted of grasses, shrubs, trees and weeds. Banks were generally low (approximately 1 m high) and gently sloping with moderate erosion. Damming side of the waterway had a more steeply sloping bank, approximately 5 m high. There were some exotic terrestrial riparian species at the site.		External Impacts: Moderate External impacts at the site were mostly associated with the surrounding land-use and included: <ul style="list-style-type: none"> • reduced terrestrial vegetation as a result of land clearing • grazing by livestock, and feral animals. 														
		Water Quality:

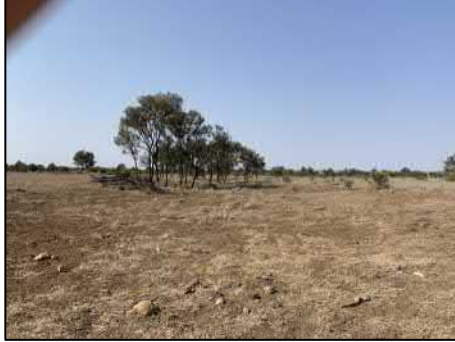
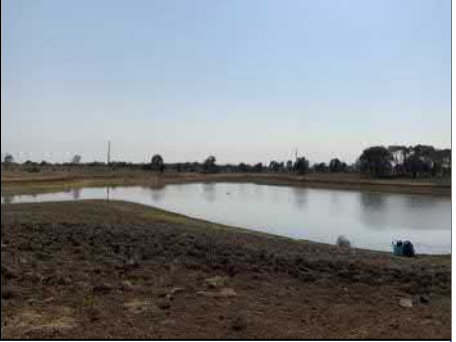
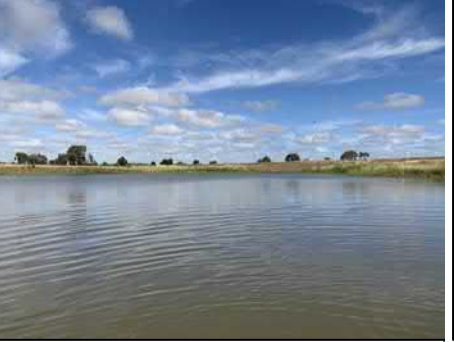
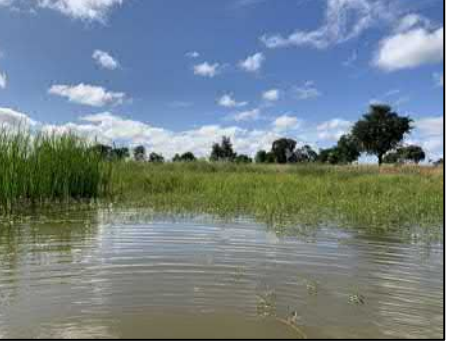
Site: HT1D		Location: Within Project Footprint		Stream Order: 1		Waterway: Unmapped farm dam																						
Upstream: December 2019		Downstream: December 2019		Upstream: April 2020		Downstream: April 2020

Aquatic Ecosystem Value: Moderate		MNES/MSES: None present or likely to occur		Dry season refuge: Yes		Connectivity: Poor, isolated from main watercourse by dam																						
In-stream condition: Fair Key habitat features included: <ul style="list-style-type: none"> • farm dam on ephemeral channel • aquatic plants lining channel • shallow & deep pools • predominately silt/clay sediments • little trailing bank vegetation and woody debris, and • some detritus. 		Riparian condition: Poor The riparian zone was isolated around the perimeter of the waterway, and the extent of the vegetation had been reduced due to historical clearing for agriculture. Vegetation consisted grasses, ferns and weeds. Banks were low (approximately 2.5 m high) and gently sloping with moderate erosion. There were some exotic terrestrial riparian species at the site.		External Impacts: Extreme External impacts at the site were mostly associated with the surrounding land-use and included: <ul style="list-style-type: none"> • reduced riparian vegetation as a result of land clearing • grazing by livestock • feral animals, and • the presence of an artificial dam. 		Water Quality: Poor

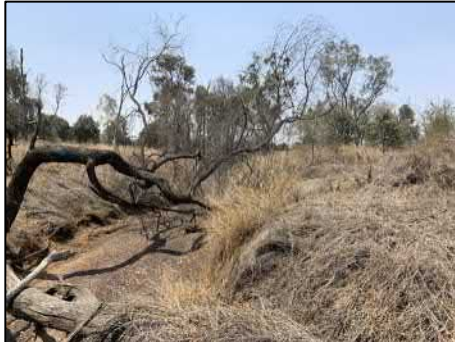
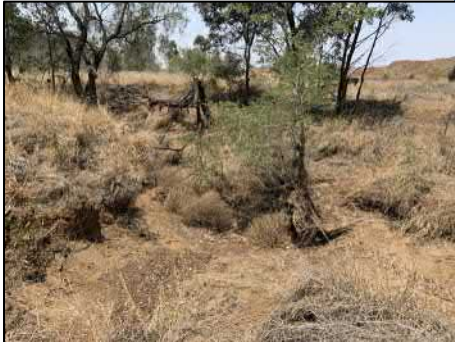
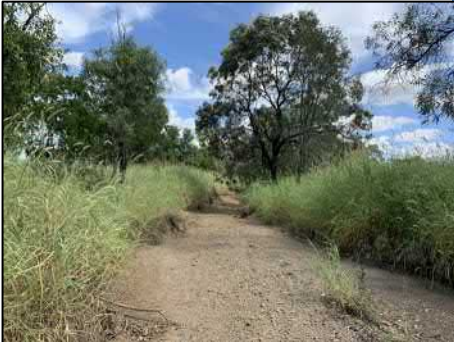
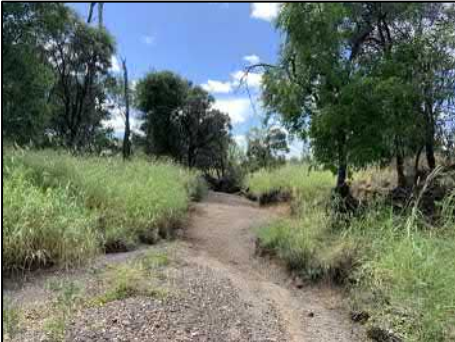
Site: H1		Location: Downstream		Stream Order: 2		Waterway: Horse Creek																						
Upstream: December 2019		Downstream: December 2019		Upstream: April 2020		Downstream: April 2020

Aquatic Ecosystem Value: Low		MNES/MSES: None present or likely to occur		Dry season refuge: No		Connectivity: Limited, during periods of flow																						
In-stream condition: Fair Key potential habitat features included: <ul style="list-style-type: none"> • ephemeral waterway • predominately sandy sediments with some gravel and pebbles, and • moderate snags and woody debris. The site was dry during both the December and April surveys.		Riparian condition: Fair The riparian zone was semi-continuous around the perimeter of the waterway, and the extent of the vegetation had been reduced. Vegetation consisted grasses, trees and weeds. Banks were low (approximately 1.8 m high) and gently sloping with moderate bank and extensive bed erosion. There were some exotic terrestrial riparian species at the site.		External Impacts: High External impacts at the site were mostly associated with the surrounding land-use and included: <ul style="list-style-type: none"> • reduced riparian vegetation as a result of land clearing • grazing by livestock, and • feral animals. 		Water Quality: N/A

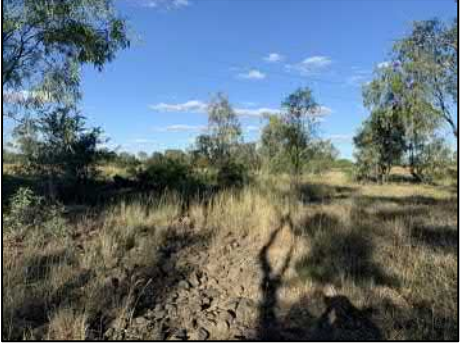
Aquatic Ecosystem Value: Low		MNES/MSES: None present or likely to occur		Dry season refuge: No		Connectivity: Limited, during periods of flow																						
<p>In-stream condition: Poor</p> <p>Key potential habitat features in April included:</p> <ul style="list-style-type: none"> • ephemeral waterway • rocky narrow channel • predominately cobbled sediments with some sand • little snags and woody debris, and • little trailing & overhanging vegetation. <p>The site was not sampled during the December survey and was dry during the April survey.</p>		<p>Riparian condition: Fair</p> <p>The riparian zone was semi-continuous around the perimeter of the waterway, and the extent of the vegetation had been reduced. Vegetation consisted grasses, trees and weeds. Banks were low (approximately 1 m high) and gently sloping with moderate erosion. There were some exotic terrestrial riparian species at the site.</p>		<p>External Impacts: High</p> <p>External impacts at the site were mostly associated with the surrounding land-use and included:</p> <ul style="list-style-type: none"> • reduced riparian vegetation as a result of land clearing • grazing by livestock, and • feral animals. 		<p>Water Quality: N/A</p>

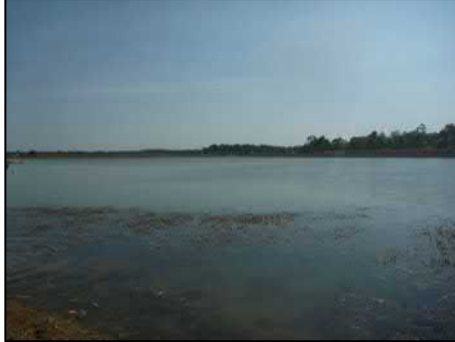
Site: LW1		Location: Downstream		Stream Order: 3		Waterway: Mapped lacustrine wetland on Horse Creek																						
Upstream: December 2019		Downstream: December 2019		Upstream: April 2020		Downstream: April 2020

Aquatic Ecosystem Value: Moderate		MNES/MSES: None present or likely to occur		Dry season refuge: Yes		Connectivity: Limited due to high dam walls																						
In-stream condition: Fair Key habitat features included: <ul style="list-style-type: none"> • shallow & deep pools • aquatic plants • predominately fine sediments (sand & silt/clay) • little trailing & overhanging vegetation, and • some snags, woody debris & detritus. 		Riparian condition: Fair The riparian zone was a scattered continuous mix with isolated trees around the perimeter of the waterway, and the extent of the vegetation had been reduced. Vegetation consisted grasses, shrubs, trees and weeds. Banks were low (approximately 3 m high) and gently sloping with moderate erosion. There were some exotic terrestrial riparian species at the site.		External Impacts: High External impacts at the site were mostly associated with the surrounding land-use and included: <ul style="list-style-type: none"> • reduced riparian vegetation as a result of land clearing • grazing by livestock • feral animals, and • presence of an artificial dam. 		Water Quality: Poor

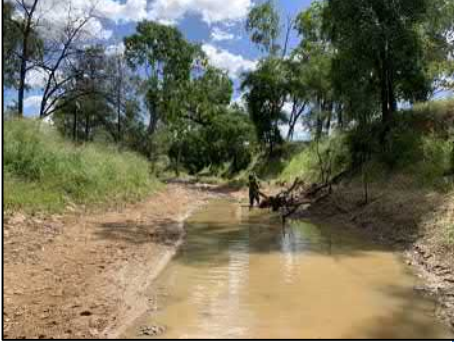
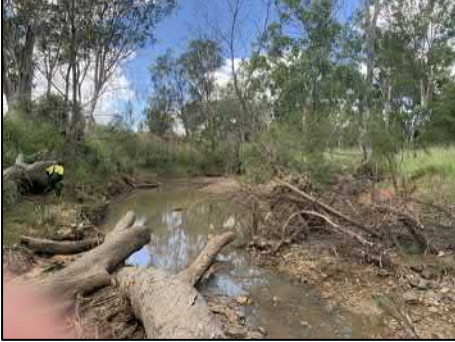
Site: G1		Location: Downstream		Stream Order: 5		Waterway: Grosvenor Creek																						
Upstream: December 2019		Downstream: December 2019		Upstream: April 2020		Downstream: April 2020

Aquatic Ecosystem Value: Moderate		MNES/MSES: None present or likely to occur		Dry season refuge: No		Connectivity: Good, during periods of flow																						
In-stream condition: Good Key habitat features in April included: <ul style="list-style-type: none"> • ephemeral channel • predominately sandy sediments with some pebbles, gavel and clay/silt • moderate overhanging vegetation • some shallow pools, and • some snags, woody debris & branches. The site was dry during the December survey.		Riparian condition: Good The riparian zone was a scattered semi-continuous/continuous mix around the perimeter of the waterway, and the extent of the vegetation had been reduced. Vegetation consisted grasses, shrubs, trees, ferns and weeds. Banks were low (approximately 4 m high) and gently sloping with moderate erosion. There were some exotic terrestrial riparian species at the site.		External Impacts: High External impacts at the site were mostly associated with the surrounding land-use and included: <ul style="list-style-type: none"> • reduced riparian vegetation as a result of land clearing • grazing by livestock, and • feral animals. 		Water Quality: Fair

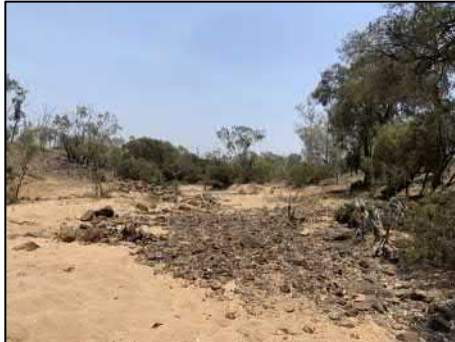
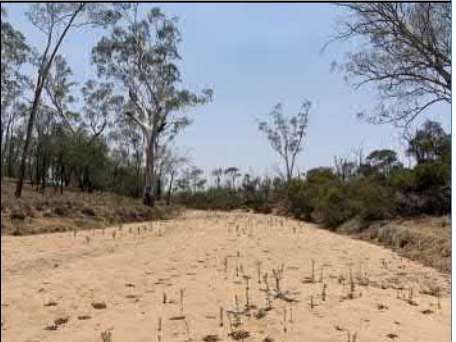
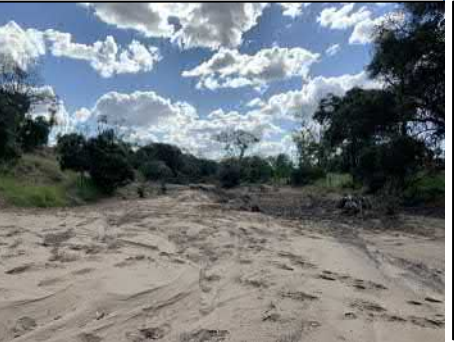
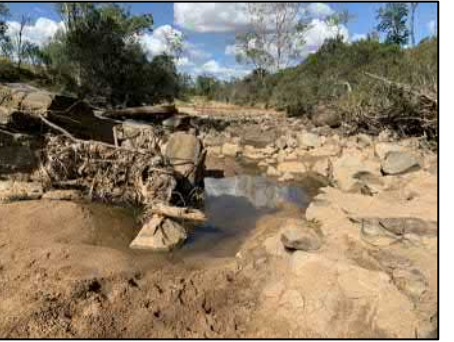
Site: Ch3		Location: Downstream		Stream Order: 5		Waterway: Cherwell Creek																						
Upstream: December 2019		Downstream: December 2019		Upstream: April 2020		Downstream: April 2020

Aquatic Ecosystem Value: Moderate		MNES/MSES: None present or likely to occur		Dry season refuge: No		Connectivity: Good, during periods of flow																						
In-stream condition: Good Key habitat features in April included: <ul style="list-style-type: none"> • ephemeral channel • shallow pools • predominately sandy sediments with some pebbles, gavel and clay/silt • little overhanging & trailing vegetation, and • little snags, woody debris & branches. The site was dry during the December survey.		Riparian condition: Good The riparian zone was a continuous width around the perimeter of the waterway, and the extent of the vegetation had been reduced. Vegetation consisted grasses, shrubs, trees, ferns and weeds. Banks were low (approximately 4 m high) and gently sloping with moderate erosion. There were some exotic terrestrial riparian species at the site.		External Impacts: Moderate External impacts at the site were mostly associated with the surrounding land-use and included: <ul style="list-style-type: none"> • reduced riparian vegetation as a result of land clearing • grazing by livestock, and • feral animals. 		Water Quality: Good

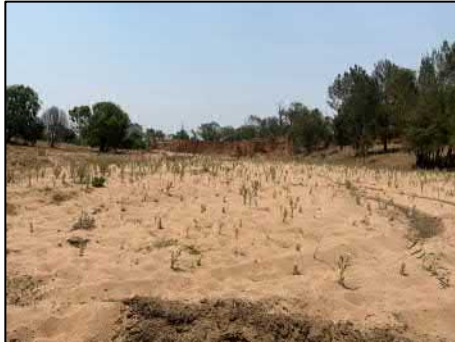
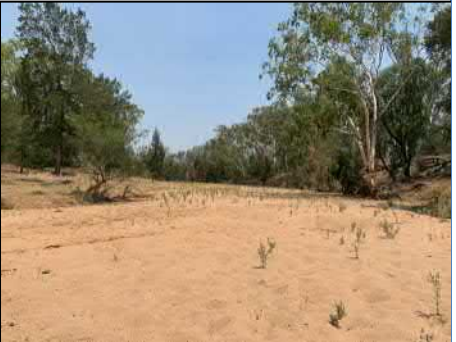
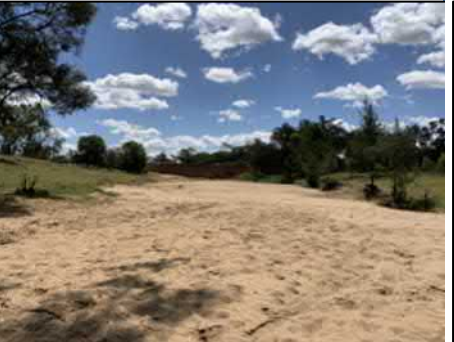
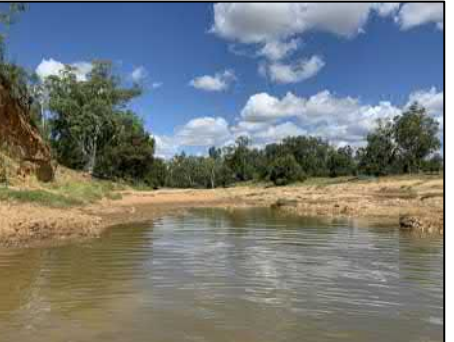
Site: Ch4		Location: Downstream		Stream Order: 5		Waterway: Cherwell Creek																						
Upstream: December 2019		Downstream: December 2019		Upstream: April 2020		Downstream: April 2020

Aquatic Ecosystem Value: Moderate		MNES/MSES: None present or likely to occur		Dry season refuge: No		Connectivity: Good, during periods of flow																						
In-stream condition: Good Key habitat features in April included: <ul style="list-style-type: none"> • ephemeral channel • predominately sandy sediments with some clay/silt • some overhanging vegetation • little snags, woody debris & branches • shallow pool at eroded bend. The site was dry during the December survey.		Riparian condition: Fair The riparian zone was a semi-continuous/ continuous mix around the perimeter of the waterway, and the extent of the vegetation had been reduced. Vegetation consisted grasses, shrubs, trees, ferns and weeds. Banks were low (2.5 m – 3.5 m high) and gently sloping with extensive erosion. There were some exotic terrestrial riparian species at the site.		External Impacts: Moderate External impacts at the site were mostly associated with the surrounding land-use and included: <ul style="list-style-type: none"> • reduced riparian vegetation as a result of land clearing • grazing by livestock, and • feral animals. 		Water Quality: Fair

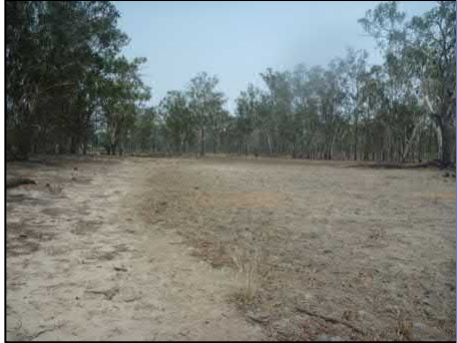
Site: PW1		Location: Downstream		Stream Order: N/A		Waterway: Mapped WPA / HES palustrine wetland																						
December 2019		December 2019		April 2020 N/A		April 2020 N/A

Aquatic Ecosystem Value: Low		MNES/MSES: None present or likely to occur		Dry season refuge: No		Connectivity: Limited, would only hold water during periods of high flow																						
<p>In-stream condition: Poor</p> <p>Key potential habitat features in December included:</p> <ul style="list-style-type: none"> • predominately clay/silt sediments • little overhanging & trailing vegetation • emergent aquatic plants, and • little snags, woody debris & branches. <p>The site was dry during the December survey and was not sampled during the April survey due to property access issues.</p>		<p>Riparian condition: Fair</p> <p>The riparian zone was reduced but continuous around the perimeter of the wetland, and the extent of the vegetation had been reduced. Vegetation consisted trees predominantly eucalyptus, grasses and shrubs. There was some erosion in the dry bed. There were some exotic terrestrial riparian species at the site.</p>		<p>External Impacts: Moderate</p> <p>External impacts at the site were mostly associated with the surrounding land-use and included:</p> <ul style="list-style-type: none"> • reduced riparian vegetation as a result of land clearing • grazing by livestock, and • feral animals. 		<p>Water Quality: N/A</p>

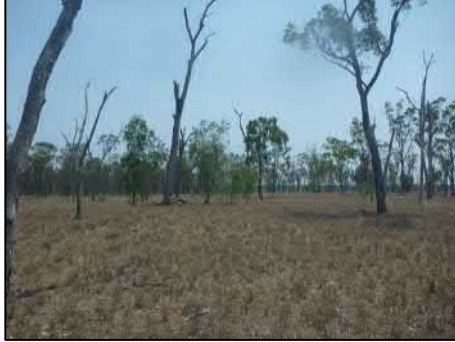
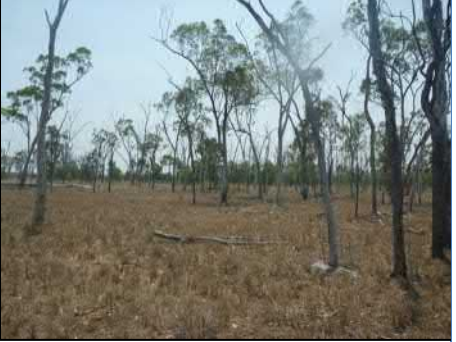
Site: PW2		Location: Downstream		Stream Order: N/A		Waterway: Mapped palustrine wetland																						
December 2019		December 2019		April 2020		April 2020

Aquatic Ecosystem Value: N/A		MNES/MSES: N/A		Dry season refuge: N/A		Connectivity: N/A																						
<p>In-stream condition: N/A</p> <p>No aquatic habitat features recorded at this site. Site is likely incorrectly mapped as a palustrine wetland, with terrestrial ecological values only.</p>		<p>Riparian condition: Fair</p> <p>This site did not feature a riparian zone as no aquatic ecological features were evident, however, terrestrial vegetation in the broader region consisted grasses, shrubs, trees, and weeds. There some exotic terrestrial species at the site.</p>		<p>External Impacts: Moderate</p> <p>External impacts at the site were mostly associated with the surrounding land-use and included:</p> <ul style="list-style-type: none"> • reduced terrestrial vegetation as a result of land clearing • grazing by livestock, and • feral animals. 		<p>Water Quality: N/A</p>

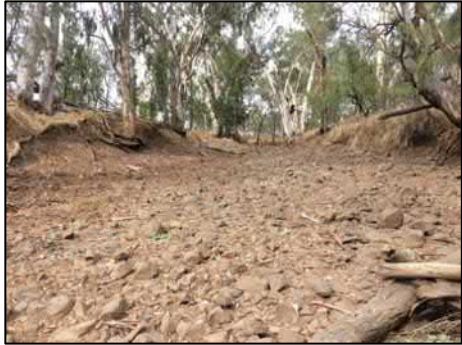
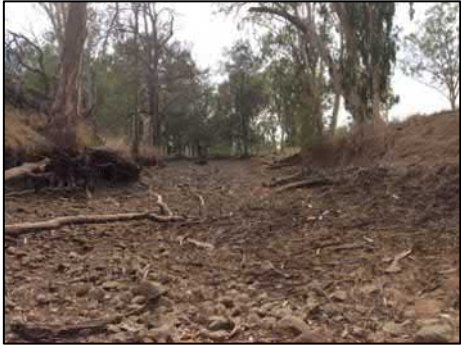
Site: GC03		Location: Downstream		Stream Order: 5		Waterway: Grosvenor Creek															
Upstream: November 2020		Downstream: November 2020

Aquatic Ecosystem Value: Moderate		MNES/MSES: None present or likely to occur		Dry season refuge: N/A		Connectivity: N/A															
In-stream condition: Fair Key habitat features in November 2020 included: <ul style="list-style-type: none"> • substrate predominately sand, rocks and pebbles • moderate shading of reach • extensive snags, woody debris & branches, and • some terrestrial detritus. The site was dry during the November 2020 survey.		Riparian condition: Good The riparian zone was a scattered semi-continuous/continuous mix of grasses, large trees, and weeds. Both banks were approximately 4 m high, with some eroded bank areas around tree roots, providing good habitat for fish and macroinvertebrates. Channel was approximately 10 m wide. Large trees in the riparian zone provided moderate-extensive shading throughout the reach.		External Impacts: Moderate External impacts at the site were mostly associated with the surrounding land-use and included: <ul style="list-style-type: none"> • reduced terrestrial vegetation as a result of land clearing • grazing by livestock, and feral animals. 		Water Quality: N/A

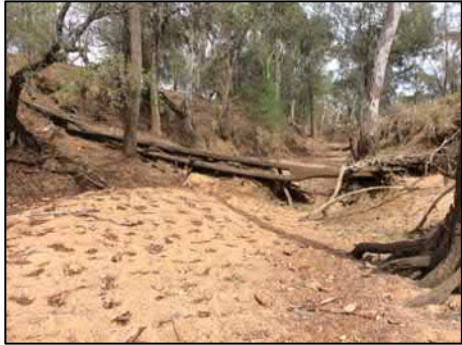
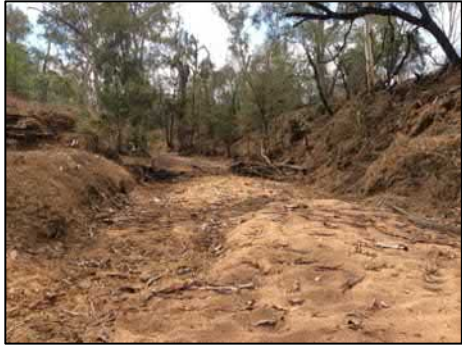
Aquatic Ecosystem Value: Moderate		MNES/MSES: None present or likely to occur		Dry season refuge: N/A		Connectivity: N/A															
<p>In-stream condition: Fair</p> <p>Key habitat features in November 2020 included:</p> <ul style="list-style-type: none"> • substrate predominately unconsolidated sand • moderate-extensive shading of reach • extensive snags, woody debris & branches • some large snags, and • extensive terrestrial detritus. <p>The site was dry during the November 2020 survey.</p>		<p>Riparian condition: Good</p> <p>The riparian zone was a scattered continuous mix of grasses, large trees, and weeds. Both banks were approximately 3 m high, with some eroded bank areas around tree roots, providing good habitat for fish and macroinvertebrates. Channel was approximately 10 m wide. Large trees in the riparian zone provided moderate-extensive shading throughout the reach.</p>		<p>External Impacts: Moderate</p> <p>External impacts at the site were mostly associated with the surrounding land-use and included:</p> <ul style="list-style-type: none"> • reduced terrestrial vegetation as a result of land clearing • grazing by livestock, and feral animals. 		<p>Water Quality: N/A</p>

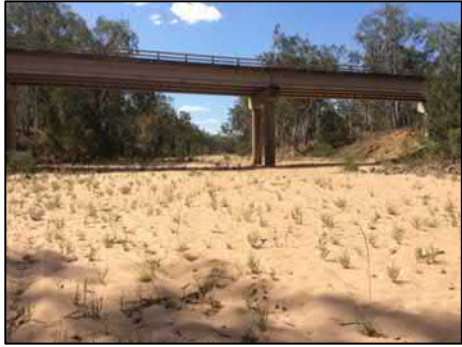
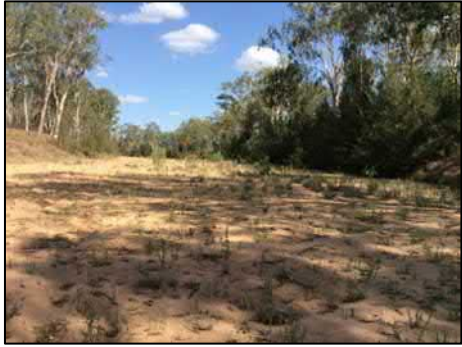
Aquatic Ecosystem Value: Moderate		MNES/MSES: None present or likely to occur		Dry season refuge: N/A		Connectivity: N/A															
In-stream condition: Poor Key habitat features in November 2020 included: <ul style="list-style-type: none"> • ephemeral channel • unconsolidated sand sediments • established terrestrial weeds in the channel • moderate shading of reach • some snags, woody debris & branches, and • little detritus. The site was dry during the November 2020 survey.		Riparian condition: Good The riparian zone was a scattered semi-continuous/continuous mix of grasses, large trees, and weeds. Left bank downstream was gently sloping while right bank was a higher reaching steep bank. The confluence of Grosvenor Creek and Isaac River was approximately 100 m upstream of the bridge. Channel was approximately 40 m wide.		External Impacts: Moderate External impacts at the site were mostly associated with the surrounding land-use and included: <ul style="list-style-type: none"> • reduced terrestrial vegetation as a result of land clearing • grazing by livestock, and • feral animals. 		Water Quality: N/A
