Solar Partners XI, LLC
Biological Assessment
Gemini Solar Project
N-84631

June 2019

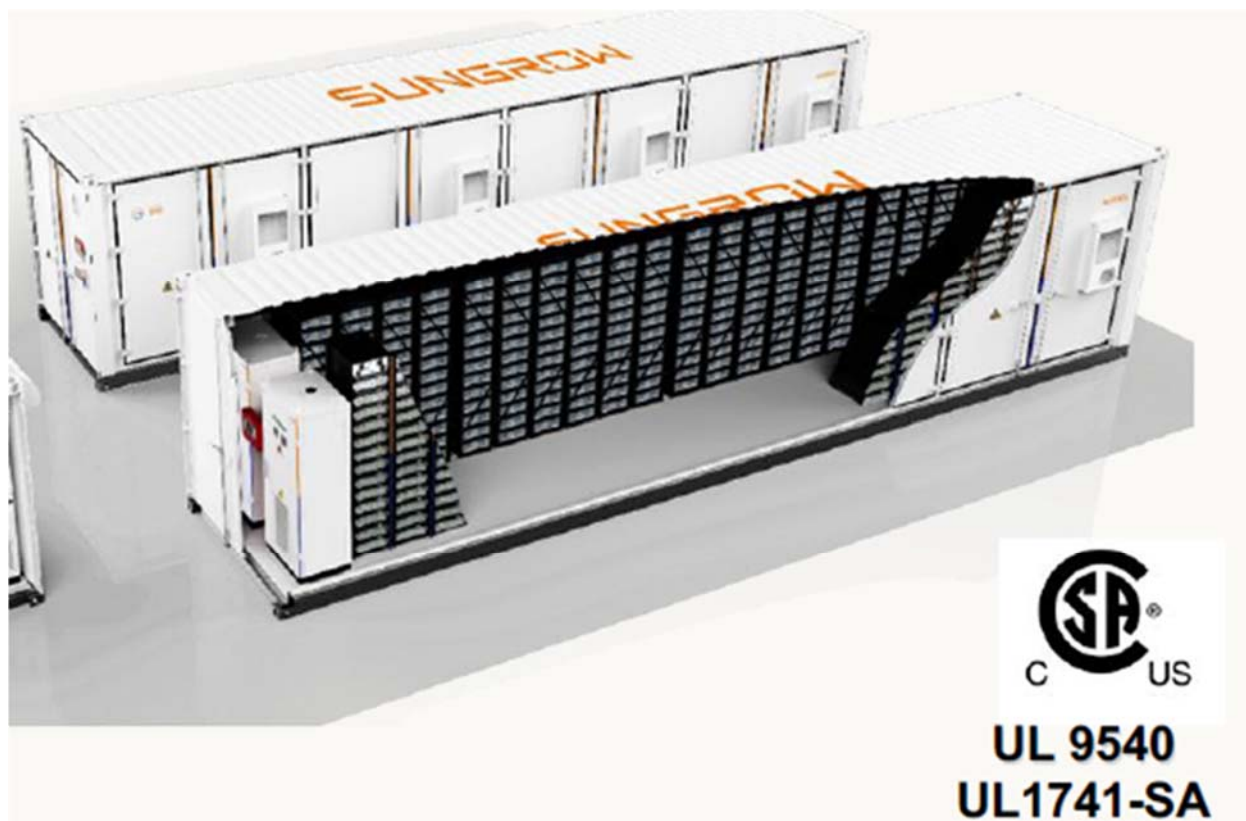
Figure 9 Photograph of a Battery Energy Storage System

inverter/PCS. The batteries may be lithium ion, but the technology for battery storage is changing rapidly and the appropriate technology at the time of construction would be utilized. The units would be installed adjacent to the DC/DC power converter and PCS, on a foundation or piles, as needed to protect the unit from stormwater. The brand and type of unit is not currently known. The battery systems would be enclosed in a container typically 40 feet (12.2 meters) long, by 9.5 feet (2.9 meters) wide, by 8 feet (2.4 meters) tall and are configured as a climate-controlled enclosure for batteries (Figure 9). The climate control system would be powered by the solar panels. A DC/DC power converter would be housed in a container, typically 10-foot (3-meter) long, 9.5-foot (2.9-meter) wide, and 8-foot (2.4-meter) long, adjacent to the battery container. The units would be painted colors determined by the BLM. Each unit would have a fire suppression system, which involves use of clean fire suppression gas. Alternatively, battery storage may also be located adjacent to the Project substations within the footprint of the substations.

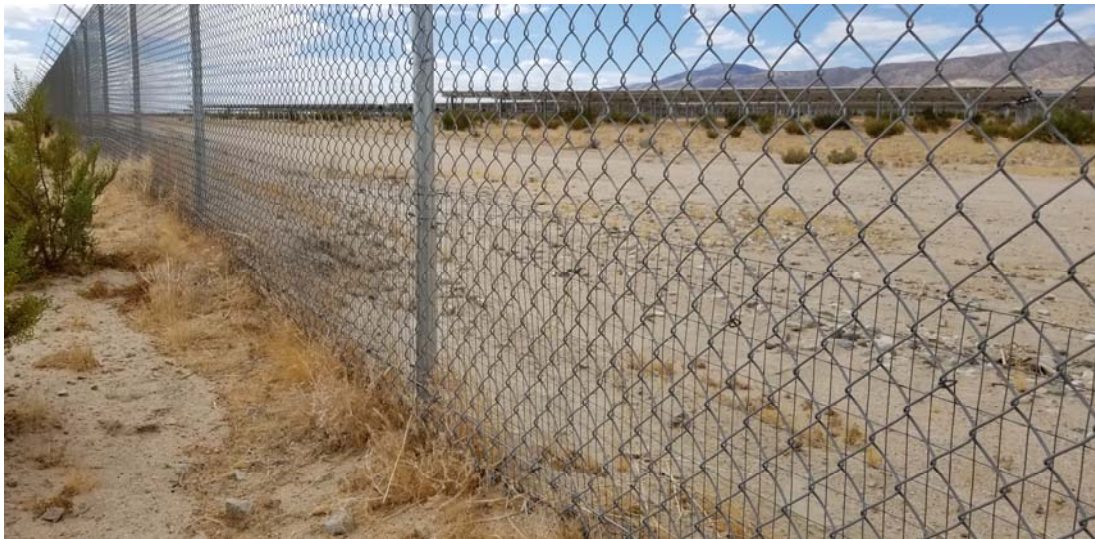
Figure 11 Example Tortoise and Security Fencing

at the site entrance. The perimeter fence would be an approximately 6- to 7-foot-high (1.8- to 2.1-meter-high) chain link fence, installed on posts, with 1-foot-high (0.3-meter-high) three-strand barbed-wire at the top (the security fence in proximity to the gen-tie lines would be properly grounded). The fence would be treated with a chemical dulling agent that reduces the galvanized steel's potential for glare and reduces contrast. The perimeter security fencing would have a gap of approximately 8 inches (20 centimeters) between the bottom of the fence and the ground around mowed areas to allow desert tortoise to reenter and exit the area after construction. For the approximately 35 percent of the facility developed using traditional methods where permanent tortoise exclusion is needed, tortoise exclusion fencing would be installed on the external perimeter security fence (Figure 11) and, along internal fencelines, permanent desert tortoise fencing would be installed on T-posts. A tortoise barrier guard would be required across every access road traveling between areas constructed via mowing and traditional methods. Tortoise exclusion fencing would also be maintained around the substations.
