The Poole Iron Age Logboat

Jessica Berry, David Parham
and Catrina Appleby

Cover: 3D laser scan of the physical remains of the Poole logboat

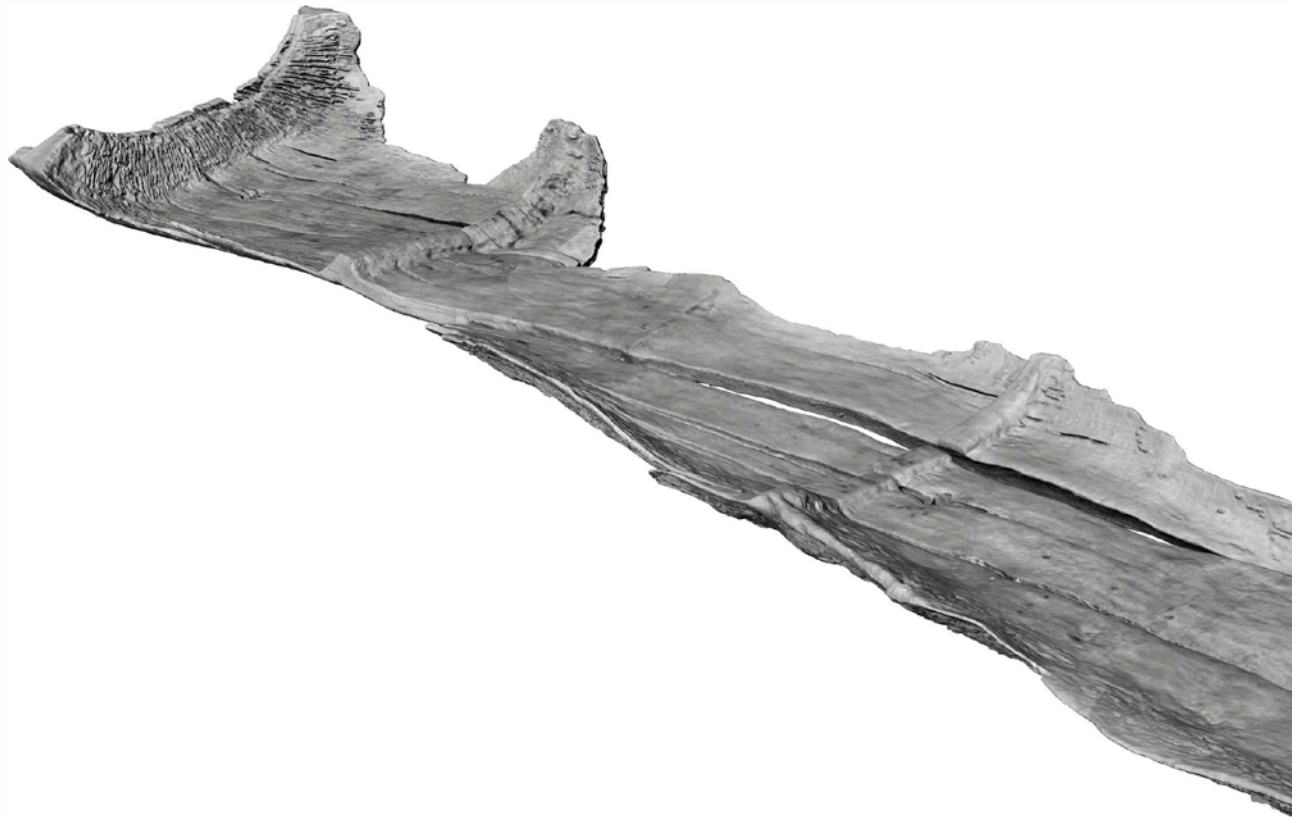
Figure 4.1 3D laser scan of physical remains

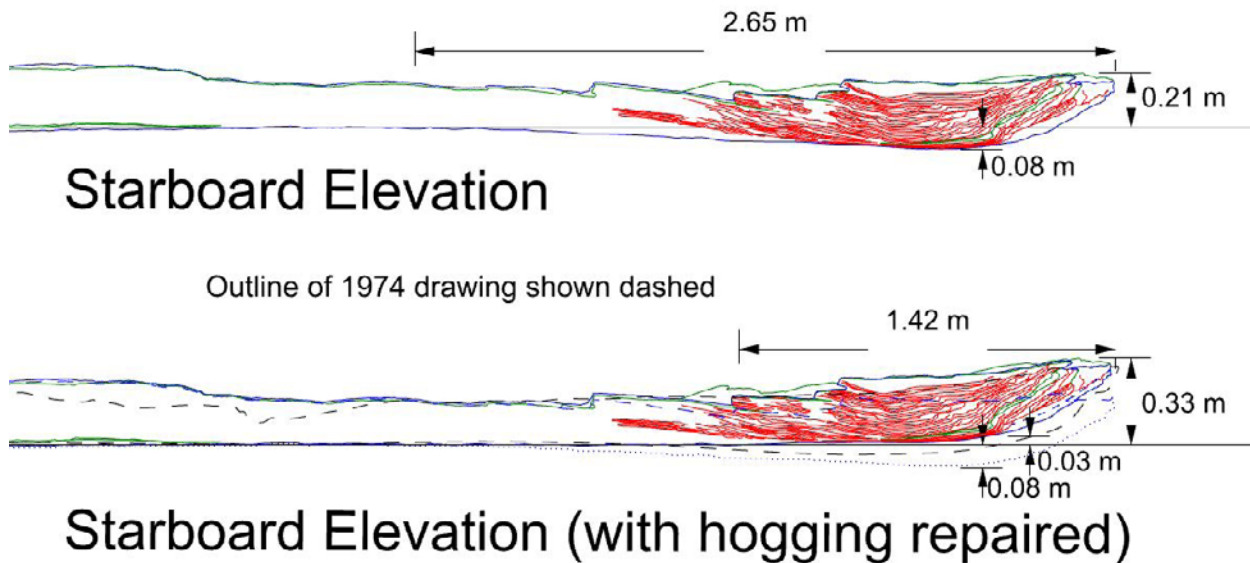
Figure 4.12 Hogging at bow area

The bend command in the Rhinoceros 3D modelling software was used to repair the longitudinal shape in order to remove the hogging. As the recorded material potentially included the full overall length and parts of the sheerline, a ‘minimum reconstruction’ as defined by Crumlin-Pedersen and McGrail was considered feasible (Crumlin-Pedersen and McGrail 2006, 57).

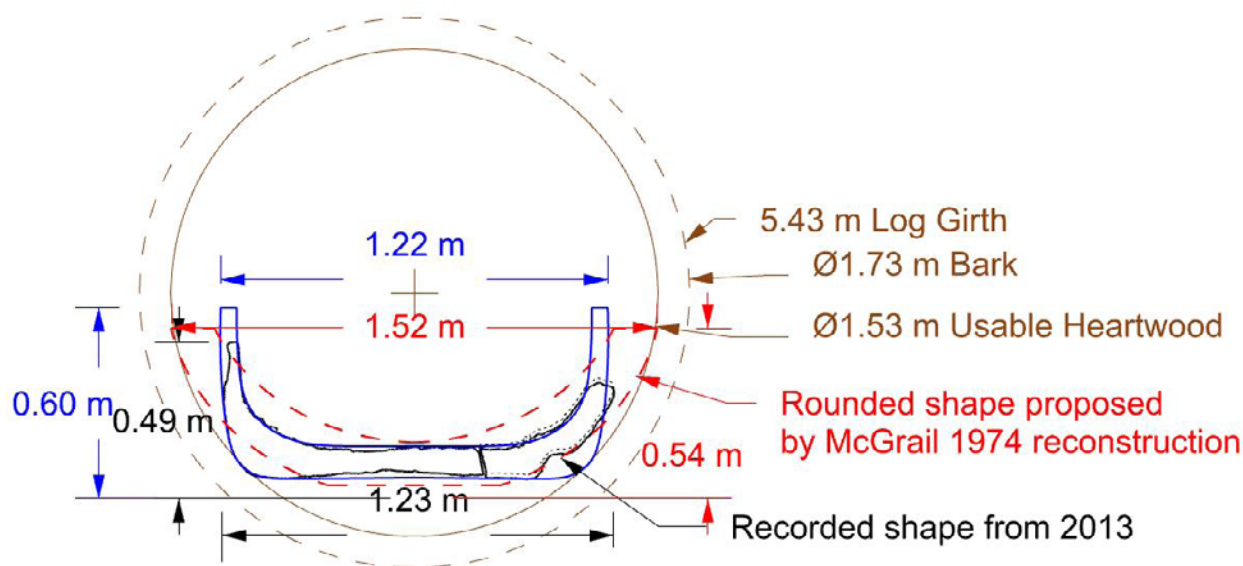
Figure 4.16 Preferred stern profile shape

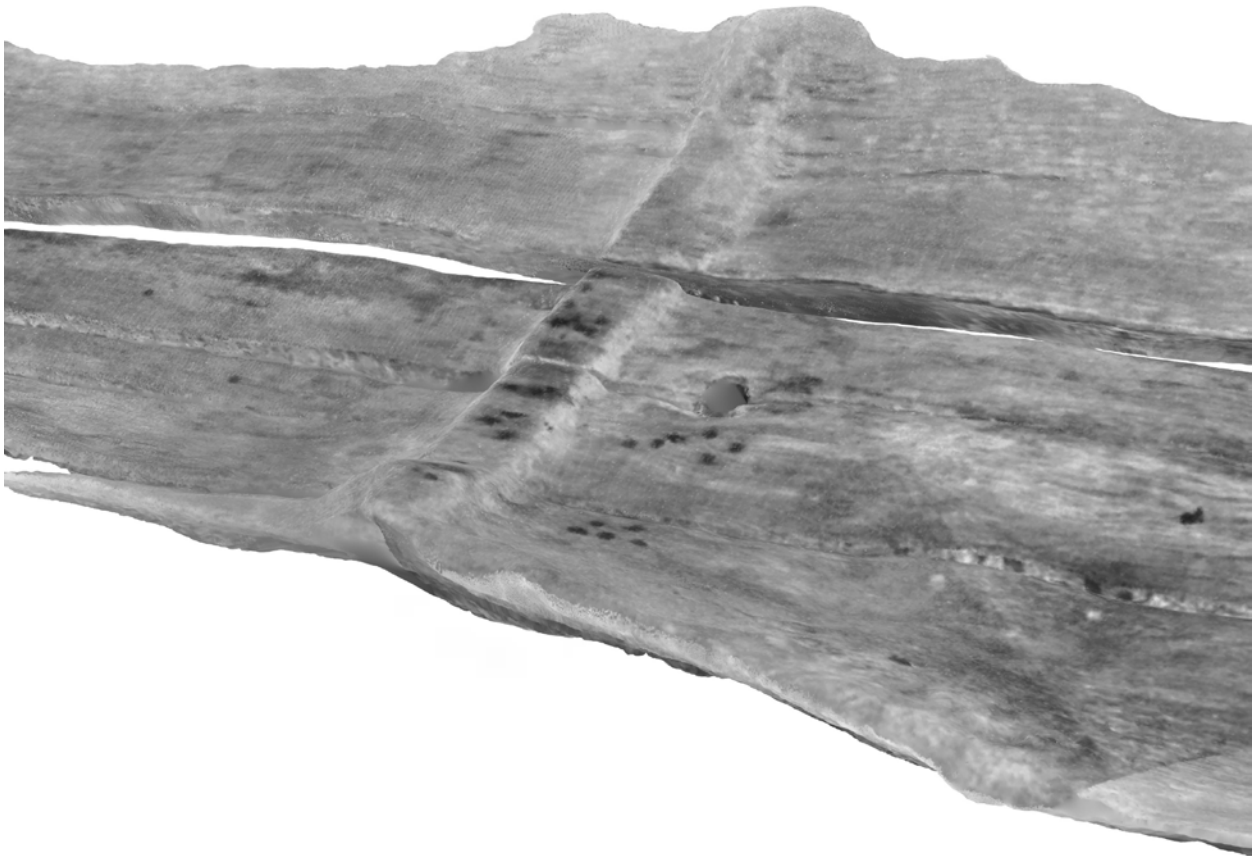
Figure 4.25 Forward transverse ridge

It was tentatively suggested by McGrail (1978, 315) that the transverse ridges divided logboats into functional spaces such as areas for propulsion, cargo, command and steering.

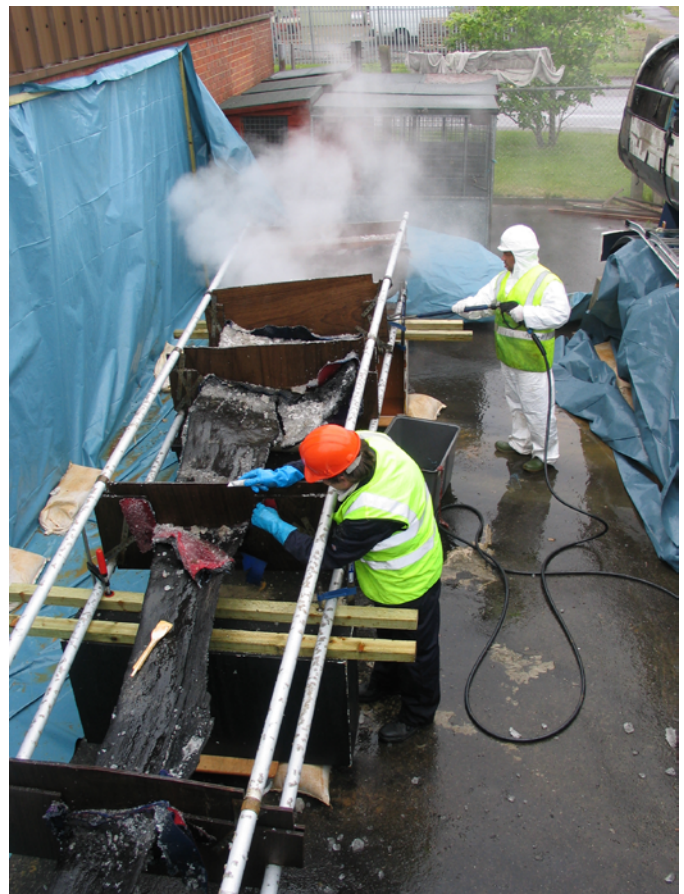
Figure 5.7 Power-hosing sucrose crust from boat in May 2005

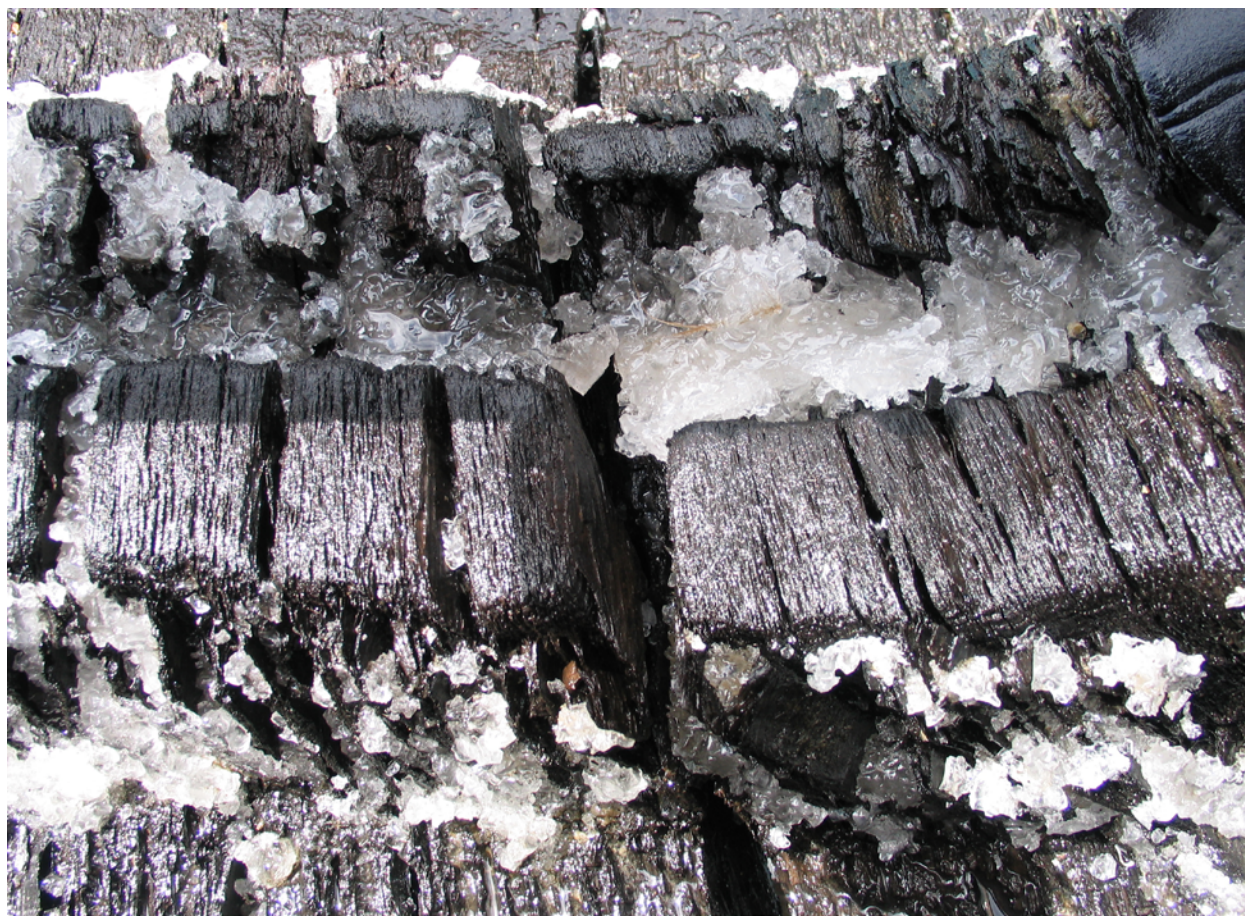
Figure 5.8 Sucrose crystals in open grain and the transom slot in May 2005 (photo courtesy of Jeremy Hutchings)

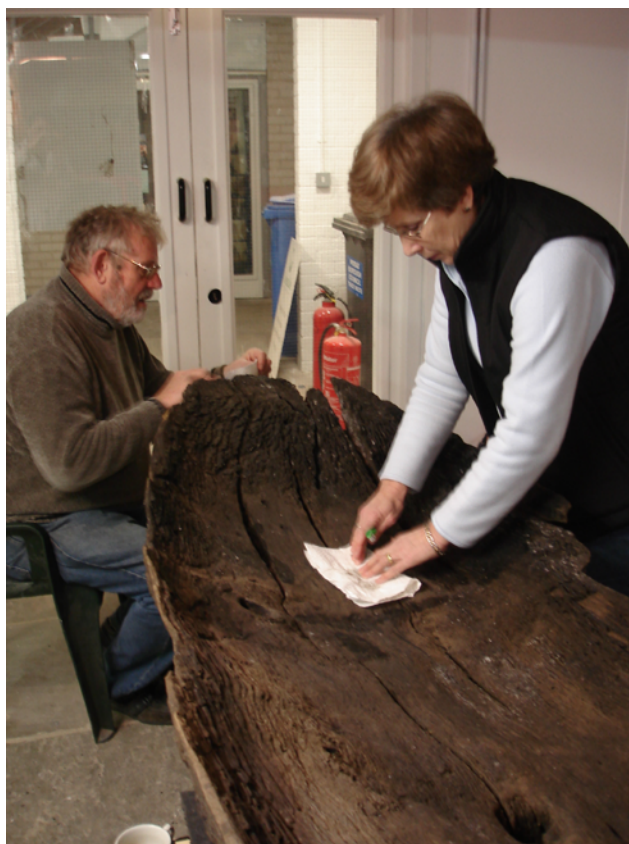
Figure 5.14 Localised cleaning using water and absorbent paper

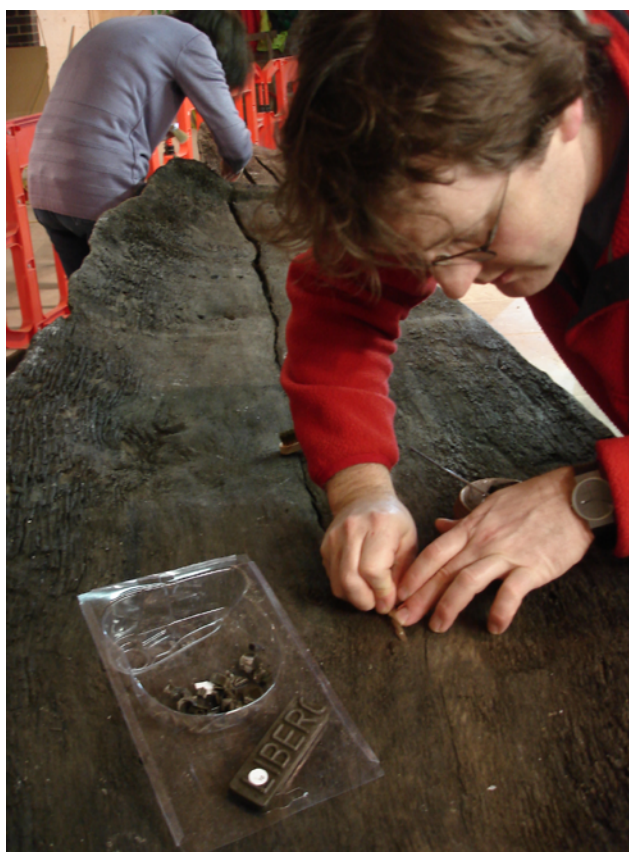
Figure 5.15 Plugging core sample holes with coloured Liberon™ wax filler
