Frost Resistance of Cover and Liner Materials for Landfills and Hazardous Waste Sites

Edwin J. Chamberlain, Allan E. Erickson, and Craig H. Benson

December 1997

Special Report 97-29

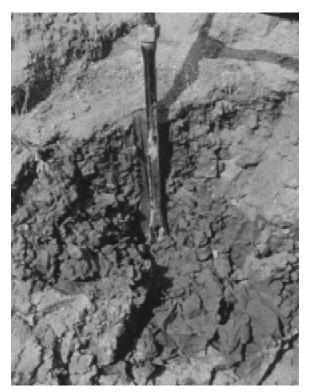
Figure 12. Test pit showing blocky soil structure caused by freeze-thaw cracking—Valley Trail test pad.

after thawing. Excavation in the test pads after thawing was complete exposed structures (Fig. 12) consisting of many block–aggregates, approximately 1 in.³ (1.6 cm³) in size, separated by vertical and horizontal cracks.
