# **Camp Century Movement Record**

by Robert W. Waterhouse, Wayne N. Tobiasson,  
and Barrat G. Scott

U. S. ARMY COLD REGIONS RESEARCH  
AND ENGINEERING LABORATORY  
Hanover, New Hampshire

This report presents the measurement methods and data of USA CRREL Subtask 5010.02203 (Greenland Project 13a) at Camp Century, Greenland. It covers the period from October 1960, when the first measurements were taken, through May 1962.

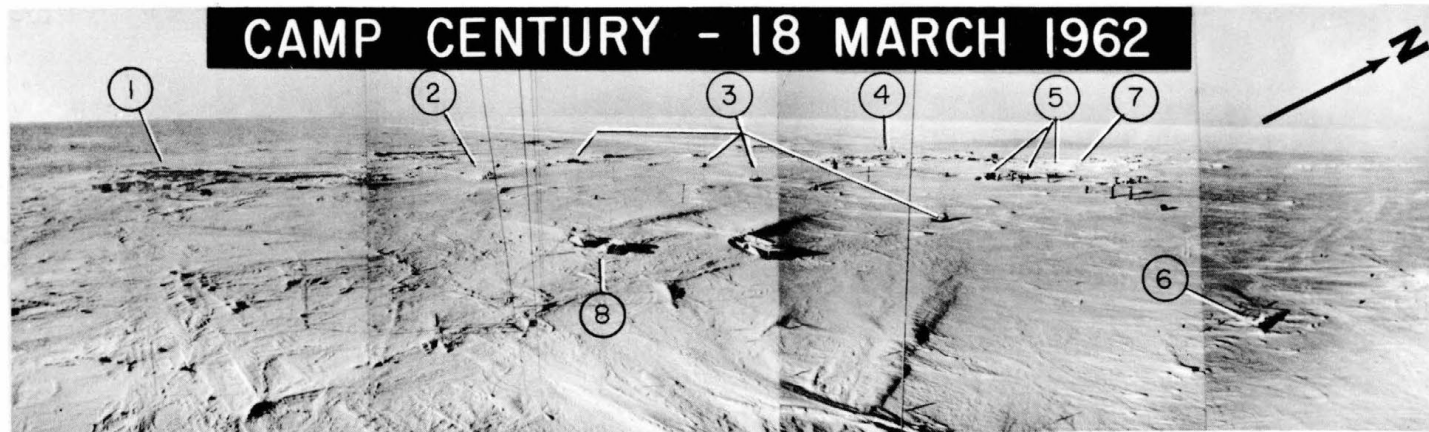
Panoramic View - 1962

- 1. SOUTH PORTAL
- 2. STANDBY DIESEL EXHAUST
- 3. ESCAPE HATCHES

- 7. NORTH PORTAL
- 8. WANIGANS

- 4. VEHICLE MAINTENANCE ENTRANCE
- 5. AIR BLAST COOLER EXHAUSTS
- 6. WATER SUPPLY TRENCH ESCAPE HATCH

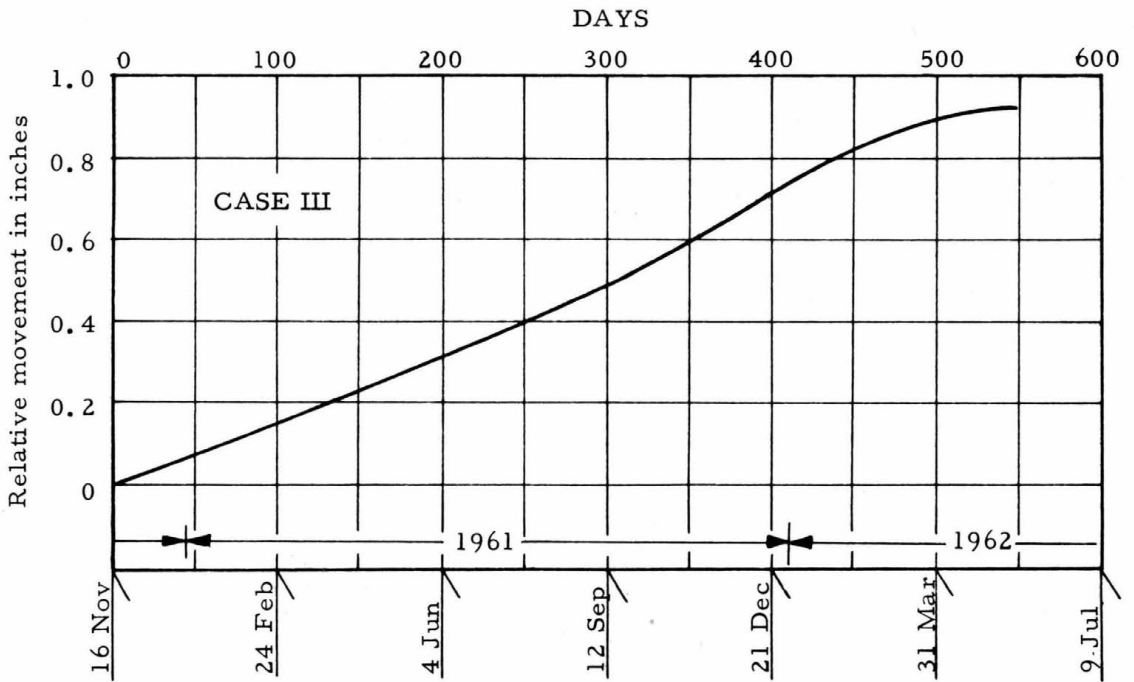
HELIPOT # 1

Installed 11 Oct '60; Zero time 16 Nov '60  
 Several thousand gallons water removed 6 Dec '60 (20th day)  
 8,000 gallons water added 4 Feb '61 (80th day)

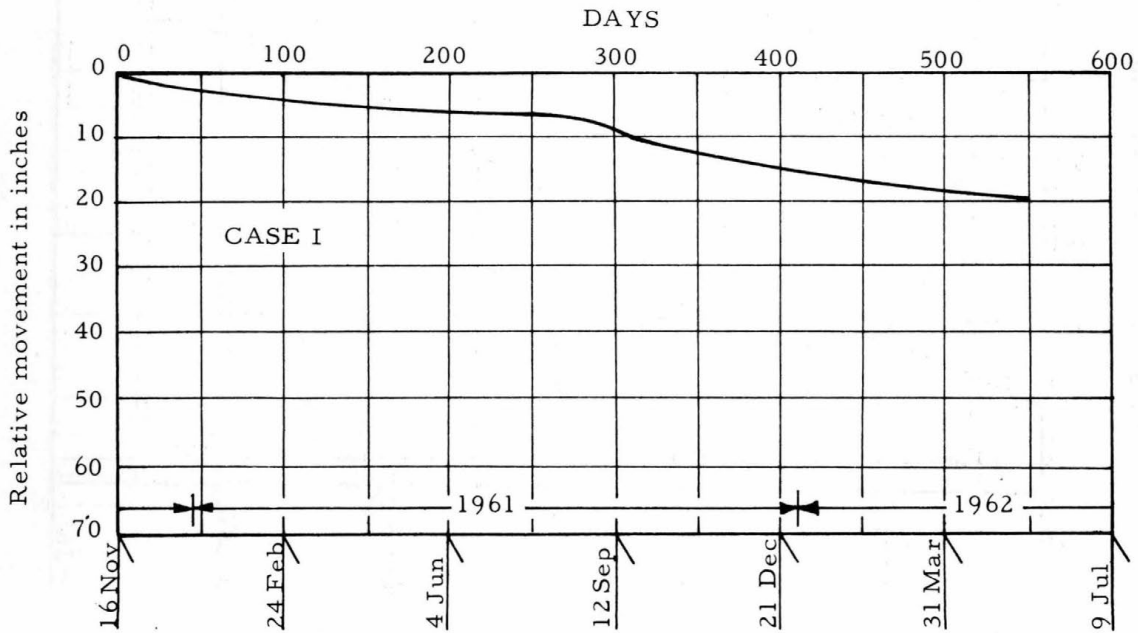
HELIPOT # 2

Installed 12 Oct '60; Zero time 16 Nov '60

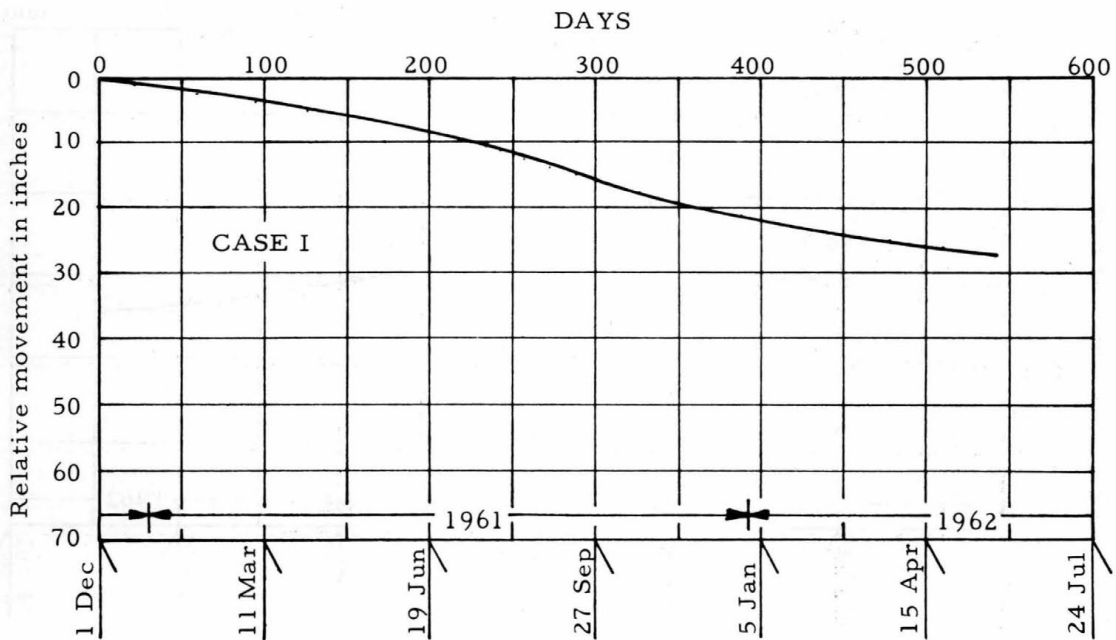
HELIPOT # 7

Installed 18 Nov '60; Zero time 1 Dec '60

\* 7 Aug '61 Helipot removed, new Helipot having sprocket and chain linkage installed.

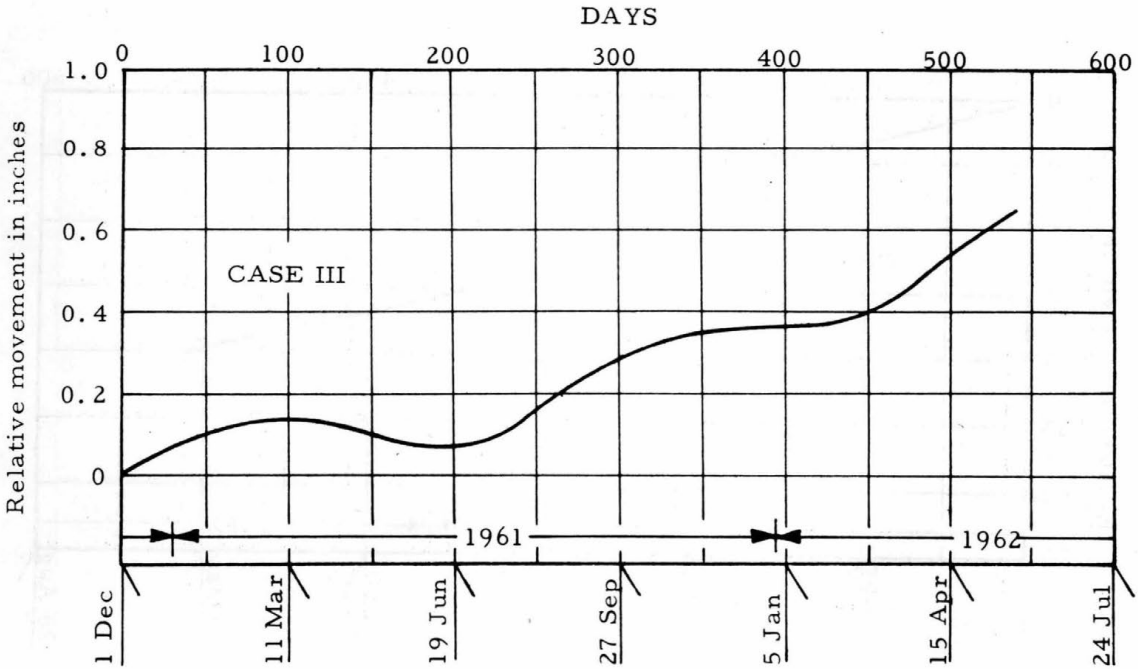
HELIPOT # 12

Installed 2 Jan '61 (Zero time)

Dimensions on sketch taken 2 Jan '61

Granco arch removed Sept '61

This trench warm compared to reactor area trenches

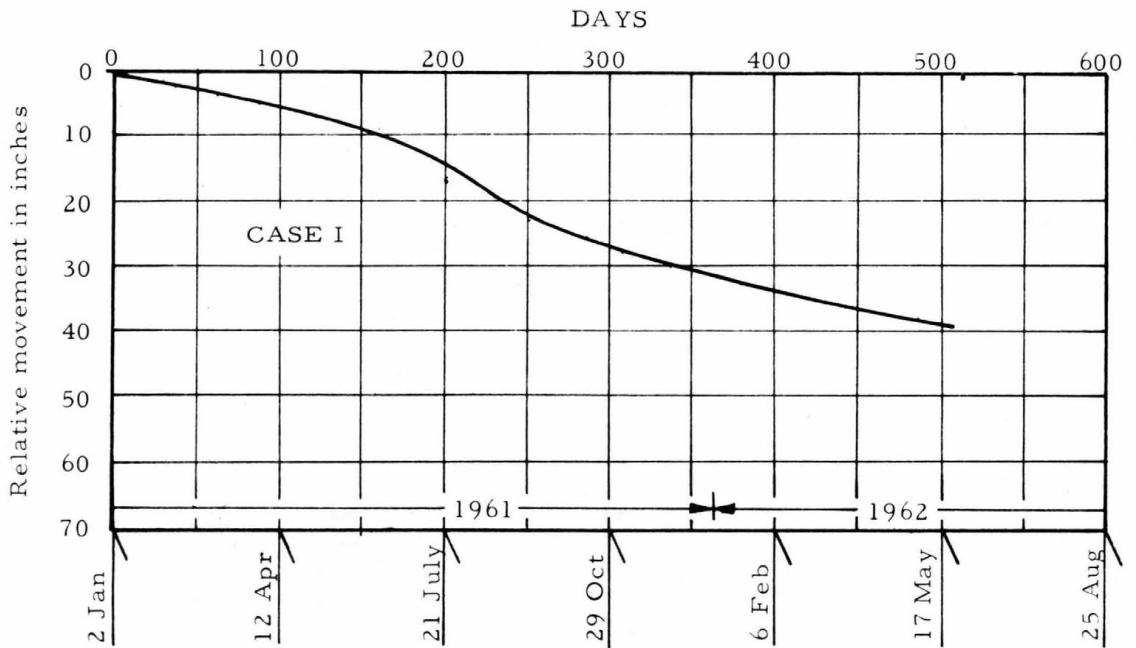
HELIPOT # 13

Installed 23 Nov '60 (Zero time)

Dimensions on sketch taken 23 Nov '60

\* Helipot removed because of snow cutting operations

† Helipot re-established

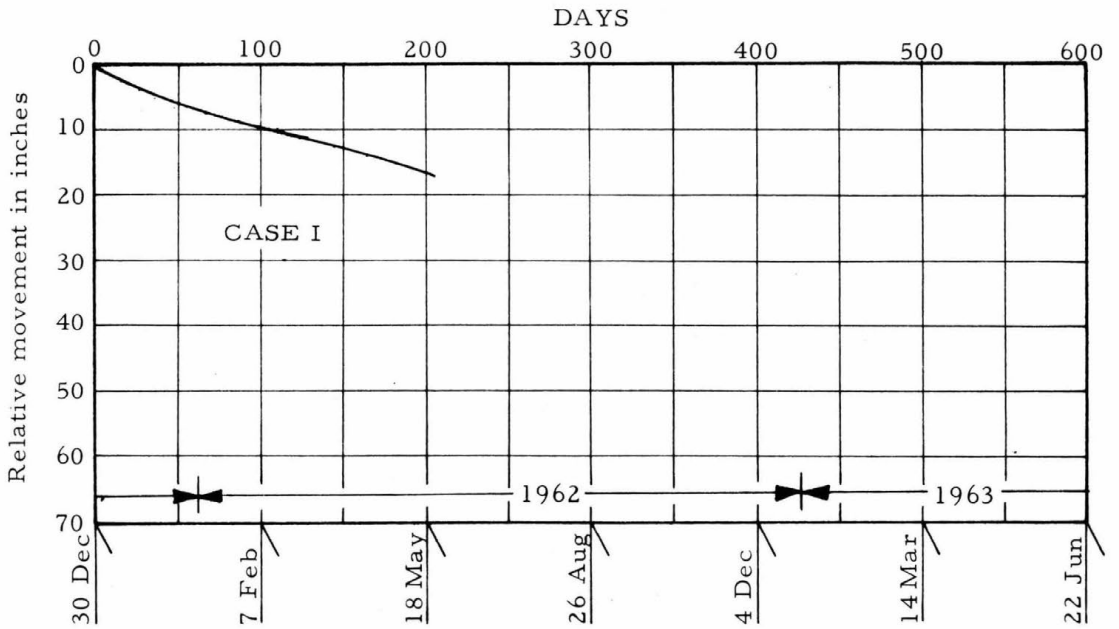
HELIPOT # 28

- Installed 29 Jul '61 (Zero time)
- Trench 19 was first side trench constructed
- Granco Arch removed 19 Jan '62
- \* Helipot removed

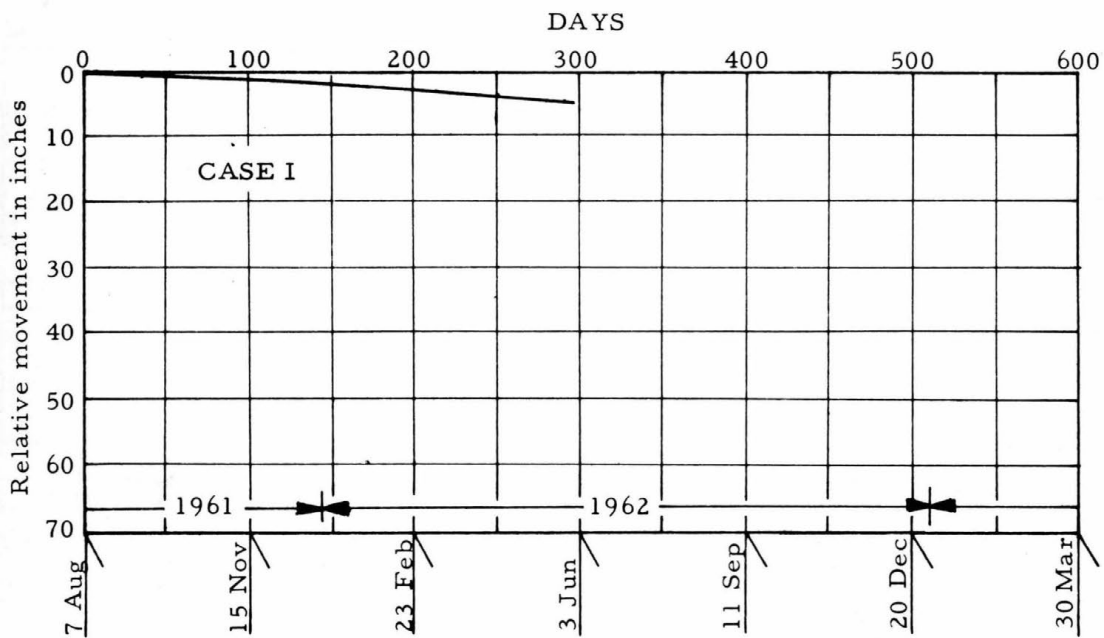
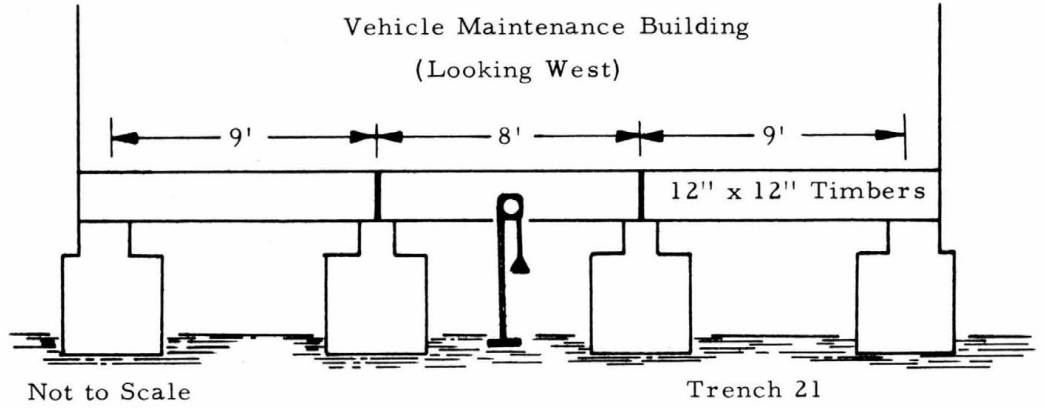
HELIPOT # 33

Installed 7 Aug '61 (Zero time)  
 Heavy tractors are moved into this building for repairs  
 Helipot has sprocket and chain linkage

To obtain a more positive transmittal of anchor movement into sheave rotation, Helipots 33, 34, 35 and 36 have sprocket and chain linkages rather than sheave and wire systems. The small sprocket used also gives more precise readings, the 1/64 in. available previously being reduced to 0.005 in.

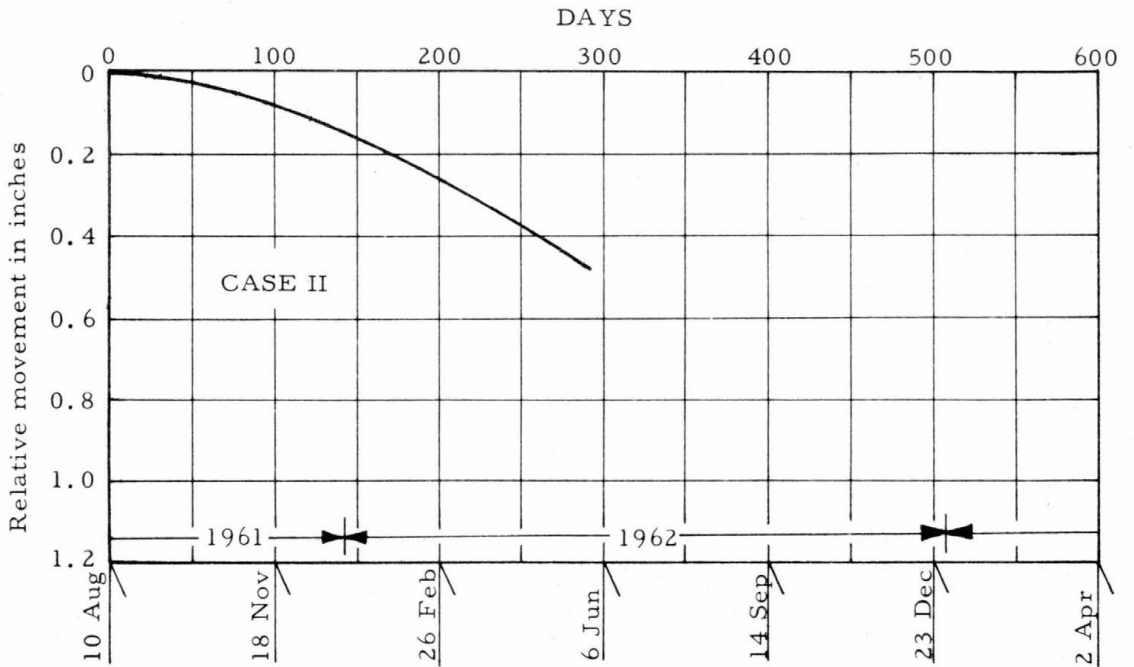
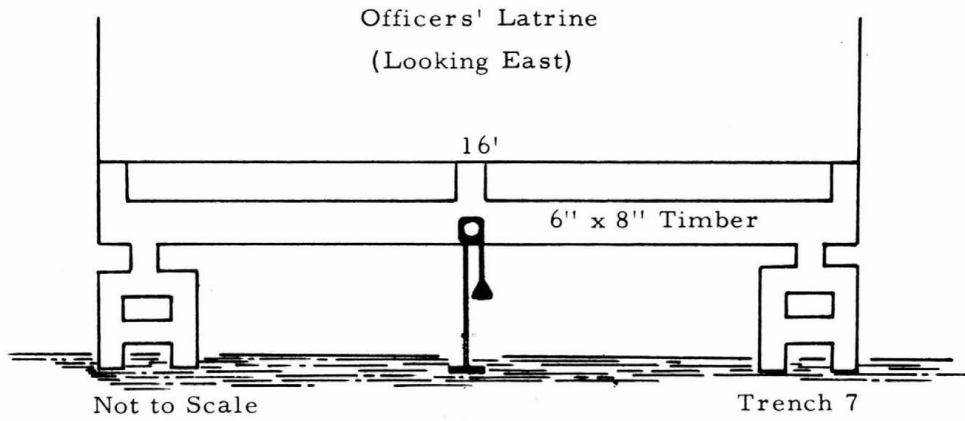
HELIPOT # 36

- Installed 3 Oct '61 (Zero time)
- Industrial spin drier causes foundation to vibrate
- Helipot has sprocket and chain linkage

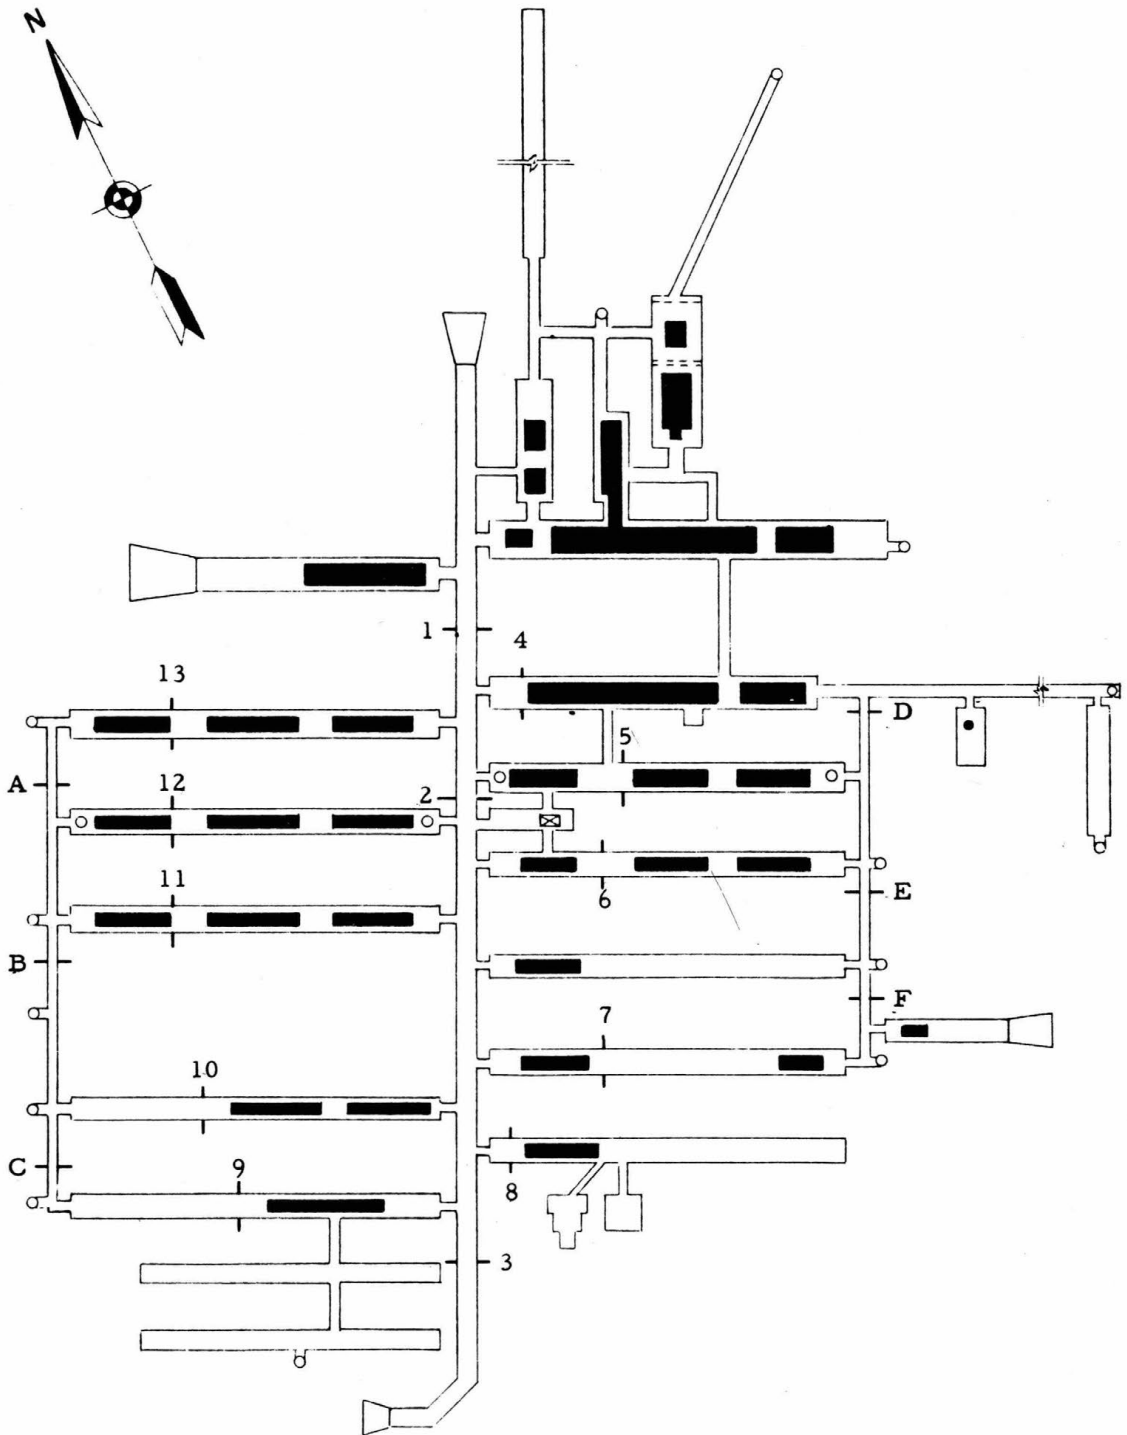
Location of Control Cross Sections

Table II. Cross Section Locations.

<u>Cross Section No.</u>	<u>Trench</u>	<u>Station</u>
1	Trench 1 - Main Trench	2 + 97.6
2	Trench 1 - Main Trench	6 + 00.0
3	Trench 1 - Main Trench	9 + 89.5
4	Trench 6 - Mess Hall Trench	0 + 57.5
5	Trench 7 - Officers' Latrine Trench	1 + 54.7
6	Trench 9 - Enlisted Men's Latrine Trench	1 + 60.2
7	Trench 11 - R&D Offices Trench	1 + 58.4
8	Trench 12 - R&D Trench	0 + 48.2
9	Trench 15 - Stand-by Power Trench	2 + 53.9
10	Trench 16 - Theatre-Chapel Trench	2 + 51.8
11	Trench 18 - Enlisted Men's Quarters Trench	2 + 59.4
12	Trench 19 - Officers' and NCOs' Quarters Trench	2 + 62.1
13	Trench 20 - USA PR&DC HQ Trench	2 + 59.7
A	West Manifold Trench	
B	West Manifold Trench	
C	West Manifold Trench	
D	East Manifold Trench	
E	East Manifold Trench	
F	East Manifold Trench

2. Cross sections. The size and shape of a cavity in snow determines to a large degree the nature of its deformation with time. In order to study these effects, periodic measurements of both horizontal and vertical dimensions of various trench cross sections were initiated.

At 19 stations throughout the camp, wooden reference pegs have been set at various heights in trench walls. A steel tape is used to measure the horizontal and vertical distances between these pegs. As the trench floors are quite irregular and unstable, string stretched between the two lowest pegs is used for horizontal reference when measuring the vertical distances.

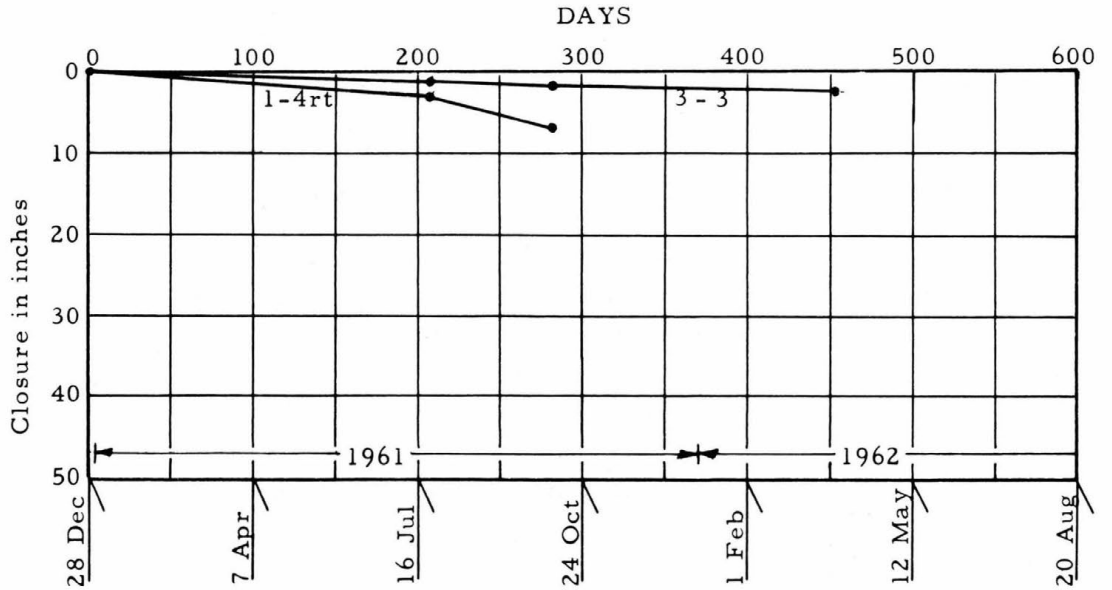
GROSS SECTION 1

Main Trench  
2 + 97.6

NOTES: 28 Dec '60 Dist. 3 - 3 = 10.94'  
 28 Dec '60 Dist. 1 - 4 rt. = 12.64'  
 \* Arch 21 Apr '62, down 1.4'

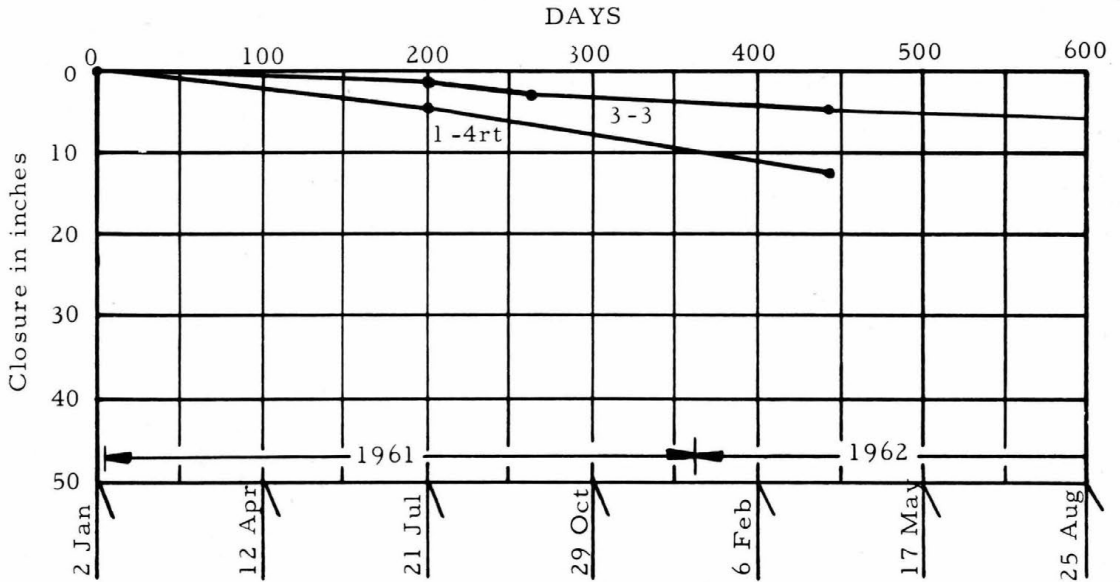
CROSS SECTION 4

NOTES: 28 Dec '60 Dist. 3-3 = 18.60'  
 28 Dec '60 Dist. 1-4 rt. = 11.60'  
 All pegs destroyed by trimming Sept '61; reinstated Oct '61  
 \* Arch 21 Apr '62, down 4.1'

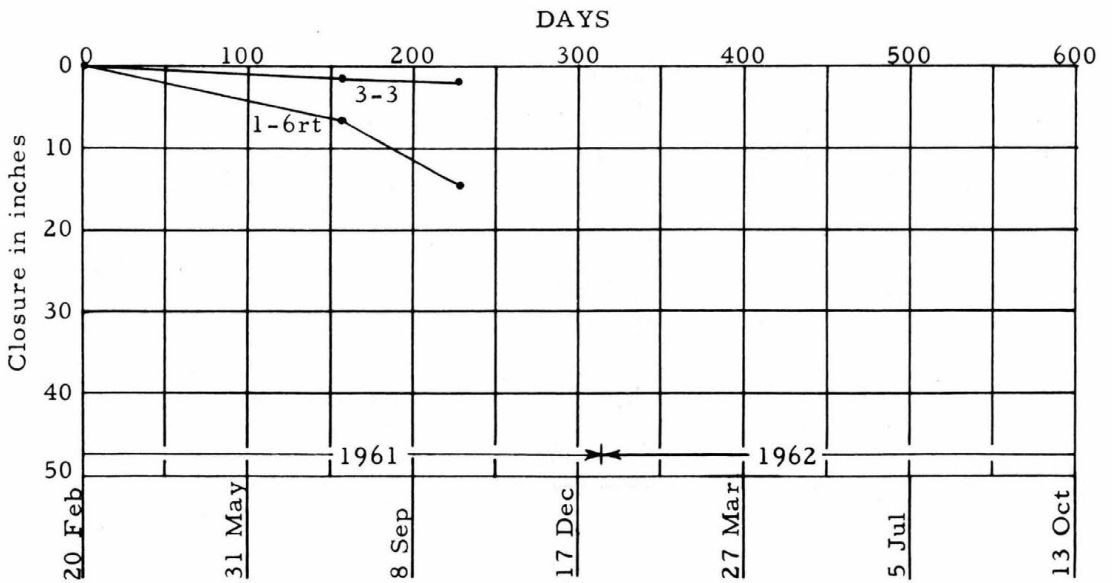
CROSS SECTION 5

NOTES: 20 Feb '61, Dist. 3-3 = 19.37'  
 20 Feb '61, Dist. 1-6 rt. = 15.26'  
 \* Arch 21 Apr '62, down 2.6'  
 Readings suspended because original points were obliterated

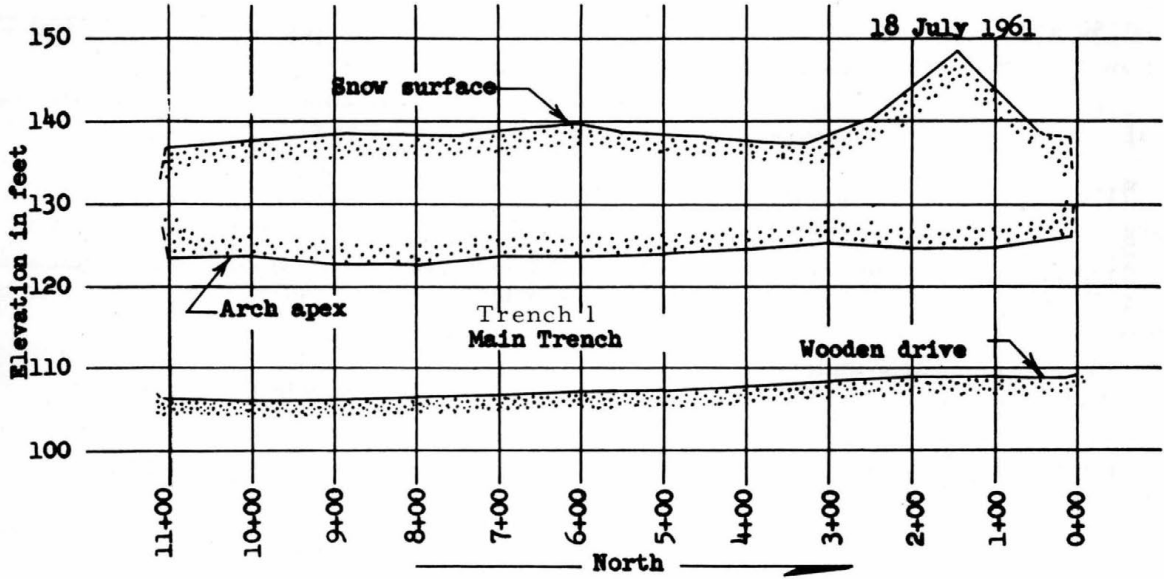
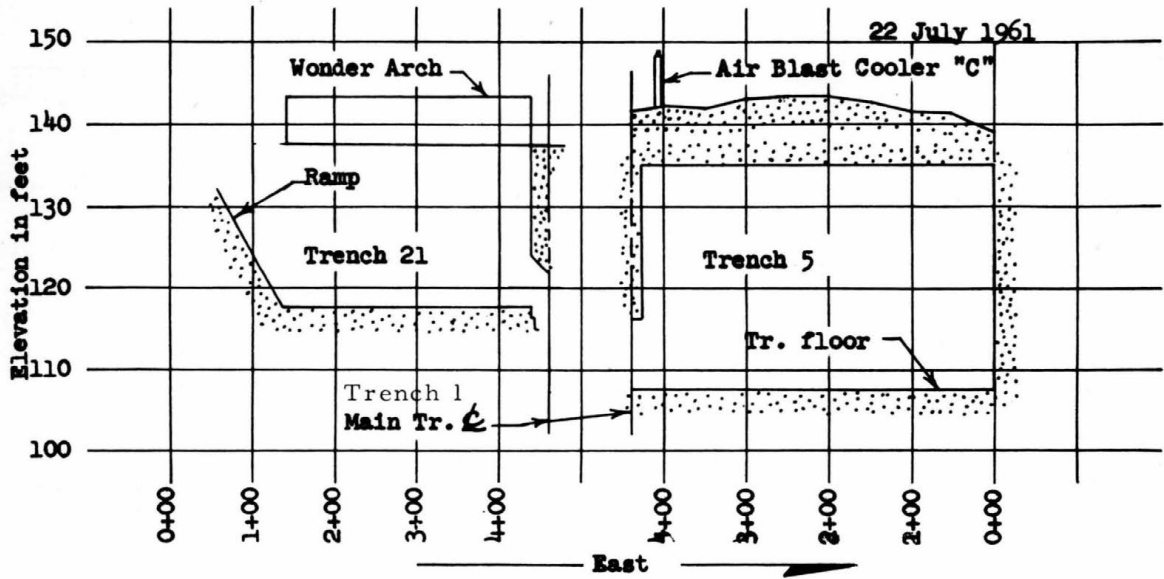
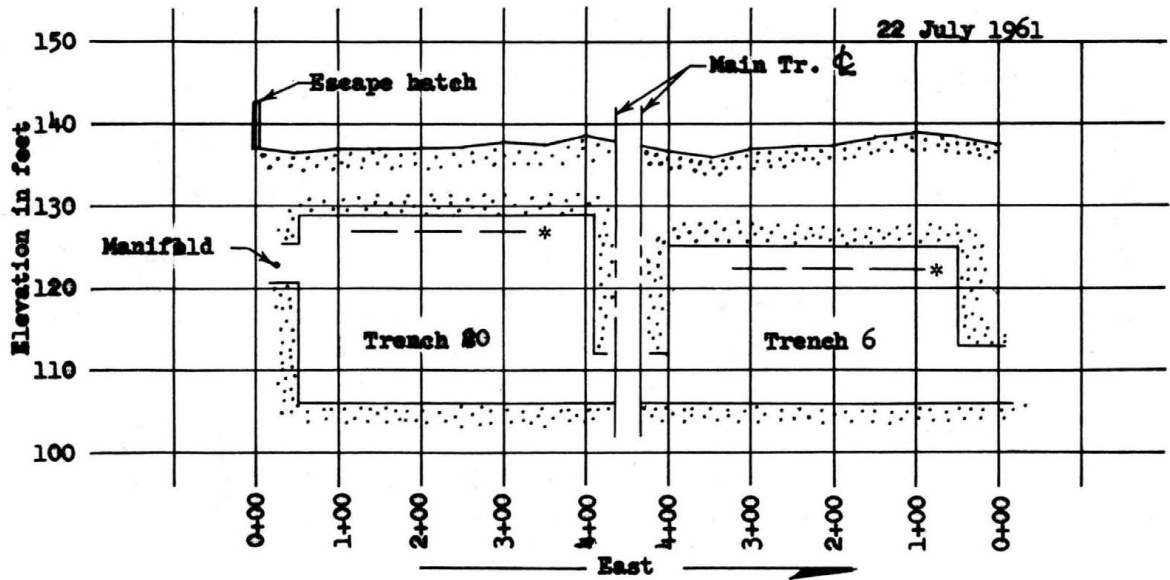
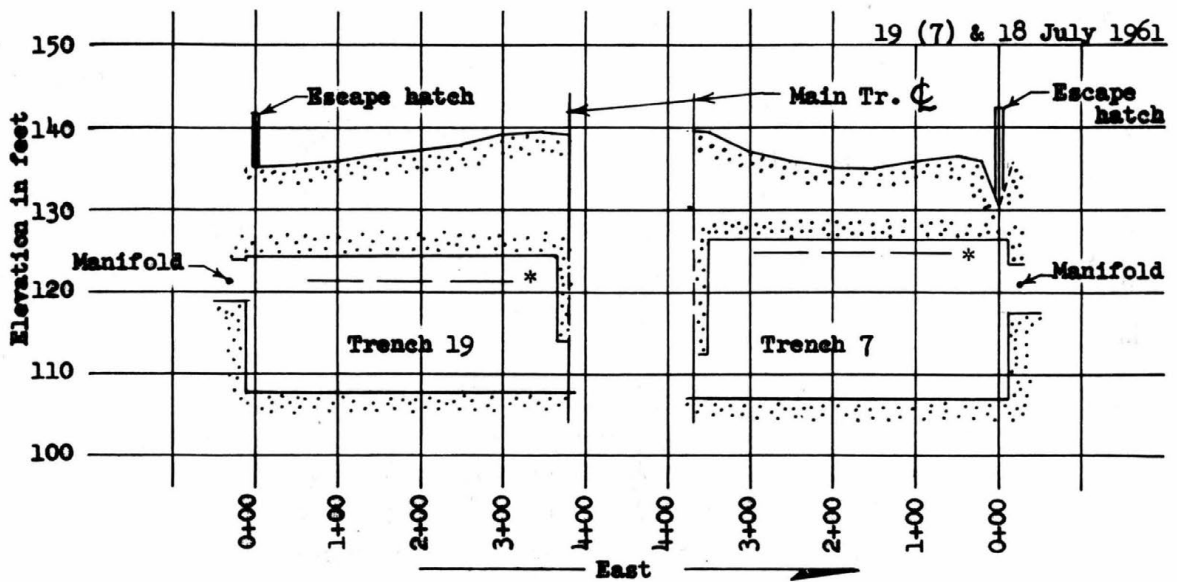
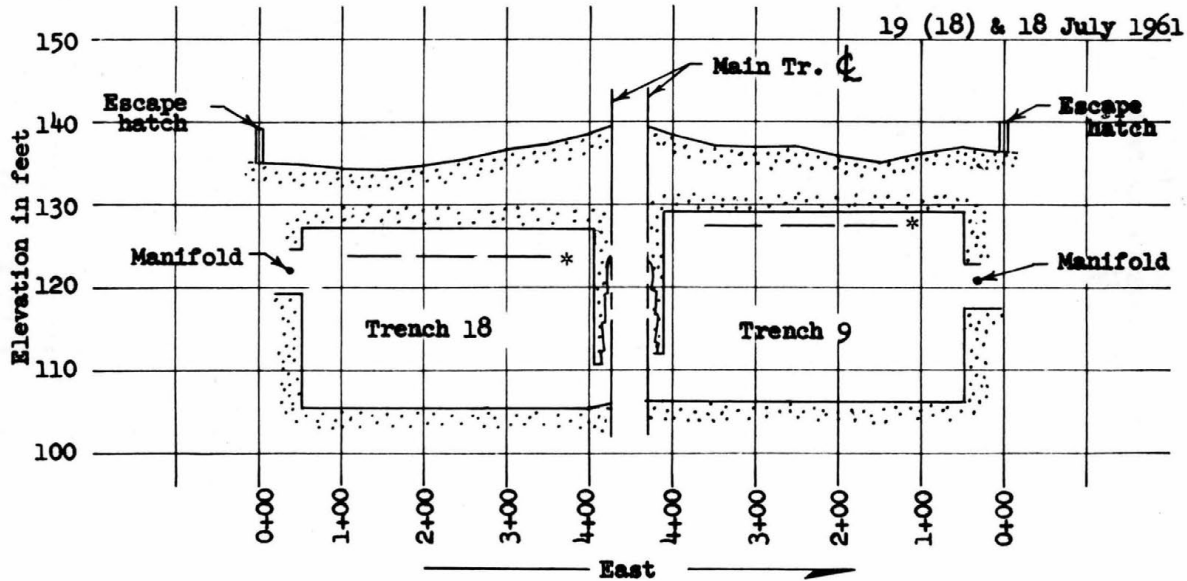
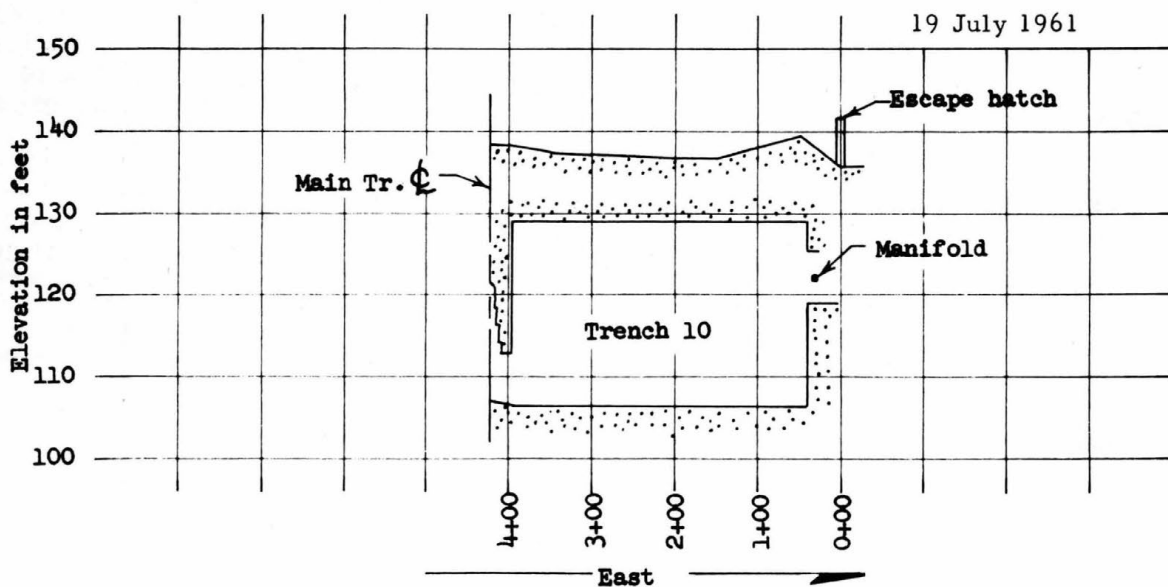
The purpose of the trench profile plots is to provide means for determining the snow overburdens and arch and floor depths for each trench.

In these plots, the vertical scale is ten times the horizontal scale; thus, all vertical dimensions are exaggerated in relation to the horizontal dimensions.

All profiles were measured at the trench centerlines. Therefore, all arch elevations were measured at the apexes, whereas settlement problems begin at the arch shoulders as the shoulders first come into contact with the buildings in the trench.

The snow surface above camp is 7 to 15 feet higher than the undisturbed snow surface away from camp, which averaged about 129.0 feet in elevation at the time of this survey.

The Trench 21 Wonder Arch (page H4) was above the surface when this survey was undertaken. It was still not completely buried after the winter of 1961-62.

The Trench 12 surface profile is an estimate as there were no escape hatches to utilize as centerline guides as in the other trenches.

Manifold trench elevations are approximate as level data are sketchy in these areas.

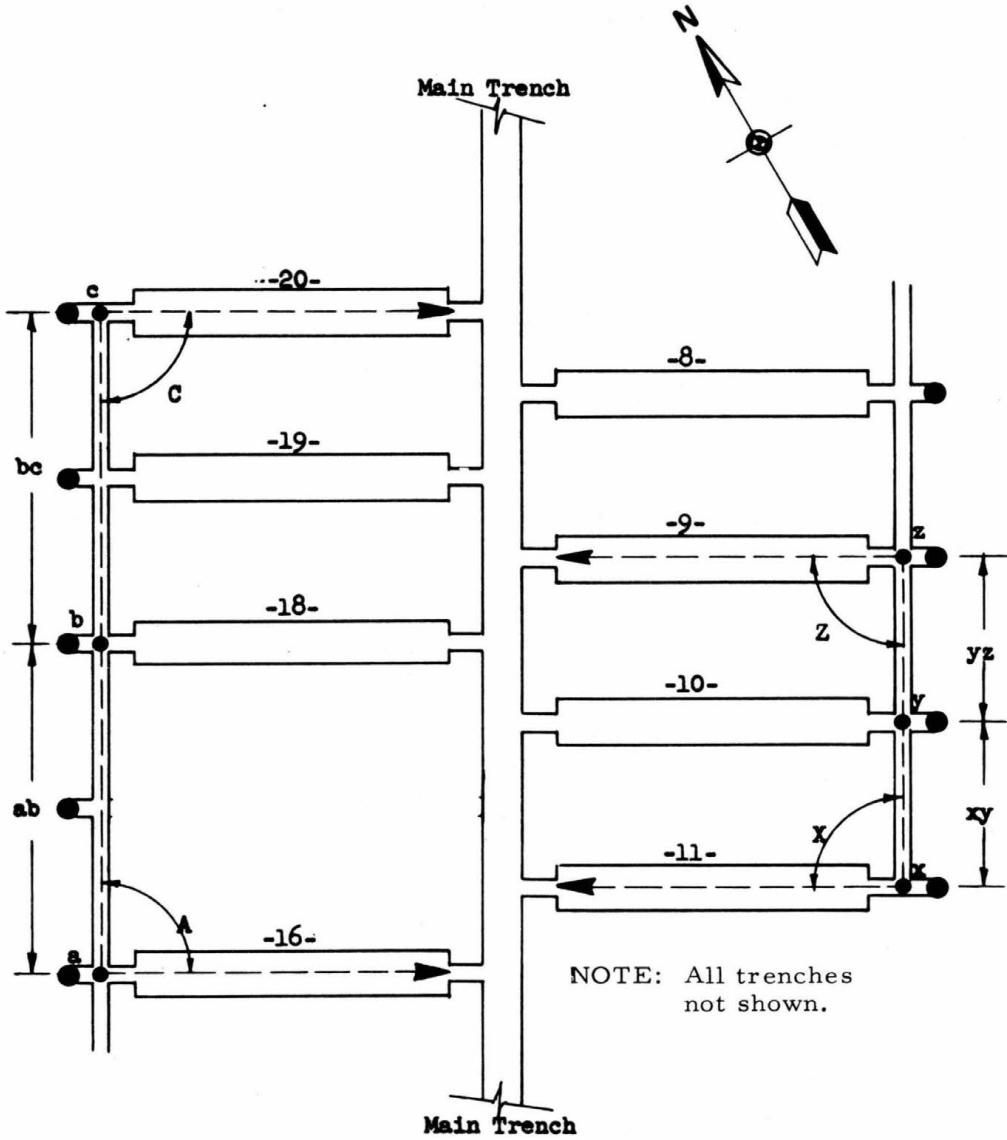
Plan - Horizontal Distortion Survey

Table V. Horizontal distortion survey data.

Angle	20 Aug 61	5 Nov 61	Diff. from original	9 Apr 62	Diff. from original
A	90°02'13"	90°02'27"	+00'14"	90°05'47"	+03'34"
C	90°01'33"	90°02'33"	+01'00"	90°05'53"	+04'20"
X	90°09'27"	89°50'33"	-18'54"	89°49'27"	-20'00"
Z	89°48'33"	89°47'27"	-01'06"	89°47'07"	-01'26"
<hr/>					
Dist.					
ab	200.51 ft	-	-	200.97 ft	+0.46 ft
bc	199.38	-	-	198.66	-0.76
xy	99.77	-	-	99.74	-0.03
yz	100.16	-	-	100.12	-0.04

5. Horizontal distortion survey. The camp horizontal distortion survey was undertaken in order to provide some information on the lateral displacement of Camp Century.

A Gurley transit was used to turn the four horizontal angles and to set hubs a, b, and c (West Mainfold Trench floor) and x, y, and z (East Manifold) on line as shown on page J1. The distances between hubs were measured with a 100-ft steel tape.

It was observed that endwall settlement toward the entrance and utility portals (Fig. 6) would be likely to affect the survey's angular changes. Since this would obscure the camp's horizontal distortion pattern, additional points are scheduled for placement on building roofs in the summer of 1962 to more accurately reflect the camp's lateral displacement.

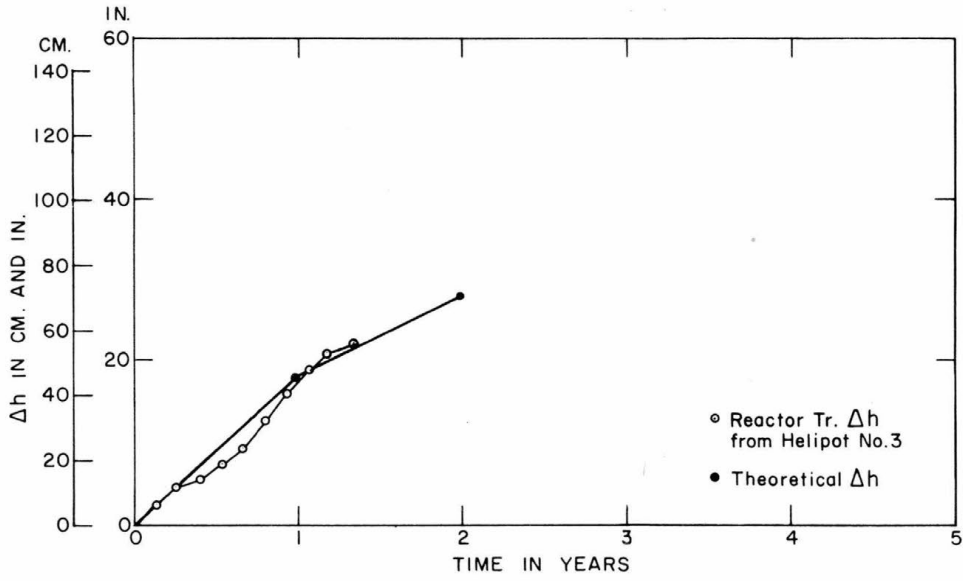
Figure 8. Theoretical settlement under surcharge and actual settlement of the walls of Trench 4.

Figure 8 shows how the theoretical settlement of the walls in Trench 4 under a  $100 \text{ g/cm}^2$  surcharge compares with the actual settlement as obtained from helipot #3 located in that trench.

range. It is quite likely, then, that the  $d\gamma/dh$  constancy is untenable — departing from it, however, raises more difficulties. For the present, progress must rest with the demonstration that a feasible surcharge can account for the densifications being encountered. It is reasonable to set the surcharge on the walls of Trench 4 at  $100 \text{ g/cm}^2$ , as is done in Figure 8.
