Stability and Overtopping Study of Montrose to Irving Reach of Chicago, IL, Shoreline Revetment

Elizabeth C. Burg and Jeffrey A. Melby

February 2008

Final report

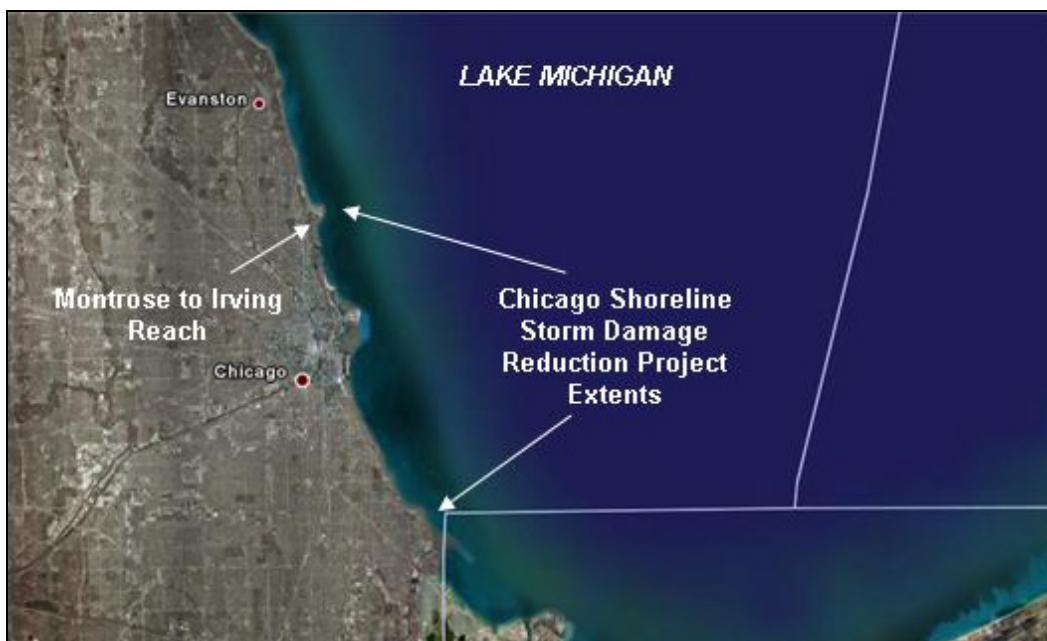
Figure 1. Project limits for Chicago Shoreline Storm Damage Reduction Project.

The purpose of the Chicago Shoreline Storm Damage Reduction Project is to provide storm damage protection along the Lake Michigan shoreline. The authorized project includes the Chicago shoreline between Montrose Avenue and 56th Street (Figure 1). Of particular concern is the protection of Lake Shore Drive, which is a Federal highway and a major thoroughfare in the city of Chicago. This study focuses on a small section of shoreline known as the Montrose to Irving reach, which extends south from Montrose Harbor approximately 610 m (2,000 ft) (Figure 2).

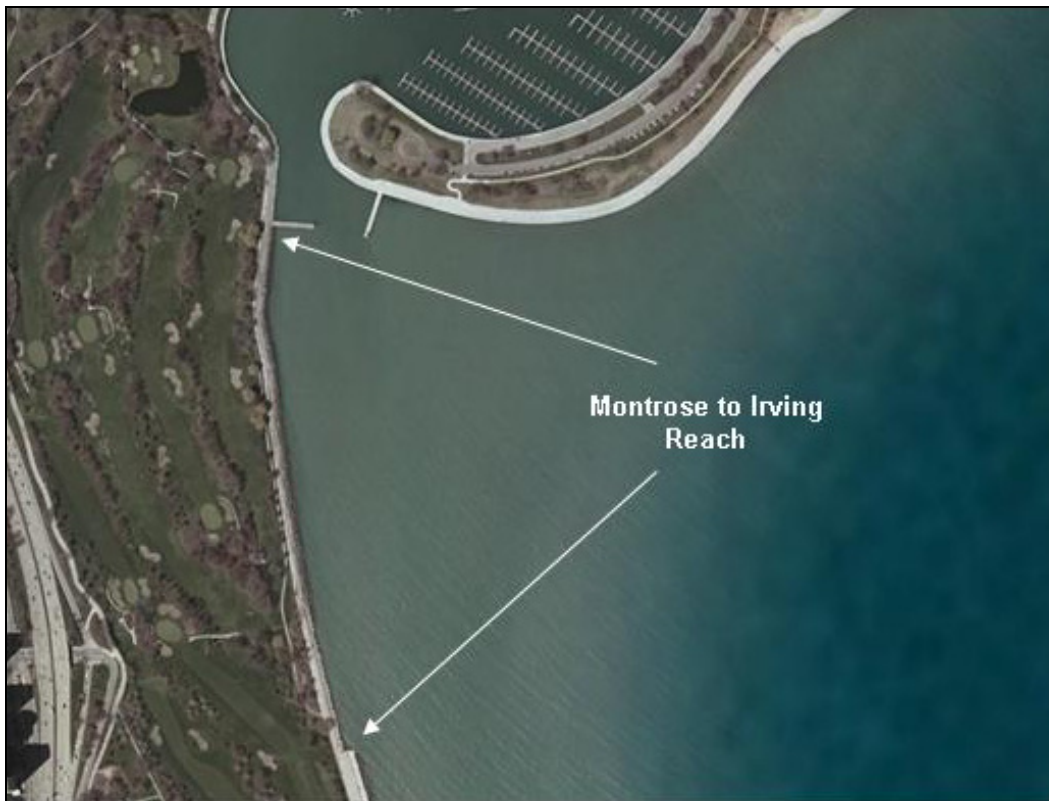
Figure 2. Physical model study limits, Montrose to Irving Reach.

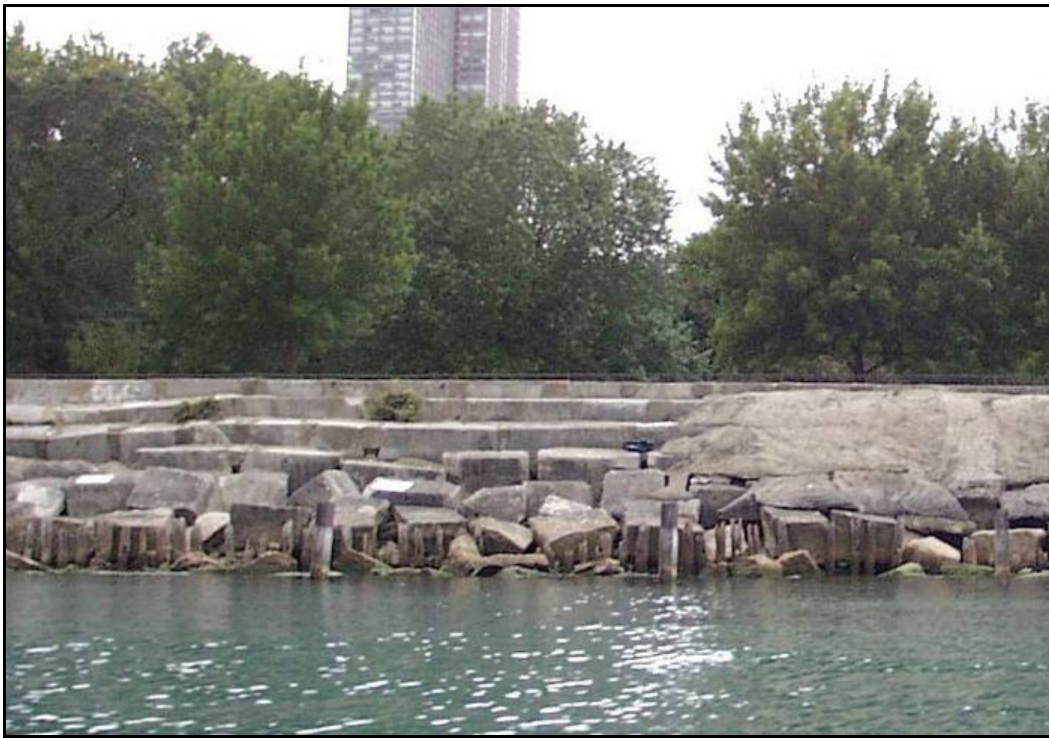
Figure 4. Example of revetment failure along Montrose to Irving reach (photograph courtesy of U.S. Army Engineer District, Chicago).

Water levels in Lake Michigan have fluctuated significantly since the initial construction of the revetment and, in the process, exposed portions of the wood pilings that were previously submerged. The exposed timber piles have deteriorated and, in some locations along the shoreline, failed (Figure 4). The cut limestone blocks, which are fixed in place by concrete mortar, have started to collapse into voids left by backfill erosion. Several attempts have been made to repair the structure, including the addition of grout and concrete overlays, and the installation of steel piles and armor stone to buttress the revetment. Currently, the revetment along the Montrose to Irving reach is in need of reconstruction.

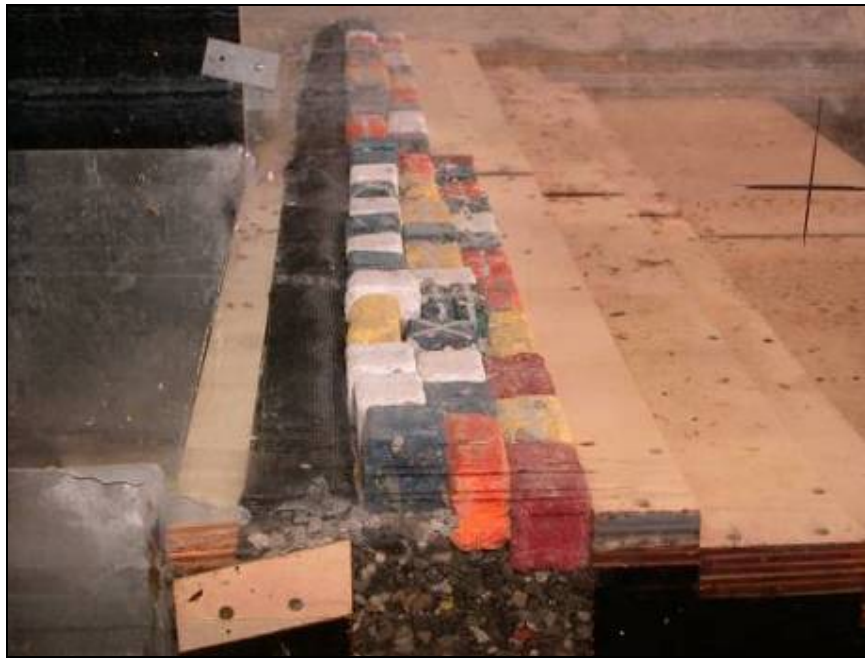
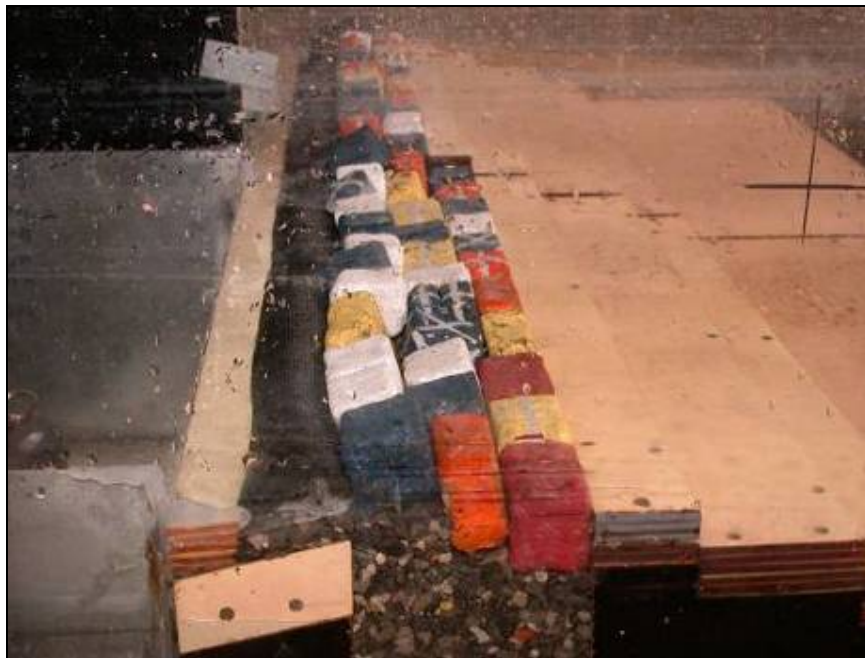
(a) Before storm.

(b) After storm.

Figure 12. Side photographs from before and after the 20-year storm event (three- and two-stone row structures are separated by a plexiglass wall, with three-stone row structure closest to observer and two-stone structure on far side of flume).

A simulated storm hydrograph was used to ramp up to the design wave condition. Waves with heights of 25, 50, 70, 85, and 100 percent of the design H_{mo} (Table 2) were run in the flume for 15 min each (model time). This equates to a storm segment length of 74 min prototype, with the entire storm hydrograph lasting 6.1 hr. Stone movement was first observed during the 50 percent run. Several stones in the most landward row began to lean slightly against the mattresses, but both the two- and three-stone row structures remained intact. During the 70 percent run, the three-stone row design showed slightly more damage. The back row continued to lean landward, and there was visible sagging in the center of the row. Stones in the middle row also started to lean against the back row. During the 85 and 100 percent runs, stones in the landward rows of each structure continued to shift and lean, but the seaward rows of both structures showed no signs of movement. Underlayer material that filled the gaps between stones was washed out, but during testing, no stone moved beyond a repairable limit state.

Figures 12, 13, and 14 show before and after photographs of the cross sections, including the cut stone rows and marine mattresses, from one of the 20-year event tests. One test and one repeat were run for this storm event, with the structure being rebuilt between the first and second test series. The structure performed similarly in both test series. Based on the observations from this event, it is recommended that stones no smaller than 35.6–44.5 kN (4–5 tons) be used in construction of the seaward steps and that all stones in the structure be no smaller than 26.7–35.6 kN (3–4 tons) for the design conditions. Data are not available for designs other than those used in these experiments, and it is unknown how smaller and/or larger stones would react to the conditions tested.

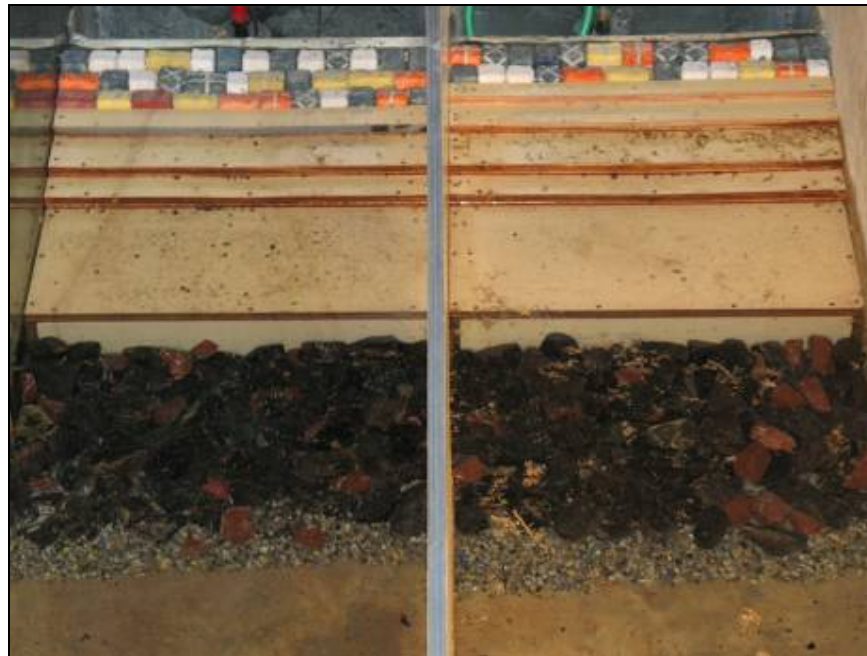
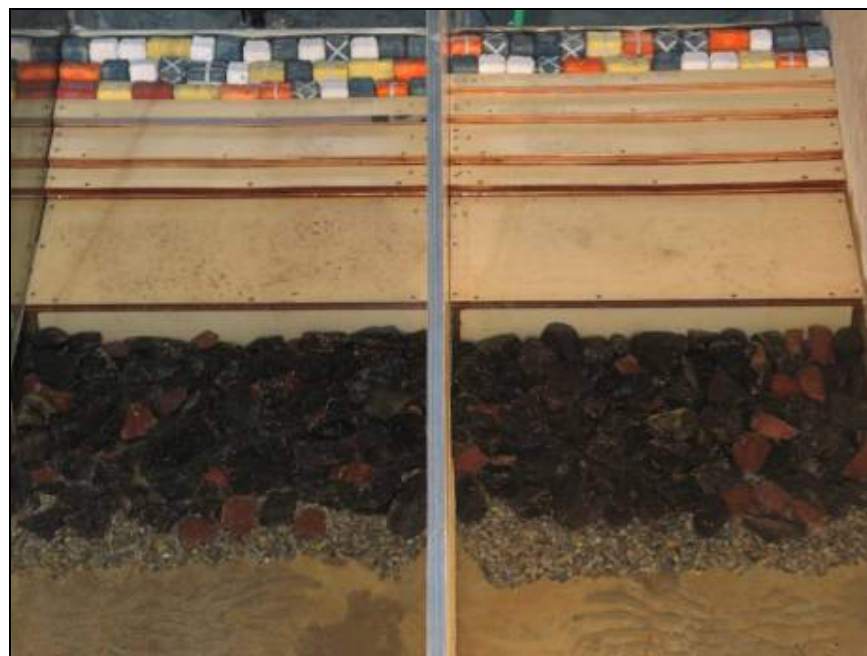
(a) Before storm.

(b) After storm.

Figure 13. Overhead photographs from before and after the 20-year storm event (three-stone row design is on left and two-stone row design on right).

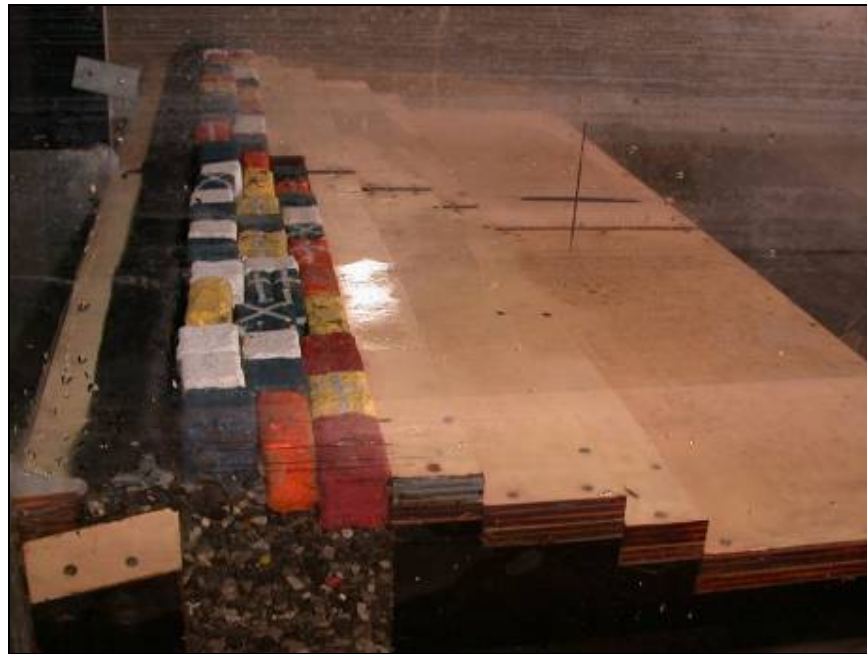
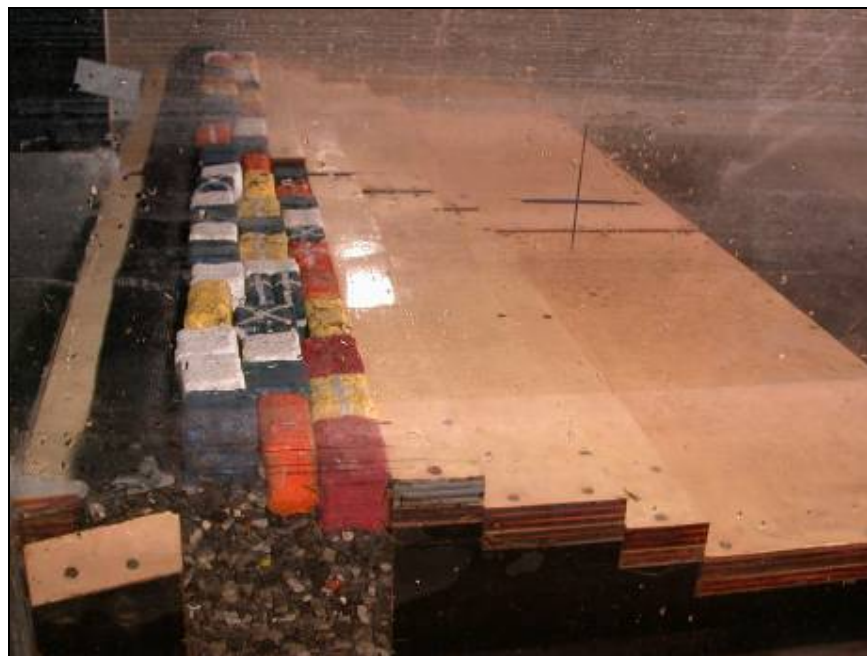
Figure 15. Side photographs from before and after the 2-year storm event.

Similar to the 20-year storm, a simulated storm hydrograph was used for the 2-year storm event. The same percentages of design H_{mo} were used to build up to the maximum wave. During the simulated storm, no significant stone movement on the structures was observed. Fill material from gaps between the stones did wash out, but not to the extent that was observed during the 20-year storm. Before and after photographs of the cross sections, including the cut stone rows and marine mattresses, from the 2-year event are shown in Figure 15 (side) and Figures 16 and 17 (overhead).

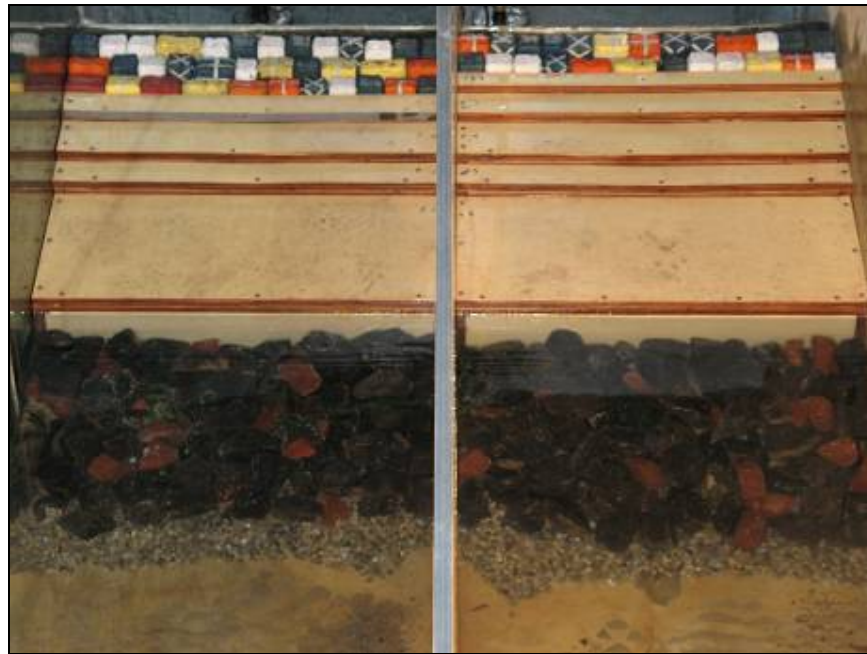
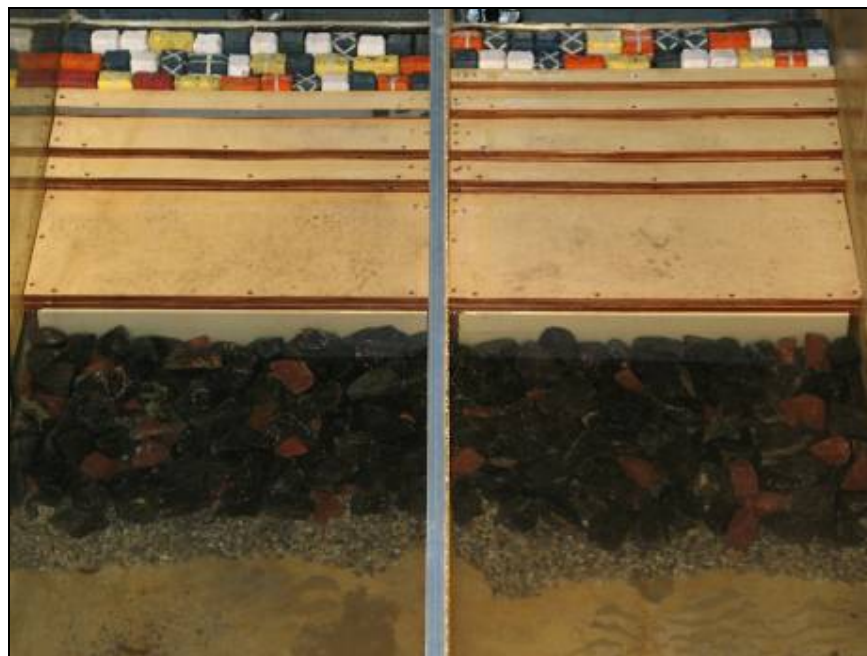
Figure 16. Overhead photographs from before and after the 2-year storm event.

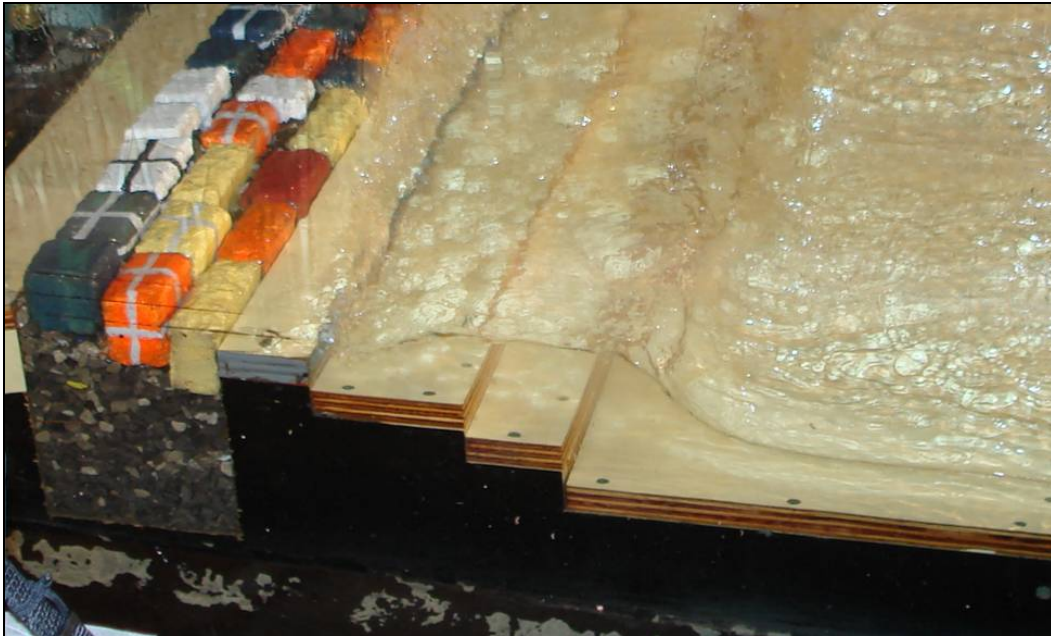
Figure 18. Wave runup on concrete steps (prior to marine mattresses being installed) (photograph courtesy of Drew Benziger, Chicago District).

Overtopping was captured in watertight metal catch basins located landward of each structure. The water was pumped out of the catch basins at regular intervals, and volumes were recorded. Once measurements had been taken, the water was pumped back into the flume to keep the water level constant during the test. Despite having the same crest elevations, the three-stone row design consistently had more overtopping than the two-stone row design. The overtopping difference between the two designs does not fall outside the range of scatter in the data and is therefore not significant. The flat slope approaching the structure produced a large surf zone, which resulted in many of the waves breaking before reaching the structure. Significant reflection was also observed during testing because of waves hitting the vertical face of the structure.

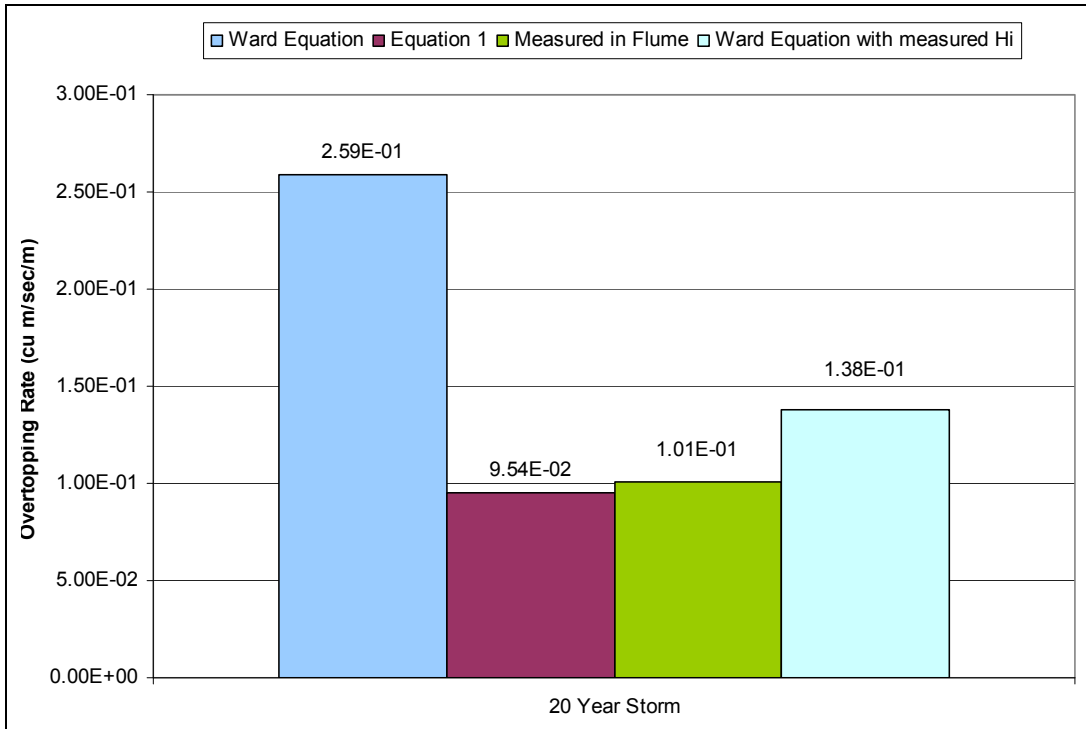
Figure 21. Comparison of results from Equation 1, measured overtopping recorded during testing, and Ward's equation for revetment geometry during 20-year storm event.

As previously mentioned, in an earlier investigation, equations were developed to estimate the overtopping volume for stepped revetments along the Chicago shoreline (Ward 2003). A comparison of Equation 1 and Ward's equation using the geometry of the Montrose to Irving reach revetment is shown in Figures 21 and 22 for the 20-year and 2-year storm events, respectively. The measured overtopping rate is the average of both the first run and the repeat of both the two- and three-stone row sides. Table 5 gives the geometric parameters for the cross section that were used to calculate the overtopping as outlined by Ward (2003, pages 44–45).

Calculations were originally made in non-metric units, and the geometric parameters of the structure did not change between the 20-year and 2-year storm events. It can be seen that the overtopping rate predicted by Ward's equation is significantly higher than is predicted by Equation 1 and the measured overtopping. This may be partially due to the differences in measurement and analysis of waves between the two experiments and, to a lesser extent, the details of wave-structure interaction and wave reflection. Ward used an analytically estimated wave height based on Goda's semi-empirical method (Goda 1985) and an equivalent deep-water wave height. The estimated shallow-water significant wave height using this method was 3.72 m (12.2 ft). This yields a ratio $H_{mo}/\text{depth} = 0.67$ for the 20-yr storm, which is very high for the flat offshore bathymetry. The measured wave height of 2.47 m (8.11 ft) was much more reasonable. Using $H_{mo} = 2.47$ m (8.1 ft) in Ward's equation yields a $q = 0.14$ cu m/sec-m (0.57 cu ft/sec-ft), which is very close to the overtopping calculated by Equation 1 for the conditions. This also explains the large discrepancy in the 2-yr storm results. Because overtopping is a threshold event and the 2-yr storm is near the threshold of overtopping, small differences in wave height will produce large differences in predicted overtopping.
