NNP1 Access Road from Ban Nonsomboun to the Main Dam

Environmental Assessment For Access Road

Nam Ngiep One Power Company

January 2014

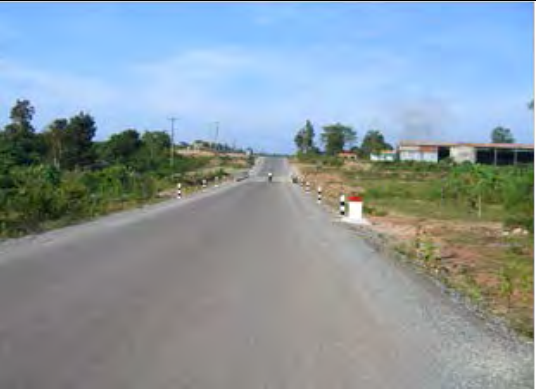
| Section | Dimensions | Condition | Photograph |
|---|--|--|--|
| Pakxan to Ban Nonsomboun | Length: 19.9 km Width: 6m | Existing road. Asphalt paved up to Ban Nonsomboun from Pakxan, crossing a PC bridge on the way (Capacity: 80 t, Width: 6 m, Length: 25 m) | |

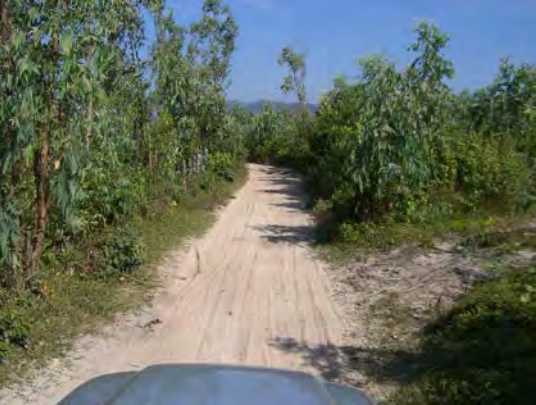
| Section | Dimensions | Condition | Photograph |
|---|--|--|--|
| Ban Nonsomboun to Ban Hat Gniun | Length: 21.2 km Width: 5 - 10 m | Upgraded existing dirt road. | |

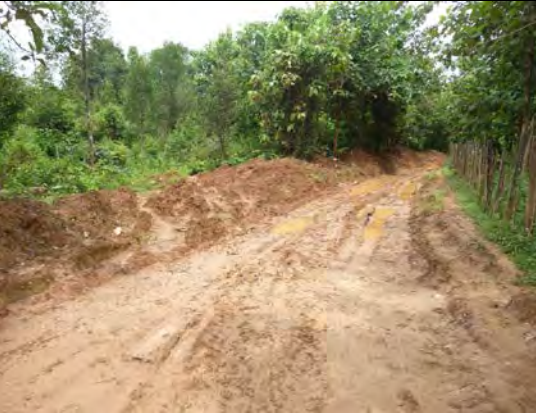
| Section | Dimensions | Condition | Photograph |
|---|--|--|--|
| Ban Hat Gniun to Dam Site (Jica Road) | Length: 9.25 Width: 4.5 - 13.5 m (Average 6.6m) | Existing dirt road, with some potholes, erosion, fallen branches and trees, and areas with standing water. | |

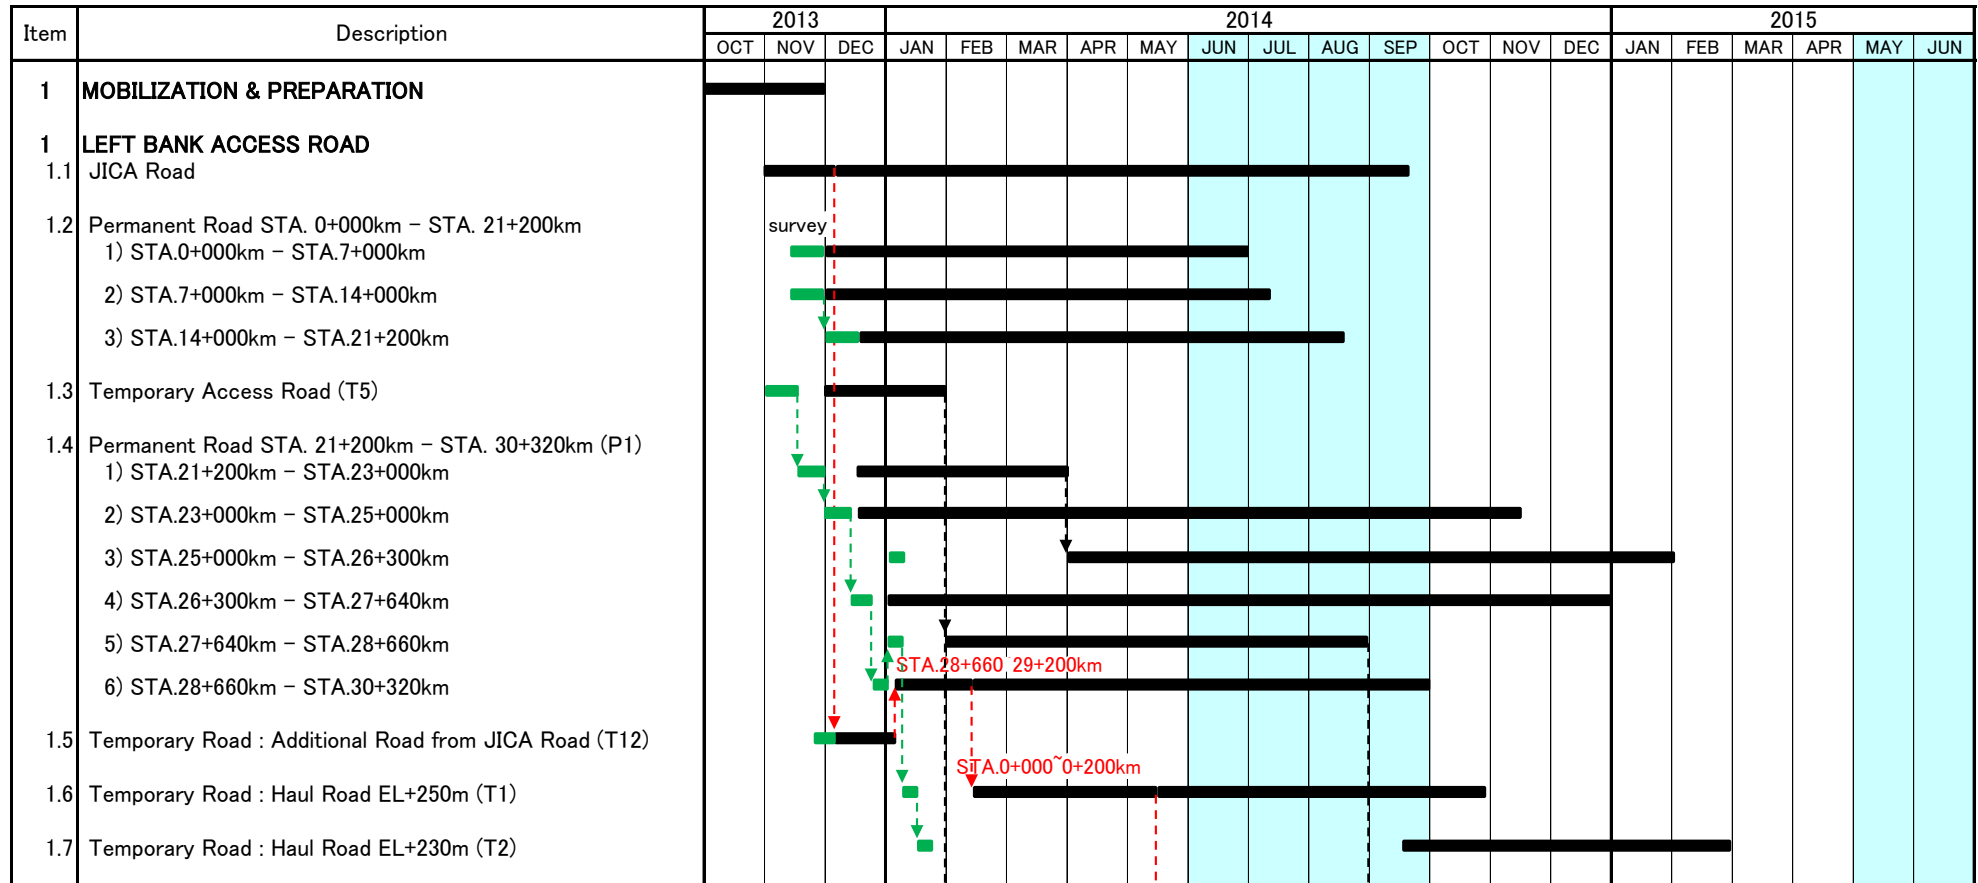
Figure 2.4 Construction Schedule of Road Work (NNP1PC - November 2013)

Figure 2.4 (continued) Construction Schedule of Road Work Continued (NNP1PC - November 2013)

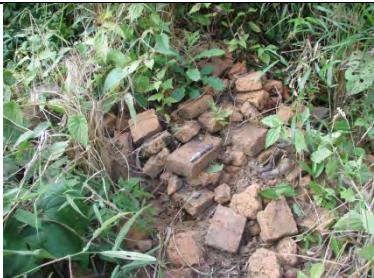
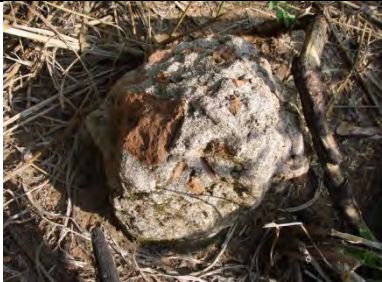
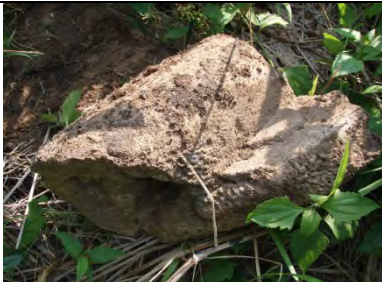
Note: Site No. 1: Remains of a Buddhist temple in Ban Thahuea. The brick structure of the altar and sanctuary, along with fragmented Buddha statues, are still visible at the site.
 1 and 3: A mound of ruins covered by vegetation.
 2: Stone image of Buddha seated on Naga, from Maravijaya period.
 4 and 5: Fragment of arm and body of the main Buddha statue made of mortar and bricks.

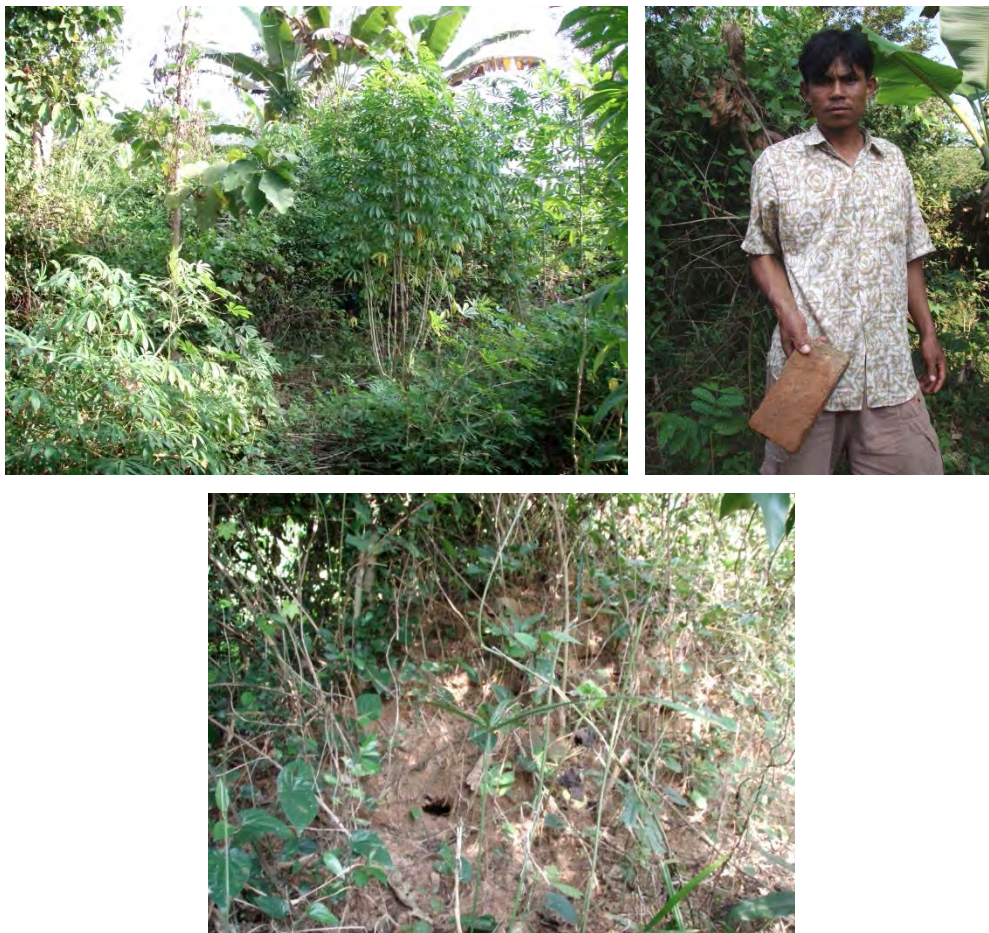
Figure 3.18 Site no. 2, Remains of Buddhist temple

Potsherds of historic significance were also observed by the survey team in the vicinity of these ruins; this may indicate the presence of important historic settlements in this area. According to Mr. Sombat Chaleunsay, similar but smaller ruins once existed in the village; this might indicate that dense populations have once settled in this area.

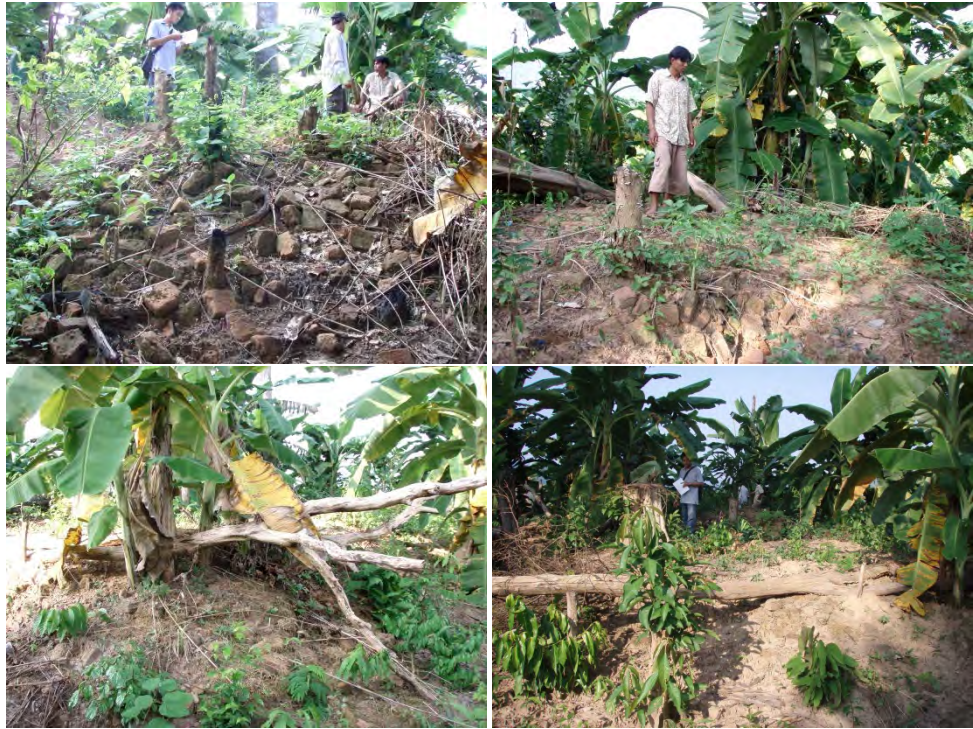
Figure 3.19 Site no. 3, Remains of Buddhist temple

This site is located about 400 m south-west of Site No.2. Its size is approximately 12 x 18 m, oriented NE-SW. The remaining brick platform is about 2 m high. Brick size: 6 x 12 x 24cm.

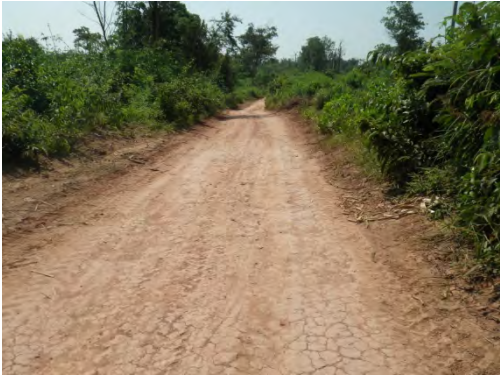
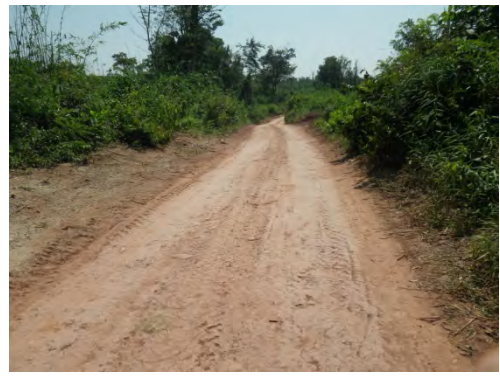
| No | Location | Photo before construction (8/10/2013) | Photo on the month (21-24/10/2013) | Photo of the previous month |
|---|--|--|--|---|
| 21. | B Nonsomboun Sta. 2km+400m to the direction of Nonsomboun | A dirt road with a cracked surface, surrounded by dense green vegetation. | A dirt road with a smoother surface, showing tire tracks, surrounded by dense green vegetation. | |

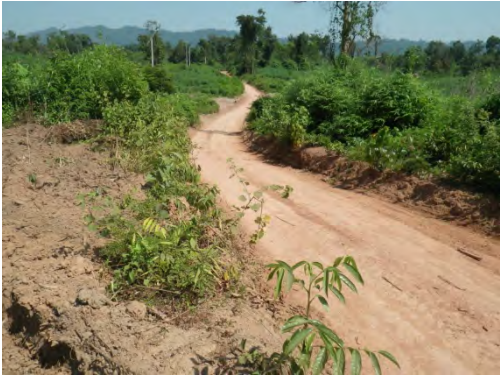
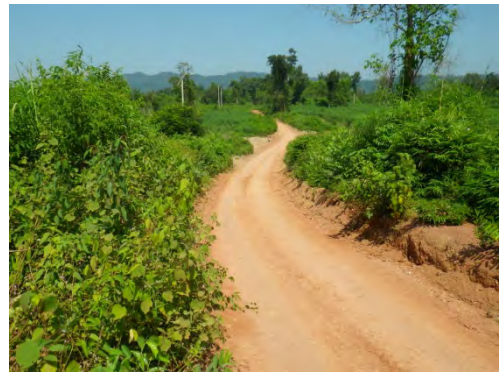
| No | Location | Photo before construction (8/10/2013) | Photo on the month (21-24/10/2013) | Photo of the previous month |
|---|--|--|--|---|
| 22. | B Nonsomboun Sta. 2km+400m to the direction of B Hat Gniun | A dirt road with a rough surface, surrounded by dense green vegetation. | A dirt road with a smoother surface, showing tire tracks, surrounded by dense green vegetation. | |

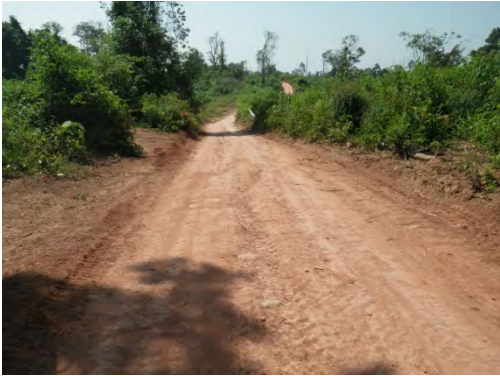
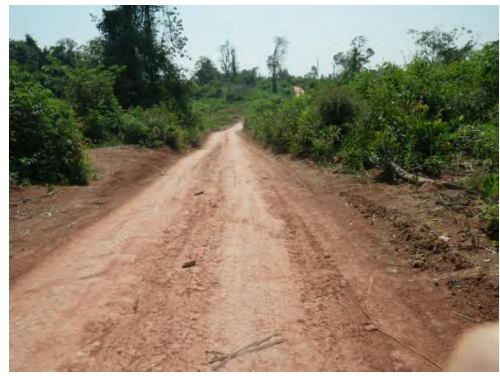
| No | Location | Photo before construction (8/10/2013) | Photo on the month (21-24/10/2013) | Photo of the previous month |
|---|--|--|--|---|
| 23. | B Nonsomboun Sta. 2km+625m to the direction of Nonsomboun | A dirt road with a rough surface, surrounded by dense green vegetation. | A dirt road with a smoother surface, showing tire tracks, surrounded by dense green vegetation. | |

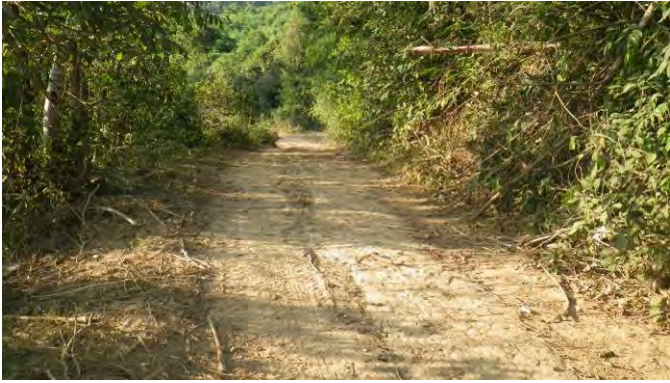
| <p>Point-6 (KM3+100m, W=4.5 m)</p> | <p>Point-7 (KM3+650m, W=5.5 m)</p> |

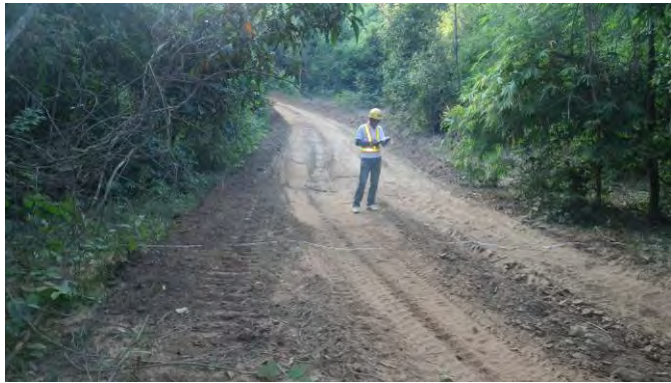
| <p>Point-8 (KM4+190m, W=5.5 m)</p> | <p>Point-9 (KM4+680m, W=5.0 m)</p> |

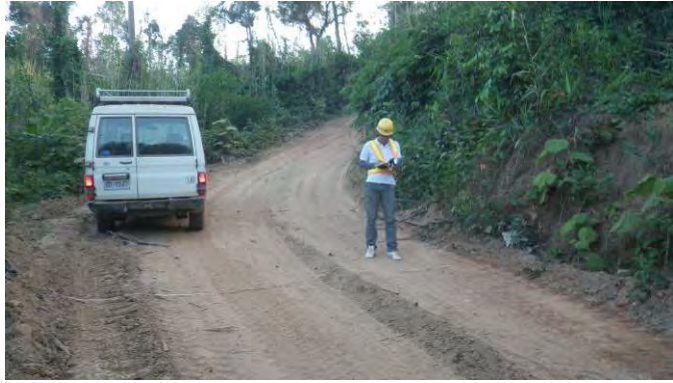
| <p>Point-14 (KM7+230m, W=5.5 m)</p> | <p>Point-15 (KM7+690m, W=6.0 m)</p> |

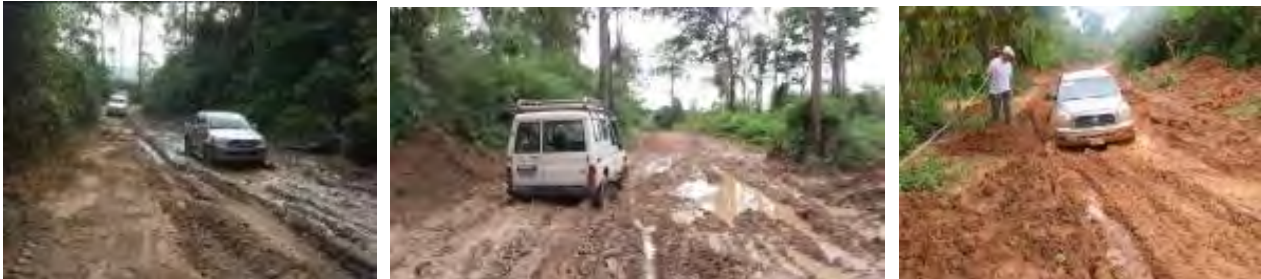
Figure-2 Road conditions in rainy season before the Works

Thafuea village sometimes had crossed the Nam Xao River by swimming in rainy season to go to school at B Hat Gniun. It was very difficult and not safe situation for villagers to access the public services (e.g. school and hospital) in rainy season by using the existing road.

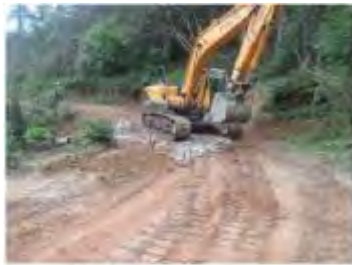
For prevention of soil erosion and discharging soil from road surface to sensitive areas such as paddy field, gravel was placed on road surface and outlet of drainage, and settling pond was installed.

Sta. 15+200
Road improvement by Gravel filling

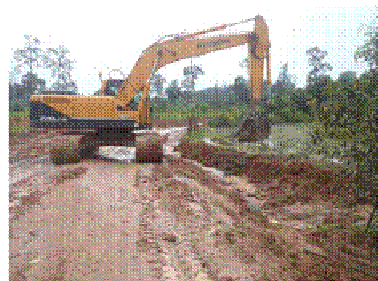
Sta. 17+200_Drainage improvement by gravel filling

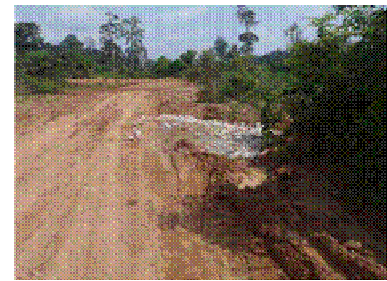
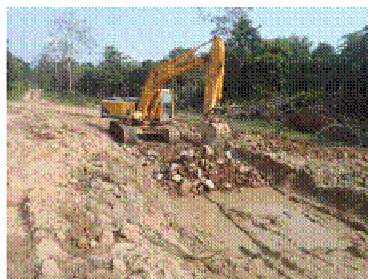
Sta. 22+200
Road improvement by gravel filling

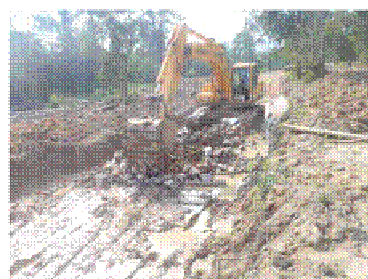
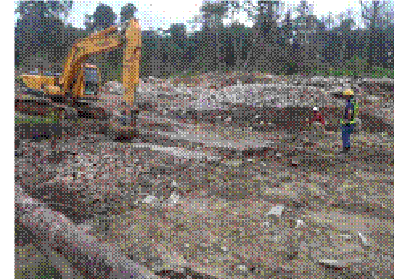
Km 16+00 Quarry
Settlement pond installation

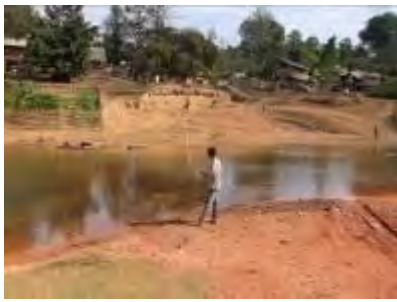
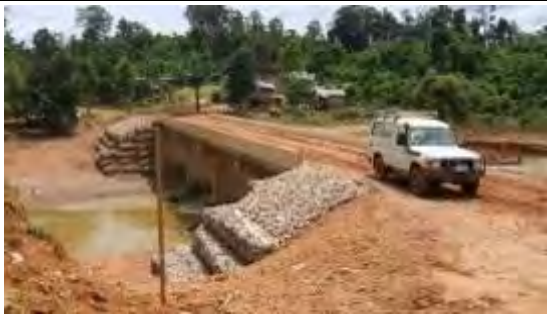
2-4-1 Nam Xao bridge

| | Before construction | After improvement |
|---|--|---|
| Improvement | <ul style="list-style-type: none"> - No turbid water due to vehicle passage inside the river - No soil erosion from road surface in the bridge section - Becoming accessible during rainy season not only for project survey but villagers to access public services such as hospital and school. | |

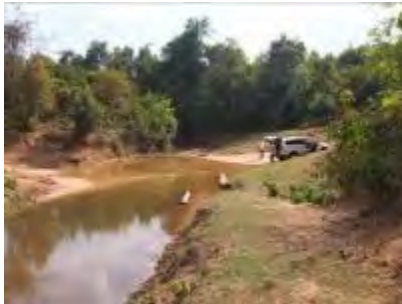
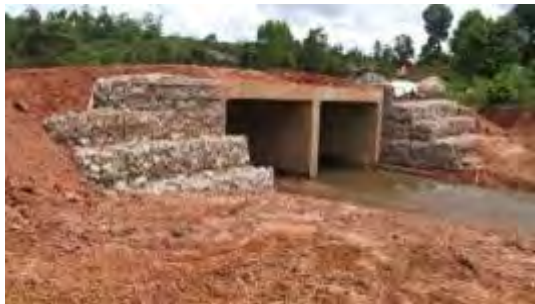
2-4-2 Nam Thak and Nam Miang box culvert

| | Before construction | After improvement |
|---|---|--|
| Photograph | <p style="text-align: center;">Nam Thak box culvert</p> | <p style="text-align: center;">Nam Thak box culvert</p> |
| Improvement | <ul style="list-style-type: none"> - No turbid water due to vehicle passage inside the river - Becoming accessible during rainy season not only for project survey but villagers to access public services such as hospital and school. | |

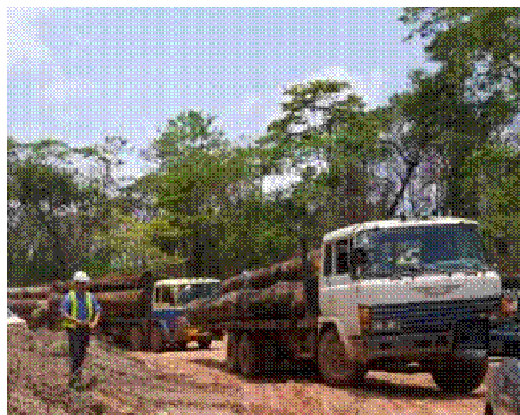
During the Works, not only works related to the NNP1 Project but also electric pole installation works by EDL, logging works by timber companies, and slush and burn activities by local residents were carried out along the access road. These caused some damages to the road surface inducing soil erosion.

Figure-13 Timber truck on site on 22 May 2013 which is not related with road rehabilitation works of NNP1PC

NNP1PC has not yet started the road construction works by the main civil contractor on time. The road construction works for the access road with environmental mitigation measures will be done after the consent by authorities concerned and lenders. The road construction works are expected to start before the next rainy season when soil erosion may occur seriously.

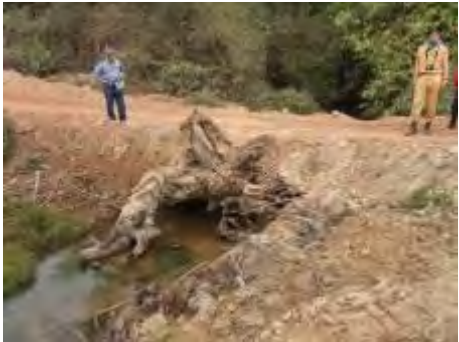
| | Photograph | Explanation(works done/impacts/mitigation) |
|--|--|--|
| Original condition | | <ul style="list-style-type: none"> a) Timber installed b) Road surface soil is eroded and discharge into the small stream. c) In case of flood, embanked soil, timber will be discharged and becoming inaccessible d) No environmental mitigation measure taken |

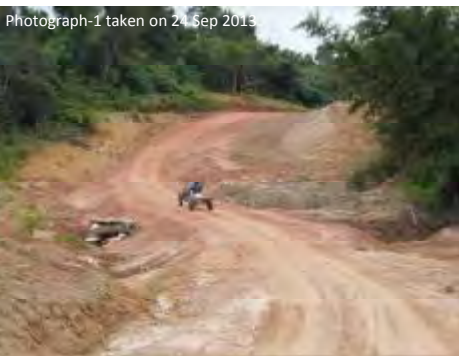
| | Photograph | Explanation(works done/impacts/mitigation) |
|--|--|--|
| Current improved Condition/ Remaining impacts | <p>Photograph-1 taken on 24 Sep 2013</p> | <ul style="list-style-type: none"> a) Pipe culvert, side ditch installed, becoming accessible during the rainy season b) No turbid water due to vehicle passage in the river c) Soil erosion from a part of a embankment and cut slope d) Soil erosion from road surface |

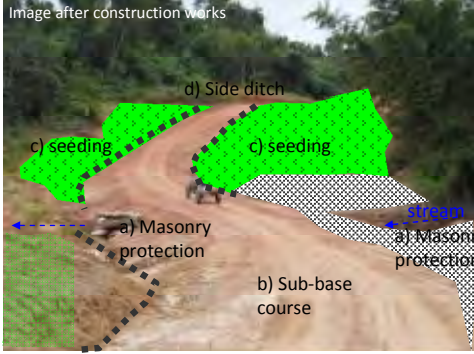
| <p>Mitigation measures</p> | <p>Image after construction works</p> | <p>a) Stone masonry: Installed on the embankment slope up the elevation the river water rises during the rainy season</p> <p>b) Seeding for cutting slope: Applying to the excavated slope</p> <p>c) Sub-base course by gravel for road: Applying to the road surface</p> <p>d) Side ditch: In the case the gradient is steep, stone masonry is applied.</p> <p>e) If mitigation measures the above are not completed by the next rainy season, gravel placement or sheet cover for embankment slope, pit digging for sedimentation, sub-base course placement are to be taken as a temporary mitigation measure.</p> |

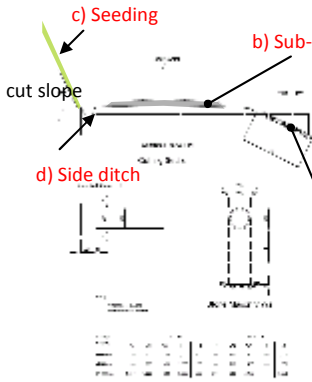
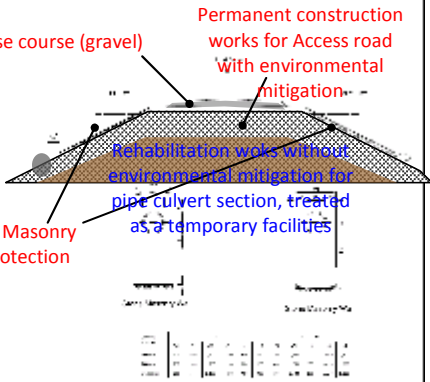
| | | <p>Drawings of Permanent pipe culvert by OBAYASHI</p> |

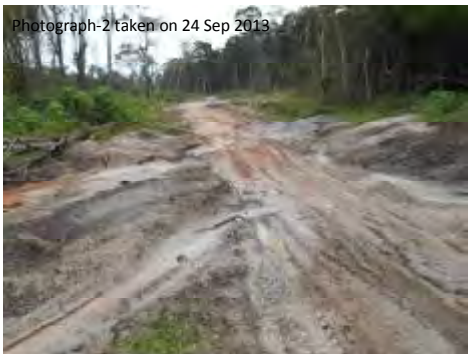
5-2 Photograph-2 km15.9 inside PPA

| | Photograph | Explanation |
|--|--|---|
| Current improved Condition/ Remaining impacts | | a) No repairing works was implemented b)The current road and surrounding environment were damaged because many vehicles, not only NNP1PC, and contractors of the Road Rehabilitation Works, but also many logging companies, passed this section during the dry and rainy seasons. |

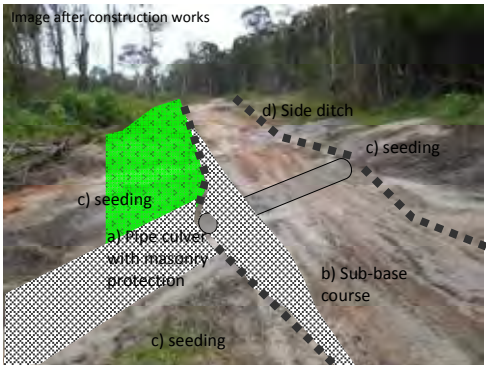
| | Photograph | Explanation |
|--|--|---|
| Mitigation measures | | a) Pipe culvert installation including stone masonry b) Seeding for cutting slope: Applying to the excavated slope c) Sub-base course by gravel for road: Applying to the road surface d) Side ditch: In the case the gradient is steep, stone masonry is applied. |

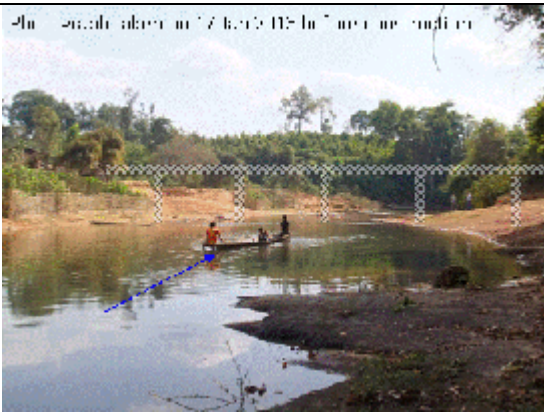
5-3 Photograph-3 Nam Xao bridge at Ban Thafuea "inside PPA"

| | Photograph | Explanation |
|---|---|---|
| Original condition | | a) Villagers can't cross the river be vehicle during rainy season even in case of emergency. b) Turbid water occur due to vehicle passage in the river |

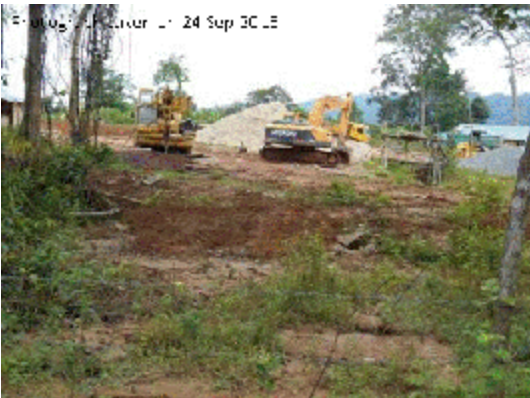
| <p>Current improved Condition/ Remaining impacts</p> | | <ul style="list-style-type: none"> a) Vegetation cleared b) No protection for soil erosion taken c) Construction material and machinery are scattered. |

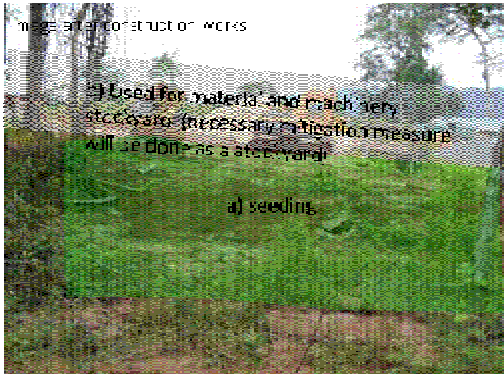
| <p>Mitigation measures</p> | | <ul style="list-style-type: none"> a) Seeding: Applying to the cleared place b) Clearing stocked material and equipment c) Placing sub-base course d) Installation of temporary drainage facility <p><i>Notes: The land is owned by GoL (Ban Thafue). The area will be used as material and machinery stockyard. Part of the camp during the Works will be cleared and used as a land for primary school.</i></p> |

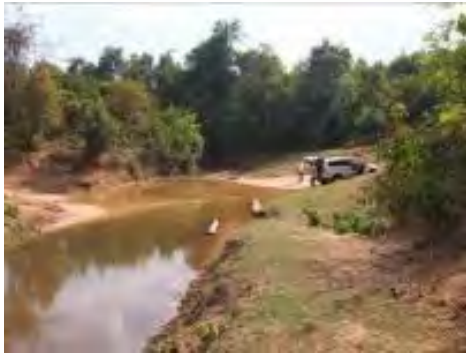
5-5 Photograph-5 Nam Thak box culvert at Ban Thafuea "outside PPA"

| | Photograph | Explanation |
|---|--|---|
| Original condition | | <ul style="list-style-type: none"> a) No river crossing facilities b) Turbid water due to crossing river c) Villagers can't cross the river by vehicle during rainy season even in case of emergency. |

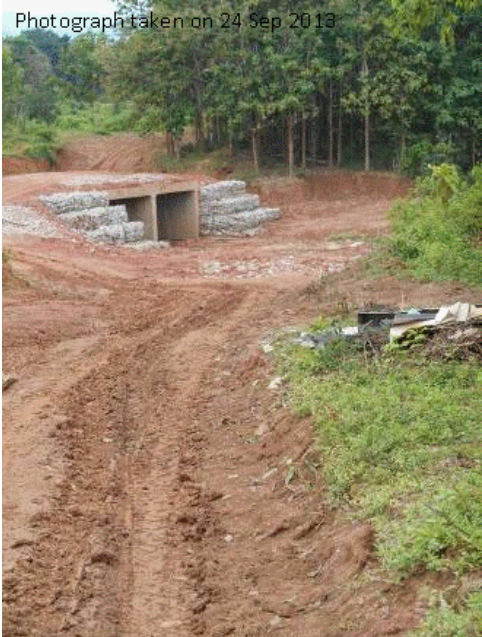
| | Photograph | Explanation |
|---|--|---|
| Current improved Condition/ Remaining impacts | <p>Photograph taken on 24 Sep 2013</p> | <ul style="list-style-type: none"> a) The box culvert crossing the Nam Thak River was built as a permanent facility. For the erosion protection, gabion boxes were installed. |

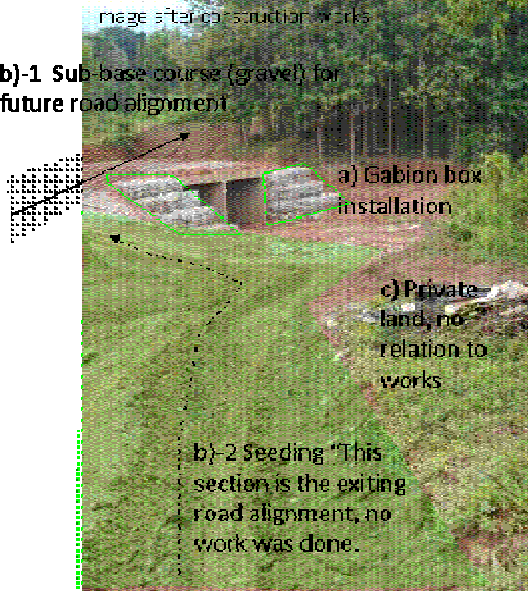
| | Photograph | Explanation |
|---|--|---|
| Mitigation measures | <p>Image after construction works</p> <p>b)-1 Sub-base course (gravel) for future road alignment</p> <p>a) Gabion box installation</p> <p>c) Private land, no relation to works</p> <p>b)-2 Seeding "This section is the existing road alignment, no work was done."</p> | <ul style="list-style-type: none"> a) The environmental mitigation measures to be done are as follows, b)-1 Sub base course (gravel) will be placed for the permanent road construction works. b)-2 Seeding will be carried out c) If mitigation measures the above are not completed by the next rainy season, sheet cover for embankment slope and sub-base course placement for existing road alignment will be taken as a temporary mitigation measure. |

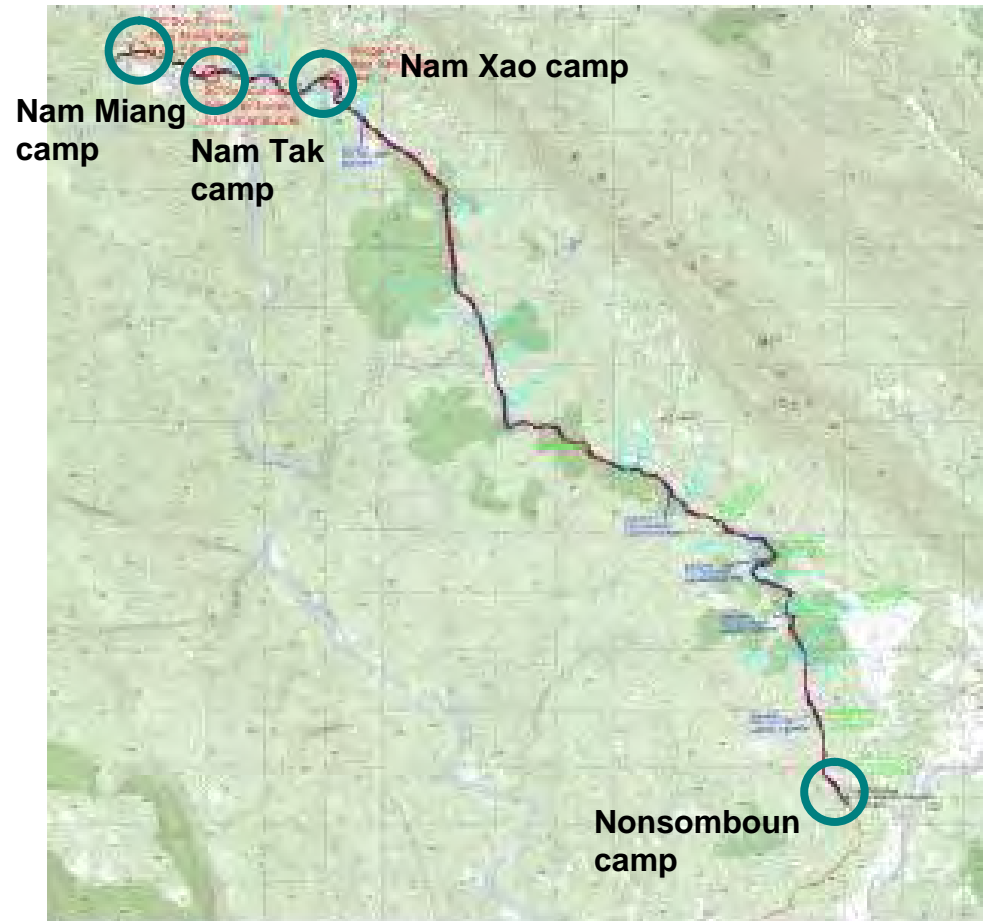
Labor camp location

Maximum;
Approximately 100 workers / day

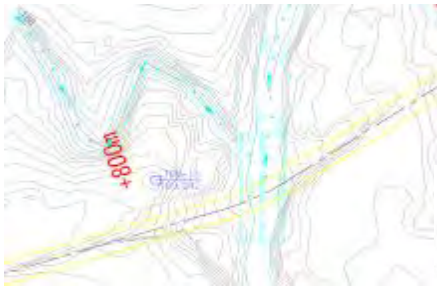
Nam Tak River flood water level

| Items | Unit | amount | Remarks |
|---|---|---|--|
| Maximum discharge | m³/sec | 281.61 | >> over 100-year flood of 280 m³/s |

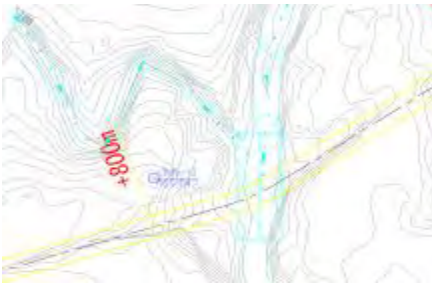
Nam Miang River flood water level

| Items | Unit | amount | Remarks |
|---|---|---|---|
| Maximum discharge | m ³ /sec | 63.08 | >> over 100-year flood of 52 m ³ /s |

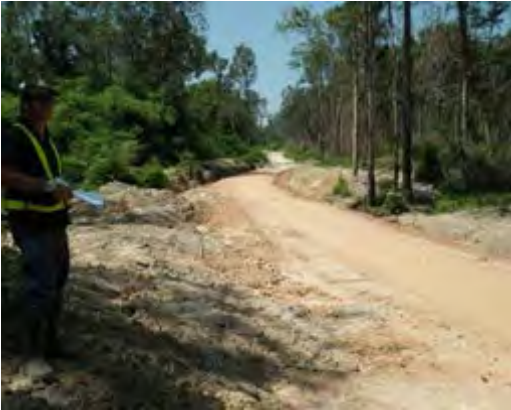
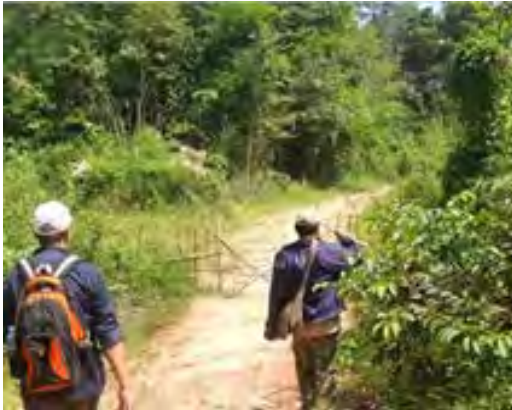
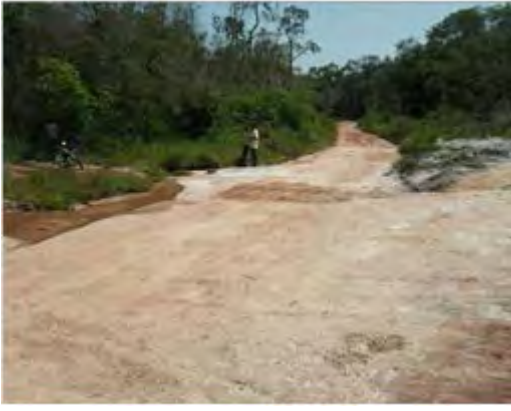
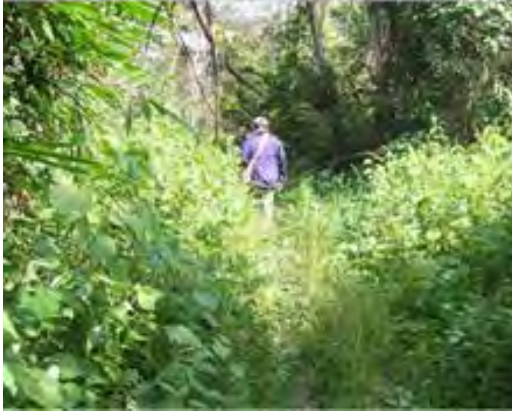
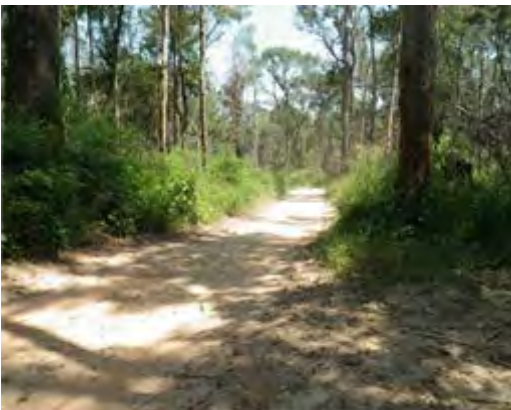
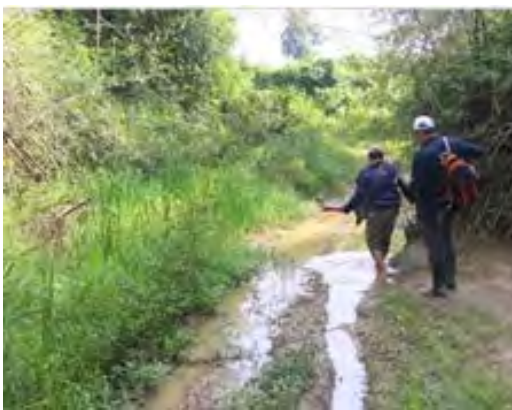
Table 5-10 Photos of Proposed Road and Alternative Route.

| Proposed Road | Alternative Route |

The assessment of the Proposed Road and Alternative Route indicated that each scenario would have similar environmental and social impacts. These impacts are outlined in *Table 5-11*.
