Background on the March 13-14, 2007 Flooding in  
Browns Valley (Traverse County), Minnesota

**Report to the Minnesota Governor's Office**

Prepared by:  
Minnesota Department of Natural Resources  
Waters Division  
April 20, 2007

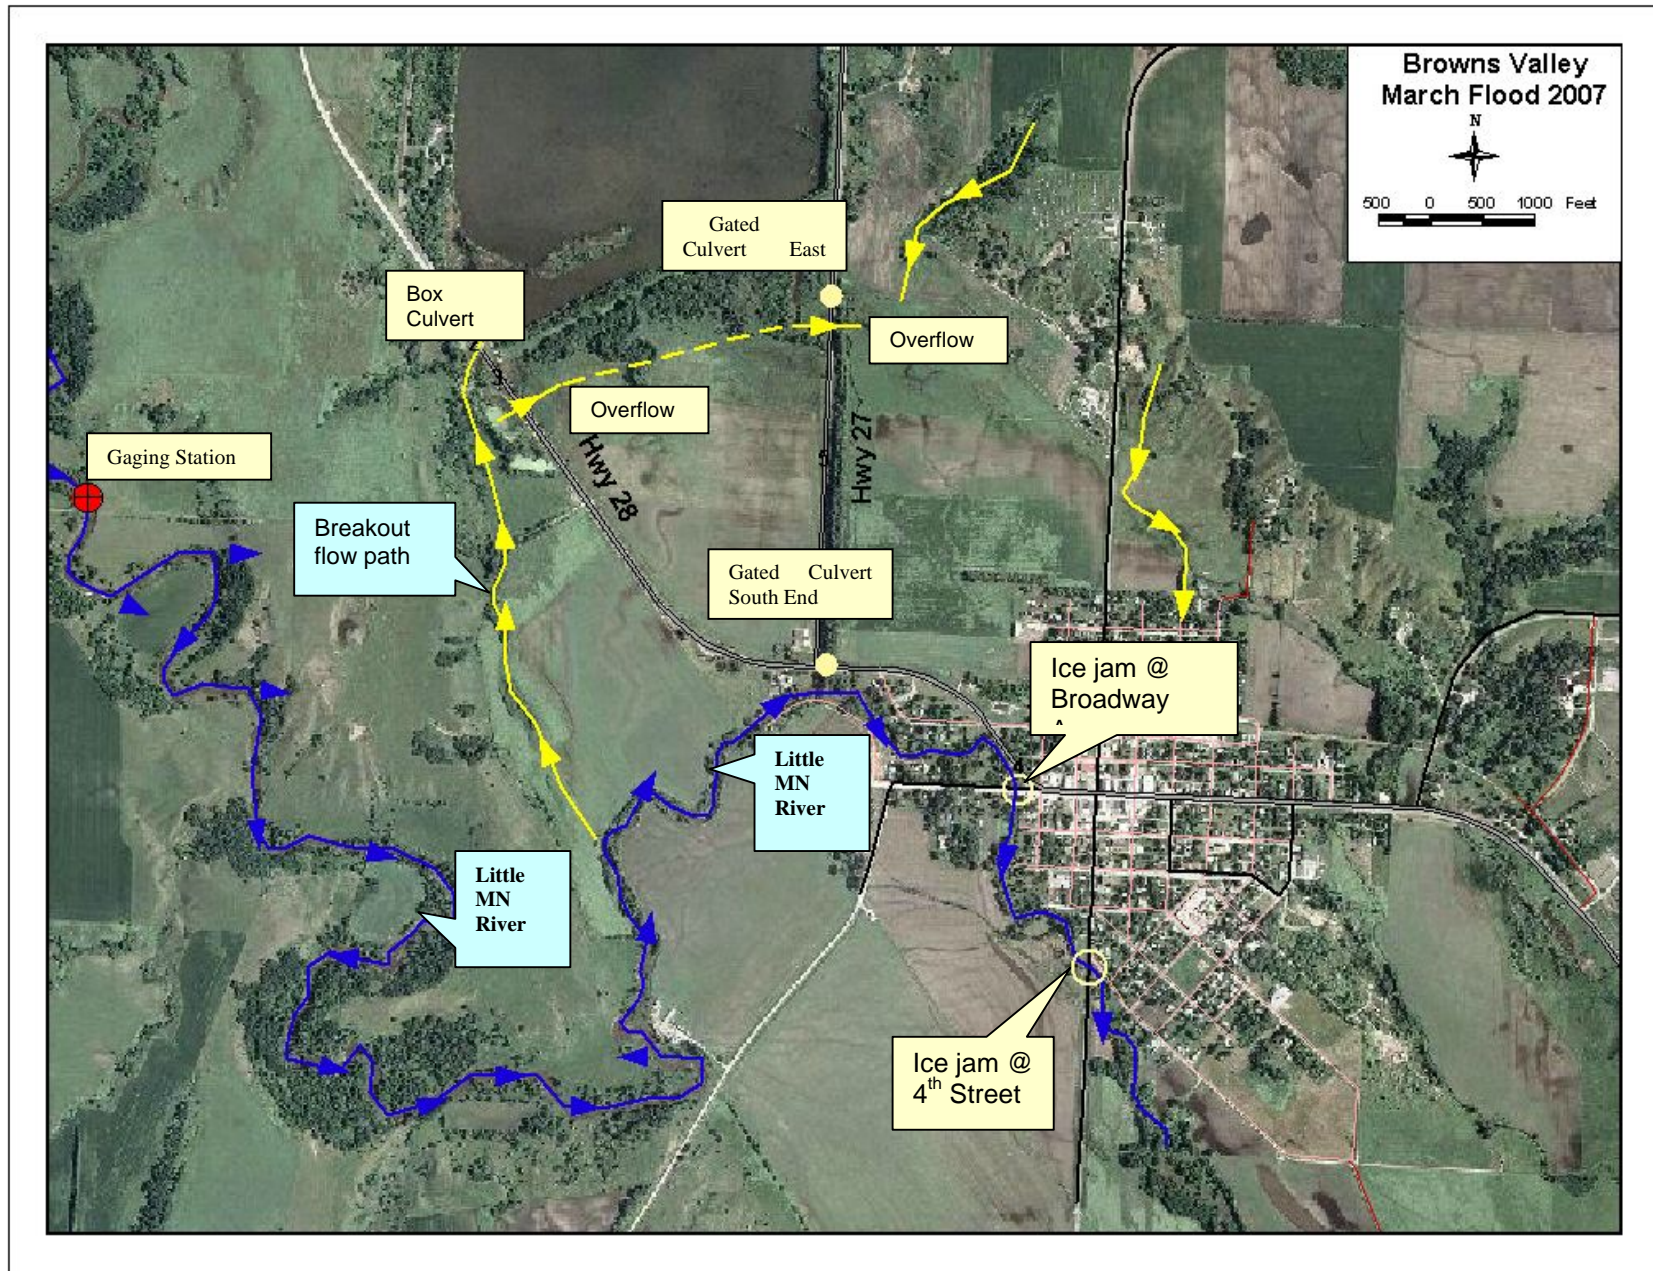
Figure 3. Schematic of flows during March 13-14, 2007 flood in Browns Valley (Traverse County)

Ice jamming occurred in the vicinity of the two bridges in Browns Valley, Broadway Avenue and 4th Street (County Highway 4). The jam caused water levels in the river to back up, and rise to flood elevations. The increase in water levels as a result of the ice jams caused floodwaters from the Little Minnesota River to flow north parallel to Highway 28 and through box culverts into Lake Traverse through the natural flood flow breakout area. The box culverts appeared to function as designed. Near Lake Traverse along Highway 28, water overflowed a low portion of the highway and filled the area bounded by Highway 28 to the west and south, Highway 27 to the east and Lake Traverse to the north. Flood waters from this area then flowed across Highway 27 into Browns Valley.

It appears that the flooding occurred as a result of the following: (1) ice jams reduced the amount of flow through the bridges over the Little Minnesota River in Browns Valley, (2) this caused water elevations upstream to rise higher than they would have with unobstructed flow conditions, (3) as water levels increased upstream, water broke out and went towards Lake Traverse, (4) significant flows (estimated at greater than 1,000 cfs by U.S. Army Corps of Engineers' staff) went into Lake Traverse, (5) additional overland flows overtopped Highway 28 and, as flood water storage areas were filled, flow continued through a gated culvert and over Highway 27, and (6) this overland flow, combined with local runoff from the north, flooded the north end of Browns Valley.

See figure 3 (page 3), which shows a schematic of flows observed during the March 13-14, 2007 flood.

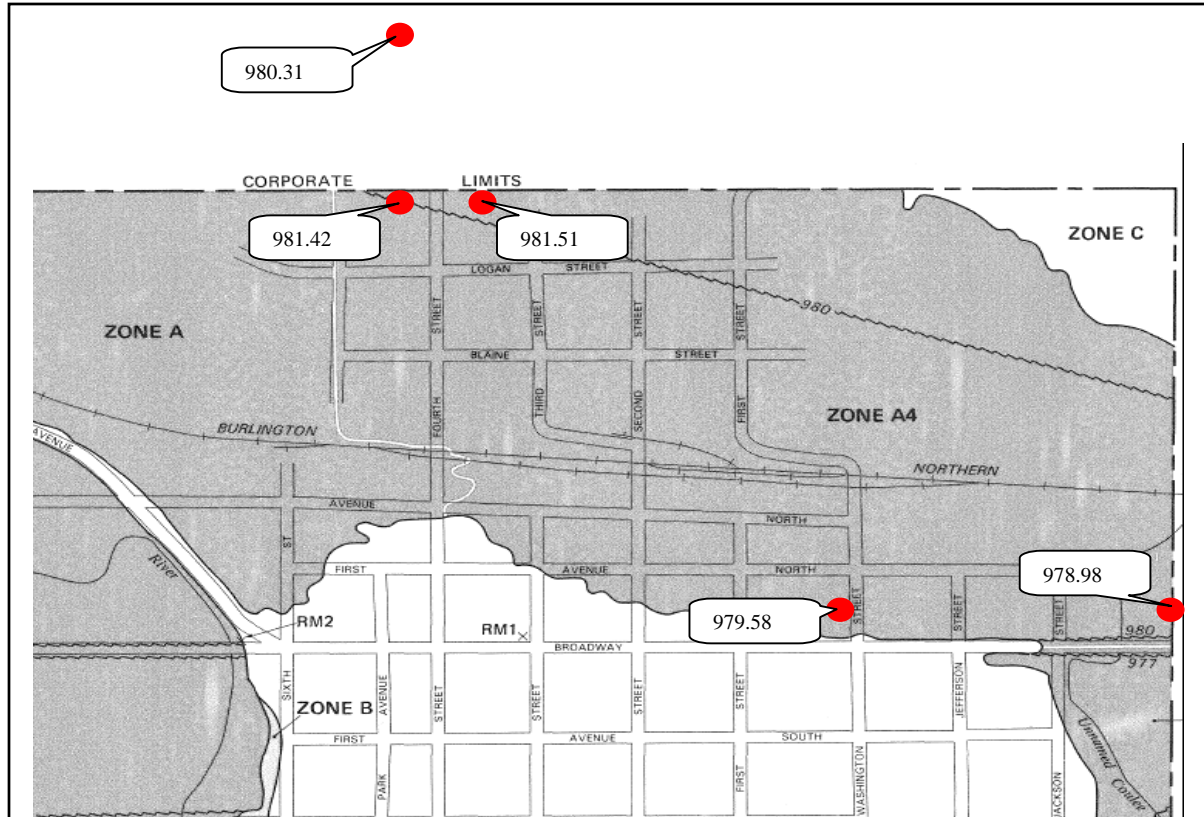
**Figure 4. Spot elevations of high water from March 13-14, 2007 flood in Browns Valley (Traverse County) shown on the Flood Insurance Rate Map for Browns Valley**

The FIS 1% annual chance (100-year) flood level elevations are indicated on the Flood Insurance Rate Map by wavy contour lines labeled with the appropriate elevation. This reveals that the observed high water marks were higher than the 100-year flood elevation of 980 feet MSL at the north end of the city, and just below the 100-year flood elevation as you go further south towards Broadway.

Since the gage was compromised by ice, it is not possible to determine how the discharge (flow volume) for this flood compares to the 1% annual chance (100-year) flood discharge in the FIS. It was possible to compare the elevations of a few high water marks in the city and surrounding area with the 100-year flood elevation published by FEMA on the city’s Flood Insurance Rate Map (FIRM). See figure 4 below.

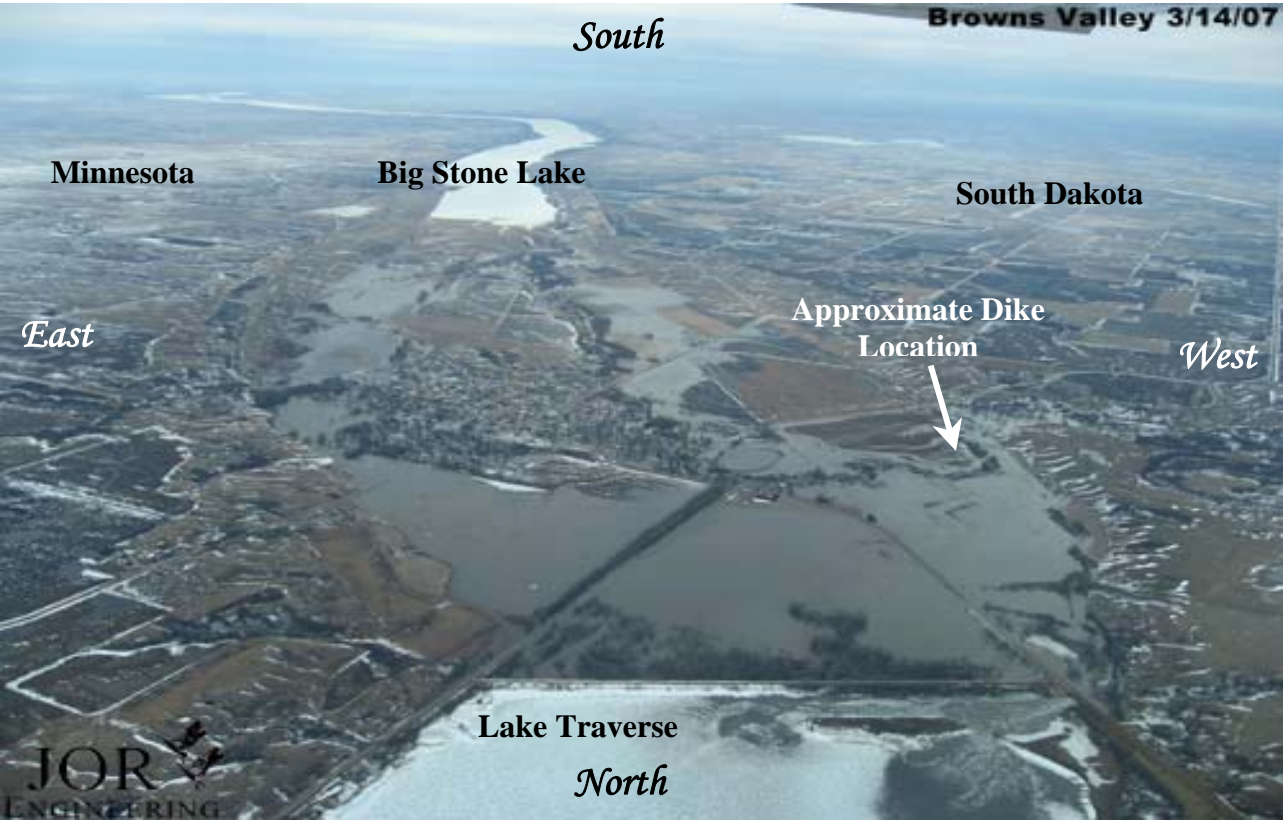
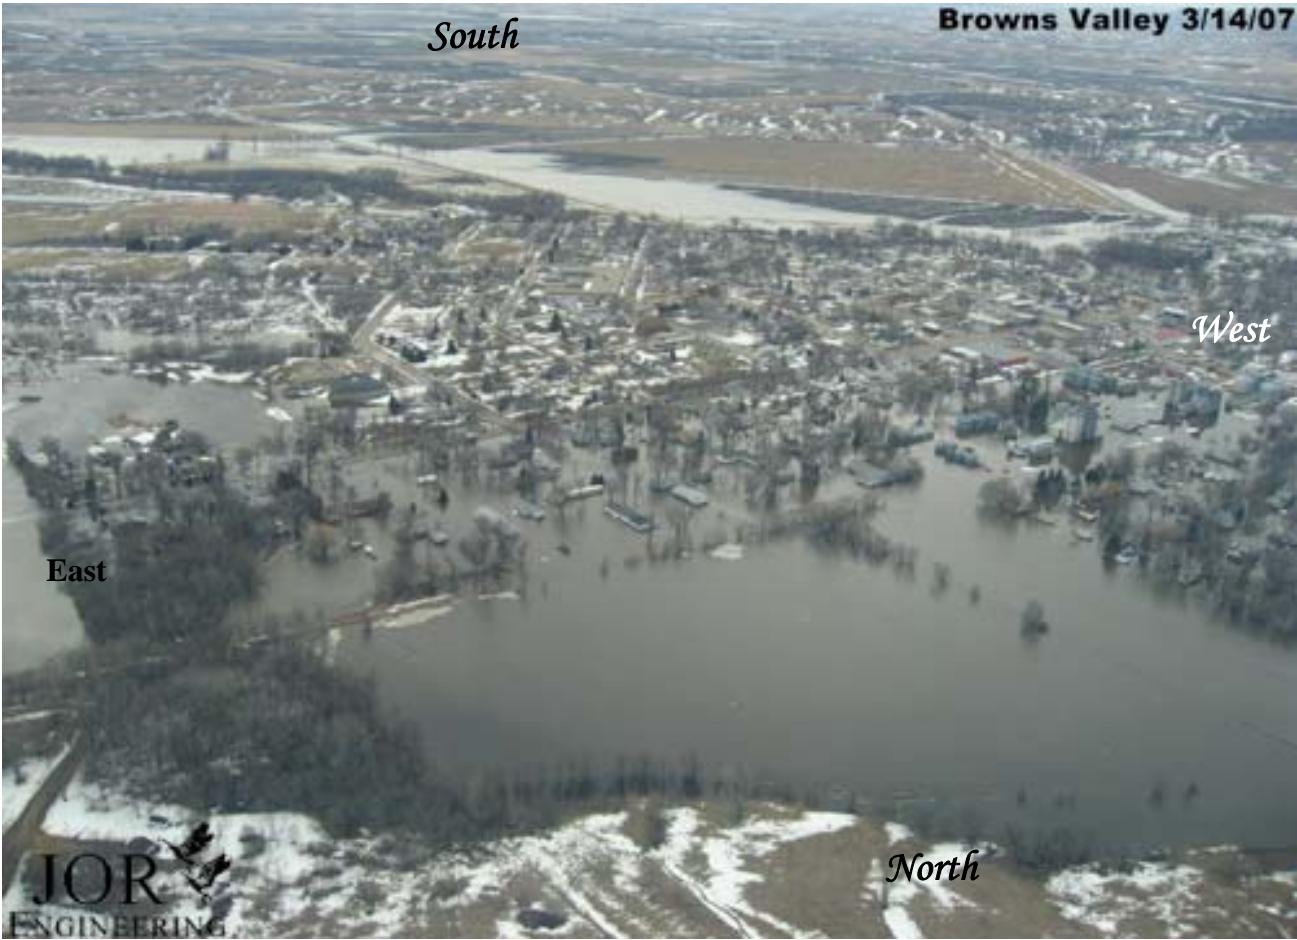
Figures 5a & 5b. JOR Engineering aerial photos taken March 14, 2007

Photos taken by JOR Engineering on March 14, 2007, just after the peak of the flood, are included in figures 5a and 5b (on page 8). The location of the diking in question is labeled on the first photo. It can be observed that flood waters were backed up to the area that included the diking.

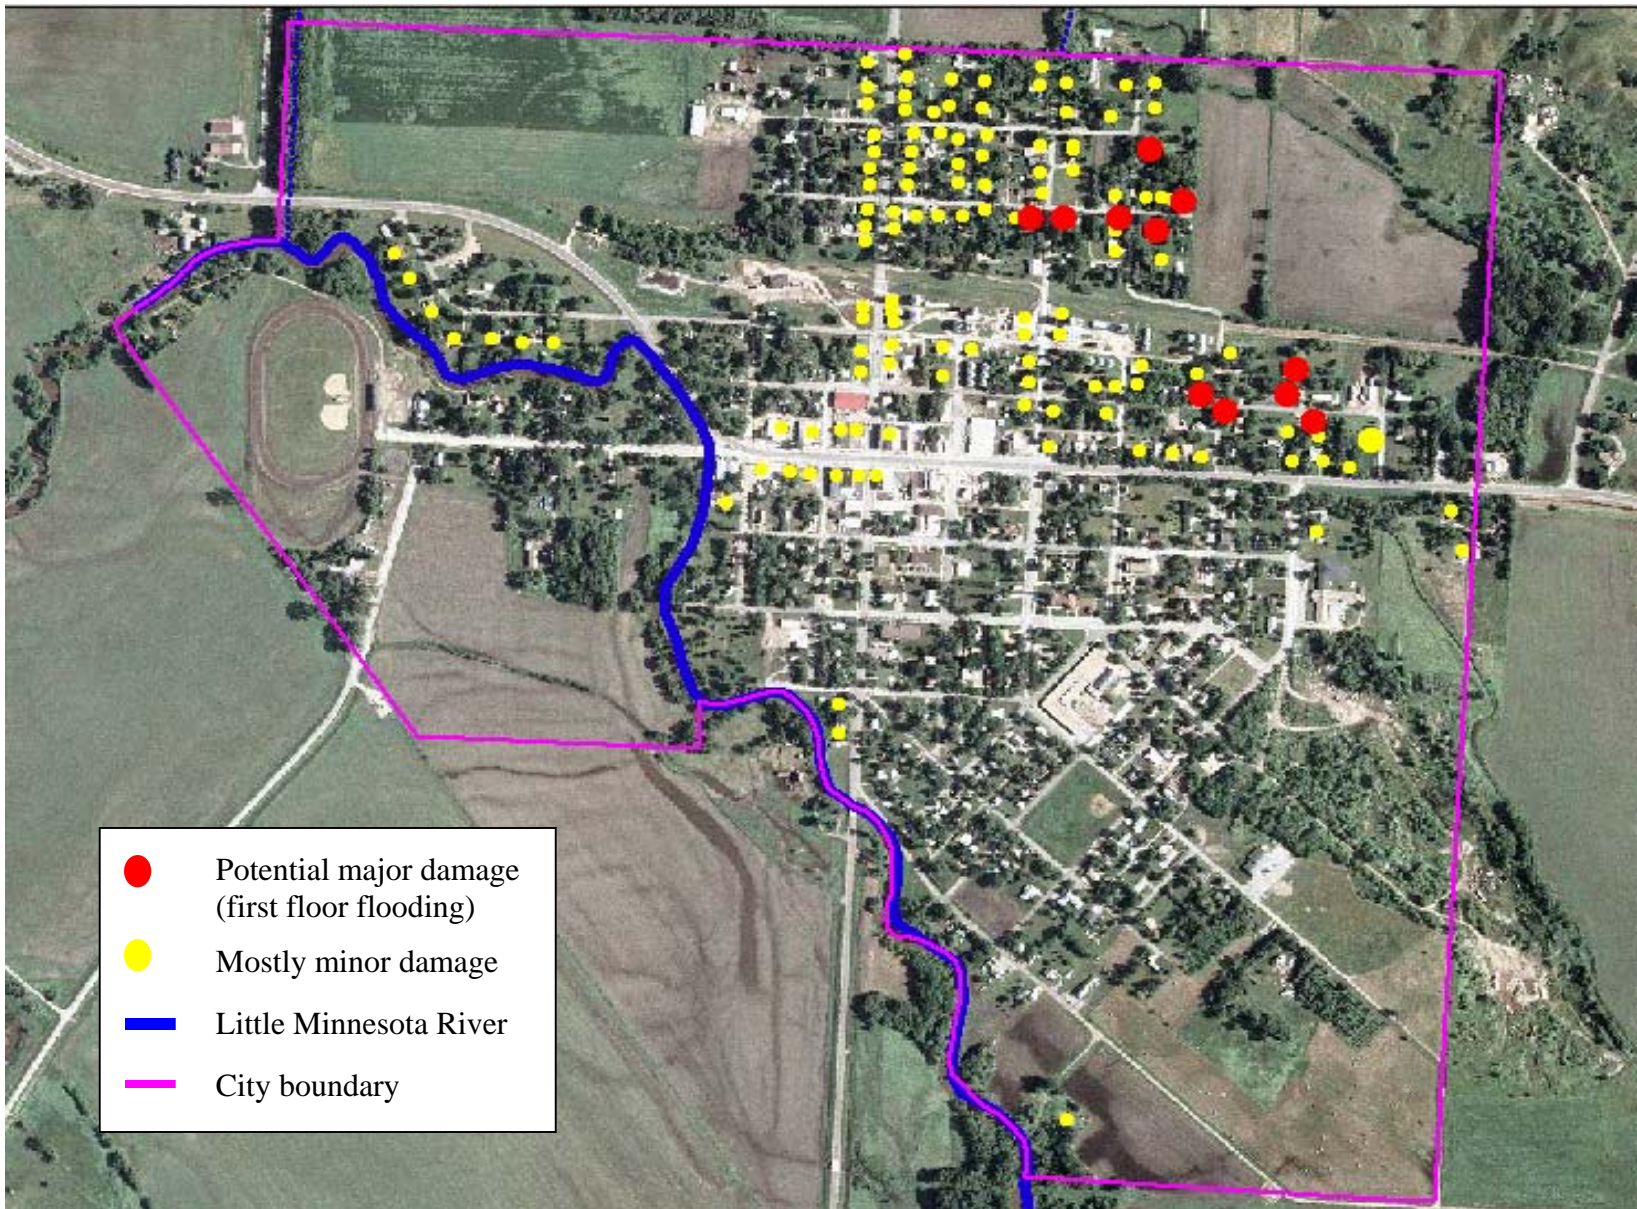
Figure 7. Approximate location of structures with possible damage during the March 13-14, 2007 flood in Browns Valley (Traverse County)

The preliminary results for the inspected structures, as located on Figure 6, indicate that the vast majority of these structures had damage essentially to the basement only (i.e., primarily building utilities and electrical wiring) and were likely not substantially damaged. These structures can be repaired without having to comply with the city's floodplain ordinance once the city formally determines them to not be substantially damaged. Compliance would mean that the structure would need to be elevated or floodproofed.

Eleven of the 100 non-rental properties had water on the first floor and appear to have suffered major damage. An additional five properties may not have had first floor flooding but appear to be substantially damaged anyway. The city will use the inspection data and market values of these 16 structures to make the final determination of which structures were substantially damaged, as defined in the city's floodplain management ordinance. Any substantially damaged structures must be retrofitted to meet the elevation or floodproofing requirements of the city's floodplain ordinance or be relocated from the floodplain. The structures with water on the first floor that were not substantially damaged (3 properties) can be repaired without having to fully elevate or floodproof the structure to the regulatory flood protection elevation. DNR staff were unable to obtain the market values of the rental properties so could not determine whether they incurred 50% (substantial) damage.
