LANDOWNERS AND TMK's
Ke Ala Kahawai O Waimea,
Waimea Trails and Greenways
Draft Environmental Assessment

Natural resources assessment update report for the Waimea Trails and Greenways Project, Kamuela Island of Hawai'i¹

AECOS No. 920B

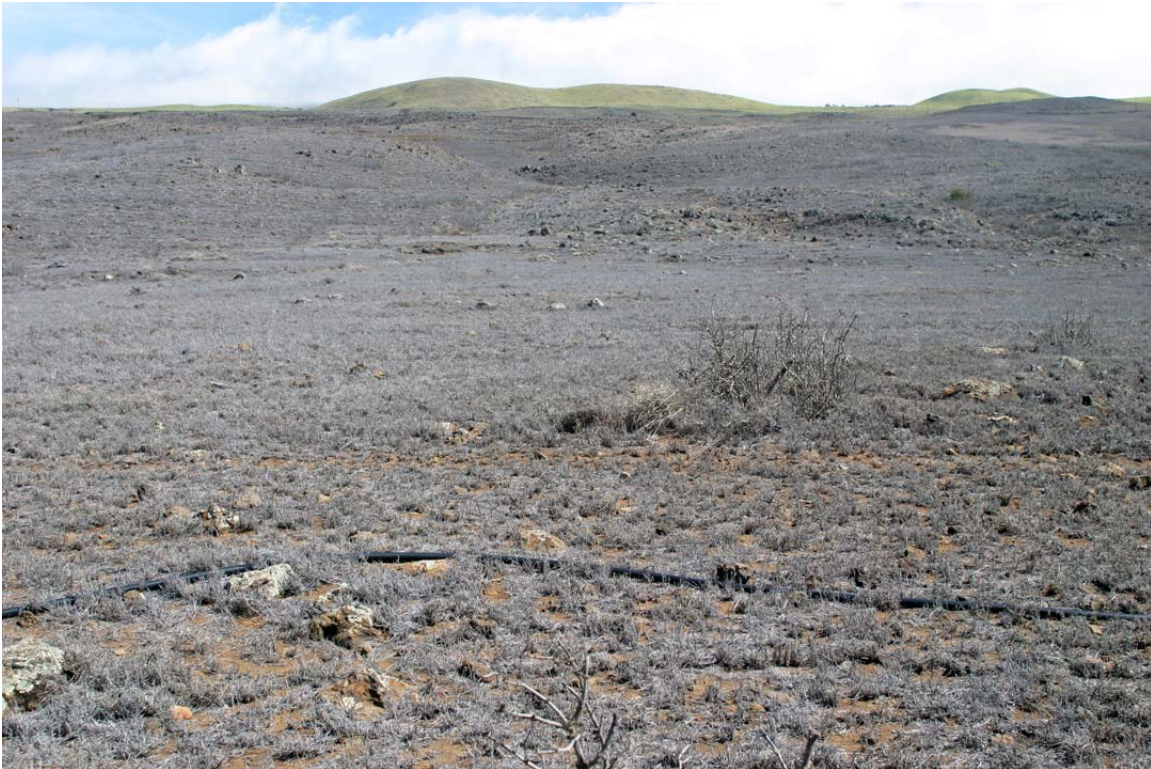
Figure 2. Pastureland, photographed September 2010, near the western end of the project area illustrating impact of extreme drought conditions on vegetation.

Conditions in September 2010 were far drier than those encountered in 2000 (Dicus, 2007; CWRM, 2010; see Fig. 2). At the best of times the area west of Waimea Town is extremely dry, averaging perhaps 15 in (38 cm) of rain or less a year; during 2010, the Kawaihae and 'Ouli areas were classified as suffering "D4" or exceptional drought conditions (Climate Prediction Center, National Weather Service, 2010).

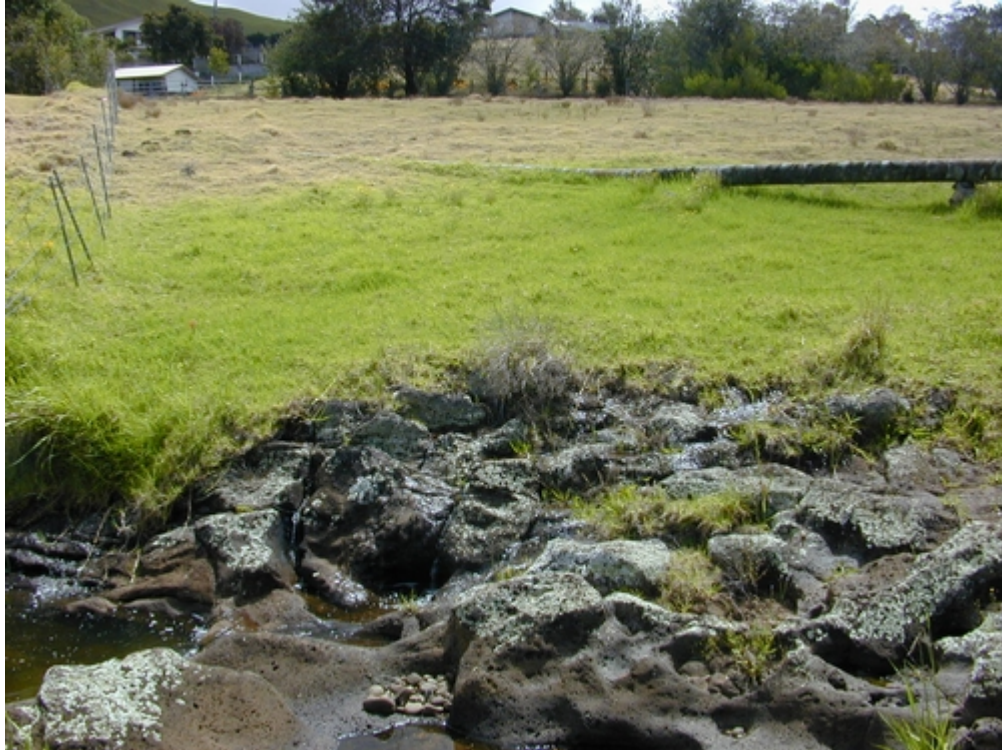
Figure 3. Right bank of Waikoloa Stream near Puu Opelu Rd. Water transmission pipe that was the source of most of the flow observed in 2000 below this point appears in background. No flow was occurring at this time (June 5, 10:25 AM), although flow started sometime within the next 30 minutes.

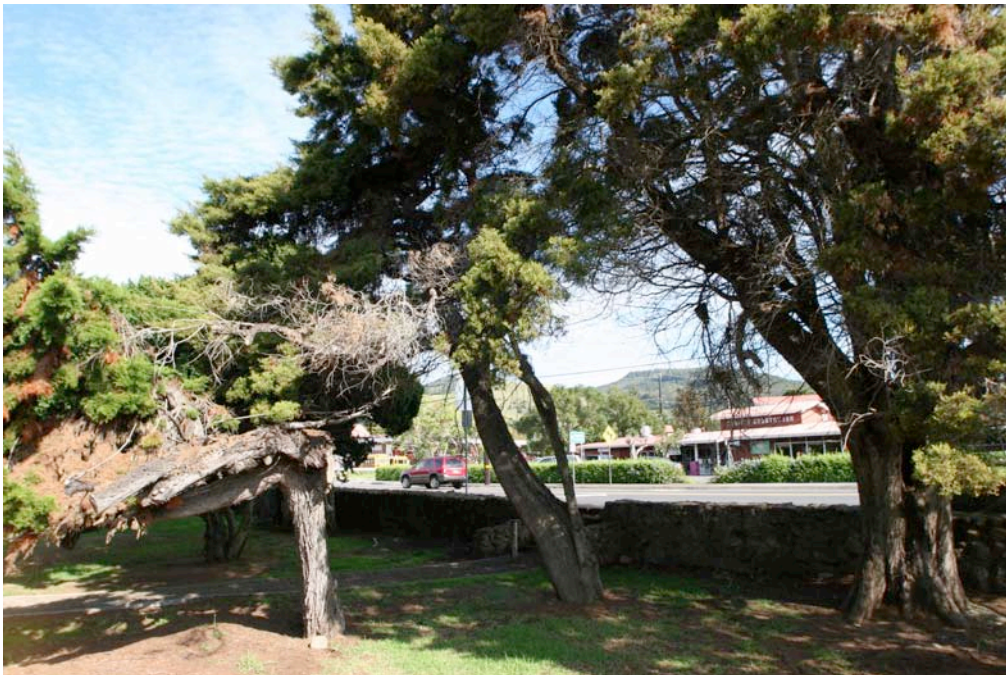
Tree 3

7. Defective root conditions: None
8. Trunk defects: None
9. Scaffold limb defects: None
10. Previous tree and limb failures: Top is missing

Management Recommendations: Located within the trail, remove.

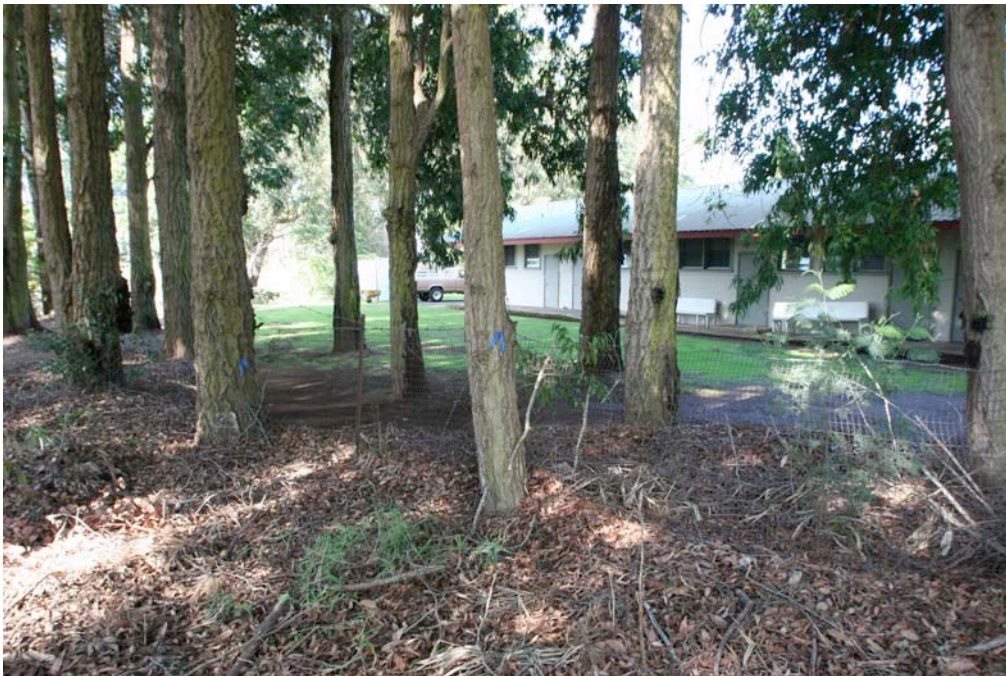
Tree 22

1. Species: Blackbutt Eucalyptus
2. Size: DBH 9", Height 48', Crown spread 16'
3. Targets: Trail
4. Form and Crown class: Asymmetrical, suppressed
5. Tree health: Fair
6. Adverse site conditions: Leans toward the trail
7. Defective root conditions: None
8. Trunk defects: Barbed wire fence nailed to the trunk. some discoloration at fencing nails.
9. Scaffold limb defects: None
10. Previous tree and limb failures: None

Management Recommendations: Prune roots before trail construction, safety prune, crown clean.

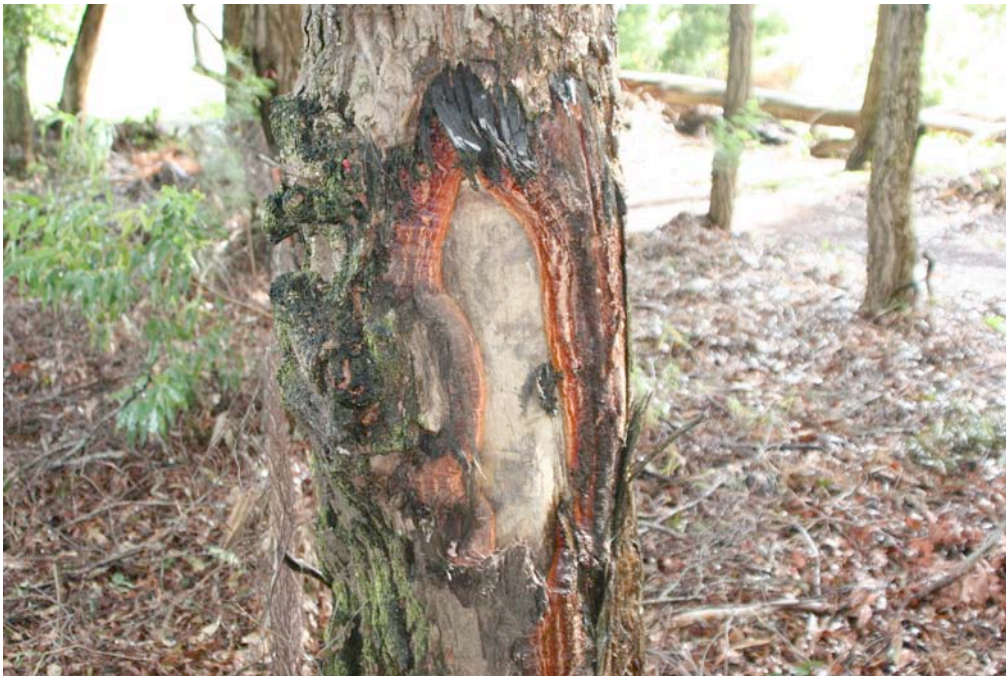
Tree 23

1. Species: Blackbutt Eucalyptus
2. Size: DBH 19", Height 113', Crown spread 35'
3. Targets: Trail
4. Form and Crown class: Symmetrical and Co-dominant
5. Tree health: Good
6. Adverse site conditions: none
7. Defective root conditions: none
8. Trunk defects: wound near trunk base and barb wire from an old fence in the trunk.
9. Scaffold limb defects: none
10. Previous tree and limb failures: none

Management Recommendations: Crown clean and safety prune.

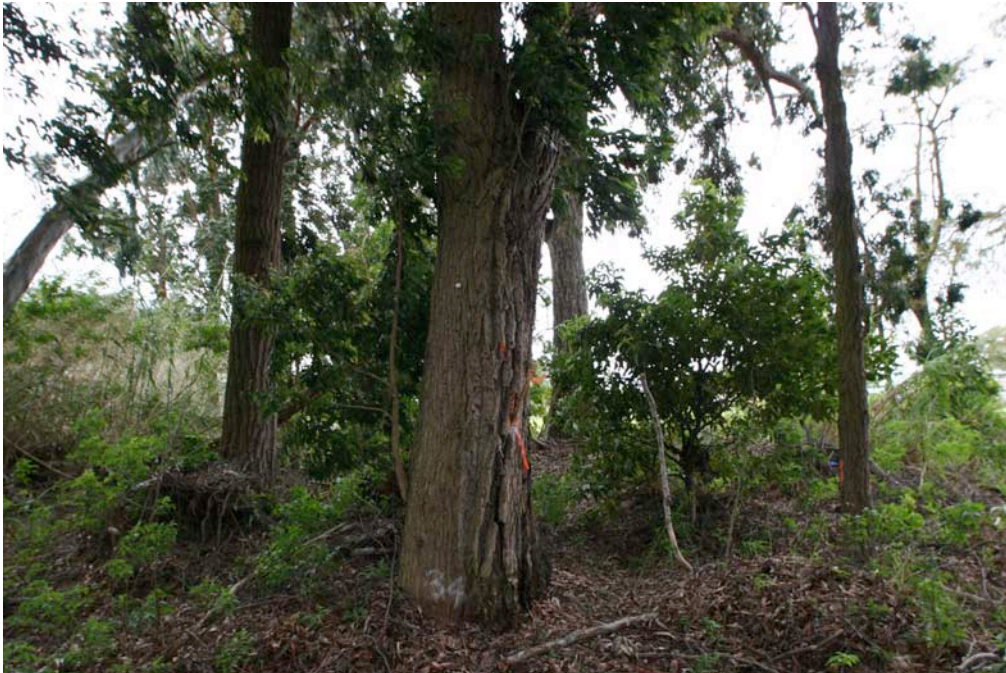
Tree 34

1. Species: Blackbutt Eucalyptus
2. Size: DBH 31", Height 80', Crown spread 50'
3. Targets: Trail
4. Form and Crown class: asymmetrical; Co-dominant
5. Tree health: good
6. Adverse site conditions: in trail.
7. Defective root conditions: none
8. Trunk defects: Sap flux, double trunk, heavy lean
9. Scaffold limb defects: none
10. Previous tree and limb failures: none

Management Recommendations: This tree is growing in the trail..., remove.

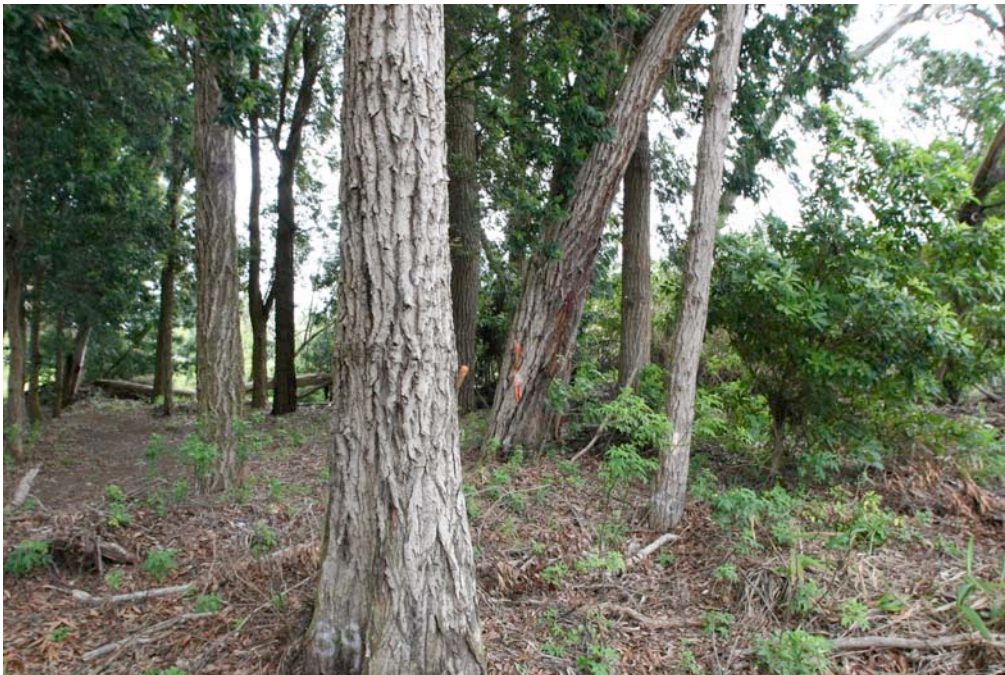
Tree 39

1. Species: Blackbutt Eucalyptus
2. Size: DBH 25, Height 115, Crown spread 52
3. Targets: Trail
4. Form and Crown class: Asymmetrical; Co-dominant
5. Tree health: Good
6. Adverse site conditions: in trail
7. Defective root conditions: none
8. Trunk defects: none
9. Scaffold limb defects: none
10. Previous tree and limb failures: none

Management Recommendations: This tree is growing in the trail..., remove

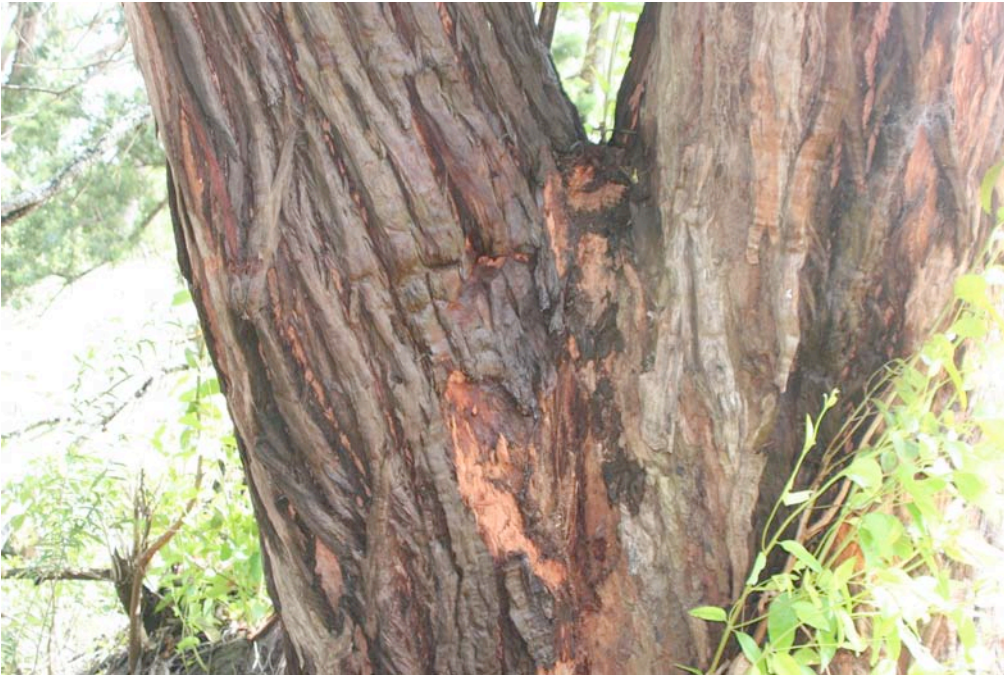
Tree 55

1. Species: Eucalyptus robusta
2. Size: DBH 60", Height 148', Crown spread 50'
3. Targets: Trail and bridge.
4. Form and Crown class: a Symmetrical; Co-dominant
5. Tree health: Fair
6. Adverse site conditions: Some erosion on stream side.
7. Defective root conditions: Erosion on stream side.
8. Trunk defects: Multiple trunks with included bark.
9. Scaffold limb defects: Weak crotches, included bark.
10. Previous tree and limb failures: none

Management Recommendations: Tree is located at the end of the bridge – remove.

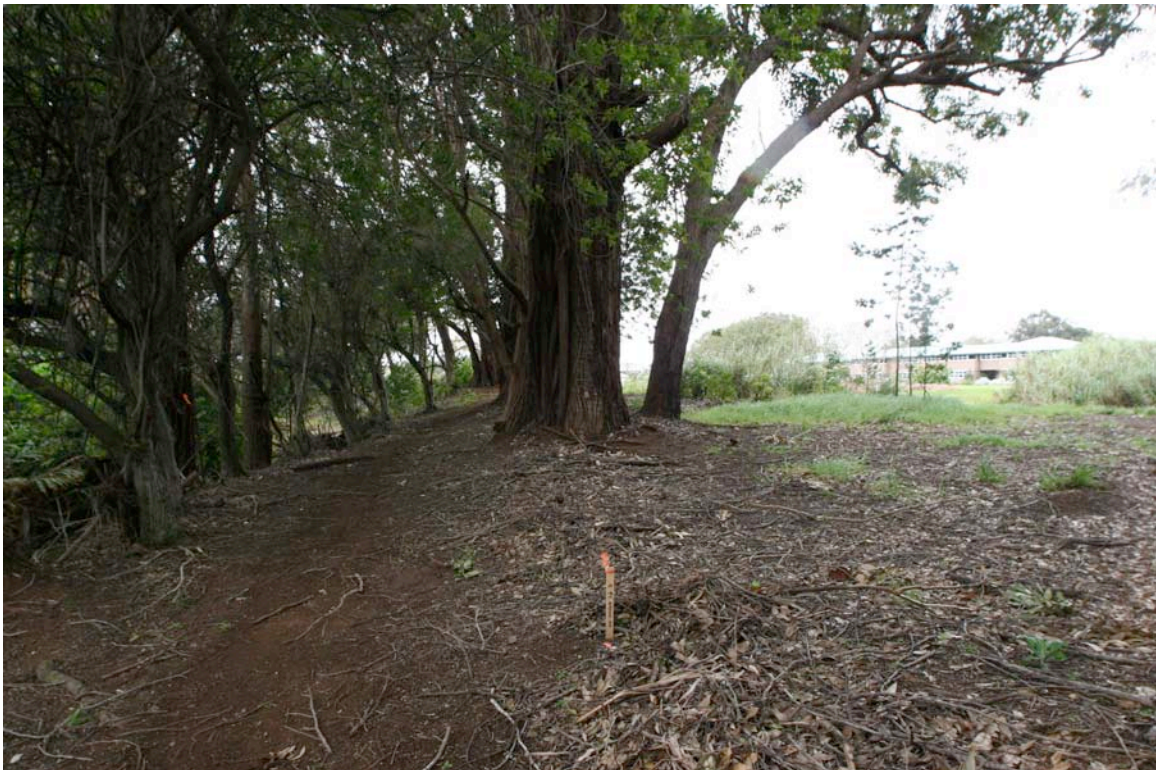
Tree 60 Tree 58

1. Species: Eucalyptus robusta
2. Size: DBH 59", Height 107', Crown spread 75'
3. Targets: Trail
4. Form and Crown class: Asymmetrical; Dominant
5. Tree health: Fair
6. Adverse site conditions: in trail
7. Defective root conditions: none
8. Trunk defects: none
9. Scaffold limb defects: Large broken branches and stubs
10. Previous tree and limb failures: none

Management Recommendations: Tree is located in the trail recommend removal.

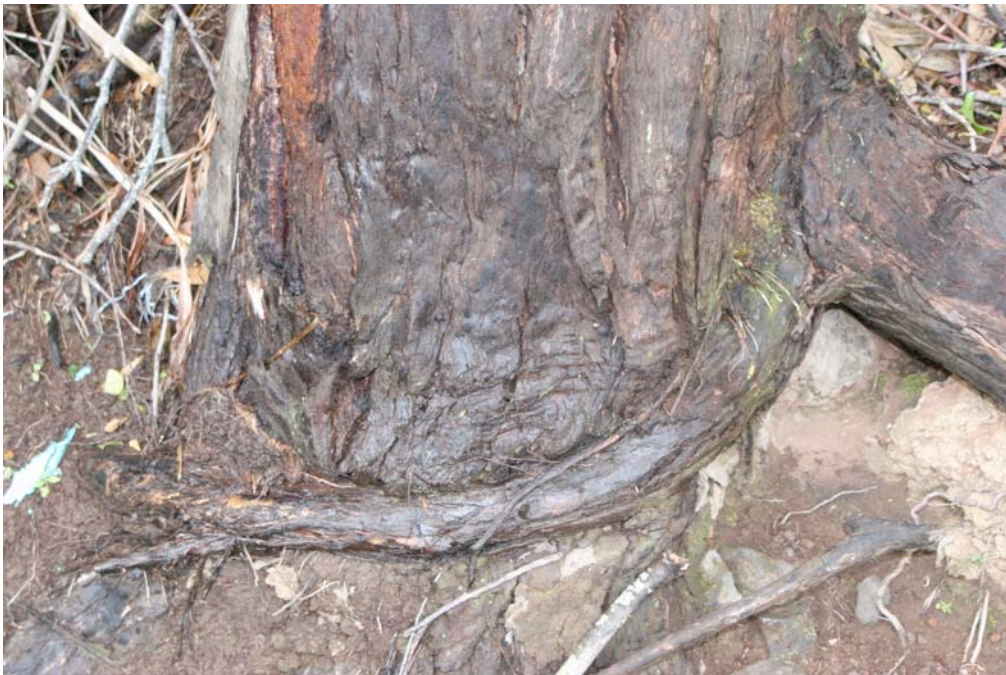
Tree 63

1. Species: Eucalyptus robusta
2. Size: DBH 18", Height 53', Crown spread 27'
3. Targets: Church parking lot
4. Form and Crown class: Asymmetrical; Suppressed
5. Tree health: Good
6. Adverse site conditions: Trunk base and root crown extend into stream area..., some erosion.
7. Defective root conditions: some erosion
8. Trunk defects: Girdling root at trunk base
9. Scaffold limb defects: dead wood
10. Previous tree and limb failures: none

Management Recommendations: Remove girdling root and crown clean.

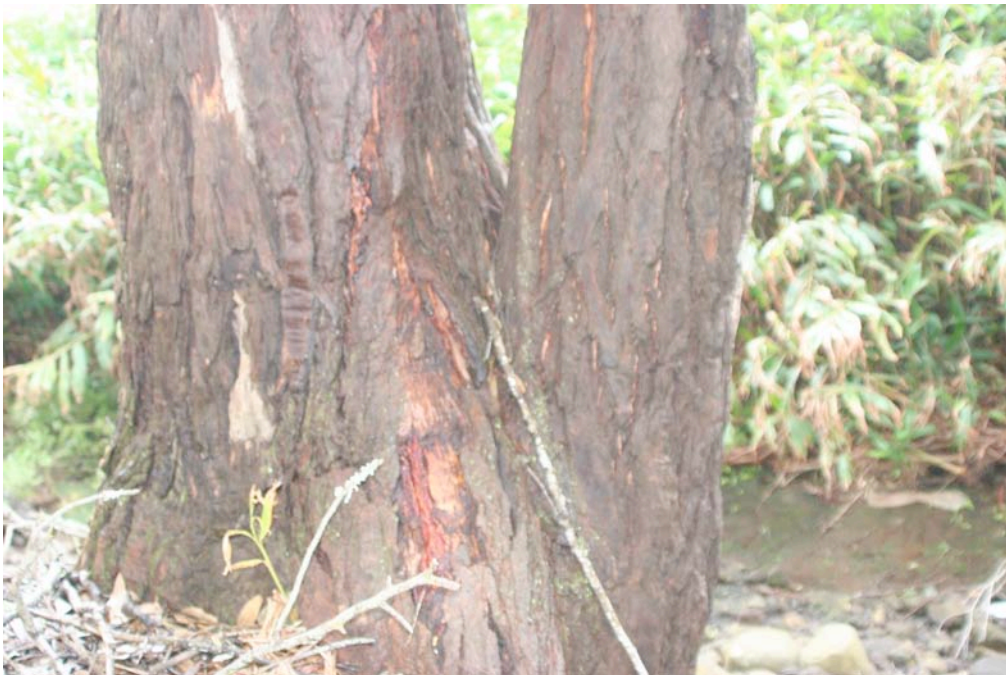
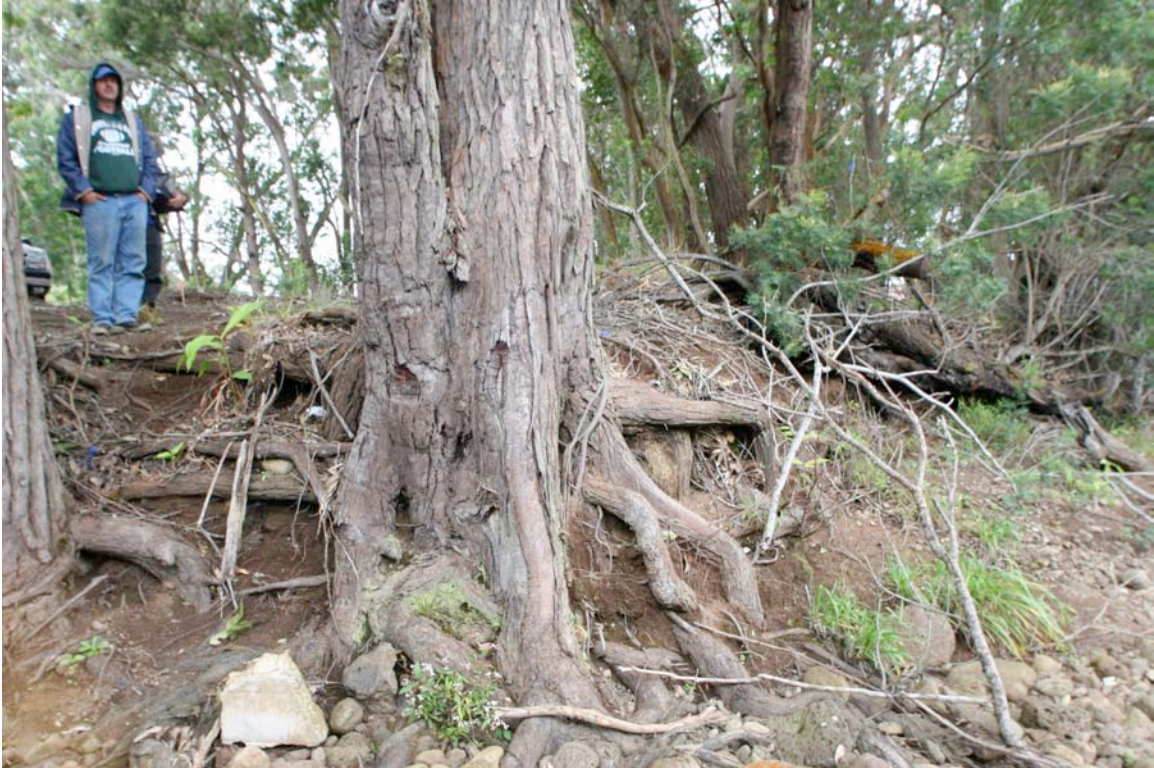
Tree 64 upper side

1. Species: Eucalyptus robusta
2. Size: DBH 27", Height 83 ', Crown spread 49'
3. Targets: Church parking lot.
4. Form and Crown class: Asymmetrical; Co-dominant
5. Tree health: Good
6. Adverse site conditions: Trunk base extends into stream area, some erosion.
7. Defective root conditions: some erosion
8. Trunk defects: Double trunk with included bark.
9. Scaffold limb defects: dead wood
10. Previous tree and limb failures: none

Management Recommendations: Remove smaller of the two trunks and crown clean

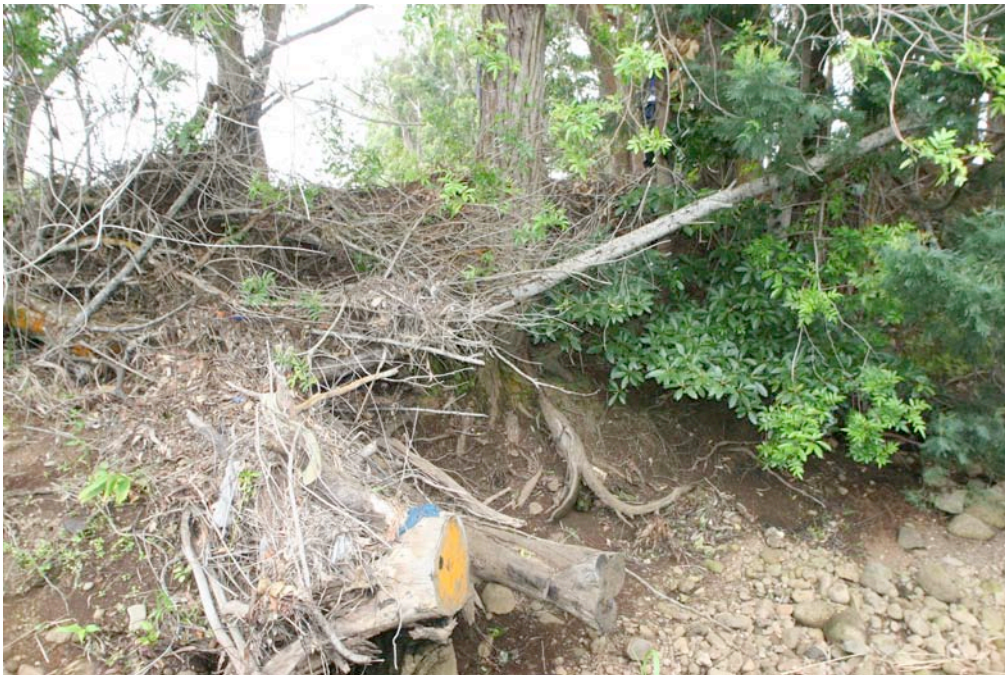
Tree 67 stream side

1. Species: Eucalyptus robusta
2. Size: DBH 19", Height 49', Crown spread 20'
3. Targets: Church parking lot
4. Form and Crown class: Asymmetrical; Co-dominant
5. Tree health: Good
6. Adverse site conditions: Erosion in root area.
7. Defective root conditions: some erosion
8. Trunk defects: none
9. Scaffold limb defects: dead wood
10. Previous tree and limb failures: none

Management Recommendations: Crown clean, prune top to reduce lean toward parking lot.

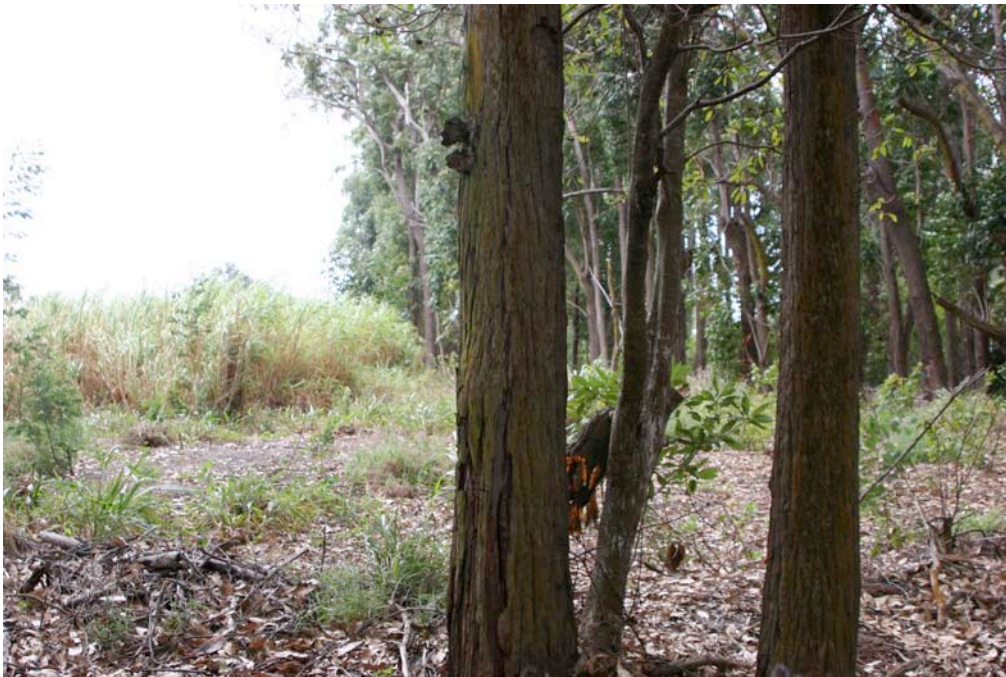
Tree 81

1. Species: Eucalyptus robusta
2. Size: DBH 14", Height 54', Crown spread 12'
3. Targets: Trail
4. Form and Crown class: Asymmetrical; Suppressed
5. Tree health: Good
6. Adverse site conditions: near the trail
7. Defective root conditions: none
8. Trunk defects: none
9. Scaffold limb defects: Broken branches
10. Previous tree and limb failures: branch stubs

Management Recommendations: this tree is near the edge of the trail – remove.

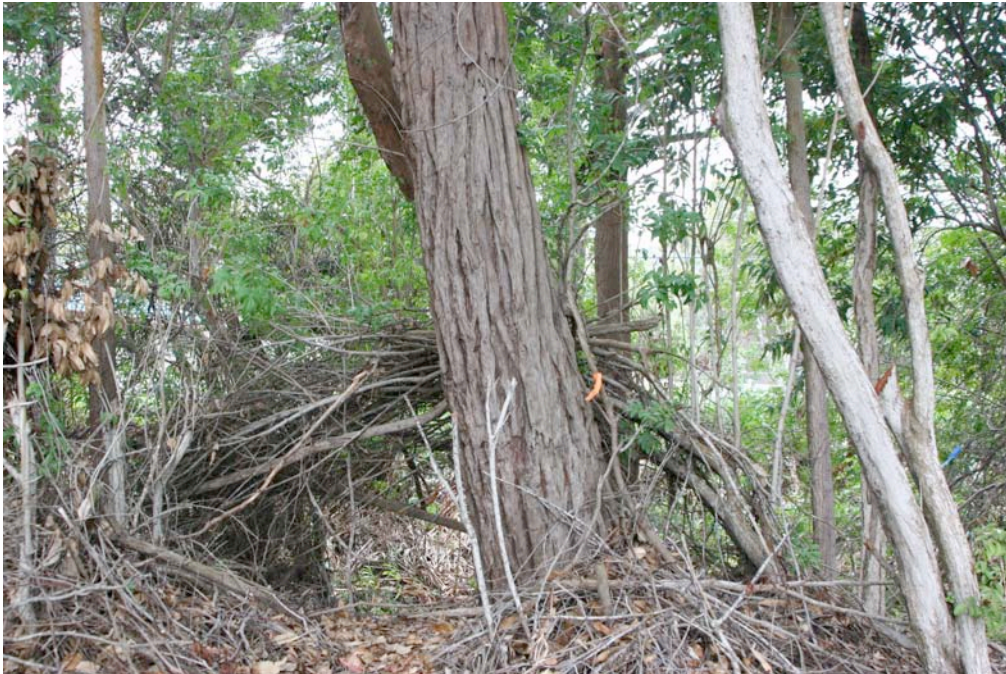
Tree 95

1. Species: Eucalyptus robusta
2. Size: DBH 23", Height 135', Crown spread 50'
3. Targets: Trail
4. Form and Crown class: Asymmetrical; Co-dominant
5. Tree health: Good
6. Adverse site conditions: near edge of trail.
7. Defective root conditions: none
8. Trunk defects: none
9. Scaffold limb defects: dead wood
10. Previous tree and limb failures: none

Management Recommendations: This is a very tall tree at the edge of the trail – remove.

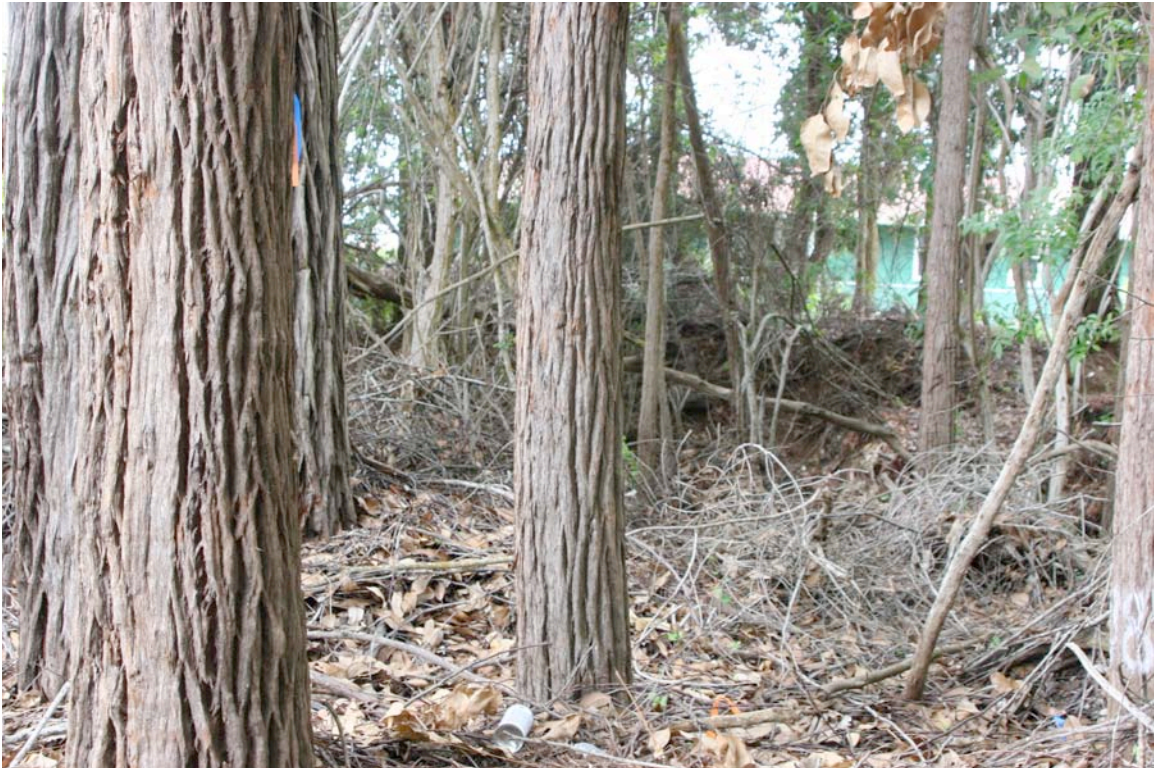
Tree 100

1. Species: Eucalyptus robusta
2. Size: DBH 16", Height 86', Crown spread 12'
3. Targets: Trail
4. Form and Crown class: Asymmetrical; Co-dominant
5. Tree health: Good
6. Adverse site conditions: in trail
7. Defective root conditions: none
8. Trunk defects: none
9. Scaffold limb defects: none
10. Previous tree and limb failures:

Management Recommendations: This tree is in the trail – remove.

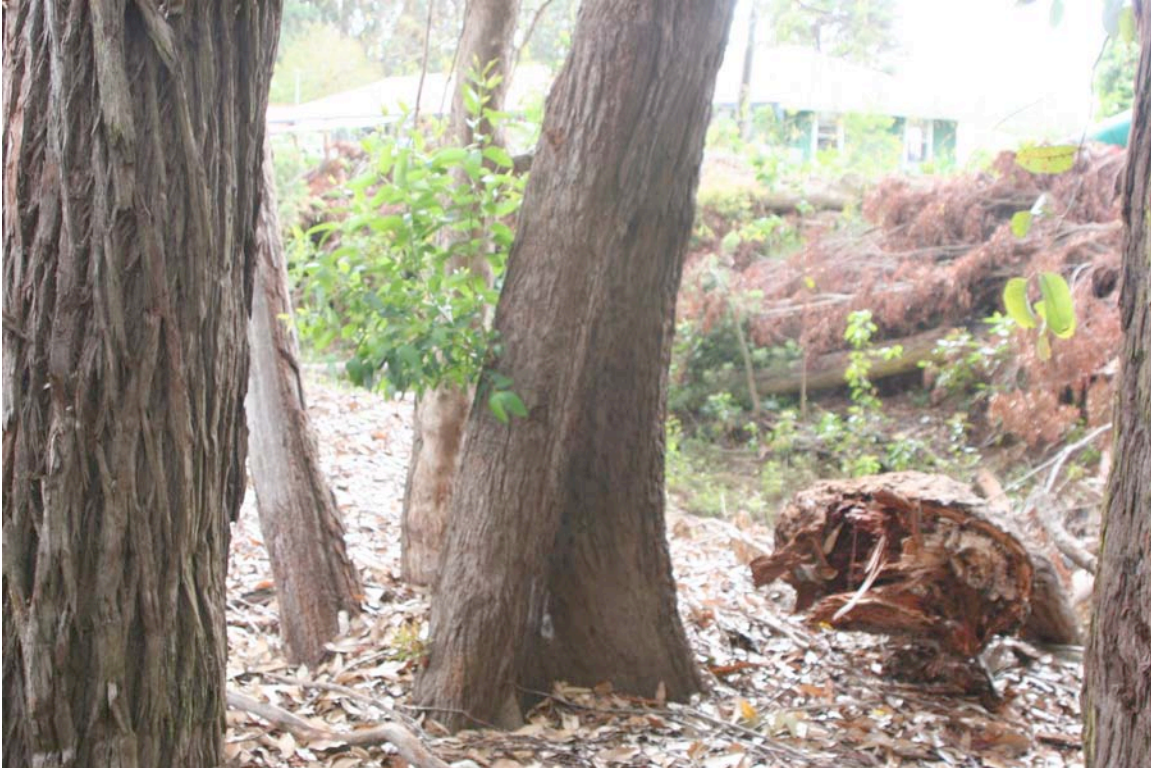
Tree 116 with broken top on the ground.

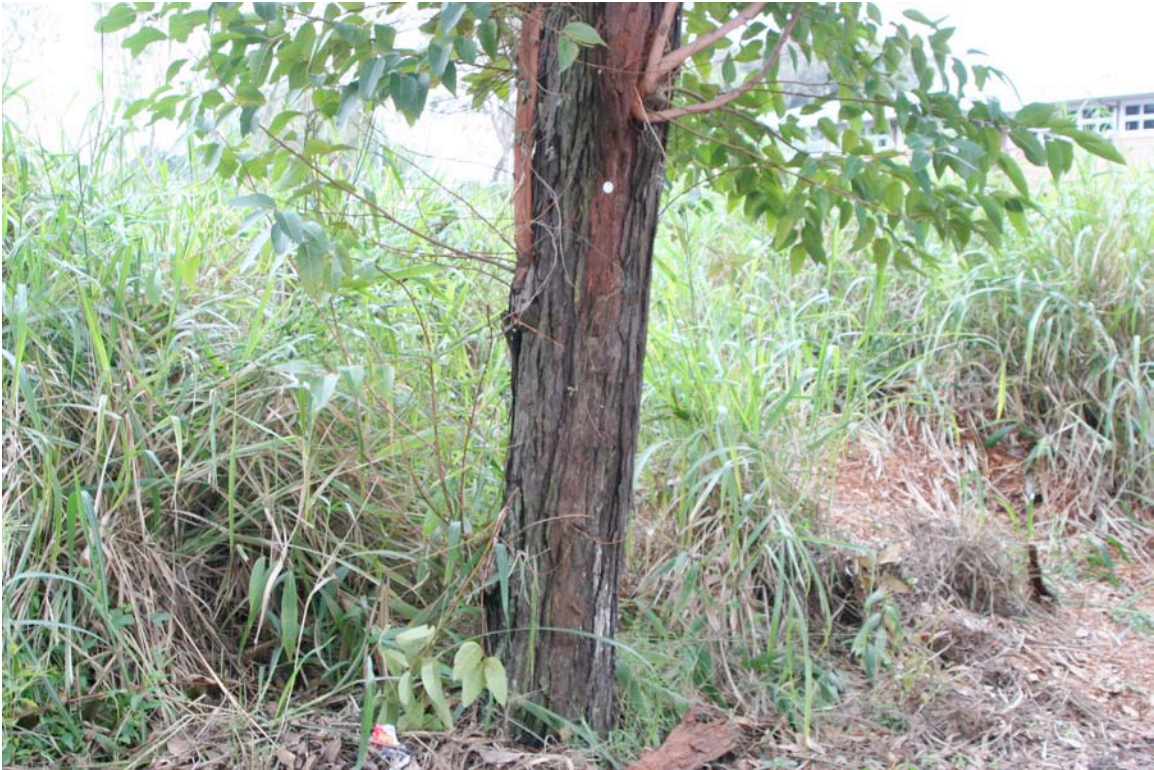
Tree 199

1. Species: Eucalyptus robusta
2. Size: DBH 13", Height 70', Crown spread 12'
3. Targets: Trail
4. Form and Crown class: Symmetrical; Suppressed
5. Tree health: Good
6. Adverse site conditions: in the trail
7. Defective root conditions: none
8. Trunk defects: none
9. Scaffold limb defects: Dead wood, broken branches.
10. Previous tree and limb failures: none

Management Recommendations: Tree is growing in the trail – remove.

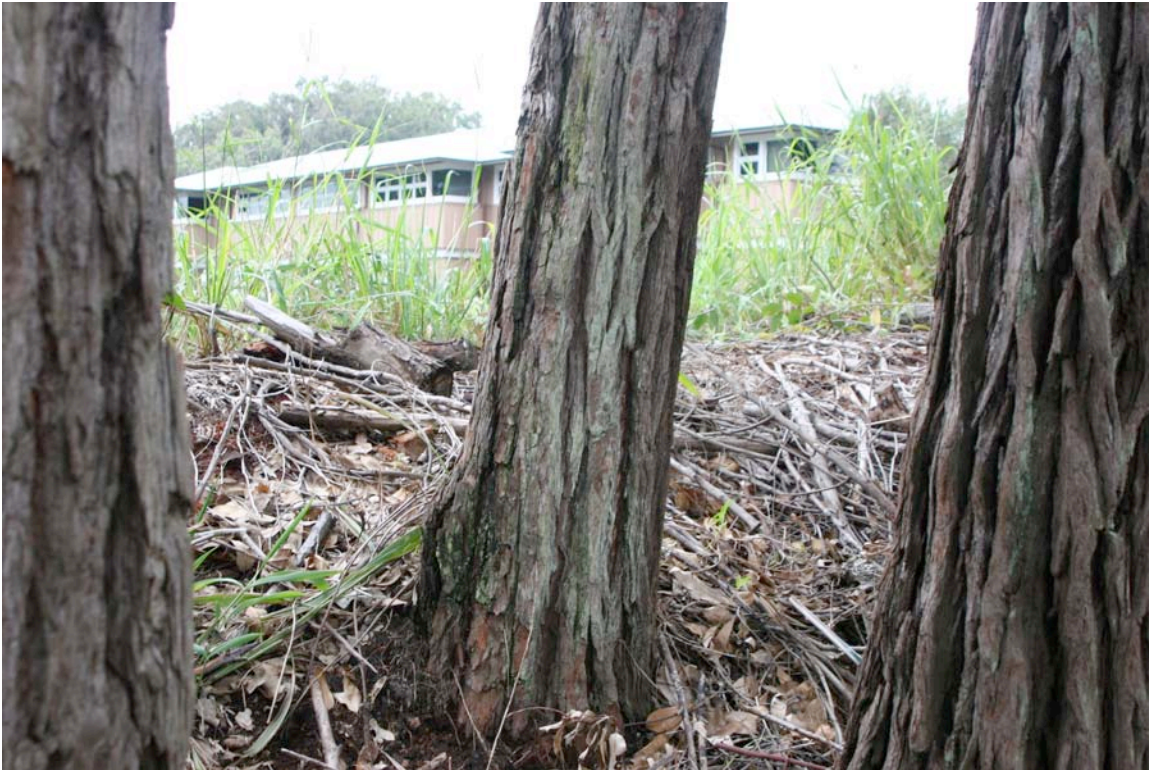
Tree 203

1. Species: Eucalyptus robusta
2. Size: DBH 17", Height 70', Crown spread 16'
3. Targets: Trail
4. Form and Crown class: Asymmetrical; Suppressed
5. Tree health: Good
6. Adverse site conditions: located at the edge of the trail.
7. Defective root conditions: none
8. Trunk defects: none, with a heavy lean towards the trail.
9. Scaffold limb defects: Some dead wood.
10. Previous tree and limb failures: none

Management Recommendations: At the edge of the trail – remove.

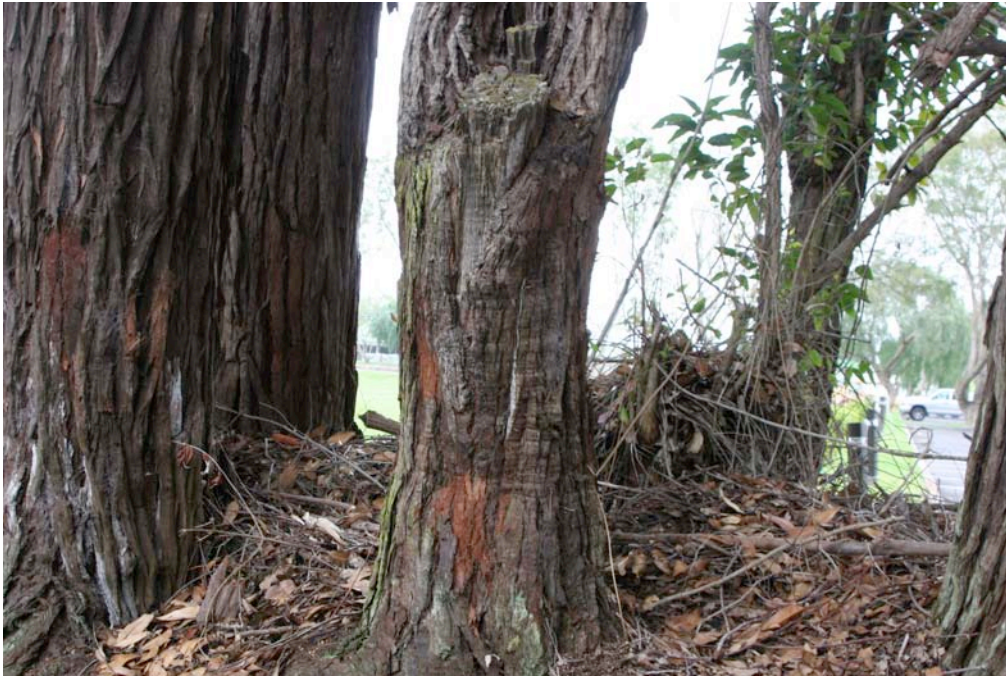
Tree 212

1. Species: *Eucalyptus robusta*
2. Size: DBH 27", Height 45', Crown spread 32'
3. Targets: Trail and parking lot
4. Form and Crown class: Asymmetrical; Suppressed
5. Tree health: Good
6. Adverse site conditions: in the trail.
7. Defective root conditions: none
8. Trunk defects: Trunk has a cavity approximately 5' up from the base.
9. Scaffold limb defects: Large broken limb hanging in the tree.
10. Previous tree and limb failures: large limb near base broke or was removed.

Management Recommendations: Tree is in the trail – remove.

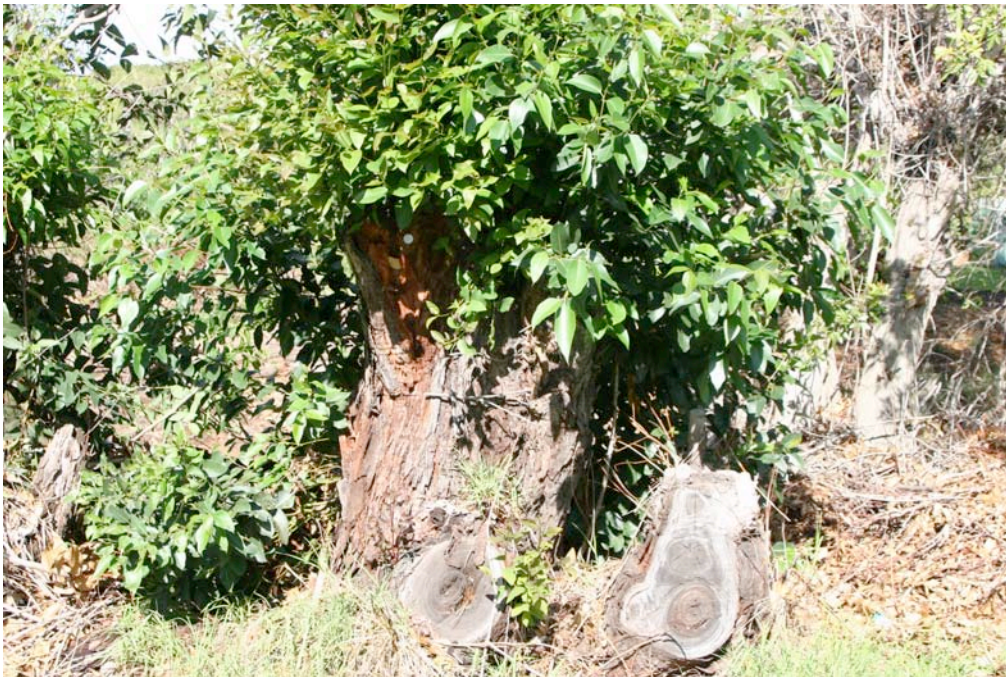
Tree 273

1. Species: Eucalyptus robusta
2. Size: DBH 36", Height 9', Crown spread 8'
3. Targets: Trail
4. Form and Crown class: Asymmetrical; Suppressed
5. Tree health: Poor
6. Adverse site conditions: in the trail
7. Defective root conditions: none
8. Trunk defects: Cut stump
9. Scaffold limb defects: New re-growth on the stump.
10. Previous tree and limb failures: stump

Management Recommendations: Tree is in the trail – remove.

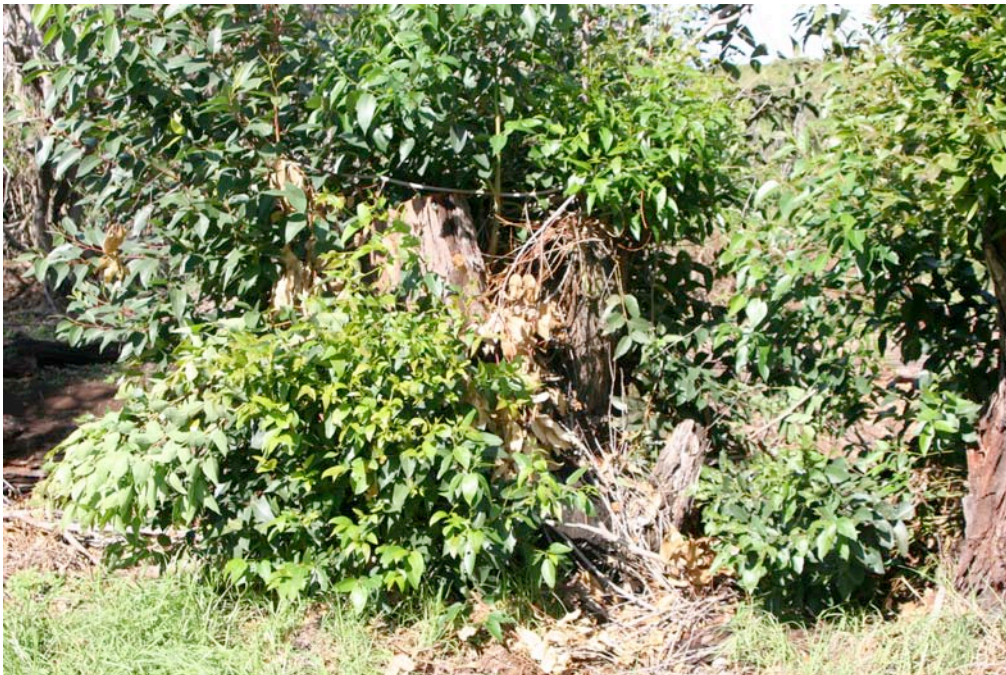
Tree 274

1. Species: Eucalyptus robusta
2. Size: DBH 49", Height 9', Crown spread 12'
3. Targets: Trail
4. Form and Crown class: Asymmetrical; Suppressed
5. Tree health: Poor
6. Adverse site conditions: in the trail.
7. Defective root conditions: none
8. Trunk defects: Cut stump
9. Scaffold limb defects: new re-growth on a stump.
10. Previous tree and limb failures: Stump with sprouts

Management Recommendations: Tree is in the trail – remove.

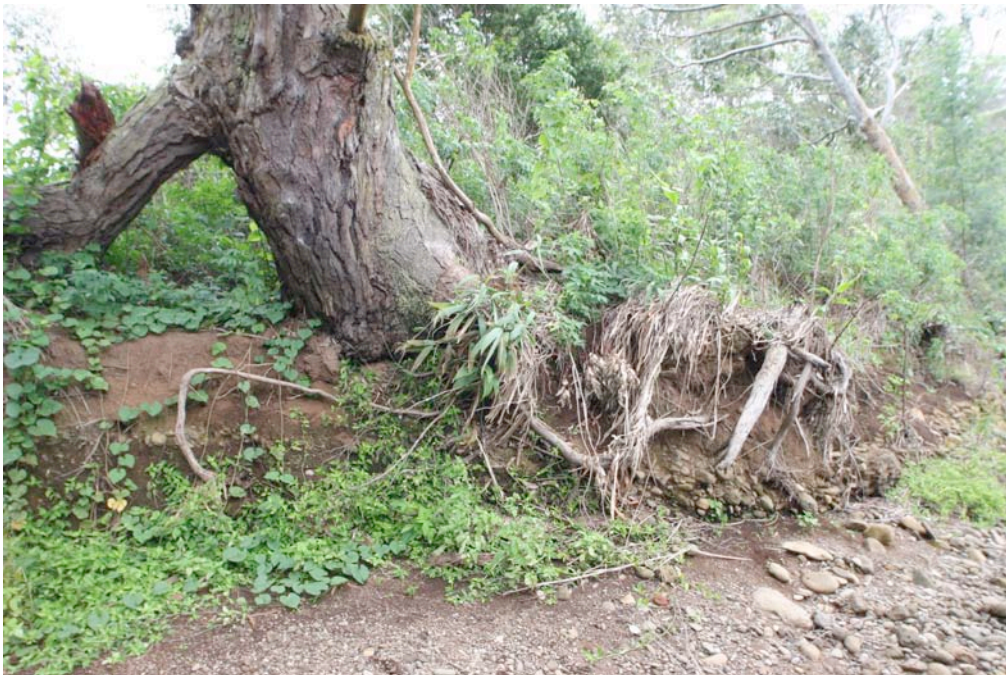
Tree 301

1. Species: Eucalyptus
2. Size: DBH 59", Height 60', Crown spread 96'
3. Targets: Trail
4. Form and Crown class: Symmetrical; Dominant
5. Tree health: Good
6. Adverse site conditions: on edge of stream across from the trail.
7. Defective root conditions: erosion of roots on stream side.
8. Trunk defects: none
9. Scaffold limb defects: Dead wood
10. Previous tree and limb failures: none

Management Recommendations: Erosion of roots on stream side – remove.

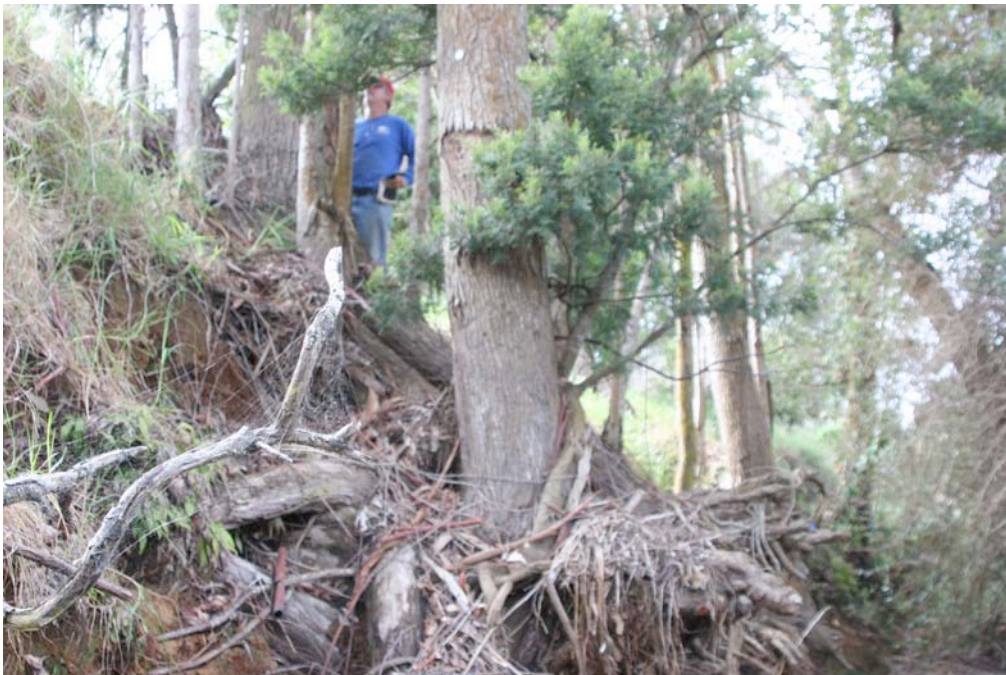
Tree 302

1. Species: Eucalyptus
2. Size: DBH 16", Height 82', Crown spread 34'
3. Targets: Trail
4. Form and Crown class: Symmetrical; Co-dominant
5. Tree health: Good
6. Adverse site conditions: growing on a severely eroded bank.
7. Defective root conditions: severe erosion of support roots.
8. Trunk defects: none
9. Scaffold limb defects: Dead wood
10. Previous tree and limb failures: none

Management Recommendations: Severe root erosion – remove.

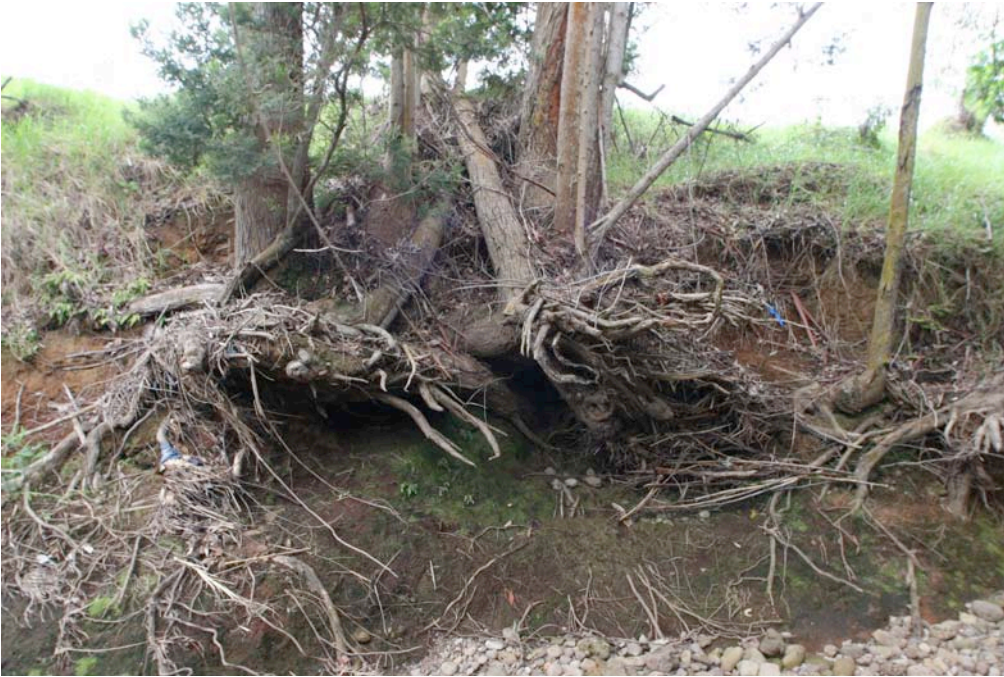
Tree 302 303 304

1. Species: Eucalyptus
2. Size: DBH 18", Height 56', Crown spread 35'
3. Targets: Trail
4. Form and Crown class: Asymmetrical; Suppressed
5. Tree health: Good
6. Adverse site conditions: on a severely eroded bank.
7. Defective root conditions: severe root erosion
8. Trunk defects: fallen trunk
9. Scaffold limb defects: Large re-growth from fallen trunk over the trail.
10. Previous tree and limb failures: tree fell due to root erosion

Management Recommendations: Remove

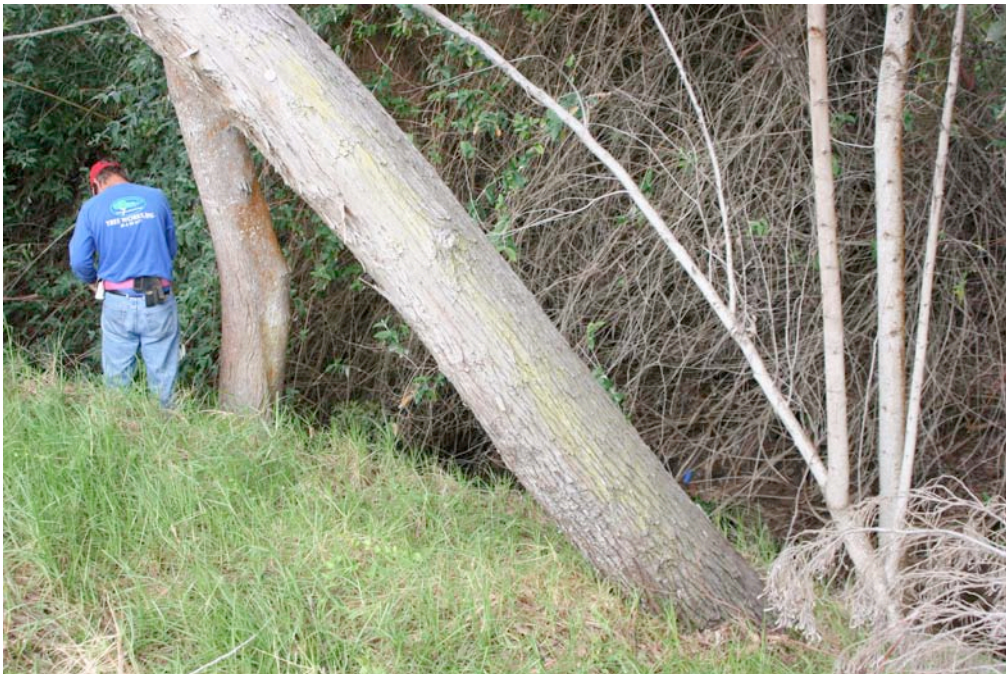
Tree 307

1. Species: Eucalyptus
2. Size: DBH 17", Height 42', Crown spread 45'
3. Targets: Trail
4. Form and Crown class: Asymmetrical with a heavy lean; Co-dominant
5. Tree health: Good
6. Adverse site conditions: Severely eroded root area
7. Defective root conditions: Severely eroded root area
8. Trunk defects: none
9. Scaffold limb defects: dead wood
10. Previous tree and limb failures: none

Management Recommendations: Heavy lean over the trail with severe root erosion – remove.
