LANDOWNERS AND TMK's
Ke Ala Kahawai O Waimea,
Waimea Trails and Greenways
Draft Environmental Assessment

Natural resources assessment update report for the Waimea Trails and Greenways Project, Kamuela Island of Hawai'i¹

AECOS No. 920B

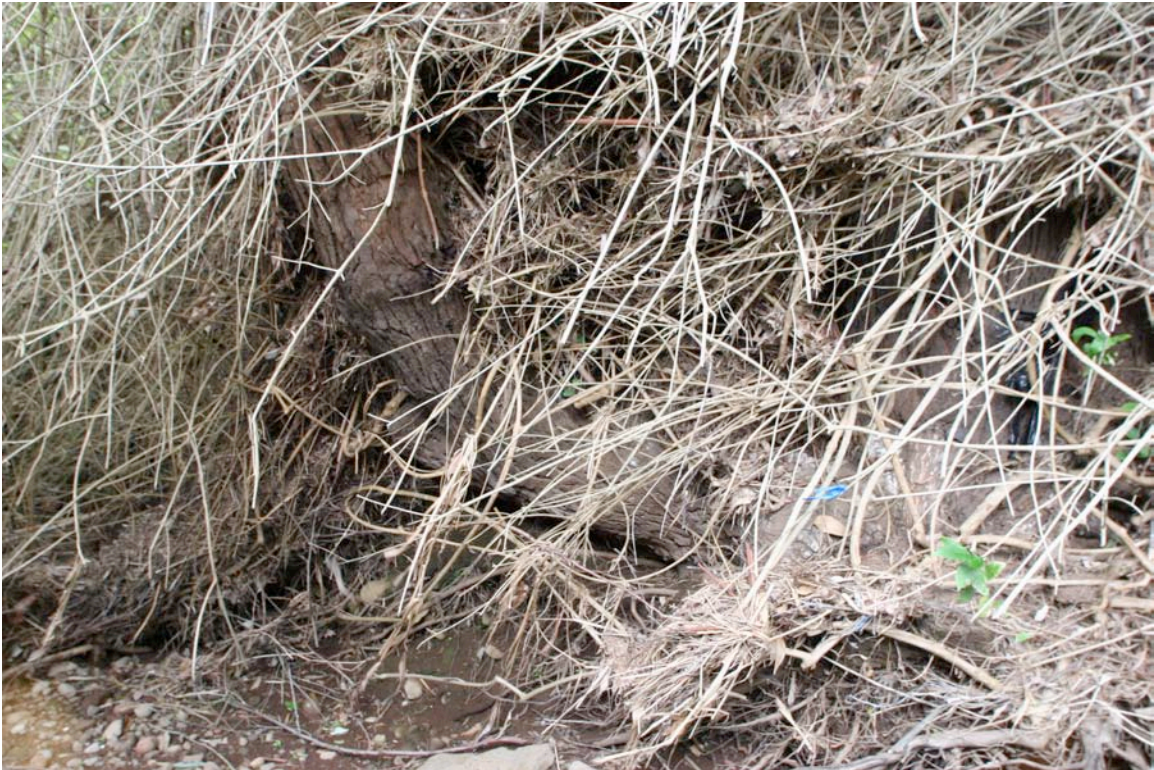
Tree 308

1. Species: Eucalyptus
2. Size: DBH 22", Height 42', Crown spread 21'
3. Targets: Trail and across river approximately four trees.
4. Form and Crown class: Asymmetrical with a heavy lean; Co-dominant
5. Tree health: Good
6. Adverse site conditions: Growing on a severely eroded stream bank.
7. Defective root conditions: severe erosion of the root system.
8. Trunk defects: heavy vine growth along the trunk
9. Scaffold limb defects: Dead wood
10. Previous tree and limb failures: stubs

Management Recommendations: Tree is across the stream leaning towards the trail with severe erosion – remove.

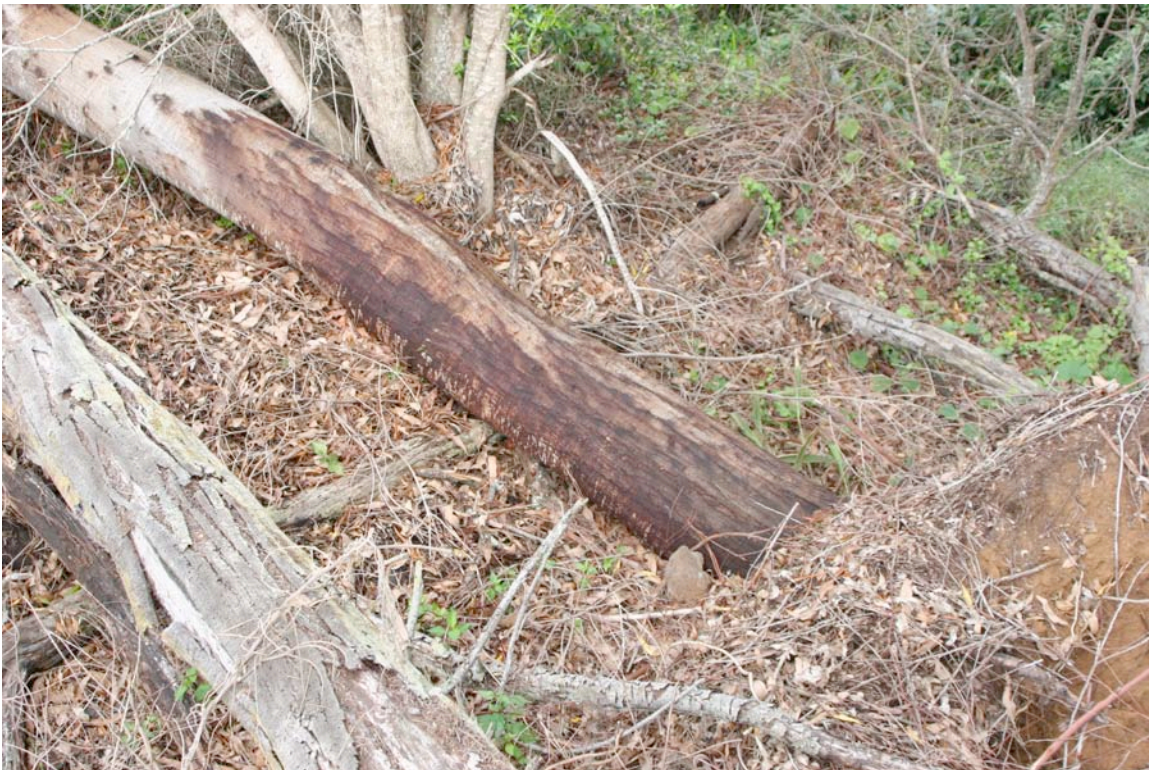
Tree 315

1. Species: Black waddle
2. Size: DBH 15“, Height 12’, Crown spread 44’
3. Targets: Trail
4. Form and Crown class: Asymmetrical; Suppressed
5. Tree health: Poor
6. Adverse site conditions: uprooted and fallen tree
7. Defective root conditions: tree is uprooted
8. Trunk defects: tree has fallen
9. Scaffold limb defects: new growth on fallen trunk
10. Previous tree and limb failures: fallen tree

Management Recommendations: Remove

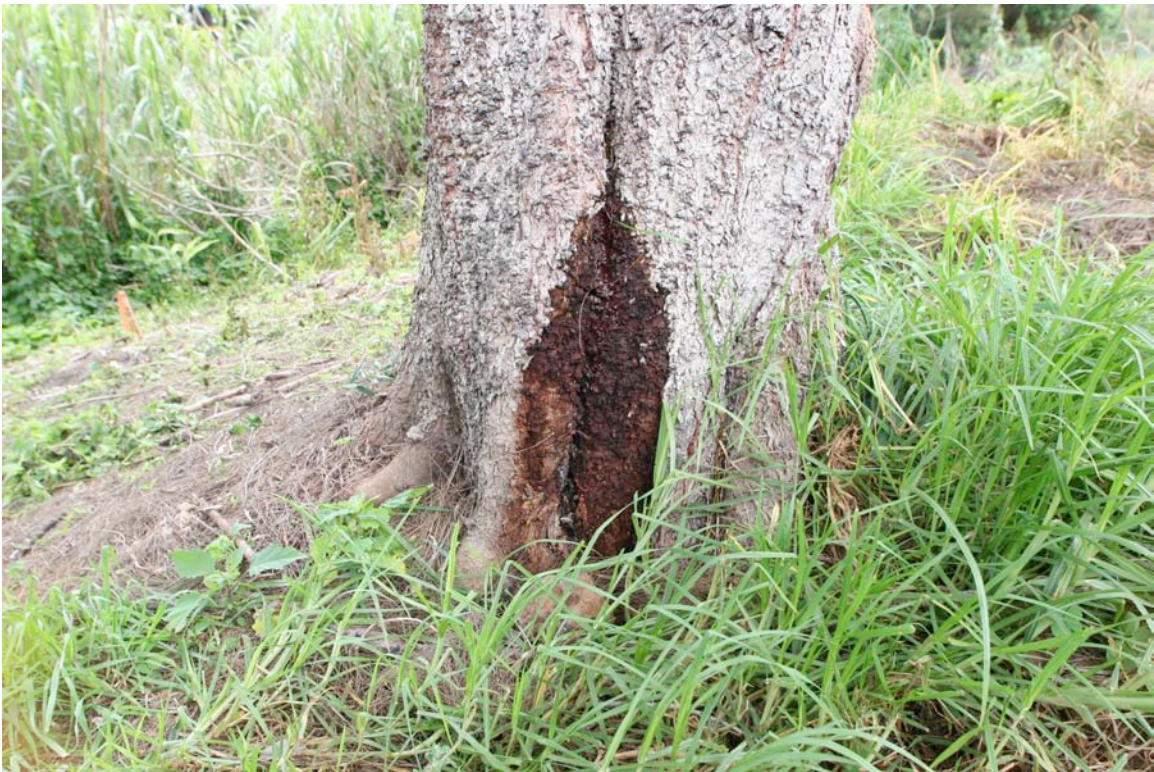
Tree 318

1. Species: Ironwood
2. Size: DBH 21“, Height 62’, Crown spread 32’
3. Targets: Trail
4. Form and Crown class: Asymmetrical; Co-dominant
5. Tree health: Good
6. Adverse site conditions: at edge of trail
7. Defective root conditions: none
8. Trunk defects: crack at base of trunk
9. Scaffold limb defects: none
10. Previous tree and limb failures: none

Management Recommendations: Near edge of trail – remove.

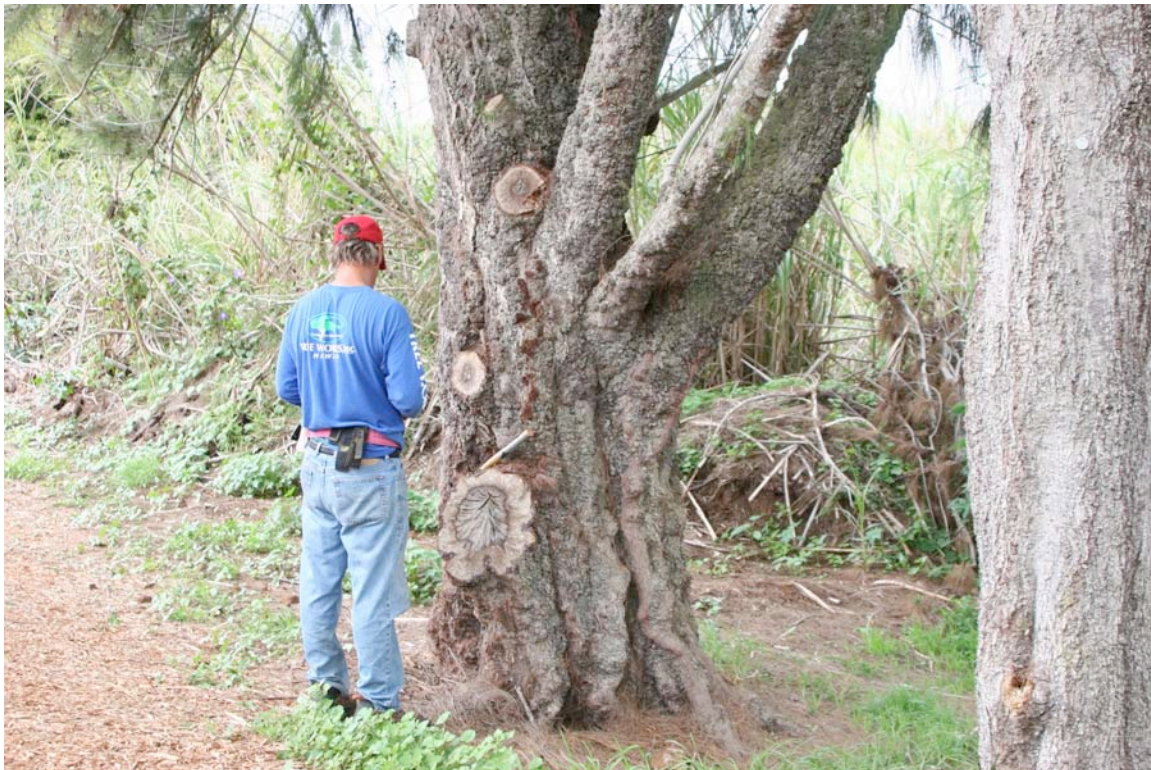
Tree 319

1. Species: Ironwood
2. Size: DBH 41“, Height 45’, Crown spread 47’
3. Targets: Trail
4. Form and Crown class: Asymmetrical; Dominant
5. Tree health: Good
6. Adverse site conditions: near edge of trail
7. Defective root conditions: none
8. Trunk defects: none
9. Scaffold limb defects: included bark on limb over trail and dead wood
10. Previous tree and limb failures: none

Management Recommendations: Near edge of trail – remove.

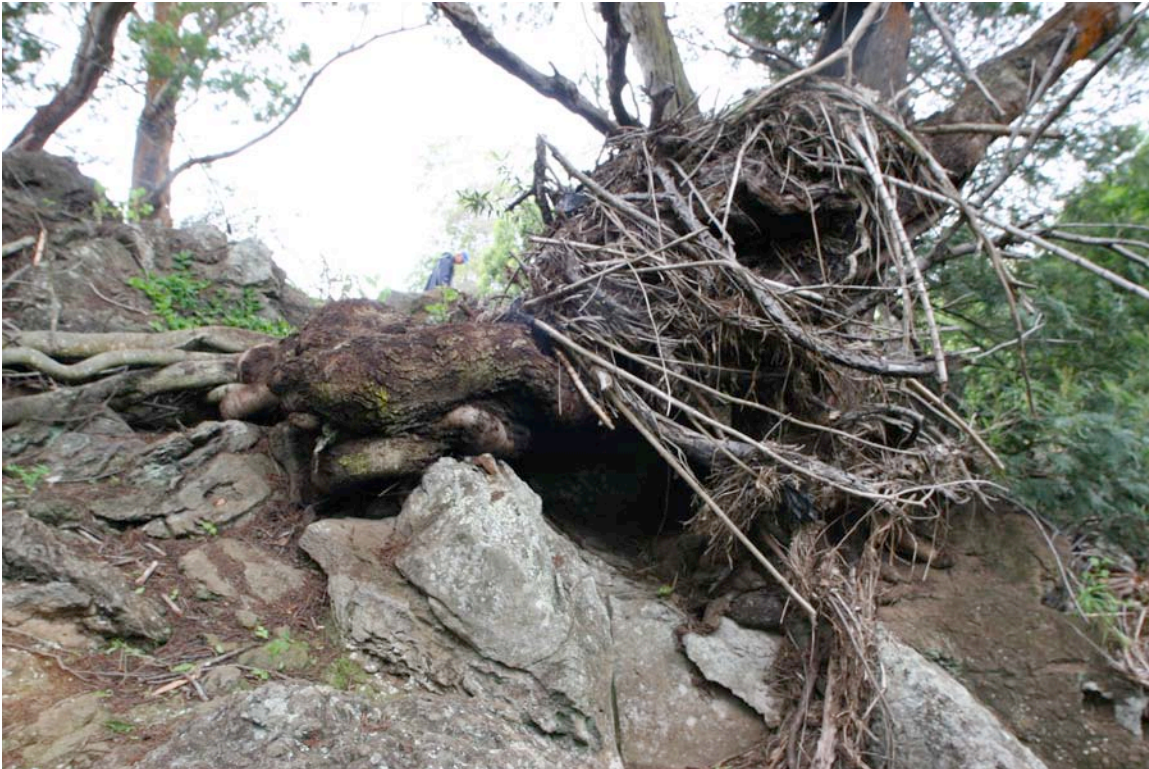
Tree 342

8. Trunk defects: none
9. Scaffold limb defects: large dead wood
10. Previous tree and limb failures: none

Management Recommendations: Remove

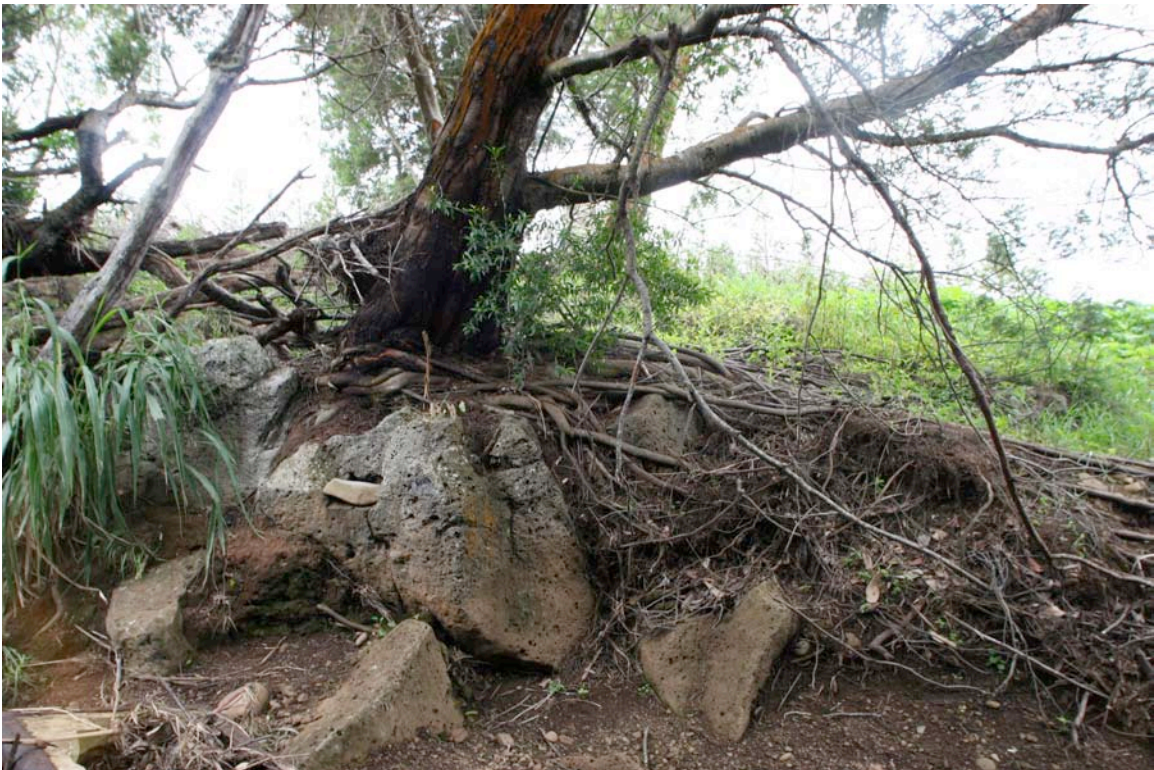
Tree 343

7. Defective root conditions: severe erosion of root area
8. Trunk defects: none
9. Scaffold limb defects: dead wood
10. Previous tree and limb failures: none

Management Recommendations: Remove

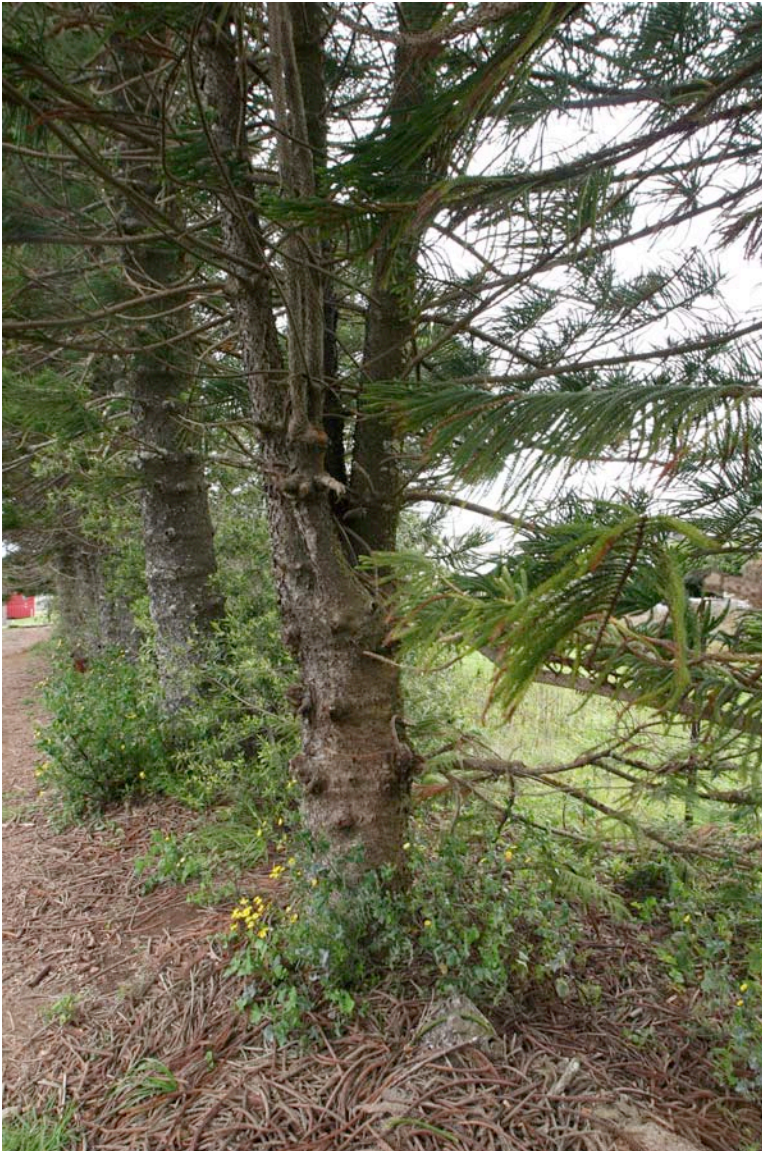
Tree 362

8. Trunk defects: tree topped 5' from ground
9. Scaffold limb defects: multiple tops from cut trunk
10. Previous tree and limb failures: cut tree

Management Recommendations: Remove

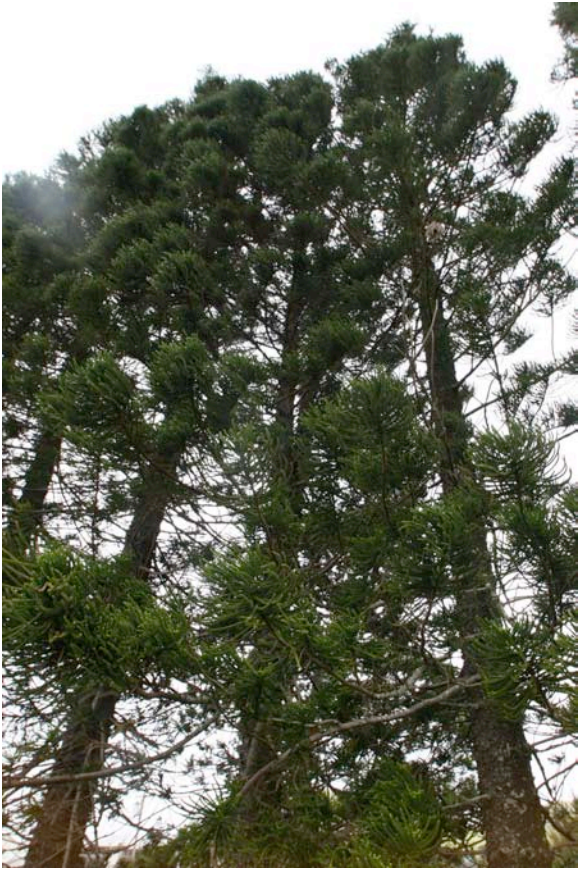
Tree 365

1. Species: Norfolk Island pine
2. Size: DBH 16“, Height 59’, Crown spread 15’
3. Targets: Trail
4. Form and Crown class: Symmetrical; Co-dominant
5. Tree health: Good
6. Adverse site conditions: near the trail
7. Defective root conditions: none
8. Trunk defects: double top
9. Scaffold limb defects: double top
10. Previous tree and limb failures: broken top

Management Recommendations: raise crown to 15’ above trail and remove one top

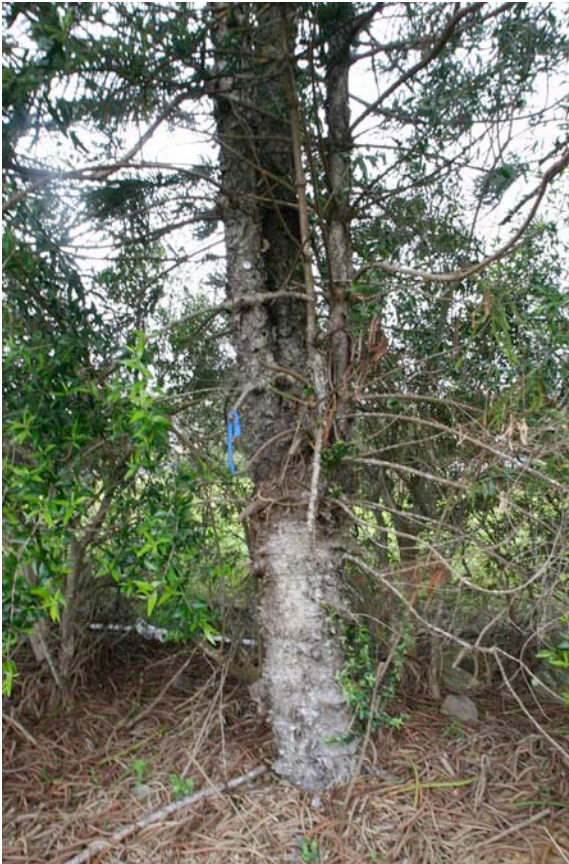
Tree 372

1. Species: Norfolk Island pine
2. Size: DBH 14", Height 34', Crown spread 7'
3. Targets: Trail
4. Form and Crown class: Symmetrical; Suppressed
5. Tree health: Fair
6. Adverse site conditions: near the trail
7. Defective root conditions: none
8. Trunk defects: topped at 5'
9. Scaffold limb defects: multiple tops from trunk cut at 5'
10. Previous tree and limb failures: cut tree

Management Recommendations: remove

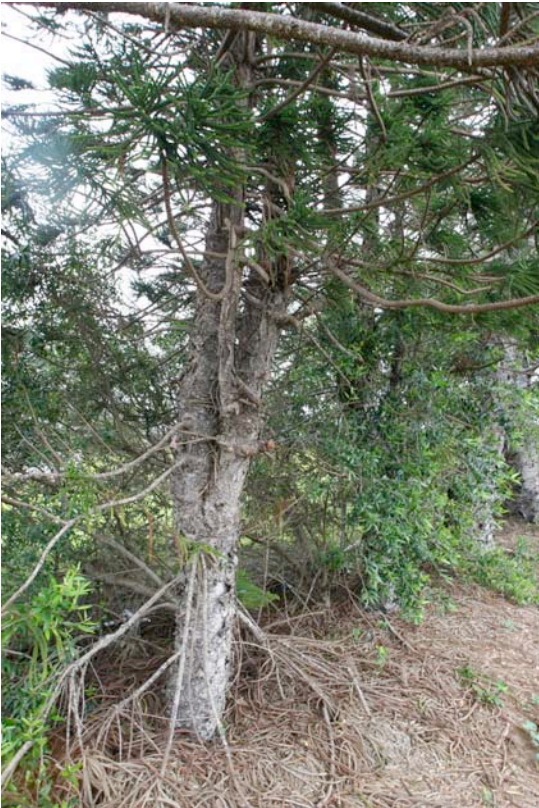
Tree 373

1. Species: Norfolk Island pine
2. Size: DBH 16“, Height 34’, Crown spread 8’
3. Targets: Trail
4. Form and Crown class: Symmetrical; Suppressed
5. Tree health: Poor
6. Adverse site conditions: near the trail
7. Defective root conditions: none
8. Trunk defects: topped at 5’, heavy sap flow from wound at base
9. Scaffold limb defects: multiple tops from cut trunk
10. Previous tree and limb failures: cut tree

Management Recommendations: remove

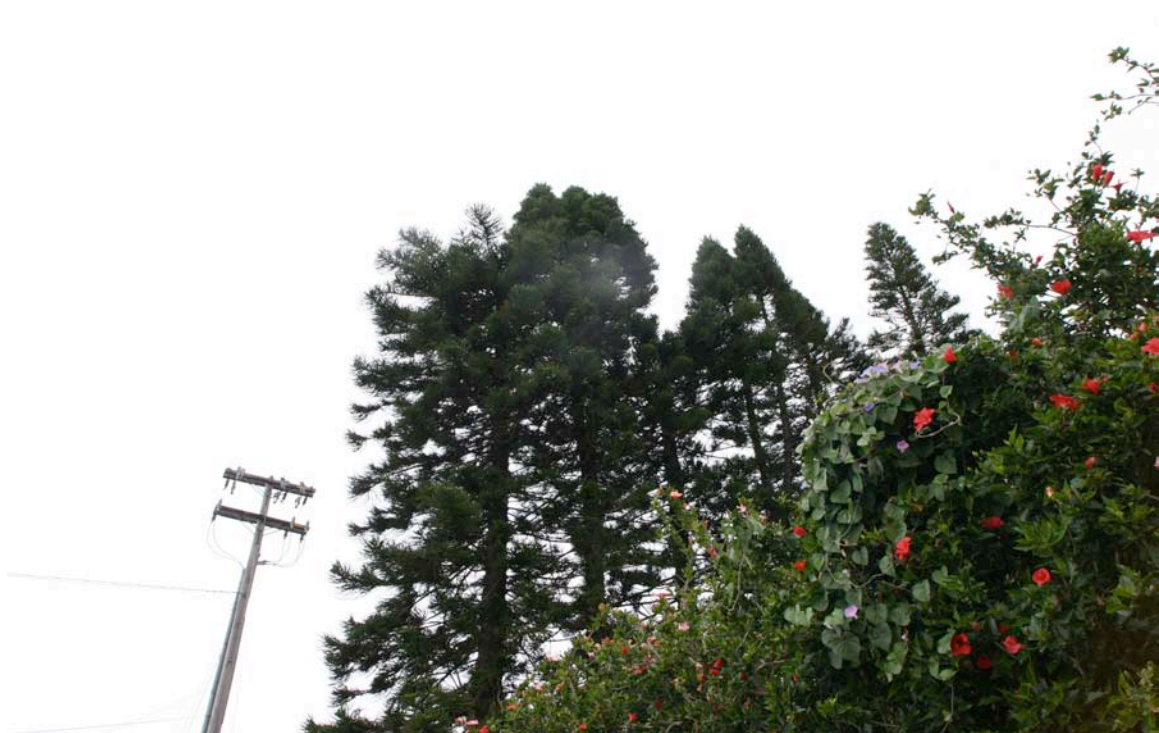
Tree 380 379 378

1. Species: Norfolk Island pine
2. Size: DBH 24 Height 53 Crown spread 17
3. Targets: Trail
4. Form and Crown class: Symmetrical; Co-dominant
5. Tree health: Good
6. Adverse site conditions: near the trail
7. Defective root conditions: none
8. Trunk defects: broken top
9. Scaffold limb defects: broken top
10. Previous tree and limb failures: broken top

Management Recommendations: raise crown to 15' above trail

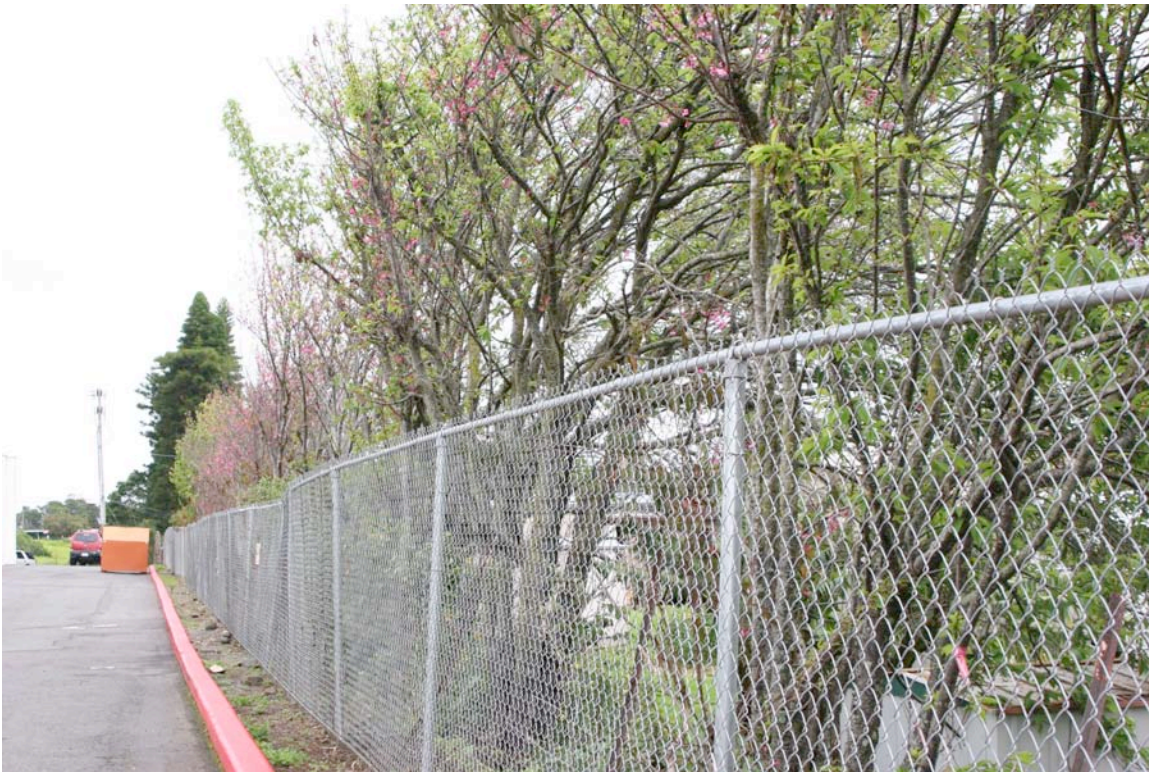
Tree 281

1. Species: Row of fourteen Cherry Blossom trees
2. Size: DBH “ N/A, Height 12’, Crown spread 8’
3. Targets: Trail and fence
4. Form and Crown class: Symmetrical; Co-dominant
5. Tree health: Good
6. Adverse site conditions: near the trail
7. Defective root conditions: none
8. Trunk defects: none
9. Scaffold limb defects: some dead wood
10. Previous tree and limb failures: none

Management Recommendations: Crown clean

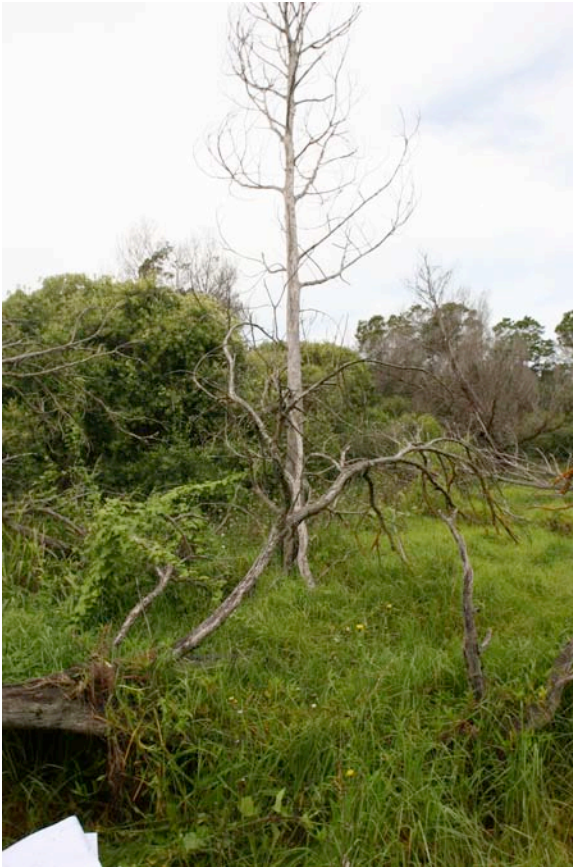
Tree 458

1. Species: Black waddle
2. Size: DBH 8“, Height 15’, Crown spread 5’
3. Targets:
4. Form and Crown class: dead
5. Tree health: dead
6. Adverse site conditions: dead
7. Defective root conditions: dead
8. Trunk defects: dead
9. Scaffold limb defects: dead
10. Previous tree and limb failures: dead

Management Recommendations: Remove

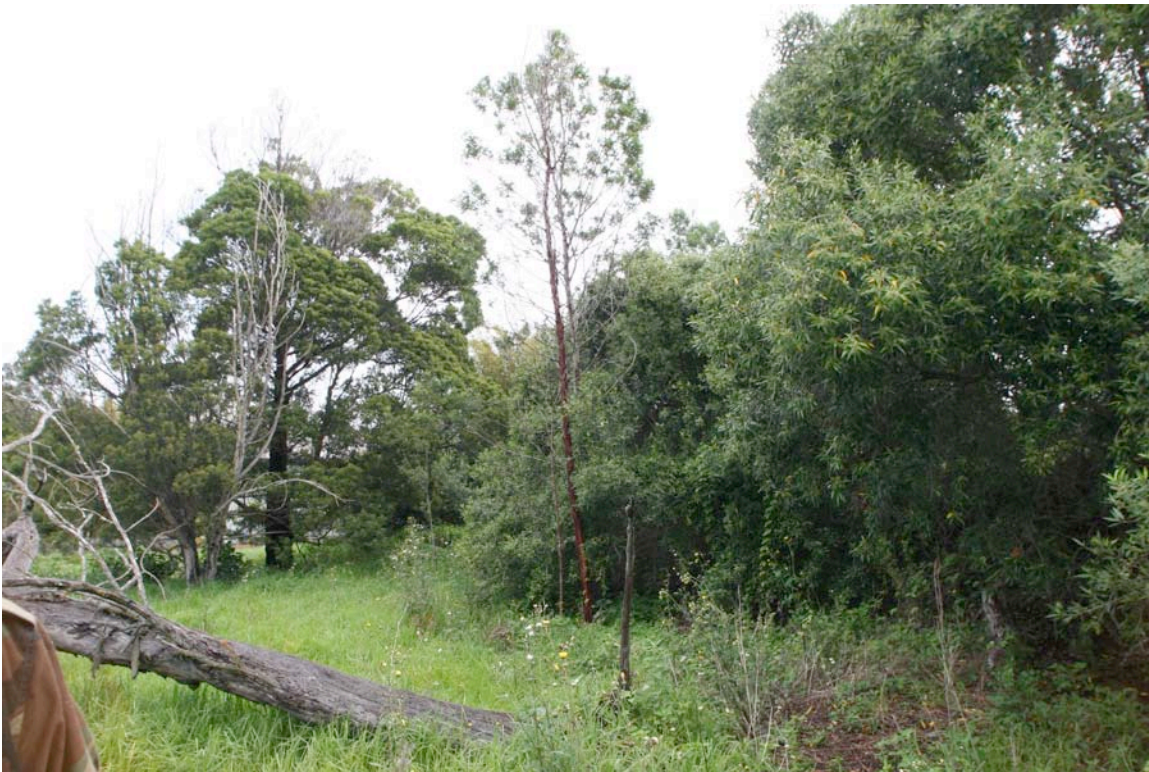
Tree 459

1. Species: Black waddle
2. Size: DBH 4“, Height 15’, Crown spread 7’
3. Targets:
4. Form and Crown class: dead
5. Tree health: dead
6. Adverse site conditions: dead
7. Defective root conditions: dead
8. Trunk defects: dead
9. Scaffold limb defects: dead
10. Previous tree and limb failures: dead

Management Recommendations: Remove

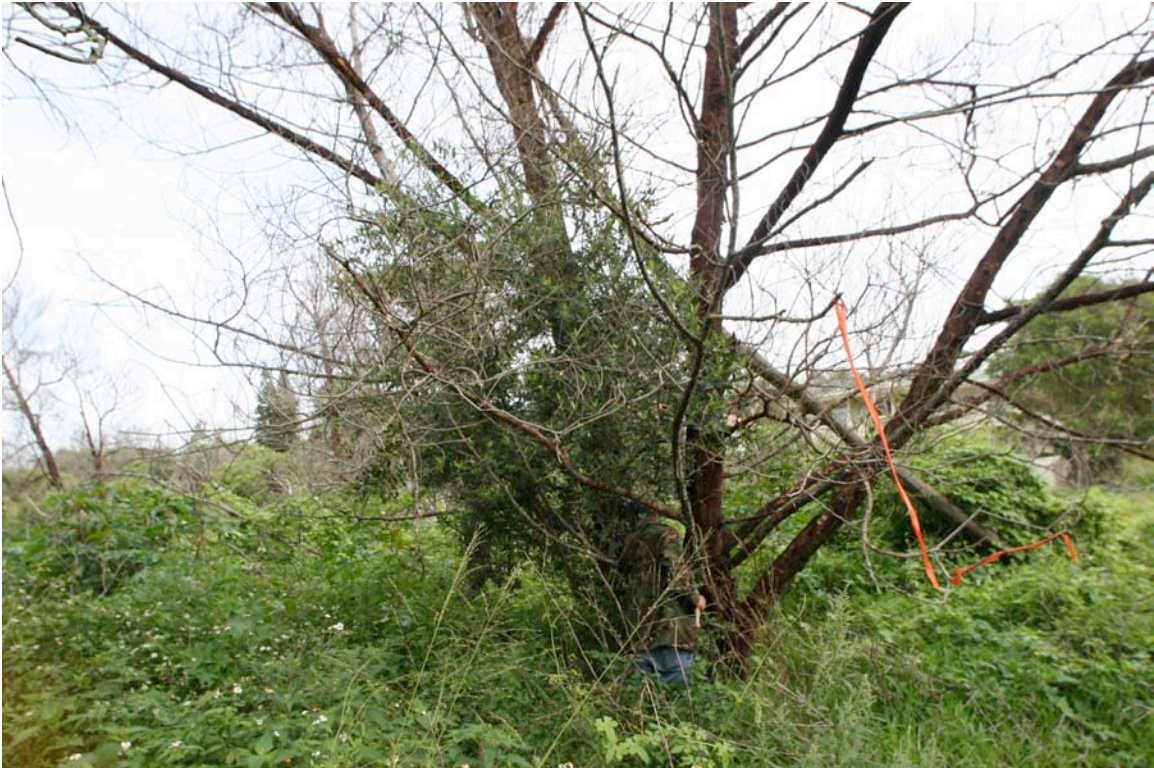
Tree 462, 461, 463

1. Species: Black waddle
2. Size: DBH 17", Height 30', Crown spread 20'
3. Targets:
4. Form and Crown class: dead
5. Tree health: dead
6. Adverse site conditions: dead
7. Defective root conditions: dead
8. Trunk defects: dead
9. Scaffold limb defects: dead
10. Previous tree and limb failures: dead

Management Recommendations: Remove

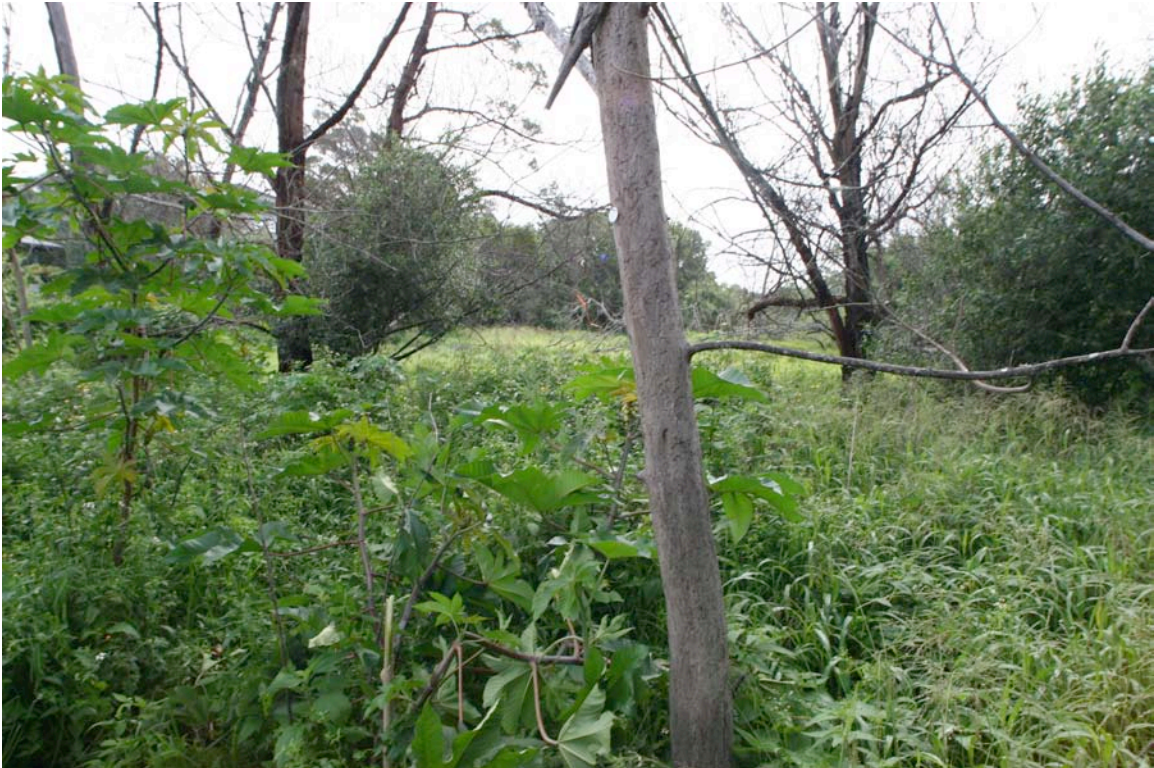
Tree 465

1. Species: Black waddle
2. Size: DBH 21“, Height 35’, Crown spread 20’
3. Targets:
4. Form and Crown class: dead
5. Tree health: dead
6. Adverse site conditions: dead
7. Defective root conditions: dead
8. Trunk defects: dead
9. Scaffold limb defects: dead
10. Previous tree and limb failures: dead

Management Recommendations: Remove

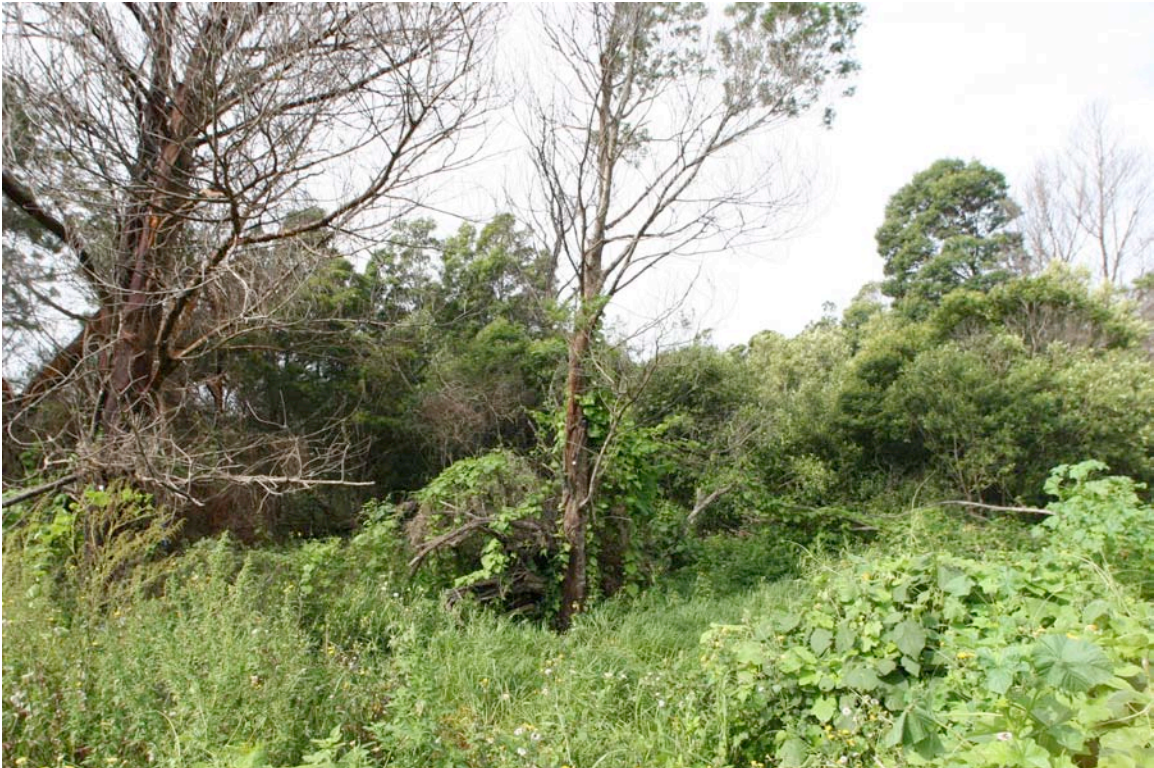
Tree 471

1. Species: Black waddle
2. Size: DBH 13“, Height 30’, Crown spread 12’
3. Targets: Trail
4. Form and Crown class: dead
5. Tree health: dead
6. Adverse site conditions: dead
7. Defective root conditions: dead
8. Trunk defects: dead
9. Scaffold limb defects: dead
10. Previous tree and limb failures: dead

Management Recommendations: Remove

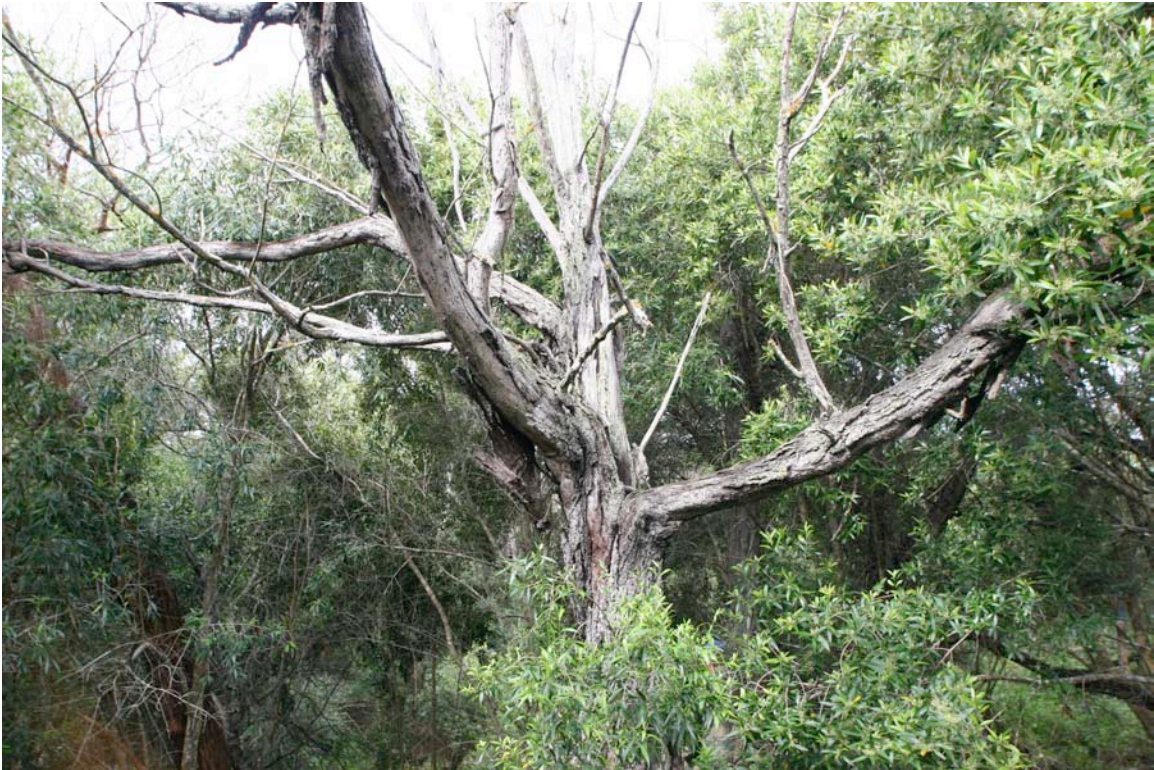
Tree 477

1. Species: Black waddle
2. Size: DBH 15“, Height 15’, Crown spread 10’
3. Targets: Trail
4. Form and Crown class: dead
5. Tree health: dead
6. Adverse site conditions: dead
7. Defective root conditions: dead
8. Trunk defects: dead
9. Scaffold limb defects: dead
10. Previous tree and limb failures: dead

Management Recommendations: Remove

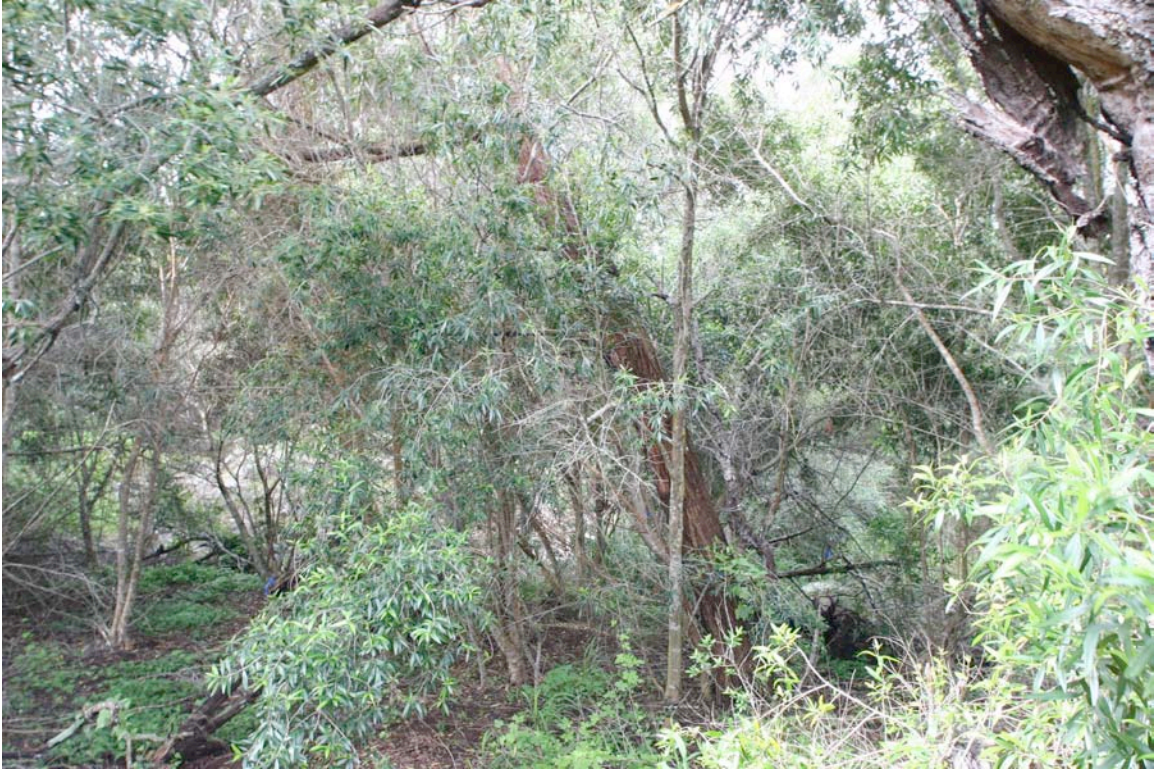
Tree 478

1. Species: Black wattle
2. Size: DBH13", Height 25', Crown spread 12'
3. Targets: Trail
4. Form and Crown class: dead
5. Tree health: dead
6. Adverse site conditions: dead
7. Defective root conditions: dead
8. Trunk defects: dead
9. Scaffold limb defects: dead
10. Previous tree and limb failures: dead

Management Recommendations: Remove

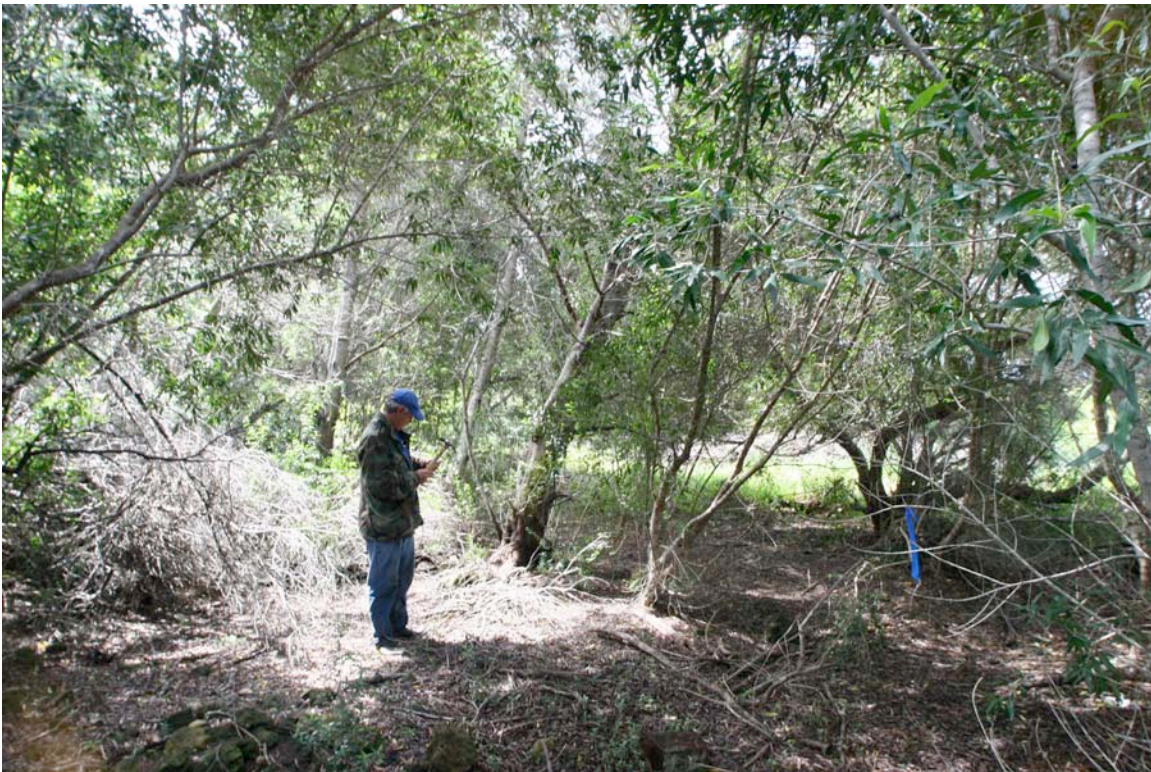
Tree 499

1. Species: Black wattle
2. Size: DBH13“, Height 25’, Crown spread 12’
3. Targets: none
4. Form and Crown class: Asymmetrical; Co-dominant
5. Tree health: Good
6. Adverse site conditions: none
7. Defective root conditions: none
8. Trunk defects: none
9. Scaffold limb defects: none
10. Previous tree and limb failures: none

Management Recommendations: none

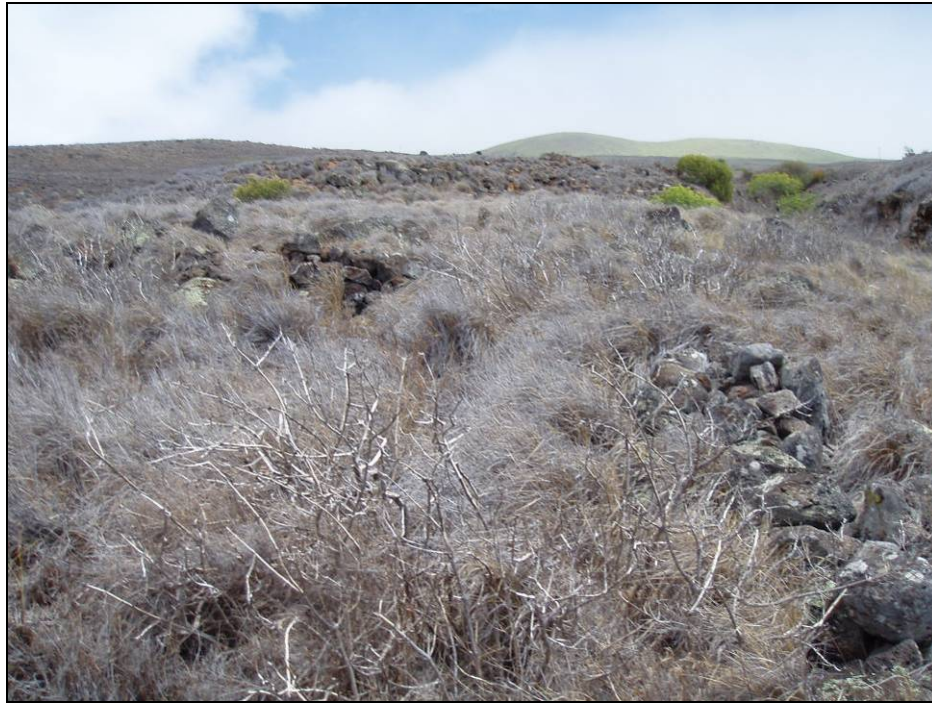
SIHP – 18568 was first recorded in 1994 by Barrera as "...a concentration of free standing stone walls located adjacent to the south end of Ouli Gulch, covering an area of 50 by 100 meters... The position of the walls and their construction technique suggest that they are animal barriers dating from the prehistoric period" (Figure 16 and Figure 17). CSH relocated the historic property and updated the description to add that the alignments appear to represent multiple large enclosures with the southern boundary located near the western end of the alternate alignment. SIHP – 18568 contains multiple enclosures, terraces, a rock shelter/overhang, a stone lined fire pit, and additional alignments. The complex is likely extensive and connects to other complexes

Figure 16. SIHP # -18568, north eastern corner of a large enclosure; view to north

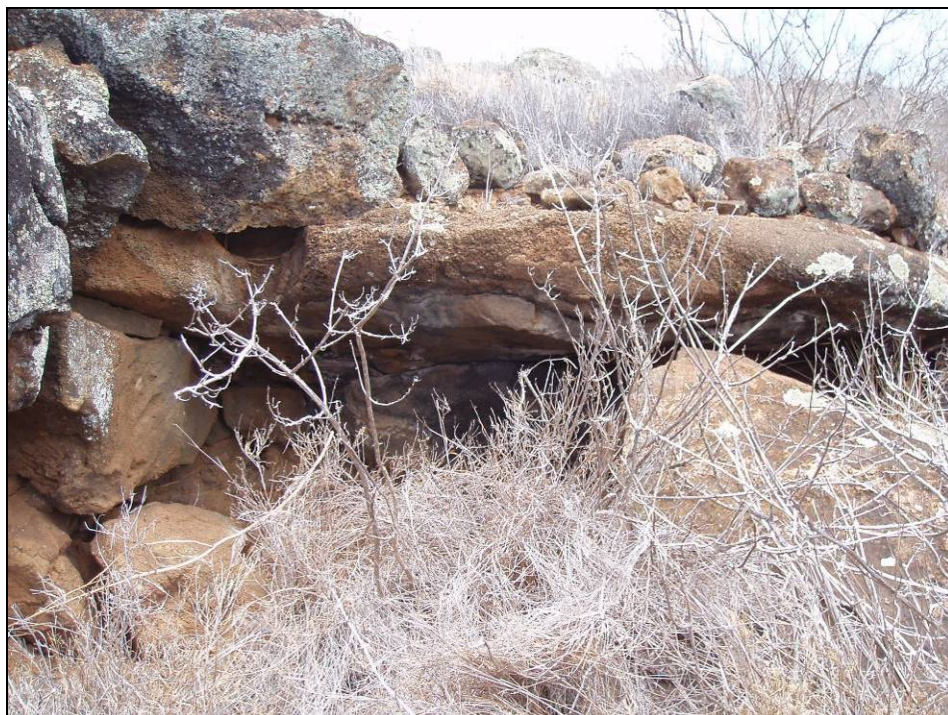
Figure 17. SIHP # -18568, rock shelter; view to west

with a series of walls and alignments. It is constructed of cobbles and boulders stacked 2-3 courses high and heads in a N/S – E/W direction. Along the alignment to the north is a second enclosure in the northeast corner with a small opening into the larger SIHP – 18568 enclosure. To the east of the enclosure, near the outside of the entrance, is a stone lined fire pit, consisting of an excavated pit with 4 upright pahoehoe slabs lining the sides. This fire pit was located on the upper tier of 2-3 terraces leading to a clearing under a tree. Above the enclosure is a rock shelter with soot on the ceiling suggesting a small shelter.

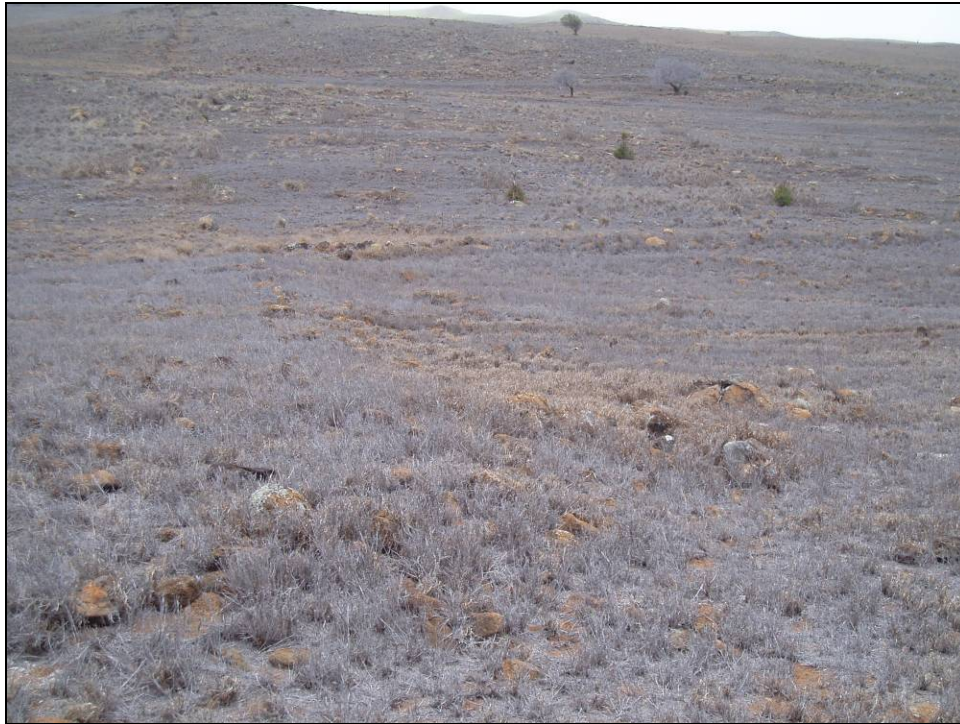
SIHP – 18581 is an agricultural complex consisting of 46 formal agricultural features located along Lanikepu Stream first recorded by Barrera in 1994 (Figure 18). Some of the features recorded by Barrera (1994) were relocated by Rechtman in 2000 and 12 new features were identified, bringing the feature total to 58. The agricultural features include earth and rock embankments, retaining walls, earth and rock berms, areas of erosion, water channels, a field well, terraces, mounds and stone piles. CSH relocated some of the SIHP – 18581 features, including: Feature 1 an earth and rock embankment and Features 26 and 27, earth embankments. Many features were located within the alternate alignment (Features 3, 4, 5, 6, 8, 23, 24, and 25) but this area appeared to have been disturbed by bulldozing and it is likely that these features have been destroyed.

Figure 18. SIHP # -18581 Feature 1, single stone alignment; view to north

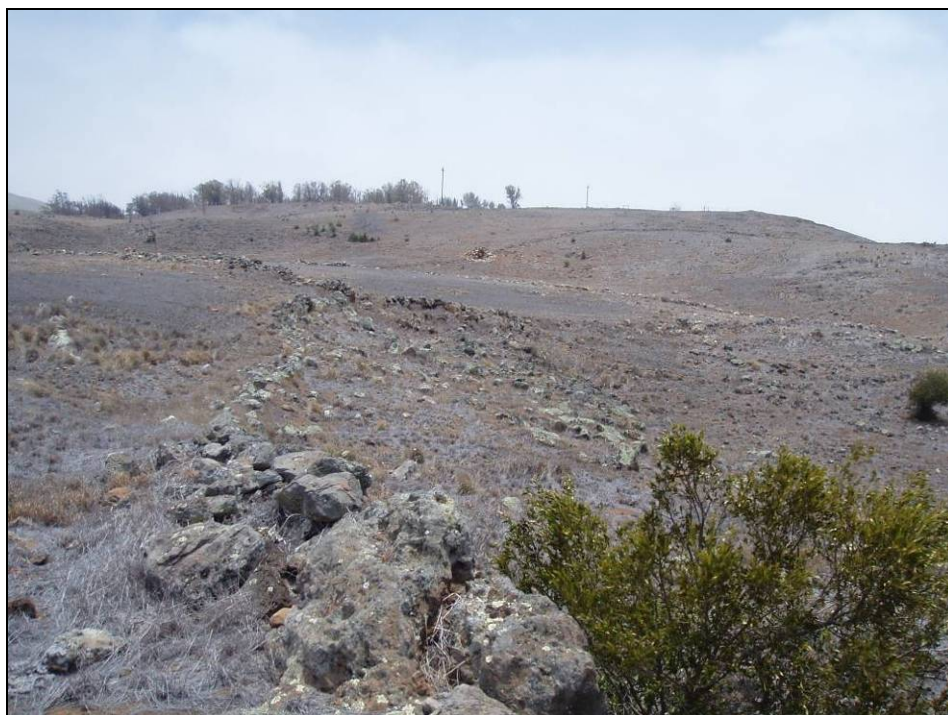
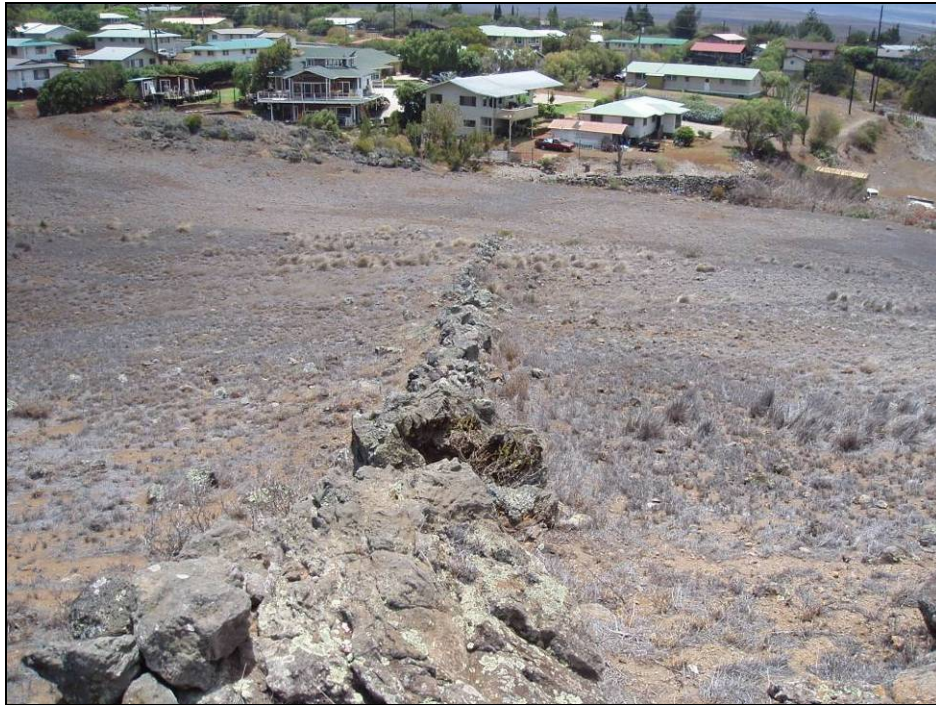
During the course of the field inspection, CSH located an area with a large concentration of historic properties, recorded in 1994 by Barrera (Figure 19 and Figure 20). This area appears to be a large site complex which has been split into multiple historic properties in the 1994 Barrera report, SIHP #'s -18569, -18583, -18584, -18585, -18586, and -18597. These historic properties consist of multiple walls, enclosures, retaining walls and sections of a trail, all of pre-Contact and post-Contact origins. CSH relocated the site complex and updated the description. The historic property is a large complex of walls and mounds that extend both N-S and E-W. The southern end of the wall, (likely part of SIHP -18583) is the point nearest to the location of the alternate alignment. The wall begins near the base of the hill and extends upslope (north), the extent of which is unknown, and additional walls can be seen running E-W, connecting to this wall. Upslope from the base of the site complex is a rock mound (SIHP -18586) on the SW side and an upright stone to the north on a hill top in the corner of a wall. A three-tiered platform (SIHP -18584) is located just east of the wall and consists of leveled platforms continuing downslope towards the project area. The level platforms are approximately 5 m wide and each terrace is approximately 50 cm in height.

Figure 19. Looking upslope to the interconnecting walls and complexes of SIHP #'s -18569, -18583, -18584, -18585, -18586, and -18597; view south

Figure 20. What is likely the southern portion of SIHP # -18583, 'garden area' walls, looking downslope towards the project area below; view south
