LANDOWNERS AND TMK's
Ke Ala Kahawai O Waimea,
Waimea Trails and Greenways
Draft Environmental Assessment

Natural resources assessment update report for the Waimea Trails and Greenways Project, Kamuela Island of Hawai'i¹

AECOS No. 920B

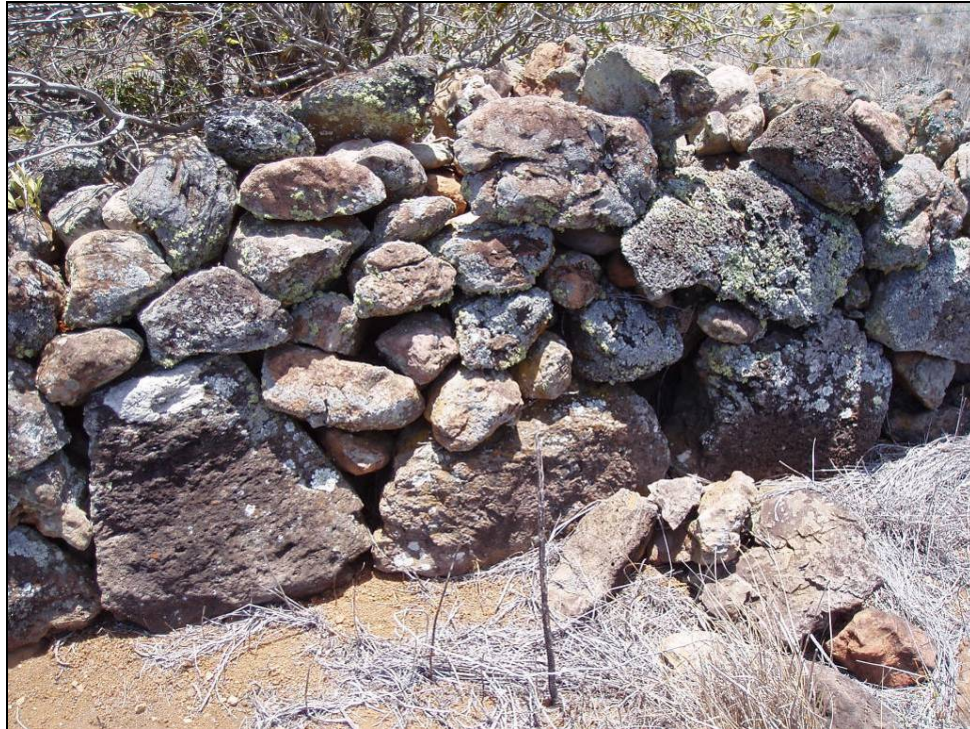
SIHP – 18587 is a boundary wall located in the western half of the project area corridor, north of the alternate alignment (Figure 21). This wall was first recorded by Barrera (1994) and was updated by Rechtman (2000) as a stacked boundary wall located along the Lanikepu/‘Ōuli Ahupua‘a boundary. Rechtman record that the wall remains intact for 118 meters and measures 1.2 m wide by 1.2 meters high and is likely a post-Contact boundary wall and post dates the surrounding fields (Rechtman 2000:12). CSH relocated this wall during the current field inspection and added that the wall extends upslope in a NE-SW direction. The wall is faced and stacked about 5 courses high and appears to have two stages of construction. The first 1-2 courses appear to be older and consist of medium basalt boulders partially inset into the slope. The remaining 3-4 courses are added onto the first portion of the wall and consist of smaller basalt cobbles and boulders.

Figure 21. SIHP # -18587, wall. Note the two stages of construction; view to northwest

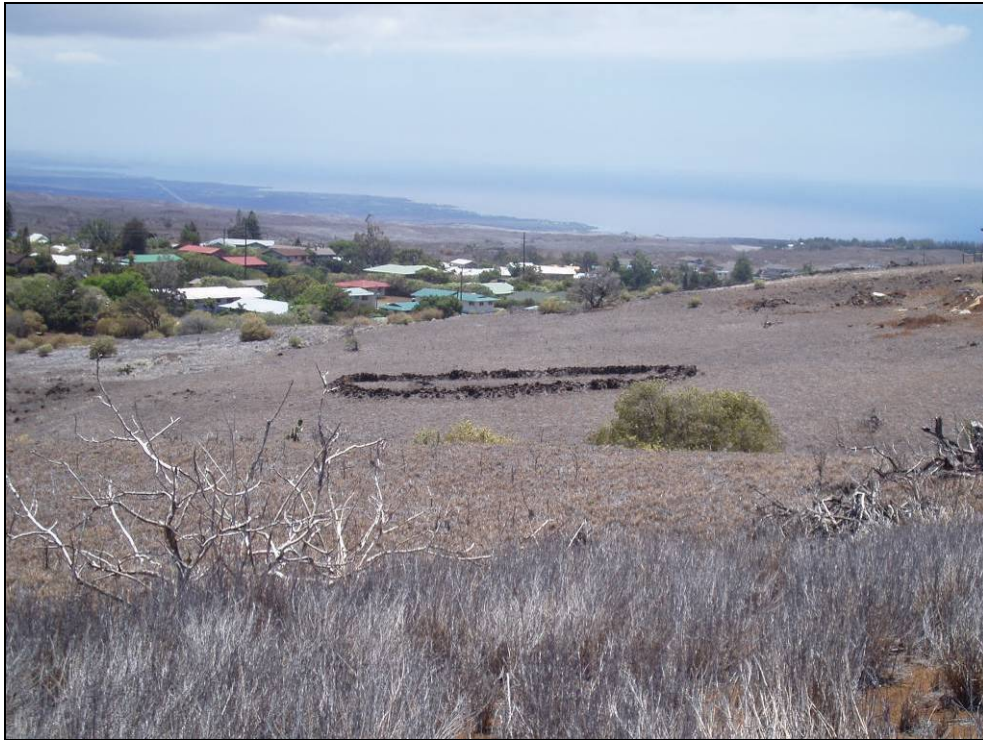
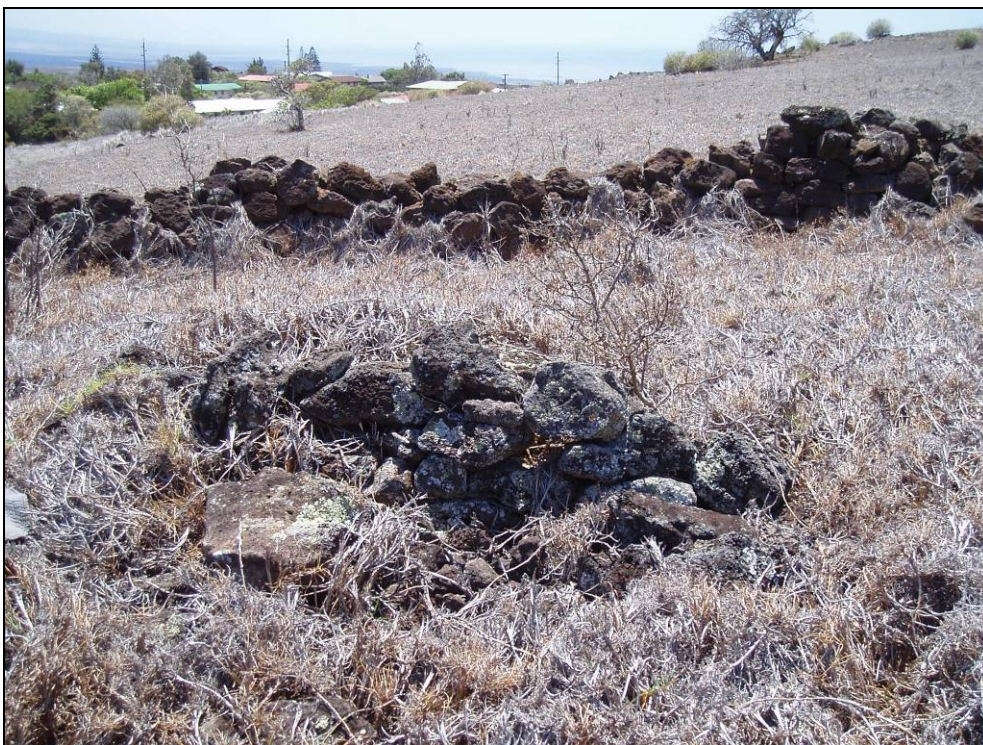
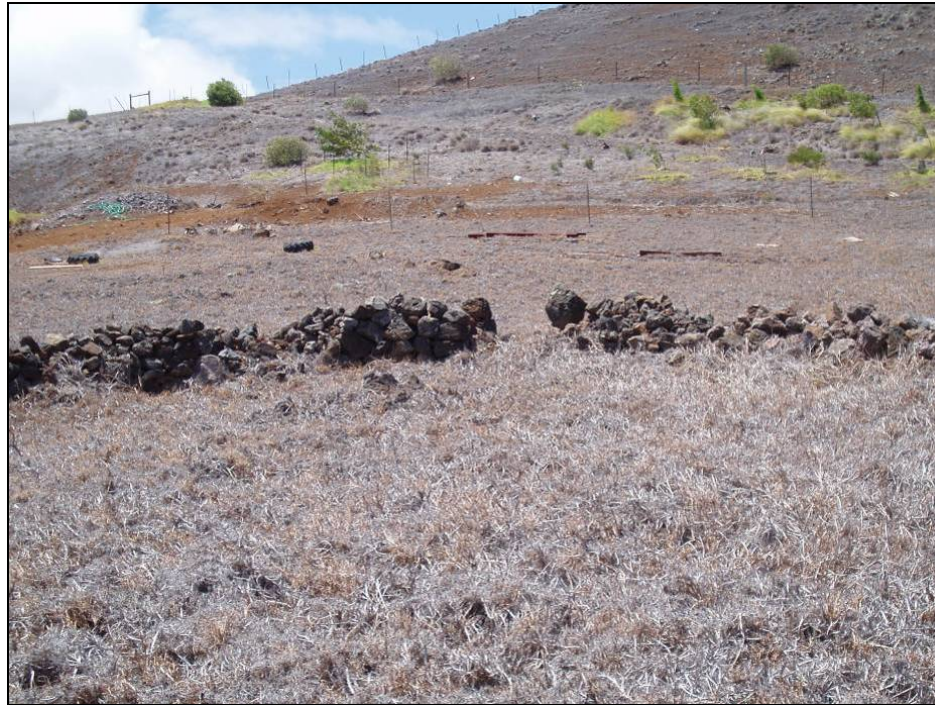
SIHP – 18588 consists of two mounds (Feature A and Feature B) first recorded by Barrera in 1994 as a pre-Contact burial location (Figure 22 through Figure 24). Barrera reported that Feature A is

Figure 22. SIHP # -18588, large protective enclosure containing two burial mounds; view to west

Figure 23. SIHP # -18588 Feature A, faced burial mound; view to west

Figure 24. SIHP # -18588 Feature B, burial mound, with entrance into the enclosure in the background; view to north

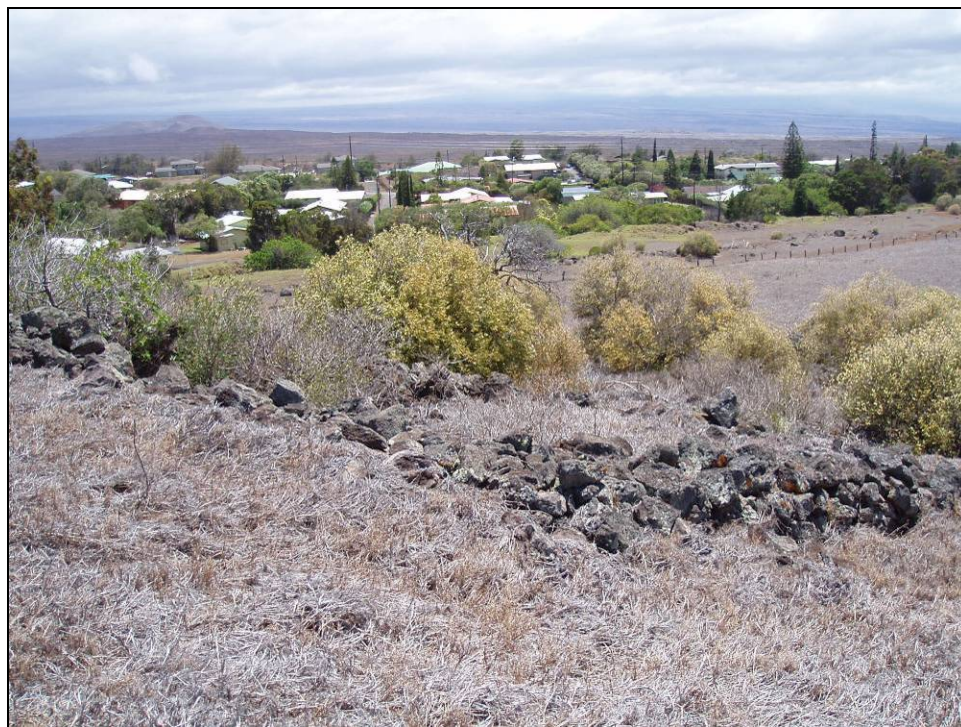
SIHP – 18590 is a pre-Contact permanent habitation located in the western half of the project area corridor, north of the alternate alignment, near the Old Kohala Mountain Road (Figure 25). Barrera originally recorded this historic property as “...a roughly square terraced enclosure measuring 10.2 by 10.6 meters...” (Barrera 1984:19). Rechtman updated the historic property as having stacked walls measuring approximately 1.5 meters wide by 1.2 meters high (2000:14). Rechtman agreed with the permanent habitation function, but felt that it was in fact associated with the historic period burials located nearby (SIHP – 18588). CSH relocated the enclosure and added that the enclosure is on an E-W sloping hillside and is largely unlevelled. It measures approximately 1m high in the SE (upslope) corner, sloping down to approximately 50cm high in the SW (downslope) corner. The upslope (east) side has interior facing of the walls, mainly in the NE and SE corners. The SE corner contains an inset faced area with a thicker faced wall running north. The inset area contains a basalt outcrop and placed semi-circle of basalt boulders stacked 1-2 courses. A partially upright boulder is placed in the center of the western wall, propped up with several cobbles, which is likely a modern addition.

Figure 25. SIHP # -18590, permanent habitation enclosure; view to southwest

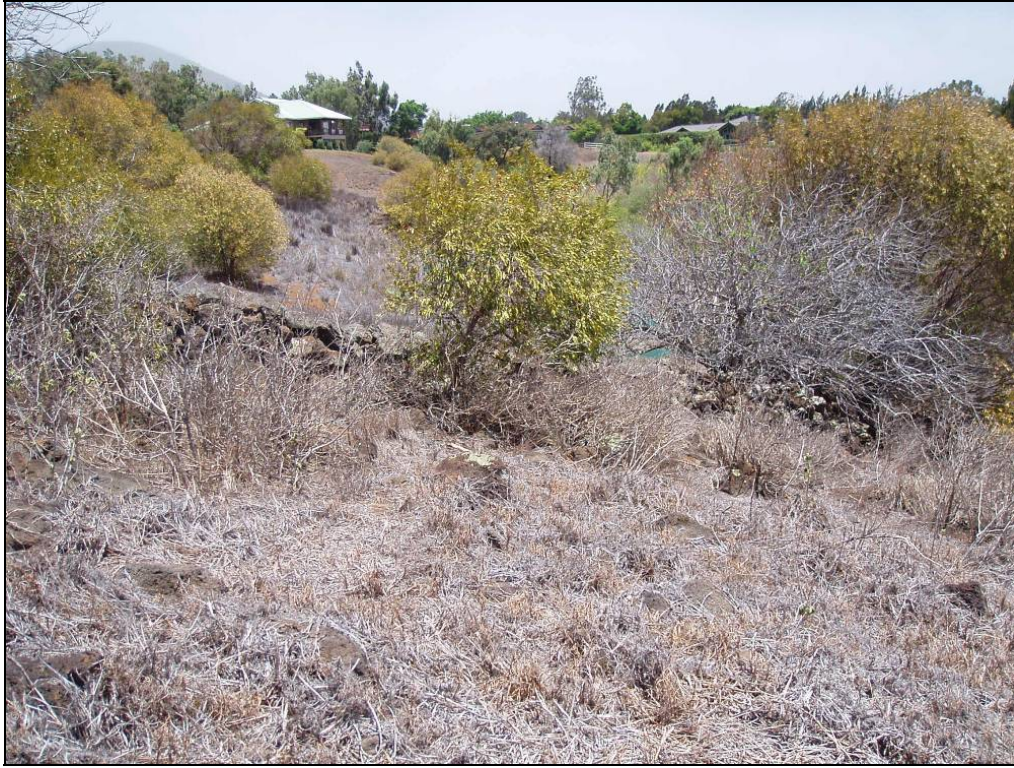
SIHP – 18593 is a wall first recorded by Barrera in 1994 and updated by Rechtman in 2000 (Figure 26). It is a freestanding wall that is approximately 40 meters long, 1 meter wide and 1 meter high. It is thought to be a remnant of a historic period ranch wall (Barrera 1994; Rechtman 2000). CSH relocated the wall and added that the wall was stacked 4 courses high and the

Figure 26. SIHP # -18593, wall; view to southeast

construction of a house that is located just upslope of this wall likely destroyed a portion of this wall.

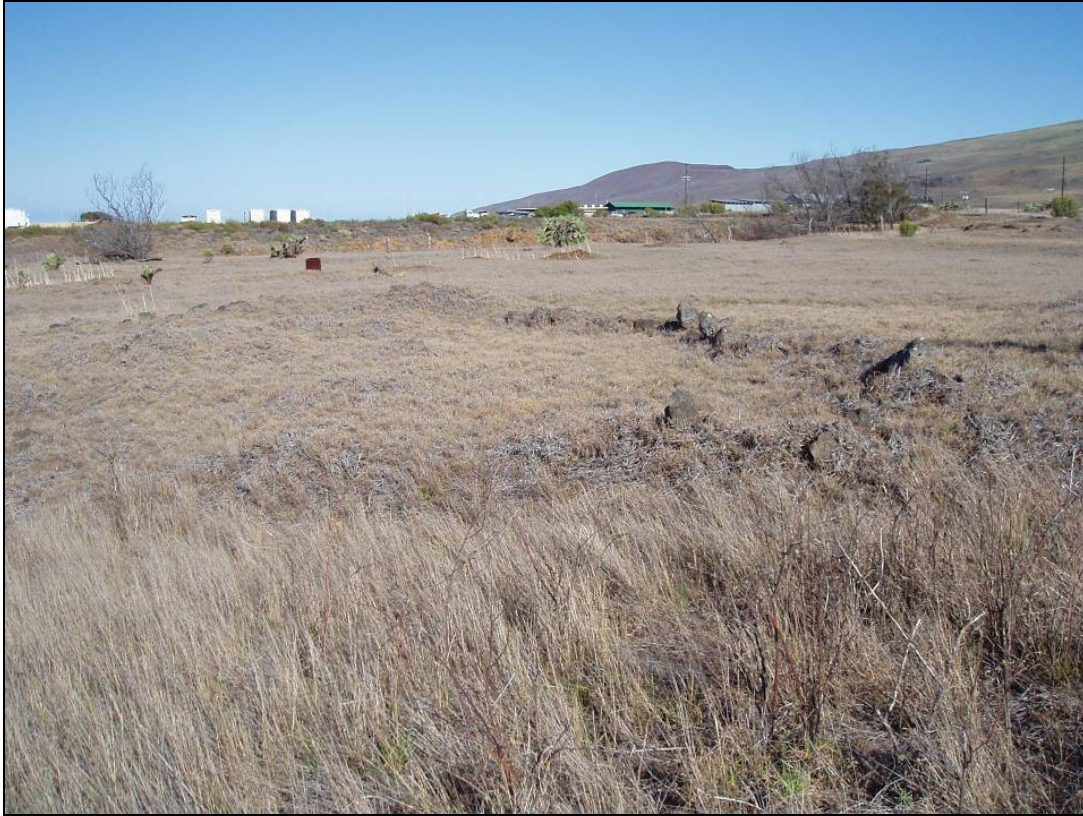
CSH 001 is an L-shaped alignment within a field adjacent to the Waimea Transfer Station (Figure 27). This area appears to have been heavily disturbed by bulldozer activities, likely associated to the transfer station and industrial buildings in the area. The alignment consists of small boulders stacked 1-2 courses high. The area upslope of the alignment is raised slightly suggesting a possible terrace, but based on the level of disturbance surrounding the alignment it is likely the result of bulldozer push. Haun et al (2002) conducted an archaeological inventory survey of a 266.4-acre area, which included the 17-acre Future County Park which contains a portion of the current project area. Haun identified an agricultural complex, SIHP – 22632, that consisted of 700 agricultural features, 15 of which were within the Future County Park area (Haun et al. 2002). CSH 001 appears to be further southeast than the southernmost feature recorded by Haun, but may be an additional feature of SIHP -22632.

Figure 27. CSH 001, L-shaped alignment adjacent to the Waimea Transfer Station; view to west

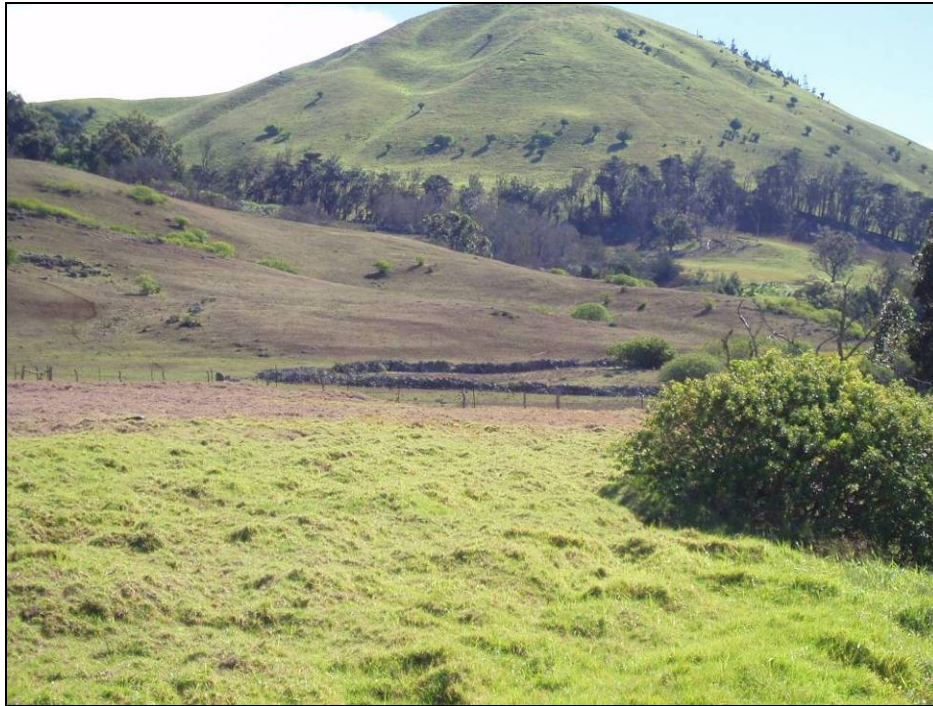
CSH 002 is a large enclosure, located in the northeastern portion of the alternate alignment (Figure 28). This area was not accessible during the field inspection and was viewed from an area approximately 150 meters to the west. A GPS point was taken from the location the historic property was viewed from, to the west of the enclosure within the driveway of 65-1508 Kawaihae Road, on the north side of Kohākōhau Stream. The enclosure is located just north of a private property and appears to be fenced in as part of that property. The walls appeared to be approximately 1.5 – 2 m high, and looked to be slightly collapsing. Only the northwest corner could be seen and it is possible that it functioned as a post-Contact animal enclosure. It may also be a pre-Contact structure modified for post-Contact use.

Figure 28. CSH 002, enclosure, located in the northeastern portion of the alternate alignment; view to east

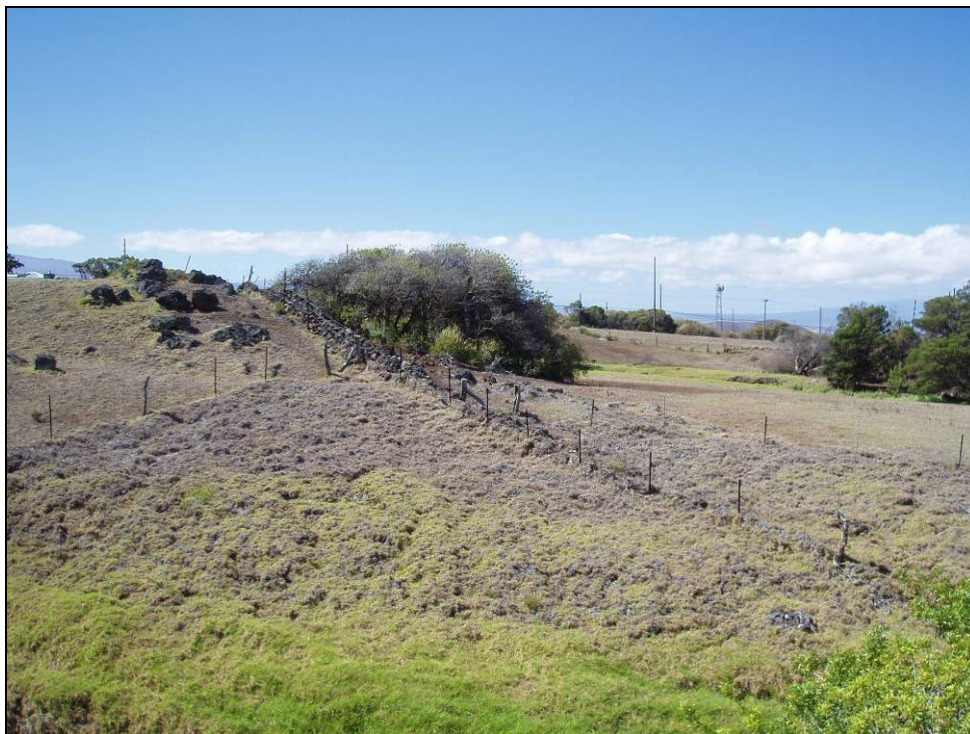
CSH 003 is a wall located just west of the Hawaii Preparatory Academy (HPA) campus, on the south side of Kohākōhau Stream (Figure 29). The wall was observed from the north side of the stream and appears to be approximately 50 cm high, 4-5 courses, with an associated barbed wire fence. It is likely that this wall is a post-Contact in origin, based on the barbed wire, though it could be a modified pre-Contact wall. CSH 003 borders the stream and the residences that are located along the stream and is oriented E/W. The total length is unknown.

Figure 29. CSH 003, wall, on the south side of Kohākōhau Stream; view to south

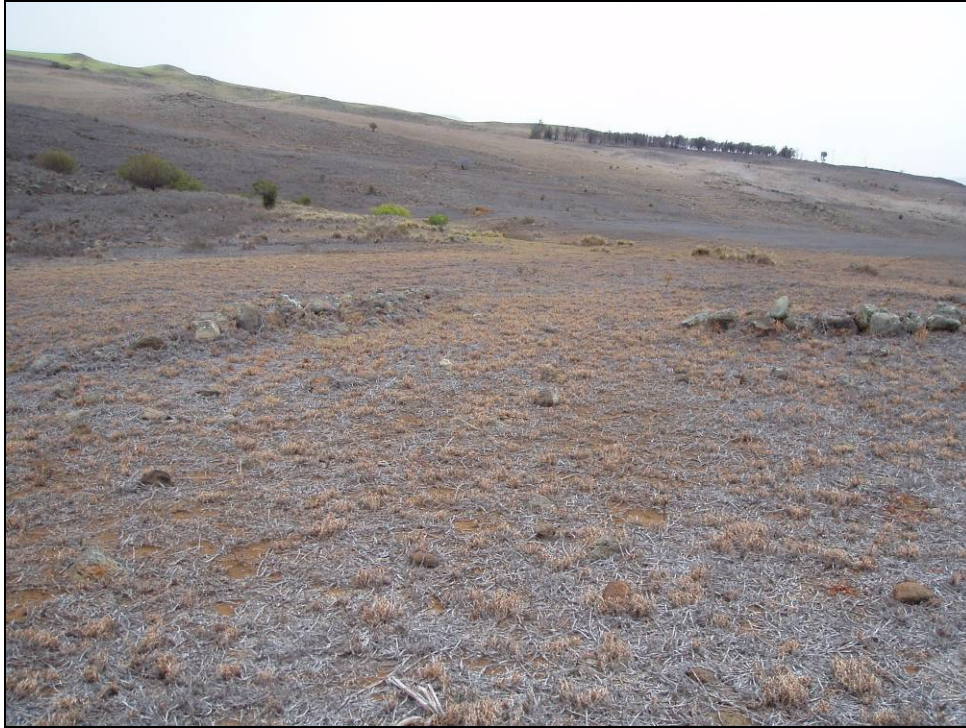
CSH 004 consists of two terraces located just south of the alternate alignment on its western edge (Figure 30). The terraces are constructed from basalt boulders and cobbles and measure approximately 50 cm wide 4 m long and 40 cm high. One terrace is oriented E/W while the other

Figure 30. CSH 004; two terraces; view to east

is oriented N/S and they form a shape similar to an L-shaped alignment. The terraces appear to have been previously disturbed and are likely remnants. This historic property is likely an additional feature to SIHP – 18581, an agricultural complex recorded by Barrera in 1994.

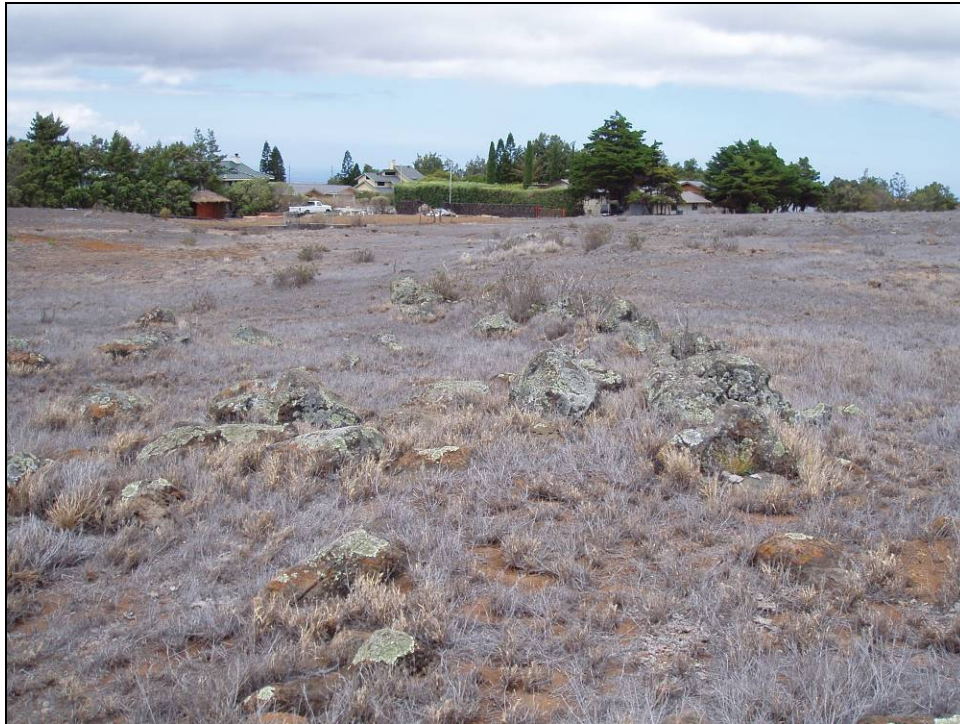
CSH 005 is an L-shaped alignment located in the western edge of the alternate alignment to the north of the alignments location (Figure 31). There is an area to the east of the alignment that may have been a third wall, but it appears to be heavily disturbed. CSH 006 measures approximately 1 m wide and contains no facing. The function of this alignment was not determined.

Figure 31. CSH 005, L-shaped alignment; view to southwest

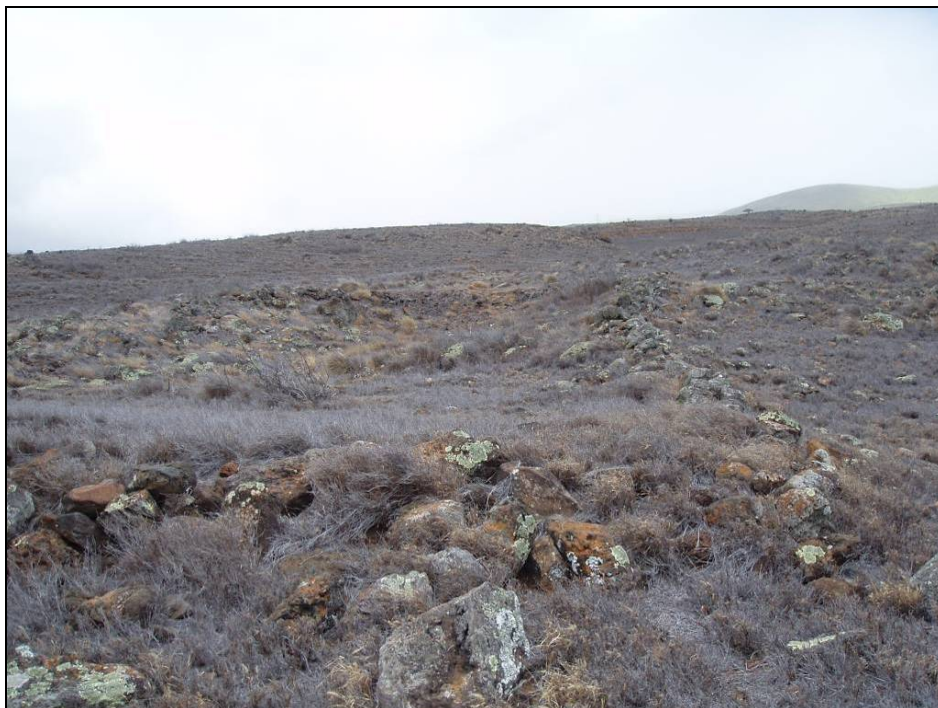
CSH 006 is a large enclosure with associated terracing and platforms (Figure 32). The enclosure extends north (upslope) and is situated so that the central upslope (north) half is within a small gulch, acting as a sort of bowl which may have been used as a windbreak. The walls are low with no facing. The two terraces are located on the southeast side (downslope) of the enclosure and are stacked 3 courses high, measuring approximately 70cm high and 80 cm wide with no facing. The terraces create large level areas approximately 5 m wide. East of the enclosure is a natural rock formation/crevice, with some minimal cobble filling. The function of this historic property was not determined.

Figure 32. CSH 006, large enclosure with associated terracing and platforms; view to north

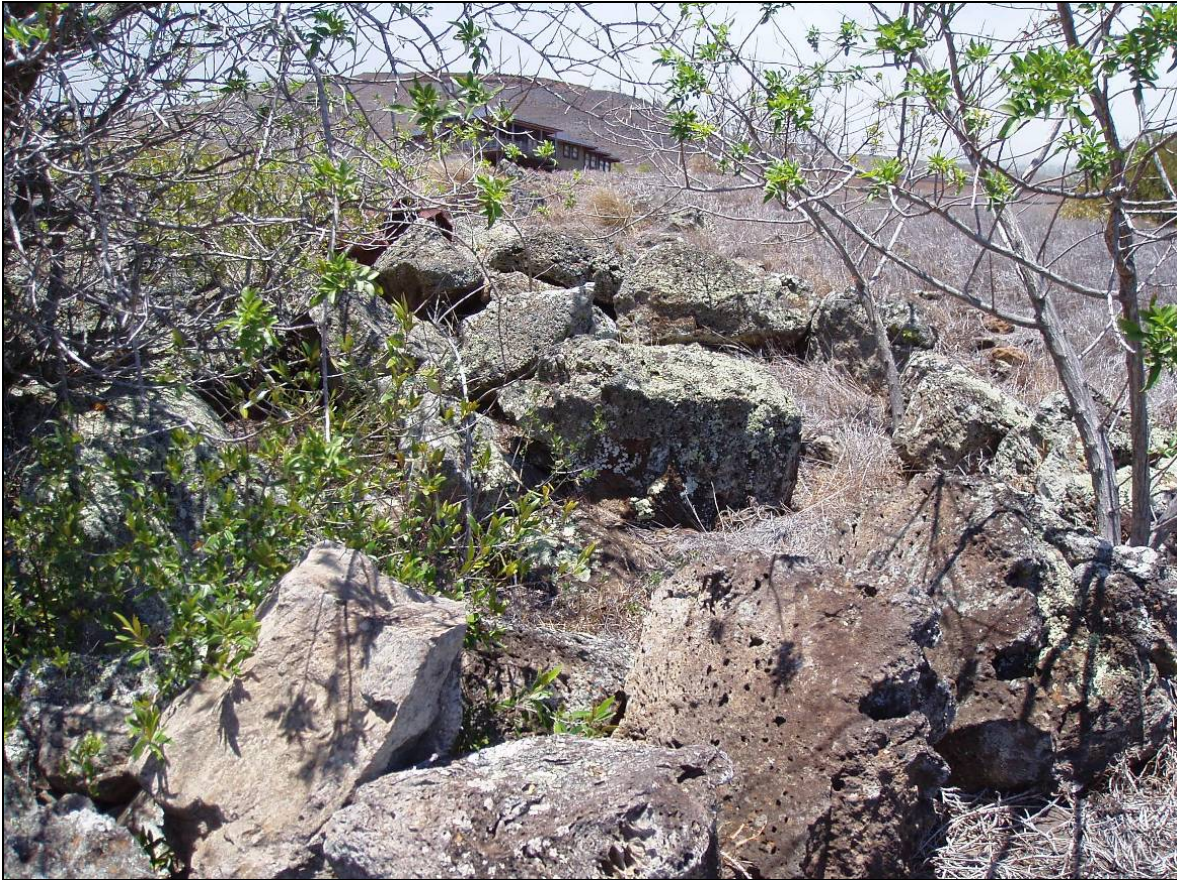
Figure 33. CSH 007, semi-circular single boulder alignment/enclosure; view to north

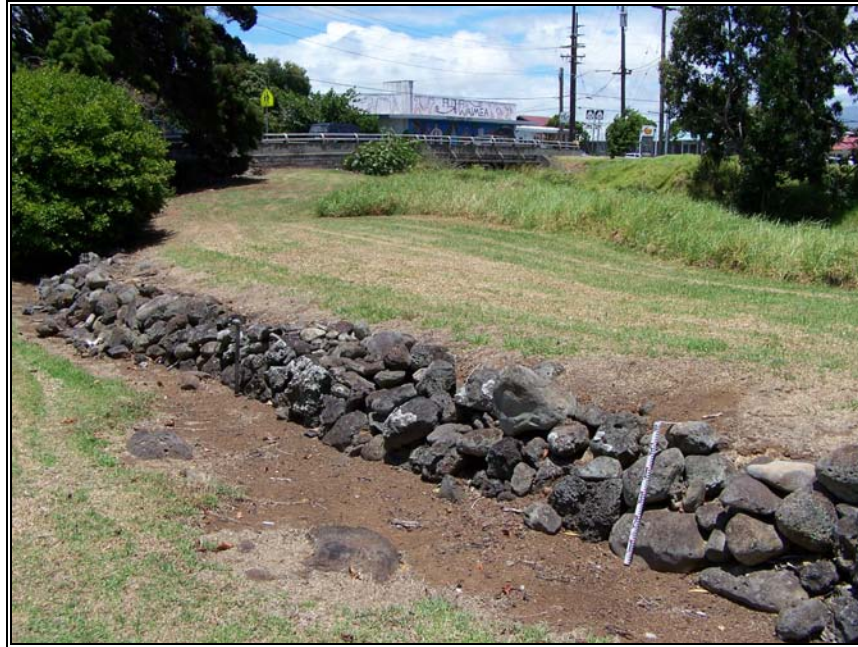
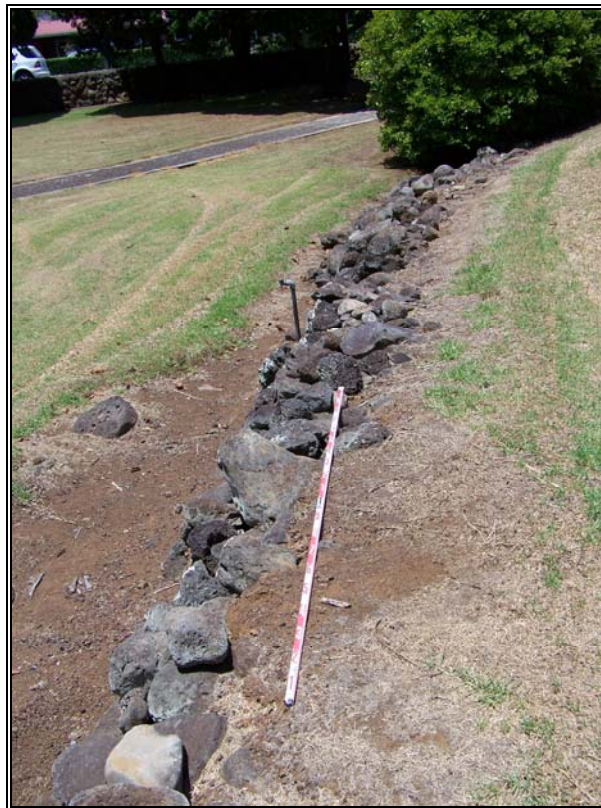
The terrace is located near the eastern end of the project area adjacent to the Lindsey Road Bridge along the edge of Lanakila Park (Figure 16 and Figure 17). The terrace measures approximately 50 m long with a maximum width of 1.5 m and a maximum height of 0.8 m. The terrace is constructed of water-rounded to sub-angular basalt cobbles to medium boulders. Concrete was observed throughout the terrace adhering to the basalt stone. A one inch metal water line was observed extending from ground surface to the top of the terrace and capped by a closed valve. Collapse was observed in several areas. The terrace was determined to be a modern landscaping modification associated with Lanakila Park. After WWII, the raised bed between the terrace and the edge of Waikōloa Stream was planted with flowers. Currently the terrace is surrounded by mowed grass and shrubbery.

Figure 16. Stone terrace bounding Lanakila Park near Lindsey Road Bridge, view to southeast

Figure 17. Stone terrace bounding Lanakila Park near Lindsey Road Bridge, view to east

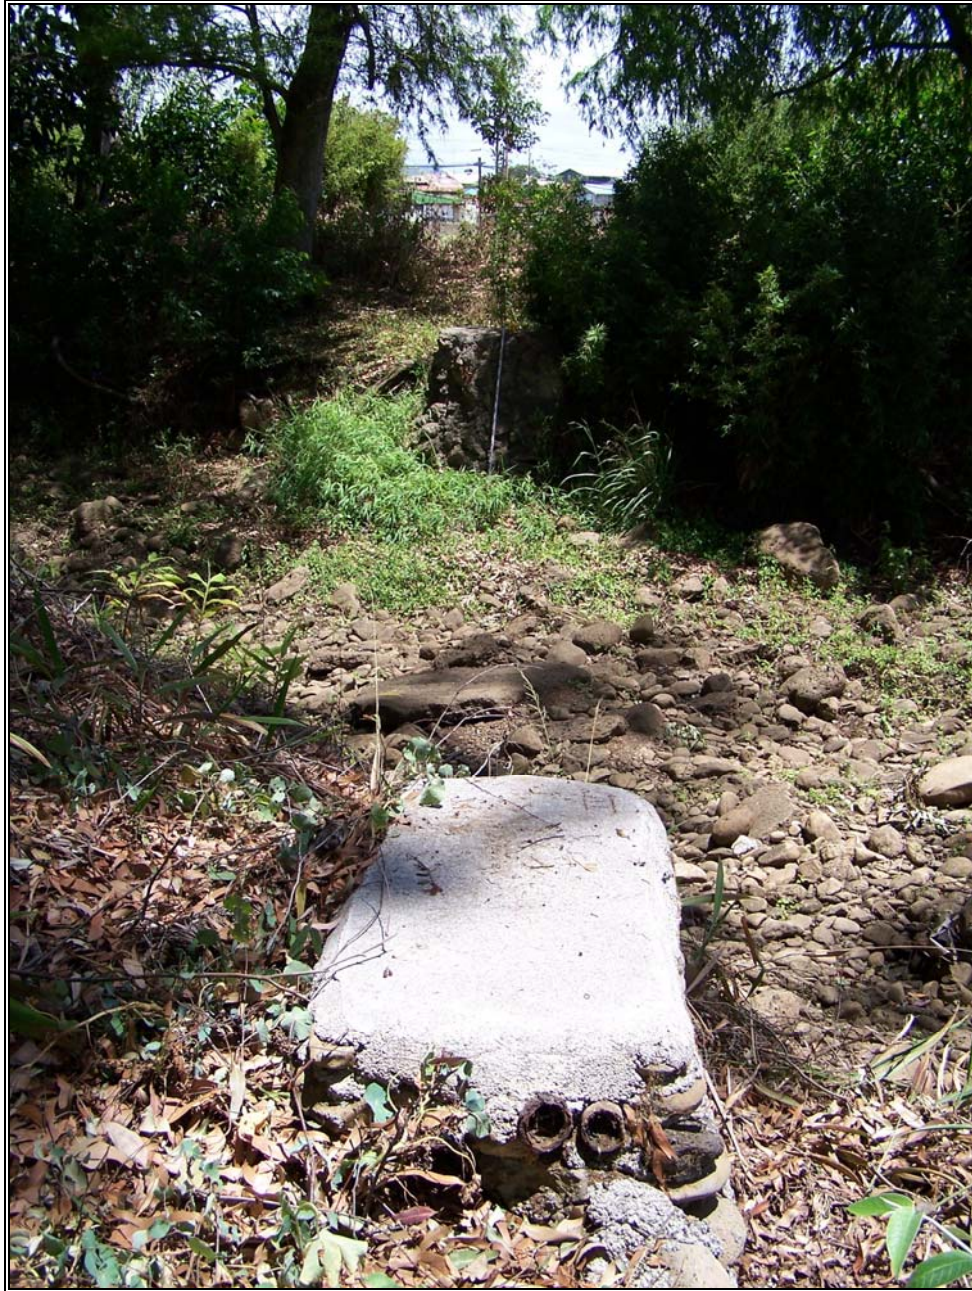
The pipeline support consists of two basalt cobble and concrete wall segments built into the sides of Waikōloa Stream behind the Catholic Church complex (Figure 18). Corroded steel pipes were observed within the foundation of one of these support walls. The pipeline support wall located within the current project area appeared to have been recently and informally constructed (Figure 19). The roman numeral "IV" was observed etched into the top of the support (Figure 20). The pipeline support on the opposite edge of Waikōloa Stream, outside of the current project area, appears to be slightly older but lacked the site integrity needed for eligibility as an historic property.

Figure 18. Two pipeline supports along Waikōloa Stream, view to south

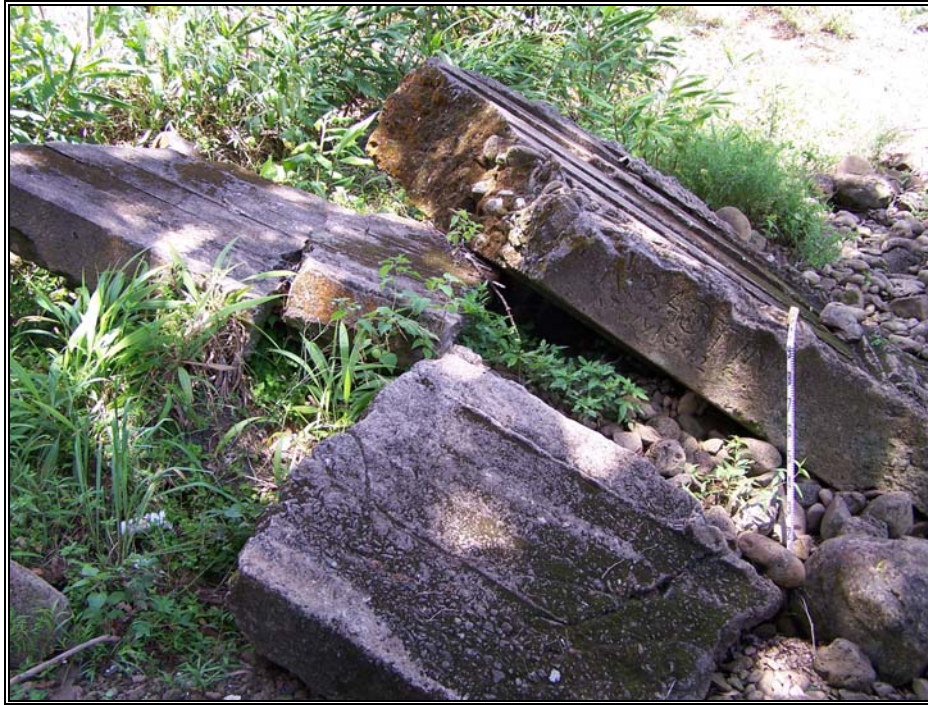
Figure 21. SIHP# -26871 Feature A within Waikōloa Stream, view to northeast

Feature A is a collapsed and nearly destroyed ford or stream crossing consisting of a concentration of seven concrete slabs within the bed of Waikōloa Stream (Figure 21 and Figure 22). The southern edge of Feature A is located approximately 2.0 m north of the proposed trail stream crossing. Characteristics of the concrete slabs of Feature A include variable thickness (35-75 cm), uneven surfaces, and internal composition consisting of basalt gravel and water-rounded cobbles all suggesting expedient and informal construction. The name "A BASTIN" and the date "JULY 1942" were observed etched into the side of the largest slab of concrete (Figure 23). The construction techniques, function, date, and proximity to Camp Tarawa of Feature A all suggest that it was expediently constructed during the early part of WWII as a stream crossing for pedestrians and potentially vehicles moving to and from Camp Tarawa and Waimea town.

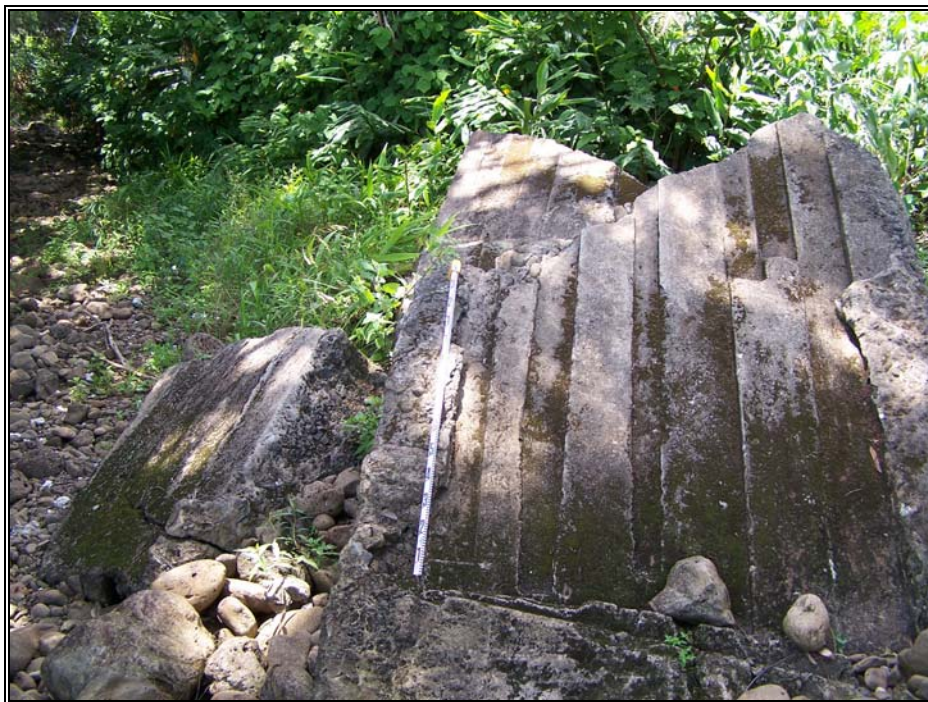
Figure 22. SIHP# -26871 Feature A within Waikōloa Stream, view to north

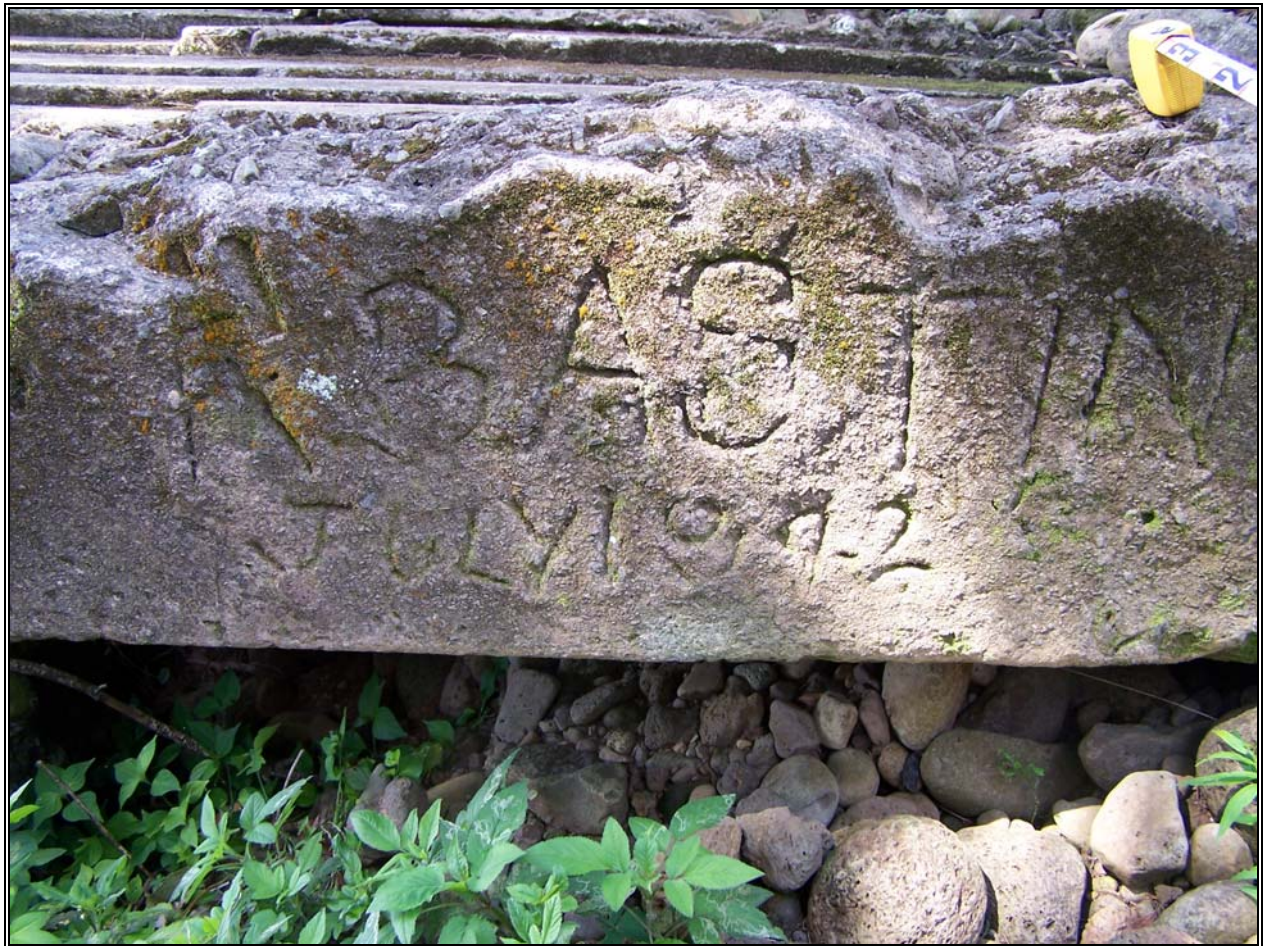
Figure 23. SIHP# -26871 Feature A inscription on concrete slab, view to east

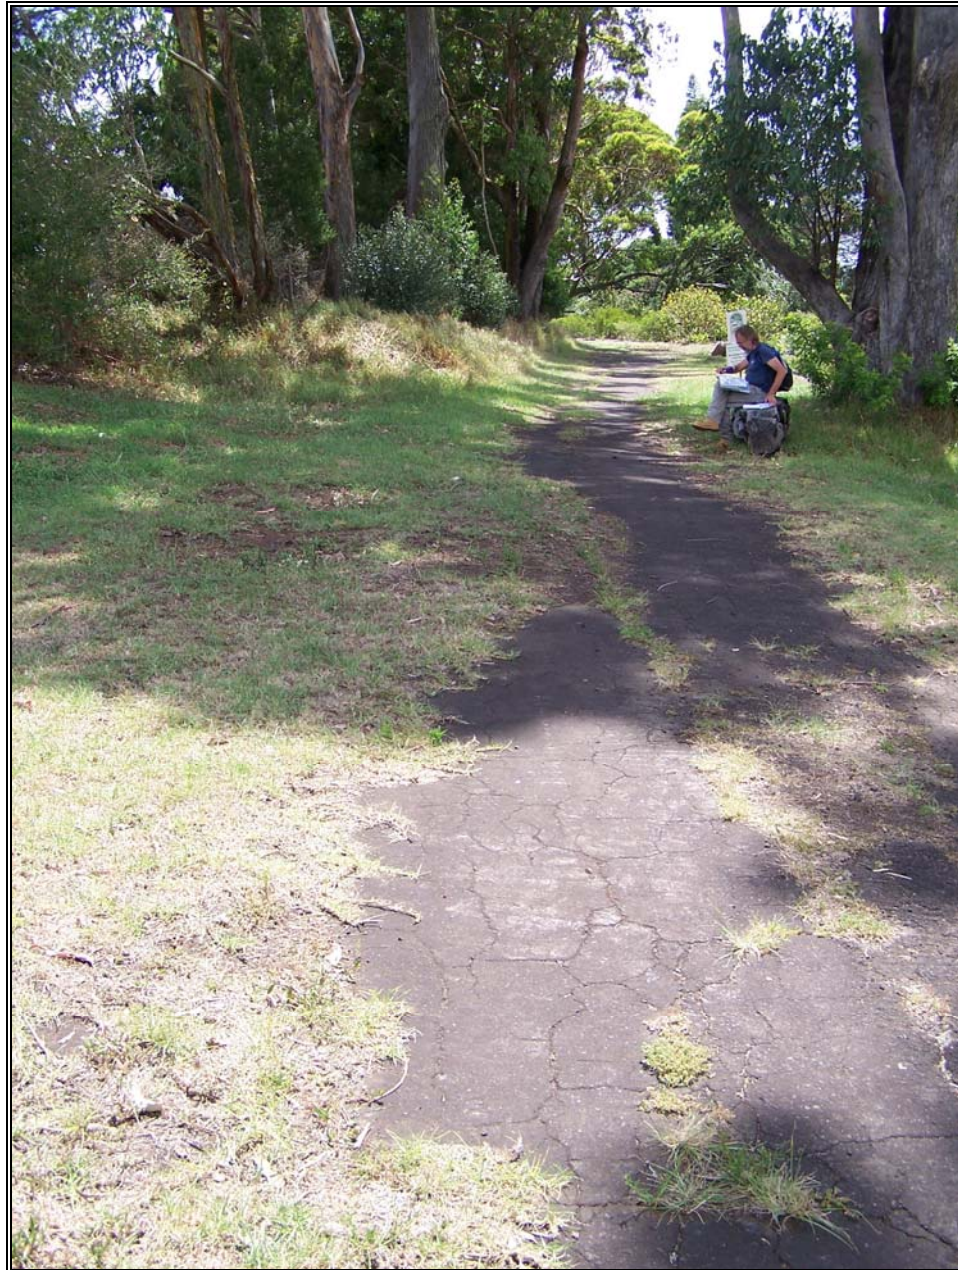
Figure 24. SIHP# -26871 Feature B remnant roadway, view to west

Feature B is a remnant portion of paved roadway that extends along the western edge of the Waimea Nature Park within the proposed trail alignment (Figure 24). The majority of the roadway segment is covered with mowed grass except a well-trodden central portion. The roadway is bounded in several locations by large trees and shrubbery. A tall berm (approximately 2.0 m) rises along the southern perimeter of Feature B to the edge of several private residences delineated by a stacked basalt stone wall 3 to 6 courses high (Figure 25) SIHP# -26871 Feature B is likely the remnant of Abemama Road that extended northeast to southwest through Camp Tarawa (See Figure 12).

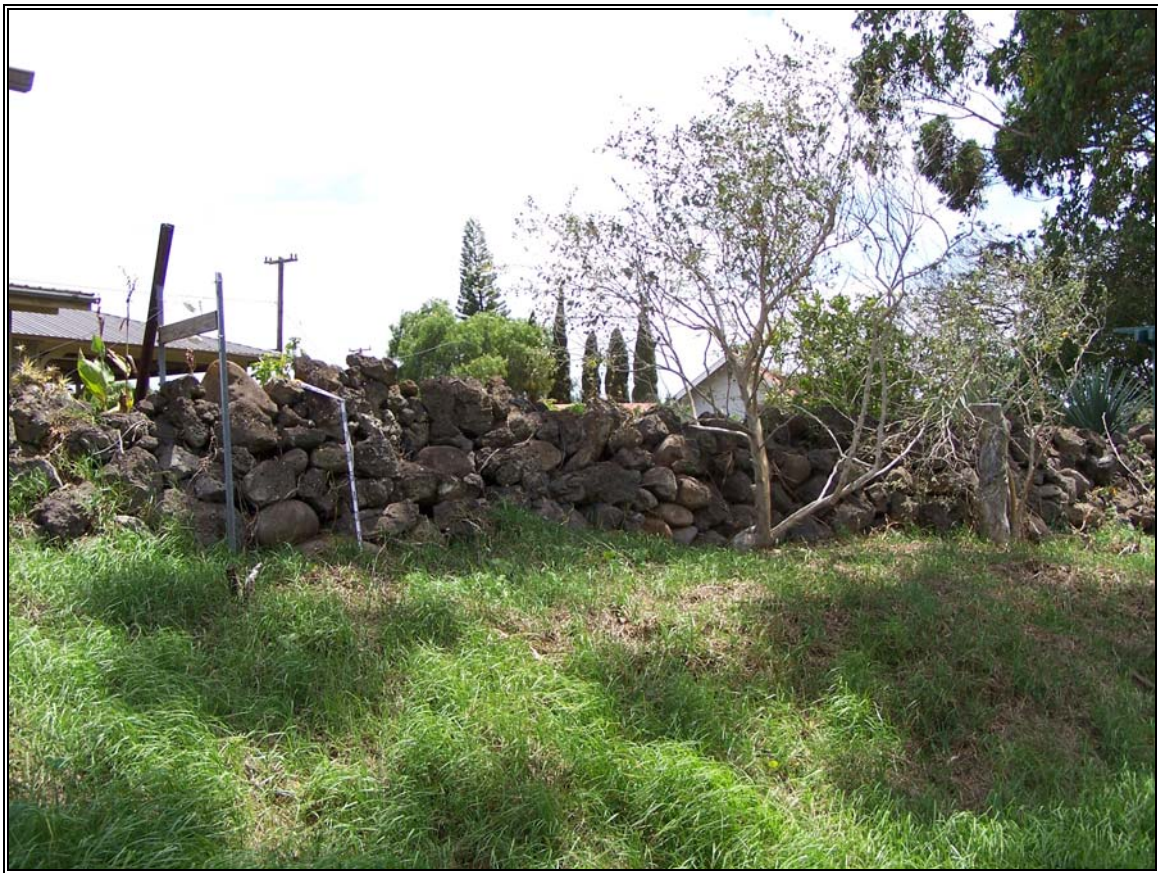
Figure 25. Boundary wall adjacent to SIHP# 26871 Feature B, view to south

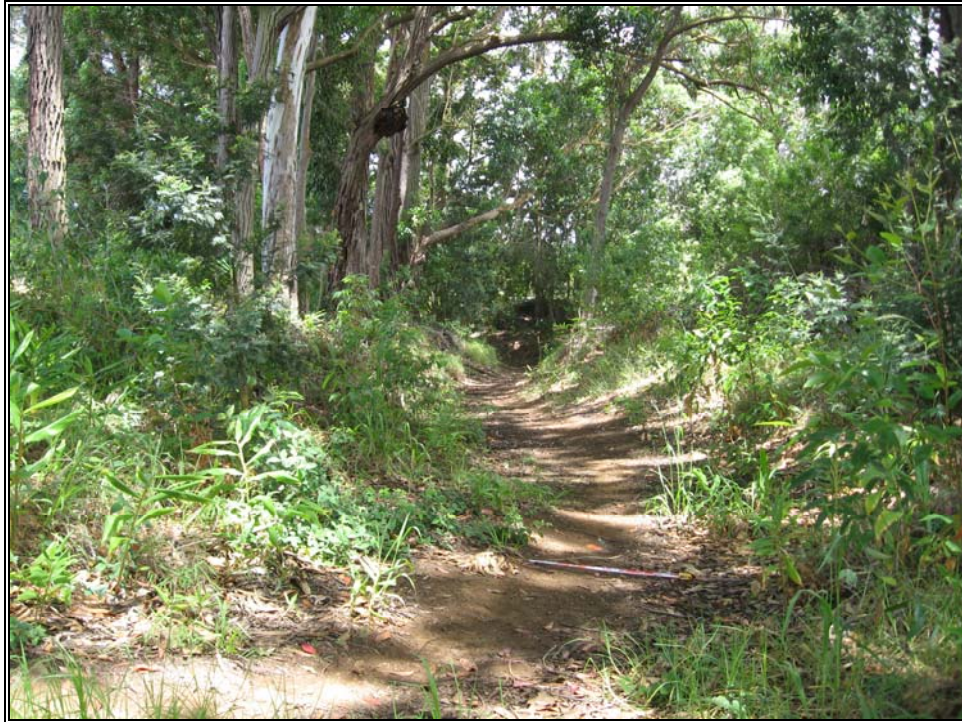
Figure 26. SIHP# 26872 (Akona's *'Auwai*), view to west

SIHP# -26872 (CSH 2) consists of an earthen ditch located within the eastern half of the project area. The ditch originates at a sharp bend in Waikōloa Stream and continues to the southwest effectively bypassing a large meander in the stream (Figure 26 and Figure 27). The ditch measures approximately 143.5 linear m with a width ranging from 3 to 6 m and a maximum depth of 1.9 m. The western end of the ditch segment has been filled in near SIHP# -26871 Feature B suggesting that this portion of the ditch was graded during construction of Camp Tarawa (Figure 28). A sediment berm has been constructed at the eastern end of the ditch where it connects to Waikōloa Stream so that water is properly diverted into the main meandering channel of the stream (Figure 29). SIHP# -26872 is bounded by house lots to the south and the Waimea Nature Park to the north.

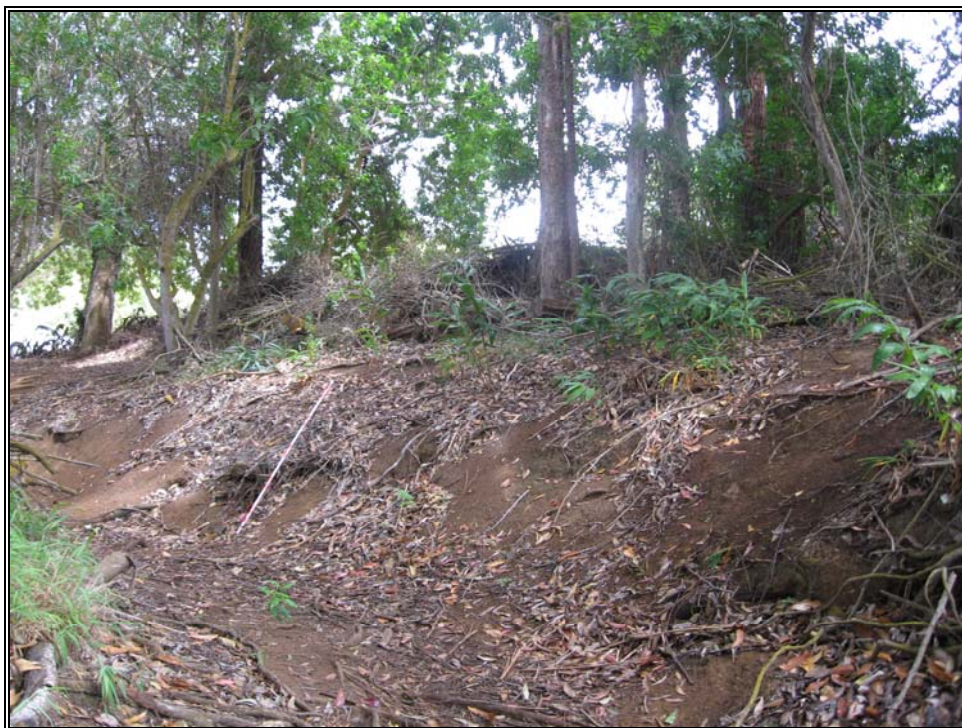
Figure 27. SIHP# 26872 (Akona's *'Auwai*), view to southwest

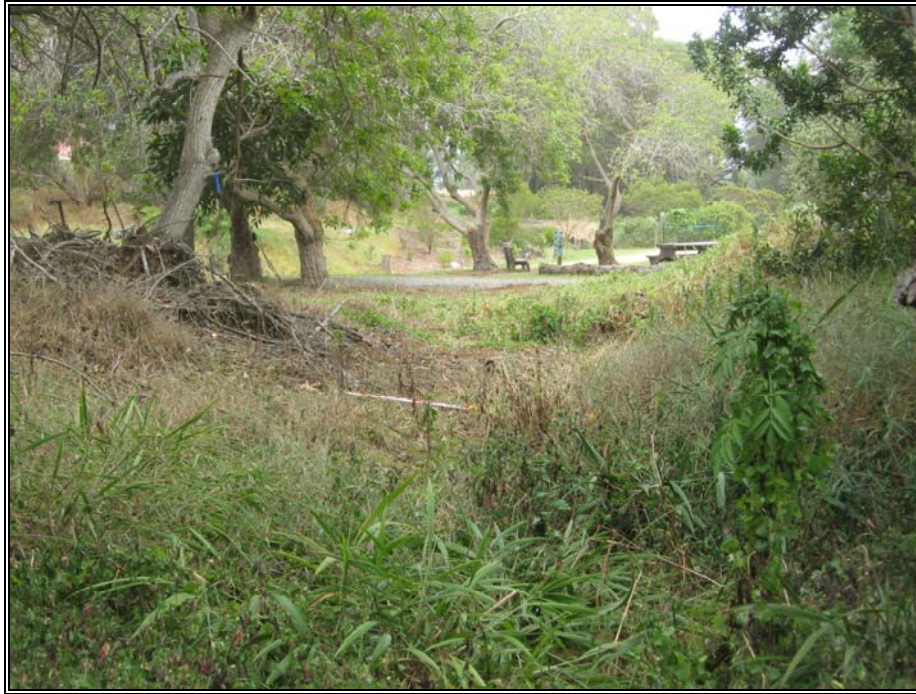
Figure 28. Western end of SIHP# 26872 (Akona's 'Auwai) showing the Waimea Nature Park, view to west
