LANDOWNERS AND TMK's
Ke Ala Kahawai O Waimea,
Waimea Trails and Greenways
Draft Environmental Assessment

Natural resources assessment update report for the Waimea Trails and Greenways Project, Kamuela Island of Hawai'i¹

AECOS No. 920B

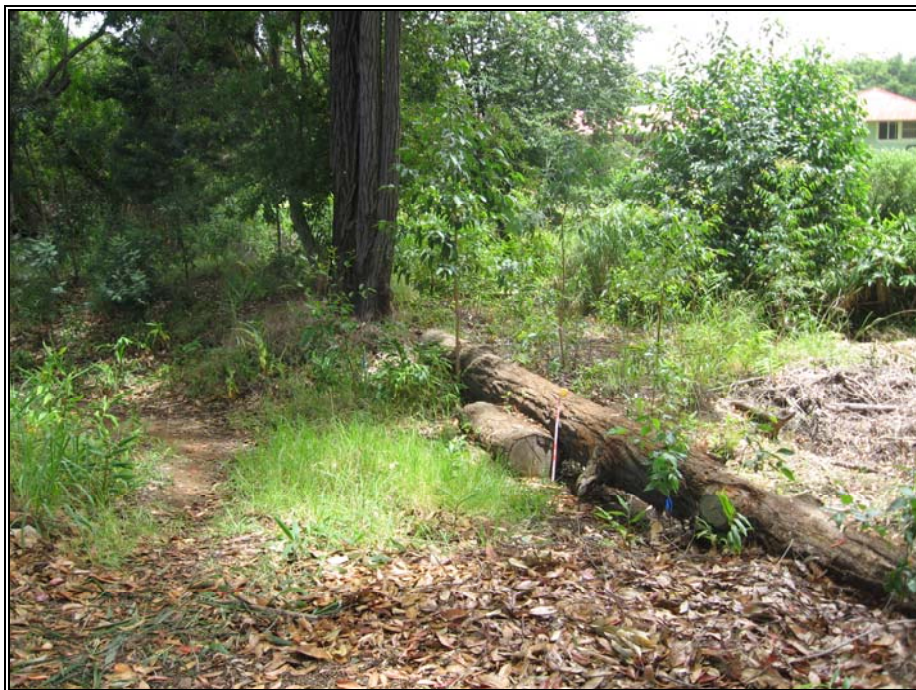
Figure 29. Eastern end of SIHP# 26872 (Akona's 'Auwai) at connection with Waikōloa Stream showing sediment berm and placed log, view to north

SIHP# -26872 (CSH 2) consists of an earthen ditch located within the eastern half of the project area. The ditch originates at a sharp bend in Waikōloa Stream and continues to the southwest effectively bypassing a large meander in the stream (Figure 26 and Figure 27). The ditch measures approximately 143.5 linear m with a width ranging from 3 to 6 m and a maximum depth of 1.9 m. The western end of the ditch segment has been filled in near SIHP# -26871 Feature B suggesting that this portion of the ditch was graded during construction of Camp Tarawa (Figure 28). A sediment berm has been constructed at the eastern end of the ditch where it connects to Waikōloa Stream so that water is properly diverted into the main meandering channel of the stream (Figure 29). SIHP# -26872 is bounded by house lots to the south and the Waimea Nature Park to the north.

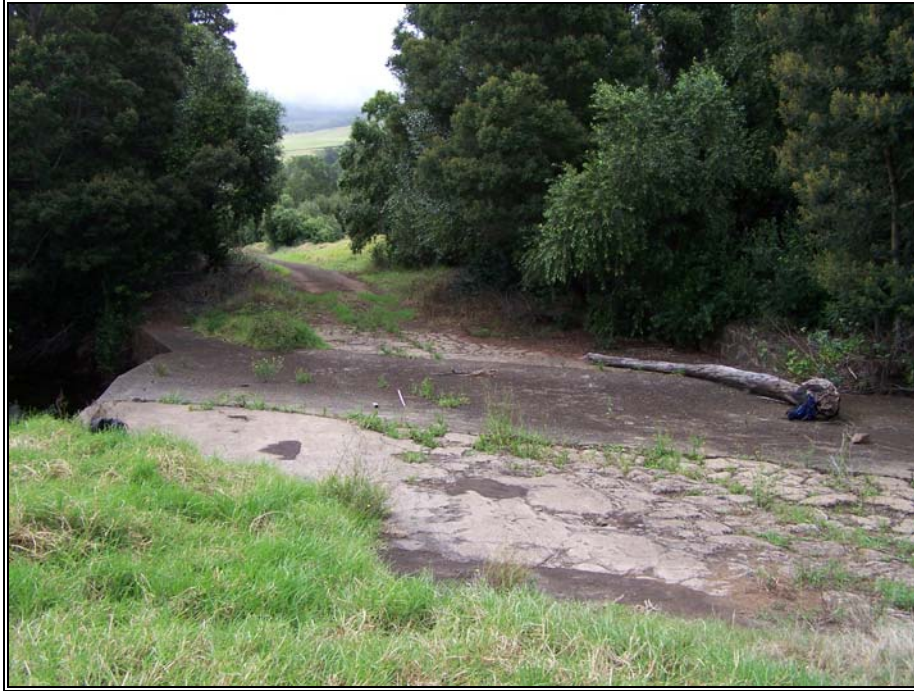
Figure 30. SIHP# 26873 ford and associated roadway, view to northwest

SIHP# -26873 consists of an intact ford and associated roadway located at the western end of the current project area (Figure 30). The ford is constructed entirely of concrete with basalt gravels. The eastern side of the ford within Waikōloa Stream consists of a concrete ramp to the north and an open channel leading to a 0.7 m diameter culvert that has been completely filled in with alluvium (Figure 30 to Figure 33). A mortared cut basalt stone wall measuring two courses high was observed at the northeastern corner of the ford extending northward approximately 5.0 m (Figure 32). The western side of the ford consists of a vertical to slightly sloping concrete face measuring 1.2 m high with the central culvert located slightly above the current stream water level (Figure 33). The surface of the ford is generally level rising slightly along its northern and southern edges to meet the adjoining roadway. The adjoining roadway consists of highly weathered cement that has been paved over with asphalt to near the edges of the ford.

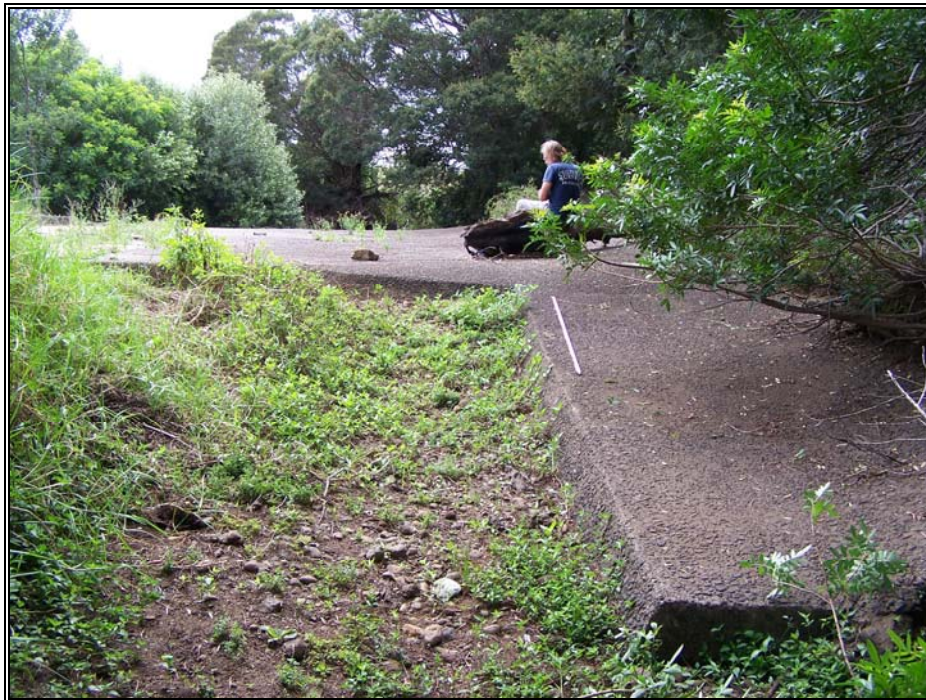
Figure 31. Eastern side of SIHP# -26873 showing concrete ramp and sediment-filled culvert opening, view to west

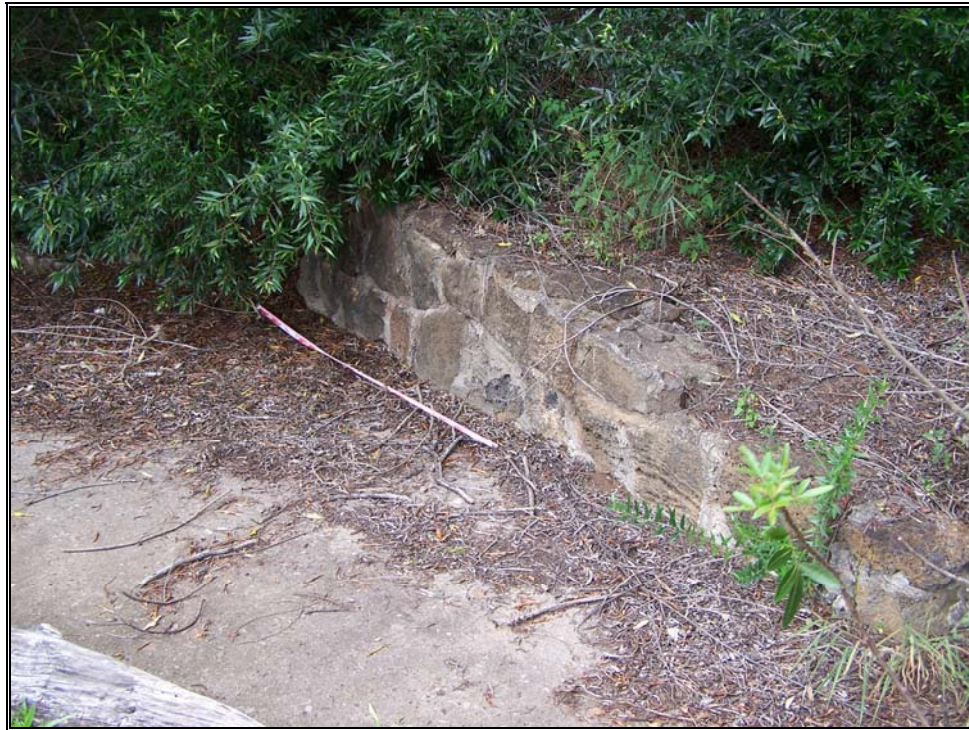
Figure 32. Cut basalt stone wall at the northeastern corner of SIHP# -26873, view to northeast

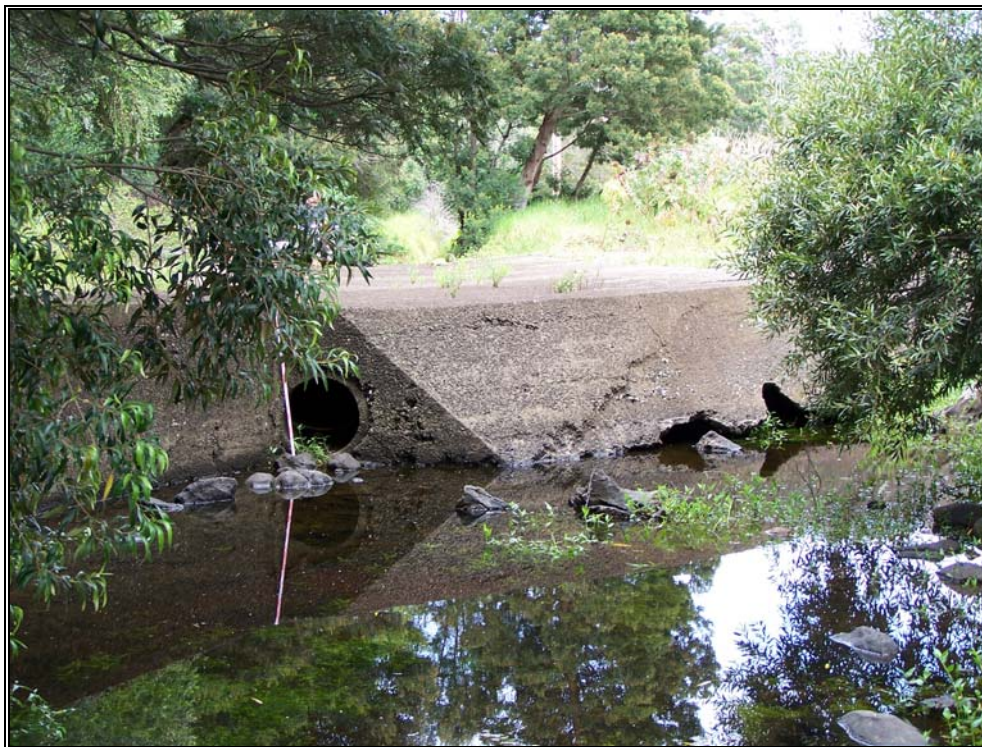
Figure 33. Western side of SIHP# 26873 showing culvert, view to east
