## **Assessment Report: Biological Impairment in the Upper Cullasaja River Watershed**

**Little Tennessee River Basin  
Macon County, N.C.**

**November 2002**

**North Carolina Department of Environment and Natural Resources  
Division of Water Quality  
Planning Branch**

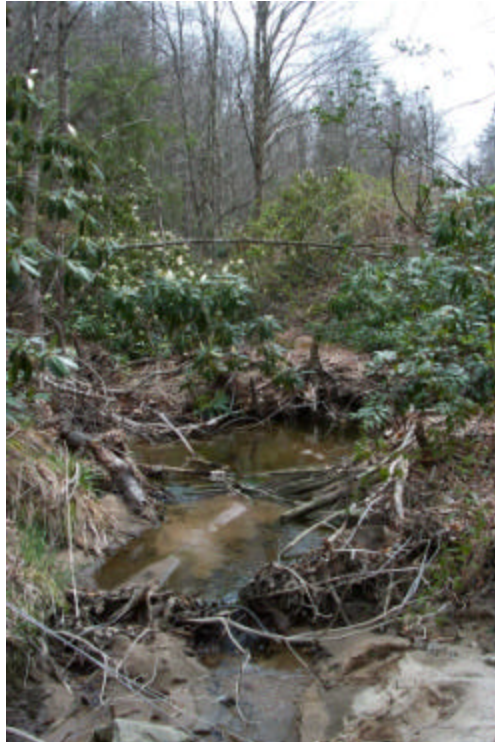
As mentioned above, the soils on the Highlands Plateau are very sandy and erodable. Land disturbance often results in erosion; build-up of coarse sand in streams below disturbed areas has been observed frequently (Figure 2.2). Development for home sites and commercial ventures is the main source of sedimentation in the watershed. Many homes are built on steep ridges, and driveways and construction sites without proper erosion control on these slopes are significant sources of sediment. When construction is sited on a creek, creek banks are sometimes cleared of vegetation, exposing bare soil and causing future bank instability.

Figure 2.2 Build-up of coarse sand in East Fork Salt Rock Branch below recent construction.

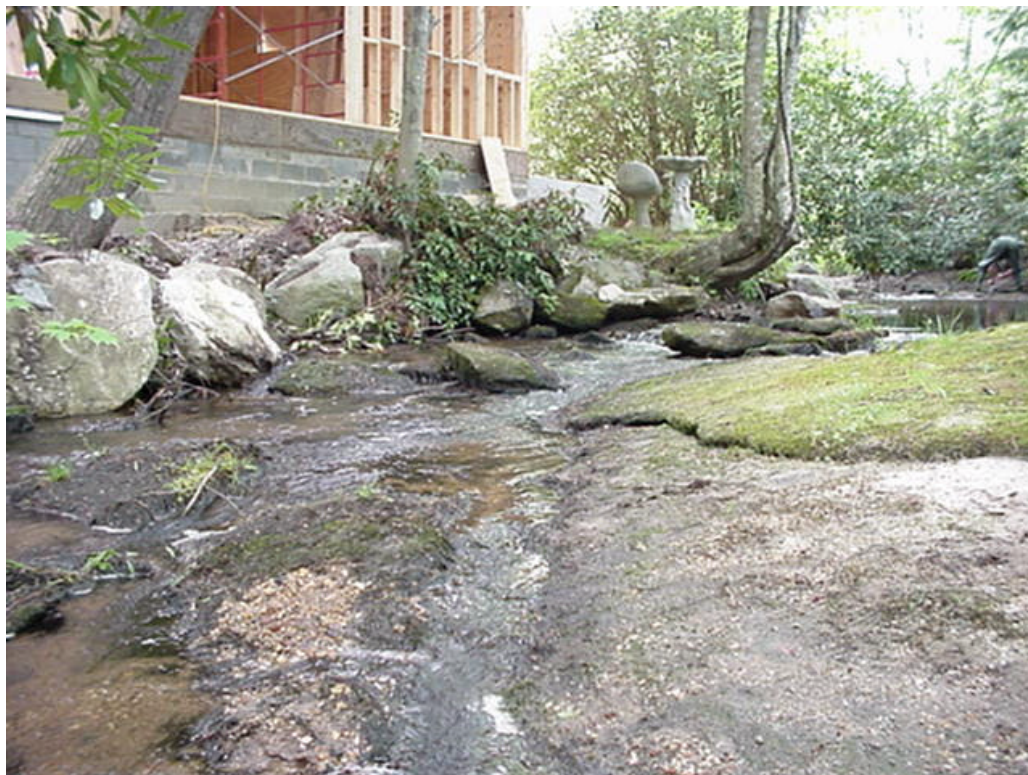
Figure 7.1 Construction of house on Mill Creek at 5<sup>th</sup> Avenue.

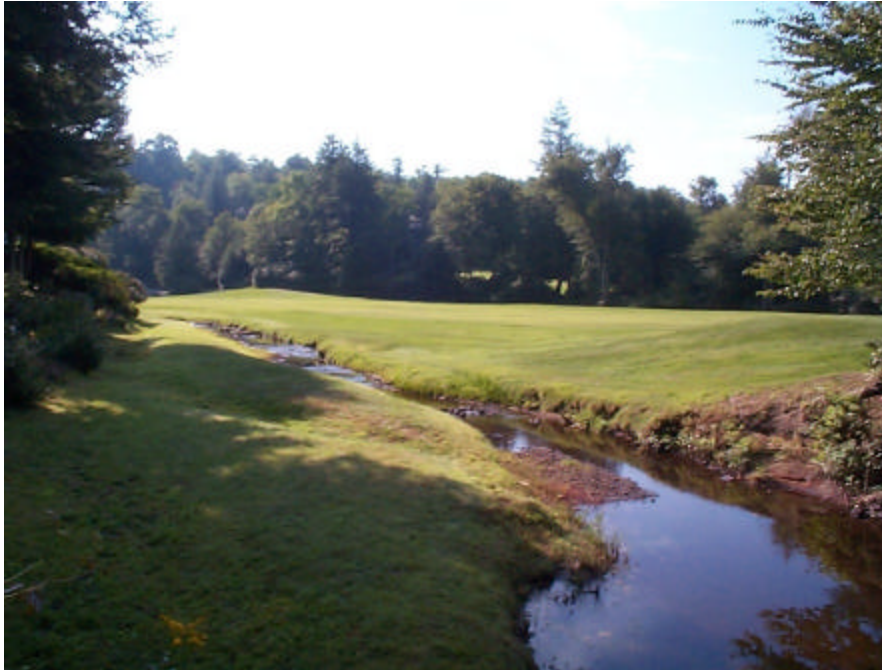
Figure C.1. The Cullasaja River running through a golf course.

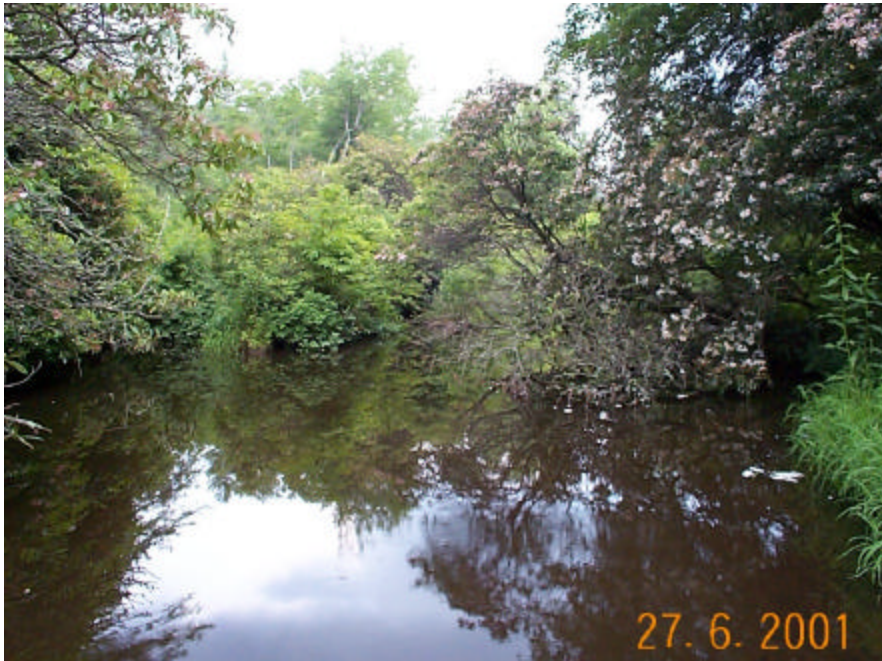
Figure C.2. Cullasaja River with forested buffer in golf course community.

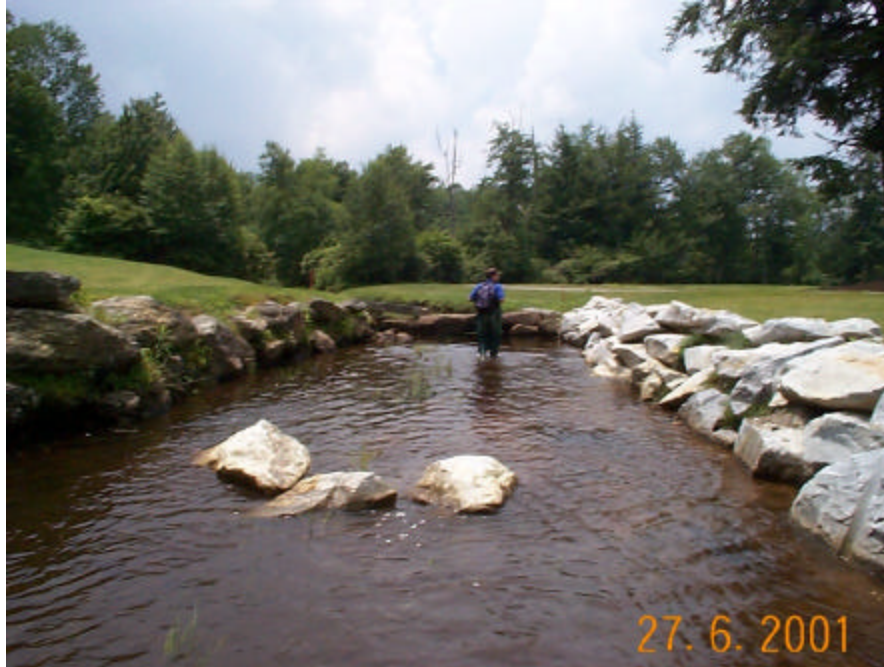
Figure C.3. Riprapped banks on the Cullasaja River in a golf course.

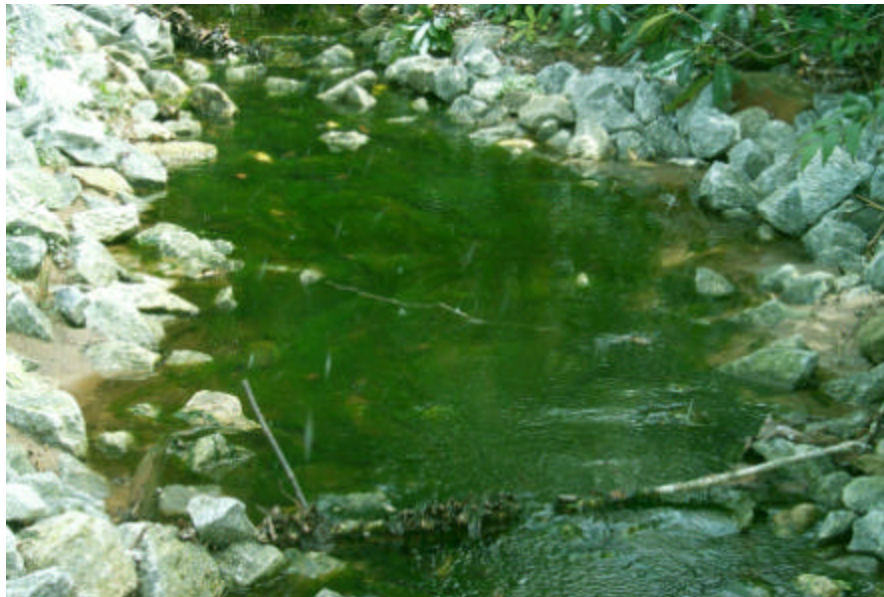
Figure C.4. Heavy growths of algae in East Fork Salt Rock Branch.
