Dagny Johnson Key Largo Hammock Botanical State Park

Advisory Group Draft Unit Management Plan

**STATE OF FLORIDA
DEPARTMENT OF ENVIRONMENTAL PROTECTION**

**Division of Recreation and Parks
August 2018**

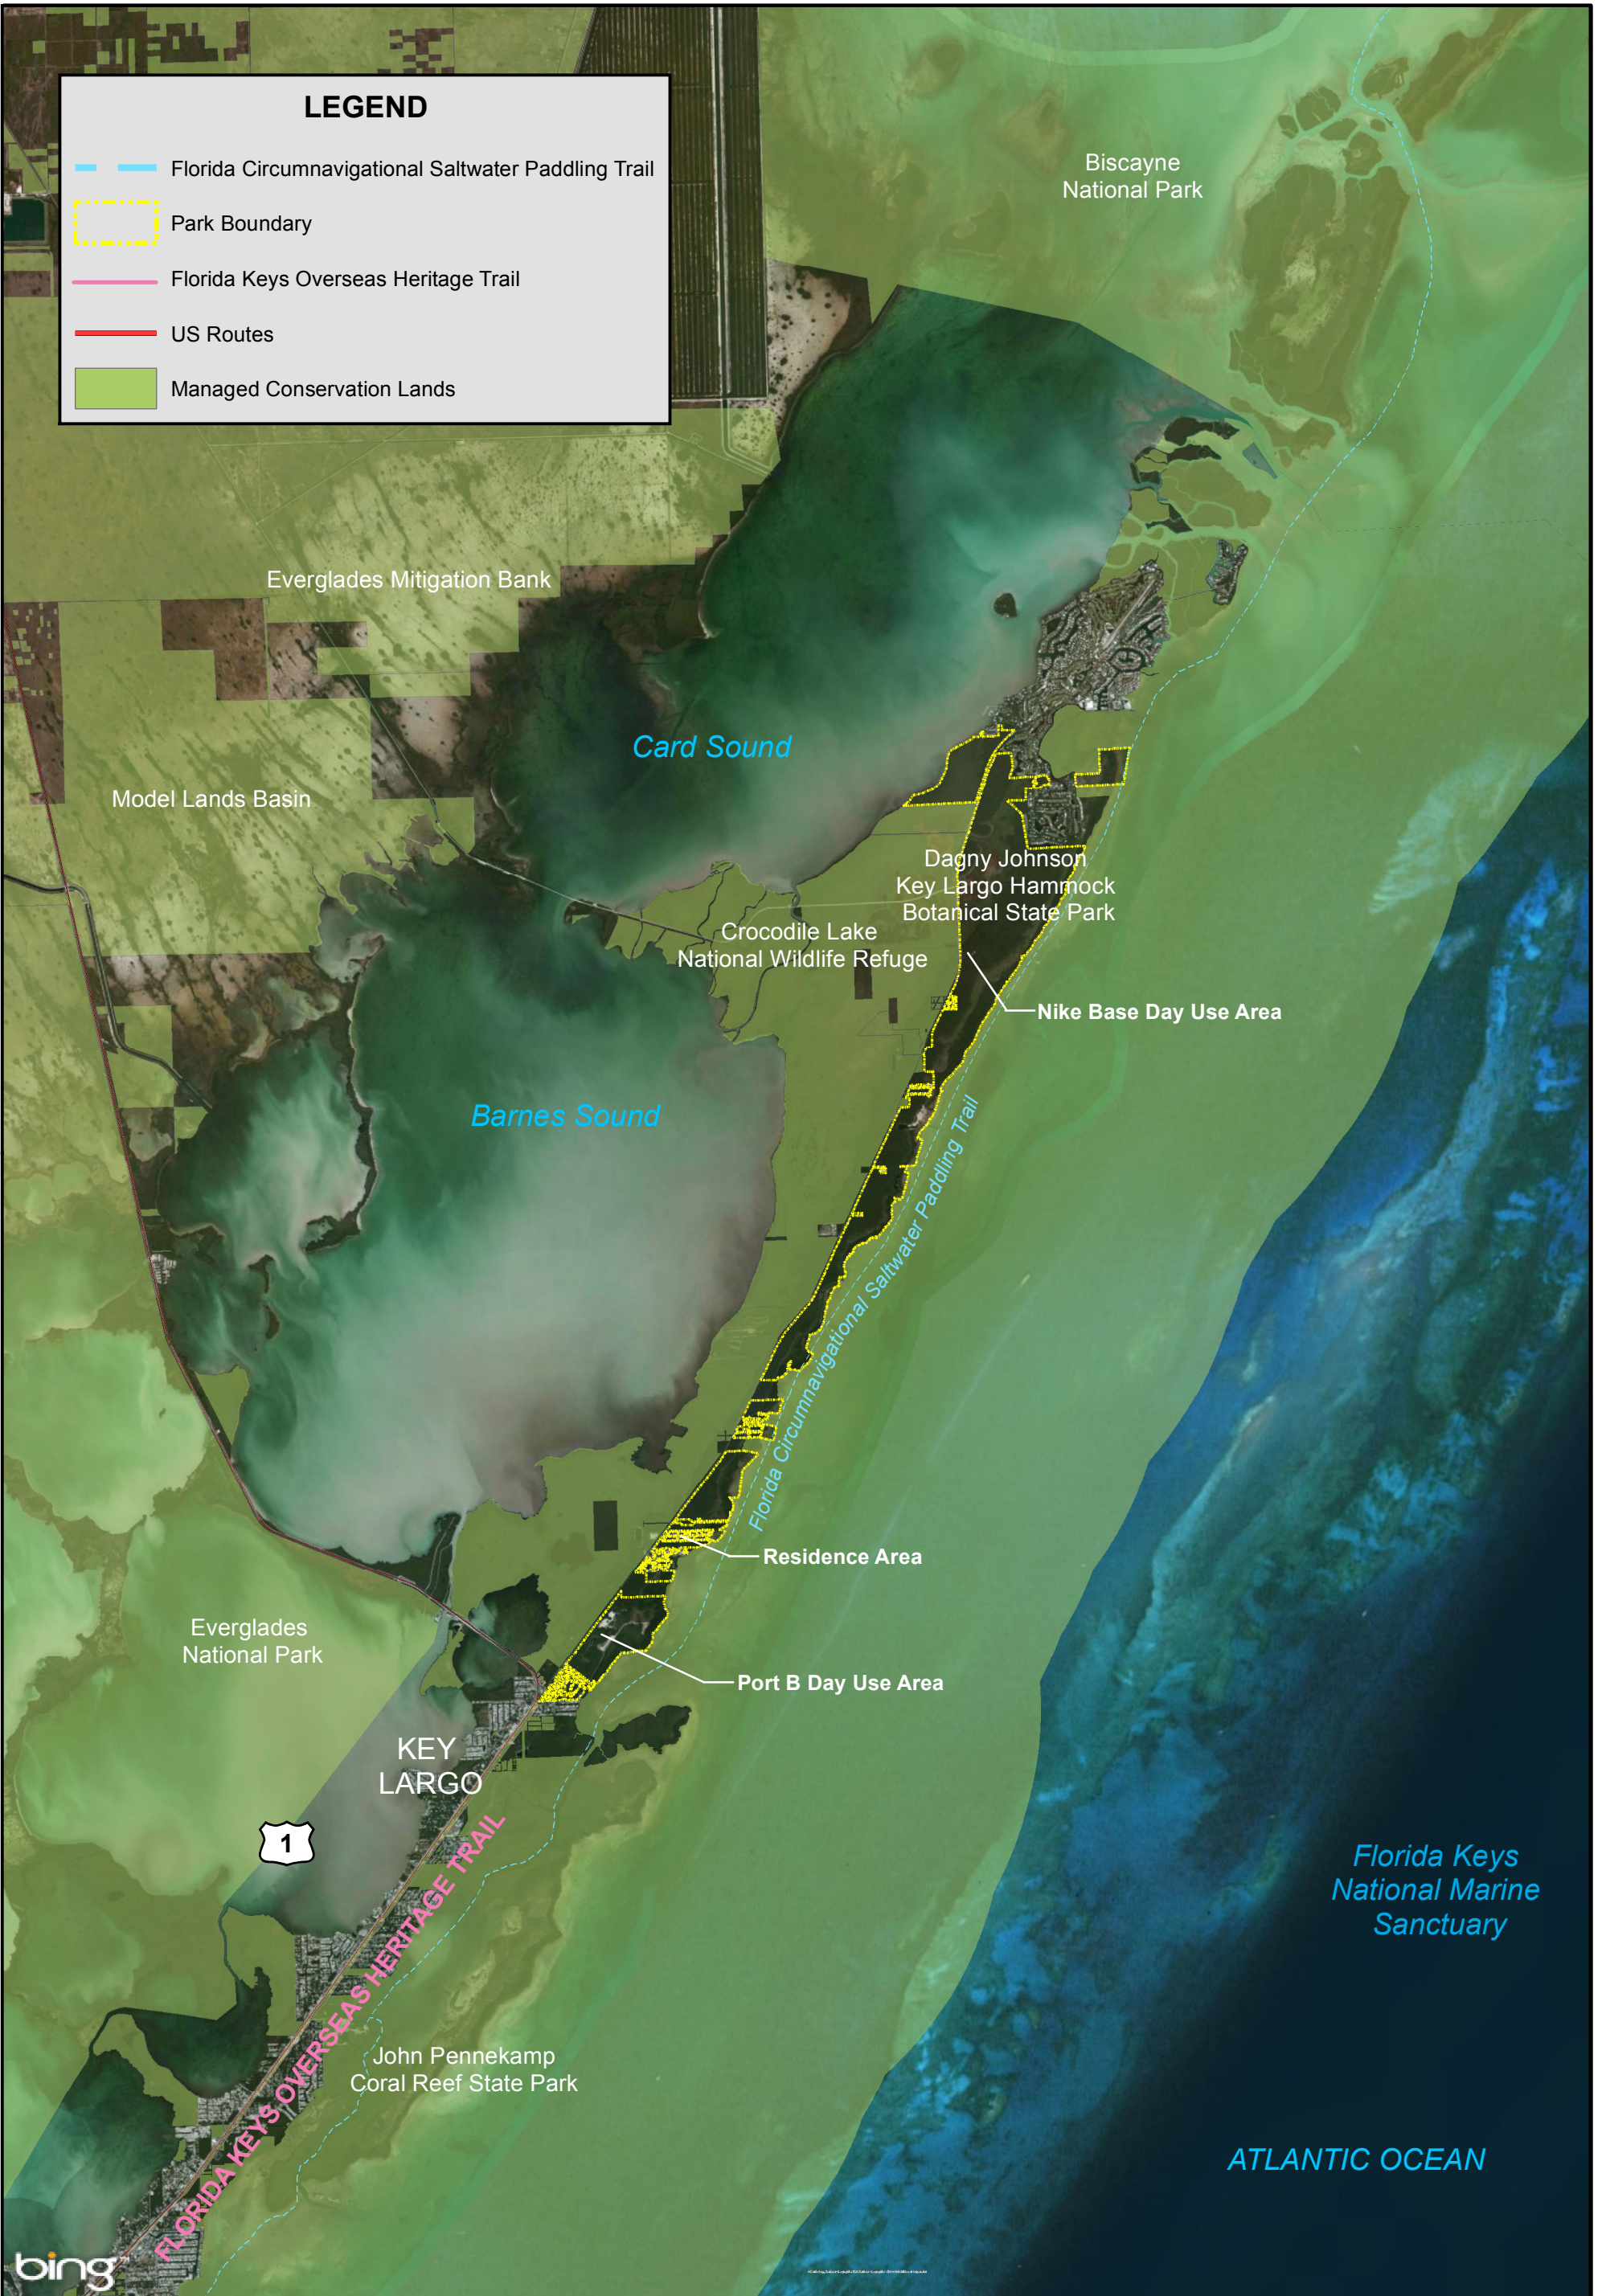
Dagny Johnson Key Largo Hammock Botanical State Park is located in Monroe County (see Vicinity Map). Access to the park is from the east side of CR 905 near the intersection with U.S. Highway 1 at MM 106 (see Reference Map). The Vicinity Map also reflects significant land and water resources existing near the park.

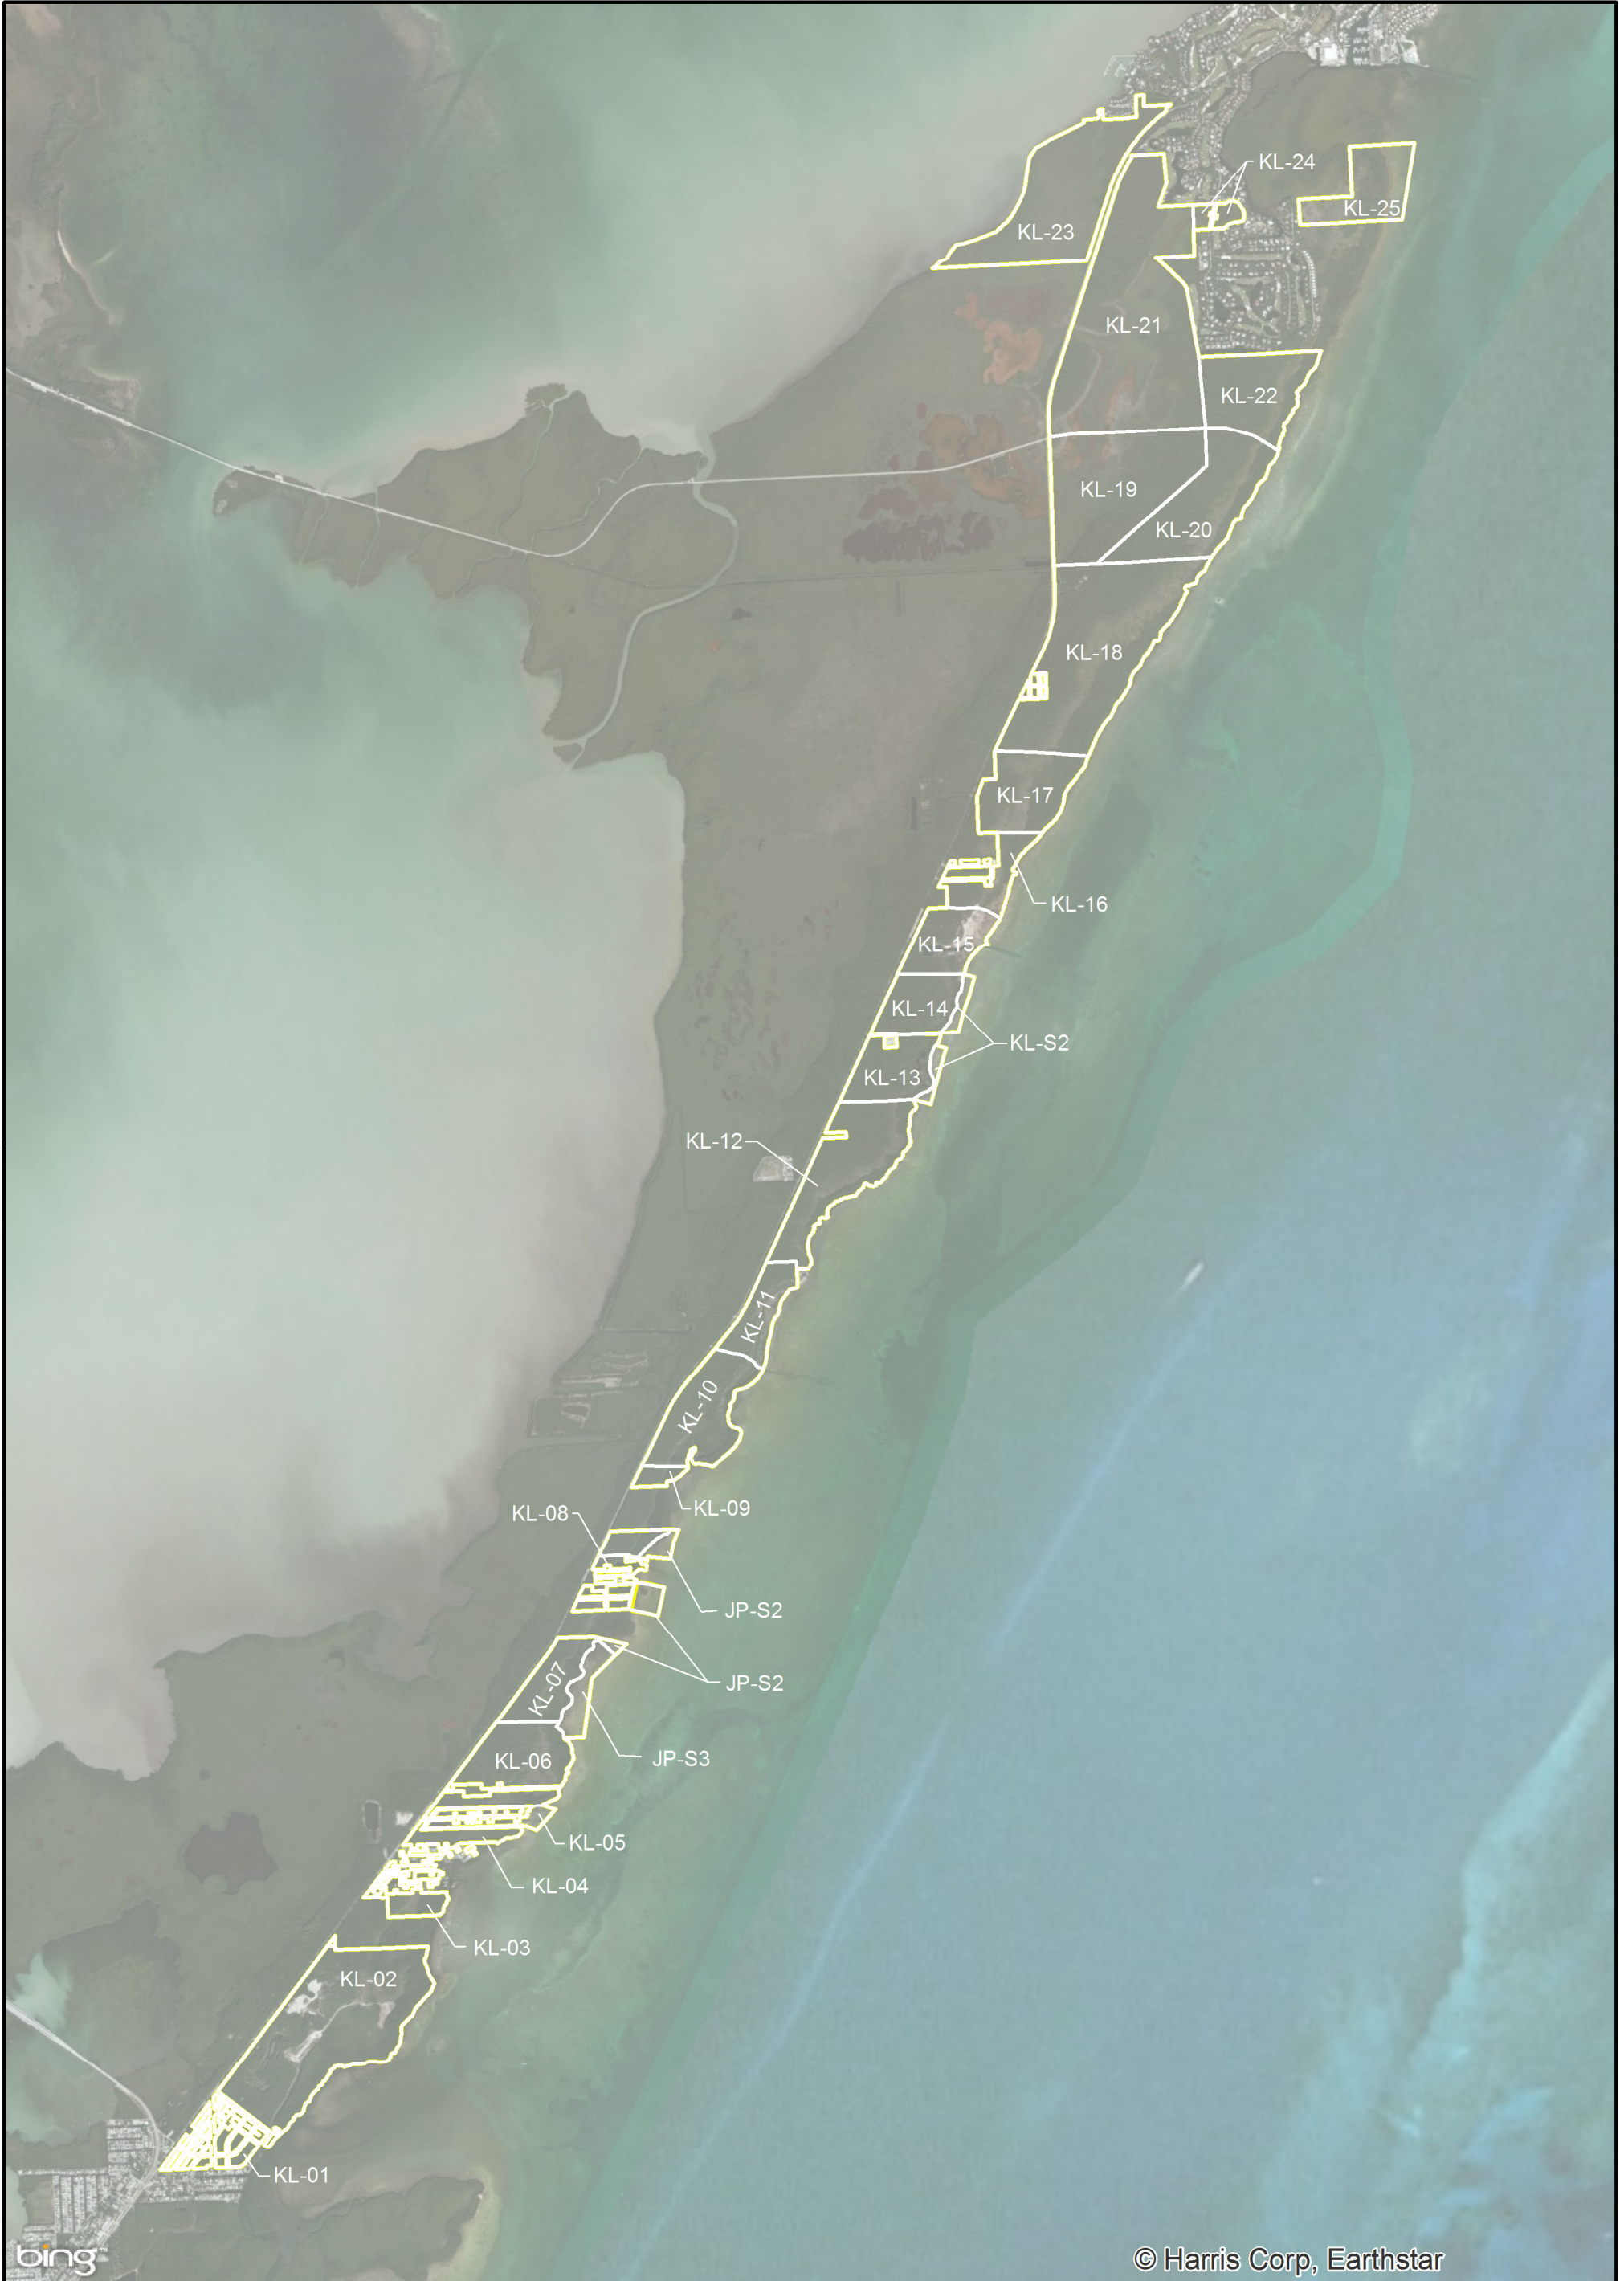
DAGNY JOHNSON KEY LARGO
HAMMOCK BOTANICAL STATE PARK

The entire park is divided into management zones that delineate areas on the ground that are used to reference management activities (see Management Zones Map). The shape and size of each zone may be based on natural community type, burn zone, and the location of existing roads and natural fire breaks. It is important to note that all burn zones are management zones; however, not all management zones include fire-dependent natural communities. Table 1 reflects the management zones with the acres of each zone.

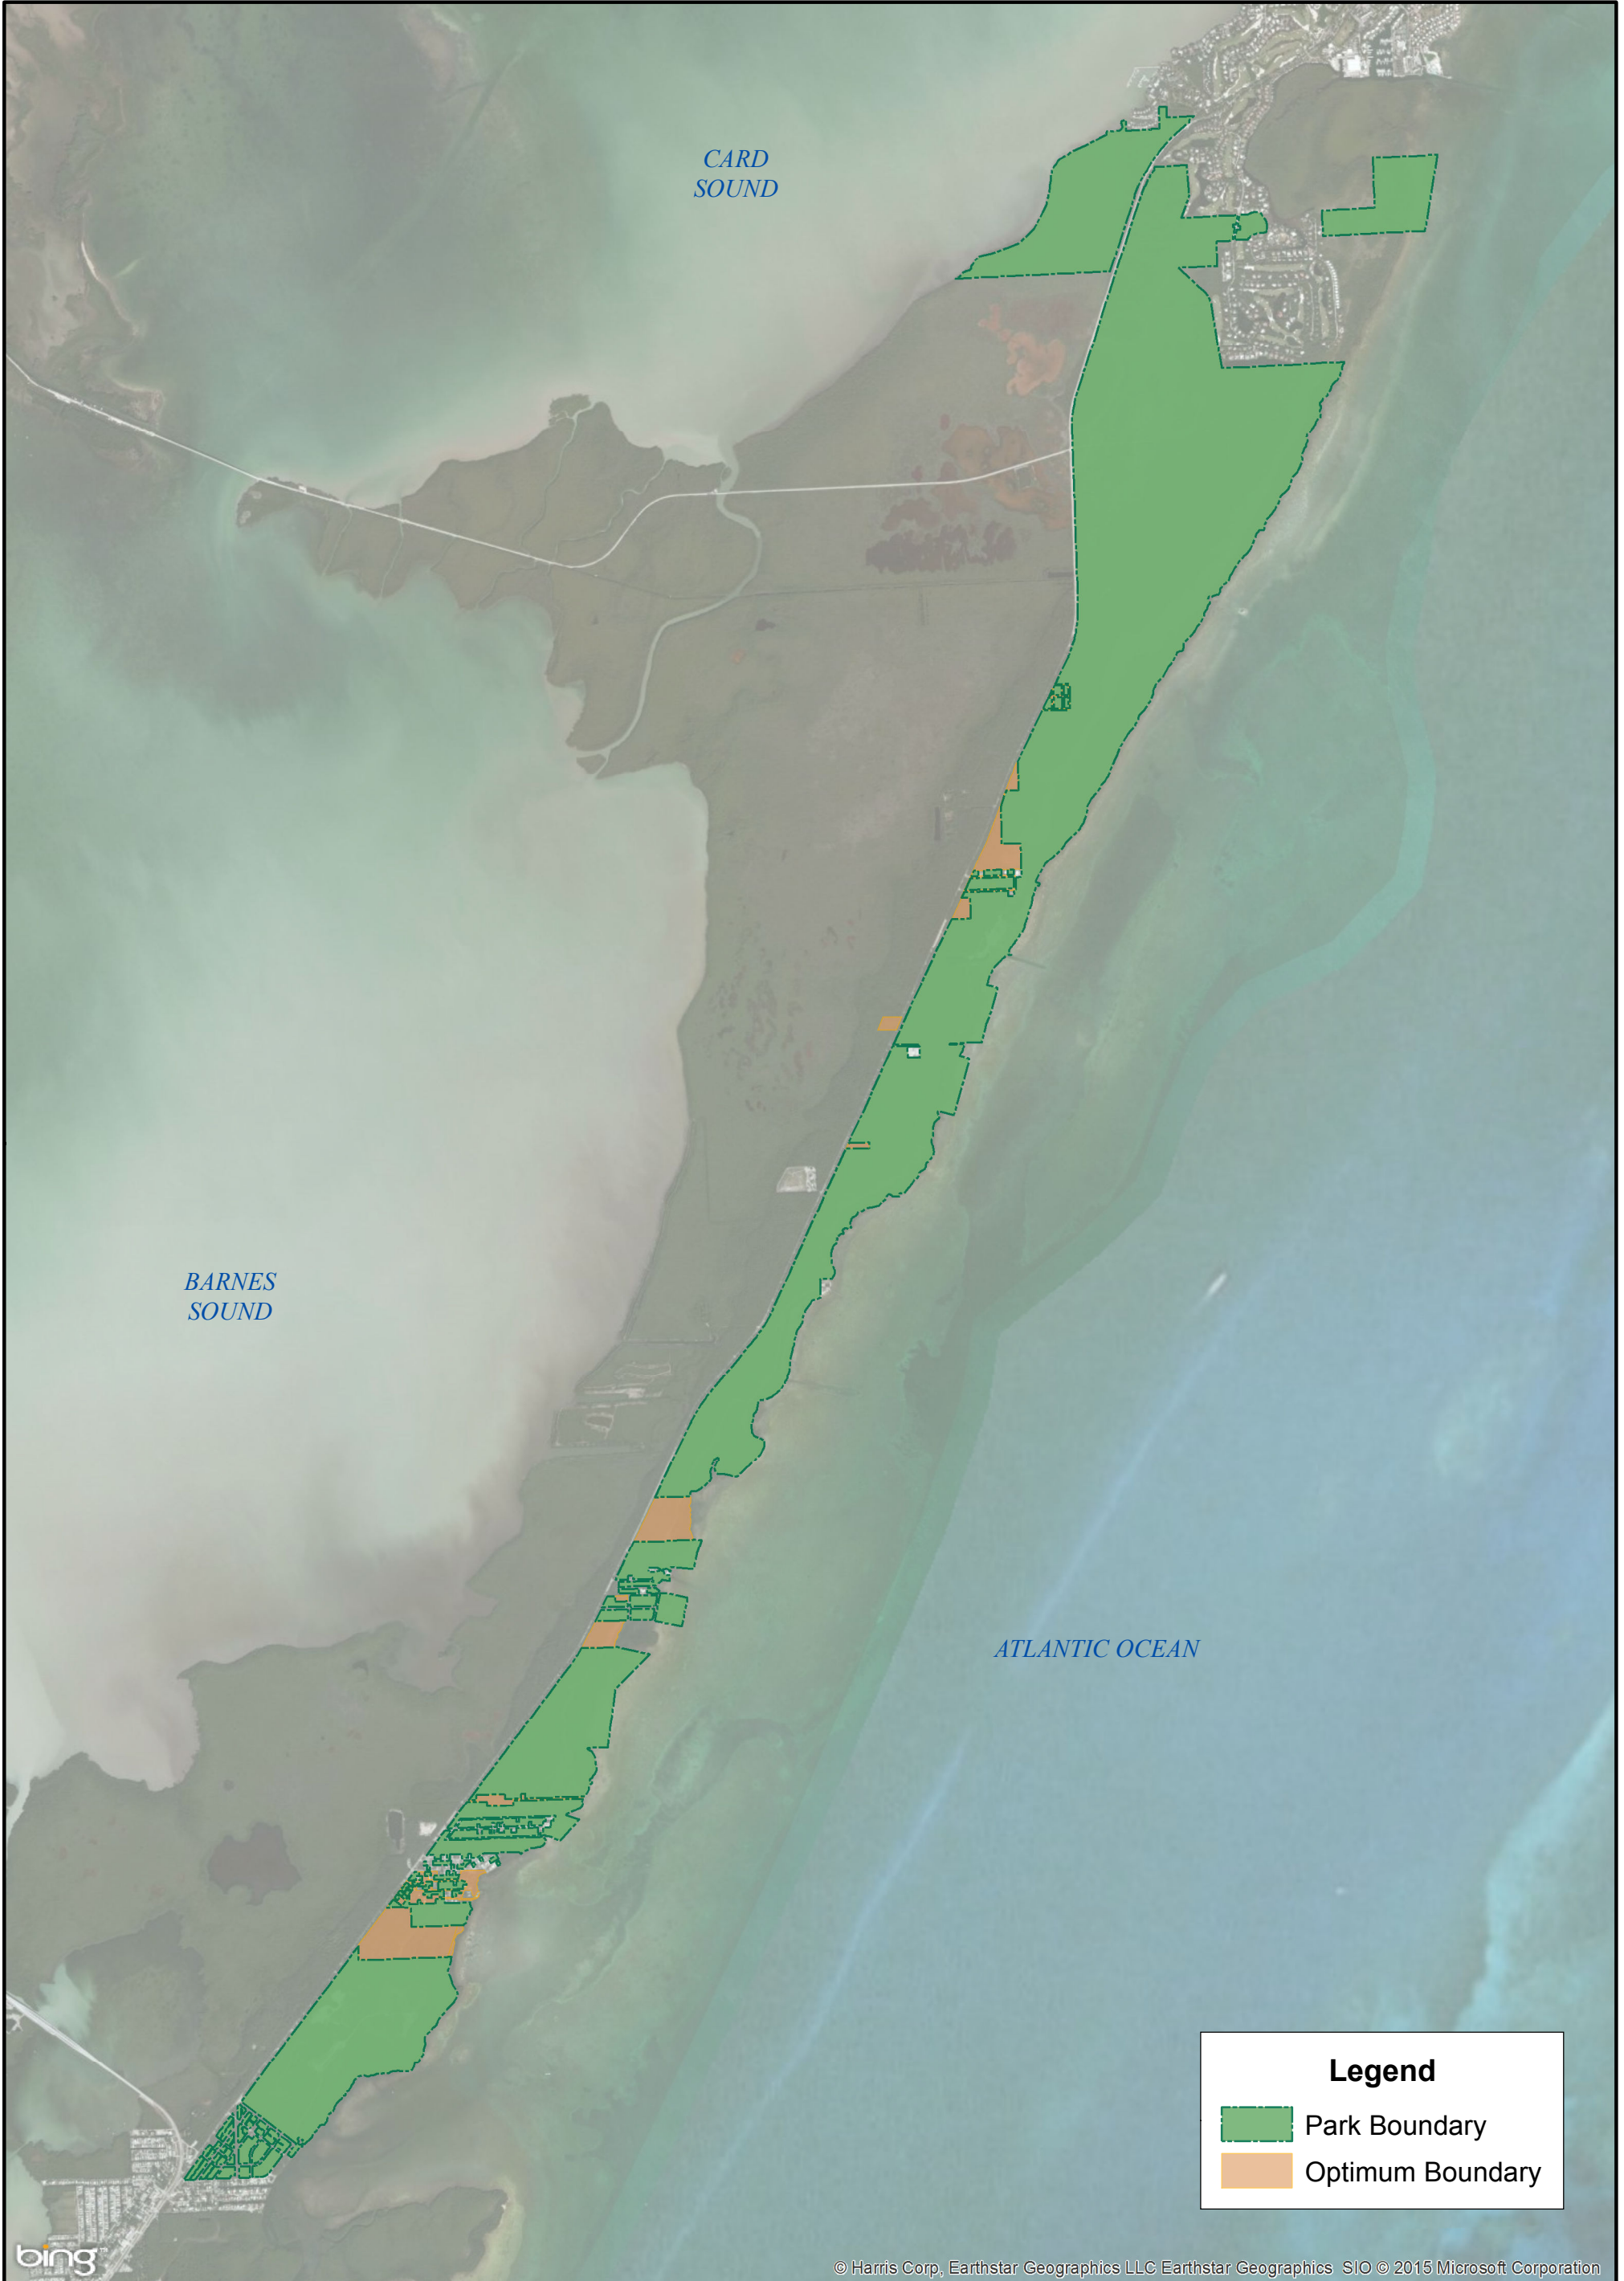
Identification of parcels on the optimum boundary map is intended solely for planning purposes. It is not to be used in connection with any regulatory purposes. Any party or governmental entity should not use a property's identification on the optimum boundary map to reduce or restrict the lawful rights of private landowners. Identification on the map does not empower or suggest that any government entity should impose additional or more restrictive environmental land use or zoning regulations. Identification should not be used as the basis for permit denial or the imposition of permit conditions.

Due to the numerous efforts to develop north Key Largo, numerous inholdings remain to the east of CR 905 often creating a discontinuous system of parcels managed by the park and parcels left over from the original planned subdivisions. By acquiring the selected parcels spread throughout the rockland hammock on the east side of CR 905, around 151 acres in total, the park will be able to better manage the unique and sensitive natural communities of north Key Largo in accordance with the park's purpose for acquisition. At this time, no lands are considered surplus to the needs of the park.

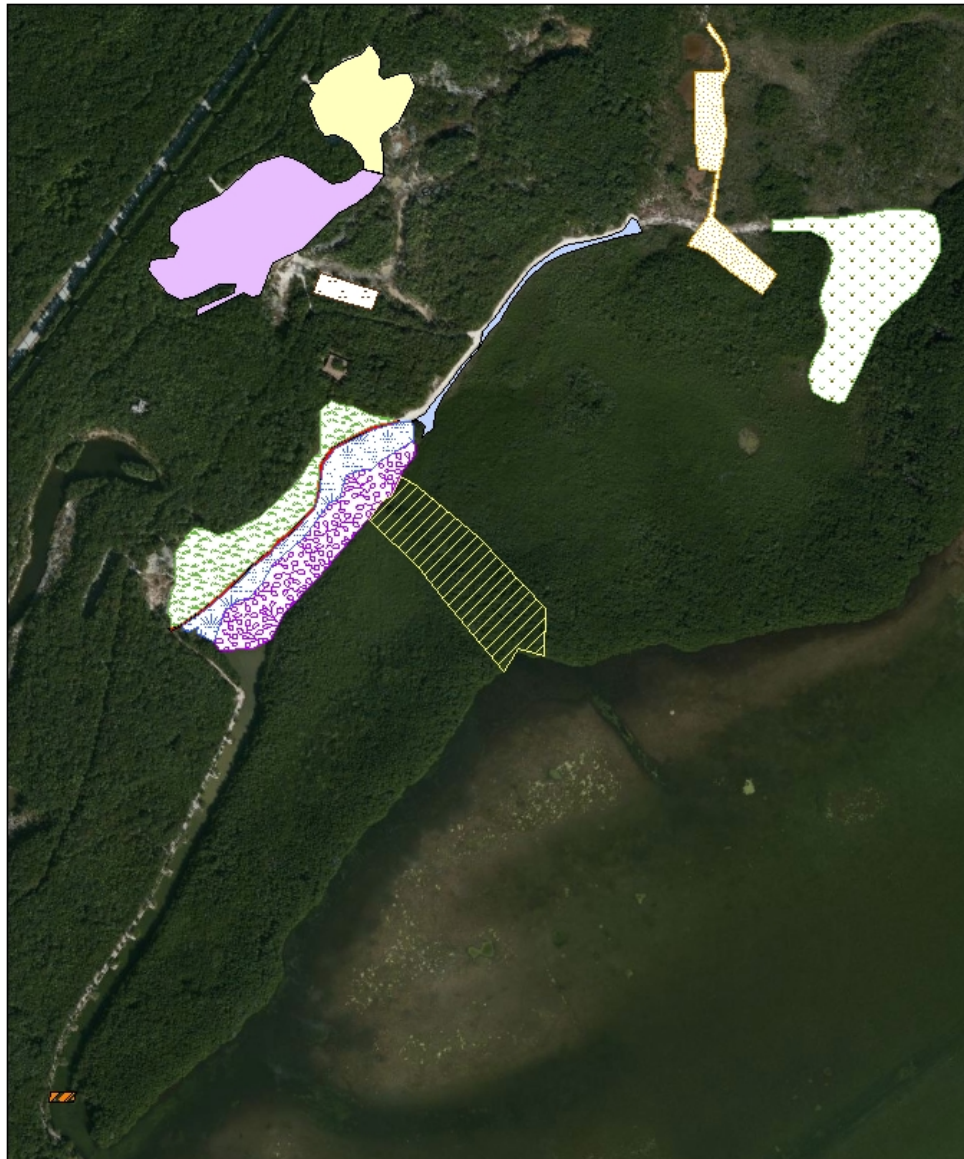
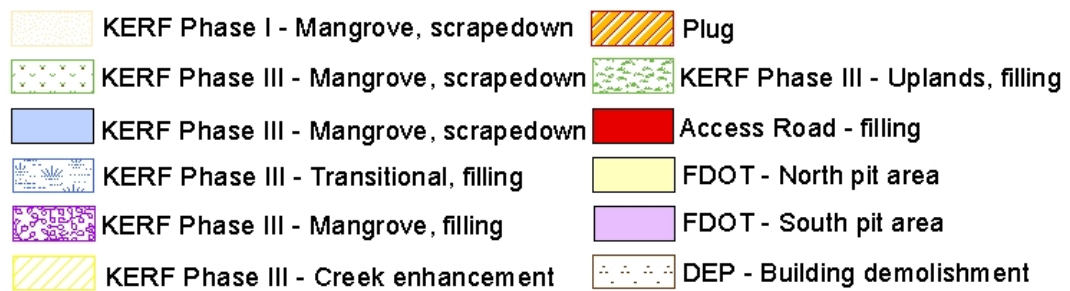
Figure 1: Restoration efforts by area

A current phase of restoration is slated to begin in March 2016. This phase will see the removal of the remaining buildings/structures and fill associated with the initial development. Most of the old roads in the area will also be removed, except for the section located in the current day-use section which will be minimized to twelve feet. The areas will be graded down to match surrounding natural elevations. (Figure 2) All acceptable materials which are produced in the course of demolition will be used to fill in the remaining open marina basin and

Port Bougainville Past Restoration Overview

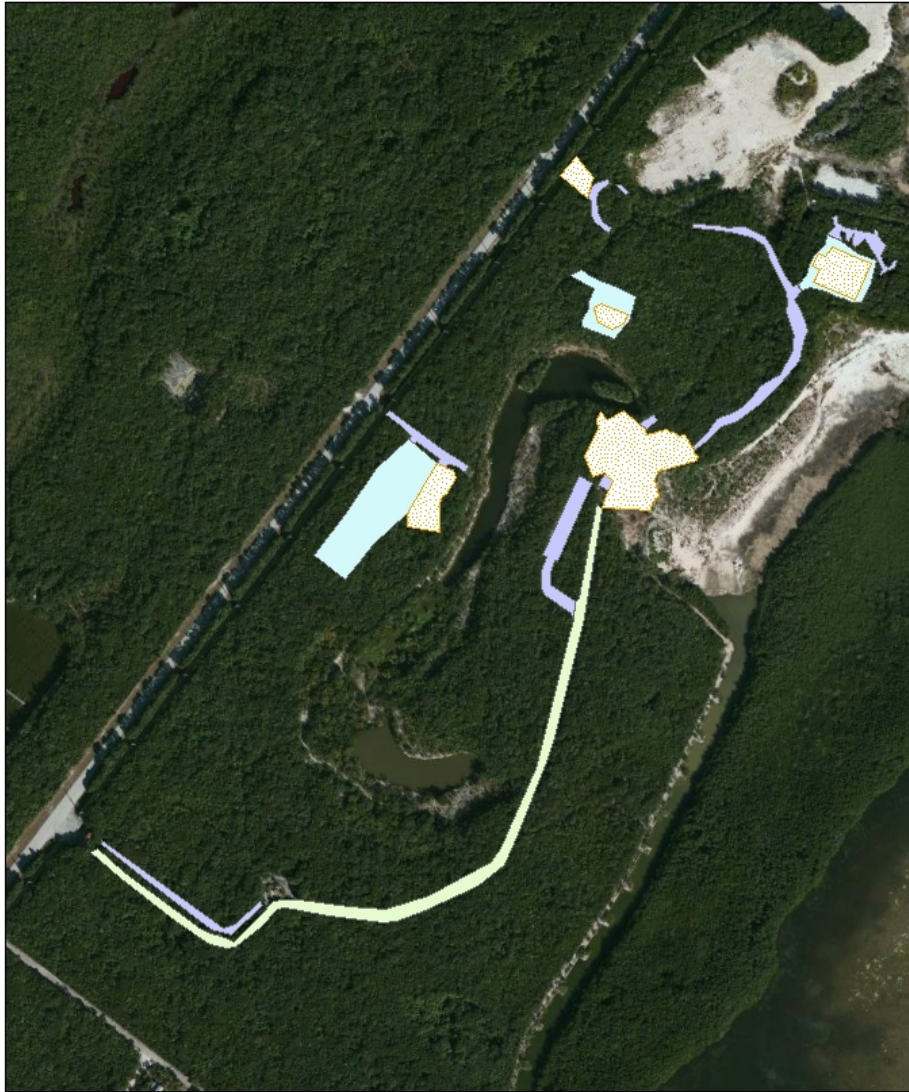
Figure 2: Currently scheduled restoration locations.

Port Bougainville Current Restoration

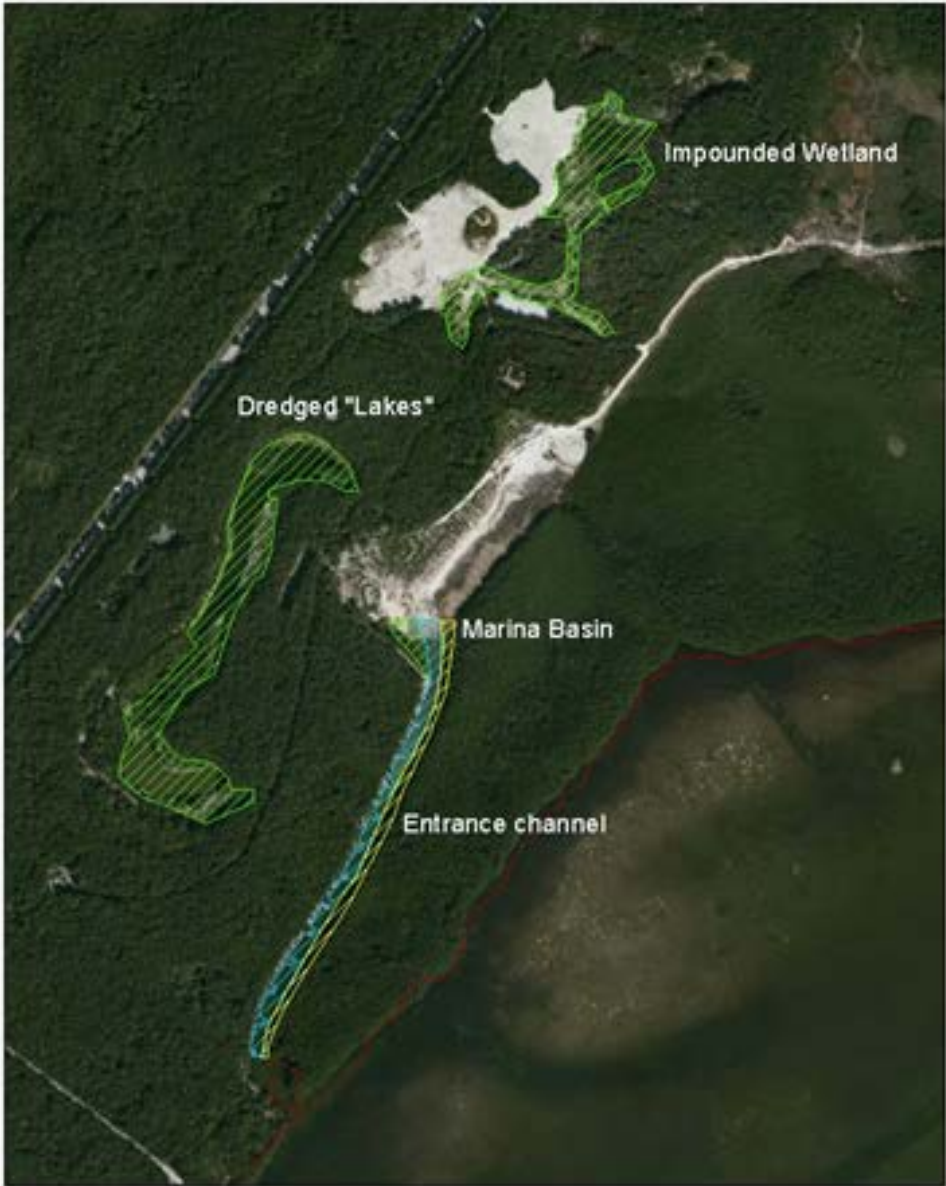
Figure 3: Remaining restoration locations.

Port Bougainville Restoration Remaining

- Remaining upland restoration: approx. 10.66 acres
- Remaining transitional wetland restoration: approx. 1.72 acres
- Remaining mangrove restoration: approx. 1.14 acres

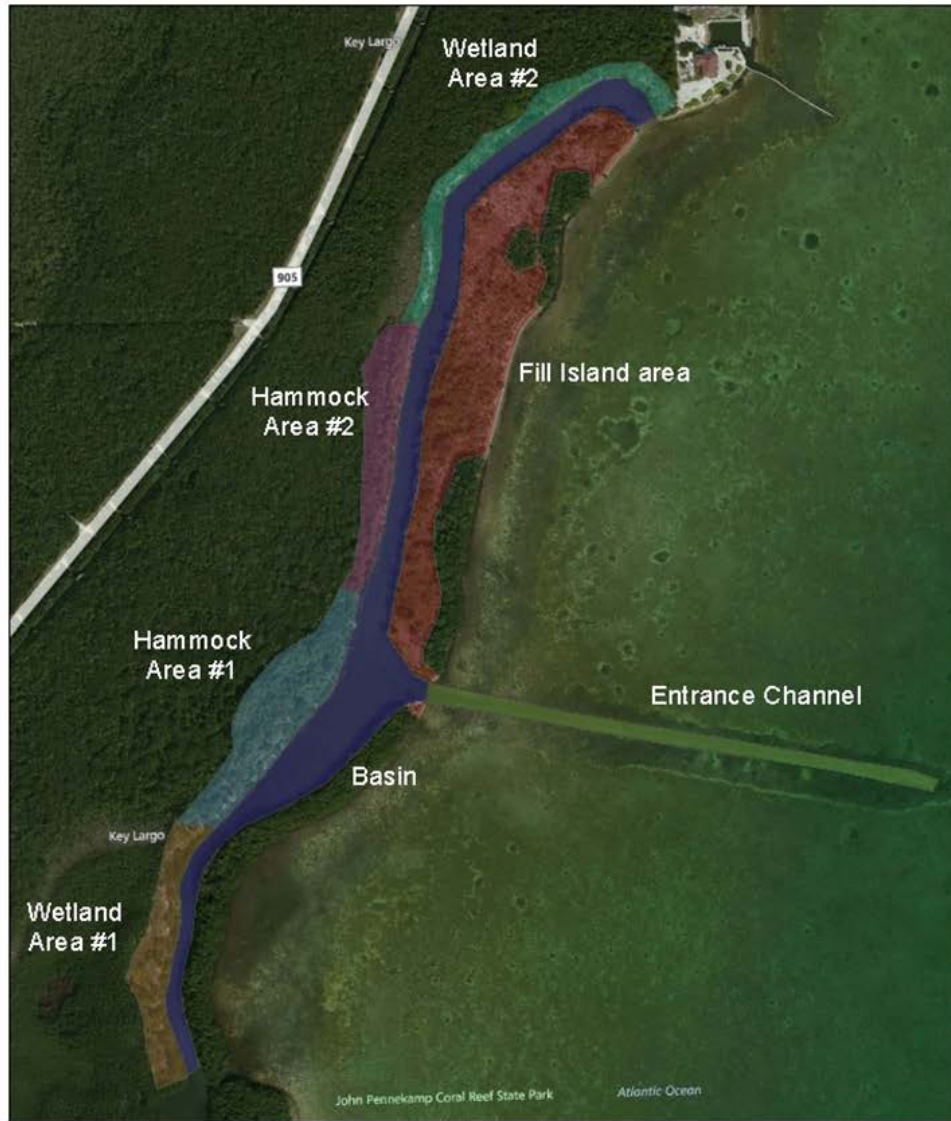
Ocean Forest Estates - Needed Restoration

Hammock Area #1	3.2 acres	67,200 cu yrds
Hammock Area #2	2.0 acres	64,320 cu yrds
Wetland Area #1	1.8 acres	17,280 cu yrds
Wetland Area #2	2.5 acres	19,200 cu yrds
Fill Island	9.9 acres	182,400 cu yrds

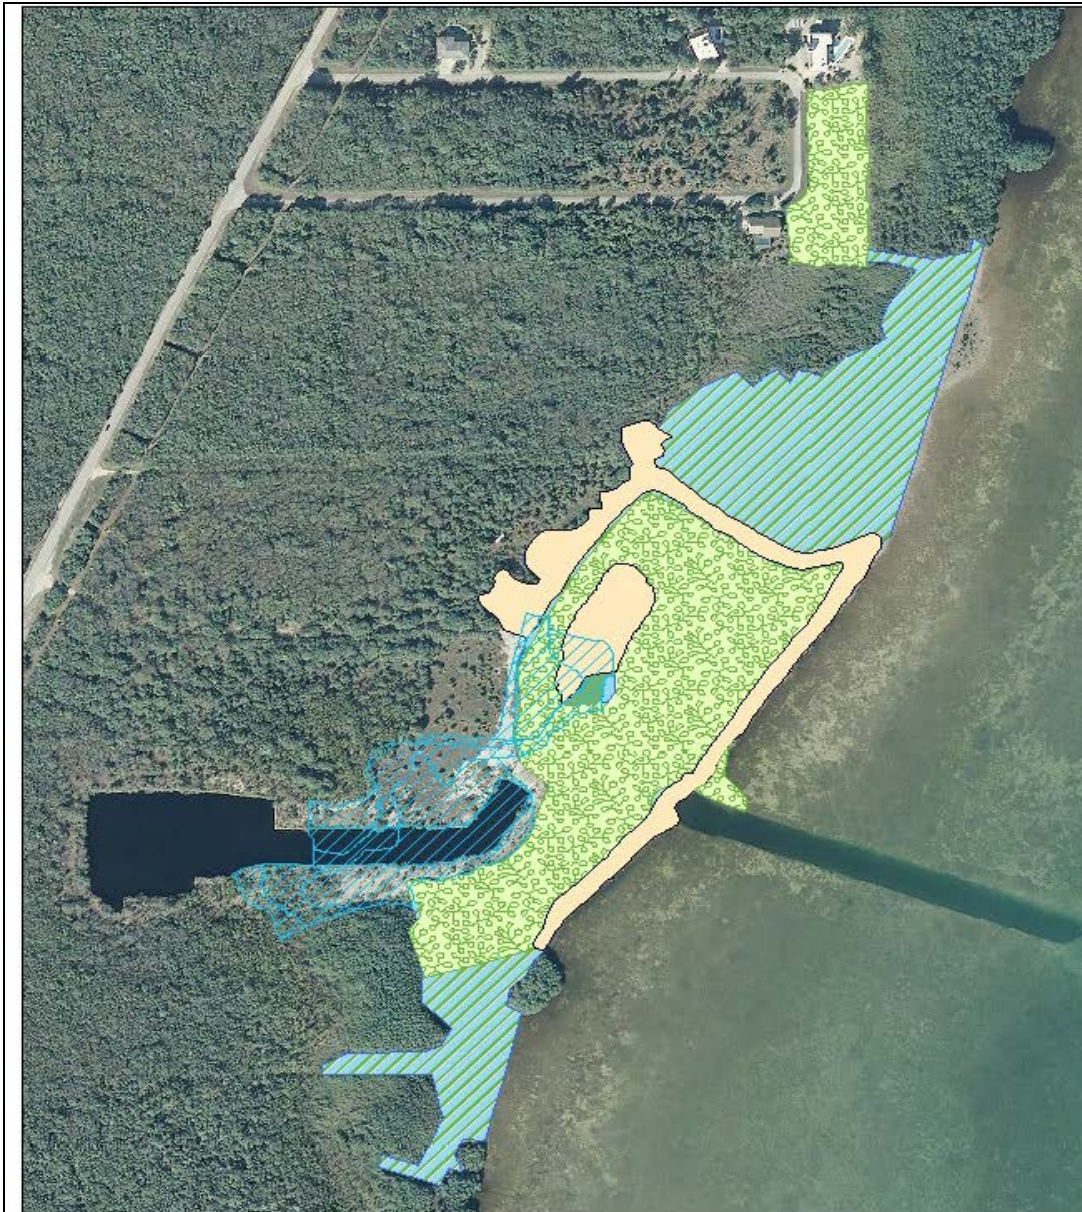
Figure 7: Overview of restoration activities at Carysfort Marina.

Carysfort Marina Restoration: 32.08 Acres of Wetland Restoration

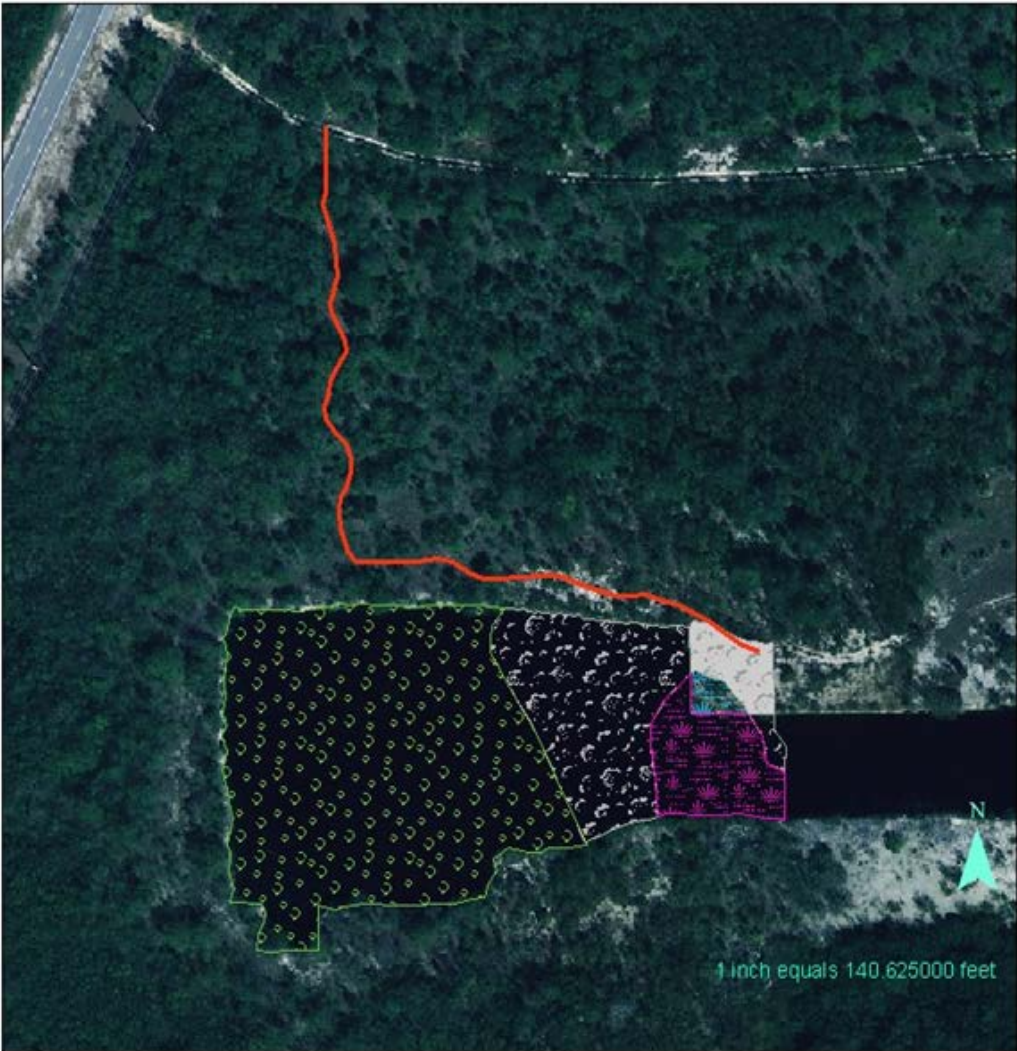
Figure 8: Remaining restoration needs at Carysfort Marina.

Remaining Restoration:
1.02 acres of wetland restoration
1.96 acres of hammock restoration
