**Vegetation Flora, Fauna and Environmental  
Considerations Report  
CPS 8400/1 Neds Corner Road Widening, South Coast  
Hwy to Yerritup Road**

Report – Environmental Officer, Katie White BSc (Hons)

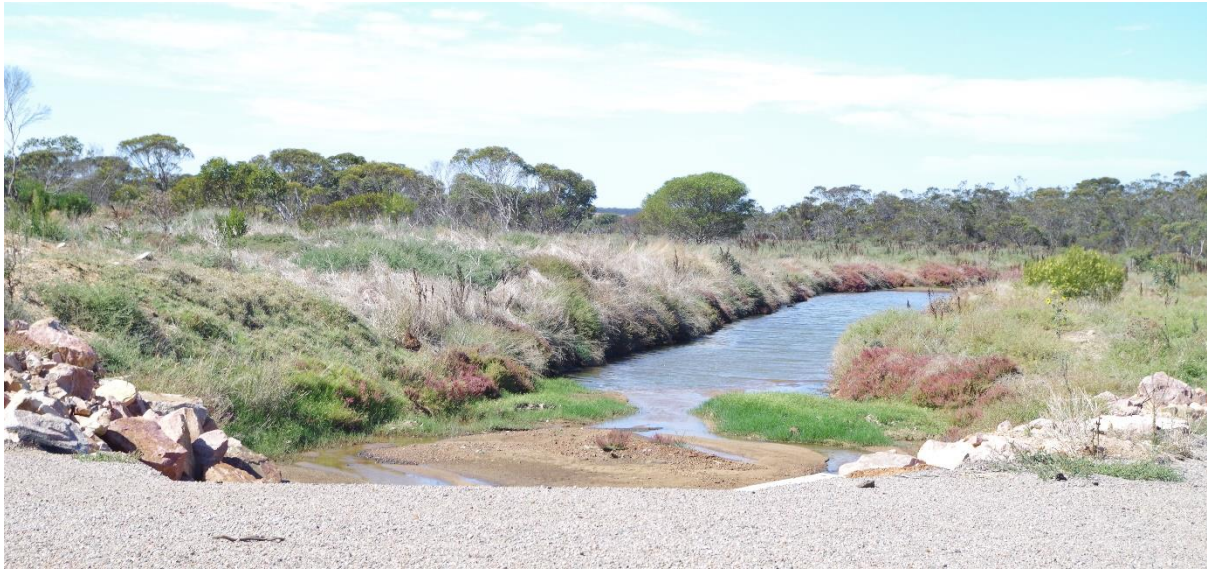
**Figure 2.** Minor creek crossing along Neds Corner Rd, approximately 2.5 km north of South Coast Hwy and within CPS 8400 area. Photo taken facing in a westerly direction.

A minor creek course intersects Neds Corner Rd, approximately 2.5 km north of South Coast Hwy (Figure 2). The road has been designed in this area with extremely large drainage pipes and shaped to allow for water flow across the road if the creek rises during a flooding event (Figure 3). The road construction design has therefore been purposefully engineered to prevent disrupting natural hydrological regimes. This will continue to be a consideration during the re-construction and widening phase, with minimal impact on the hydrological flow and course from what has already been historically impacted. Additionally, works will only be conducted during dry soil conditions, without flowing water. The vegetation surrounding the creek-line is already extremely degraded, with dominance of vegetation invasive weeds that have suffocated the native vegetation. This included Thistles, Sunflowers, Kikuyu grass, Cooch grass, African Lovegrass, Rose Pelargonium and Sorrel.

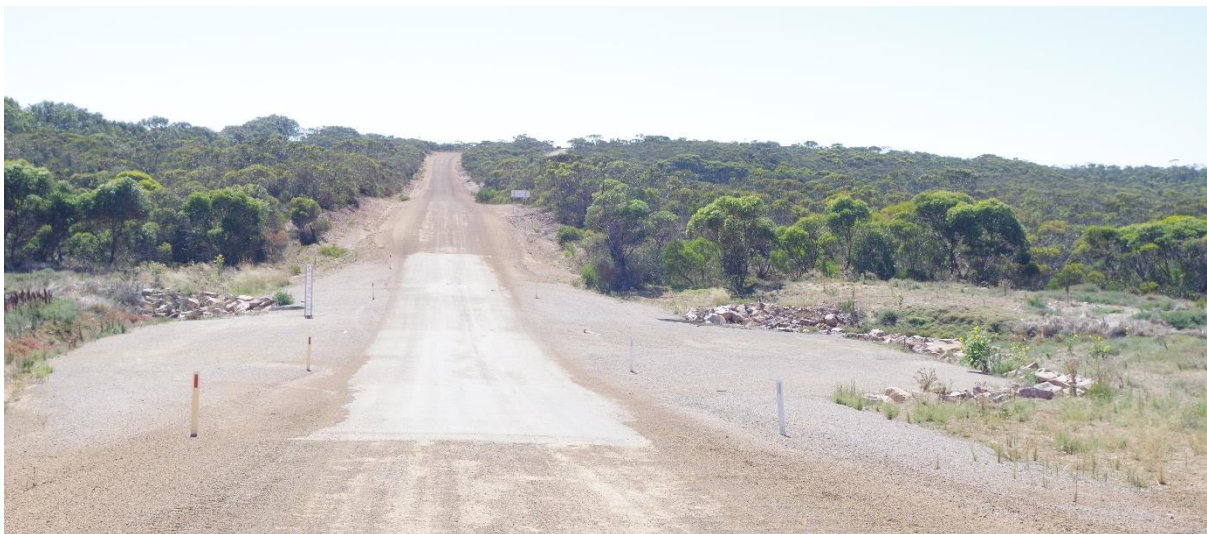
**Figure 3.** Road design along Neds Corner Rd at minor creek-line crossing been particularly shaped to allow free water flow and not interrupt hydrological water flows. Photo taken facing in a northerly direction.

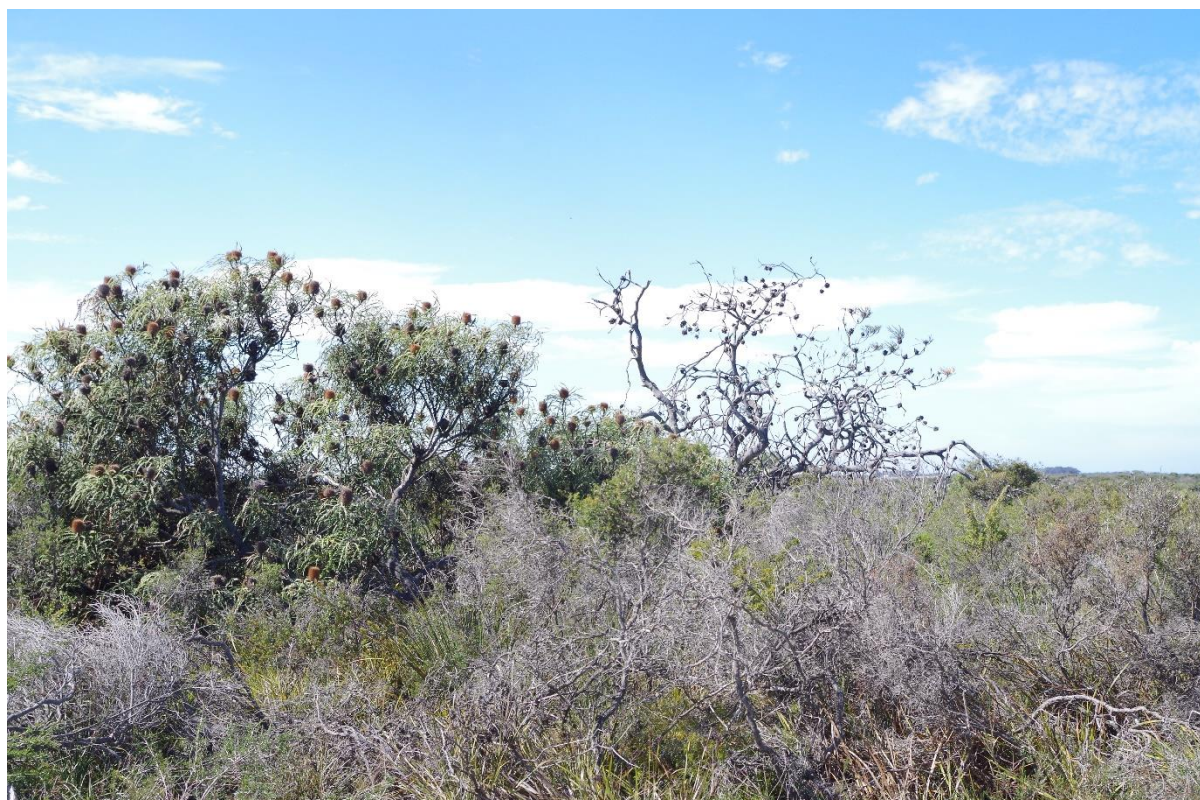
**Figure 4.** Dead *Banksia speciosa* plants interspersed with healthy *B. speciosa* and other Proteaceae species. Unknown whether plants have senesced or been killed by *Phytophthora cinnamomi* dieback. Photo taken facing in an easterly direction within Vegetation Type 1 (Table 5).

Along Neds Corner Rd, directly north of South Coast Hwy intersection for 300 m within Vegetation types 1 and 2, many large *Banksia speciosa* plants were observed dead (Figure 4; Table 5). However, it is evident that vegetation is long unburnt and *B. speciosa* plants are extremely old. It is therefore highly possible vegetation could be just senescing. Many healthy *B. speciosa* plants and other

Proteaceae species were observed as well. It is indeterminable without formal testing, but remains possible, that dieback is present.

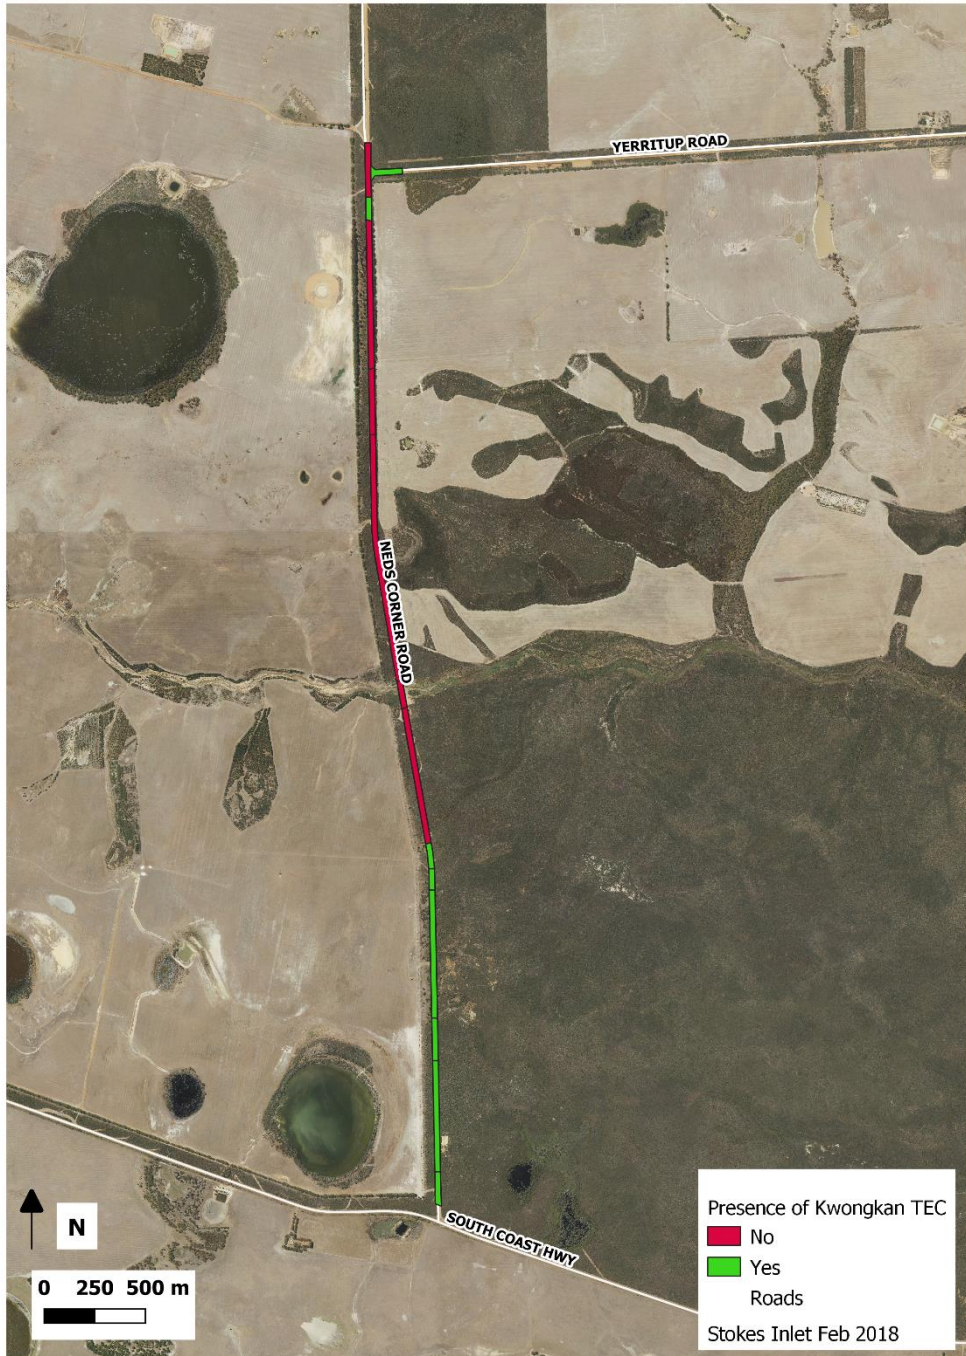
**Figure 5.** Presence of Threatened Ecological Community 'Proteaceae Dominated Kwongkan Shrubland' within CPS 8400, Neds Corner Rd widening area.

Community status was identified (Table 5). Mapping indicates that of the vegetation cleared during the widening project, will result in 2.04 ha of Proteaceae Dominated Kwongkan Shrubland, Threatened Ecological Community, being cleared. The remaining 3.36 ha does not meet TEC criteria. Of the 2.04 ha of Proteaceae Dominated Kwongkan Shrubland, 0.642 ha is in 'poor' condition, 0.2 is in 'good' condition and 1.237 is in 'very good' condition. A variety of disturbance impacts, such as rubbish, previous mining of gravel, dead plants and invasive weeds influenced these conditions, as outlined in Table 5. There are 14 vegetation changes along the permit area as a transect, with 8 different vegetation associations identified.

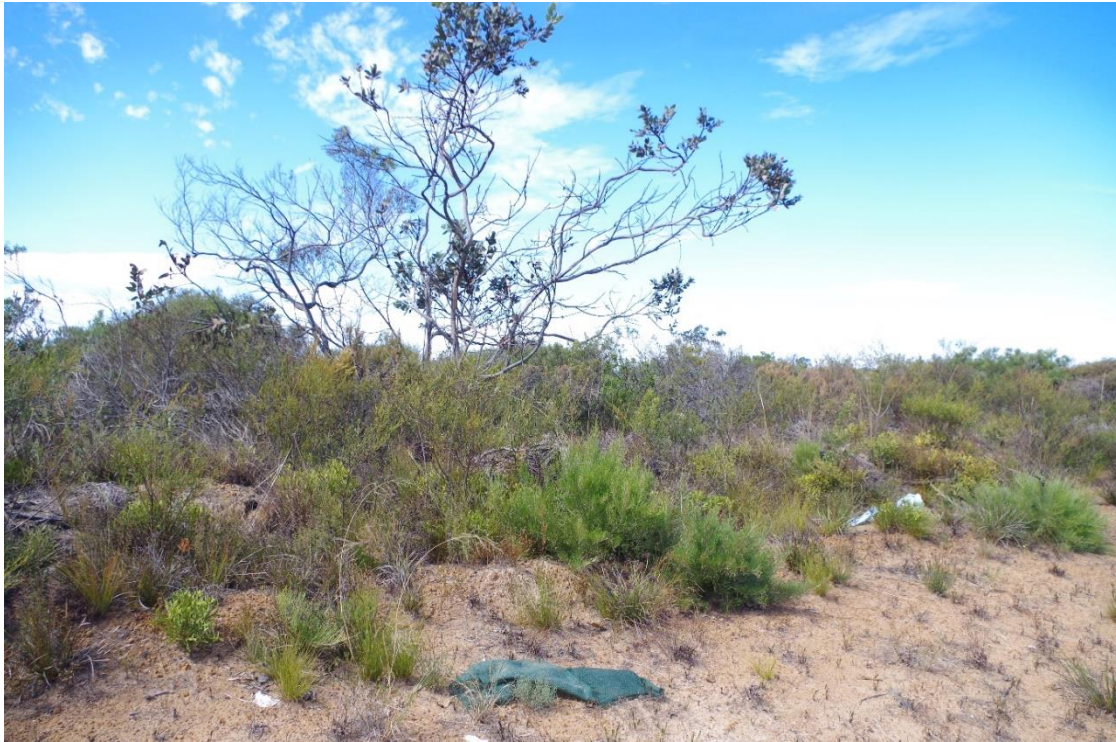
**Figure 7.** Vegetation Type 1 showing Scattered *Nuytsia floribunda* and *Eucalyptus pleurocarpa* overstorey, with dense heathland midstorey, with dominant *Calothamnus quadrifidus*. Scattered rubbish observed along spoon drain edge. Photo facing in an easterly direction.

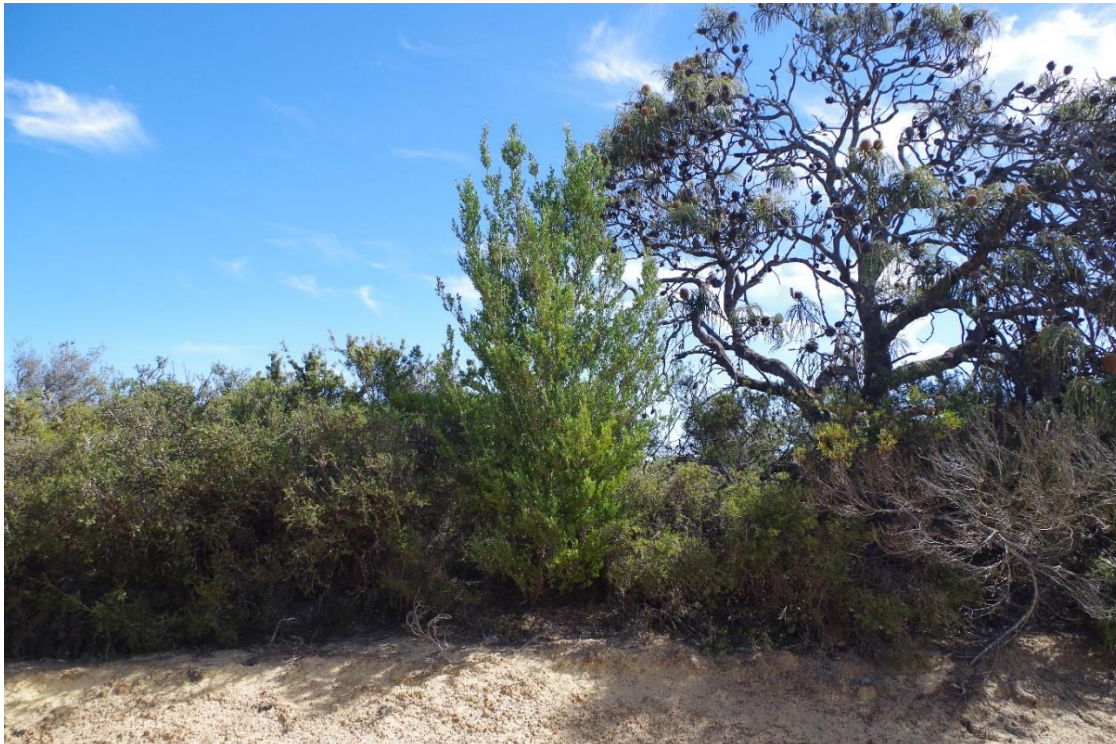
**Figure 8.** Vegetation Type 2, showing *Banksia speciosa* and scattered *Eucalyptus* overstorey, with dense *Melaleuca* midstorey and dense sedgeland understorey. Scattered Victorian Tea Tree weed on spoon drain edge (central green plant) observed. Photo taken facing in a westerly direction.

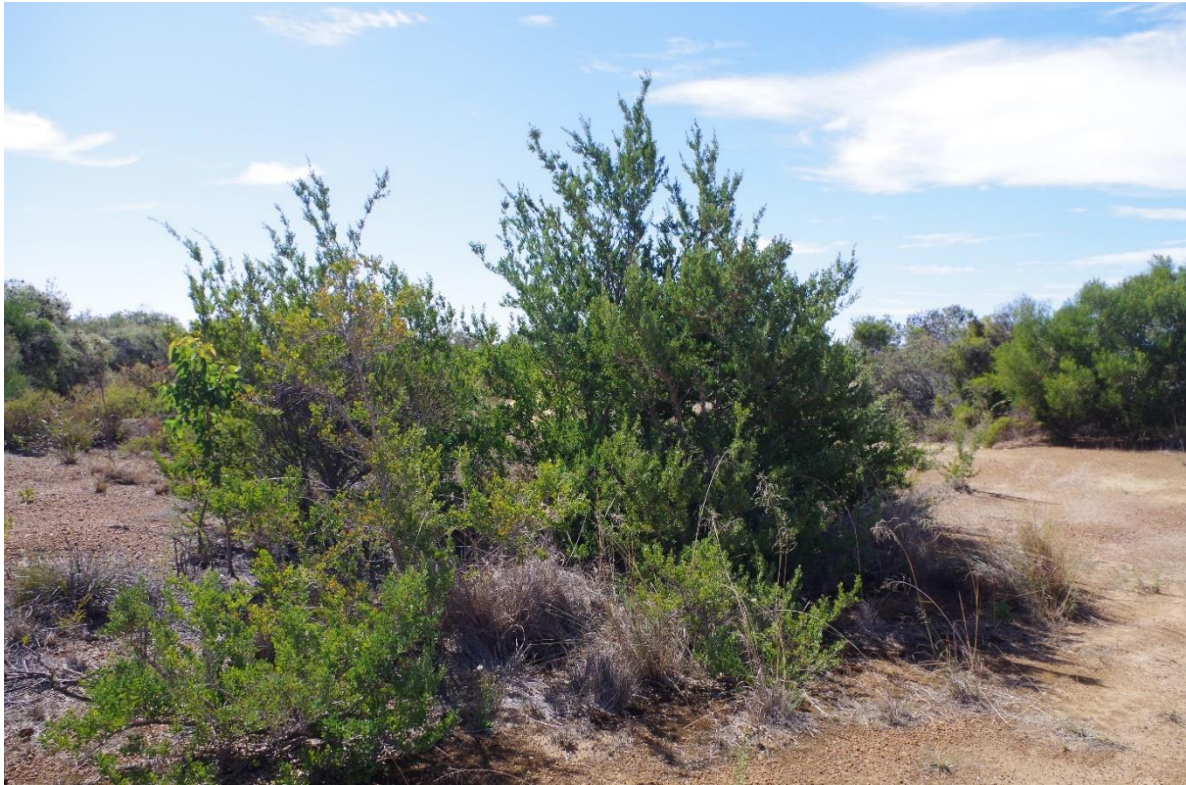
**Figure 9.** Historical sand mining pit within Vegetation Type 2. Open sand pit not within CPS 8400 area, but thick Victorian Tea Tree observed around perimeter of disturbed site and within the clearing permit area. Photo taken facing in a north-easterly direction.

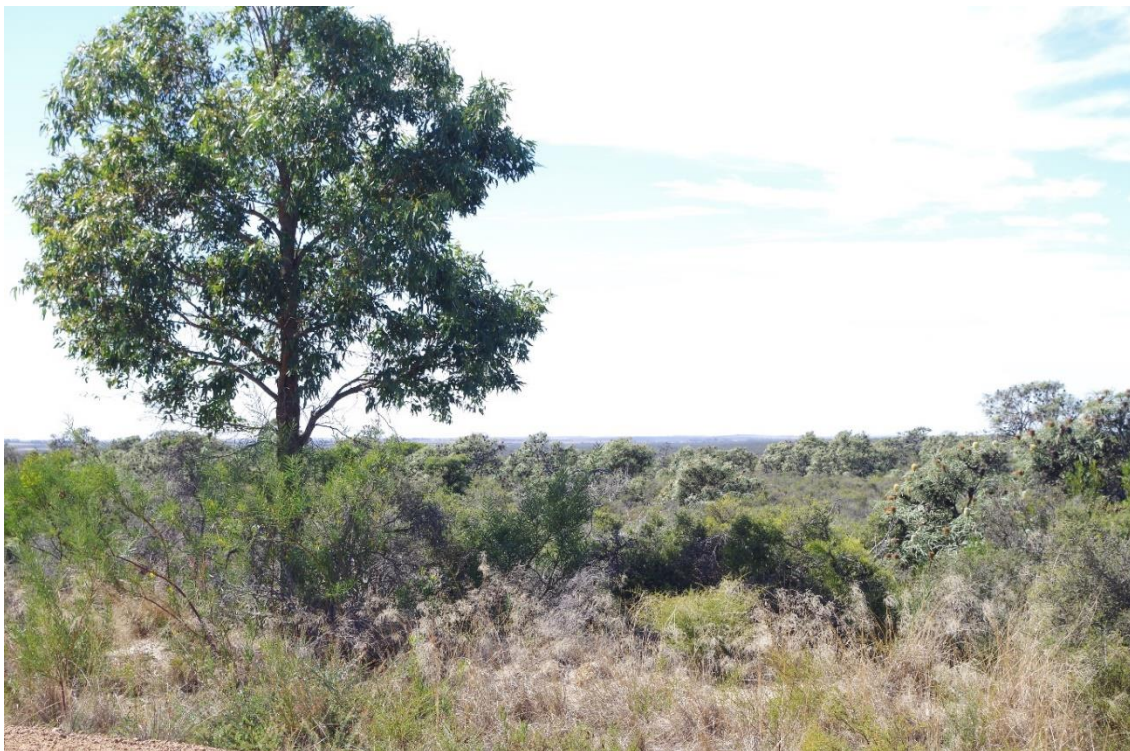
**Figure 10.** Vegetation type 2A, with same vegetation community as vegetation type 2, but higher weed density along roadside reserve of African Lovegrass, Tuarts and Victorian Tea Tree. Vegetation within clearing permit (2 to 3 m wide) is in poor condition. Photo taken facing in a easterly direction.

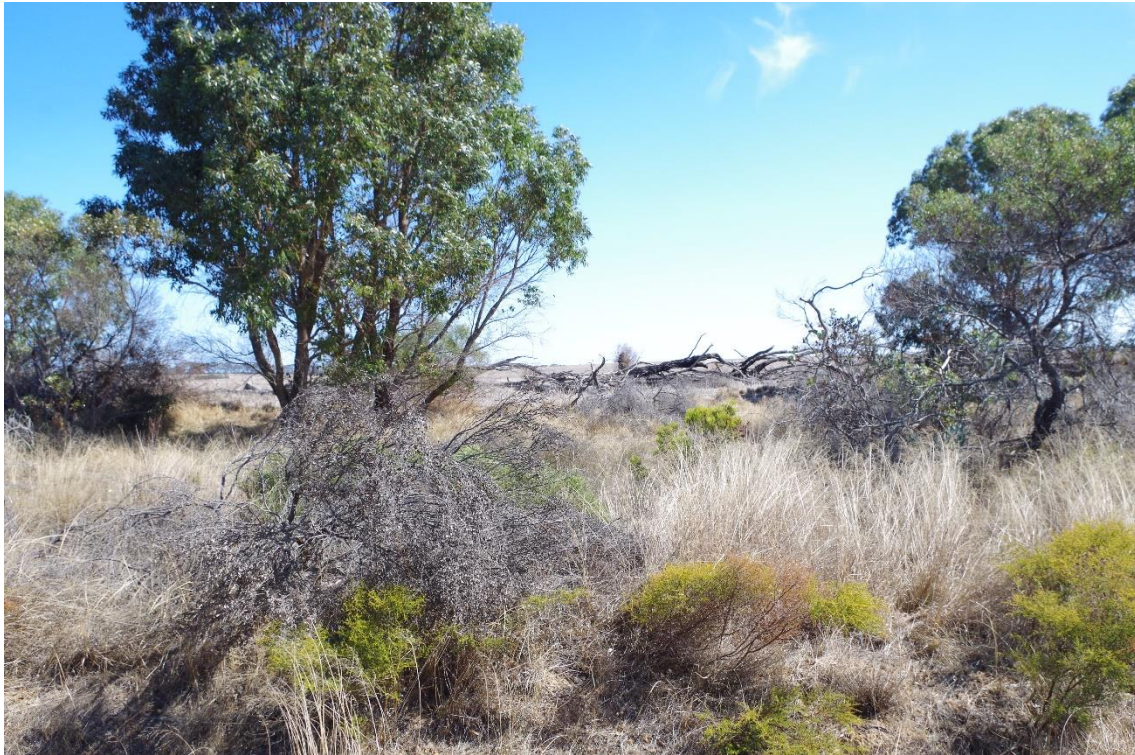
**Figure 11.** Vegetation type 3, showing highly degraded form of vegetation type 1; *Eucalyptus pleurocarpa* overstorey with heathland midstorey. Large amounts of plants dead, previous clearing, and high weed burden of African Lovegrass, Tuarts and Victorian Tea Tree. Vegetation in poor condition. Photo taken facing in a westerly direction.

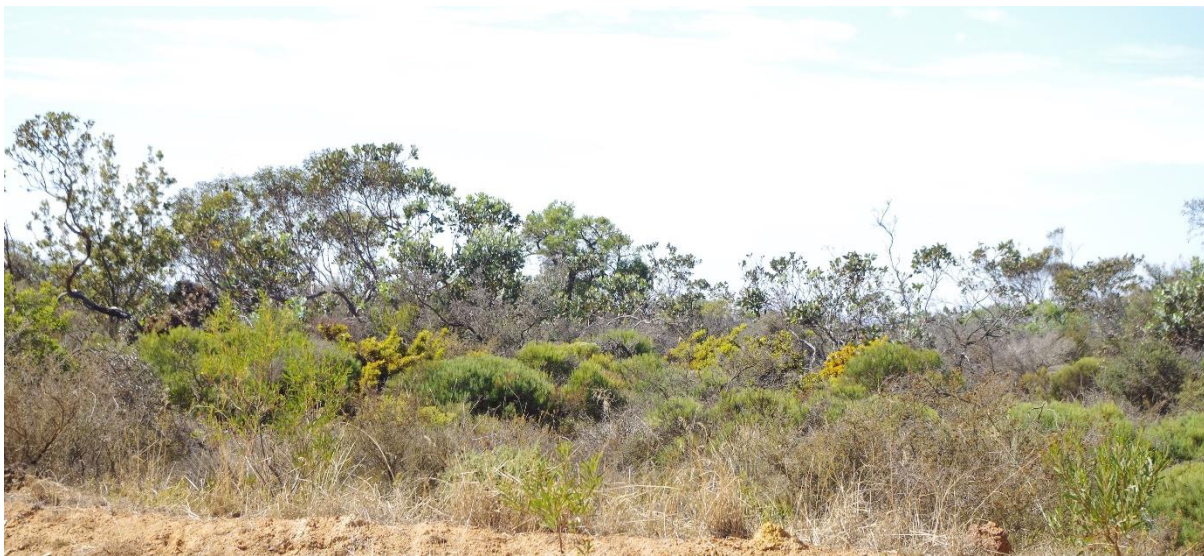
**Figure 12.** Vegetation type 4, illustrating very good condition of Vegetation type 1; Scattered *Eucalyptus pleurocarpa* over dense mixed heathland midstorey, with dominant *Calothamnus quadrifidus*. Limited disturbance observed, with only scattered African Lovegrass. Photo taken facing in an easterly direction.

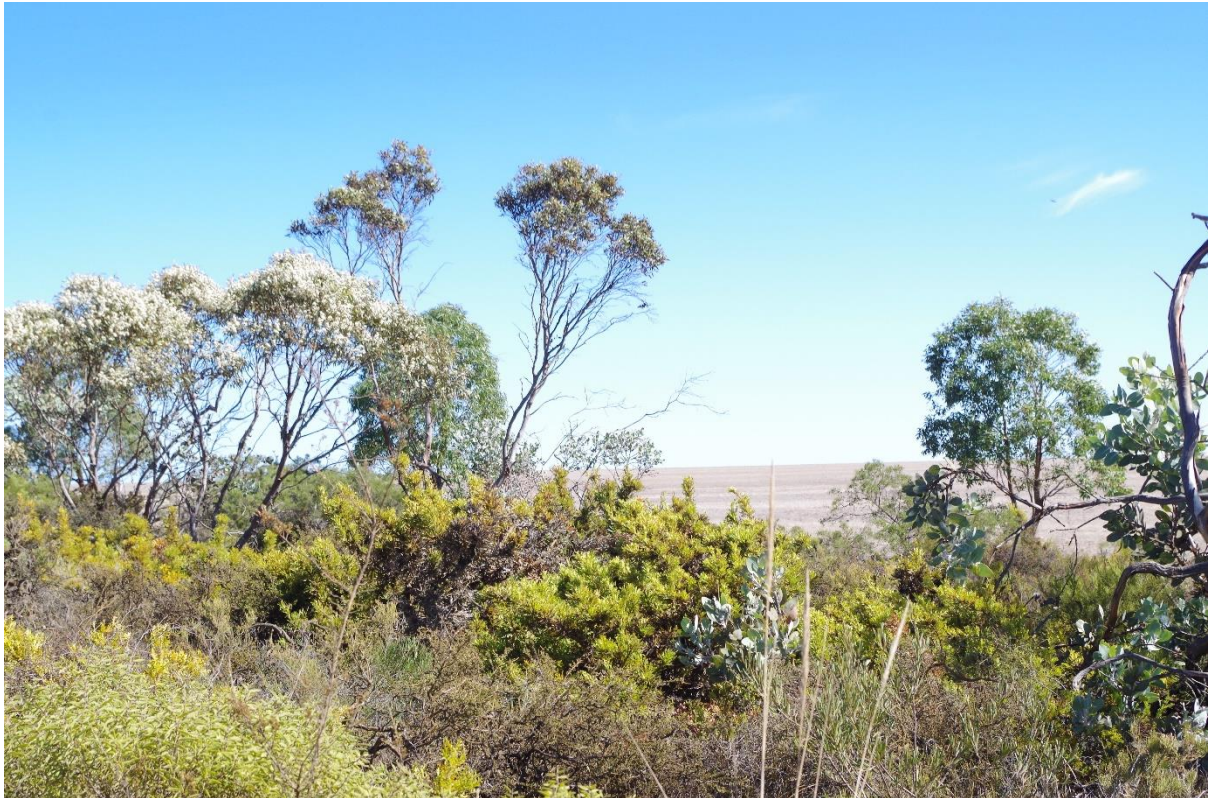
**Figure 13.** Very good condition Vegetation Type 5, showing Scattered mixed Eucalyptus dominant overstorey with dense dominant *Banksia armata*. Photo taken facing in a westerly direction.

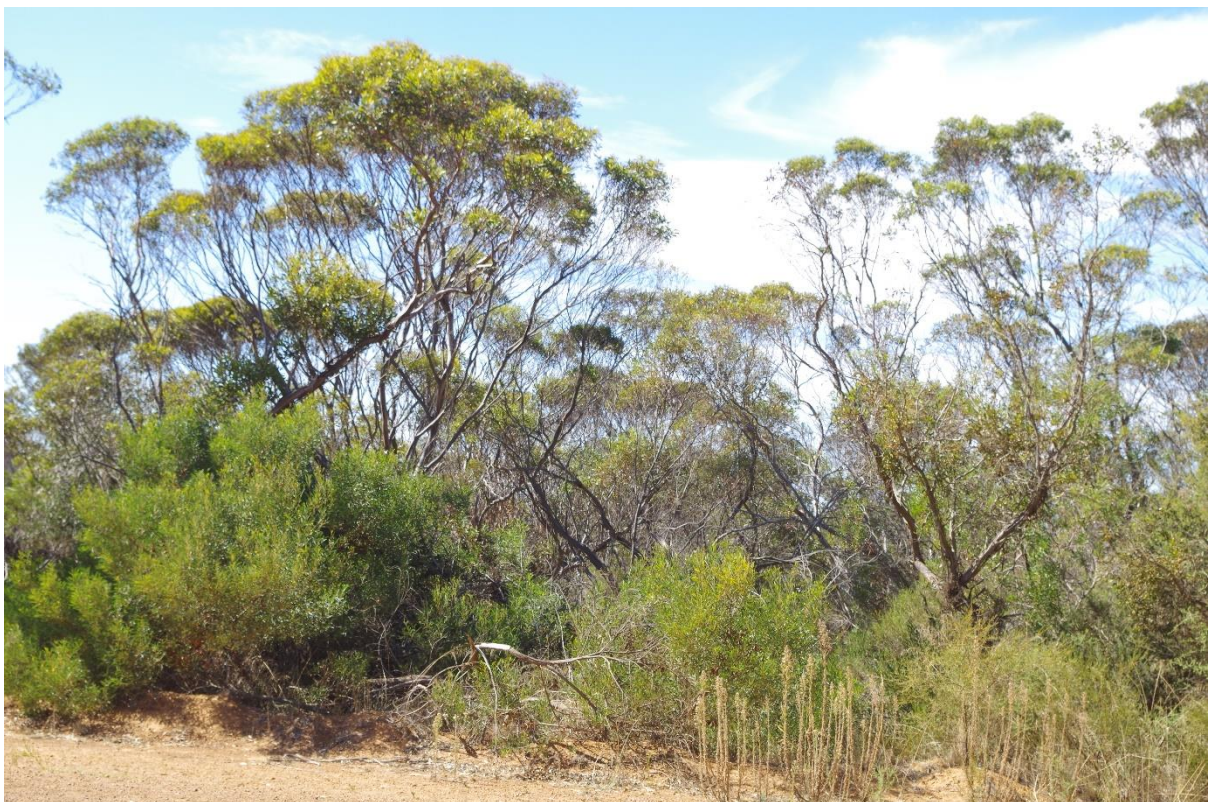
**Figure 14.** Vegetation Type 6, illustrating Dense Eucalyptus overstorey with scattered shrubland midstorey. Scattered weeds observed, such as Fleabane and Thistles. Photo facing in an easterly direction.

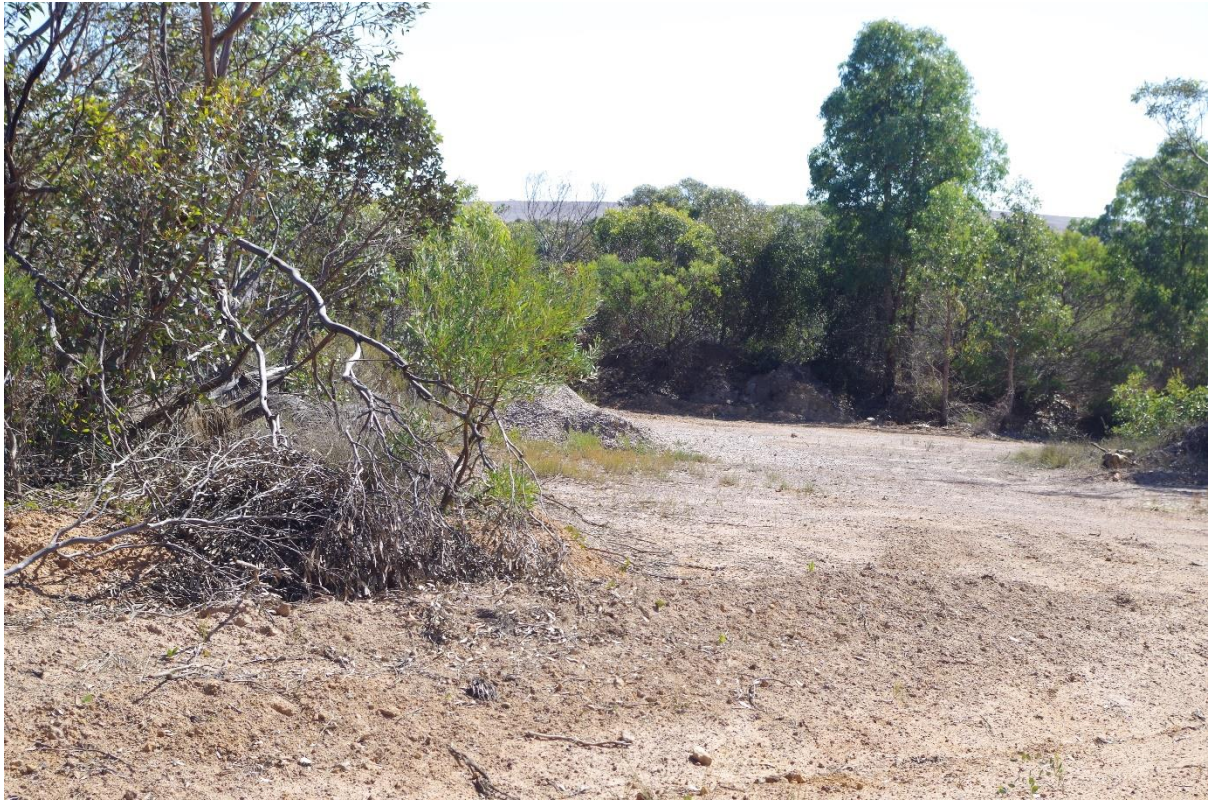
**Figure 15.** Previously disturbed gravel extraction site located within Vegetation Type 6. Photo taken facing in a north-westerly direction.

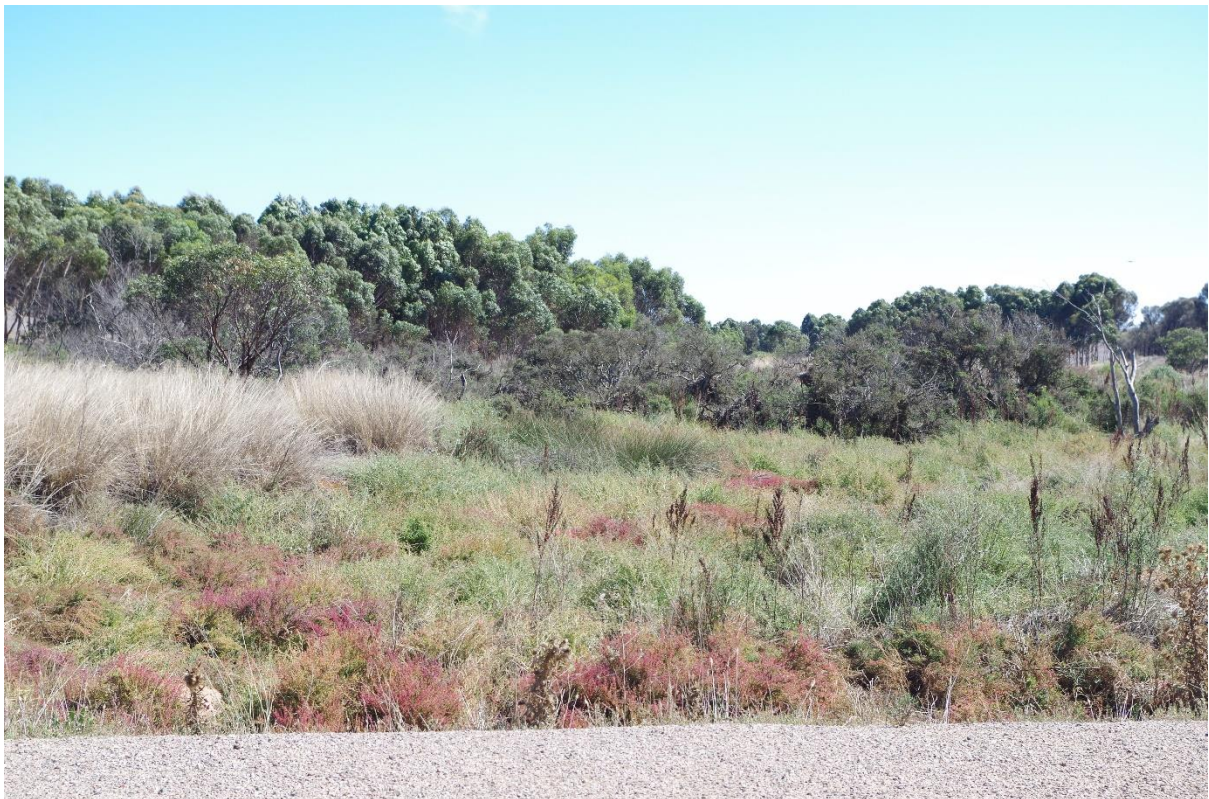
**Figure 16.** Vegetation type 7 surrounding minor creek crossing is entirely consisting of invasive weeds. Photo taken facing in a westerly direction.

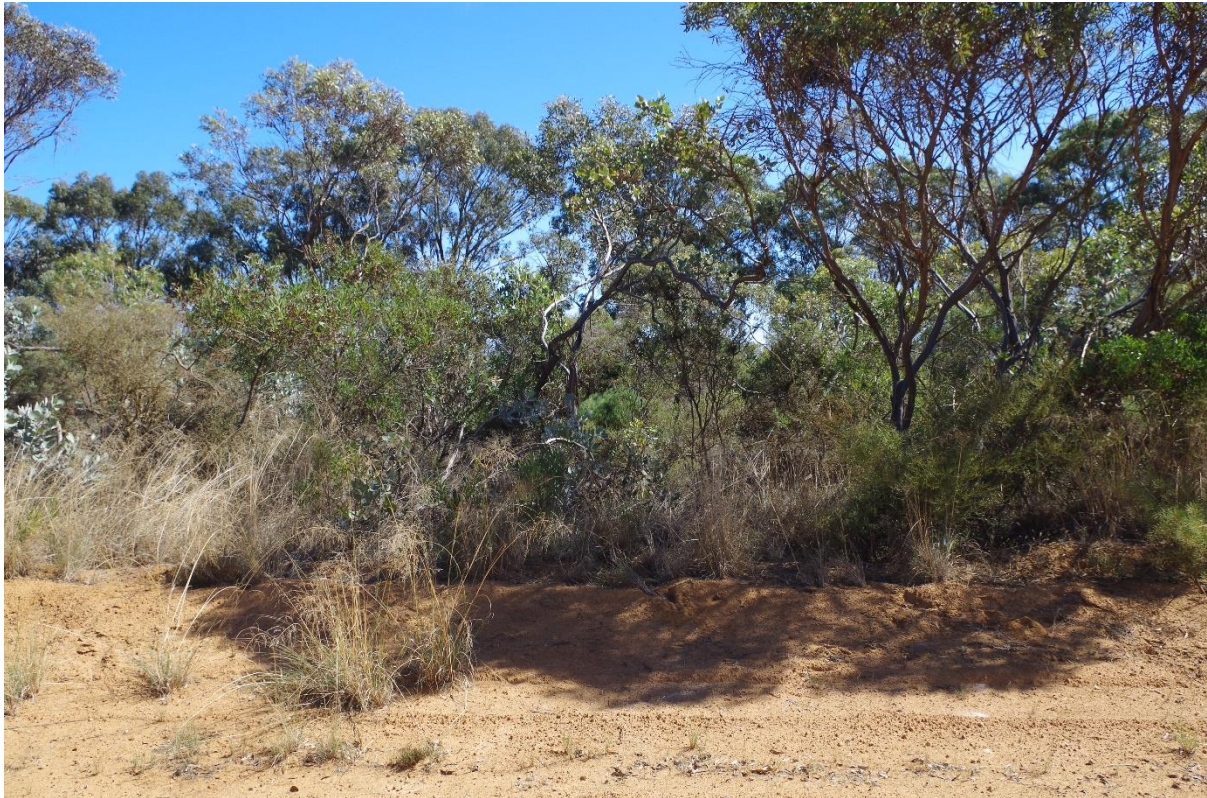
**Figure 17.** Vegetation Type 9, showing dense Eucalyptus woodland overstorey with more diverse midstorey. Scattered African Lovegrass continues to be an issue. Vegetation only present on the western road reserve. Photo taken facing in a westerly direction.

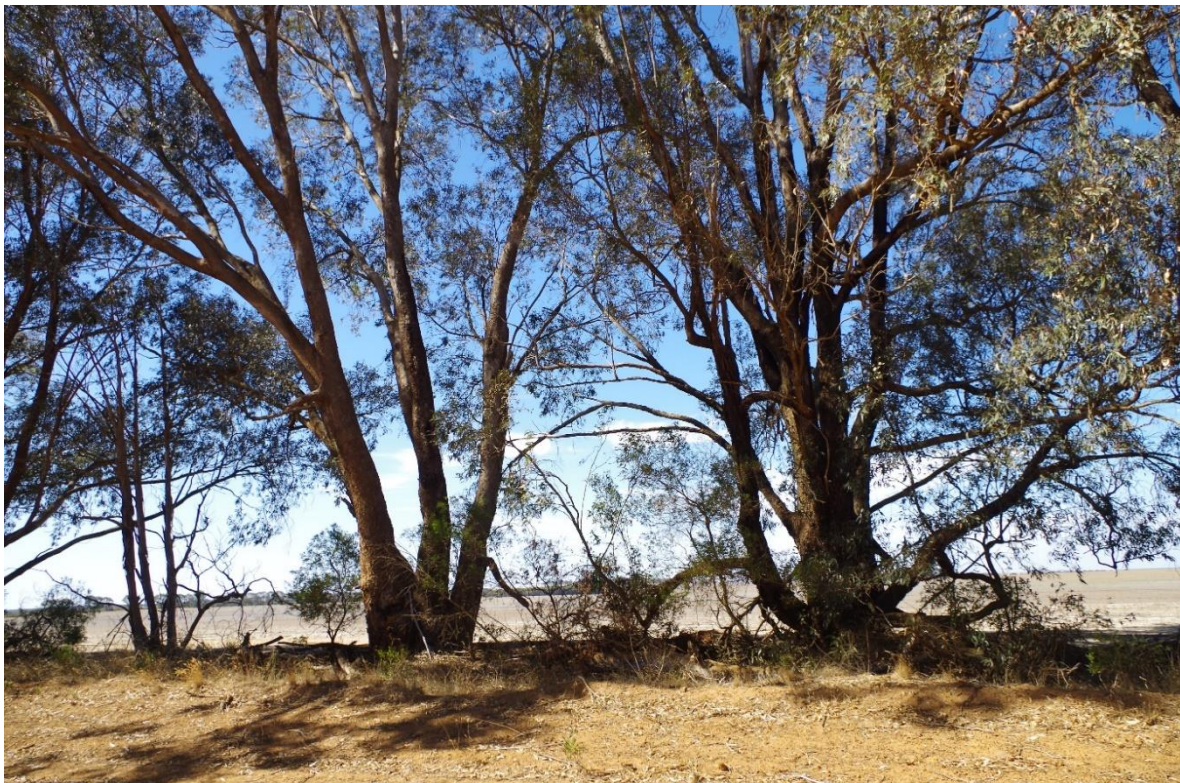
**Figure 18.** Vegetation on eastern road reserve within Vegetation type 9, which is entirely vegetated by non-native Tuart Trees. Photo taken facing in an easterly direction.

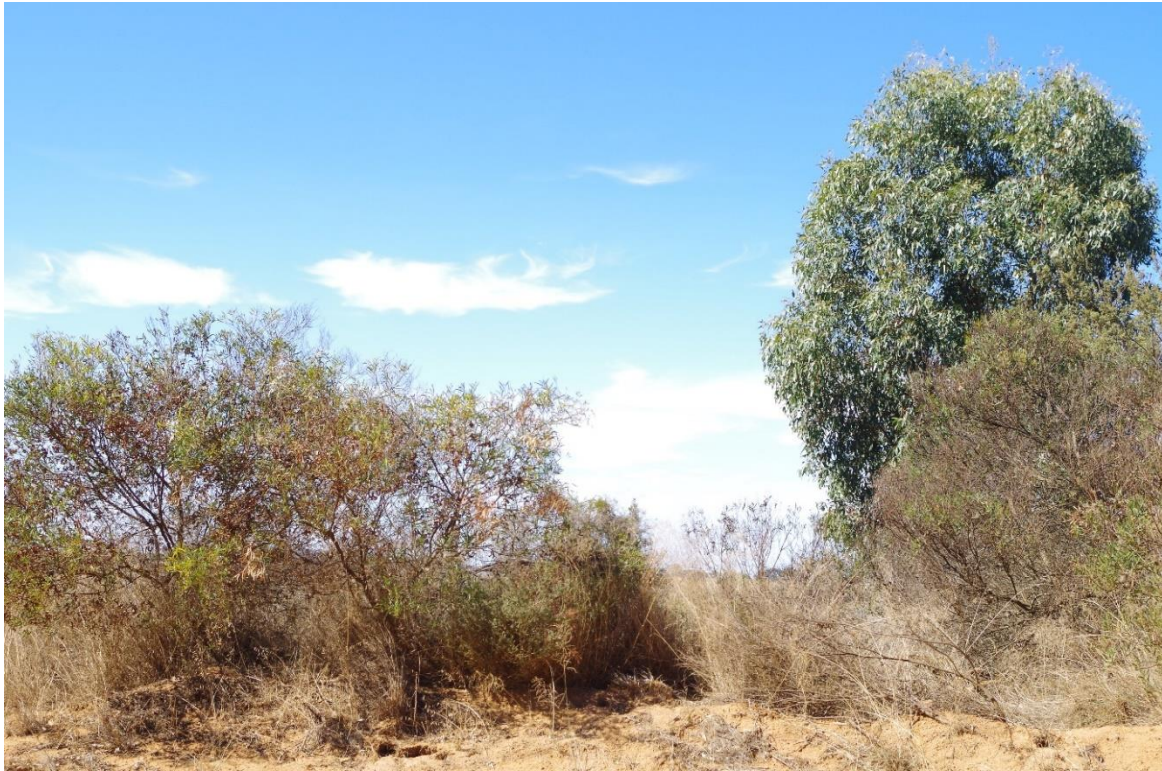
**Figure 19.** Poor condition of Vegetation type 10, with sparse vegetation present that is highly weedy, with African Lovegrass, Tuarts and Victorian Tea Tree. Vegetation community same as Vegetation Type 9; Eucalyptus woodland with diverse mixed midstorey. Photo taken facing in a easterly direction.

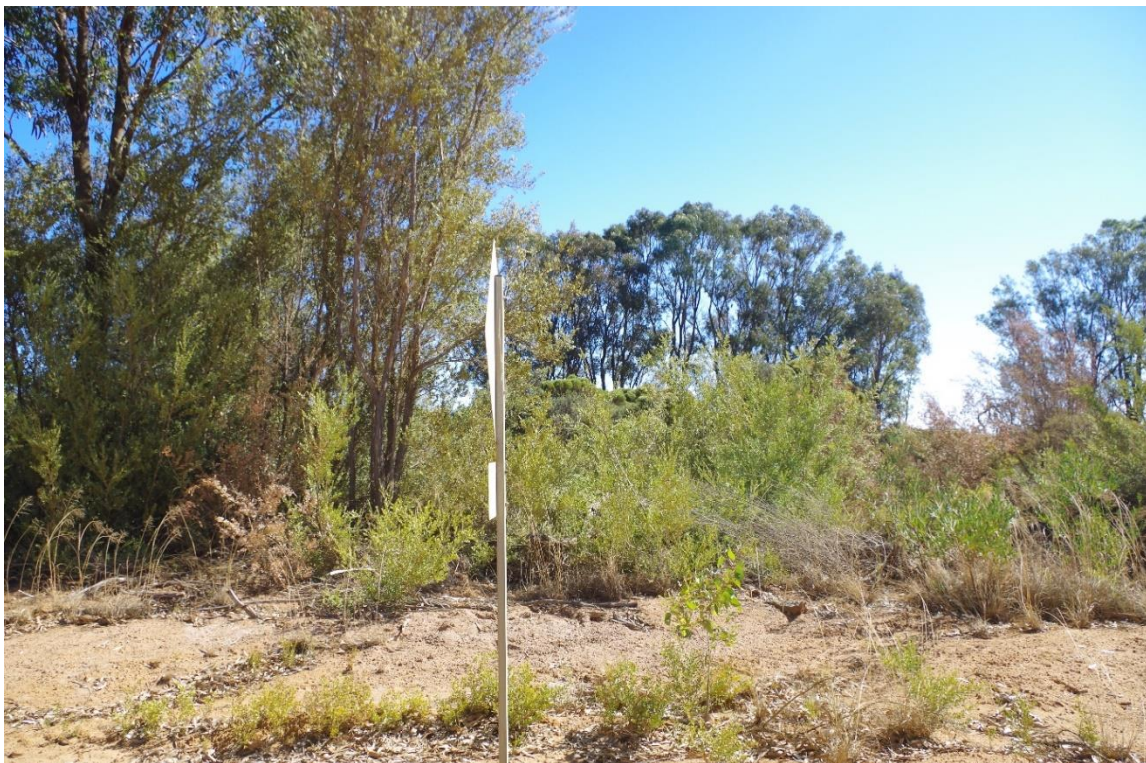
**Figure 20.** Poor condition of Vegetation Type 11, with dense Victorian Tea Tree thicket on roads edge. Vegetation community is similar to Vegetation Type 5; scattered *Eucalyptus pleurocarpa* dominant overstorey with dense dominant *Banksia armata* midstorey. Vegetation continues to only be present on western road reserve. Photo taken facing in a westerly direction.

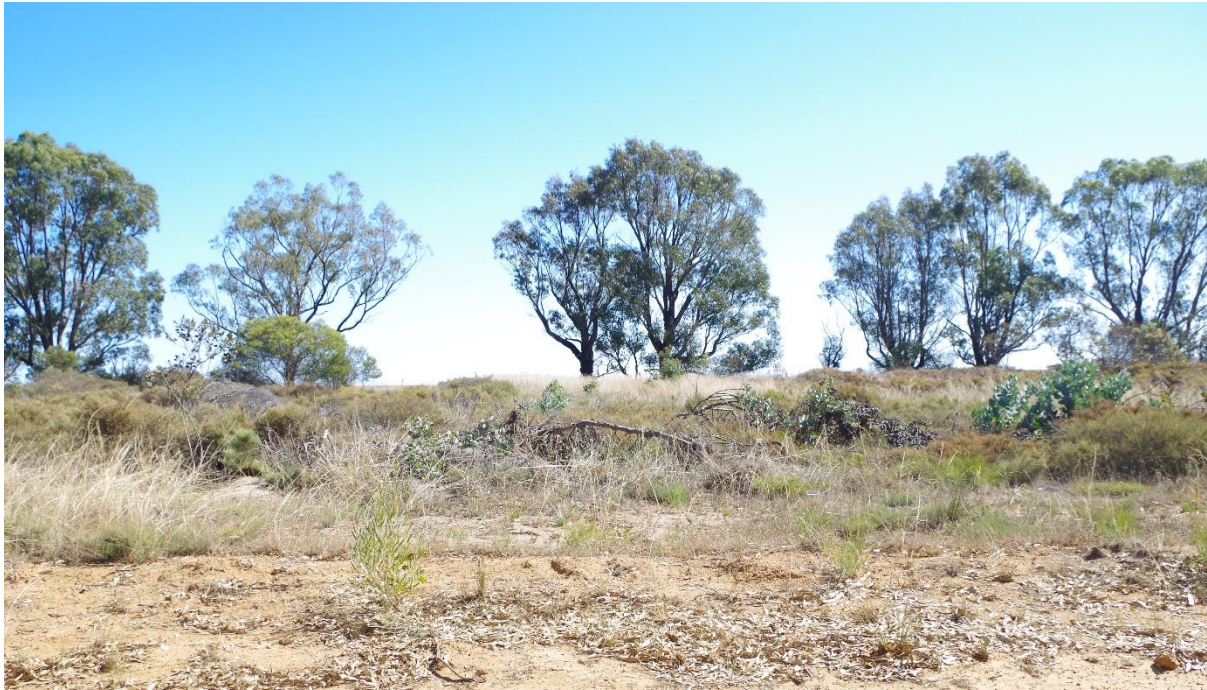
**Figure 21.** Poor condition of Vegetation Type 12, which has likely been previously cleared and is highly invaded by weed species. Vegetation community defined by scattered *Eucalyptus pleurocarpa* overstorey, with mixed *Allocasuarina* sp. and Myrtaceae midstorey. Photo taken facing in a westerly direction.

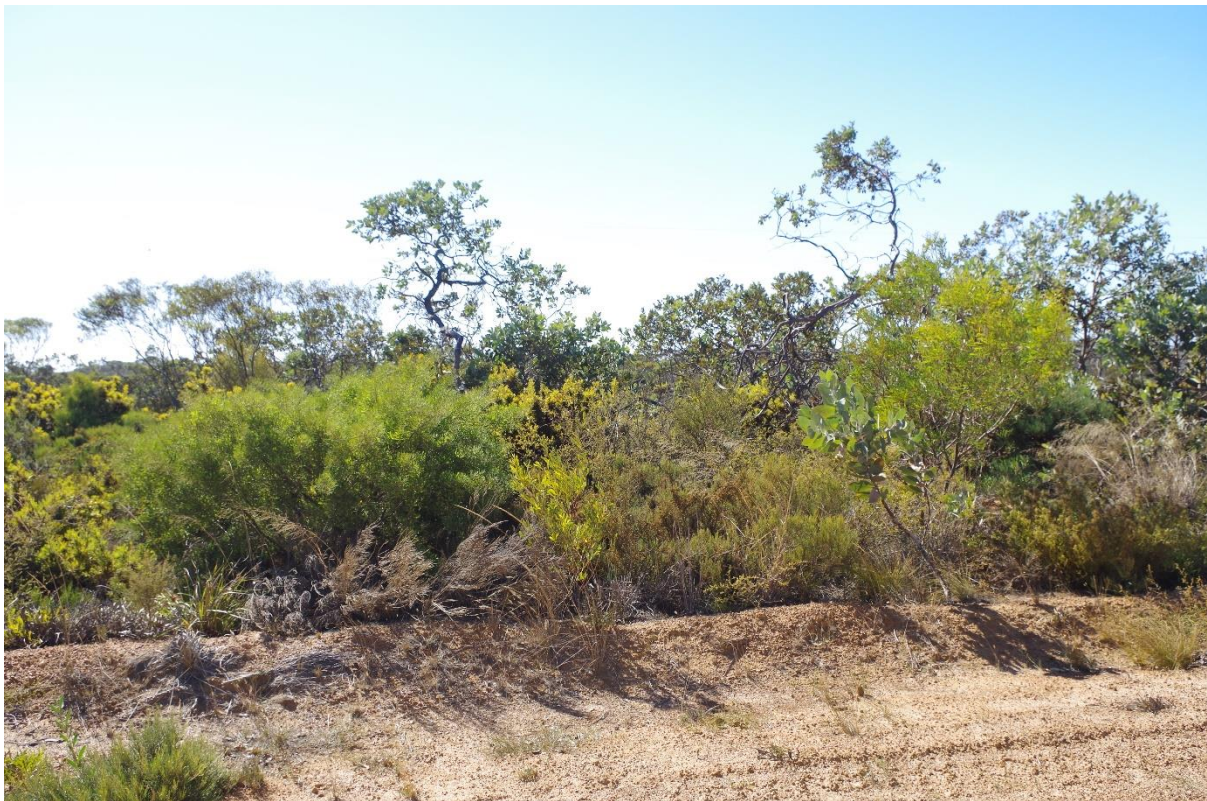
**Figure 22.** Vegetation type 13, along Yerritup Rd road reserve, with same composition as Vegetation Type 5; Scattered *Eucalyptus pleurocarpa* overstorey and dense *Banksia armata* understory. Photo taken facing a northerly direction.

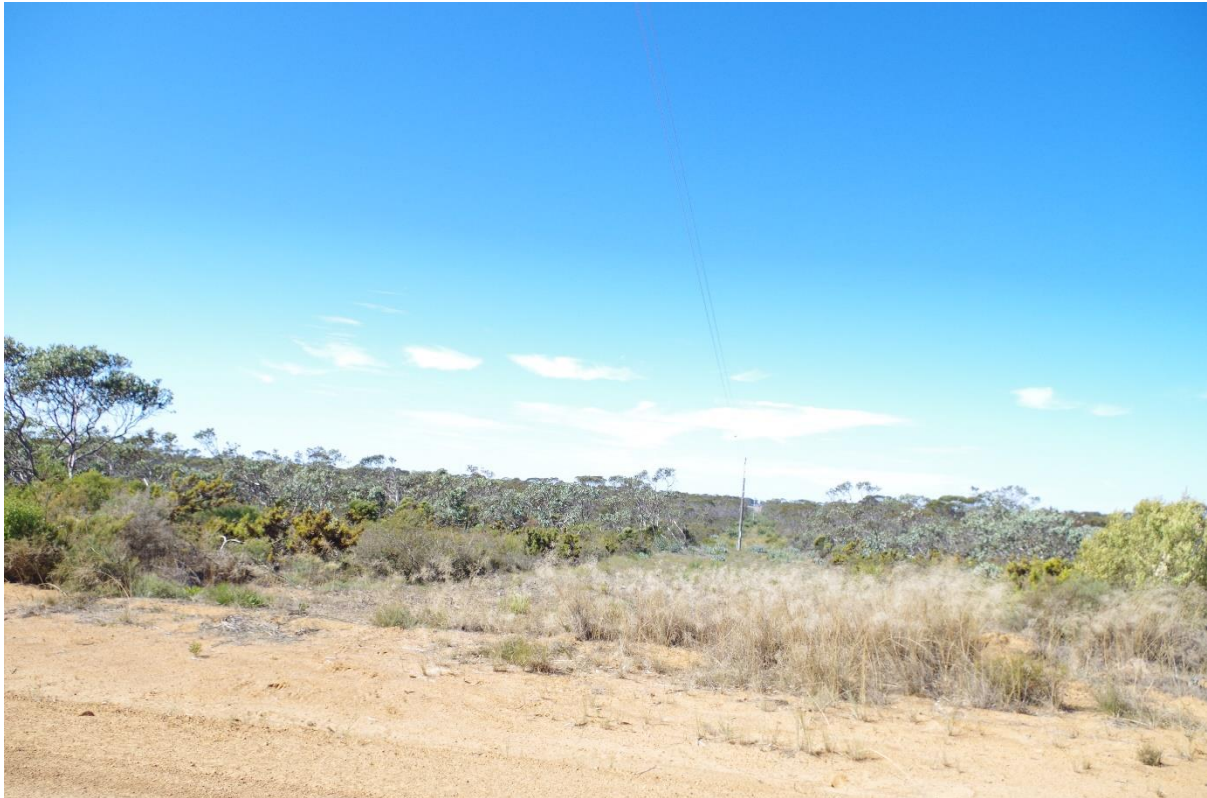
**Figure 23.** Vegetation type 13, along Yerritup Rd road reserve, showing strategic firebreak along powerline and associated infestation of African Lovegrass. Photo taken facing an easterly direction.
