KING OF THE HILLS

NATIVE VEGETATION CLEARING PERMIT

Native Vegetation Clearing Permit Supporting Document

Document No		21008-RP-HSE-0001			
Rev	Date	Status	Originated	Checked	Approved
1.0	18/06/2021	Issue for Use

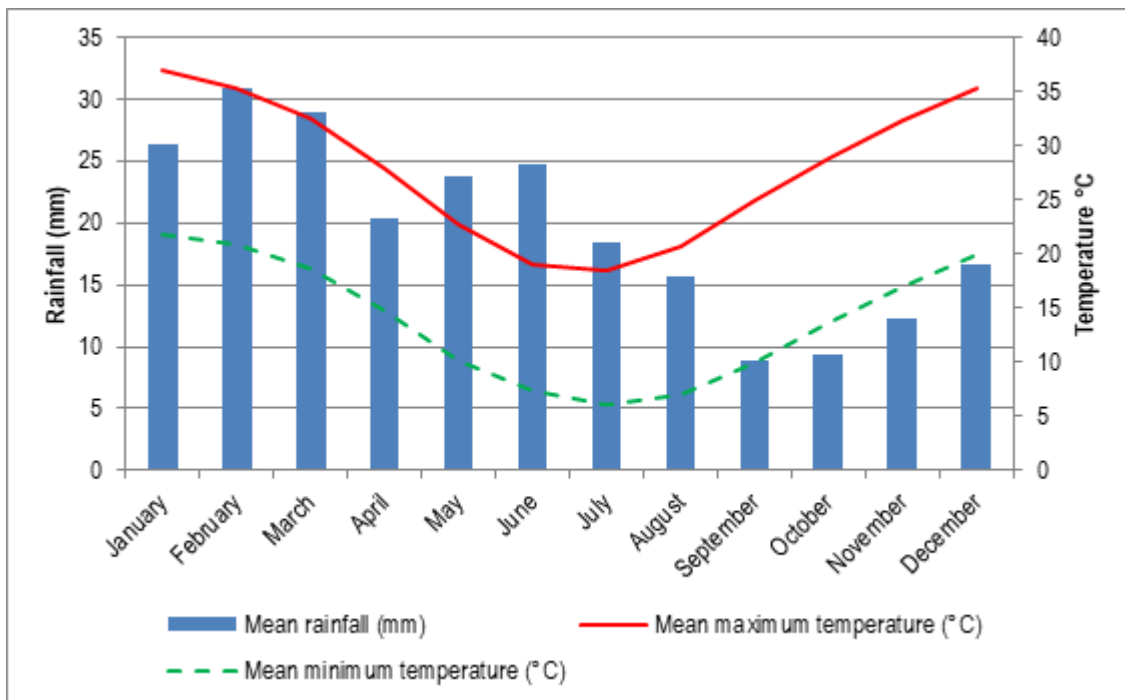
Chart 1 Climate Data for Leonora Station #12046 (BOM 2021)

Climate in the KOTHGP project region is characterised as arid. Mean annual rainfall is approximately 236.4 mm, with annual rainfall recorded at the closest meteorological station (Leonora) ranging from 57.8 mm to 552.2 mm (**Chart 1** ; BOM 2021). Rainfall is influenced by decaying tropical cyclones which originate off the northwest coast in summer, and anticyclonic systems in winter. Evaporation greatly exceeds rainfall with annual average pan evaporation rate for the Leonora region at 2.8 m. The hottest month is January with an average maximum temperature of 37°C; however, temperatures above 40.0°C occur frequently when the hot and dry, north to north easterly winds prevail. Winters tend to be cool, and July is the coldest month with average maximum and minimum temperatures of 18.4°C and 6.1°C, respectively (BOM 2021).

The mean annual rainfall is 236.4 mm (**Chart 1**), with the majority falling in summer (December to April) from thunderstorms or cyclone events. Removal of vegetation generally increases flooding whereby uptake, infiltration, moisture retention and physical barriers to reduce flow velocities provided by vegetation are removed. However, the NVCP Application Area is predominantly comprised of sandy plains which generally sheets surface water flows. Removal of vegetation alone would increase water flow, although the mechanical process of clearing and disruption of flat, hard surfaces of a watershed area are likely to increase infiltration of water into the soil profile, encouraging pooling in shallow excavations and reducing downgradient volumes.

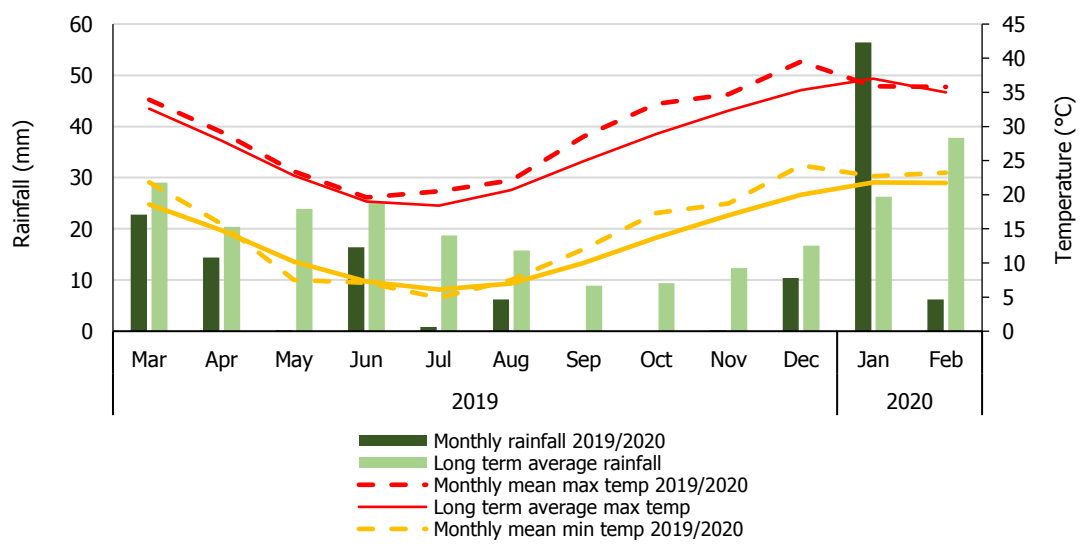
Figure 2: Climatic data for Leonora, WA (BOM 2019-2020)

The nearest Bureau of Meteorology (BOM) weather stations with the most complete long-term and the latest climate data are Leonora Station (ID 12046) and Leonora Aero Station (ID 12241), respectively, both of which are located approximately 25 km southeast of the project area (BOM 2019). Rainfall and air temperature data for the twelve months to January 2020 and averaged over the long-term (1961-1990) are shown in Figure 2. Total rainfall for the 12 months to February 2020 was 134 mm, lower than the long-term average annual rainfall of 244.2 mm. However, over that time period, over half of the total rainfall (73 mm) fell in summer (December - February 2020), just before the survey was undertaken. High rainfall is optimum for growth of annual species and for flowering and fruiting of perennial species, aiding in identification to species level. Winter rainfall promotes the growth of annual species and summer cyclonic rainfall tends to aid the growth of woody plants. However, the effectiveness of rainfall for overall plant growth is higher in winter when evaporative demand is lower due to the lower temperatures. Soil water is therefore available to plants for growth for longer periods of time (Gilligan 1994).

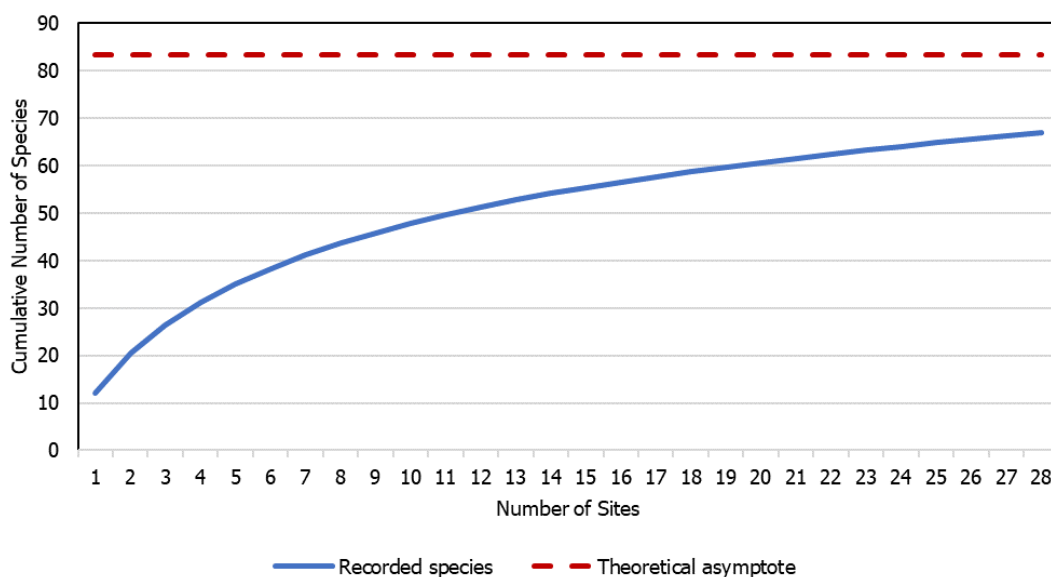
Figure 7: Species Accumulation Curve for the King of the Hills Power Corridor survey area, March 2020

A species accumulation curve (Colwell 2013) was used to evaluate the sampling adequacy and is presented in Figure 7. The incidence-based coverage estimator of species richness was 83. Based on this value and the total of 67 taxa recorded in this survey, approximately 80.68% of the flora species potentially present within the survey area were recorded.

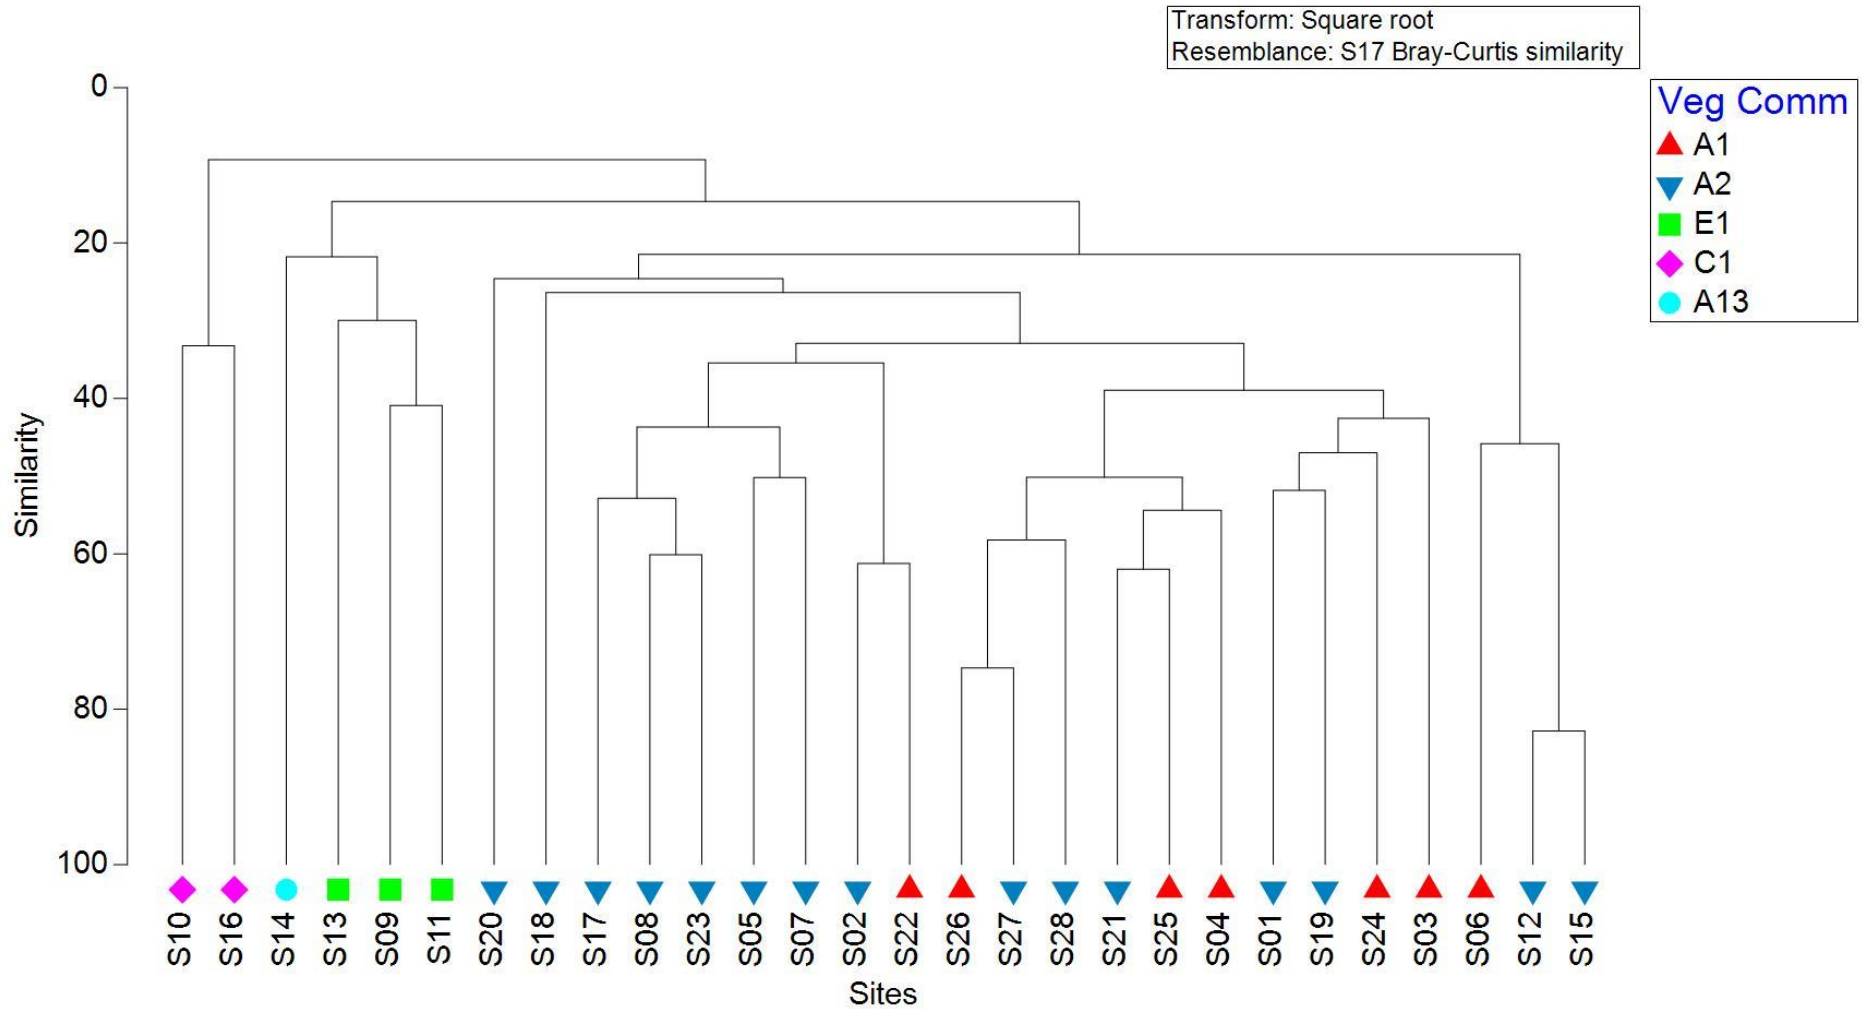
Figure 9: Dendrogram showing results of statistical analysis for vegetation communities in the King of the Hills Power Corridor survey area, March 2020

A summary of the vegetation communities defined in this survey is given in Table 2, and further details, with photographs are given in Appendix J.

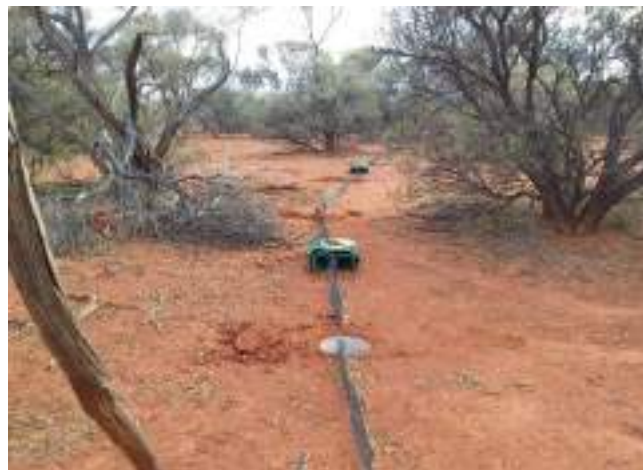
Plate 2. Trap line

Fifteen survey sites were established (Figure 3). Each site consisted of four trapping lines. Each trap line consisted of three 20L buckets, three PVC pipes (500mm deep, 150mm wide) and six funnel traps (3 pair) spread along a 30m, 250mm high fly-wire drift fence (Plate 2 and Plate 3).

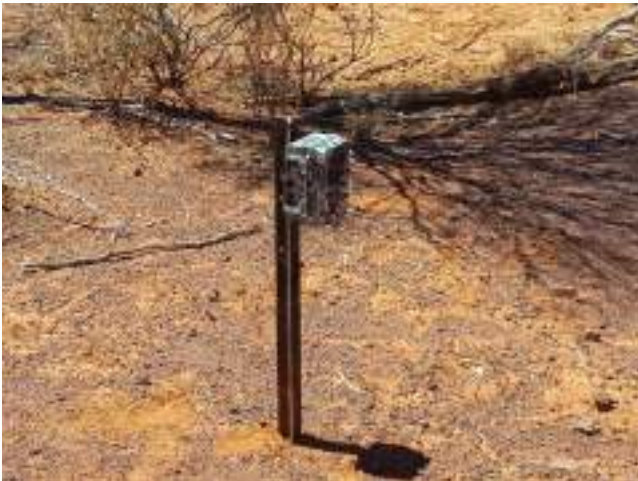
Plate 4. Camera trap

Fifty Reconyx 600 camera traps were deployed on 4 November and retrieved on 20, 21 or 22 November 2019 and 25 Reconyx HC600 camera traps were deployed on 13, 14 or 15 March and retrieved on 6 April 2020. All camera traps (Plate 4) had a non-reward bait lure (Plate 5) which consisted of peanut butter, sardines, oats and soaked in fish/whale oil. The location and deployment of camera traps is shown in Appendix E and Figure 4.

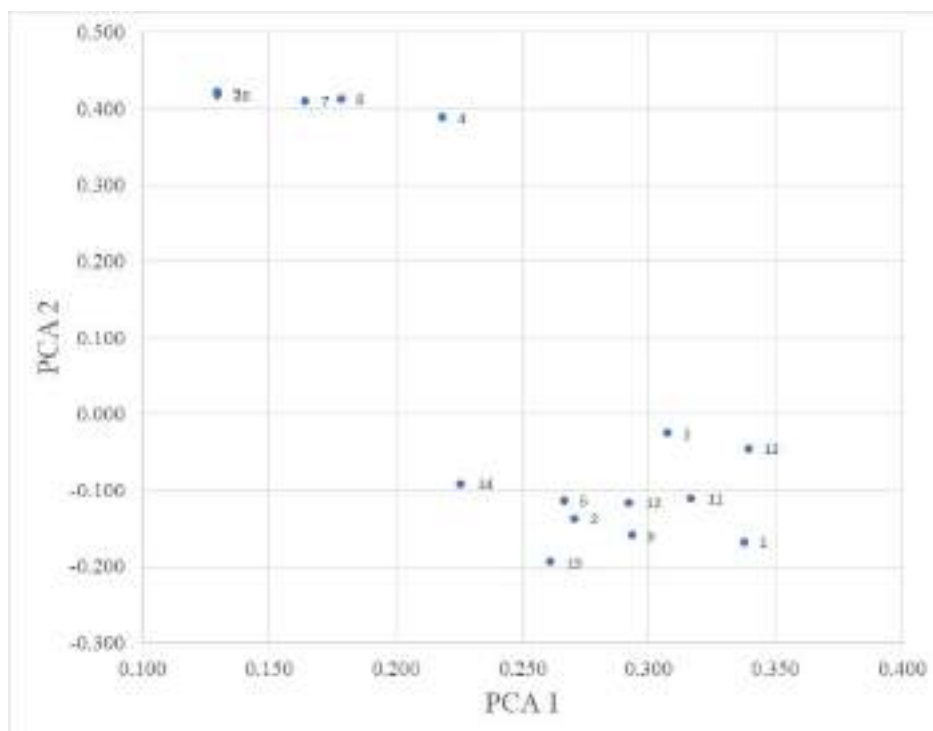
Chart 2. PCA with Eigenvectors 1 and 2

Species accumulation curves for the trapping data should therefore be calculated based on the fauna assemblages in each of these two fauna habitat types.

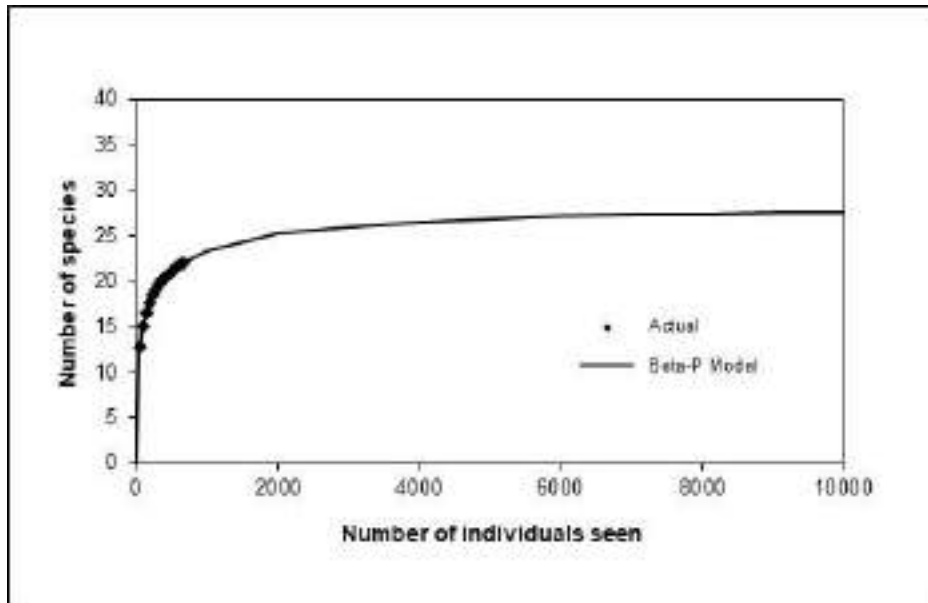
Chart 3. Species accumulation curve for the ephemeral creekline habitat

caught 33 species which is comparable to the estimate of 35 if 1000 individuals were recorded. For trappable vertebrate fauna, reasonable estimates of species richness are 23 for the ephemeral creekline and 35 for the mulga woodland.

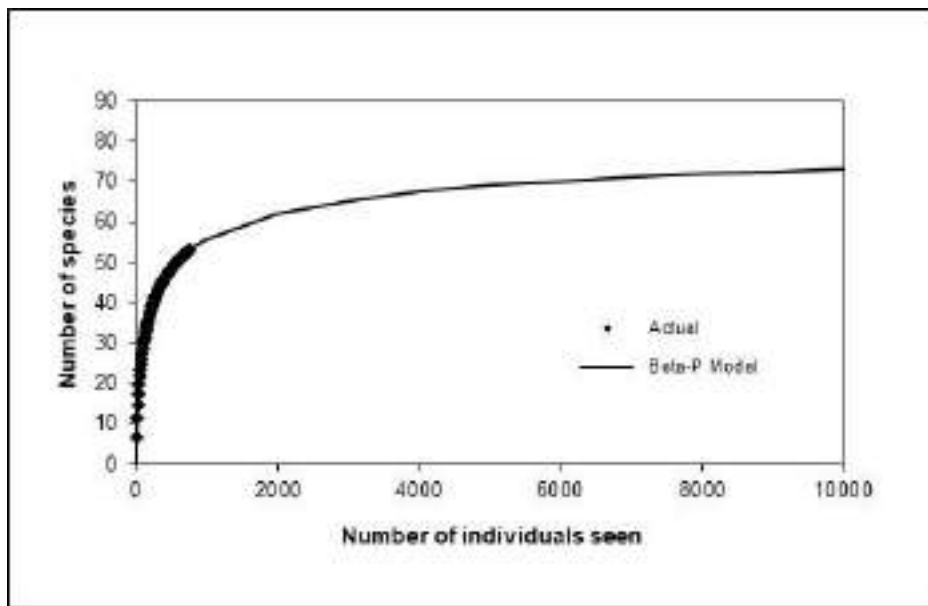
Chart 5. Species accumulation curve for all bird observations at the 87 site sites

The species accumulation curve for avifauna based on birds recorded at the 87 surveys sites is shown in Chart 5. The projected species richness was 91 species; and had 1,000 birds been recorded then the estimated number of species recorded would have been 56. When all species were included, including incidental observations, the recorded avifauna species richness was 72. However, this included the species recorded in Rainbow Pit (Appendix D) during two visits (11 and 17 March 2020). Rainbow Pit is an old, long-used mining pit that contains permanent freshwater and supported numerous waterbirds, that were not recorded elsewhere in the project area due to a lack of suitable habitat.

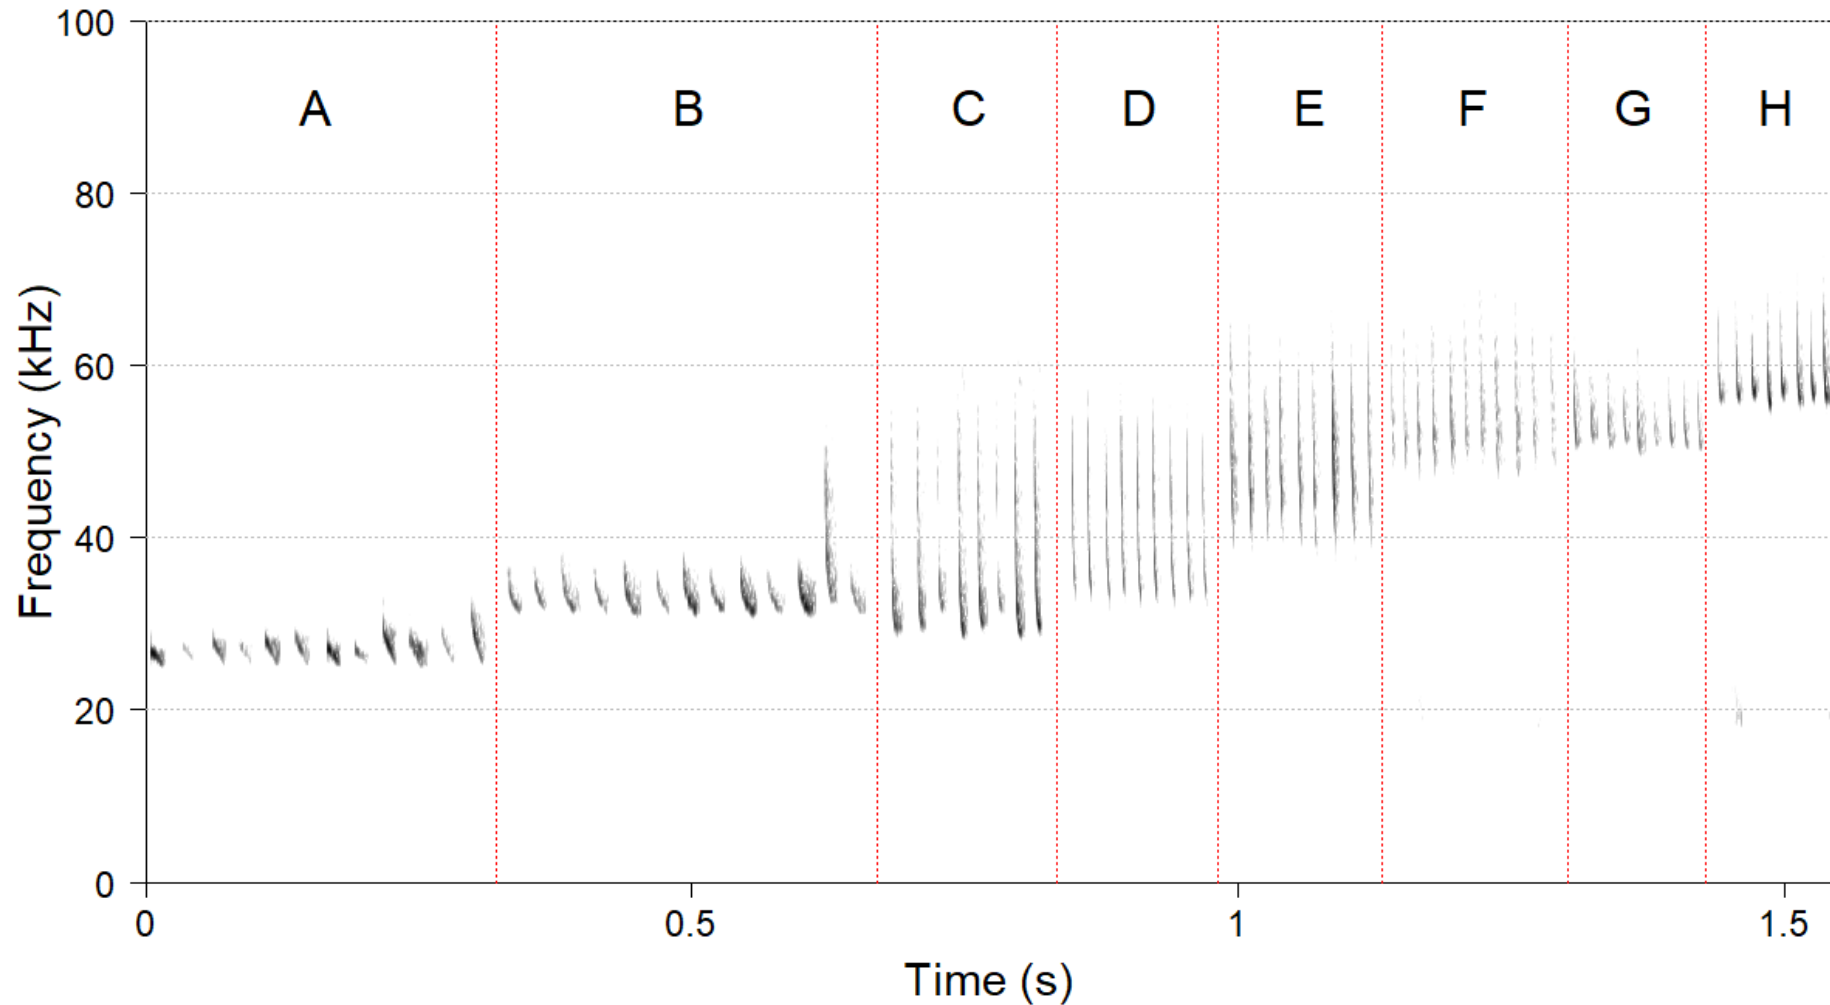
Figure 1. Representative echolocation call sequence portions of the species identified (**A:** *Ozimops kitcheneri*; **B:** *Ozimops petersi*?; **C:** *Chalinolobus gouldii*; **D:** *Scotorepens balstoni*; **E:** *Nyctophilus* sp. (40 kHz example); **F:** *Nyctophilus* sp. (45 kHz example); **G:** *Vespadelus baverstocki*; **H:** *Vespadelus finlaysoni*; time between pulses has been compressed).

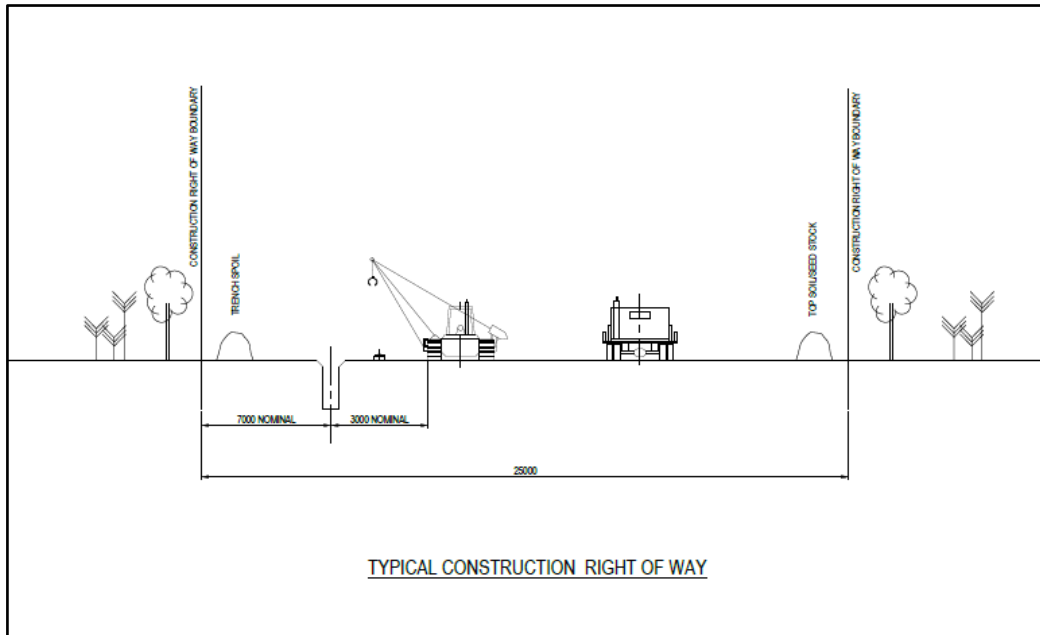
Figure 2: Agnew Gas Pipeline – Typical ROW extents & layout - RIGHT / LEFT BASED ON LOOKING DOWNSTREAM ALONG THE PIPELINE CENTRELINE WHICH IS NORMALLY TO THE WEST.

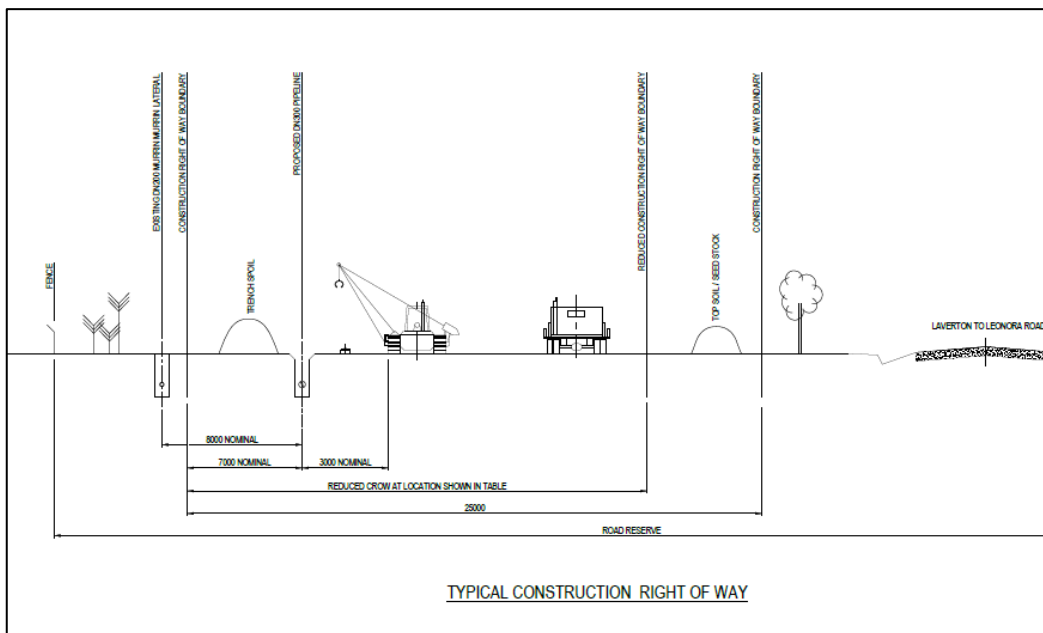
Figure 3: Murrin Murrin Looping Pipeline – Typical ROW extents & layout - RIGHT / LEFT BASED ON LOOKING DOWNSTREAM ALONG THE PIPELINE CENTRELINE WHICH IS NORMALLY TO THE WEST.

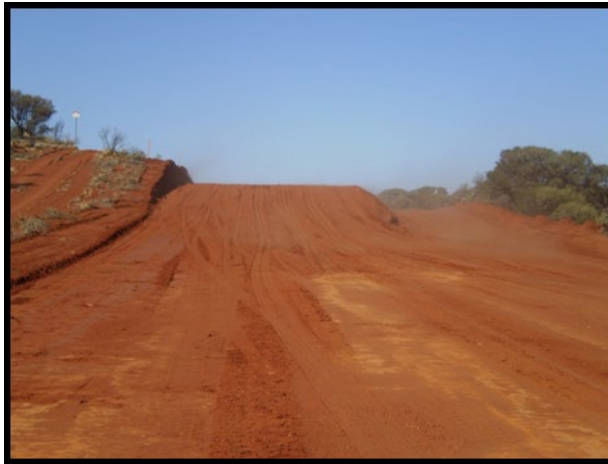
Figure 4: Example of Benching

Side slopes encountered along the pipeline route will be benched by cut method to form a level running track and level working width platform for welding and trenching operations. Where fill is required to create a level working platform this shall only take place on the running track.

Steep cut slopes will be assessed by the Superintendent and benched with stepping nominally 1m rise with 600mm cut backs where the cut slope is deemed to otherwise potentially be unstable.
