Environmental Considerations of Proposed Clearing Application at M08/494.

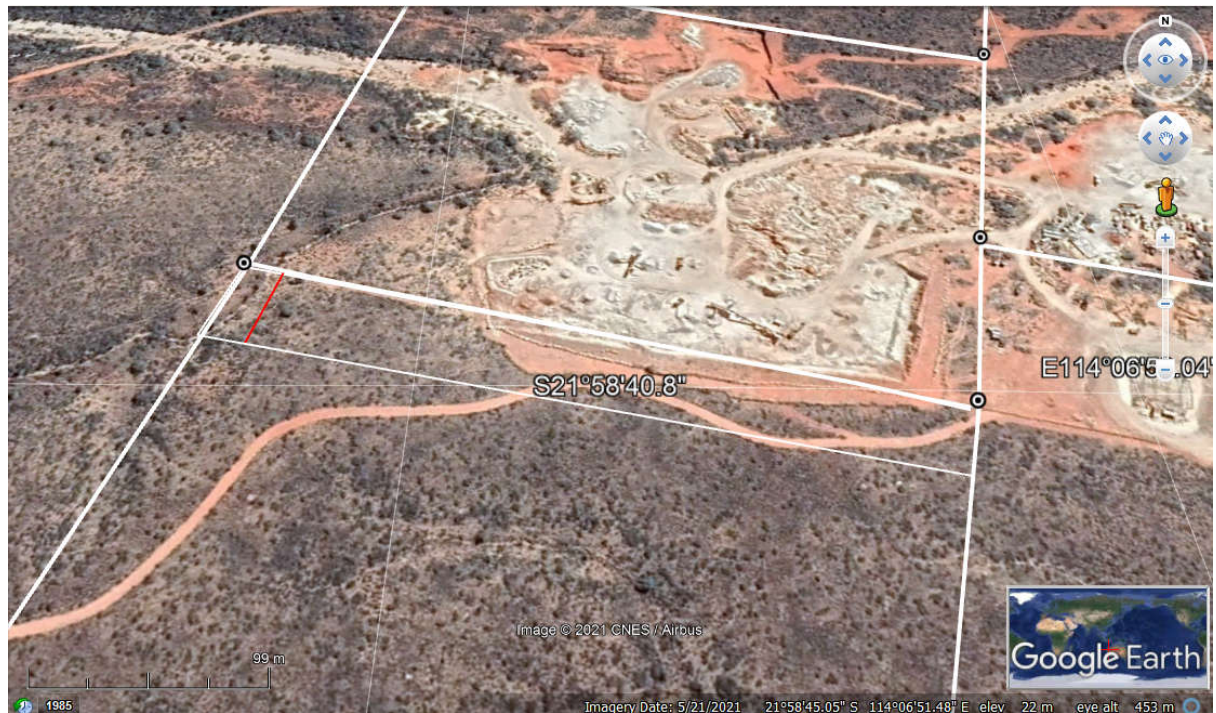
Figure 1. Aerial view of proposed clearing area, red line indicates limit of clearing.

. The application is to clear 1.875 hectares of native vegetation within tenement M08/494 for the purpose of limestone extraction (Figure 1)

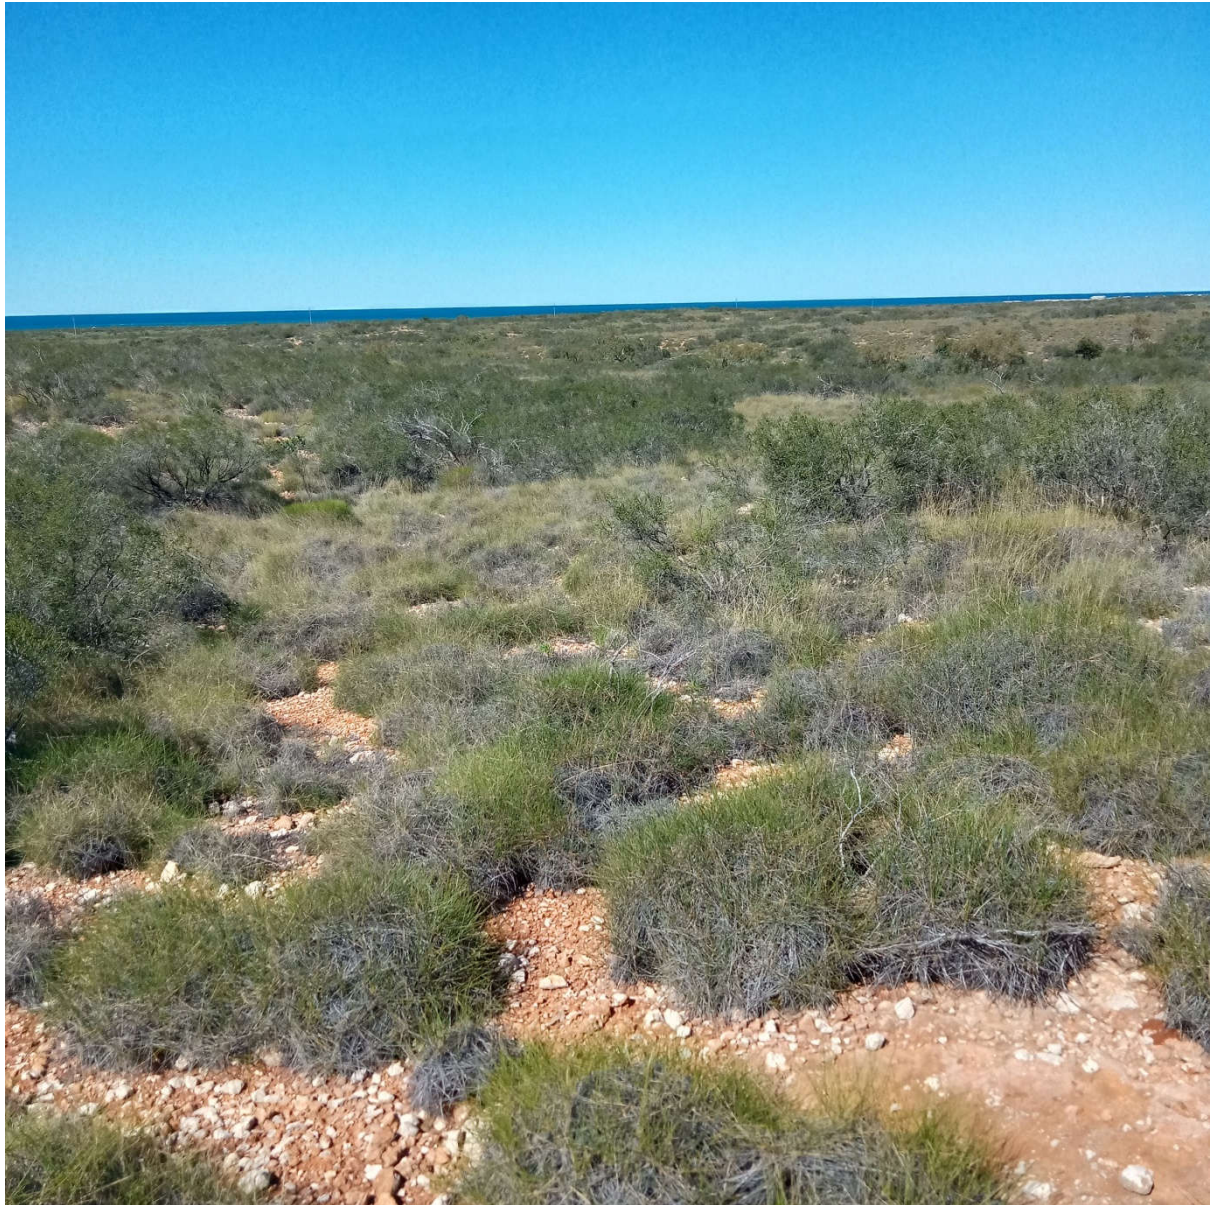
The vegetation condition of the application area was determined from a site inspection conducted 21/06/2021

Figure 2. Typical vegetation and soil in the undisturbed section of proposed clearing area.

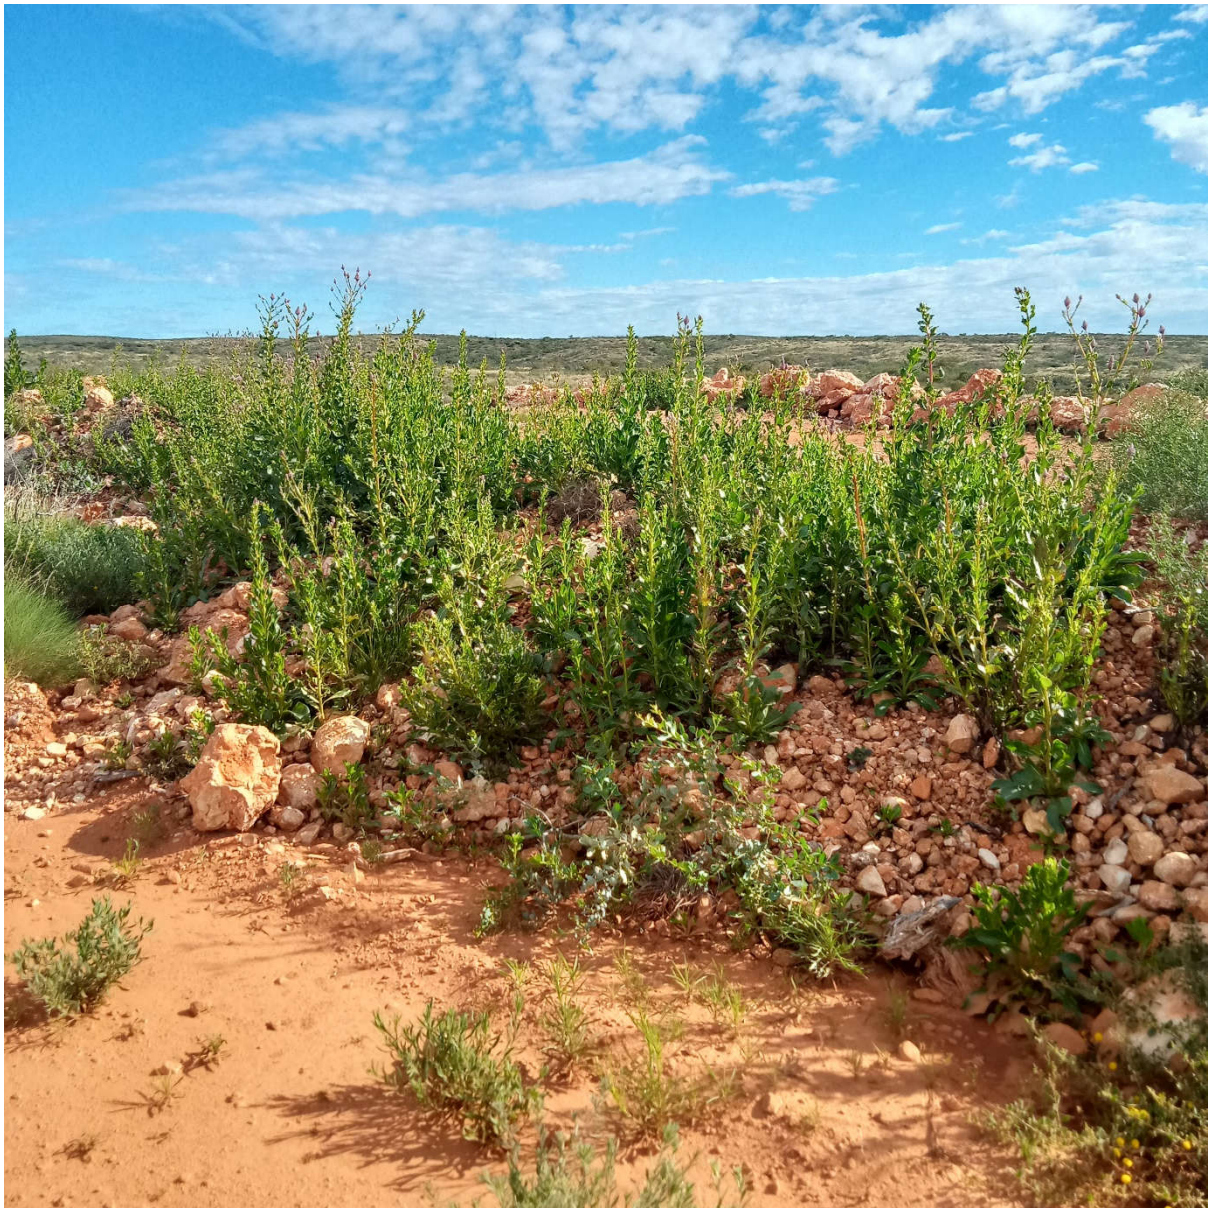
- **Landforms:** A deeply compacted limestone road traverses the proposed clearing area. The northern boundary adjoins the existing quarry and contains a safety barrier consisting of large limestone boulders, with a topsoil bund behind it .

Figure 3.Topsoil bund, sprouting *Mulla Mulla* sp. after recent rains, limestone safety barrier in the background.

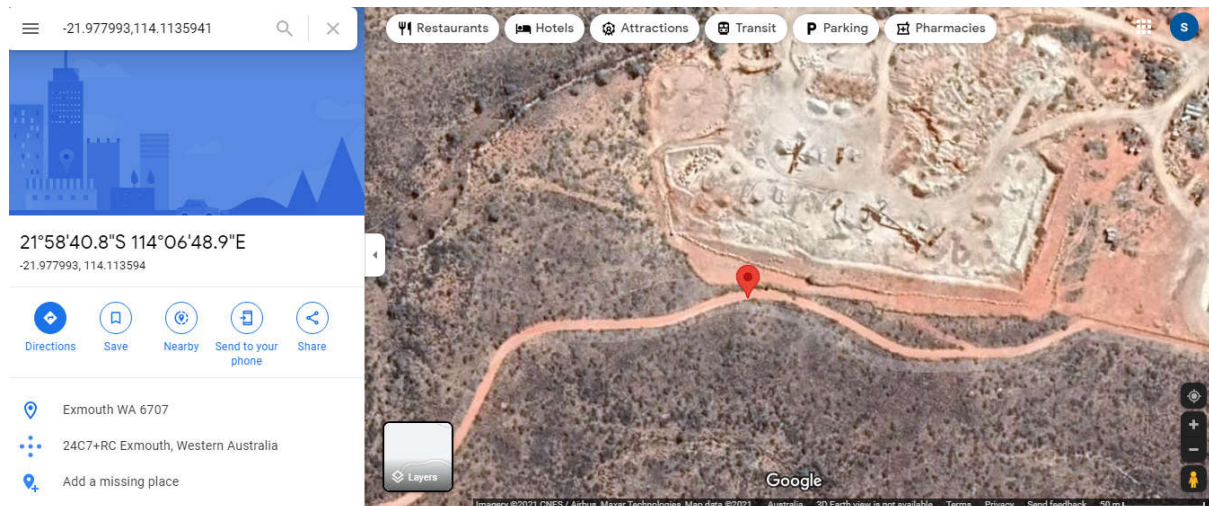
- **Topography:** Limestone outcrop, with pockets of stony soil, traversed by a compacted limestone road and other minor tracks.
- **Hydrology:** Minor tributary at the Northwestern boundary runs in a north easterly direction towards the ephemeral creek at M08/62, this tributary (gully) is excluded from the clearing application.

Figure 4. Location of figure 3. Minor tributary (gully) can be seen at the left side of the satellite image.
