# Vegetation, Flora, Fauna and Environmental Considerations, and Targeted Flora Report

Shire of Esperance Strategic Purpose Permit 2021/22 Site A – Cascade Road and Gravel Pits

February 2022

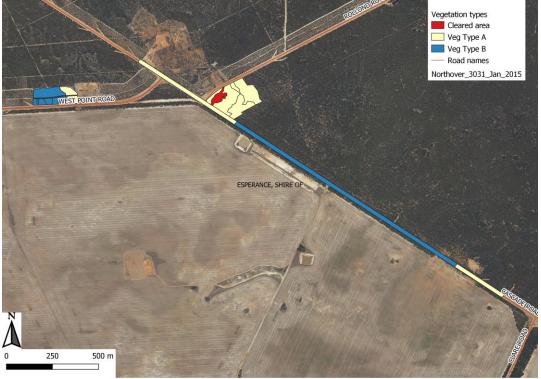
**Figure 3.** Vegetation types within the proposed Pit 2 in the 'Site A – Cascade Road and Gravel Pits' project area.

Two vegetation communities were identified within the 'Site A – Cascade Road and Gravel Pits', as defined by structure and composition (Table 1; Figure 3). The incidental flora list identified a total of 210 native species across all vegetation communities, an additional 5 non-native species were found. It is believed that the Beard (1973) vegetation associations identified in Section 3.7 are an appropriate match both vegetation types observed.

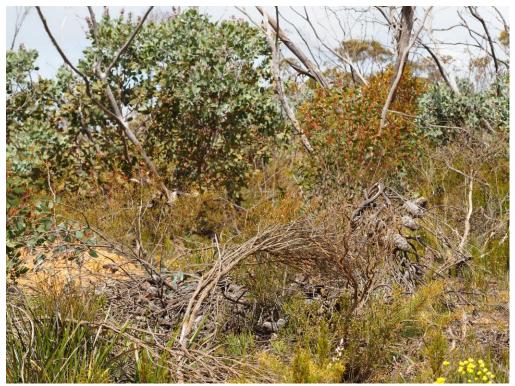
Figure 4. Vegetation type A identified in 'Site A – Cascade Road and Gravel Pits' project, described as 'Open *Eucalyptus pleurocarpa* and *Banksia* media dominated mallee woodland with Acacia, Proteaceae and Goodeniaceae understorey'

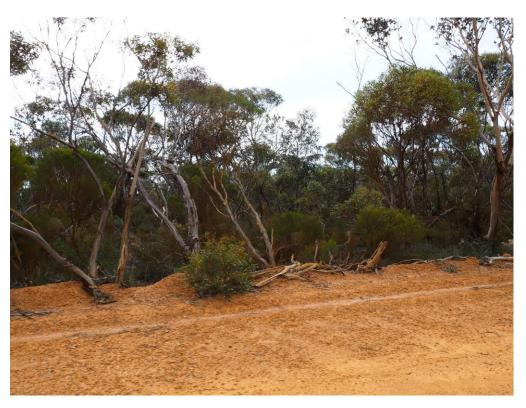
Figure 5. Vegetation type B identified in 'Site A – Cascade Road and Gravel Pits' project, described as 'Mixed Mallee over Mixed Melaleuca shrubland with Acacia and Goodeniaceae understory'

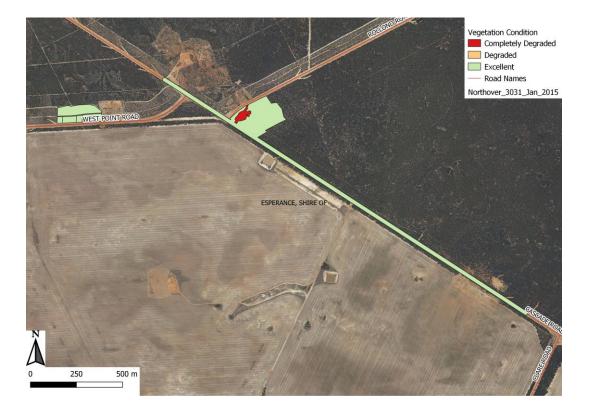
**Figure 6.** Vegetation condition across 'Site A – Cascade Road and Gravel Pits' project, ranging in condition from excellent to completely degraded, due to primarily to degradation from the presence of a rest area, previous gravel extraction, degradation from slashing and fire break maintenance.

The majority of vegetation at 'Site A – Cascade Road and Gravel Pits' is in very good or excellent condition, however there are relatively small areas of poor and completely degraded vegetation (Figure 6). Previous gravel extraction, a rest area and maintenance tracks account for the relatively restricted areas of degraded vegetation. Some areas of the permit have been recently burnt, however the vegetation remains in very good condition, with virtually no weeds and good vegetation cover. Some scattered rubbish was noted around the rest area near Pit 1.

- 6.46 ha of vegetation (98.51%) is in excellent condition,
- 0.05 ha of vegetation (0.68%) is in poor condition, and
- 0.05 ha of vegetation (0.80%) is completely degraded.

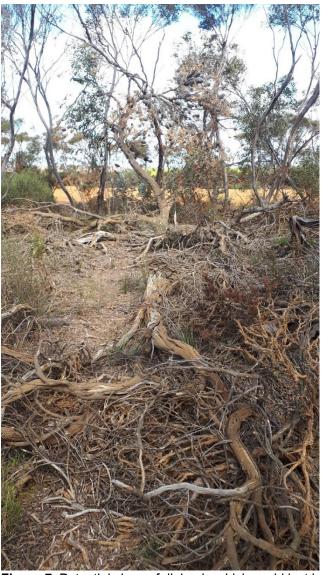
**Figure 7.** Potential signs of dieback, which could just be natural senescence, including dead *Banksia media*, observed in vegetation type A in Pit 1 at 'Site A – Cascade Road and Gravel Pits'.

Within 'Site A – Cascade Road and Gravel Pits', vegetation type A is most susceptible to Dieback due to its relatively high proportion of proteaceous species which are highly vulnerable to the disease. Vegetation type B is also susceptible to Dieback due to still containing several proteaceous species. Dieback Information Delivery and Management System (DIDMS; GAIA Resources, SCNRM & State NRM 2020) data shows no positive or negative *Phytophthora cinnamomi* or other *Phytophthora* sp. Dieback sample results in the immediate area. Concerns about scattered Dieback within Pit 1 at 'Site A – Cascade Road and Gravel Pits' were noted during surveys, with dead *Banksia media* and other Proteaceae species being observed. There were no signs of Dieback observed in Pit 2, which is likely due to the disturbed nature of the site from chaining. Due to the recent fire, in some areas at Pit 1 and 2 it was impossible to detect any signs of *Phytopthora cinnamomi* dieback disease. It is known to take at least five years for visual markers of Dieback to become apparent due to the tolerance of juveniles to the adverse effects of *P. cinnamomi*, A qualified dieback interpreter also cannot determine dieback presence for five years after fire. There was no signs of dieback along Cascade Road, the northern section which contained a high proportion of proteaceous species would be particularly susceptible to the spread of dieback.

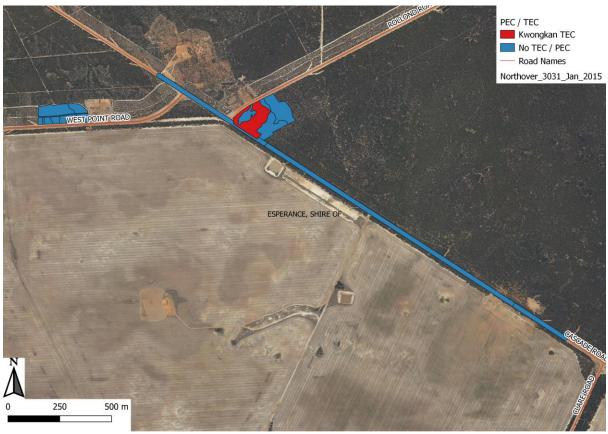
**Figure 8.** Sections of **v**egetation type A in excellent condition met threatened ecological community (TEC) 'Proteaceae Dominated Kwongkan Shrublands of the Southeast Coastal Floristic Province of Western Australia (Kwongkan)' within 'Site A – Cascade Road and Gravel Pits' project.

The southern section of Cascade Road failed to meet the >30% proteacous cover in the unburned sections and lacked the necessary diagnostic species in the burned area, a small section adjacent to Pit 2. The chained are north of pit 2 lacked the necessary >%30 proteacous cover or the necessary diagnostic species.

Due to the site recently being burnt, using the 'Approved Conservation Advice for Kwongkan (Commonwealth of Australia 2014)' for assessing the presence of Kwongkan, assessment relied on determining if two or more Proteaceae species were diagnostic, and will form a significant vegetative component when mature.
