# BARTON CREEK WATERSHED DATA REPORT

June 2019

THE MEADOWS CENTER  
FOR WATER AND THE ENVIRONMENT  
TEXAS STATE UNIVERSITY

TEXAS STREAM TEAM

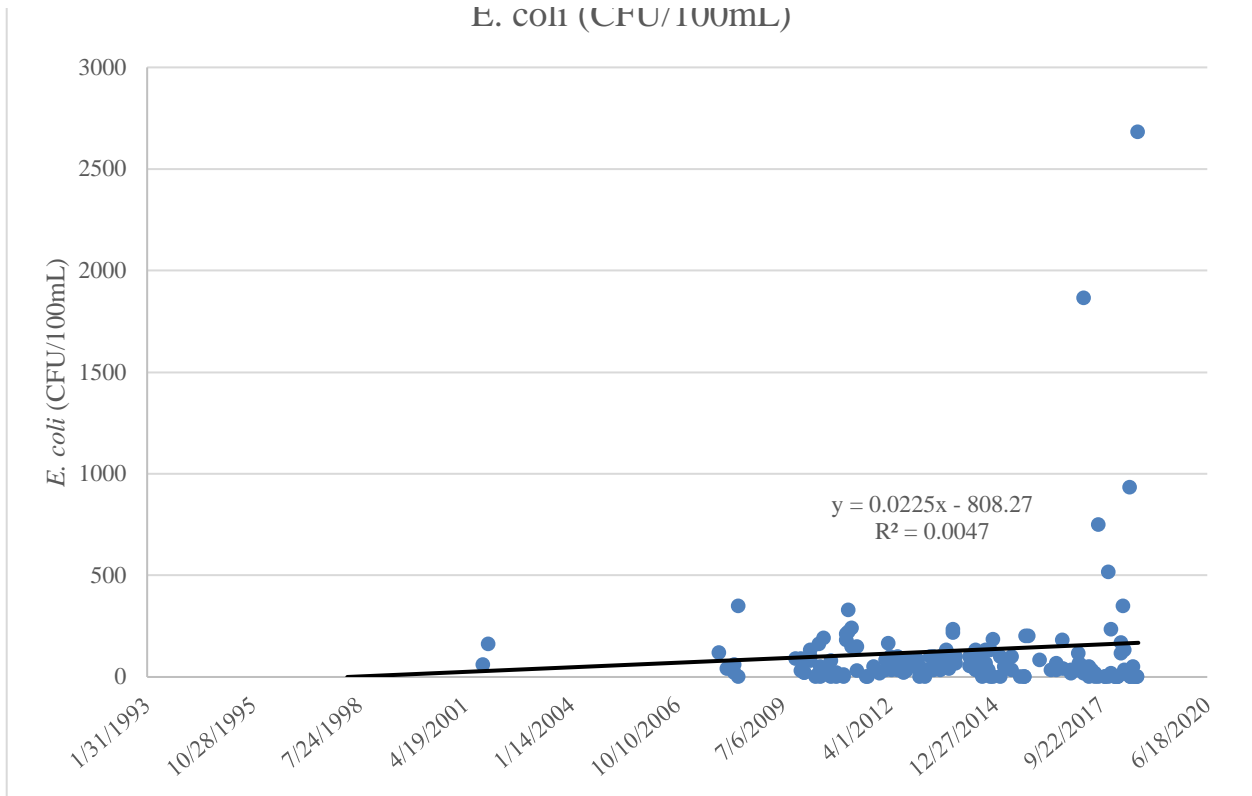
*E. coli* samples were taken throughout a quarter of the sampling events within Barton Creek watershed. A total of 158 *E. coli* samples were taken. The geomean for *E. coli* was 28 CFU/100 mL. The *E. coli* counts ranged from 1 CFU/100mL (no bacteria detected) to a high of 3513 CFU/100mL in October of 2011.

**Figure 6: *E. coli* over time at all sites within the Barton Creek watershed**

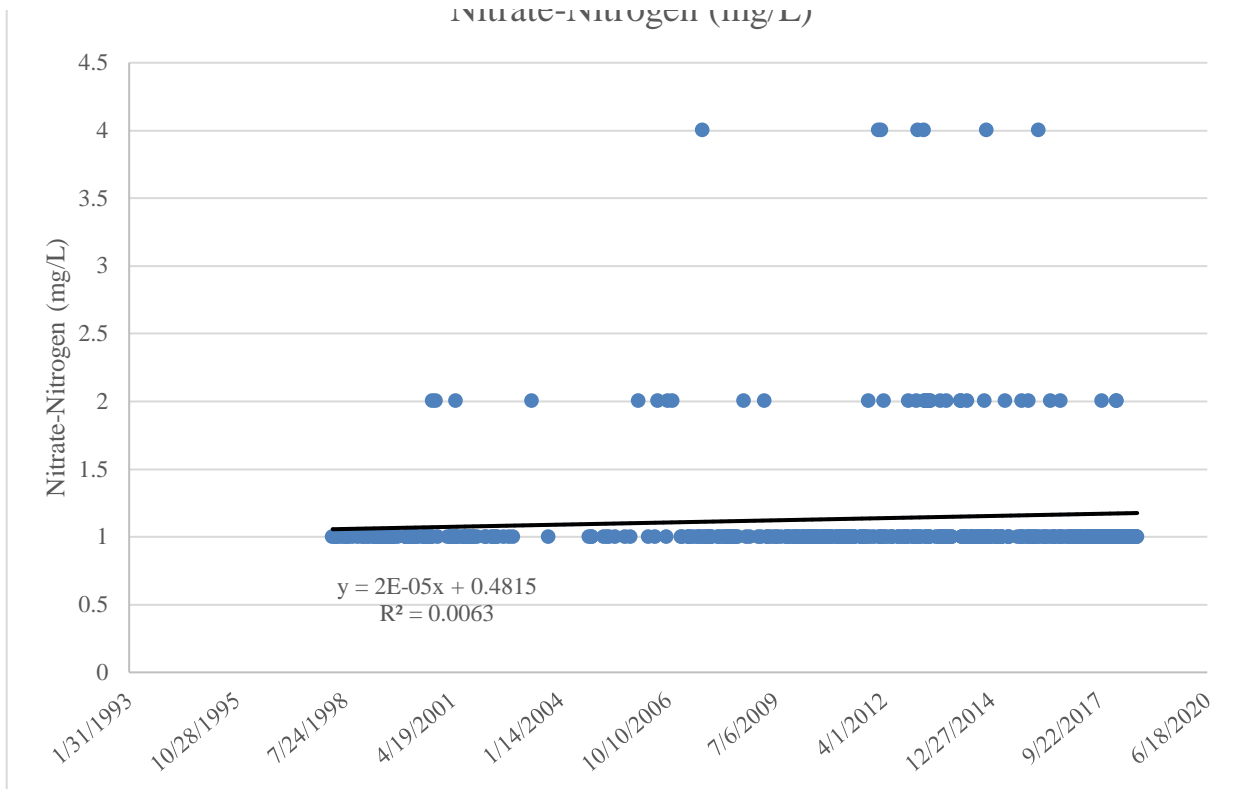
Nitrate-nitrogen concentrations were taken at nearly all of the selected sites in the Barton Creek watershed except for Site 80250 – Rocky Creek Branch near Crumley Ranch, where only one nitrate-nitrogen sample was taken. A total of 431 nitrate-nitrogen samples were taken. The mean nitrate-nitrogen concentration in the watershed was 1.13 mg/L from values ranging from 1.0 mg/L to a high of 4.0 mg/L.

Figure 7: Nitrate-nitrogen over time at all sites within the Barton Creek watershed

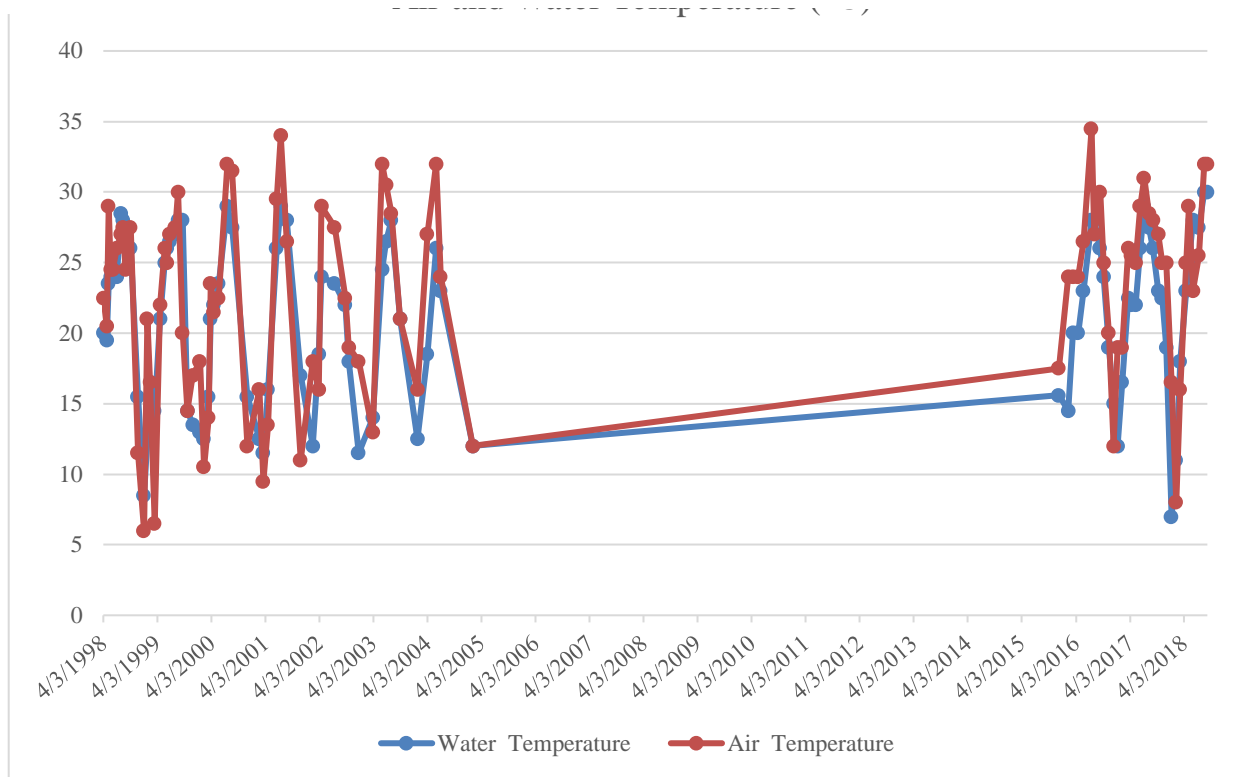
Air and water temperatures were taken 89 times at this site. The air temperatures fluctuated in a seasonal pattern with the highest temperature of 34.5°C taken in July of 2016, and the lowest temperature of 6.0°C taken in January of 1999. The mean water temperature was 21.1°C and the water temperature ranged from a low of 7°C recorded in January of 2018 to a high of 30.0°C in both August and September of 2018.

Figure 13: Air and water temperature at Site 12500

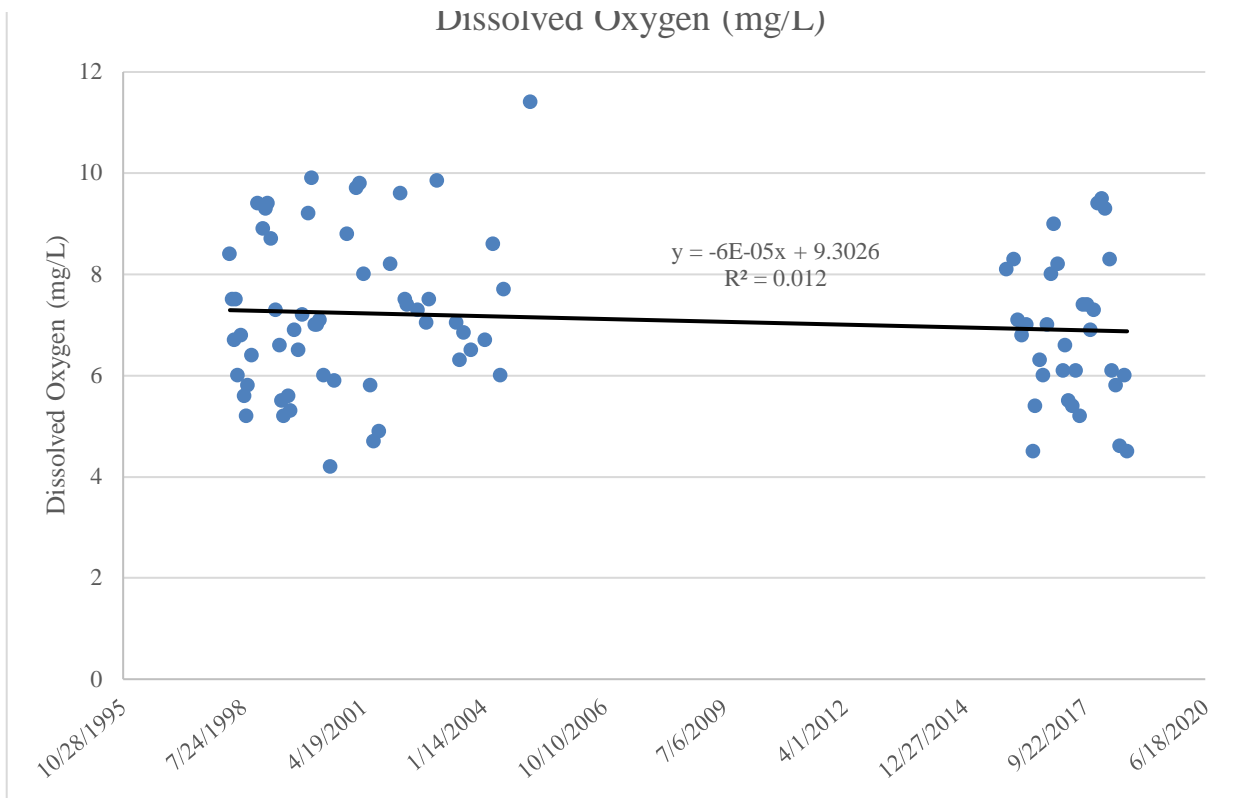
Citizen scientists took 88 DO samples at this site between 4/3/1998 and 9/7/2018. The mean DO concentration was 7.1 mg/L. DO concentrations ranged from a low of 4.2 mg/L in July of 2000 to a high of 11.4 mg/L in February of 2000.

**Figure 15: Dissolved oxygen at Site 12500**

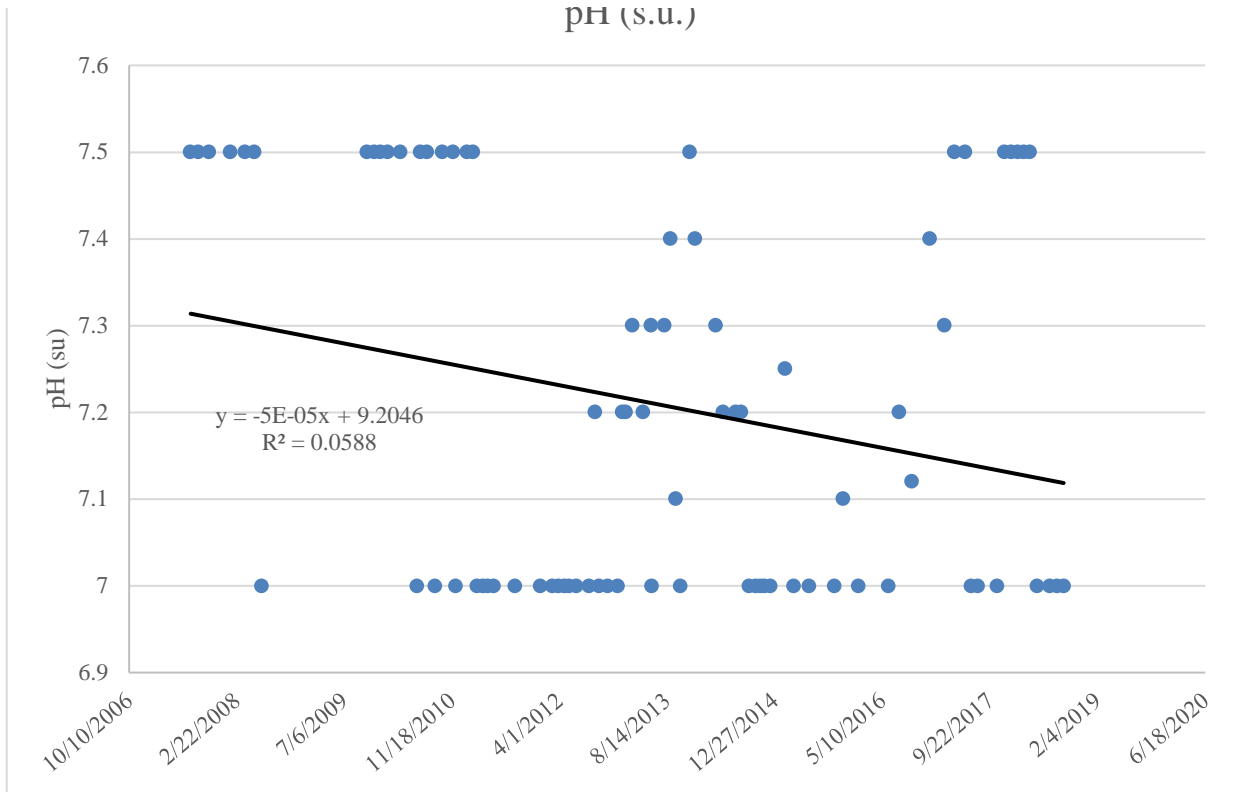
There were 83 pH measurements taken at this site between 7/23/2007 and 8/30/2018. The mean pH was 7.2 and pH ranged from a low of 7.0 taken on multiple instances to a high of 7.5 taken on multiple instances.

Figure 25: pH at Site 81480

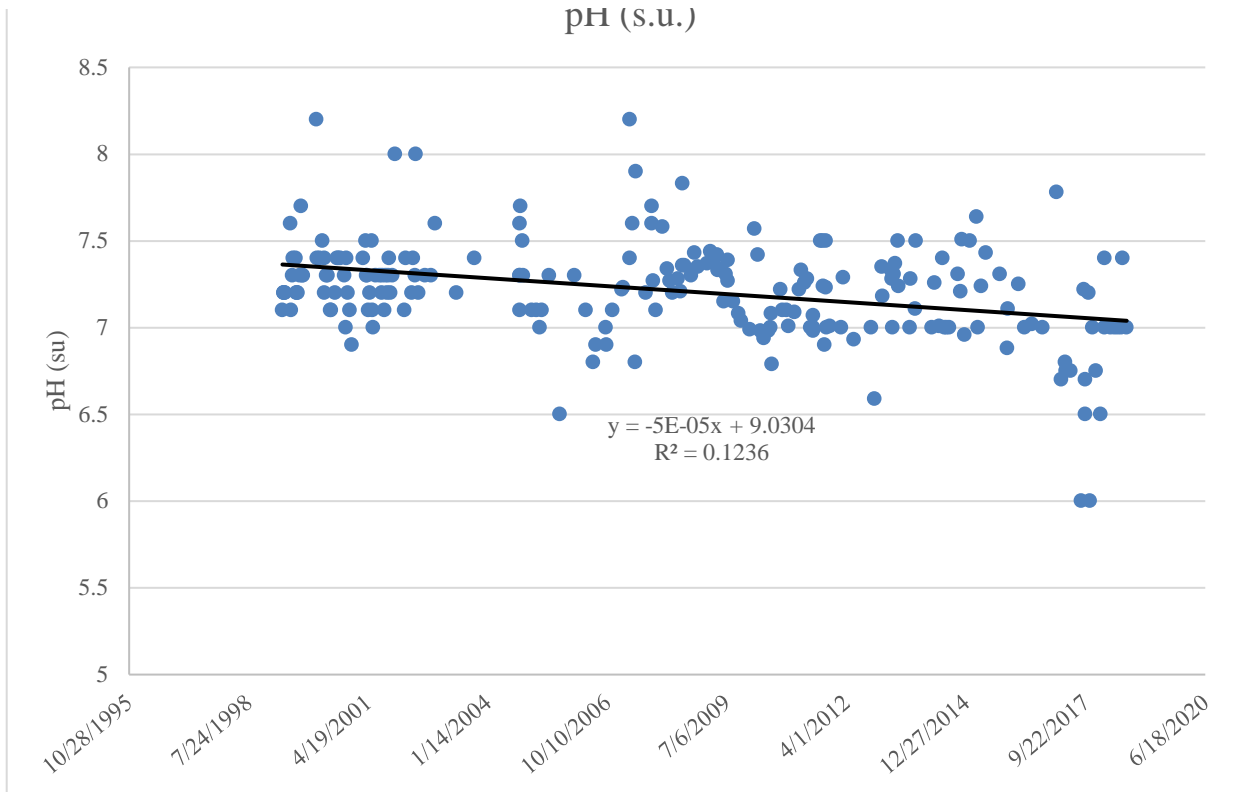
Figure 37: pH at Site 15958
