HAWAI'I DAIRY FARMS

FINAL ENVIRONMENTAL IMPACT STATEMENT

VOLUME 2 TECHNICAL APPENDICES

JANUARY 2017

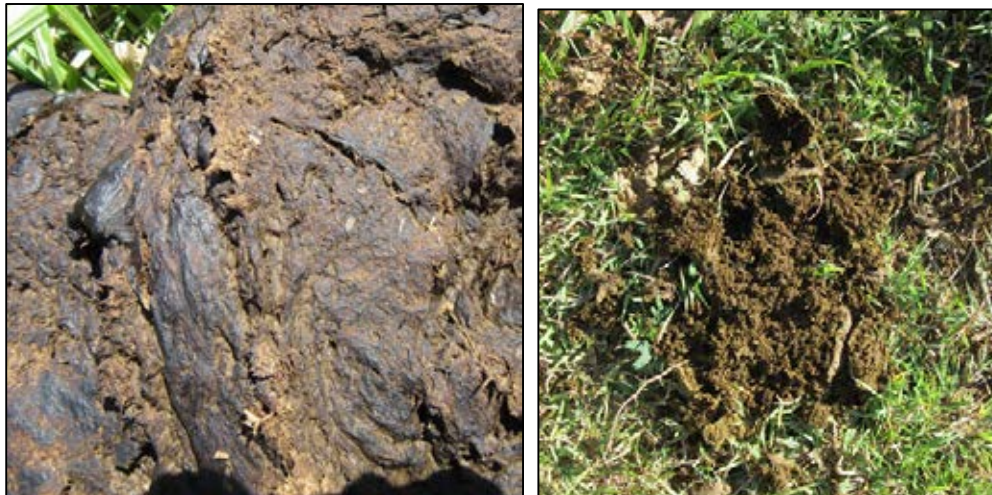
Figure 12. Undisturbed manure (left) contrasted with manure disrupted by dung beetles and birds searching for seeds or larvae (right).

Several species of birds are present. Many of them feed on seeds and small insects. Numerous manure piles showed signs of being disturbed by birds scratching at, or beaking the pile to find larvae or undigested seeds. (Figure 12) This assists in the breakdown of the piles making them more easily dissolved by sprinklers and more accessible to other colonizing insects that reduce the pile. A disturbed pile also is much less suitable habitat for fly larvae, reducing breeding success.

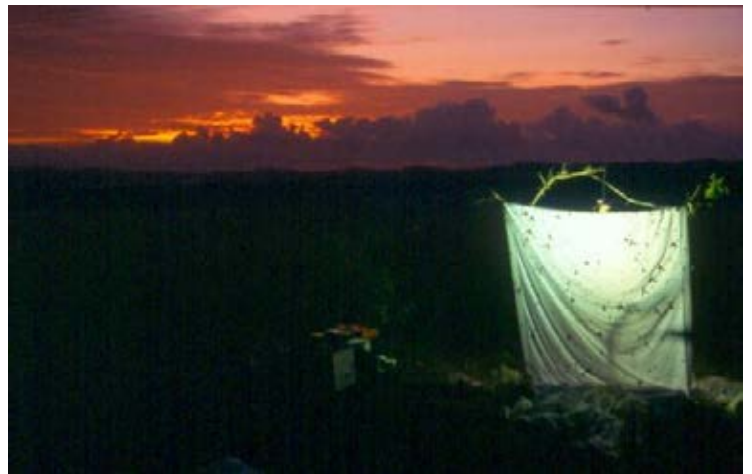
©Figure 27. Typical night collection sheet / light set up.

In the new pastures, it would be beneficial to quickly boost the breeding population of dung beetles as the cows arrive and begin defecating. This could be accomplished by transplanting adult beetles from older Kaua'i pasture locations. Dung beetles are attracted to light at night, so by visiting locations where beef cattle are established and setting up a typical entomological night collection light with white sheet (Figure 27), it would be possible to collect many adults.

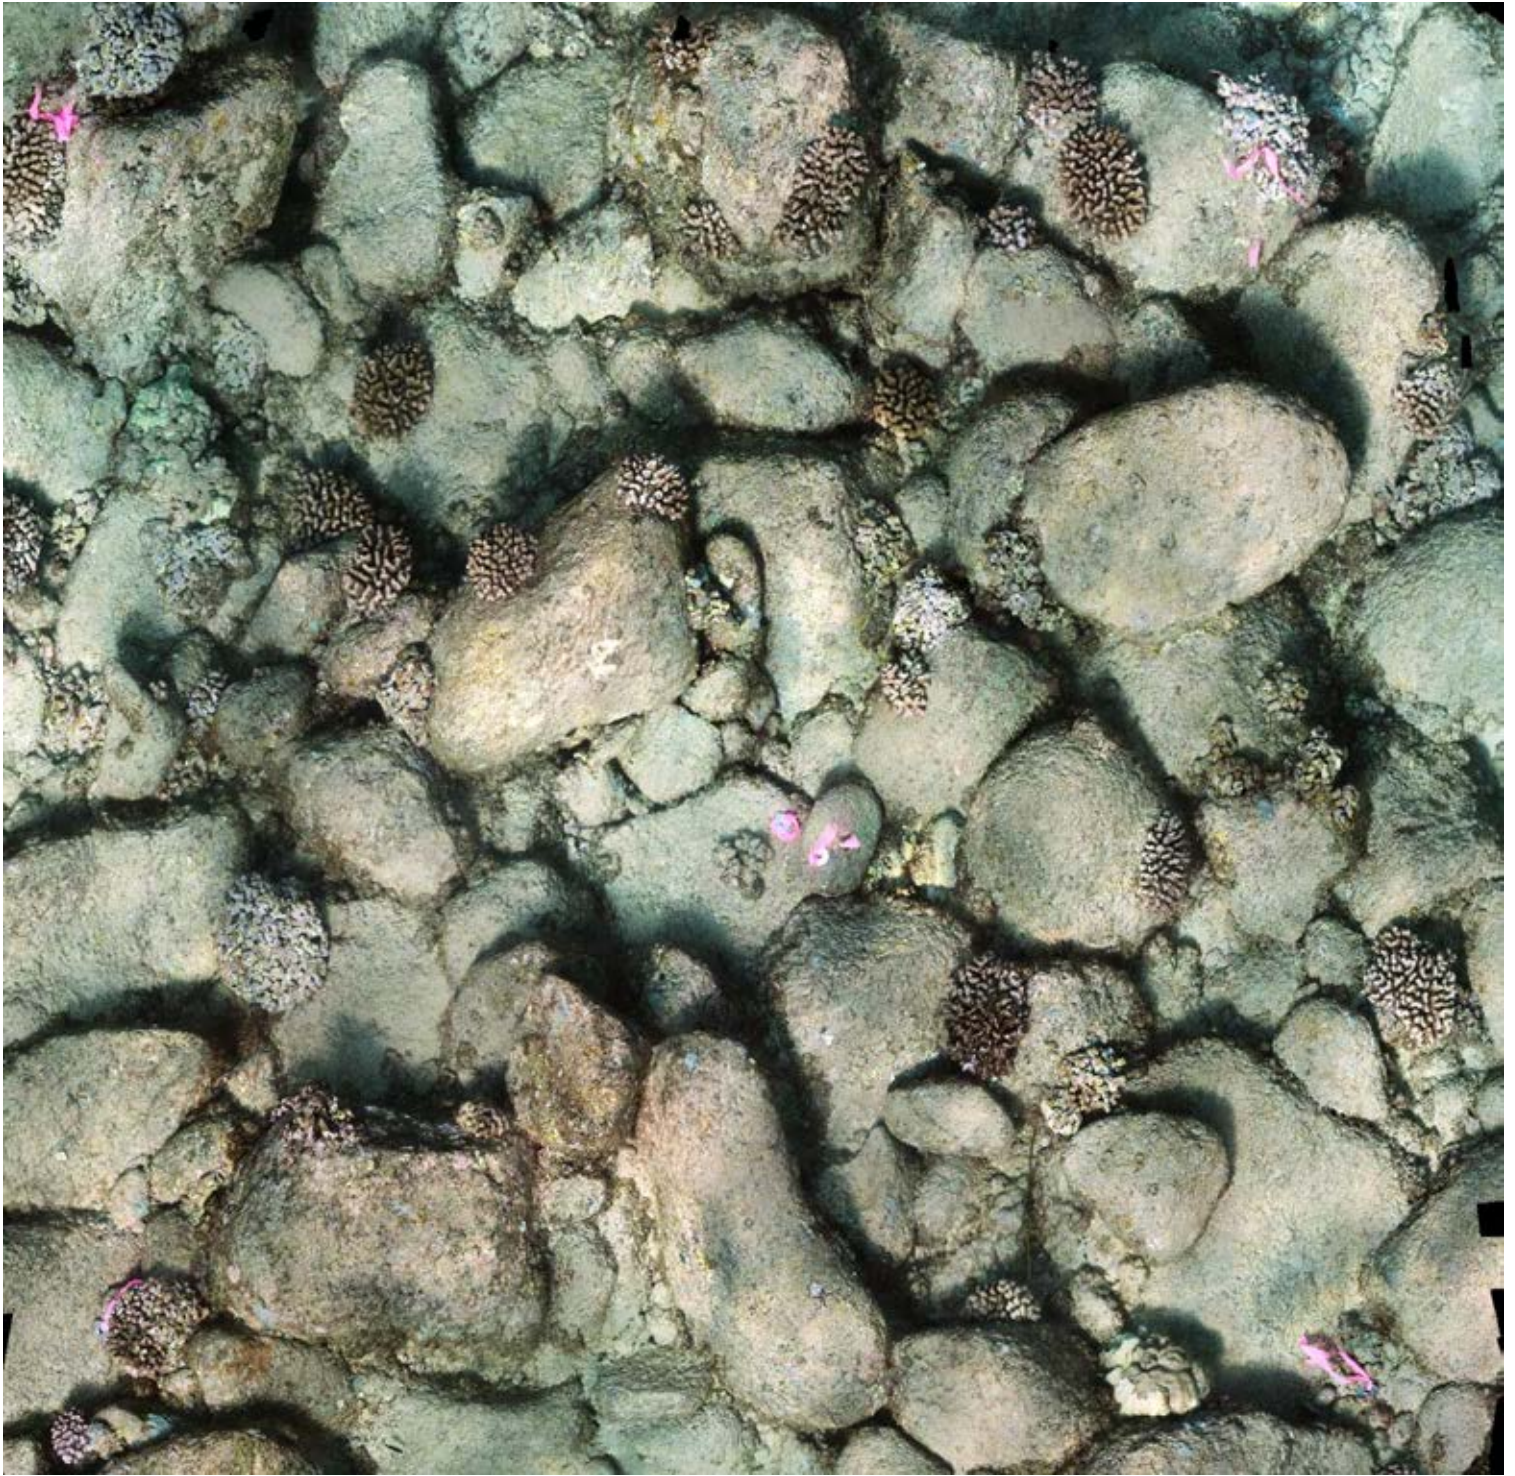
FIGURE 6. Photomosaic image of benthic habitat off Mahaulepu Beach in area marked as ZONE 7 in Figure 1. Bottom composition consists of basaltic boulders. Dominant coral is *Pocillopora meandrina*. Water depth is approximately 8 feet.

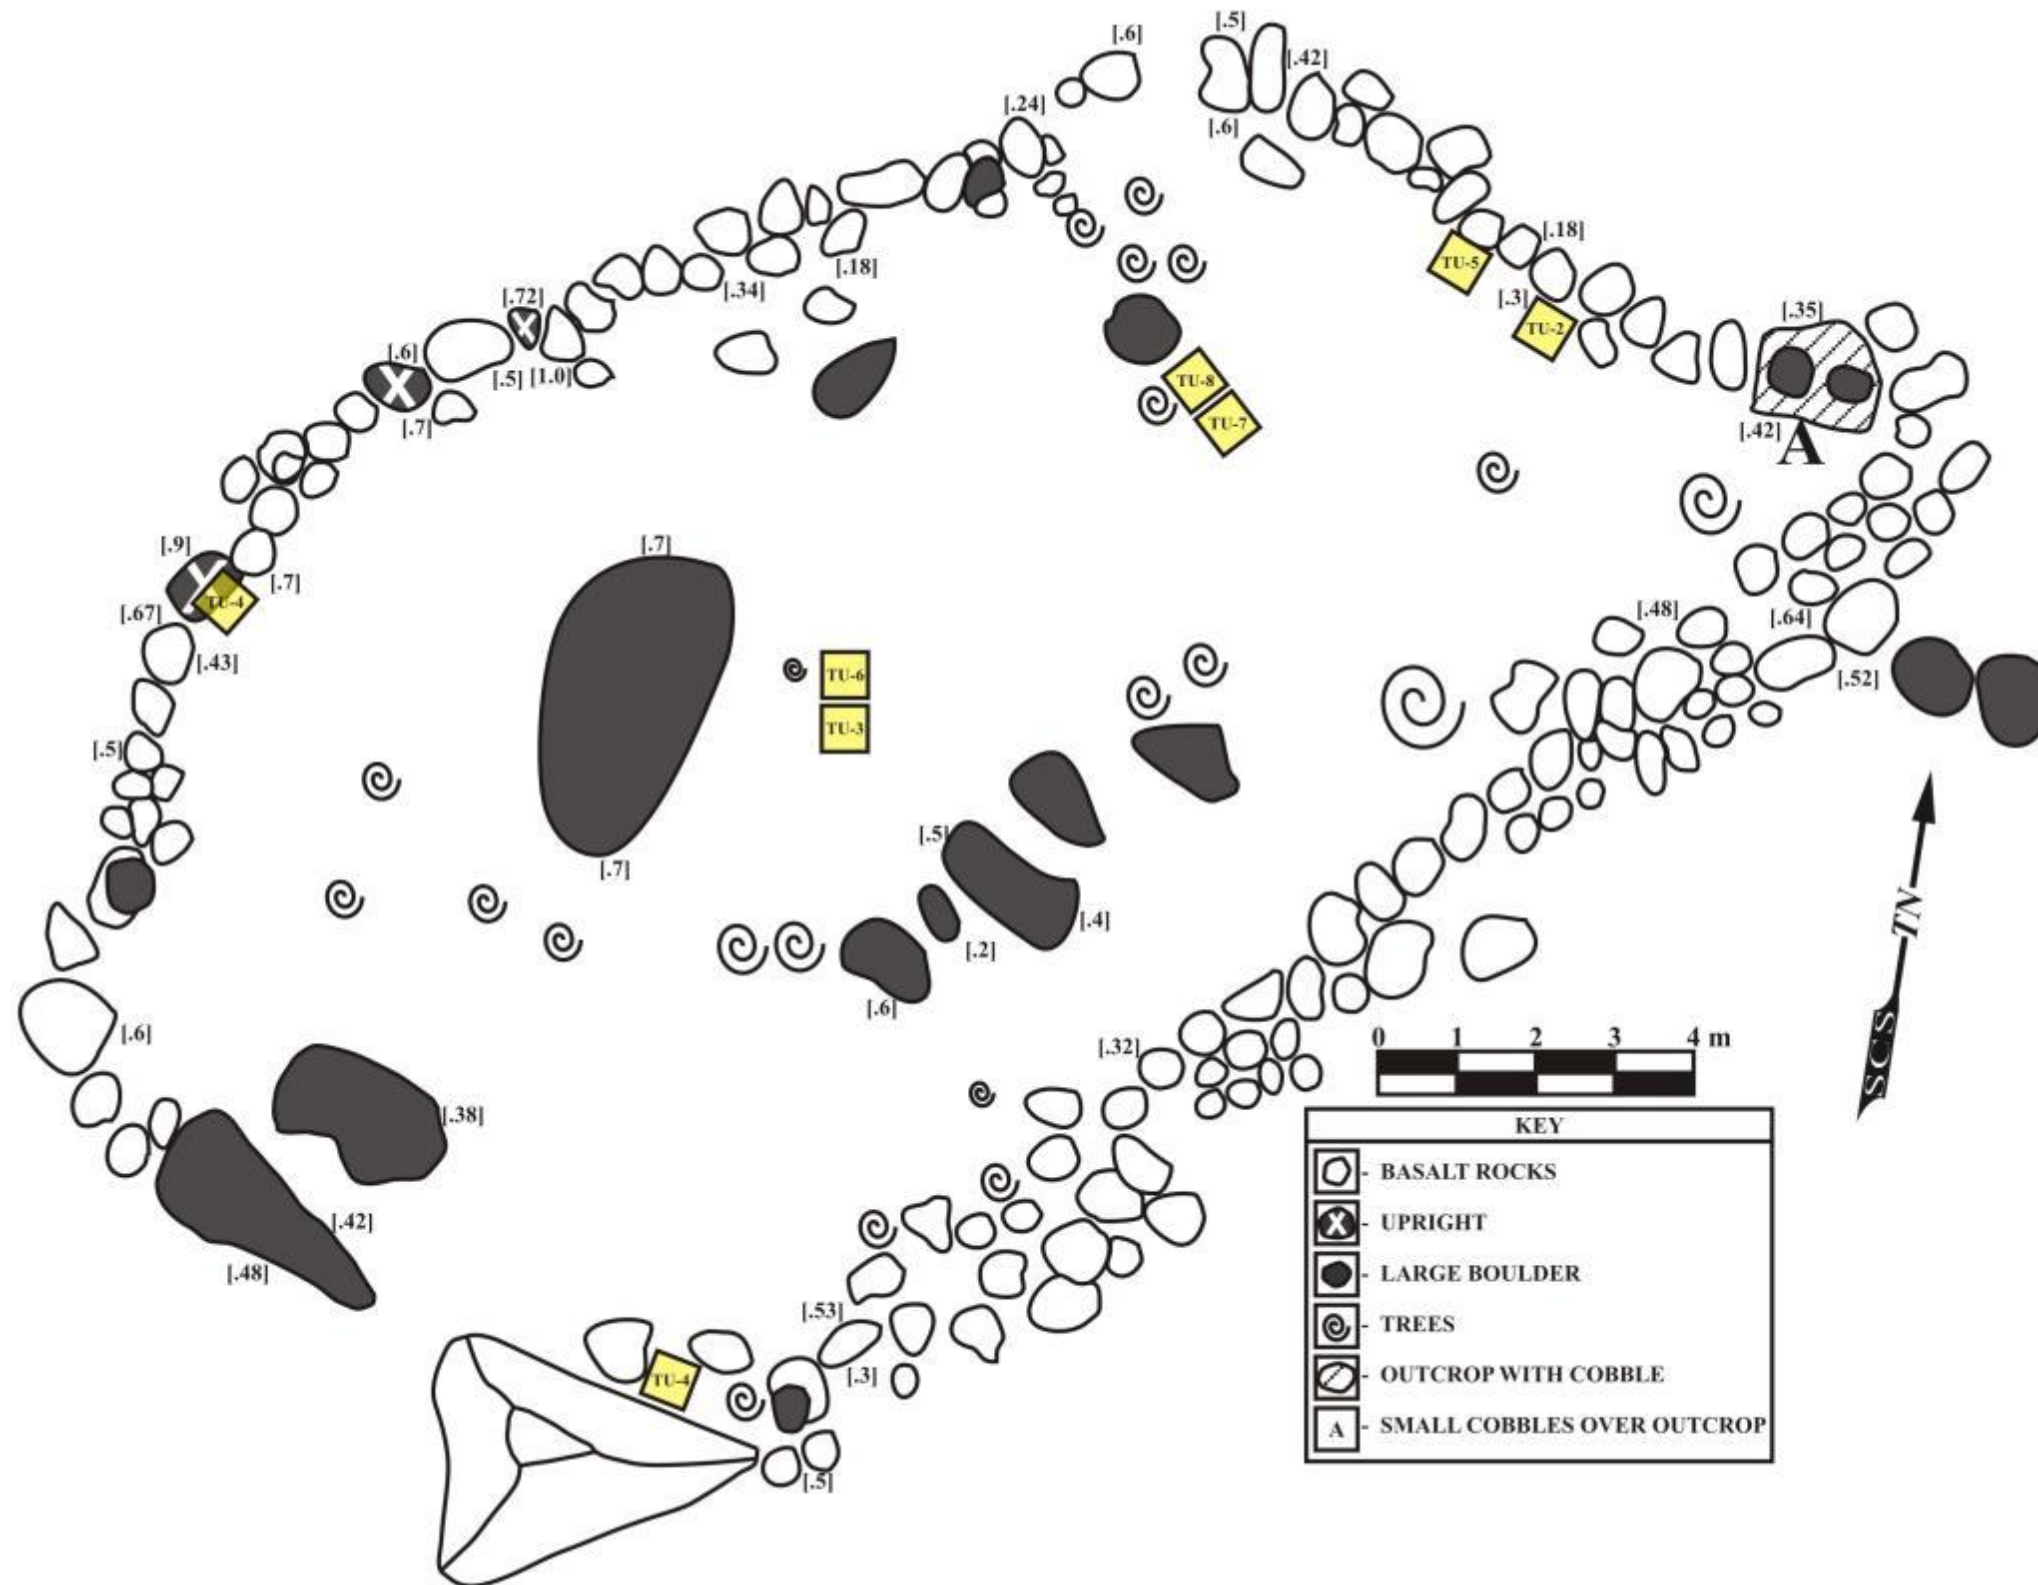
Figure 20. Plan view of Site -2250.

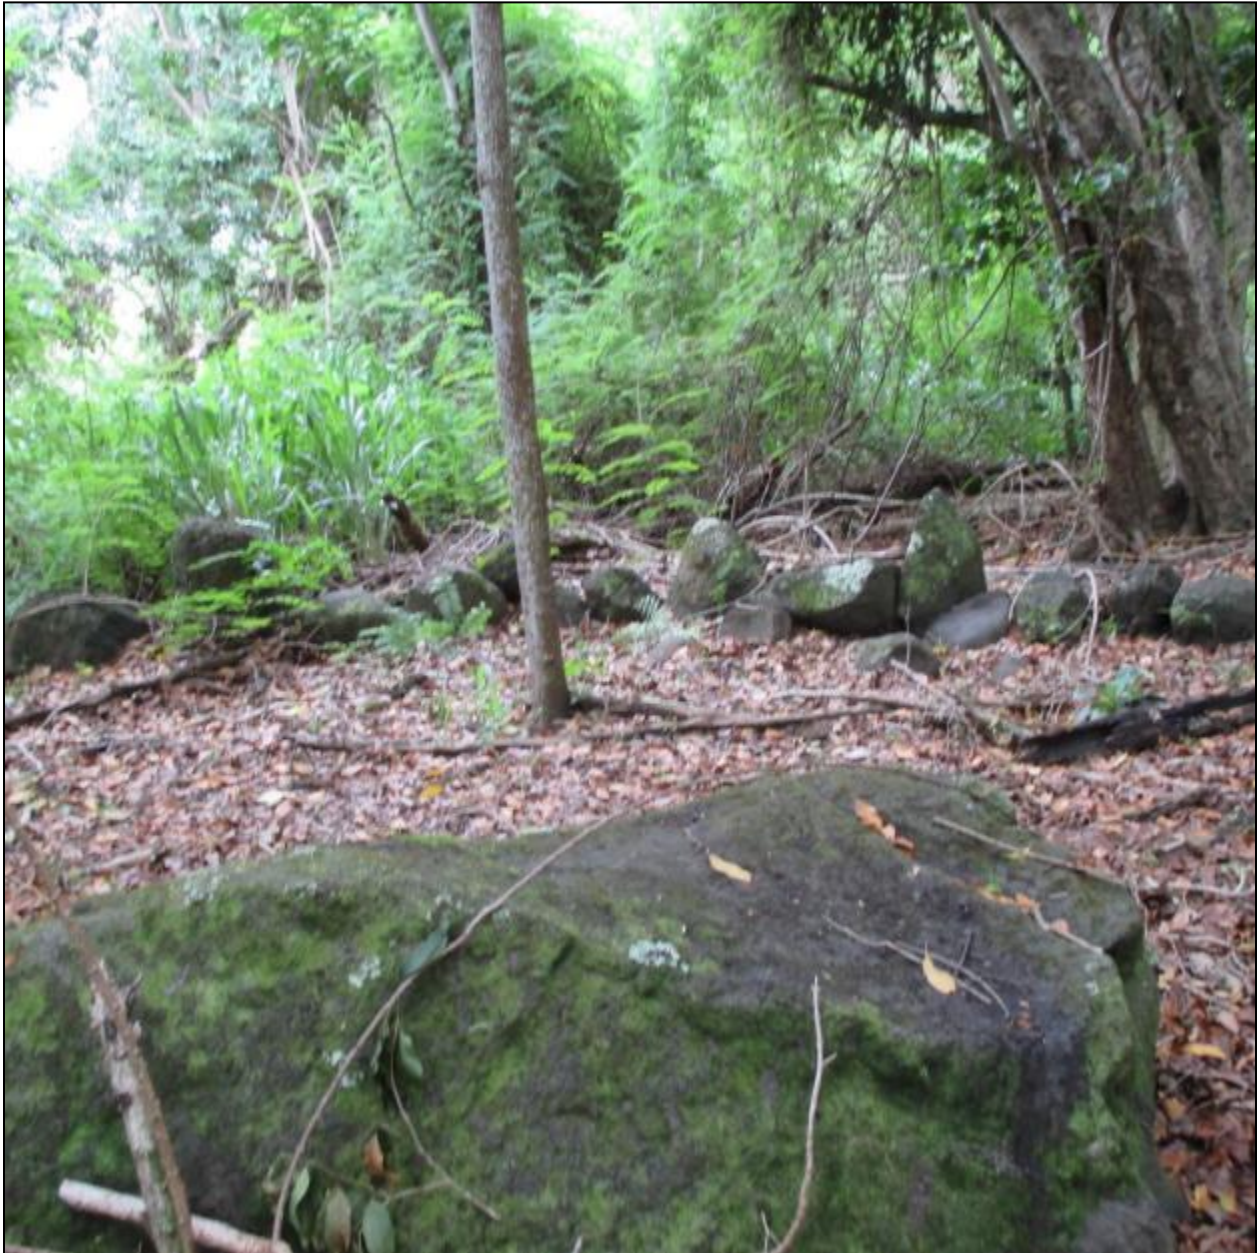
Figure 23. Site -2250. Note uprights in construction. View to west.

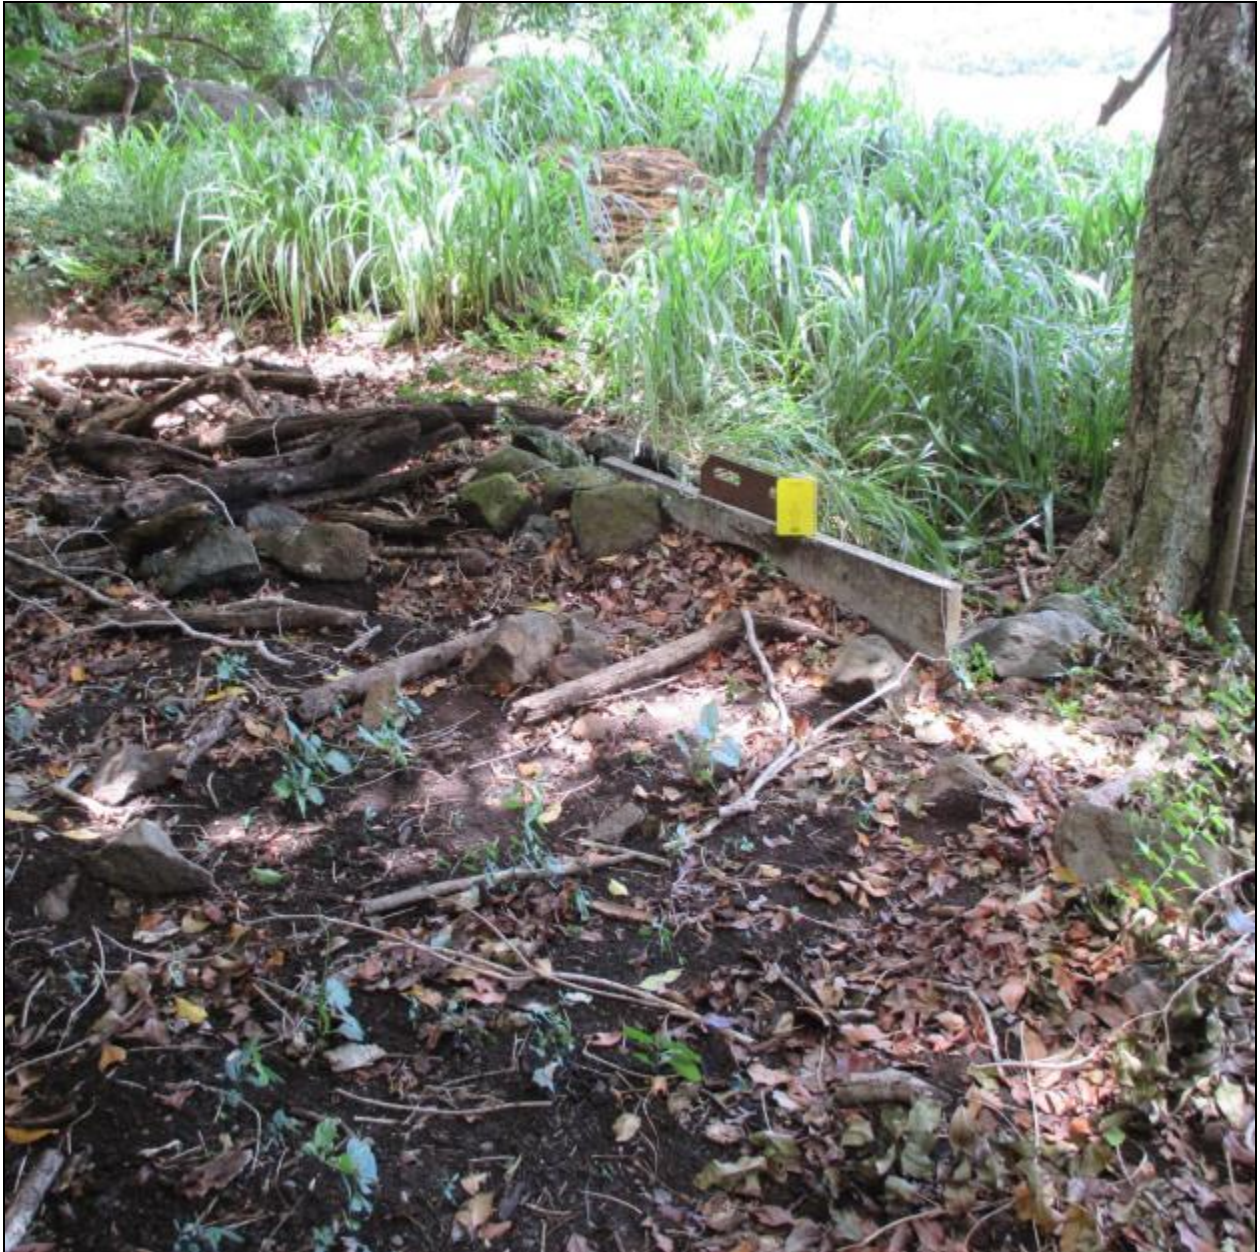
Figure 30. Site -2251, Feature 1 ditch and Feature 2 sluice gate. View to southeast.

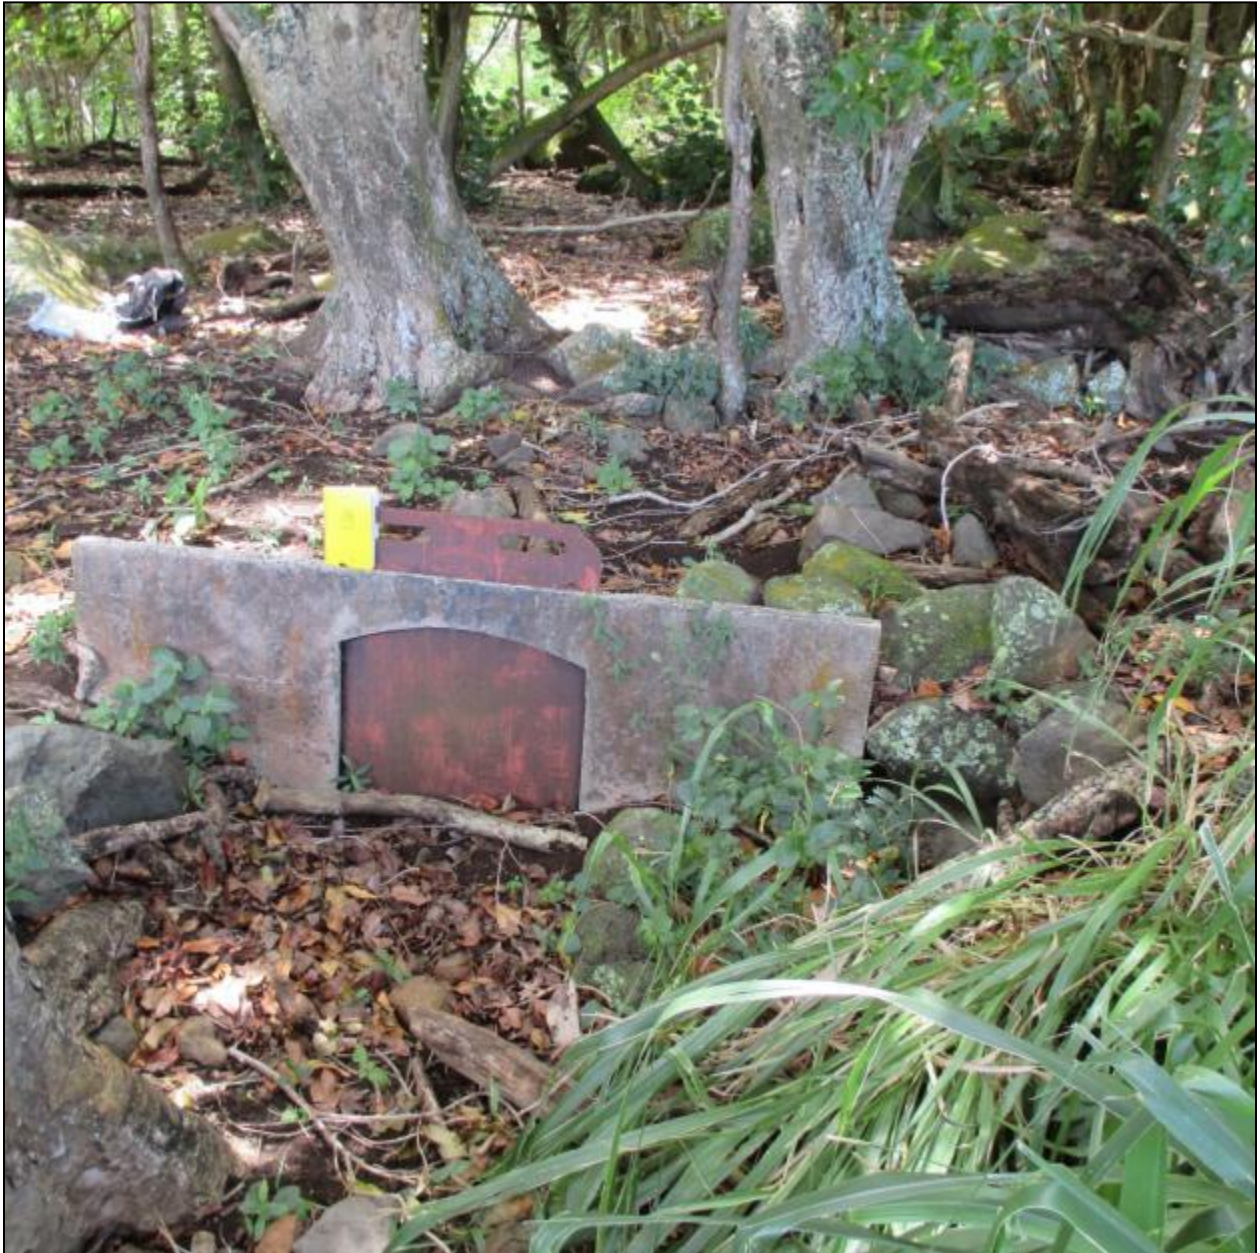
Figure 32. Site -2252, Feature 2 sluice gate. View to northwest.

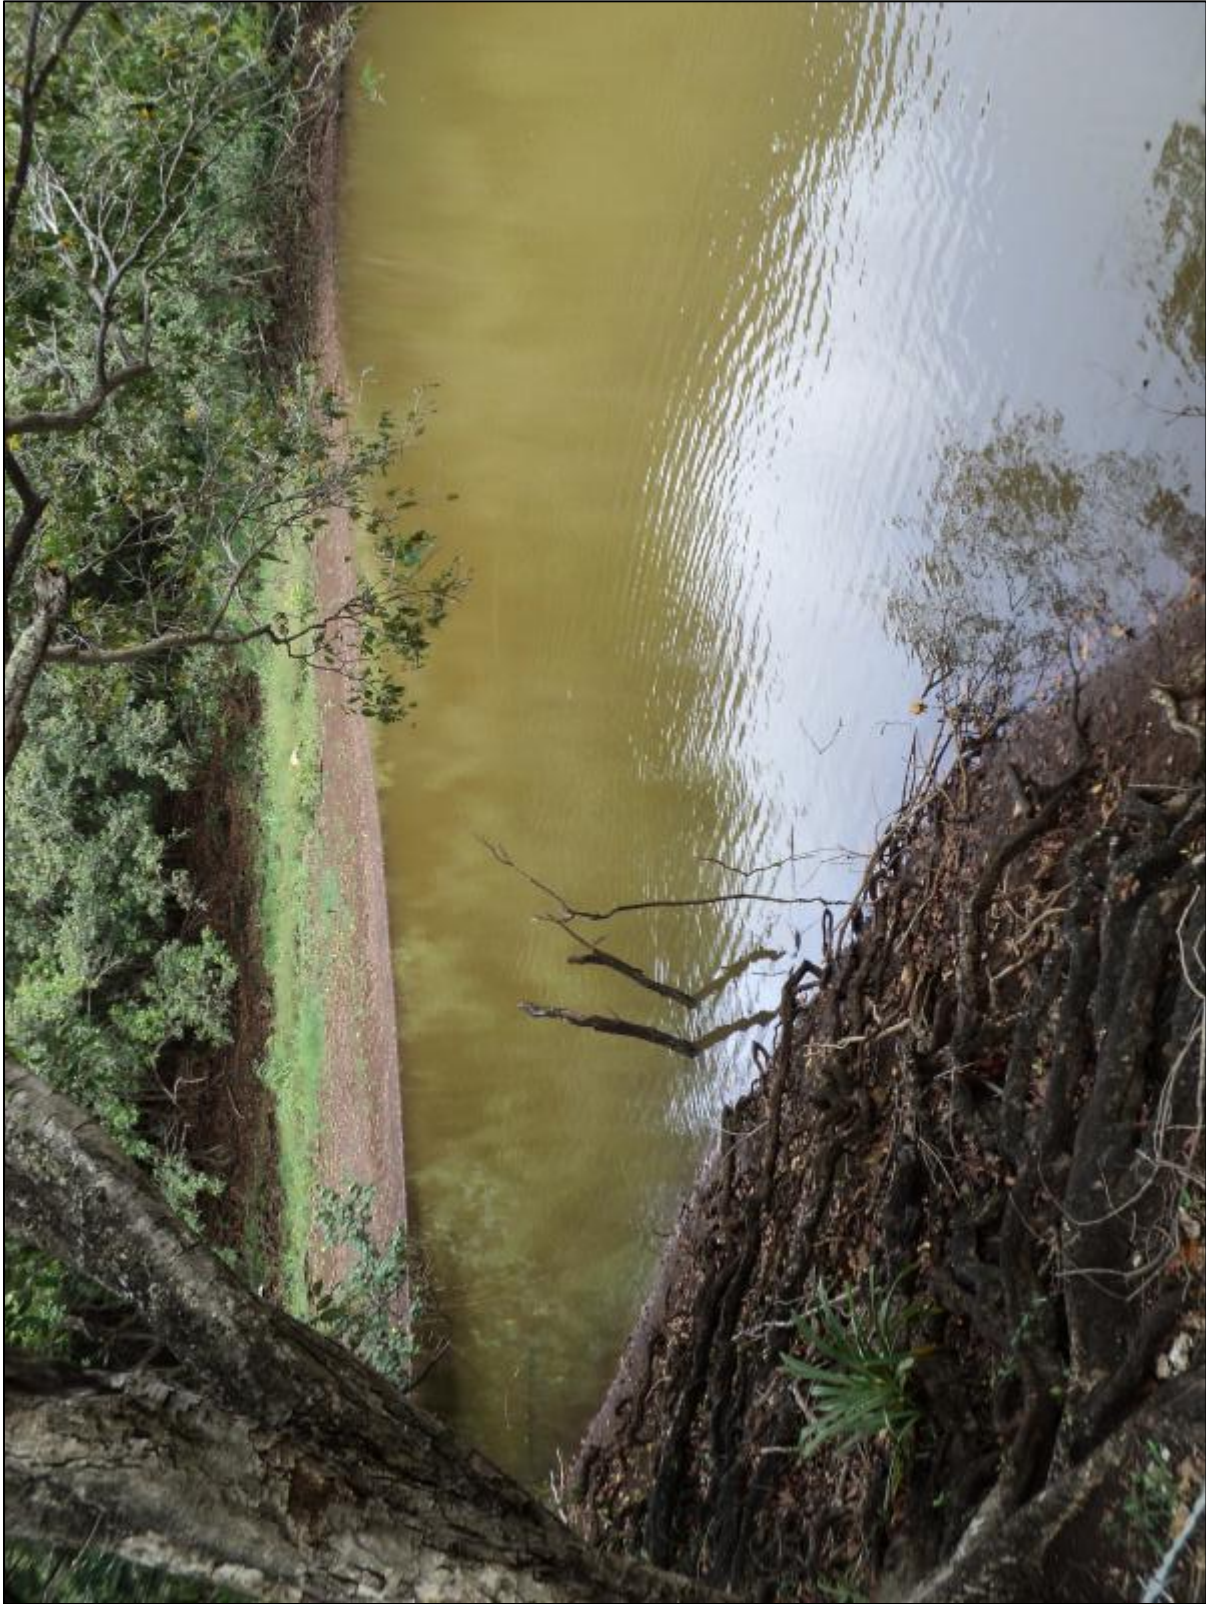
Figure 48. Site -2258 reservoir. View to southwest.

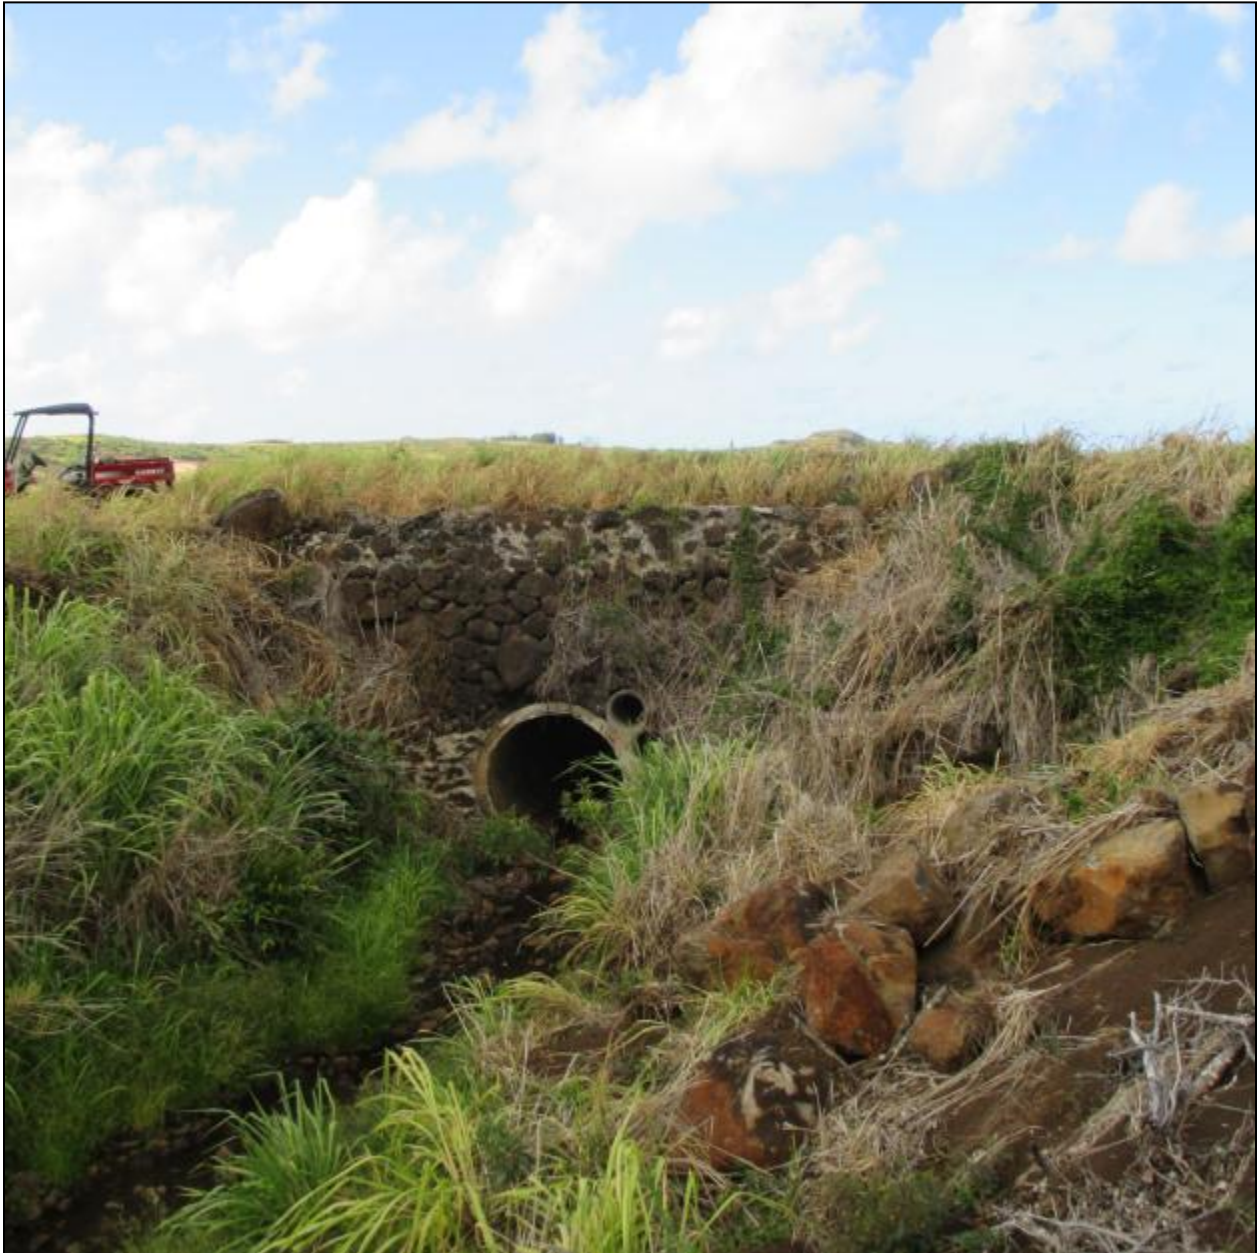
Figure 58. Site -2263 bridge. View to south.

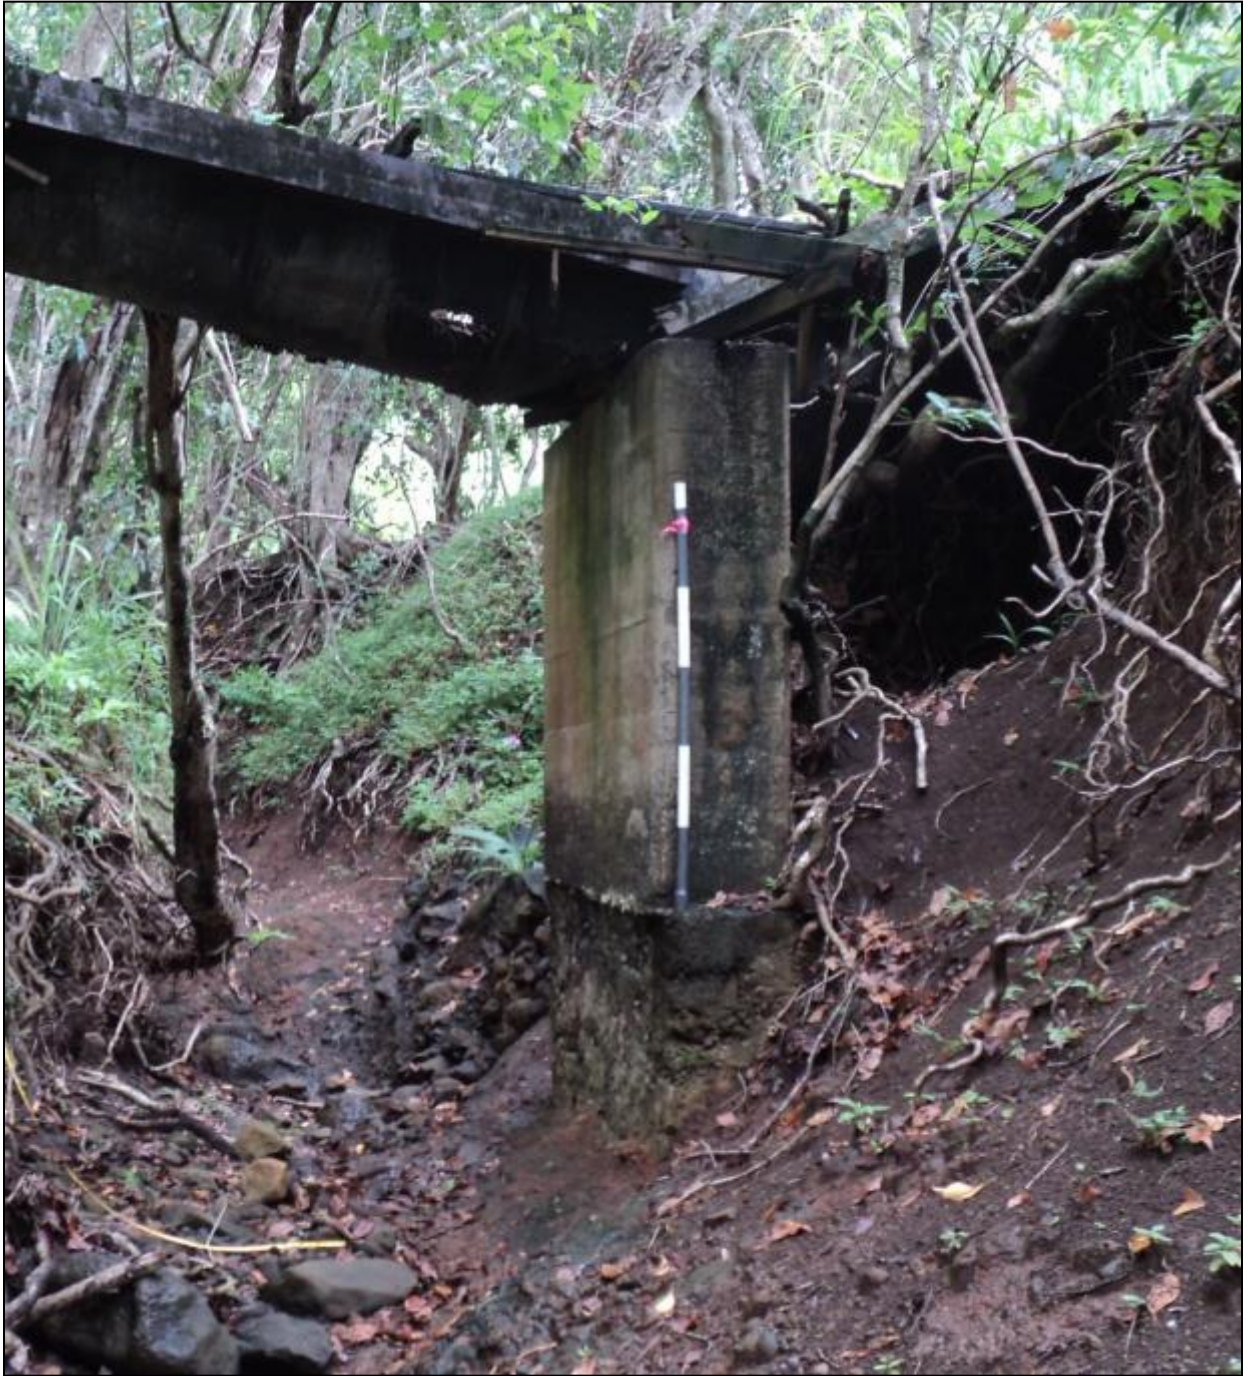
Figure 66. Site -2262 north bank foundation. View to north.

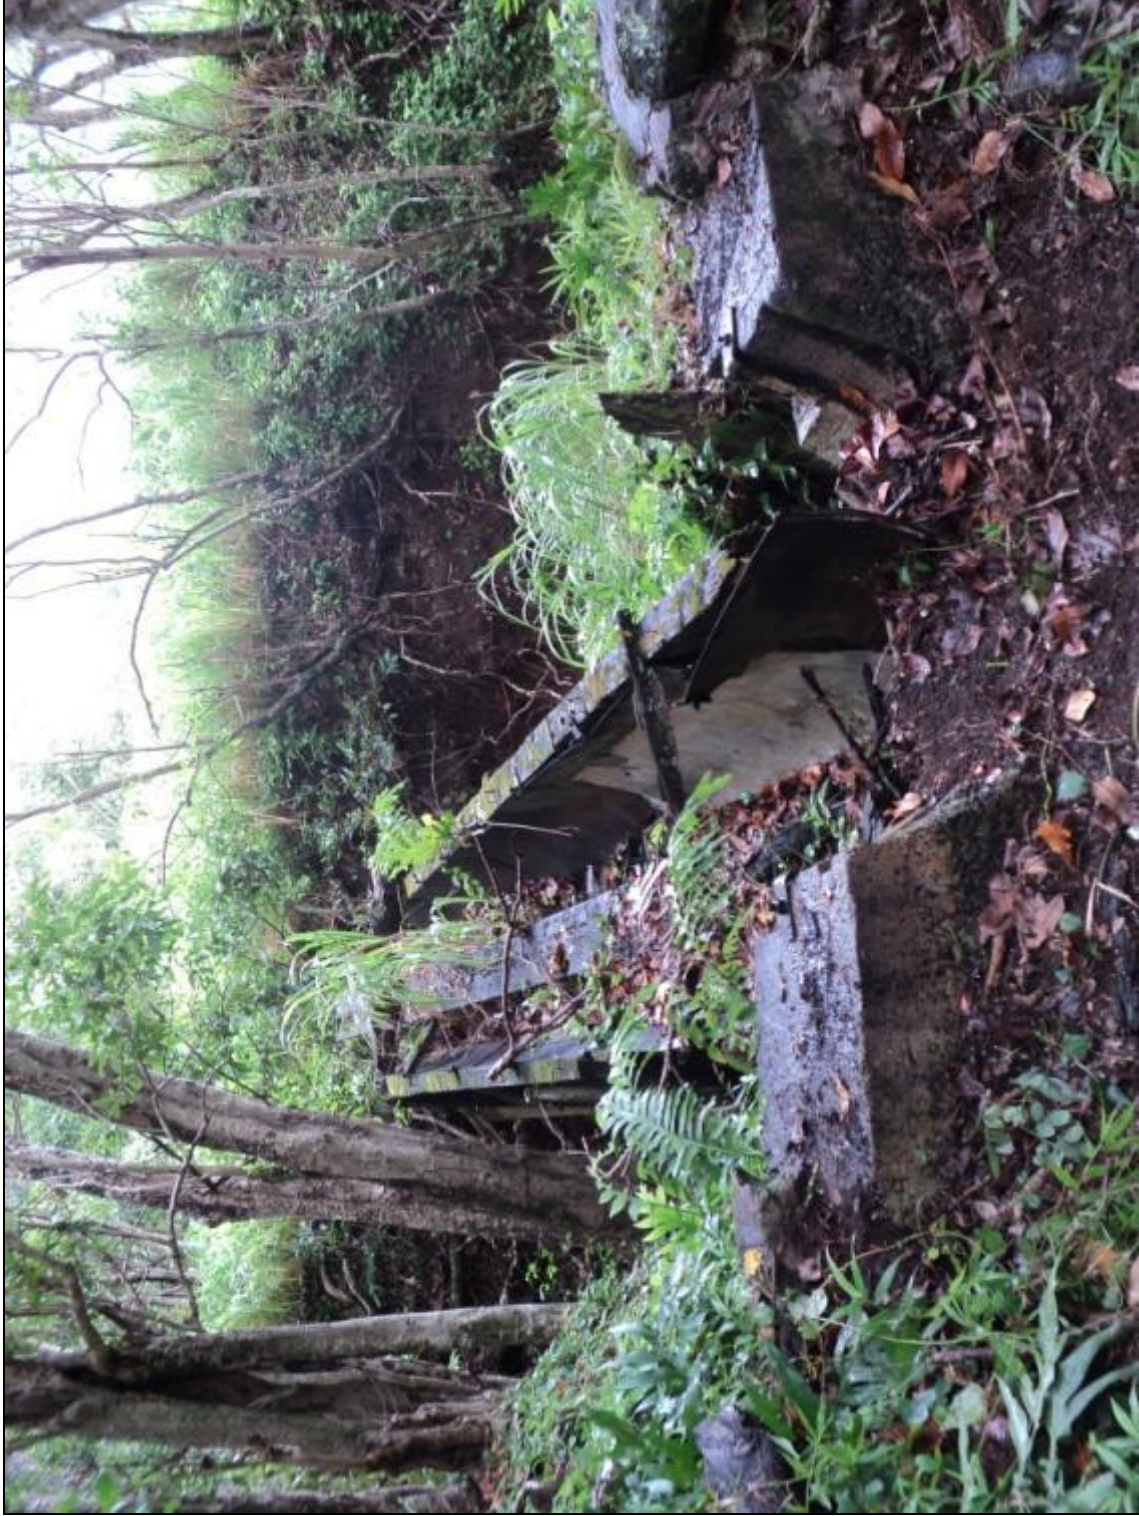
Figure 67. Site -2262 flume system. View to northeast.
