Moy Cable Route

Desk Based Assessment & Walkover Survey

Report and Recommendations

HAS Report No.	MCR20-005
Site Code	MCR20
Client	SSE Networks
Planning Reference	-
OS Grid Reference	NH 65299 42635 to NH 77267 36825
Date	07/07/2020
Author(s)	Lachlan McKeggie
Approved by	Lynne McKeggie

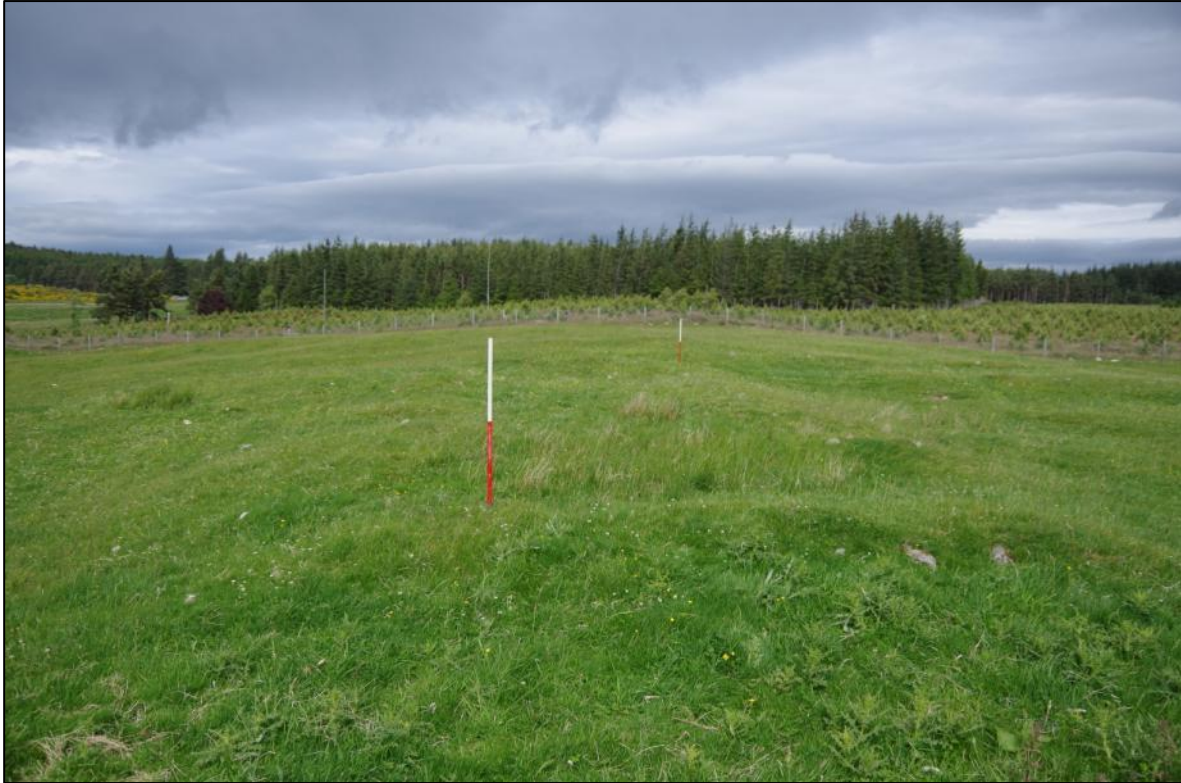
Figure 10: Photo showing W9a footings facing NW and showing ridge (1m scales, photo 7210)

Finally seven structures or footings of structures were recorded at the route's east end (W9a & b, W10a & b, W14a & b, and W15). Both W14 structures as well as W15 were poorly preserved turf covered footings, none surviving over 0.3m above surrounding ground level. The W9 footings were clearer although again totally turf covered and only up to 0.3m high. The two W9 buildings, laid out in an L shape, were also connected to two enclosures. W9c ran down the length of W9a on the west side and W9d connected the footings of a & b to form a yard between (see Figure 9). The layout of W9 was mirrored by the best preserved structures of W10a&b, which were also arranged in an L shape, although no yards or enclosures were visible. The W10a&b structures were much more substantial, stone and mortar built buildings surviving up to 2.5m high at the gables. Both W10a and W10b had fire places in each gable and evidence of window openings. W10a had a possible entrance slab on the SW side facing down the hill. Both W9 and W10 were located on the top of a rise overlooking the fields to the NE and SW. Although the W10 structures were much better preserved the mirrored form and similar sized footprints implies W10 was constructed by people who were aware of W9 and probably as direct replacements.

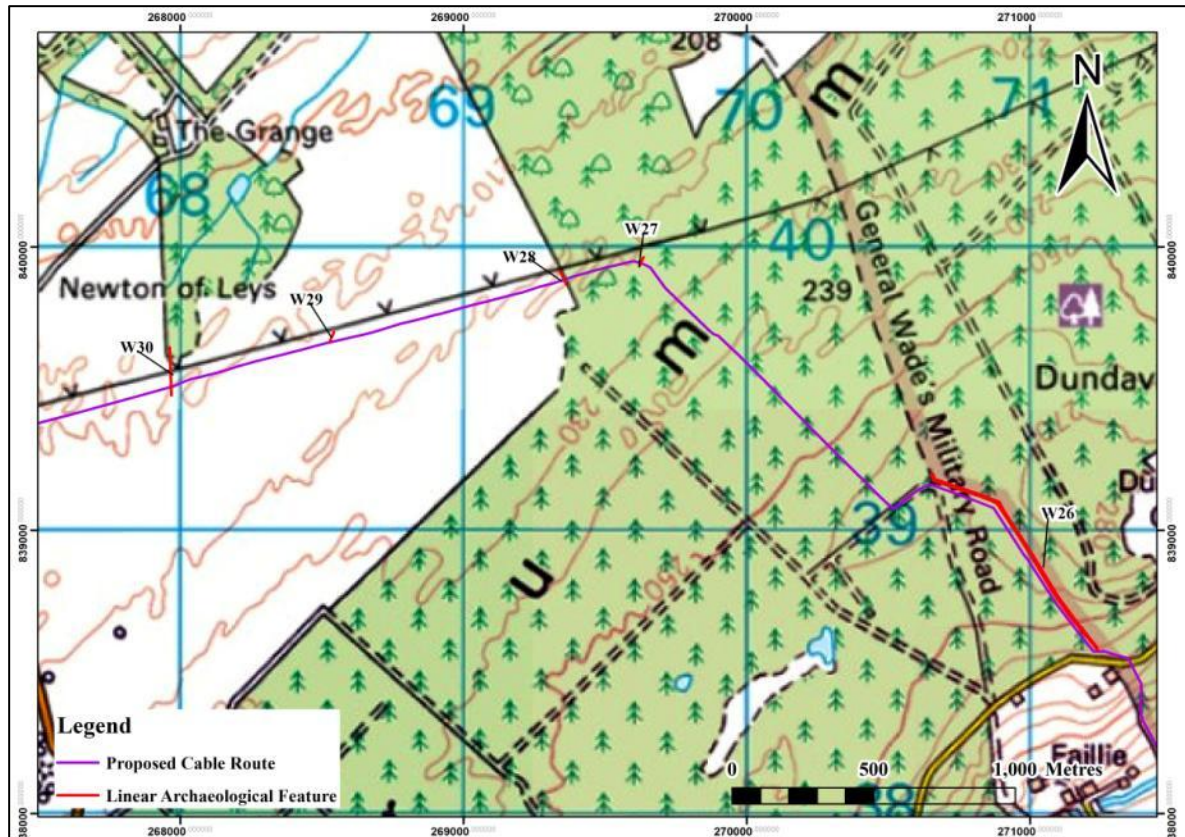
Figure 17: Features identified in the Drumossie Muir area (scale shown)

Area 3 runs from the minor road above Faillie to the B861. Five features were noted in this area four walls and one trackway.

W26 is a section of old trackway noted running just to the east of the modern path through the woods between the un-named minor road above Faillie to where the path joins Wade's Military road. At the north end the trackway appeared to continue again just to the east of the Wade road. The trackway consisted of two banks around 6m apart with a level roadway between. The west bank was only around 0.6m high and 1m wide whereas the east bank was much more substantial, around 1.3m high and 2m wide.

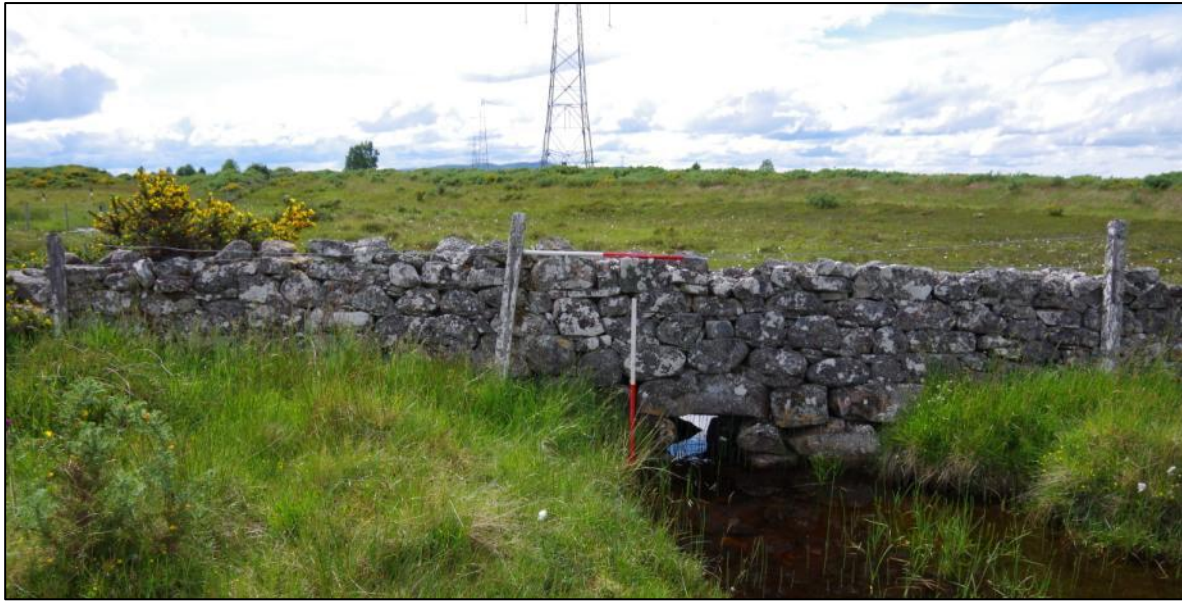
Figure 18: Photo showing W30 dry stone wall (photo 7290, 1m scales)

The other four features in this area were all dykes or walls. Two (W27 & W28) were almost completely hidden by gorse so apart from the presence of some stones and the rise in ground level little can be said about them. W29 was also very ephemeral with only a short section apparently surviving with the ditch on the east side the more obvious remains. Finally W30 was a well made and almost intact dry stone wall running almost exactly north-south bordering a small area of woodland close to Newton of Leys. W30 survived to around 1.3m high with a double skin construction and was apparently missing cap stones.

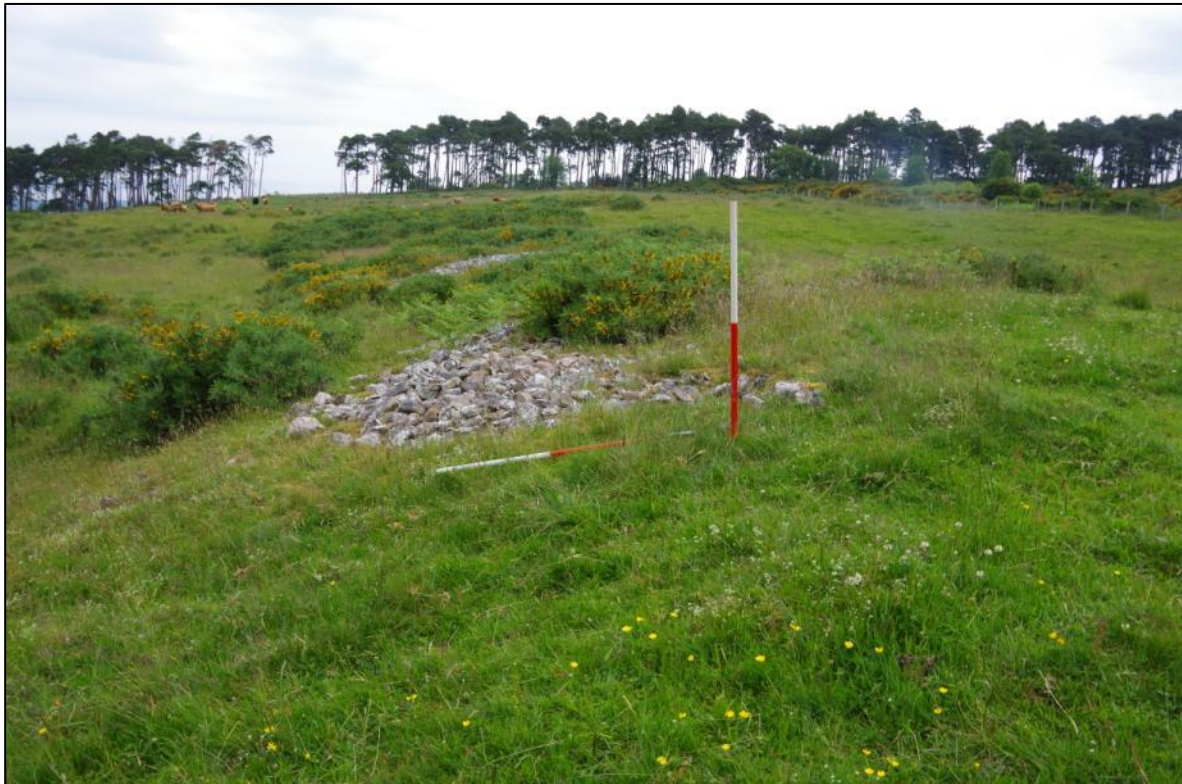
Figure 20: Photo showing W40 cairn (Photo 7329, 1m scales)

The four clearance cairns recorded in this area were again distinctive of each other. W39a and b were similar piles of loose rounded stones, of a similar size, many covered by pale lichen. Both W39 cairns were of a similar size overall (a. 6.5m by 3.8m b. 7m by 3m), up to 0.5m high and had an elongated oval shape. W37 was more turf covered with a variety of stone sizes and no lichen. W37 was roughly round and about 3m across. W40 was however much larger than the others at around 30m long and 17m wide, tapering slightly towards the NE end. The loose stones were similar to those found in W39 including the lichen, although parts were covered by turf and some gorse. The size of W40 implies it may have been a deliberately constructed cairn or structure rather than a clearance area although the sloping ground it seems to have been placed on makes this less likely (Figure 20).

- Where the line passes by features on east side of Big Burn (Area 4, W39&W40),
 - Where the line passes by features on west side of Big Burn (Area 4, W37-38 & W41)

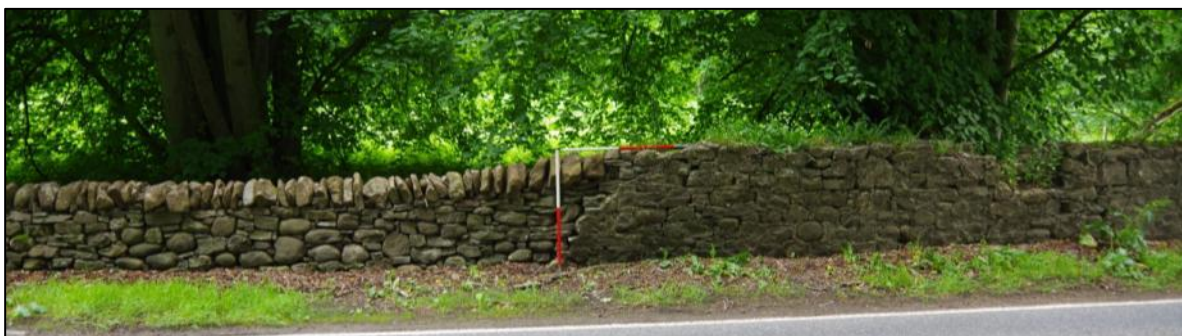
Figure 22: Photo showing modern break in W33 wall at north end (Photo 7342, 1m scales)

Walls W33 and W34 are very similar although W34 was only recorded in a short section where the route will cross it. Both are double skinned dry stone walls made using rounded local stone and are around 1m wide. W33 was recorded curving right around the minor Torbreck road and along the Dores road on the SE side. W33 had been broken at the north end for the Ness Castle housing development. W33 also had slightly better preservation on the Dores road section where it survives up to 1.3m high in places with cap stones, whereas W34 only reached 0.9m high in noted sections. The final dyke W32 also had a ditch on the west side and ran under the modern pylon line and along the edge of a ride though the woodland. The bank was low around 0.4m high although appeared up to 1m high from the base of the ditch. The bank and ditch were turf covered and under the pylon line had been partly covered with old brash.

- W36 (burn side dry stone wall),
 - W41 (prehistoric dyke),
 - W32 (ditch and dyke),
 - W33 (roadside dyke) and
 - W34 (roadside dyke).
- Where the cable route passes close to sensitive known features or groups of such a watching brief should be in place. It is recommended that this should include;

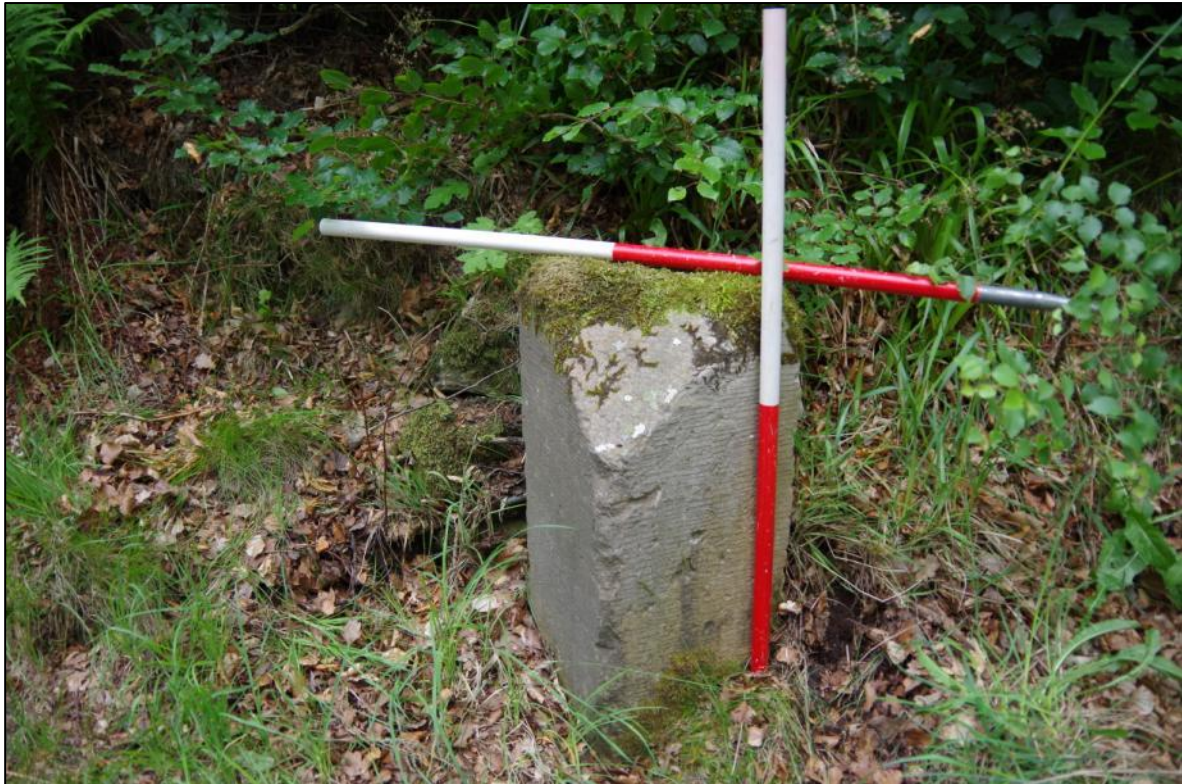
Figure 23: Photo showing W42 milestone (Photo 7337, 1m scales)

The final feature W42 was a simple carved stone milestone sitting beside the B862 Dores Road (also Wade's Road DBA 3). This was a single piece of shaped sandstone standing 0.8m high just to the north of the Torbreck junction, but does not appear to have been previously recorded.

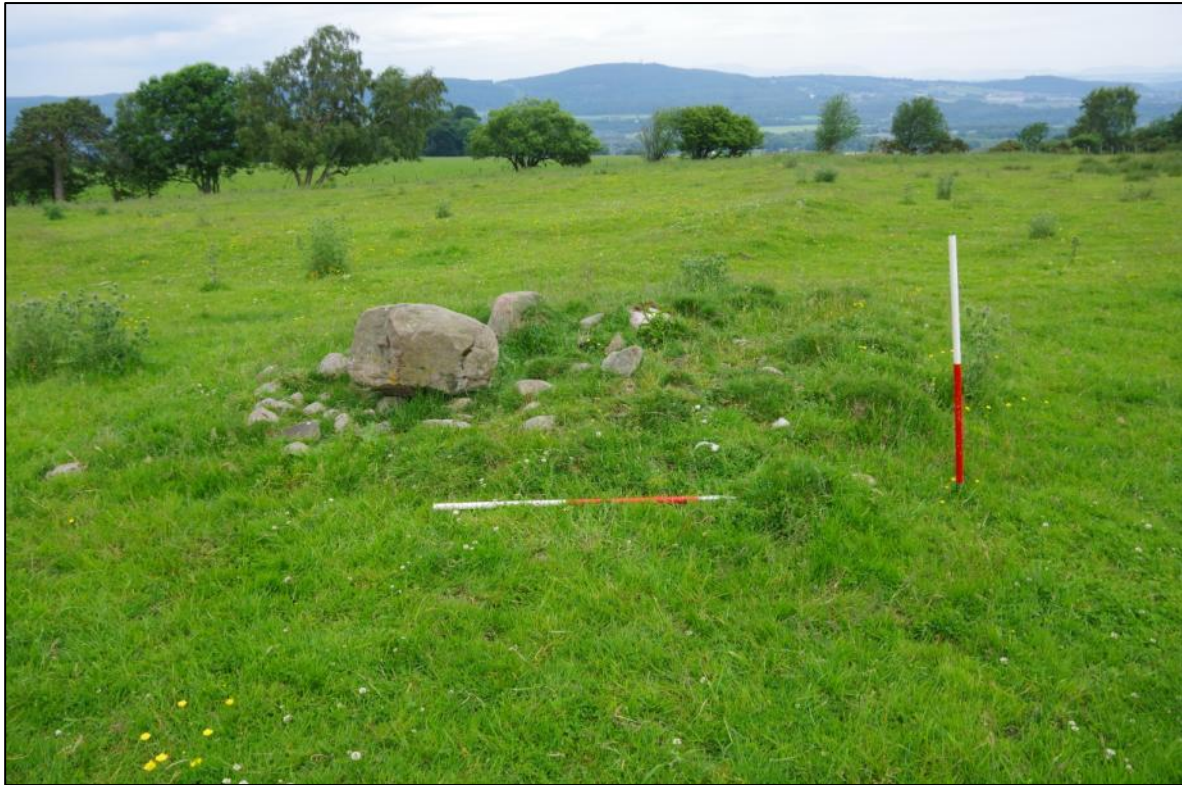
Figure 24: Photo showing W37 likely to be a prehistoric clearance cairn with dyke W38 visible in background (Photo 7321, 1m scales)

Other prehistoric features are likely to include the dykes and clearance cairn NW of Big Burn (W37, W38 and W41) these likely tie in with other prehistoric field systems further to the SW (DBA14).

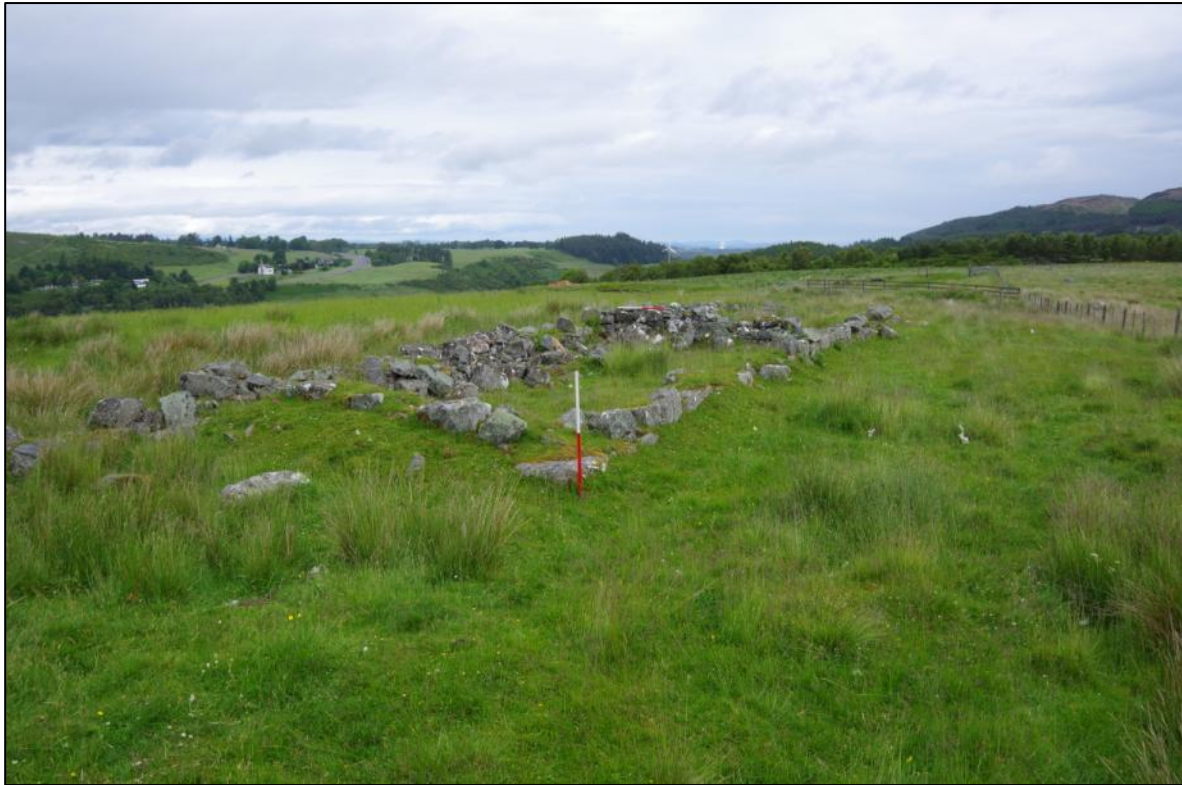
Figure 25: Photo showing W21 long house probably post-medieval in date (Photo 7255, 1m scales)

W21 was 21m long and 5m wide with a single internal division and an entrance into each space on the SE side. It was badly degraded in the NE corner but was otherwise clearly visible in the open field. W21 had the possible remains of an attached enclosure to the NE in the form of the remains of a bank that may have joined the building at the NE corner. Another section of wall abutted the SW corner and although the surviving section only ran for around 3m it may have originally joined up with W20 (see Figure 14).

- The Wade roads which are crossed in three different places (see DBA) and the milestone (W42) which is likely to be associated with this.
- The first phase of features in Area 1 at Moy particularly W8, W9, W14 & W15 which are not depicted on the OS first edition map (1867-70) or subsequent editions. Given this and their condition all these structures are likely to be pre-improvement and this activity may have spread into the field to the east that has clearly been ploughed flat since.
- The small farmstead above 'No Bother' house (W18-24) which has fallen out of use by the second edition map (1903). Although these two are shown roofed on the first edition (1867) the fact these are abandoned just 36 years later implies they were in decline at the time of the first edition.
