# Rychallich

Historical Research,  
Building Recording and Walkover Survey  
Tulloch  
Nethy Bridge  
STRATHSPEY

**HISTORICAL RESEARCH,  
ARCHAEOLOGICAL SURVEY &  
WALKOVER AT RYCHALLICH  
NETHY BRIDGE  
STRATHSPEY  
NE02**

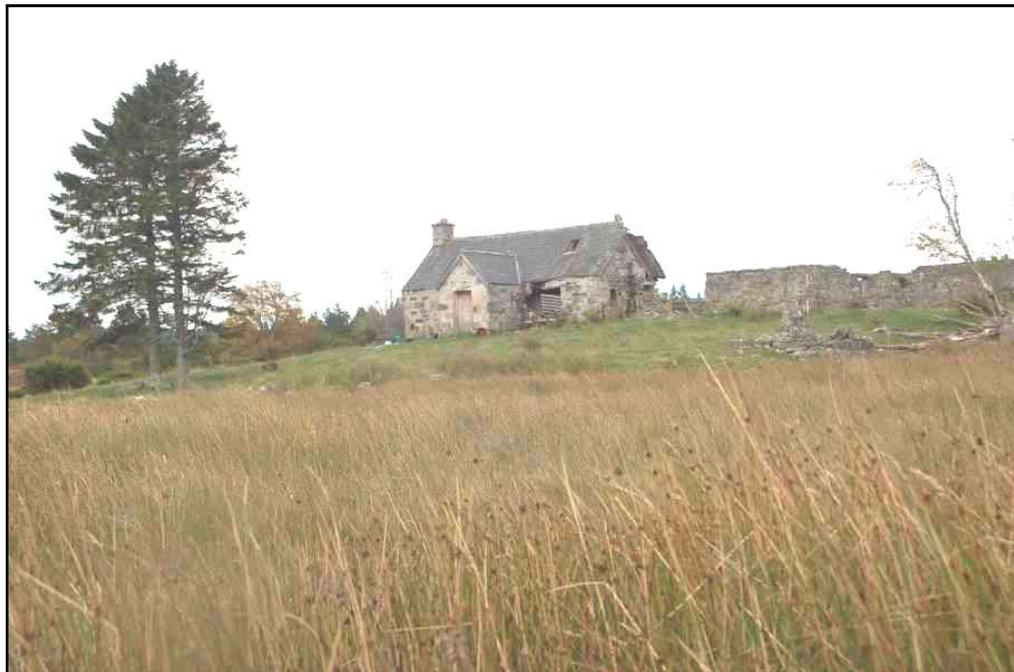
Illus 1

*Photo of the main buildings on the knoll*

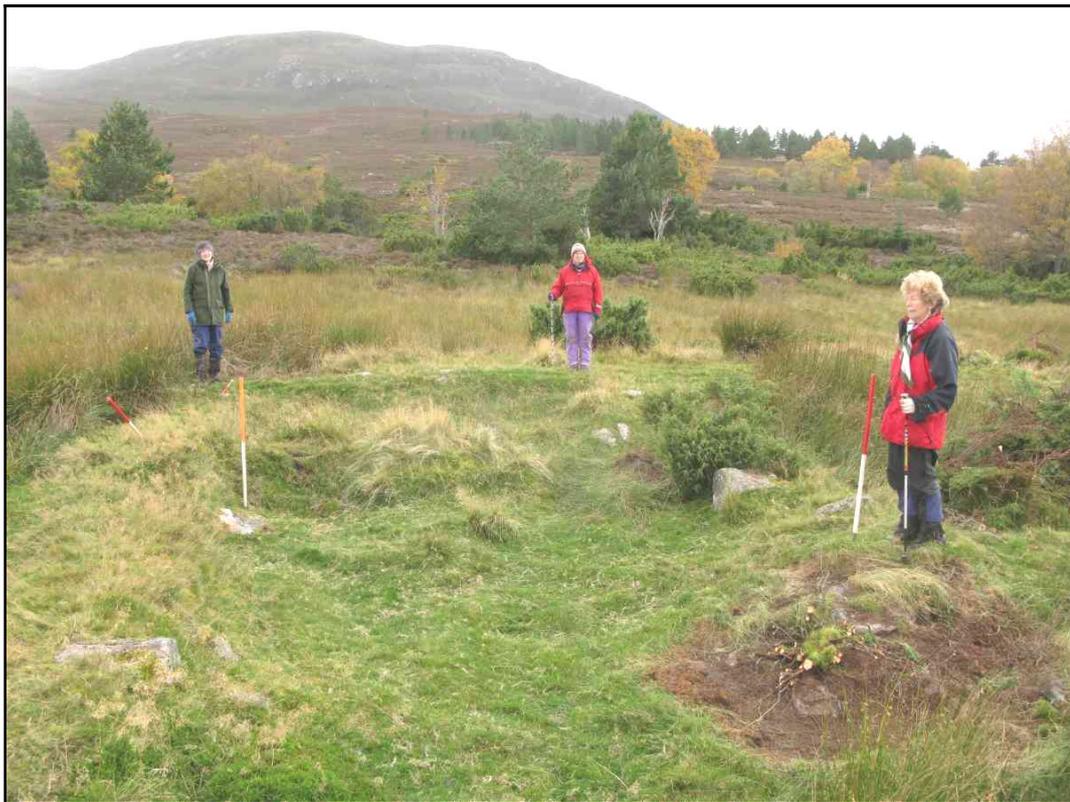
Illus 5

Five houses and a rectangular enclosure are marked where current buildings are located, just N of where the Allt Ruigh Chaillich branches. One of these houses, the L-shaped building, seems to be the structure surviving as footings that was recorded in the building survey. This structure, which has a possible fireplace and was roofed till the 1860s, may well have been a house rather than an agricultural building. If this is the case then it was probably occupied by James Grant and his son, who was murdered in 1772 on the hills behind Rychallich (see below). Another building to the N may be the footing remains found on the SE side of the current house. Outside the main boundary wall of the settlement along its SW side are a further 6 houses. Traces of these were discovered in the walkover survey, see walkover section sites *B3 and B5*. On the W side of the burn within the main boundary is a small rectangular enclosure within the area of green pasture. There are no roads or tracks shown on the plan so we can't be sure in this phase if the main access to Rychallich was via Easter Tulloch, along the current track running towards Chapelton or via Mains of Tulloch. However, there are hints from the later OS map of abandoned roads running from Crofts of Tulloch near Mains of Tulloch up to Rychallich so this may have been the original means of access.

*Footings Building 2, depicted on the 1773 Estate Plan, possibly inhabited by James Grant and his son John who was murdered in 1772*

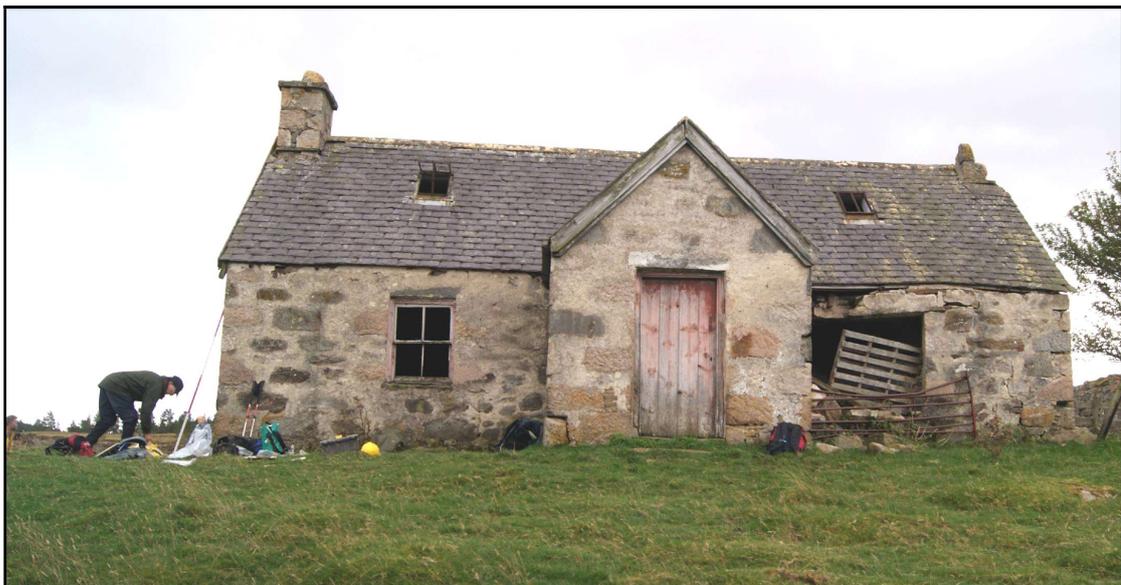
Corner stones and some of the blocks in the main face of the front elevation are formed from roughly squared granite (showing bolster marks) and whinstone blocks. The granite blocks are more extensively used on the front elevation where they would look attractive. This is also the case for window and door reveals, granite having been used on the front elevation, and whinstone on the back and SW gable wall. Sills and lintels however, seem to have been chosen to contrast with the light granite and are generally formed from coarsely shaped darker whinstone.

*General shot of the front elevation*

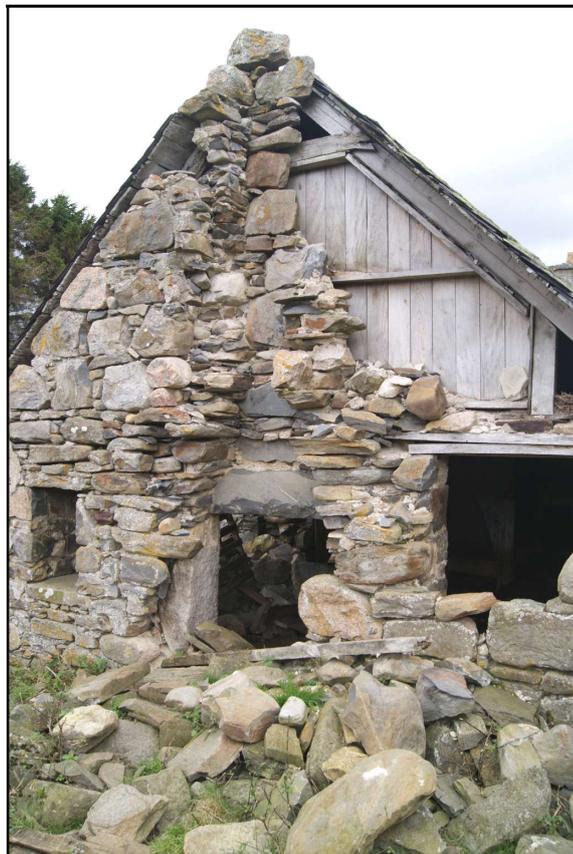
As may be obvious from the various photos, the house is in the process of decay and collapse. This seems to have started with the outside of the SW gable wall falling away which has nicely revealed the structure of the chimney. Presumably the damage started with water percolating down the chimney washing out the lime mortar in the gable wall.

*Shot looking at the collapsed SW gable*

The recess next to the fireplace would have been an area of weakness as the wall here is thin; this may be why the gable wall has collapsed to a greater extent on this side. The other area of collapse is at the foot of the valley between the SW wall of the porch and the main house. Here the entire wall NE of the window has collapsed leaving the floor joists of the upper floor exposed and the window lintel unsupported on one side overhanging the ground. Again as with the SW gable, it is probably water damage

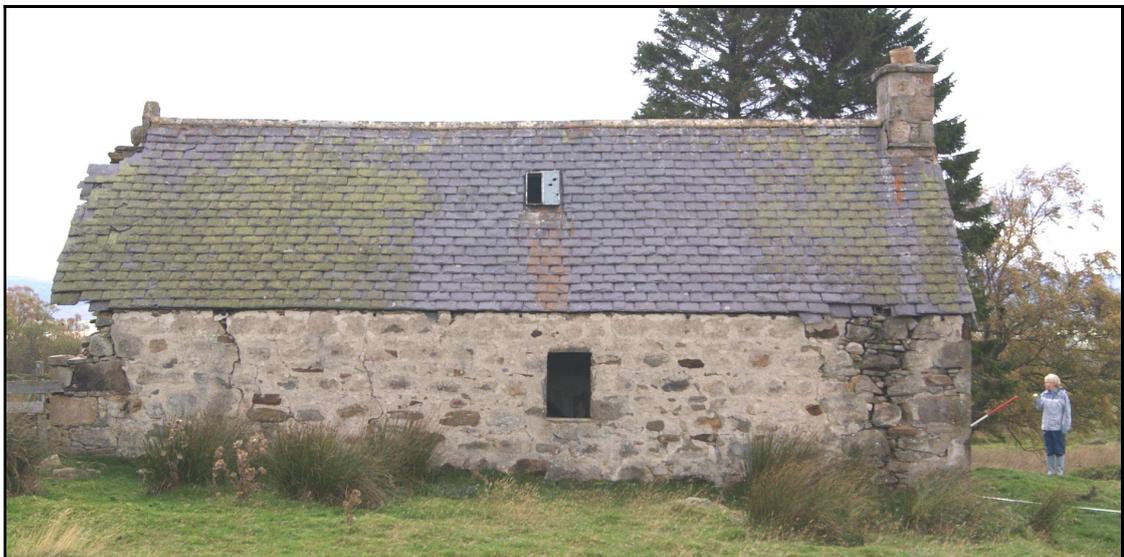
From study of the outside elevations it is clear where the next major collapse will occur. This will be around the S corner, where large cracks can be seen running vertically up the NE gable wall to the SE of the chimney. Just like the other gable this area of weakness seems to be due to the building of an internal cupboard recess here, which made the wall thin and easily damaged by water incursion. There is also another weak spot adjacent to this cupboard in the SE wall where water runs down the roof from the SW side of the chimney, and has completely washed away the lime bonding of the wall. These two weaknesses mean that the corner will soon fall away, providing sheep with yet further access to their favourite shelter.

*The SE wall showing the S corner which will soon collapse*

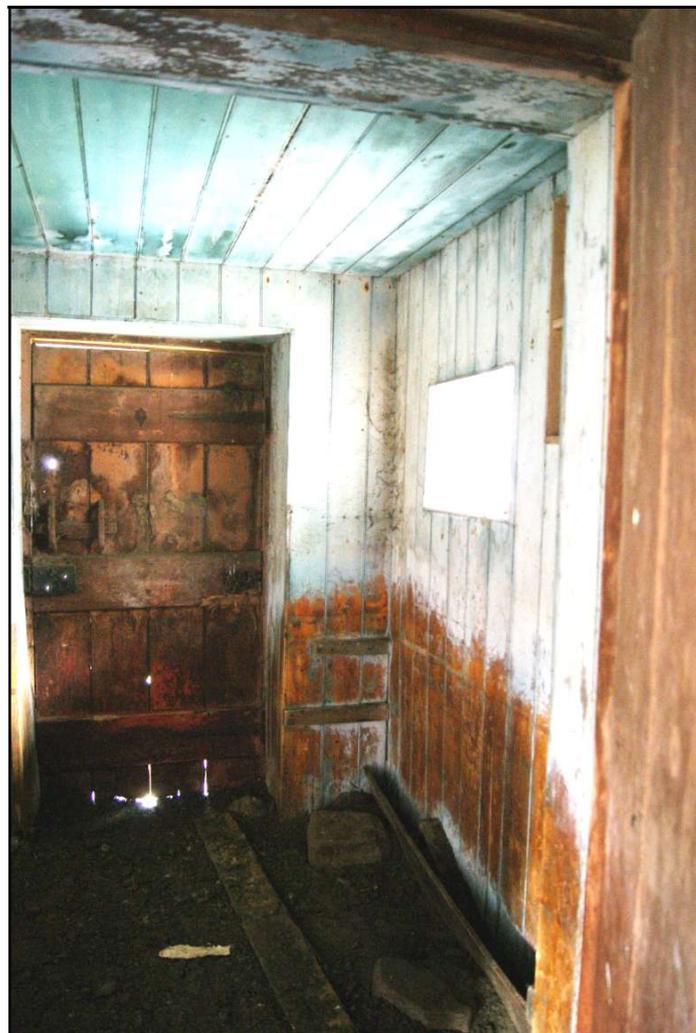
The walls and ceiling are covered in beaded pine panelling, at one time varnished and later painted light blue. The panelling is falling away on SW side exposing the rails which it is nailed to. The rails themselves are either nailed to short horizontal wooden planks cemented into the porch walls, or possibly dooks. In the recess on the NE side of the doorway short horizontal planks have been nailed to the panelling low down. These probably once supported shelves, in fact the two loose wooden planks lying on the floor below may have been these actual shelves.

*The Porch*

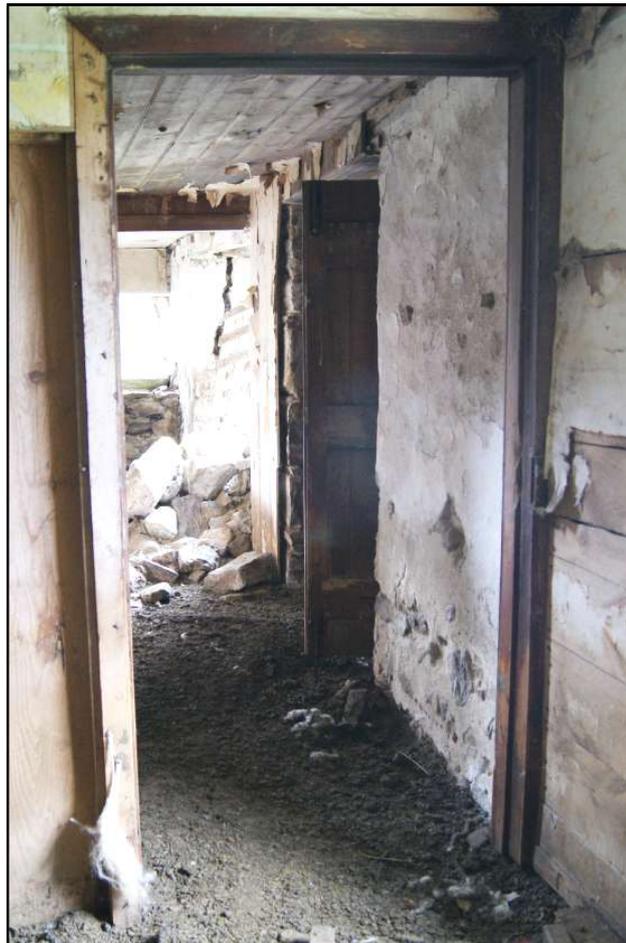
The hall is essentially a very small space next to the porch which provided access to the SW room on one side and the NE room/staircase on the other. The external walls are plastered and show traces of white paint (white walls would have been important in a space such as this which has no lighting of its own). However, these walls were later panelled as can be seen by surviving beaded pine panelling on the SW side and dooks in wall to the NE. Presumably the panelling on the NE side was taken down and burnt as firewood when the house was being used as a bothy.

*Shot looking into the Hall*

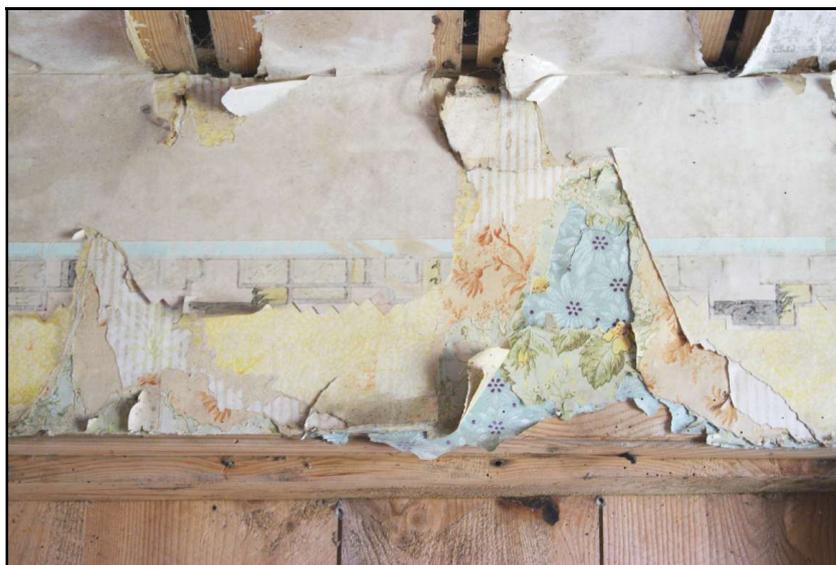
- 1) The most recent is the brown paper noted on the NW wall with the thin blue line and below this line the paper had thin geometric design and below this a yellow pattern.
- 2) Below was the yellow and white paper noted on the NW wall.
- 3) Below this was a white paper with thin vertical brown lines.
- 4) Below, a paper with a light brown background and flowers painted in darker brown.
- 5) Below, a paper with a greeny-grey background and plants with broad green leaves and yellow flowers.
- 6) Below this the very first wallpaper which had a light blue background with large whitish flowers and purple dots for stamens.

*Photo of the 6 different layers of wall paper in the NE room*

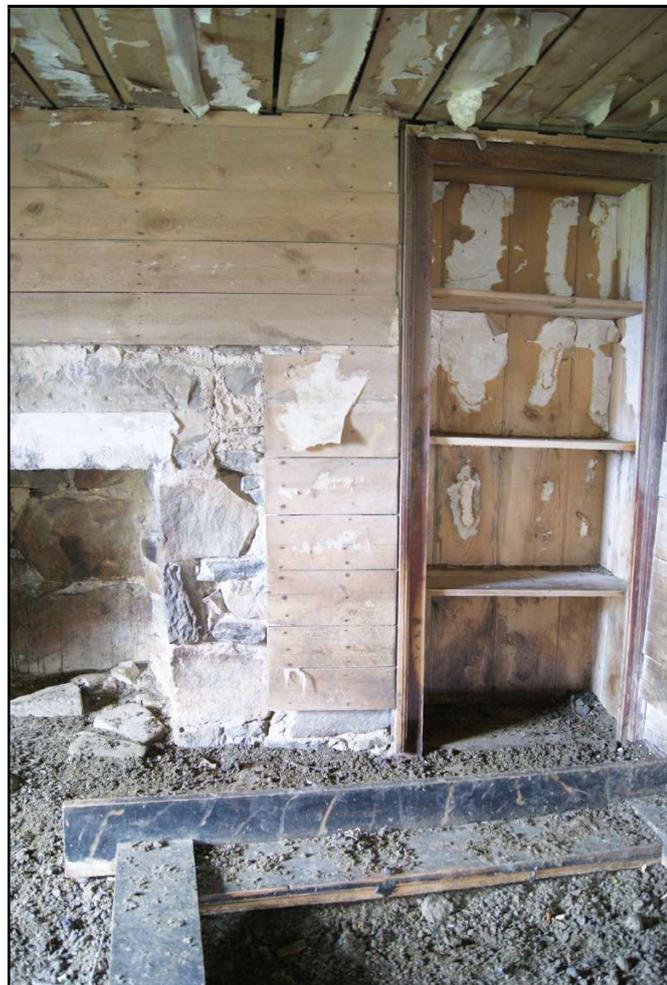
*Photo of Cupboard and Fireplace in NE Room, the crude horizontal panelling can be seen around the fireplace*

The wallpapers show that the room went through a number of phases of decoration, but there appears to have been a major change when the current horizontal panelling was installed. We know that this panelling is not original as the cupboard shows that there was once a much higher quality of panelling in the room. The wallpapers on the NW wall show that the later panelling was installed after the white wallpaper with vertical brown lines (3). Such a major change in the interior suggests that the original panelling may have become damaged, perhaps after a period of dilapidation, and was removed by the new users of the house. This may possibly coincide with Gordonstoun School starting to use the house as a bothy in the 1960s.

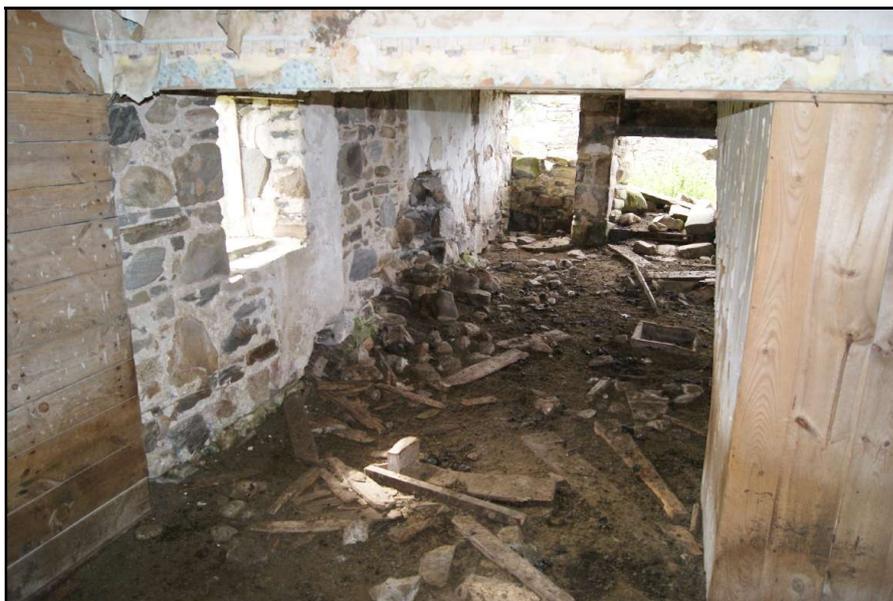
This room has lost its internal walls (NE and SW) but evidence that this was once a separate room can be seen along the internal elevation of the SE wall of the house. The position of the NE wall is marked where the panelling in the NE room ends abruptly; that of the SW wall can be seen where the plaster on the wall ends in a vertical line. The room was lit by a single small window and was accessed through a small door cut into the internal wall of the hall, under the staircase. There may have been other ways of accessing this space from the SW or NE rooms but no evidence now survives. The external wall of the room was plastered and most surfaces appear to have been wallpapered with a white and brown paper with vertical patterned design.

*Shot looking at the location of the SE room (space on either side of the small window)  
from the NE room*

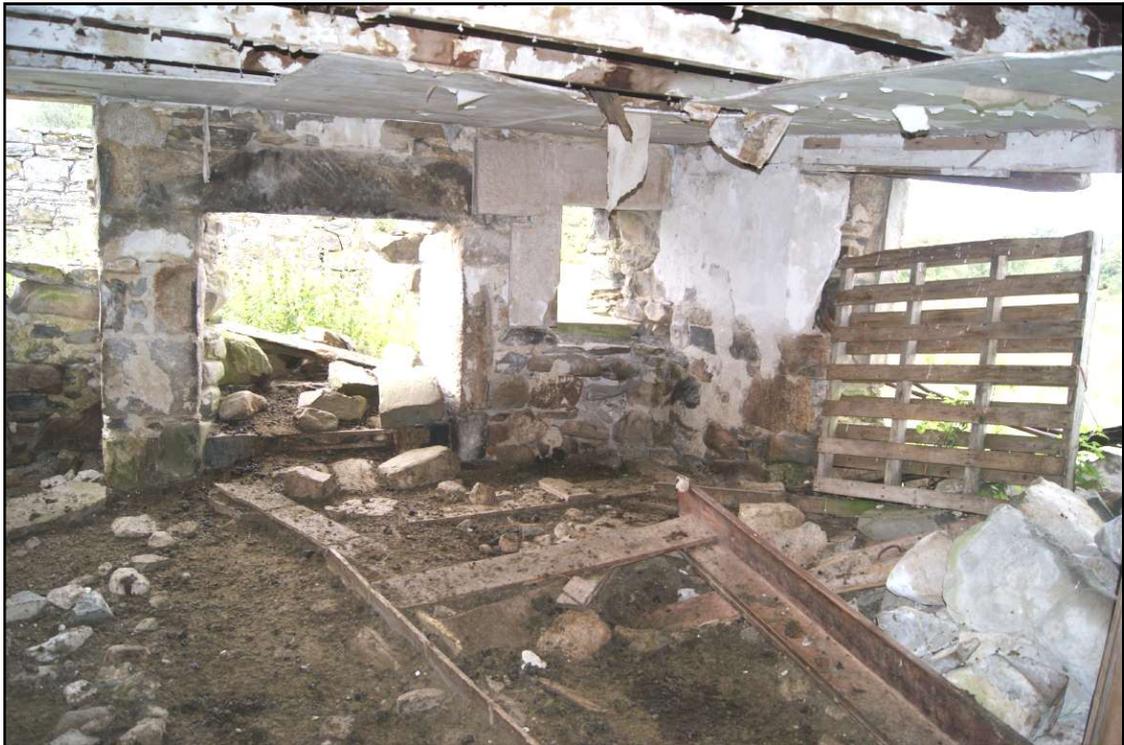
This end of the house is very unstable which made full investigation rather difficult which is why this description is shorter than those for other areas of the house. The SW gable wall has collapsed around the chimney stack and the cupboard recess to the SE. The NW wall has also collapsed to the NE of the window, and the SE wall has partly collapsed into the room.

*Shot looking at the SW room*

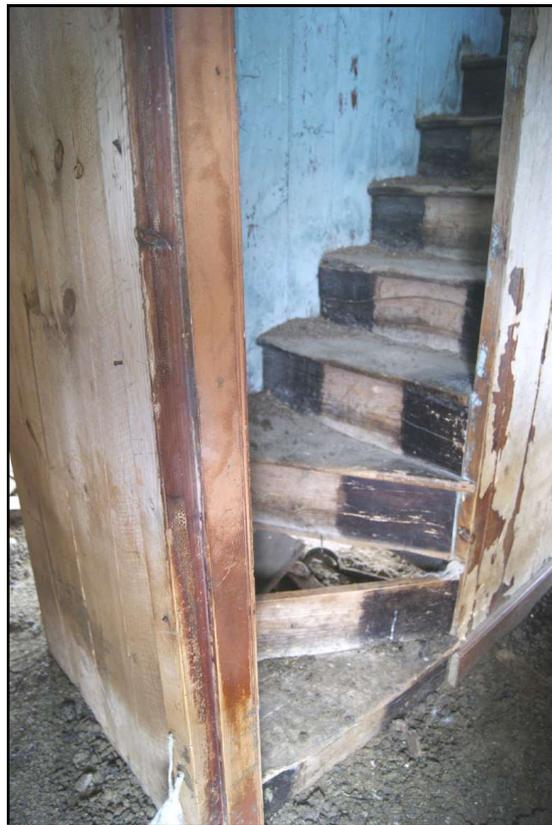
The staircase has been constructed with good carpentry skills using pine. Its walls are made from vertical tongue and groove planking (beaded), painted light blue. There was a once a narrow carpet running down the centre of the stairs and the gaps either side are painted with black/very dark red paint.

*The Staircase*

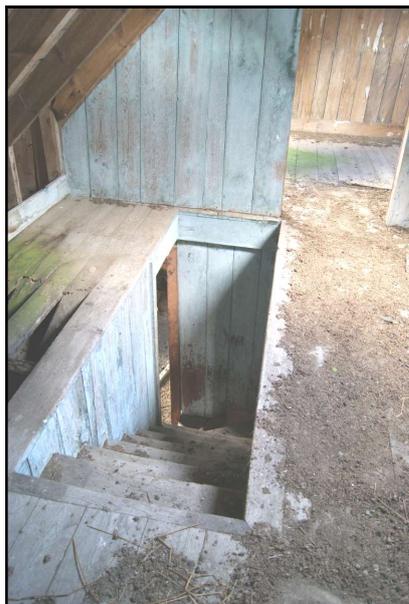
The two internal walls are formed from vertical tongue and groove planks (beaded) planks nailed to rafters; no remains of doors survive. The end walls are also formed from vertical planks though there are gaps in between them. The landing is painted the same colour as the stairwell, light blue, though much of this painted wall/ceiling planking on the NW side has been pulled away exposing the rafters. The landing has a cast iron roof light on the SE side; rain has rotted the floorboards below. There were once banisters around the stairwell but these have been removed and probably burnt as fuel.

*The Landing*

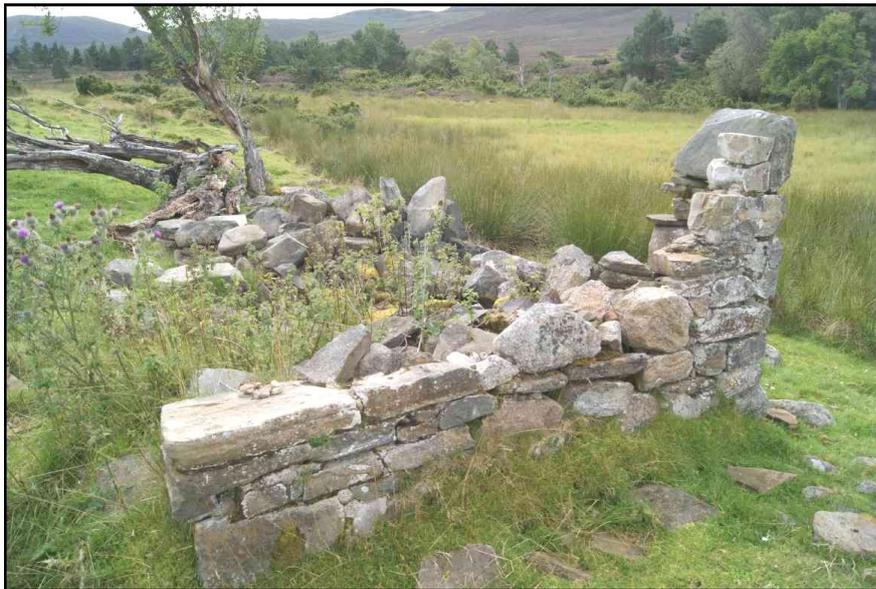
This building lies to the N of the main house and comprises a low square ruin. The walls are constructed from angular whinstone and roughly faced sub-rounded blocks of granite, most stones built to roughly level beds. These mostly survive only 3 courses high, though the N corner stands a full eight. Little can be seen of the interior as it is covered in collapsed rubble.

*The Small Building*

Given that this building is very square and has walls of similar construction to the house, it seems likely that it is contemporary, i.e. c. 1890s. Such a small structure probably served as a washhouse where a boiler would have been installed. This interpretation is considered all the more likely as the building lies close to a water supply (the burn and the possible spring / well, see site A4 from the walkover) and is positioned on the edge of the main knoll, with easy drainage to the W. Good drainage would have been essential for a washhouse where large quantities of dirty water need to be frequently emptied.

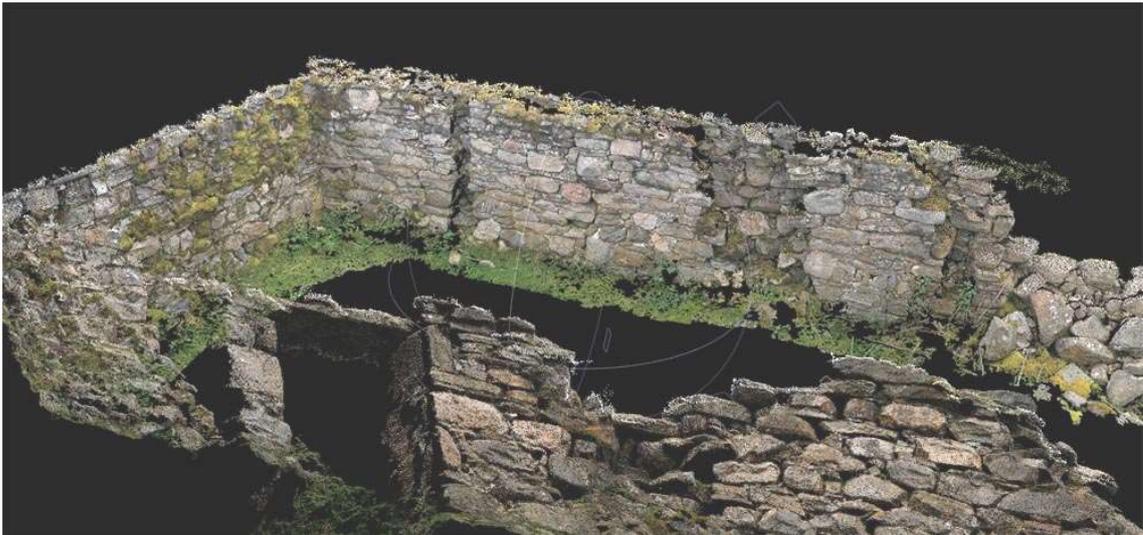
This roofless building lies to the S of the main house. Its shape is not quite rectangular, the SE wall being at a slight angle. There are no windows, but the building has 3 entrances, 2 opposite each other at the NW end and a single doorway at the SE end of the NE elevation. The walls have collapsed around the two opposing entrances and at various locations along the inner faces. The outer faces of the walls are battered (ie are not vertical but slope inwards). The walls themselves are random rubble built, fairly sparsely bonded with lime mortar, but with gaps between stones on outer faces liberally pointed.

*3D model of the internal faces of the 1840s building showing cruck slots*

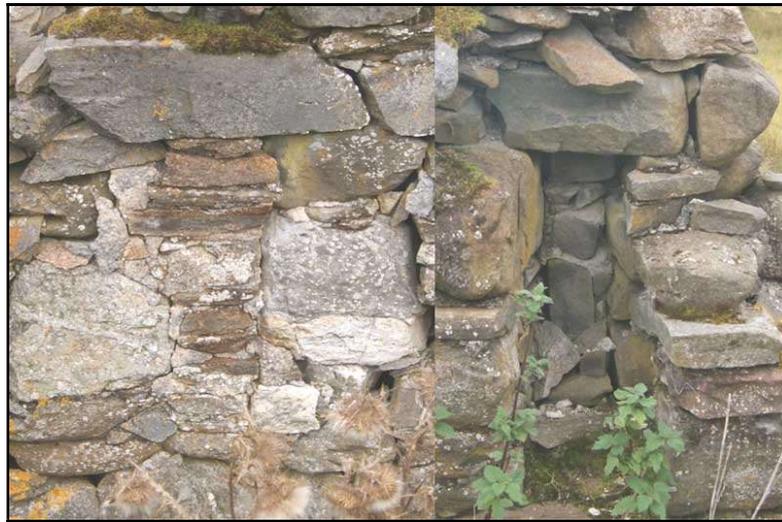
*The two opposing slots for a possible central division, one blocked, the other not.*

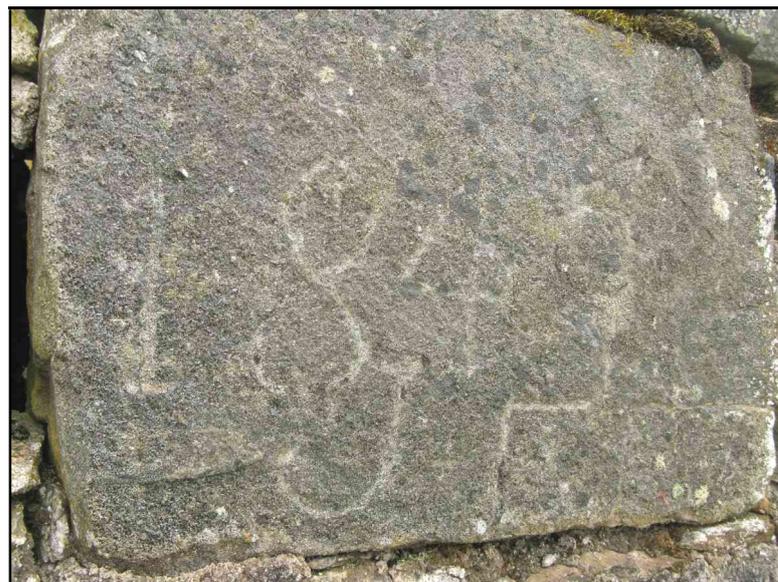
This building is known to have been constructed in 1849 due to the presence of two date stones of this date; it is possible though unlikely that these date stones mark the date of repairs to an earlier building. One of the date stones, that at the E corner, seems to have a 'J' and an 'F' marked below the date, presumably the initials of James Frazer named in the census rolls around this time. James Frazer is listed along with his mother Ann Frazer in the 1841 census, but by the 1851 census she is no longer listed, presumably having died. The similarity in dates between the building and his mother's death gives rise to the possibility that this building was constructed as part of James Frazer's improvements to Rychallich which he may have begun after taking on new responsibilities as head of the family.

*The 1849 date stone with 'JF' (James Frazer) below*

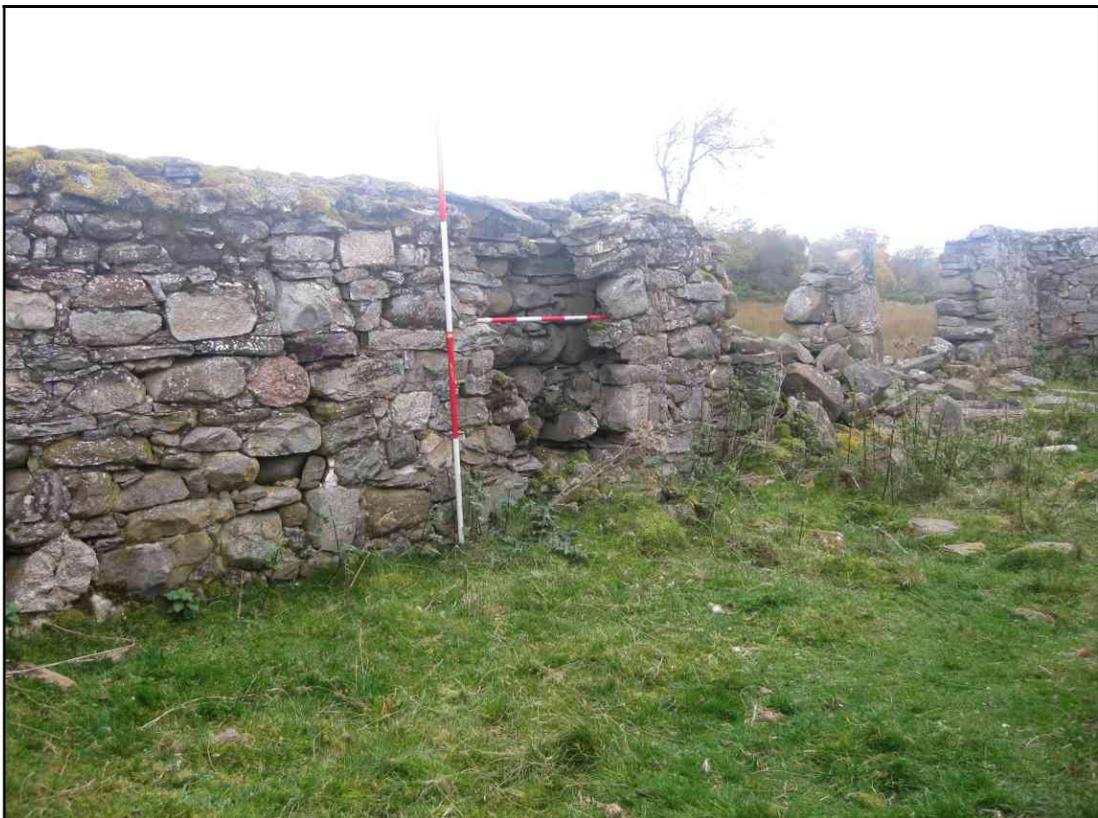
We know from the slots that the building was traditionally built with crucks supporting the roof - a roof that would have been thatched, presumably with heather divots. Its precise function however, remains unclear. There is no discernable drain running centrally through this building suggesting it would not have been used as a byre. The lack of windows in a building of this period also means it is unlikely to have been inhabited by people. The opposing doors through which a draught would have blown could be a sign that perhaps the NW end was a threshing area for oats or barley. If this were the case then maybe the SE room(s) were used as a hay or straw storage areas. However, these rooms are fairly cold owing to the thick walls of this building and may have been more suitable for the storage of root crops.

*Internal view of the 1840s building*

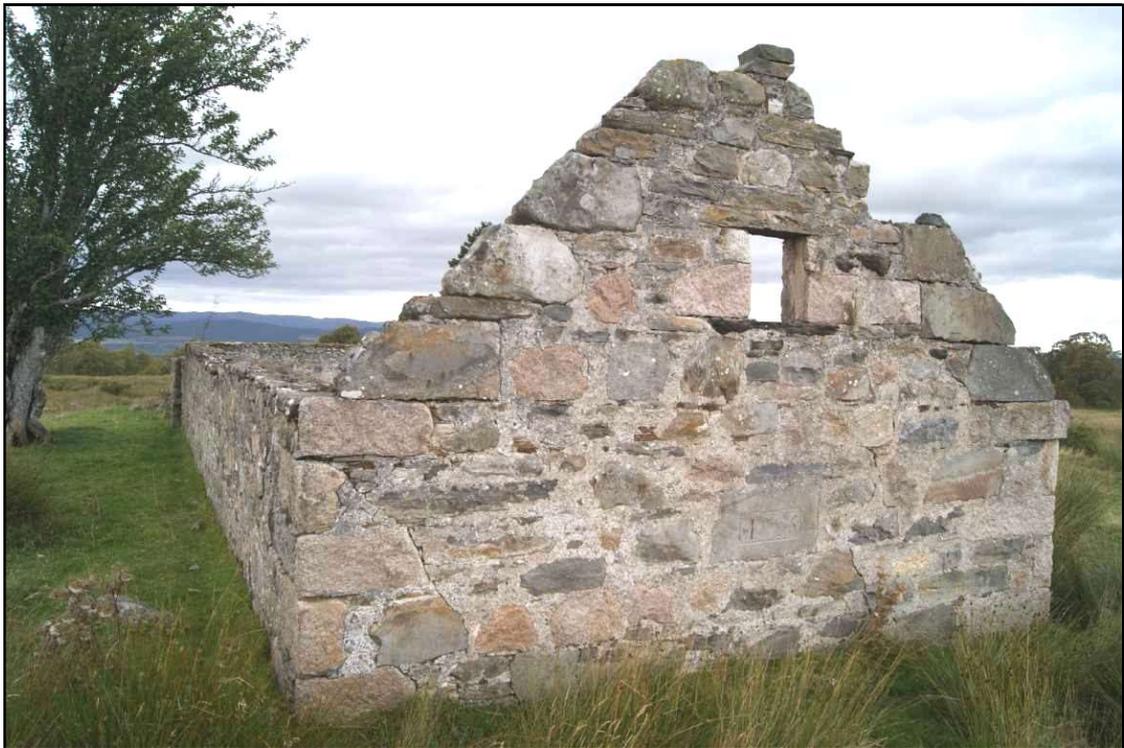
This building is in line with the 1840s building but lies a little to the SE. It comprises a long rectangular roofless structure with a gabled wall at the SE end. There are two windows, a small one in the upper part of the gable and one in the SE wall. The latter lies in between two doorways. The wall SE of the SE doorway has collapsed outwards and can be seen on the ground, grassed over. This collapsed section of wall is narrow and there are door reveals on the SE side suggesting that between it and the gable was a large entrance for a cart entrance. On the inside of the gable at wall height is a ledge which presumably once supported floor joists for an upper story at this end of the building.

*The Gable wall of the 1880s building*

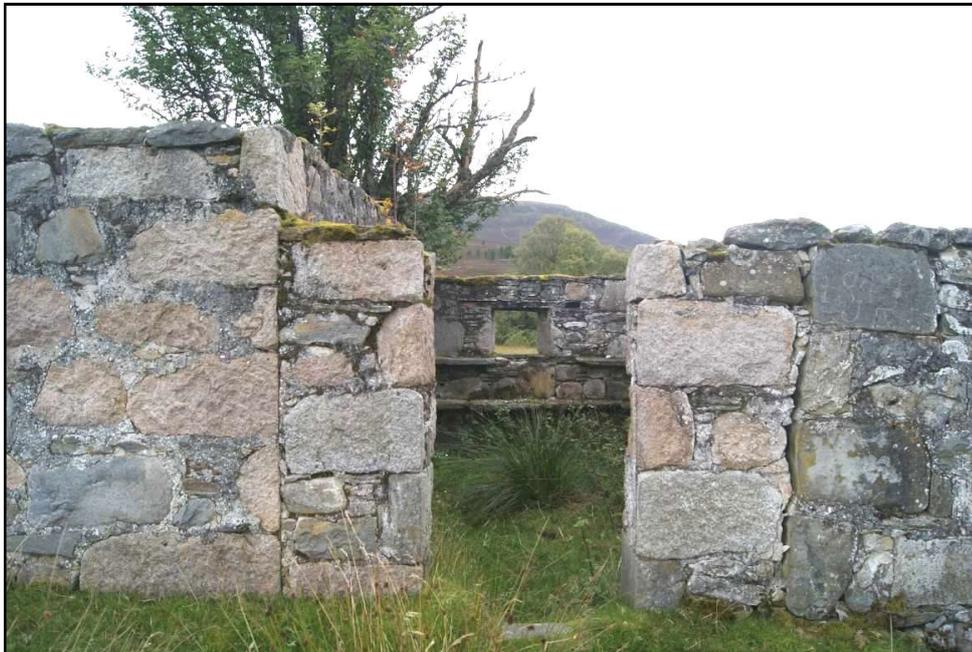
This small space was created by simply infilling the gap between the 1840s building and the 1890s building; it therefore post-dates both structures. Similarities in wall construction suggest it was built very soon after the 1880s building. The front wall is composed mainly from large well squared granite blocks and the rear from random rubble, sub-rounded to angular fieldstones, mainly small with one large squared granite block. Low down on one of the doorway reveals a 'D' rotated 90 degrees has been carved in the surface of the stone. The function or purpose of such a mark remains unclear. Inserted into the wall of the 1880s building at its N corner is an iron loop which may have been used to fix the door of the milkhouse open. Around the doorway of the milkhouse are traces of cement, which would have sealed the gap between the door frame and the wall. Holes drilled into the door reveals show where the door frame was attached.

*The entrance to the Milkhouse*

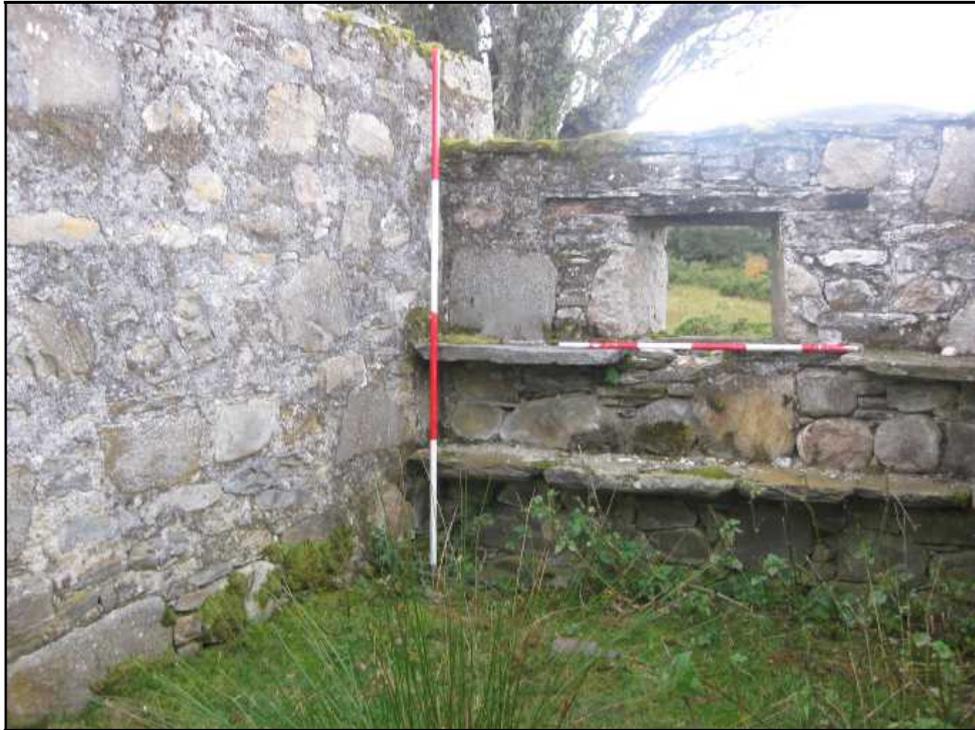
window would have provided good light for these activities. In other farmsteads, milk houses are often partly buried in a bank to keep the temperature low, however at Rychallich there was no such convenient bank. Instead the crofters used the next coldest space they could find, a gap between two thick end walls of the 1840s and 1880s buildings with additional coolness being provided by the shade of a large Rowan tree to the SW which would still have been fairly large even 120 years ago.

*Interior of Milkhouse showing stone shelves*

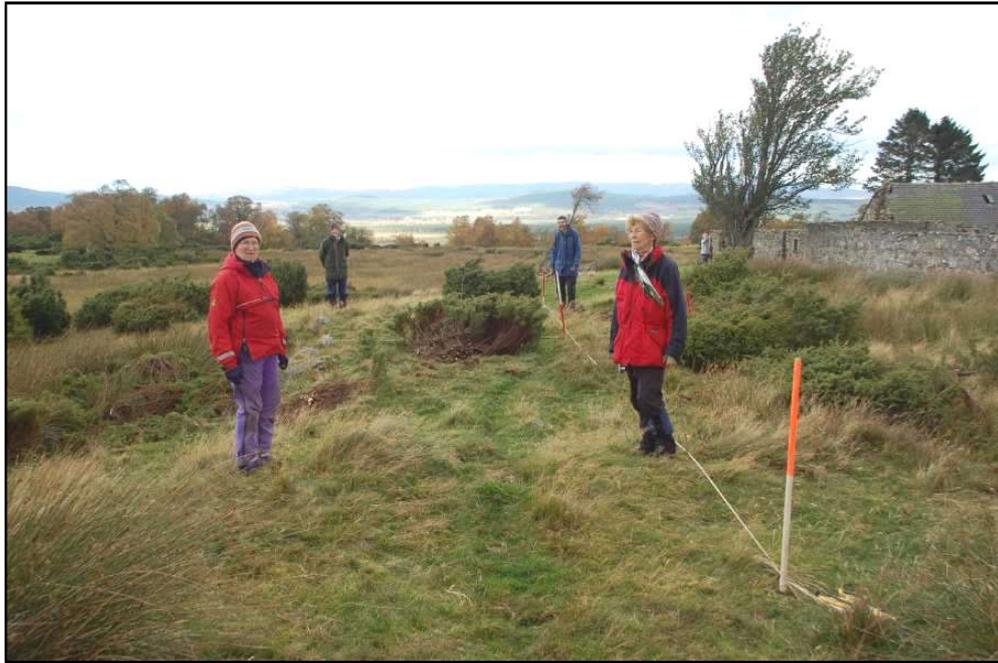
This is one of the two main early buildings at on the site surviving as earth footings. In fact the building appears to be two structures, one to the NW built on top of another to the SE. The NW structure is roughly square in shape with turf banks containing buried stones to the NW, SE and NE. The SW wall is marked by a line of stone footings with a threshold stone half way along. The corners of this first structure appeared quite squared. To the SE the possible earlier structure has a floor level lower than the other, and with possible rounded corners.

*Footings building 1 with volunteers standing on the four corners*

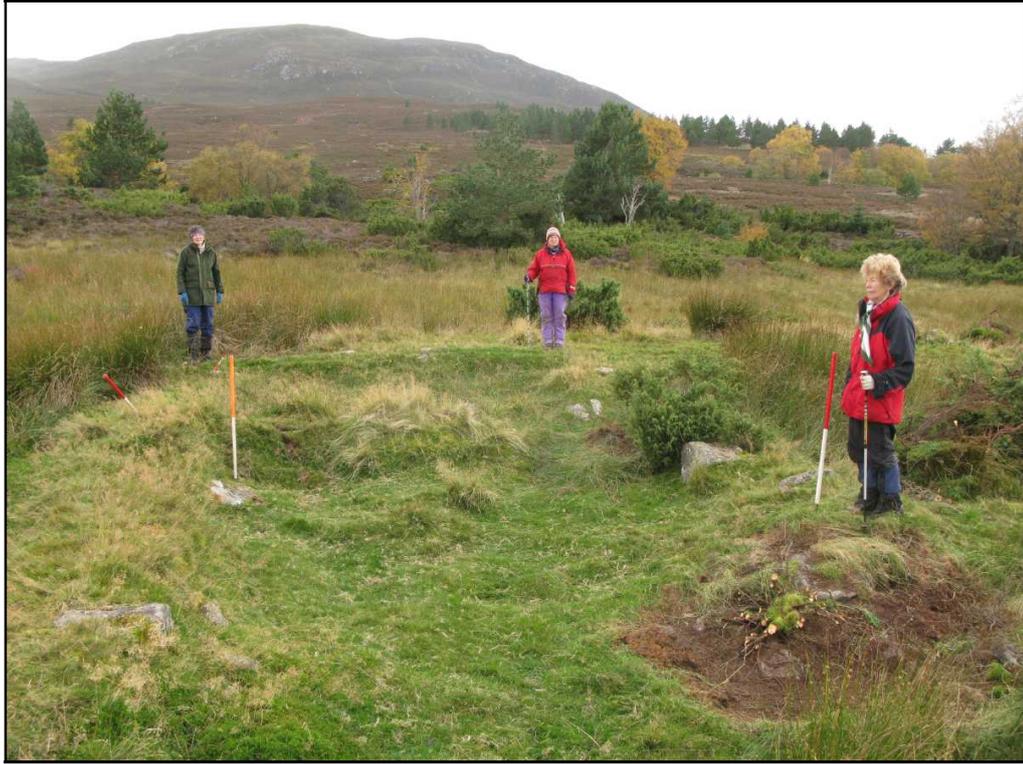
This is a large L-shaped building whose footings are well preserved at the SE end of the site. The structure survives as reasonably high turf and stone wall footings, with the NE wall having been robbed for the construction of a later dry stone dyke. There is an internal division with a doorway half way along the SW 'wing' with a recess in the NE side for a possible fireplace. Two entrances were noted: One into the square room in the SW wing and one to what was presumably the main room to the NE. This building appears to be shown on both the 1770s plan and the 1860 OS map and given its size it was probably an important building, possibly occupied as a house. This is backed up by the possible fireplace evidence. It is unclear whether the small room to the SW is part of the original structure or a small annex added onto this end of the house. The building would have been traditional cruck framed in design, possibly with windows.

*Shot of the SW 'wing' of footings building 2, orange ranging rod next to the internal division*

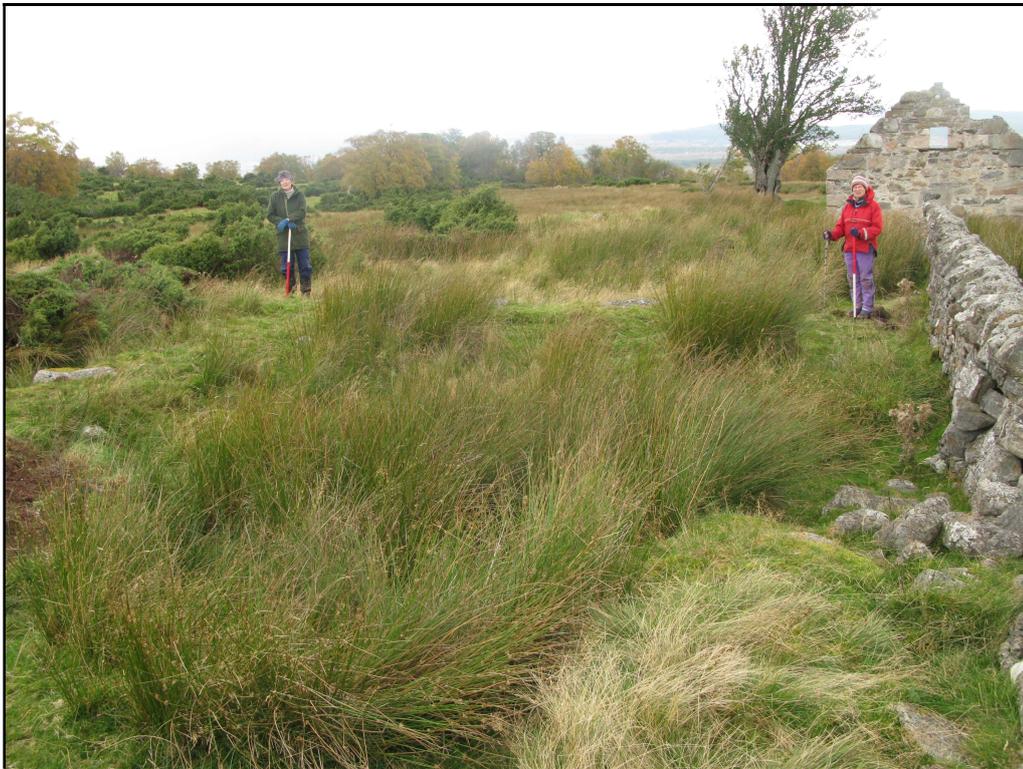
*Shot of the NW 'wing' of footings building 2, note where the NE wall has been robbed for the drystone dyke*

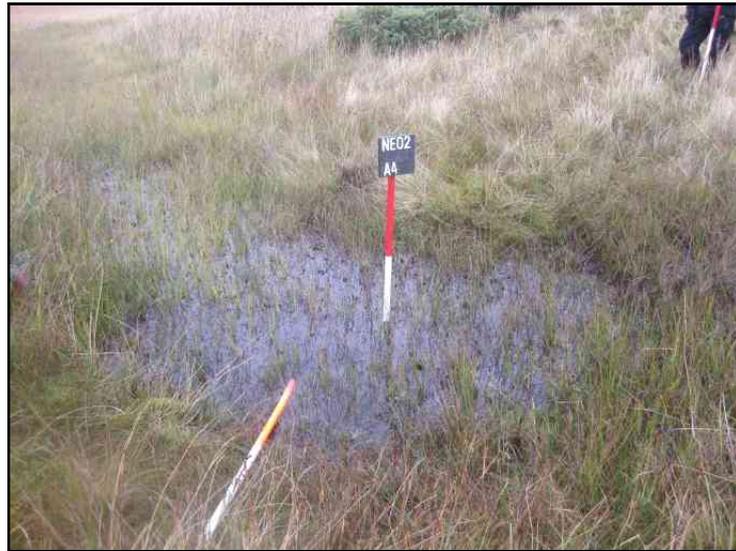
On the SW side of the main buildings is a circular pool, the start of a burn which flows into boggy ground to the N (formally cultivated land). It is possible that this is a natural spring, but probing revealed stonework below the current waterline suggesting that it may have been lined by the occupiers of Rychallich, perhaps to deter silt build up and make the well less muddy. This water supply would have been very convenient for the settlement, being much closer to the main buildings than the burn; however, it is doubtful how reliable such a water supply would have been in summer.

*The well / spring A4*

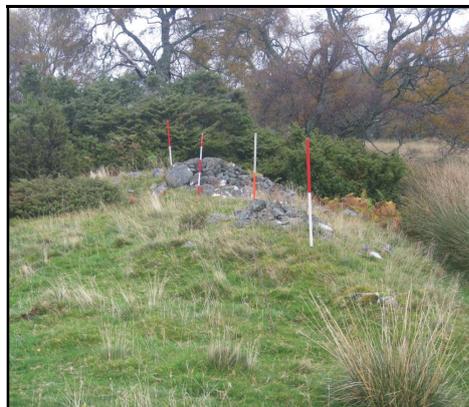
Not surprisingly, the walkover revealed a number of stone piles relating to de-stoning of arable fields. The largest of these piles runs roughly in a rough SW-NE alignment along the SE side of what had formally been a large cultivated area NE of the main buildings: A7. Another large area, A6 relates to destining of fields to the NW of the buildings. There were also three other smaller piles noted in other areas, A2 and B6.

*Field Clearance, A5*

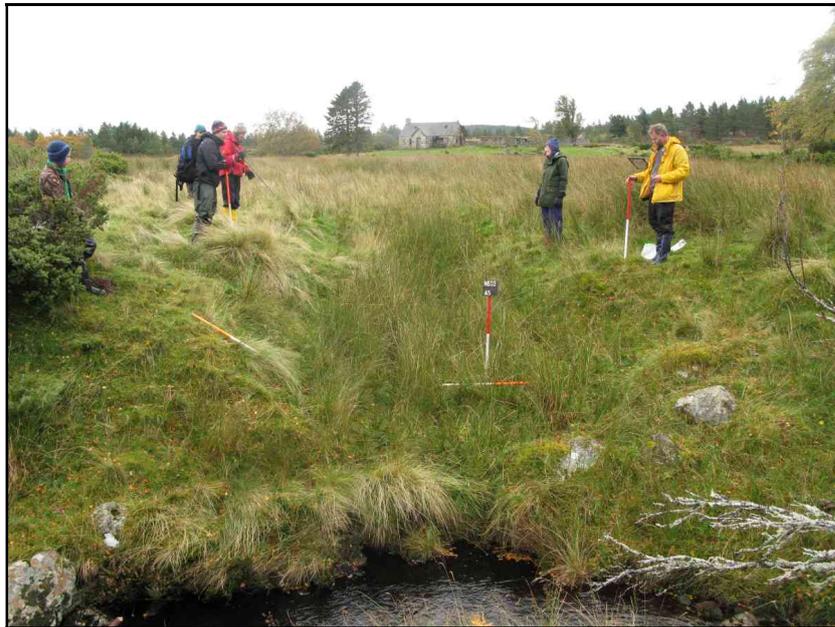
burn, possibly the location of a ford, or maybe just to a deep part of the burn, perhaps used for washing clothes, bathing etc. If this gully is part of a ford, it was probably the main access between the two field systems on either side of the burn.

*Gully - possible ford, A5*

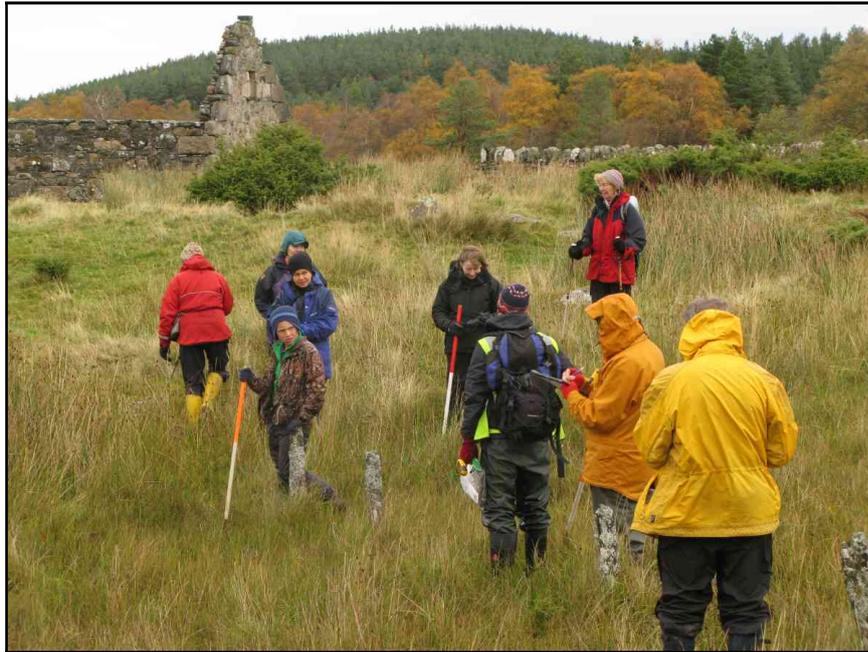
Along with the late boundary noted above at B2, there were also other post and wire fences found, just to the W of the main buildings. One of these, A1, marks a division between former arable ground to the NW and pasture to the SW, presumably to keep stock out. A little to the N was another fence, A3 which lines one side of the burn running from the well / spring, A4. Its function remains unclear if the field beside it was arable.

*Fence A1*

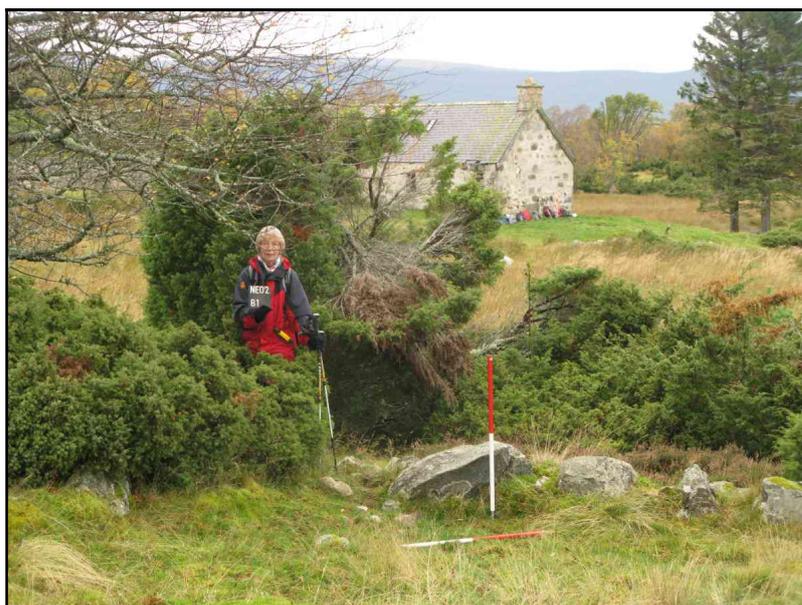
Enclosures B1 and B4 first appear on the first edition OS map, suggesting they were probably constructed in the 19<sup>th</sup> century. They appear empty on this map but by 1900 they are shown as shaded ‘garden’ areas. The small square shape of enclosure B1 is very suggestive of a Kale Yard, and indeed the W-SW facing aspect of the slope would have been good for growing vegetables. Such yards are normally constructed closer to the main buildings of settlements for convenience, but perhaps at Rychallich, the wonderful view inspired people to walk that little bit further for their greens. Alternatively, this structure may have begun life as a stock pen, possibly later being converted to a Kale Yard.

*Enclosure B1*
