# Rychallich

Historical Research,  
Building Recording and Walkover Survey  
Tulloch  
Nethy Bridge  
STRATHSPEY

**HISTORICAL RESEARCH,  
ARCHAEOLOGICAL SURVEY &  
WALKOVER AT RYCHALLICH  
NETHY BRIDGE  
STRATHSPEY  
NE02**

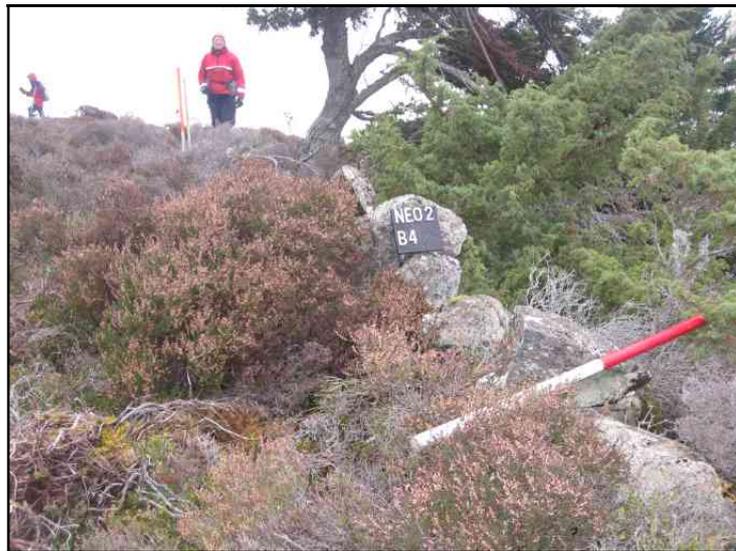
Enclosure B4, again of probable 19<sup>th</sup> century date, encloses quite a large area by comparison with B1 on both sides of the burn. Interpreting this area as a garden area makes less sense here as the W side of the burn is a steep slope which is frequently in shadow and would have been poor for cultivating. Rather, the enclosure makes more sense as a penned off area to keep animals inside, for inspection/collecting. In fact the enclosure has been constructed along the burn valley with a narrow neck where the valley is most constricted, as though it were designed to funnel animals into its interior from the S. If this was the case one wonders whether it bears any relation to track C3 which could have been used to herd animals from the NW end of Rychallich. However, Juniper is such a problem in this area, that a detailed inspection of the enclosure was not possible. Alternatively, perhaps this area was a zone to keep animals out of, for activities such as washing clothes and bathing etc.

*Enclosure B4*

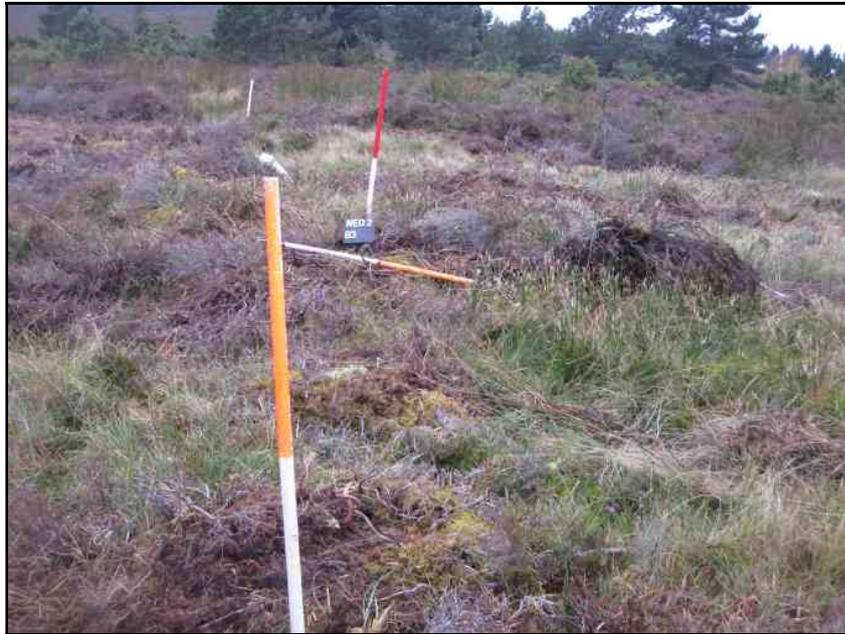
Team B discovered two areas where early footings are visible. These two areas roughly correspond to buildings shown on the 1773 estate plan (see illus 6). In the first area, B3, two stone footings were found in the heather running at right angles to one another. This is likely to be the small L-shaped building shown on the E side of the burn on the old estate plan.

*Building footings, B3*
