RCI Armadale PS DMA (Shebster WSZ) Water Main Rehab Bettyhill, Sutherland

Archaeological Desk Based Assessment and Walkover Survey

| WCAS Report # | 2022-161/ARM/22 |
| Client | Scottish Water |

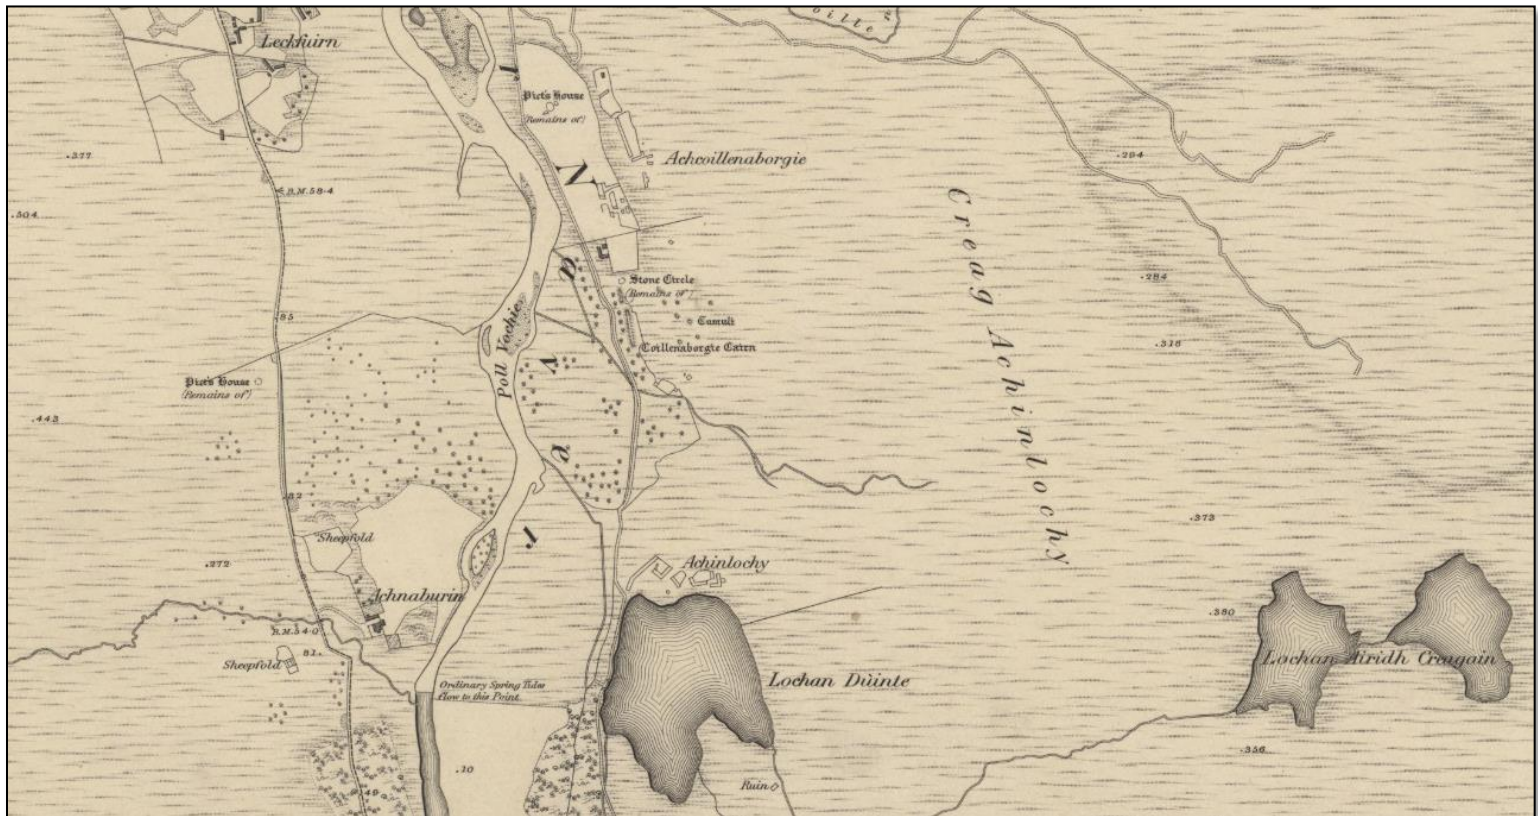
Figure 5: Excerpt from the 1st Edition 6 inch map sheet XVIII showing features between Achcoillenaborgie and Achanloch in Strath Naver – Area 5 (© NLS Edinburgh)

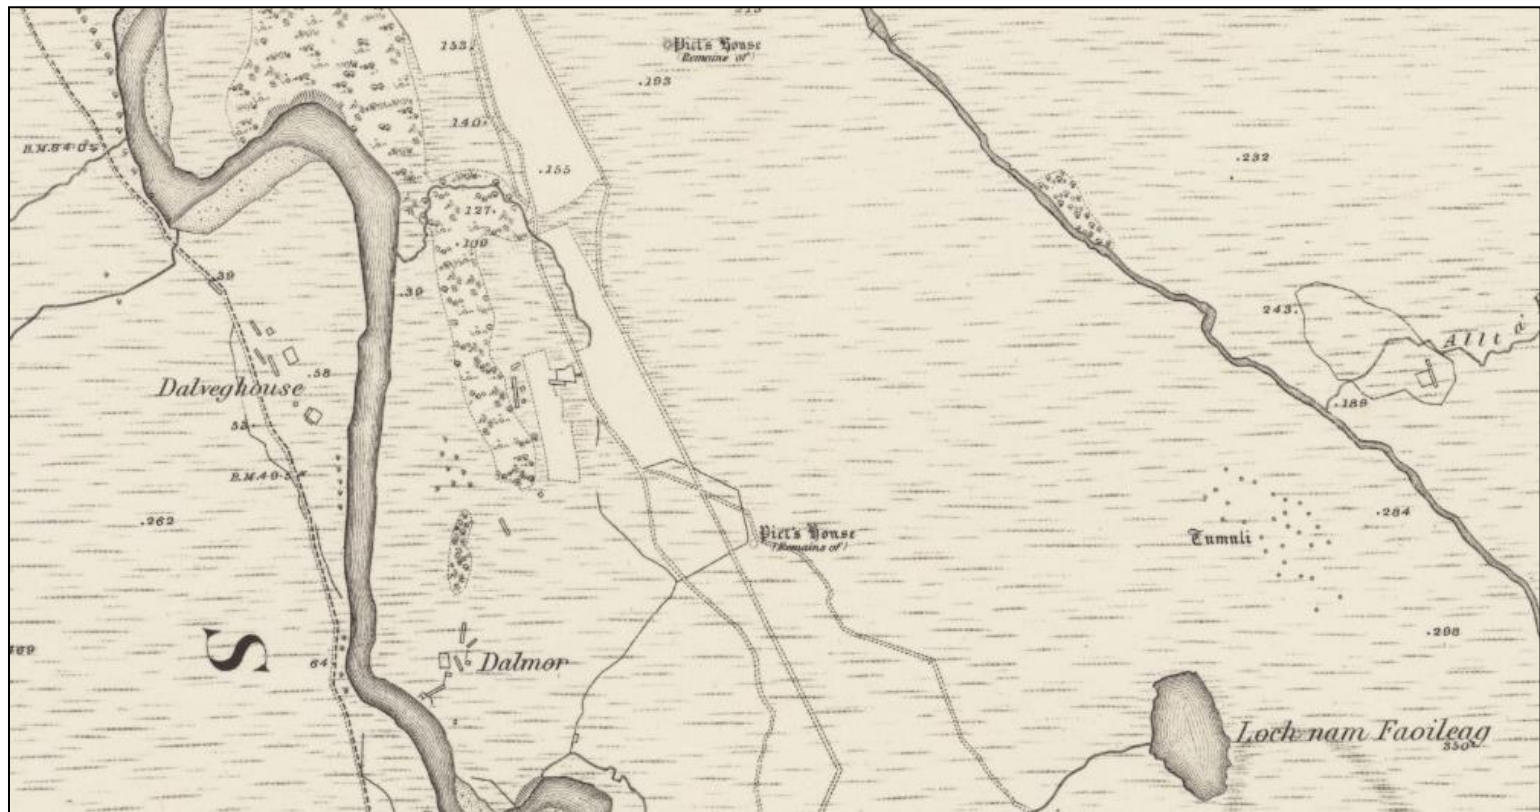
To the south of Skelpick, in Strath Naver, the 1st Edition map sheet shows a *Pict's House* (broch) to the SE of Skelpick, deserted settlement at Delveghouse including at least twelve roofless buildings and five enclosures; deserted settlement at Dalmor including ten roofless structures and one enclosure; and another *Pict's House* (broch) to the NE of Dalmor (Figure 6).

Figure 6: Excerpt from the 1st Edition 6 inch map sheet XVIII showing features between Skelpick and Dalmore in Strath Naver – Area 5 (© NLS Edinburgh)

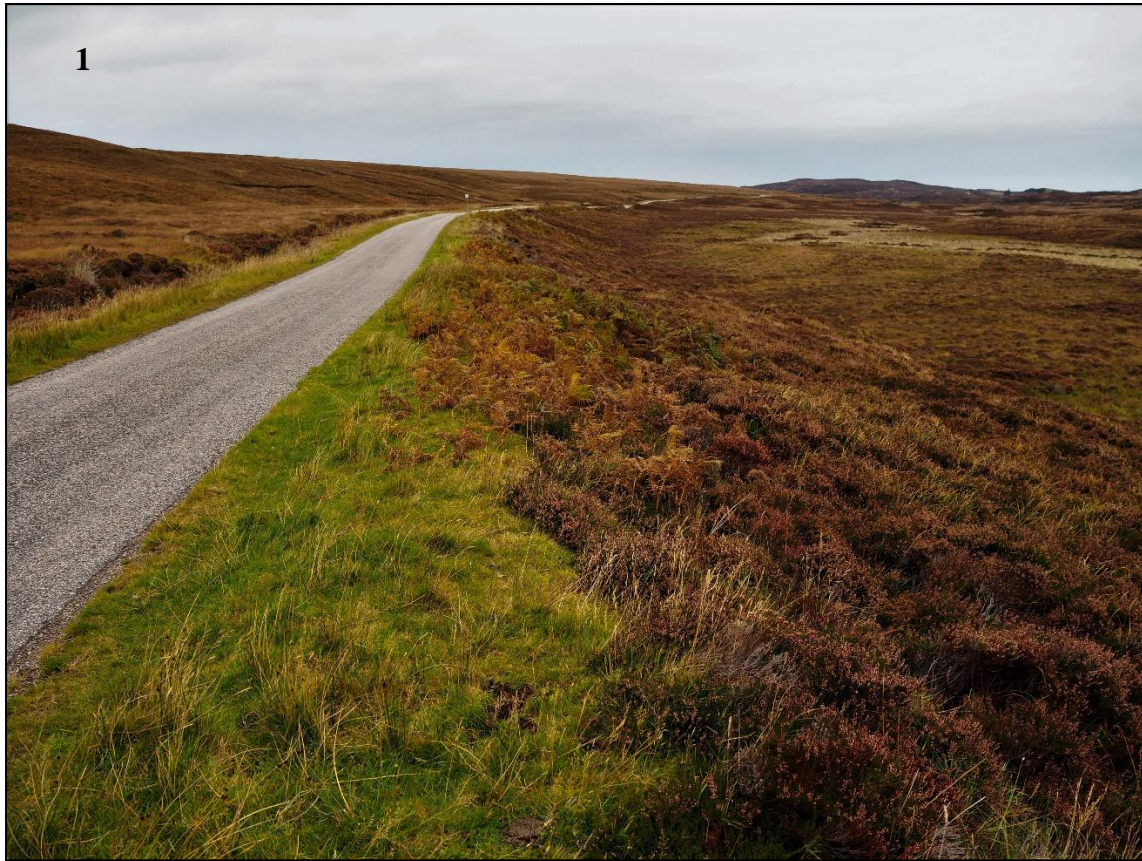
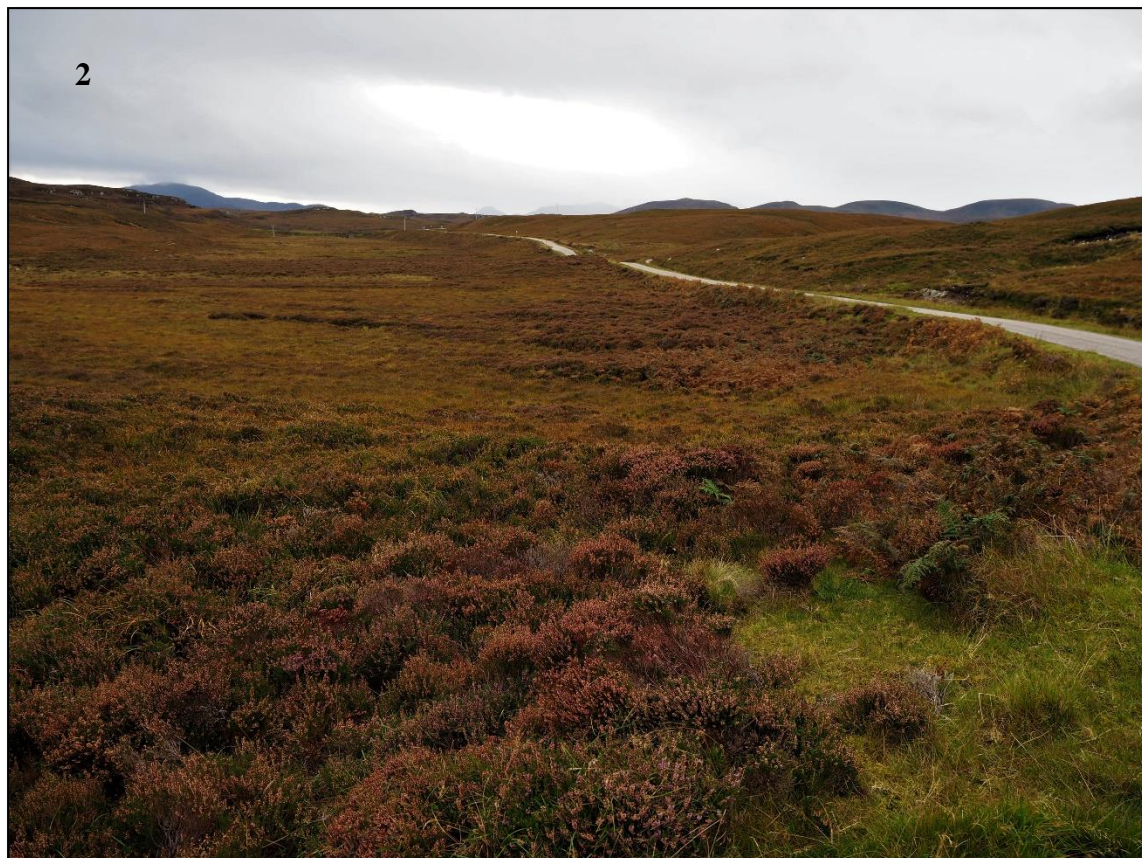
*Plate 1: View NE along glen towards Modsary, and along the pipeline route on the right side of the road;
Plate 2: View SW along Modsary glen towards its junction with the A836 main road*

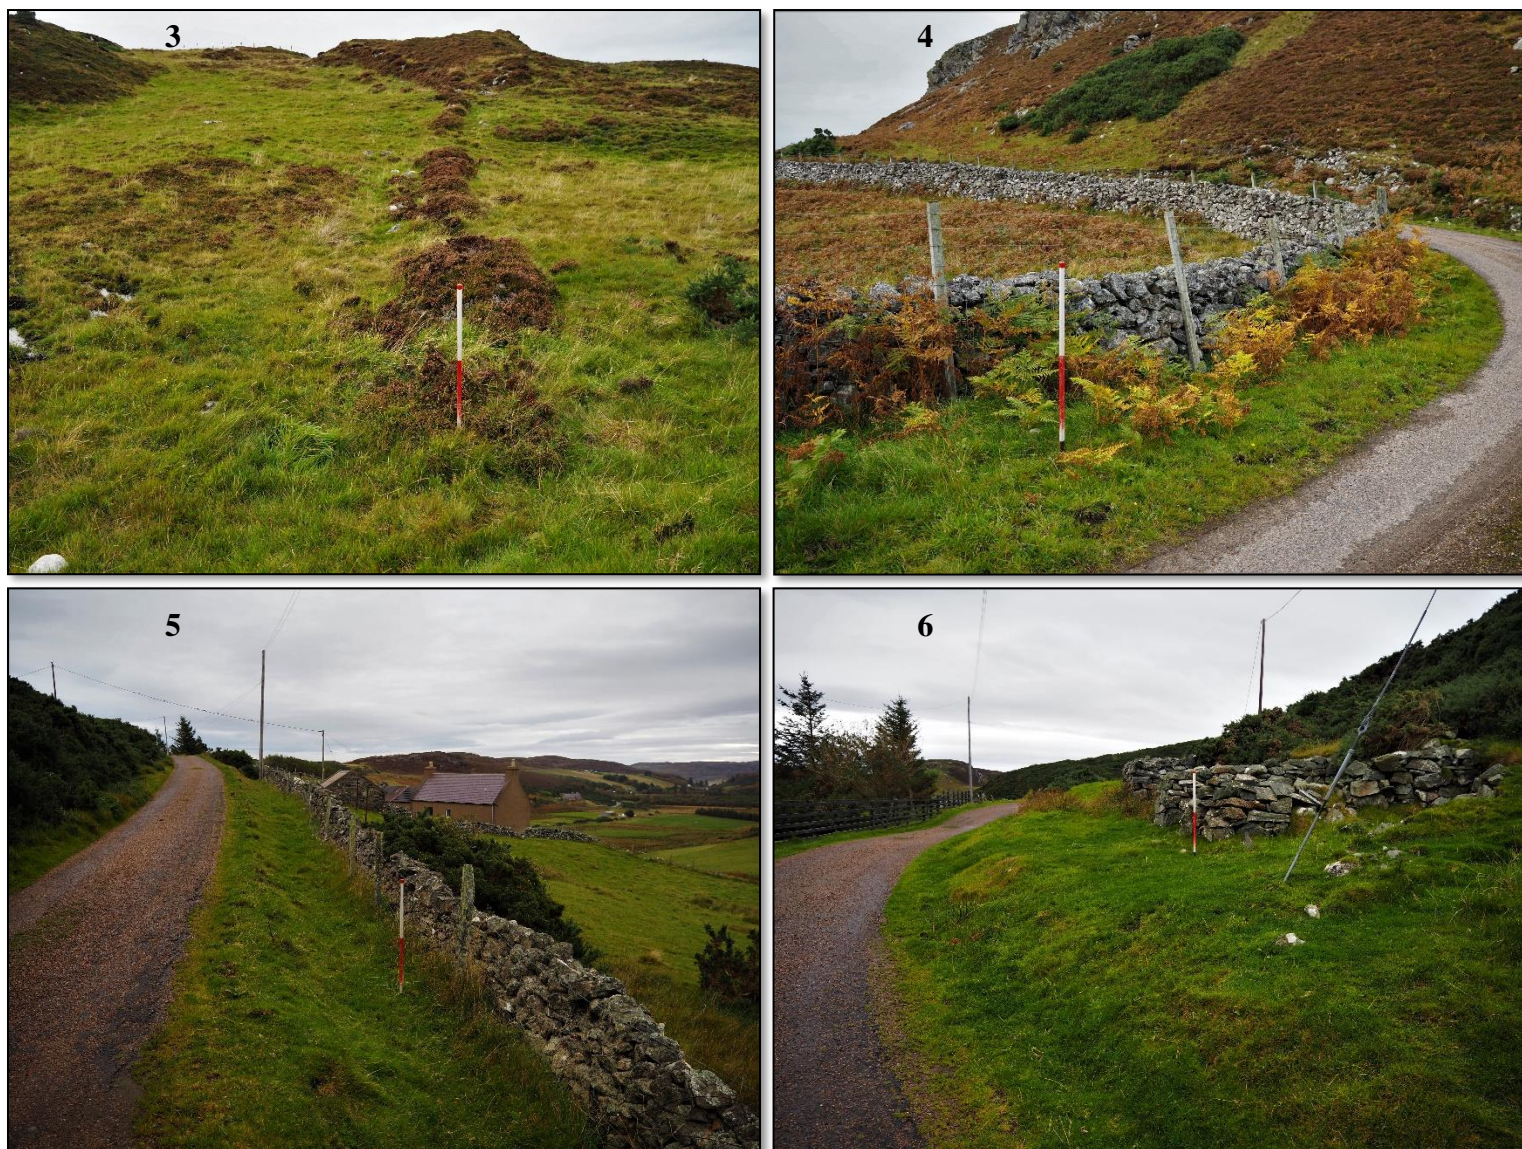
Plate 3: View NW showing stone and turf dyke (Site 2) running up slope and defining a field system at Torroy; Plate 4: View NNW showing substantial drystone dyke (Site 3) defining field at Torroy, with the road to Lamigo; Plate 5: View E over drystone dyke (Site 5) running up the side of the road at Skerray; Plate 6: View S over remains of drystone building (Site 6) at Tubeg, located on the W side of the township road

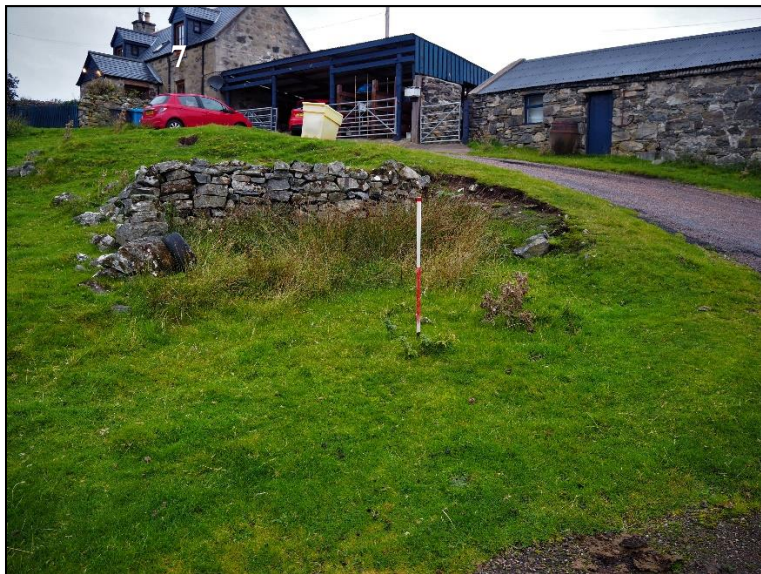
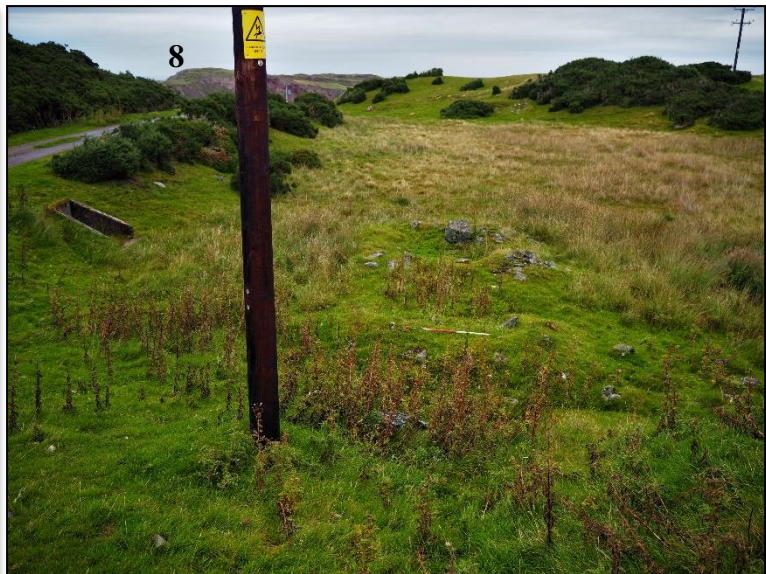
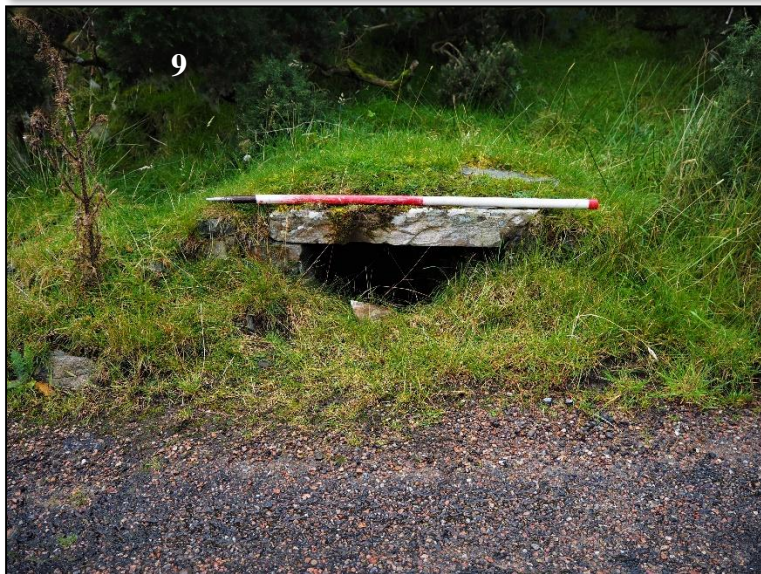
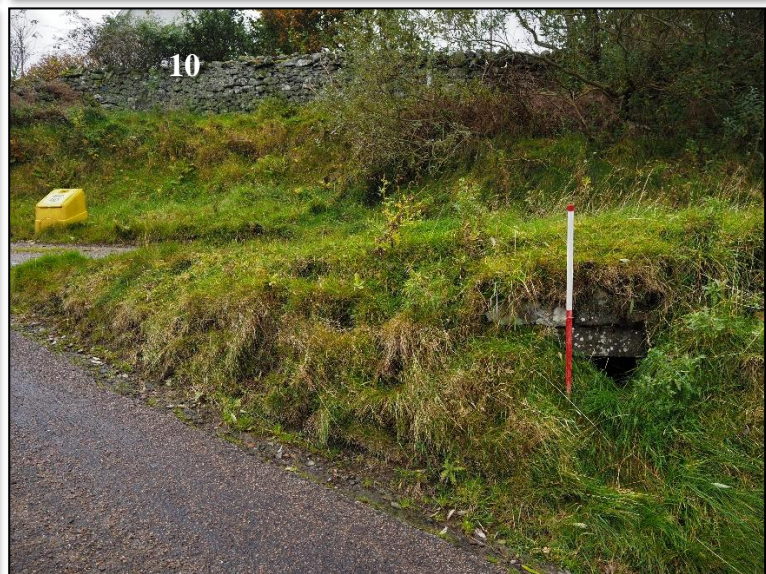
Plate 7: View NW showing very degraded and robbed remains of building (Site 7a) at Tubeg; Plate 8: View NNE showing the low foundations of the building at Tubeg (Site 8) with the Clashbuie road to left; Plate 9: View SW of the possible well or culvert (Site 9) located to the side of the road at Tubeg; Plate 10: View SW of stone culvert (Site 10) at the Skerray/Tubeg road junction with the wall of Skerray Mains visible above

| Site No. | Site Type | Site Name | Description | Alignment | Condition | Period | Easting | Northing |
|---|---|---|--|---|---|---|---|---|
| 7a | Building | Tubeg | Very degraded and robbed remains of a structure revetted into the slope and located on the side of the township road at Tubeg. The SE and NE walls have been robbed away and the structure measures c.3.2m long by 2.6m wide internally with walls 0.6m wide and standing >1.2m high max. No visible entrance but was most likely in the SE wall. | NE-SW | Very Degraded | Post Medieval | 265978 | 963489 |

- 8.3 At Skerray, it is possible that the well/culvert Site **9** and stone culvert Site **10** will be directly impacted by the cutting of the pipe trench, while the discovery of culvert Site **10** may also indicate the presence of other, unknown features of this type associated with the township roads. Where possible, damage to these features should be kept to a minimum.

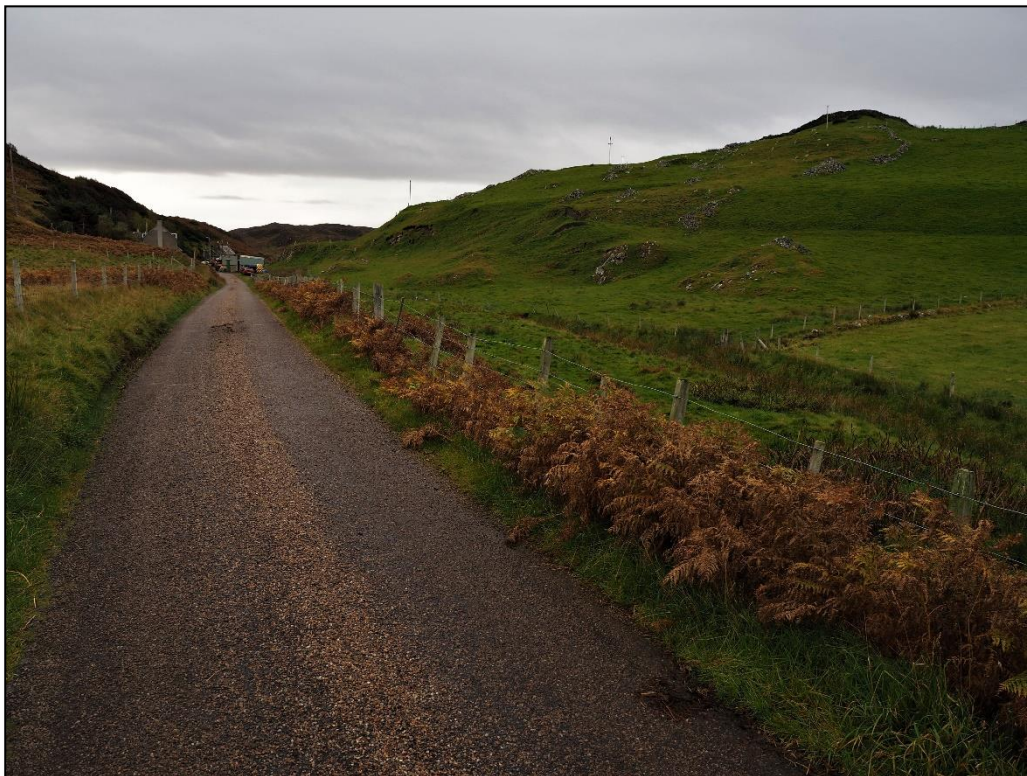
Plate 11: View SSE showing the road from Skerray Bay, with improved, hilly ground on the Tubeg side with numerous clearance cairns

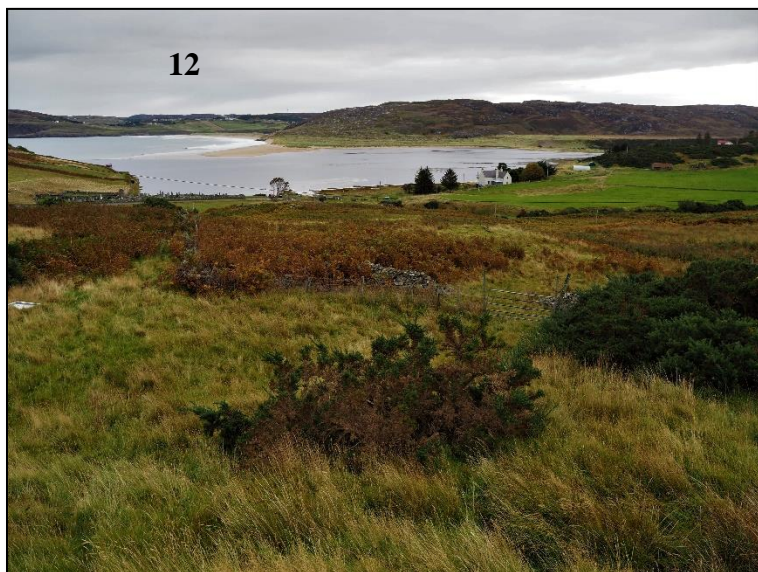
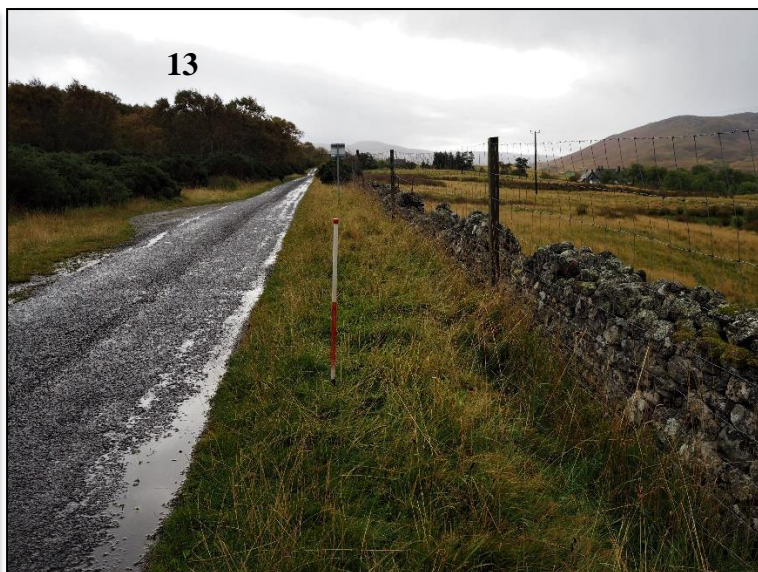
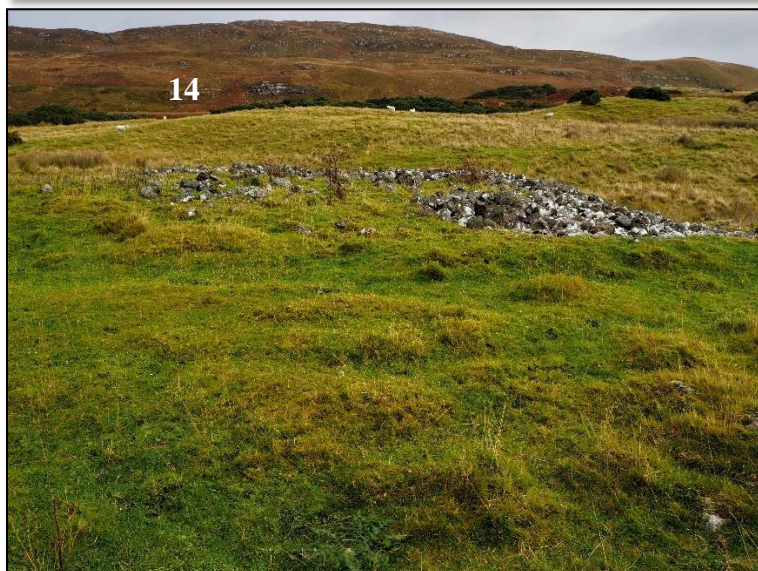
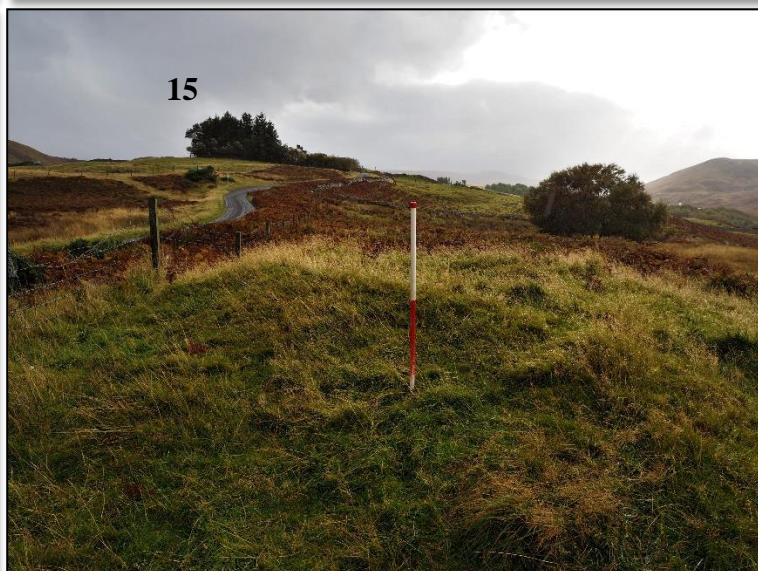
Plate 12: View ESE over pipeline route at Torrisdale and Torrisdale Bay, showing stone dyke (Site 11) forming a part of the field system; Plate 13: View ESE showing drystone dyke (Site 12) running alongside township road at Skelpick; Plate 14: View E showing stone spread (Site 13), which may represent stone clearance, or the very degraded remains of a prehistoric cairn; Plate 15: View SSW over possible burial cairn (Site 15) at Dail na Drochaide with the township road to the left

- 8.4 The open cut pipe trench will directly impact on drystone dykes at Achtoty (Site **19**), on the foundations of a possible enclosure at Borgidhweag (Site **48**), and on a section of stone dyke and a potential remains of an enclosure and building at Ruigh Ruadh (Site **22**; HHER Site **MHG18185**). Only a small section of the enclosure wall will potentially be impacted at Borgidhweag (Site **48**), so no additional archaeological input is recommended. Features identified at the Ruigh Ruadh settlement (Site **22**) were lifted off the 1st Edition Ordnance Survey map sheet (see Figure **16**). Any visible features associated with these sites appear to have been removed by agricultural activities and the construction of new buildings and tracks. The wall of a possible enclosure, located at the north end of the site, will only be impacted in one small area, while the pipeline trench will run through the location of a former long building, located to the SE of the current house at this site. Much of this structure appears to have been truncated by the access track and parking for the house, while the pipeline will run in the edge of the access track. Therefore, due to the limited impacts on these features, no further archaeological input is recommended.

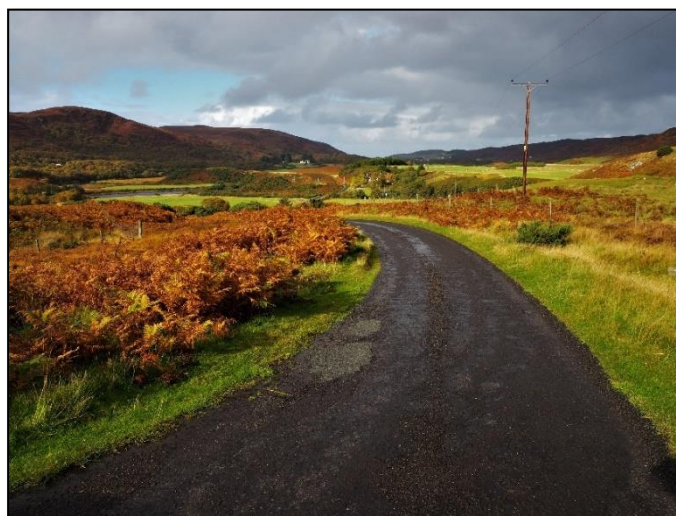
Plate 16: View NNW showing township road, close to Site 15, and Dail na Drochaide, Strath Naver

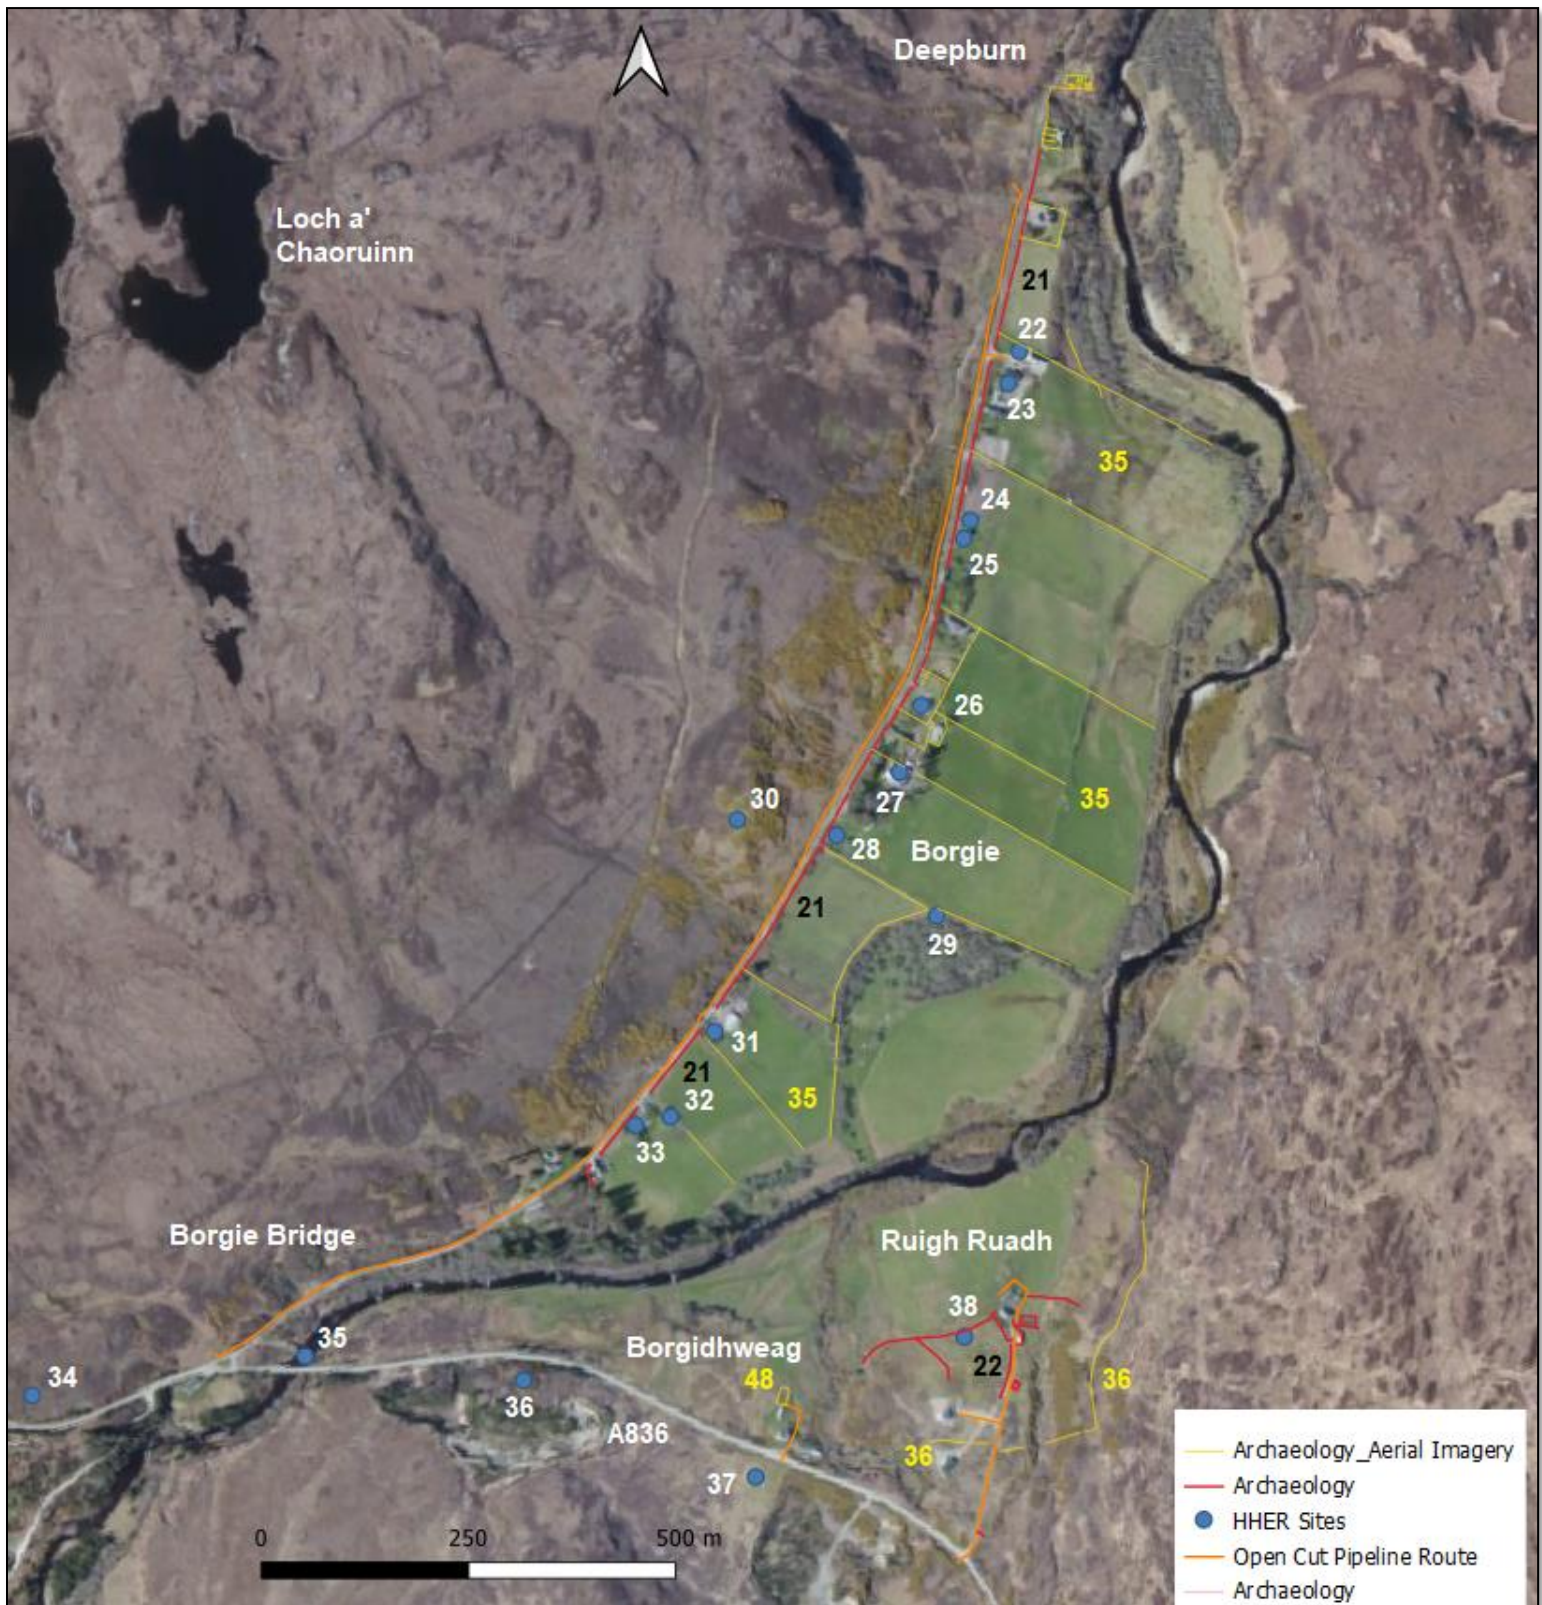
Figure 10: Aerial image screenshot showing pipeline route and distribution of recorded HHER, aerial and archaeology sites in Borgie, Borgidhweag, and Ruigh Ruadh – Area 4 (Base maps contain Ordnance Survey Data Crown Copyright and Database Rights 2022 and ESRI World Imagery © 2022)

- 3.2 The sections of open-cut trench for the new water main rehab project provide the focus for this report, most of which run through township roads, tracks and their associated verges. However, short sections of the open-cut trench run through open ground, away from the roads and tracks, at Achtoty, Airdtorrisdale, Torrisdale, Ruigh Ruadh, Skelpick, and Archoillenaborgie (Figures 9, 10, 12 and 14).

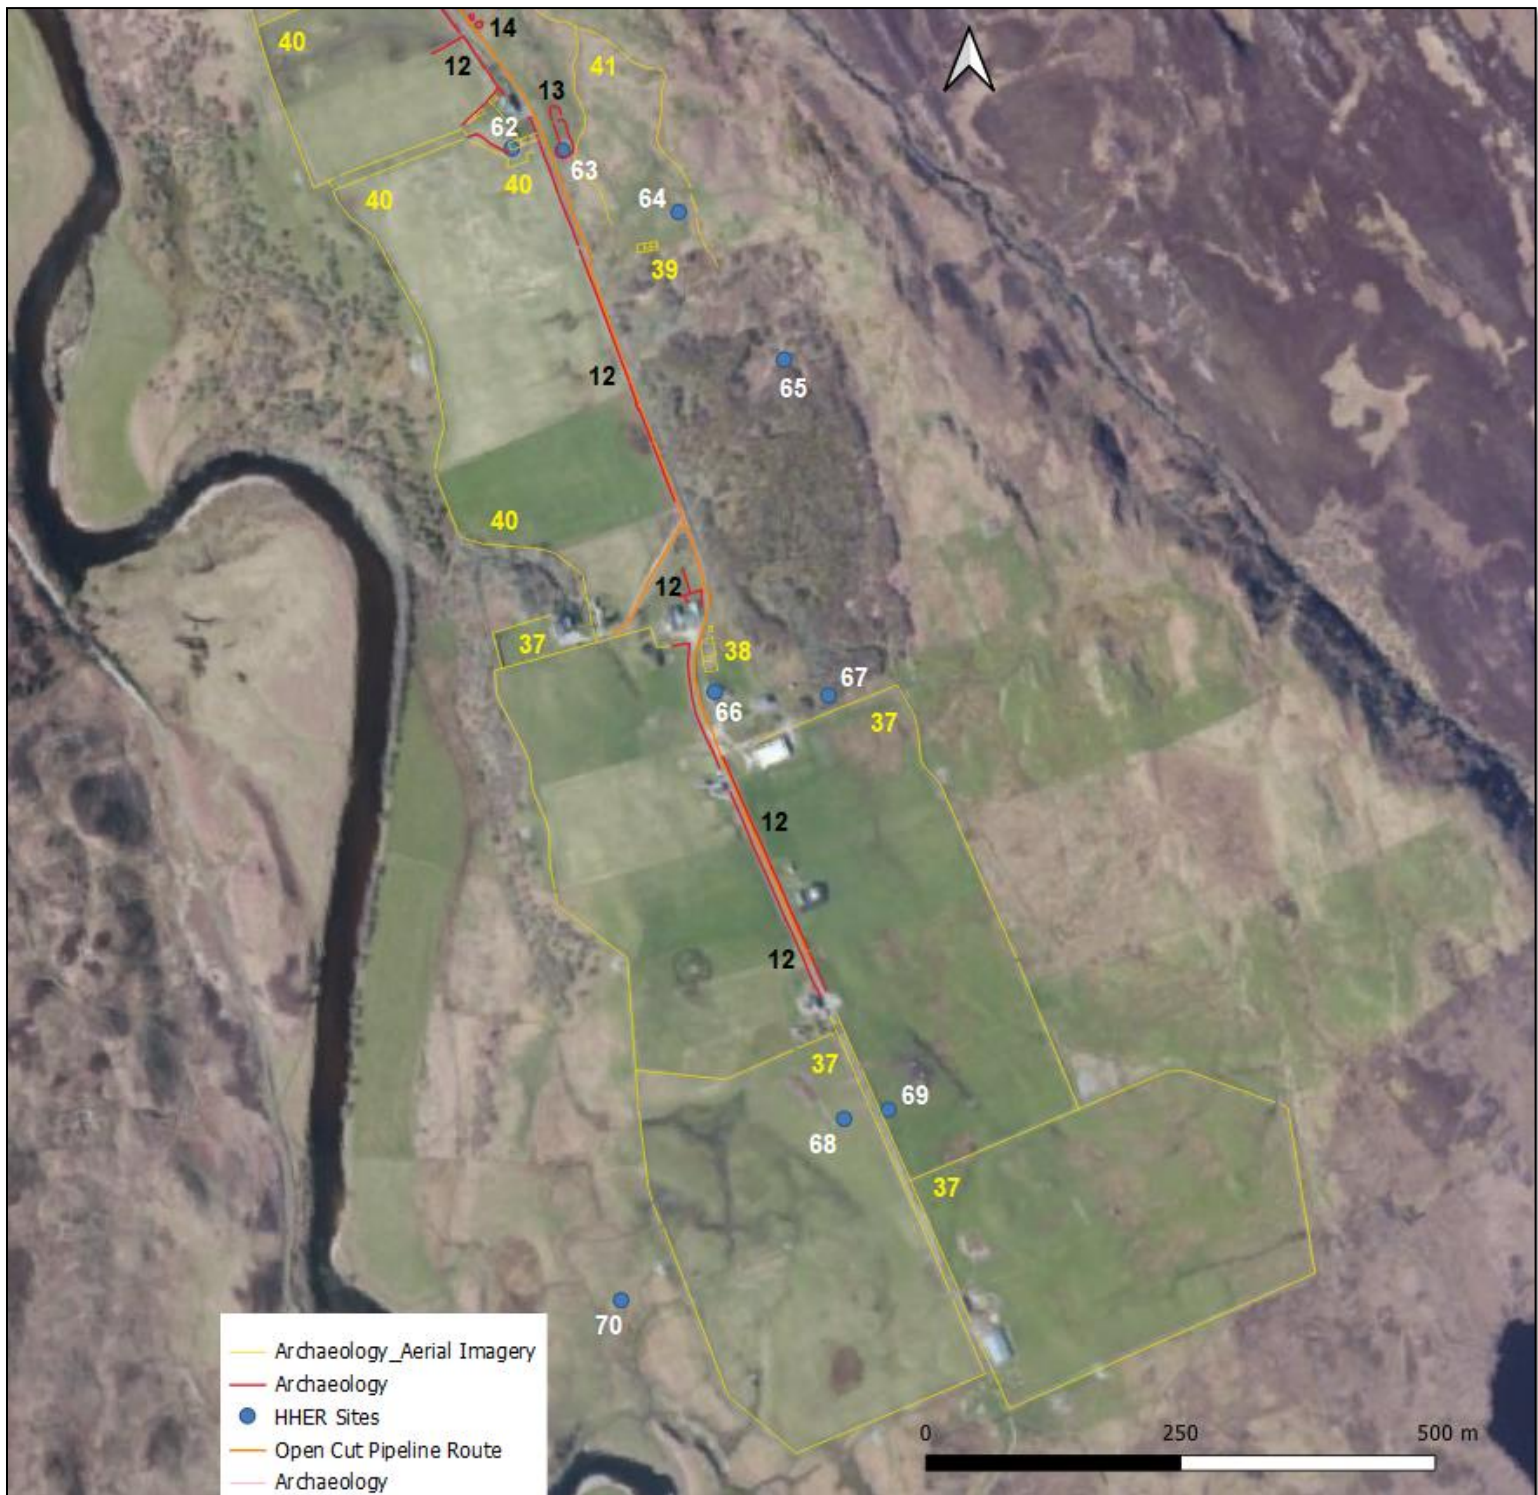
Figure 11: Aerial image screenshot showing pipeline route and distribution of recorded HHER, aerial and archaeology sites between Dalmor and Skelpick House – Area 5 (Base maps contain Ordnance Survey Data Crown Copyright and Database Rights 2022 and ESRI World Imagery © 2022)

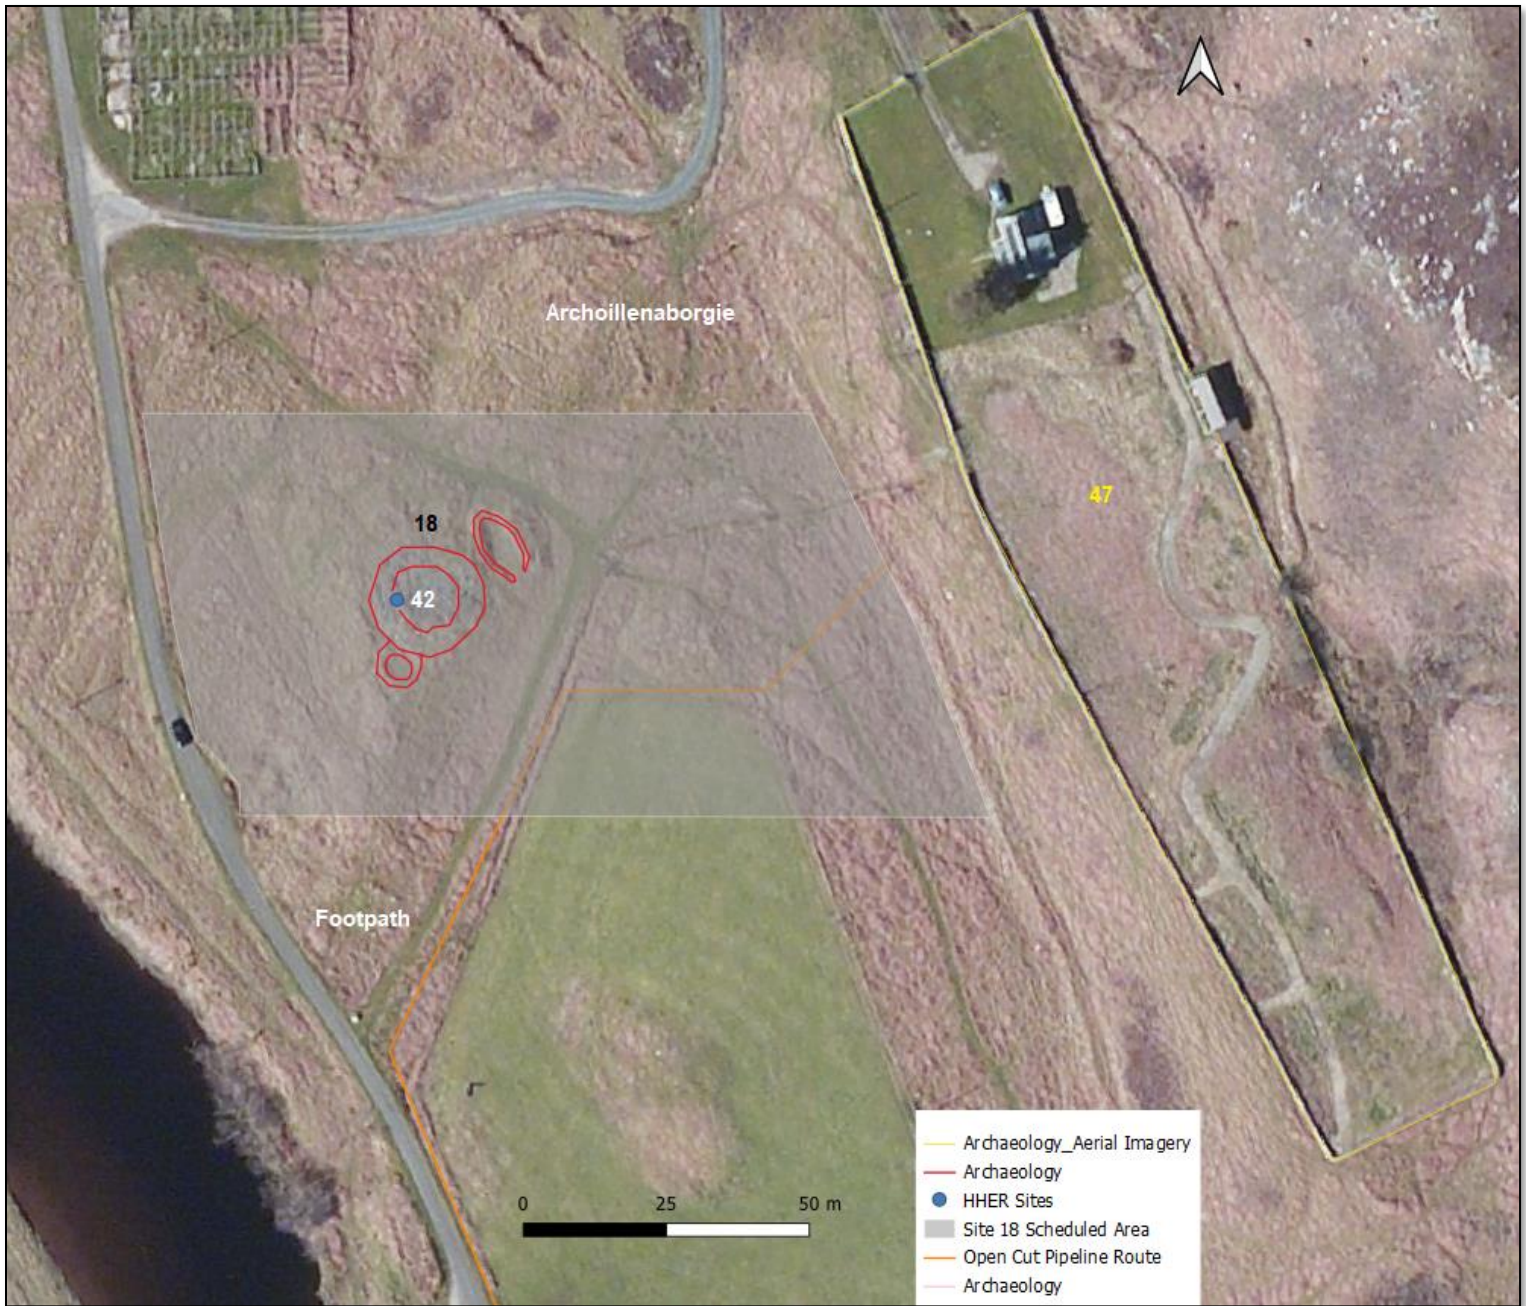
Figure 15: Aerial image screenshot showing pipeline route, location of Broch Site 18 at Achcoillenaborgie, and scheduled area for monument – Area 5 (Base maps contain Ordnance Survey Data Crown Copyright and Database Rights 2022 and ESRI World Imagery © 2022)

- 8.5 At the broch Site **18** (**MHG10772**) at Achcoillenaborgie, in Strath Naver, the proposed open-cut trench for the water main will run from the road up the SE side of the main footpath accessing the monument and will cut through the SE corner of the designated Scheduled Monument area (**SM1824**; Figure **15**). It is recommended that the pipeline route is diverted to the SE by at least 8 metres, into the edge of the improved field.

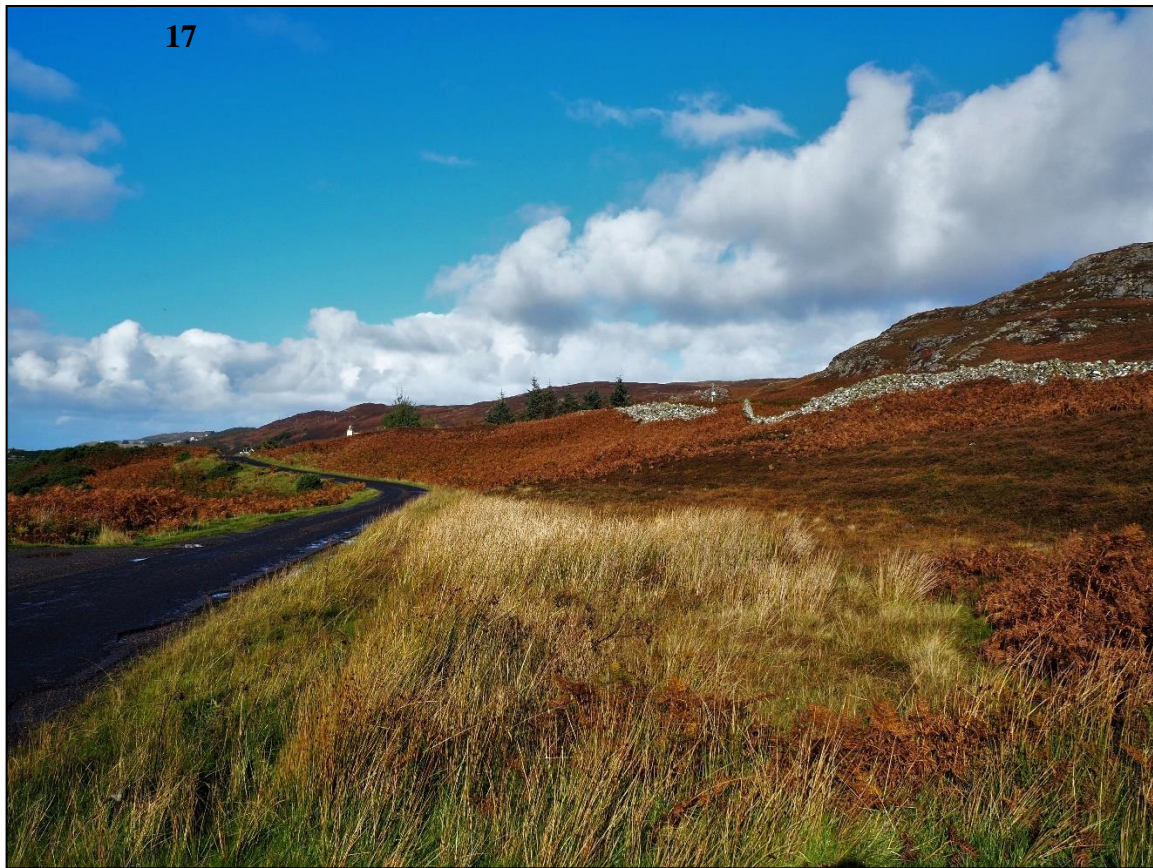
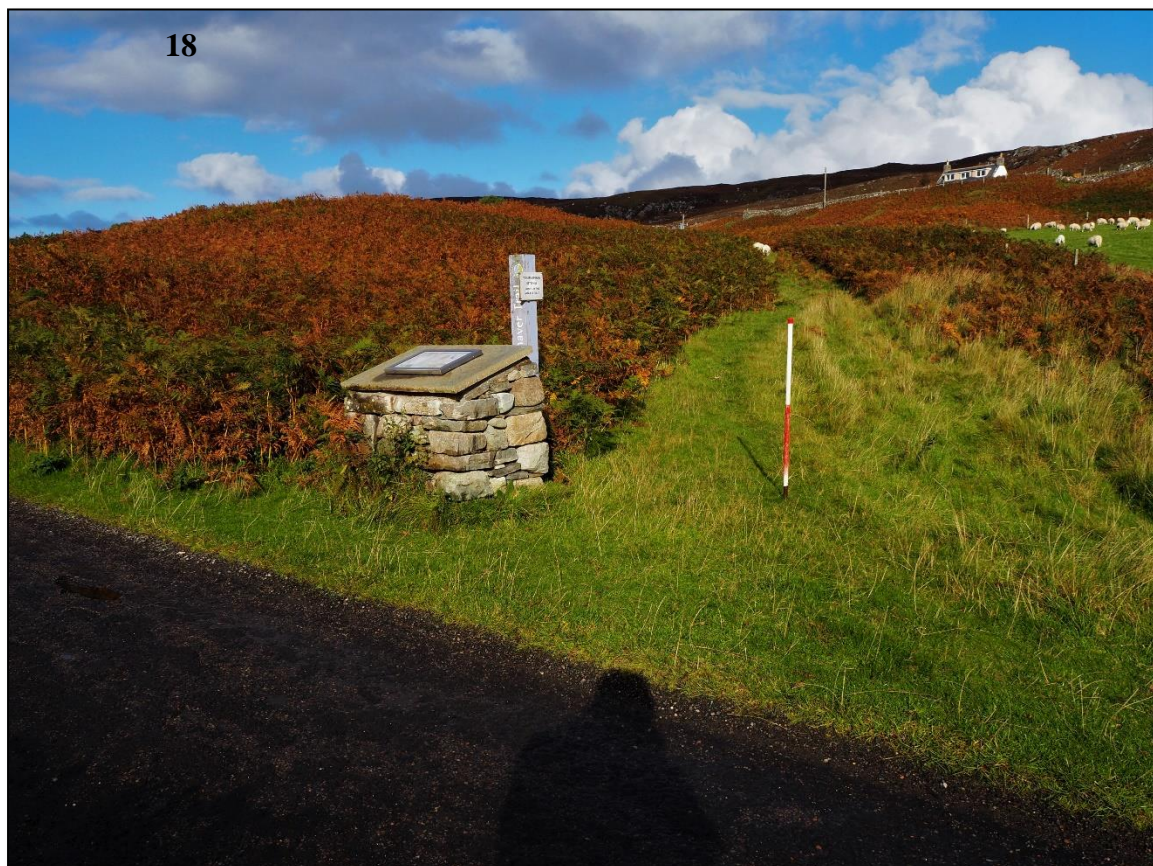
| Photo No. | Site No. | Direction facing | Description | Date | Taken by |
|---|---|---|--|---|---|
| 20 | - | S | View over the Long/Horned Cairns at Coille na Borgie, with the road and proposed pipeline route along the side of the road to the right. | 12.10.22 | SB |
| 21 | - | NNE | Image showing the access path to the broch at Achcoillenaborgie and the proposed route of the open-cut water main trench, which will run up the right-hand side of the path. | 12.10.22 | SB |

Plate 17: View N showing road and alignment of proposed pipeline route at the side of the road, in relation to the Long Cairns at Coille na Borgie; Plate 18: View NNE showing the access path to the broch at Achcoillenaborgie and the proposed route of the open-cut water main trench
