Humboldt Bay Shoreline Inventory, Mapping, and Sea Level Rise Vulnerability Assessment

Prepared for
State Coastal Conservancy
1330 Broadway, 13th Floor
Oakland, CA 94612-2530

January 2013

Humboldt Bay Sea Level Rise Adaptation Planning Project:
Phase 1
Shoreline Inventory, Mapping, and Vulnerability Assessment

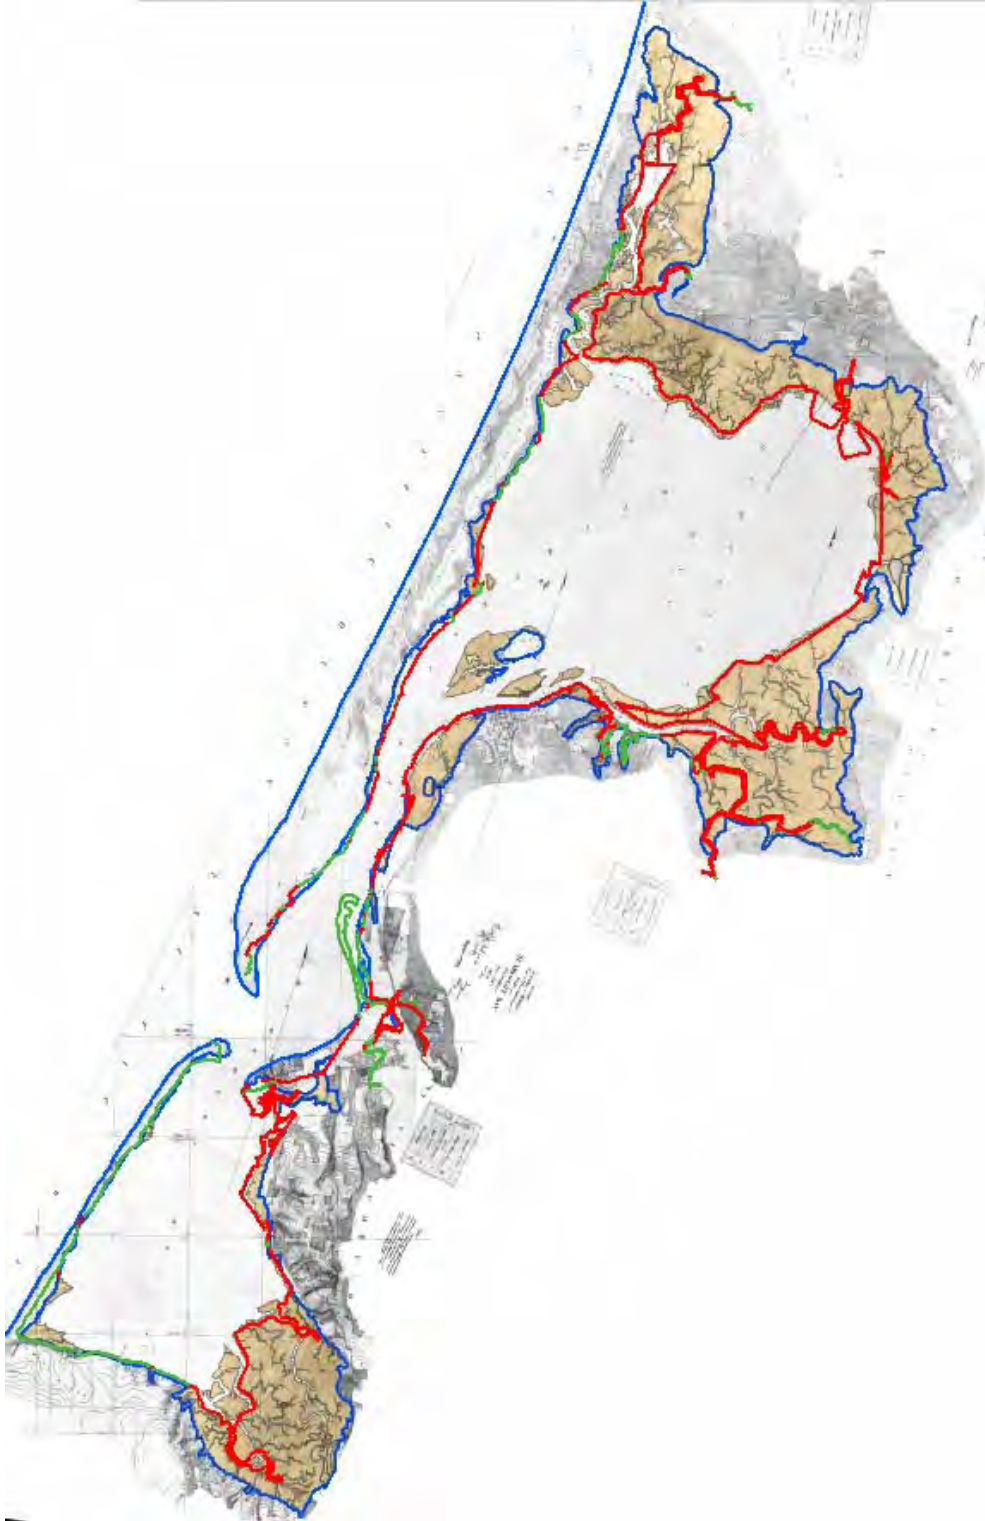
Figure 1, 1870 USCGS survey of Humboldt Bay, with 1870 shoreline (blue) and 2009 shoreline (red for artificial and green for natural) serves to illustrate the magnitude of change to the Bay.

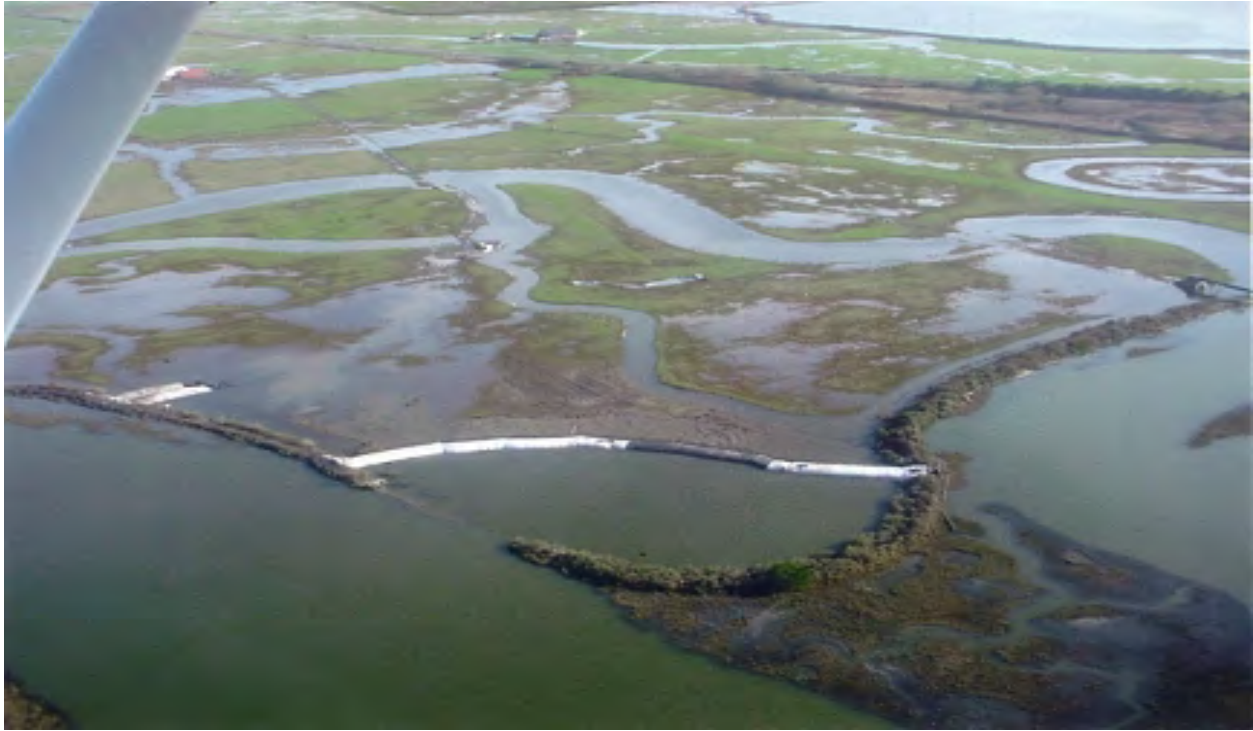
Figure 3, 2003 breach on Mad River Slough, 9.51 foot tide and storm surge (Times Standard, Andrew Bird, January 26, 2004).

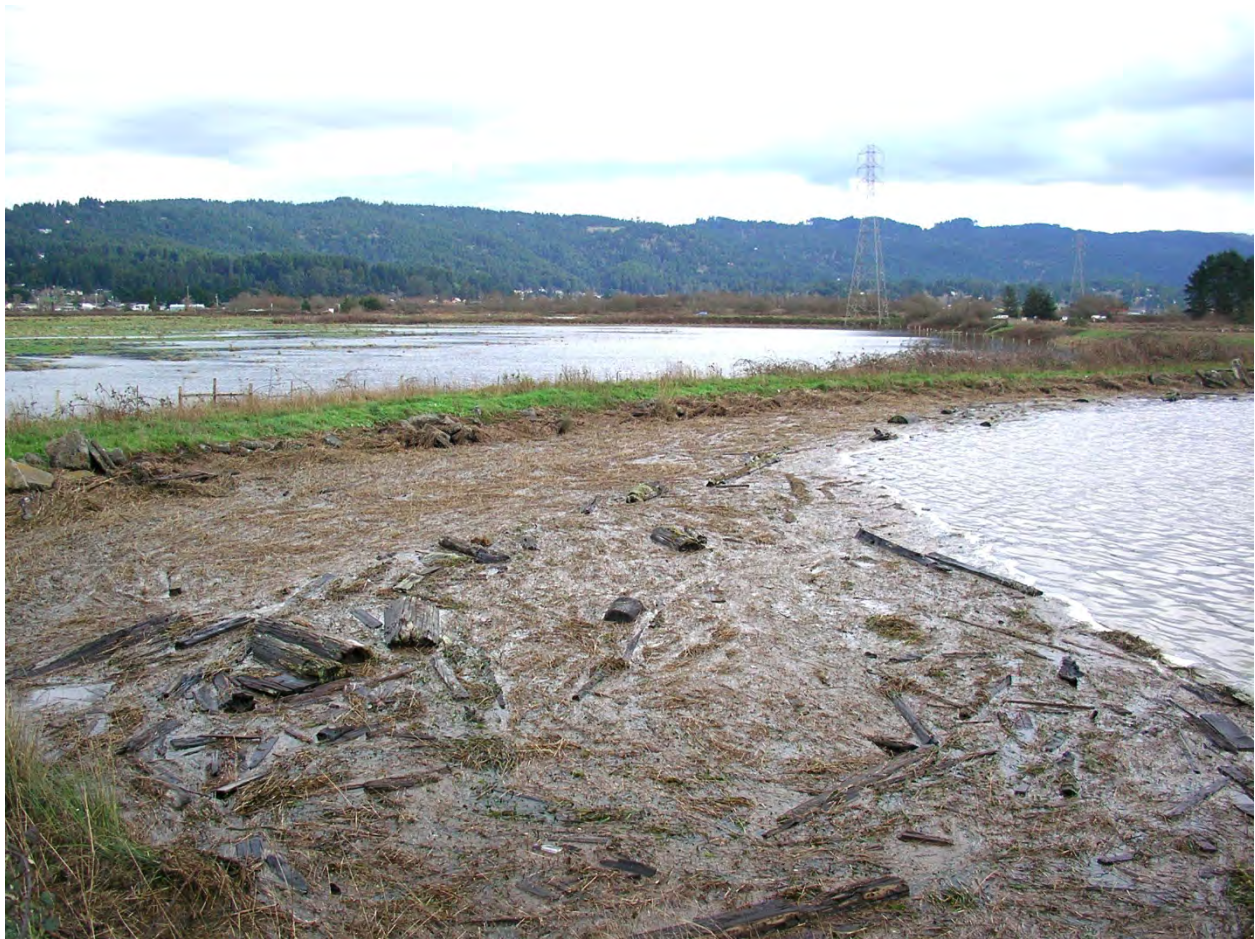
Figure 4, 2006, the maximum high tide after a period of heavy rainfall reached 9.49 feet and Arcata Bay's northern diked shoreline and City of Arcata's wastewater treatment ponds and marsh dikes were over topped in multiple locations.

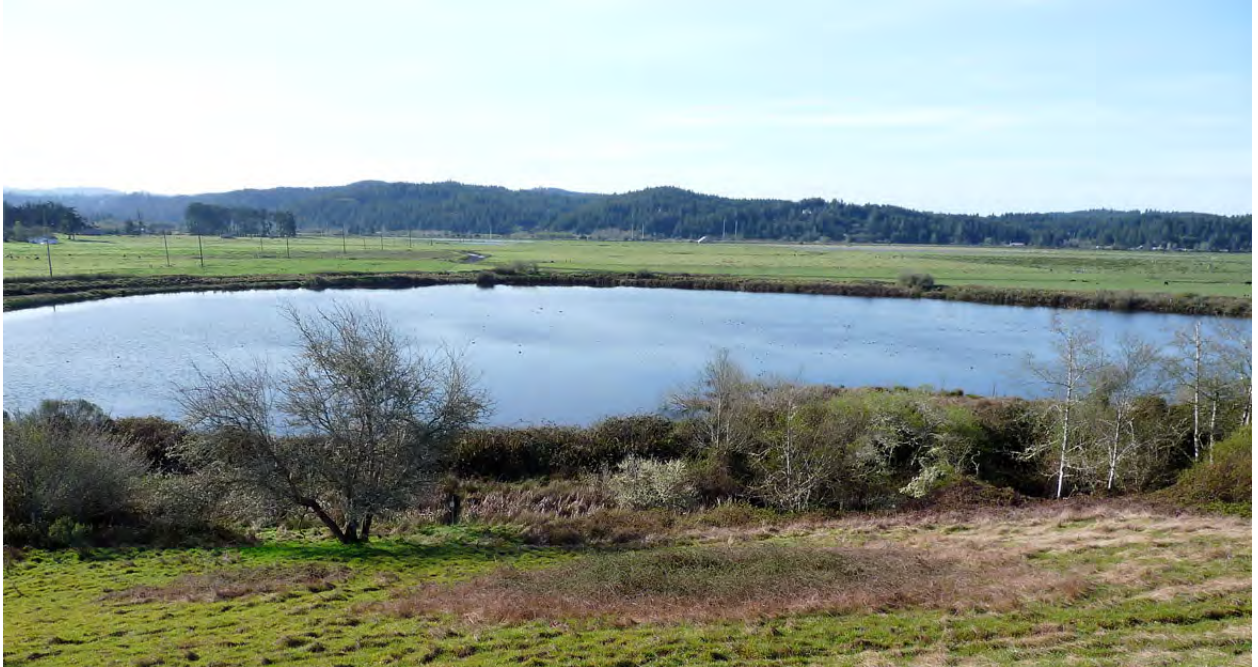
Figure 5, 2010, the maximum high tide reached 8.94 feet and a dike on Fay Slough, a tributary to Eureka Slough, was overtopped flooding 16 acres of state wildlife refuge.

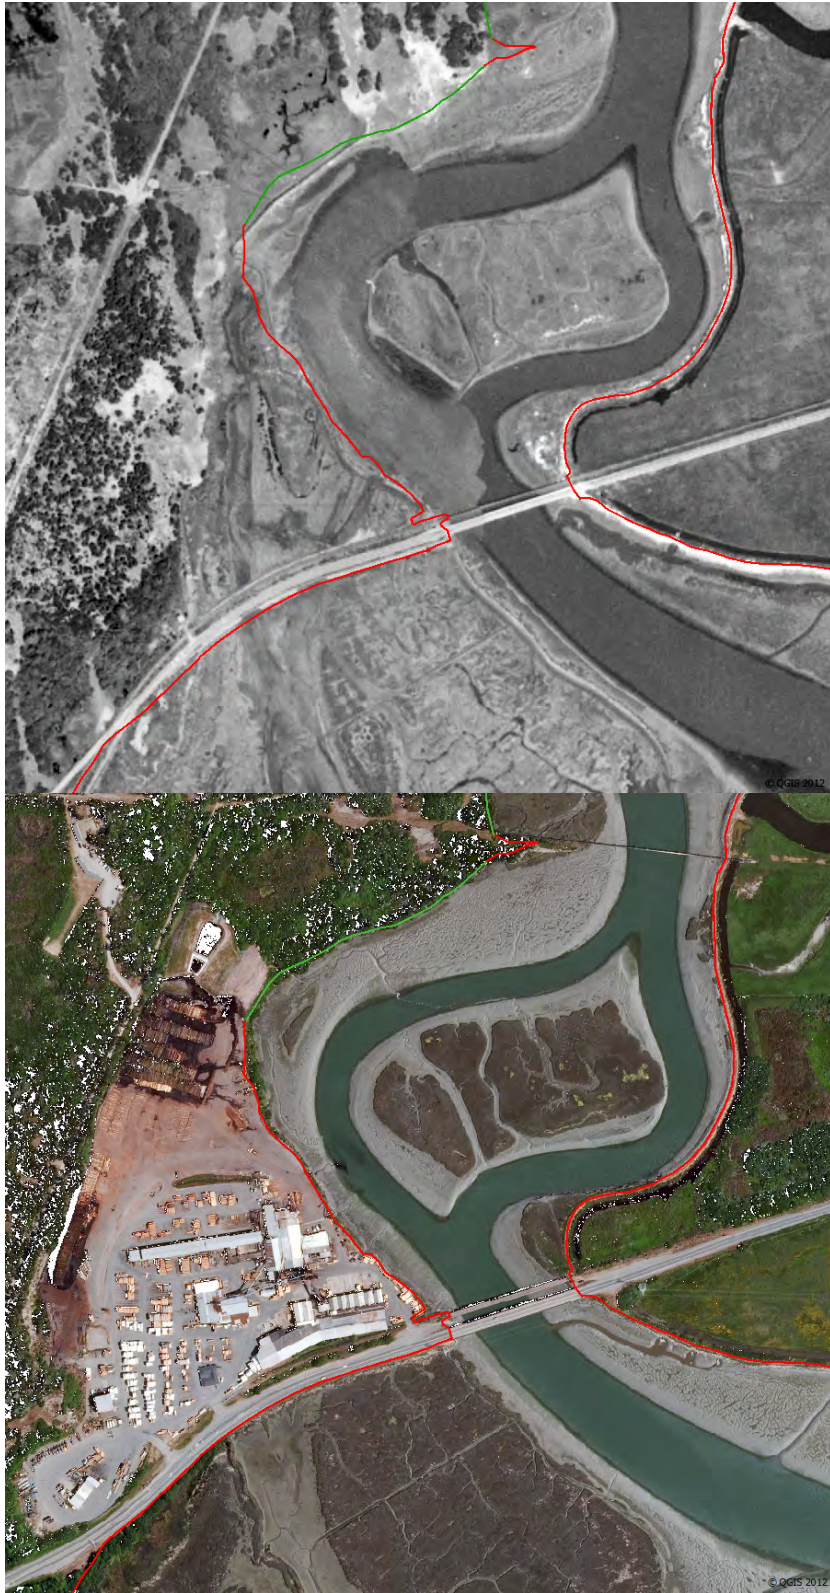
Figure 7. Comparison of 1948 and 2009 aerial photographs documents the placement of fill in Mad River Slough, current shoreline depicting artificial (red) and natural (green) segments.

Historical maps (1854, 1870, 1890, 1916, 1921, 1933, and 1942) and aerial photography (1948, 54, 58, 65, 70, 81, and 88) from the 2007 Digital Historical Atlas of Humboldt Bay and Eel River Delta (Laird 2007) were incorporated into this project's GIS database to facilitate interpretations of historical changes in shoreline conditions and location such as placement of fill (Figure 7).

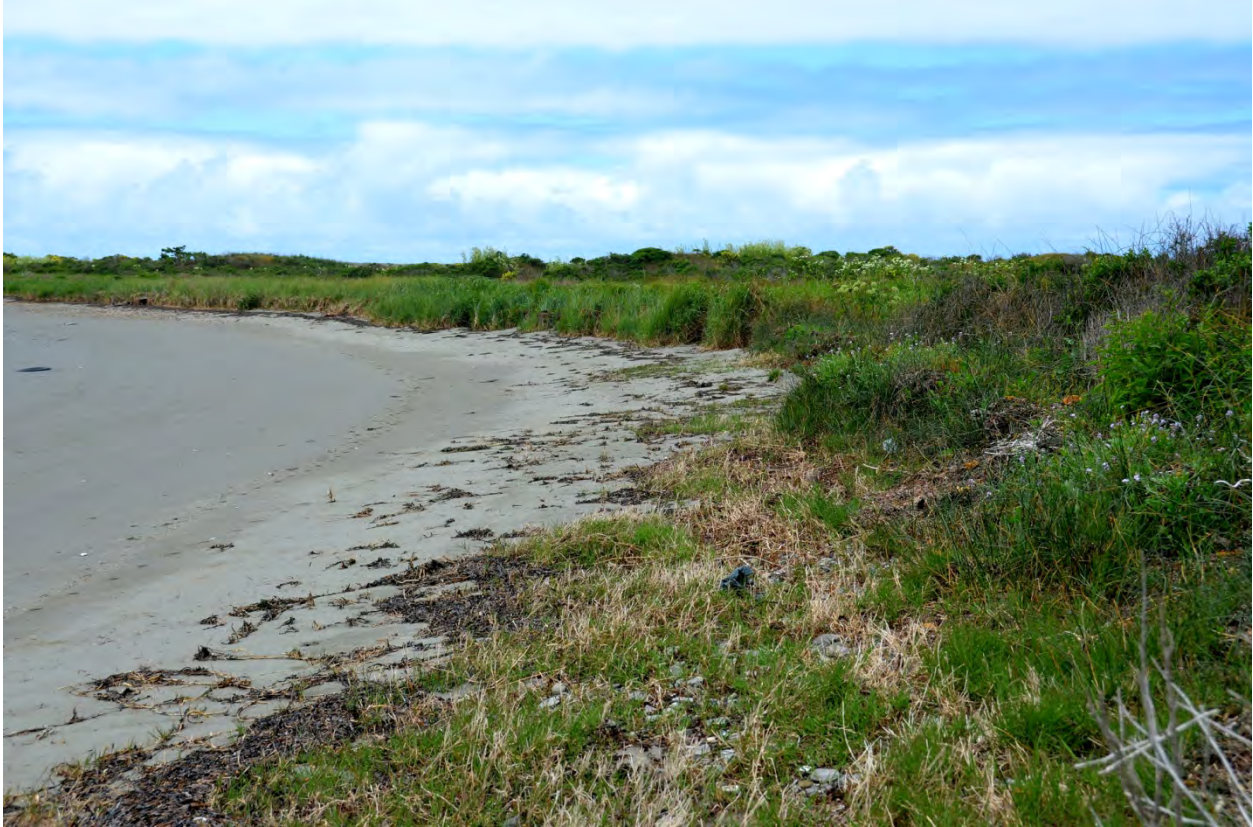
A shoreline that appears natural and when there is no historical evidence of the shoreline having been artificially manipulated (Figure 8).

Figure 8. West side of South Bay is an example of a natural shoreline.

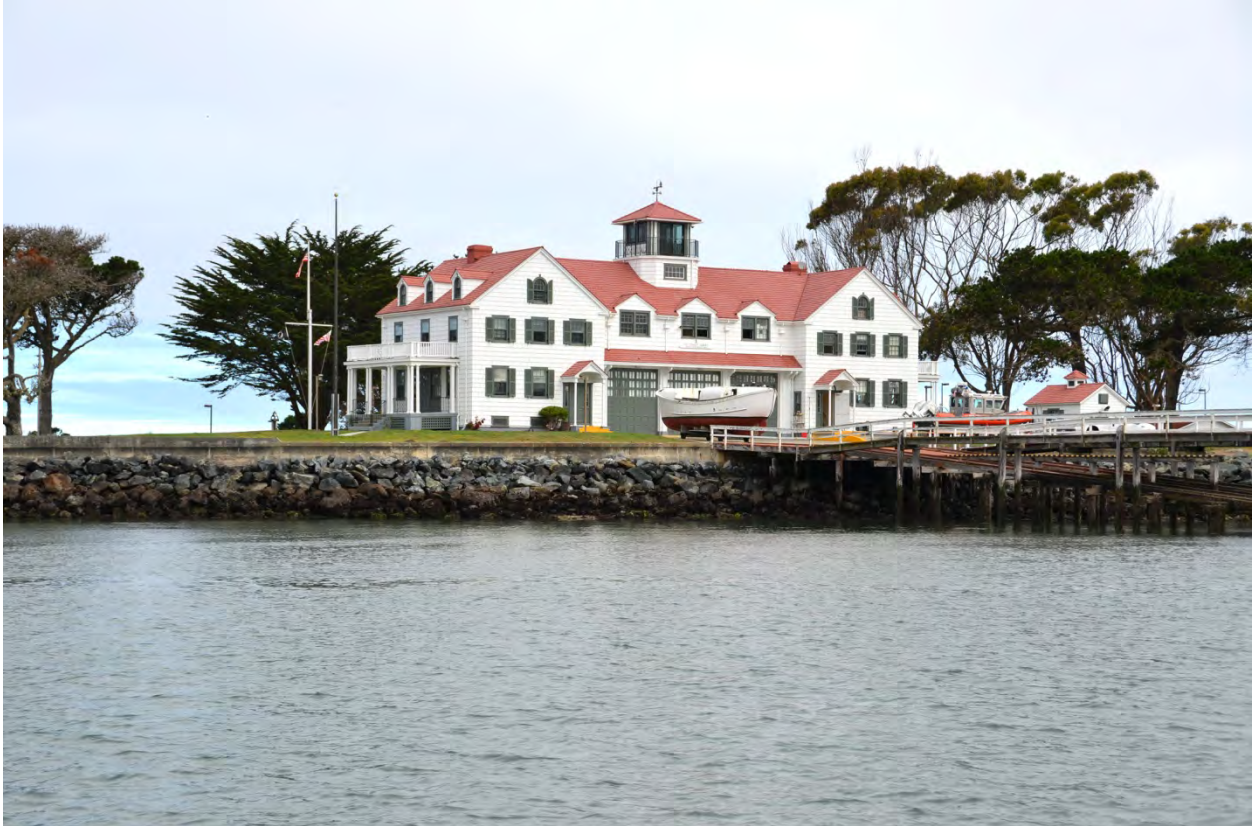
A shoreline that is composed of a man-made structure, or in the case of *fill*, where there is historical evidence of the Bay having been artificially filled (Figure 9).

Figure 9. West side of Eureka Bay, the Coast Guard station is an example of a man-made or artificial shoreline.

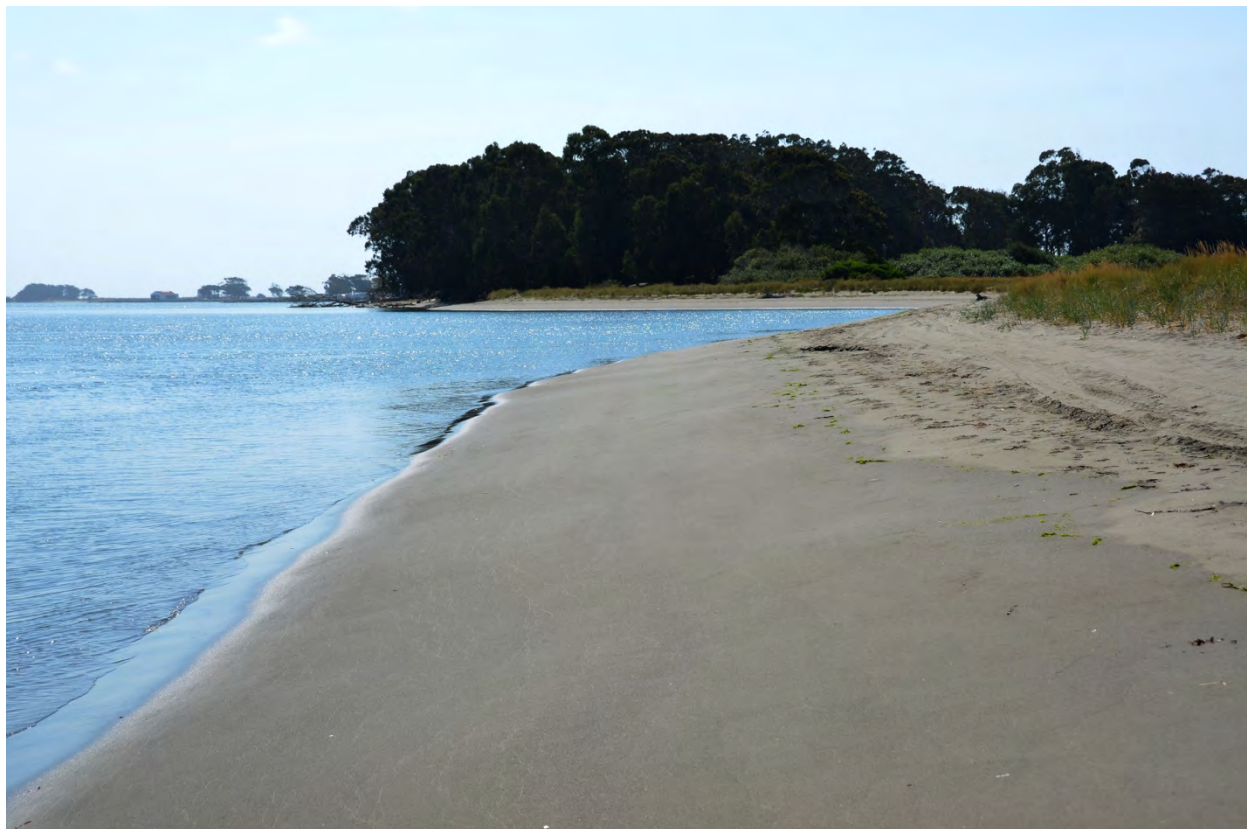
A shoreline with no structure is a natural shore or slough bank that is neither a cliff/bluff nor a fore dune (Figure 10).

Figure 10. Eureka Bay is an example of a shoreline with no structure eroding on Humboldt Bay.

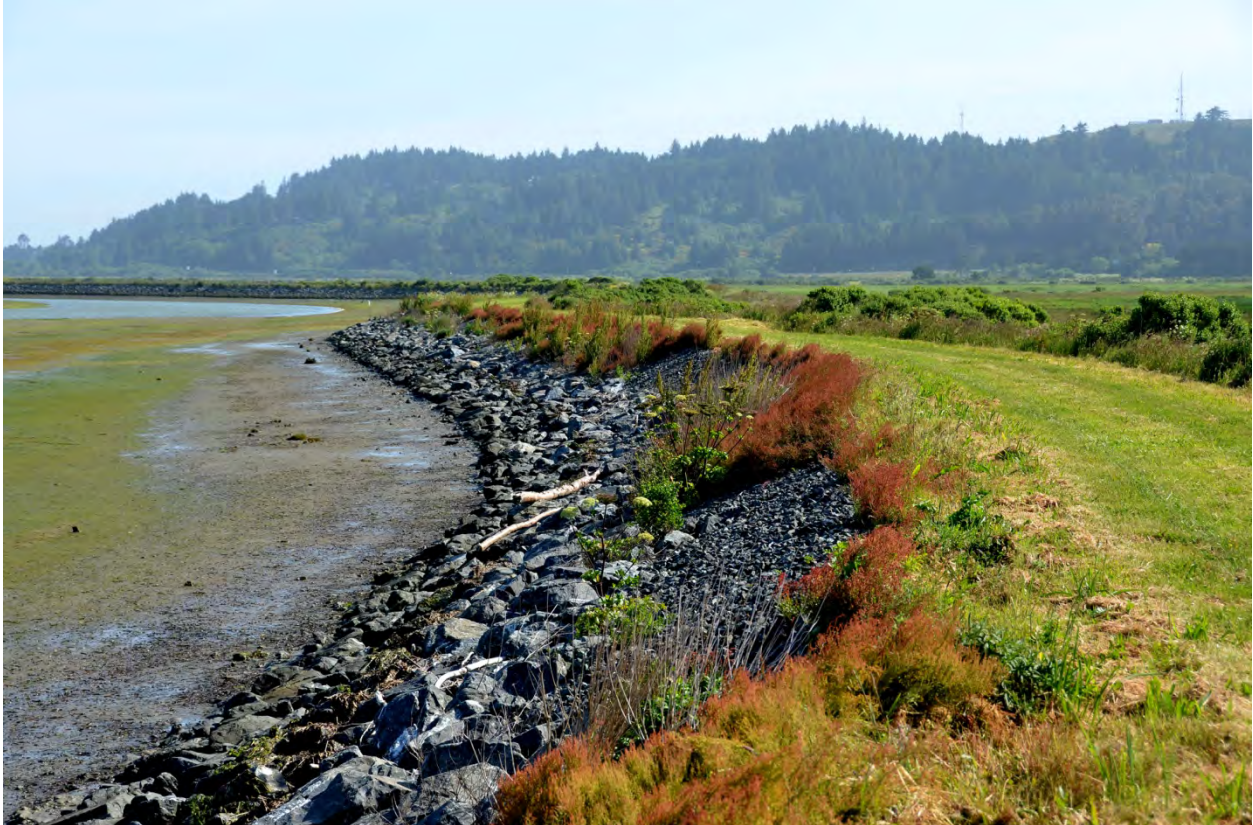
An earthen wall-like structure constructed to prevent tides from inundating land behind the dike (Figure 11). Most dikes on Humboldt Bay were constructed at the inter-tidal boundary between mudflats and salt marsh; lands behind the dikes were drained and converted to agricultural uses.

Figure 11. Hookton Slough on South Bay is an example of an earthen dike with rock revetment and roadway that is being maintained.

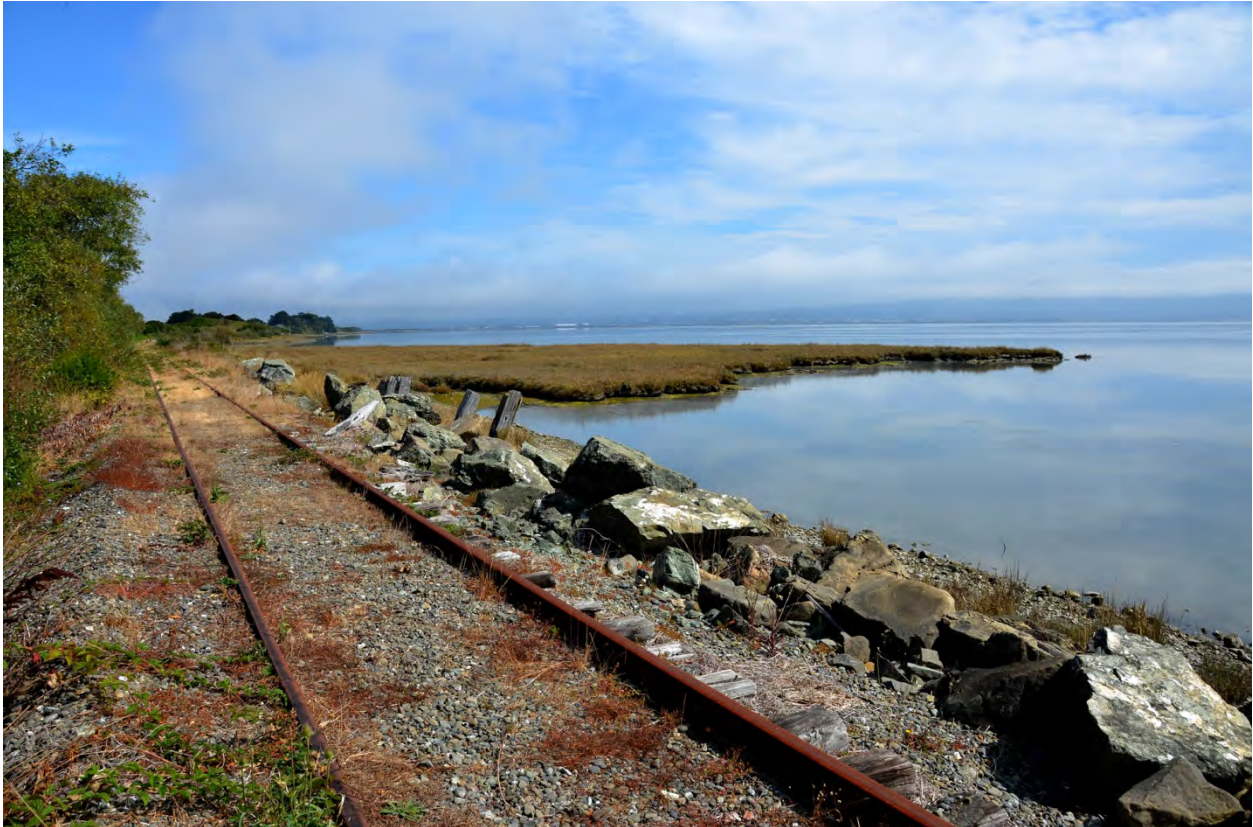
Generally a trapezoidal fill prism constructed to support rails for use by trains to transport materials and people (Figure 12). Most of the railroad grade traverses former inter-tidal areas and railroad grades provide similar protection to landward areas as do dikes on Humboldt Bay. At this time the railroad has not been used commercially for more than a decade and much of the railroad grade has not been maintained.

Figure 12. West-side of Arcata Bay is an example of the railroad grade on Humboldt Bay with rock revetment.

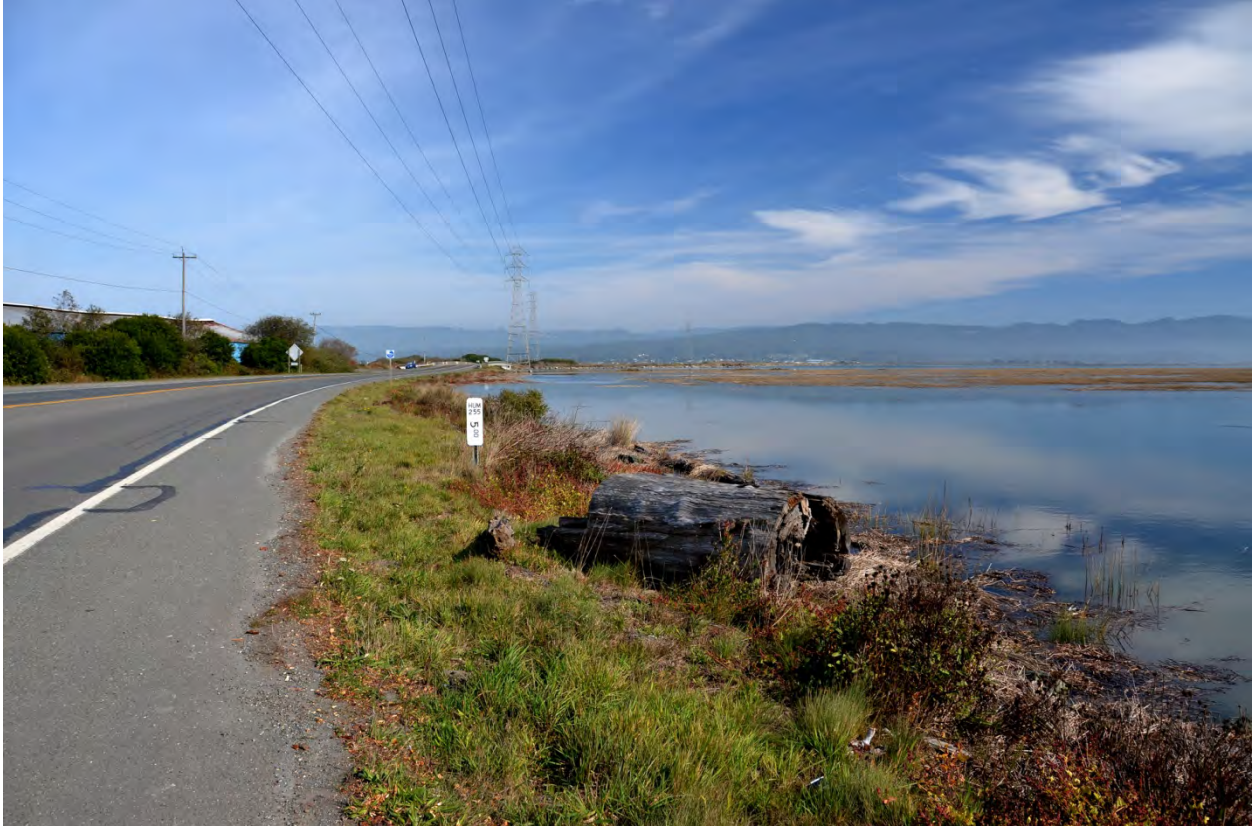
A road is a transportation corridor generally surfaced with asphalt; most often publicly owned and maintained (Figure 13).

Figure 13. Arcata Bay, State Highway 255 is an example of a roadway forming the shoreline on Humboldt Bay.

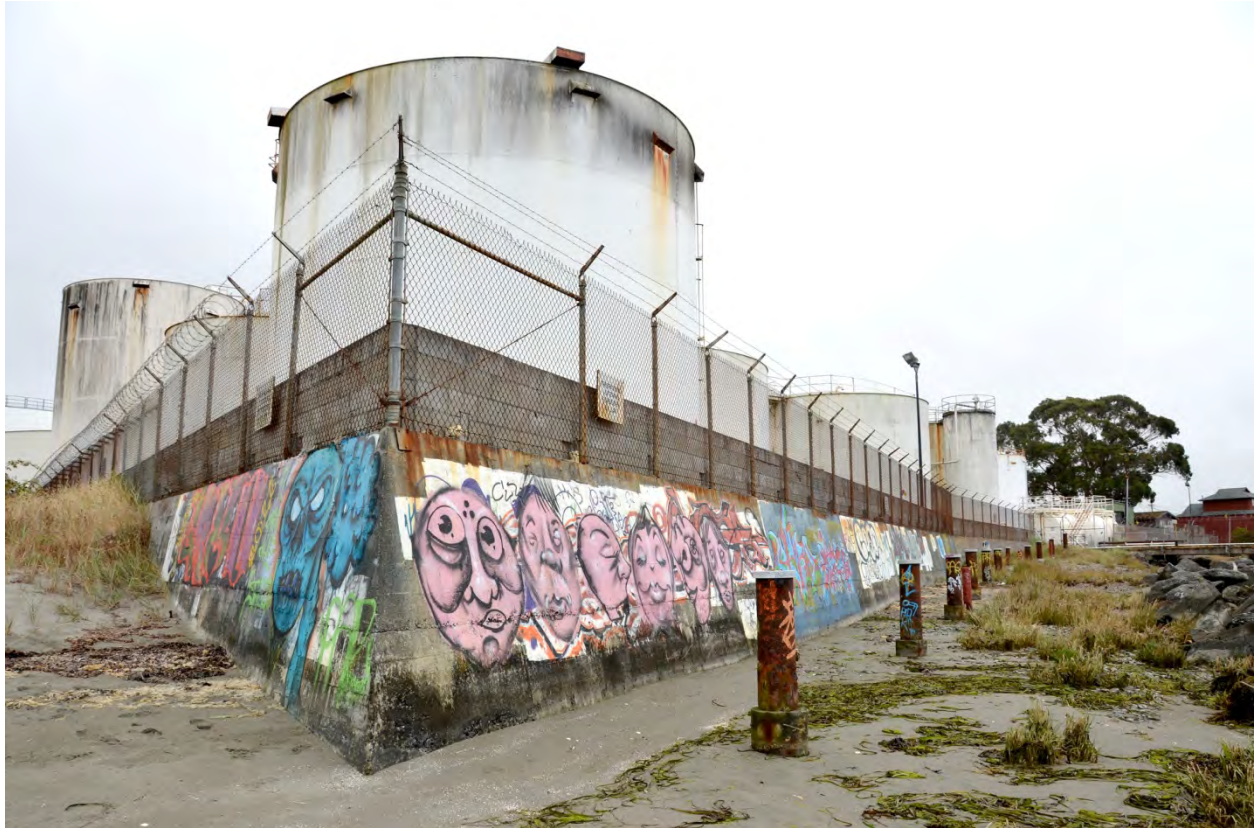
A bulwark is a solid wall generally constructed of wood, concrete, or steel to protect the land behind from wave induced erosion (Figure 14).

Figure 14. Eureka Bay is an example of a concrete bulwark forming the shoreline of Humboldt Bay.

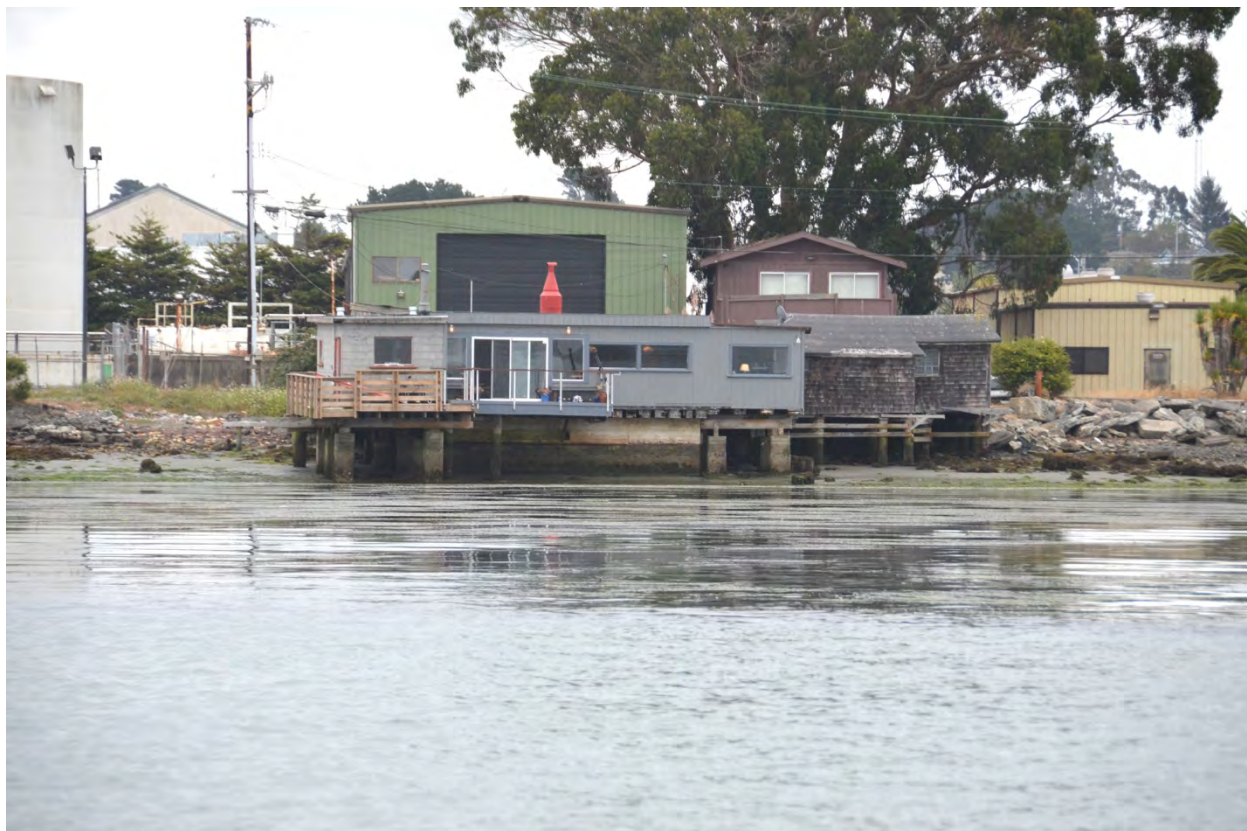
Figure 15. Eureka Bay is an example of a building and its foundation forming the shoreline of Humboldt Bay.

A structure forms the shore which is made up of a building or its foundation (Figure 15).

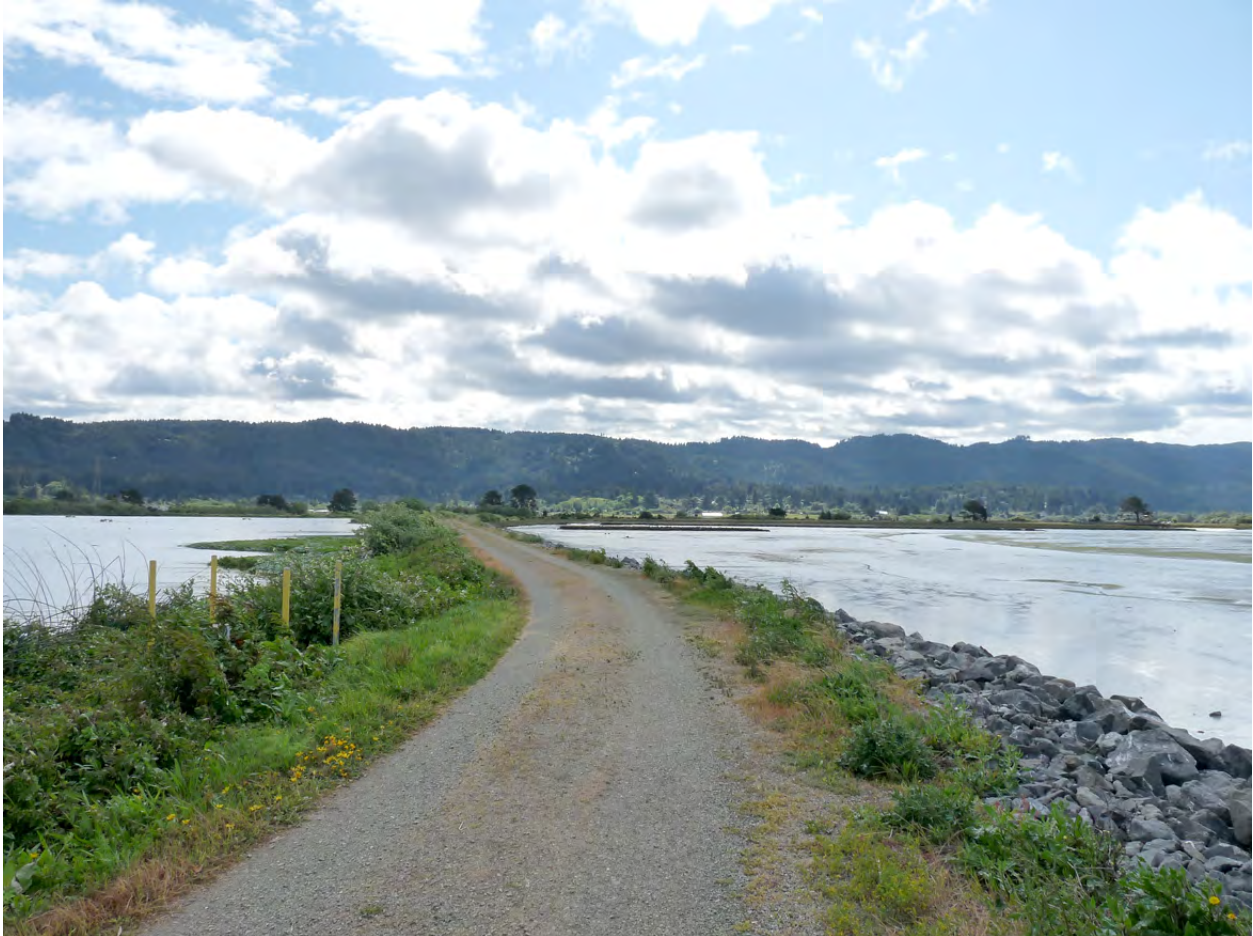
A pond is a type of dike that is constructed to enclose and protect an aquatic environment such as in a waste water treatment facility rather than former inter-tidal lands (Figure 16).

Figure 16. Arcata Bay is an example of a wastewater treatment pond forming the current shoreline of Humboldt Bay.

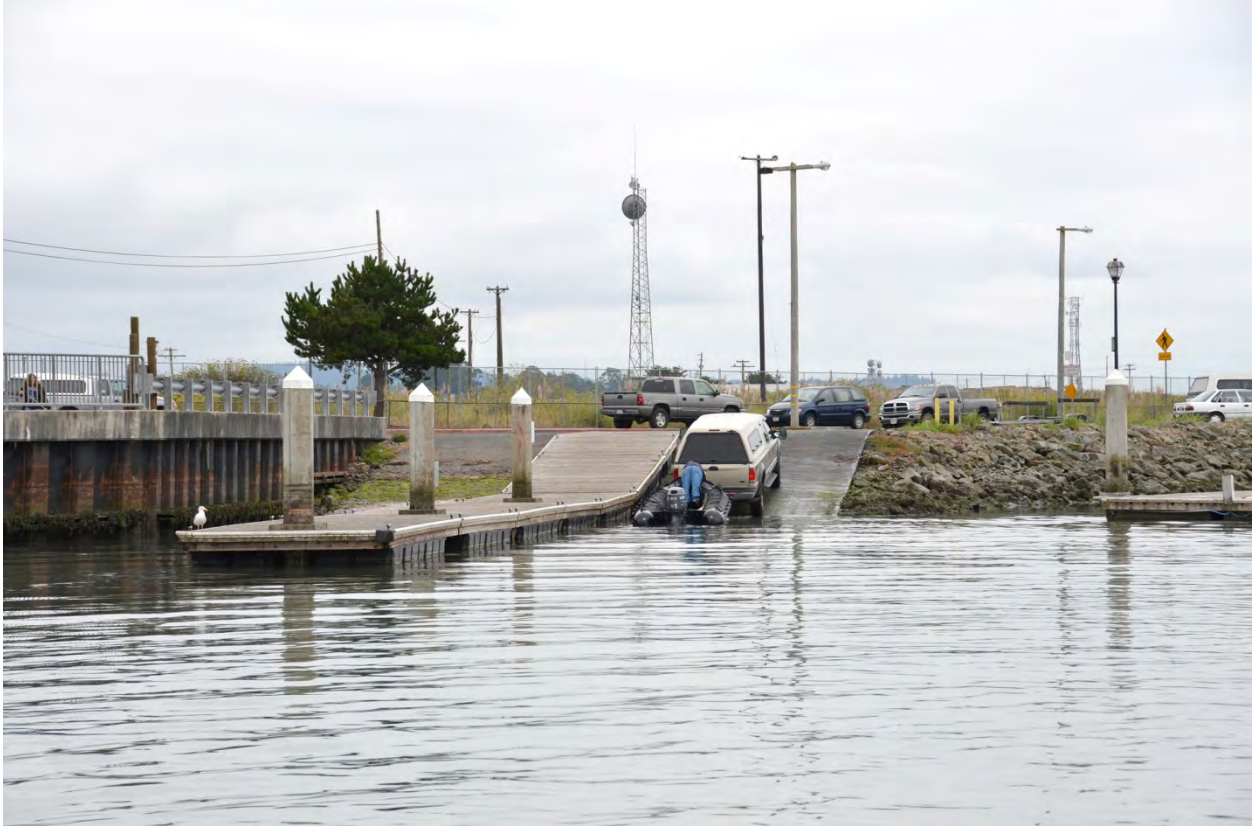
A boat ramp is a structure traversing the shore to allow boats to enter or exit the water (Figure 17).

Figure 17. City of Eureka marina is an example of a boat ramp forming the shoreline of Humboldt Bay.

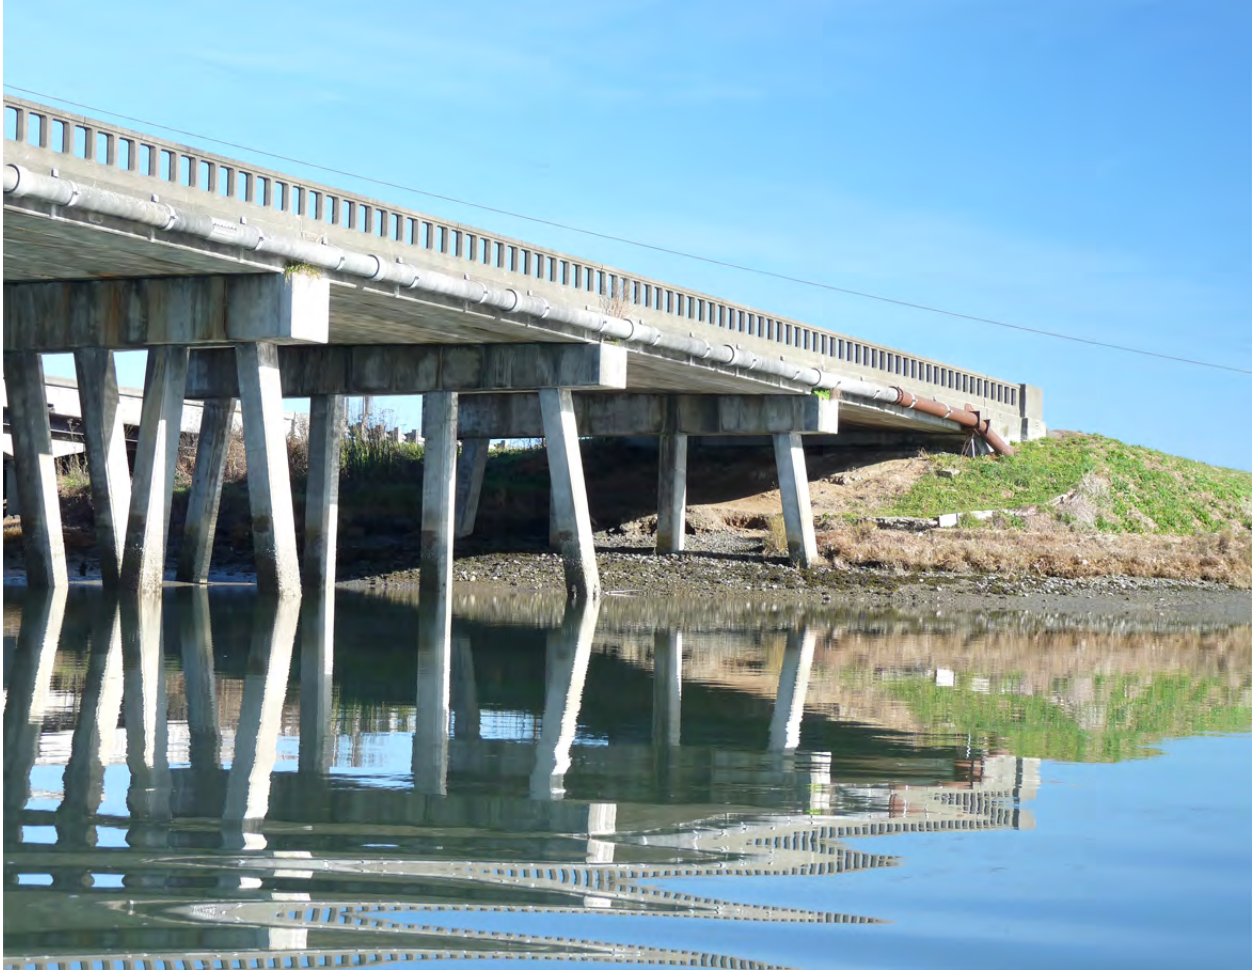
Figure 18. Eureka Slough is an example of a bridge abutment forming the shoreline of Humboldt Bay.

An abutment is a footing structure that supports one end of a bridge spanning a water body (Figure 18).

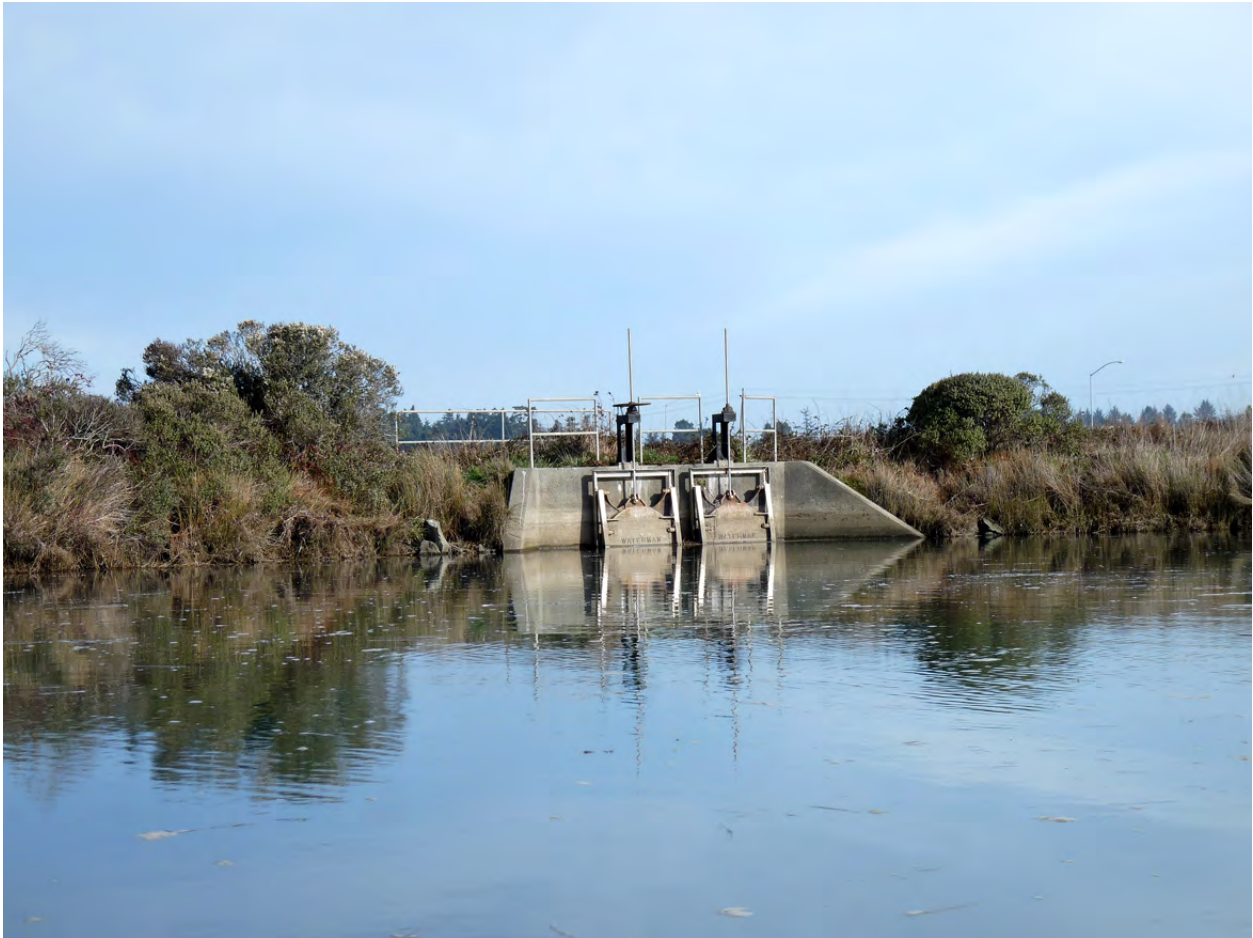
A tidegate is a water control structure, often set in a concrete wall-like structure, which enables the land behind a dike to drain on an ebbing tide but closes to prevent tidal inundation on a rising tide (Figure 19).

Figure 19. Elk River Slough is an example of a tidegate forming the shoreline of Humboldt Bay.

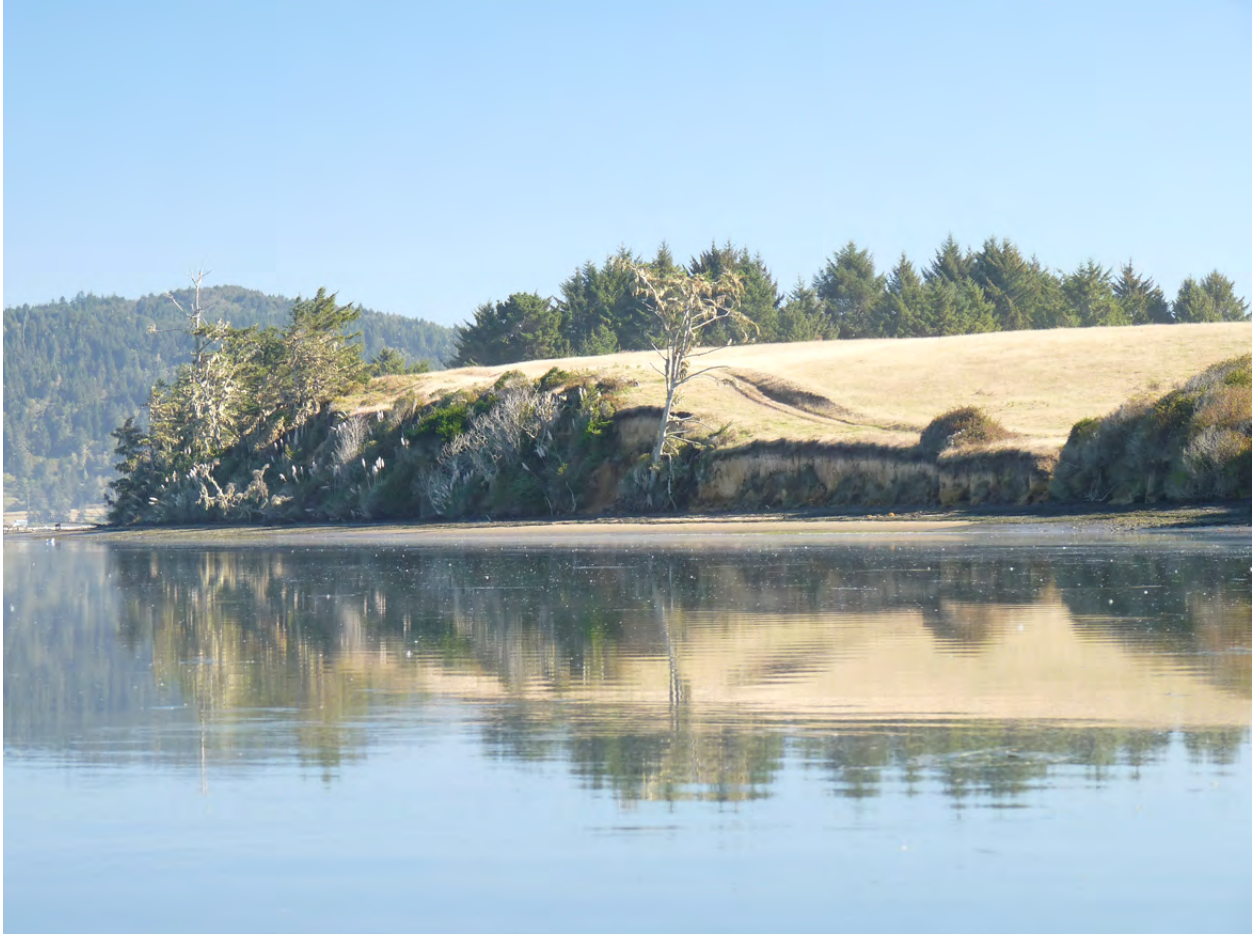
A cliff or bluff is a type of natural shoreline structure which is nearly vertical, formed by wave induced erosion or tectonic activity (Figure 20).

Figure 20. Table Bluff on South Bay is an example of a cliff/bluff forming the shoreline of Humboldt Bay.

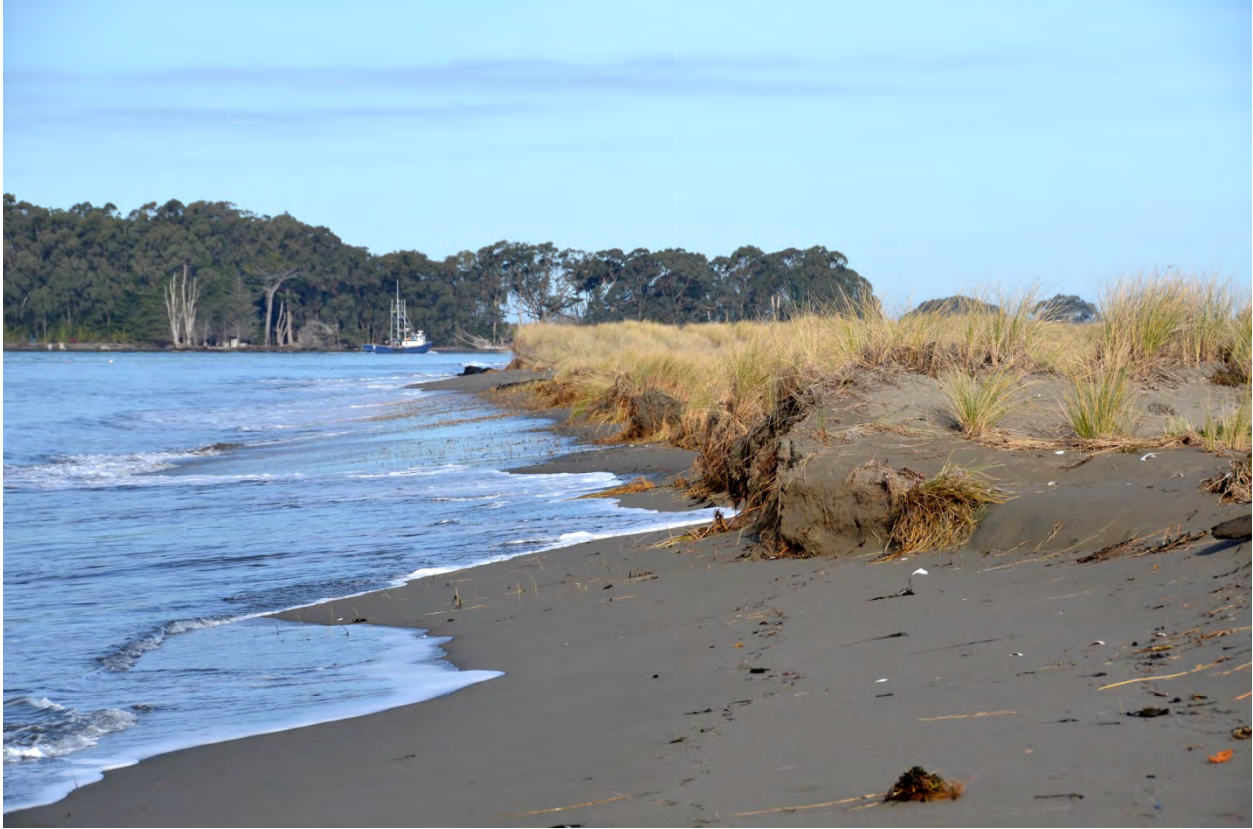
A fore dune is a type of natural shoreline structure made up of a ridge of sand parallel to the shoreline that rises above mean high water elevation and is generally vegetated with plants tolerant of sand and salt spray (Figure 21).

Figure 21. Elk River Spit on Eureka Bay is an example of a fore dune forming the shoreline of Humboldt Bay.
